**BEFORE THE NATIONAL GREEN TRIBUNAL  
SOUTHERN ZONE, CHENNAI  
OA No. 180 of 2023 (SZ)**

**IN THE MATTER OF :**

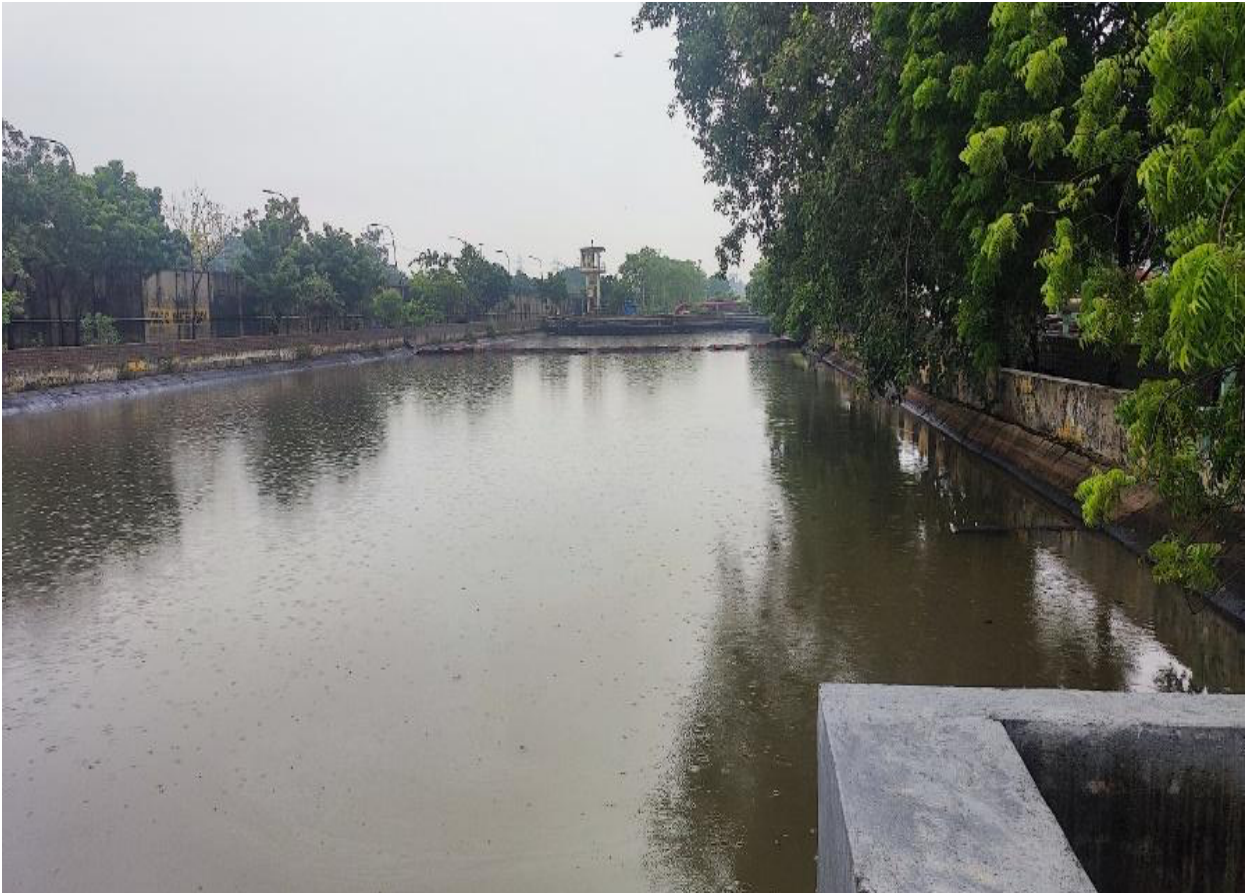
- Tank integrity study using Ground Penetrating Radar revealed that the tank integrity in CPCL is good. Among the list of tanks furnished by CPCL, Tanks were chosen on random basis for the GPR study. GPR scans of Tanks 106, 119, 121, 801, and 802 revealed no structural defects such as cracks or significant corrosion. The tanks are fit for continued service.
- The GPR study on CPCL tanks did not reveal any integrity issues. The findings suggest that these tanks are fit for continued service.
- Detailed report of tank integrity is furnished as Annexure-1

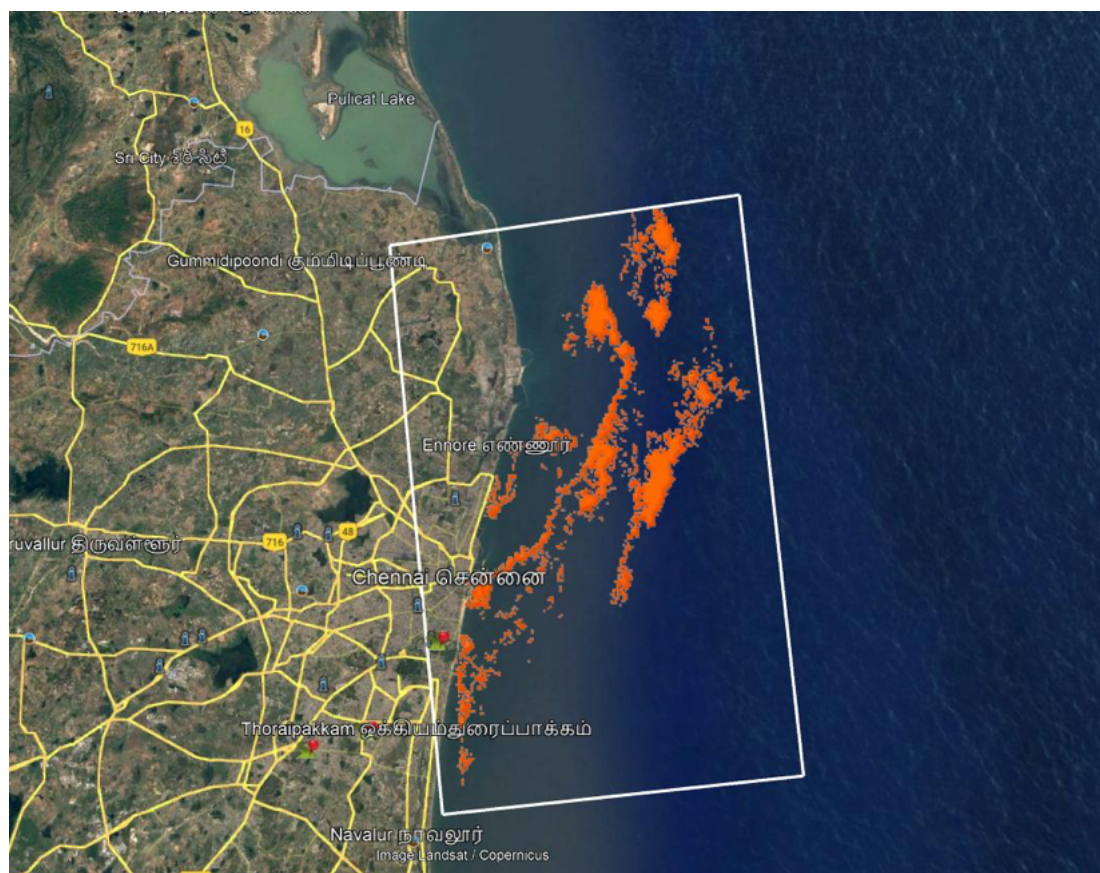
Figure 3: Oil Spill detected on January 29<sup>th</sup>, 2017

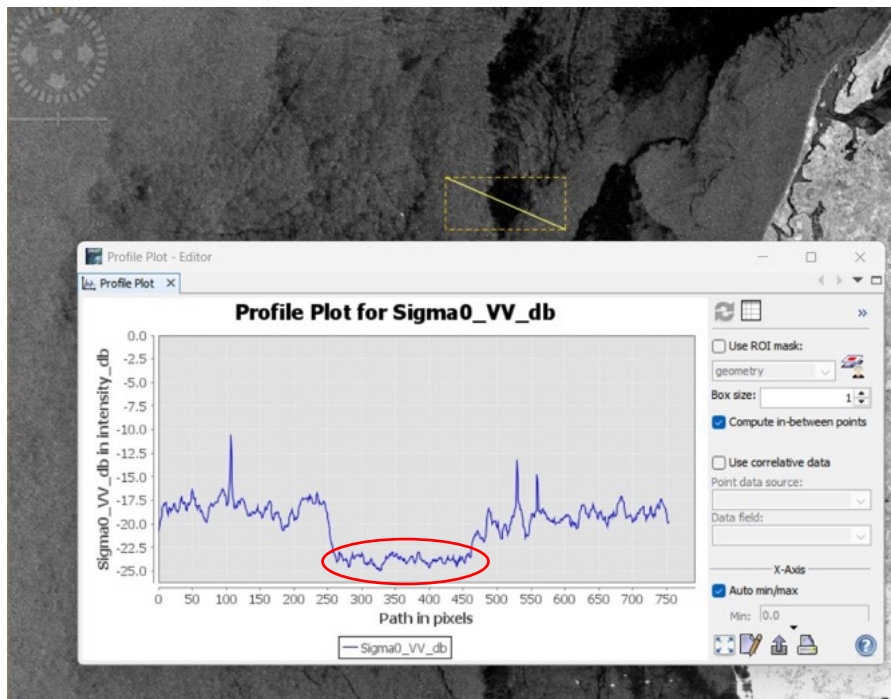
*Figure 4: Backscatter Profile plot of Oil Slick (2017)*

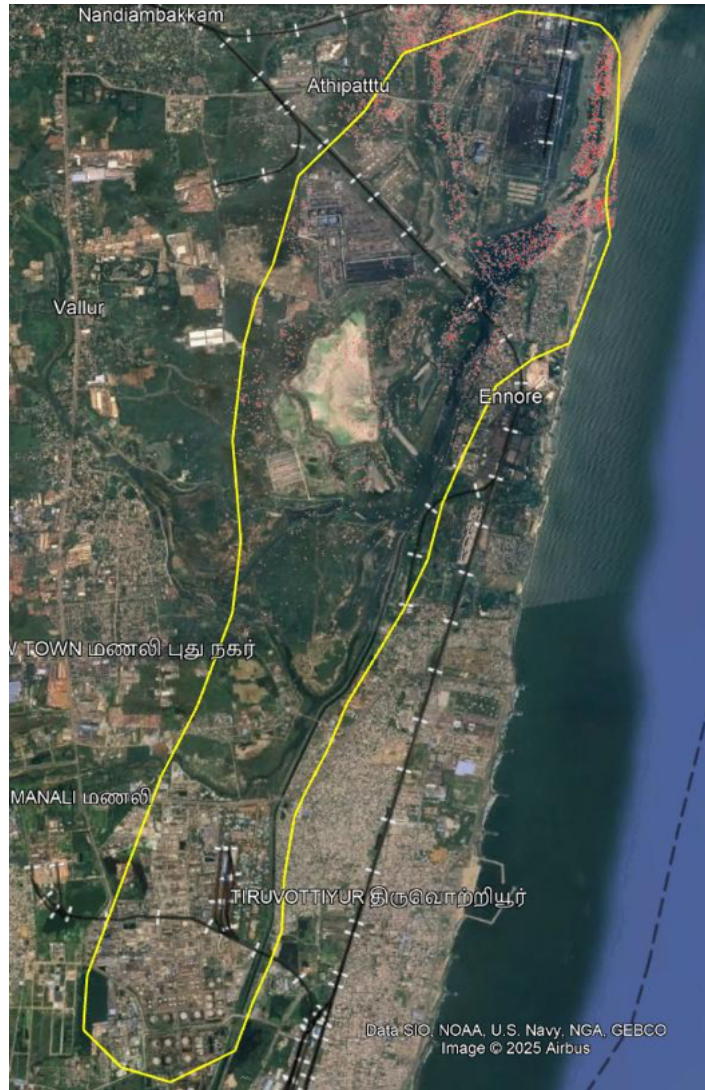
*Figure 5: Oil Spill Detected on December 6<sup>th</sup>, 2023*

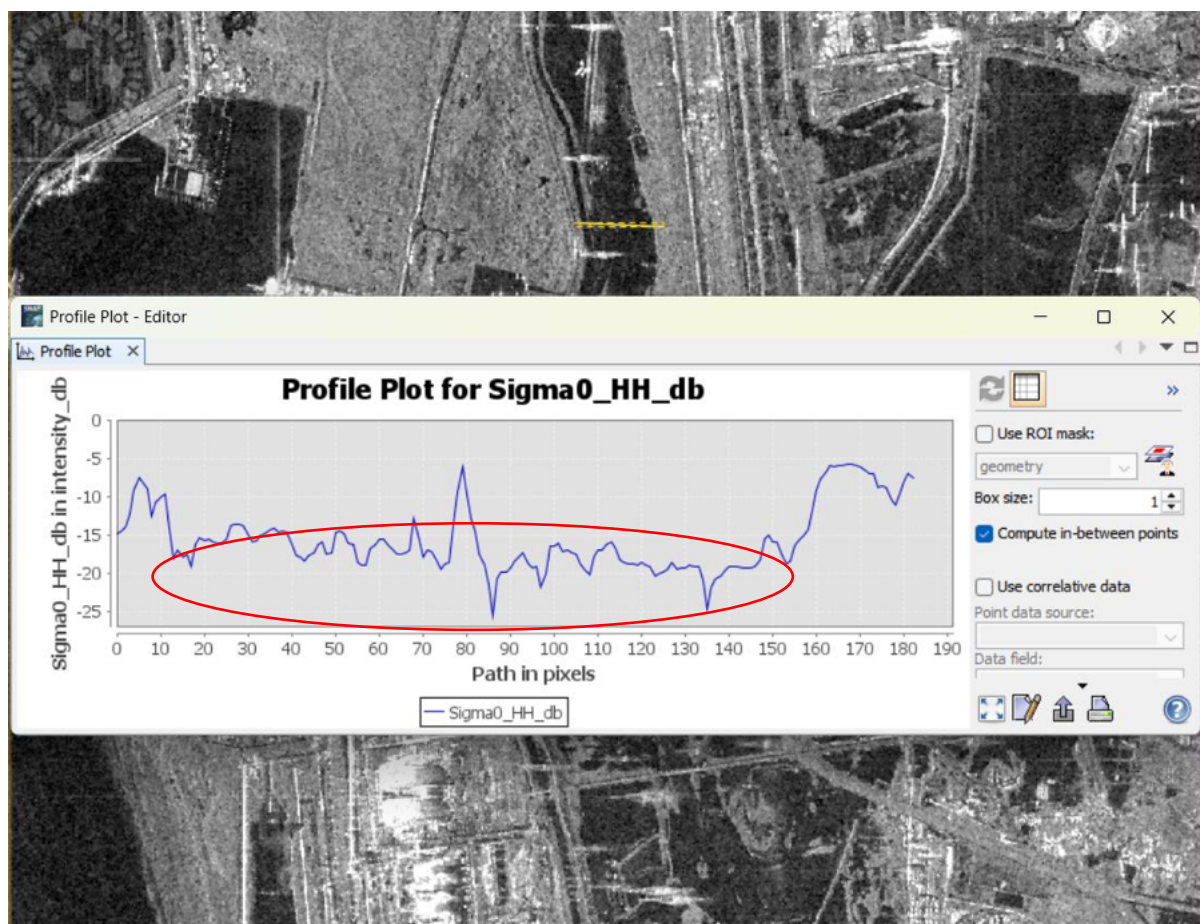
*Figure 6: Backscatter profile plot on oil slick (2023)*

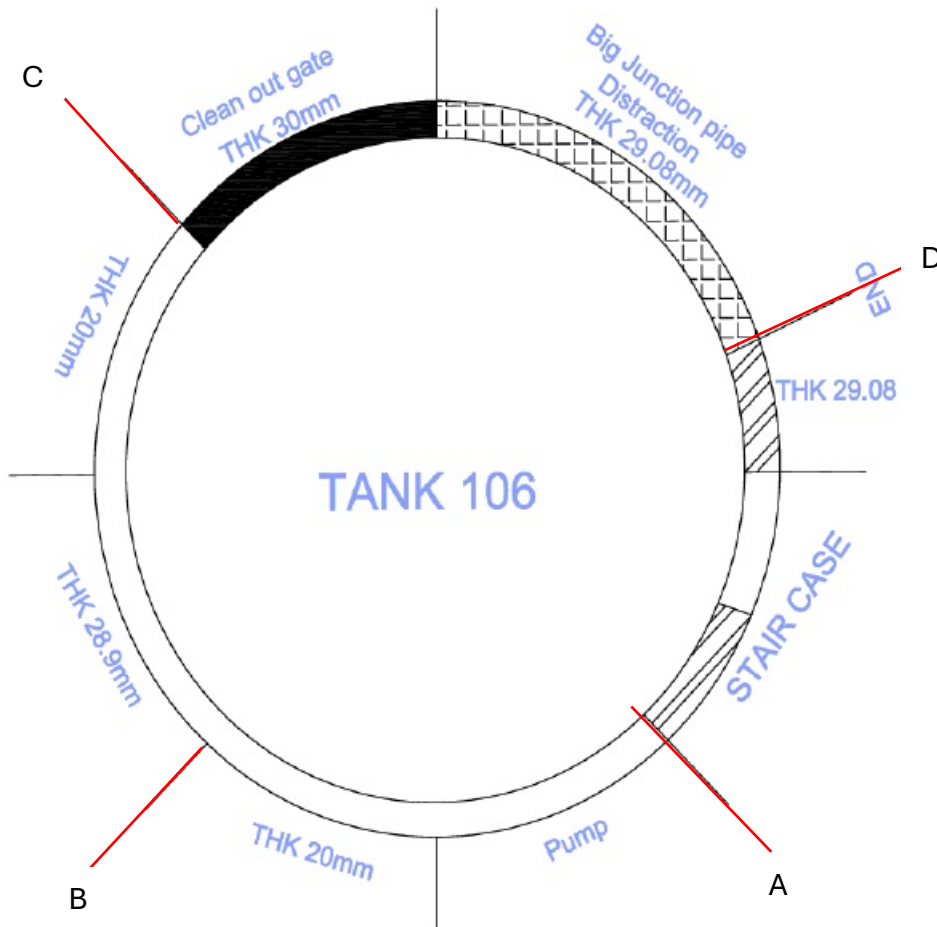
Tank No	Tank Dia, m	Tank ht, m	Thickness, mm	Nos. of shell courses	Previous Internal inspection	JOB DONE
106	79	14.4	30.0/24.0/22.0/18.0/14.0/12.0/12.0/12.0	8	Sep-23	M&I Completed in Sep-2023 Bottom, Annular & Roof top plate (Partial) Replacement was done. Tank Internal painting also done.

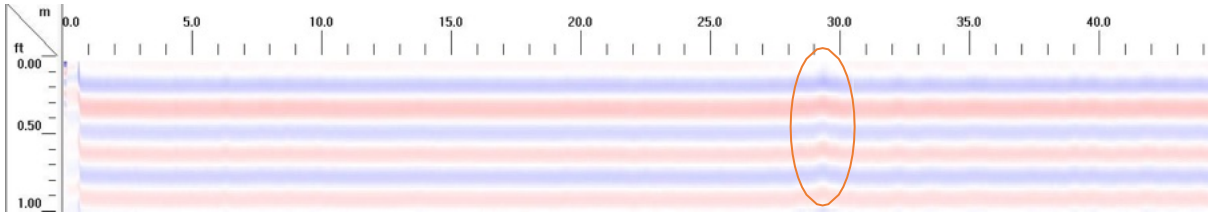
Figure 8, shows the GPR reading between points A-B, and red circle indicates joint welding which is intact.

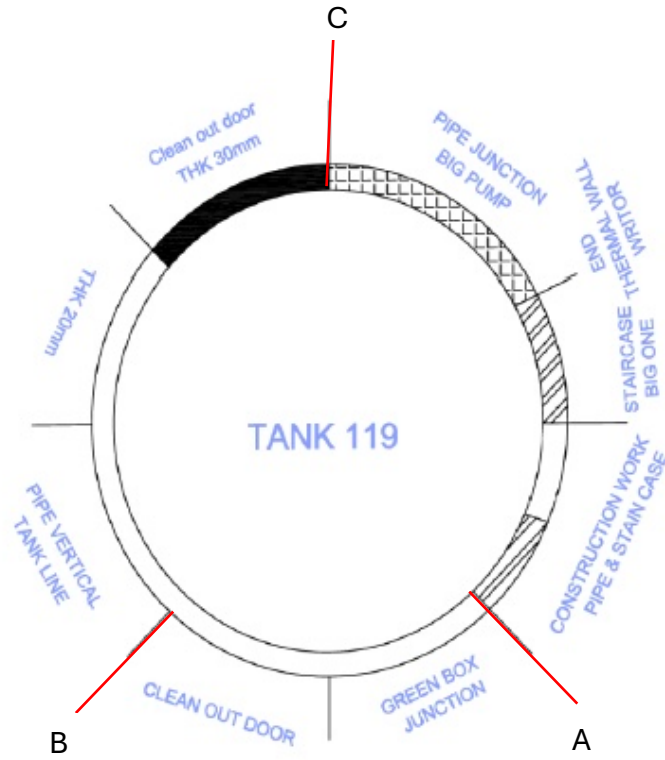
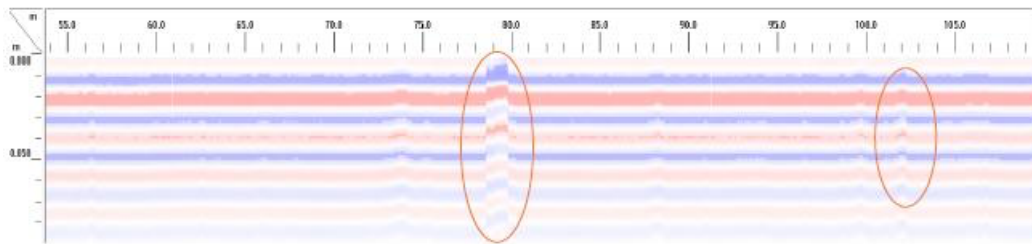
Figure 12(a), shows the GPR reading between points A-B, and red circles indicates joint welding which is intact.

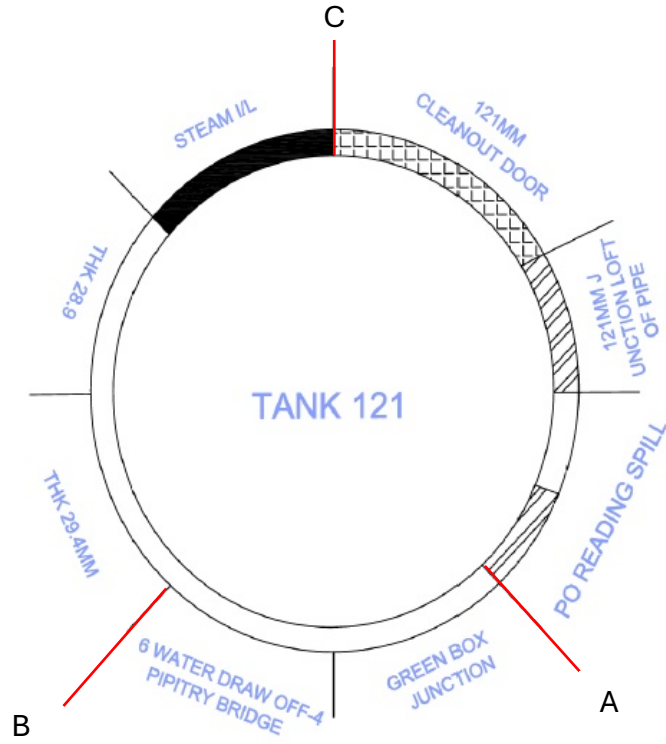
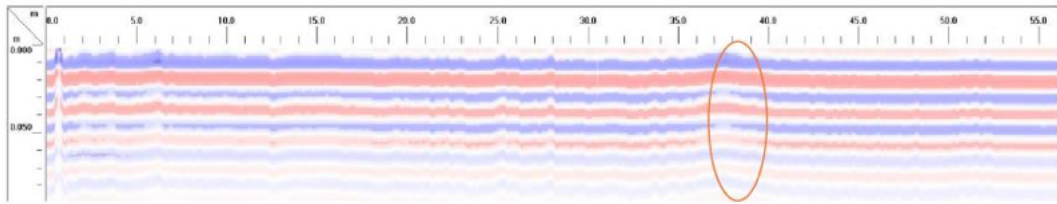
Figure 14(a), shows the GPR reading between points A-B, and red circle indicates joint welding which is intact.

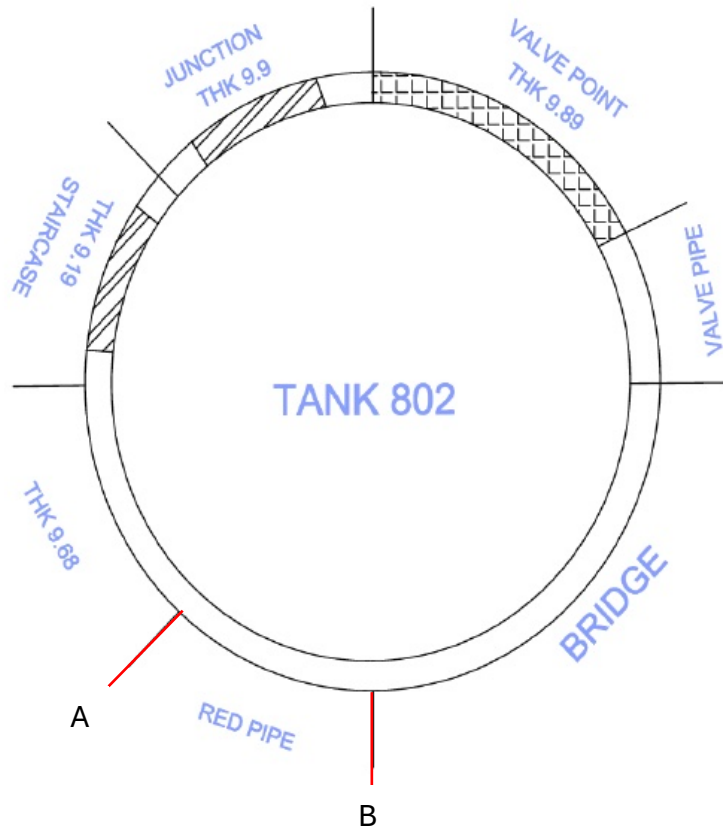
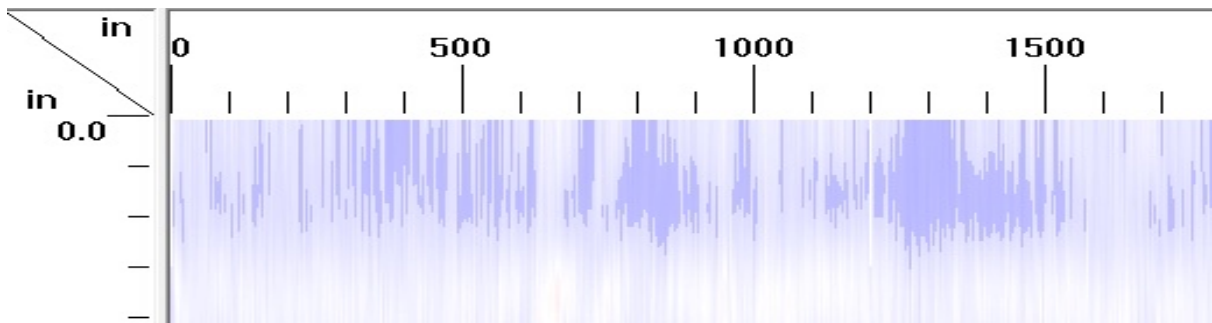
Figure 15 shows the GPR reading between points A-B

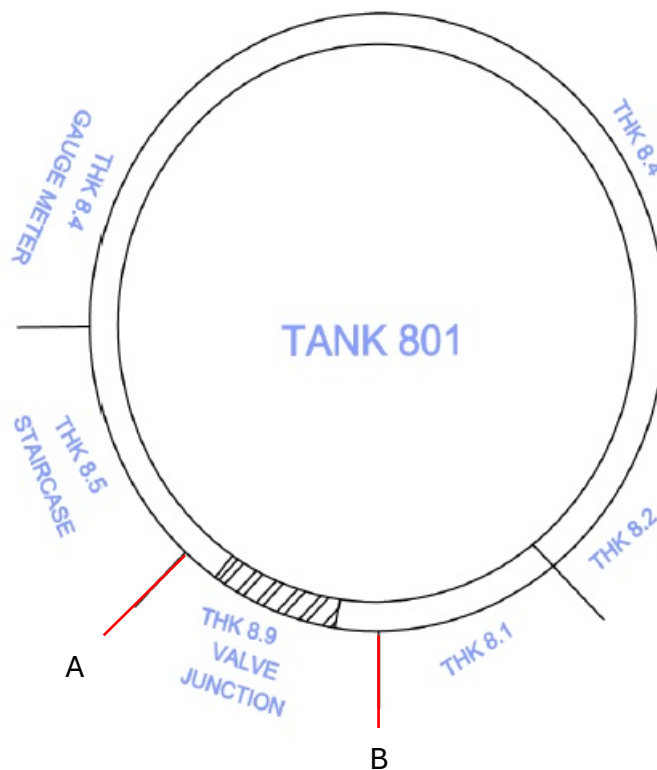
Tank No	Tank Dia, m	Tank ht, m	Thickness, mm	Nos.of shell courses	Previous Internal inspection	JOB DONE
801	16.8	7.2	8.0 / 8.0 / 8.0 / 8.0	4	Sep-22	M&I completed on Sep-2022. Roof complete replacement. Shel external patch repair & internal painting completed.

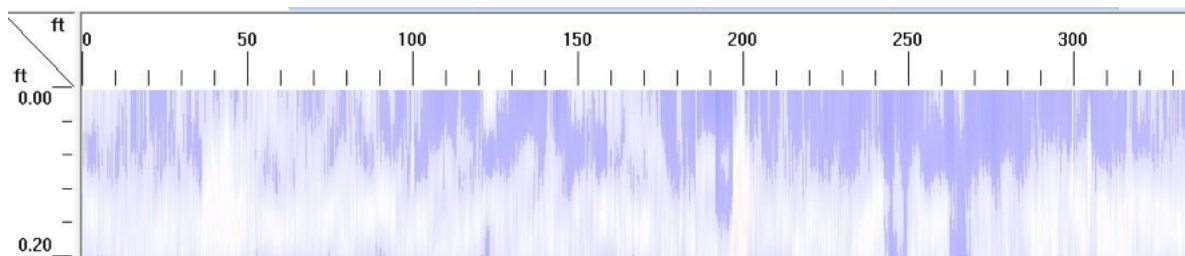
*Figure 17 shows the GPR reading between points A-B*

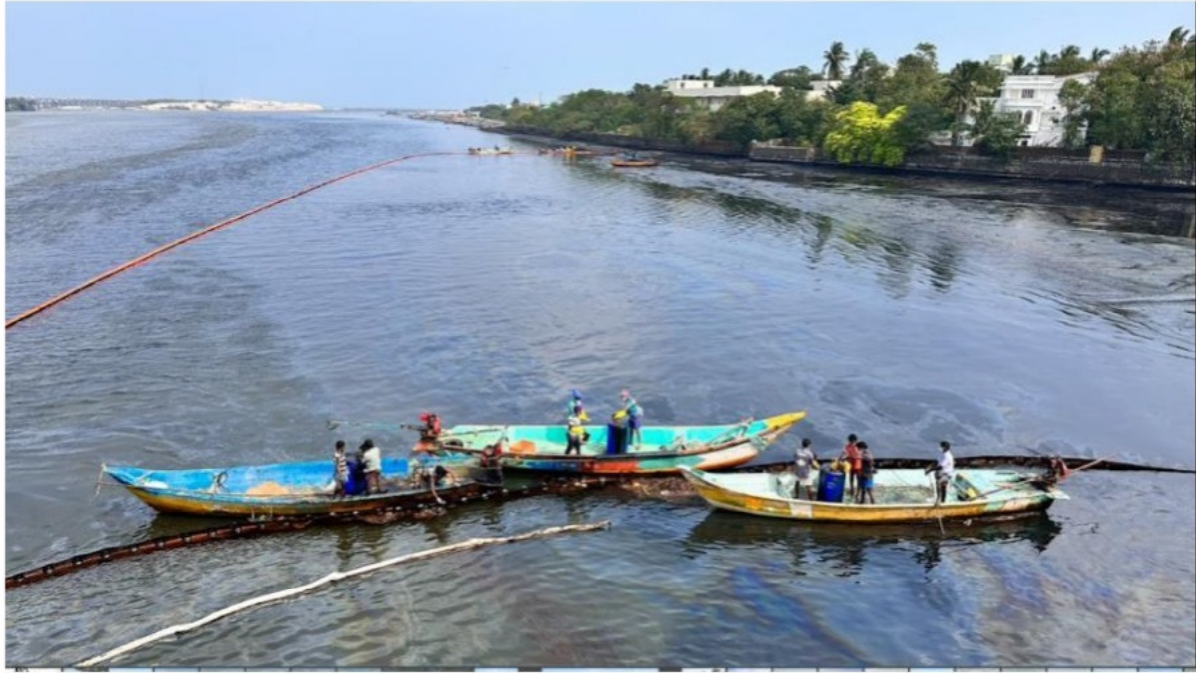
**Figure 1:** Oil spread near Ennore railway bridge

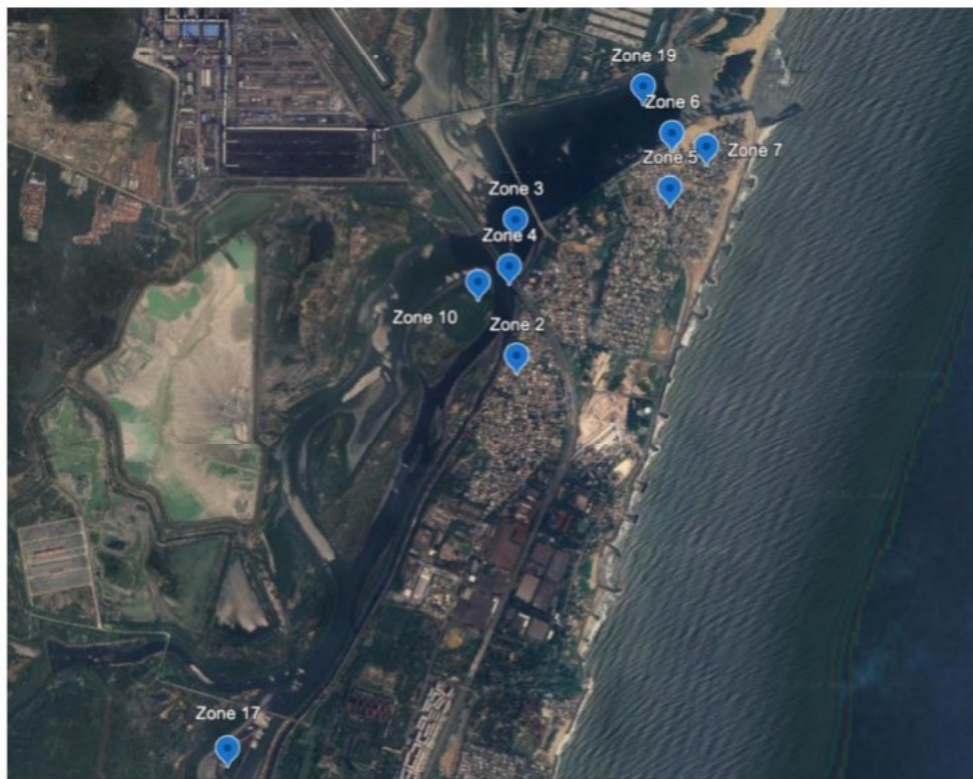
**Figure 4:** Contamination Zones from midstream of Buckingham Canal to Ennore Creek

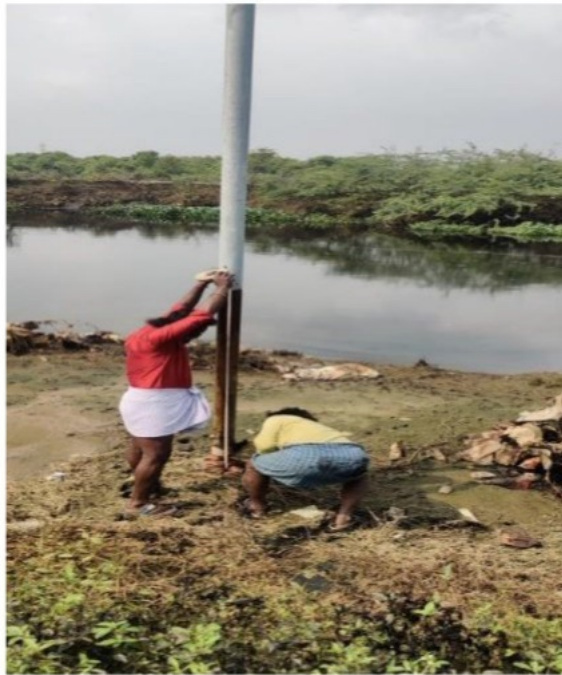
**Figure 5:** Highest oil mixed water level 7.5 feet above normal water level during the cyclone

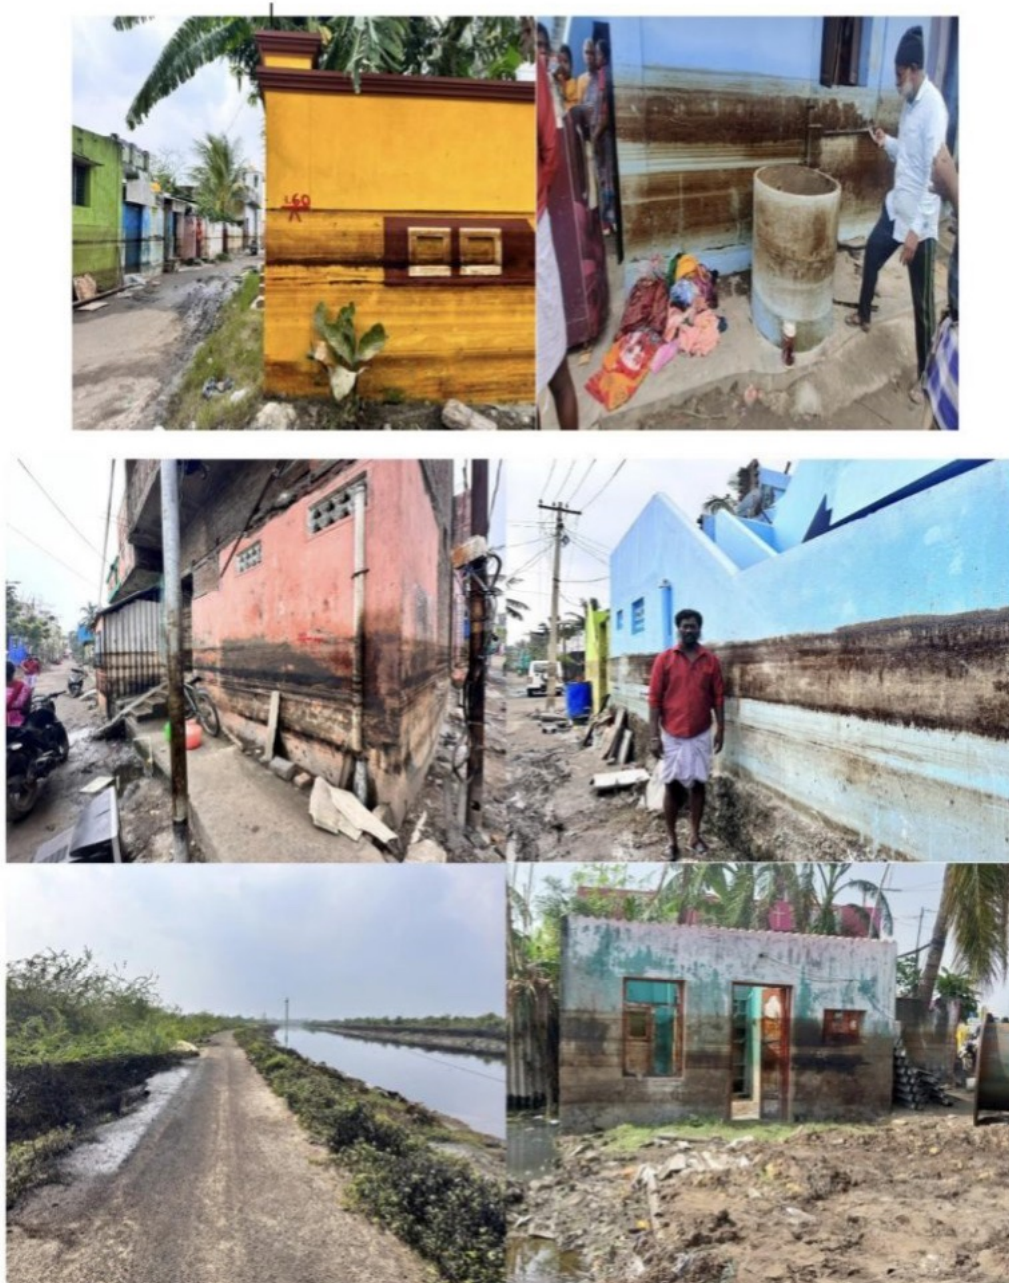
**Figure 7:** Oil marks observed in the residential localities of Ernavoor.

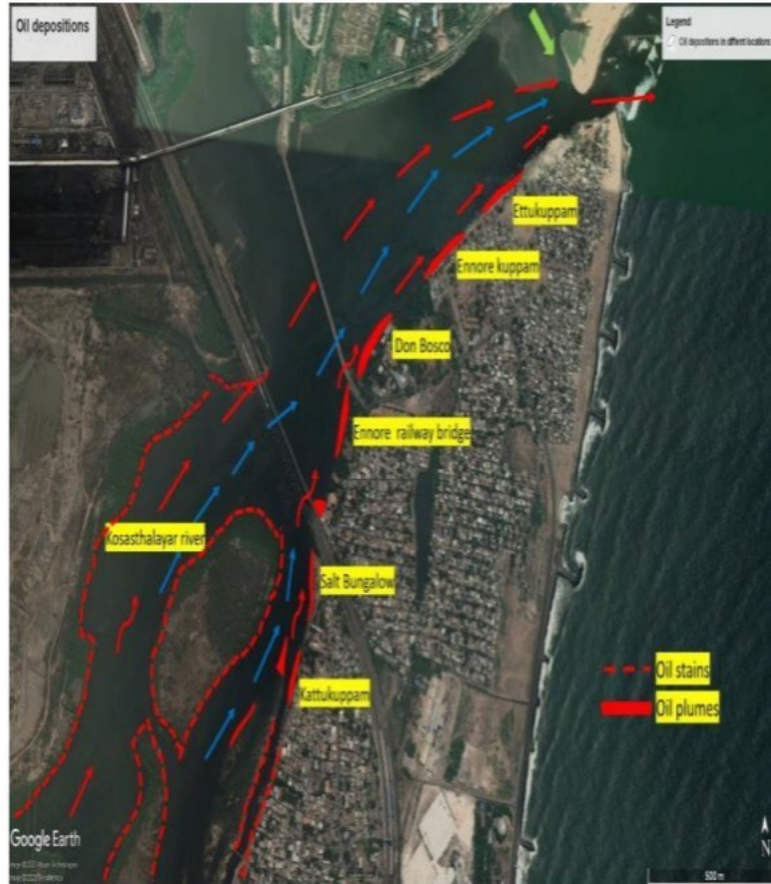
**Figure 8:** Assessment Region 1 - Downstream from ETPS to Creek Area

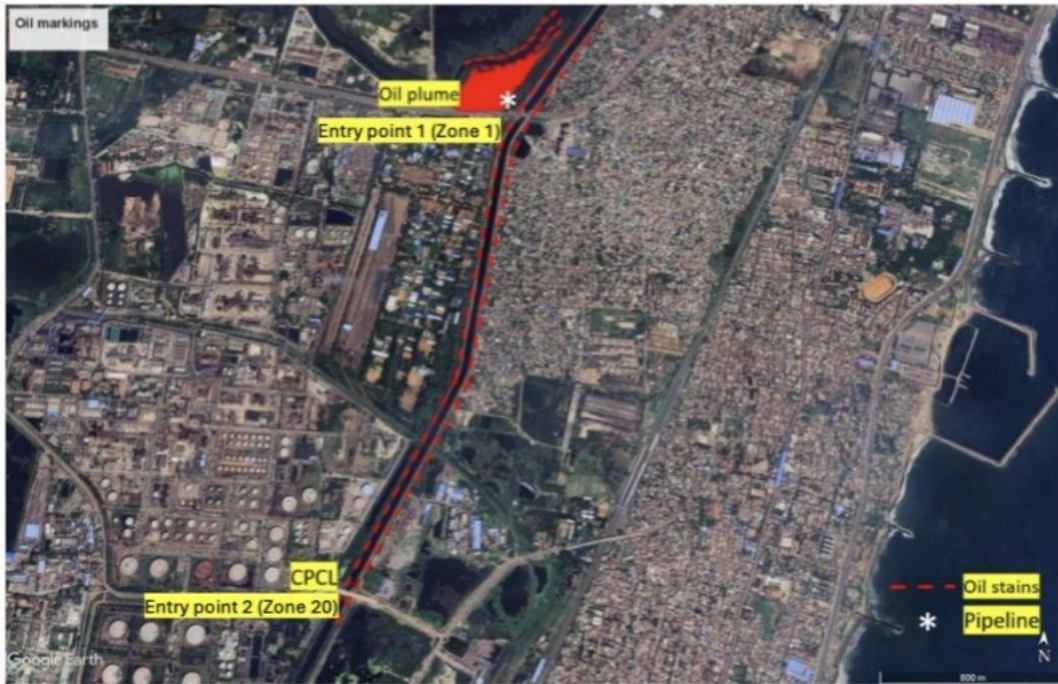
**Figure 10:** Assessment Region 3 - Upstream of B Canal from Manali High Road to Kodungaiyur showing the entry point of oil into the Buckingham Canal and Kosasthalaiyar River

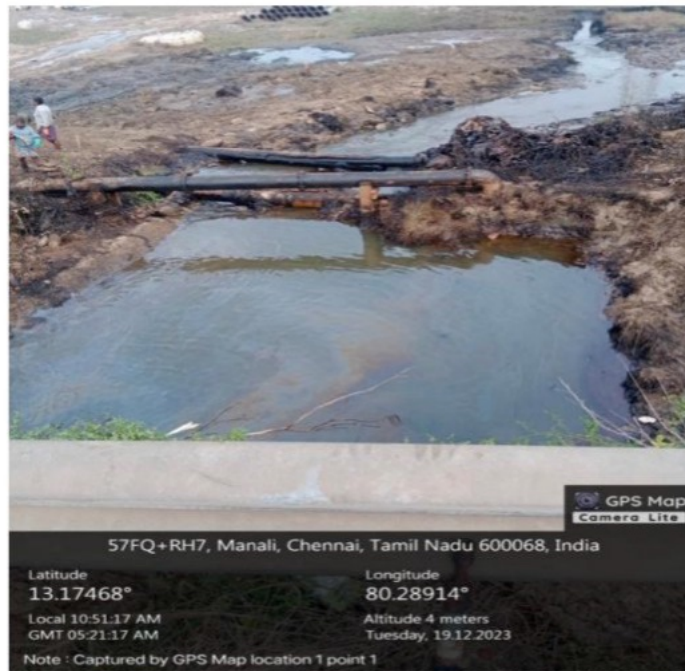
**Figure 12:** Close up view of Zone 1

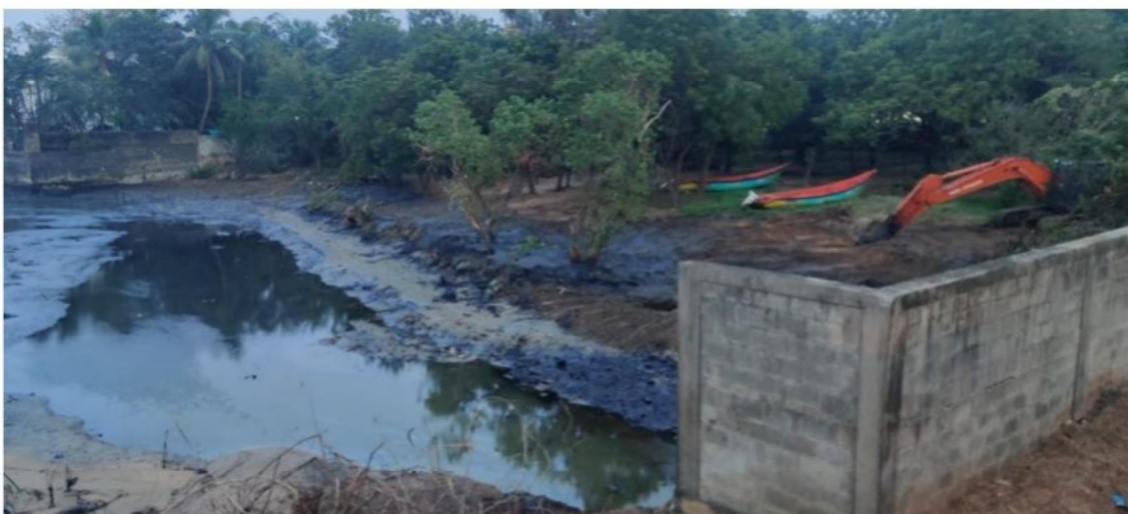
**Figure 13:** Earth moving machinery at the oil spill site

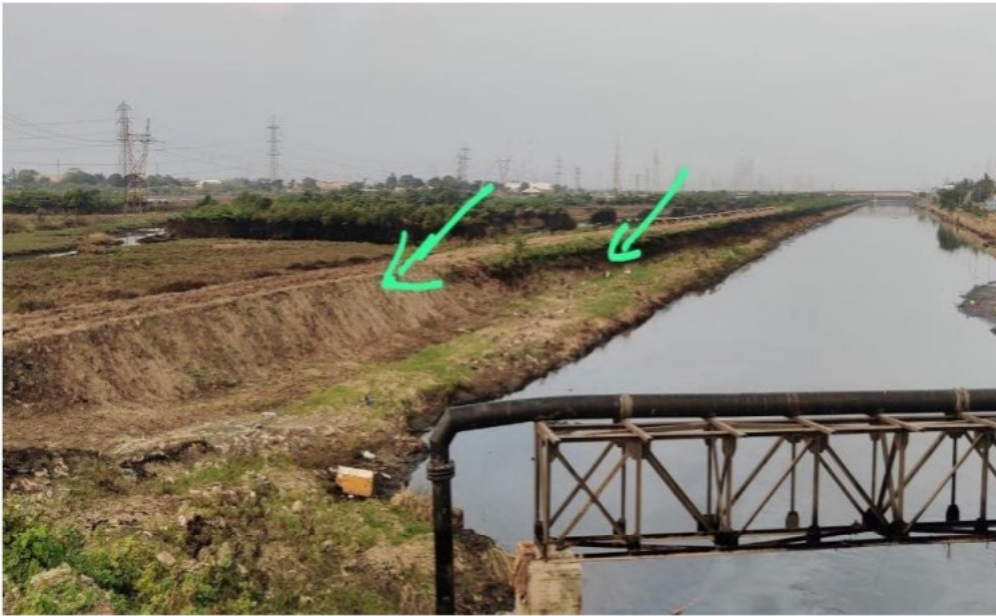
**Figure 14:** B canal possibly breached and oil stain covered.

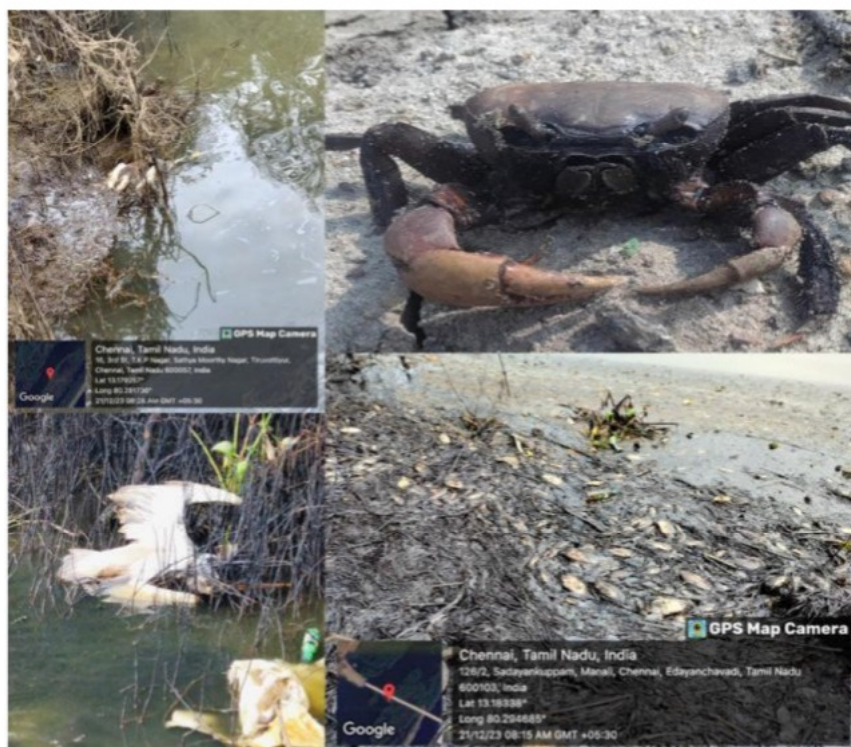
**Figure 16:** Dead birds, crabs, and fishes found in the contaminated site

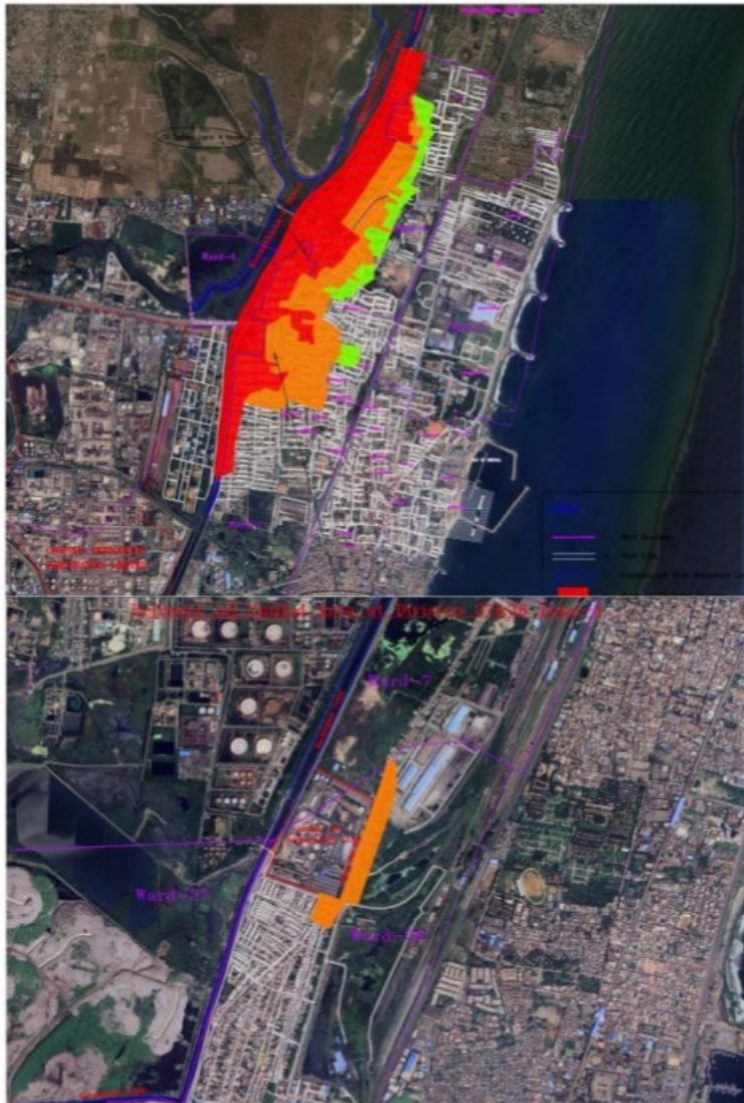
**Figure 32:** Close up view of the affected residential and industrial areas

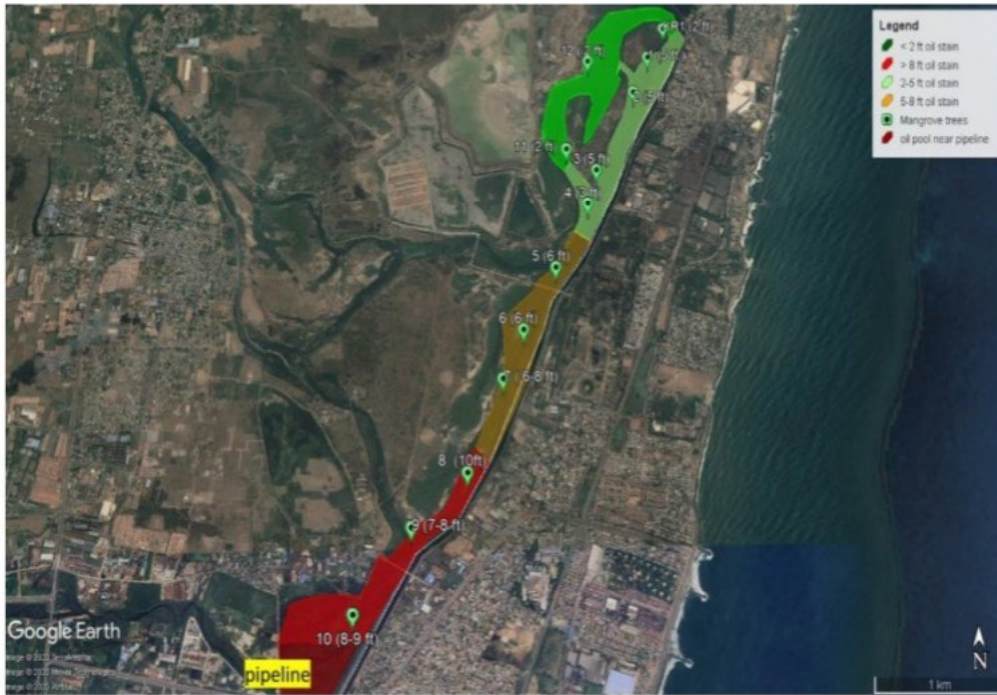
**Figure 33:** Classifying the K river with the height of the oil mark in different stretches

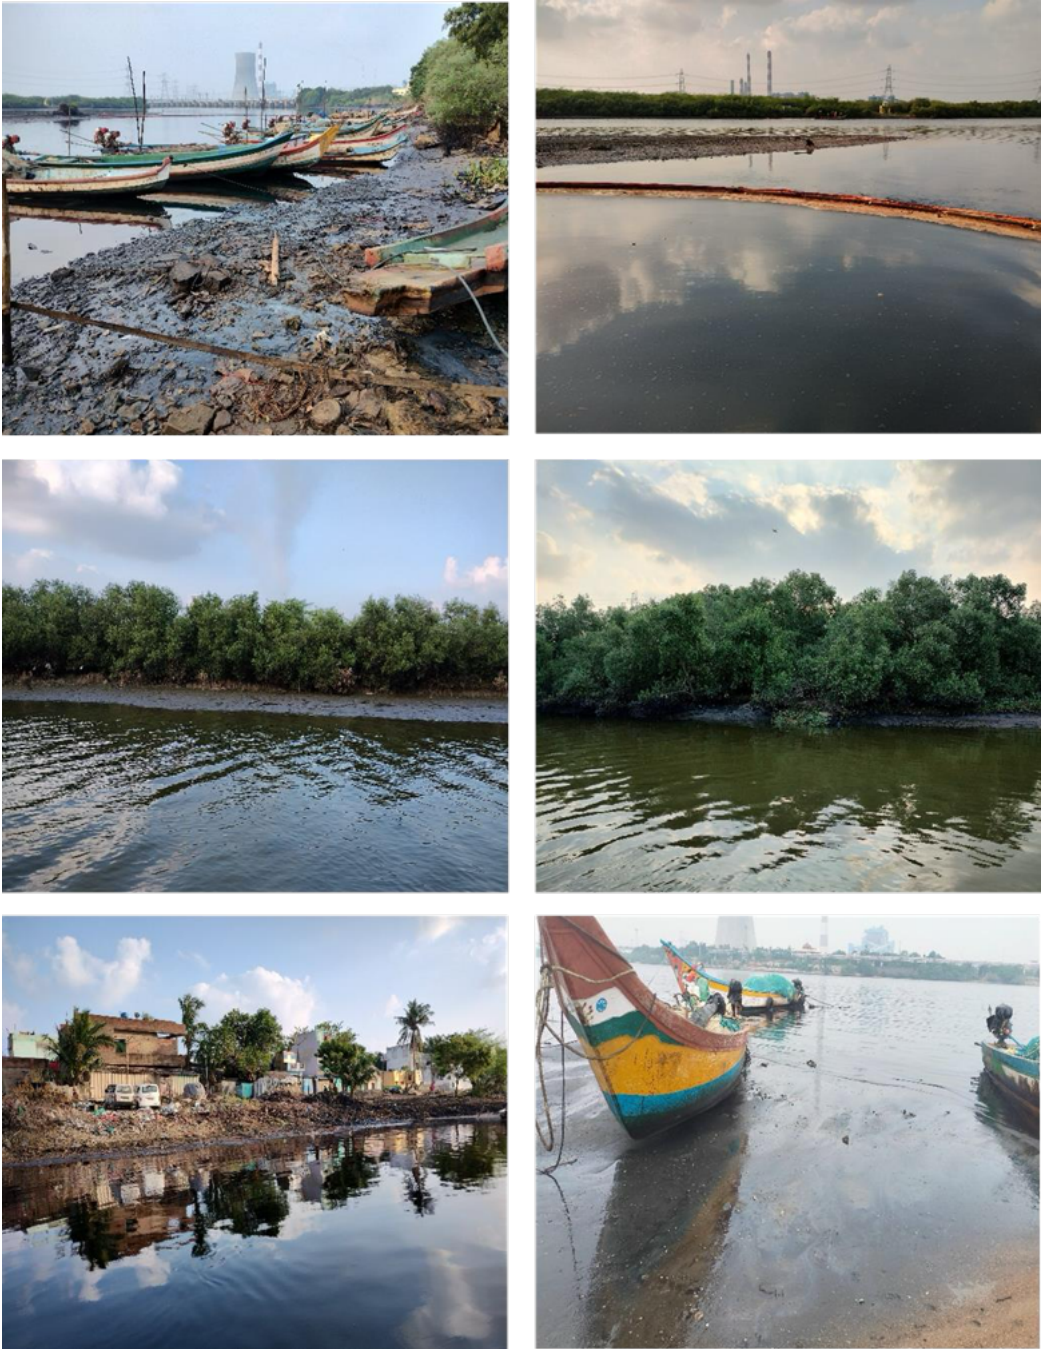
Figure 1. Field photographs taken on 18<sup>th</sup> December, 2023.

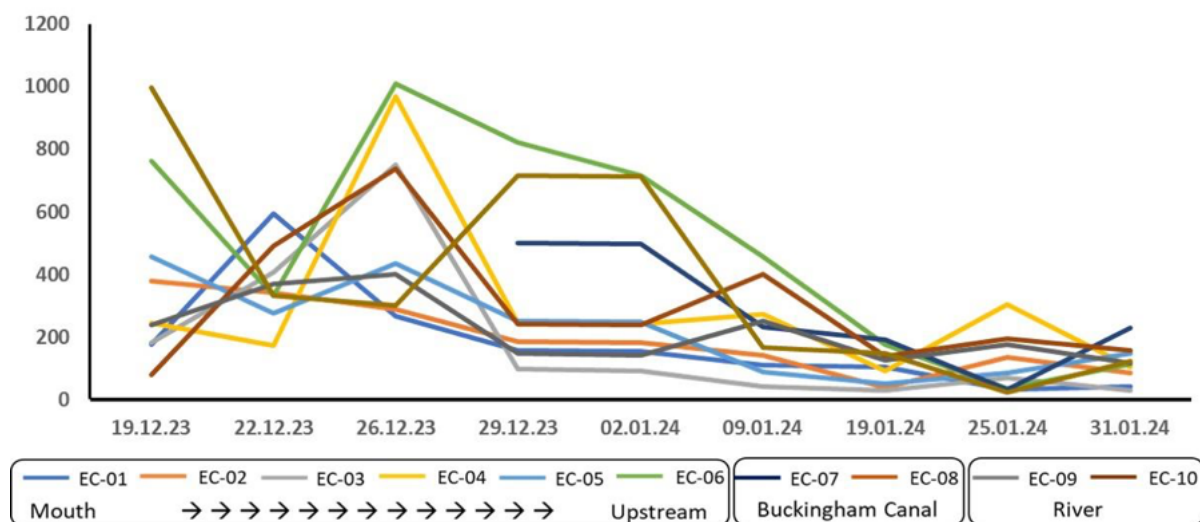
**Figure 7.** Distribution of Total Petroleum Hydrocarbons (µg/l) in the surface waters.

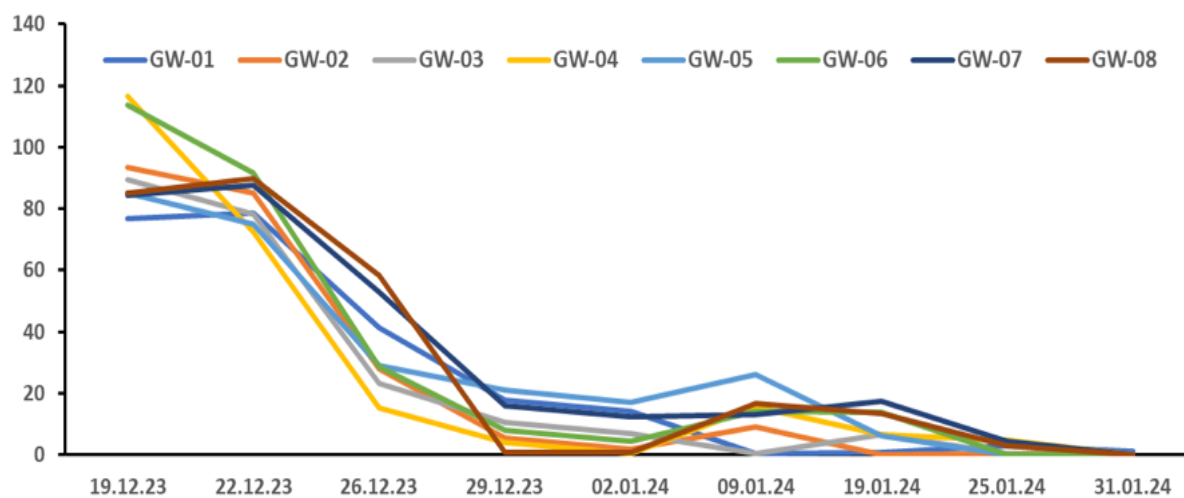
**Figure 8.** Distribution of Total Petroleum Hydrocarbons (µg/l) in ground waters.

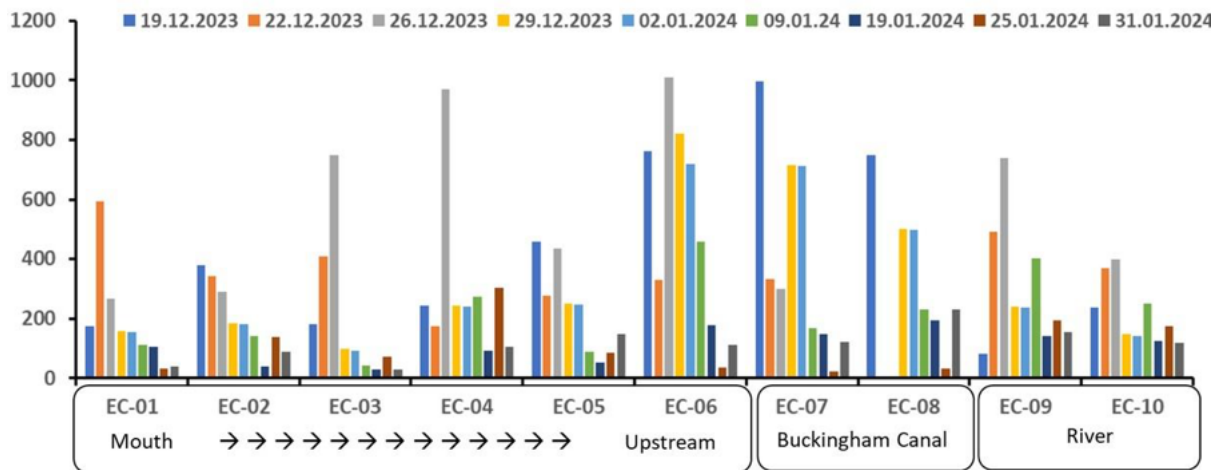
**Figure 9.** Distribution of Total Petroleum Hydrocarbons ( $\mu\text{g/g}$ ) in the sediments.

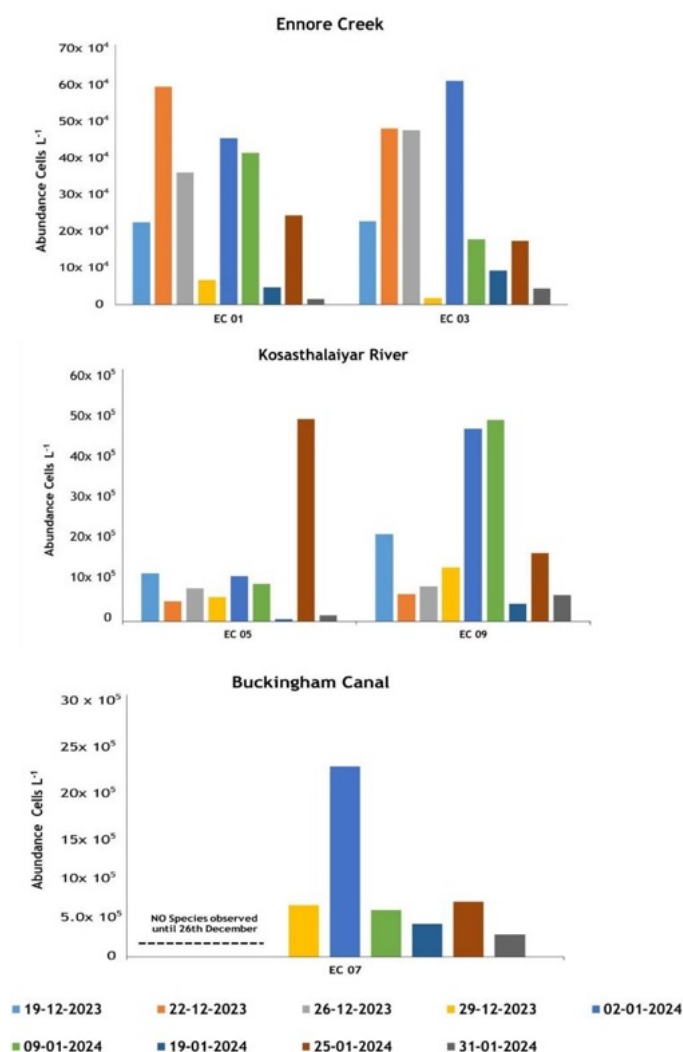
**Figure 10.** Temporal and spatial variation in phytoplankton abundance.
