**BEFORE THE NATIONAL GREEN TRIBUNAL  
SOUTHERN ZONE, CHENNAI  
OA No. 180 of 2023 (SZ)**

**IN THE MATTER OF :**

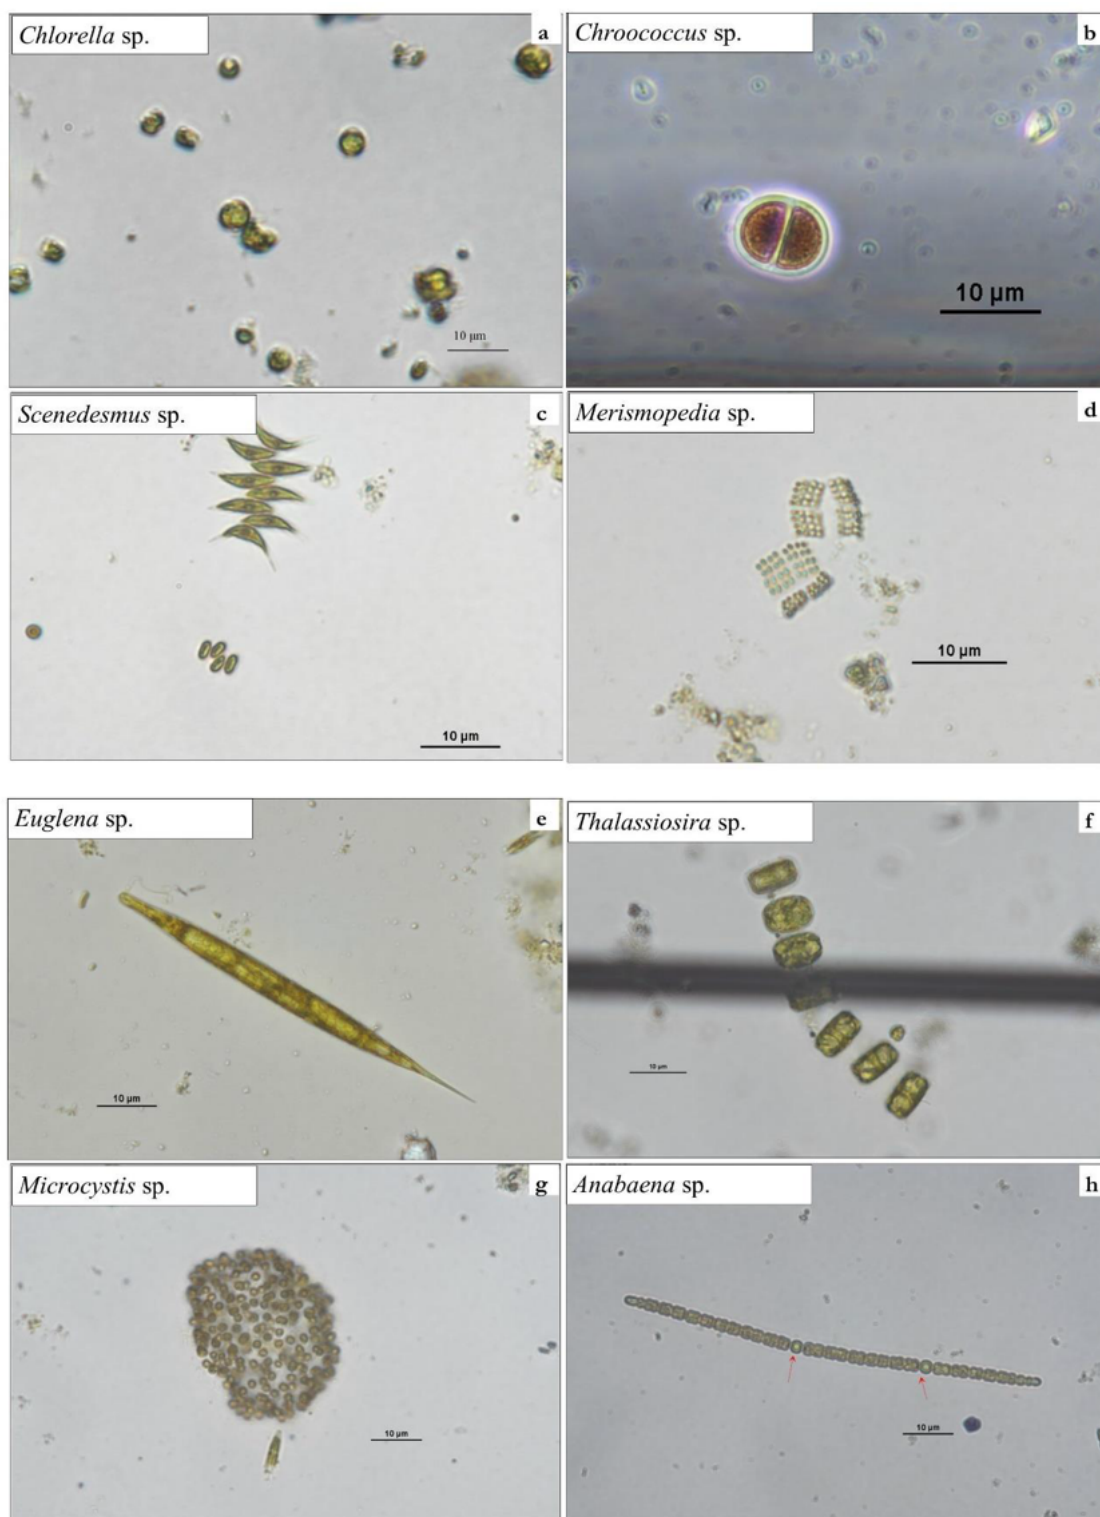
**Figure 11.** Dominant freshwater phytoplankton species (a-h) observed.

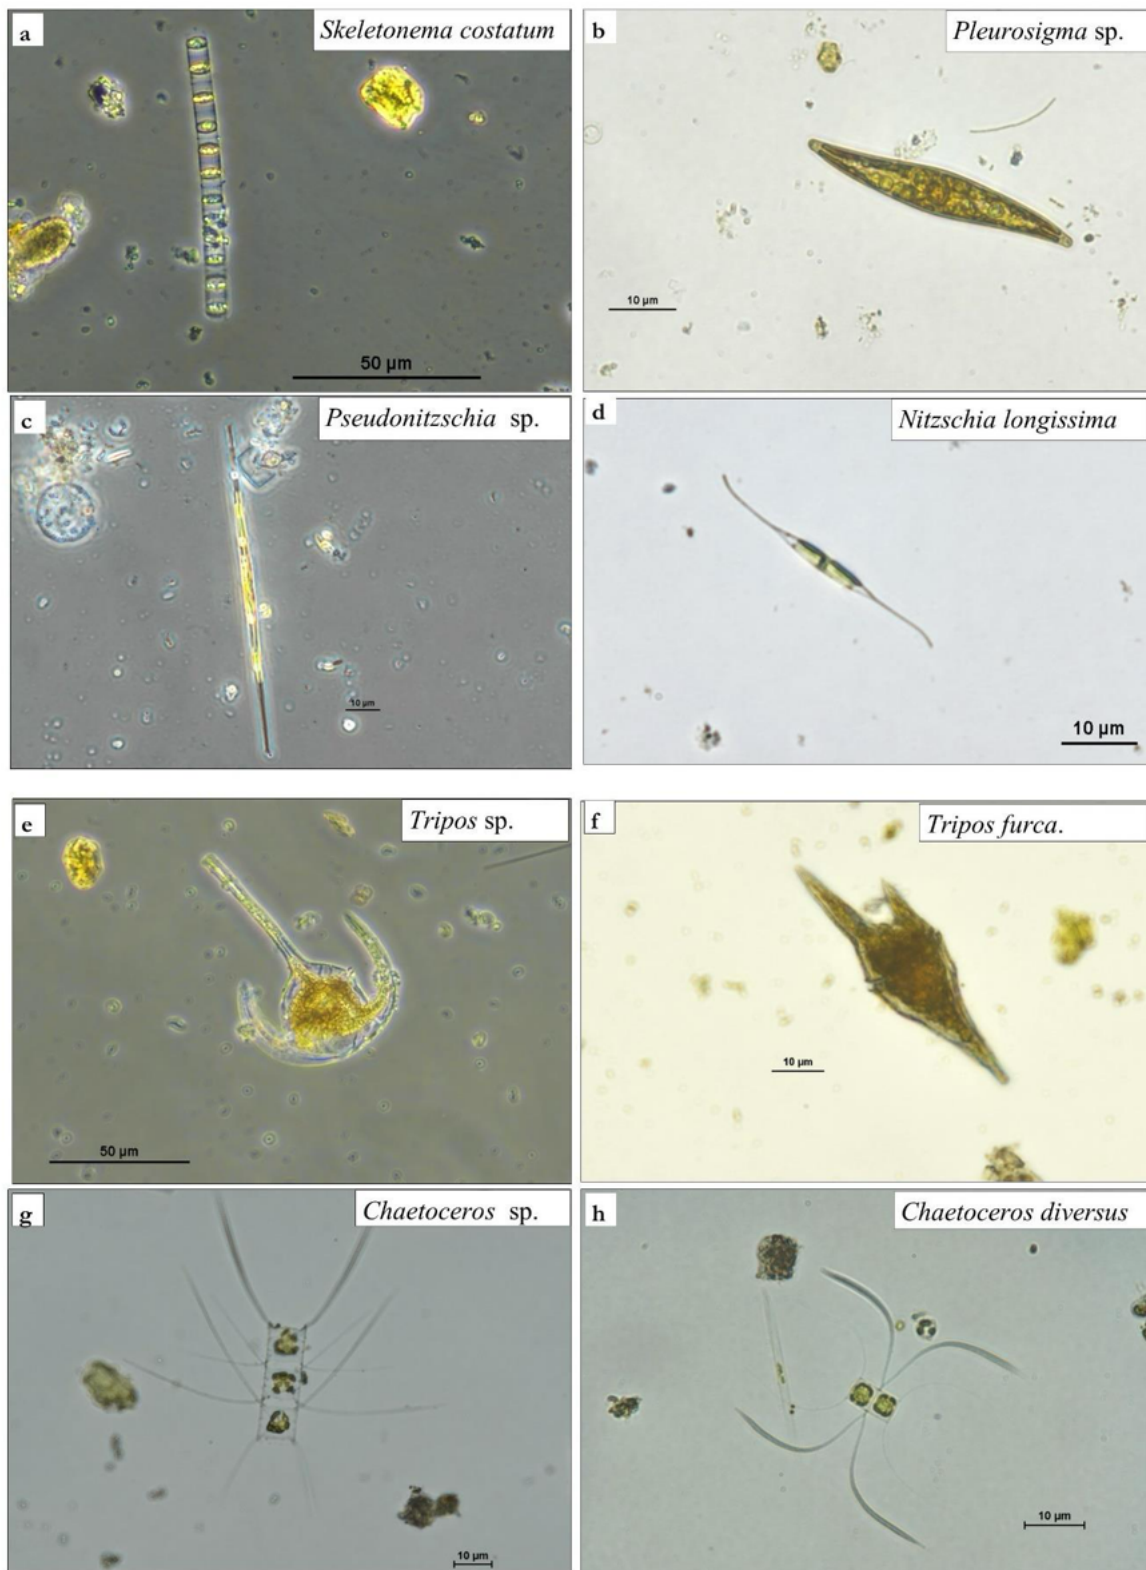
Figure 12. Estuarine phytoplankton species (a-h) observed on the 25<sup>th</sup> and 31<sup>st</sup> January 2024.

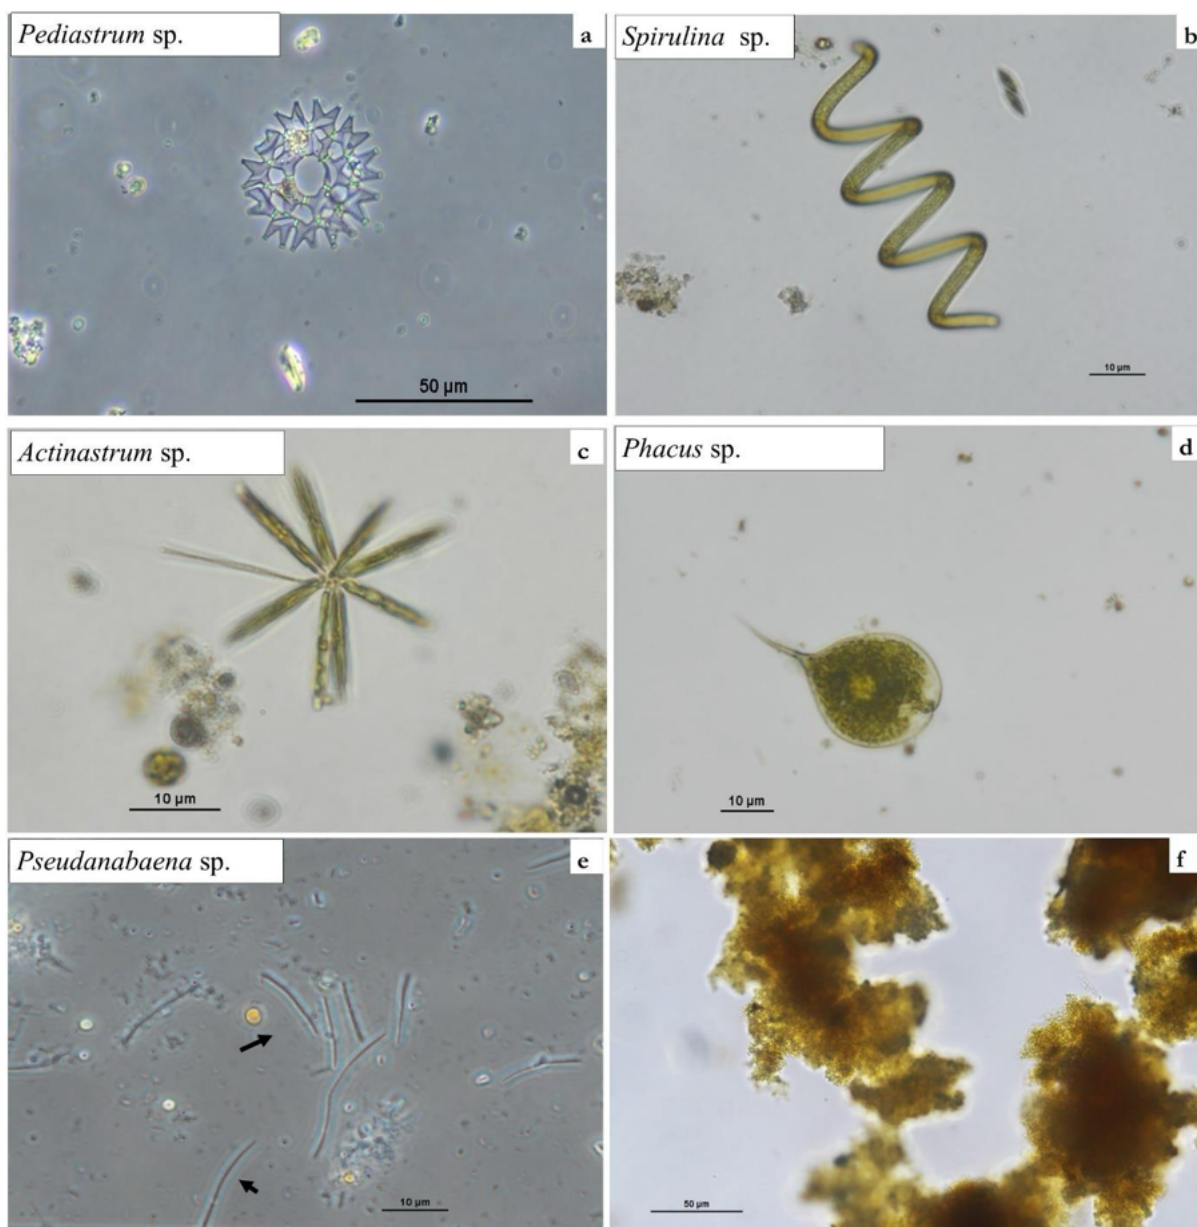
**Figure 13.** The freshwater phytoplankton species (a-e) observed in Buckingham Canal (EC-07) after 26<sup>th</sup> December, 2023 and suspended particles (f) observed during the first phase of sampling.

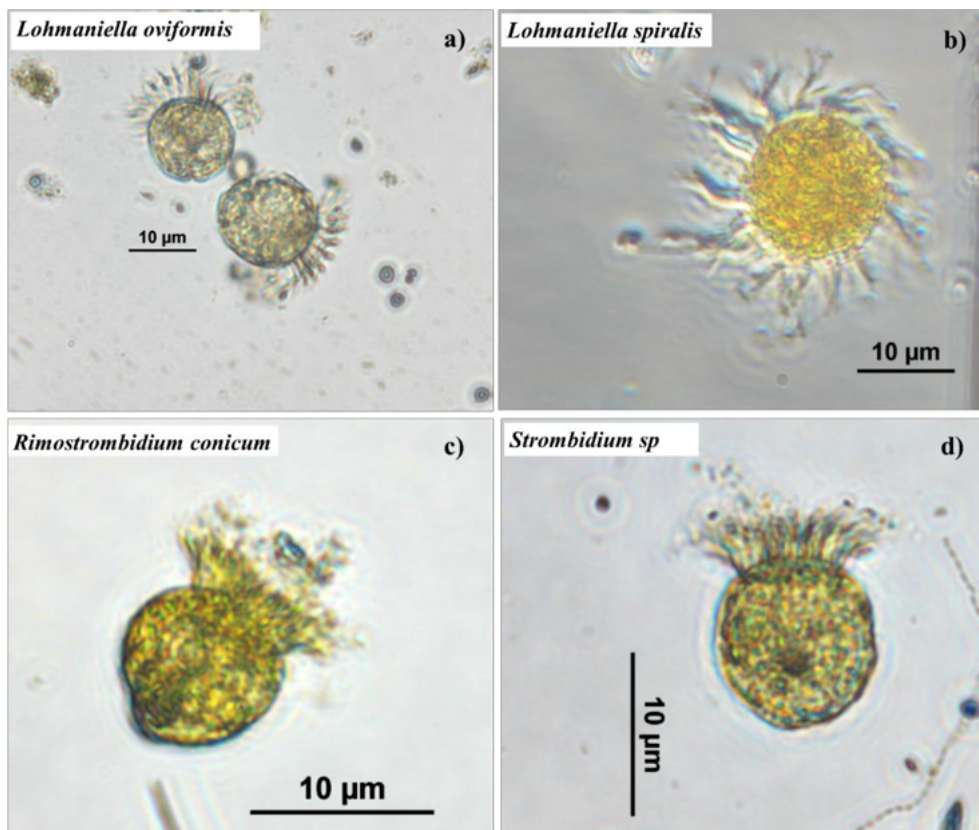
**Figure 14.** Dominant microzooplankton observed.

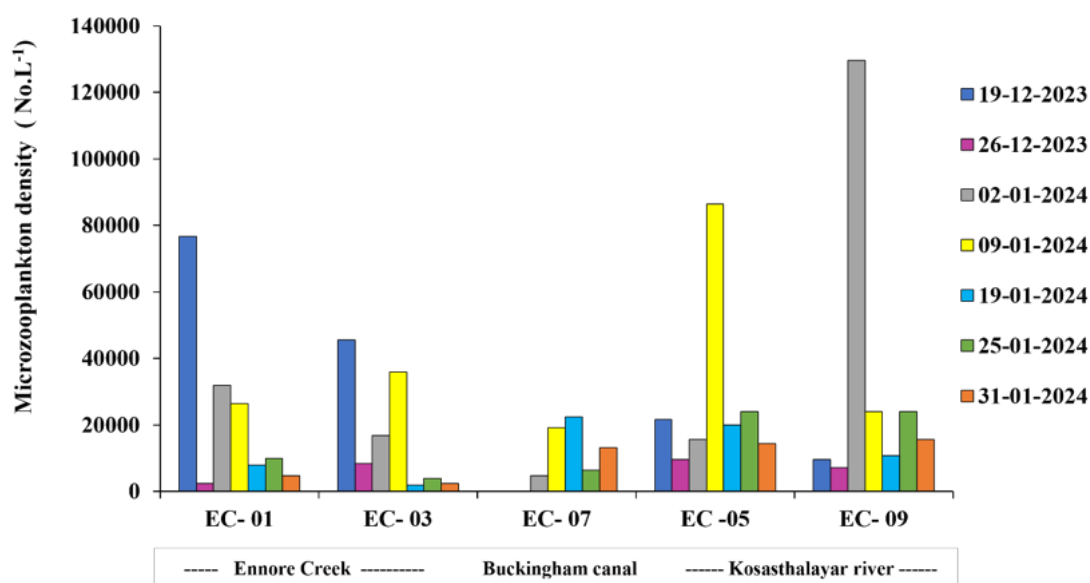
**Figure 15.** Microzooplankton density (No. L<sup>-1</sup>) at the different stations in Ennore Creek.

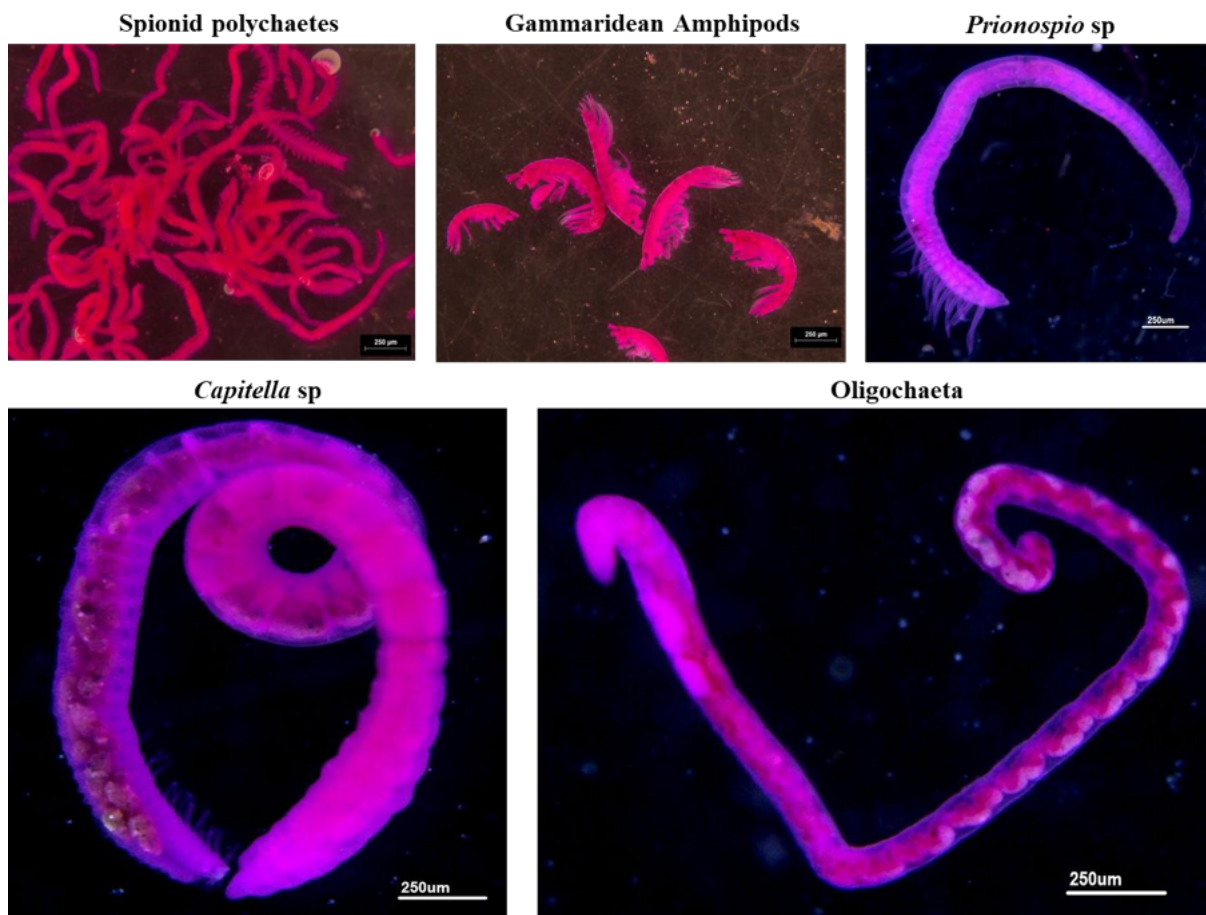
**Figure 18.** Common macrobenthos fauna observed in the sediment samples.

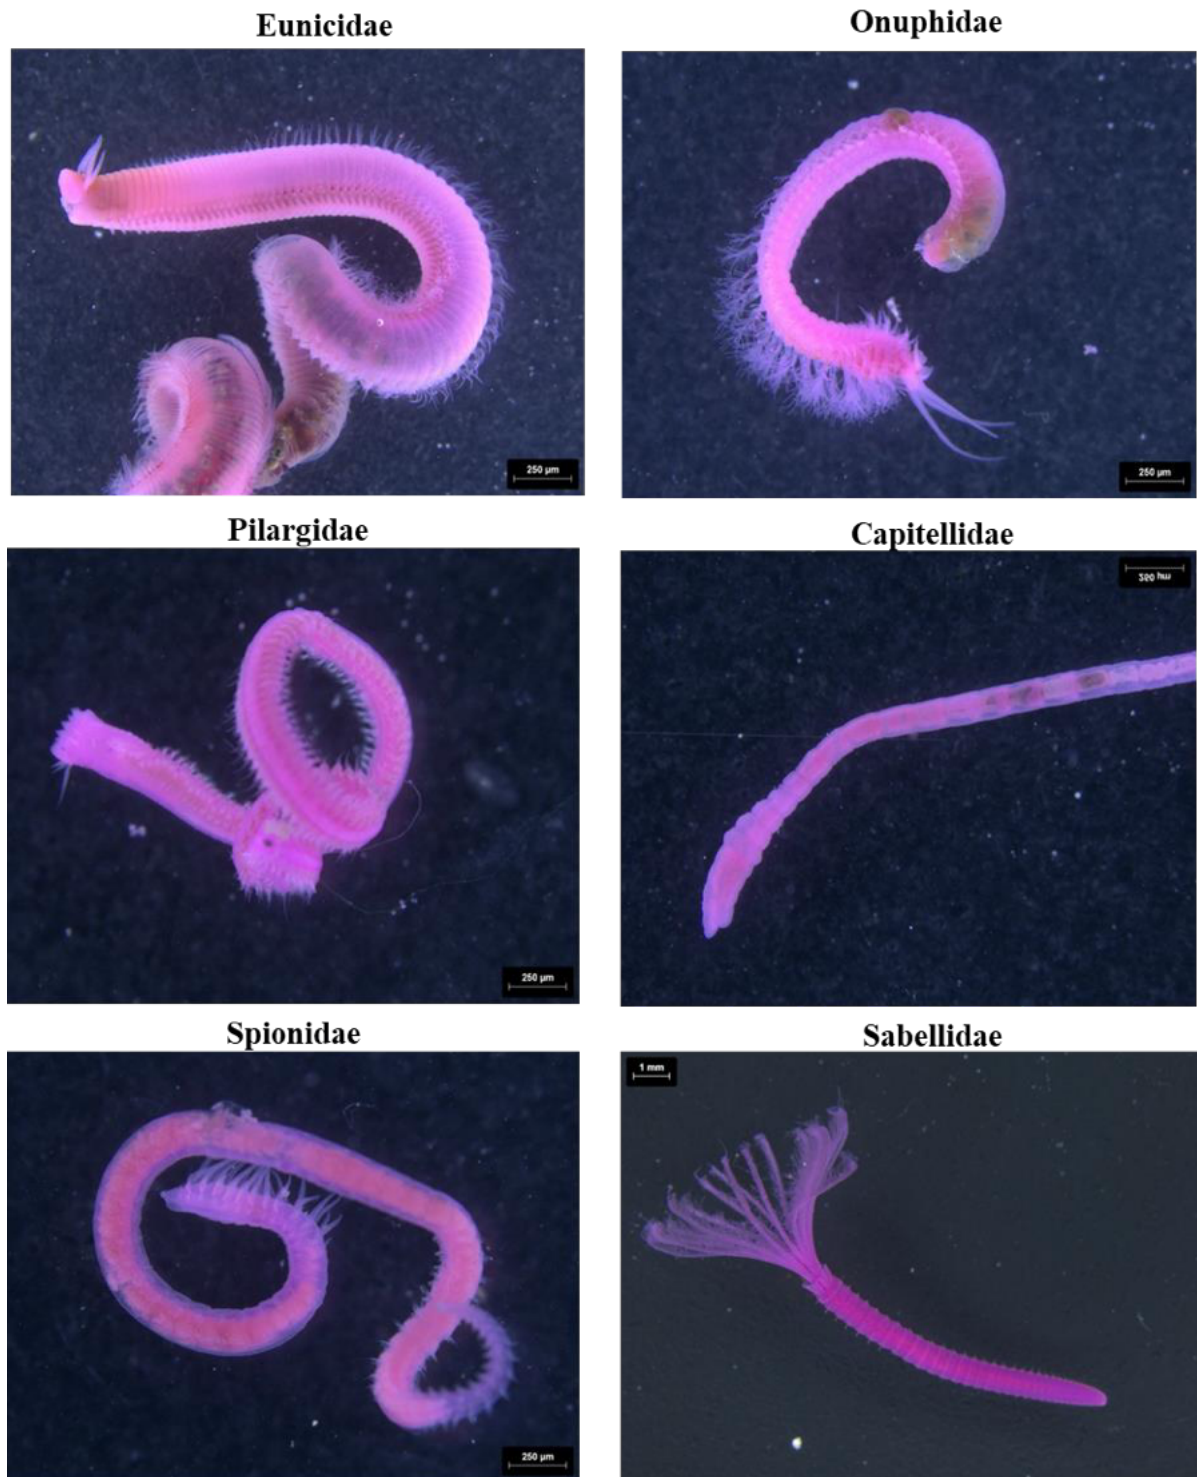
Figure 19. Dominant families of polychaetes found in the mouth of Ennore Creek.

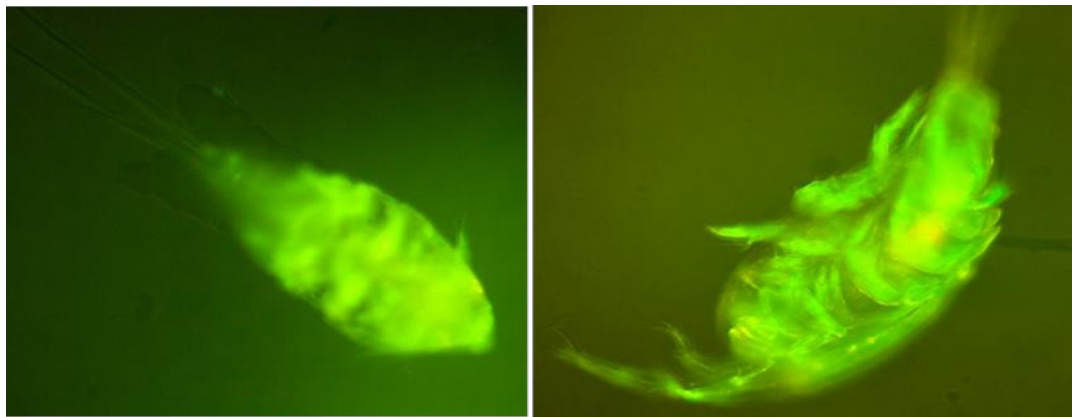
**Figure 20.** Emission of green fluorescence by live copepod observed under epifluorescence microscope.

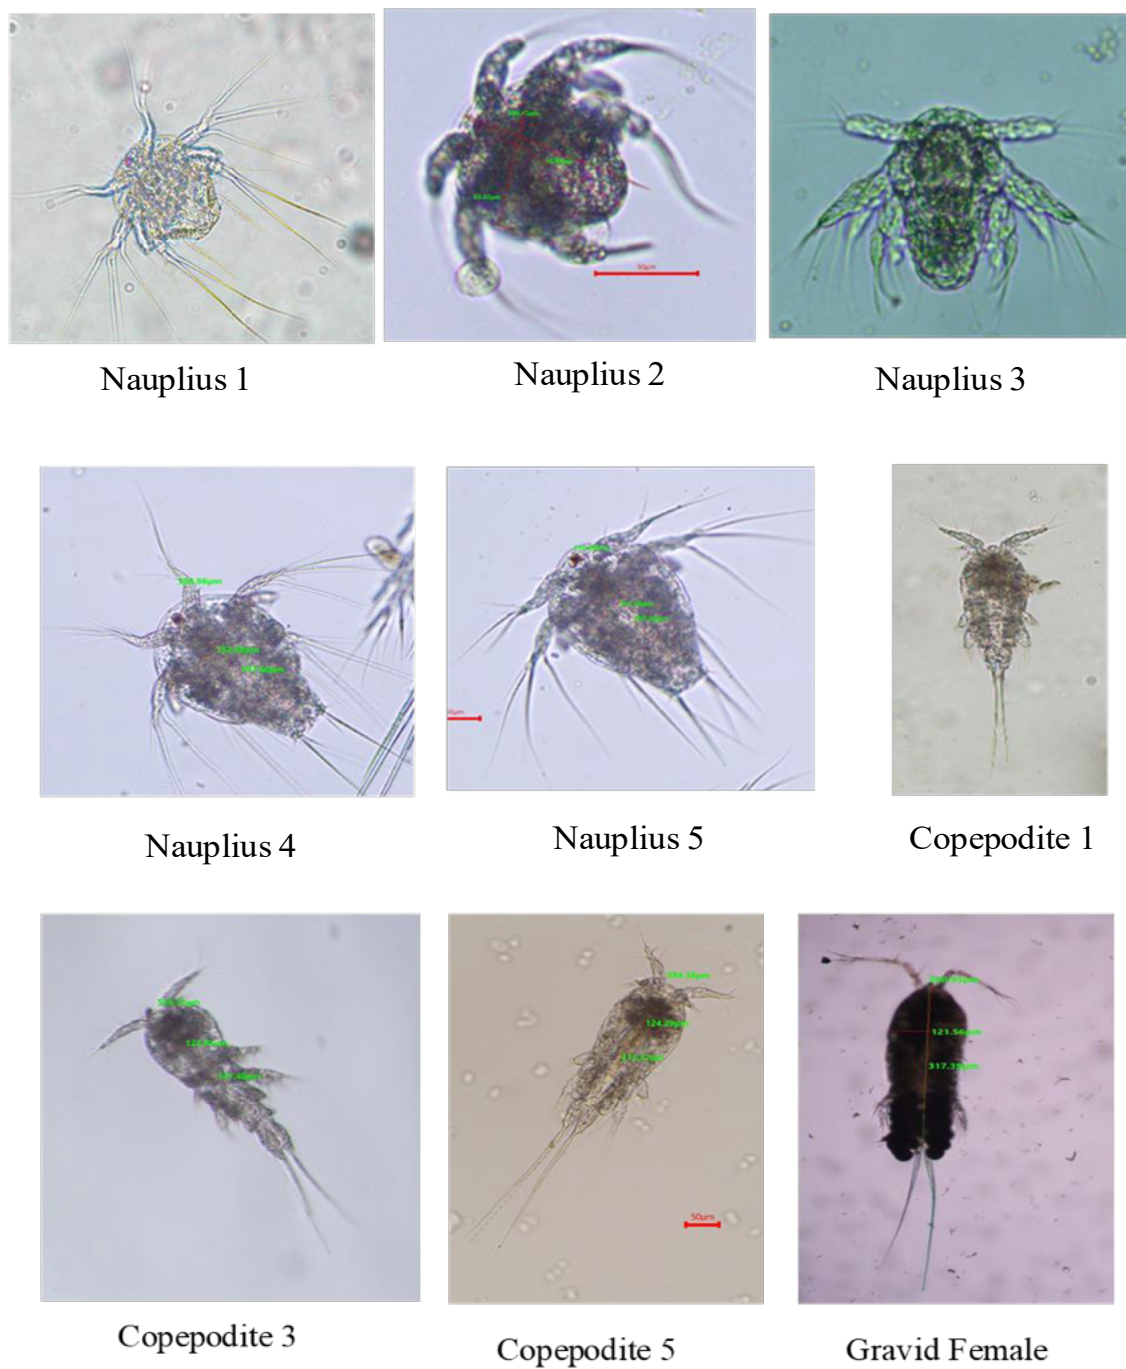
**Figure 21.** Different life-stages of the copepod observed under light microscope.

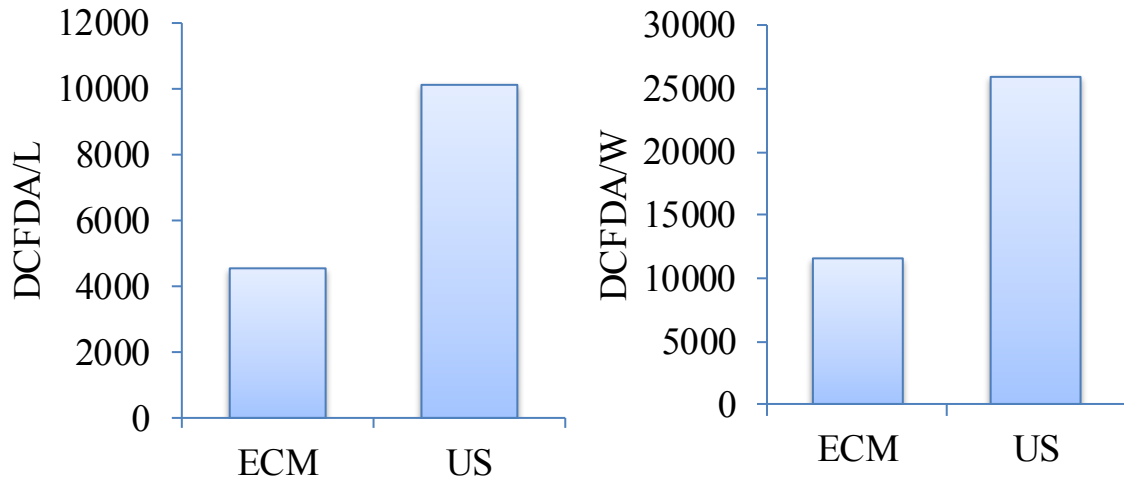
**Figure 22.** Ratio of size and DCFDA hydrolysis by the nauplius larvae of harpacticoid copepod, *Tisbe furcata* on 30 min exposure to seawater collected from Ennore estuary after the oil spill event (L: length; W: width; ECM: Ennore Creek Mouth; US: Upstream)

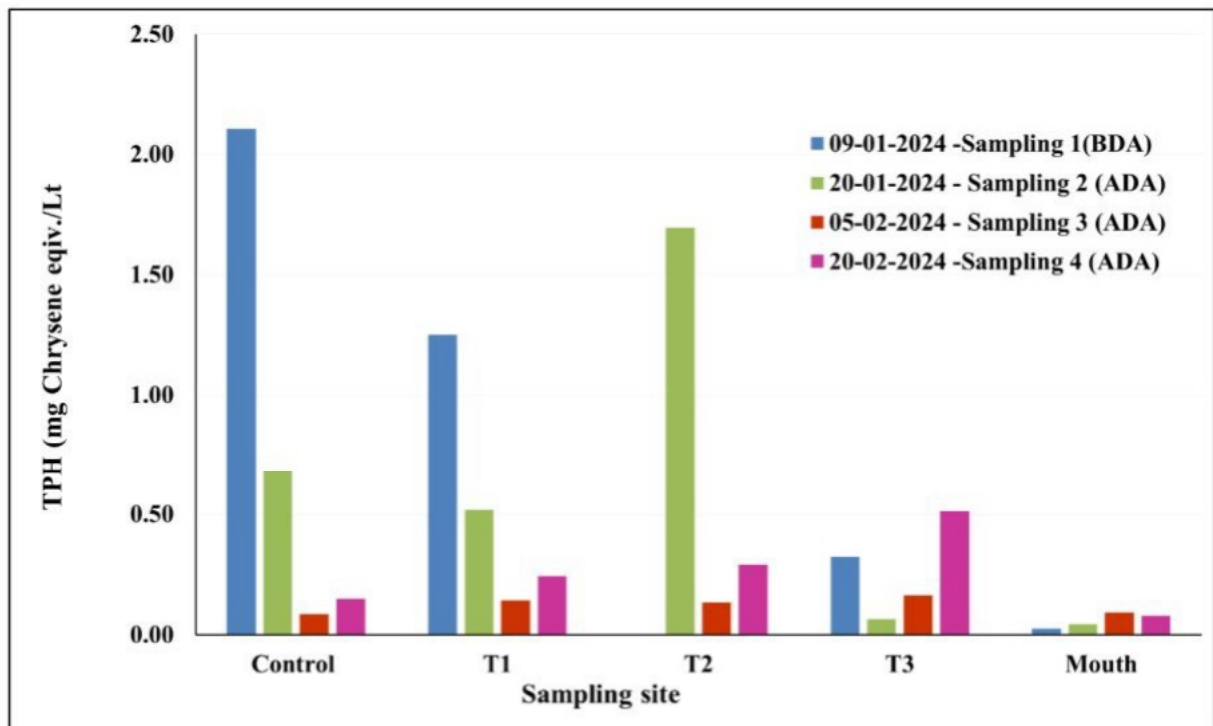
**Figure 8.** Distribution of TPH in water samples of 05 sampling sites during four consecutive field samplings.

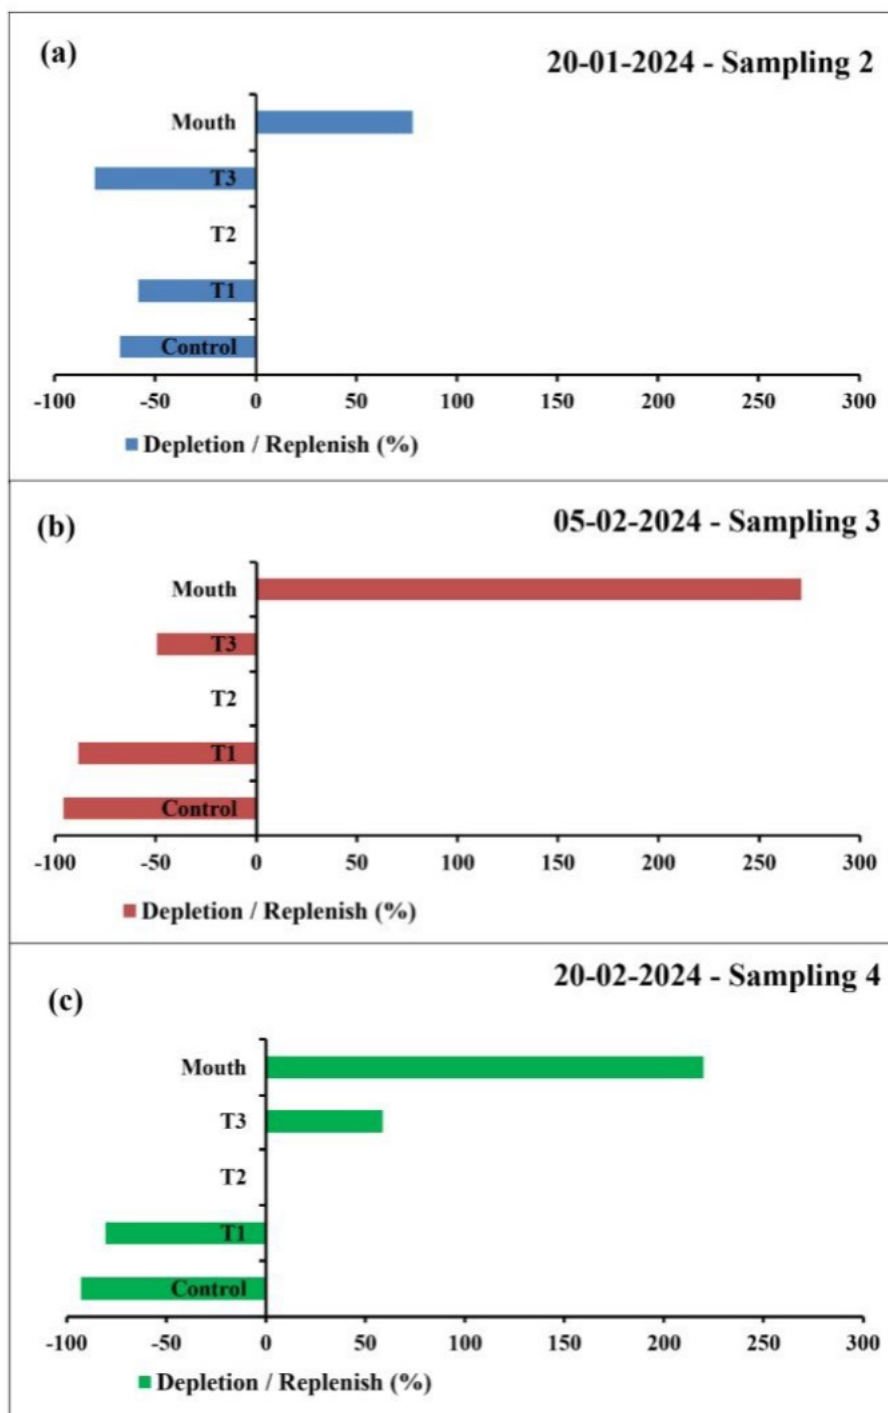
*Figure 10. Depletion/replenish percentage of TPHs in water samples*

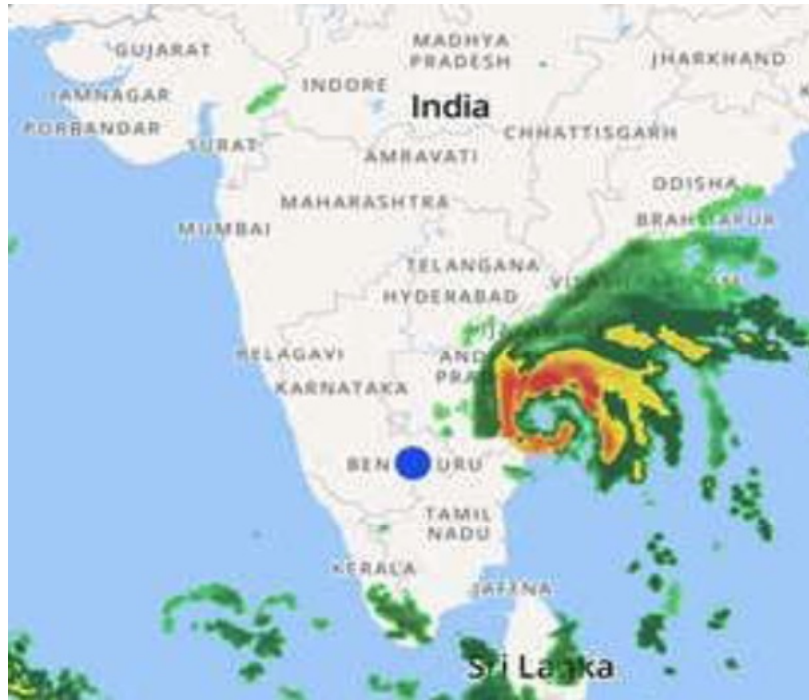
**Fig. 1 Severe Cyclonic Storm causes rampage across Tamil Nadu and Andhra Pradesh coast**

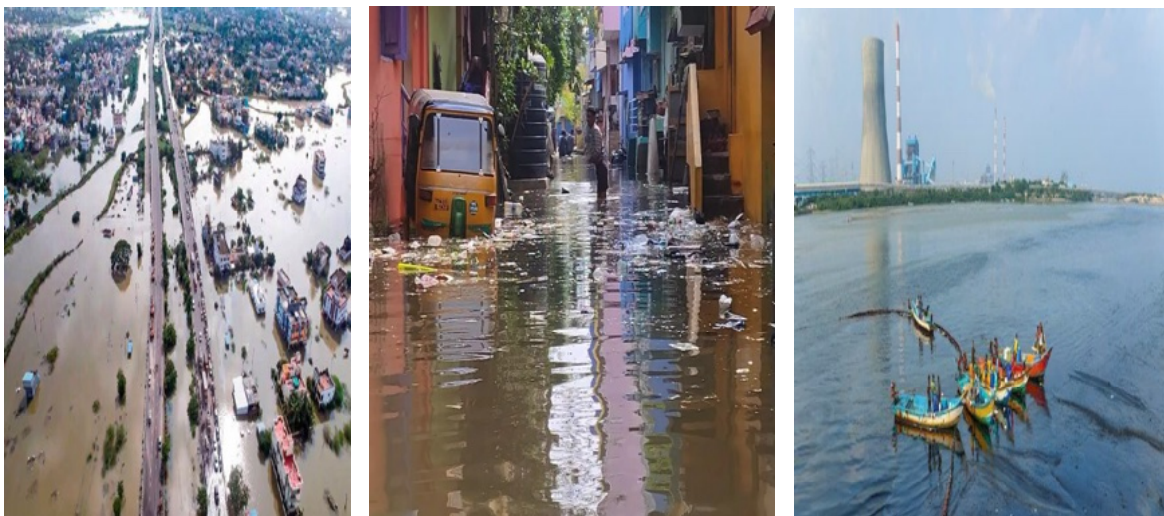
**Fig.2 A drone visual shows an area that is flooded after the landfall of Cyclone Michaung, in Chennai on December. 6, 2023**

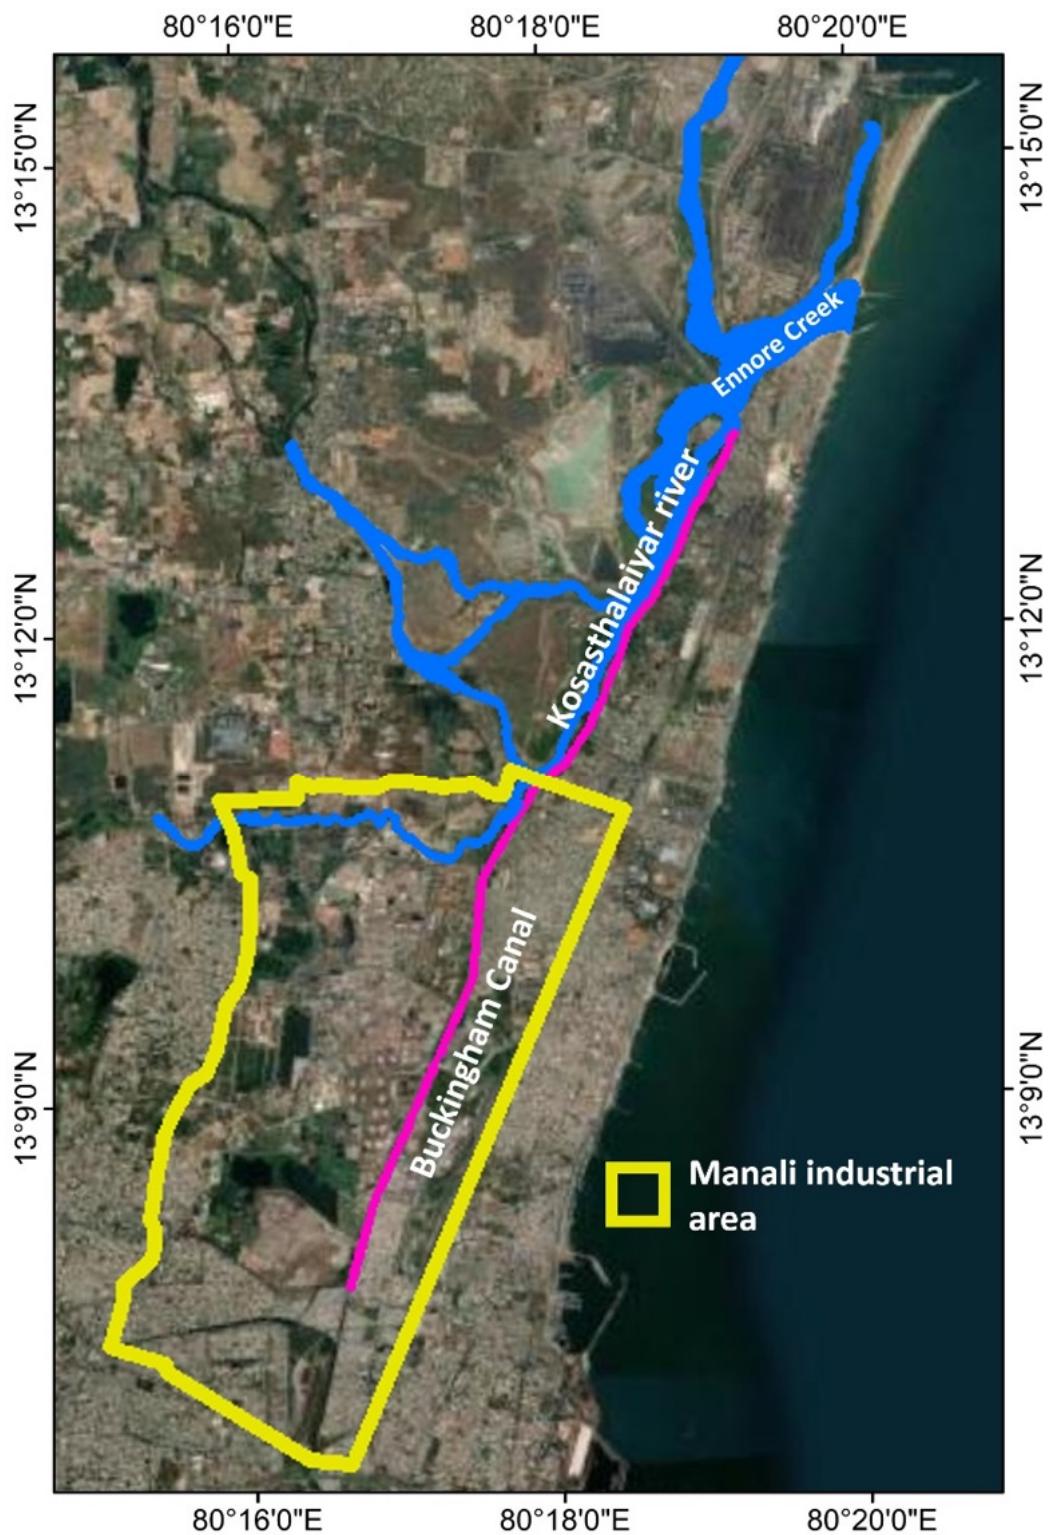
**Figure 1.** Geographic representation of the study area in Northern Chennai.

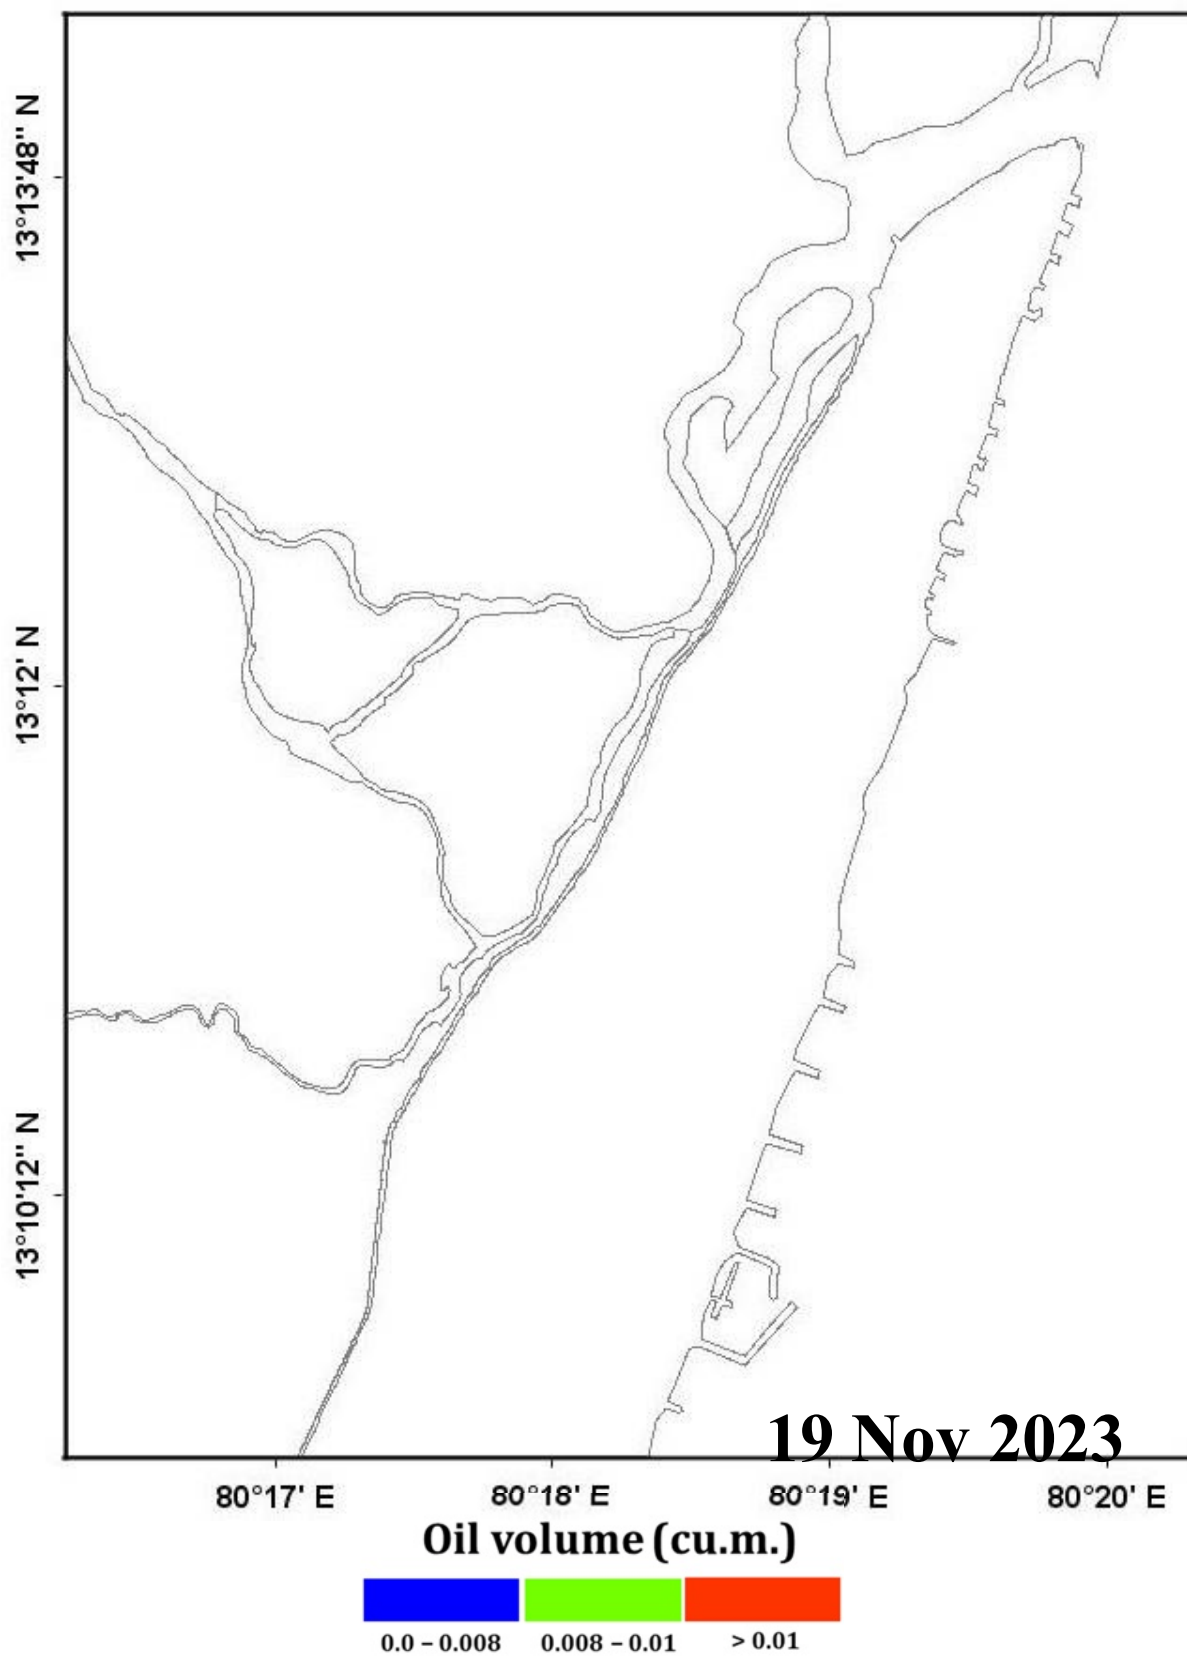
**Figure 3.** Map showing oil volume image derived from the PlanetScope data of the Chennai coast, on 19 November 2023 (no oil patches were observed in this image).

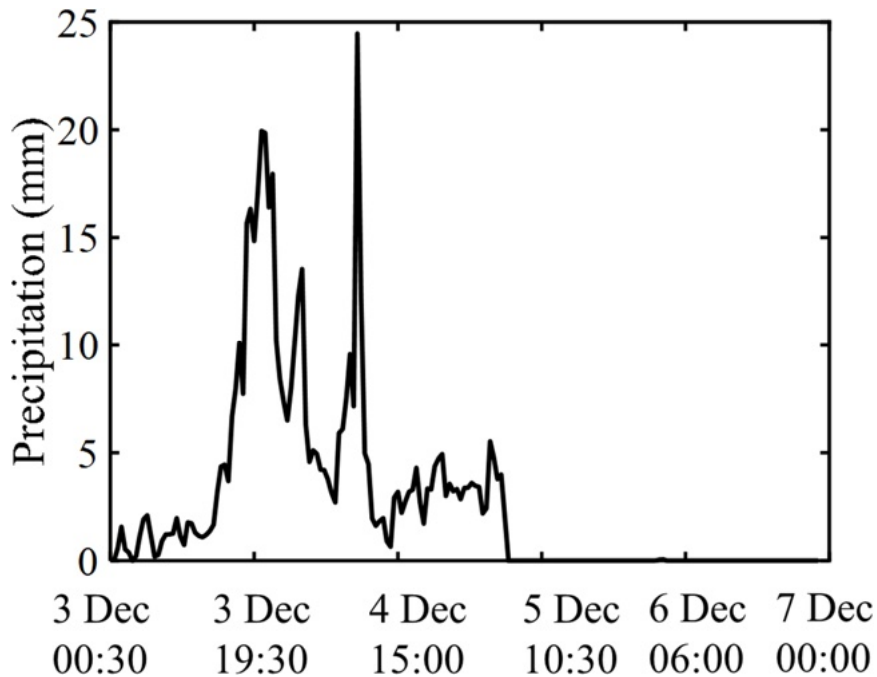
**Figure. 10** Precipitation data downloaded from the IMERG for the Chennai region from 3 to 7 Dec 2023.

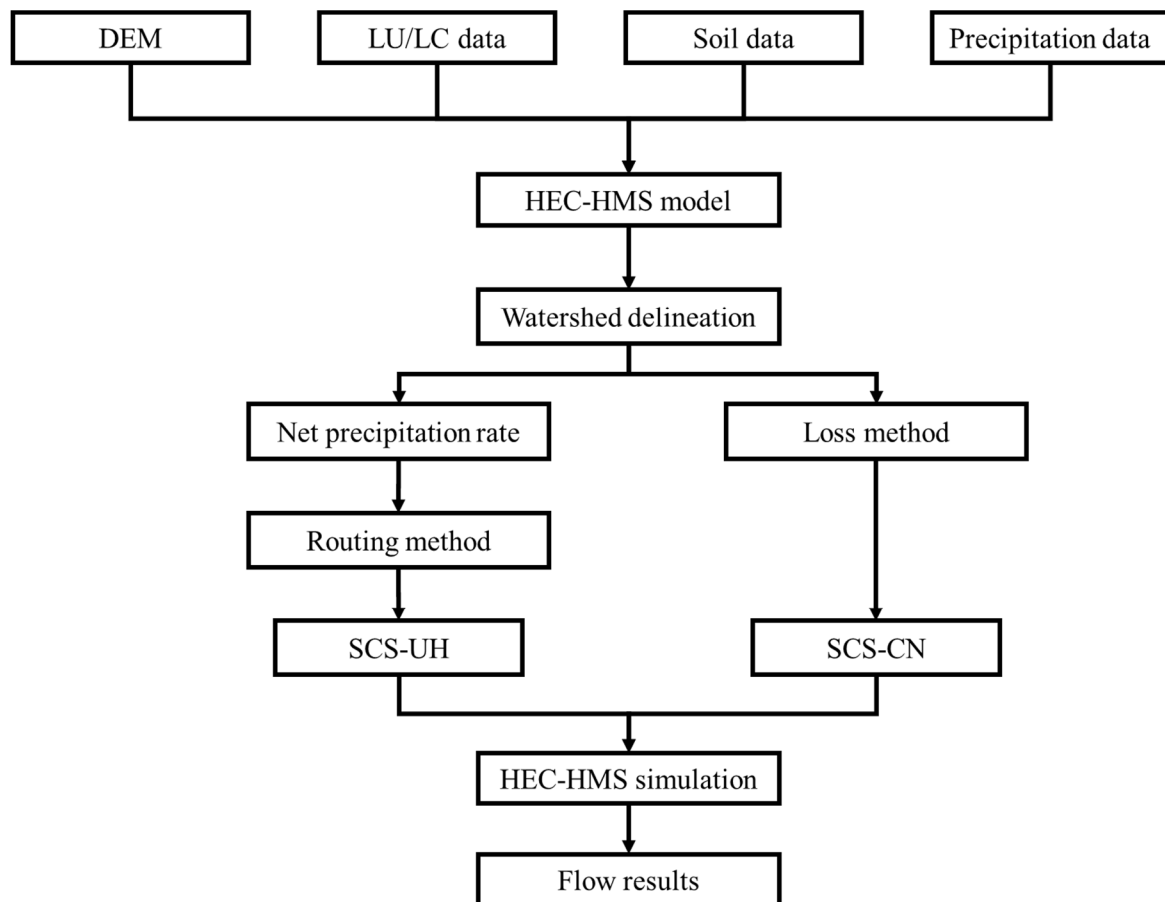
**Figure. 12** The schematic representation and simulation flow chart of the HEC-HMS model.

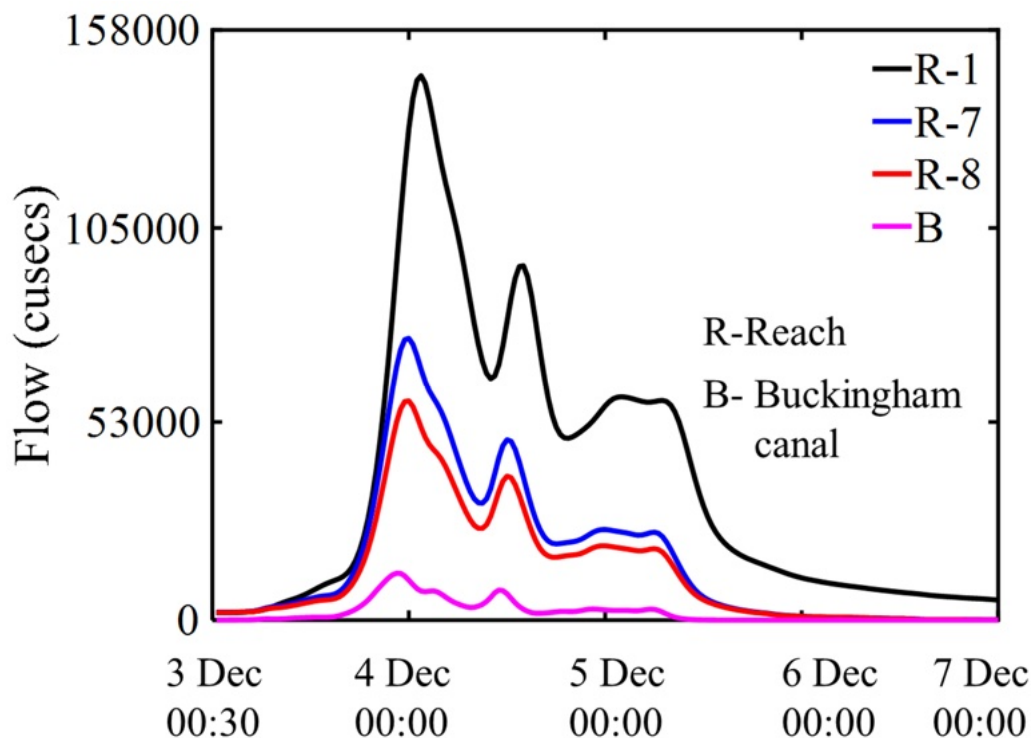
**Figure. 13** Simulated flow hydrographs for the reaches in the study area using the HEC-HMS model for the Michaung Cyclonic event with precipitation and outflow data from the Poondi and Puzhal Lakes.

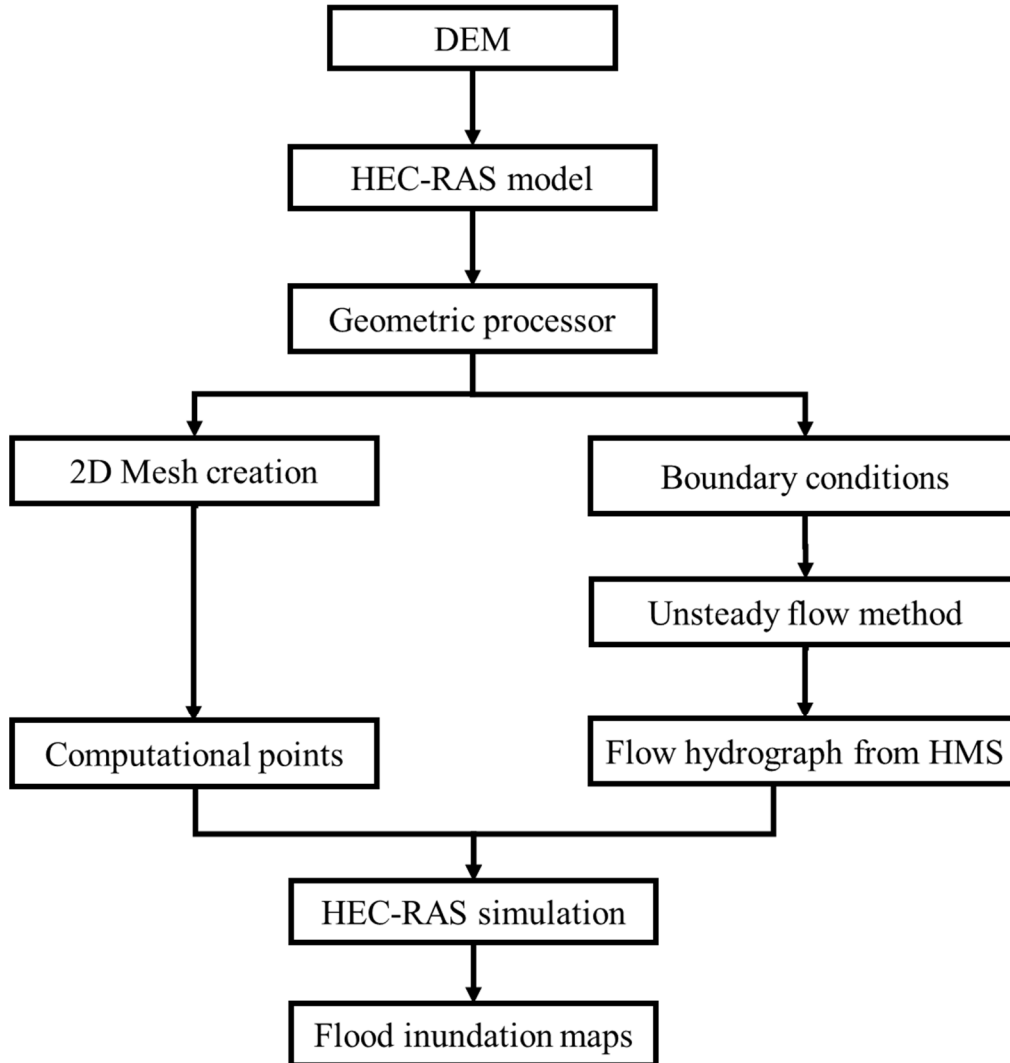
**Figure. 17** The schematic representation and simulation flow chart of the HEC-RAS model.
