**BEFORE THE NATIONAL GREEN TRIBUNAL  
SOUTHERN ZONE, CHENNAI  
OA No. 180 of 2023 (SZ)**

**IN THE MATTER OF :**

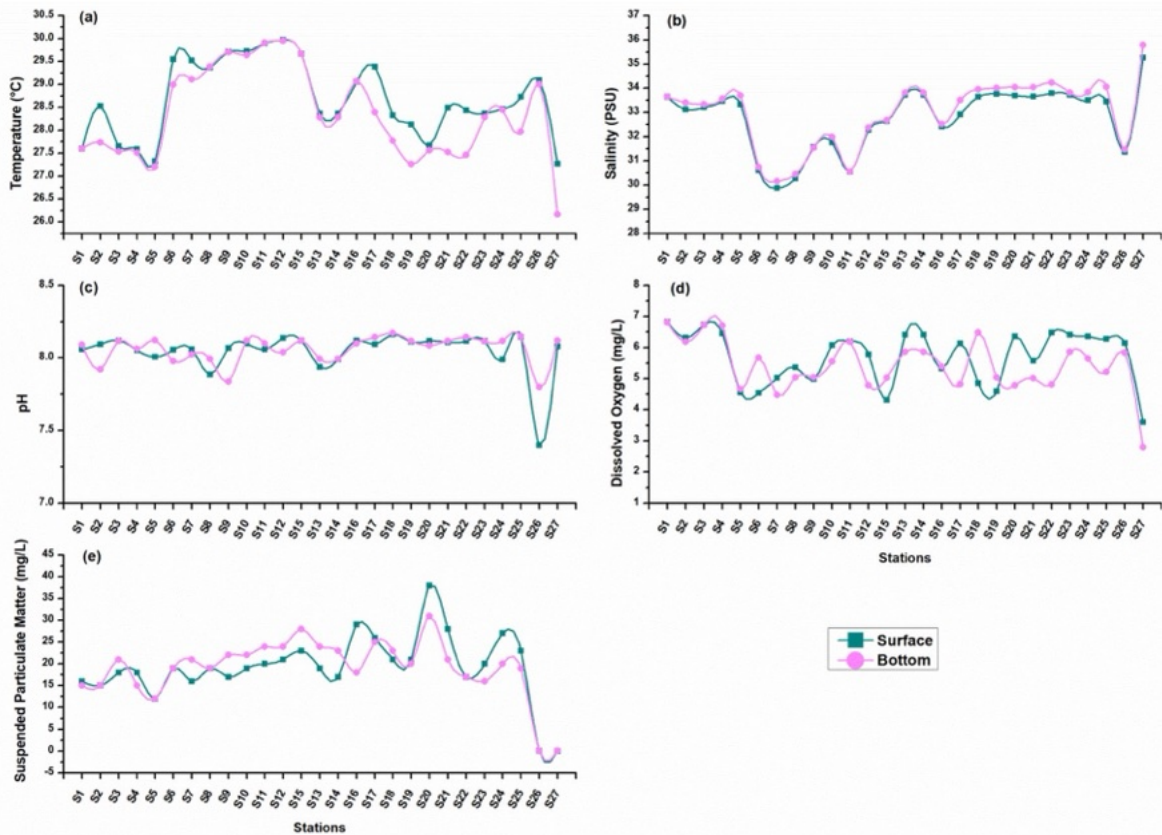
**Fig. 2** a–e Physicochemical parameters of the coastal waters of Tamil Nadu, **a** temperature, **b** salinity, **c** pH, **d** dissolved oxygen (DO) and **e** suspended particulate matter (SPM)

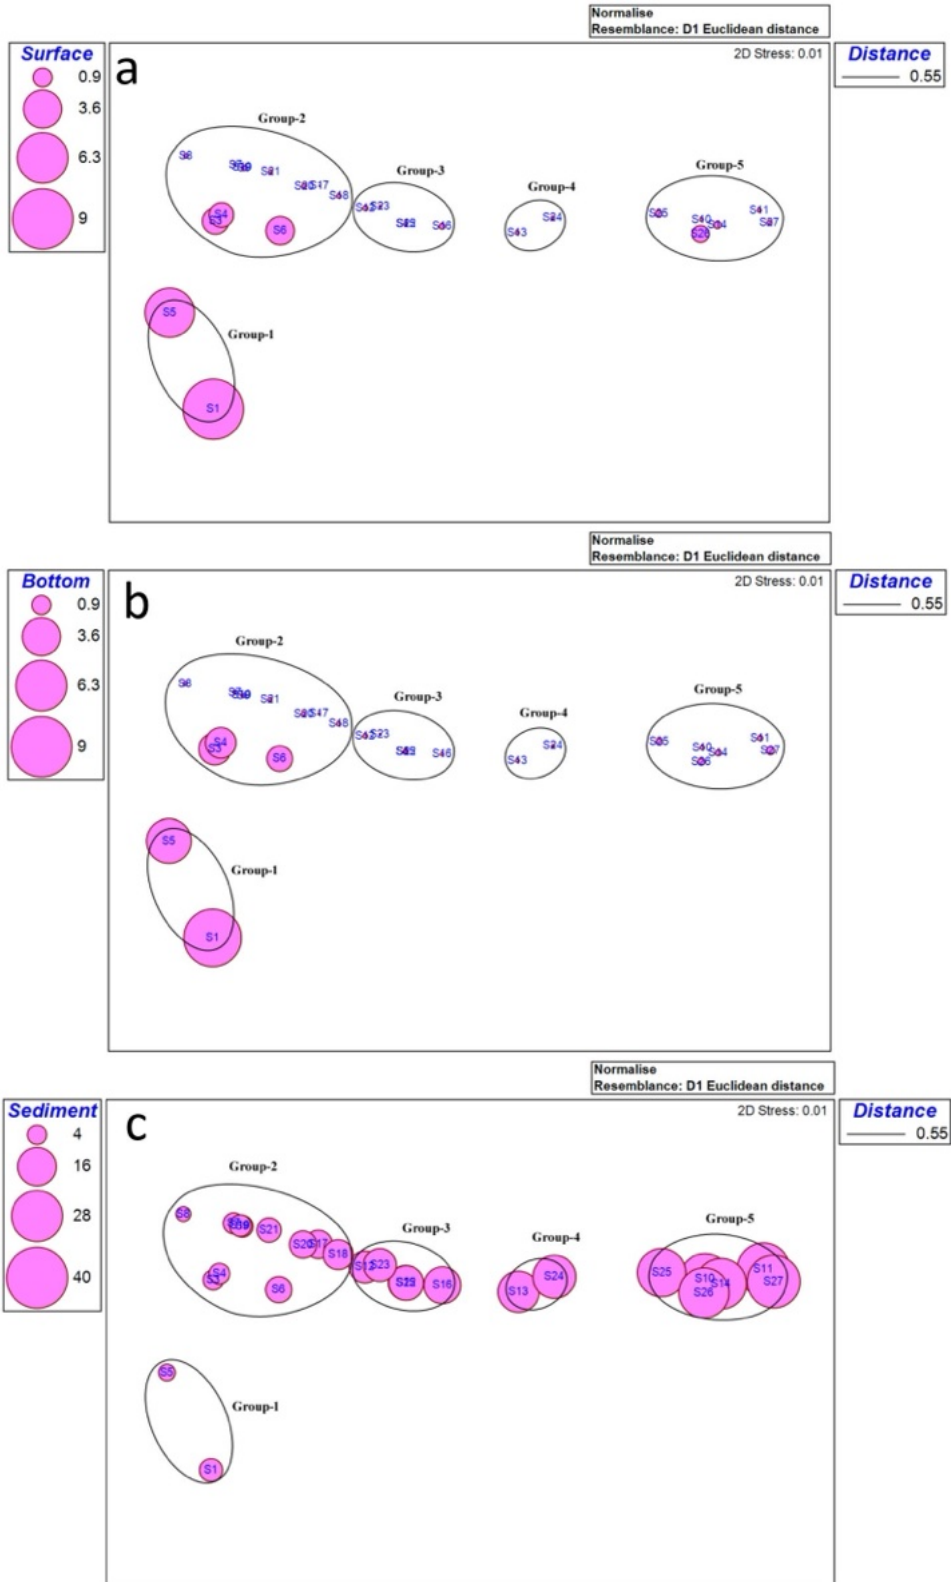
◀**Fig. 5** Non-multidimensional scaling (n-MDS) bubble plot showing similarities and grouping of sampling stations surface water (a), bottom water (b) and sediments (c). The circle indicates that the division of the 5 main groups separated by similarity and bubbles indicates the relative values of TPH for each station of Tamil Nadu coast. The size of the bubbles indicates the level of TPH concentrations during the study

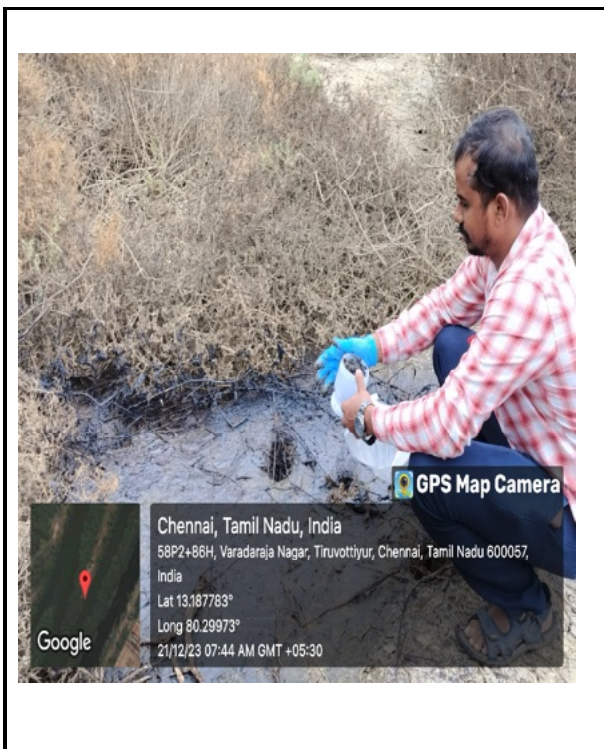
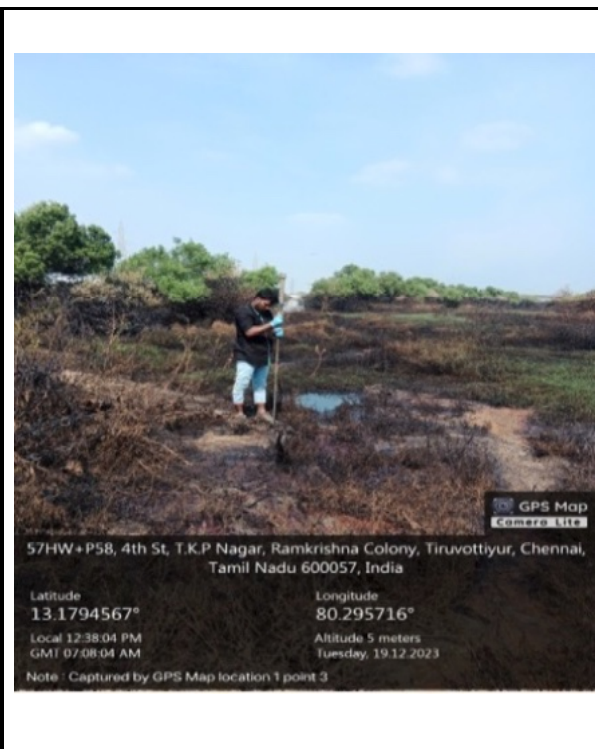
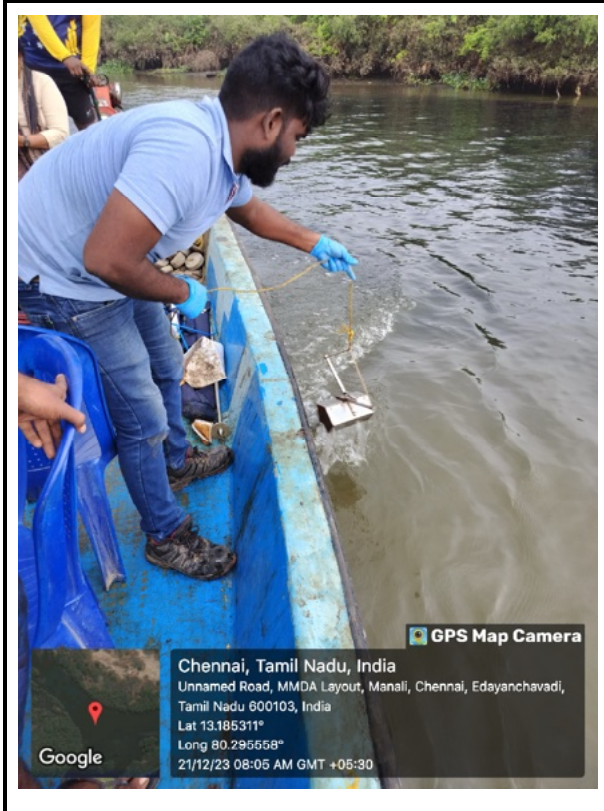
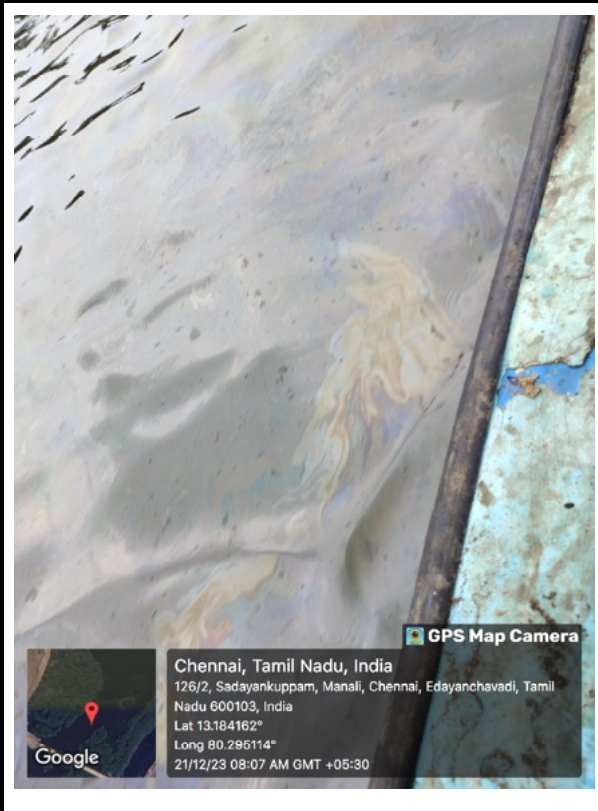
**The images below contain GPS coordinates and sampling dates, confirming that the samples were collected from the affected locations. The dates indicate sampling occurred near the completion of cleanup activities, which, according to news reports ([oil-spill-in-ennore-brings-fishing-to-a-standstill](#)), concluded on December 20, 2023.**

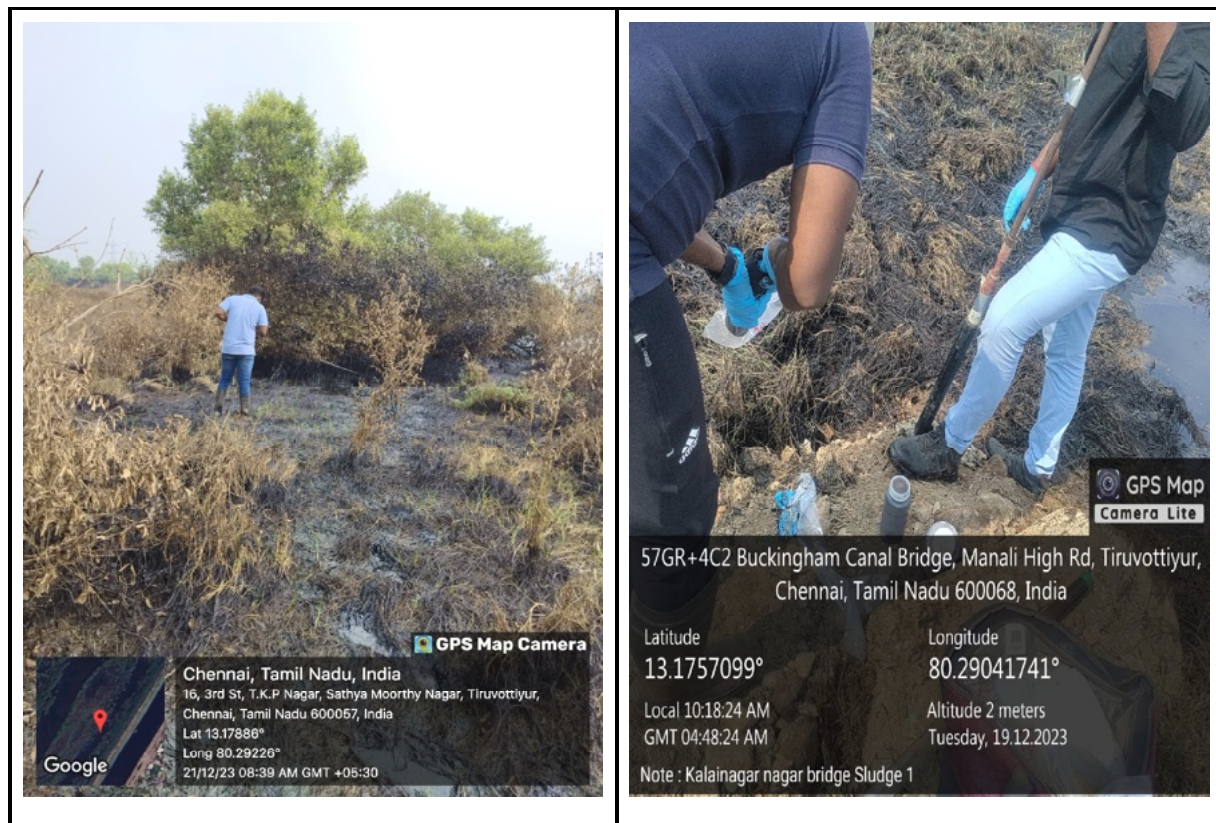
**3. “As stated in statement 4 of the order...THE STUDY OF THE DEPTH OF THE OIL WAS NOT DONE, AS THEY HAD TAKEN ONLY RANDOM SAMPLES.”**

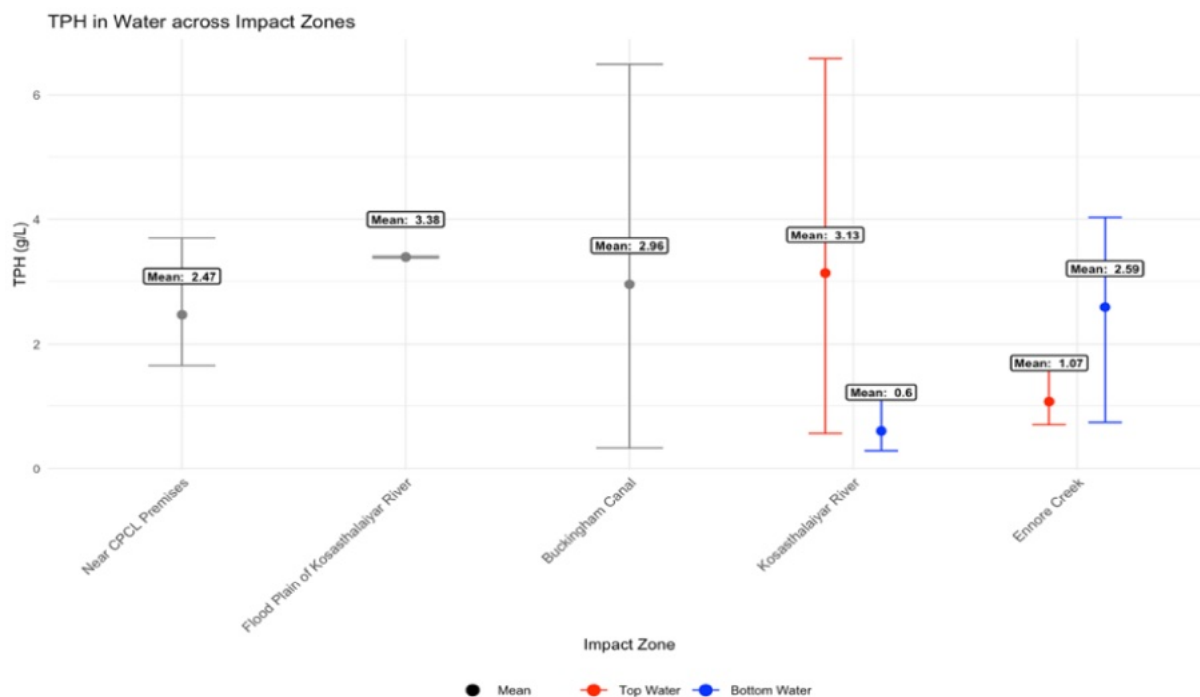
Across all five impact zones, the mean Total Petroleum Hydrocarbon (TPH) levels in the collected samples ranged from  $0.29 \pm 0.09$  g/L to  $6.58 \pm 0.13$  g/L. **Highest concentrations were found in Buckingham Canal and Kosasthalaiyar River, with peak values exceeding 6 g/L.** Given that **no specific CPCB standard exists for TPH in water**, these findings emphasize the need for continuous monitoring and pollution control measures since TPH contamination could pose long-term environmental and ecological risks, affecting water quality, sediment health, and aquatic ecosystems.

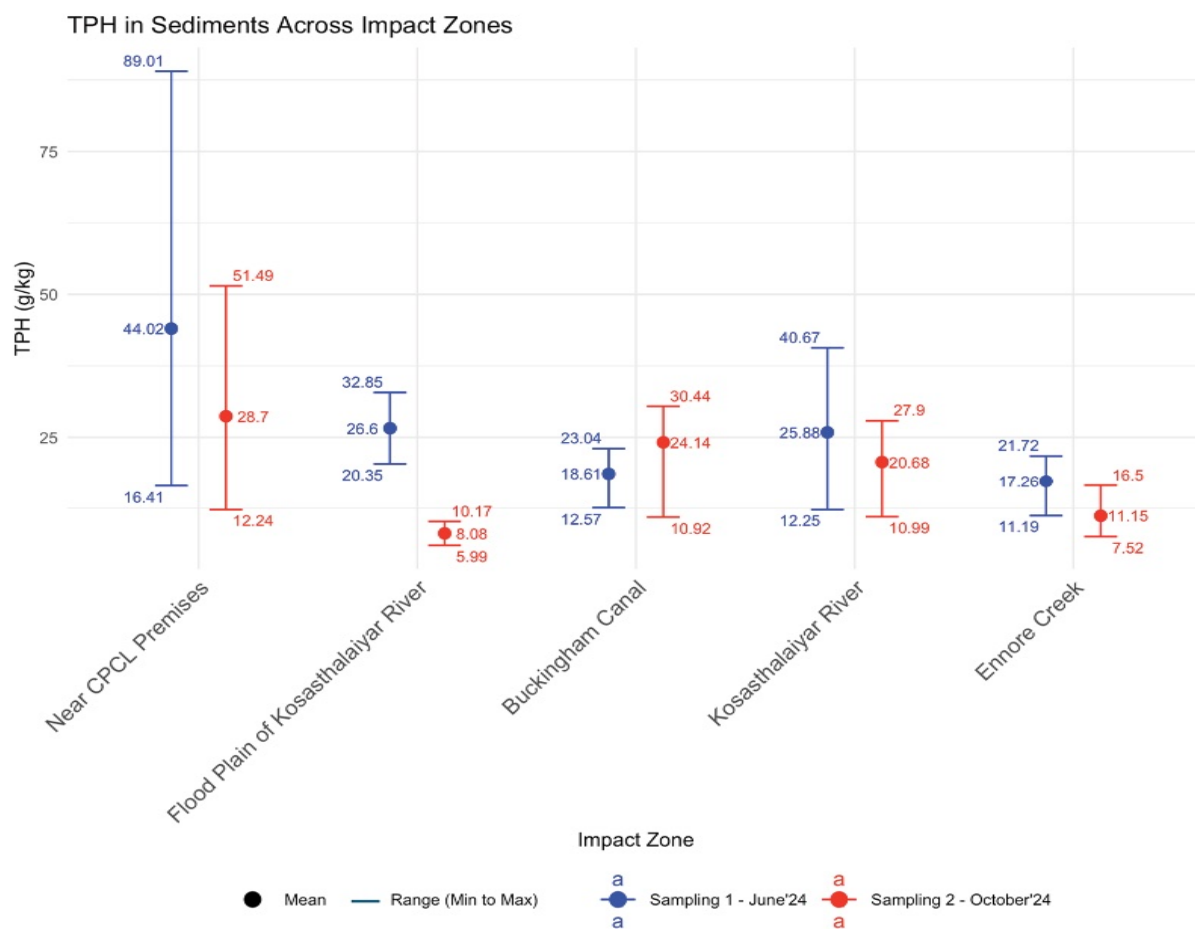
The data reveals that TPH concentrations in sediments remain significantly high across all impacted zones, extending to the creek, indicating persistent contamination. **The highest levels were recorded at L19, near the CPCL premises, with 89.01 g/kg in June 2024 and 51.49 g/kg in October 2024.** While TPH levels have decreased in certain areas between June and October, this reduction is not consistent throughout all locations. The continued presence of TPH after several months highlights that surface-level cleanup efforts were inadequate in addressing deeper sediment contamination. Unlike water, sediments act as a repository for petroleum hydrocarbons, posing long-term ecological risks, which underscores the need for more comprehensive remediation strategies.

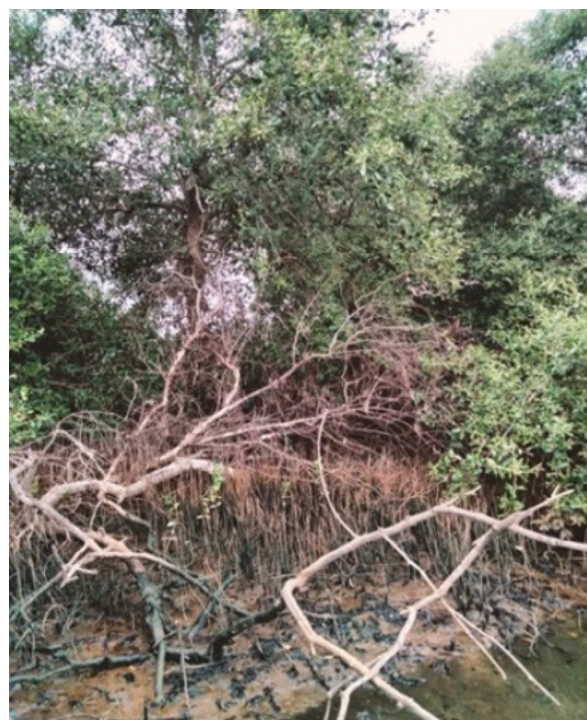
Black stains seen on pneumatophores in June 2024

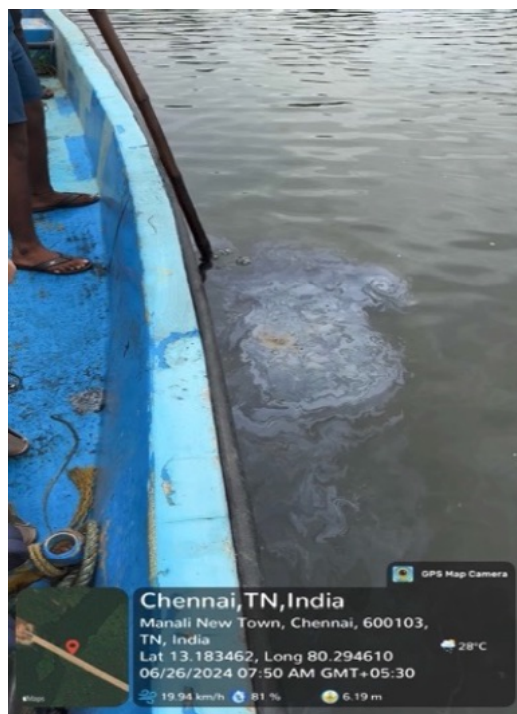
Oil sheen observed when the river sediments were disturbed

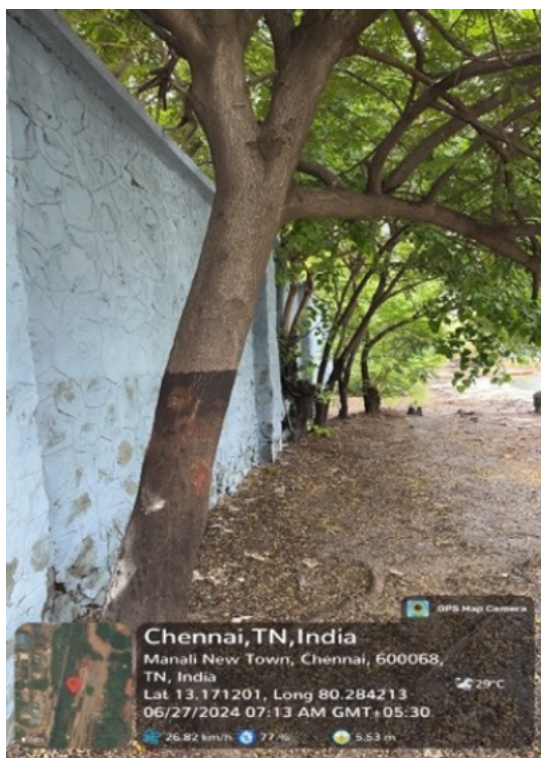
Oil stains seen on trees and walls near CPCL premises

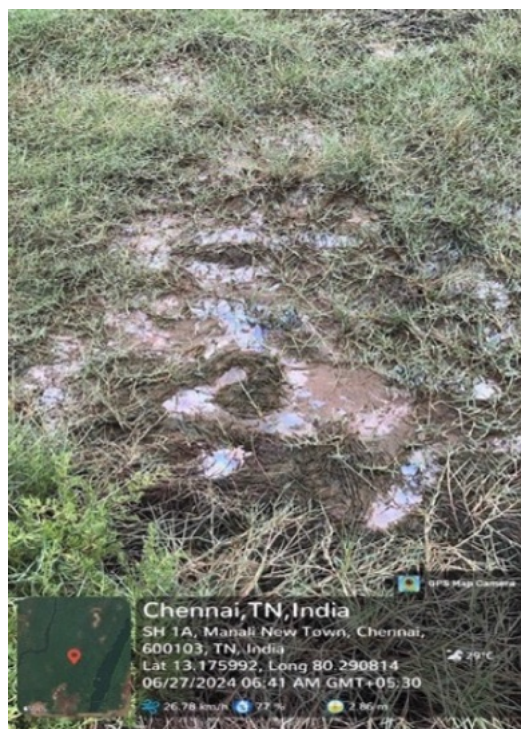
Oil sheen observed at Entry Point 1 - Storm water canal discharge into surplus canal of Kosasthalaiyar River in June 2024

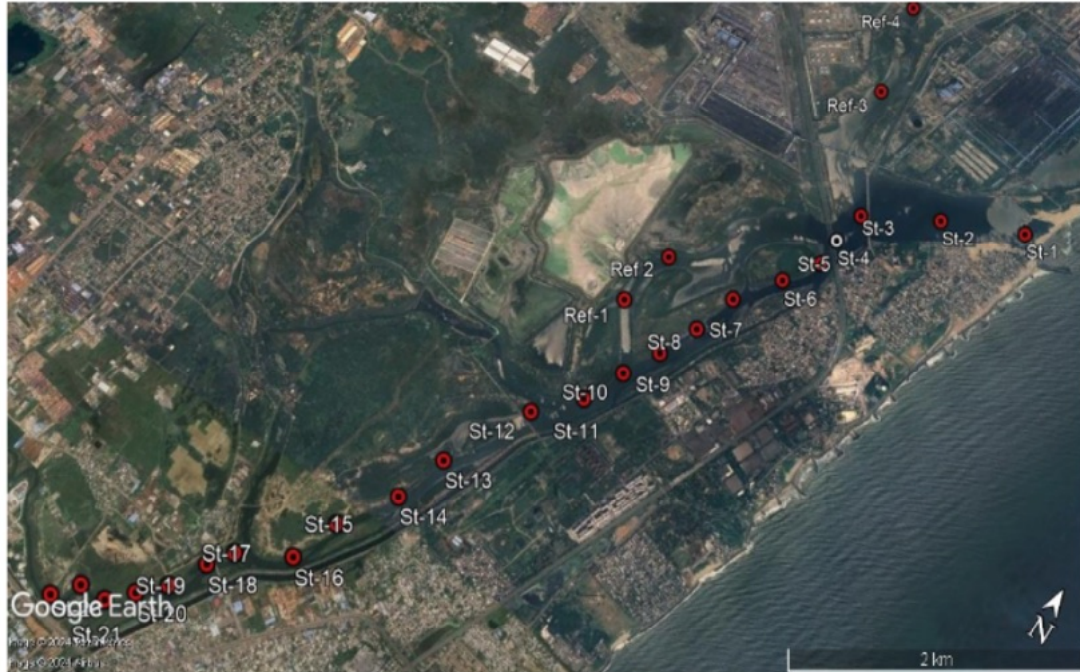
Sampling locations of the study region used to collect the water sediment samples for biological parameters.

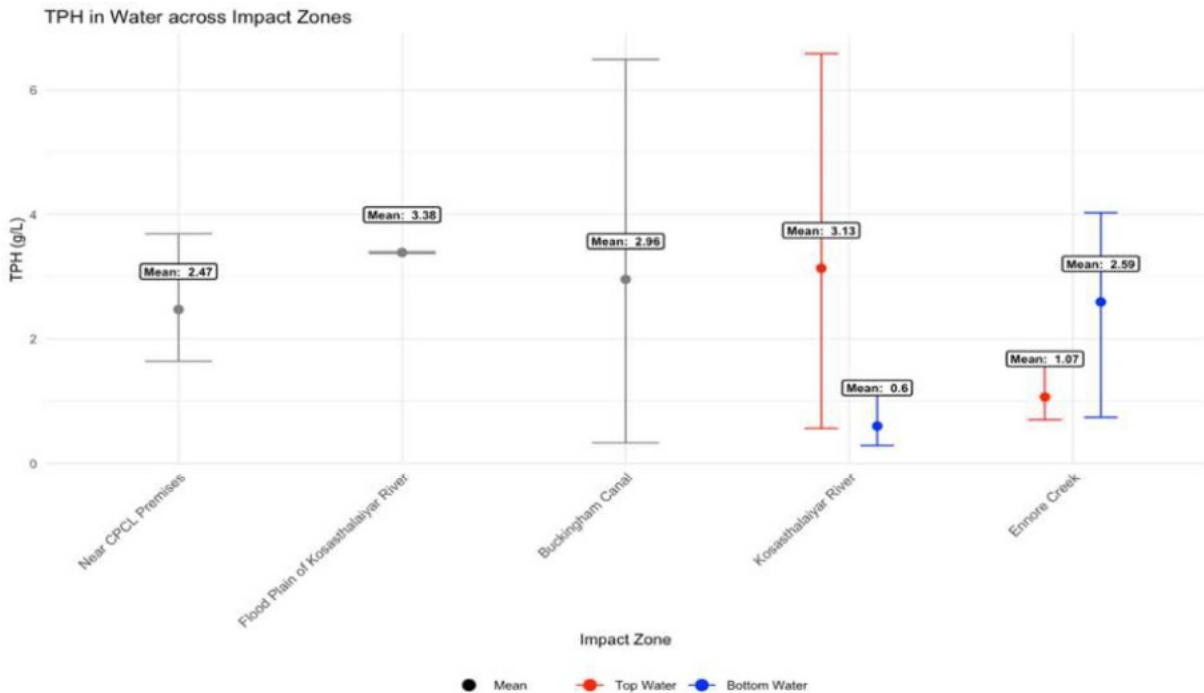
Across all five impact zones, the mean Total Petroleum Hydrocarbon (TPH) levels in the collected samples ranged from  $0.29 \pm 0.09$  g/L to  $6.58 \pm 0.13$  g/L. **Highest concentrations were** found in Buckingham Canal and Kosasthalaiyar River, with peak values exceeding **6 g/L**. Given that **no specific CPCB standard exists for TPH in water**, these findings emphasize the need for continuous monitoring and pollution control measures since TPH contamination could pose longterm environmental and ecological risks, affecting water quality, sediment health, and aquatic ecosystems.

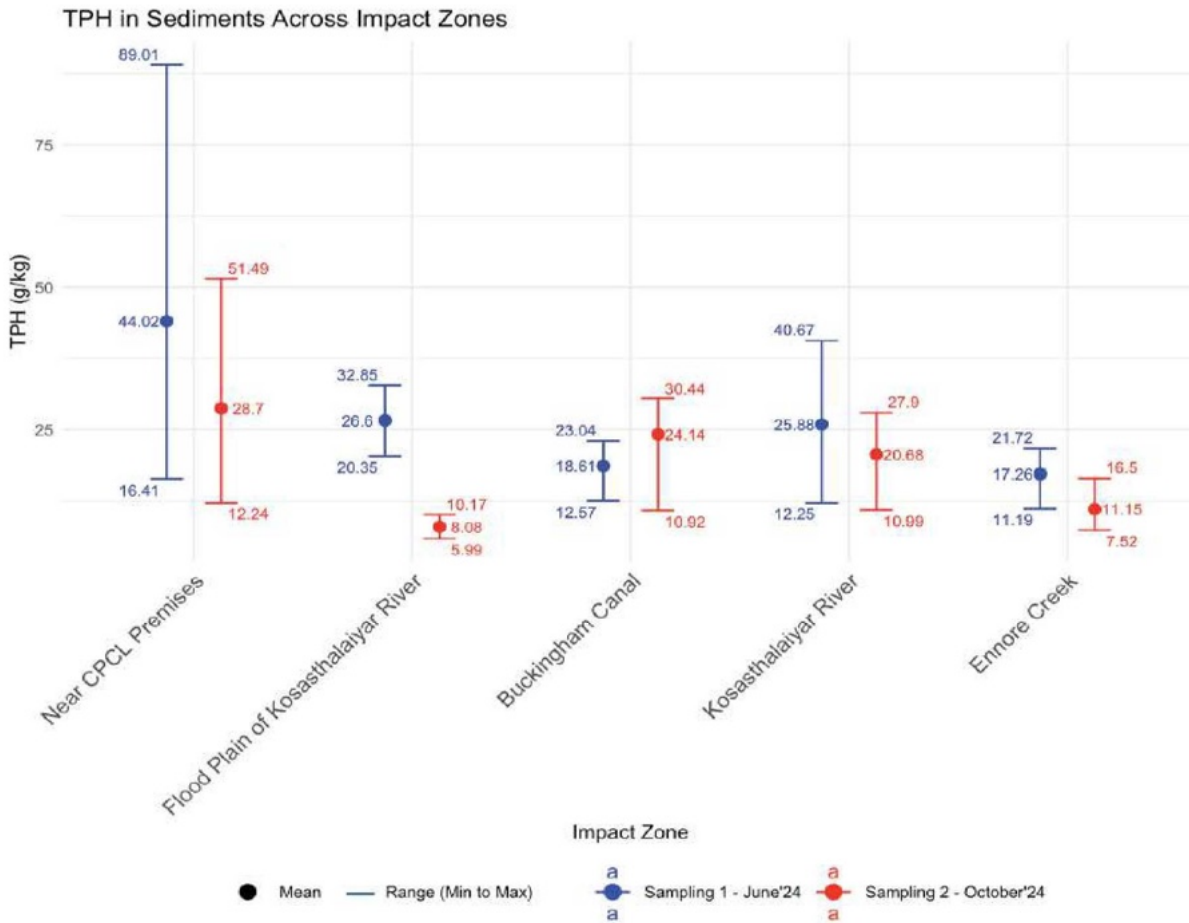
The data reveals that TPH concentrations in sediments remain significantly high across all impacted zones, extending to the creek, indicating persistent contamination. **The highest levels were recorded at L19, near the CPCL premises, with 89.01 g/kg in June 2024 and 51.49 g/kg in October 2024.** While TPH levels have decreased in certain areas between June and October, this reduction is not consistent throughout all locations. The continued presence of TPH after several months highlights that surface-level cleanup efforts were inadequate in addressing deeper sediment contamination. Unlike water, sediments act as a repository for petroleum hydrocarbons, posing long-term ecological risks, which underscores the need for more comprehensive remediation strategies.

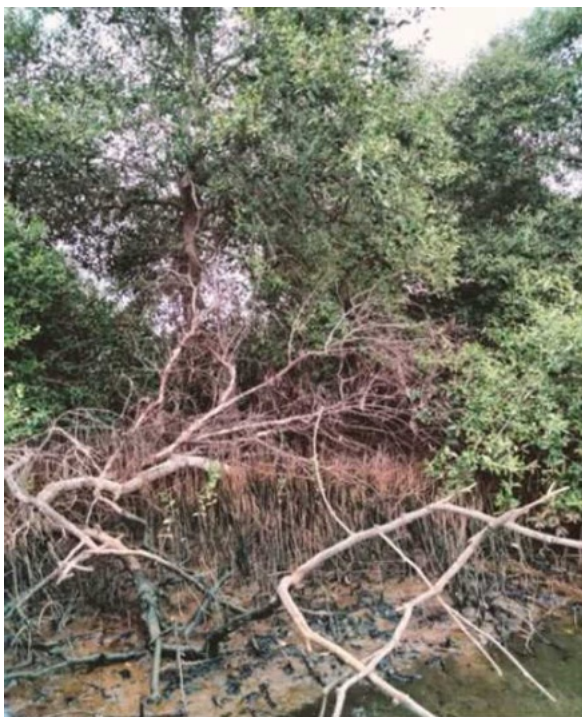
Black stains seen on pneumatophores in June 2024

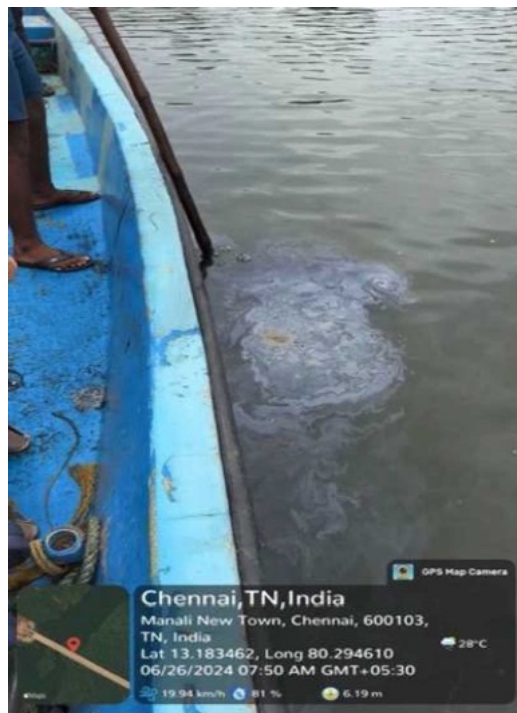
Oil sheen observed when the river sediments were disturbed

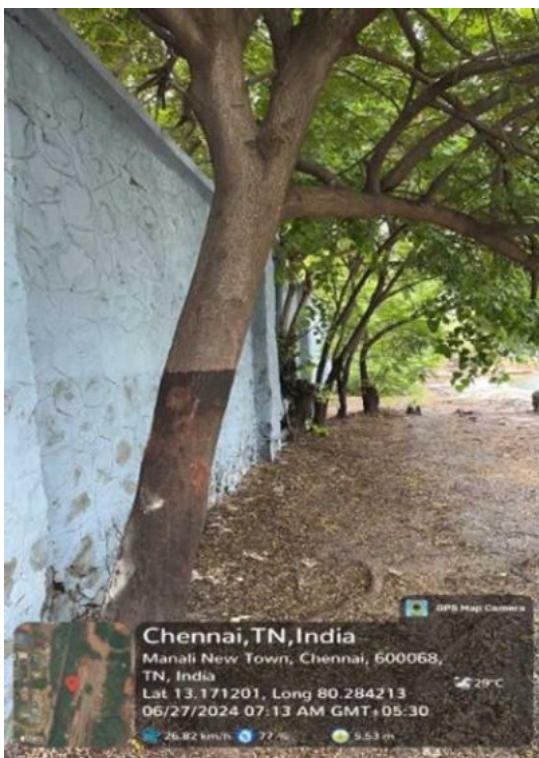
Oil stains seen on trees and walls near CPCL premises

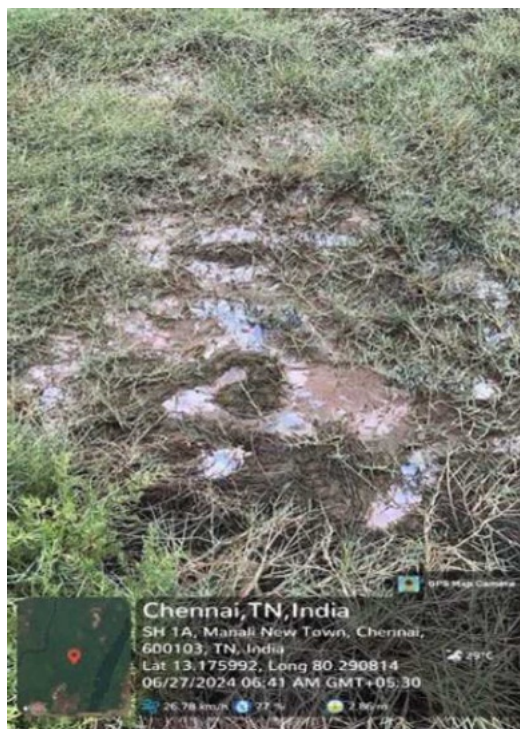
Oil sheen observed at Entry Point 1 - Storm water canal discharge into surplus canal of Kosasthalaiyar River in June 2024

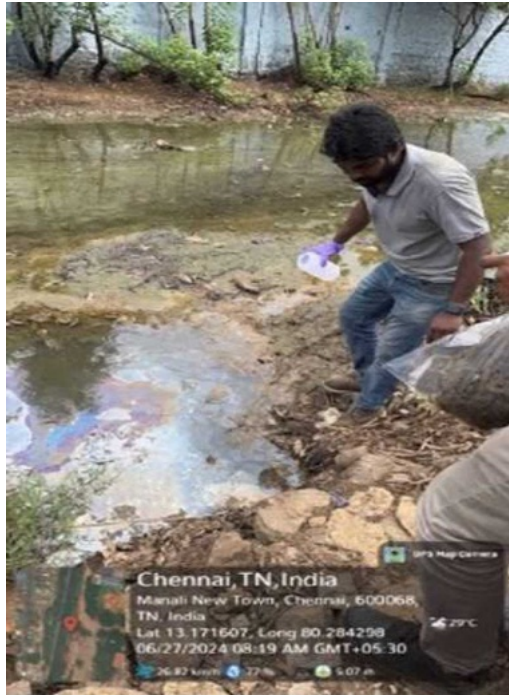
Oil sheen seen near storm water drain outlets near CPCL premises

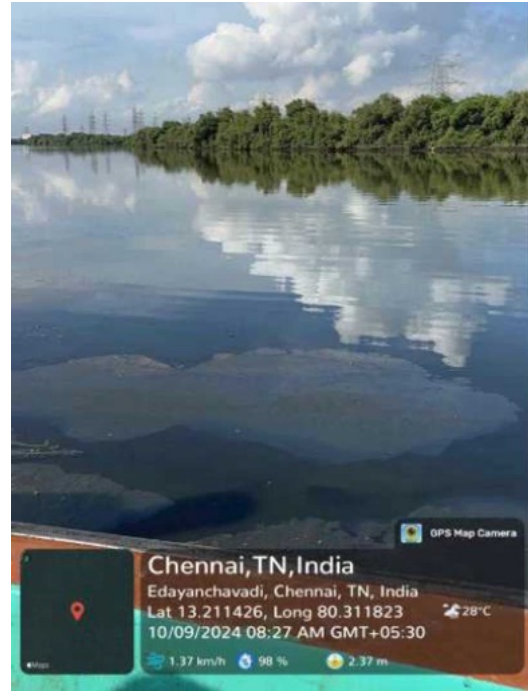
Oil sheen observed on Kosasthalaiyar river in October 2024

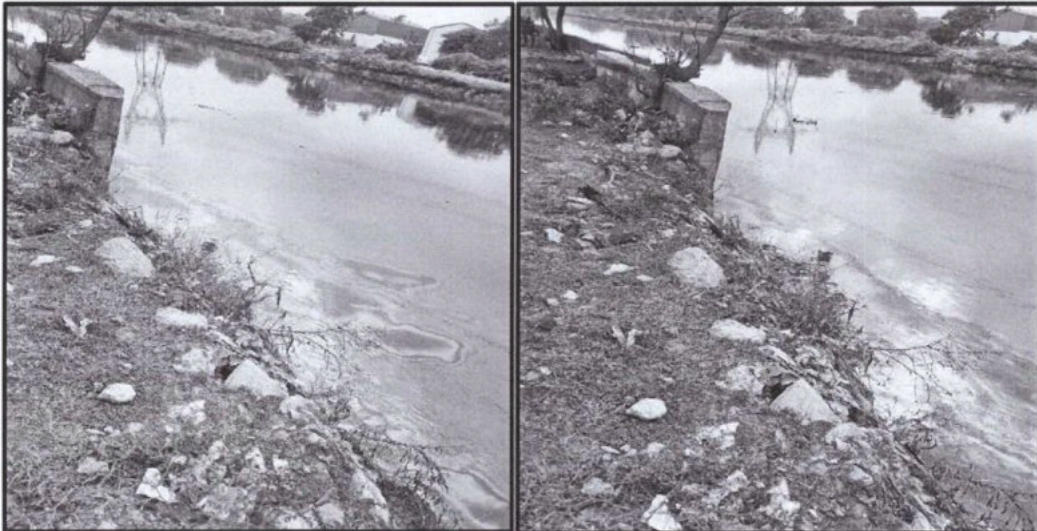
At this juncture, the team attempted to find out the source of the oil and found that, there was some stagnant storm water along with oil, adjoining the storm outlet near South Gate of Chennai Petroleum Corporation Limited, which slowly contributed to oil traces. However, it was observed that during inspection the stormwater coming out of the Chennai Petroleum Corporation Limited premises on the southern side was not found to have oil.

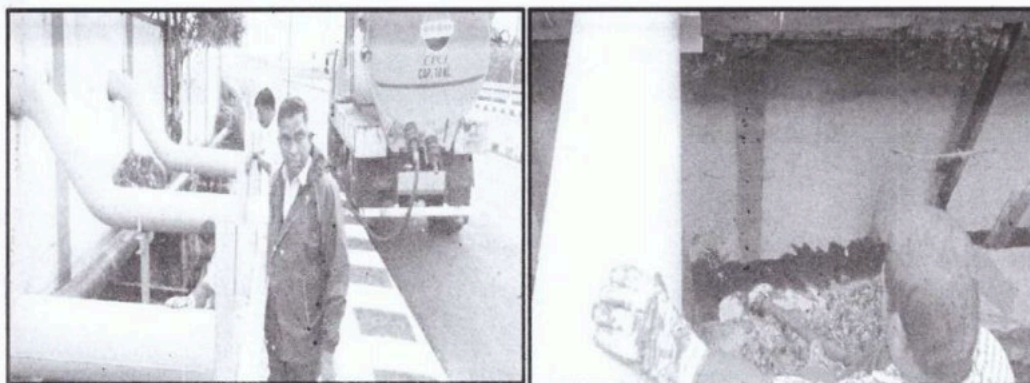
#### **Stagnated oil with storm water removal using Gully sucker**

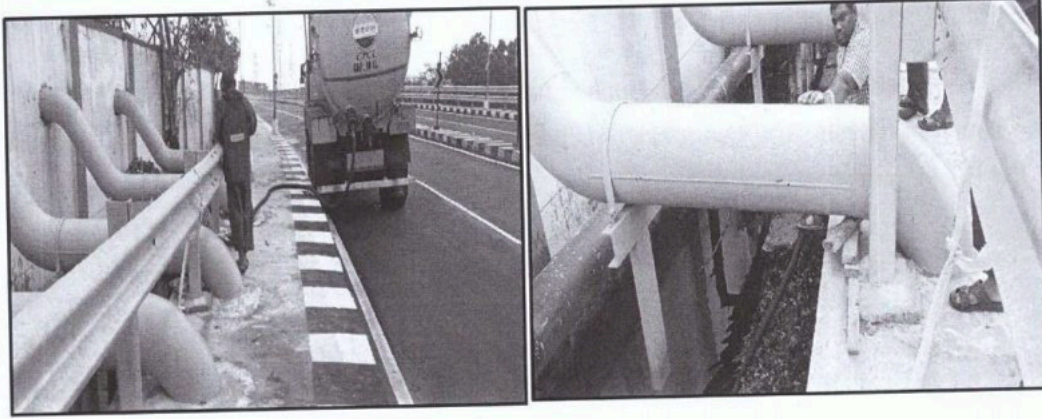
However, the inspecting team found that slight traces of oil is also found coming from the upstream of the Chennai Petroleum Corporation Limited from Kodungaiyur / Tondiarpet areas from Indian Oil Corporation Limited, Tondiarpet Terminal and container Terminal located along the Buckingham Canal at Korrukupet and Kodungaiyur areas.

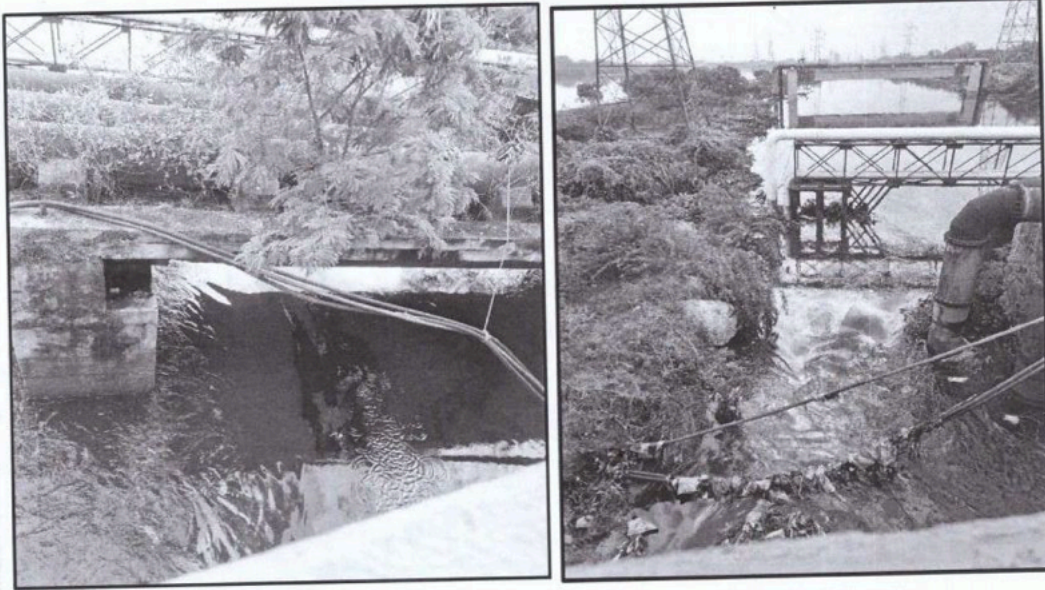
**Oil traces near Kodungaiyur IOCL, Container Terminal facility**

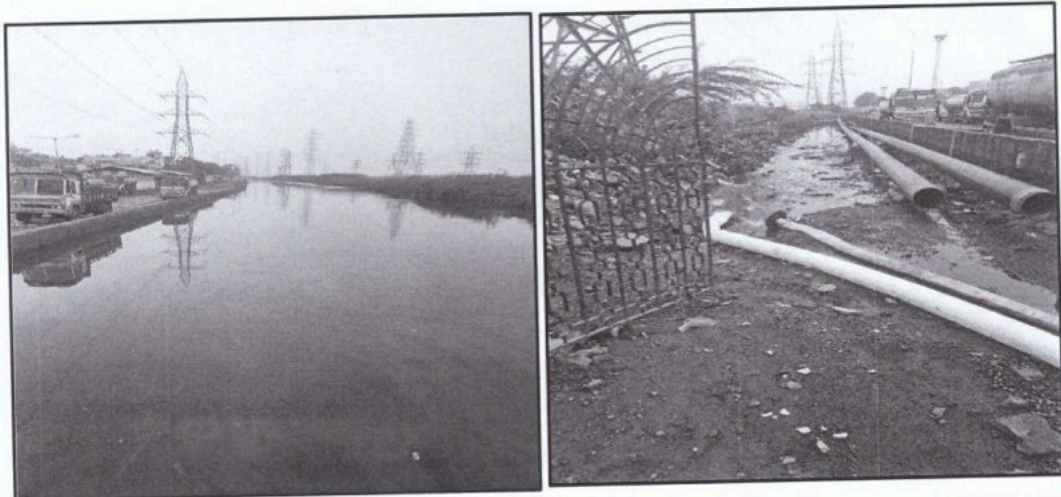
The team felt mild oily odour during the afternoon, when the climate was sunny, due to the volatilization of the hydrocarbon present in the oil traces. However, the same subsided in the evening.
