ORIGINAL APPLICATION NO. 180 OF 2023(SZ)

**TERI REPORT FILED BY 7th RESPONDENT -
CHENNAI PETROLEUM CORPORATION LIMITED**

**Assessment of environmental quality of oil spill
contaminated sites in and around Buckingham Canal to
the Ennore Creek aftermath of floods due to Cyclone
Michaung**

Chennai Petroleum Corporation Limited (CPCL), Chennai

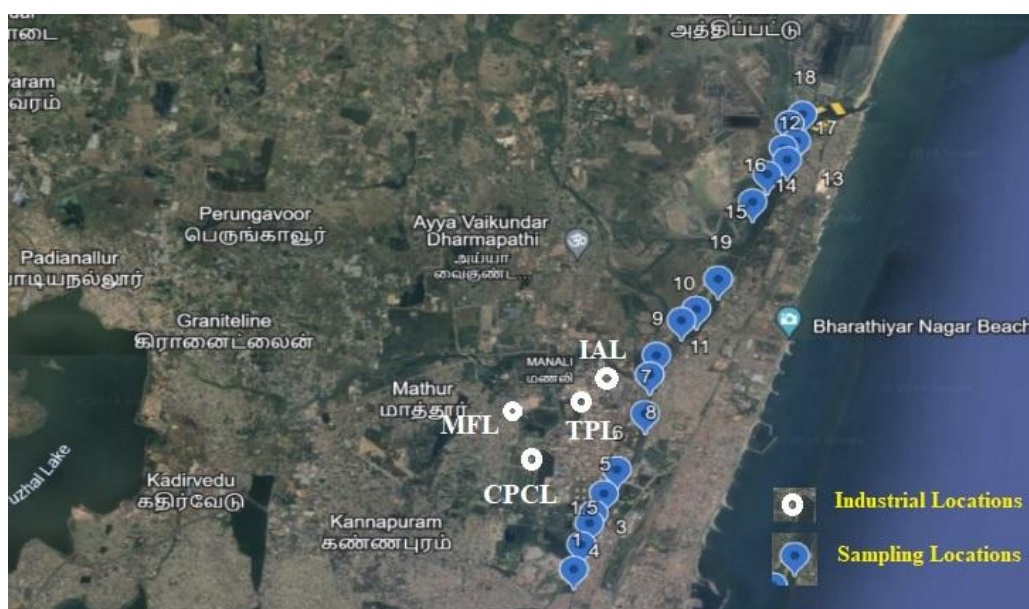
Fig. 6 Location showing on-site dissolved oxygen measured

Sampling Locations	DO (mg/L)	Site	DO (mg/L)
1	0.12	12	0.35
2	0.23	13	0.45
3	0.43	14	0.023
4	0.04	15	0.023
5	0.54	16	0.023
6	0.14	17	0.023
7	0.60	18	0.023
8	0.08	P1	1.34
9	0.05	P2	4.76
10	0.53	P3	3.87
11	0.46
