BEFORE THE HON'BLE NATIONAL GREEN TRIBUNAL,
SOUTHERN ZONE- CHENNAI
O.A NO. 180 of 2023
AND
O. A NO.183 OF 2023

Tribunal on its own motion SUOMOTU based
on the Visual media titled Chennai Rains
Makkalai Vathaikkum Oil Companies-
Shocking Story - Michaung Ground Report
covered by on VIKATAN TV Chennai
dt.06.12.2023

**ASSESSMENT OF ENNORE OIL SPILL DURING
MICHAUNG CYLCONE**

**Environment Engineering Division
Department of Civil Engineering
Indian Institute of Technology Madras, Chennai – 600036**

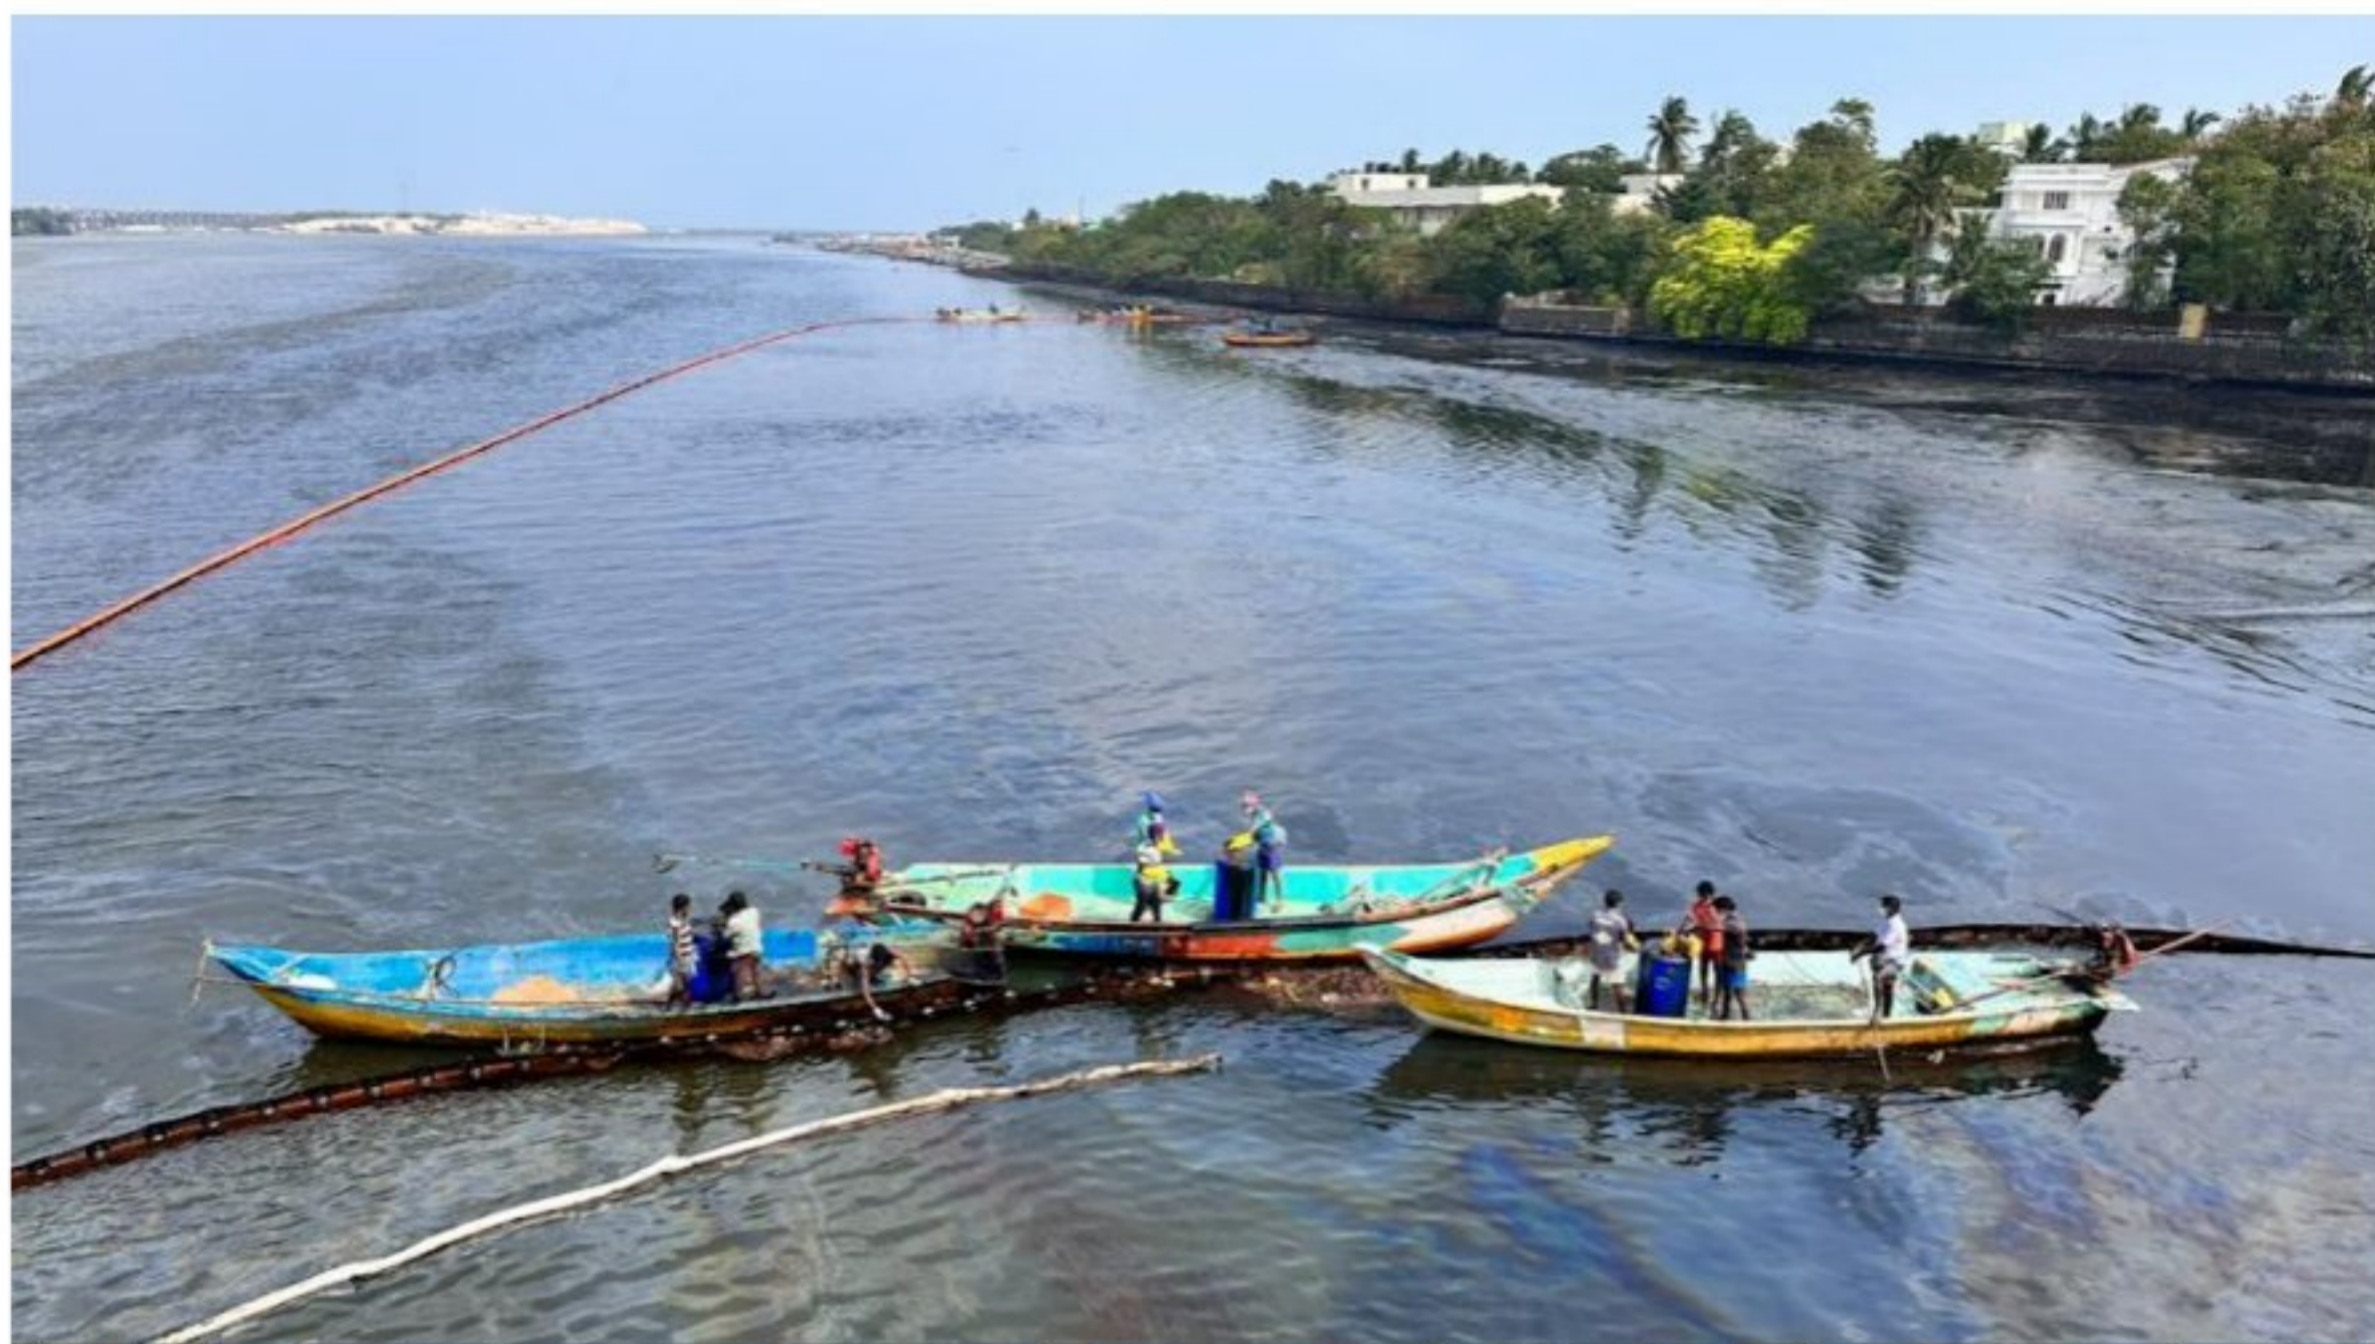
Figure 1: Oil spread near Ennore railway bridge

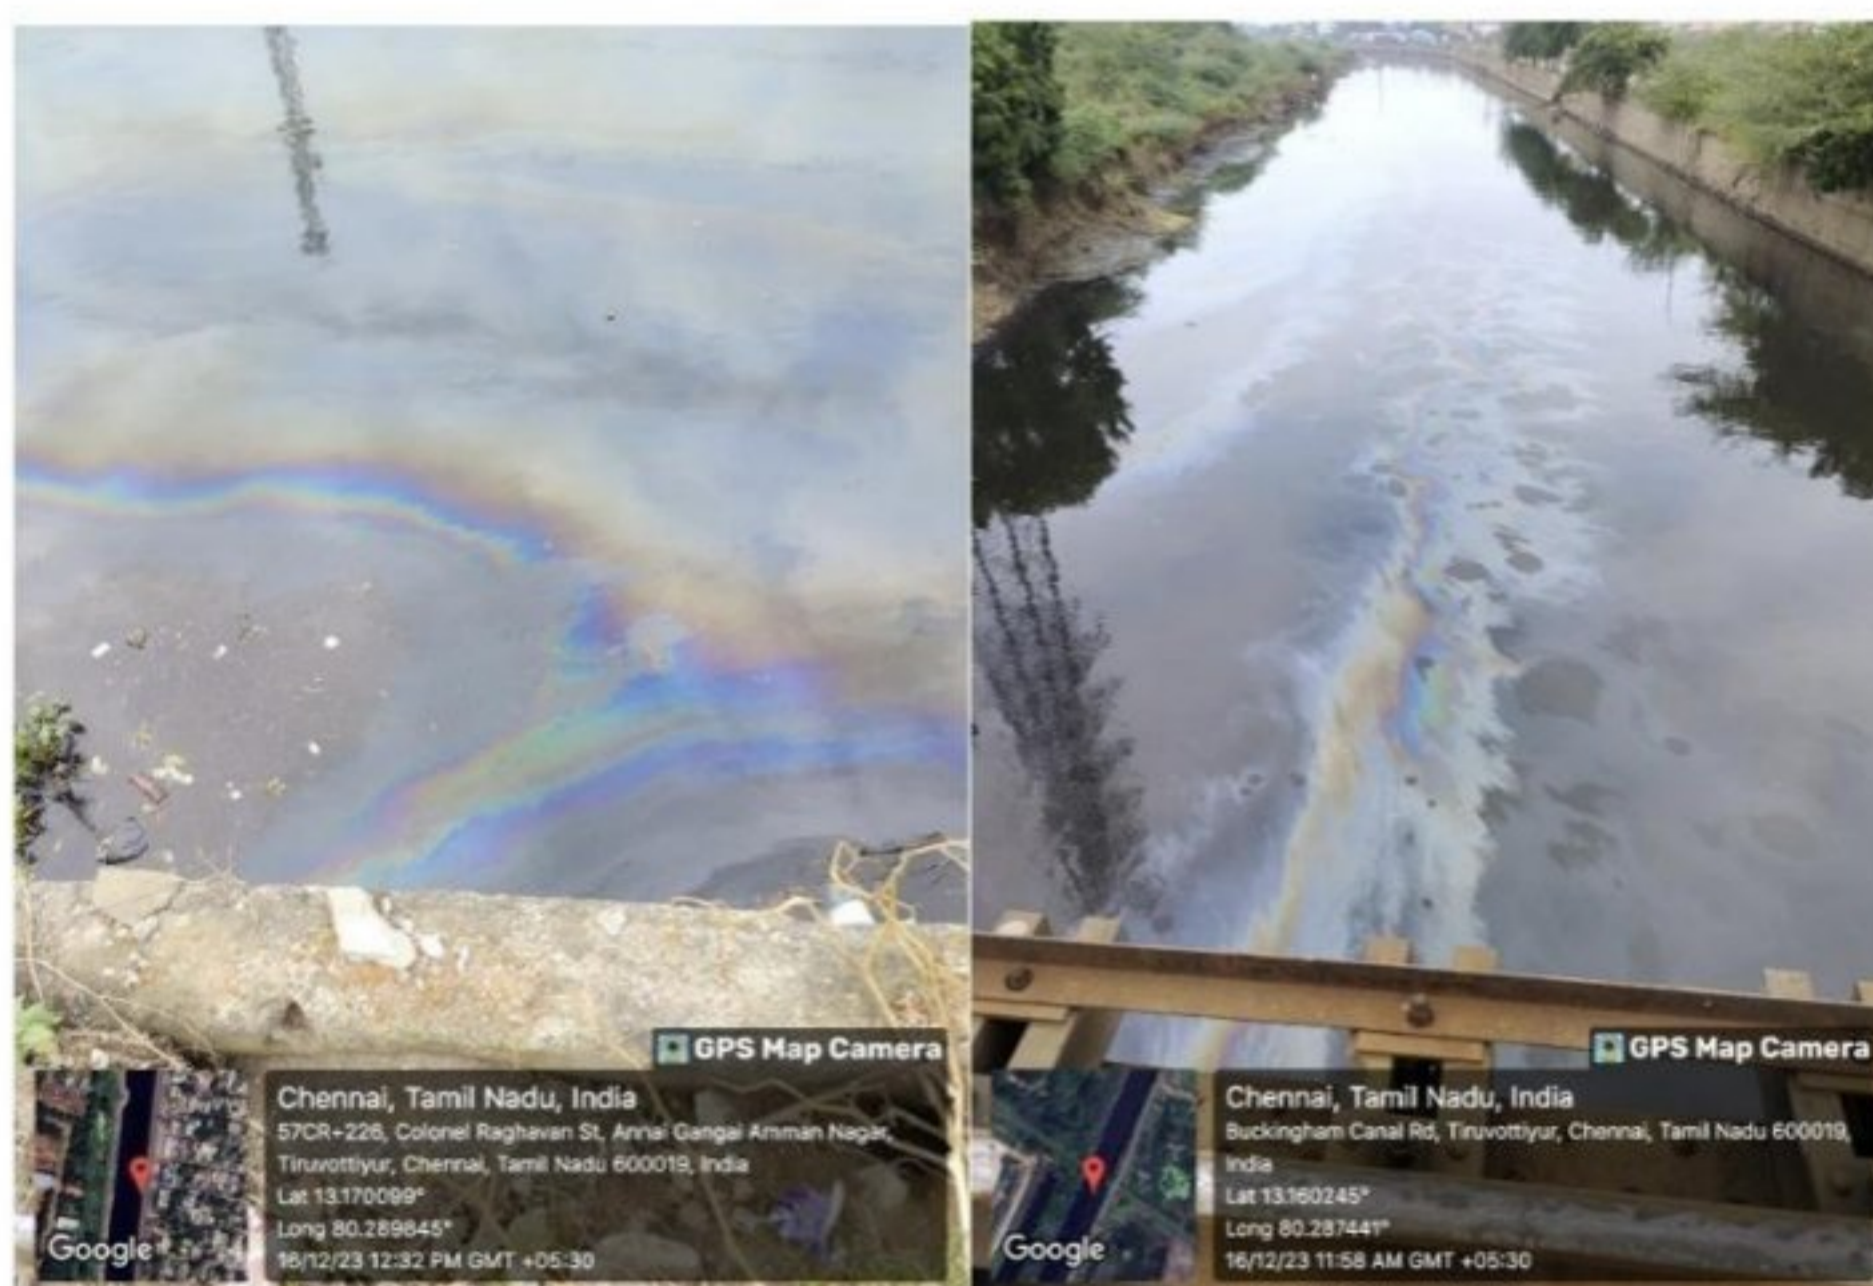
Figure 2: Oil contamination in Buckingham Canal

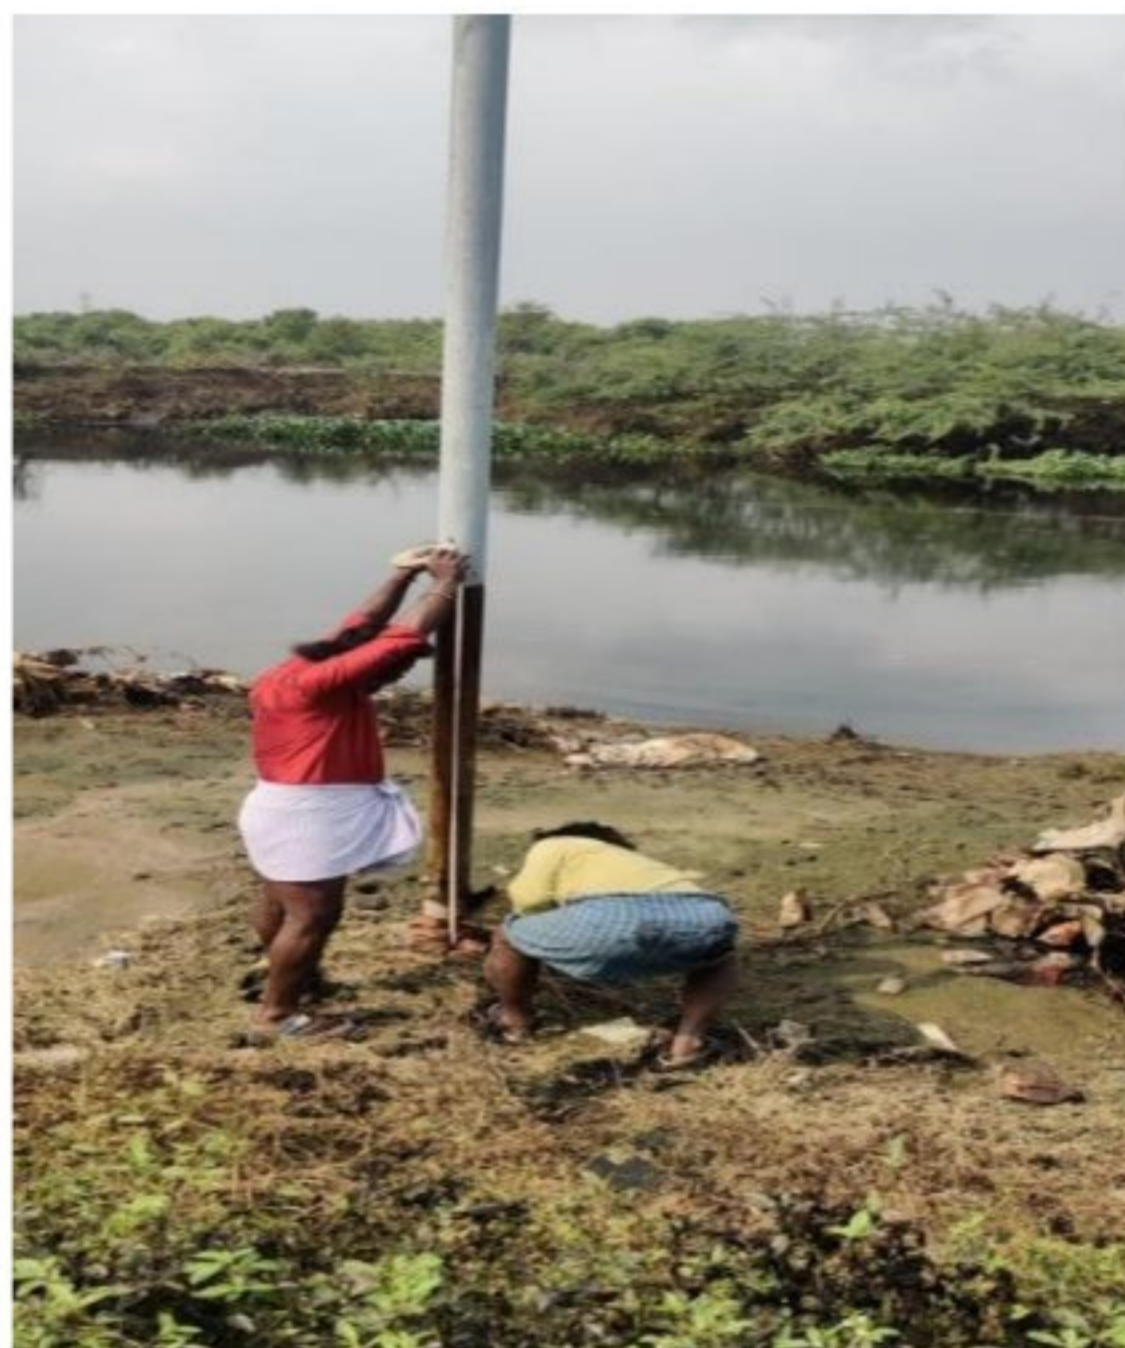
During the flood event, B Canal experienced overflow of oil mixed water, inundating the residential areas of Ernavoor (Zone 11). Lamp posts positioned within the residential vicinity along the B Canal exhibited signs of oil spillage, while flood-affected houses showed oil stains on their walls, reaching heights of 5 to 6 feet. The overflowing oil mixed water adversely affected vegetation, residential buildings, vehicles, and the open wells that serve as sources of groundwater. The field images below provide visual representation of the extent of oil contamination within the residential zones of Ernavoor.

Figure 5: Highest oil mixed water level 7.5 feet above normal water level during the cyclone

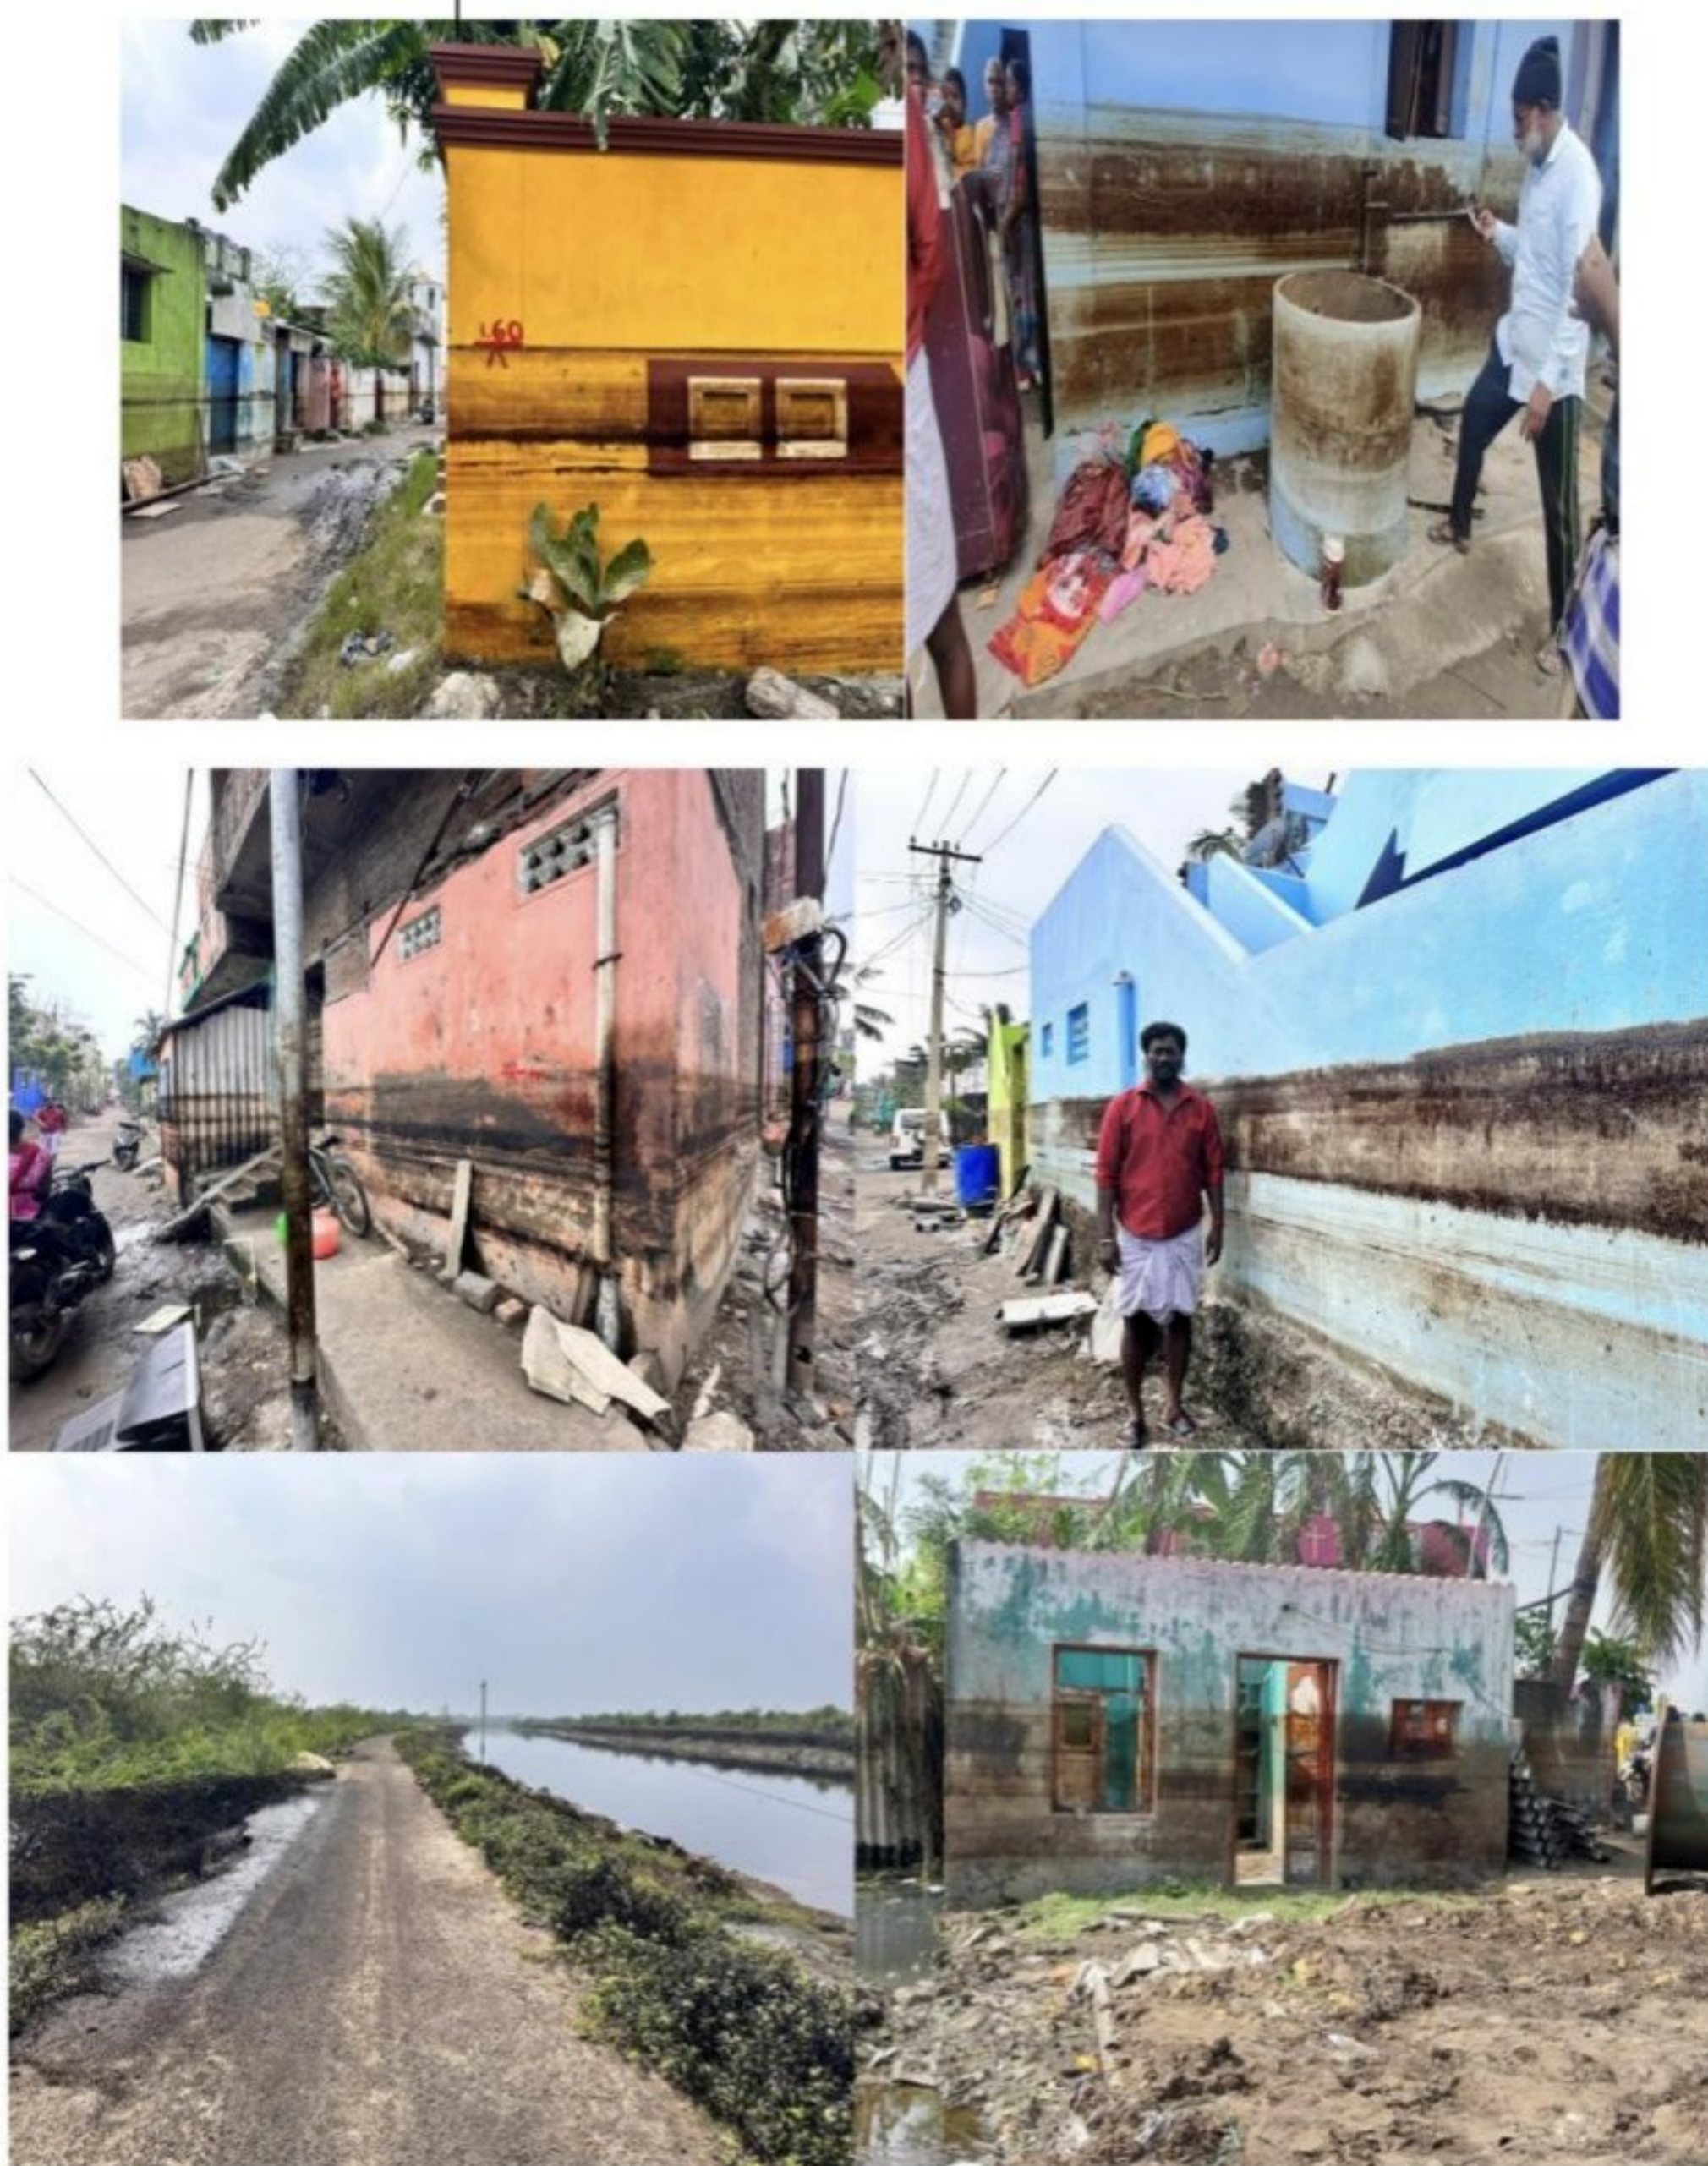
Figure 7: Oil marks observed in the residential localities of Ernavoor.

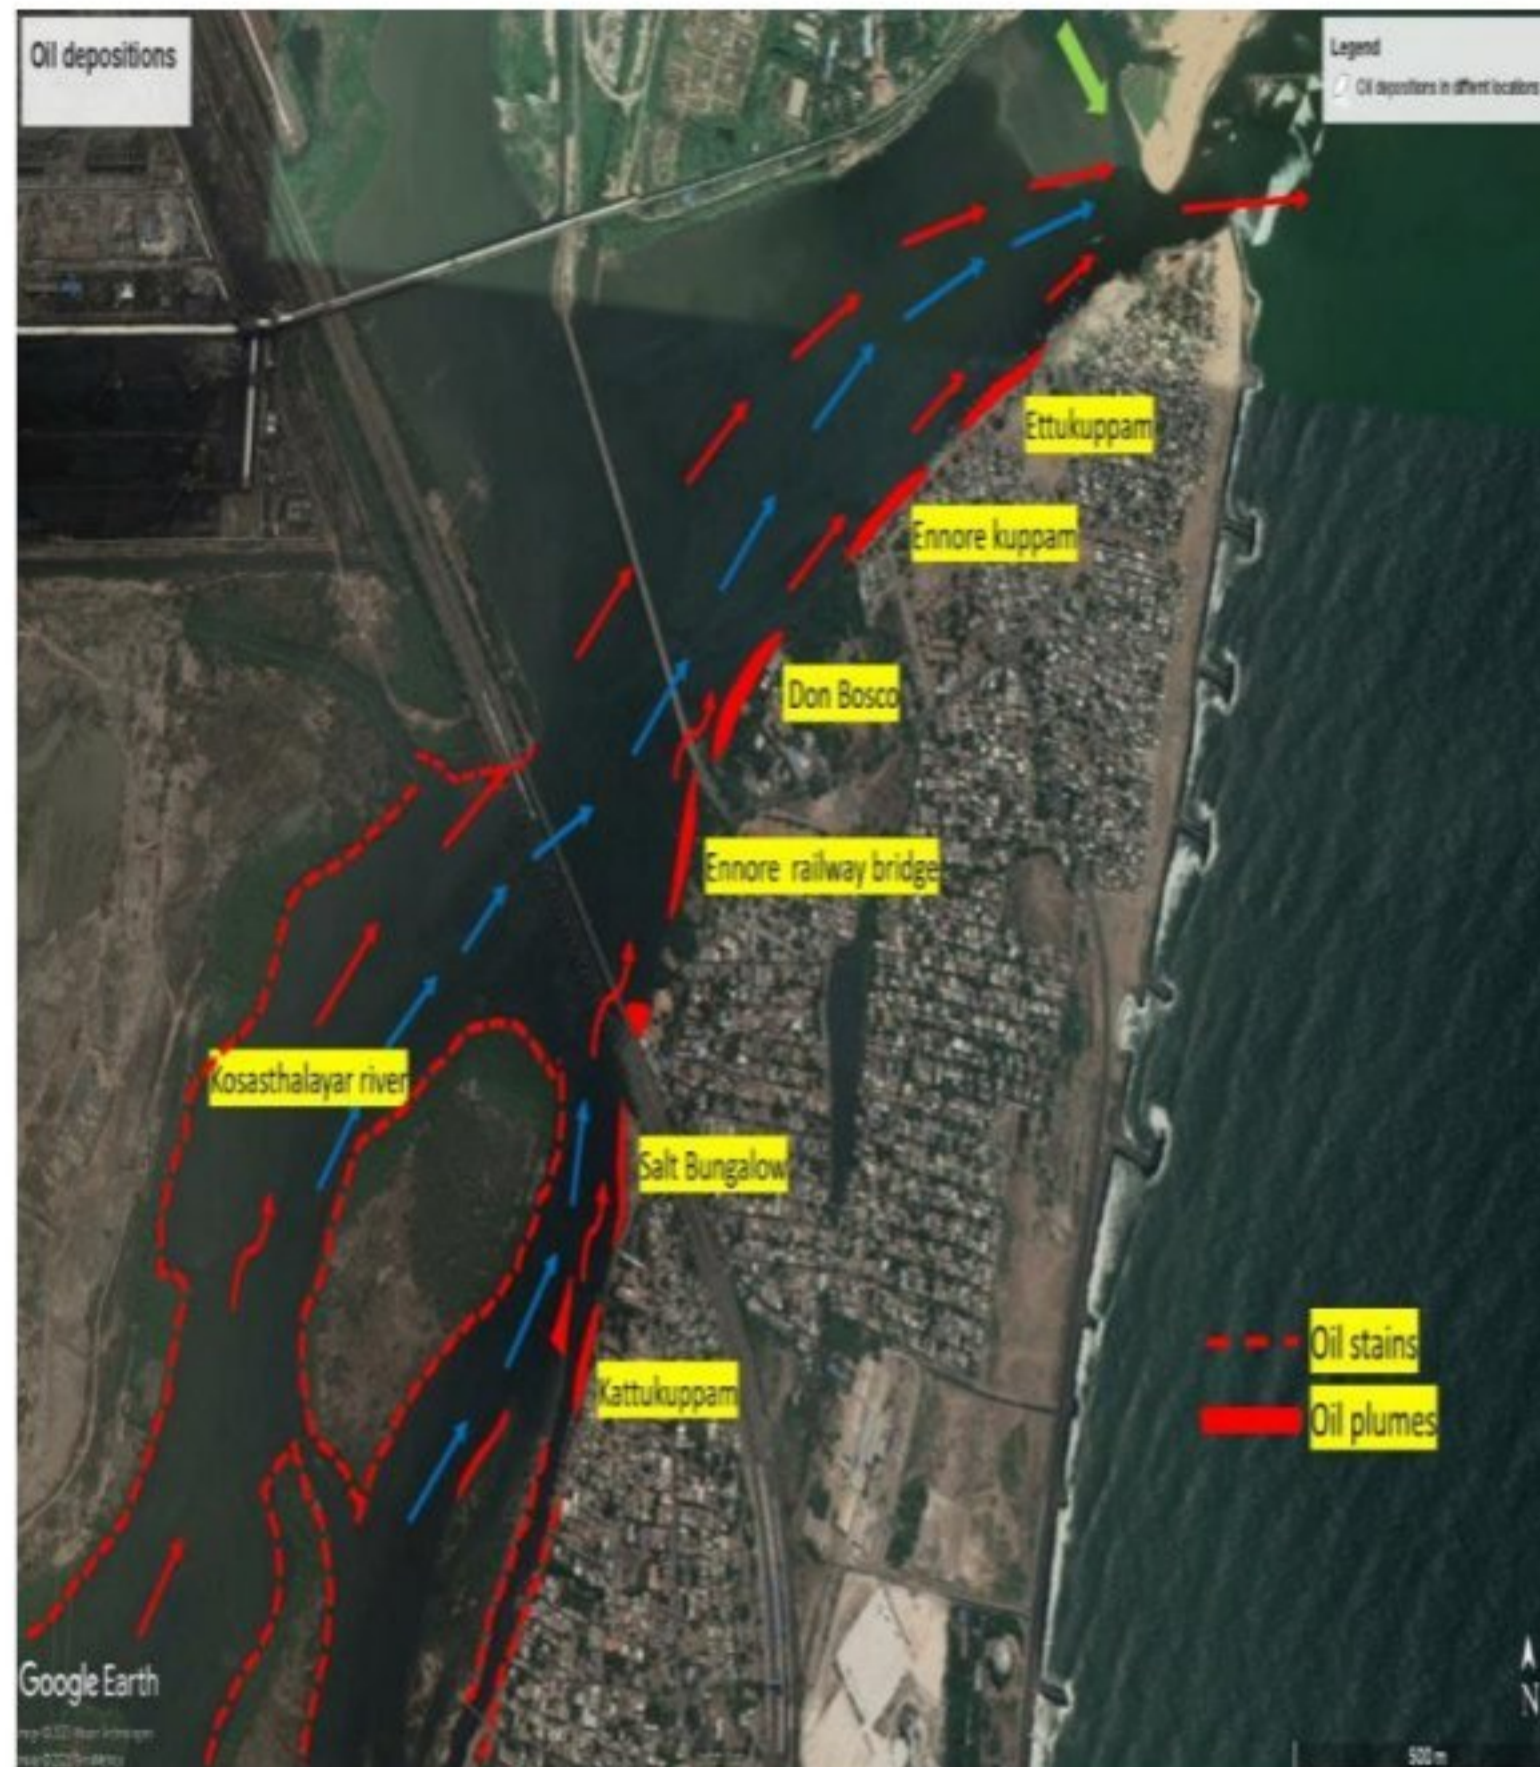
Figure 8: Assessment Region 1 - Downstream from ETPS to Creek Area

The depicted figure illustrates the flow of oil, represented by red arrows, along the B Canal and K River after the floodwaters receded. Dotted lines signify the presence of oil stains along all banks of these water bodies and islands. Hotspots, where substantial oil deposits occurred, are highlighted as red patches along the eastern banks of the Creek, extending from Kattukuppam to Nettukuppam.

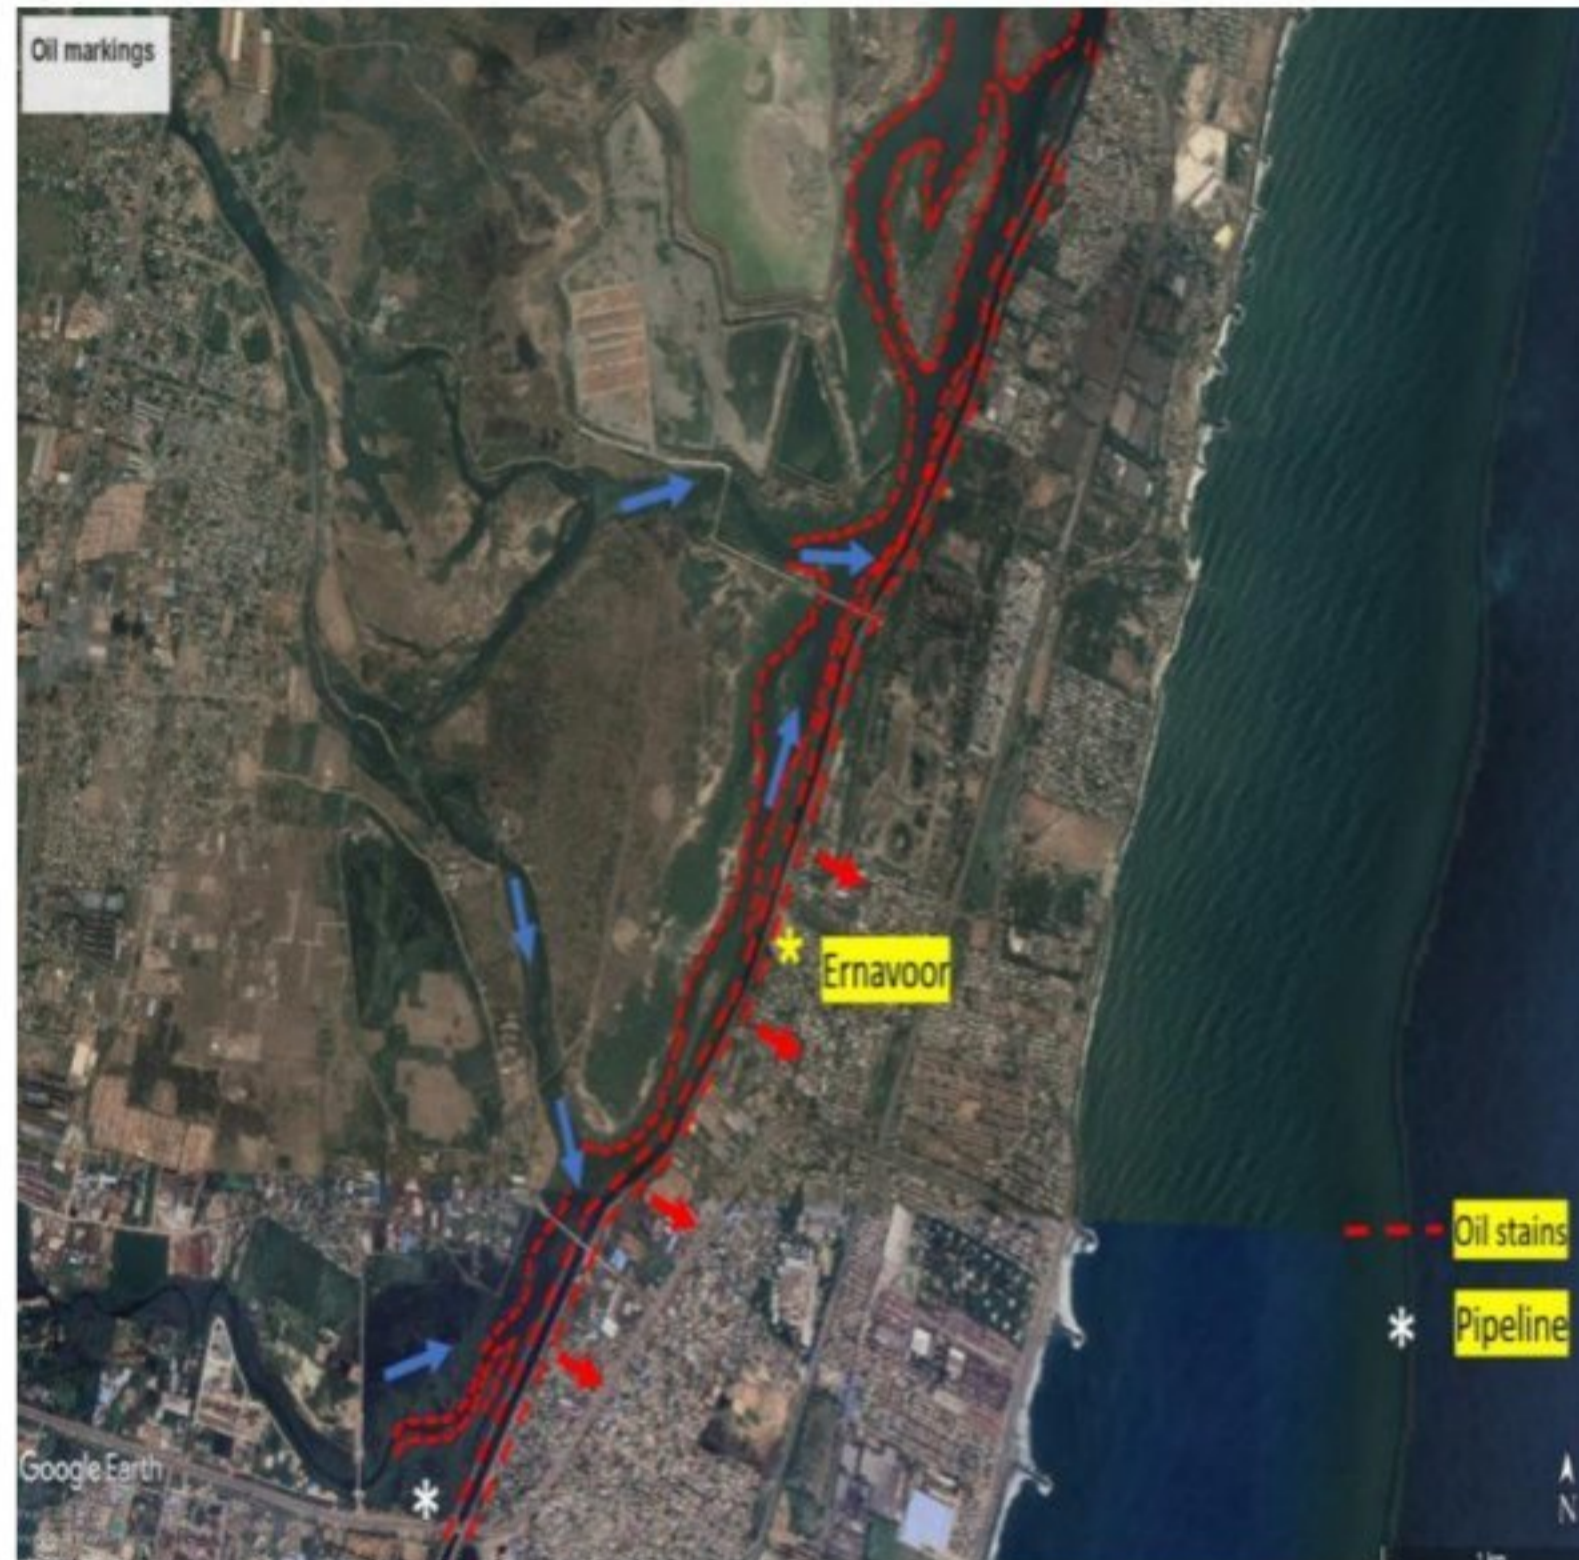
oil with it, over the B Canal bank into the adjoining residential and industrial areas of Ernavoor and Sathyamoorthy Nagar. Once the flood water/surplus water receded, the oil must have flown downstream into the Kattukuppam all the way to Nettukuppam.

Figure 9: Assessment Region 2 - Midstream From ETPS to Manali High Road Bridge

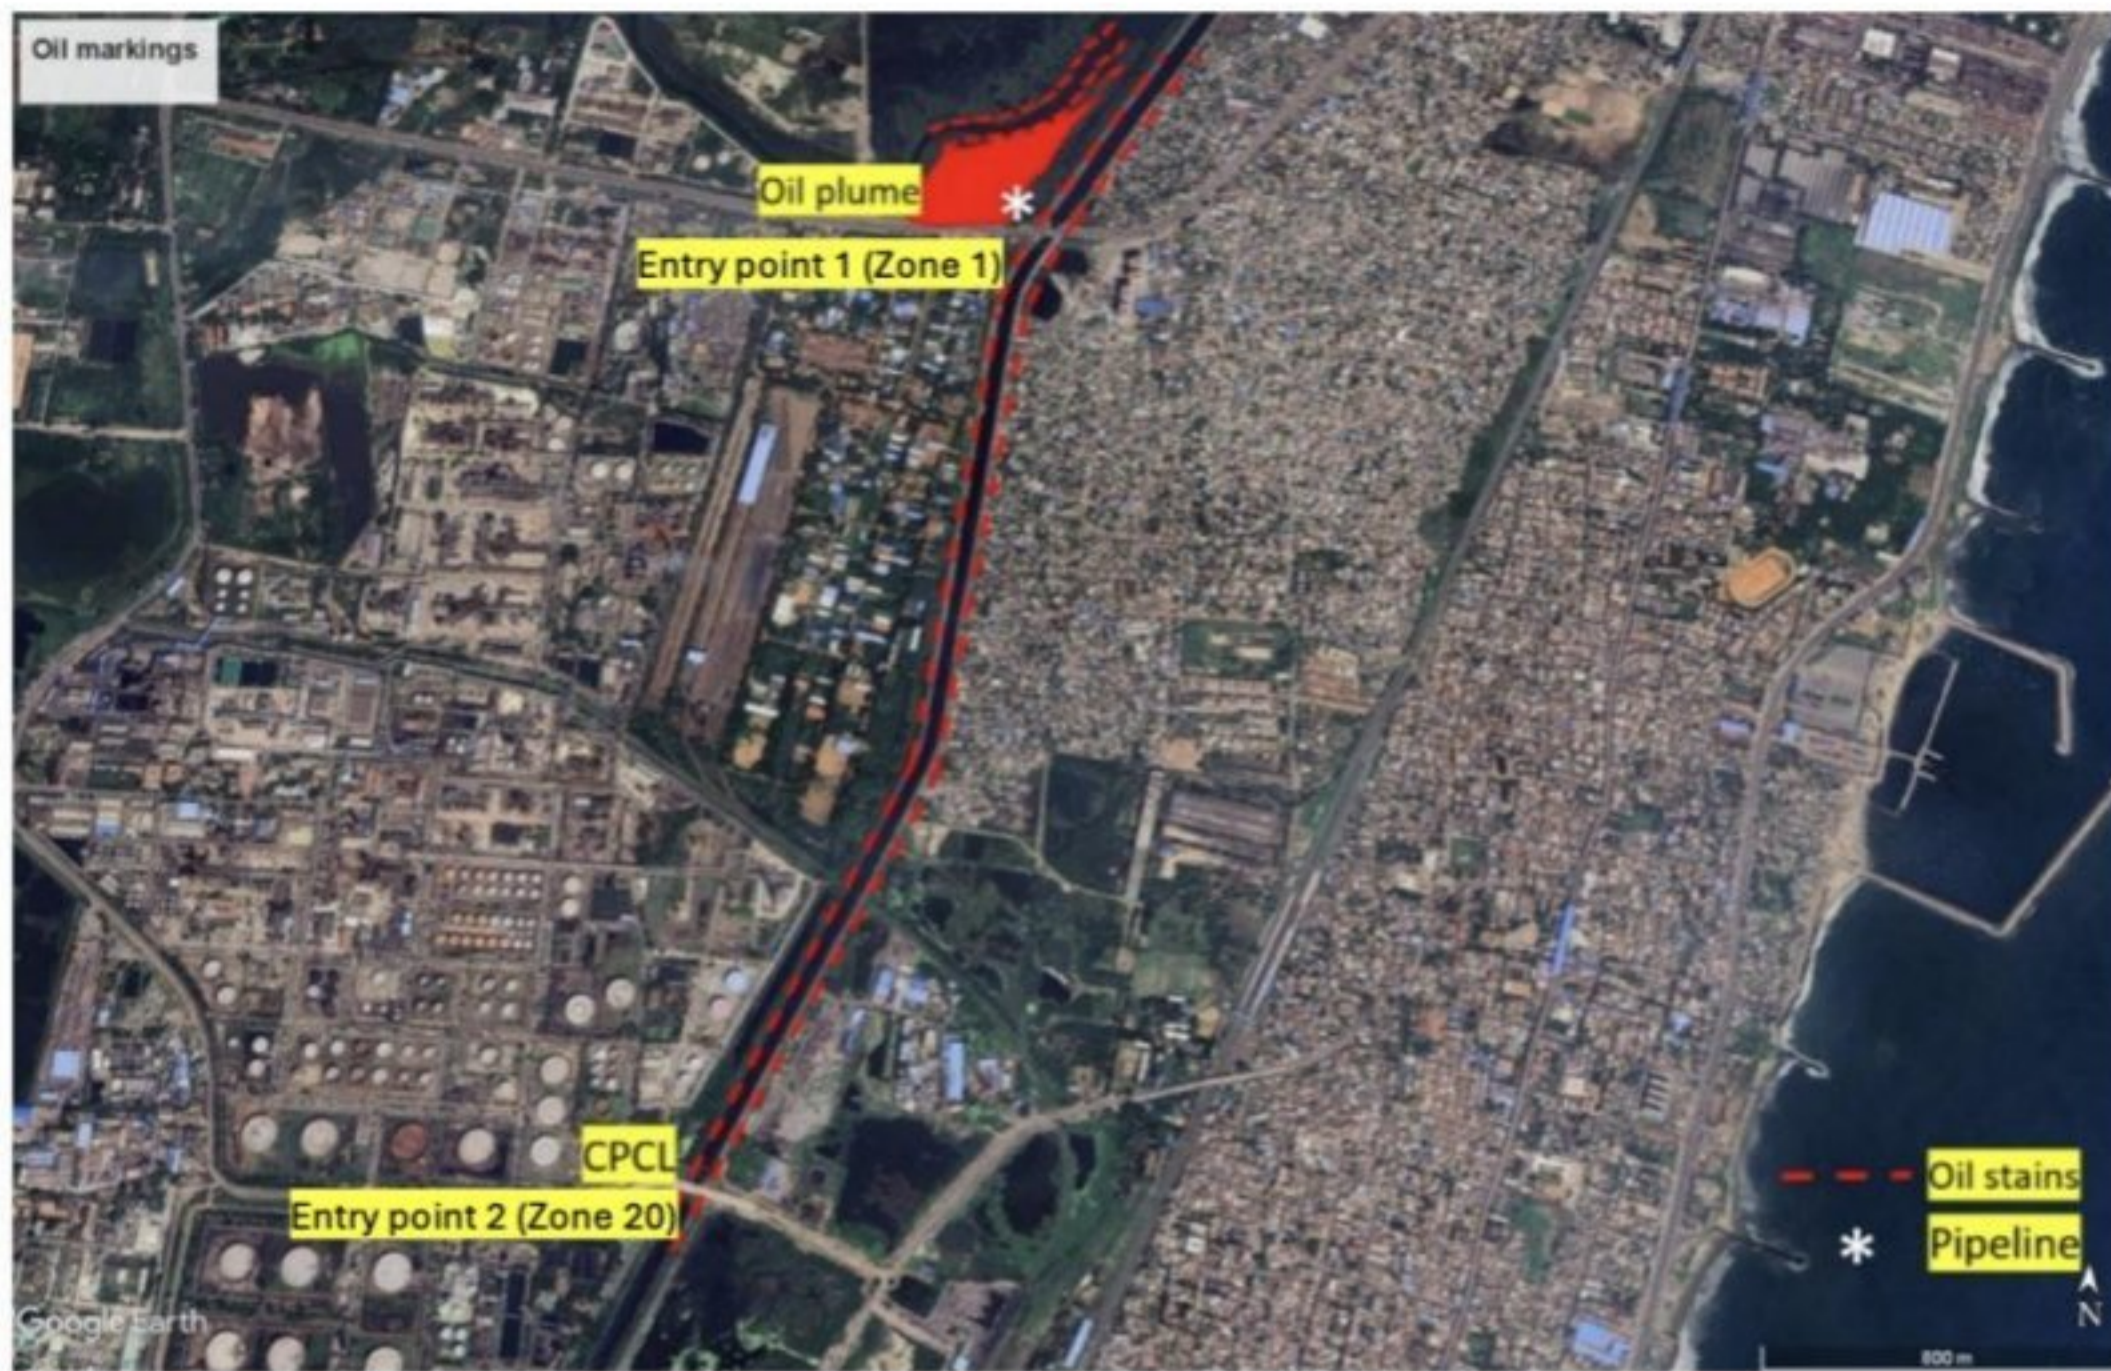
Two oil discharges from the M/s CPCL stormwater drain have occurred in the locations: one in the south (entry point 2), directly into the B Canal, and another in the north (entry point 1), flowing through the stormwater drain adjacent to India Additives, into the flood plains of K river (Zone 1 indicated by the large red patch). Stormwater drains within M/s CPCL were tracked, revealing breaches in the outlet and walls, with all drains and tanks heavily stained with oil. Numerous open oil-water collection tanks were present at ground level, lacking preventive measures to contain oil during flooding or to prevent its escape from the premises.

Figure 10: Assessment Region 3 - Upstream of B Canal from Manali High Road to Kodungaiyur showing the entry point of oil into the Buckingham Canal and Kosasthalaiyar River

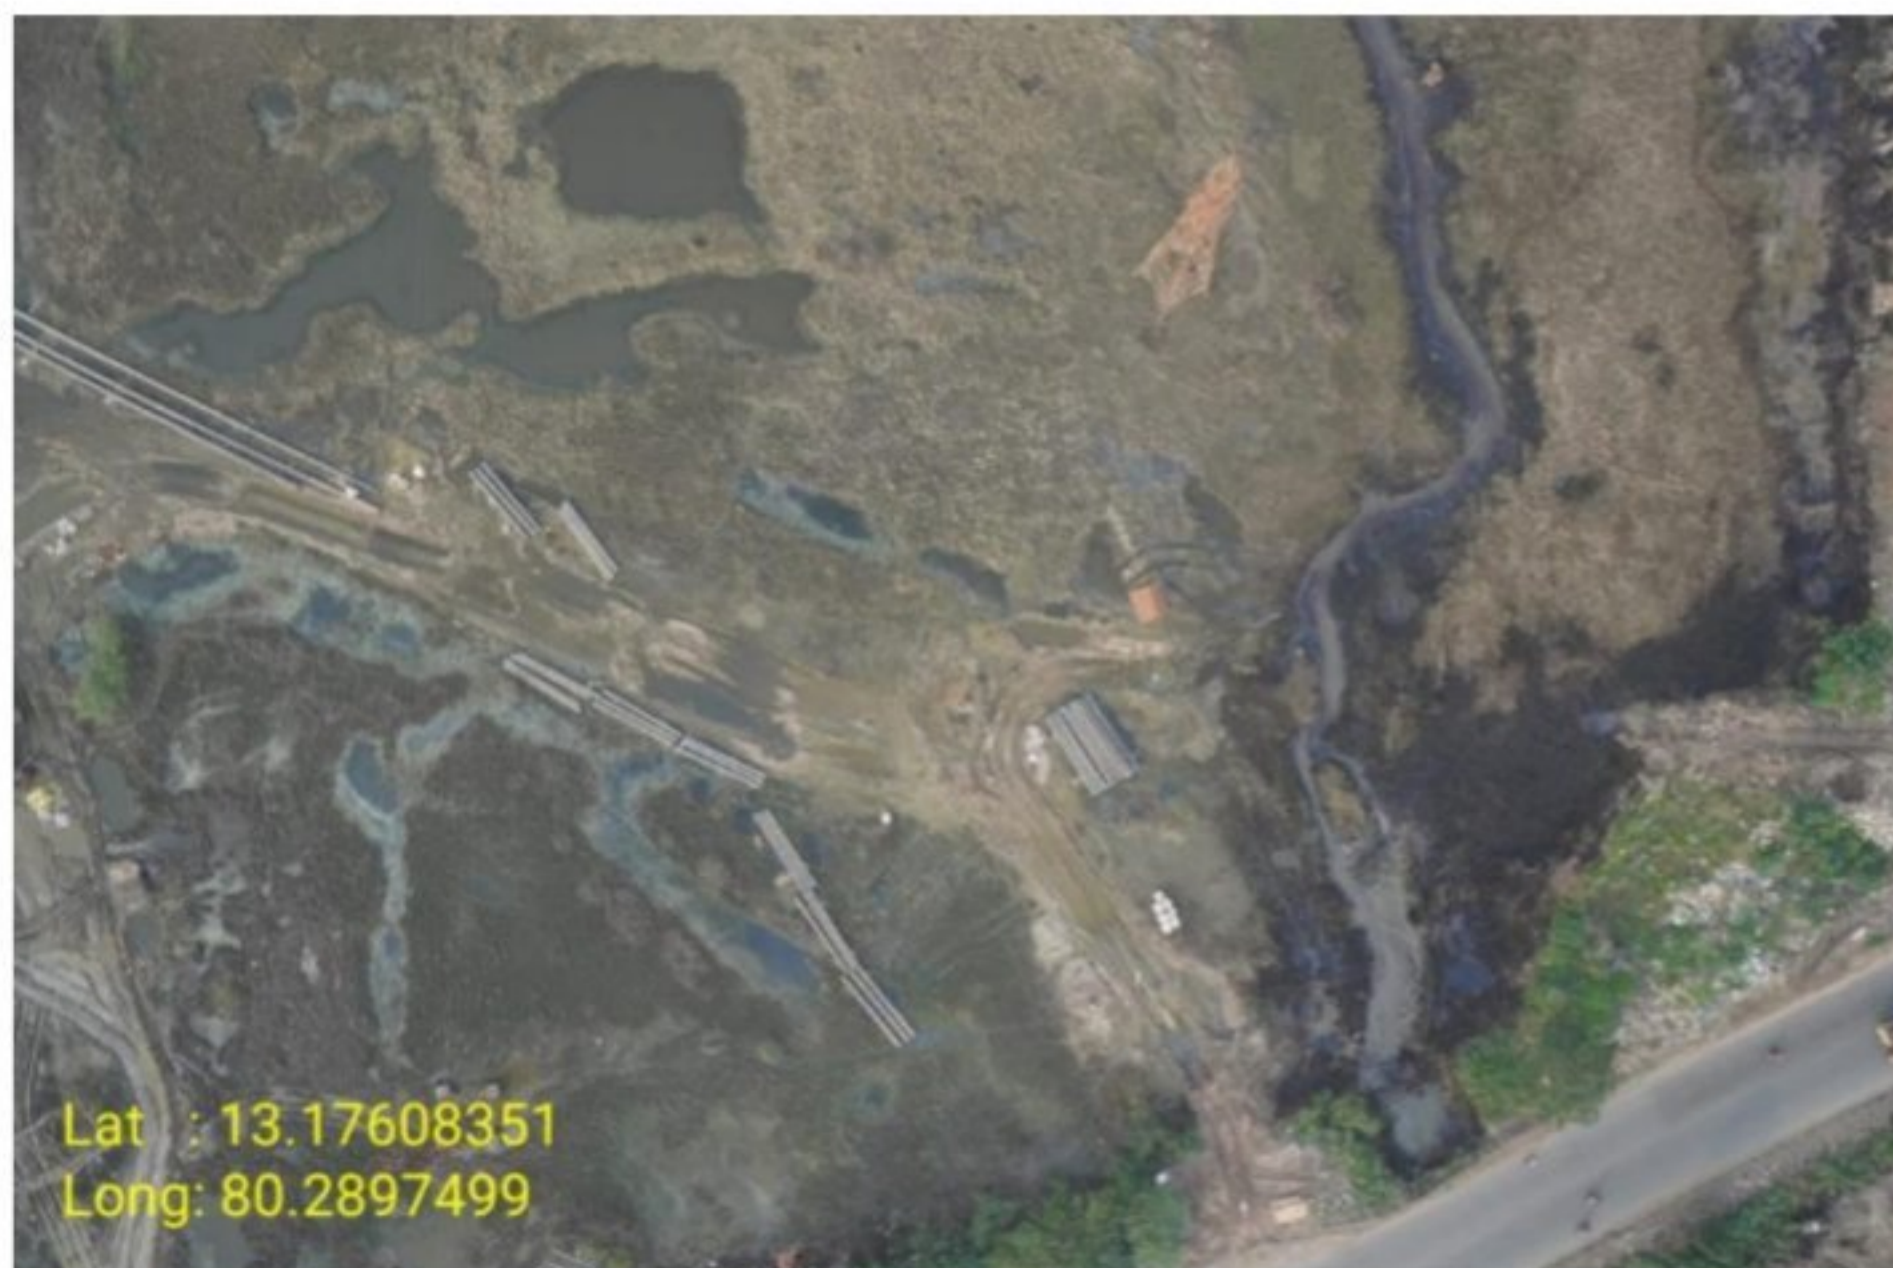
The soil samples collected at Zone 1 had oil markings present up to 2m (max.) depth from the surface. This may have long-term impacts on the region as it is mostly an unconfined aquifer where there are possibilities of contamination of the ground water.

Figure 11: Drone image of Zone 1
