BEFORE THE HON'BLE NATIONAL GREEN TRIBUNAL,
SOUTHERN ZONE- CHENNAI
O.A NO. 180 of 2023
AND
O. A NO.183 OF 2023

Tribunal on its own motion SUOMOTU based
on the Visual media titled Chennai Rains
Makkalai Vathaikkum Oil Companies-
Shocking Story - Michaung Ground Report
covered by on VIKATAN TV Chennai
dt.06.12.2023

**ASSESSMENT OF ENNORE OIL SPILL DURING
MICHAUNG CYLCONE**

**Environment Engineering Division
Department of Civil Engineering
Indian Institute of Technology Madras, Chennai – 600036**

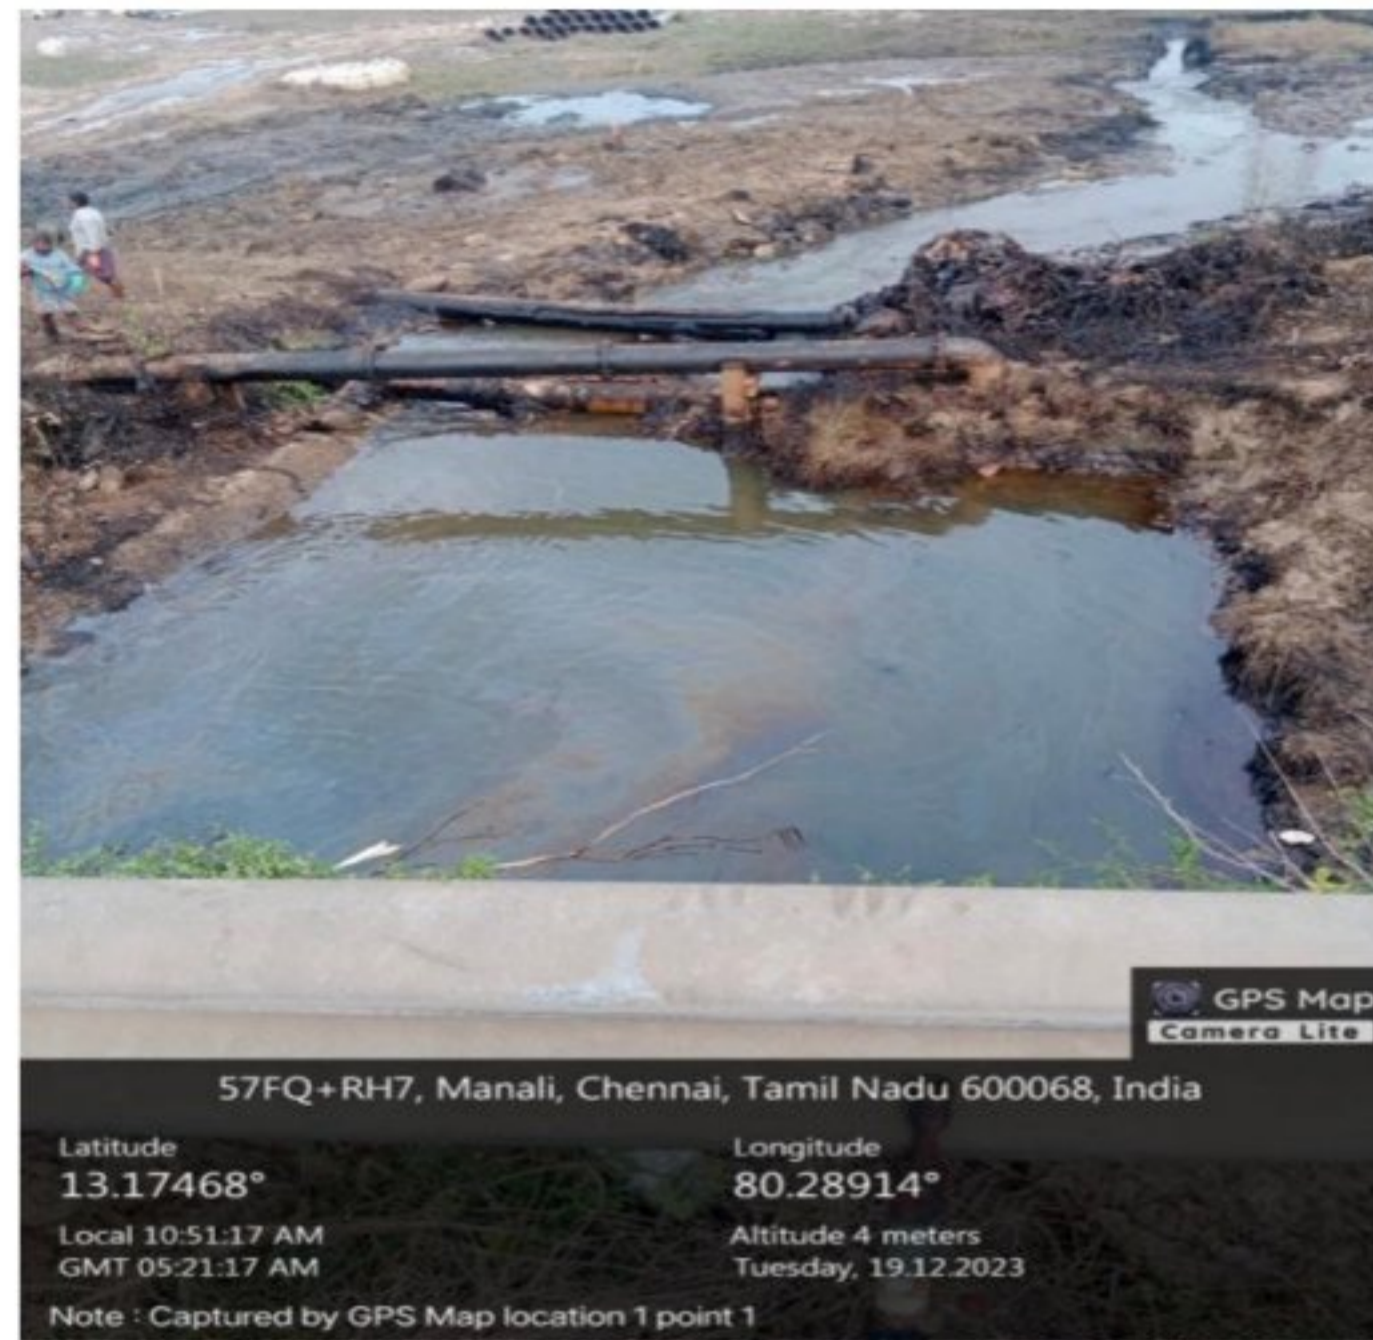
Figure 12: Close up view of Zone 1

Verified through drone camera images, the dark patches in the above image signify the presence of oil pools surrounding the stormwater outlets flowing towards the K River. Extensive sampling of soil and water at this contaminated site revealed high oil content. Upstream from this contaminated site, deposits of oil-contaminated sludge are still present, likely resulting from backflow from this leakage point. However, no significant oil spill or sludge deposition was observed beyond 100 meters from this location, indicating that Zone 1 is likely the initial point of oil spillage or the source itself.

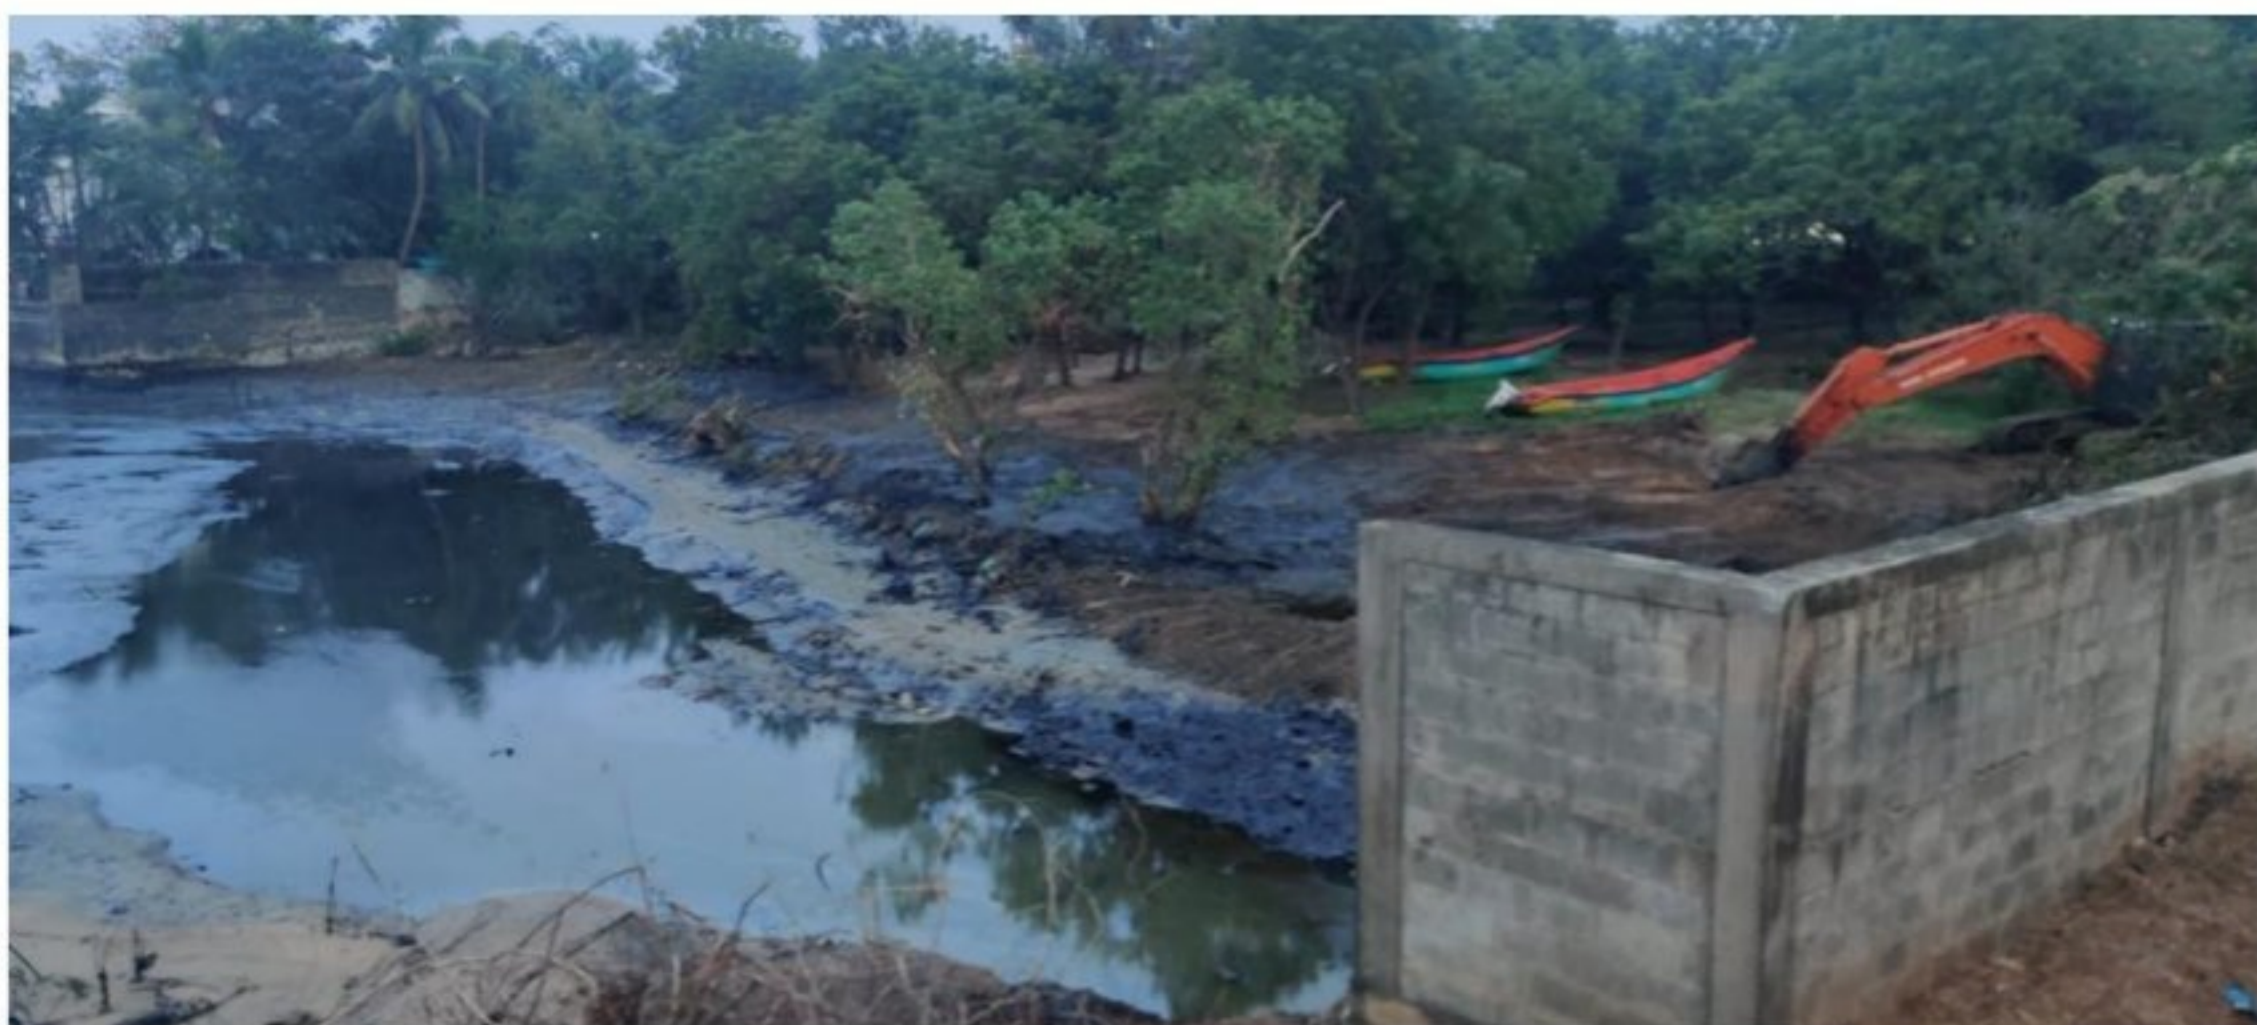
Figure 13: Earth moving machinery at the oil spill site

Numerous earthmoving machines were on-site (Figure 13), along with several laborers tasked with covering the oil stains in the floodplain. Arrows pointing towards the two locations in the Buckingham Canal (Figure 14) distinctly indicate that the bund has been reworked following the oil spill, with one section appearing clean and the other section visibly stained with oil.

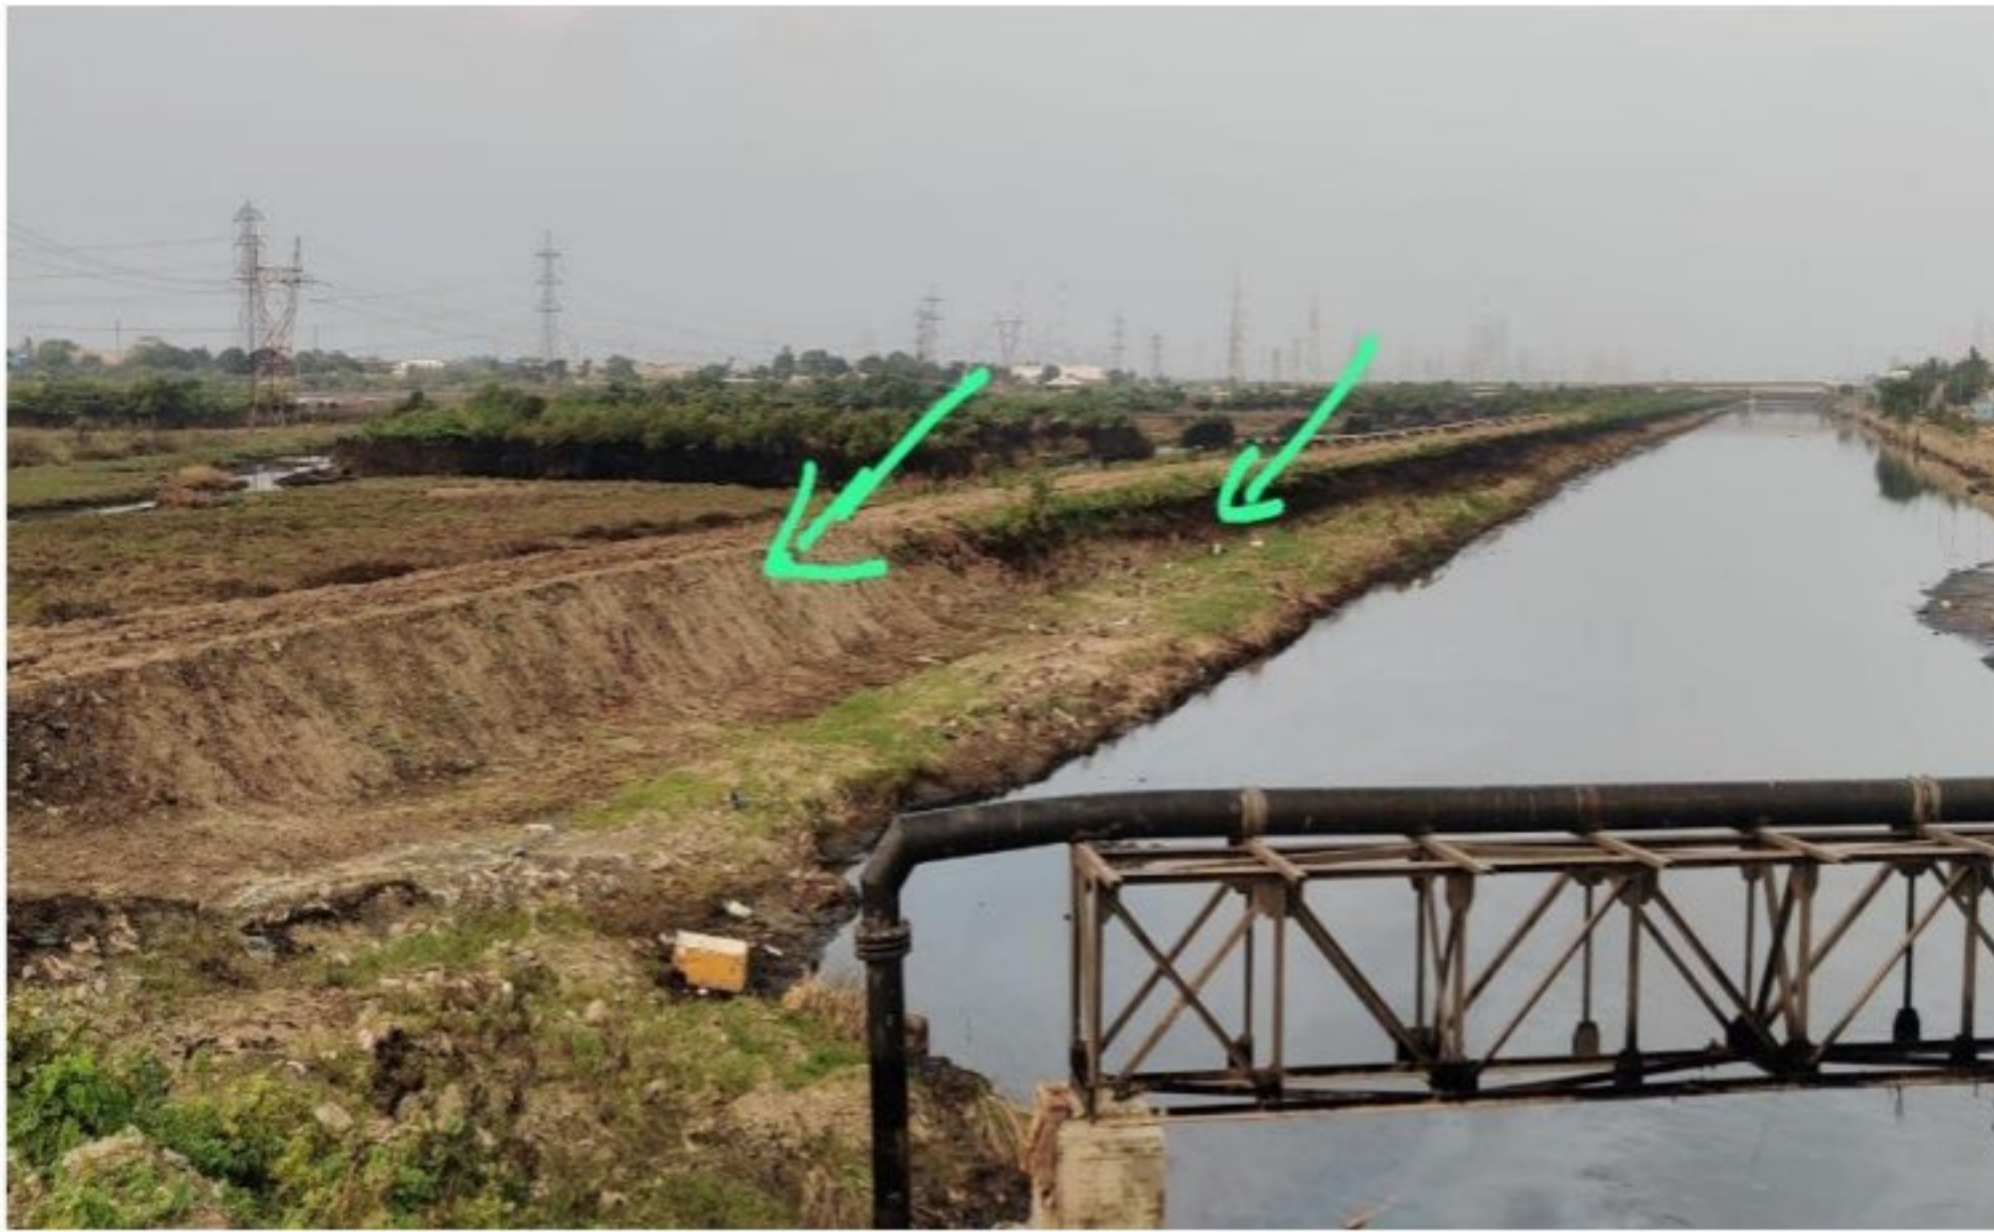
Figure 14: B canal possibly breached and oil stain covered.

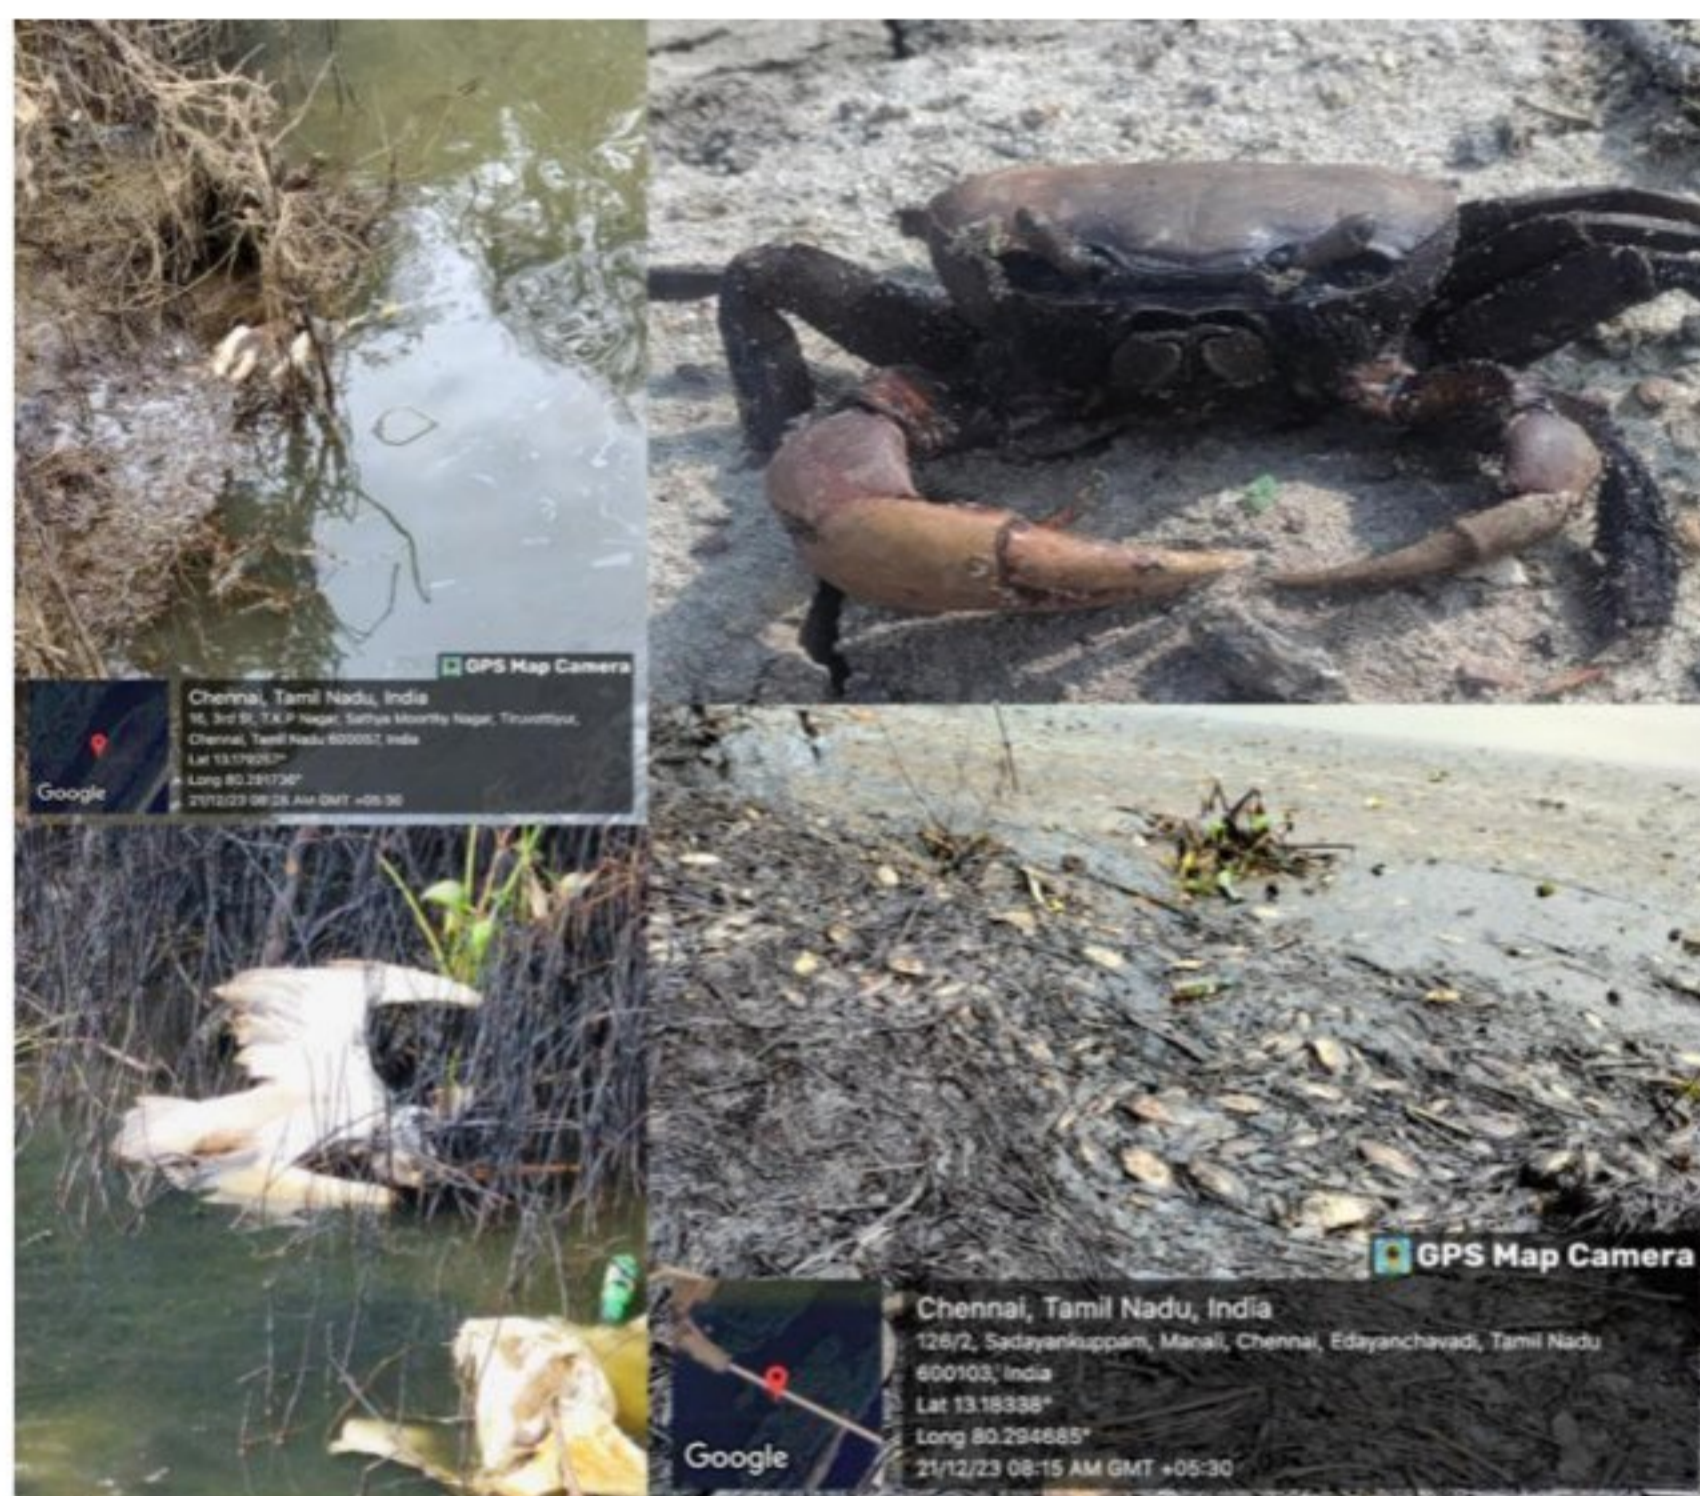
Figure 16: Dead birds, crabs, and fishes found in the contaminated site

The oil spill has posed a significant threat to biodiversity (Figure 15 and 16) in the affected area, impacting mangroves and various organisms such as crabs, fishes, and birds.

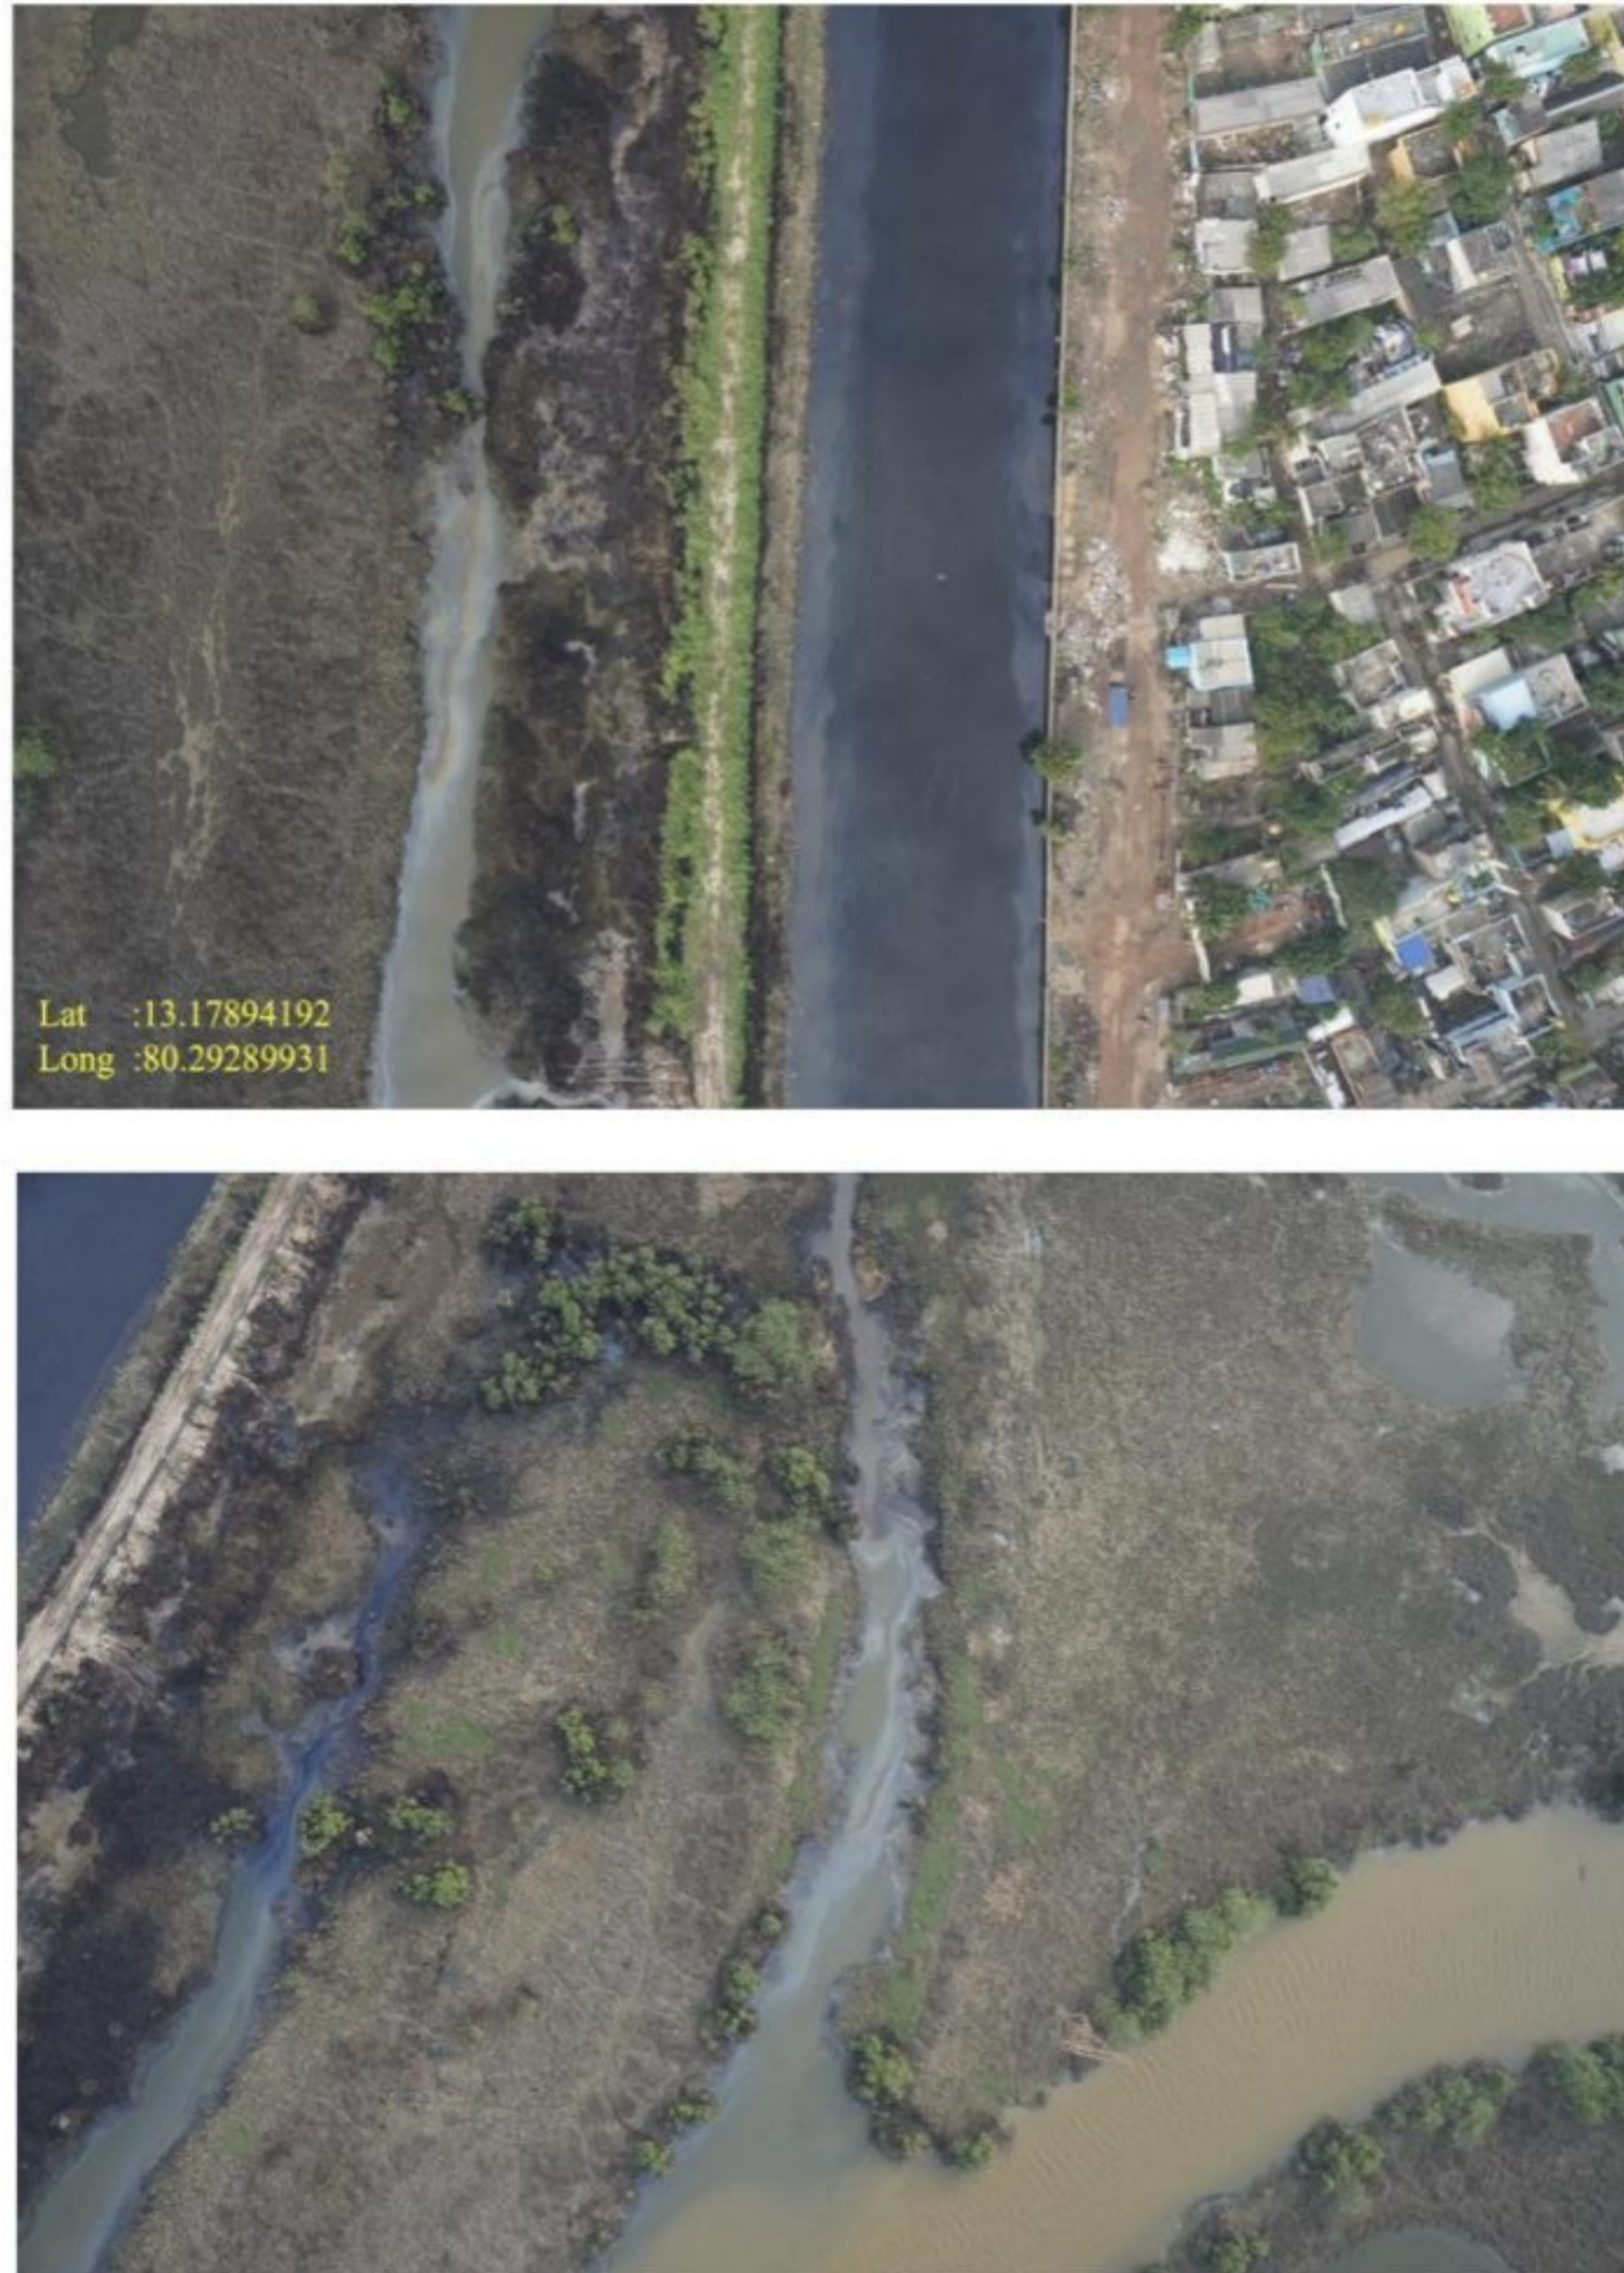
A drone survey was carried out to quantify the oil contamination spatially. Drones were employed to capture the hyper-spectral aerial images, that will help us differentiate water from oil. The drone images captured (Figure 24) show the oil sheen floating on B canal and K River.

Figure 24: Drone images showing oil contamination in B Canal and K River

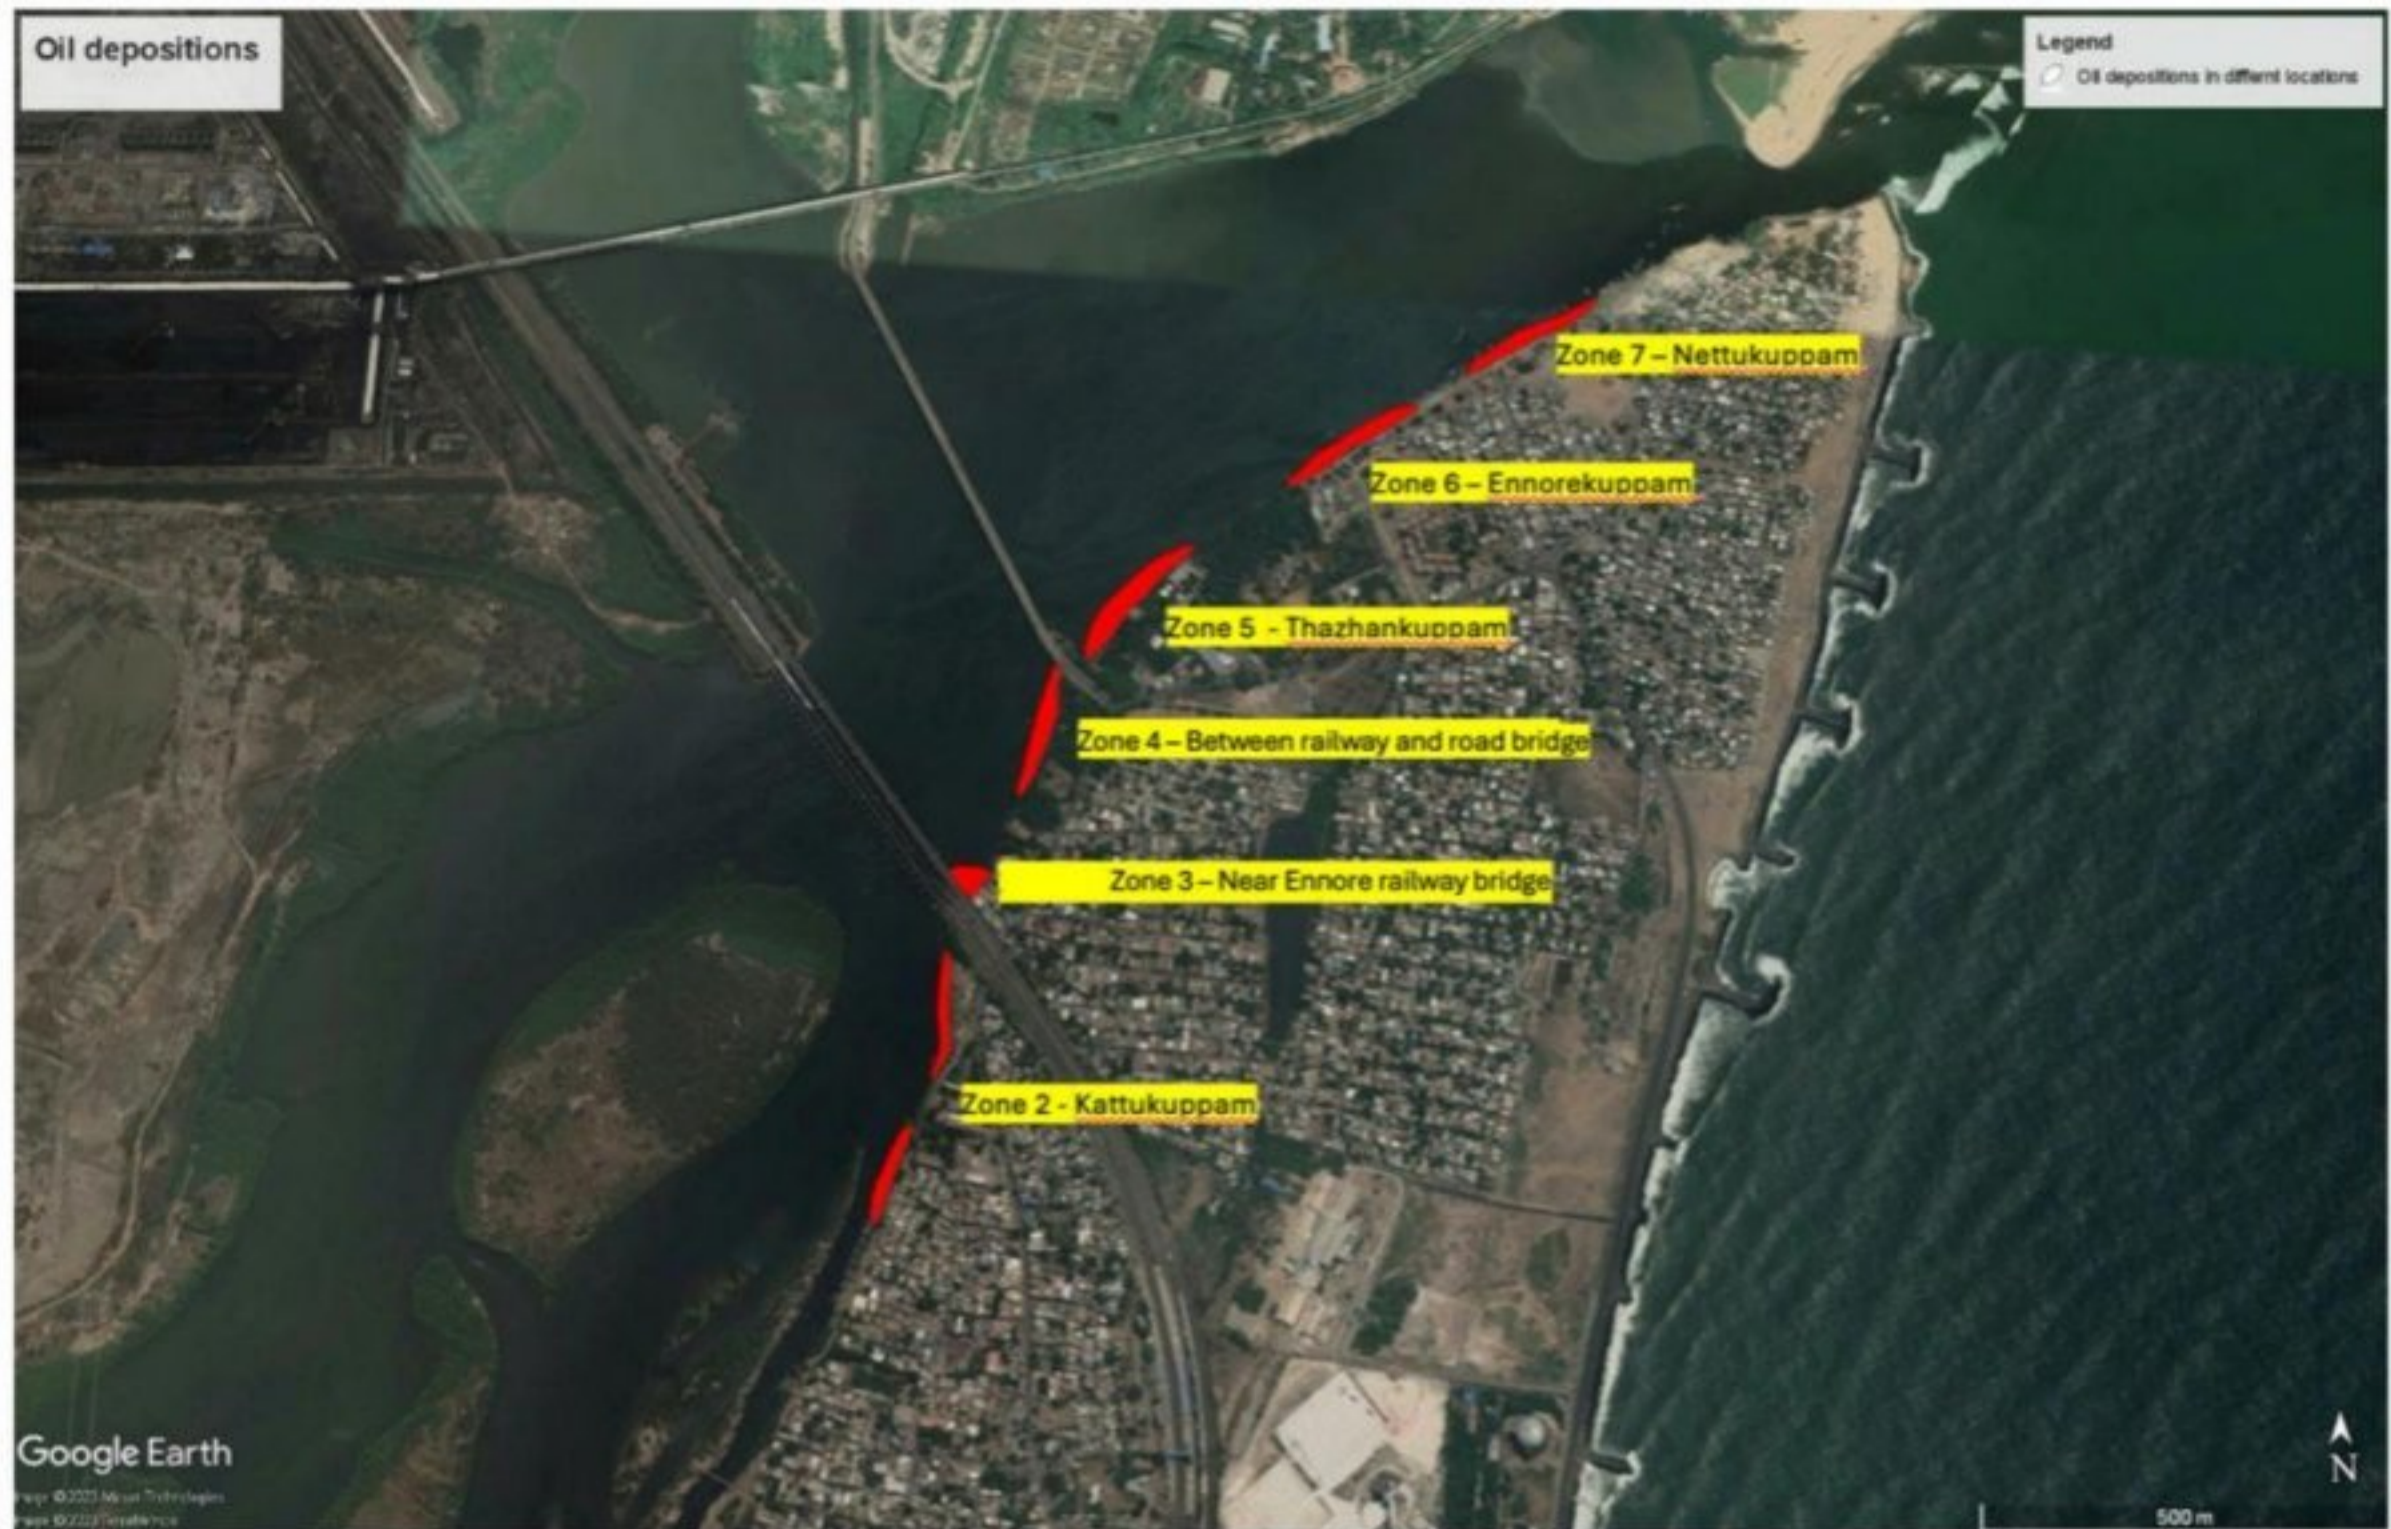
Figure 28: Soil Contamination Zones

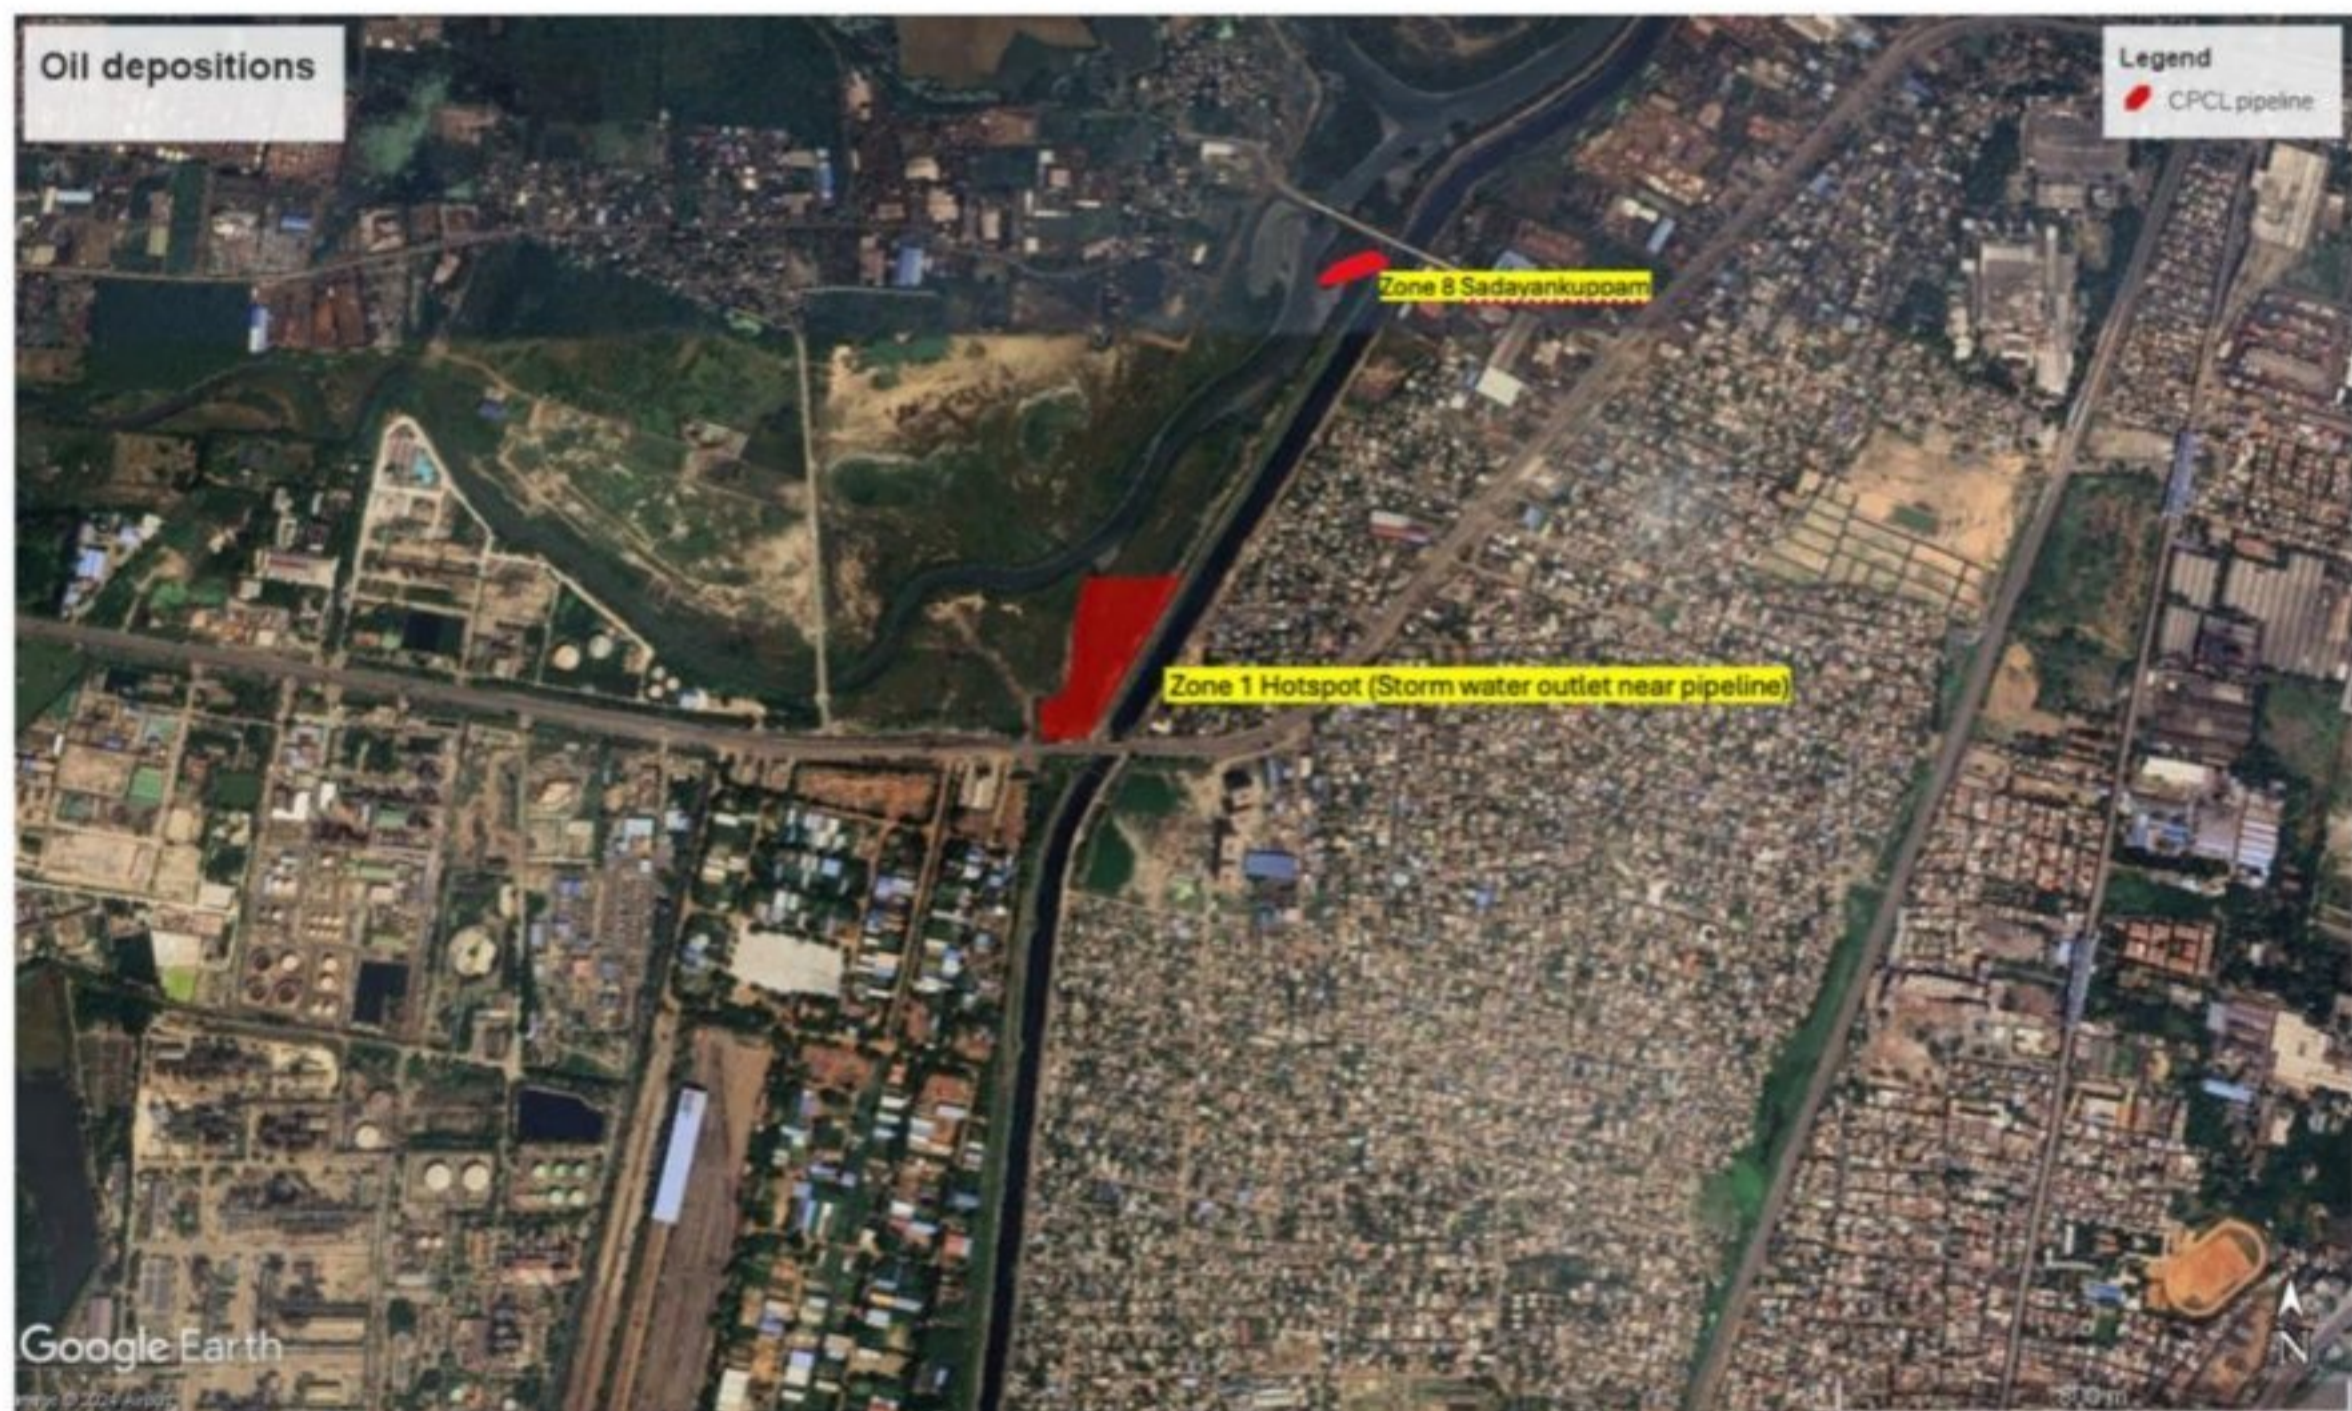
Figure 29: Soil Contamination Zones

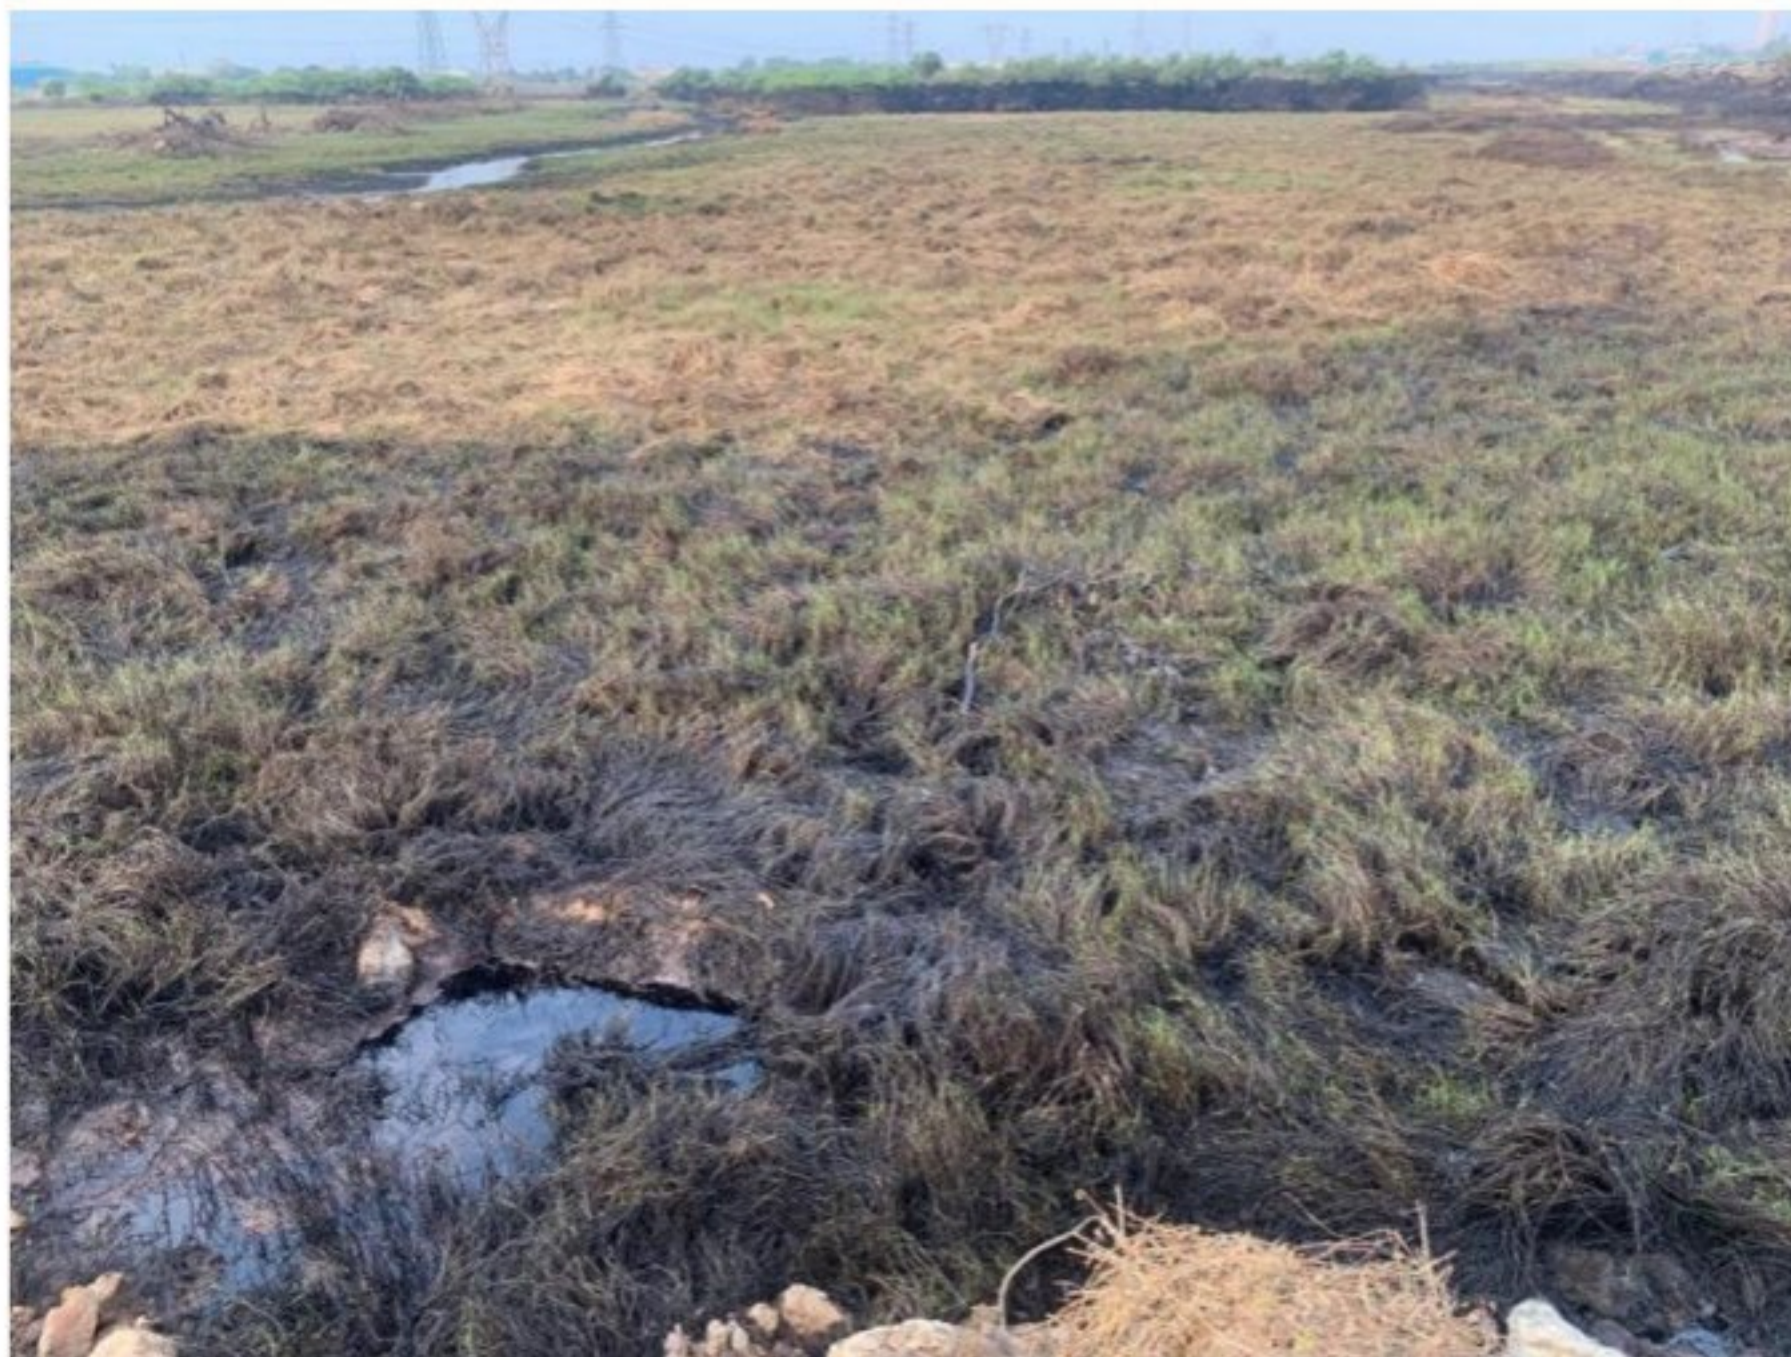
Oil was found ponding along the B Canal in the upstream stretch where maximum flood levels had taken the oil above the bank of the canal and into the eastern residential and industrial areas. Oil was also found ponding within the mangrove islands after the flood water receded. Largest oil ponding was observed in Zone 1. Area of the contamination zones for oil pools were estimated using Google Earth Pro. The volume of oil ponded could be anywhere between 31.4 cu.m. to 314 cu.m.

Figure 30: Oil pools on K river flood plain
