BEFORE THE HON'BLE NATIONAL GREEN TRIBUNAL,
SOUTHERN ZONE- CHENNAI
O.A NO. 180 of 2023
AND
O. A NO.183 OF 2023

Tribunal on its own motion SUOMOTU based
on the Visual media titled Chennai Rains
Makkalai Vathaikkum Oil Companies-
Shocking Story - Michaung Ground Report
covered by on VIKATAN TV Chennai
dt.06.12.2023

**ASSESSMENT OF ENNORE OIL SPILL DURING
MICHAUNG CYLCONE**

**Environment Engineering Division
Department of Civil Engineering
Indian Institute of Technology Madras, Chennai – 600036**

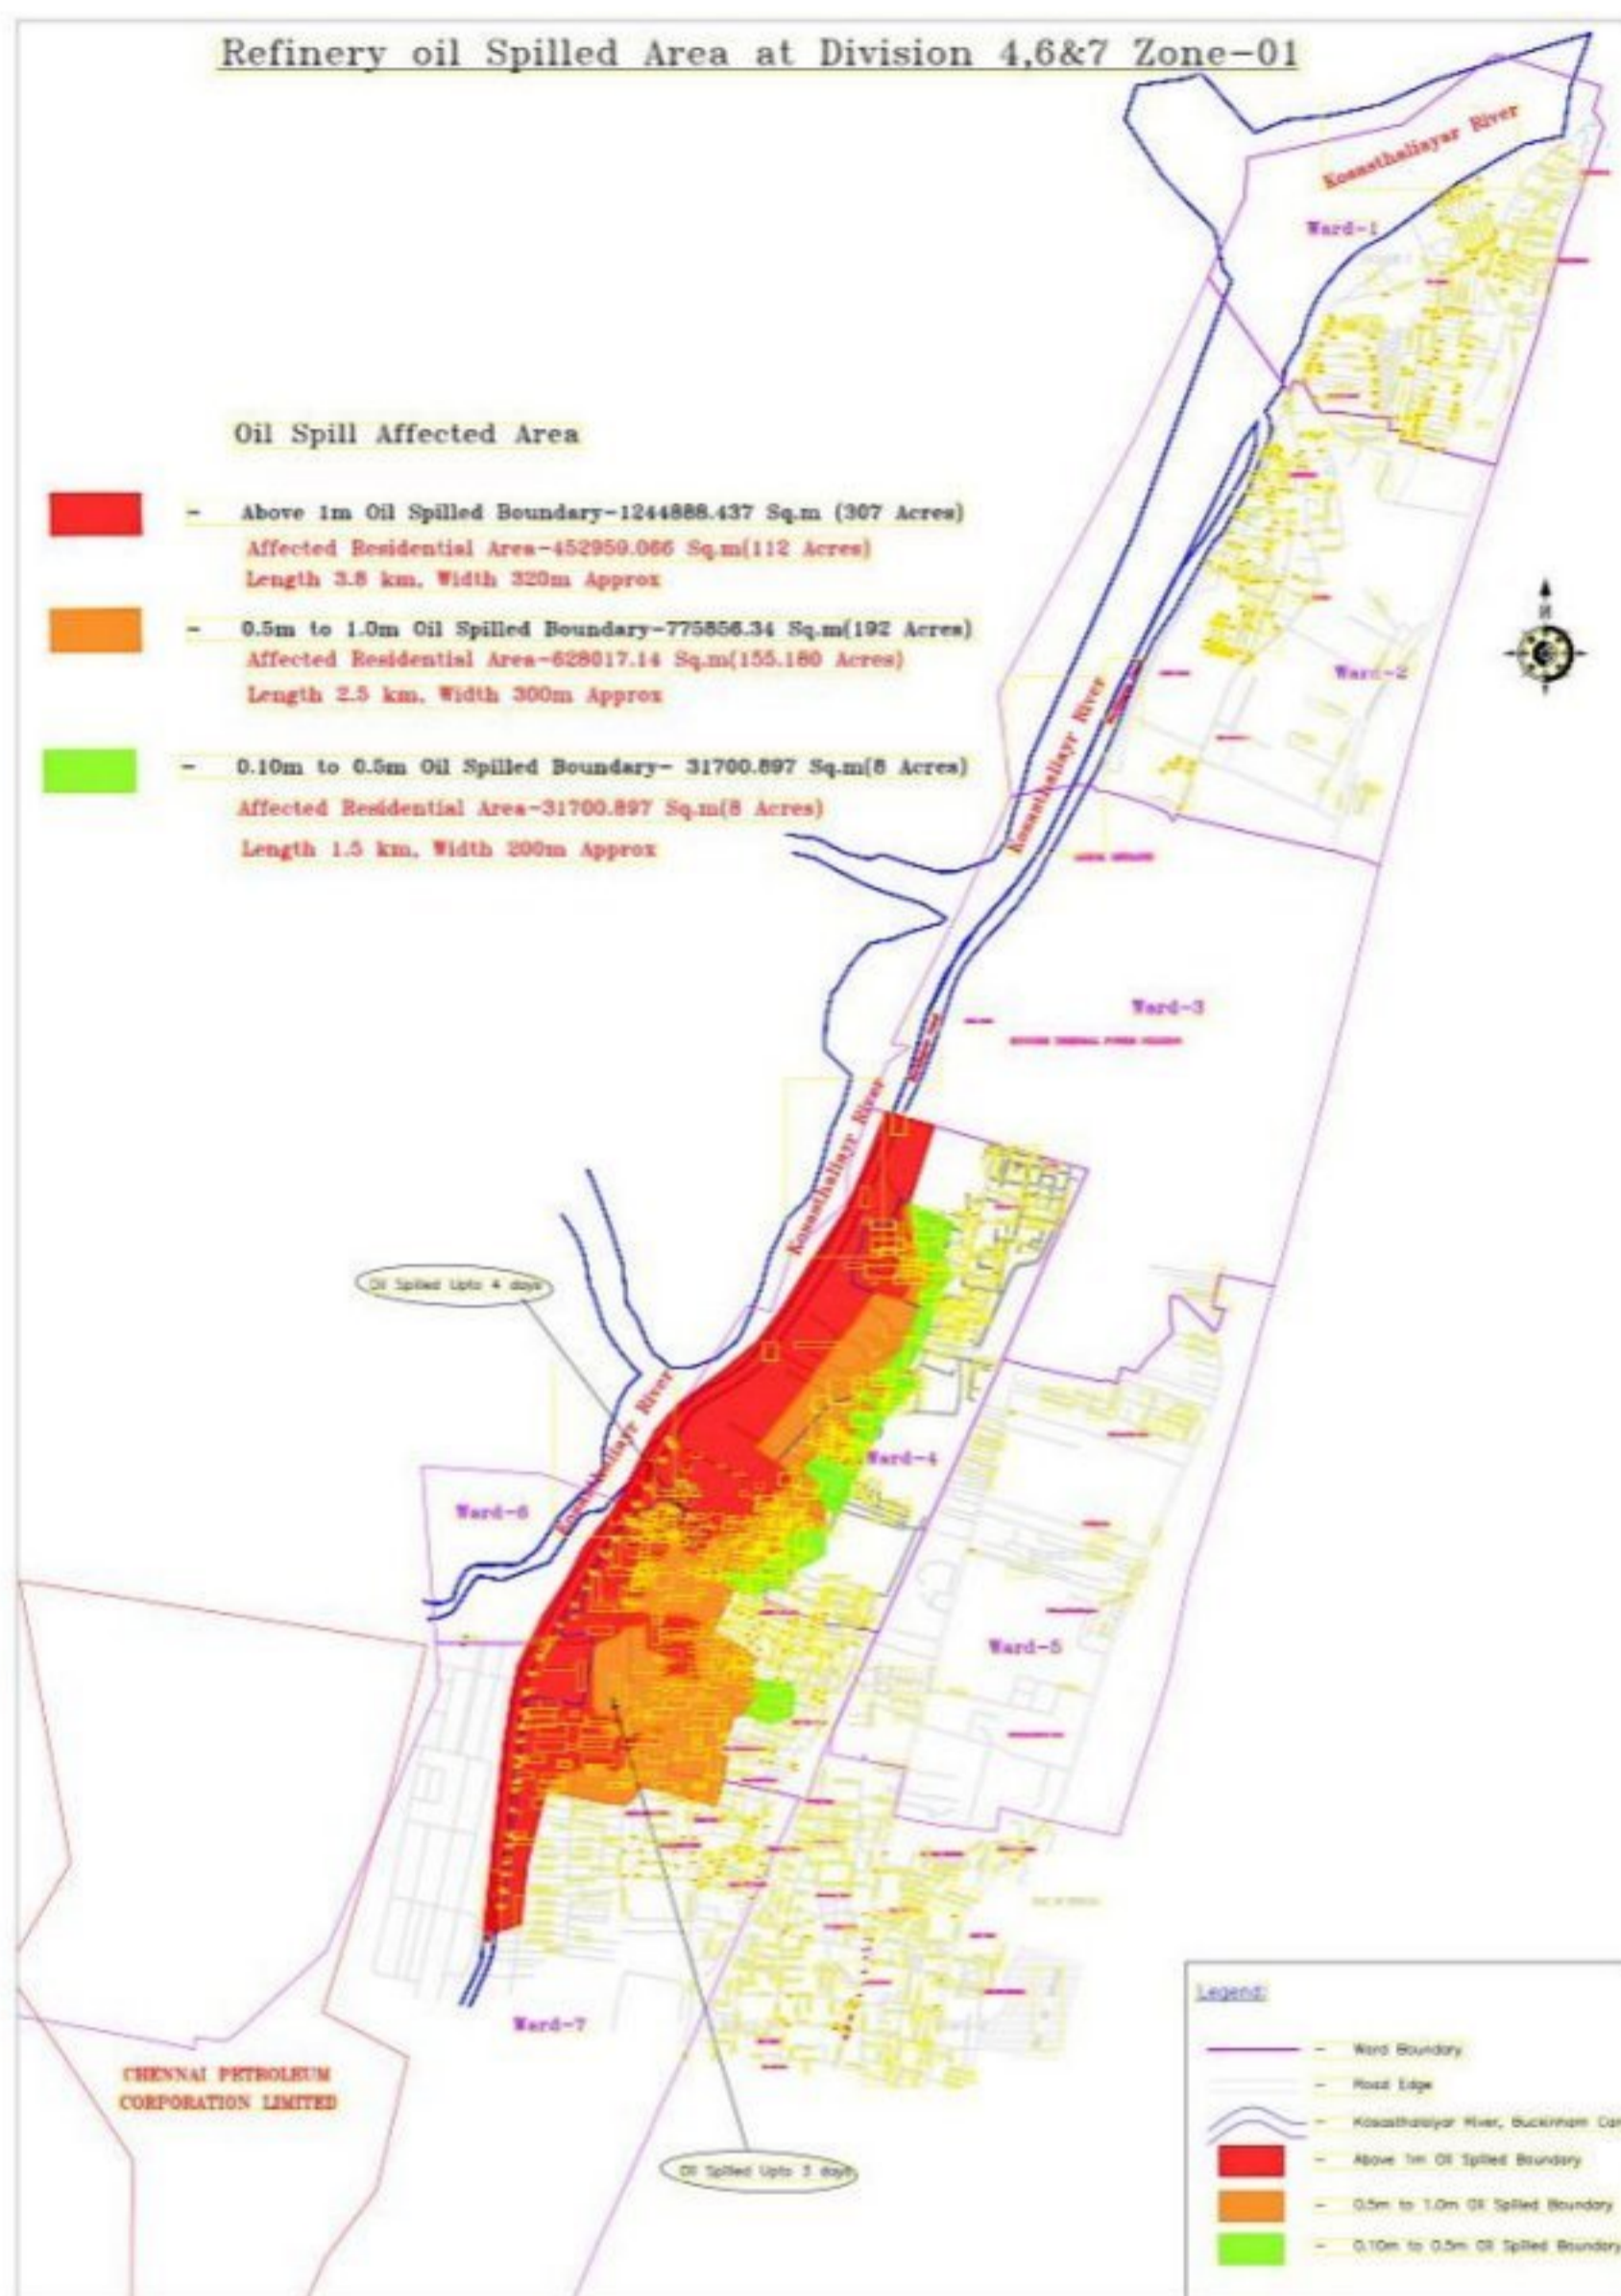
The area under each zone is given below along with presumed depth of oil which was present when the flood water inundated their area. The average quantum of oil inundation is estimated as 117 cu.m. assuming only 0.1 mm of oil.

Figure 31: Map showing three levels of inundation

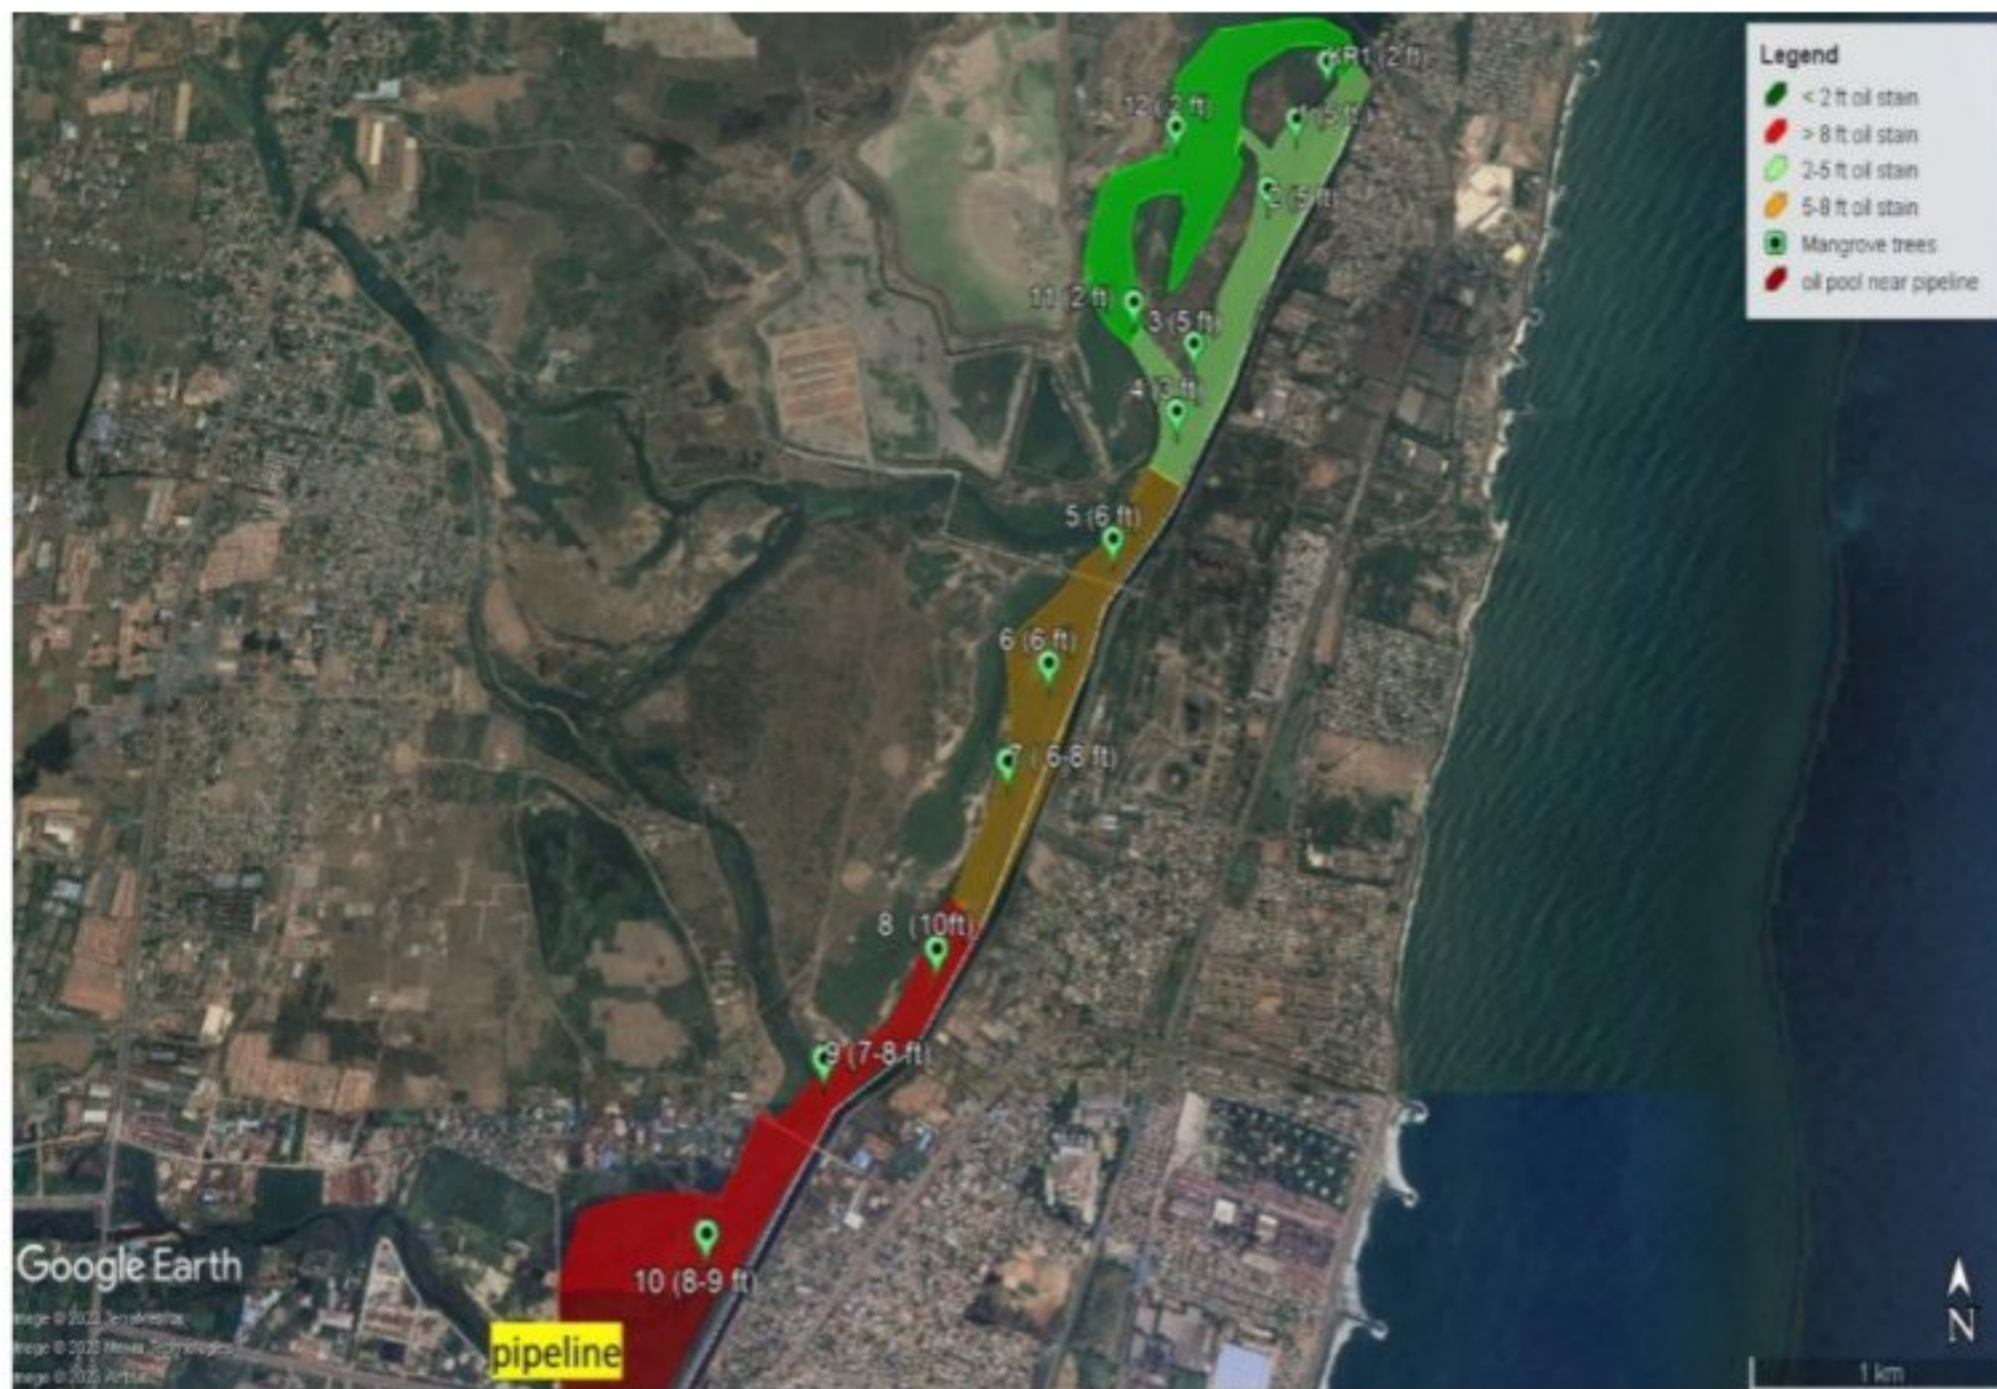
Based on the observed length and height of the stains left behind on the banks of the K river and B canal, we estimated the oil on the river banks and mangroves assuming different thicknesses of oil layer starting from 0.01 mm, 0.1 mm and 1 mm. The average volume of oil inundation is conservatively estimated as 0.3849 cu.m. assuming only 0.01 mm of oil was floating on water.

Figure 33: Classifying the K river with the height of the oil mark in different stretches

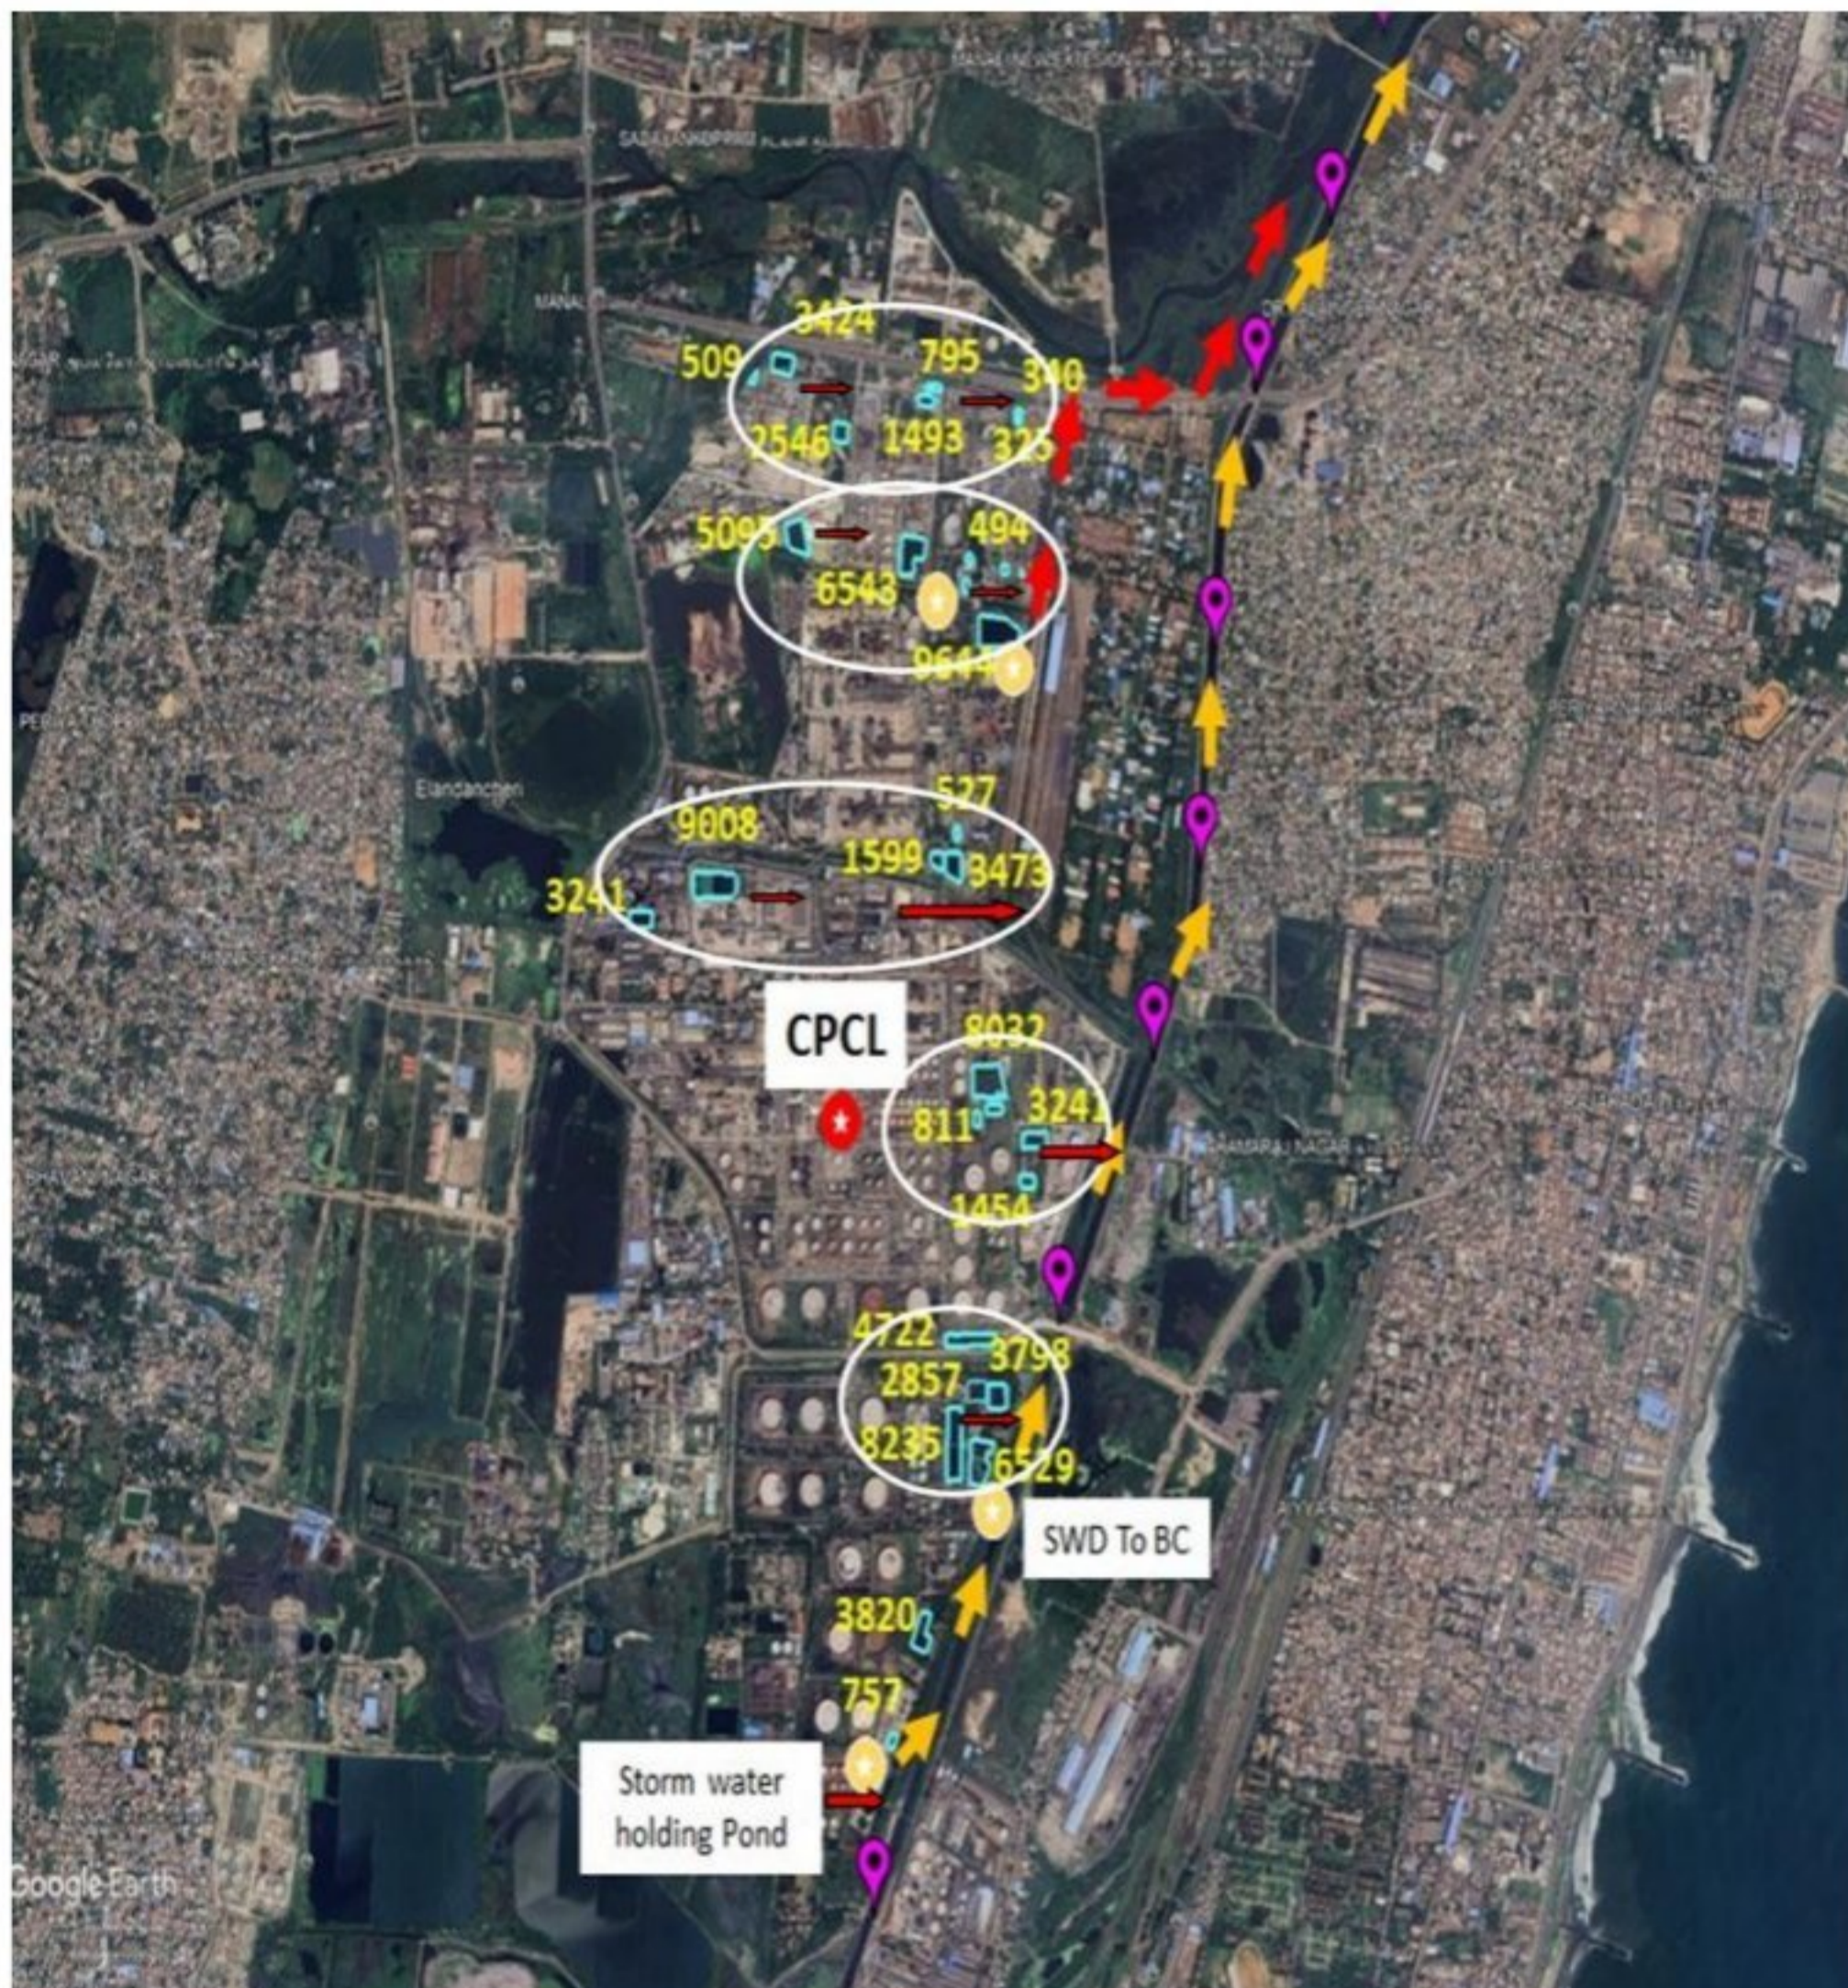
Google Earth images were used to assess the open tanks in M/s CPCL close to the two storm water outlets. The total area of these open tanks are worked out as 95,058 sq.m.

Figure 34: Open tank locations and area in sq.m.

We identified 12 out of 29 tanks containing oil-contaminated water, with six of them discharging into the stormwater drain located north of M/s CPCL (Zone 1), while the remaining six drained into the southern drain of the premises (Zone 20). Table 9 provides an

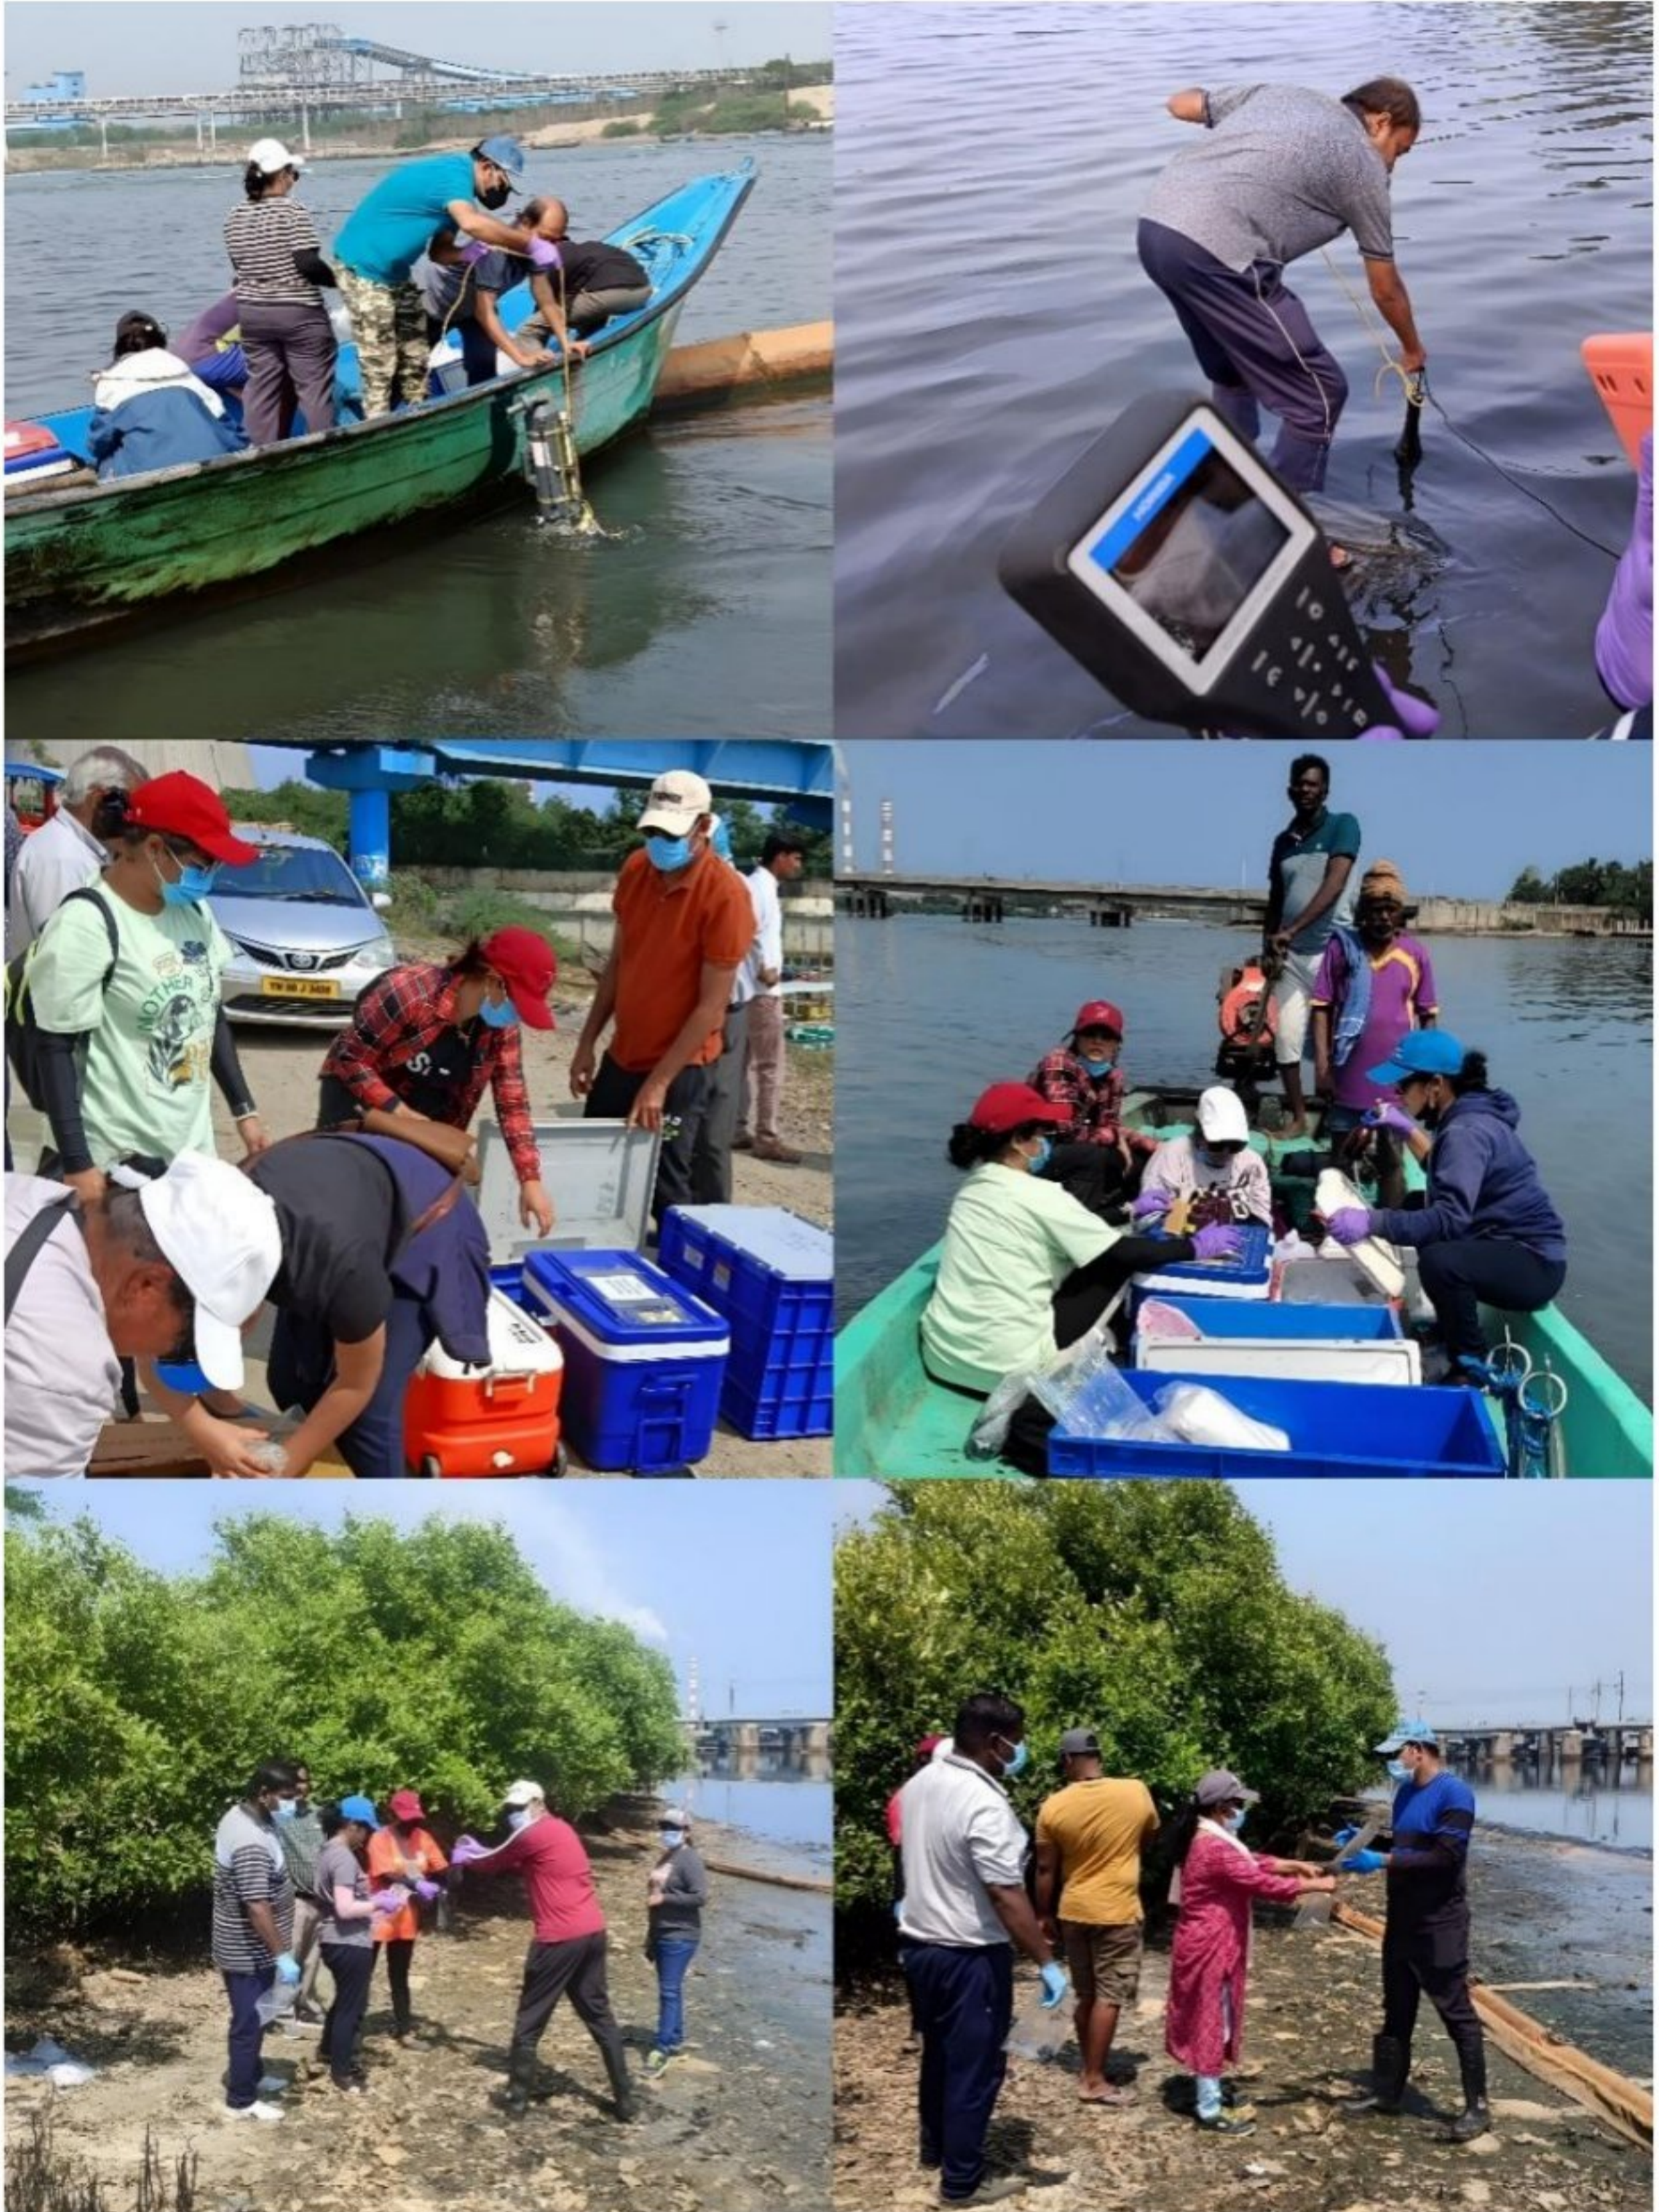
Figure 4. Collection of water and sediment samples at different stations by the CSIR-NIO team and TNPCB & CPCL officials.

Water samples were collected by using a pre-cleaned Niskin water sampler, while sediment samples were collected with a mini-core sampler. All sample collections were performed from a fishing dinghy provided by CPCL, Chennai. Figure 4 shows a few glimpses of the sampling activities at different sites along Ennore Creek. The complete details of the field sampling have been mentioned in the following section.

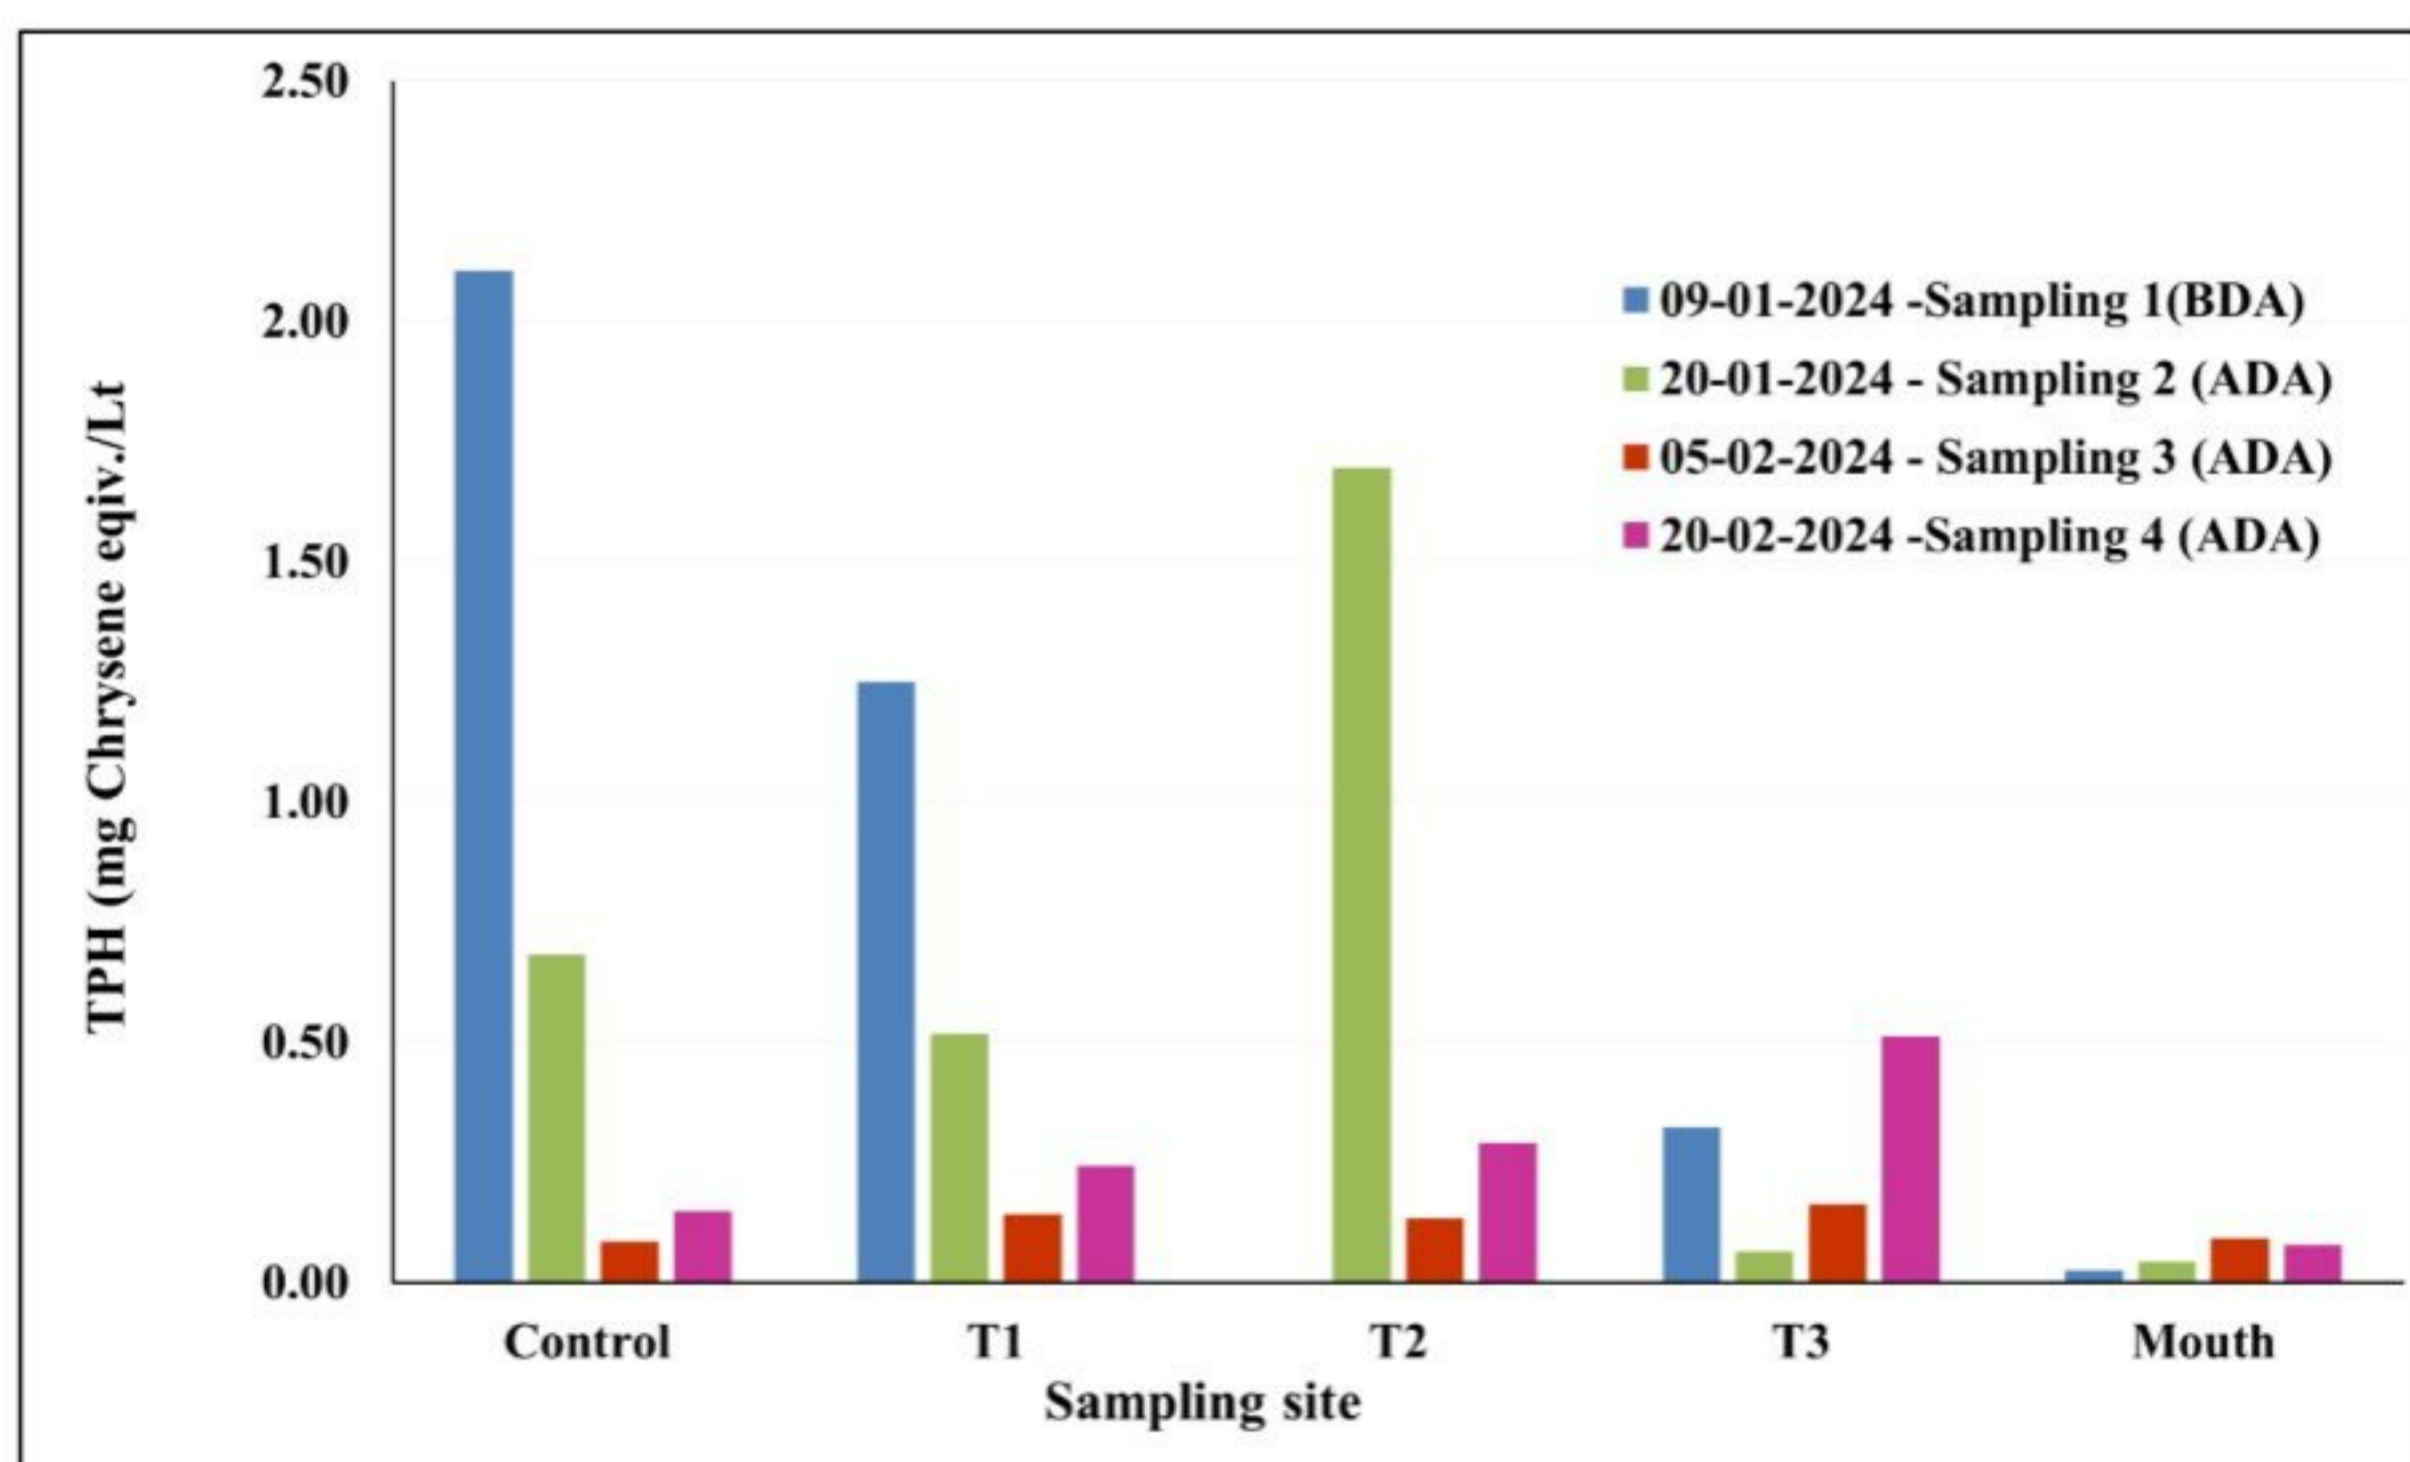
During the first sampling (i.e., before the application of the dispersant), the estimated TPHs in the surface water samples around the study area were 2.11 mg/L, 1.25 mg/L, 0.32 mg/L, and 0.025 mg/L at C, T1, T3, and M stations, respectively (Fig. 8). No samples were collected at T2 due to extreme low tide during the first sampling.

Figure 8. Distribution of TPH in water samples of 05 sampling sites during four consecutive field samplings.

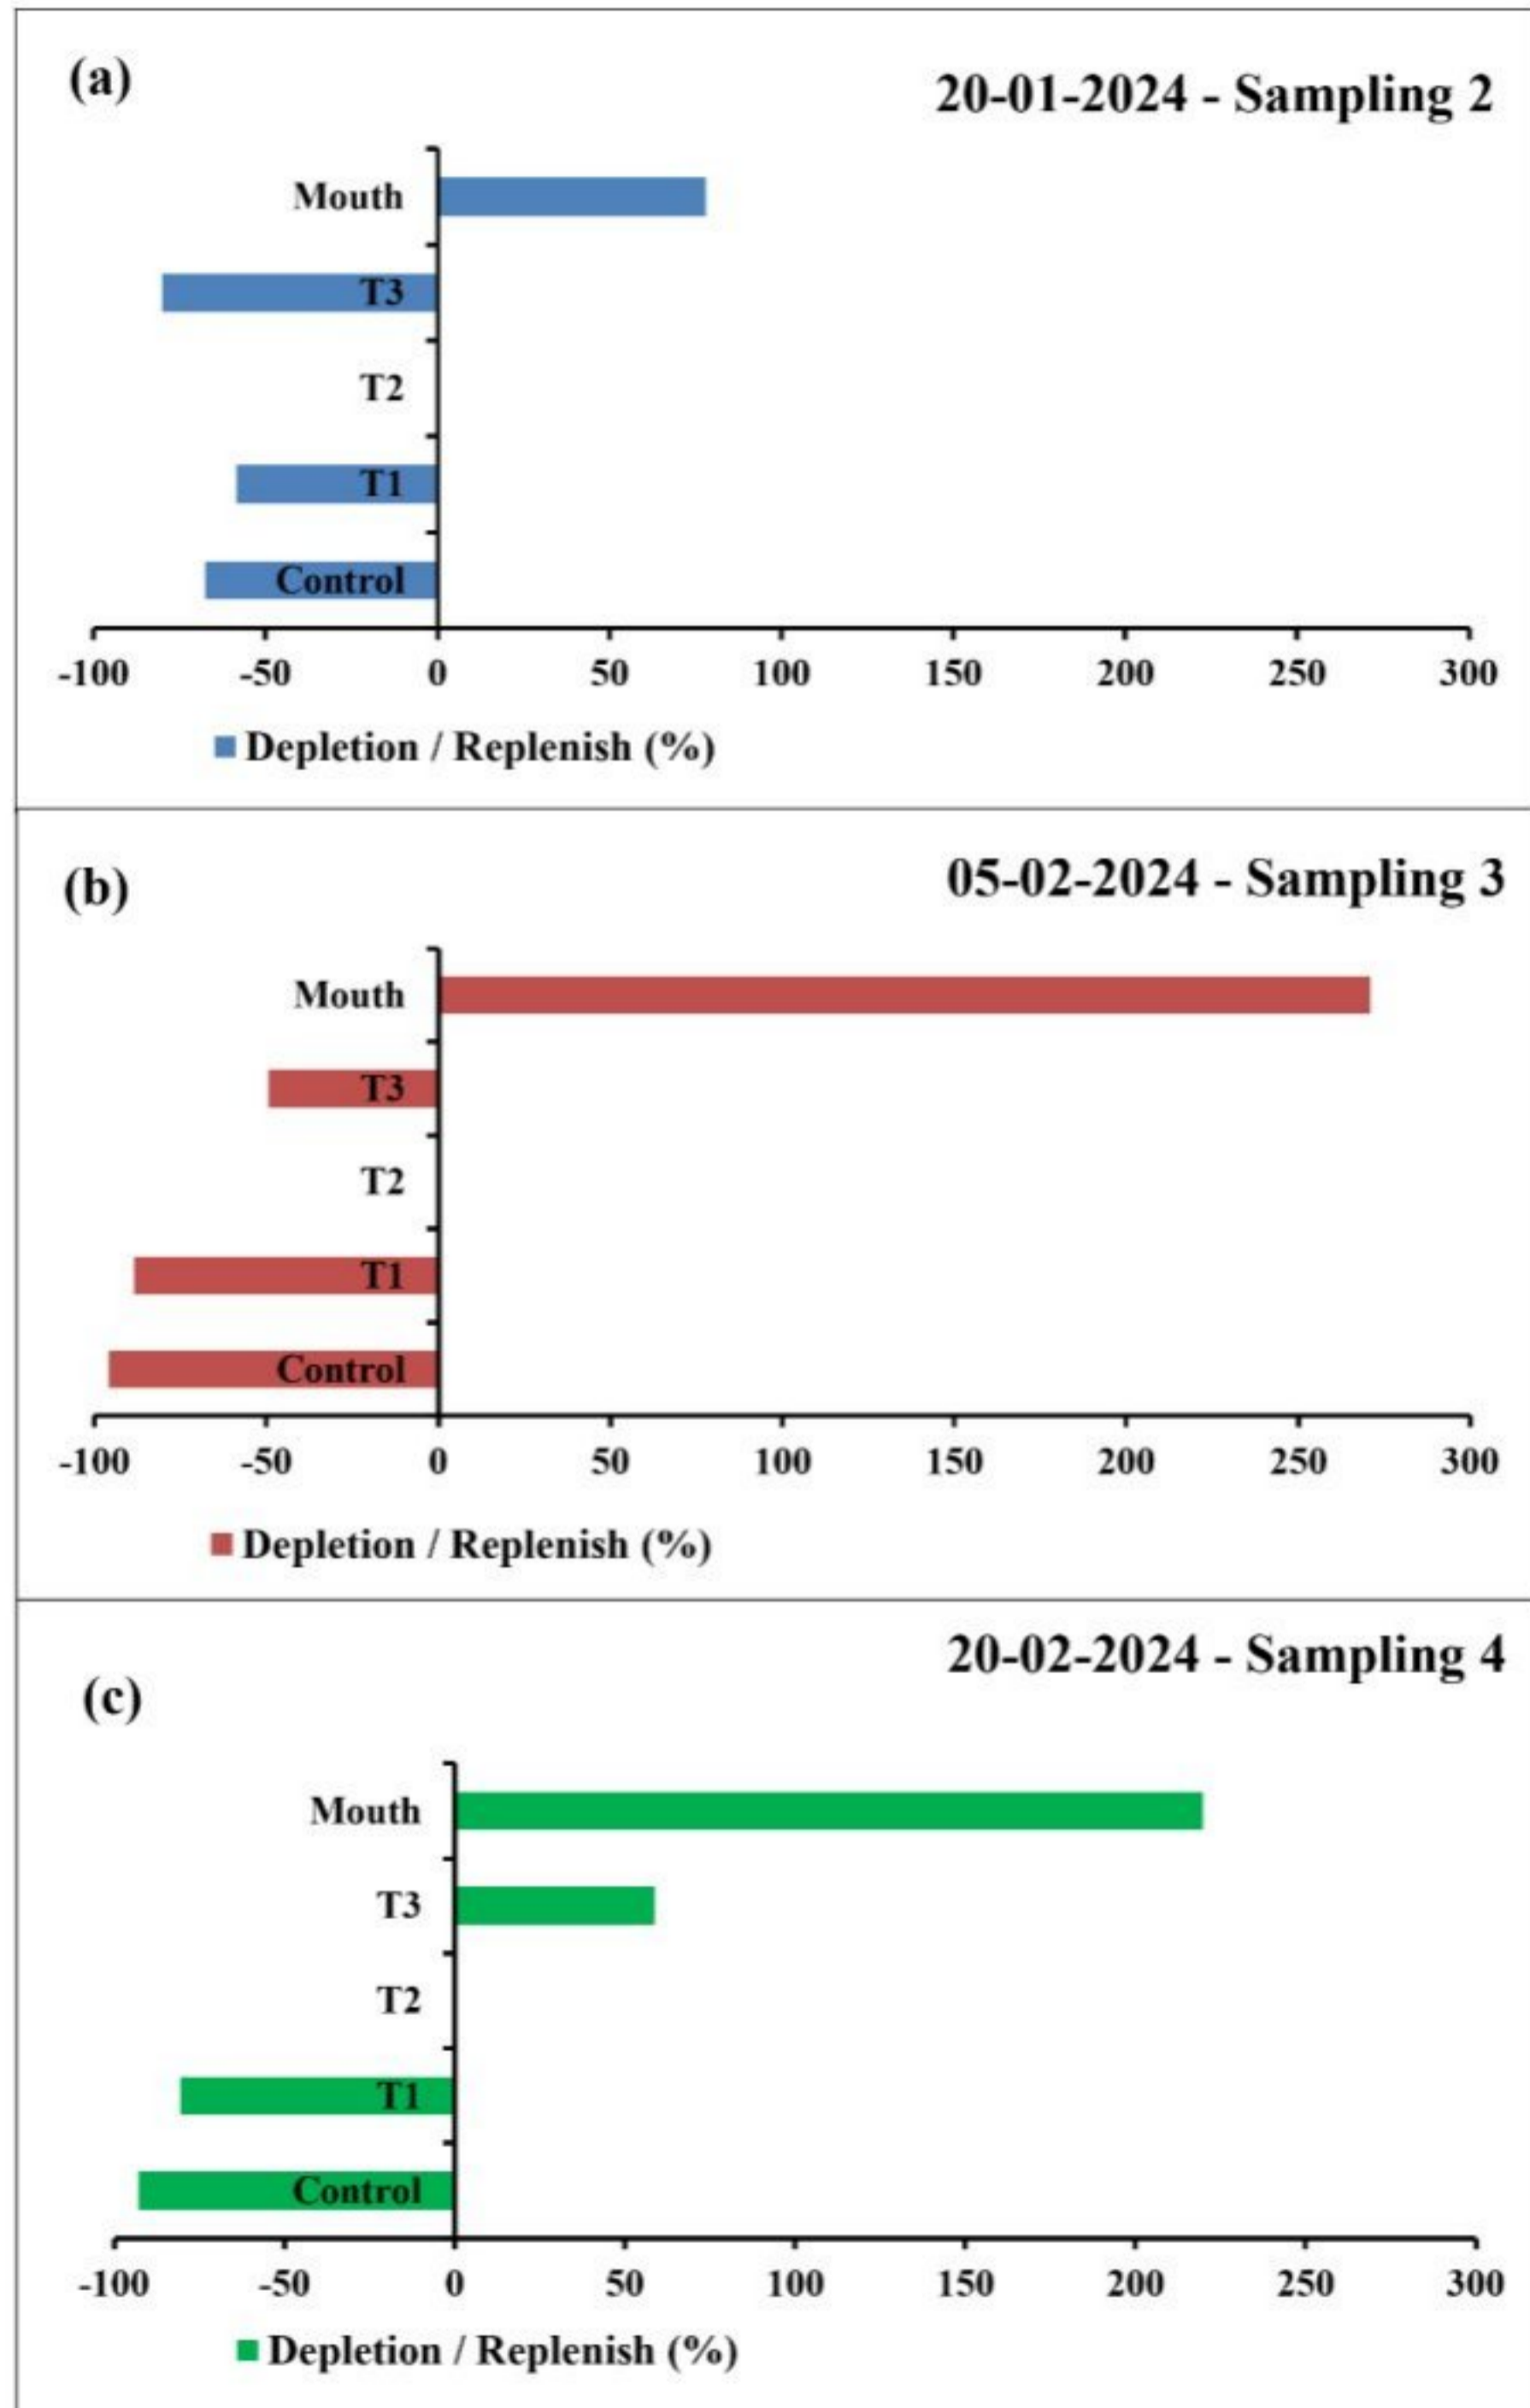
which was found to get fully submerged during the high tide (due to proximity of site C to the Mouth compared to the other stations) and thus regular washing off Site C might have contributed to significantly higher depletion in TPH levels.

Figure 10. Depletion/replenish percentage of TPHs in water samples
