BEFORE THE HON'BLE NATIONAL GREEN TRIBUNAL,
SOUTHERN ZONE- CHENNAI
O.A NO. 180 of 2023
AND
O. A NO.183 OF 2023

Tribunal on its own motion SUOMOTU based
on the Visual media titled Chennai Rains
Makkalai Vathaikkum Oil Companies-
Shocking Story - Michaung Ground Report
covered by on VIKATAN TV Chennai
dt.06.12.2023

**ASSESSMENT OF ENNORE OIL SPILL DURING
MICHAUNG CYLCONE**

**Environment Engineering Division
Department of Civil Engineering
Indian Institute of Technology Madras, Chennai – 600036**

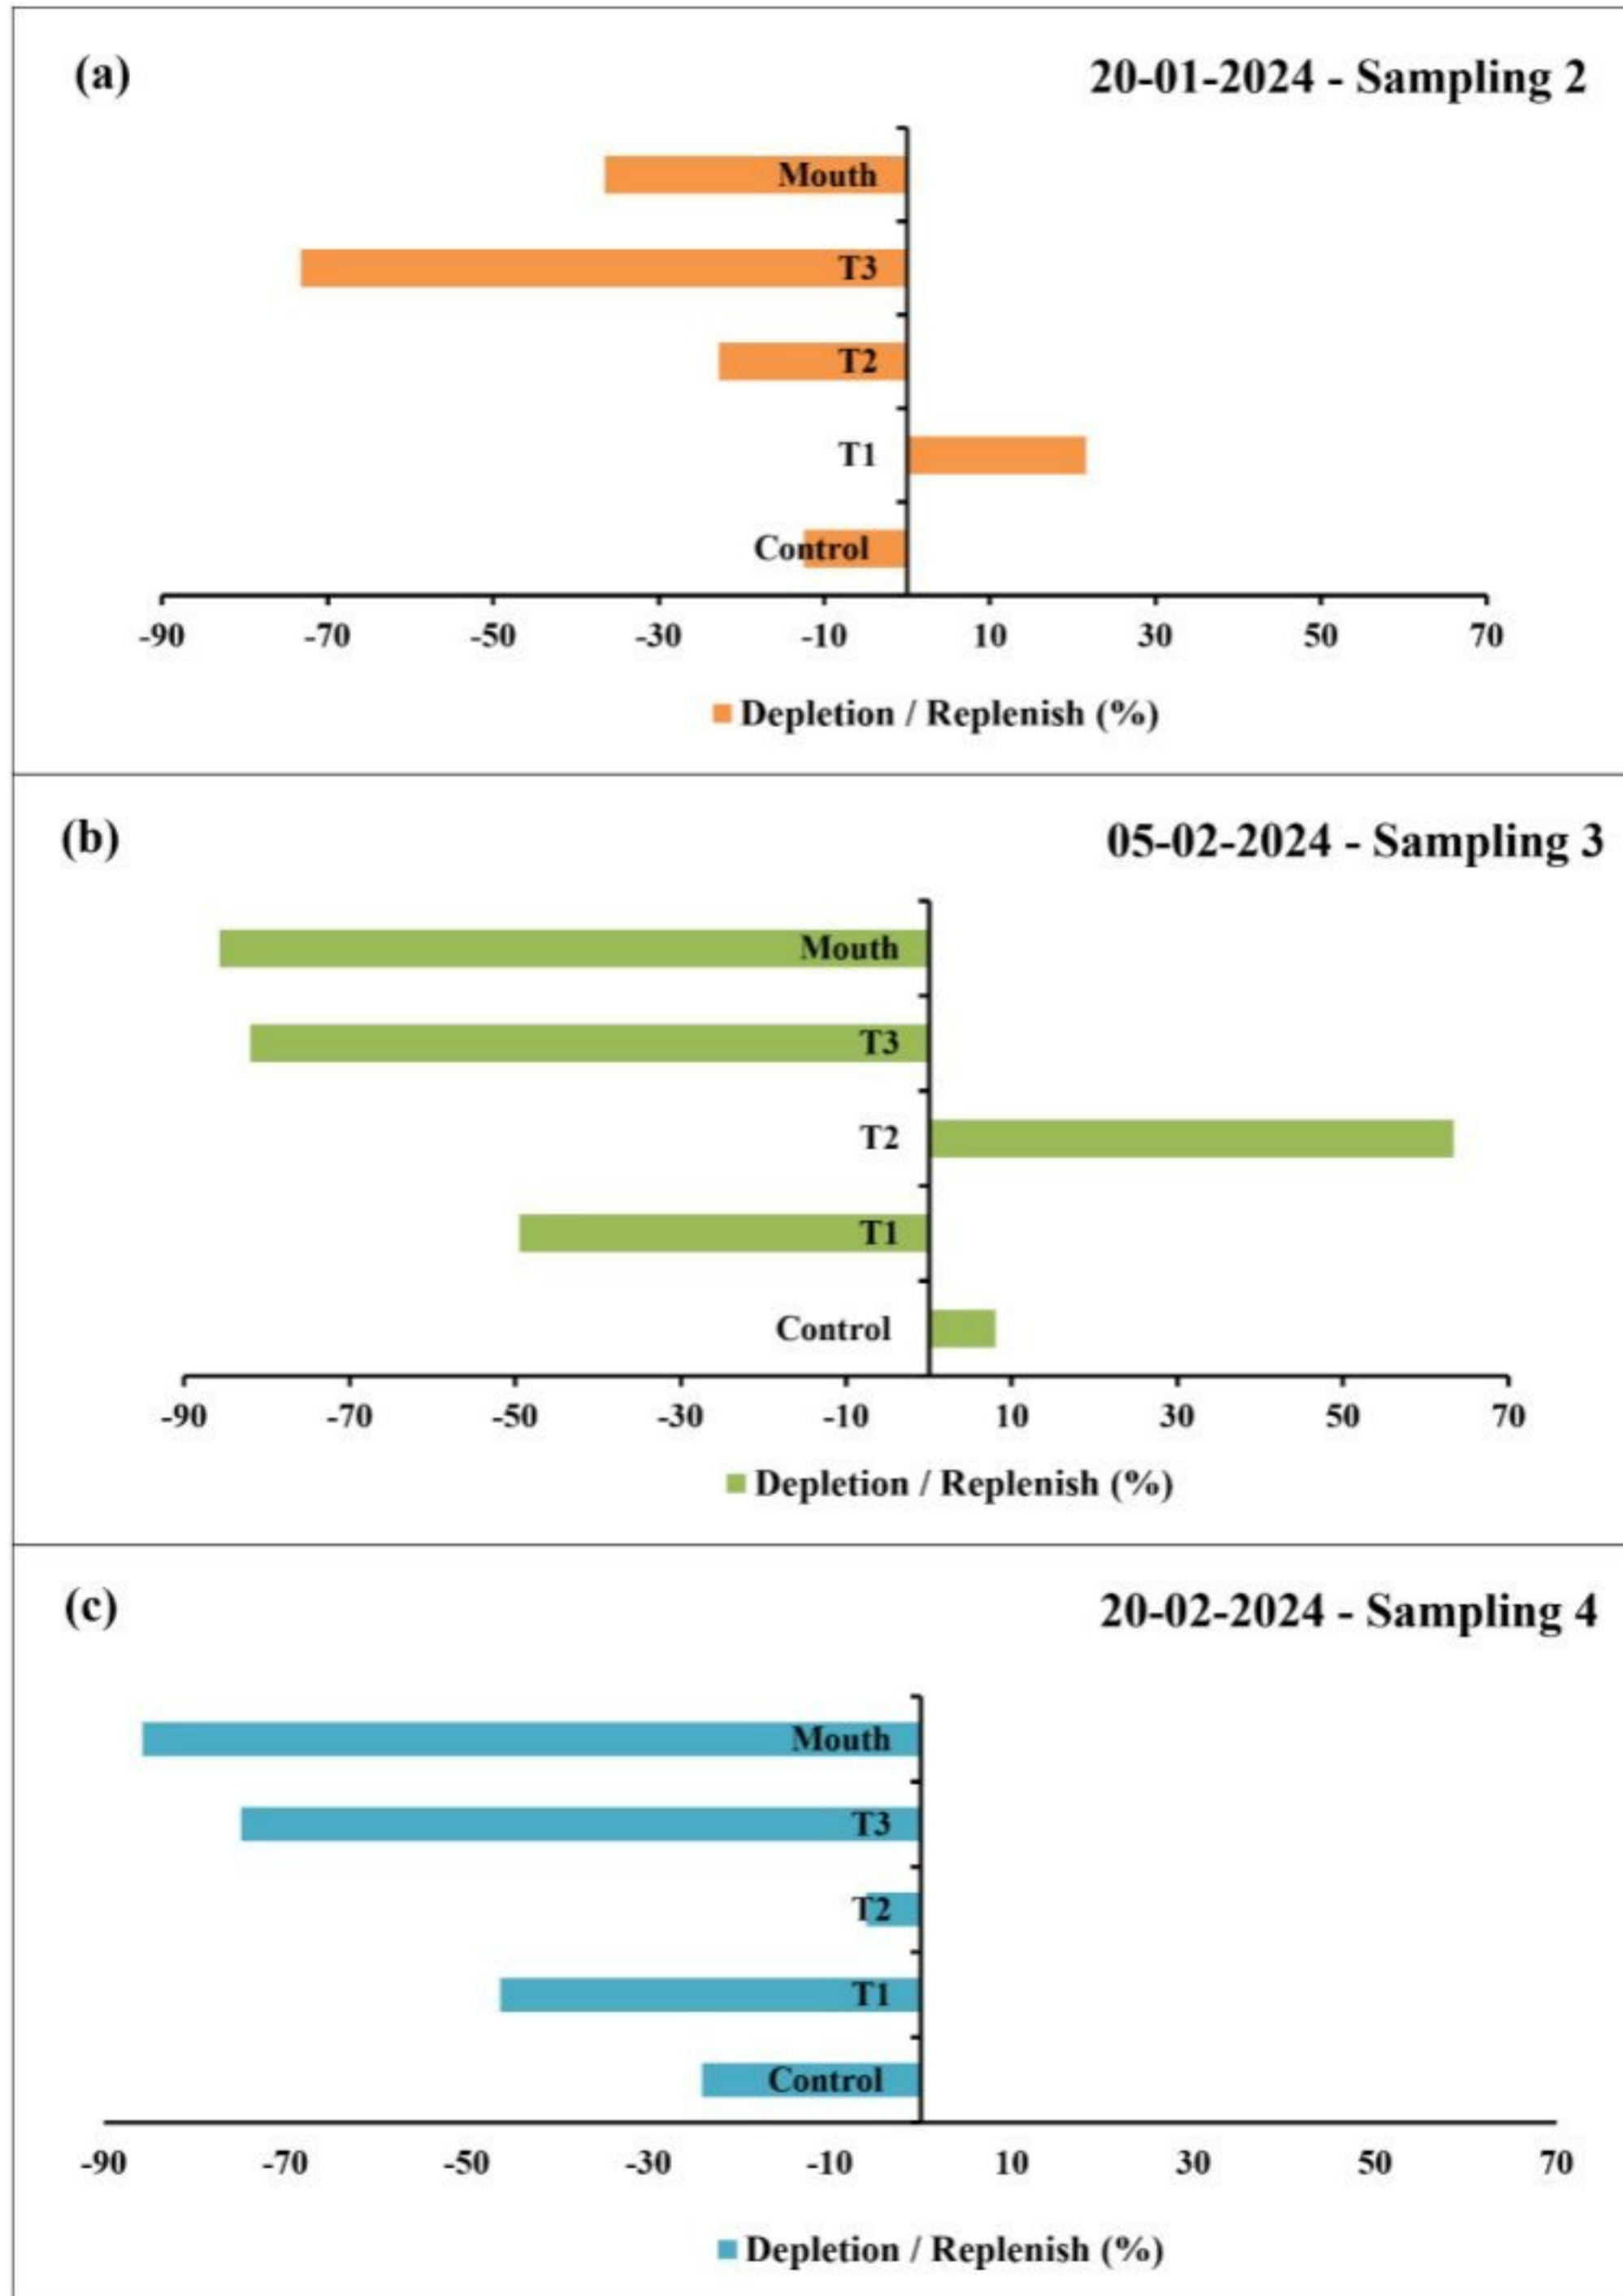
However, T1 and T3 (dispersant-applied locations) showed a depletion of 49% and 81%, respectively. During the fourth sampling, 40 days after the Biodispersant application, the control station showed only a 24% depletion. Meanwhile, stations T1, T2, and T3 showed 46%, 6%, and 74% depletion in TPH.

Figure 12. Depletion percentage of TPHs in sediment samples.
