**BEFORE THE HON'BLE NATIONAL GREEN TRIBUNAL,  
SOUTHERN ZONE- CHENNAI**

**O.A NO. 180 of 2023**

**TECHNICAL TEAM REPORT ON COMPUTATION OF ENVIRONMENTAL COMPENSATION TO BE LEVIED TO CHENNAI PETROLEUM CORPORATION LIMITED FOR THE OIL SPILLAGE IN ENNORE CREEK AREA DURING THE FLOODS CAUSED BY MICHAUNG CYCLONE IN DECEMBER 2023**

**Environment Engineering Division**  
**Department of Civil Engineering**  
**Indian Institute of Technology Madras, Chennai-600036**

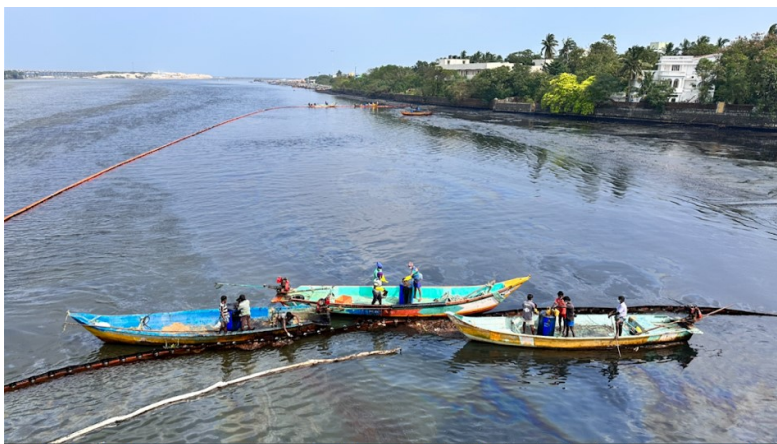
**Figure 1:** Oil spread near Ennore railway bridge

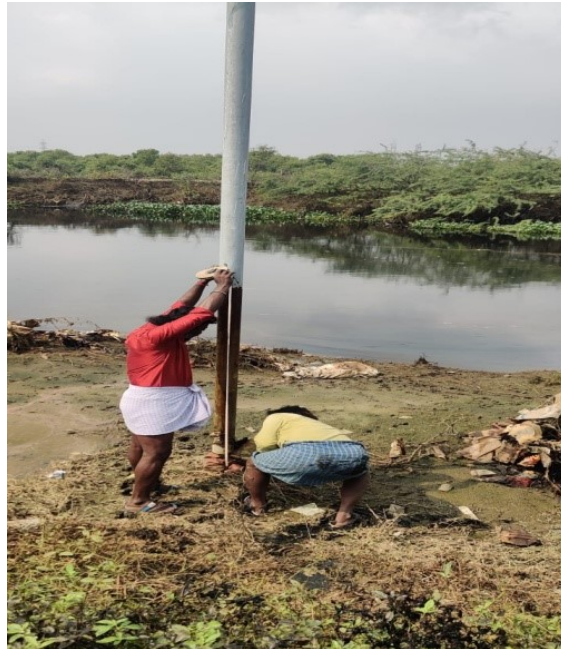
During the flood event, B Canal experienced overflow of oil mixed water, inundating the residential areas of Ernavoor (Zone 11). Lamp posts positioned within the residential vicinity along the B Canal exhibited signs of oil spillage, while flood-affected houses showed oil stains on their walls, reaching heights of 5 to 6 feet. The overflowing oil mixed water adversely affected vegetation, residential buildings, vehicles, and the open wells that serve as sources of groundwater. The field images below provide visual representation of the extent of oil contamination within the residential zones of Ernavoor.

**Figure 4:** Highest oil mixed water level 7.5 feet above normal water level during the cyclone

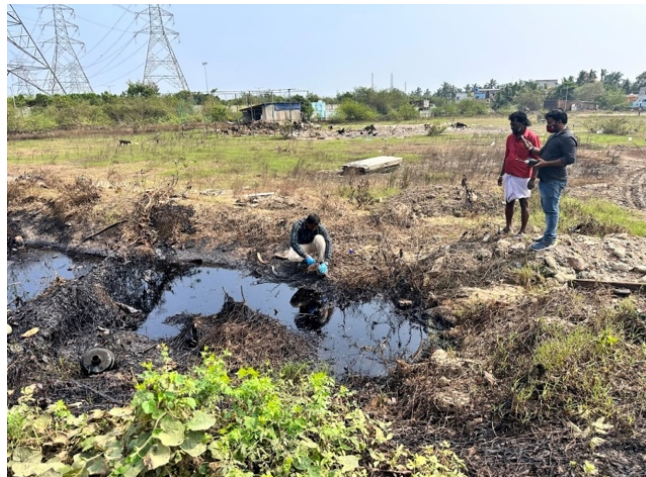
**Figure 5:** Collection of samples from the oil overflown along the banks of B Canal.

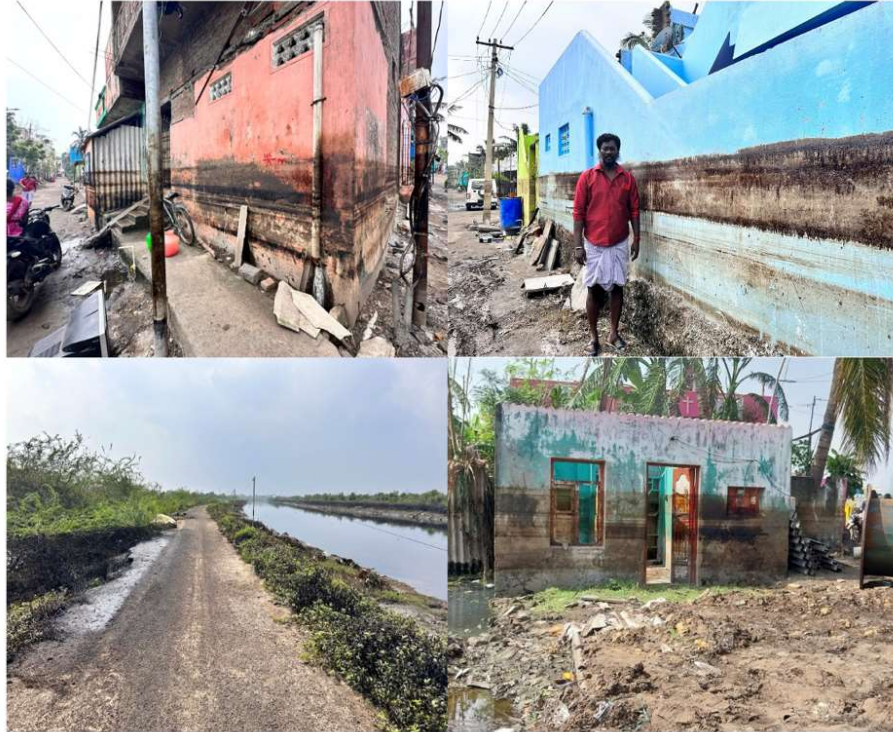
**Figure 6:** Oil marks observed in the residential localities of Ernavoor.

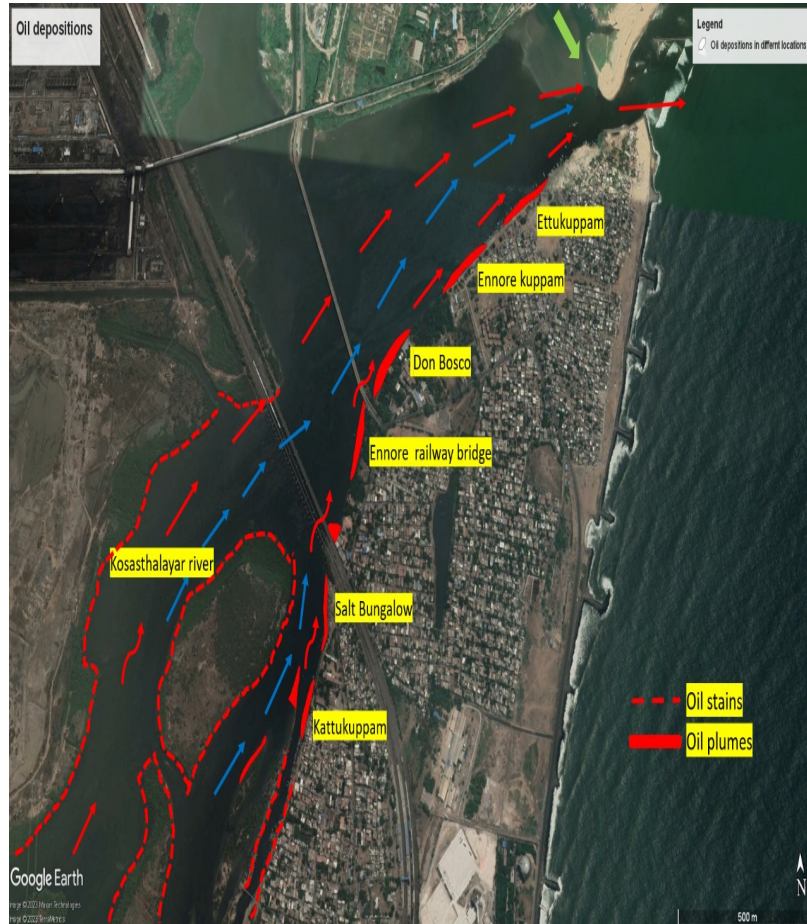
Figure 7 illustrates the flow of oil, represented by red arrows, along the B Canal and K River after the floodwaters receded. Dotted lines signify the presence of oil stains along all banks of these water bodies and islands. Hotspots, where substantial oil deposits occurred, are highlighted as red patches along the eastern banks of the Creek, extending from Kattukuppam to Nettukuppam.

**Figure 7:** Assessment Region 1 - Downstream from ETPS to Creek Area

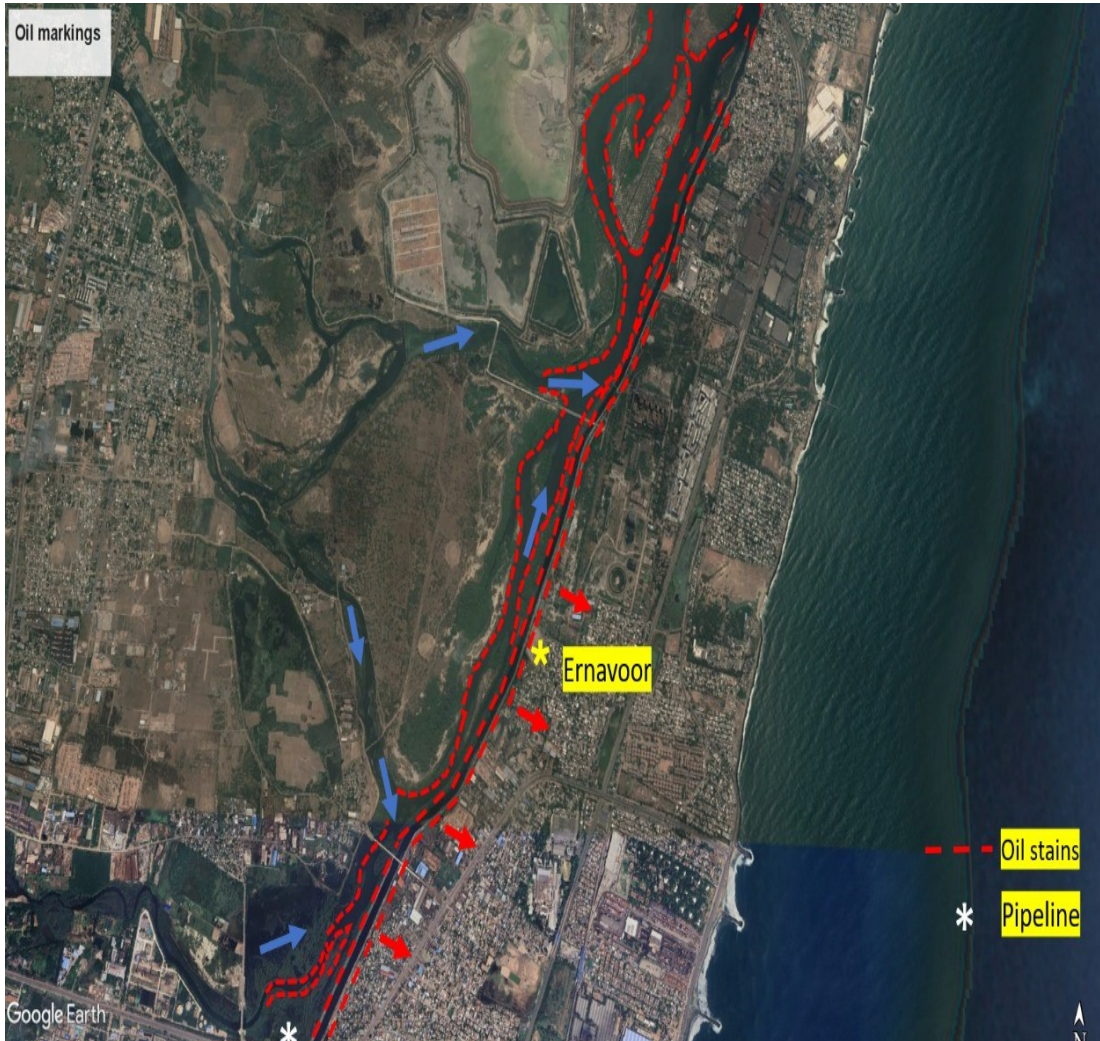
The midstream stretch of B Canal extending from the junction of K River and surplus canal from Redhillsup to ETPS is the crucial area to pay attention. The surplus from Puzhal and Poondi Lakes discharged high quantum of water into the two K River branches which trapped the oil in this mid-stream stretch. The flood water rose to 7 to 9ft in this section carrying the oil with it, over the B Canal bank into the adjoining residential and industrial areas of Ernavoor and SathyamoorthyNagar. Oncethe flood water/surplus water receded, the oil must have flown downstream into the Kattukuppam all the way to Nettukuppam.

**Figure 8:** Assessment Region 2 - Midstream From ETPS to Manali High Road Bridge

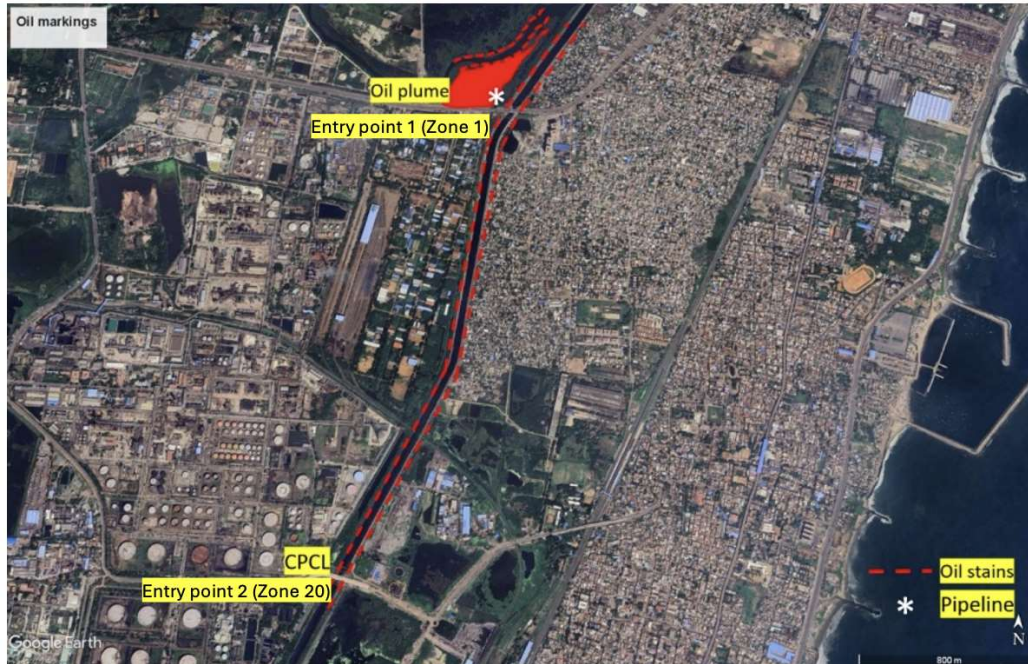
Two oil discharges from the M/s CPCL stormwater drain have occurred in the locations: one in the south (entry point 2), directly into the B Canal, and another in the north (entry point 1), flowing through the stormwater drain adjacent to India Additives, into the flood plains of K River (Zone 1 indicated by the large red patch). Stormwater drains within M/s CPCL were tracked, revealing breaches in the outlet and walls, with all drains and tanks heavily stained with oil. Numerous open oil-water collection tanks were present at ground level, lacking preventive measures to contain oil during flooding or to prevent its escape from the premises.

**Figure 9:** Assessment Region 3 - Upstream of B Canal from Manali High Road to Kodungaiyur showing the entry point of oil into the Buckingham Canal and Kosasthalaiyar River

2. Diversion of the northern storm water drain entry from Redhills surplus canal to the Buckingham canal is recommended to prevent accidental entry of oil in the KRiver in future.

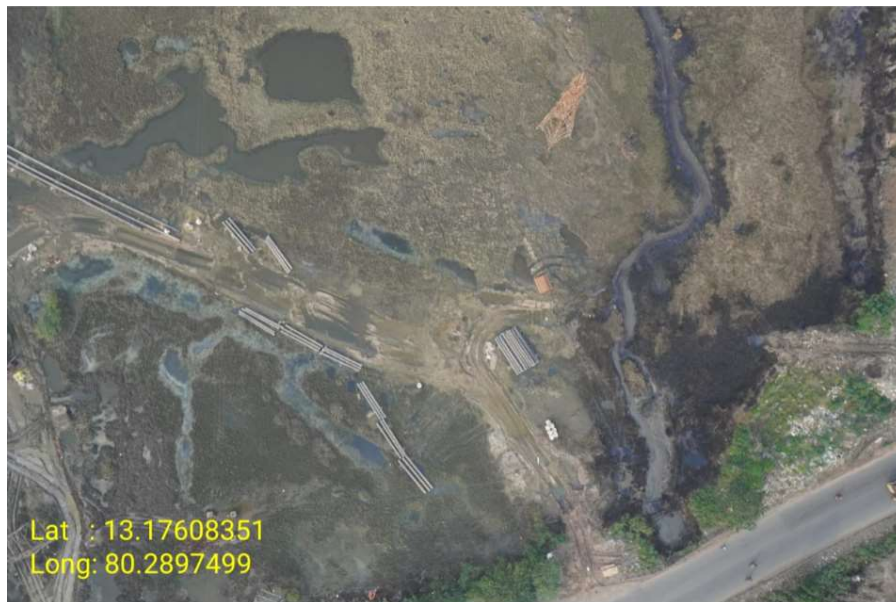
The soil samples collected at Zone 1 had oil markings present up to 2m (max.) depth from the surface. This may have long-term impacts on the region as it is mostly an unconfined aquifer where there are possibilities of contamination of the ground water.

**Figure 10:** Drone image of Zone 1

Verified through drone camera images, the dark patches in the above image signify the presence of oil pools surrounding the stormwater outlets flowing towards the K River. Extensive sampling of soil and water at this contaminated site revealed high oil content. Upstream from this contaminated site, deposits of oil-contaminated sludge are still present, likely resulting from backflow from this leakage point. However, no significant oil spill or sludge deposition was observed beyond 100 meters from this location, indicating that Zone 1 is likely the initial point of oil spillage or the source itself.

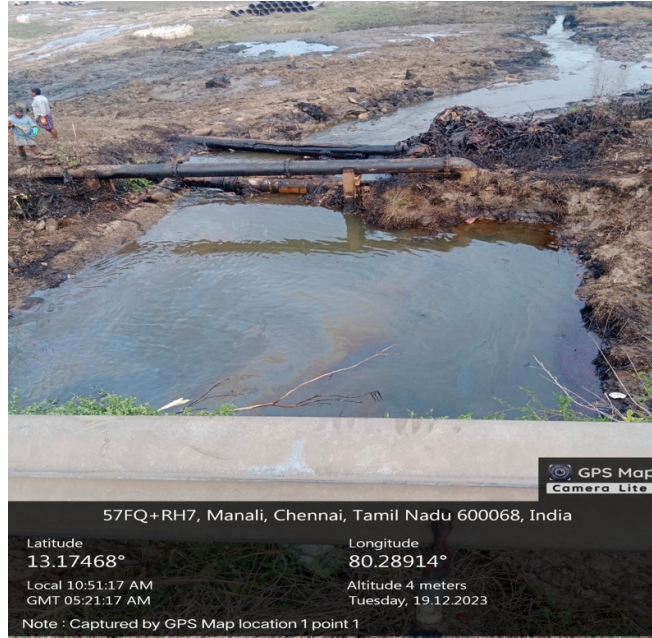
**Figure 11:** Close up view of Zone 1

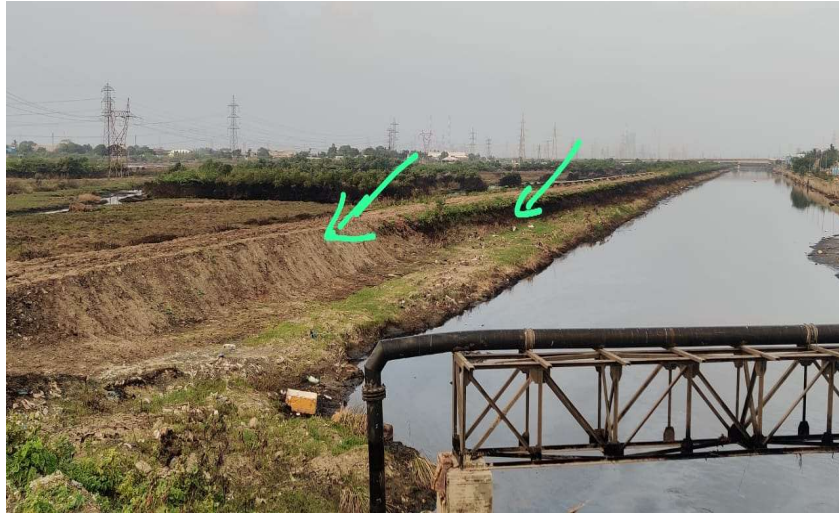
**Figure 13:** B canal possibly breached and oil stain covered.

Numerous earthmoving machines were on-site (Figure 13), along with several laborers tasked with covering the oil stains in the floodplain. Arrows pointing towards the two locations in the Buckingham Canal (Figure 14) distinctly indicate that the bund has been reworked following the oil spill, with one section appearing clean and the other section visibly stained with oil.

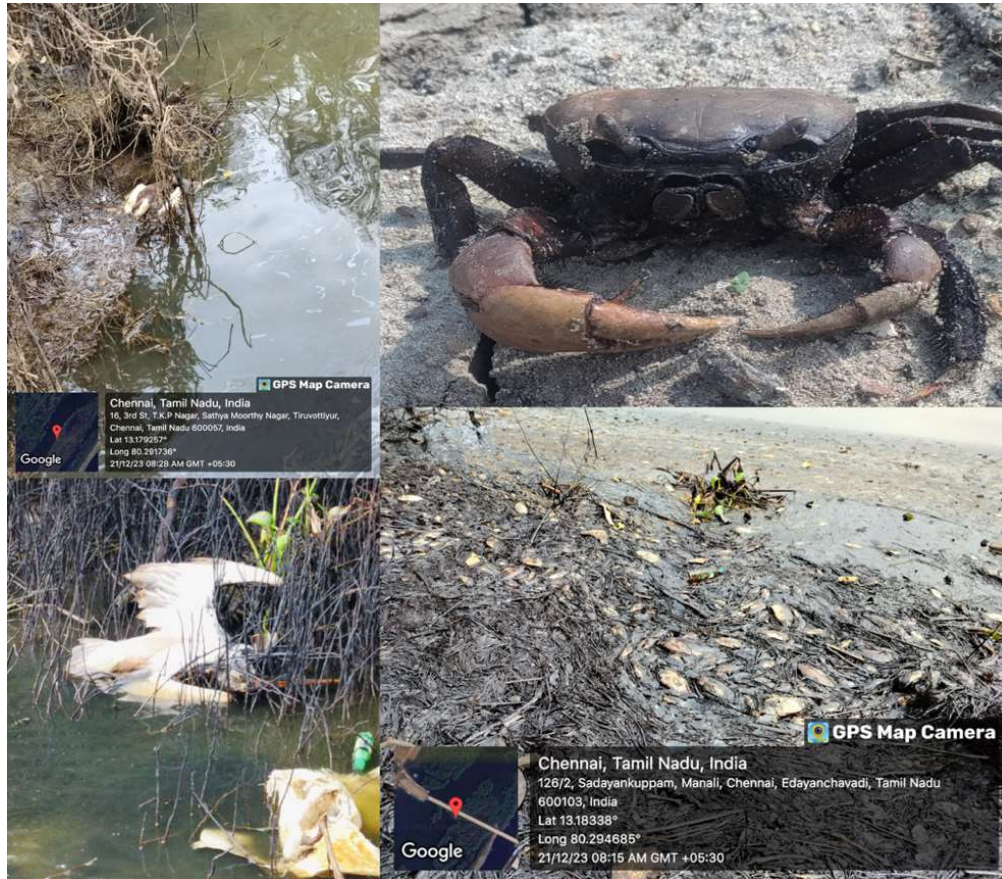
**Figure 15:**Dead birds, crabs, and fishes found in the contaminated site

The oil spill has posed a significant threat to biodiversity in the affected area, impacting mangroves and various organisms such as crabs, fishes, and birds. Visual observation of dead fishes, large number of crabs in the mangrove islands and dead mangrove saplings and 4 to 8 feet of oil-stained mangroves was documented (Figure 15 and 16). M.S. Swaminathan Research Foundation and National Centre for Coastal Research studies have documented these impacts. Long term sublethal damage to the mangroves can be assessed only through periodic monitoring. On the mangrove islands, the oil is likely to be stagnant in burrows made by crabs which can severely impact the mangroves and the associated flora and fauna. The benthic organisms such as shrimp and crabs in Kosasthalaiyar River and mangroves will take months or years to come back to normal if the contaminated soil is not removed or bio-remediated. This has severely affected the livelihood of the fishing villages along Kosasthalaiyar River who now must go to the sea.

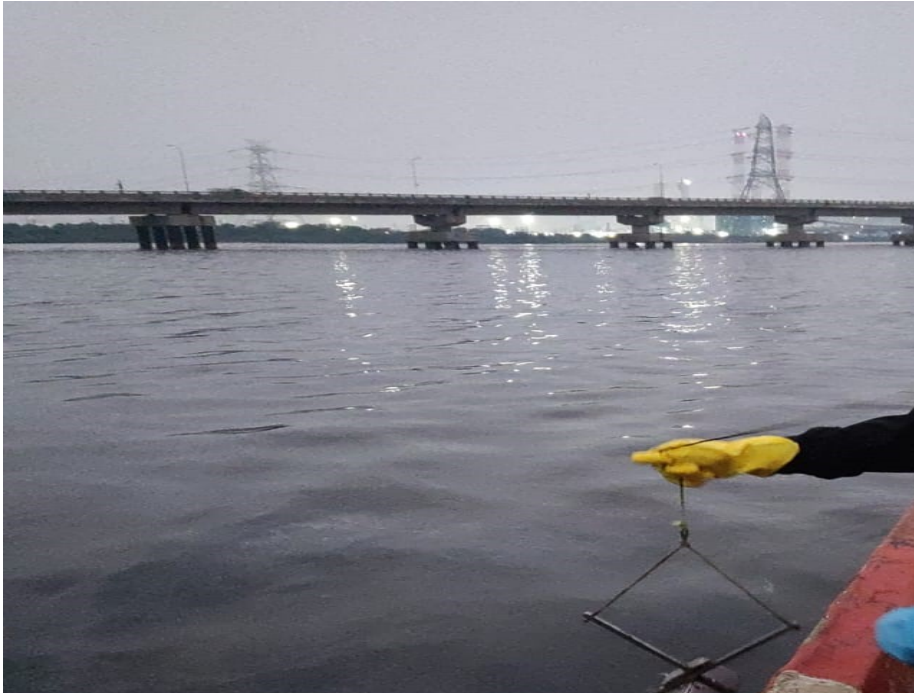
**Figure 17:** Collecting sediment samples using a grab sampler

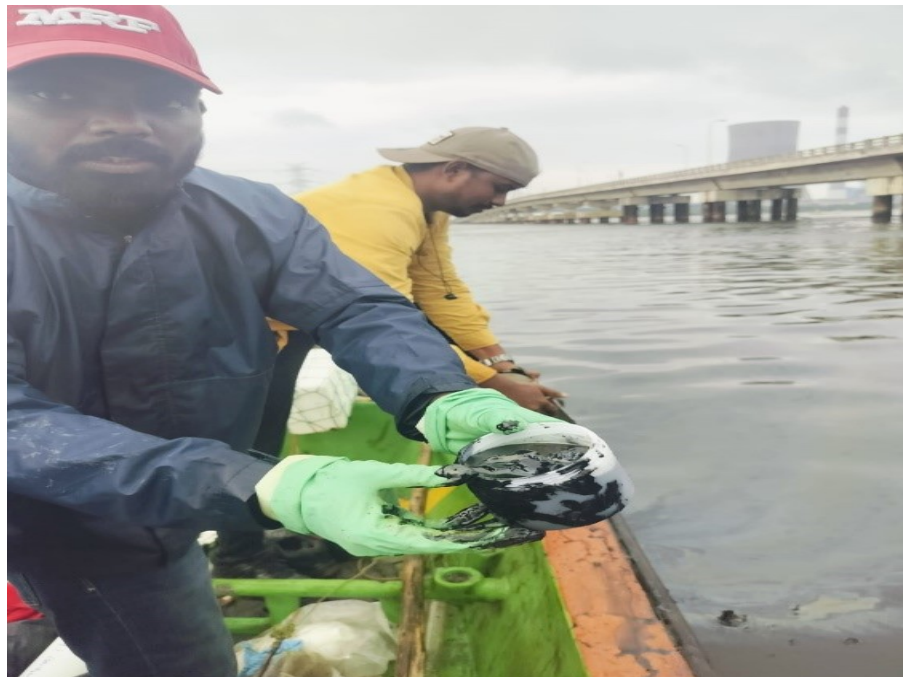
**Figure 18:** Sediment samples with the oily sludge were collected from midstream and banks

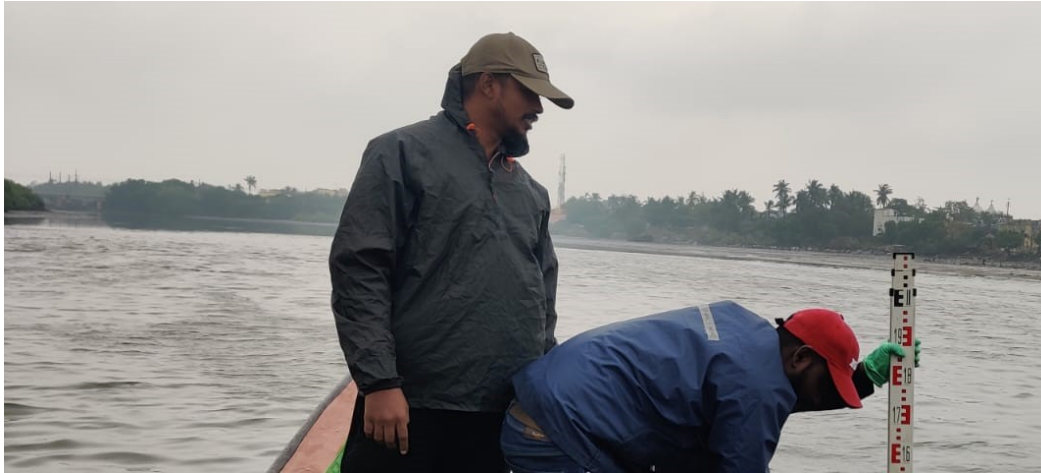
**Figure 19: Depth measurement**

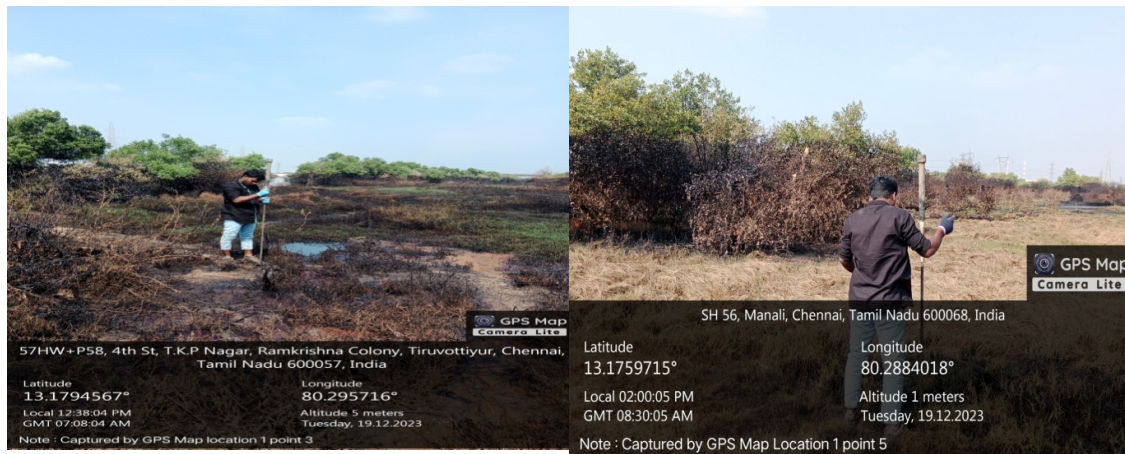
**Figure 20: Sampling of soil cores**

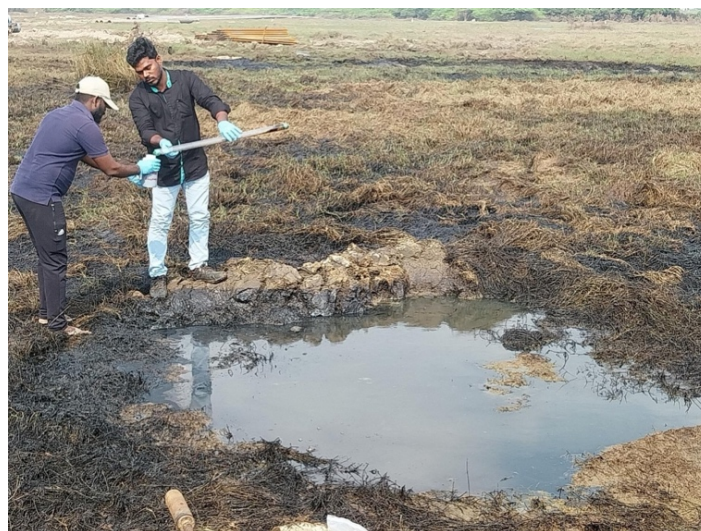
**Figure 21: Collecting water samples using a bailer**

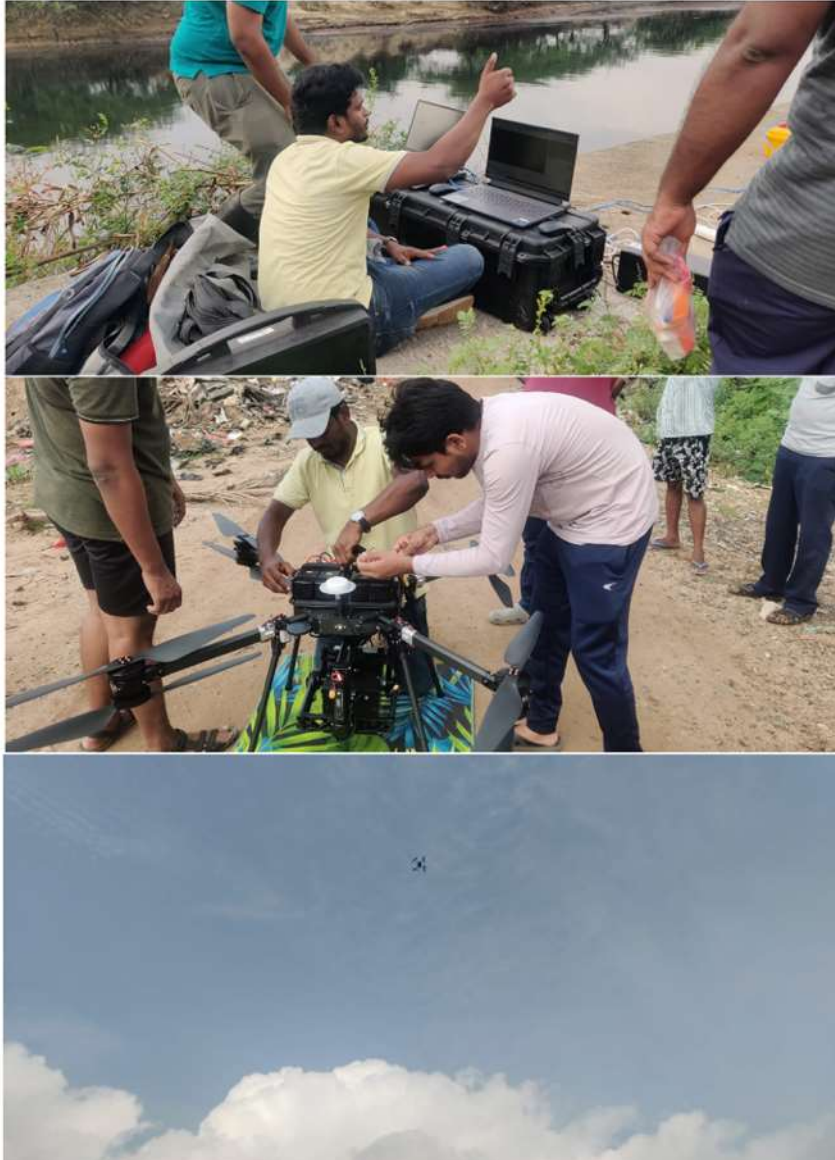
A drone survey was carried out to quantify the oil contamination spatially. Drones were employed to capture the hyper-spectral aerial images, that will help us differentiate water from oil. The drone images captured (Figure 24) show the oil sheen floating on B canal and K River.

**Figure 22:** Capturing high-resolution images using drone survey

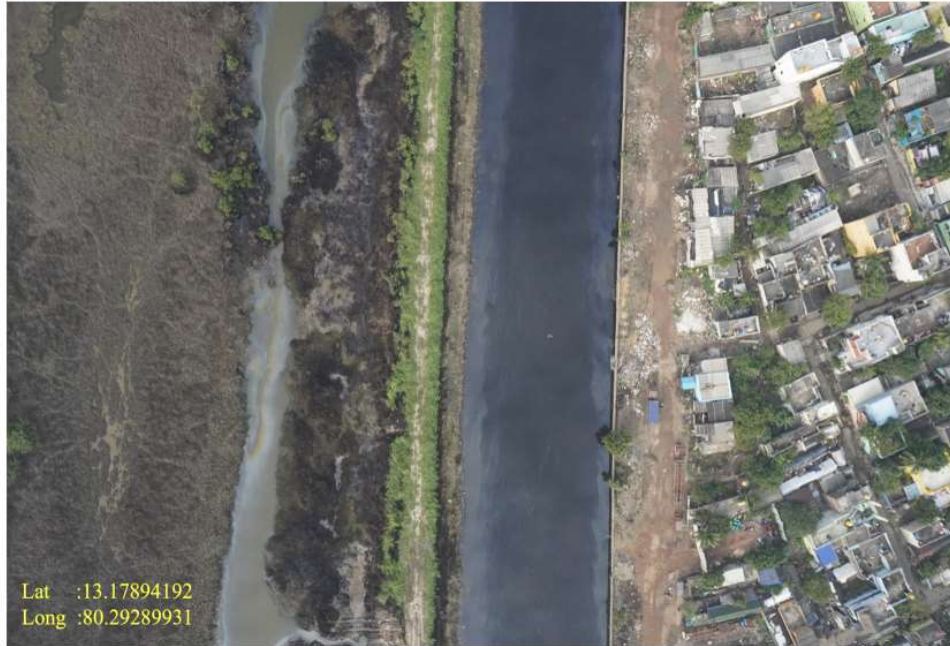
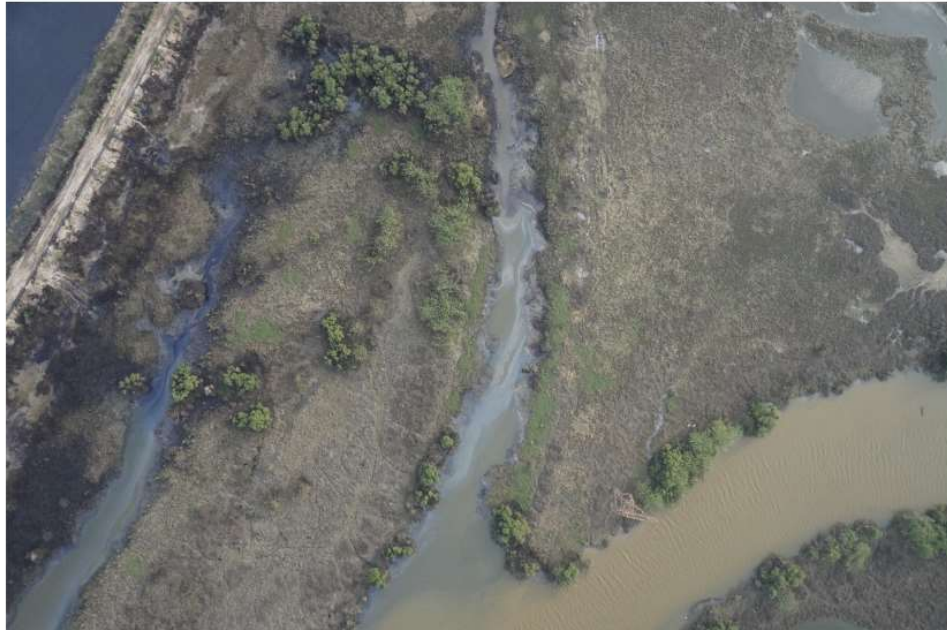
**Figure 23:** Drone images showing oil contamination in B Canal and K River

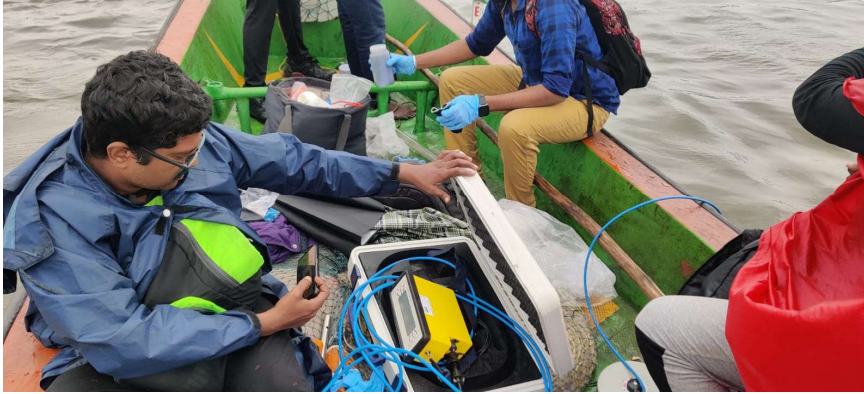
**Figure 24:** Water quality using field probe and flow measurement using FLOWFLAT

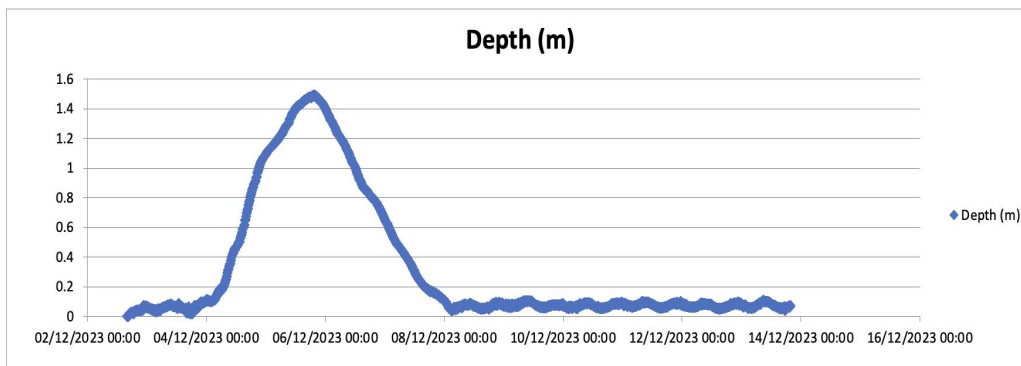
The installation of water level meters at M/s CPCL by IIT Madras provided valuable data regarding the timing and extent of the peak water level, particularly noting the peak occurring on December 6<sup>th</sup>, 2023. This suggests that a significant influx of water has exacerbated the spread and impact of the oil spill in several ways.

**Figure 26:** Water level metre at Bottling plant at CPCL

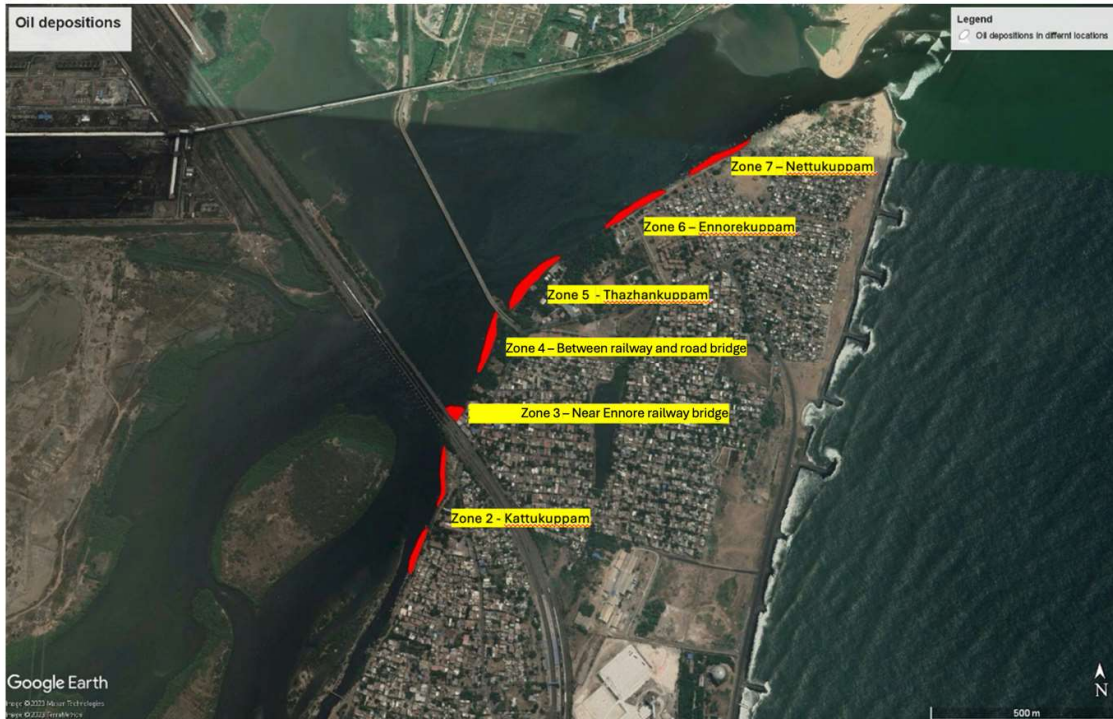
Hotspots/Area		Volume of soil contaminated [cu.m.]	Mass of soil contaminated [kg]	Oil measured in soil [kg]	Volume of oil [cu.m.]	Conservative estimate of volume of oil assuming only 1/3rd of the soil mass is contaminated [cu.m.]
Location	Area [sq.m.]	Upto 1 foot depth = 0.3 m	Specific gravity of soil = 2.65	TPH concentration ~ 30g/kg	Density of oil ~ 0.8 kg/m <sup>3</sup>	
Zone 1: Entry Point 1 - Storm water canal discharge into surplus canal of Kosasthalaiyar River	30296	9088.8	24085.32	722.55	903.19	<b>270.95</b>
Zone 2 (Kattukuppam)	3007	902.1	2390.56	71.71	89.64	<b>26.89</b>
Zone 3 (B/w railway and road bridge)	3163	948.9	2514.58	75.43	94.29	<b>28.28</b>
Zone 4 (near Ennore railway bridge)	2886	865.8	2294.37	68.83	86.03	<b>25.81</b>
Zone 5 (Thazhankuppam)	5139	1541.7	4085.50	122.56	153.20	<b>45.96</b>
Zone 6 (Ennorekuppam)	3742	1122.6	2974.89	89.24	111.55	<b>33.46</b>
Zone 7 (Nettukuppam)	3232	969.6	2569.44	77.08	96.35	<b>28.90</b>

Zone 8 (bridge pier/ island in KRiver near Sadayankuppam)	3000	900	2385	71.55	89.43	<b>26.83</b>
<b>Total volume of oil [cu.m.]</b>						<b>487.12</b>
<b>Note:</b>						
<ul style="list-style-type: none"> <li>• Area was estimated using Google Earth Pro.</li> <li>• Average TPH measured in soil samples were 30g/kg.</li> <li>• Average density of oil is assumed as 0.8 kg/m<sup>3</sup></li> <li>• We assumed only 1/3rd of the soil mass is contaminated.</li> </ul>

**Figure 27: Soil Contamination Zones**

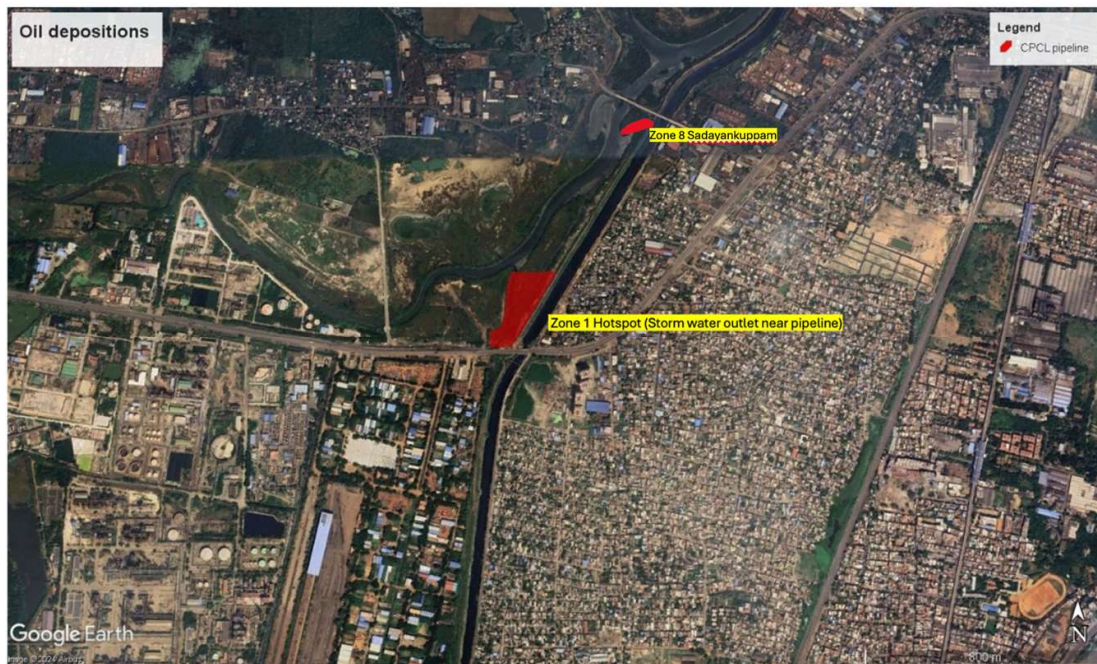
**Figure 28: Soil Contamination Zones**

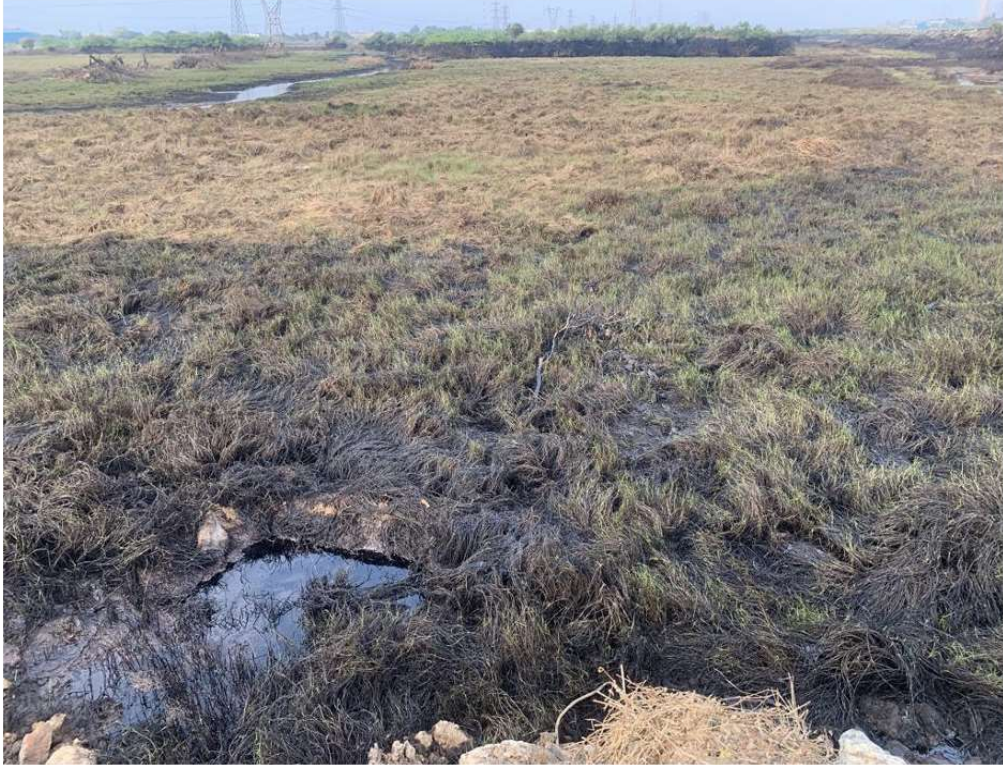
**Figure 29:** Oil contamination in Zone 1

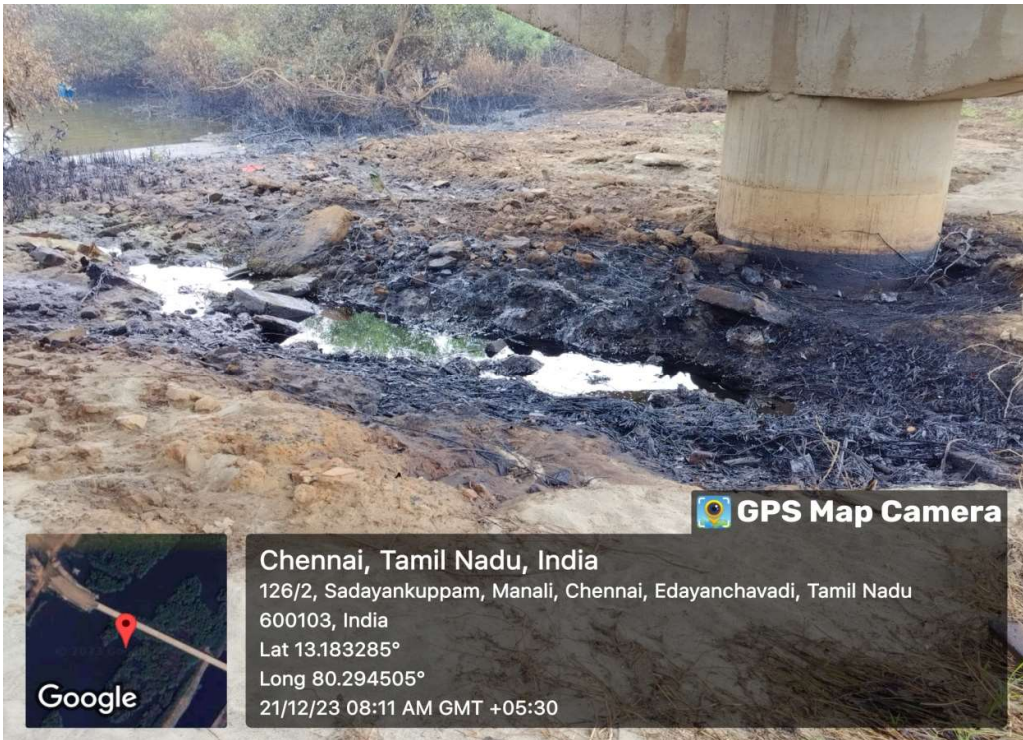
**Figure 30:**Oil contamination in Zone 8

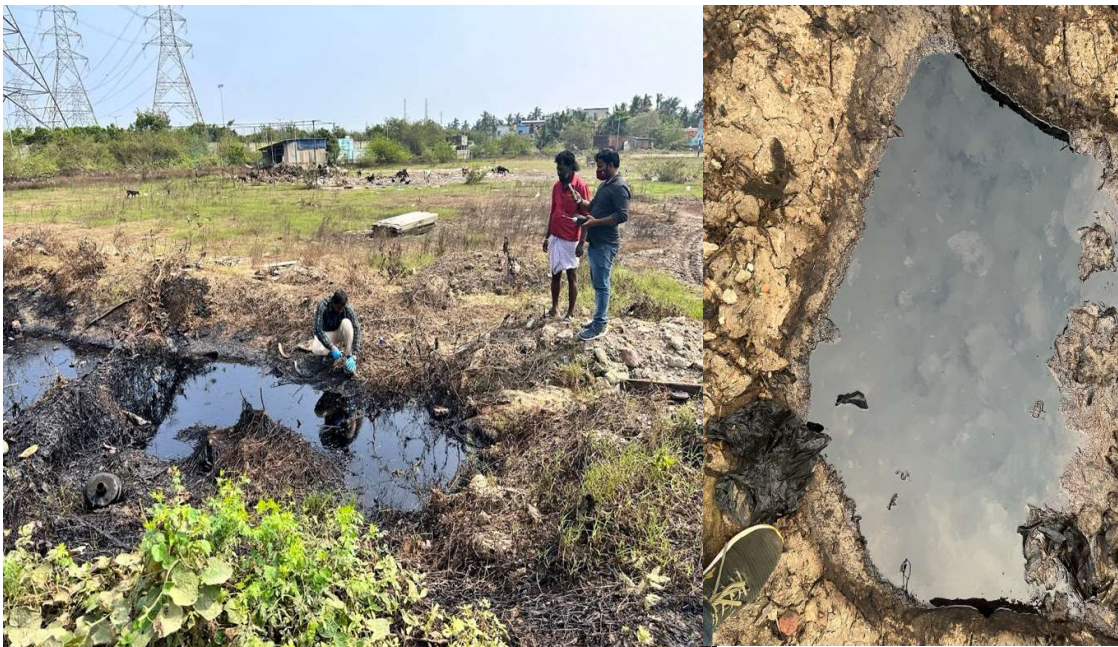
Oil pools in hotspots	Area [sq.m.]	Volume of oil in for 1 mm ponding depth [cu.m.]	Volume of oil for 5 mm ponding depth [cu.m.]	Volume of oil for 10 mm ponding depth [cu.m.]	Conservative estimate of volume of oil (1 mm ponding depth) [cu.m.]
Overflowed along B canal	11403	11.40	57.01	114.03	<b>11.40</b>
In mangrove islands	10000	10	50	100	<b>10</b>
Oil pool near pipelines	10000	10	50	100	<b>10</b>
<b>Total volume of oil [cu.m.]</b>		<b>31.40</b>	<b>157.01</b>	<b>314.03</b>	<b>31.40</b>
<b>Note:</b>					
<ul style="list-style-type: none"> <li>• Area was estimated using Google Earth Pro.</li> </ul>

**Figure 31: Oil pools near B Canal**

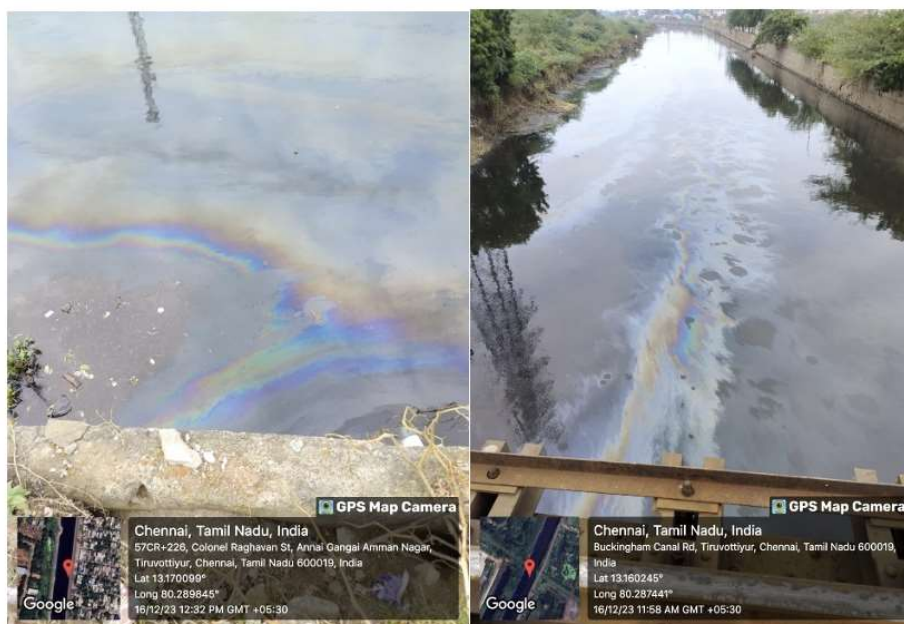
Oil sheen in water courses from drone				
Location	Area [sq.m]	Volume of oil for 0.01 mm sheen thickness [cu.m.]	Volume of oil for 0.05 mm sheen thickness [cu.m.]	Conservative estimate of volume of oil (0.01 mm sheen thickness) [cu.m.]
Buckingham Canal	121765	1.21	6.08	<b>1.21</b>
Kosasthalaiyar River	1032988	10.32	51.64	<b>10.32</b>
<b>Total volume of oil [cu.m.]</b>		<b>11.54</b>	<b>57.73</b>	<b>11.54</b>
<b>Note:</b>				
<ul style="list-style-type: none"> <li>• Area was estimated by the coast guard.</li> </ul>

**Figure 32:** Oil sheen on B Canal

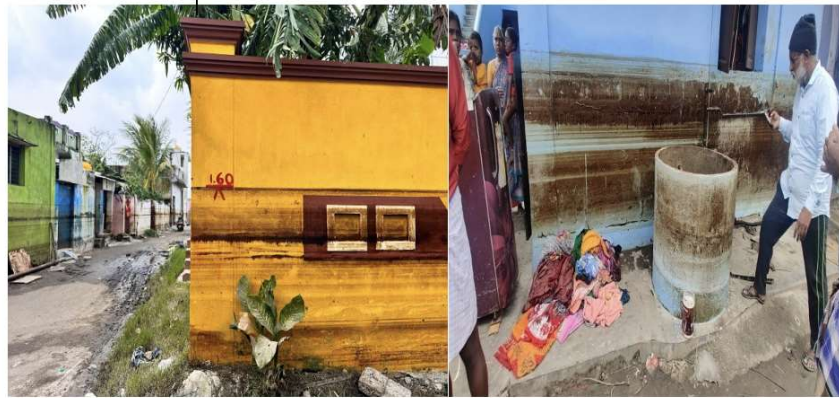
**Figure 36:** Oil stains seen on the walls of the residential buildings

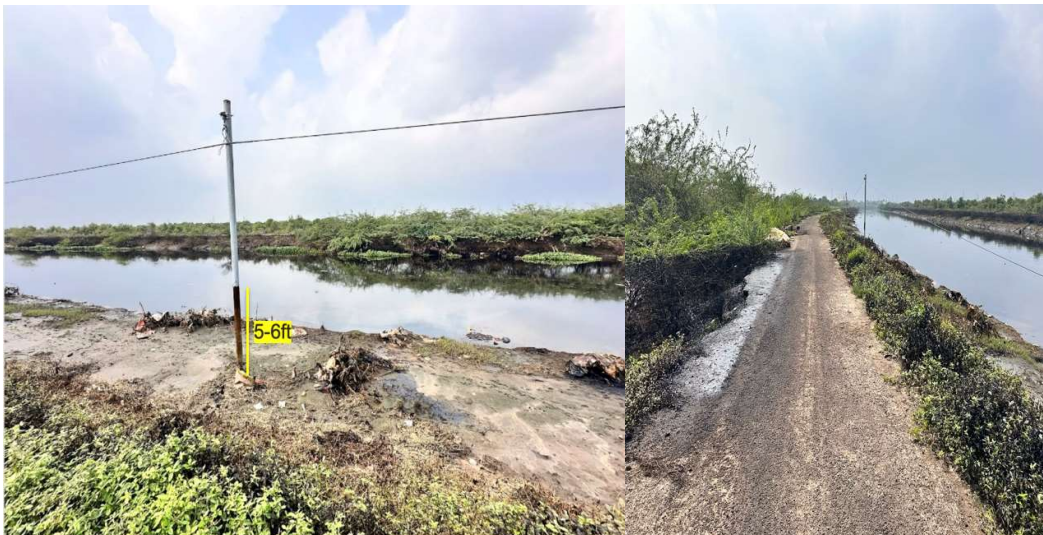
Based on the observed length and height of the stains left behind on the banks of the K River and B canal, we estimated the oil on the river banks and mangroves assuming different thicknesses of oil layer starting from 0.01 mm, 0.1 mm and 1 mm. The average volume of oil inundation is conservatively estimated as 0.38 cu.m. assuming only 0.01 mm of oil thickness.

**Figure 38:** Oil stains on the banks of B Canal

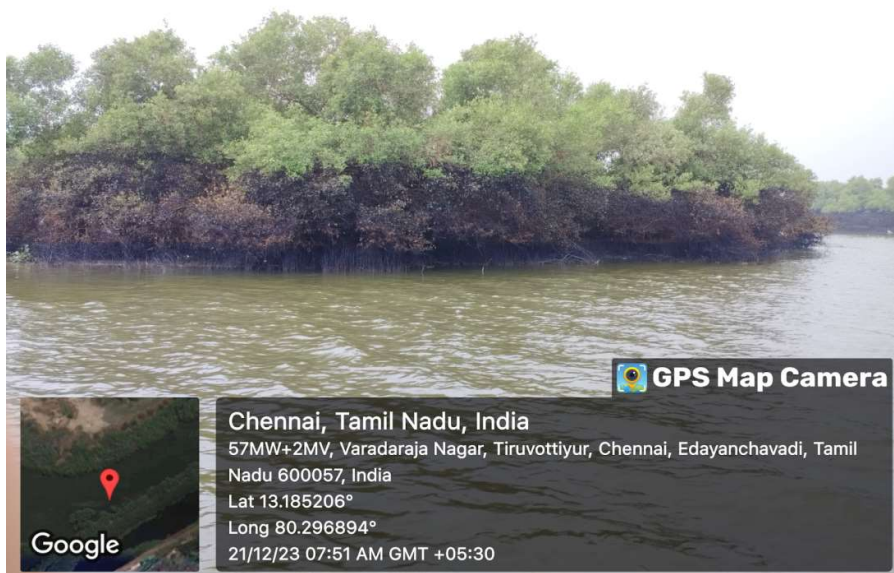
**Figure 39:** Oil stains on the mangroves**Overall Estimates:**
