O.A. NO 261 OF 2024

**Note on the preliminary assessment of landslide at Shirur, Uttara
Kannada District, Karnataka, India**

Engg. Geology & Landslide Division
State Unit: Karnataka & Goa
Southern Region

Preliminary Note on Shirur Landslide, Uttara Kannada District, Karnataka, India.

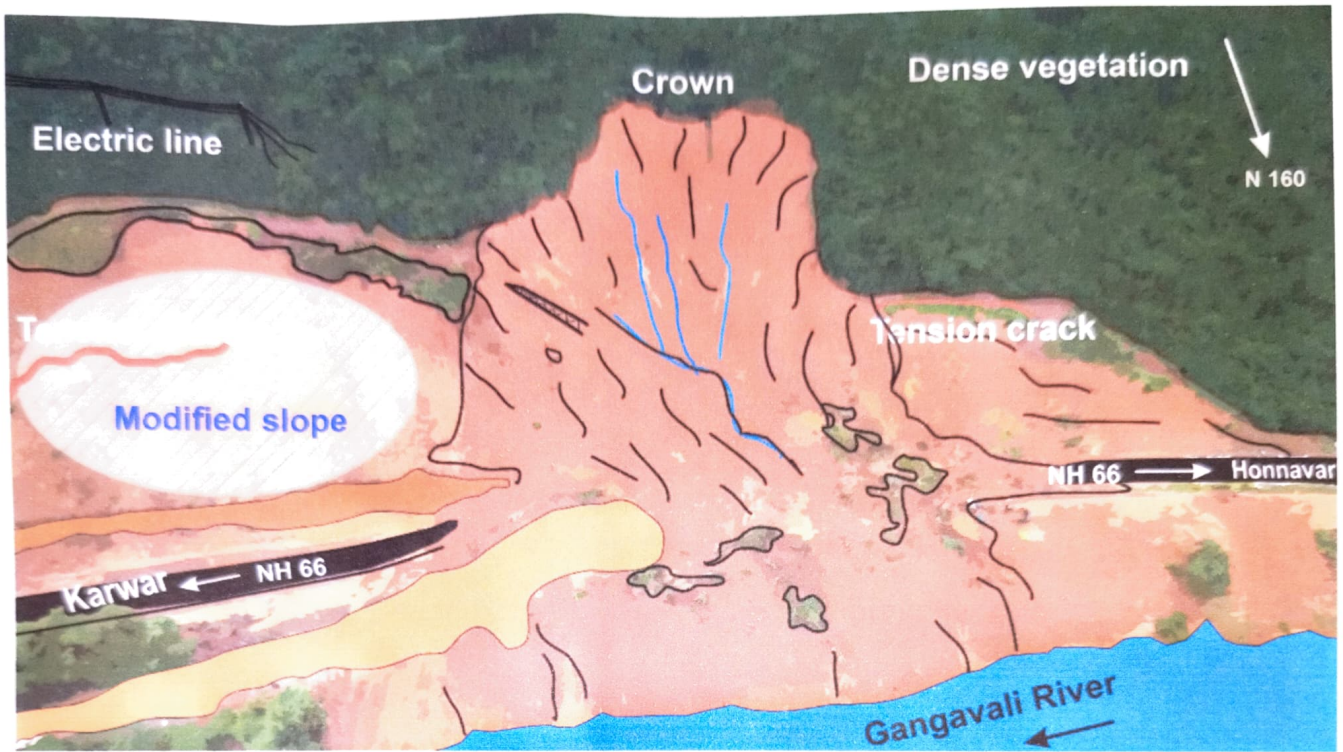
Fig.1: Schematic diagram of Shirur landslide (not to scale)

The landslide incident at Shirur village, Ankola Taluk, in Uttara Kannada district occurred on 16th July 2024 at approximately 08:30 Hrs. The location of the event is at the left-hand side of Chainage number 148.000 (14.603554°N / 74.371219°E) of NH-66 (**Fig.1**). The landslide is characterized as a deep rotational debris flow with approximate dimensions: Length - 110m, Width - 130m, and Height - 50m. This event obstructed communication through the National Highway, with a runout distance exceeding 150m, depositing debris material into the river channel. Local reports indicate that the substantial volume of debris influx into the river caused an impact wave, resulting in the destruction of four houses on the opposite bank.

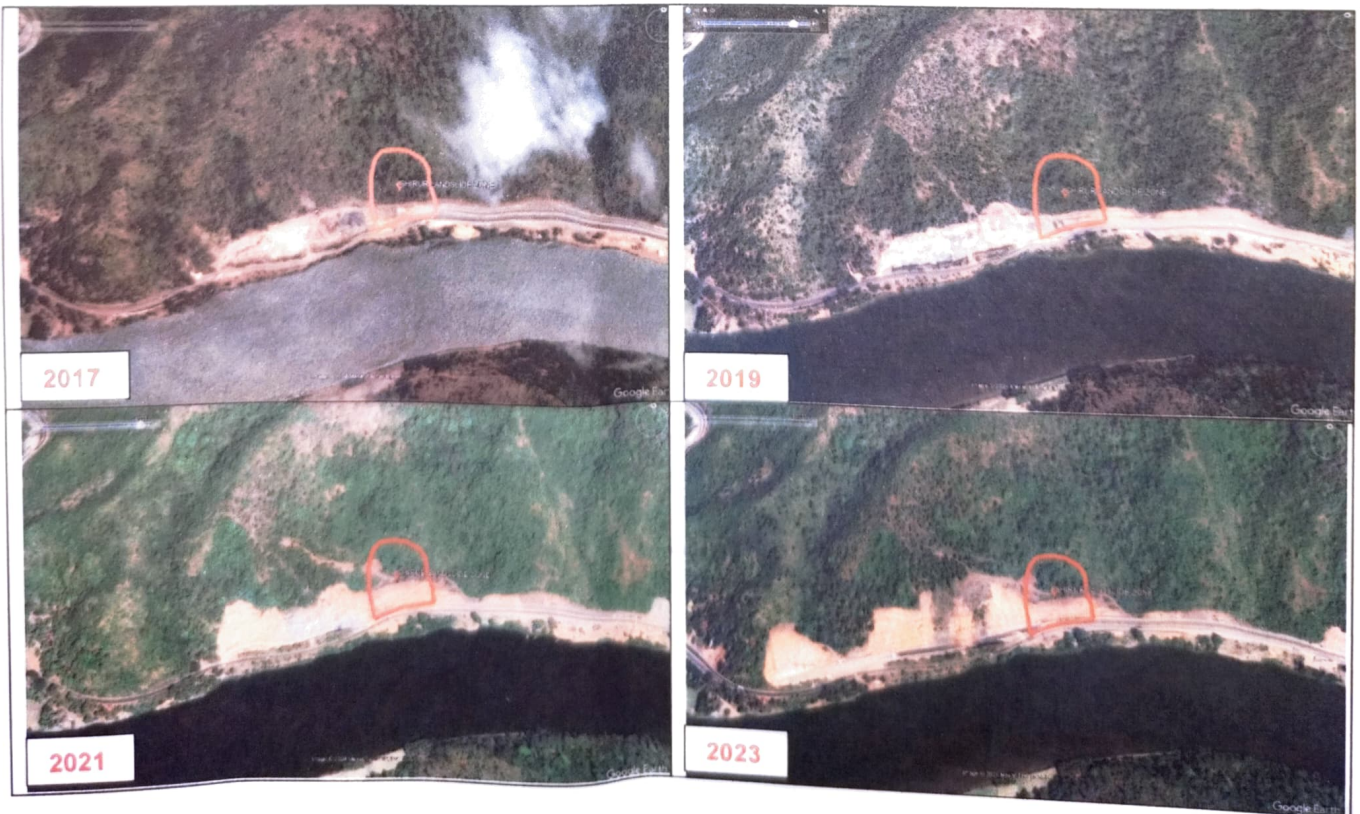
Fig.2 Multi-temporal satellite imageries of the landslide zone.

NH-66, which passes through the area, makes a left bend at Shirur village and runs parallel to the right bank of the Gangavali River until the Gangavali highway bridge. To facilitate four-lane traffic, the hill slopes in this road section had to be modified. Satellite imagery from Google Earth (**Fig.2**) shows that slope modifications have been initiated in the area since 2017, with modifications up to 40m in height. Local reports indicate that the location of the Shirur landslide was modified with benches measuring 6m x 2m.

- ✚ Multi-temporal satellite imagery indicates anthropogenic interference on the slopes from Chainage number 147.400 to 148.200 since 2017, with some landslide scars above the cut slopes.

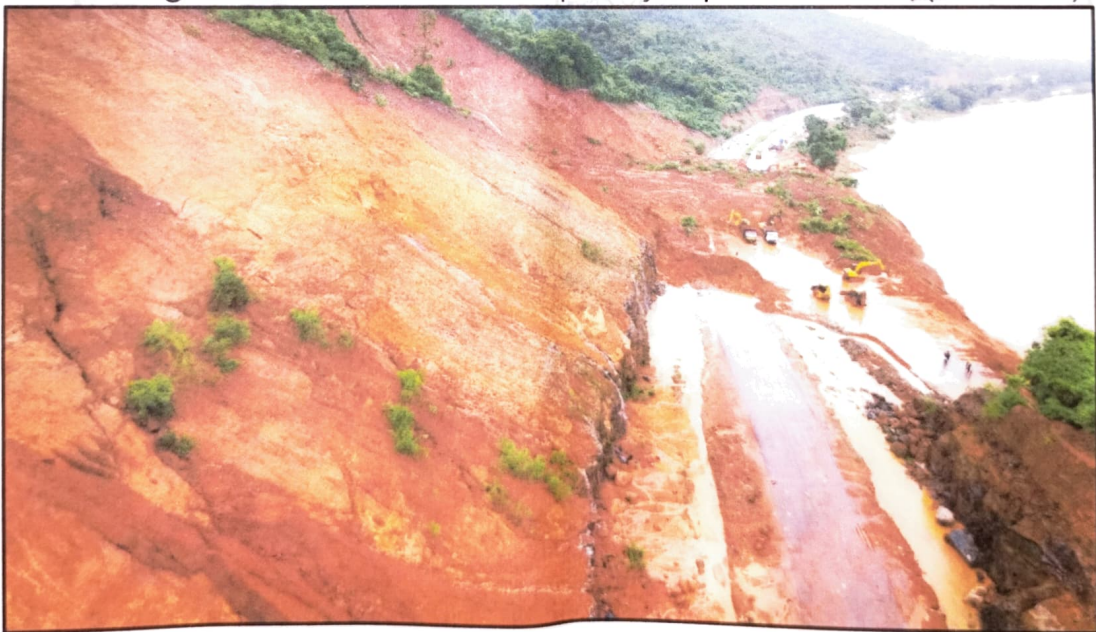
Fig. 5 Transverse cracks on the right flank of the landslide

- ✚ The landslide movement is extremely rapid and currently active, with the potential for enlargement.
- ✚ The adjoining slope on the right of the landslide has a gradient of approximately 40° without benches. Fresh tension cracks present in this area may lead to failure in case of continuous rainfall (**Fig. 5**). The debris thickness here is also considerable. Tension cracks of 2 feet depth were observed in the left flank also (**Fig. 6**).

- The gradient at the slope sector from 147.400 to 148.200 should adhere strictly to BIS codes for slope gradient with benching, based on the geotechnical properties of the soil. The bench width should enable the slope segments to act independently, as prescribed in IS code 14680:1999.
- Benches should be provided with lined ditches or drainage to reduce erosion and infiltration along with slope reinforcement measures.
- The natural drainage path is modified due to extensive slope cutting at the site. A culvert with sufficient diameter pre-cast pipes should be provided to accommodate water and debris discharge at the toe of the landslide at Ch. No. 148.000.
- Monitor for tension cracks and possible displacement of slope material at the crown area.
