**BEFORE THE NATIONAL GREEN TRIBUNAL  
SOUTHERN ZONE, CHENNAI**

**ORIGINAL APPLICATION NO. 261/2024  
[EARLIER O.A. NO. 1055/2024 (PB)] .**

**REPORT ON BEHALF OF RESPONDENT NO. 5 (KARNATAKA  
STATE DISASTER MANAGEMENT AUTHORITY)**

**EXPERT COMMITTEE REPORT ON  
COST EFFECTIVE LONG-TERM REMEDIAL MEASURES FOR  
LANDSLIDE PRONE AREAS IN HILLY REGIONS**

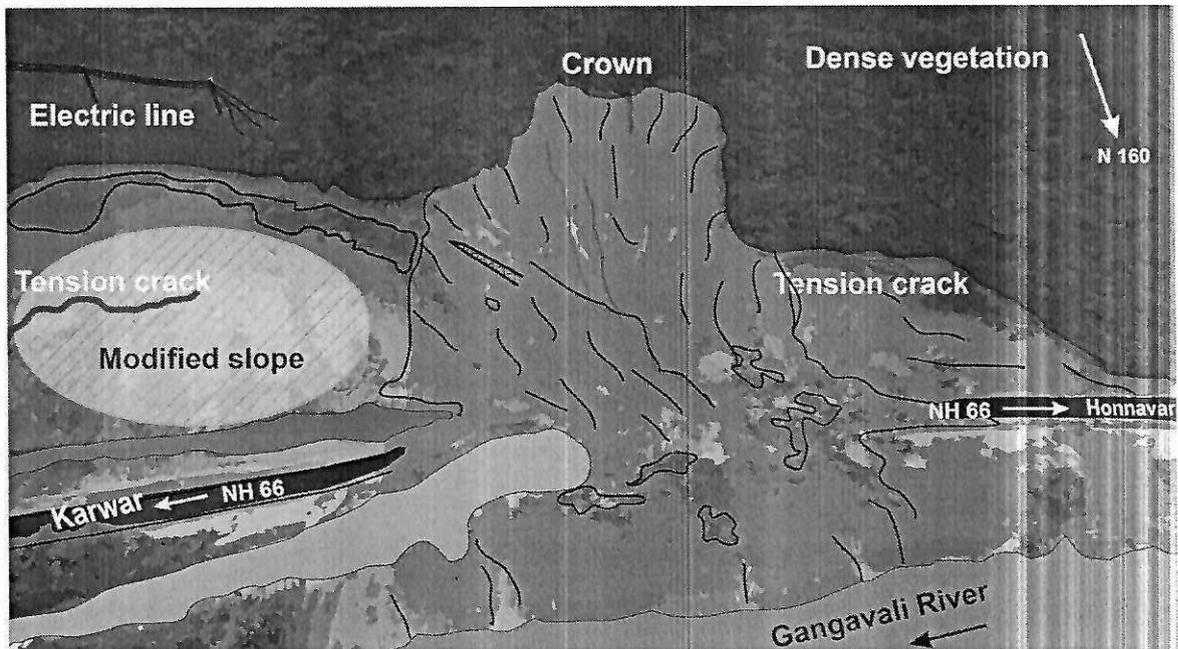
Fig.1: Schematic diagram of Shirur landslide (not to scale)

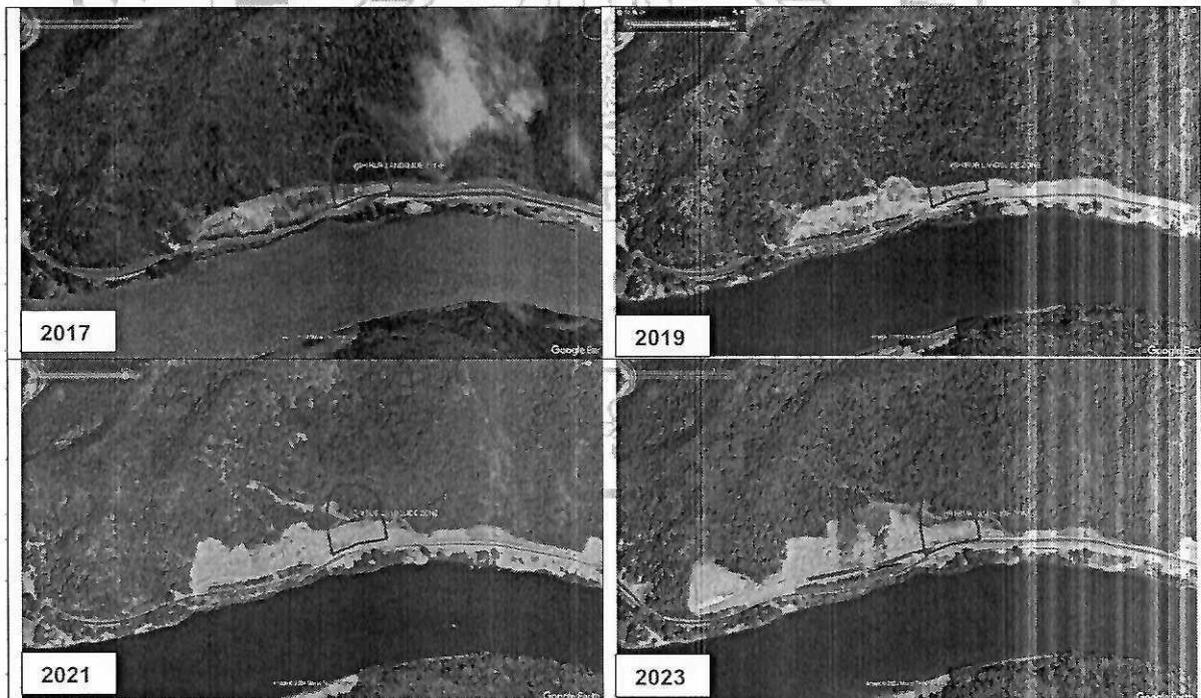
Fig.2 Multi-temporal satellite imageries of the landslide zone.

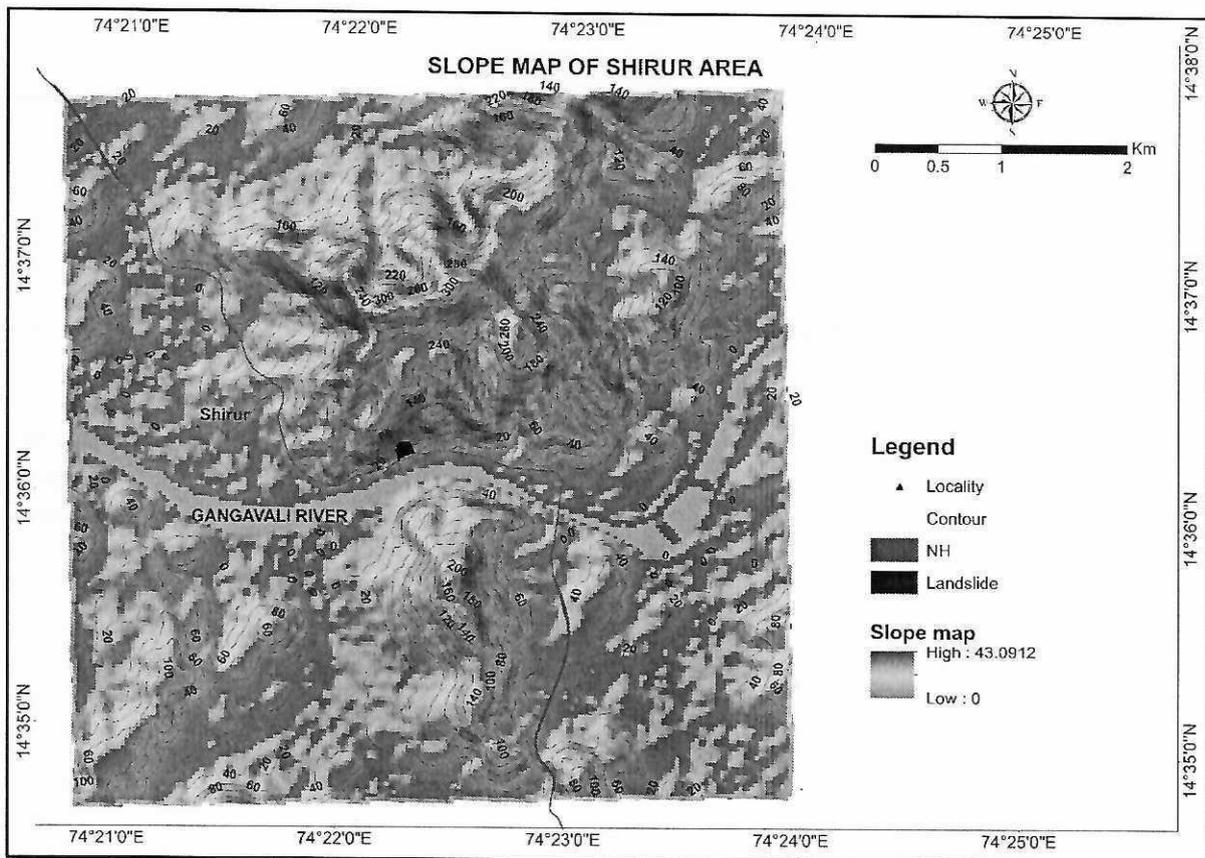
Fig. 3. Slope map of Shirur area derived from SRTM DEM

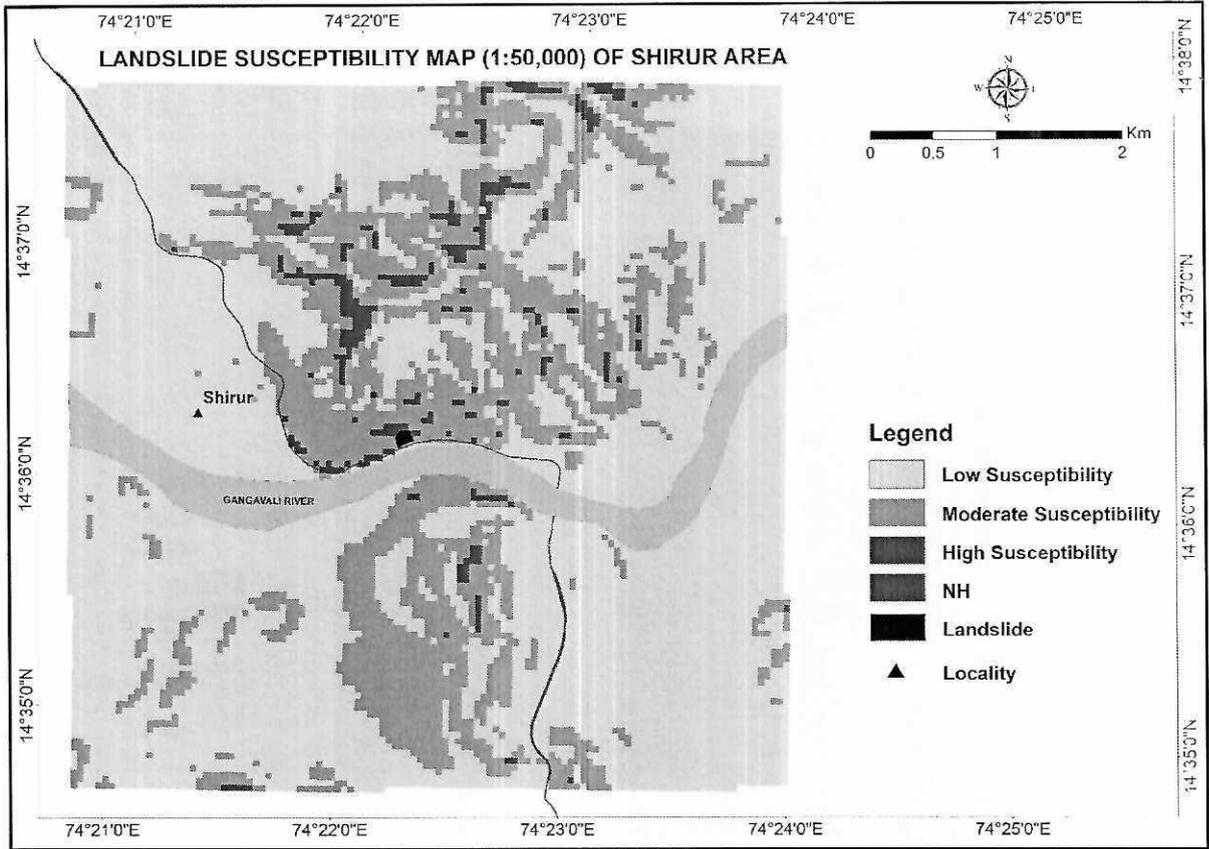
Fig. 4 National Landslide Susceptibility Map of Shirur area, (NLSM GSI)

National Landslide Susceptibility Mapping (NLSM) with an aim to cover the 0.42 million sq. km landslide prone areas of the country. GSI prepared GIS-based seamless Landslide Susceptibility Maps of India on 1:50,000 scale and submitted the following reports to Government of Karnataka during May 2024. Based on National Landslide Susceptibility Mapping (NLSM) by GSI, list of landslide susceptible Gramapanchayats in Coastal (Dakshina Kannada, Udupi and Uttara Kannada) and Malnad (Kodagu, Hassan, Chikkamagalur and Shivamogga) Districts were identified. The details of types of landslides and causes of landslides in Karnataka is annexed as **Annexure 2**.

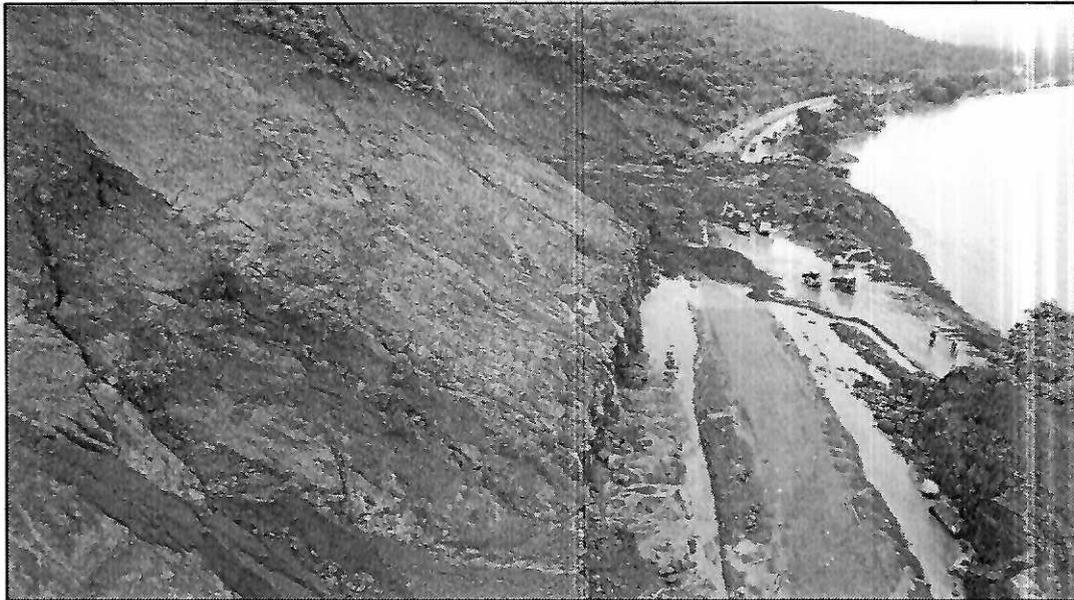
- ✦ The landslide movement is extremely rapid and currently active, with the potential for enlargement.
- ✦ The adjoining slope on the right of the landslide has a gradient of approximately 40° without benches. Fresh tension cracks present in this area may lead to failure in case of continuous rainfall (Fig. 5). The debris thickness here is also considerable. Tension cracks of 2 feet depth were observed in the left flank also (Fig. 6).

Fig. 5 Transverse cracks on the right flank of the landslide

- The gradient at the slope sector from 147.400 to 148.200 should adhere strictly to BIS codes for slope gradient with benching, based on the geotechnical properties of the soil. The bench width should enable the slope segments to act independently, as prescribed in IS code 14680:1999.
- Benches should be provided with lined ditches or drainage to reduce erosion and infiltration along with slope reinforcement measures.
- The natural drainage path is modified due to extensive slope cutting at the site. A culvert with sufficient diameter pre-cast pipes should be provided to accommodate water and debris discharge at the toe of the landslide at Ch. No. 148.000.
- Monitor for tension cracks and possible displacement of slope material at the crown area.

- Given the excess subsurface water flow, engineered slopes should include provisions to drain subsurface water, such as perforated horizontal pipes of appropriate diameter, depending on site conditions.
- A comprehensive geotechnical investigation is recommended to determine appropriate slope stabilization strategies for the Shirur site.

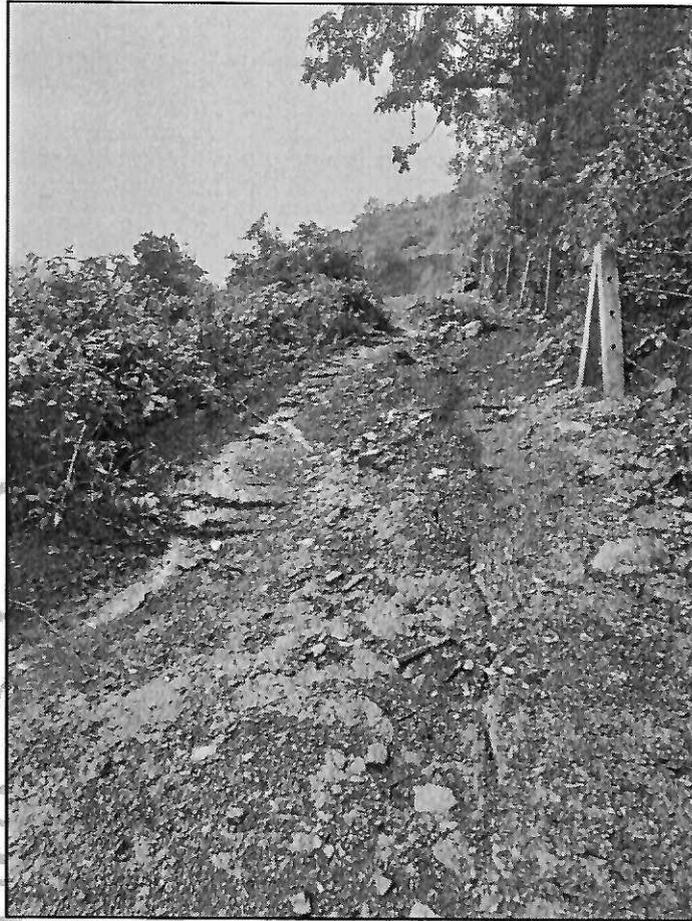
Fig. 6 Transverse cracks on the left flank of the landslide

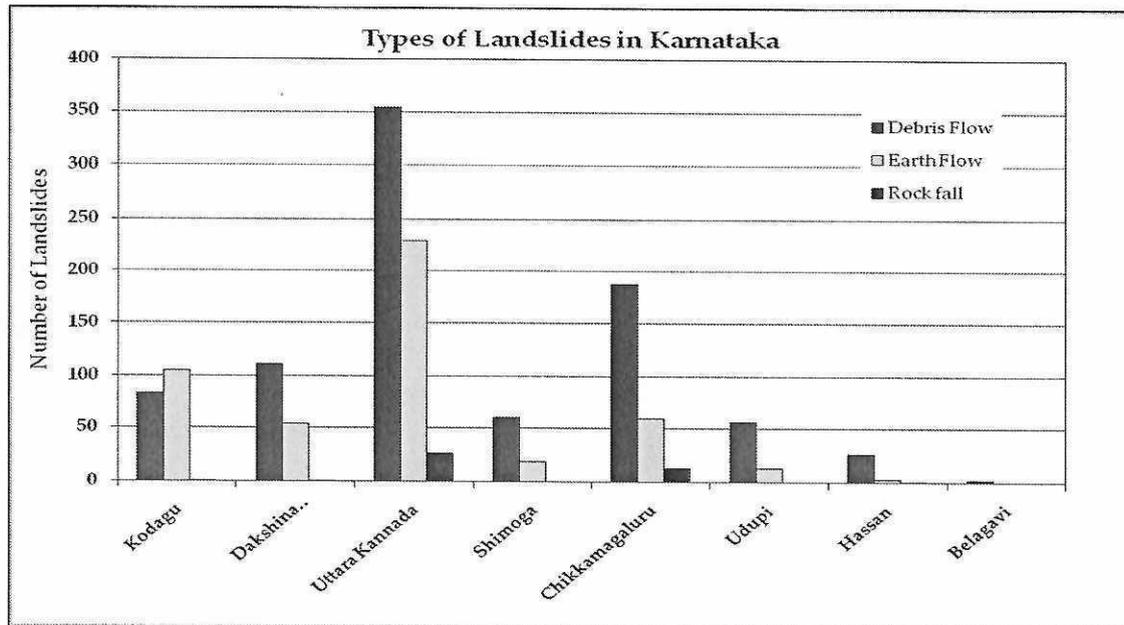
#### District wise Types of landslides

Majority of the landslide types are debris flow followed by earth/mud flow and rock fall. Uttara Kannada, Chikkamagalur and Dakshina Kannada districts recorded highest number of debris flow type of landslides.

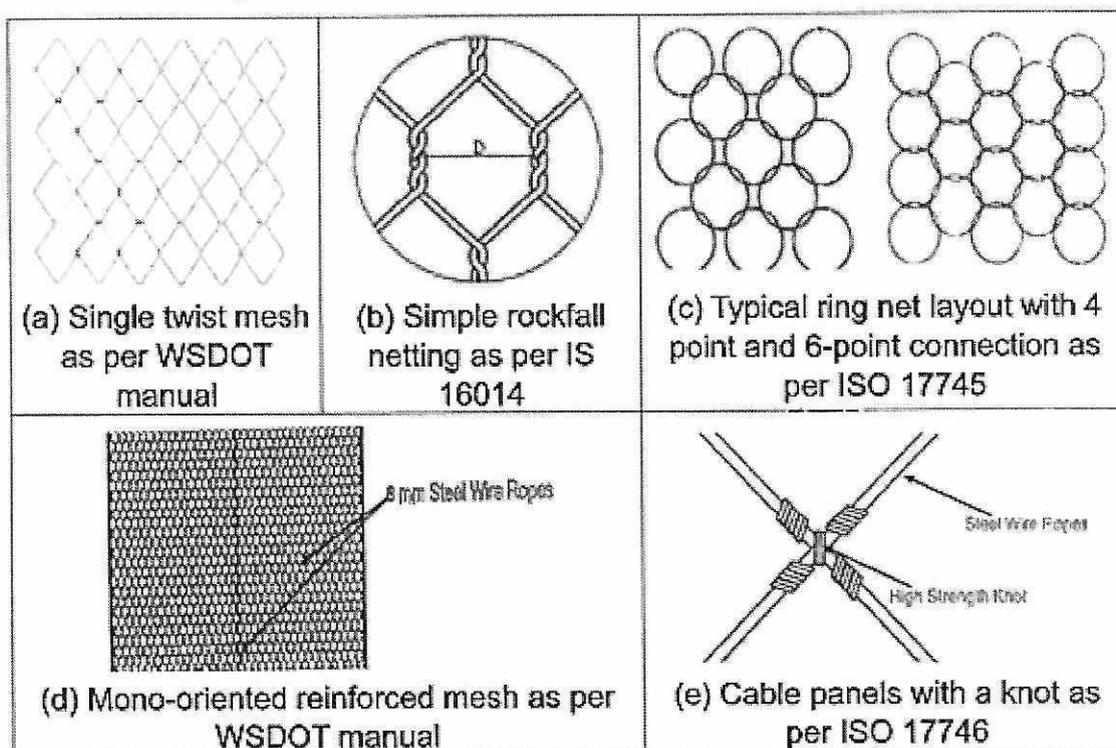
- (i) Drapery systems will be a significant component of most of the protection, retention and prevention systems. Many times, their function will be to act as facia systems where prevention or retention is mainly done through long nails/anchors/bolts or surfaced nails/anchors/bolts. A typical example showing different types of products and their specification standards are given in Fig. 4.26

Figure A1. Examples of Types of Drapery Systems used for Rock fall Mitigation measures

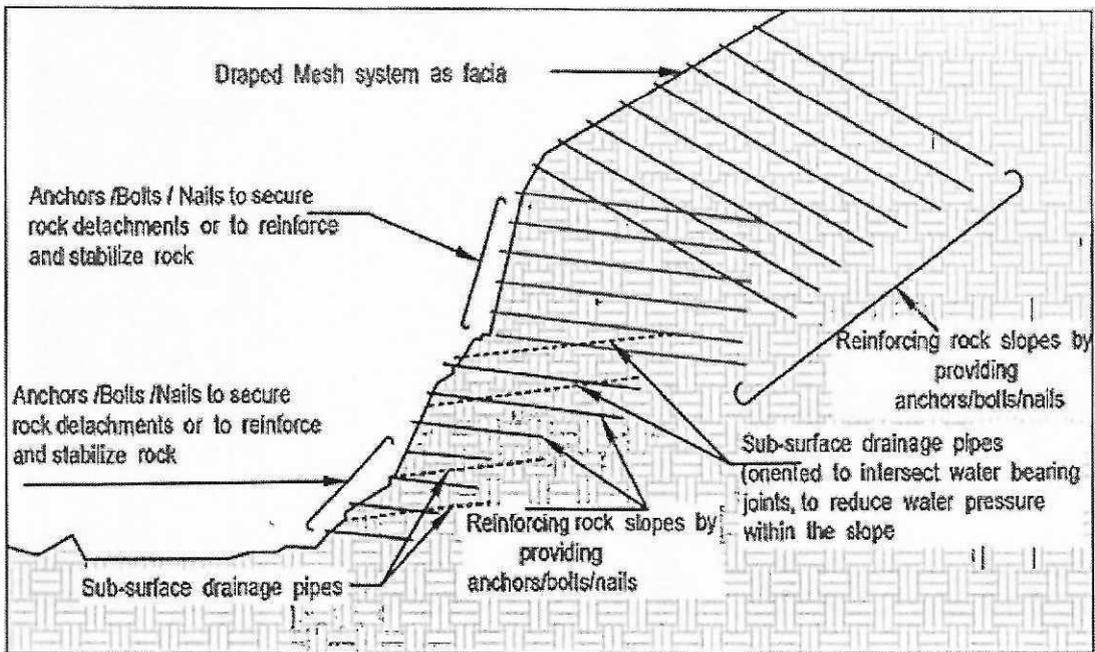
Figure A2. Typical Cross-section of Reinforcing Rock slope by Anchors/Bolts/Nails

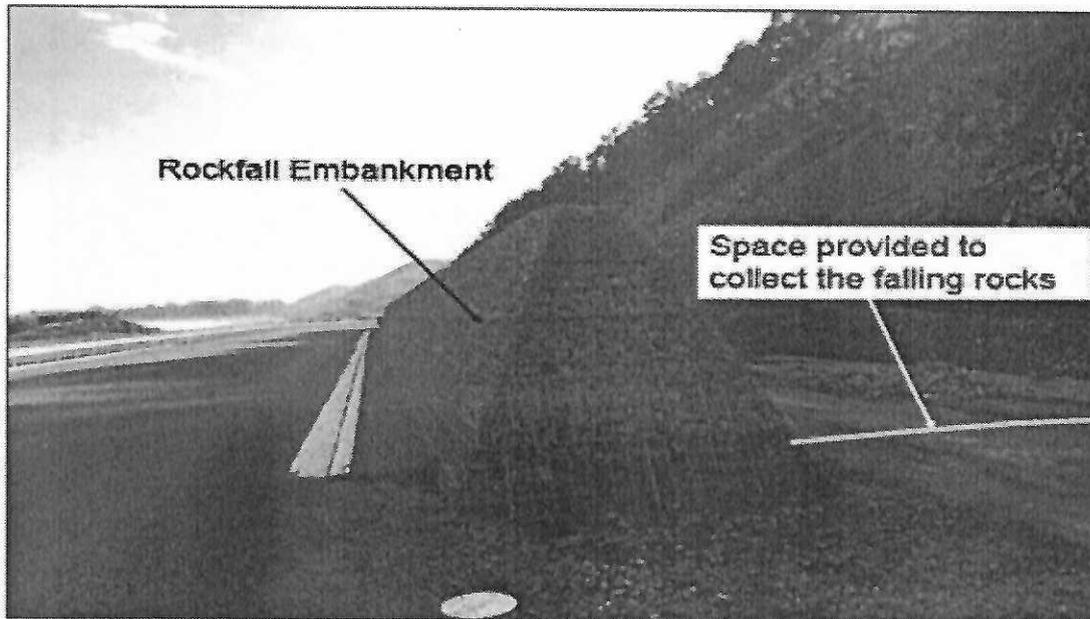
Figure A3. Rockfall Embankment to protect infrastructure and roads at the foot of cliff

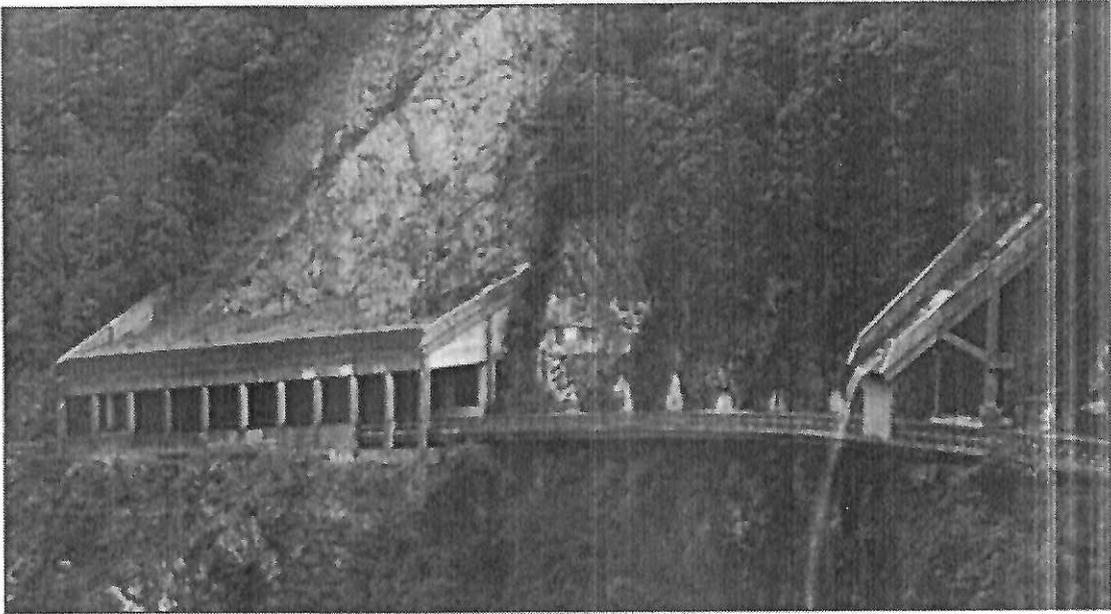
**Figure A4. Site Photograph of Rock Shed**

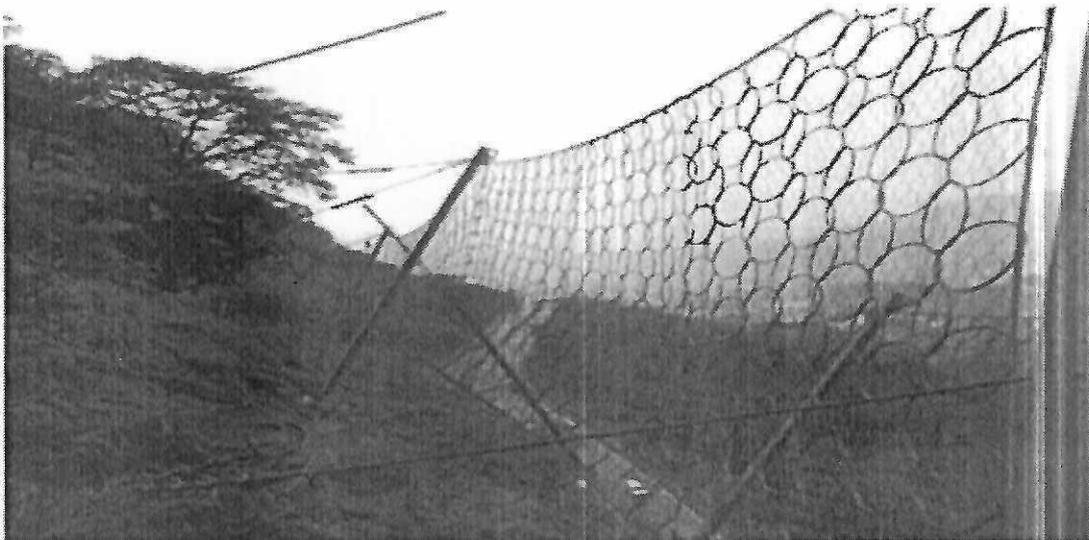
**Figure A5. Flexible Rockfall Barriers**

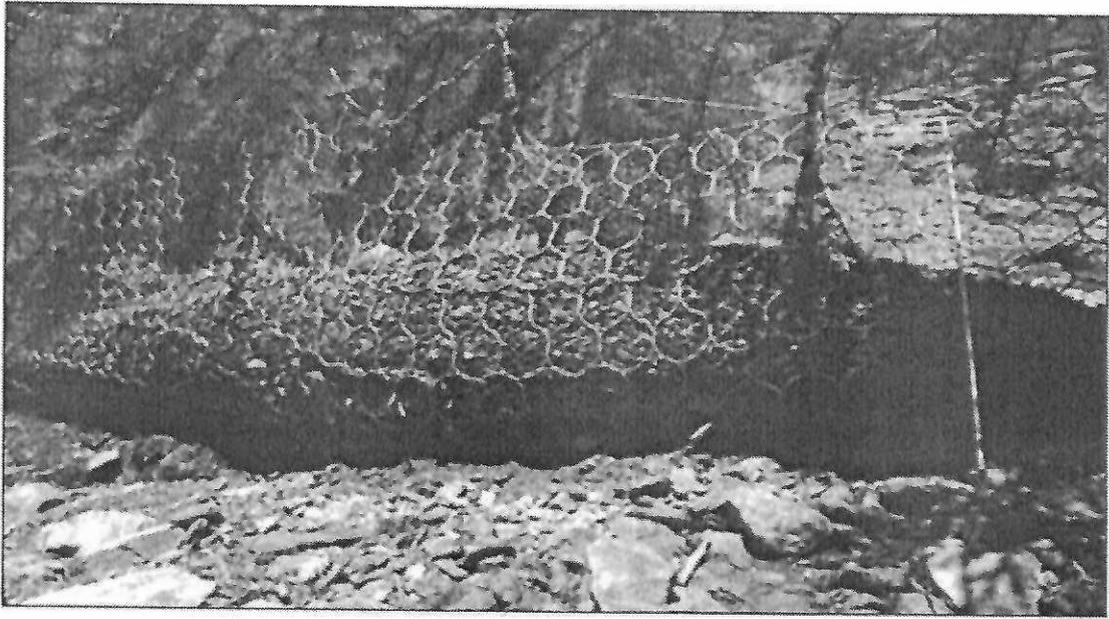
Figure A6. Debris Flow Barrier

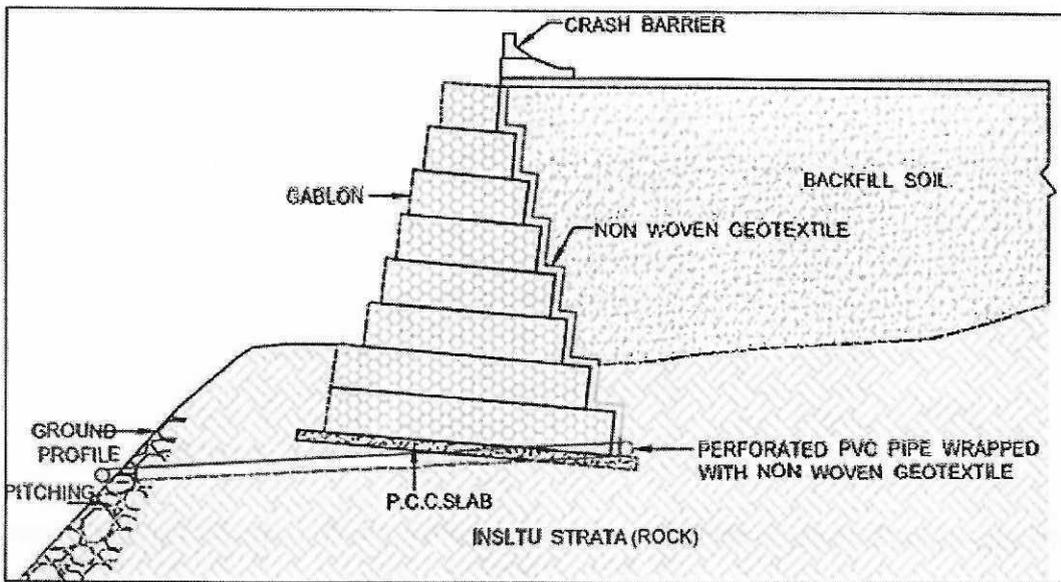
Figure A7. Indicative Cross-section of Gabion Retaining Wall

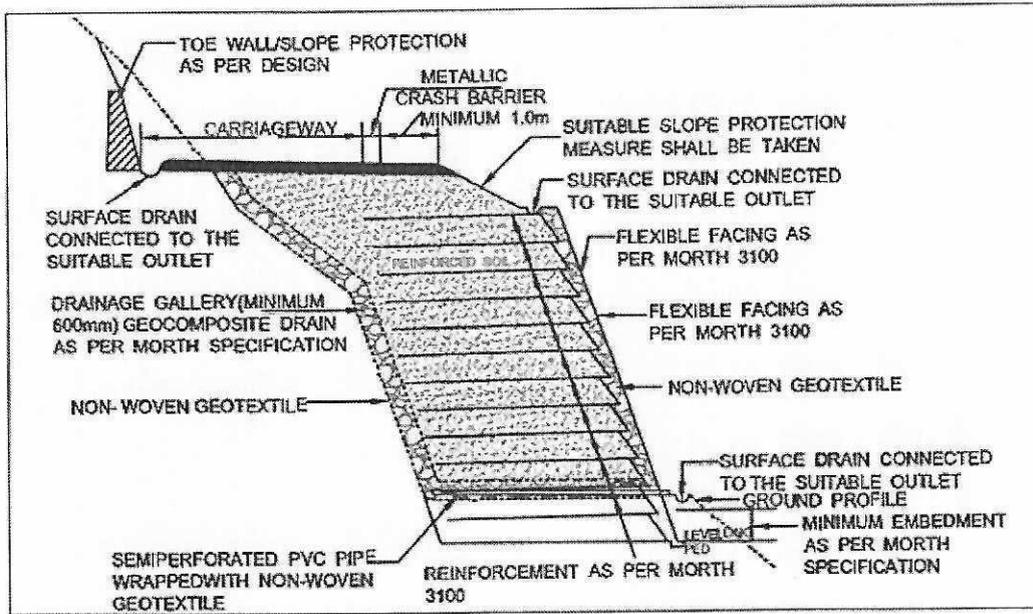
Figure A8. Cross-section of Reinforced Soil Slope with Flexible Facing

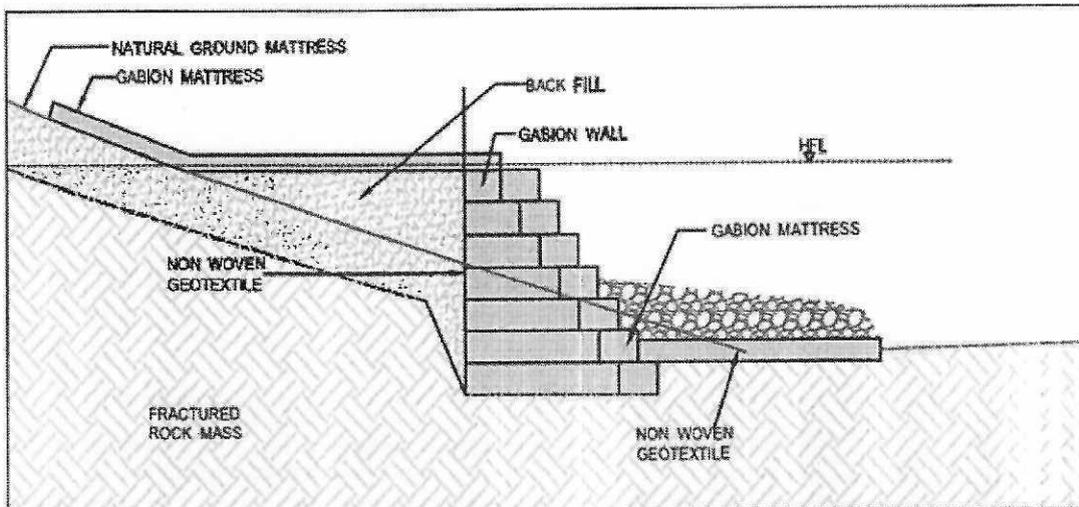
Figure A9. Cross-section of Gabion Retaining Wall with Launching Apron on River Bed

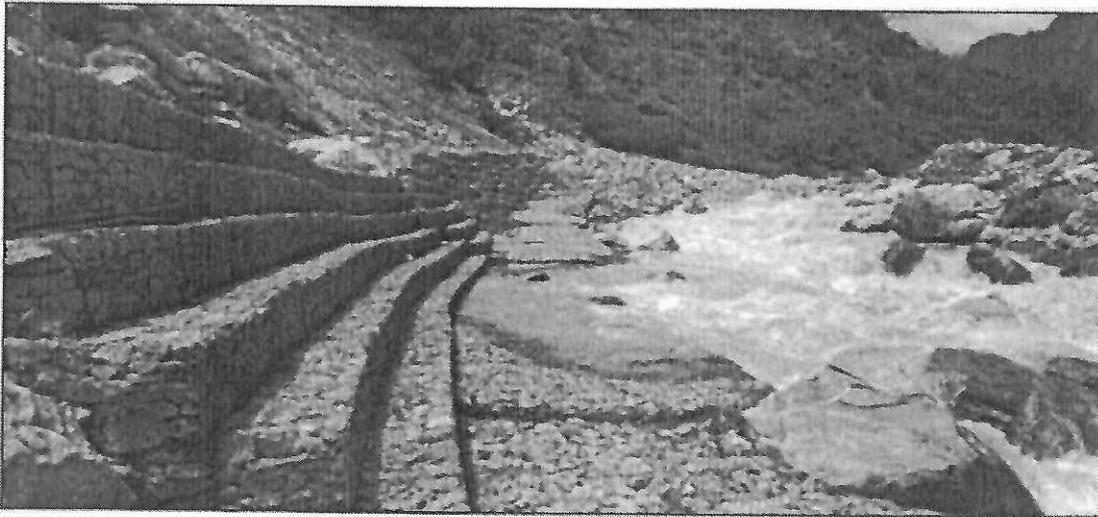
Figure A10. Photograph of Gabion Retaining Wall with Launching Apron on River Bed

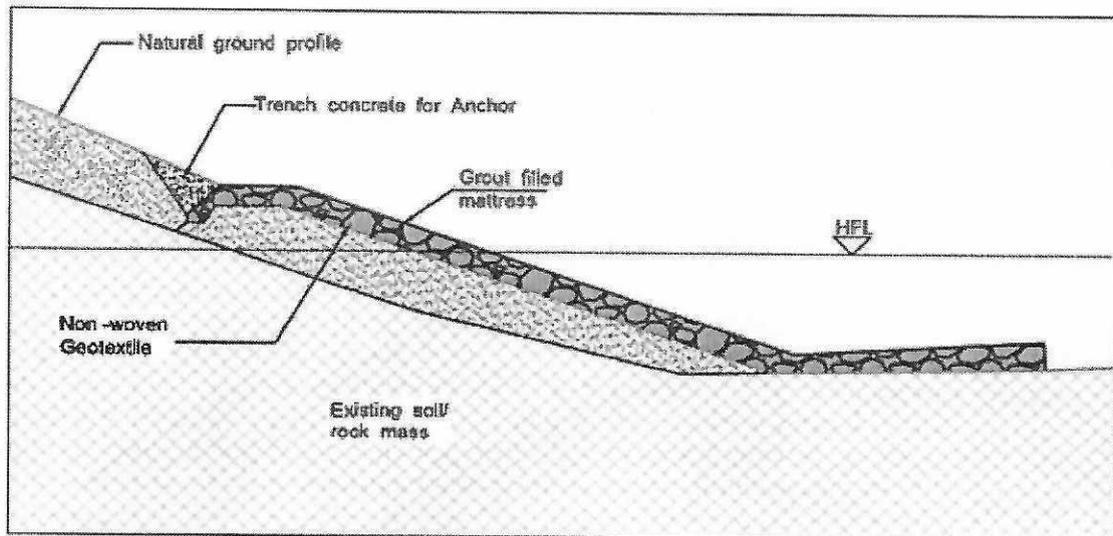
Figure A11. Cross-Section of Fabric Form Mattress with Launching Apron on River Bed

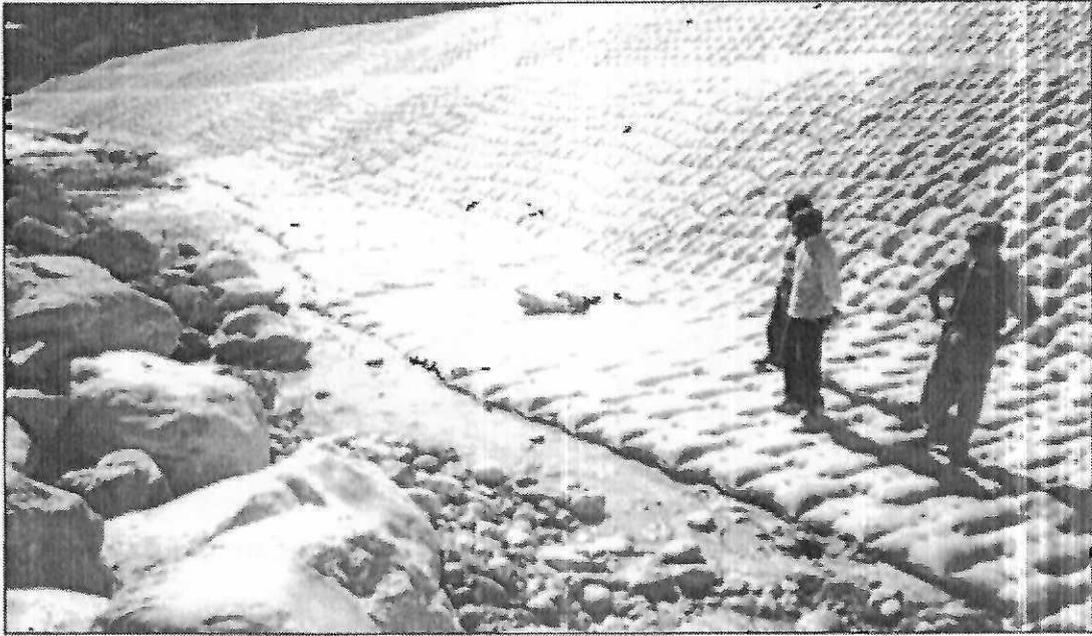
Figure A12. Photograph of Fabric Form Mattress with Launching Apron on River Bed

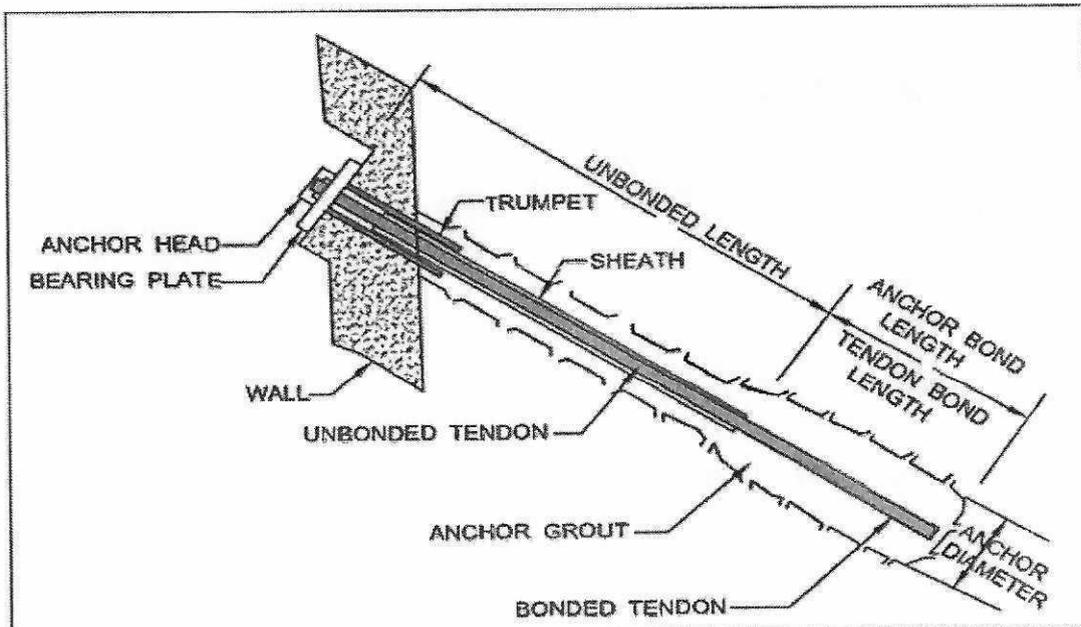
Figure A13. Typical Components of a Ground Anchor
