**Investigation into Alleged Environmental Violations by  
Central Coalfields Ltd in Purnadih OCP:**

**Report of Committee appointed by Hon'ble National Green  
Tribunal in *Sanjay Chauhan vs CCL & Ors (OA 37/2020/EZ)*  
*vide order dt.22.06.2020***

Date of submission: 14 September 2020

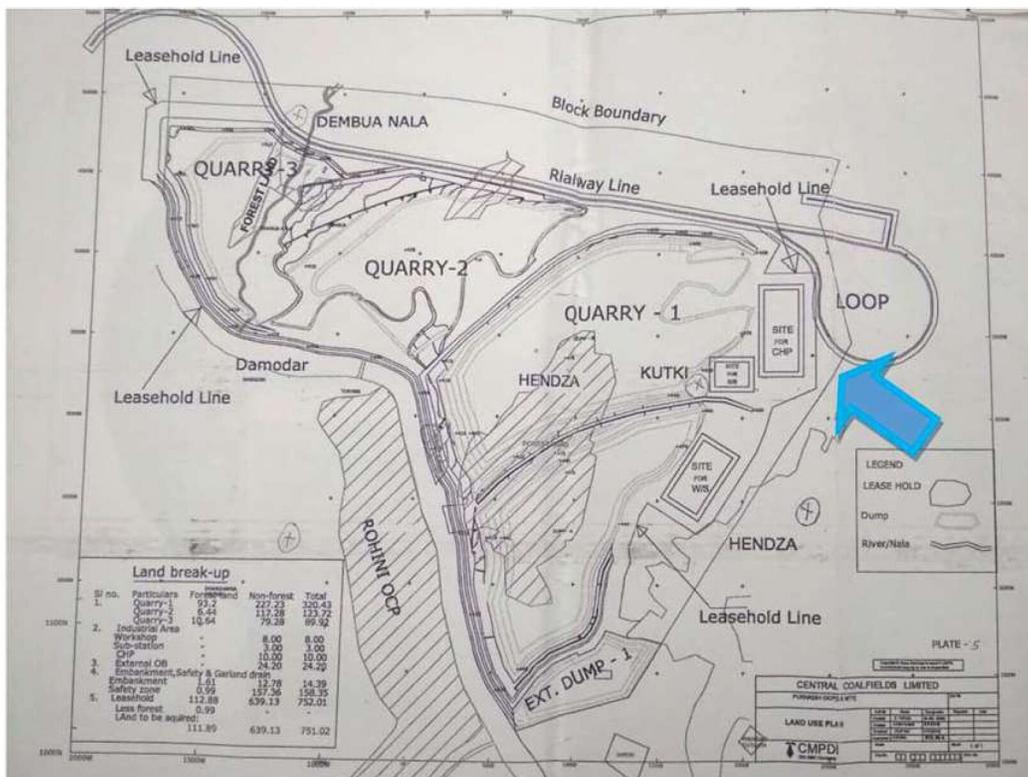
**Figure 2. Map (land use plan) of Purnadih OCP as given in the EIA document of 2008, showing location of CHP, railway line including loop (blue arrow).**

- In the EIA/EMP of 2008 (in the land use plan) it is clearly shown that a CHP was to be constructed in Purnadih project in area of 10 ha (see Figure 2), along with a dedicated rail line with loop to the CHP.
- Further, on page 54 of the EIA/EMP report, it is mentioned that “CHP [will] convey the coal from feeder breaker/crusher to loading point” and describes several arrangements to be made along the conveyor belt, transfer house, and wagon loading point to suppress dust.
- On page 16 on the EIA/EMP report, it is stated that “Railway siding has been planned to serve Ashoka East OCP, Piparwar OCP and this (Purnadih) project, which would run on northern side of the (Purnadih) project. .... However,

**This combined reading of the EIA/EMP and EC indicates that a CHP, including conveyor belt, transfer house and arrangements to load rail wagons was an integral part of the project.**

- a) **CHP and railway line/siding as shown in the land use plan (Figure 2) have not been constructed. Since 2009 till date, the coal is being transported on trucks to KDH railway siding located approx. 5 km from the mine.**
- b) Furthermore, the field visit showed that road transport of coal was resulting in much spillage of coal on the road. **This coal dust was observed to be flowing off the road into drains, nallahs and even into river Damodar** (see Figure 3-left). In the dry season, this dust will also create serious air pollution.

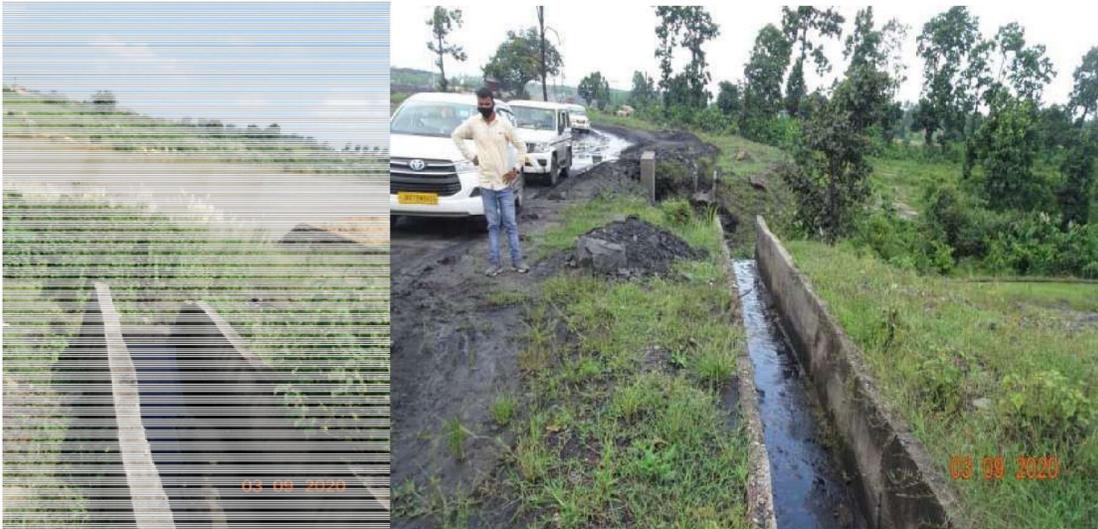
**Figure 3. Water with coal dust from road connecting Purnadih project to KDH siding flowing from roadside channels into Damodar river (left); water with coal dust from coal dump flowing into local nallahs near weighbridge area (right).**

- a) It was observed that mouth of pucca drains constructed by project authorities along the road used for coal transport were let into the Damodar river without any effective arrangement for preventing coal dust flowing into the river (see Figure 3-left).

- d) Coal dust also flowed down into the seasonal nallah from the pucca drains constructed by project authorities along the road leading to the KDH siding (see Figure 3-right).

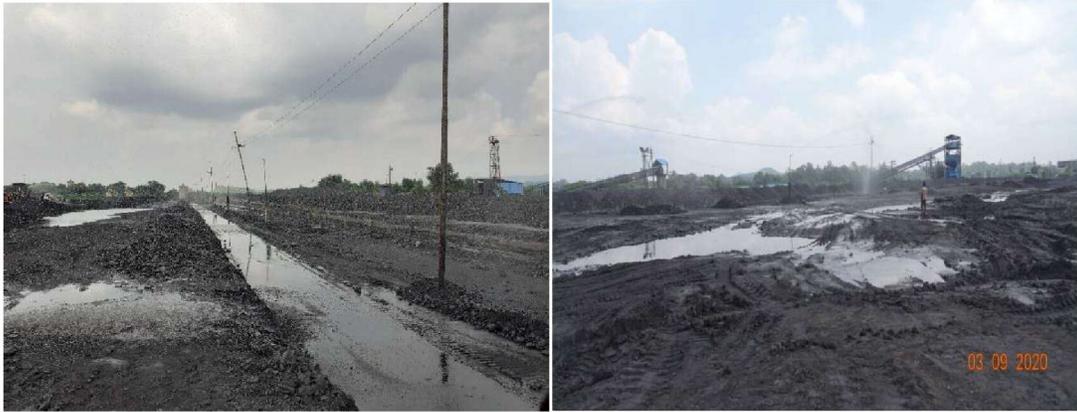
- c) Finally, the KDH railway siding is only in partial compliance with CPCB's 2015 guidelines for environmental management of railway sidings. Though fixed water sprinklers at KDH railway siding were in operational condition (see Figure 4-right), the siding and track were layered with coal dust (see Figure 4-left). Greenbelt development around the siding was not satisfactory. Due to absence of catch drains, siltation ponds coal dust would flow from KDH railway siding area to nearly low lying area and ultimately to river drainage system. Inadequate tarpaulin covering was observed on some of the coal transportation trucks at KDH railway siding (see Figure 5). This was the likely reason for coal spillage on the roads, which will result in serious air pollution during the dry season and is clearly resulting in water pollution during the wet season.

**Figure 4. Status of KDH siding: thick layer coal dust on platform and tracks and no windscreen (left), operation of fixed water sprinklers (right)**

- e) Due to absence of catch drains and siltation ponds, coal dust would flow from KDH railway siding area to nearly low lying area and ultimately to river drainage system (see Figure 4-right).

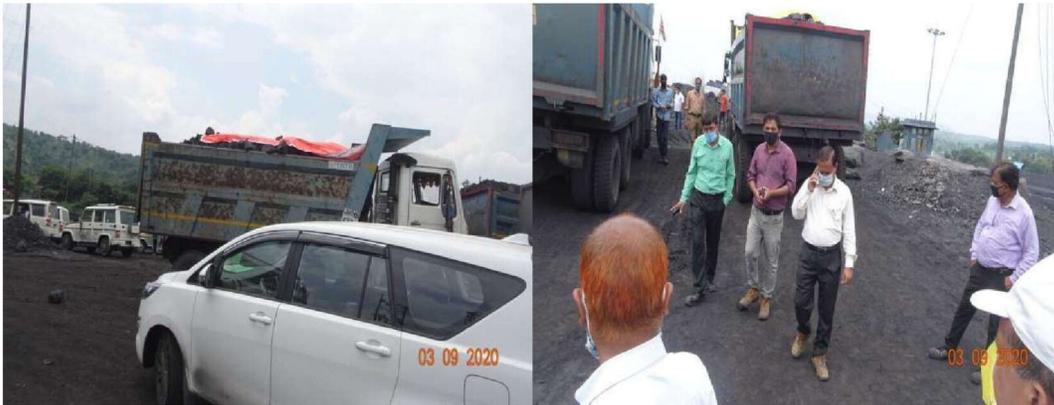
**Figure 5. Photo of inadequate tarpaulin covering over coal transportation trucks, resulting in coal spillage over the roads.**

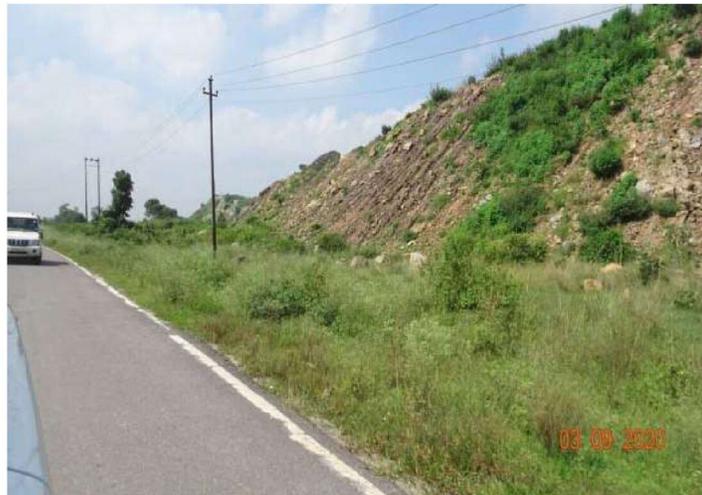
- a) Green belt development in the project was less than satisfactory. Project authorities did not do any plantations for last three-four years. Project authorities showed old plantations done on OB dump that had been carried out long back.
- b) Grassing and vegetation have come up in some portions of external O/B dump in Purnadih project (see Figure 6). But in other portions O/B material was still exposed and there was no grassing and vegetation there.

**Figure 6. Partial grass and vegetation over external OB dump**

- f) Catch drains and siltation ponds were not made around the external OB dump in the Purnadih mine project (see Figure 6).

**Overall, plantation and green belt development was not found to be satisfactory. Project authorities have not done plantations as per their commitment in EIA/EMP report and as laid down in the EC.**

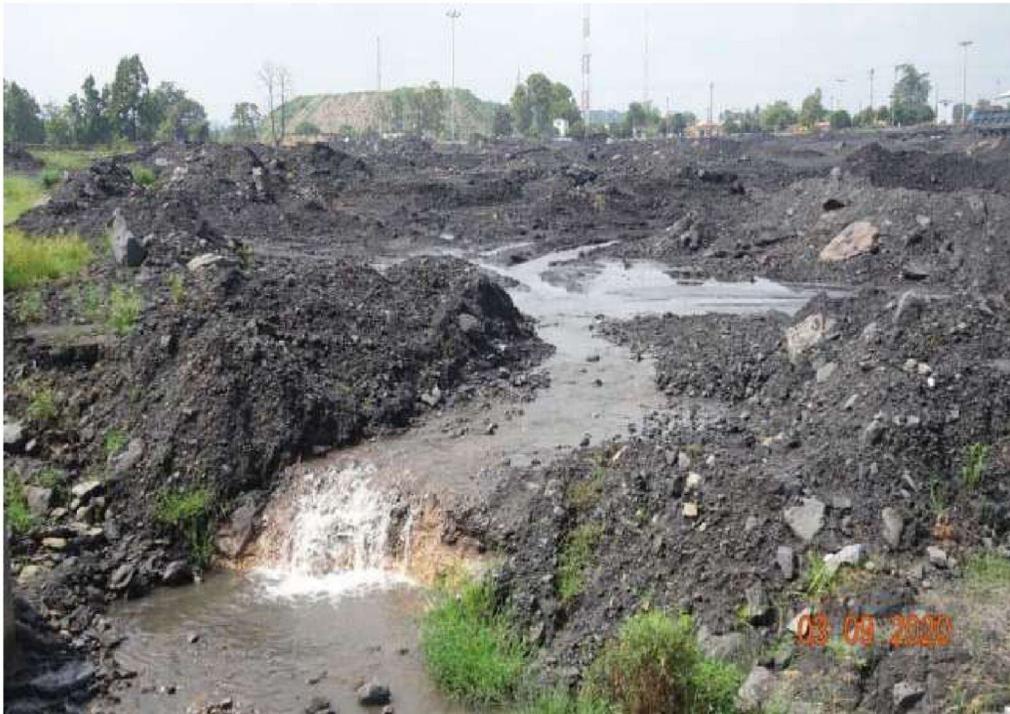
- b) From one of the coal dumps in the project site, the surface runoff was flowing out without any catch drain, siltation ponds, etc. (see Figure 7)
- c) In the weighbridge area there was coal heaps/ dump but no catch drain or siltation ponds had been provided around it. There was a seasonal nallah adjacent to those coal heaps/dump in which coal dust would flow (see Figure 8)).

**Figure 7. Coal dump in Purnadih OCP with runoff flowing into low lying areas**

Overall, in spite of attention being drawn in the monitoring report by MOEFCC's Ranchi Regional Office, there continues to be non-compliance/partial compliance with the conditions relating to control of soil erosion and prevention of silt and coal dust runoff from the OB and coal dumps.

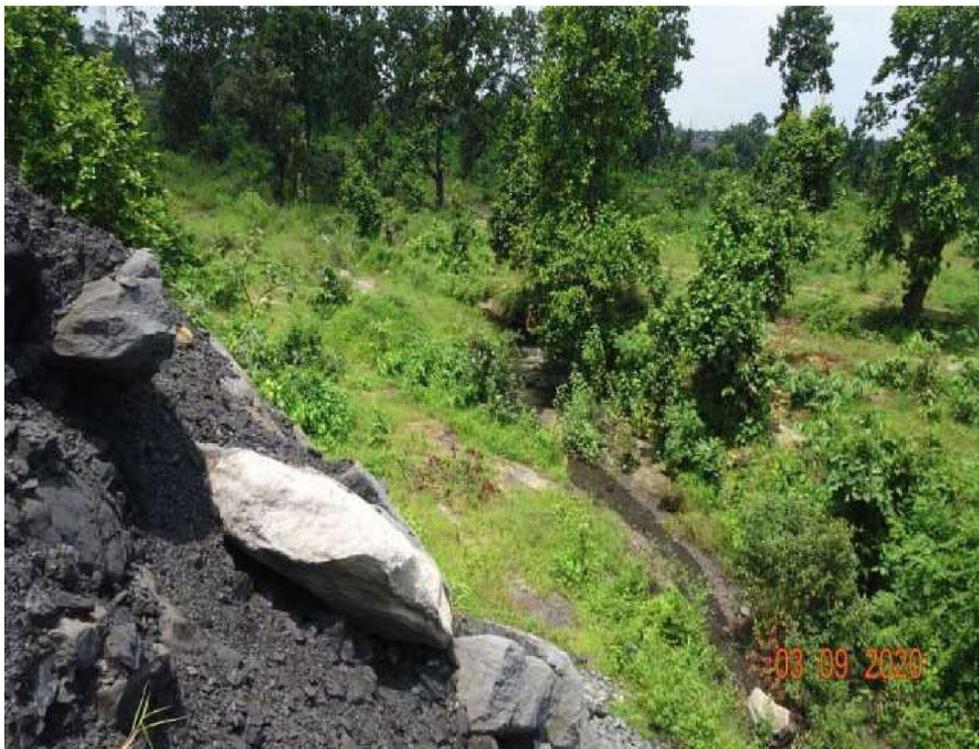
**Figure 8. Coal/shale dump/ heaps without catch drain or siltation ponds and incomplete toe wall, just adjacent to a seasonal nallah**

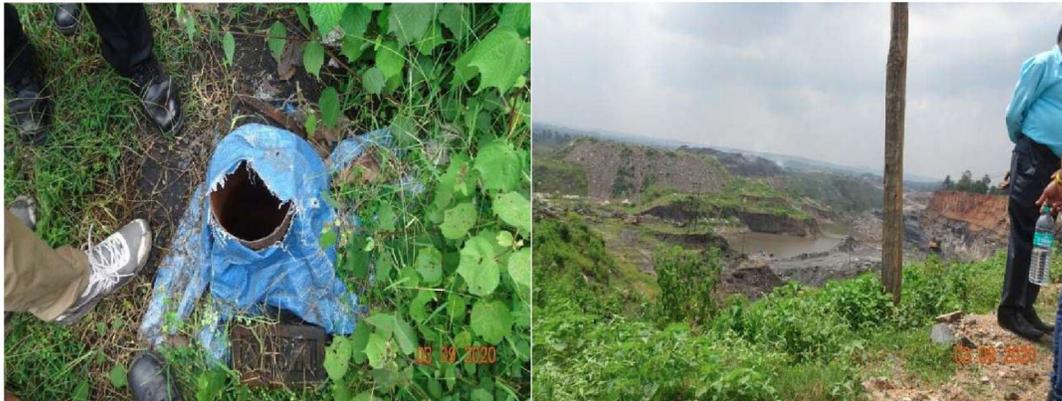
**Figure 9. Borehole for measuring groundwater level (left); water stored in sump created in mined out area (right)**

- a) Project authorities showed one borehole (see Figure 9-left) from where ground water level measurement is done.

- b) Water was observed in the sump of mine (see Figure 9-right). There was a large water body in the previously mined-out pit in the project.
- c) Furthermore, as per details submitted by Project Proponent to this Committee of groundwater monitoring is done by CMPDI in a network of wells. Project Proponent has submitted monitoring data of the year 2016, 2017, 2018 (Pre and Post monsoon) and 2019, 2020 (Pre Monsoon), and the same is reproduced in Table 1 below.

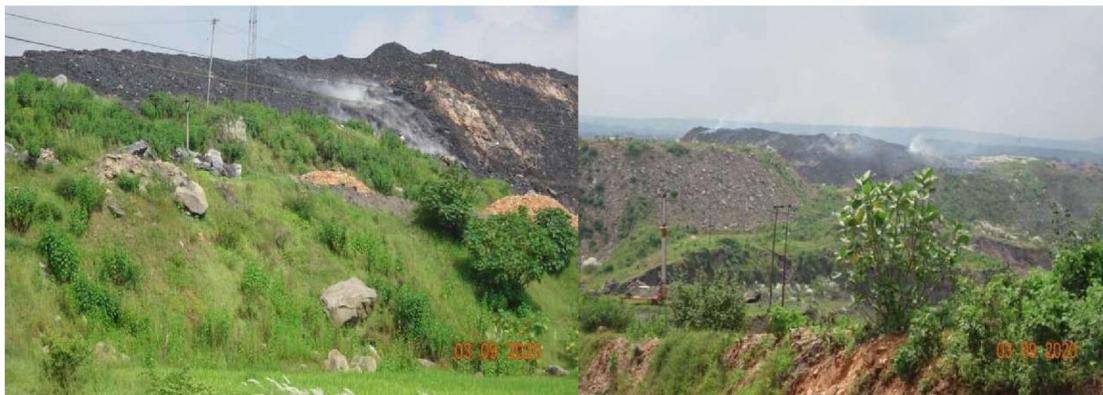
In coal dumps inside the Purnadih mine, spontaneous combustion was observed with lot of smoke emissions continuously (see Figure 10), although we visited the mine during the rainy season.

**Figure 10. Spontaneous coal combustion observed at different coal dumps in Purnadih OCP.**
