**BEFORE THE HON'BLE NATIONAL GREEN TRIBUNAL
SOUTHERN ZONE, CHENNAI**

O.A. NO.93 OF 2024 (SZ)

REPLY STATEMENT FILED BY THE 6TH RESPONDENT

**State Level Environment Impact Assessment Authority
(SEIAA) Kerala**

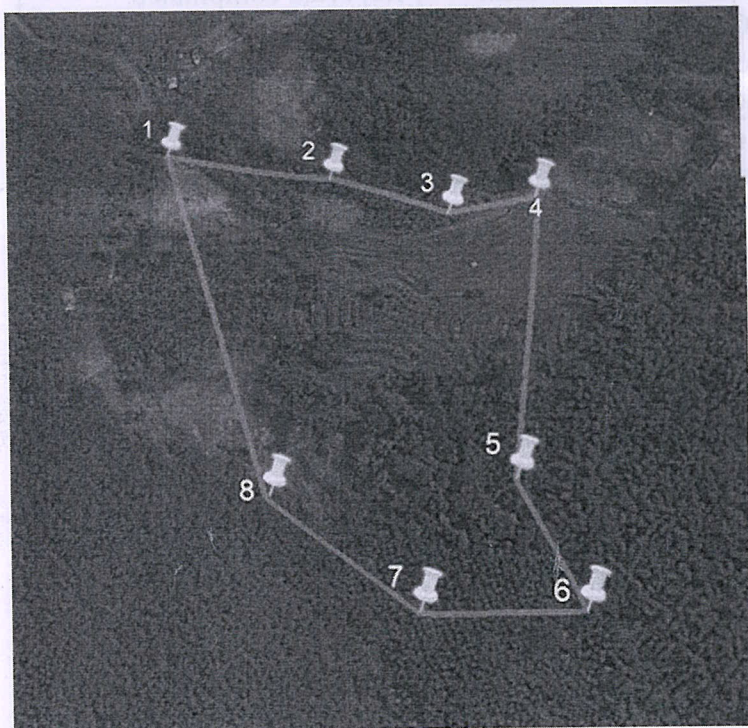
Google imagery of 2011.

On evaluation of the google imagery (2011) it is observed that the quarry operations were carried out near BP 1, BP 8 and north east of BP 4. (Fig.1).

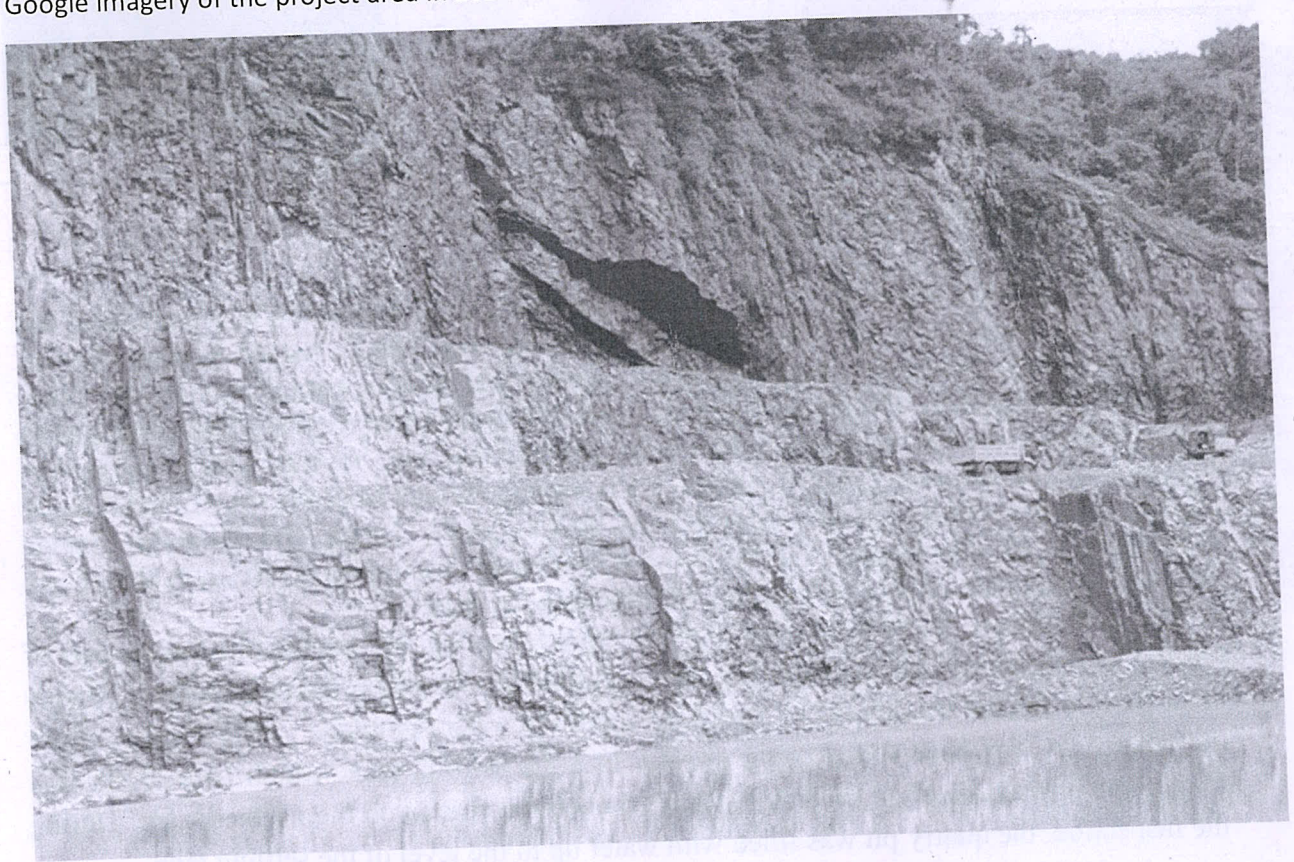
Fig.2 Fracture pattern on quarry wall.

Many vertical fractures are observed on the eastern wall of the quarry. Inclined fracture dipping opposite direction of the slope also observed on the same wall (Fig 2).

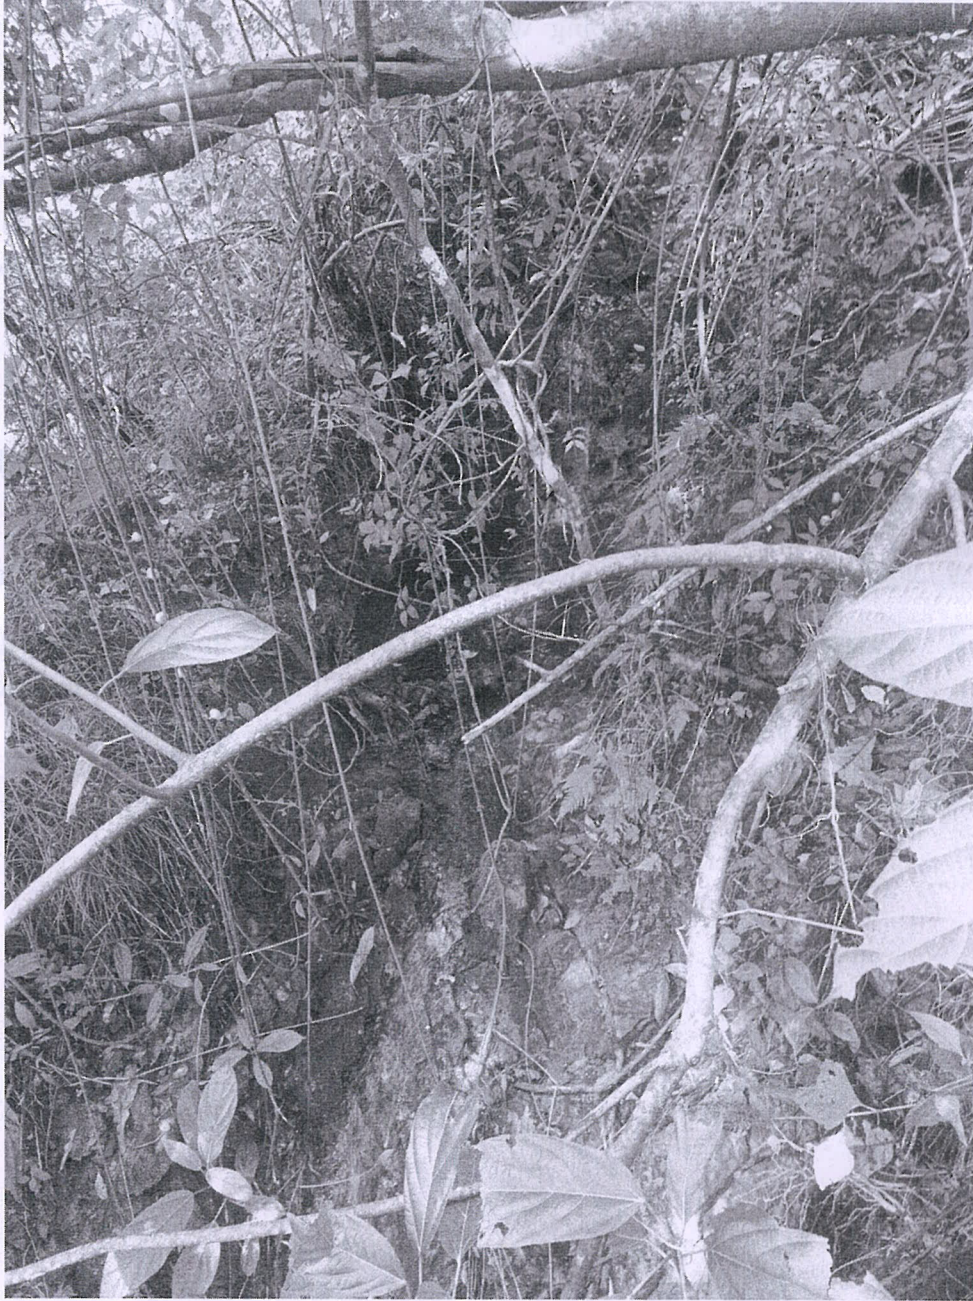
6. A natural stream was observed on the south side of the project area near the OB dump, flowing directly into the project area. It appeared that recent modifications had been made to this channel, diverting it towards the quarry pit.

Natural stream on the hilly area of southern part of the project area

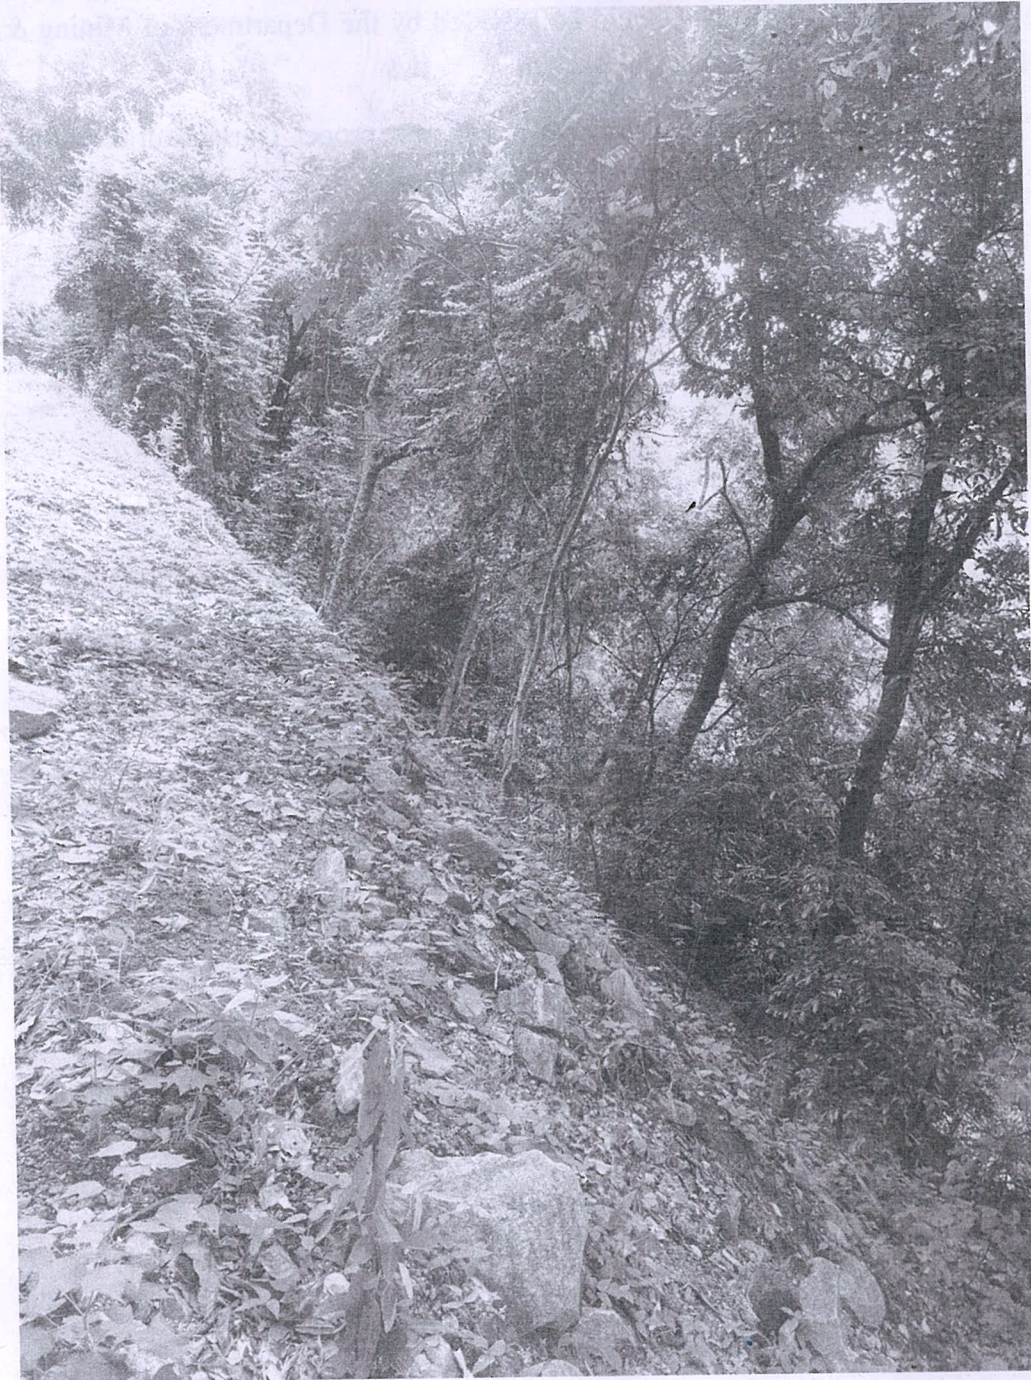
2. Overburden (OB) dumping was observed on the high-altitude southern side, outside the designated quarry area, without safety measures, and at angles exceeding 45 degrees.

OB Dump without protection

1. Many of the conditions stipulated for EC are not found complied. Some of the stipulated conditions are only partially complied. Hence appropriate action should be taken against the Proponent with immediate effect.
2. A gabion or reinforced concrete wall should be constructed to secure the OB dump on the southern side.
