**BEFORE THE HONOURABLE NATIONAL GREEN TRIBUNAL,SOUTH ZONE
CHENNAI.**

ORIGINAL APPLICATION NO. 93 of Year 2024.

STATEMENT OF FACTS.

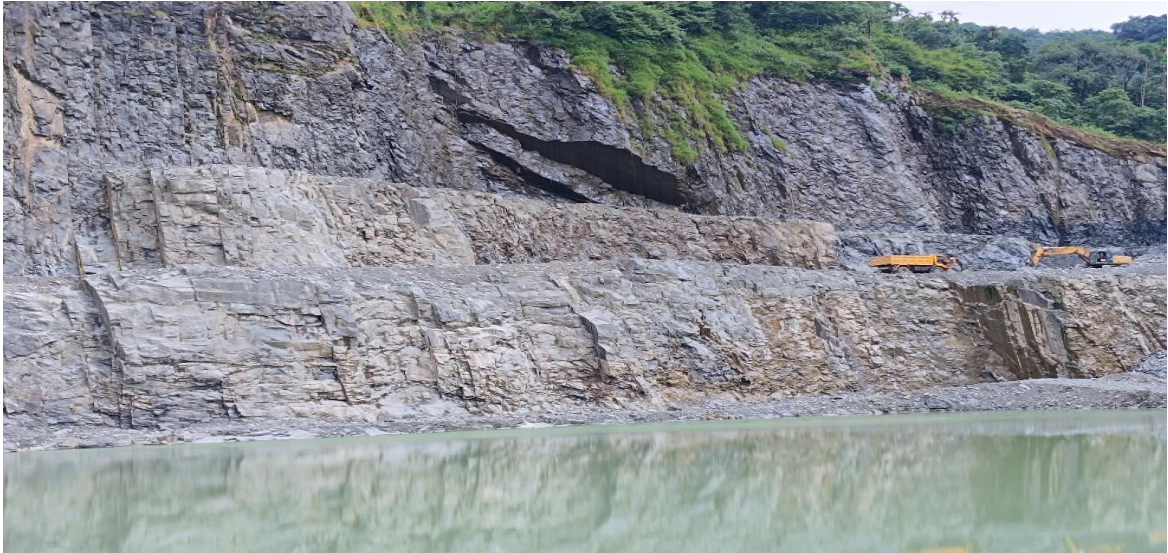
ANNEXURE-1A.

Quarrying activities have extended beyond the required buffer zone of the adjoining forest, raising concerns of encroachment and violations of environmental regulations. This expansion poses serious risks to human and animal safety due to steep slopes and deep contaminated water and steep height.

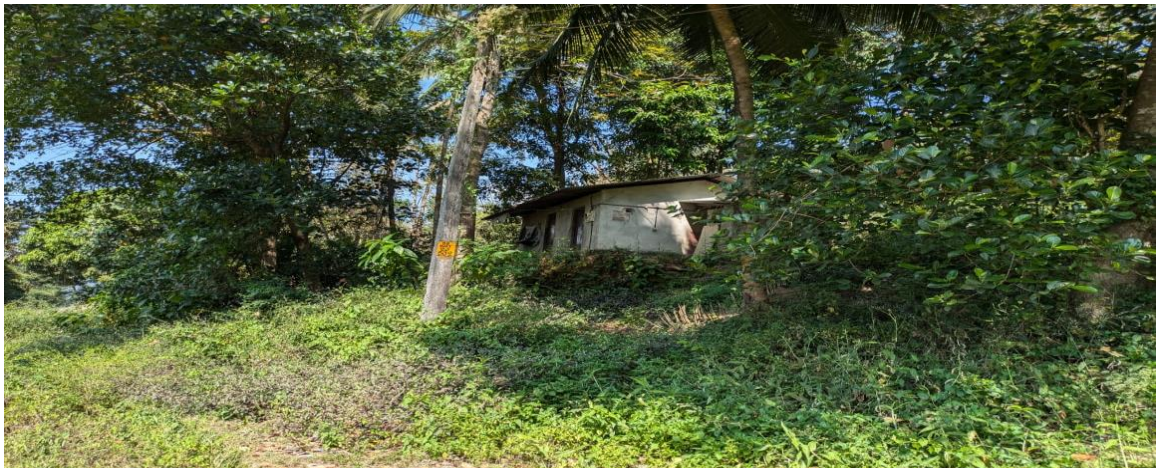
ANNEXURE-1B.

The house of one of the three residents, who has vacated the premises, belongs to Sri. Sunny Karimpanakkal and is located adjacent to the quarry site.

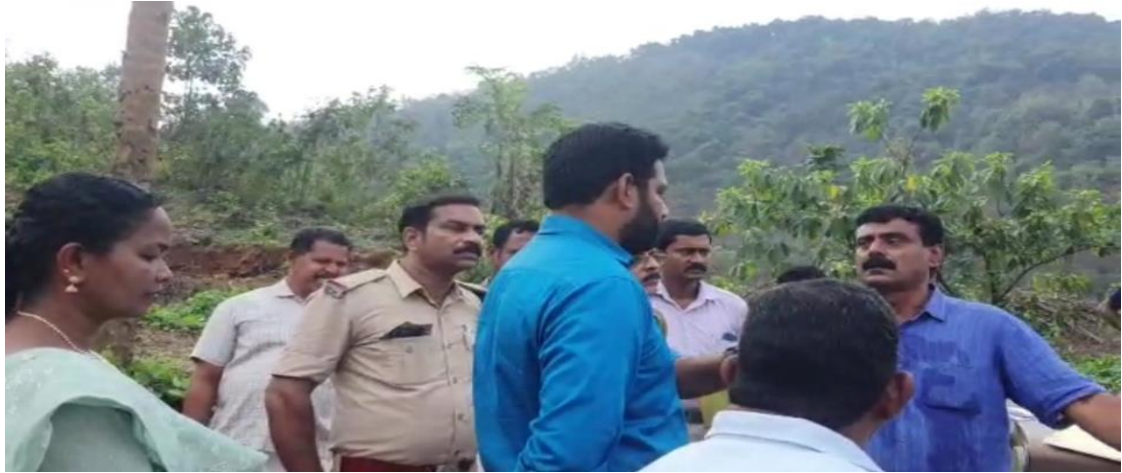
ANNEXURE- 2A & B.

The Koodaranhi Panchayat President has been observed questioning the Quarry Operator recently for diverting the Panchayat road in an attempt to maintain the required 50-meter distance.

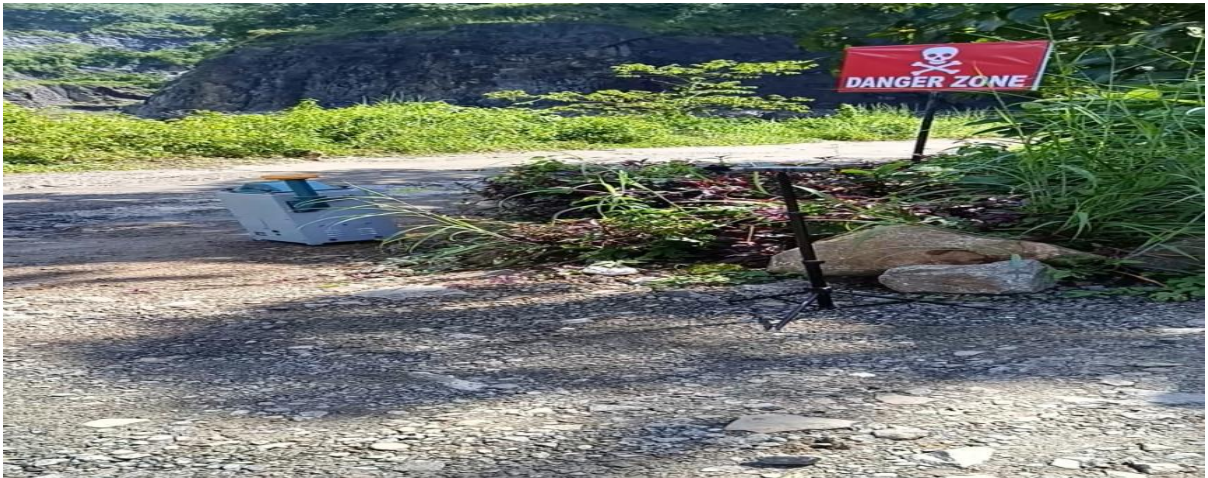
B.

The required distance from the quarry site to the public road, as stipulated by law, has not been maintained,

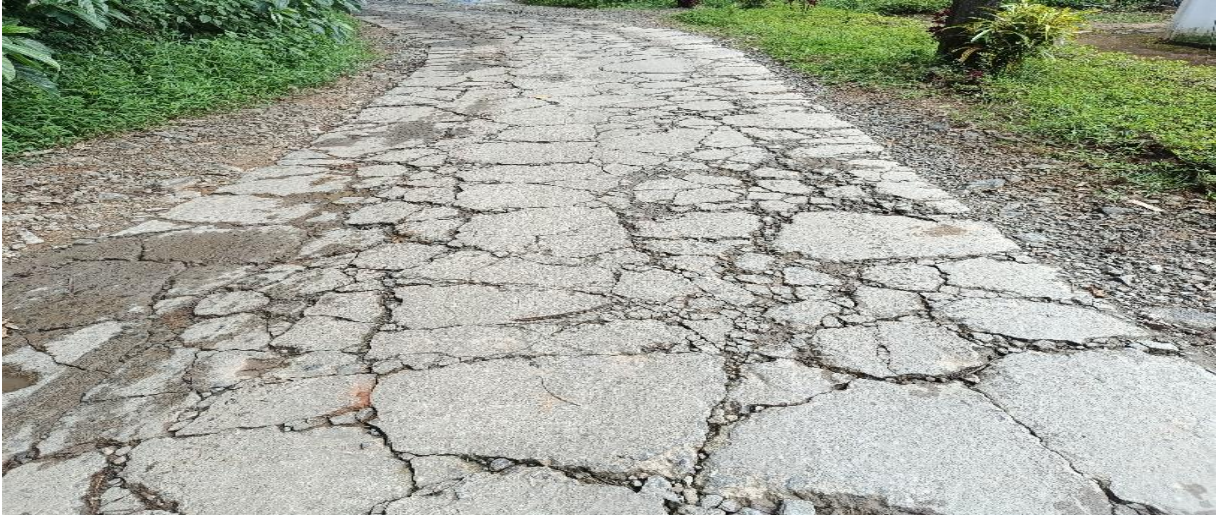
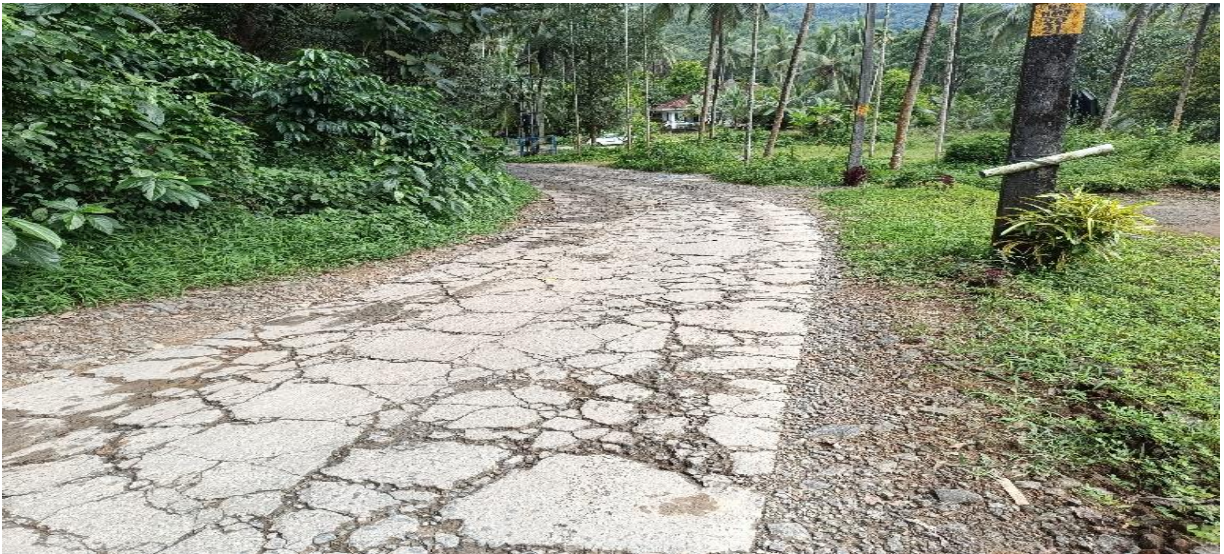
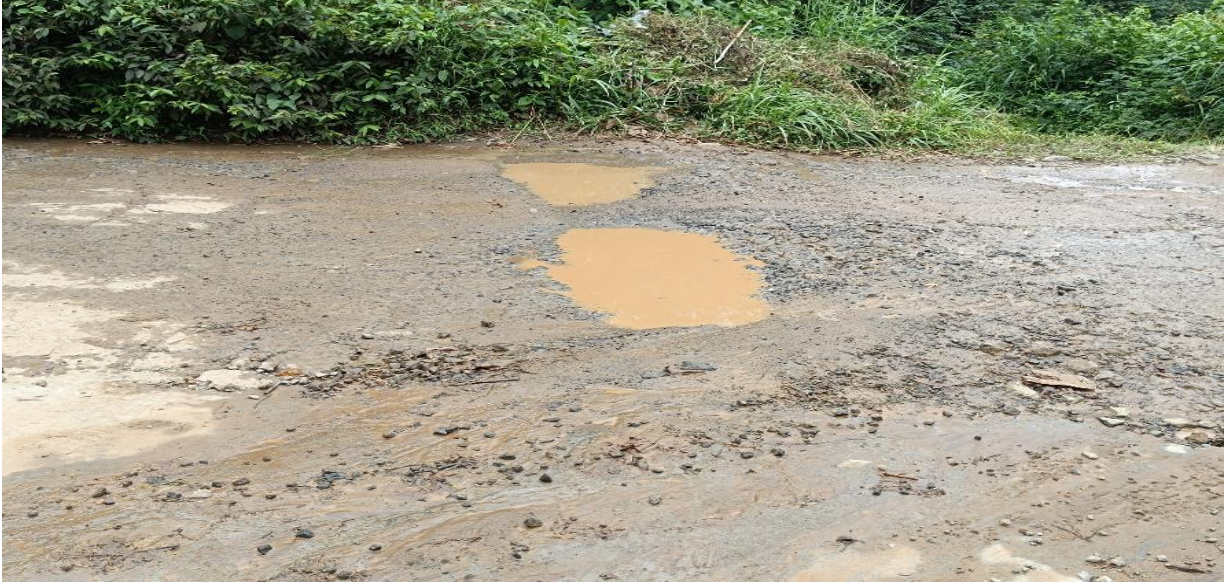
ANNEXURE-3A,B &C.

The Panchayth Public road has been severely damaged due to the spraying of contaminated water and the heavy load of vehicles, leading to dangerous and unsafe conditions.

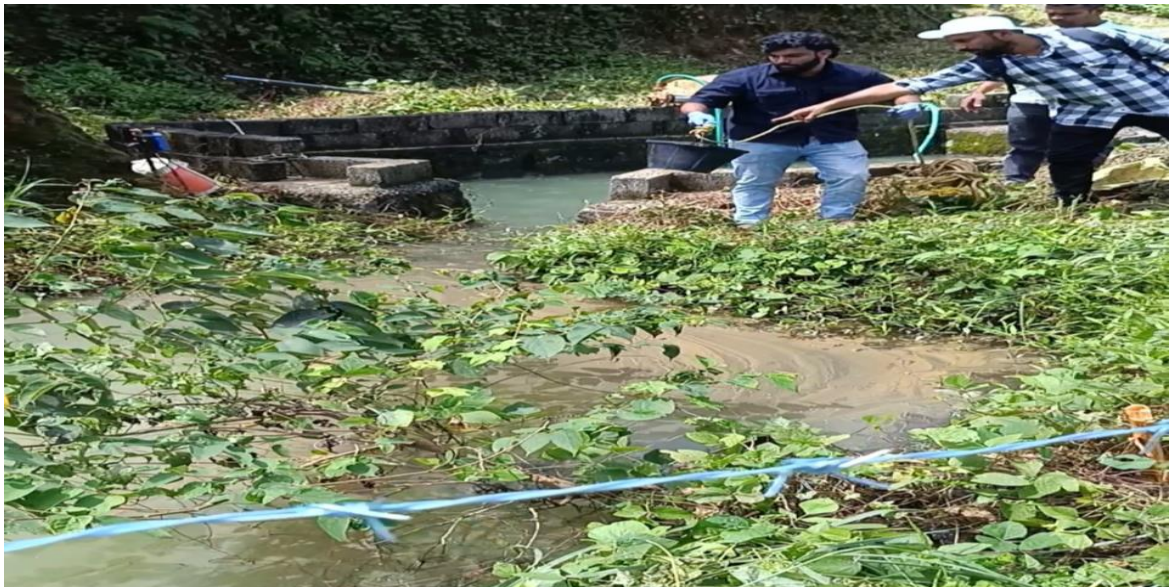
D.

Contaminated water has accumulated at ground level within the filtration plant, posing a significant risk of regular overflow, which spills into the natural stream, further degrading the water source. The filtration unit is not being operated regularly and properly.

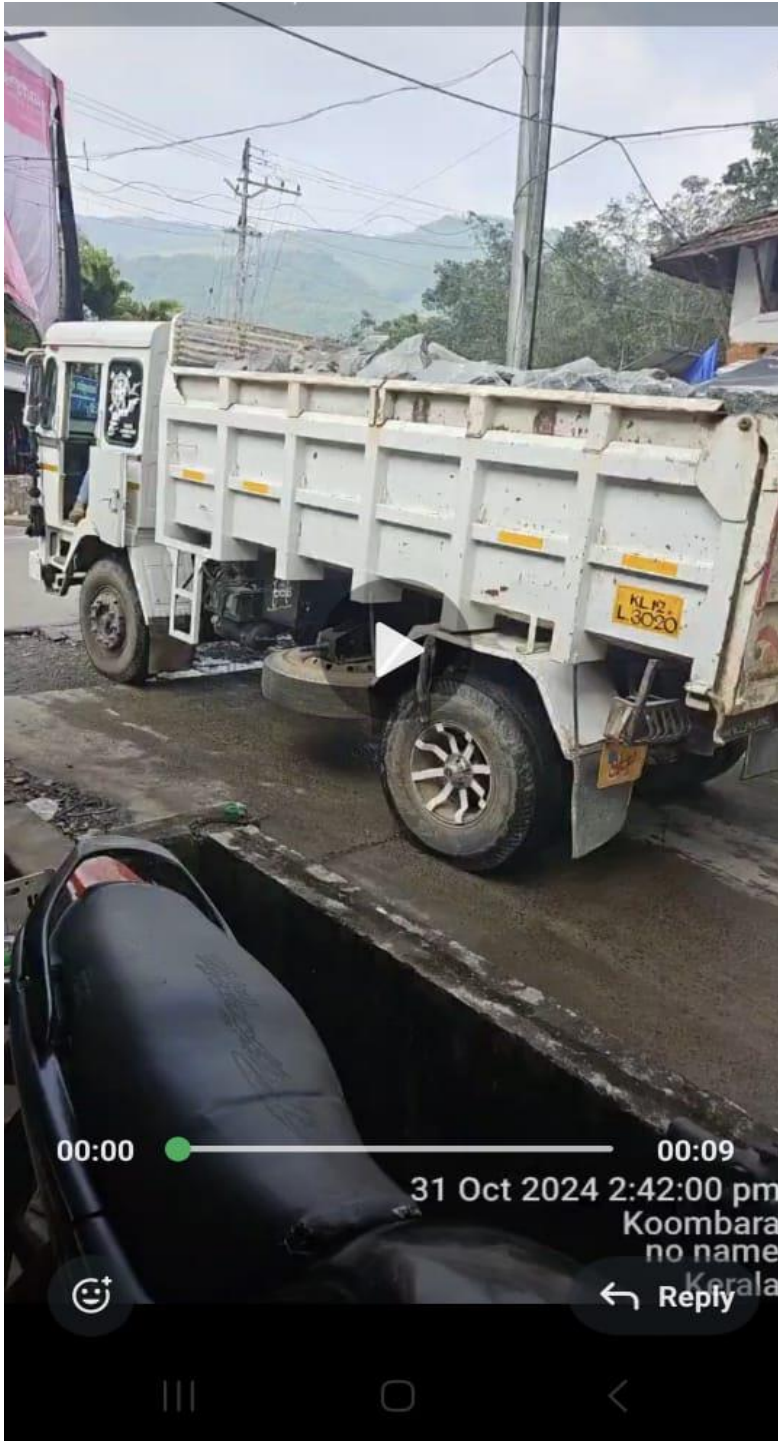
C.

Overloaded lorry without safety cover at Koombara to Punnakadve road

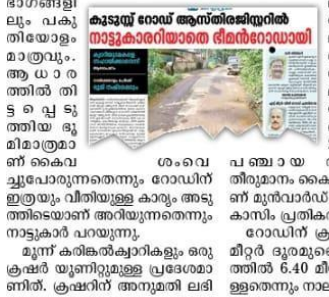
The original survey stone adjacent to Mr. Joseph NJ has been destroyed, and a duplicate stone has been placed inside his property to falsely represent the road width as 8 meters. This action aims to protect an illegal compound wall that encroaches upon the public road.

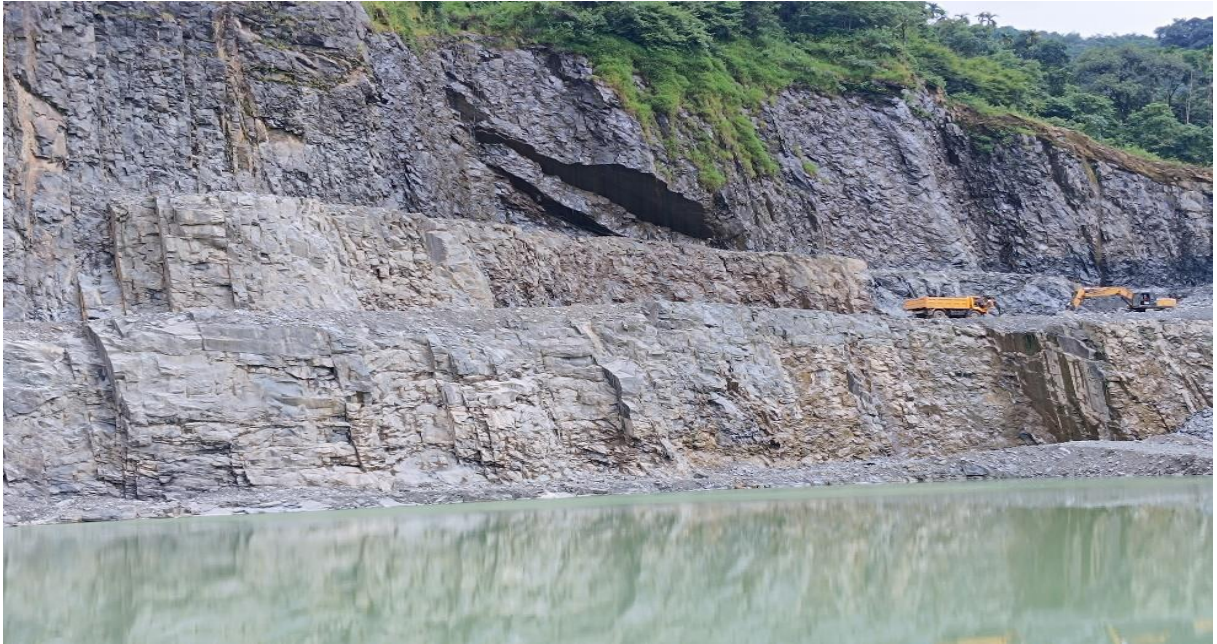
D.

Quarrying activities have been observed extending beyond the required buffer zone from the adjoining forest land, raising concerns of potential encroachment and clear violations of environmental regulations. This unauthorized expansion presents serious risks to both human and animal safety, particularly due to the steep slopes and dangerously deep levels of contaminated water present at the site. Additionally, significant cracks have been identified on the upper side of the quarry, likely caused by the diversion of the natural stream flow away from its original course. This disruption of the stream's natural flow represents a major environmental risk, potentially leading to further destabilization of the area

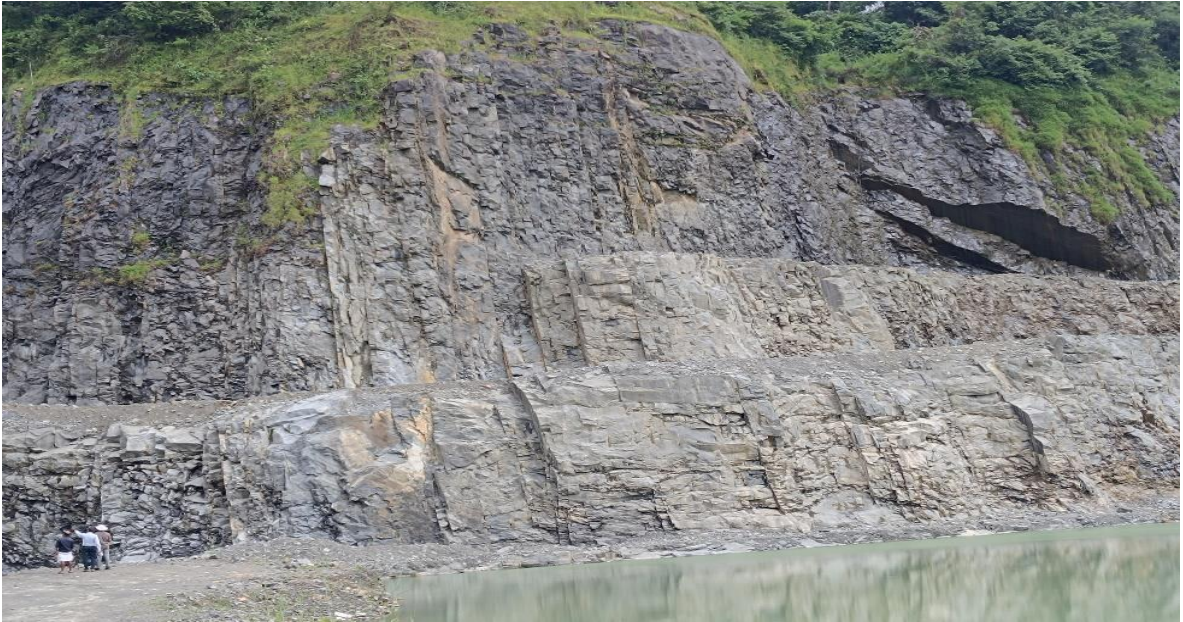
E.

The excavation pit has reached a dangerously high level, encroaching upon forest land without maintaining the required buffer zone. This violation poses significant environmental risks and threatens the safety of both humans and wildlife. The extreme depth of the pit exacerbates the potential for catastrophic consequences, including soil erosion, contamination, and the destruction of natural habitats.

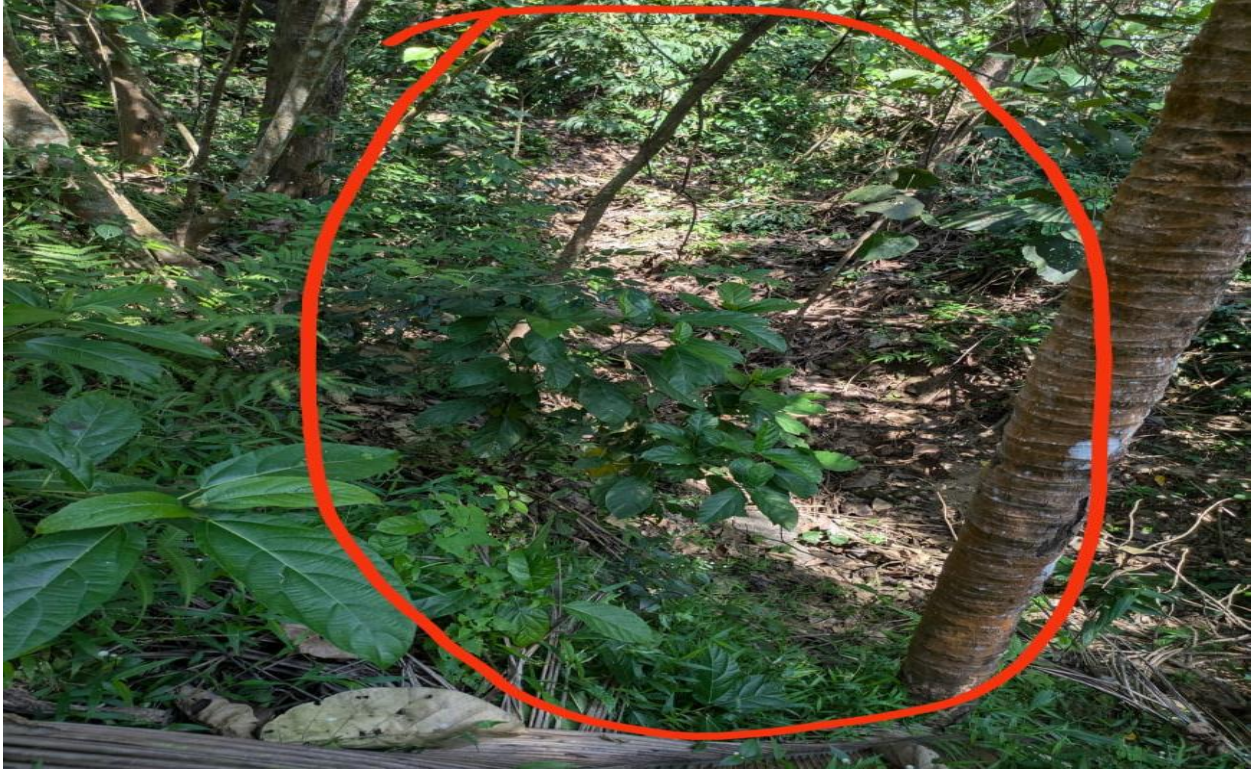
ANNEXURE -12A,B,C,D &E.

A landslide picture nearby the forest and quarrying area.

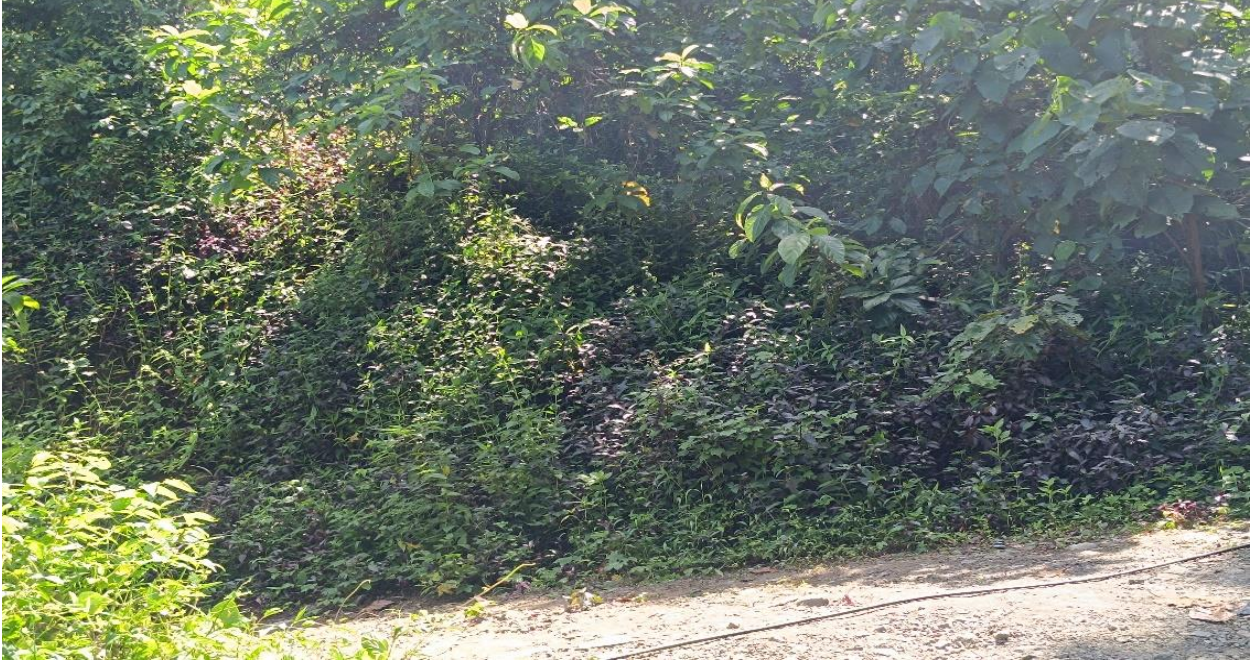
B.

Overburden at a very substantial height by blocking the stream.

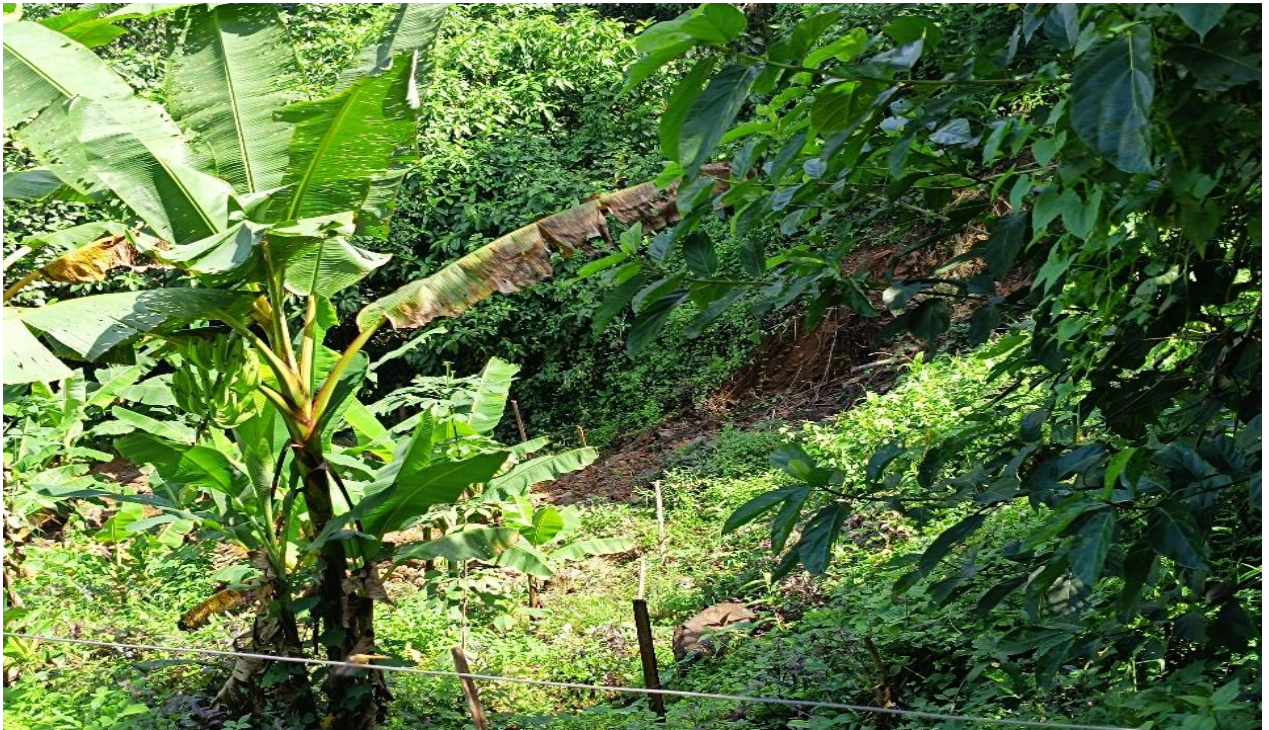
C.

Another view of the overburden at a very substantial height by blocking the stream.

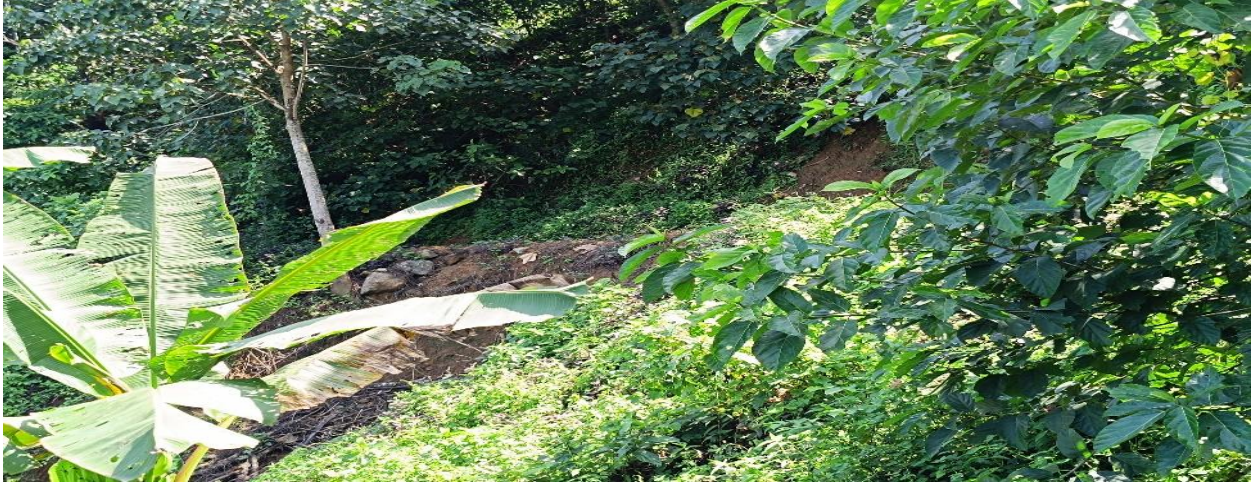
D.

The quarry waste has been piled to a substantial height, entirely blocking the stream, which constitutes a violation of environmental regulations and disrupts the natural water flow and ecosystem. Additionally, a mud road leading to the upper side of the quarry has been observed and landslide, further exacerbating the environmental degradation.

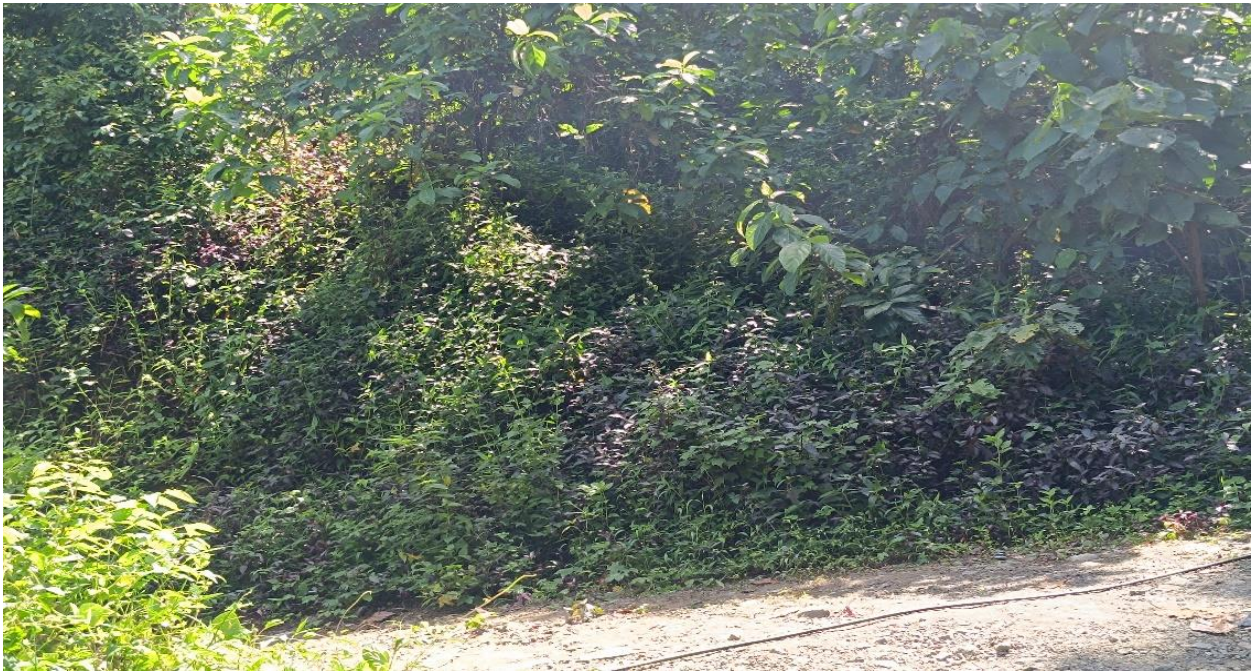
E.

The primary stream has been completely obstructed due to a substantial accumulation of quarry waste at very height level, effectively blocking its natural flow. This obstruction presents significant environmental risks, disrupting the local ecosystem and endangering the water resources that the community relies on. Additionally, multiple landslides occurred between 1982 and 2000 while we were residing in this area, highlighting the on-going vulnerability of the region to such environmental hazards.

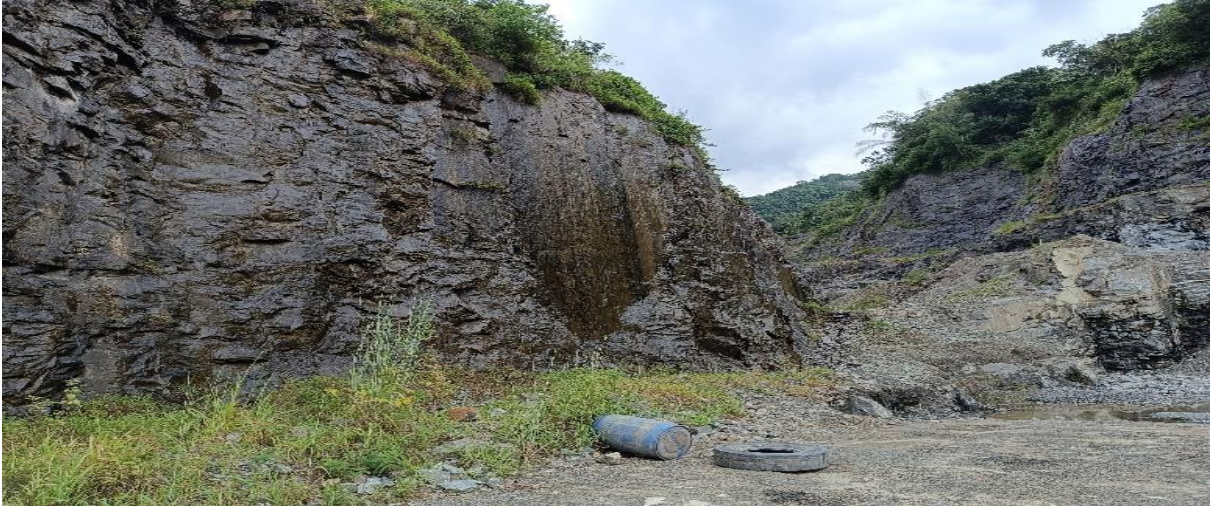
ANNEXURE -15.

Another major stream has been significantly narrowed due to the expansion of quarrying activities, leaving only a small portion remaining, which is partially diverted into the quarry site. This diversion causes the overflow of contaminated water, rendering the natural flow of the stream, which has been relied upon by residents, completely unusable due to the high levels of chemical contamination.
