Subject: Independent Engineer services for Four Laning of Mugaiyur to Marakkanam section of NH-332A from Km 31.000 to Km. 62.000 (Design Chainage) under Bharatmala Pariyojana Phase-I (Feeder Routes) on HAM in the State of Tamil Nadu (Package-II of Mahabalipuram Puducherry) – **Submission of Status Report on the issue of construction of excess length of cofferdam in Odiyur Lagoon – regarding.**

STATUS REPORT ON THE ISSUE OF DUMPING OF SOIL, QUARRY RUBBLE AND OTHER MATERIALS IN ODIYUR LAGOON IN THE CASE UNDER O.A. No. 106 OF 2024

COFFERDAM REMOVAL WORK FROM P5 TO A1 AT 37+146 MJB

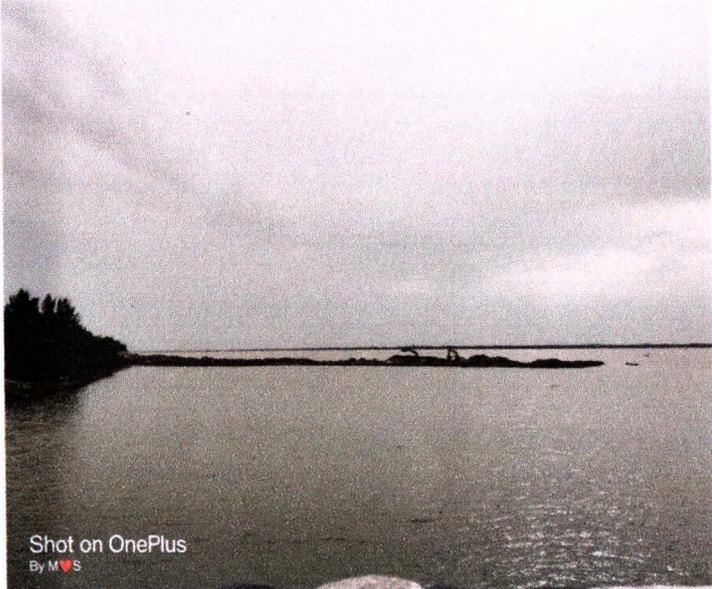
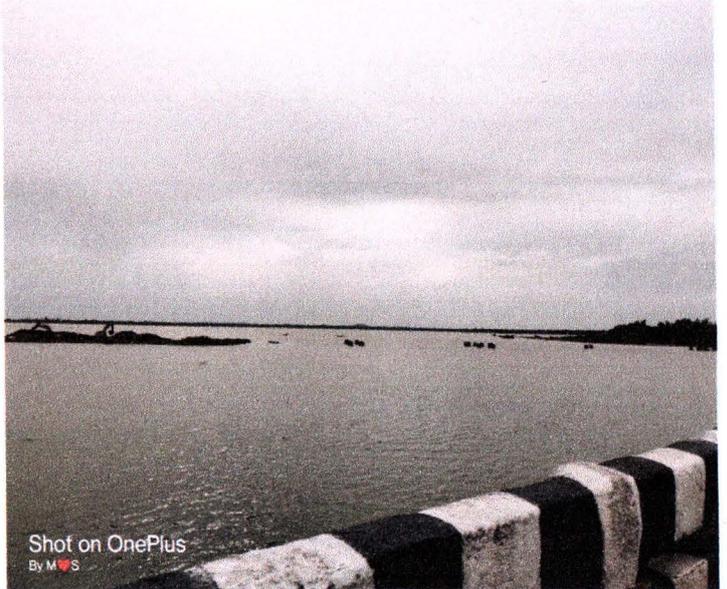
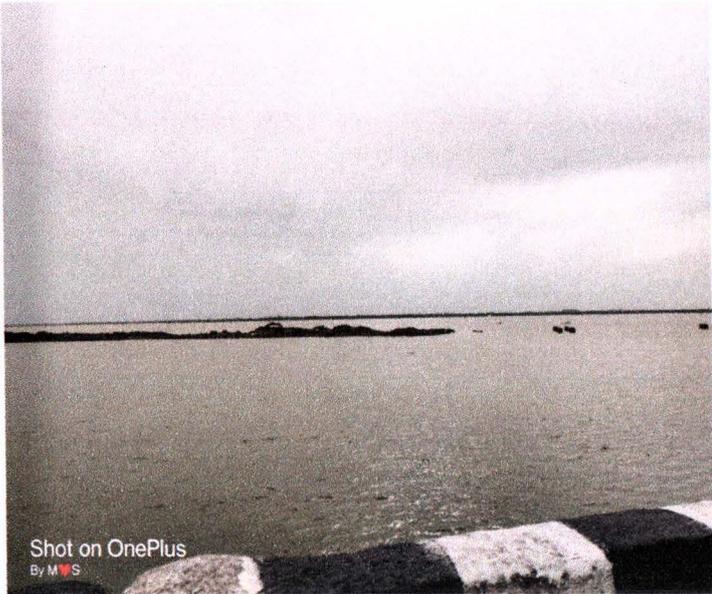
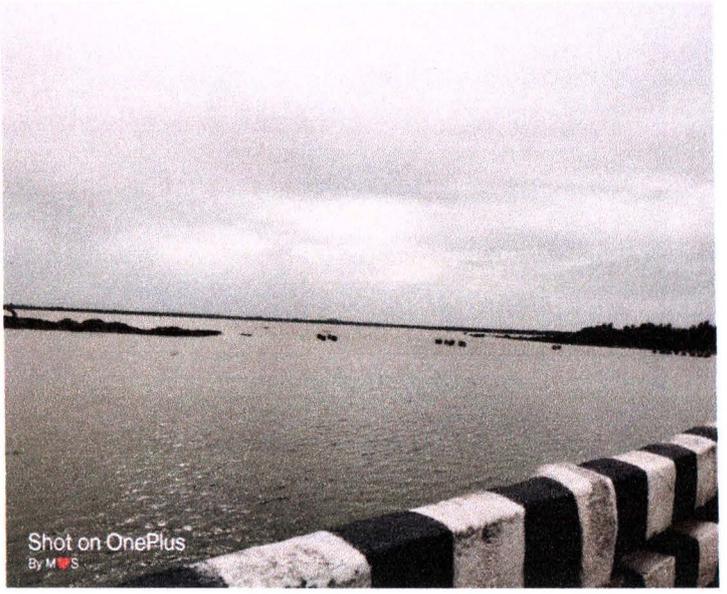
Meantime, PD, NHAI and IE of the project had instructed the Concessionaire to remove the excess dumped materials immediately and stick on the assurance given by the Concessionaire. On receiving such instruction, Concessionaire of the project started removing the excess dumped soil and other materials and 50% of the waterway is kept open from one end the lake. A schematic diagram has been prepared and enclosed for ready reference which is showing the clearance of the waterway as mentioned above.
