**BEFORE THE HON'BLE NATIONAL GREEN TRIBUNAL  
SOUTHERN BENCH, CHENNAI**

**Original Application No. 199 of 2021(SZ)  
& I.A No.96 of 2022 (SZ)**

**ACTION TAKEN REPORT IN COMPLIANCE TO HON'BLE NGT ORDER DATED 29/04/2024 IN ORIGINAL APPLICATION NO. 199 OF 2021 (SZ) & I.A NO 96 OF 2022 (SZ) IN THE MATTER OF SRI SHANKAR NARAYANA BALA KRISHNA, TELANGANA AND ORS. VS STATE OF TELANGANA REP BY ITS CHIEF SECRETARY, HYDERABAD AND ORS.**

**CENTRAL POLLUTION CONTROL BOARD  
Parivesh Bhawan, East Arjun Nagar, Delhi-110032**

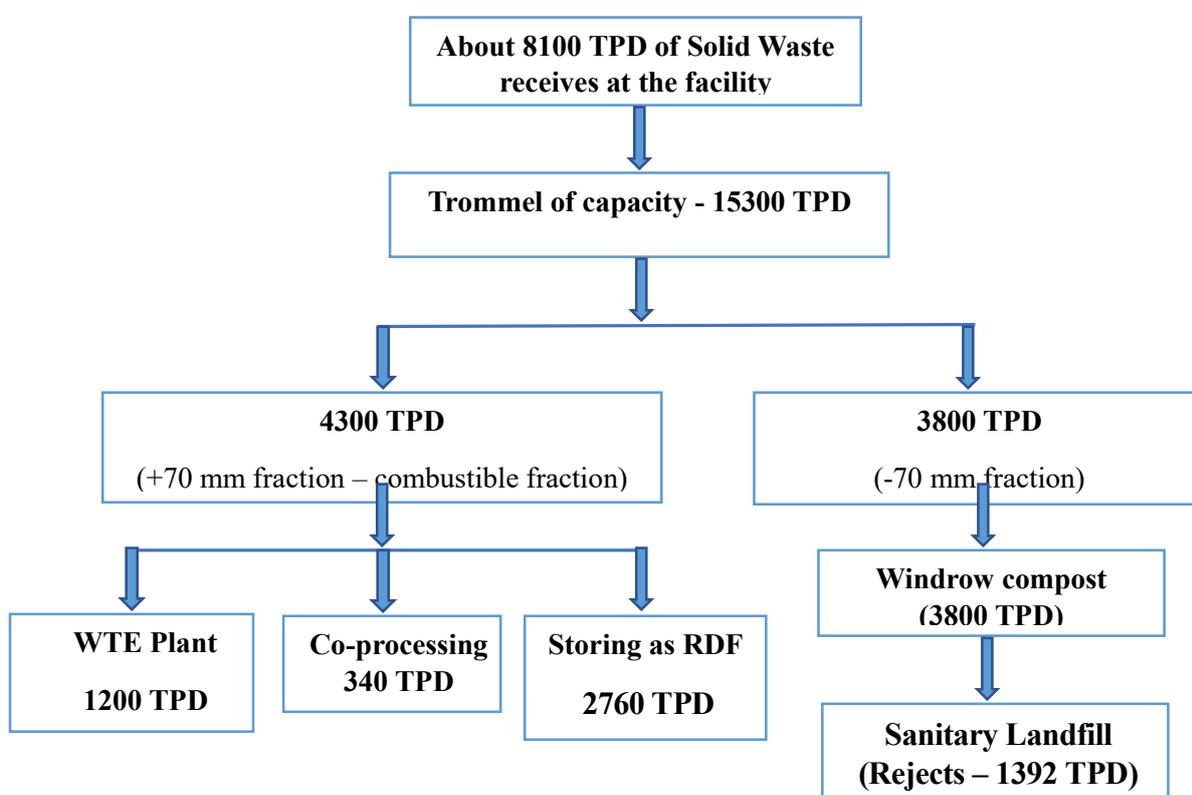
**Flow diagram for treatment of solid waste generation of 8100 TPD**

- vi. The incoming waste to the facility is not segregated, thus unit receives mixed waste, which is passed through Trommels to separate larger fractions (+70 mm) (4300 TPD) of solid waste called as RDF. A fraction of said RDF or semi-processed solid waste is being utilized in 24 MW capacity WTE Plant (about 1200 TPD) for electricity generation and 340 TPD of RDF is being sent to cement industry. Hence, the total utilization of RDF per day at present is about 1540 TPD and remaining 2760 TPD is stored in temporary covered dumps within the premises.

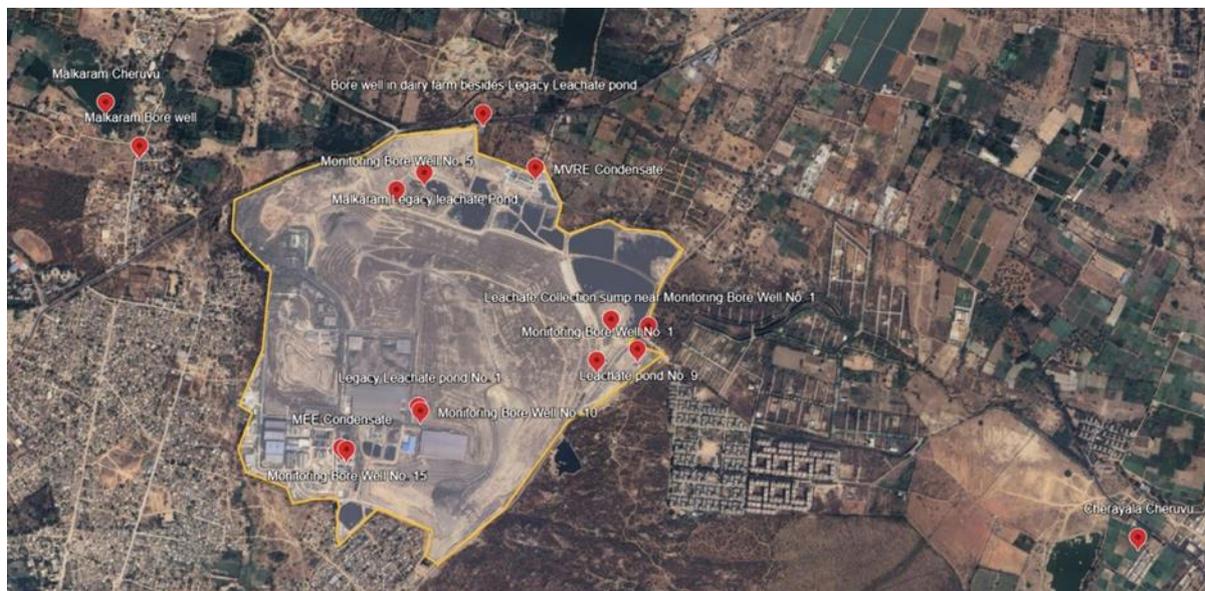
*Picture 1: Sampling locations at Google Earth Map*

During inspection, samples were collected from the piezometric wells (monitoring wells) located in & around the capped legacy waste, leachate from collection ponds, nearby ponds, and borewells outside the dumpsite to assess the present status of quality in groundwater & surface water. The

samples collected by the team has been given to one of the EPA recognized laboratory namely M/s B S Envi-Tech Pvt. Ltd., Tarnaka, Secunderabad, Telangana for analysis. The sampling locations are plotted in google earth map and shown in picture 1 below and the co-ordinates is shown in **table 4**. The analysis results for four parameters are given in **Table 5**.

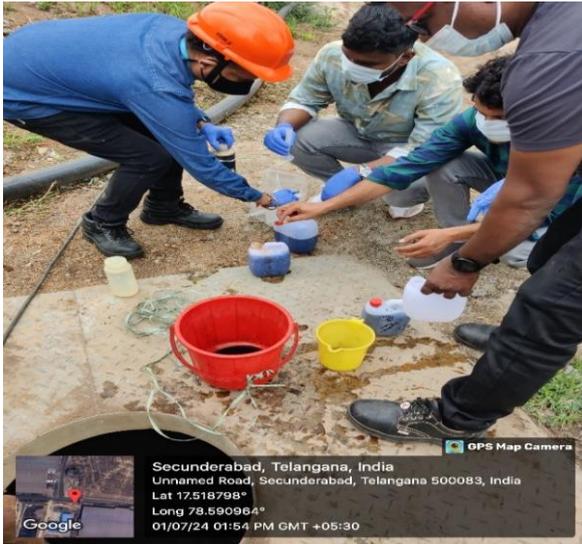
| S. No. | Sampling location | Parameters | | | |
|--|---|---|---|---|---|
| 4 | Leachate collection pond near monitoring bore well no.1 | 8.62 | 800 | 13280 | 2024 |

*Sampling at Legacy Leachate Collection Sump No. 1*

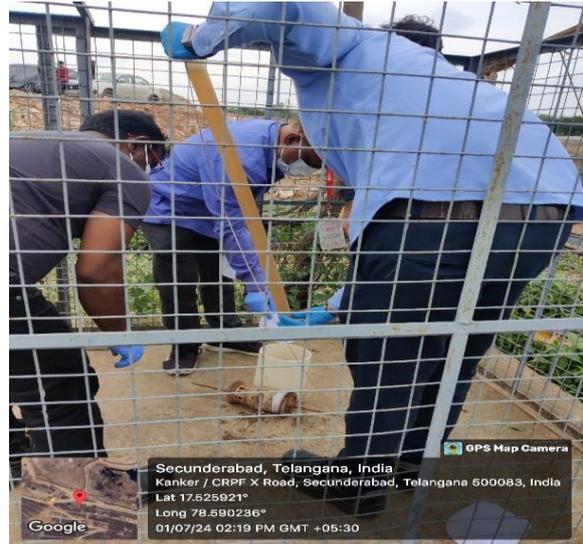
| S. No. | Sampling location | Parameters | | | |
|--|---|---|---|---|---|
| 9 | Monitoring borewell no. 5 | 8.27 | 550 | 3815 | 675 |

*Sampling at Monitoring Bore Well No. 5*

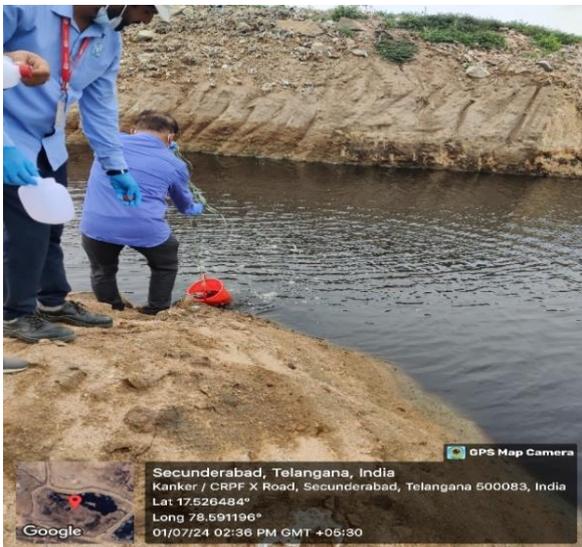
| S. No. | Sampling location | Parameters | | | |
|--|---|---|---|---|---|
| 2 | Malkaram Legacy leachate pond | 8.66 | 10460 | 20188 | 7857 |

*Sampling at Malkaram Legacy Leachate pond*

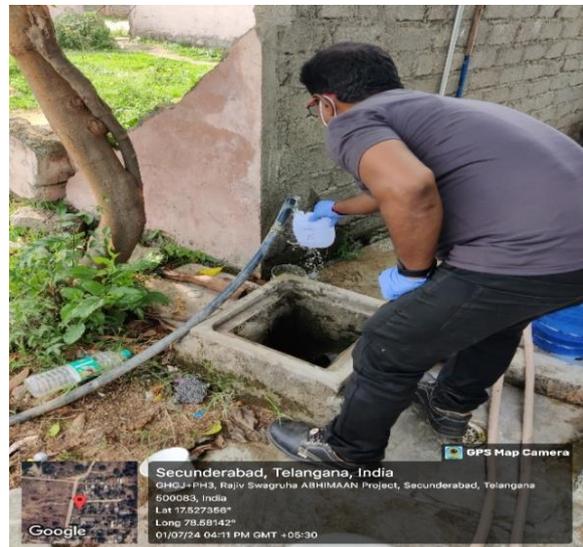
| S. No. | Sampling location | Parameters | | | |
|--|---|---|---|---|---|
| 12 | Bore well near Malkaram pond | 6.96 | Less than 5 | 738 | 26 |

*Sampling at Malkaram Bore Well*

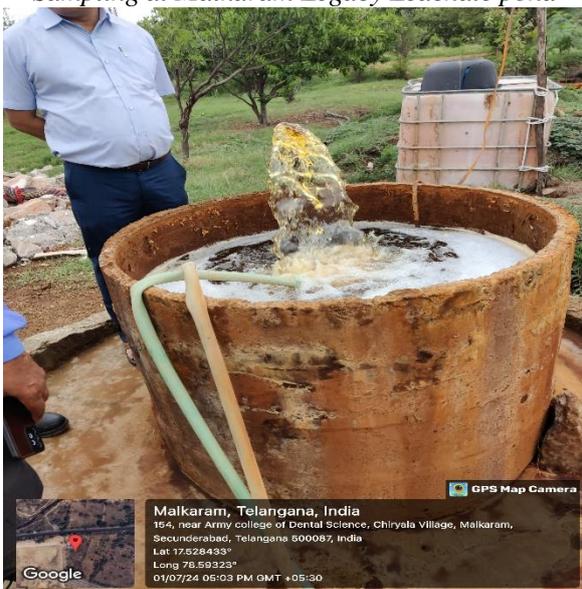
| 13 | Bore well in dairy farm besides legacy leachate artificial ponds | 6.91 | 290 | 10092 | 1409 |

- ii. The bore well sample collected from the dairy farm adjacent to artificial ponds created for storing legacy leachates also shows higher concentration of TDS & COD. It was informed by owner of the farm that the bore well water is not used from past 06 years due to contamination.

*Sampling at Bore Well in a dairy farm besides Malkaram Legacy Leachate pond*

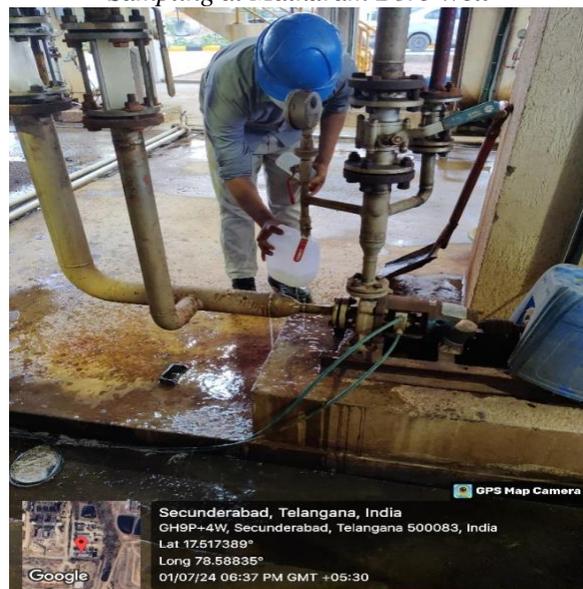
- iv. The MEE condensate from the Leachate treatment plant of 01 MLD capacity, shows high concentration of COD, indicating that the treatment system is not efficient. It is partly utilized in ash quenching of WTE plant, while the rest is disposed in natural storm water drain. Conditions for discharge of MEE have not been stipulated in the Consent issued by TSPCB.

*Sampling of MEE Condensate water*

- v. The MEE condensate from the Leachate treatment plant of 01 MLD capacity, also shows high concentration of COD, indicating the inefficiency of the leachate treatment system. It is partly utilized in ash quenching of WTE plant, while the rest is disposed in natural storm water drain. Conditions for discharge of MEE have not been stipulated in the Consent issued by TSPCB. TSPCB shall immediately prescribe standards for treated leachate and

its utilization/discharge and GHMC shall also immediately conduct efficacy assessment of the leachate treatment system and improve its performance.

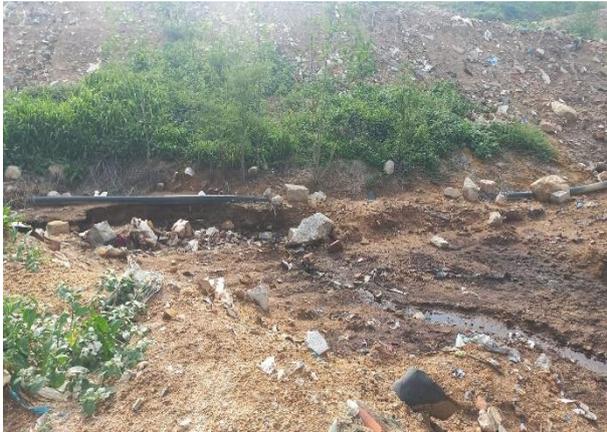
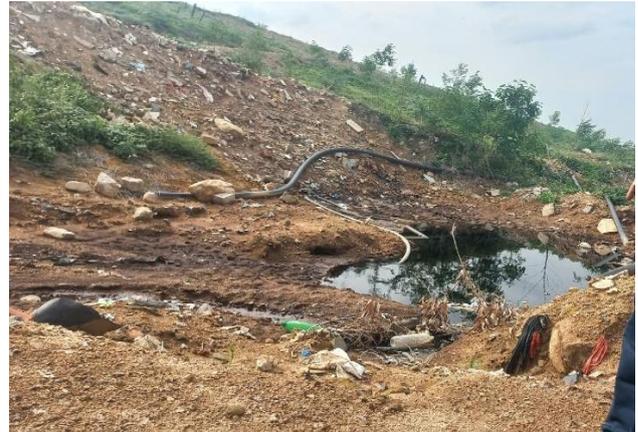
During inspection, it was noticed that accumulated leachate in Malkaram pond of 28 acres of area has been treated in MVR plant. The pond was almost empty except for some water at the bottom which is under pumping for treatment. However, inspection team noticed active seepage of leachate into the pond from adjacent disposal site. In addition, the two artificial ponds (both unlined) namely pond 3(3.3 acres) and pond 4 (01acre) were cleared and the top soil of the pond was scrapped and dumped in the sanitary landfill. The ponds were filled with fresh soil. The RO reject is presently stored in two lined ponds and one unlined pond posing a risk of seepage /groundwater contamination. There is also a risk of overflow from storage ponds in case of heavy rains.

*Legacy Leachate flowing and stagnation*

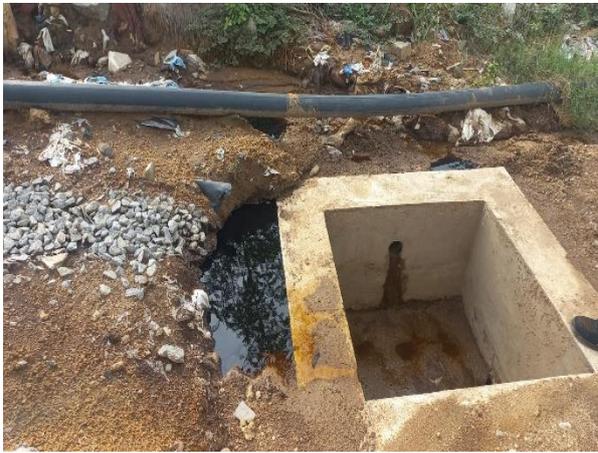
*Leachate collection ponds*

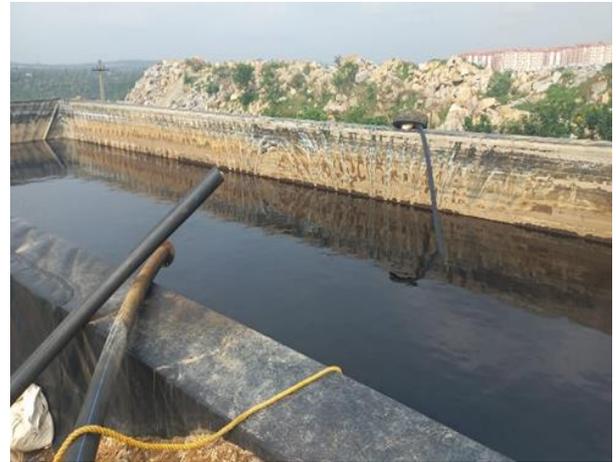
*Leachate collection sump*

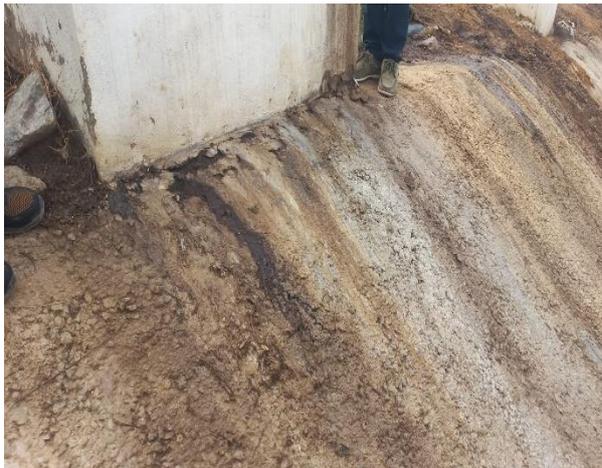
*Leachate flowing through collection pond*

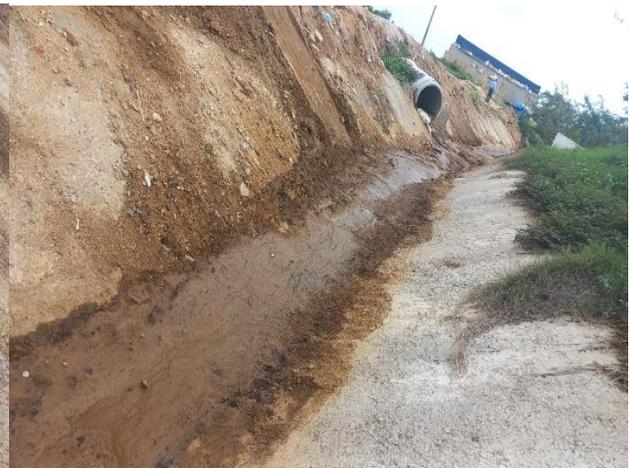
*Leachate flowing in garland drains*

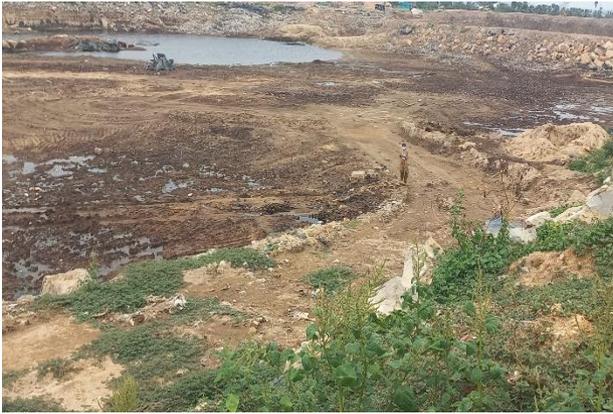
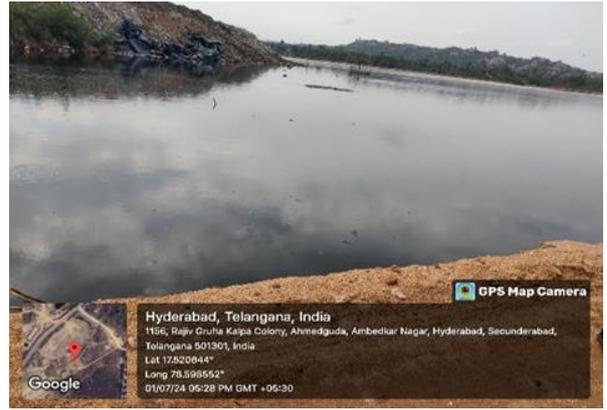
- ii. Drying of fresh waste on unlined surface
  - iii. Run-off from operational areas of various solid waste processing facilities.
  - d. Seepage from one unlined leachate storage ponds

*Unlined Legacy Leachate pond*

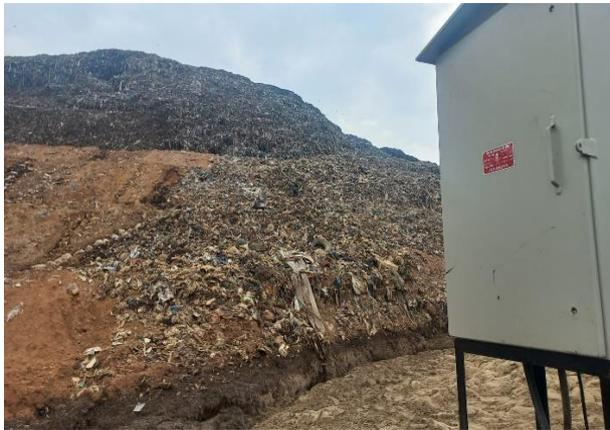
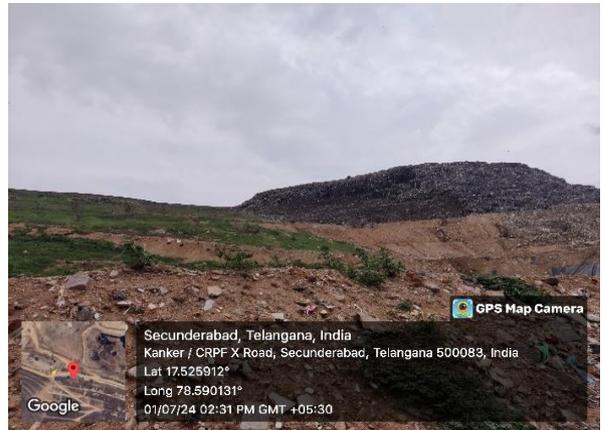
- vii. It is observed that excess (un-utilizable) semi-processed solid-waste was initially stored at one identified location within the premises, which is 11 lakh MT stored in 61 acres of land near to RDF processing facility, located in west direction of processing plant and a total height of this is about 60m. It was observed that an active storage of semi-processed solid waste has taken place between the capped sites and also above the capped areas. It was also observed that a temporary cap of 1.5mm HDPE sheet is laid over the levelled mounds of solid waste. At present 68,17,487 MT of un-utilized semi processed waste is stored in the processing facility.
- viii. Accumulated semi-processed waste (RDF) in last 12 years is given in below Table 1:

*Semi-processed waste dumped at site as RDF*

- ii. In compliance to Hon'ble NGT order dated December 7, 2017 in OA No. 780 of 2017 in the matter of Peddi Mohan Reddy & Ors VS. State of Telangana, (PB) Delhi; GHMC has identified three sites at Pyranagar, Lakdaram and Khanapur for processing solid waste generated from GHMC area and to minimize the load on Jawaharnagar facility. Even after 07 years, the other processing facilities have not been made operational. GHMC may either develop these sites on priority, and manage the fresh waste in these facilities instead of accumulating it in HIMSWM Project or develop additional processing/utilization capacity at HIMSWM Project. GHMC to evaluate the same and take immediate actions in this regard. Further, GHMC to operationalize the WTE Plant being set up in HIMSWM Project and also identify additional avenues for processing of RDF accumulated (68.17 lac T) on its premises.

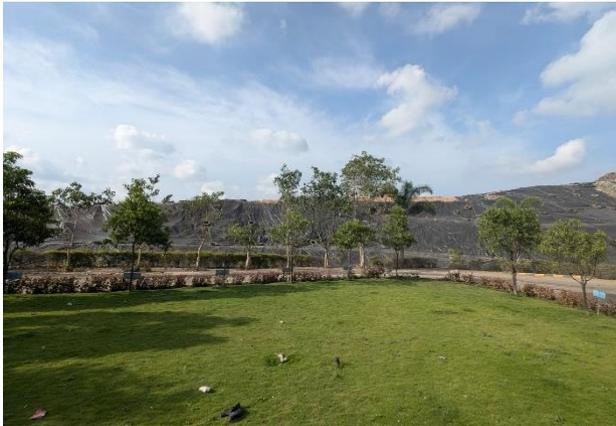
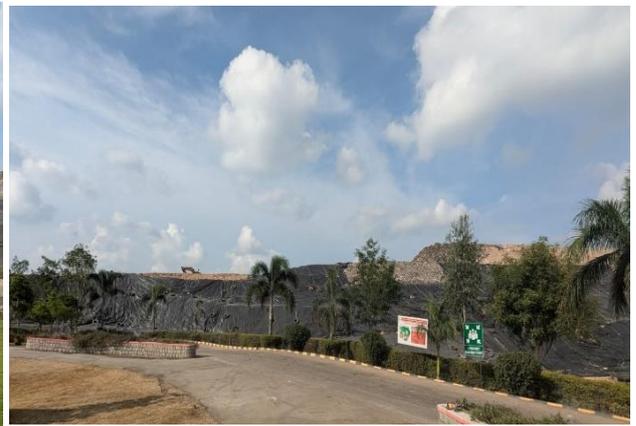
- x. It is observed that the entire area of Jawaharnagar waste processing has been utilized and scope for expansion is limited. As explained in above paras, there is no additional storage space, and the semi-processed waste is being stored in spaces between capped sites and above the capped sites leading to additional quantity of leachate being generated from the dumpsite.

*Semi processed waste dumped over capped dumpsite*

- iii. Further, the other accumulated semi-processed waste in HIMSWM Project also needs to be processed/utilized on priority. Thereafter, the capped site is to be opened gradually in phase wise planned manner for biomining.

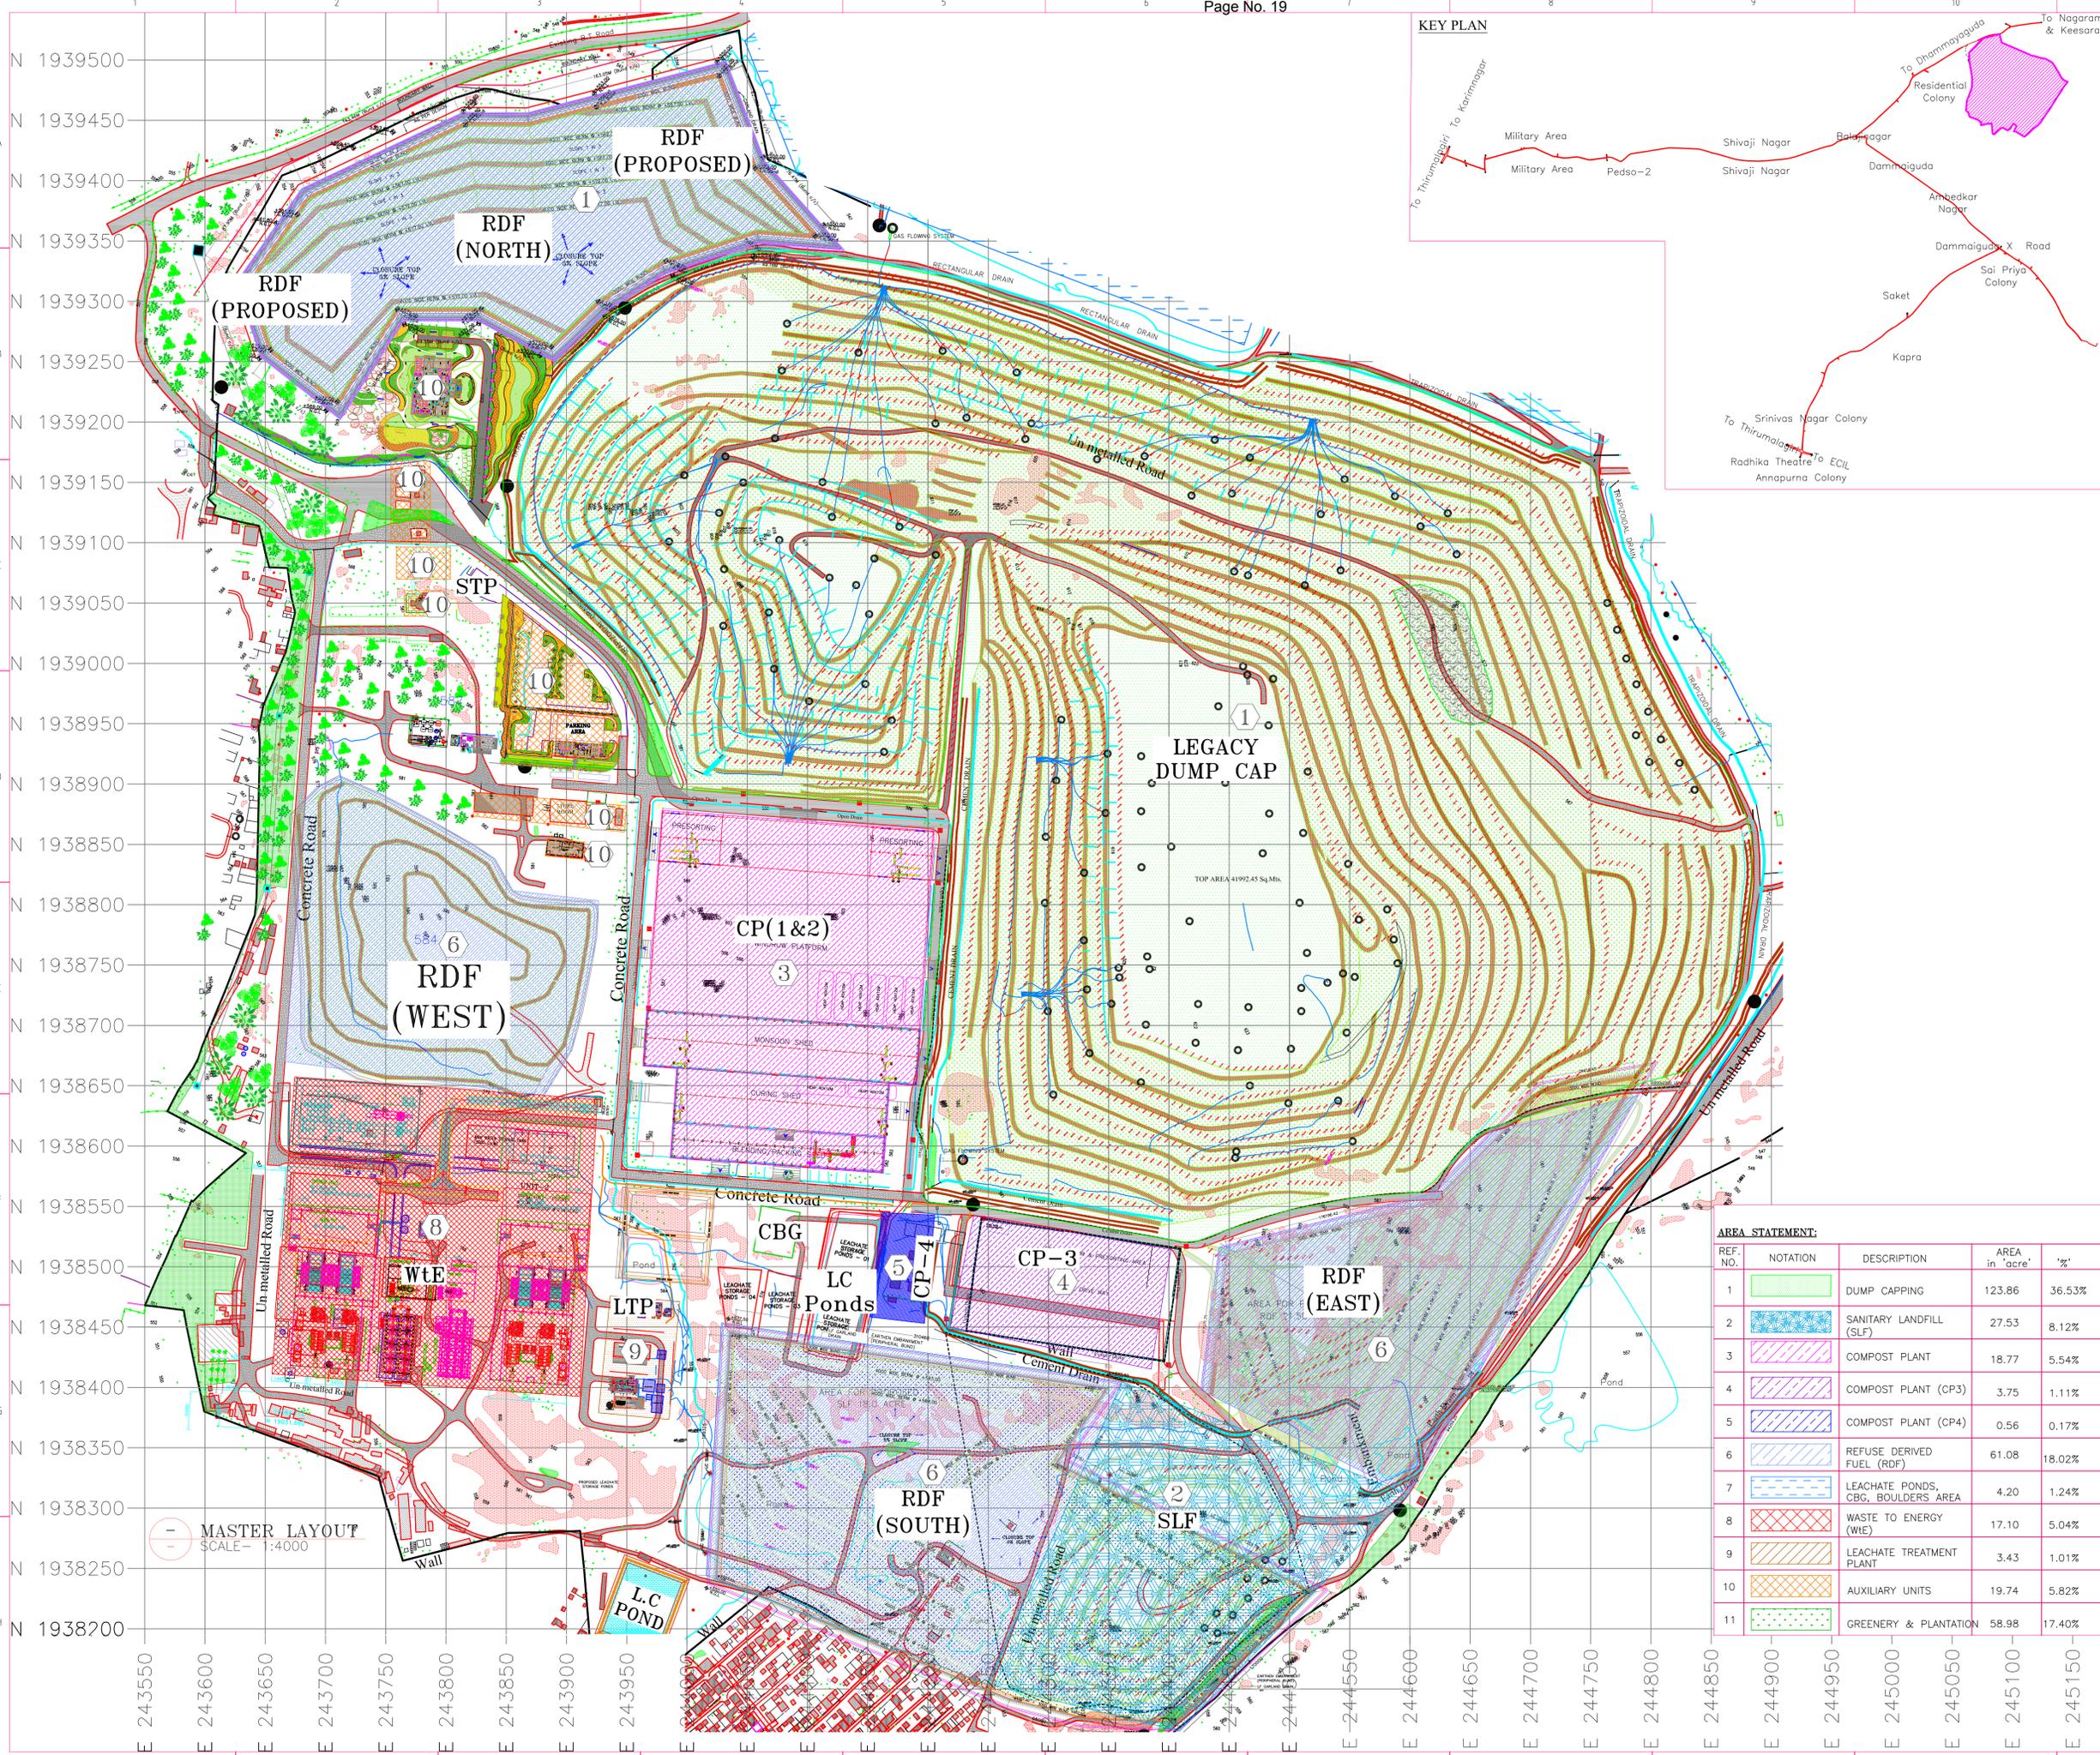
# Annexure - I

- xi. The details of land utilized with area is given in Table 2 below and a map showing the same is attached as *Annexure 1*.

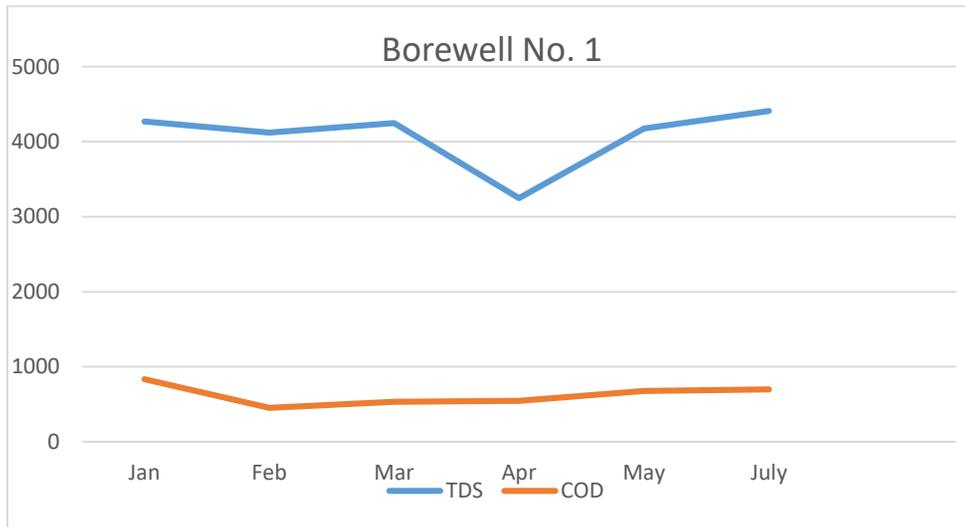
- TDS for the sample taken during Inspection from Bore Well No. 1 is 4410 mg/l. TDS graph is showing an increasing trend from the month of April.
- COD for the sample taken during Inspection from Bore Well No. 1 is 698 mg/l. COD graph is showing an increasing trend from the month of February.

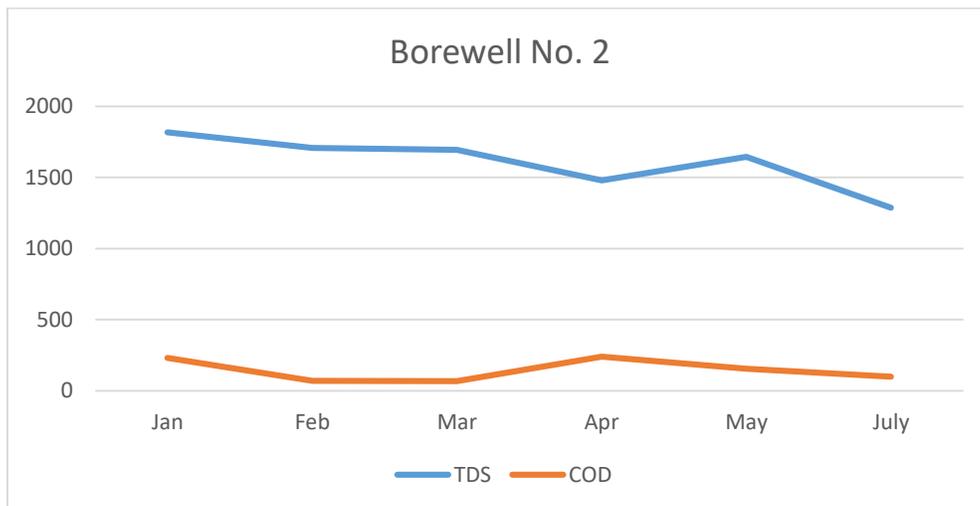
- TDS for the sample taken during Inspection from Bore Well No. 2 is 1287 mg/l. The % decrease in TDS as compared to May month is 21.76 %.
- COD for the sample taken during Inspection from Bore Well No. 2 is 99 mg/l. The % decrease in COD as compared to May month is 36.13 %.

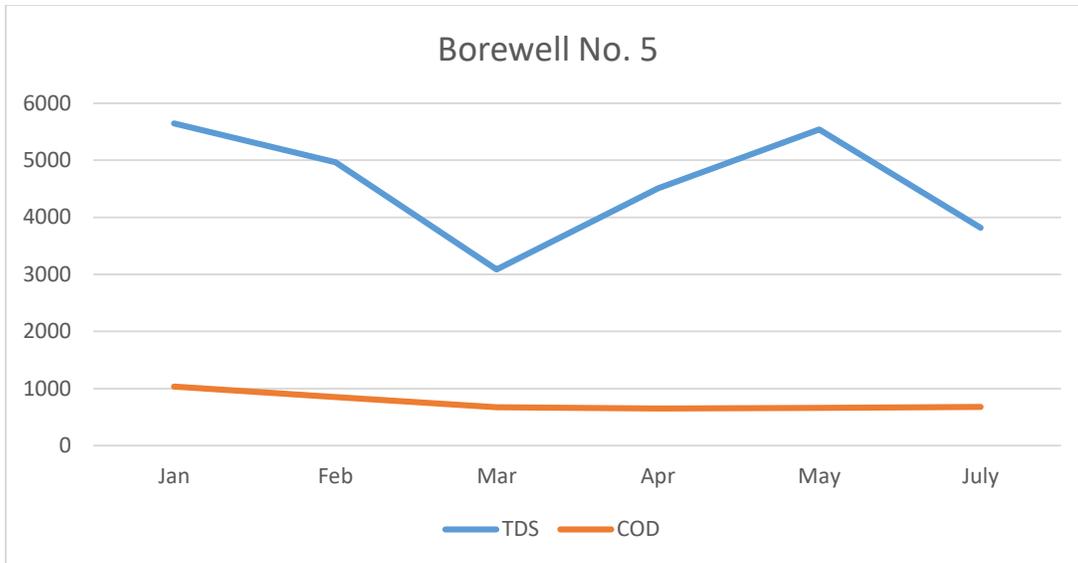
- TDS for the sample taken during Inspection from Bore Well No. 5 is 3815 mg/l. The % decrease in TDS as compared to May month is 31.15 %.
- COD for the sample taken during Inspection from Bore Well No. 5 is 675 mg/l. COD graph is showing an increasing trend from the month of February.

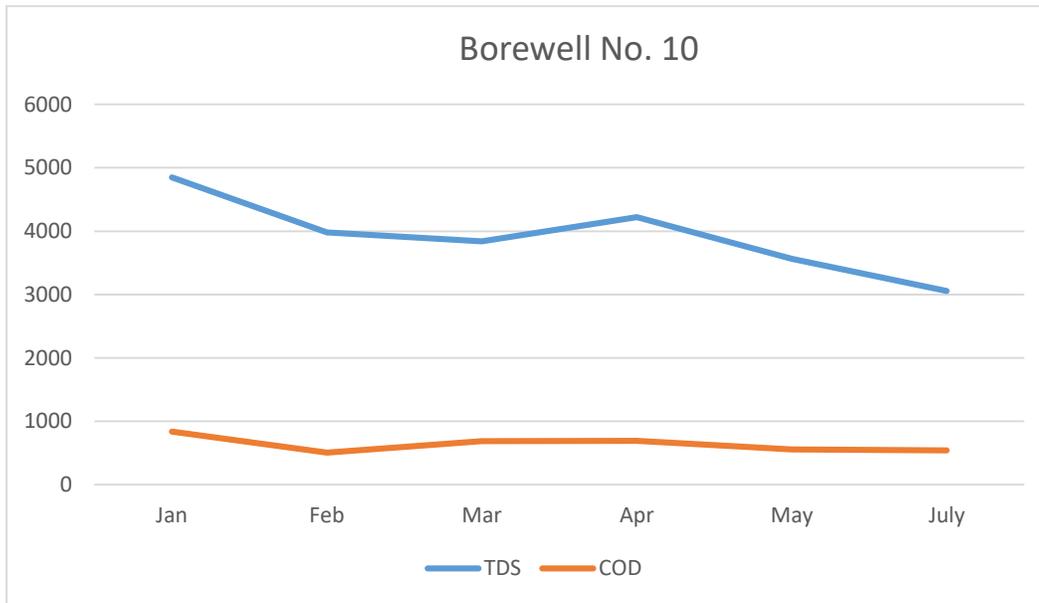
- TDS for the sample taken during Inspection from Bore Well No. 10 is 3058 mg/l. TDS graph is showing decreasing trend from the month of March.
- COD for the sample taken during Inspection from Bore Well No. 10 is 540 mg/l. COD graph is showing decreasing trend from the month of April.

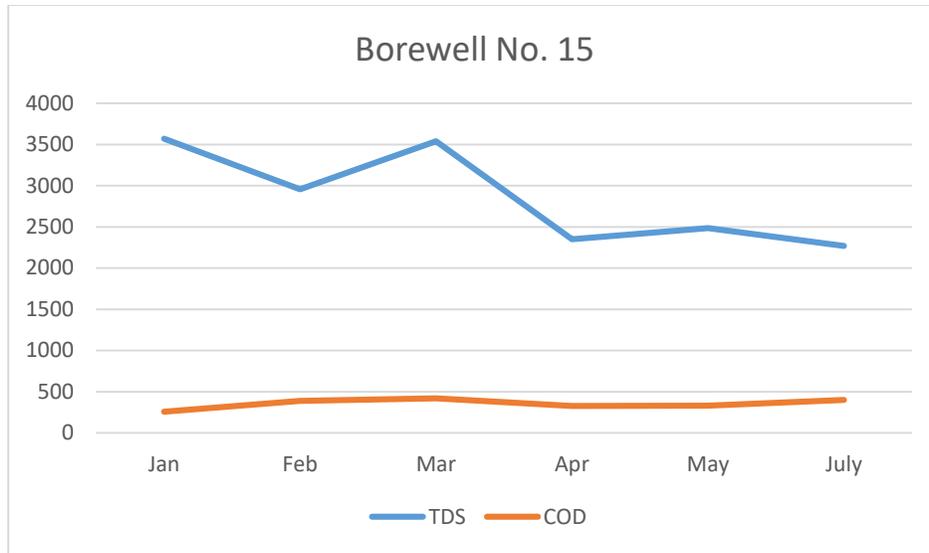
- TDS for the sample taken during Inspection from Bore Well No. 15 is 2268 mg/l. The % decrease in TDS as compared to May month is 8.8%
- COD for the sample taken during Inspection from Bore Well No. 15 is 401 mg/l. The % increase in COD as compared to May month is 21.14%

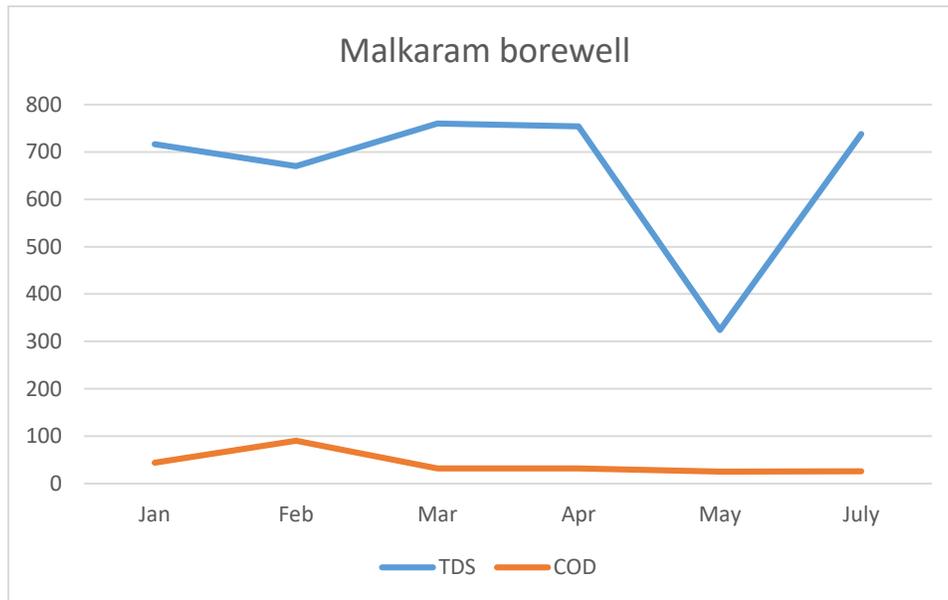
- TDS for the sample taken during Inspection from Malkaram Bore Well is 738 mg/l. The % Increase in TDS as compared to May month is 127.7%
- COD for the sample taken during Inspection from Malkaram Bore Well is 26 mg/l. COD graph is showing decreasing trend from the month of April.

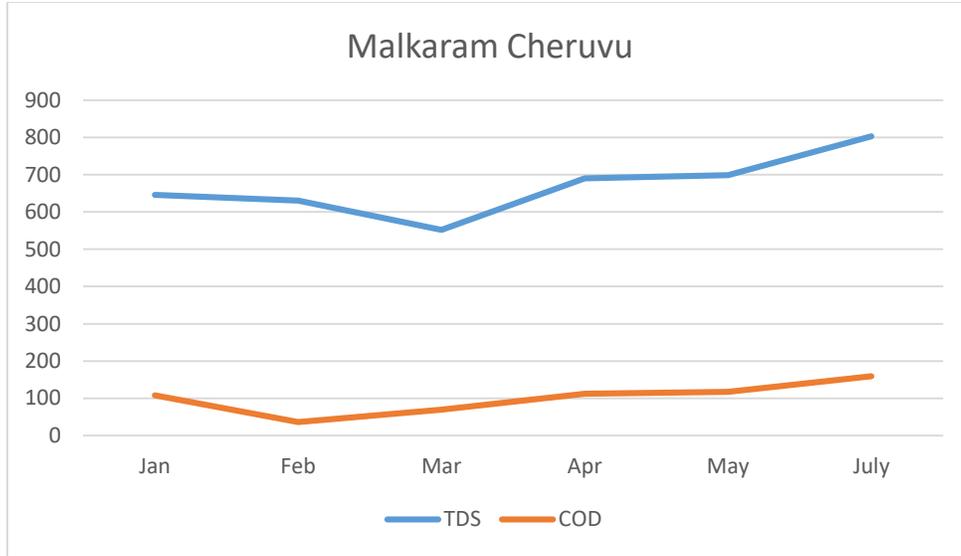
- TDS for the sample taken during Inspection from Malkaram cheruvu is 803 mg/l. TDS graph is showing increasing trend from the month of April.
- COD for the sample taken during Inspection from Malkaram cheruvu is 159 mg/l. COD graph is showing increasing trend from the month of March.

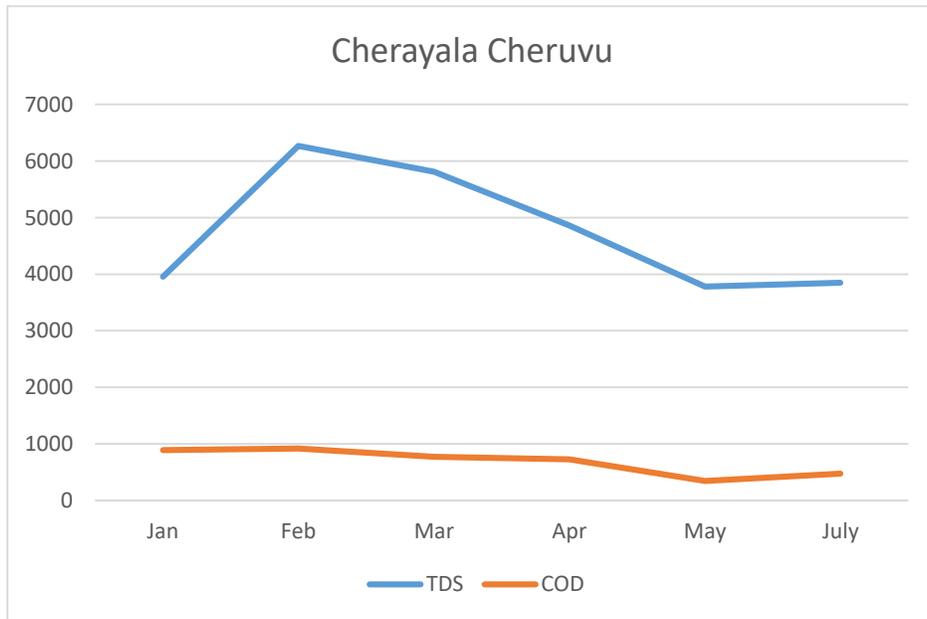
- TDS for the sample taken during Inspection from Cherayala cheruvu is 3850 mg/l. COD graph is showing decreasing trend from the month of February.
- COD for the sample taken during Inspection from Cherayala cheruvu is 476 mg/l. COD graph is showing decreasing trend from the month of February.
