SECTION: 6

ENVIRONMENTAL IMPACT ASSESSMENT

The proposed widening to 2-lane, re-alignment and geometric improvement of NH 54 under this report is from Km 431+00 to Km 562+000 of existing chainage in Mizoram. This road will serve as connectivity between two Southern District Headquarter. The Multi Model transit route is branching from Km 473.30 of NH-54, which is going to serve the International trade road between India & Myanmar for economically and culturally. This work will include improvement of gradient, re-alignment, pavement, retaining walls, culverts etc. In order to improve the gradient of this road, some stretches of the road will have to be re-aligned whereas some existing stretches can be improved to conform to single lane specification in respect of its gradient, curves, super elevations etc.

UTTARAKHAND DISASTER 2013

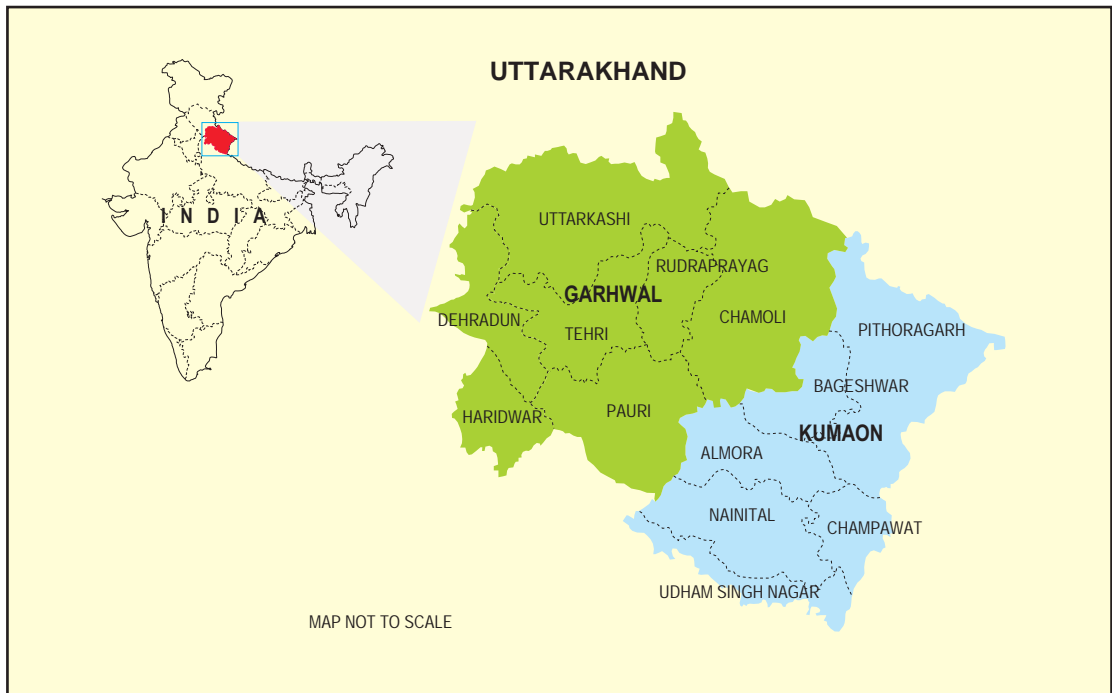
Figure 2.1: Map of Uttarakhand

The Himalayan State of Uttarakhand is located between 28° 43' - 31° 27' N latitude and 77° 34' - 81° 02' E longitude and is divided into two divisions - Garhwal and Kumaon (Figure 2.1) and 13 districts. It consists of 76 towns and 95 development blocks. Dehradun, the largest city in the region, is the capital of Uttarakhand. The State includes 320 km long stretch of the mountains between the Kali River forming the Indo-Nepal border in the East and the Tons-Pabbar valleys forming the eastern border of the Himachal Pradesh in the West.

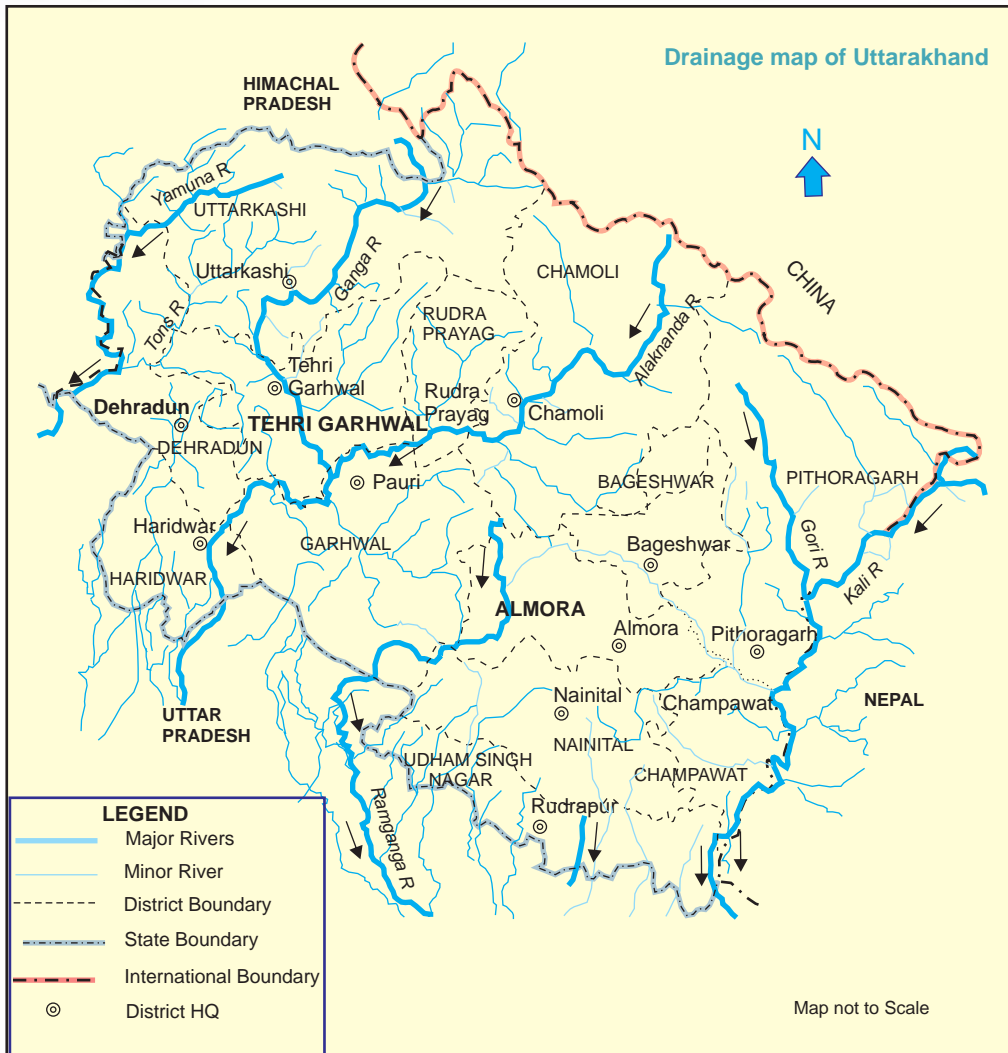
Figure 2.2: Drainage map of Uttarakhand³

Several rivers which are lifelines to one of the most densely populated areas in the world (the Gangetic Plains of India) originate in this region (Figure 2.2). Rivers Ganga (comprising Alaknanda and Bhagirathi) and Yamuna, which originate at Gangotri and Yamunotri respectively, are the most important rivers of the region. Another mighty river that brings misery when in its spate is the river Kali on the eastern border of the State.

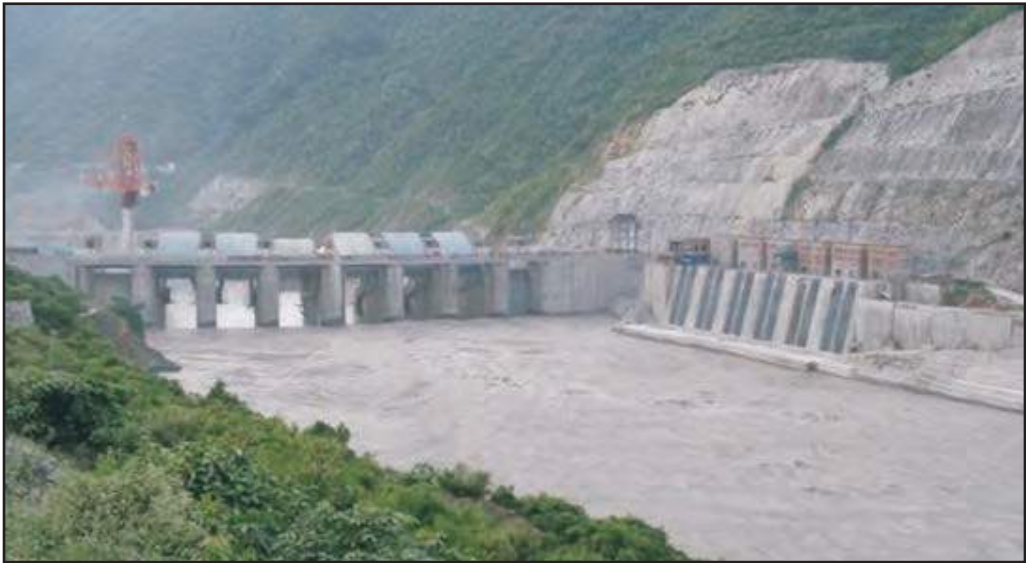
Figure 2.8: Hydel power project in Srinagar, Uttarakhand⁴⁴.

Dams or reservoirs are constructed on a river to impound or divert water for generation of electricity, flood control or irrigation (Figure 2.8). These are man-made structures creating an artificial check in the natural flow of river. Such artificial checks in river flow are known to disturb the normal flow pattern of the river disturbing the equilibrium in the ecosystem. Modification of land-use, and broadly saying the landscape, due to construction of dams may also increase vulnerability to hazards. In this regard, the Central Water Commission has stipulated Guidelines / Codal provisions for incorporating adequate measures to safeguard the environmental / ecological / geological / geo-technological concerns while evaluating the river valley projects, so that the vulnerability to disasters is minimized or avoided considerably.

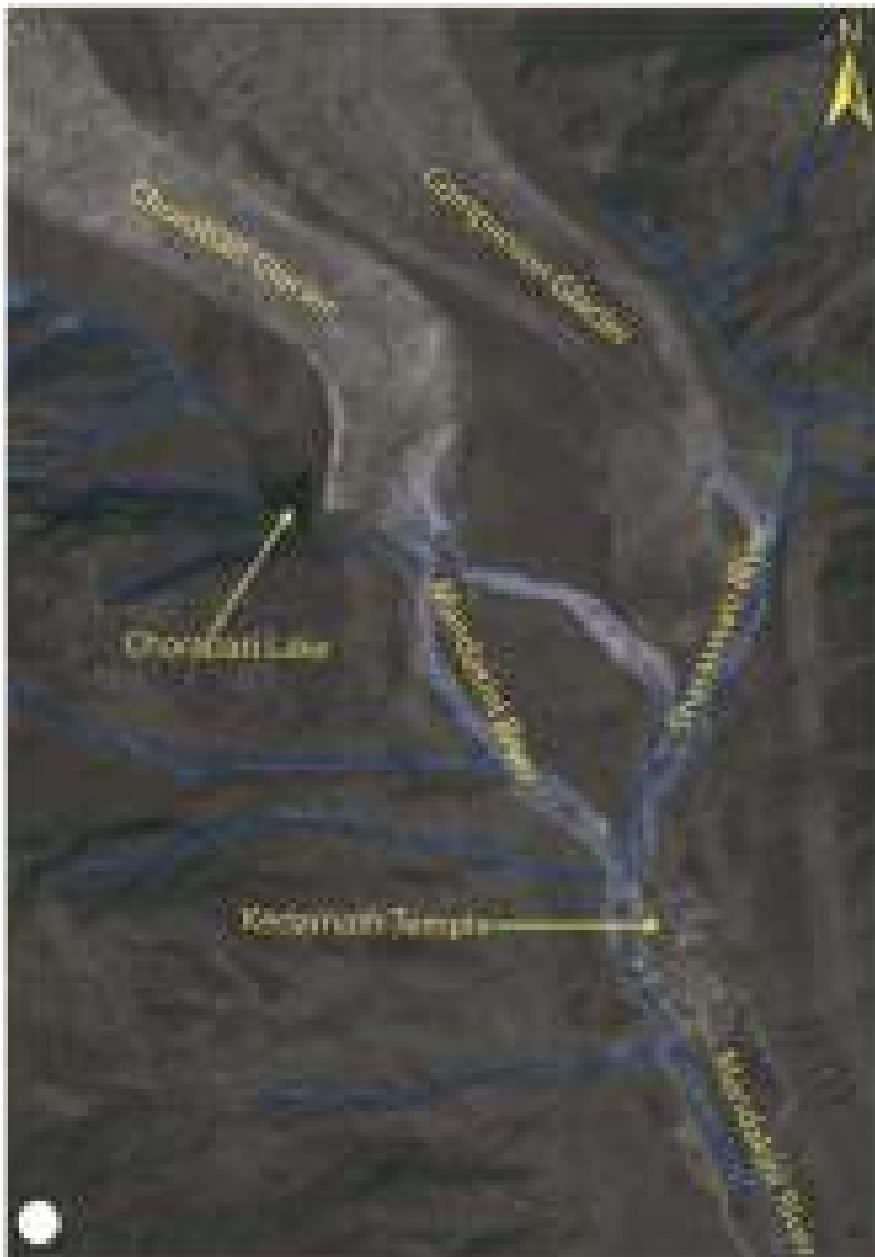
Figure 2.9: Satellite view of Kedarnath showing drainage system, glaciers, lake and township⁴⁸

The Satellite view of Kedarnath area, showing drainage system, glaciers, lake and township is given in Figure 2.9.

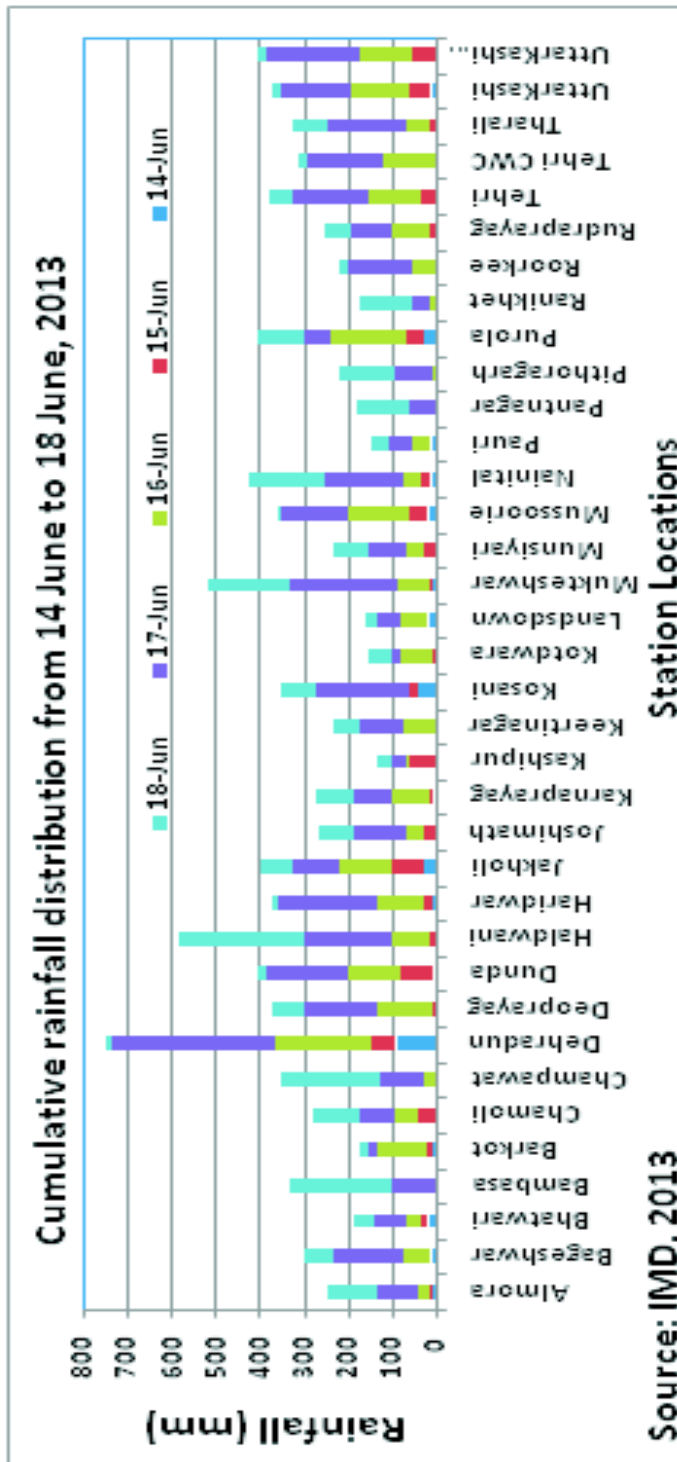
Figure 2.11 : Station-wise accumulated rainfall from 14 to 18 June 2013⁵⁵
