BEFORE THE HON'BLE NATIONAL GREEN TRIBUNAL,
PRINCIPAL BENCH, NEW DELHI

O.A. NO. 127/2-24

MINISTRY OF ROAD TRANSPORT AND
HIGHWAYS & ORS.

A.M. Singh
Sr. Geologist
 L.N.M. Infra Projects Pvt. Ltd.
 NH-707, Paonta Sahib

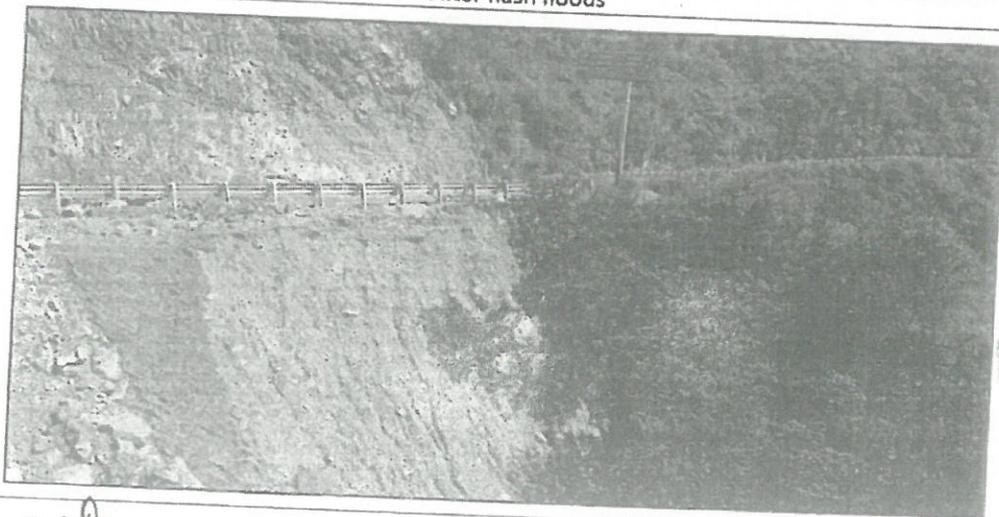
Before flash floods

After flash floods

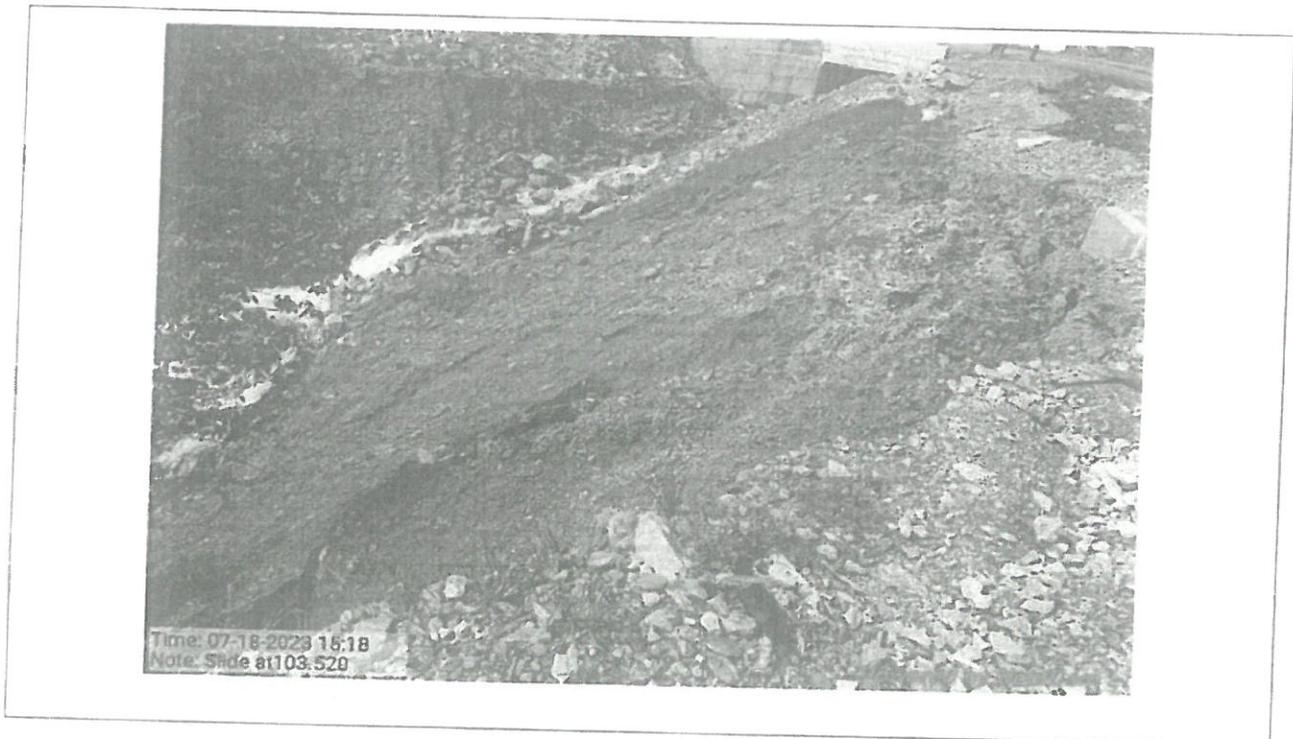
Sr. No.	2
Location No.	RD102/720 near Fediz bridge.
Issues	Unauthorized and illegal dumping of debris on forest and private land without any protection measures.
Comment	This location is not a dumping zone and no dumping has been done by the Contractor at this location. The Valley side slope was already stabilized with slope protection measures with geocell with hydroseeding, bamboo plantation and hydroseeding. However, due to unprecedented rainfall and landslide, the damage took place at this location. Detailed report (submitted to insurance company for claim) attached herewith may also be referred in this regard. Further, retaining structures and slope protection measures have been completed and are being maintained by the Contractor.
Before flash floods

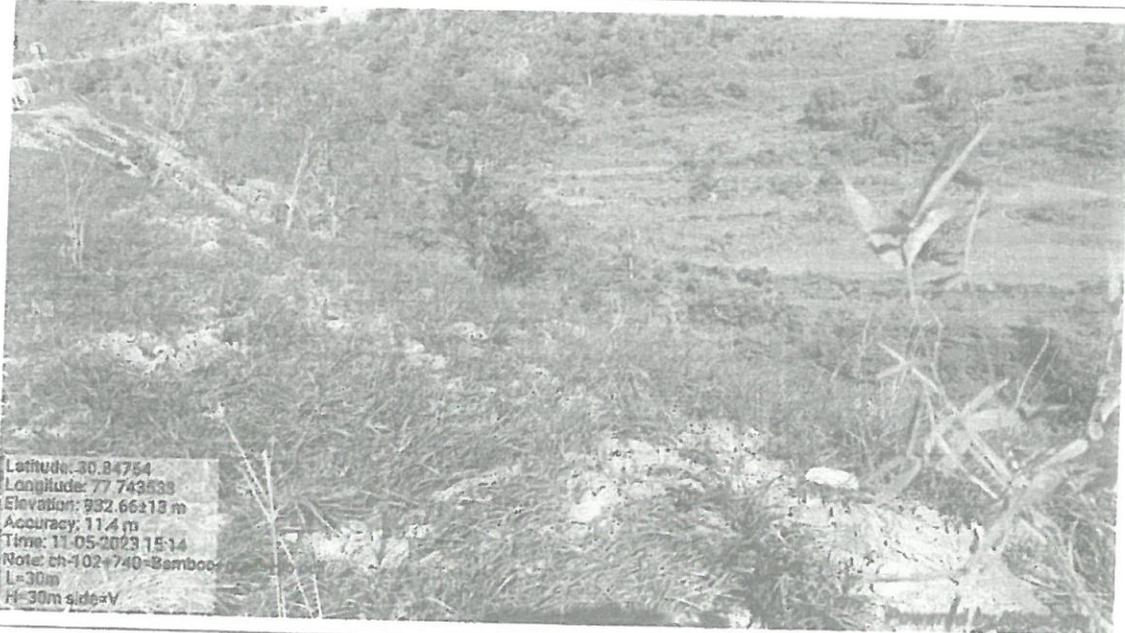
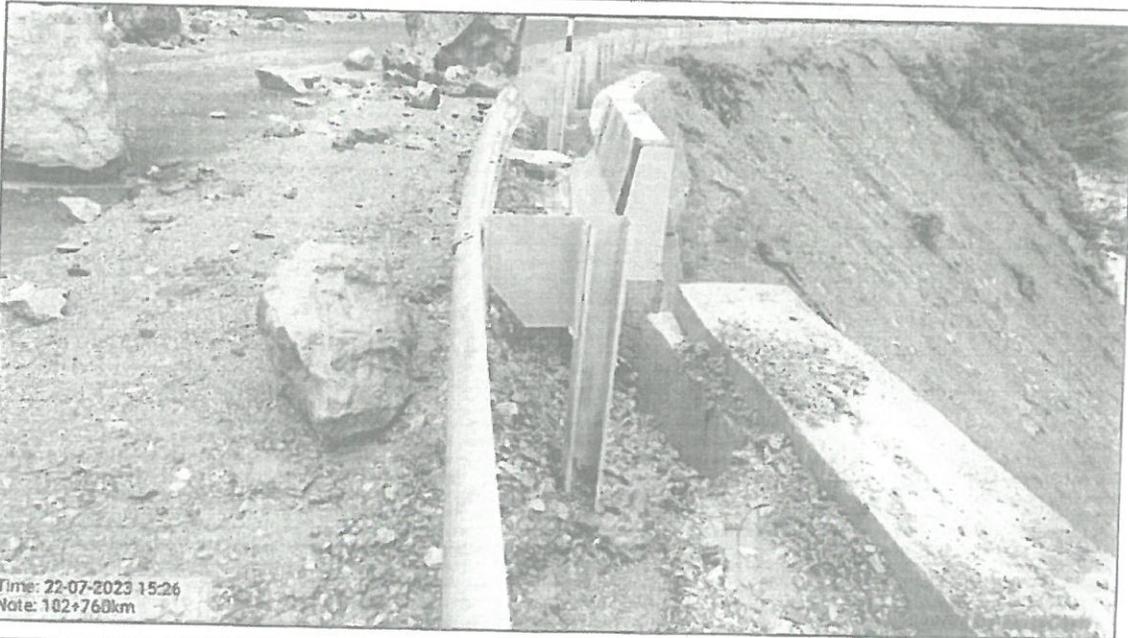
Latitude: 30.84754
 Longitude: 77.749533
 Elevation: 932.66±13 m
 Accuracy: 11.4 m
 Time: 11-05-2023 15:14
 Note: bh-102+740-Bamboo
 L=30m
 H=30m side+V

After flash flood

Time: 22-07-2023 15:26
 Note: 102+760km

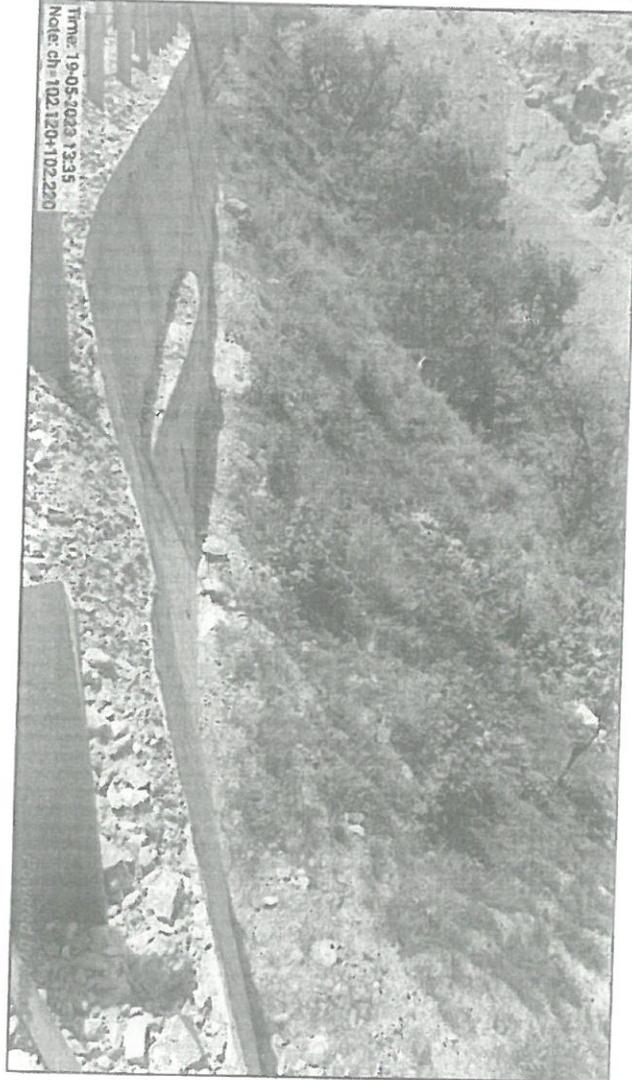
Sr. No.	3
Location No.	RD102/200
Issues	Unauthorized and illegal dumping of debris on forest and private land without any protection measures.
Comment	This location is not a dumping zone and no dumping has been done by the Contractor at this location. Valley Side slope was already stabilized using Geo-cell with hydroseeding and bamboo plantation. However, debris crossed the highway during extreme adverse weather condition of rainfall in 2023. Detailed report (submitted to insurance company for claim) attached herewith may also be referred in this regard. Further, retaining structures and slope protection measures have been completed and are being maintained by the Contractor.
Before sliding

After flash floods

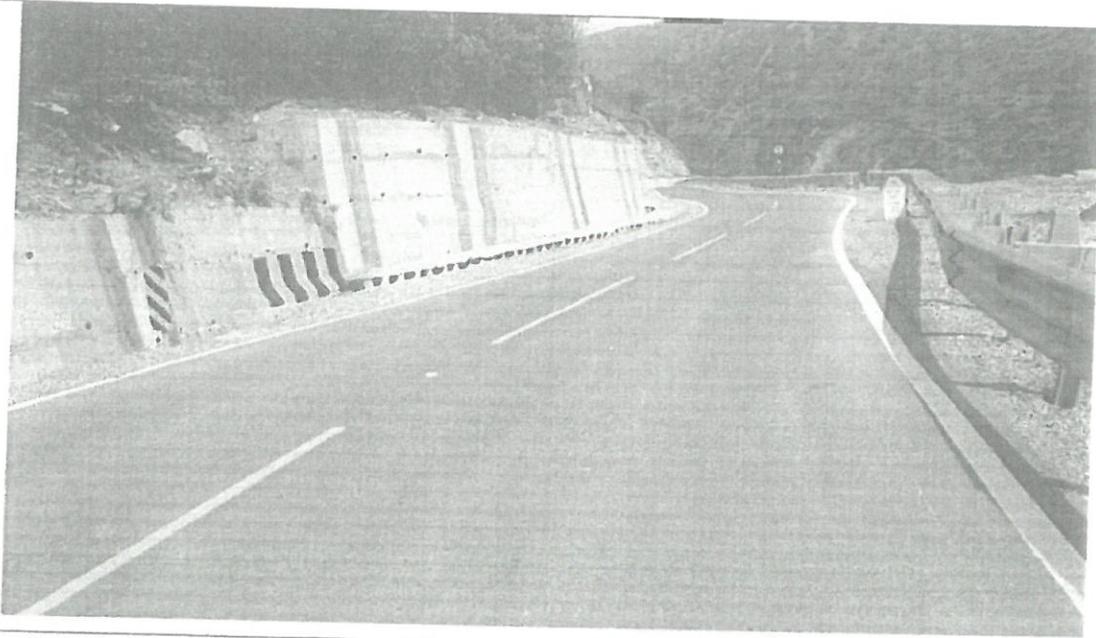
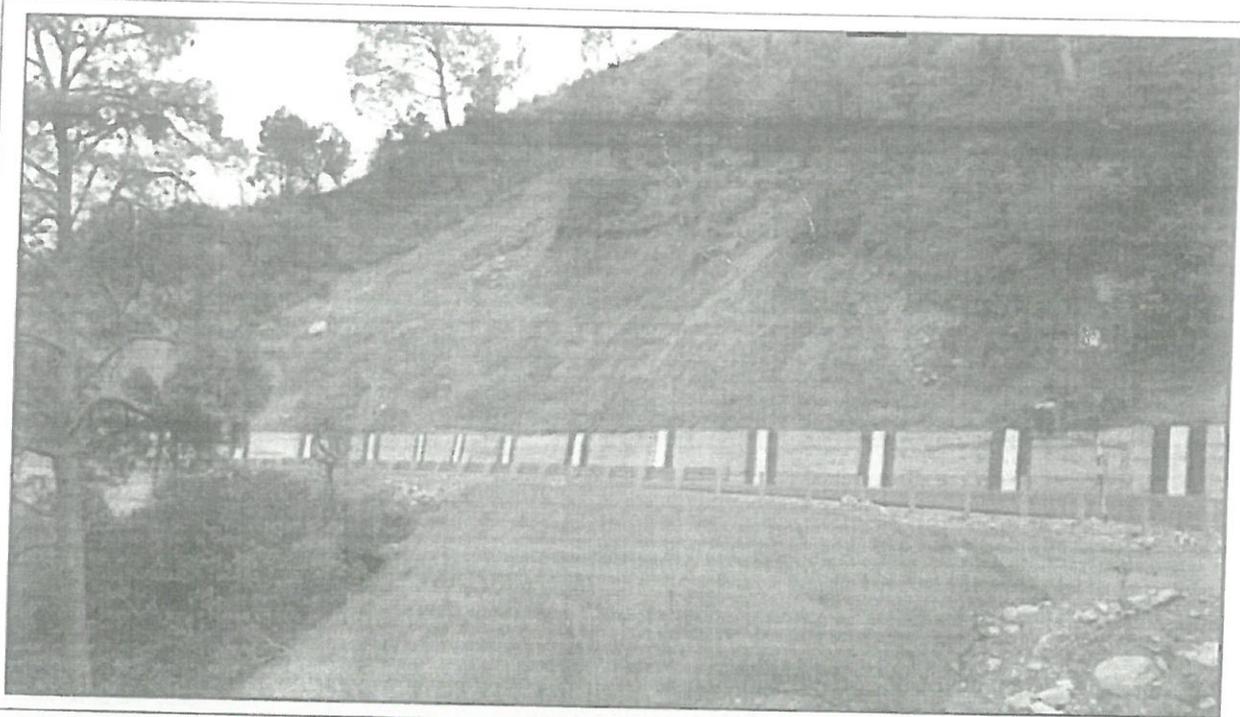
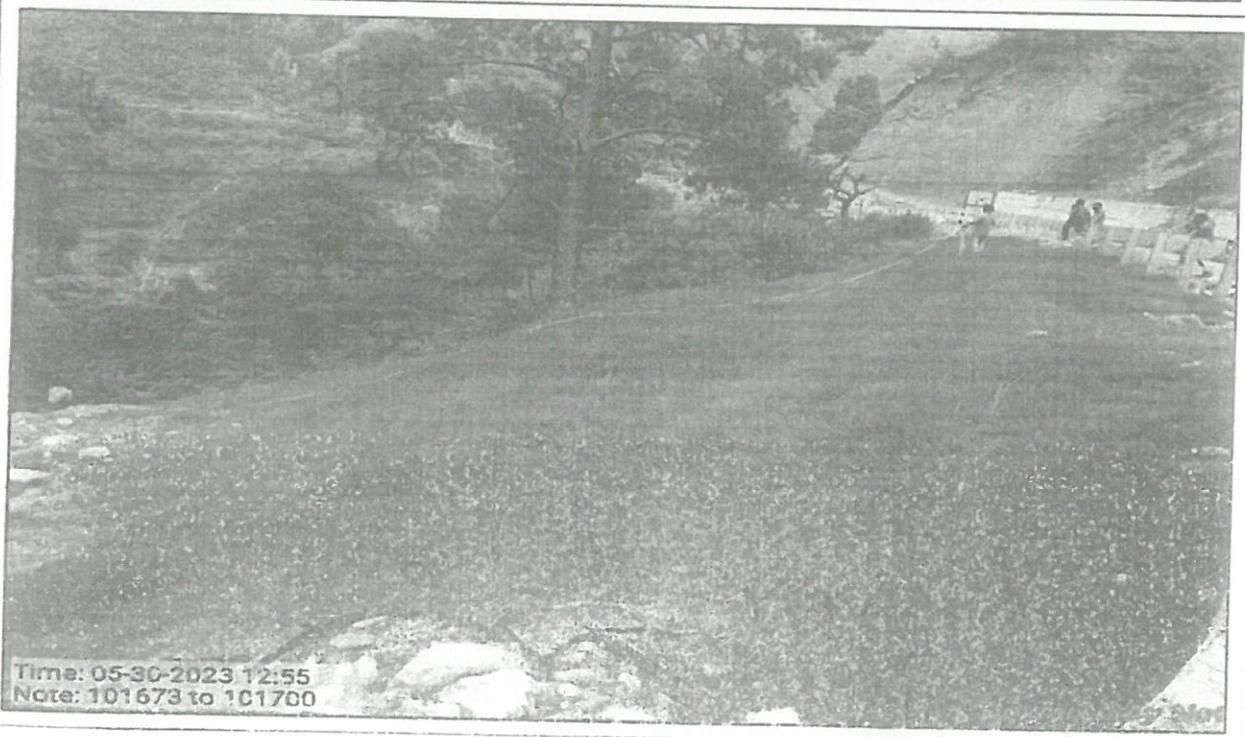
Sr. No.	4
Location No.	RD101/700
Issues	Unauthorized and illegal dumping of debris on forest and private land without any protection measures.
Comment	This location is not a dumping zone and no dumping has been done by the Contractor at this location. Valley Side slope was stabilized using hydroseeding, breast wall and retaining wall. However, debris from catchment outside RoW crossed the highway during extreme rainfall of 2023. Detailed report (submitted to insurance company for claim) attached herewith may also be referred in this regard. Further, retaining structures and slope protection measures have been completed and are being maintained by the Contractor.

Before slide

Time: 05-30-2023 12:55
Note: 101673 to 101700

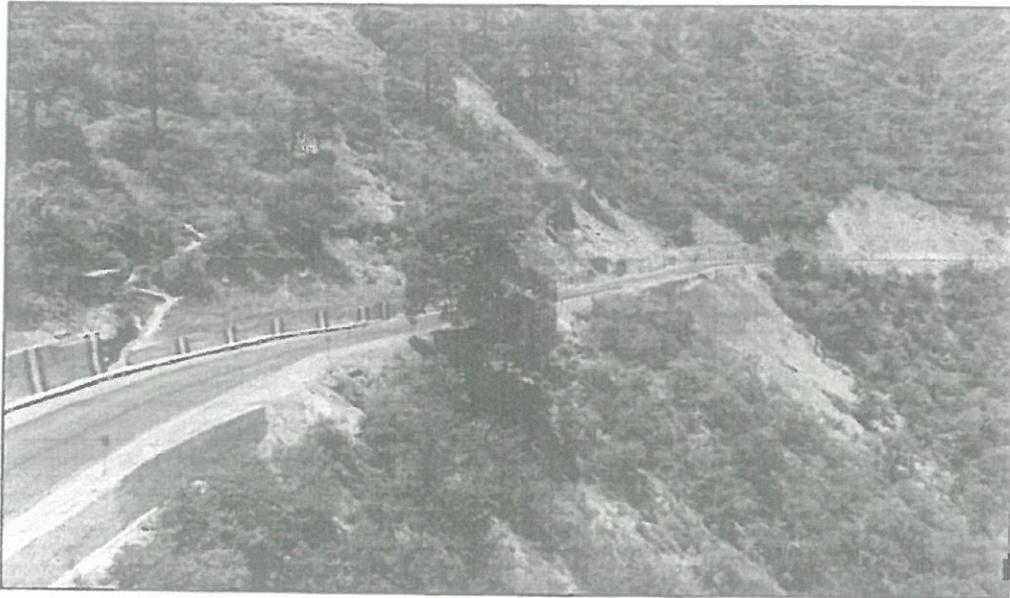
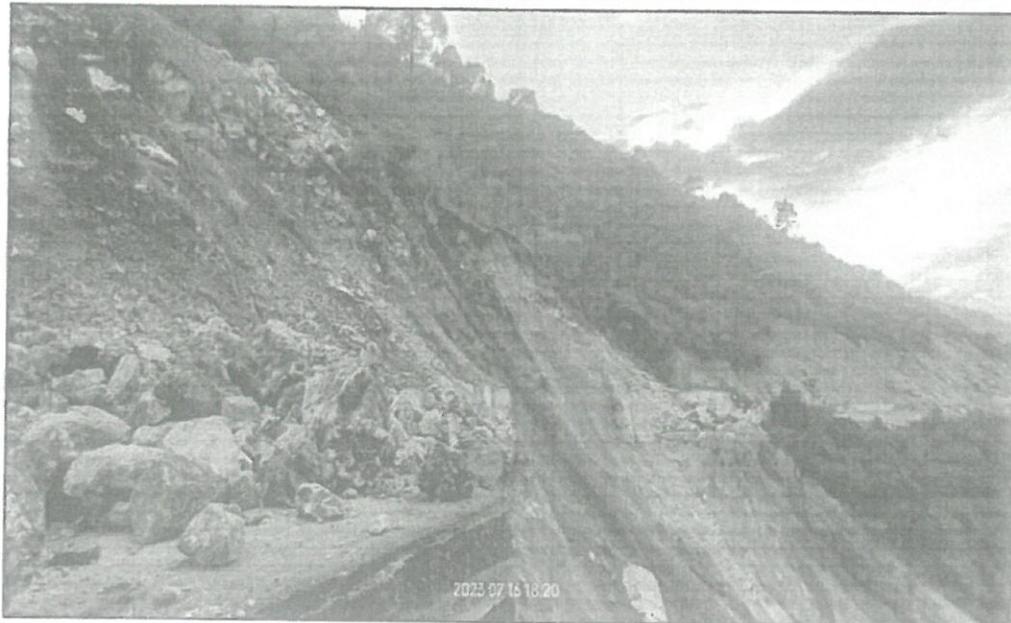
Sr. No.	5
Location No.	RD101/160
Issues	Unauthorized and illegal dumping of debris on forest and private land without any protection measures.
Comment	This location is not a dumping zone and no dumping has been done by the Contractor at this location. This area was severely affected by cloud bursts. The landslide occurred from beyond the ROW and the road was washed away to the valley. The hillside breast wall and culverts were also damaged. The road was closed for 15 days and the Same was intimated to the local police station and Sub-divisional Officers (SDO) of Chopal and Shillai. The gabion at the toe and hydroseeding on the valley slope were constructed to control erosion. The hillside breast wall was also reconstructed to control further landslides. The road was repaired/ rehabilitated for safe movement of passengers. Further, retaining structures and slope protection measures have been completed and are being maintained by the Contractor.

Before damage

Damage

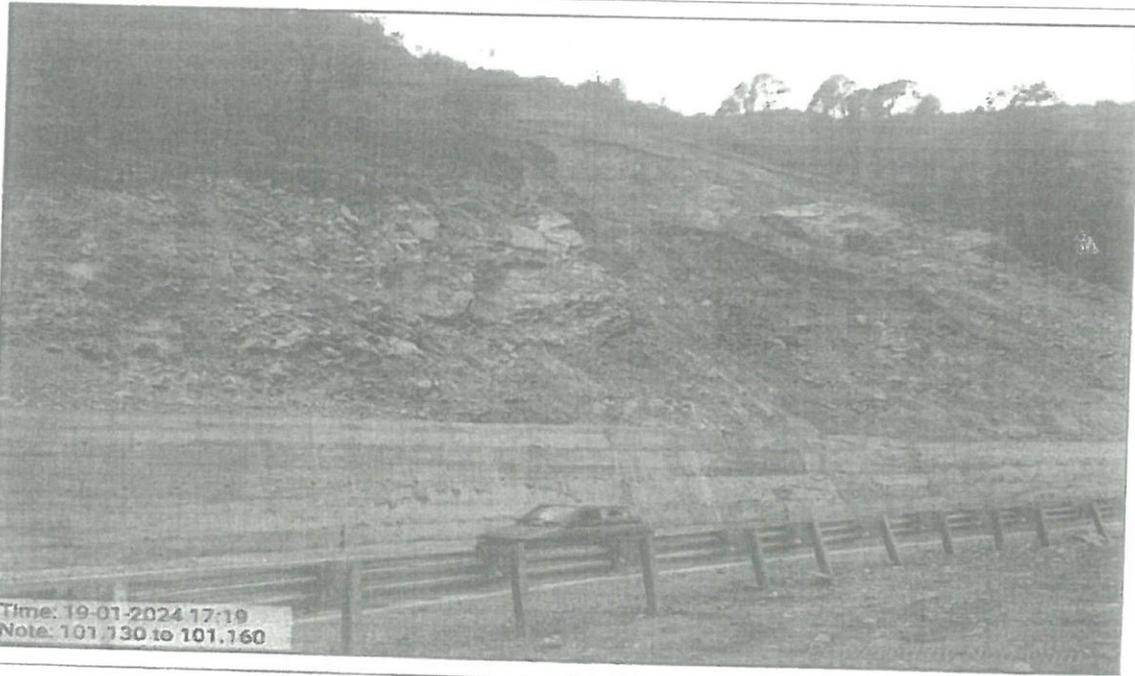
After restoration

Time: 19-01-2024 17:19
Note: 101.130 to 101.160

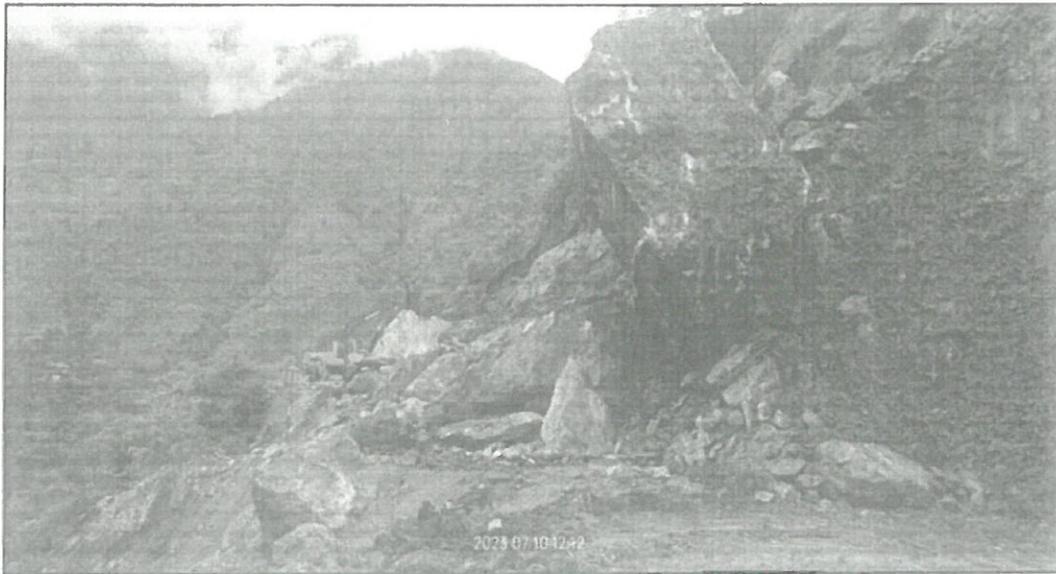
Sr. No.	7
Location No.	RD100/610
Issues	Unauthorized and illegal dumping of debris on forest and private land without any protection measures.
Comment	This location is not a dumping zone and no dumping has been done by the Contractor at this location. However, due to unprecedented rainfall damages occurred. Requisite breast wall have been reconstructed to protect the hill. The road was closed on 09.07.2023 and 12.07.2023 due to a slide at this location. The same information was communicated to the District Disaster Management Authority (DDMA).

Sliding

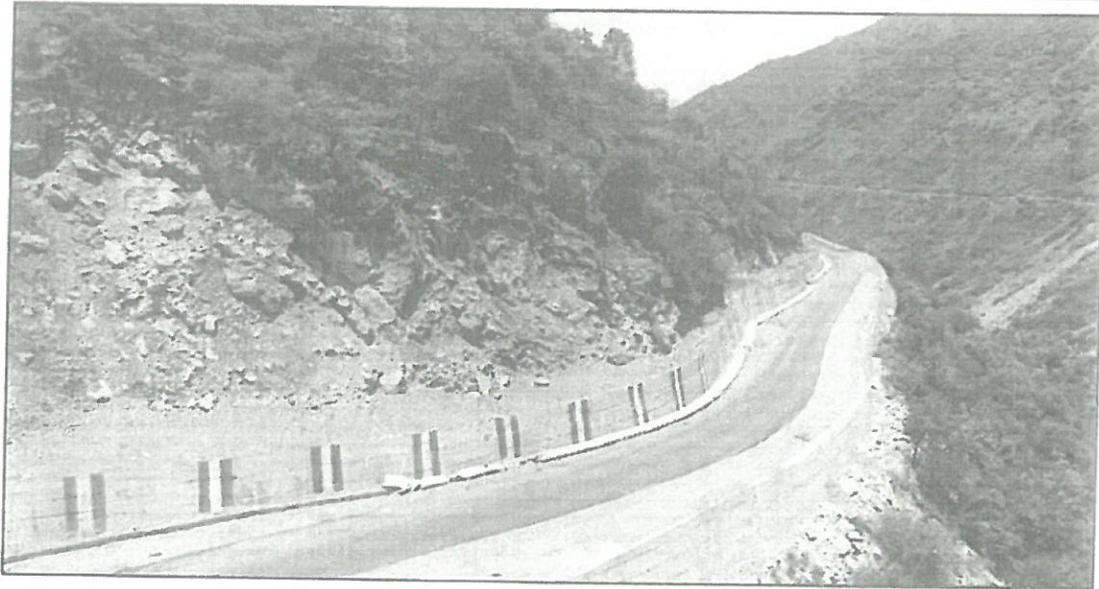
Sr. No.	8
Location No.	RD100/170
Issues	Unauthorized and illegal dumping of debris on forest and private land without any protection measures.
Comment	This location is not a dumping zone and no dumping has been done by the Contractor at this location. However, due to unprecedented rainfall and flash floods, rock fall occurred and debris slid into the valley. A retaining wall has been provided to prevent further erosion. The road was closed and many vehicles were stuck for nearly 24 hours. The same information was communicated to the District Disaster Management Authority (DDMA).

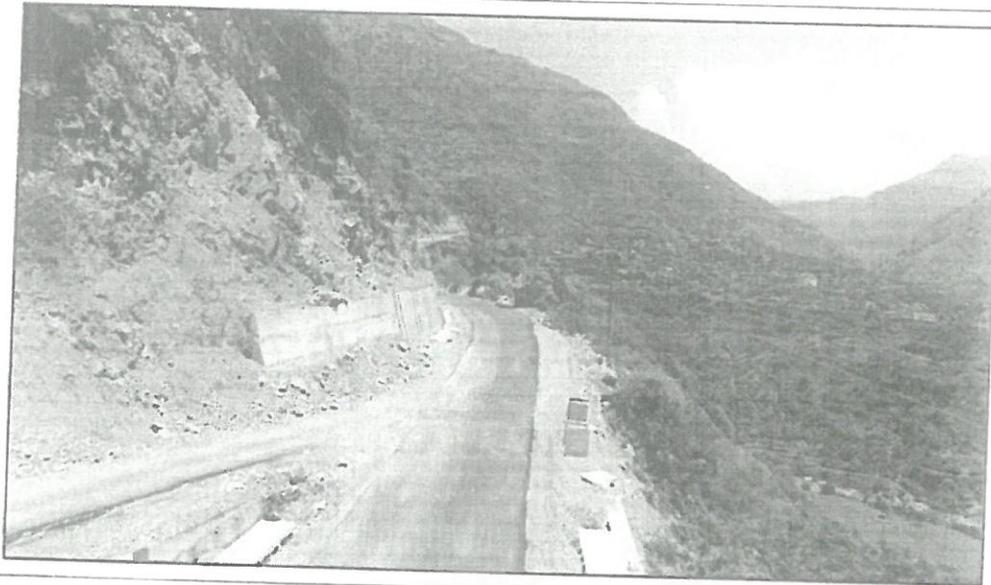
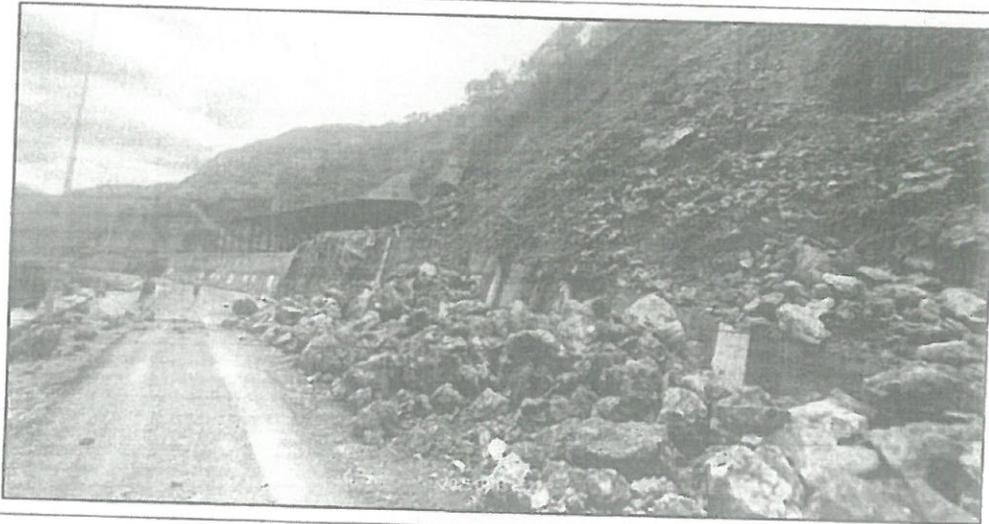
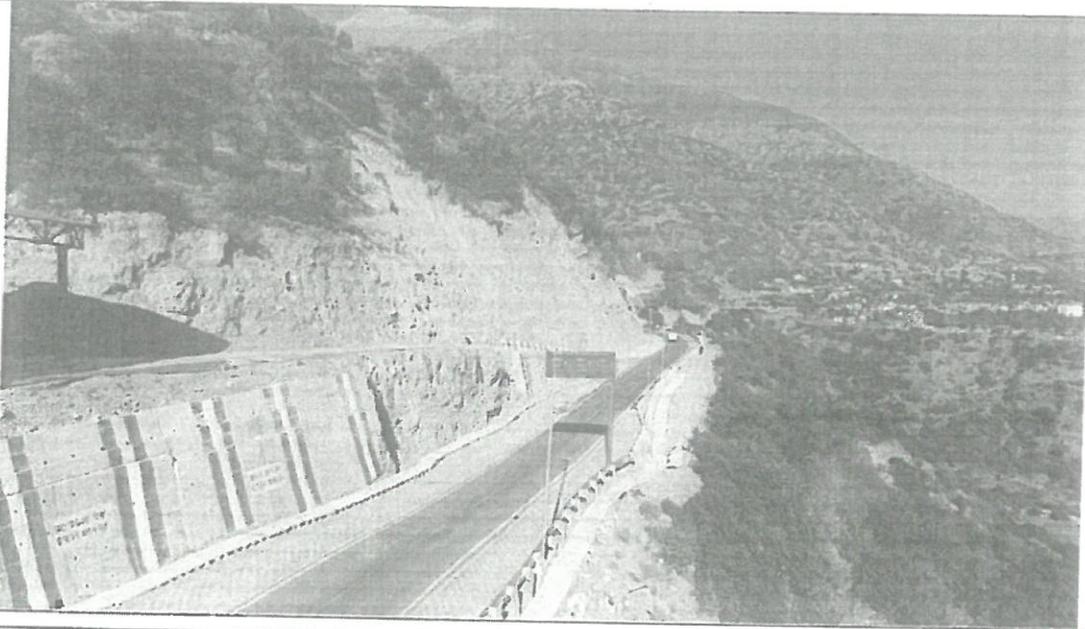
Sr. No.	9
Location No.	RD99/390
Issues	Unauthorized and illegal dumping of debris on forest and private land without any protection measures.
Comment	This location is not a dumping zone and no dumping has been done by the Contractor at this location. However, due to unprecedented rainfall and flash floods debris went sliding into the valley. The retaining wall has been reconstructed to prevent further erosion on the valley side and Breast wall on hill side has also been restored. The road was closed on 09.07.2023 due to a slide at this location. The same information was communicated to the District Disaster Management Authority (DDMA).

Before sliding

After Sliding

After rectification

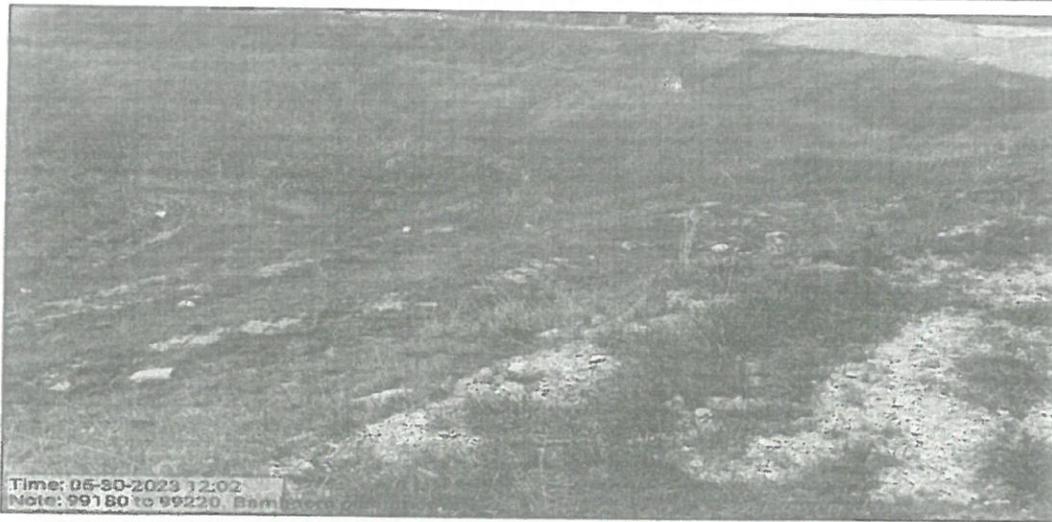
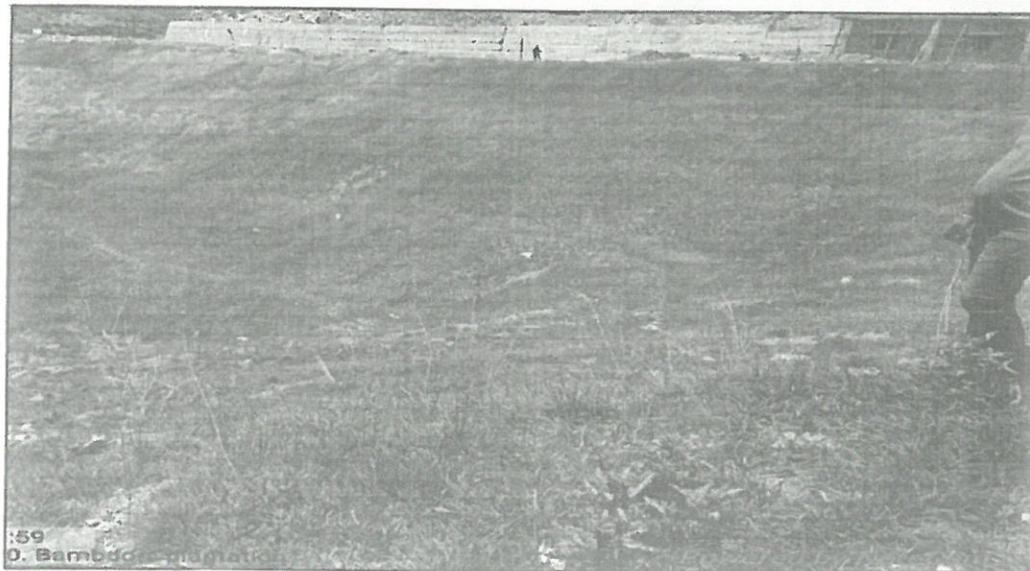
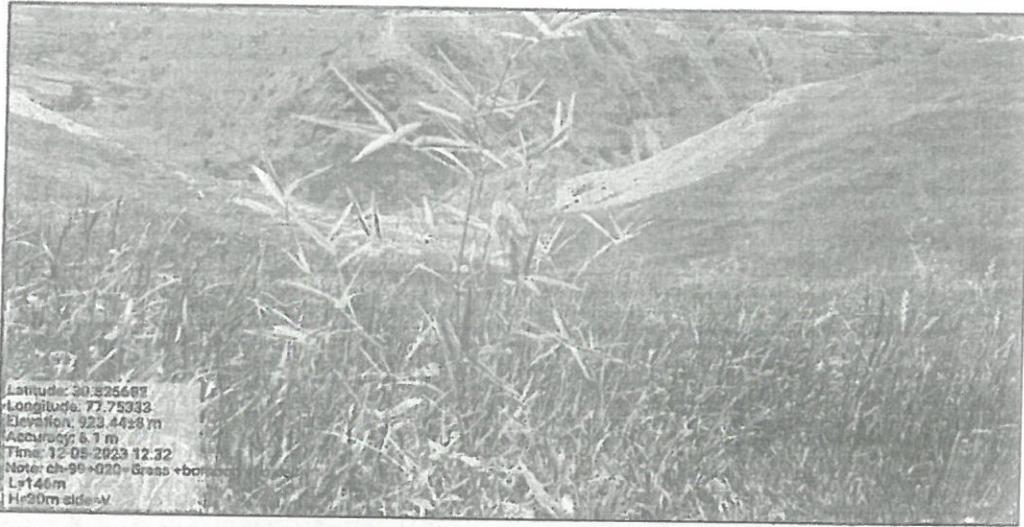
Sr. No.	10
Location No.	RD99/050-99/25 dumping zone-II
Issues	Unauthorized and illegal dumping of debris on forest and private land without any protection measures.
Comment	This is a designated dumping zone. The dumping zone has been protected with gabion wall at the toe. Soil compaction benching, geocell with hydroseeding and bamboo plantation have been provided to control the erosion. A breast wall has also been constructed to support the hillside.

Latitude: 30.325607
 Longitude: 77.75333
 Elevation: 923.4428 m
 Accuracy: 5.1 m
 Time: 12-05-2023 12:32
 Note: ch-99-020-Gress +bamboo
 L=146m
 H=20m side=V

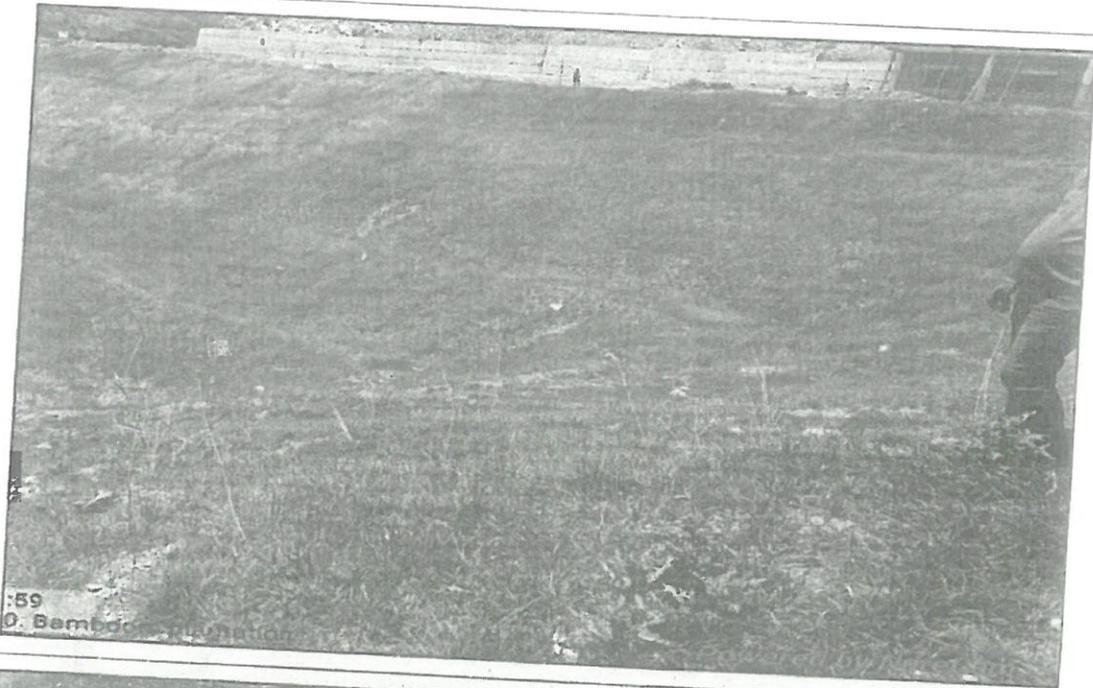
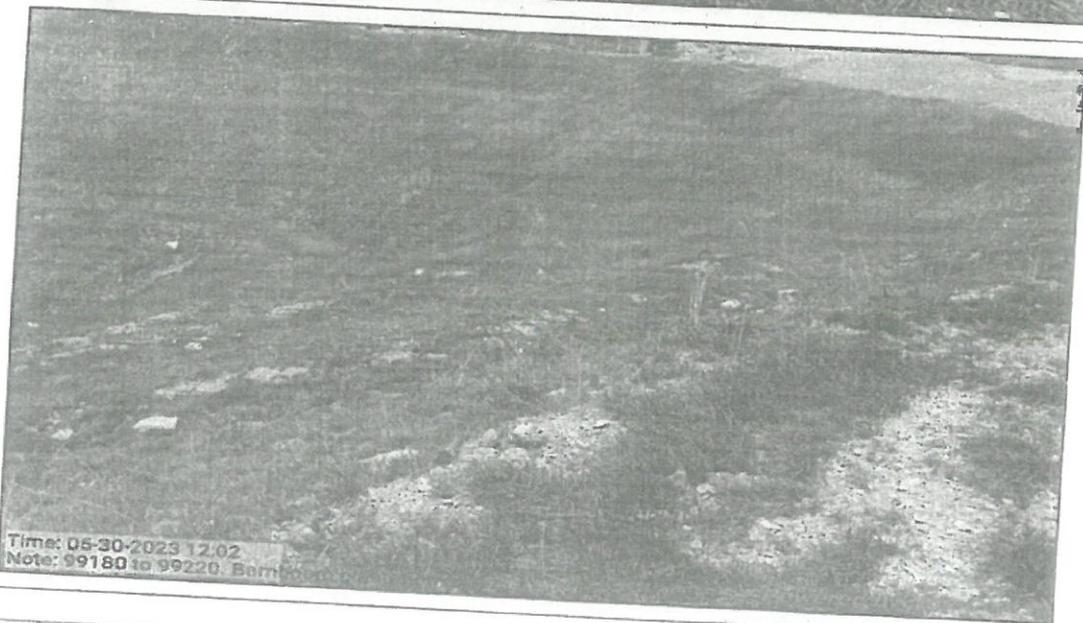
Sr. No.	11
Location No.	RD99/150
Issues	Unauthorized and illegal dumping of debris on forest and private land without any protection measures.
Comment	(Location is already included in Sr. No. 10) This is a designated dumping zone. The dumping zone has been protected with gabion wall at the toe. Soil compaction benching, geocell with hydroseeding and bamboo plantation have been provided to control the erosion. A breast wall has also been constructed to support the hillside.

Time: 06-30-2023 12:02
 Note: 99180 to 99220, Bam...

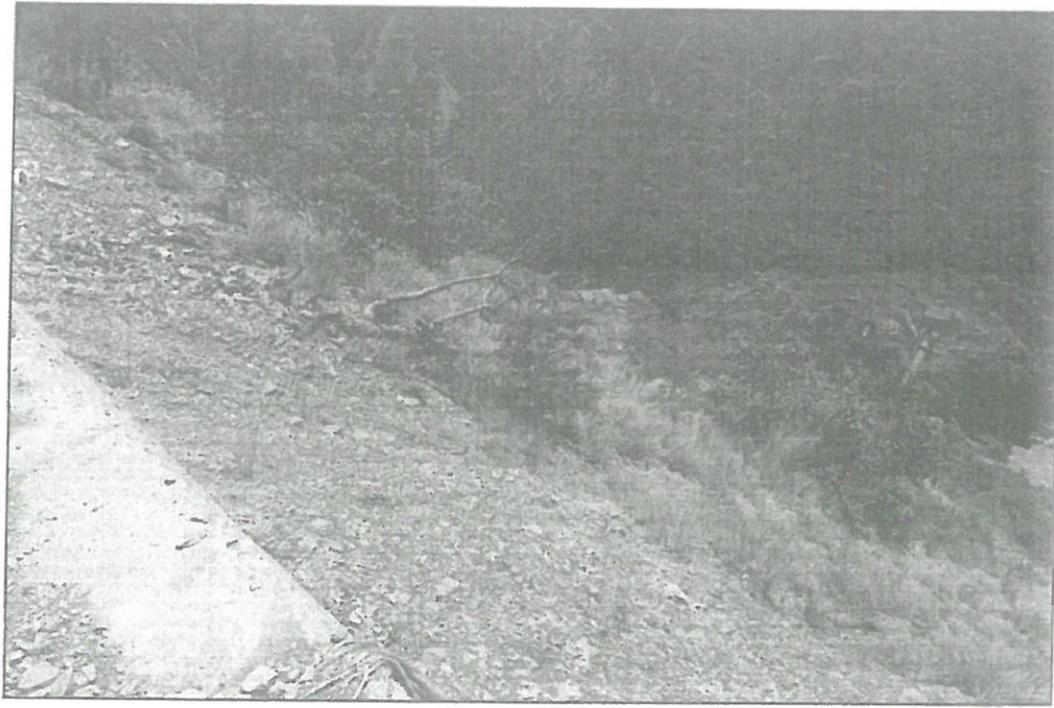
Sr. No.	12
Location No.	RD98/930
Issues	Unauthorized and illegal dumping of debris on forest and private land without any protection measures.
Comment	This location is not a dumping zone and no dumping has been done by the Contractor at this location. Hillside slide and valley-side soil erosion have happened during extreme adverse weather condition of

rainfall in 2023. Bamboo plantation has been done to control the erosion. Detailed report (submitted to insurance company for claim) attached herewith may also be referred in this regard. Further, retaining structures and slope protection measures have been completed and are being maintained by the Contractor.

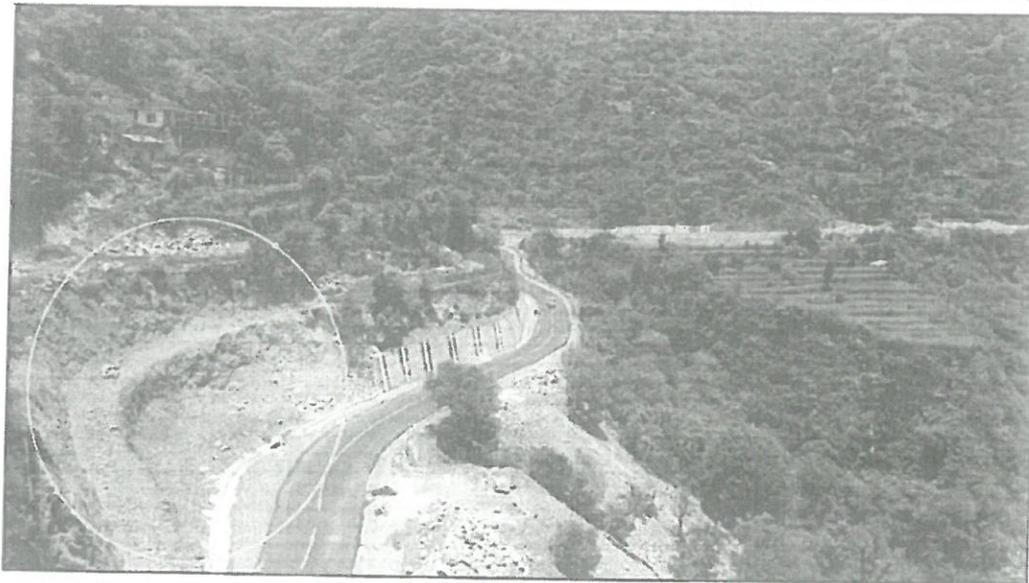
Sr. No.	13
Location No.	RD98/540 near village Antravali
Issues	Unauthorized and illegal dumping of debris on forest and private land without any protection measures.
Comment	This location is not a dumping zone and no dumping has been done by the Contractor at this location. During heavy rainfall debris from catchment beyond RoW was transported and accumulated in the valley. The retaining wall of the state highway towards Paban village was damaged and debris flowed with water to the valley. Detailed report (submitted to the insurance company for claim) attached herewith may also be referred in this regard.

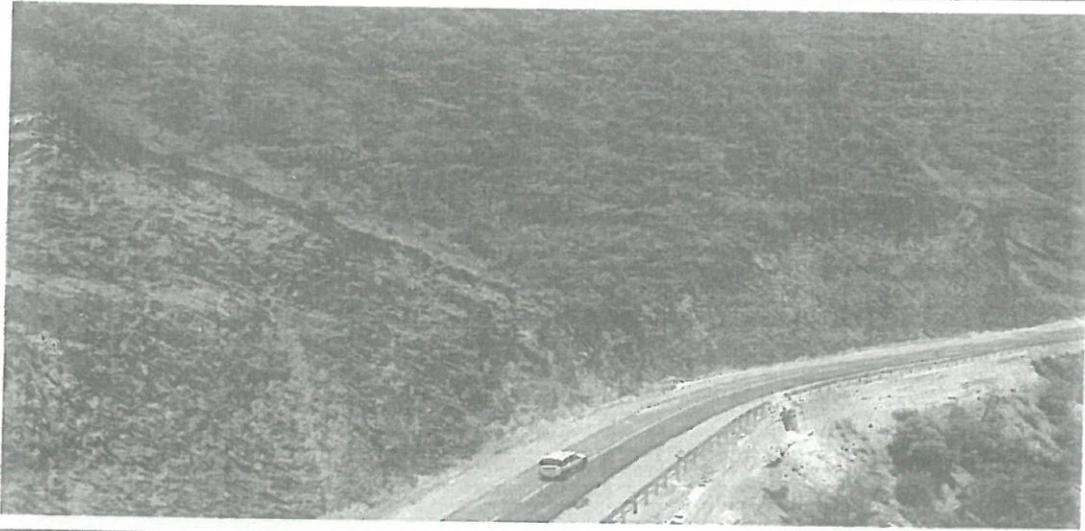
Sr.no.	17
Location No.	RD 96/350-96/250 dumping Zone-I, Boie
Issues	Unauthorized and illegal dumping of debris on forest and private land without any protection measures.
Comment	It is a designated dumping zone. Gabion wall has been constructed to support the dumping zone at toe of the valley. The site has been further stabilized by benching/ compacting and subsequent stabilization by slope protection measures of hydroseeding, Geocell with hydroseeding and bamboo plantation to

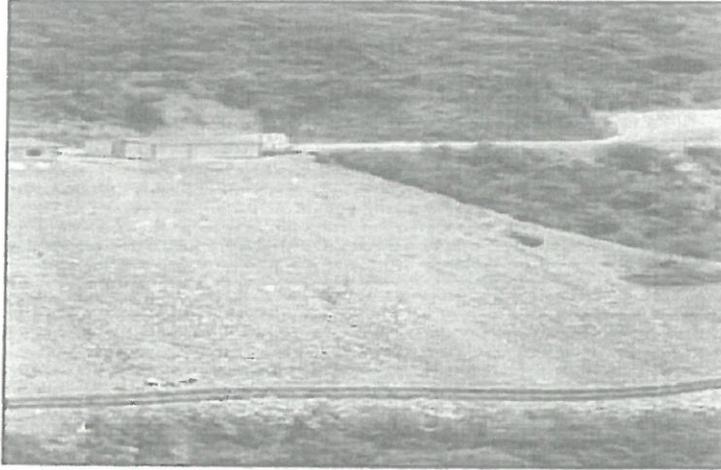
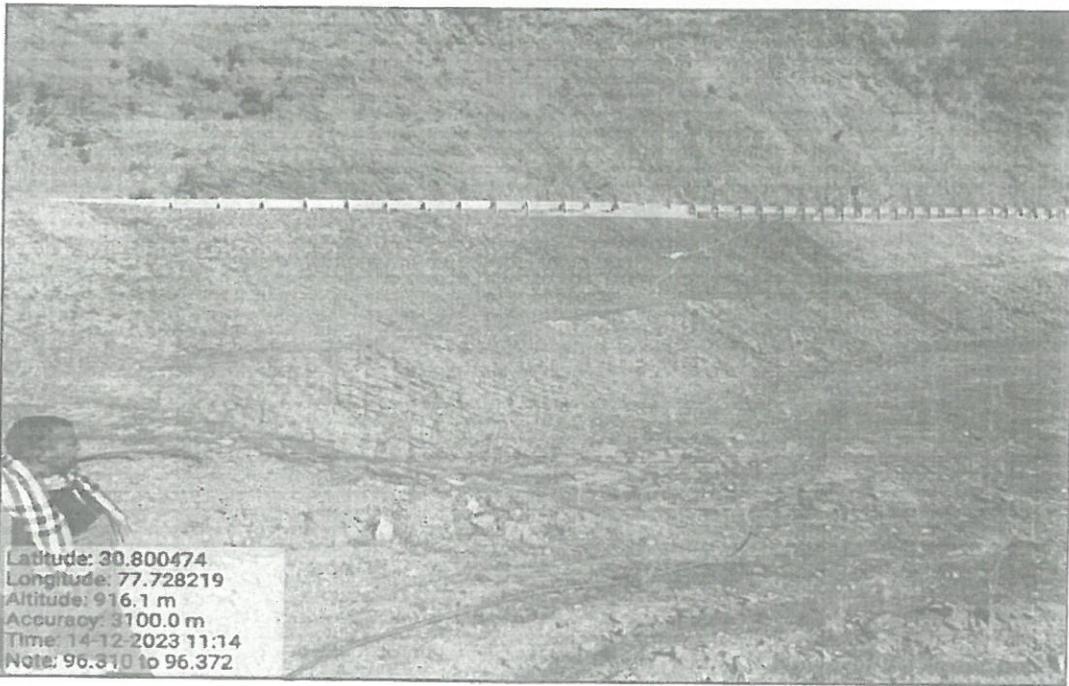
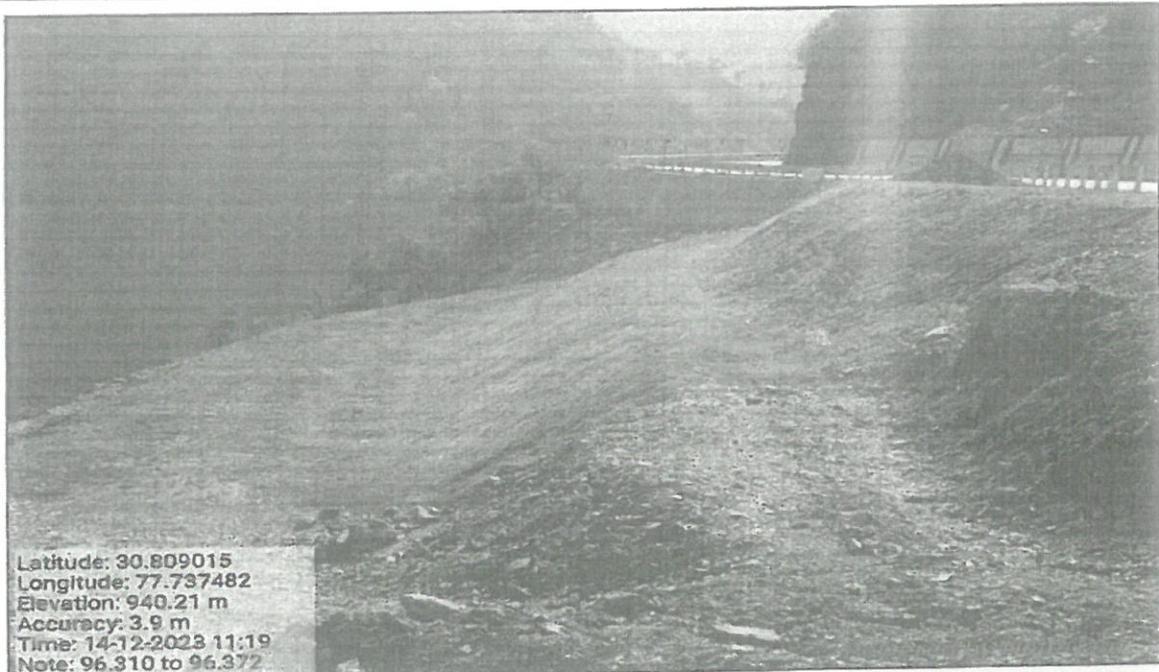
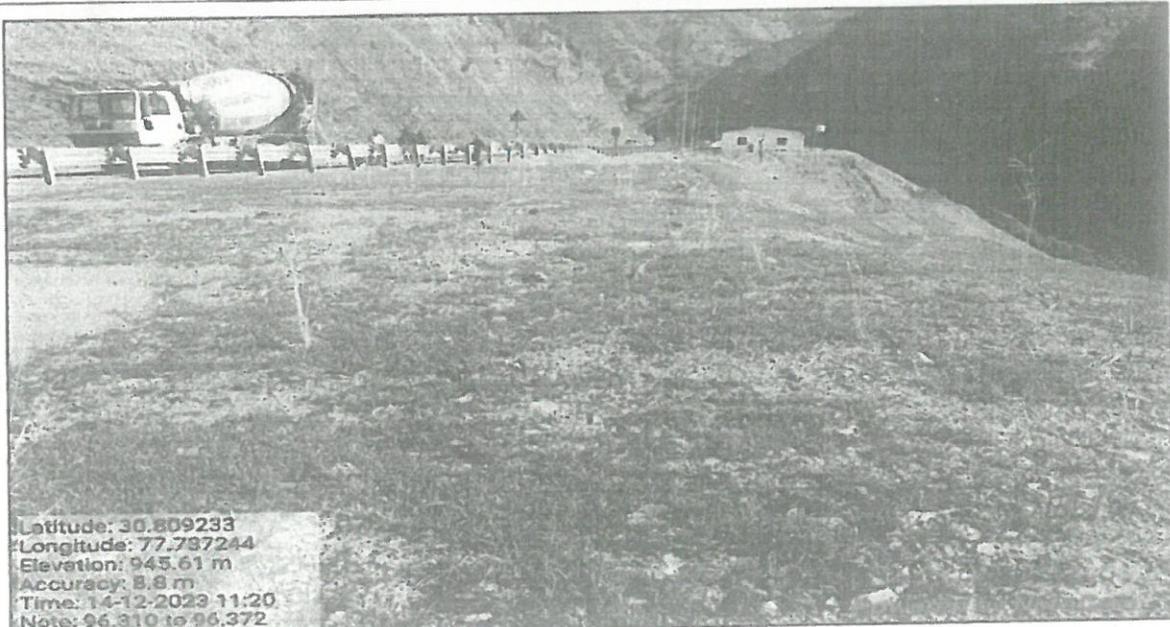
prevent the soil erosion from the dumping site.

Latitude: 30.800474
 Longitude: 77.728219
 Altitude: 916.1 m
 Accuracy: 3100.0 m
 Time: 14-12-2023 11:14
 Note: 96.310 to 96.372

Latitude: 30.809015
 Longitude: 77.737482
 Elevation: 940.21 m
 Accuracy: 3.9 m
 Time: 14-12-2023 11:19
 Note: 96.310 to 96.372

Latitude: 30.809233
 Longitude: 77.737244
 Elevation: 945.61 m
 Accuracy: 8.8 m
 Time: 14-12-2023 11:20
 Note: 96.310 to 96.372

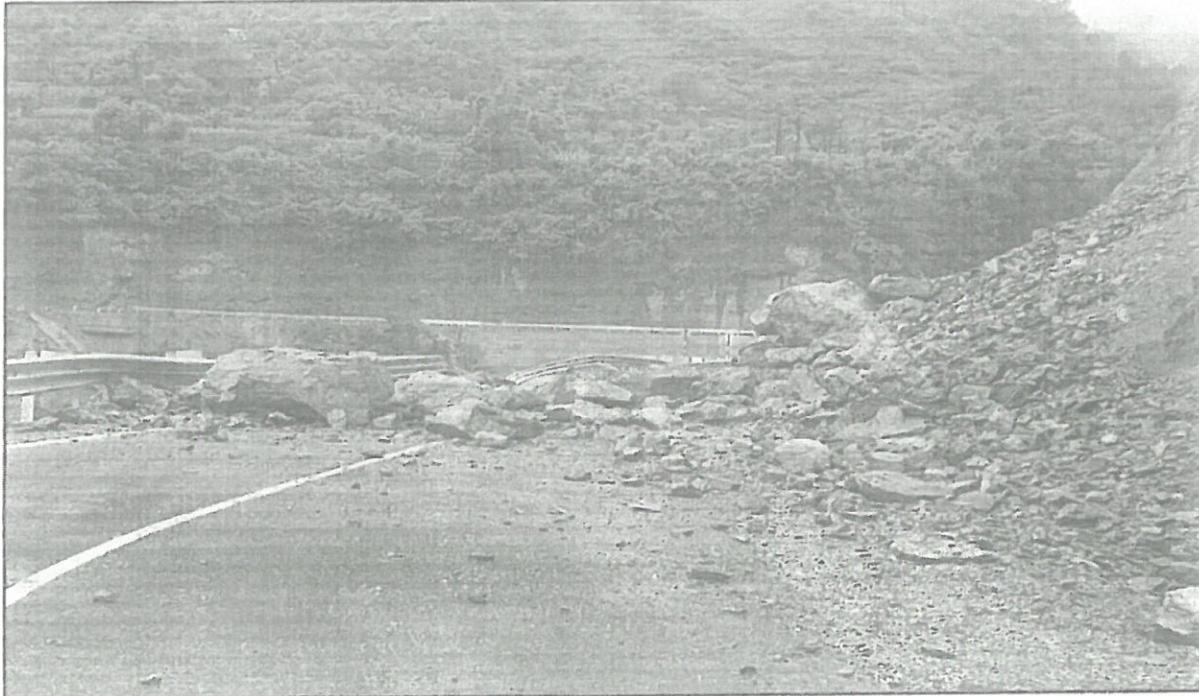
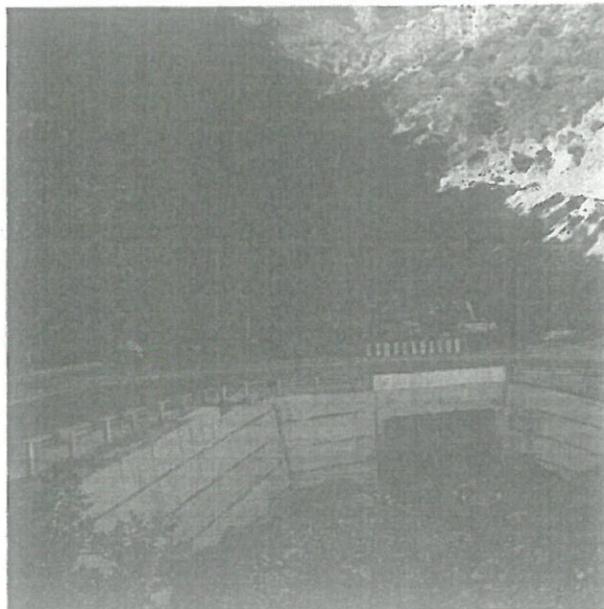
Sr. No.	18
Location No.	RD 96/980 Near Village Gumma
Issues	Unauthorized and illegal dumping of debris on forest and private land without any protection measures.
Comment	This location is not a dumping zone and no dumping has been done by the Contractor at this location. The damage is due to extremely adverse weather conditions of rainfall. Detailed report (submitted to the insurance company for claim) attached herewith may also be referred in this regard.

After rectification

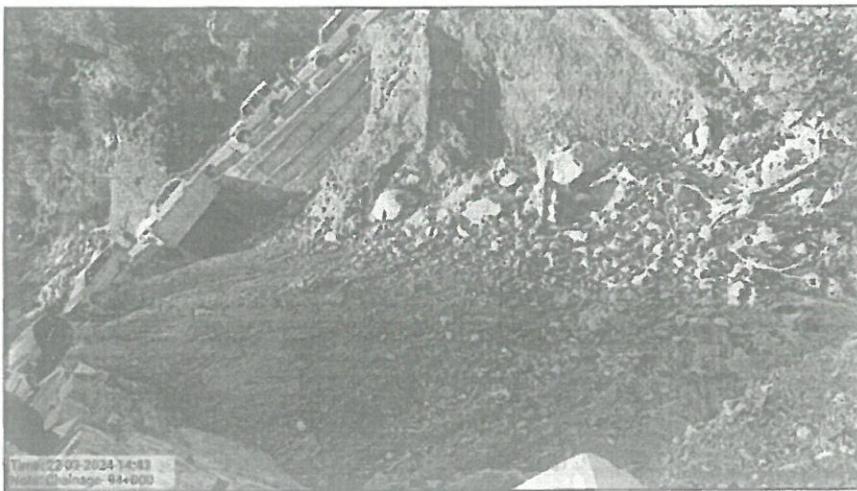
Sr. No.	20
Location No.	RD94/100
Issues	Unauthorized and illegal dumping of debris on forest and private land without any protection measures.
Comment	This location is not a dumping zone and no dumping has been done by the Contractor at this location. The debris from catchment beyond RoW has flown on valley side during rainfall of 2023 and is being cleared by the Contractor. Further, retaining structures and slope protection measures have been completed and are being maintained by the Contractor.
