BEFORE THE HON'BLE NATIONAL GREEN TRIBUNAL,
PRINCIPAL BENCH, NEW DELHI

O.A. NO. 127/2-24

MINISTRY OF ROAD TRANSPORT AND
HIGHWAYS & ORS.

A.M. Singh
Sr. Geologist
 L.N.M. Infra Projects Pvt. Ltd.
 NH-707, Paonta Sahib

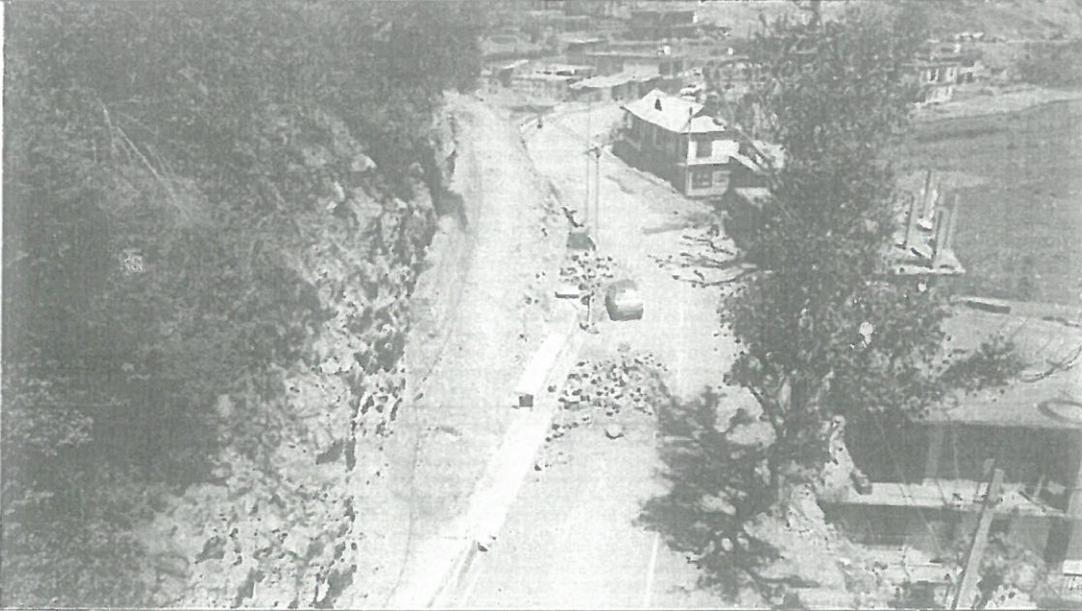
Comment This location is not a dumping zone and no dumping has been done by the Contractor at this location. The location pertains to built up area with structures on both side of the carriageway.

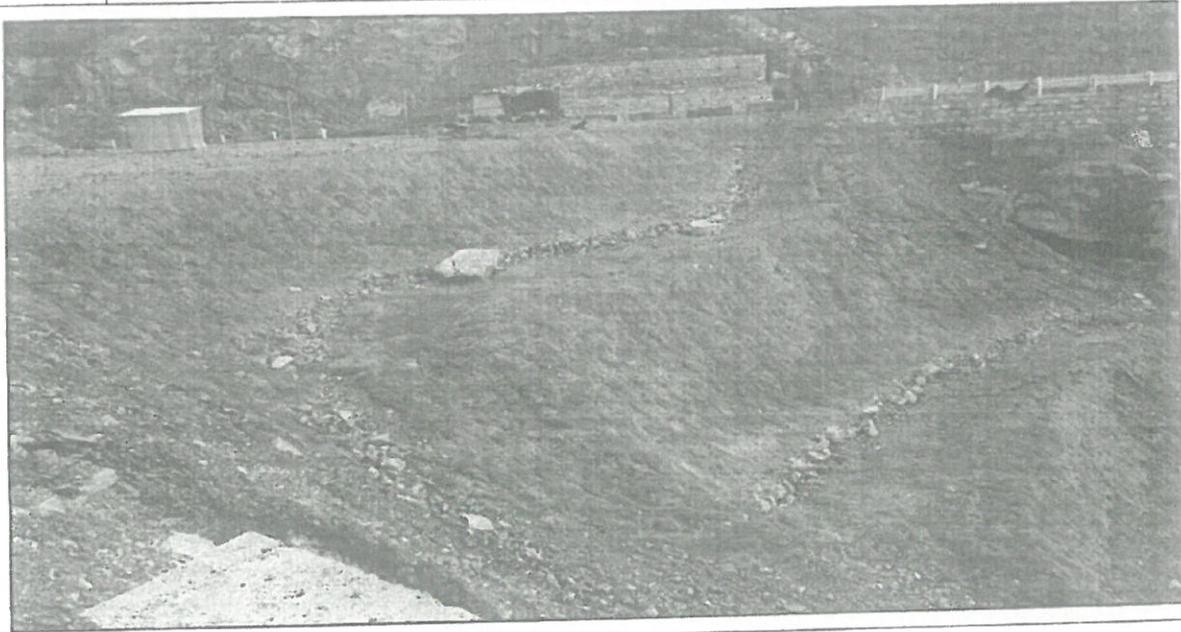
Location No.	RD90/800
Issues	Unauthorized and illegal dumping of debris on forest and private land without any protection measures.
Comment	The dumping is being done with the consent/permission/agreement of the concerned Department. The site has been stabilized by benching/ compacting and subsequent stabilization by slope protection measures of hydroseeding, grass strip and plantation to prevent the soil erosion from the dumping site.

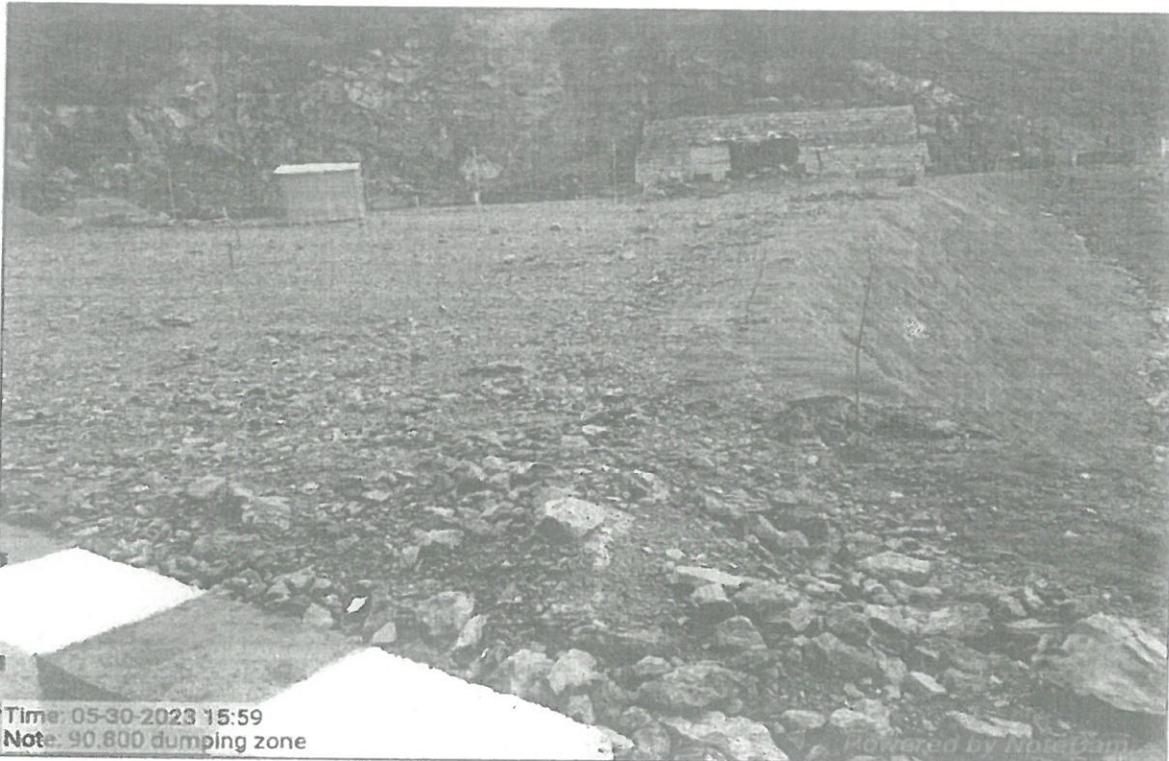
Sr. No.	25
Location No.	RD88/600
Issues	Unauthorized and illegal dumping of debris on forest and private land without any protection measures.
Comment	This location is not a dumping zone and no dumping has been done by the Contractor at this location. The road was closed on 06.02.2023 due to a slide at this location. The same information was communicated to the District Disaster Management Authority (DDMA).

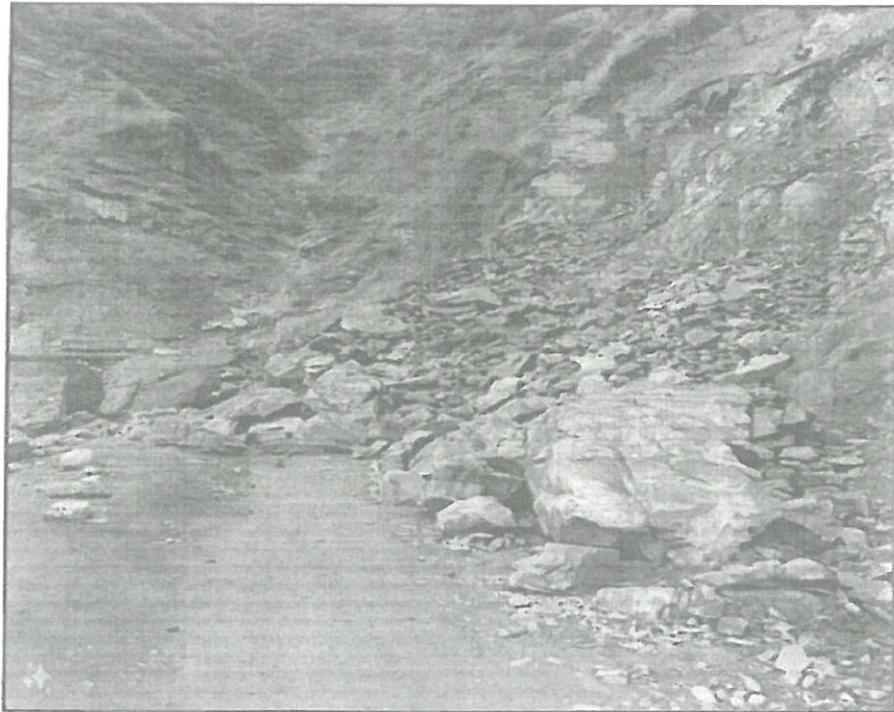
Sr. No	23
Chainage	41+000 to 41+100
Place	Kali Khan
Grievances raised by the applicant	Throwing muck randomly in slope of the hill, due to which debris has been accumulated in the lower parts of the mountains and there is a possibility of tragedy in the rainy season for resident of the villager living in lower part of the hill.
Comment	Owing to the available narrow width of the carriageway and continuous slide resulting in subsequent road closure, the debris from the hillside slid down the slope on the valley side. However, no dumping on the valley side has been done by the Contractor. The road was closed on 29.05.2022, 09.07.2023 and 17.03.2024 due to a slide at this location. The same information was communicated to the District Disaster Management Authority (DDMA).

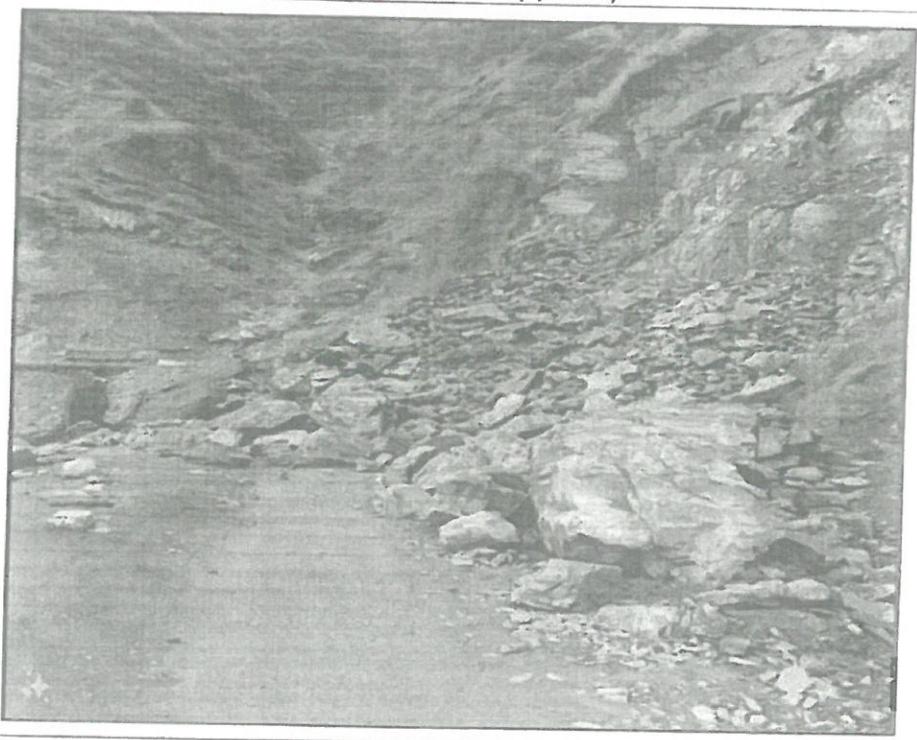
Sr. No	23
Chainage	41+000 to 41+100
Place	Kali Khan
Grievances raised by the applicant	Throwing muck randomly in slope of the hill, due to which debris has been accumulated in the lower parts of the mountains and there is a possibility of tragedy in the rainy season for resident of the villager living in lower part of the hill.
Comment	Owing to the available narrow width of the carriageway and continuous slide resulting in subsequent road closure, the debris from the hillside slid down the slope on the valley side. However, no dumping on the valley side has been done by the Contractor. The road was closed on 29.05.2022, 09.07.2023 and 17.03.2024 due to a slide at this location. The same information was communicated to the District Disaster Management Authority (DDMA).

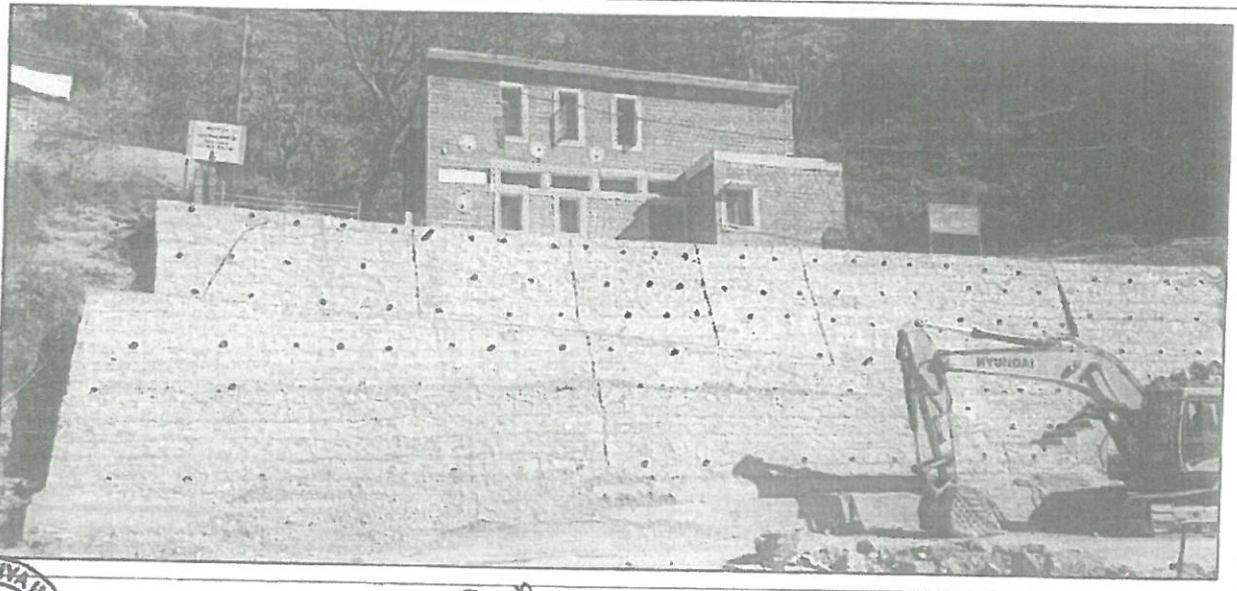
<p>Grievances raised by the applicant</p>	<p>The Construction work of the National Highway has been done just below the Shilla Village and passes through the fertile land of the village and the contractor of the construction authority used poor quality material in the breast wall and Danga, so the foundation of the village Shilla has become weak and cultivating land of many farmers along with trees has slide downward and Patwar Khana/Ayurvedic Dispensary, GPS, Shilla and house of Sh. Om Parkash S/o Jagat Singh, Shupa Ram S/o Pritam Singh, and Kapil s/o Khatri Ram are in danger and crack has been occurred In the whole village and many water sources have been buried under the muck and there is a possibility of a huge landslide in the rainy season and Construction authority have no additional action plan to protect the village.</p>
<p>Comment</p>	<p>The matter does not pertain to OA no. 127. However, this is to put on record that necessary protection measures have been provided and further slope protection measures are under progress.</p>

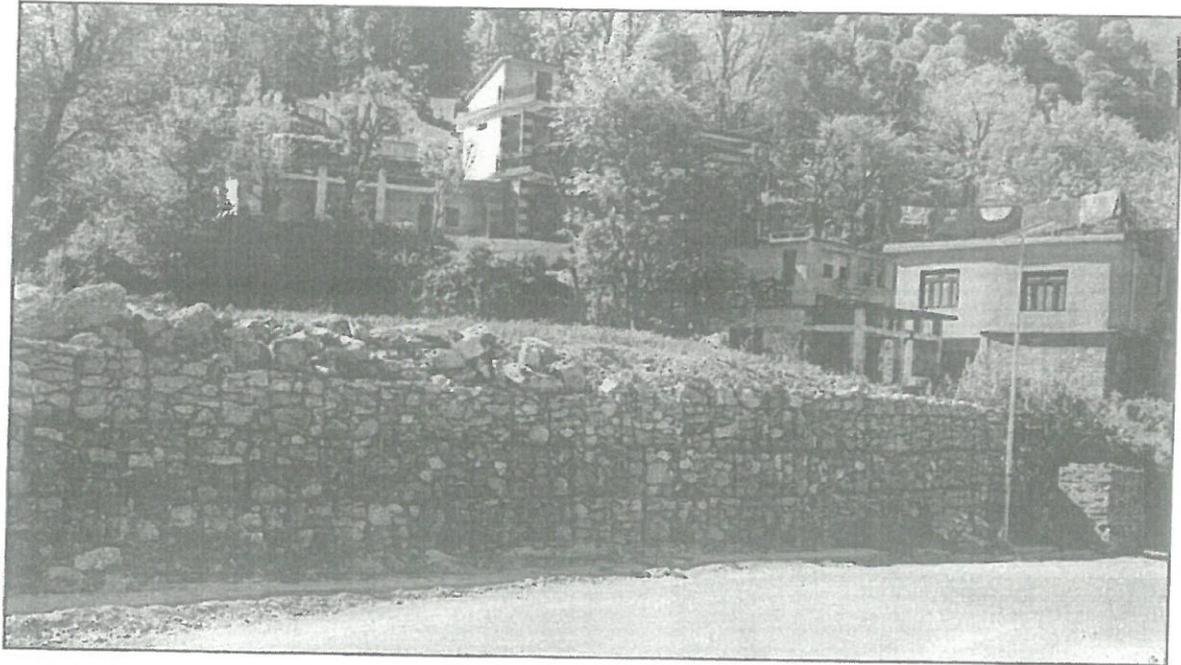
Grievances raised by the applicant	There is no Breast wall has been constructed by the construction authority along with the road due to which cultivated land of farmers has slide downward with the trees.
Comment	Construction of the Gabion wall has already been completed at this location and no tree has been damaged.
