BEFORE THE HON'BLE NATIONAL GREEN TRIBUNAL,

Original Application No. 513/2019

Report on Sand Mining Ghats on River Son in Aurangabad and Rohtas Districts, Bihar

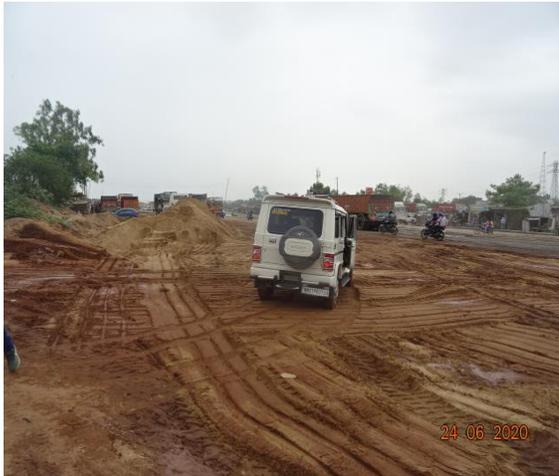
- (3) Sand stock was observed just adjacent to the highway near the Kesao Ghat area (photo 1).
 - (4) Foot prints of crawlers of Heavy Earth Moving Machinery (HEMM) were observed on the road adjacent to the river Son (photo 9). It implied that HEMM (Backhoe/Shovels etc.) were used on the Sand Ghats very close to the river. Project authorities explained that they use the HEMM for road construction/repair.

Photo01:Photo of sand stock kept adjacent to highway near Kesaoghat.

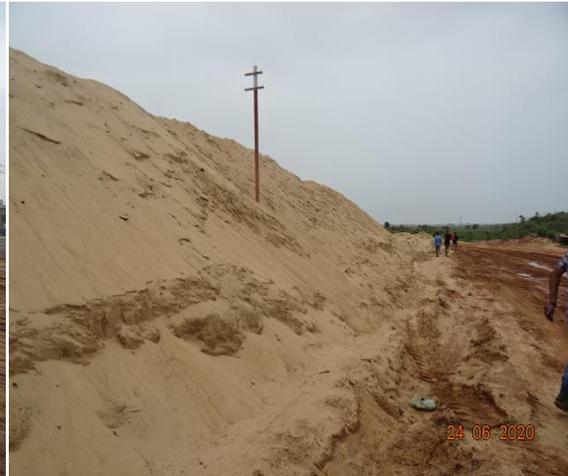
- (5) Stocks of sand were observed near the Ghats (photos 02 and 03).
 - (6) The aerial distance of the place (where committee members visited and collected lat., long.) from the bridge (over river Son connecting Aurangabad and Rohtas) was approx 250m (as per the Google maps website) photo attached (see Google image photo 1)

Photo 02:Photo of sand stocks near Kesaoghat.

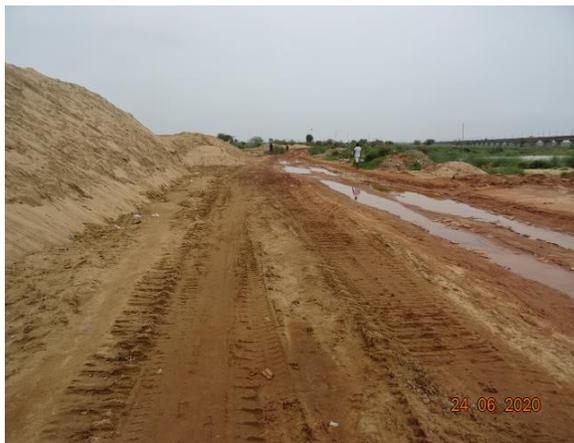
Photo03: Photo of broken road to the Kesaoghatconnecting Aurangabad and RohtasDistricts .Photo taken from Kesaoghat road

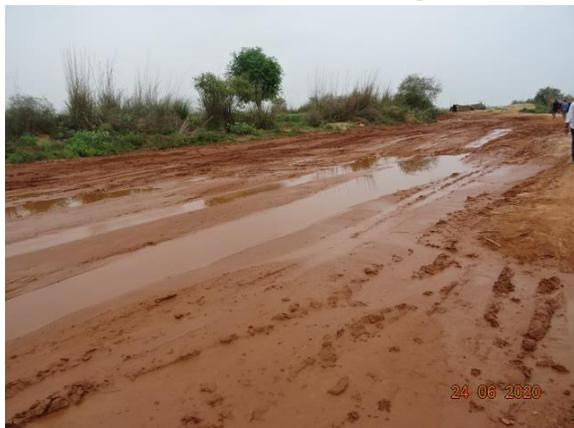
Photo 05: Photo of broken road to the KesaoKesaoghatghat (submerged in water in river Son)

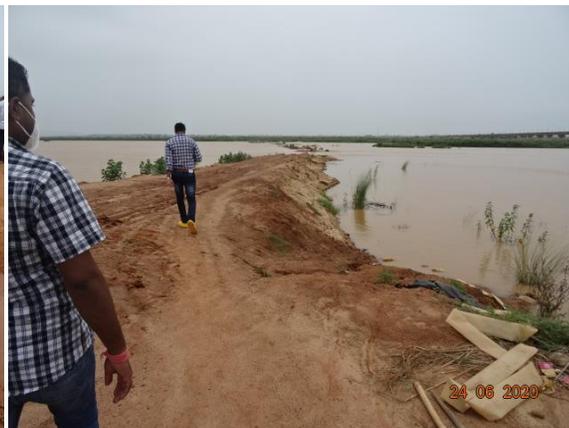
Photo 06: Photo of road towards

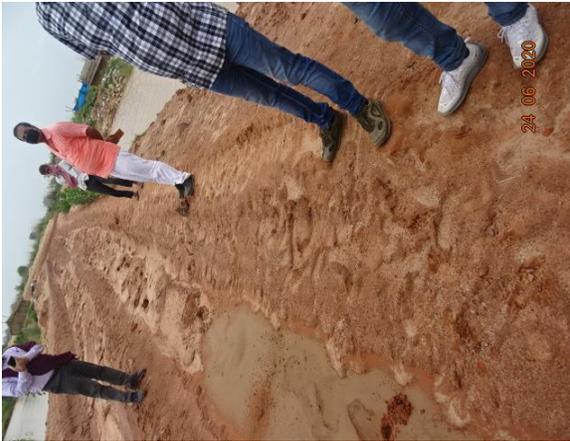
Photo 09: Photo of footprints of HEMM on the way to Kesaoghat.

- vi. No HEMM, trucks of heavy vehicle were found to be under use for mining during the inspection. However, foot prints of crawlers of Heavy Earth Moving Machinery (HEMM) were observed on the road adjacent to the river Son (photo 9). It implied that HEMM (Backhoe/Shovels etc.) were used on the Sand Ghats very close to the river/even inside the river. Project authorities explained that they use the HEMM for road construction/repair.

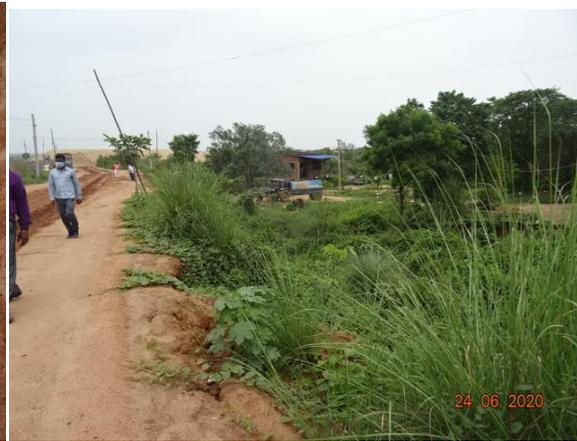
Photo10:Photo of some plantations near

- (9) Some plantations were developed by the project authorities near their office area (photo 10) but overall green belt development was not satisfactory.

- v. Some plantations were developed by the project authorities near their office area (photo 10) but overall green belt development was not satisfactory.

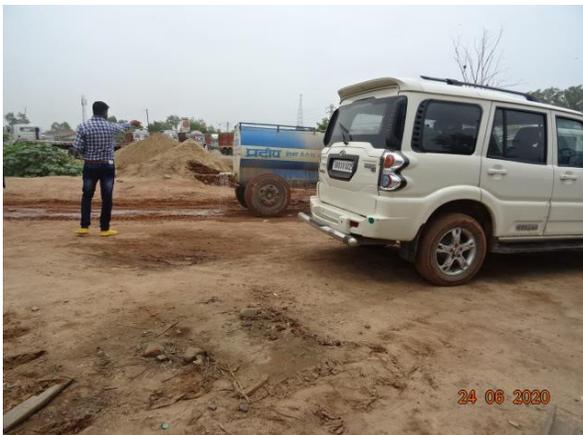
- (7) A water tanker attached with tractor was observed near the sand Ghat that was utilized for spraying water over the roads for dust suppression (photo 11).

Photo11:Photo of water tanker near project proponent office around KesaoGhat

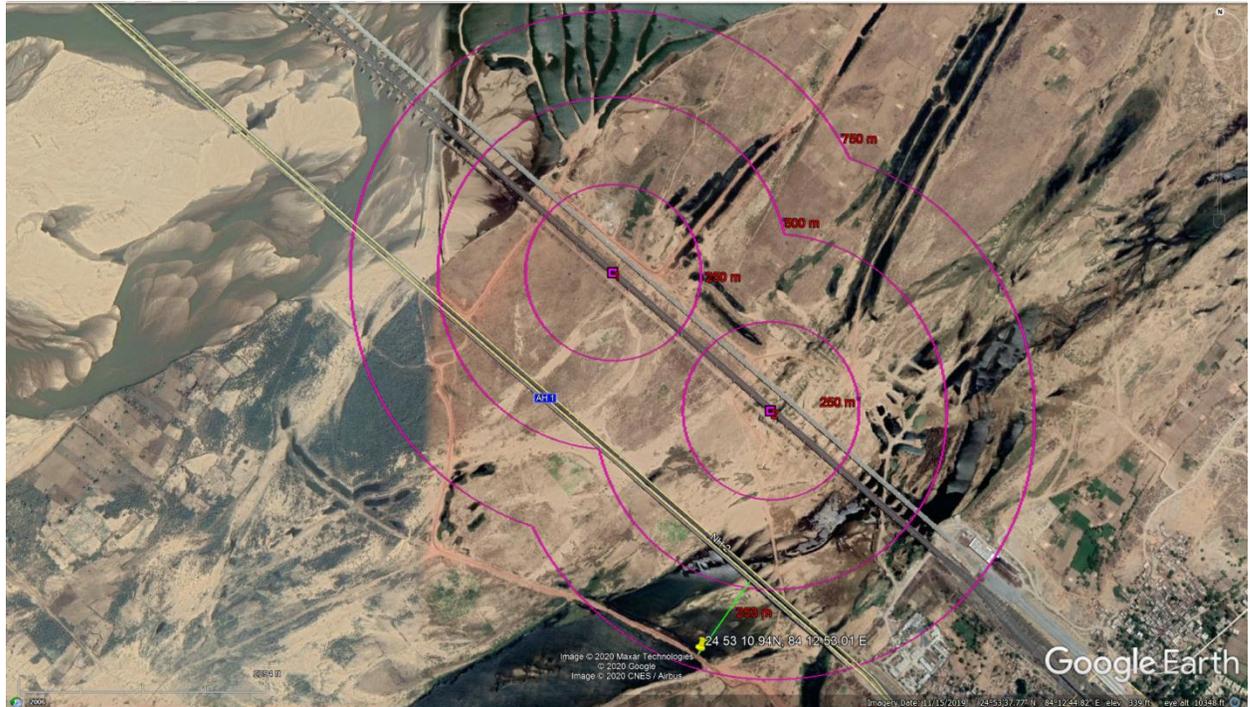
Google image Photo 1: Photo showing distance of place of visit near Kesao sand ghat and the bridge.

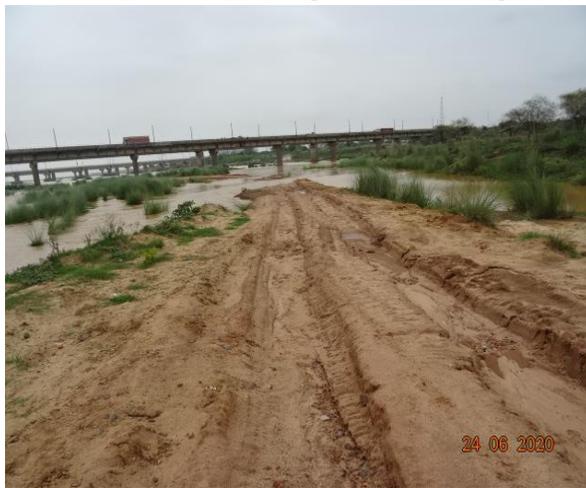
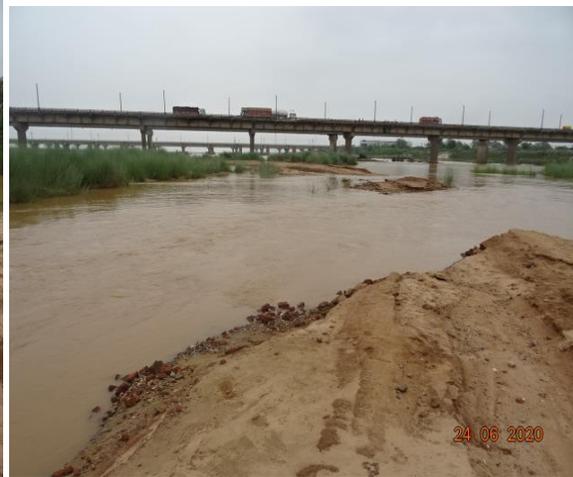
- (8) Illegal sand mining has been reported (as reported by project executives of Kesao Ghat and District Mining Officer, Aurangabad) near the Kesao sand mining ghat (photos 12 and 13). Footprints of HEMM were visible on the illegal sand mining ghat also. This illegal sand mining ghat was about 225m from the bridge (over river Son connecting Aurangabad and Rohtas). It was observed on the illegal sand mining ghat that a kutcha pavement (for movement of machinery) was made inside the river Son. Due to rains and water flow in the river the kutcha pathway has broken at few places (photo 13). This is in violation to Bihar Minerals (Concession, Prevention of illegal mining, Transportation & Storage Rules, 2019* {BM(C.P.T.&S) Rules 2019 { rule 29 (A) 2 (i)} and also dangerous for the safety of the bridge.

Photo 12: Footprints of Heavy Earth moving Photo 13: Illegal sand mining ghat machinery on the way to illegal sand mining near Kesaoghat close to the bridge.

- vii. There was an illegal sand mining Ghat near the Kesao sand mining ghat. Footprints of HEMM were visible on the illegal sand mining ghat also. This illegal sand mining ghat was approx 225m from the bridge (over river Son connecting Aurangabad and Rohtas). It was observed on the illegal sand mining ghat that a kutcha pavement (for movement of machinery) was made inside the river Son. Due to rains and water flow in the river the kutcha pathway has broken at few places. However, it implied that illegal sand mining

was being carried out before rains very close to the bridge (within 200-225m distance) which was in violation to **Bihar Minerals (Concession, Prevention of illegal mining, Transportation & Storage Rules, 2019*** {BM(C,PT& S) Rules 2019}and also dangerous for the safety of the bridge. This illegal sand mining activity by other than the lease holder is on record of DMO and as report certain action has been initiated.

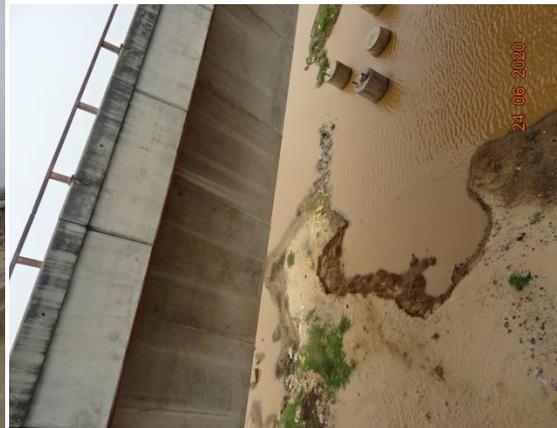
(1) At few places below the bridge where river water level was less it appeared that sand mining/extraction was done below and near the bridge pillars (photos 15,16,17 and 25). It was dangerous for the safety of the bridge and in violation to Bihar Minerals (Concession, Prevention of illegal mining, Transportation & Storage Rules, 2019* {BM(C,PT& S)

Photo 15: Photo of sand cutting near the pillars of the bridge over river Son

- viii. At few places below the bridge where river water was less river bed erosion was observed below and near the bridge pillars. It is dangerous for the safety of the bridge. However field situation suggest of possibility that sand cutting is may be due to natural erosion at some places below the bridge.In some areas in the river where water was less, it was observed that there was no/negligible sand and clay material below sand was visible.

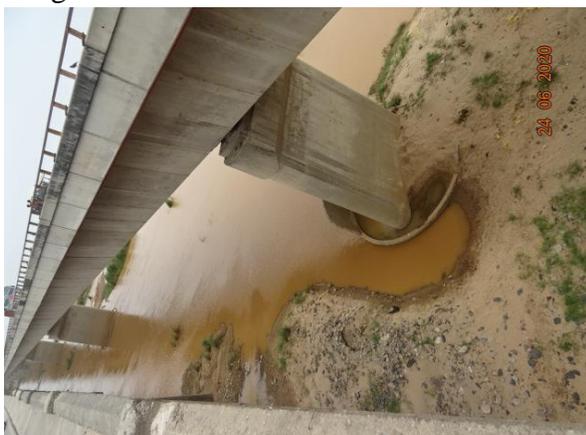
Photo 16: Photo of pot holes formed near Pillars of bridge over river Son

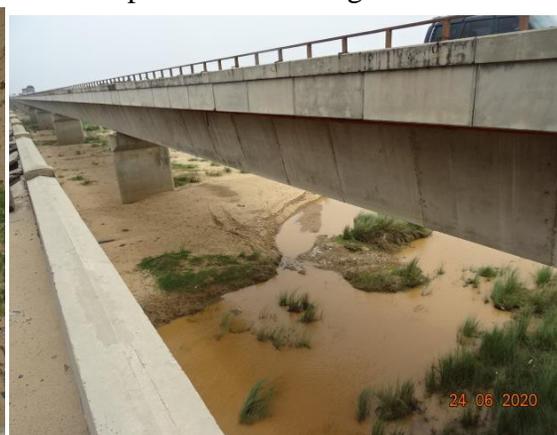
Photo 17: Photo of sand cutting near the pillars of the bridge over river Son

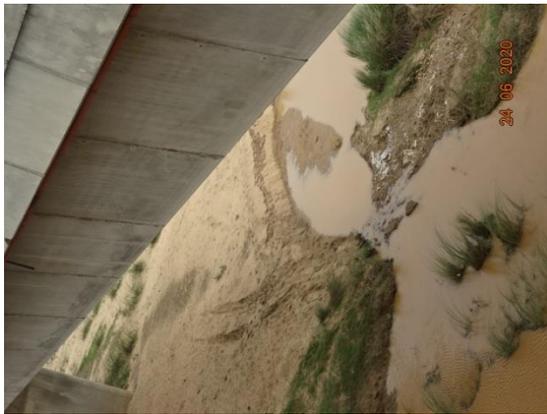
Photo 18: Photo of sand cutting and clay material visible under the bridge stretches of river Son.

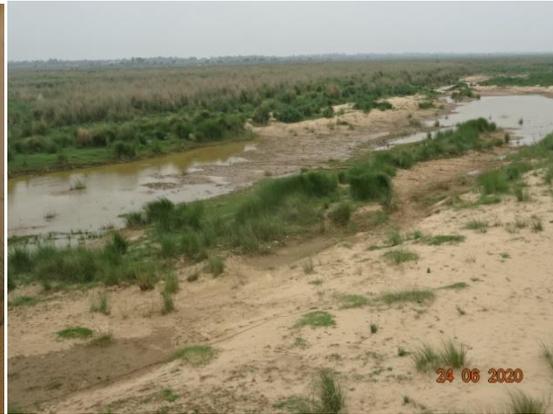
- (2) In some areas in the river where water level was less, it was observed that there was no/negligible sand and clay material below sand was visible (photos 19 and 20).
- (3) There was a pathway/road constructed with morrum/earth material in the middle of river and passing below the bridges (both road & railway) (photos 22 and 23). It was informed by district officials that the road was built for gas pipe line by a Gas Company.
- (4) At many portions along the bridge there was such level and current of water flow in the Son river that occurrence of sand extraction, if any, could not be observed (photo 21).
- (5) At some places near and below the Railway bridge (over Son river connecting Aurangabad and Rohtas) such surface features were observed that could be indicative of sand extraction (photos 24, 26 and 27) and apparently distinct from natural erosion and bank formation.

Photo 19: photo of clay material visibility with no/negligible sand over some stretches of river Son.

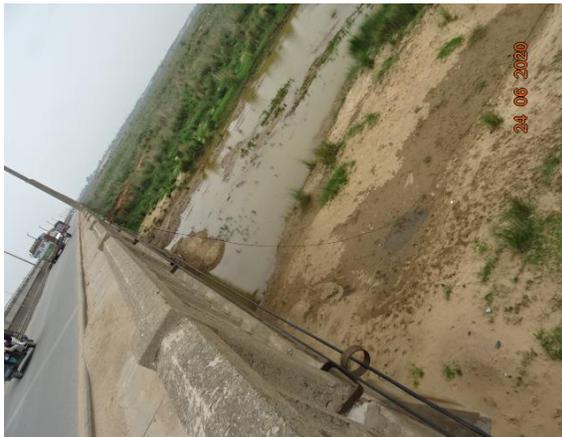
Photo 20: Photo of clay material Visibility with no/negligible sand over some stretches of river Son near bridge.

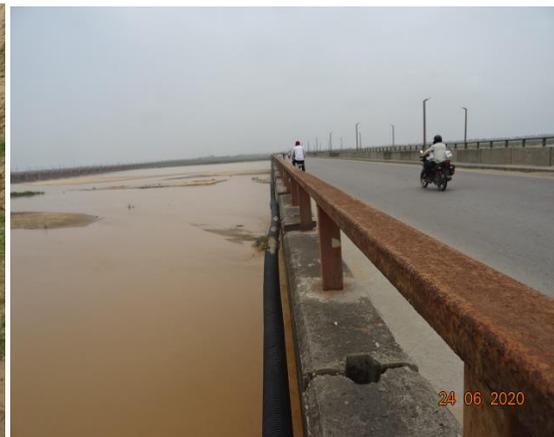
Photo 21: Photo of water in the river Son

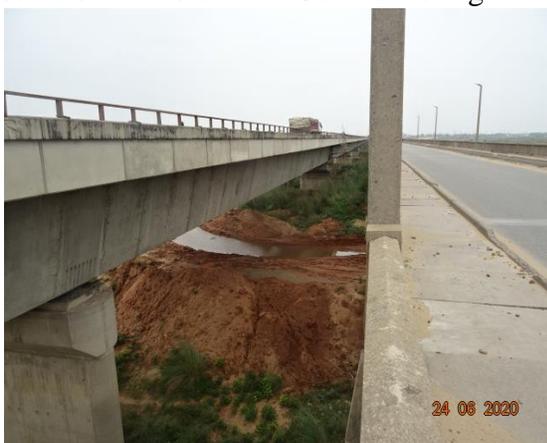
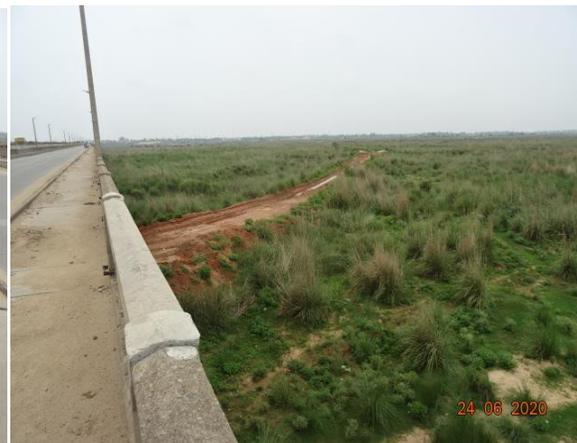
Photo 22 & 23: Photo of pathway/kutchha road built in the middle of river Son and under the bridge. (reportedly by some Gas pipeline company).

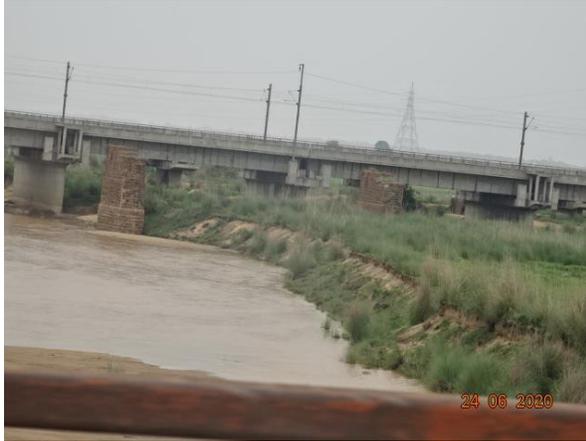
Photo 24: Photo of level difference in the river Son near the railway bridge (may be due to cutting of sand)

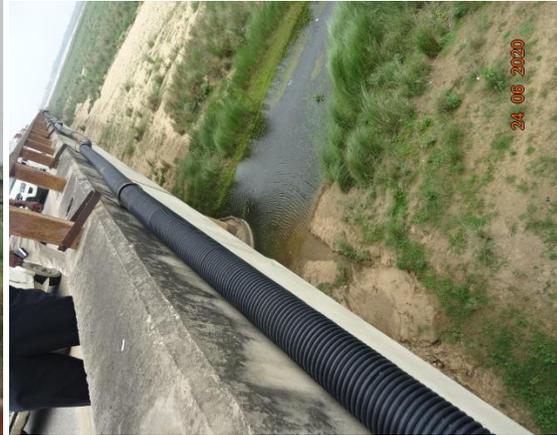
Photo 25: Photo of pot hole like structures adjacent to pillar of bridge over Sonriver.

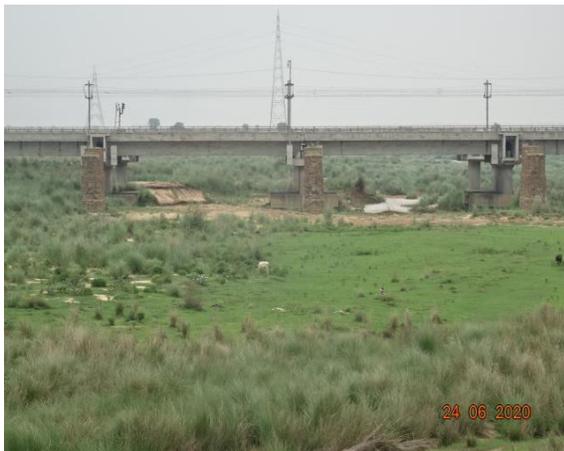
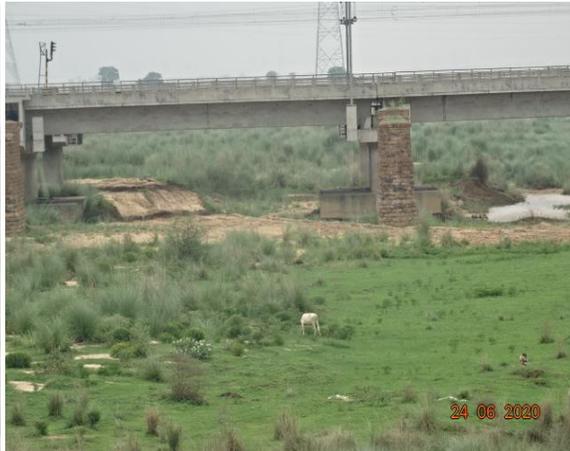
Photo 26& 27: photo of indication of sand extraction under the Railway bridge over Son river as can be seen from substantial level difference.

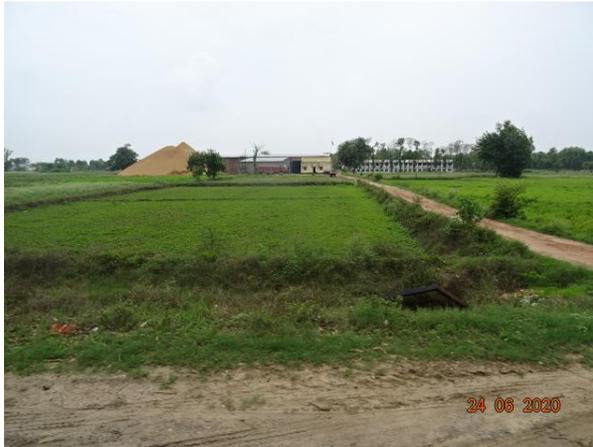
- (1) During visit it was observed that at few places sand stocks were kept in agricultural fields / close to housed/habitations and those places were very far from Ghats (see photo 28). Such stocks of sand can have adverse impact on agricultural fields besides creating nuisance for nearby habitations (people) due to loading, transportation, Air and Noise Pollution.

Photo28:Photo of large sand stock kept in the Agricultural field near human habitations.

- ix. It was observed at few places sand stocks were kept in agricultural fields / close to housed/habitations and those places were very far from Ghats. Such stocks of sand can have adverse impact on agricultural fields besides creating nuisance for nearby habitations (people) due to loading, transportation, Air and Noise Pollution. However, project representation informedthat stock is on permitted site. Document could not be produced in support of claim during the visit.

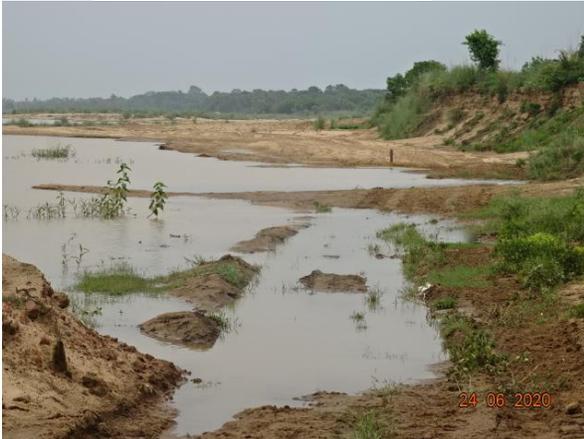
- (1) Only one pillar was observed at KeraGhat (see photo 29). Project executives explained that they have built pillars around the Ghat boundary but due to water flow, those pillars were broken and not visible.

- (4) On the bank/edge of river at KeraGhat clay material was visible (photos 29 and 32).
- (5) Sand stock was observed near the KeraGhat (photo 34).
- (6) Location of site of visit at the KeraGhat – Latitude: 25⁰04'08.54" ; Longitude :84⁰25'55.85".

Photo 29: Photo of a pillar at KeraGhat. Clay material can also be seen.Keraghat.

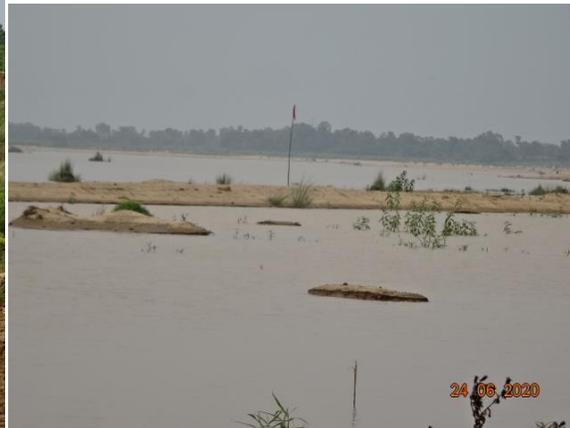
- (2) Footprints of HEMM (Shovel/Backhoe) were observed on the ghat very close to the river indicating the use of Heavy machineries in the river.
- (3) In most portions in the Ghats substantial water level was found with moderate current in the river and amount/extent of cutting of sand for extraction in river could not be even visually assessed.(see photo 30).

Photo 30: Photo of water in the Son River at

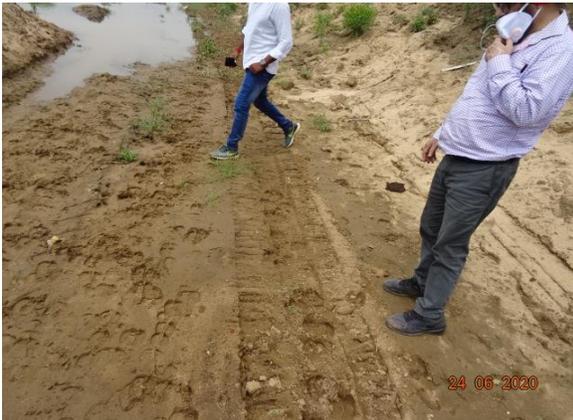
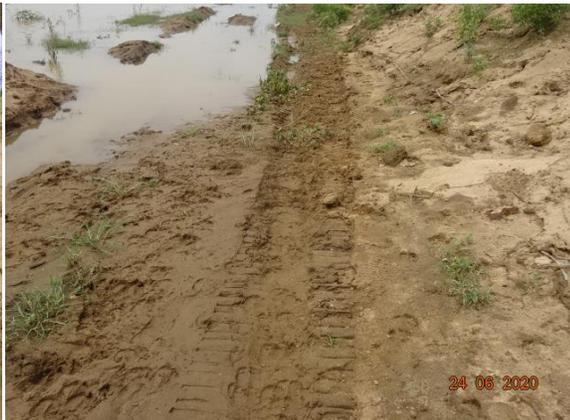
Photo 31&32:Photo of footprints of Heavy Earth moving machinery very close/touching the river at Keraghat.

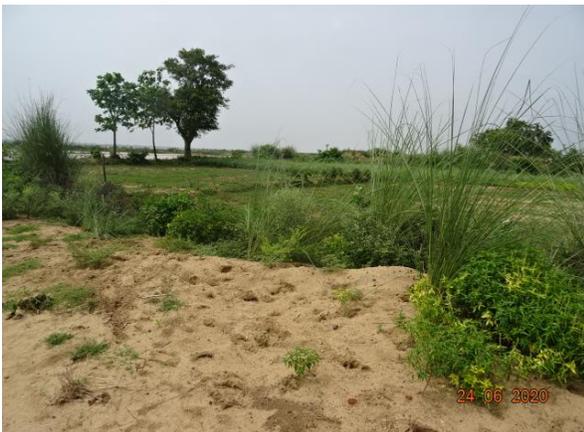
- (7) Some plantations were shown by project authorities on the bank of river at KeraGhat (photo 33). Overall the green belt development was not satisfactory.

Photo 33: Photo of some plantations near Kera Ghat.

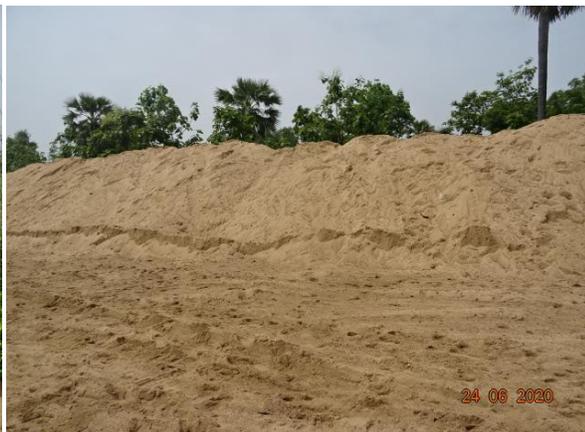
Photo 34: Photo of large sand stock near KeraGhat.

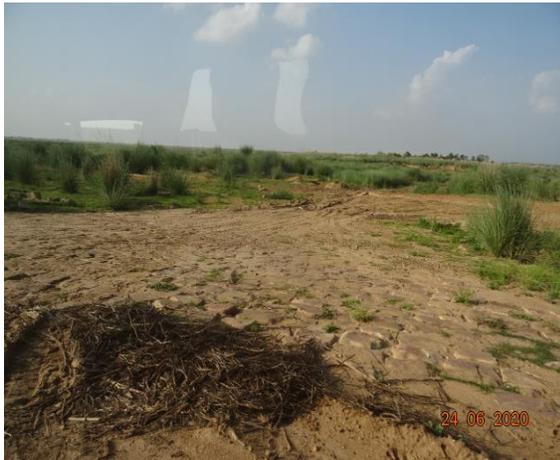
- (1) Committee members visited old G.T. road that was passing across Son River (photos 35 and 37). At a place it was observed that lots of rocks have broken/ interlocking broken lying as such at the spot (see photo 38).

Photo 35:Photo of old G.T road on the way to AnikatGhat

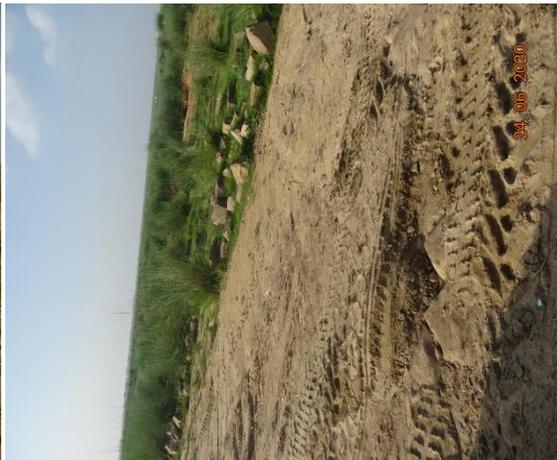
- (4) There was water filled in the river at AnikatGhat as can be seen from photos 40 and 42 Footprints of HEMM, trucks, Tractors could be observed on the old G.T. road and on the way to AnikatGhat (photo 36).

Photo 36:Photo of footprints of Tractors, HEMM on the way to AnikatGhat

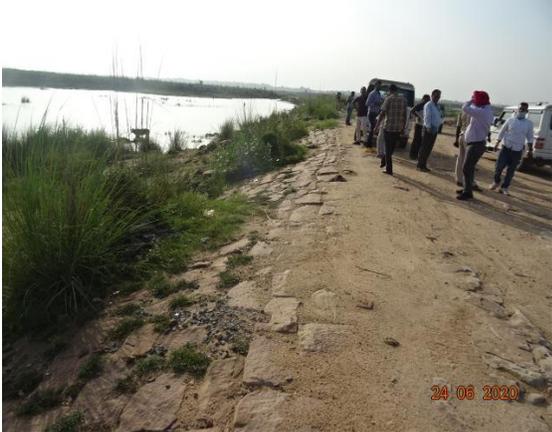
Photo37:Photo of old GT road on the way to AnikatGhat

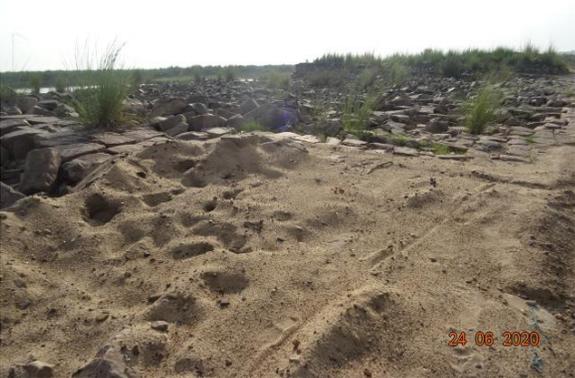
Photo38:Photo of broken/loose rocks adjacent to old GT road on the way to AnikatGhat.

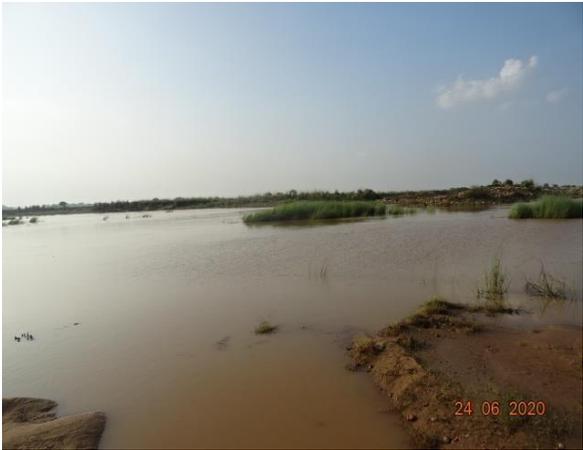
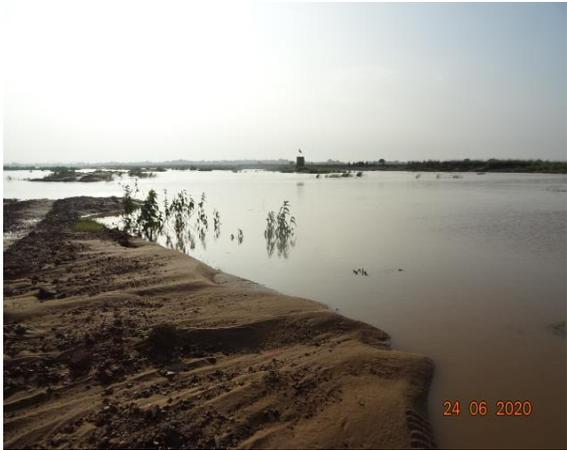
- (2) This old G.T. Road was the path for AnikatGhat. Committee members visited the place after which water was flowing in the river (see photos 39 and 40). Project authorities informed that there was no working in this AnikatGhatfor thelast 2½ -3 months because of local law and order problem. However,it was informed by other local sources that Ghat was closed from last two weeks or so.

Photo 39& 40: Photo of water in the Son river near AnikatGhat

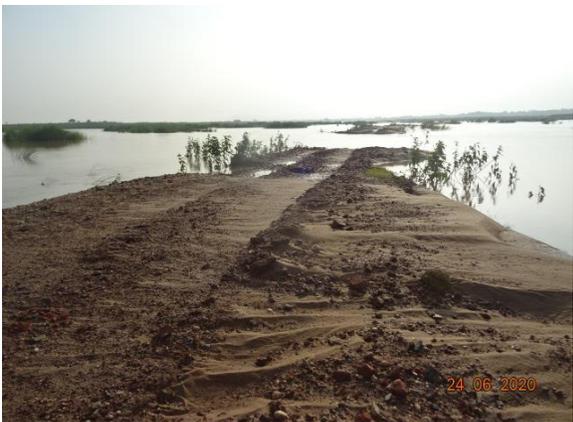
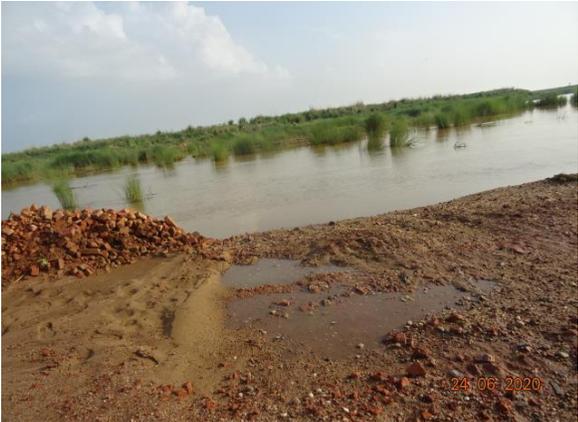
- (3) Lots of Bricks and Brick pieces were observed near the AnikatGhat in the river (photos 41 and 42) which indicated bricks were used for road making in the river.

Photo 41&42: Photo of Bricks kept and also used on the path to AnikatGhat

- x. Lots of Bricks and Brick pieces were observed near the AnikatGhat in the river which indicated bricks were used for road making in the river.
- xi. There was an old barrage/rock structure between G.T. road and the bridge (over Son river connecting Aurangabad and Rohtas) but committee members could not reach to the place due to non-availability of proper approach road. However photo by camera was taken. Long grasses have developed on the sides of that rock structure.

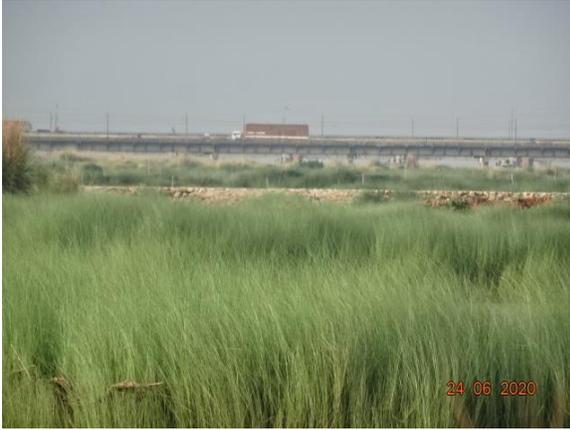
Photo 43:Photo of rock structure in between old GT road and bridge (over river Son).

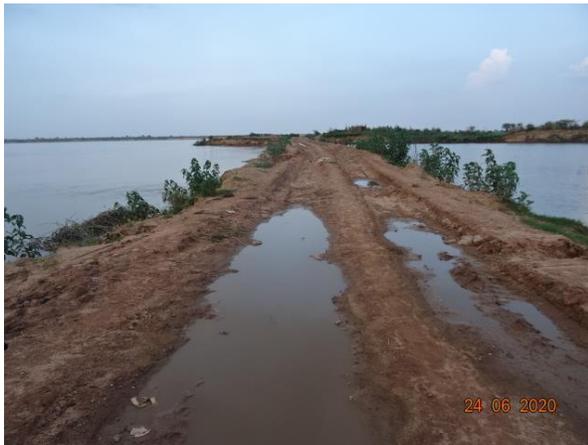
Photo 44:Photo of pathway made to Dalmianagar Ghat

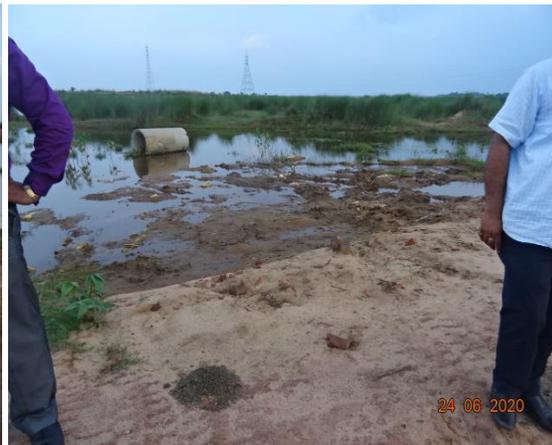
- (1) Committee members visited DalmianagarGhat in Rohtas district which has also submerged (photos 44,45 and 46) in the water flowing in Son river and no sand extraction could be observed due to water in river.
- (2) No pillars were observed at DalmianagarGhat and boundary of the Ghat could not be known.
- (3) Some plantations were observed near the banks of DalmianagarGhat (photo 47) but overall the green belt development was not satisfactory.

Photo 45:Photo on the way to DalmianagarGhat.

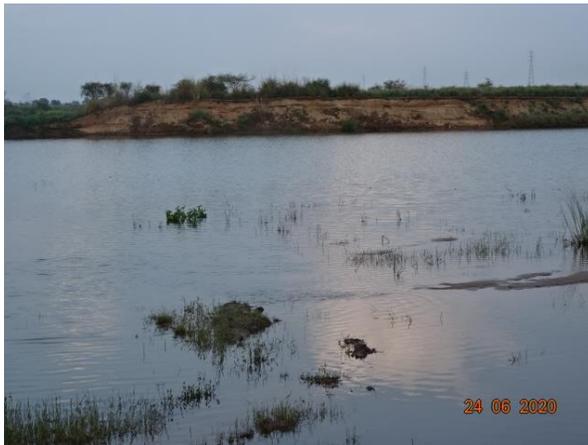
Photo 46:Photo of water in river Son near DalmianagarGhat

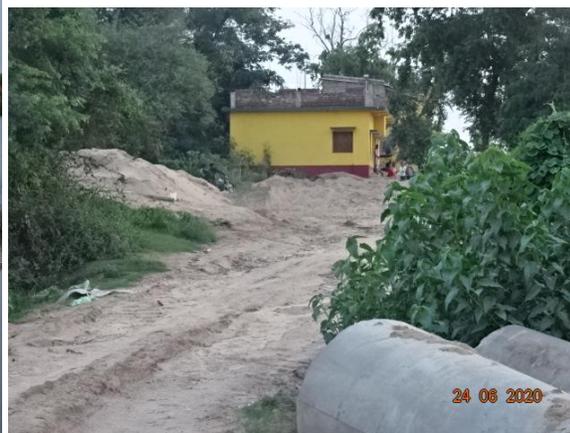
Photo 47:Photo of some plantations on the banks near DalmianagarGhat

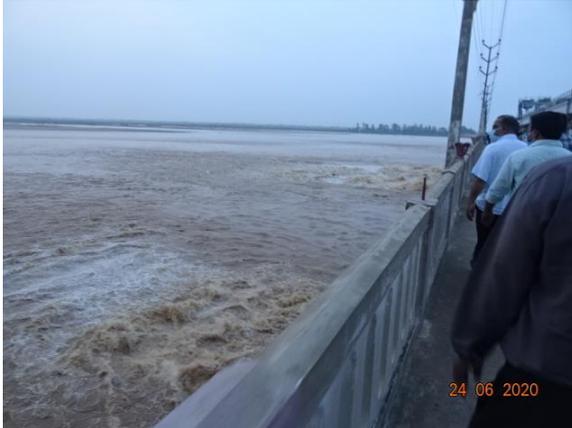
- (8) Indrapuri Barrage over Son river was also visited by Committee members (photo 48)
The barrage was almost inundated to a good extent and water was being discharged in the river Son also.

Photo 48: Water flow from Indrapuri Barrage.
