BEFORE THE HON'BLE NATIONAL GREEN TRIBUNAL
PRINCIPAL BENCH, DELHI
ORIGINAL APPLICATION NO. 553 of 2024

News item titled "From Ropar to Hoshiarpur via HP 30-km detour as illegal mining damages bridge" appearing in The Indian Express dated 10.04.2024.

Action Taken Report of CPCB in compliance to the orders of Hon'ble National Green Tribunal dated 20/05/2024 and 28/07/2024 in Original Application No. 553/2024; News item titled "From Ropar to Hoshiarpur via HP: 30-km detour as illegal mining damages bridge" appearing in The Indian Express dated 10.04.2024.

3.0. Overall Findings of Punjab Engineering College (PEC), Chandigarh:

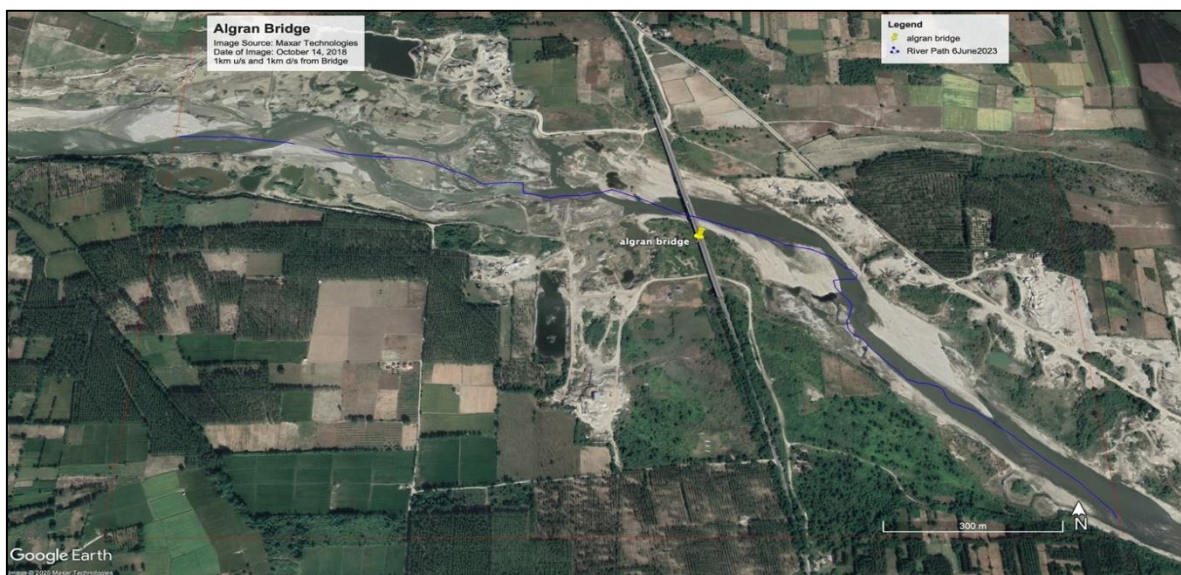
Figure 3.4 October 14, 2018 Satellite Image (WorldView)

The image shown in figure 3.4 has been captured just after the monsoon season in 2018. As evident from the figure 3.4 that water seems to be receding in the river and surrounding areas where excess flow was seen in figure 3.3. Also, it can be inferred from the image that sediments deposits can be seen near the u/s and d/s of the bridge. The river continues to show signs of sedimentation and changes in flow paths.

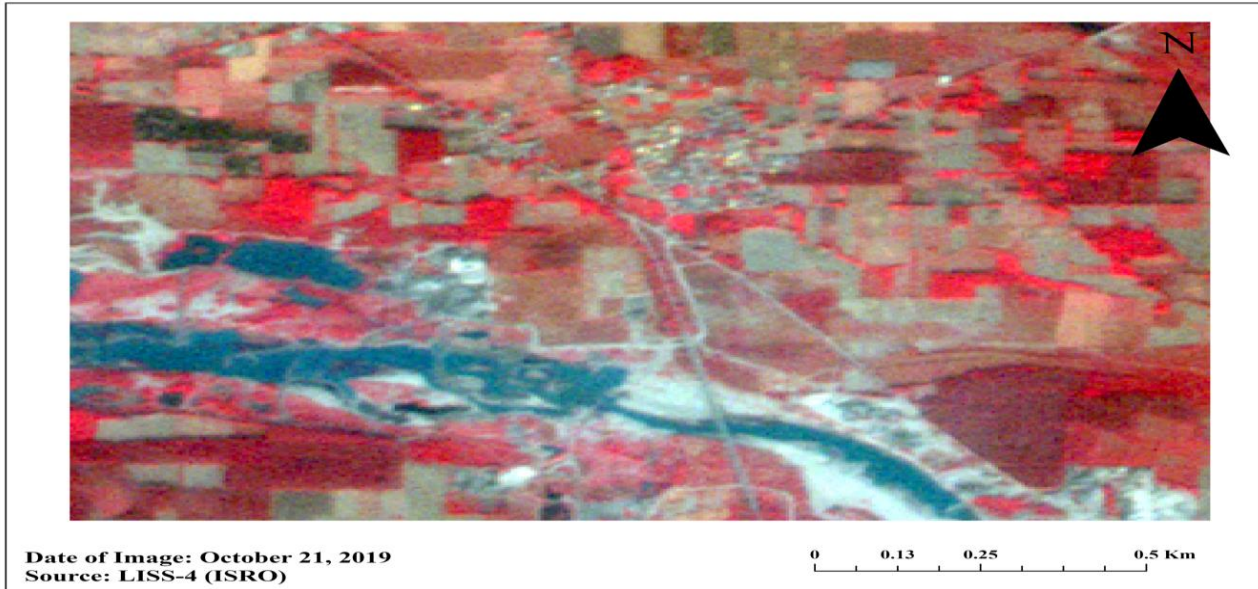
Figure 3.5 Medium Resolution Image Procured from ISRO October 21, 2019

For year 2019 the image has been procured from ISRO which is captured by LISS4 sensor of Resourcesat 2 satellite. The sensor provides an image with a pixel size of 5m x 5m. As the sensor doesn't have Blue Band so the true color image can't be created. However, the image shown in figure 3.5 is a False Color Composite in which water can be seen in Blue Color, vegetation in Red Color. Bright colored areas represent stones/sediments/gravel. It is evident from the image that there are dumps of sediments/stones/gravel is visible

in a small area in u/s as well as d/s of the bridge. The possible mining activity could not be assessed as the image is medium resolution as well as no pits of water can be visible.

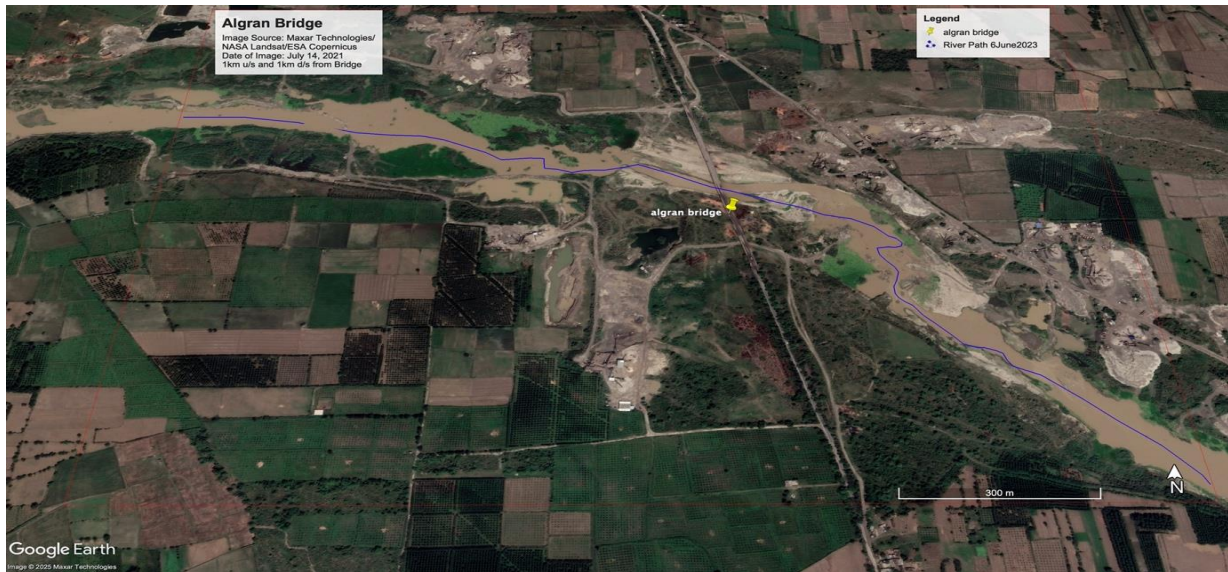
Figure 3.7 July 14, 2021 Satellite Image (WorldView)

The image shown in Figure 3.7 has been captured in July 2021 which is a monsoon season in the region. It is also evident from the muddy water flowing in the river. The natural pits in u/s can be seen filled with muddy water, although in d/s the pits along with the river have been created due to mining activities in the past which

were not there in earlier images. Also, the patch of stone/gravel/sediment remains like previous images in u/s of the river close to bridge.

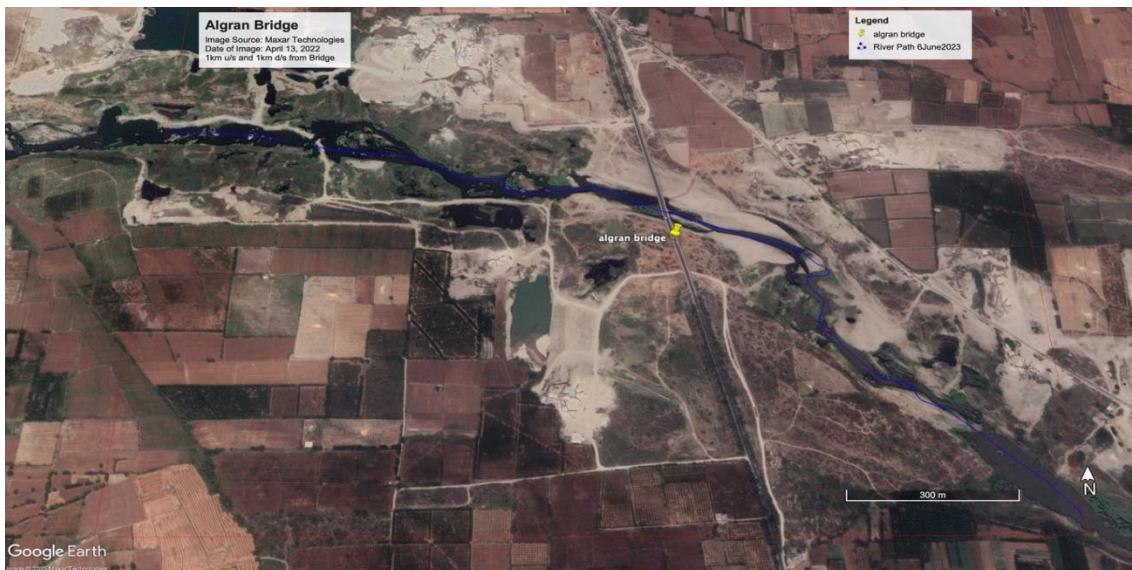
Figure 3.8 April 13, 2022 Satellite Image (WorldView)

Significant land excavation was observed along the upstream and downstream sections of the river as shown in figure 3.8. However, site inspections confirm that the pits on the right side of the upstream area are natural depressions that typically fill with water during the monsoon season. In contrast, large open pits, likely formed due to sand and gravel extraction, are evident along the river course. Mining/Crushers activities have also expanded into adjacent agricultural zones, leading to a noticeable reduction in vegetation cover. The river appears more channelized, with a shift in its course, potentially influenced by both natural processes and

human interventions. Increased sediment deposition is visible in certain areas, suggesting that mining activities may be contributing to altered sediment transport dynamics. Additionally, some water-filled pits from earlier years now appear dried up or replaced by land excavation, indicating progressive landscape modifications over time.

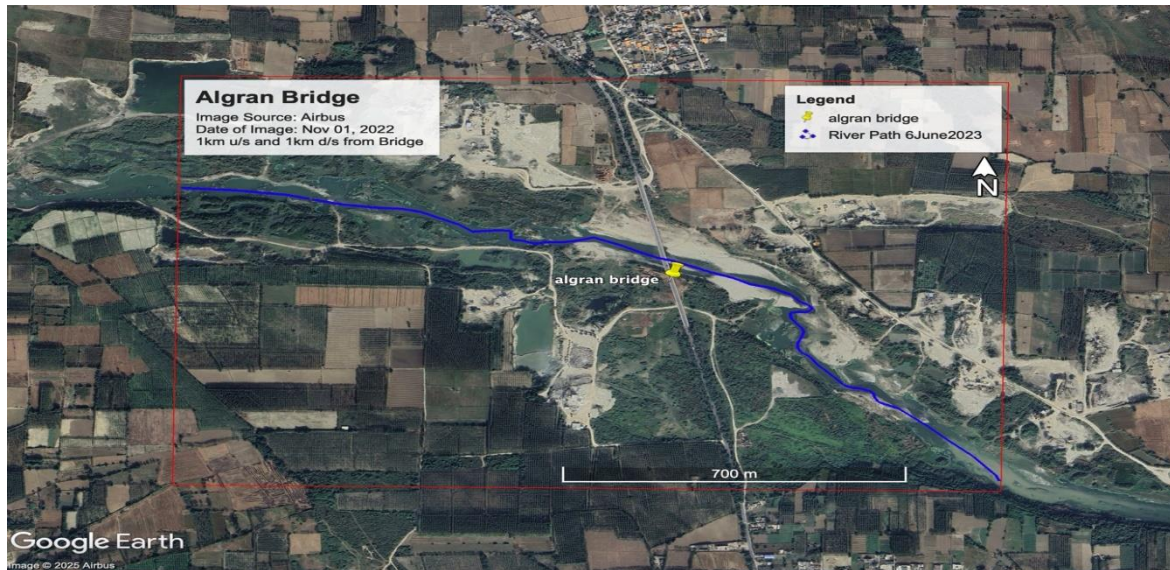
Figure 3.10 November 01, 2022 Satellite Image (Pléiades Neo)

In the image shown in figure 3.10 the river has narrowed in certain sections, likely due to sediment deposition and artificial changes. The mining areas have expanded significantly compared to previous years. Excavation pits are more widespread, especially downstream of Algran Bridge. The exposed sand and gravel deposits indicate ongoing and active extraction. Increased meandering is visible downstream, indicating continuous hydrodynamic adjustments. The riverbanks appear more eroded, suggesting instability caused by reduced vegetation in d/s while in the u/s close to the bridge sediment/gravel deposits can be seen like previous years

while vegetated areas are also there in u/s showing the least chances of mining with in the 1km u/s and d/s of the bridge. Some areas that were cultivated in earlier years appear abandoned or disturbed.

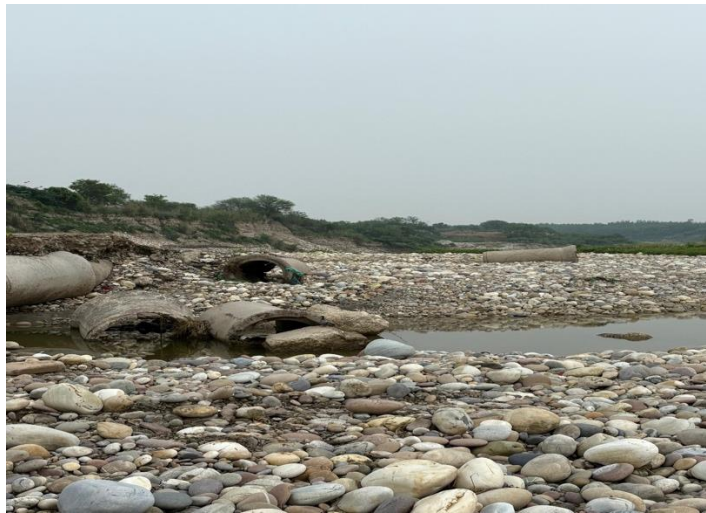
Figure 3.12 Obstruction of flow seen on the river during site visit

Also, flow obstruction was evident from satellite images as well as field visits. Images shown in figure 3.12 and 3.13 shows the flow obstruction in the u/s and d/s of the bridge.

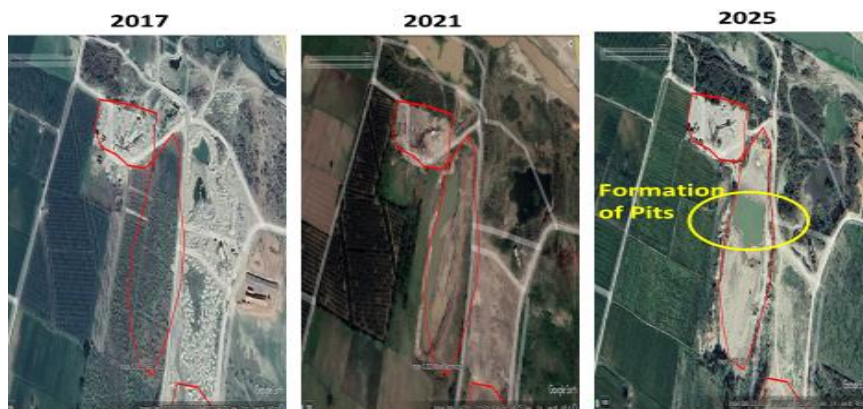
- ii. **Field Verification:** Ground surveys corroborate the patterns observed in satellite imagery, confirming the presence of mining and crusher activities consistent with the remote sensing data (Photographs given in Fig. 3.14, 3.15 and 3.16 of the PEC Report attached as **Annexure-3**)

Figure 3.14 Time Series of images Showing formation of pits with time

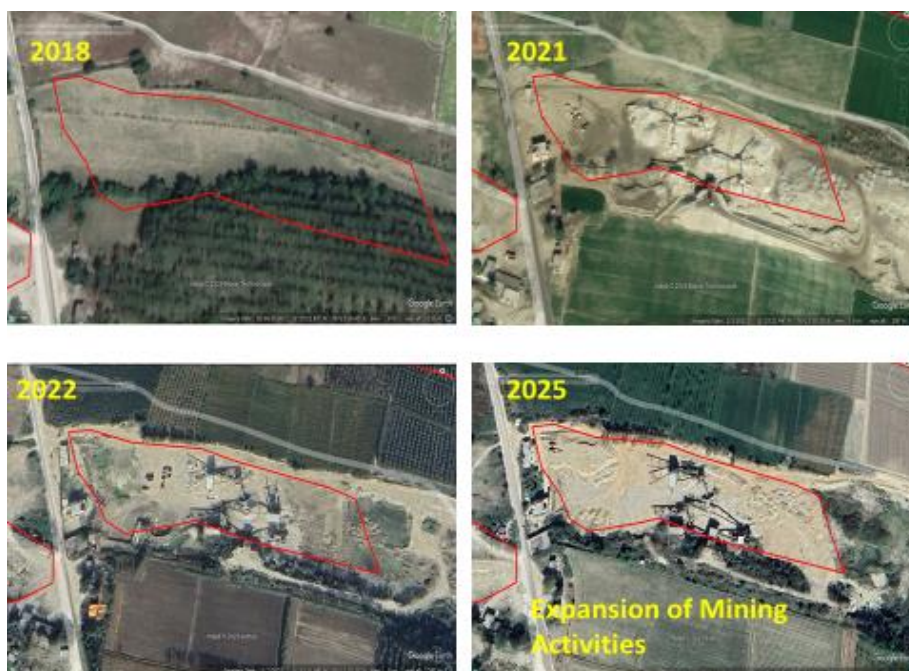
Figure 3.16: Time series of images showing expansion of mining activities

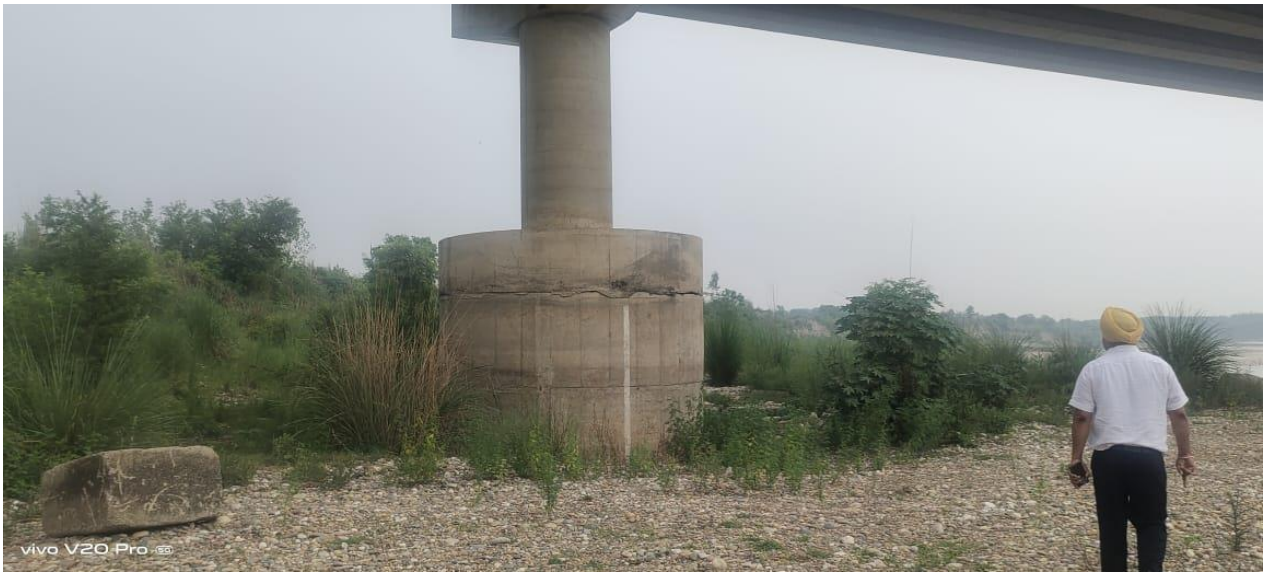
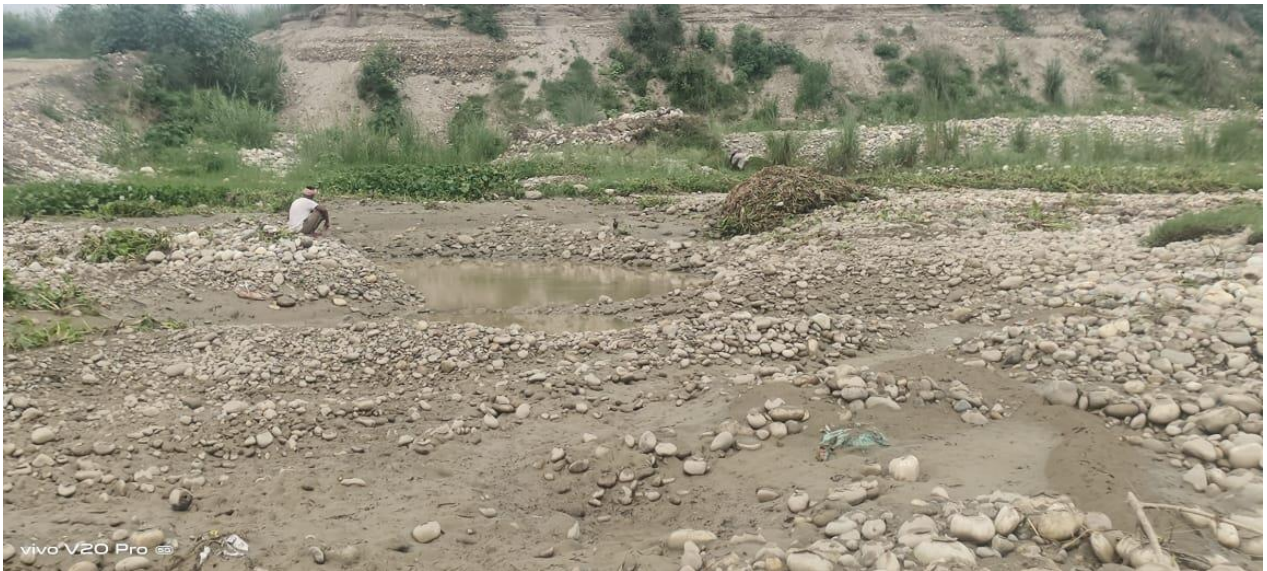
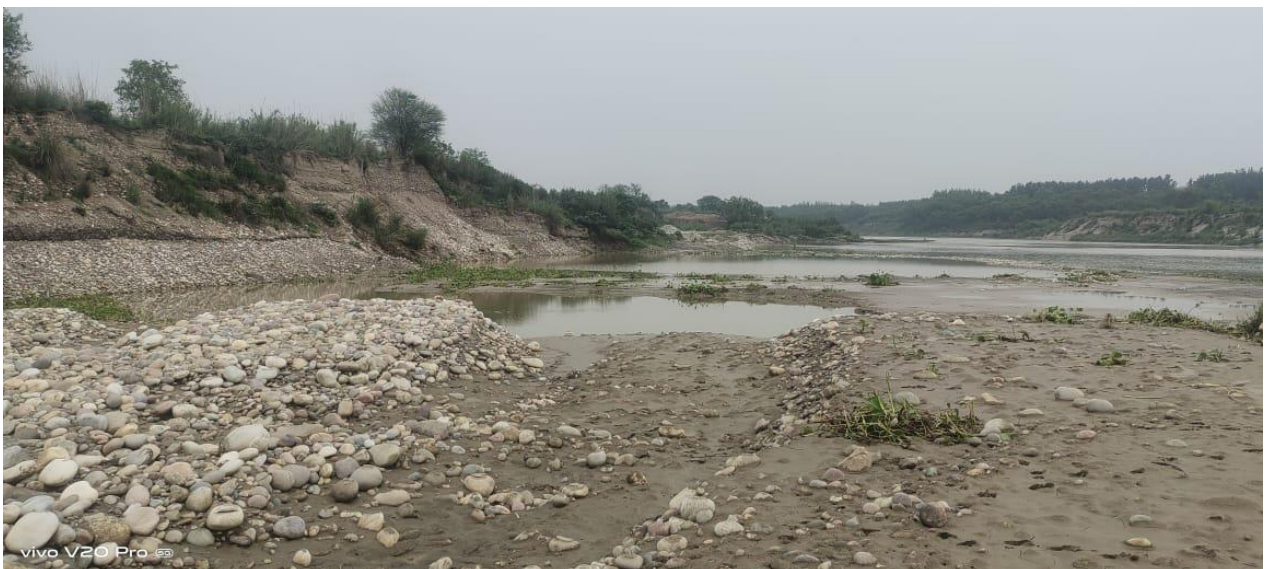
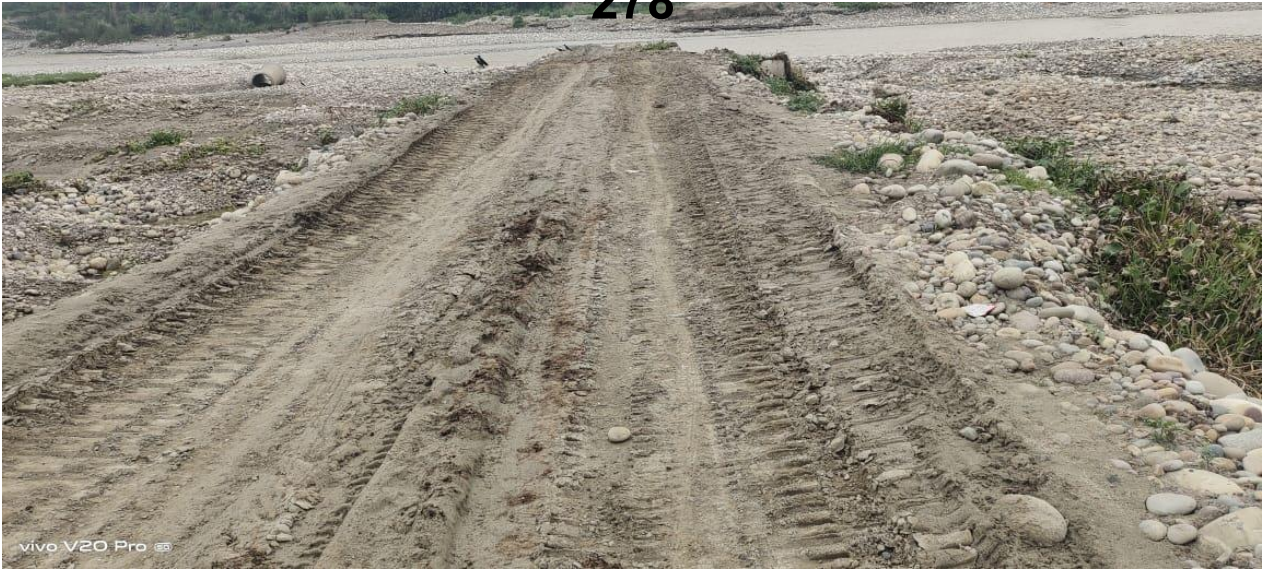
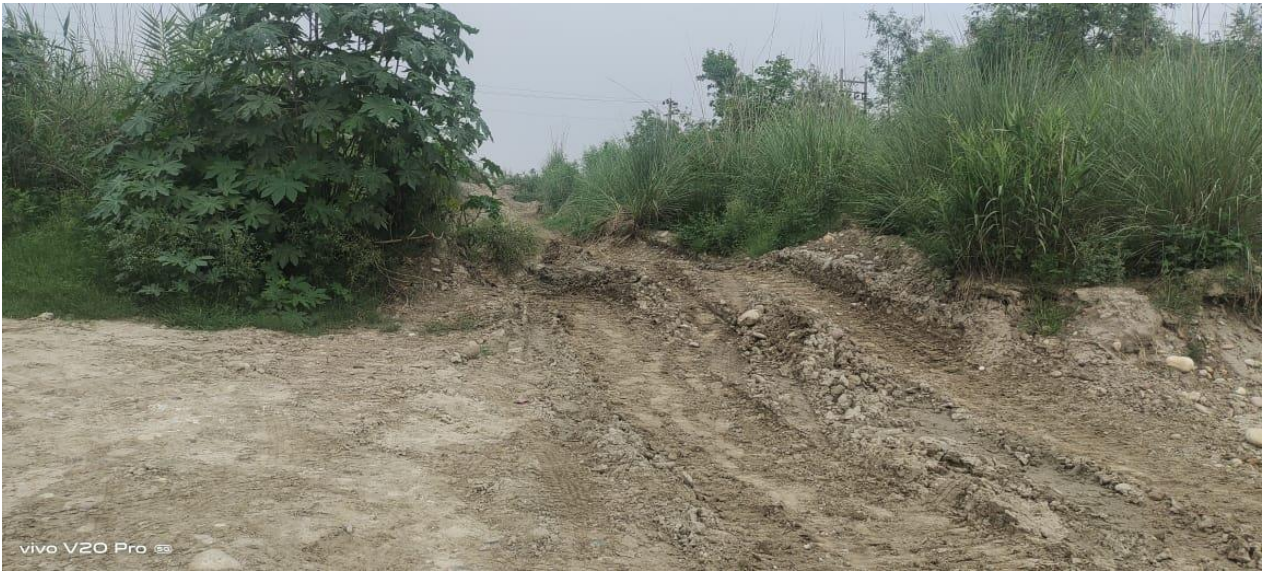
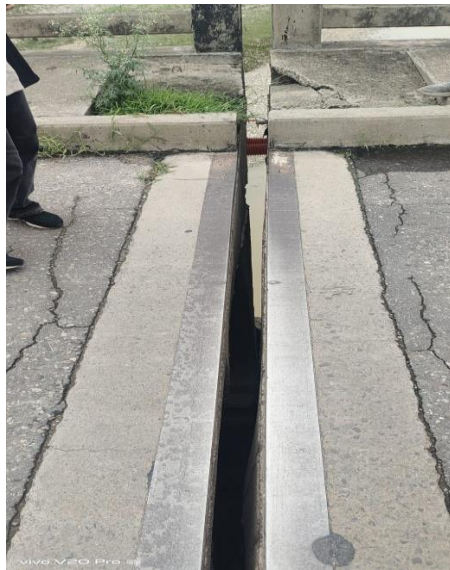
Appendix-II (Site Visit Photos)

- **Field Verification:** Ground surveys corroborate the patterns observed in satellite imagery, confirming the presence of mining and crusher activities consistent with the remote sensing data.

- Conduct a detailed investigation into the impacts of existing crusher operations.
- Implement periodic remote sensing-based monitoring to track ongoing activities.
- Perform a comprehensive safety audit of the Algran Bridge structure to assess its stability.
- Establish GIS-based regulatory frameworks to promote sustainable riverine management and mitigate further environmental degradation.
