Original Application No. 539/2024

News item titled "On revamp priority list Satpula Lake being filled up with raw sewage from drain" appearing in The Times of India dated 06.04.2024

**STATUS REPORT ON BEHALF OF DELHI POLLUTION CONTROL  
COMMITTEE IN COMPLIANCE TO THE ORDER DATED  
16.05.2024.**

Annexure-1 (Colly)

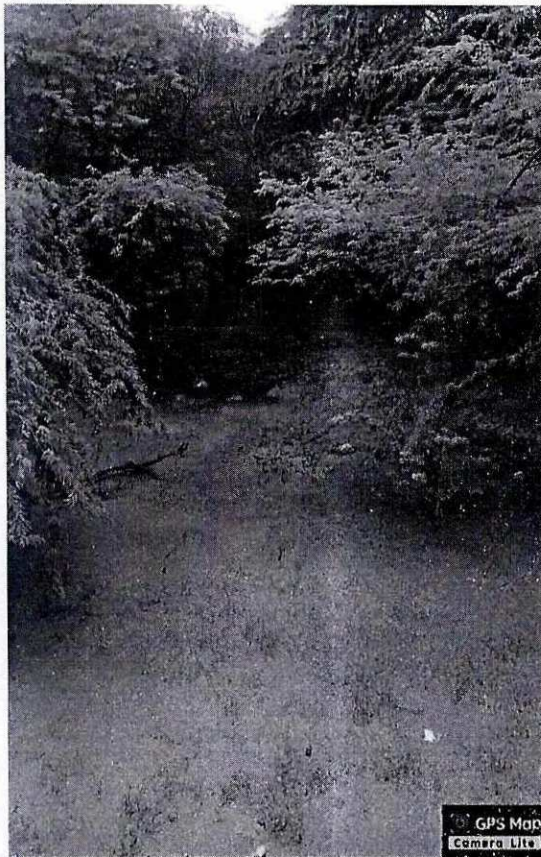
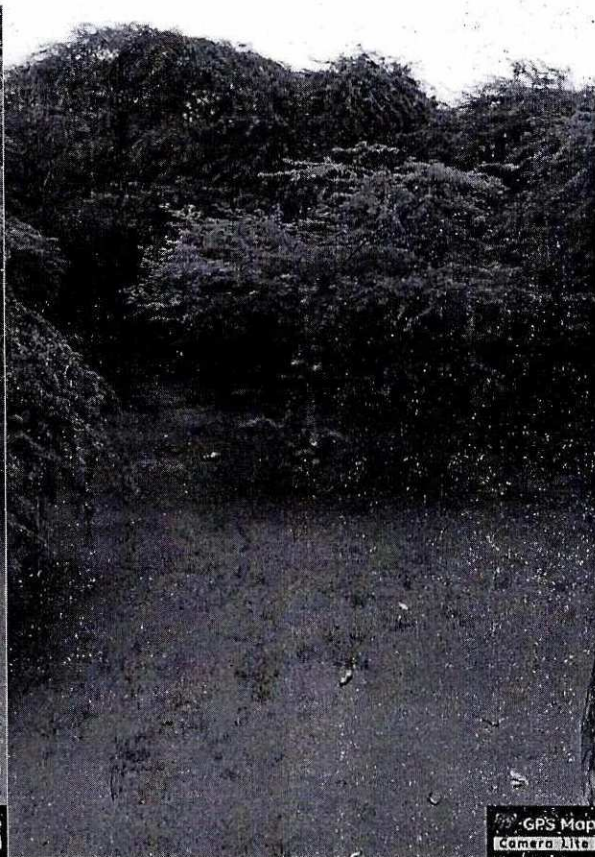
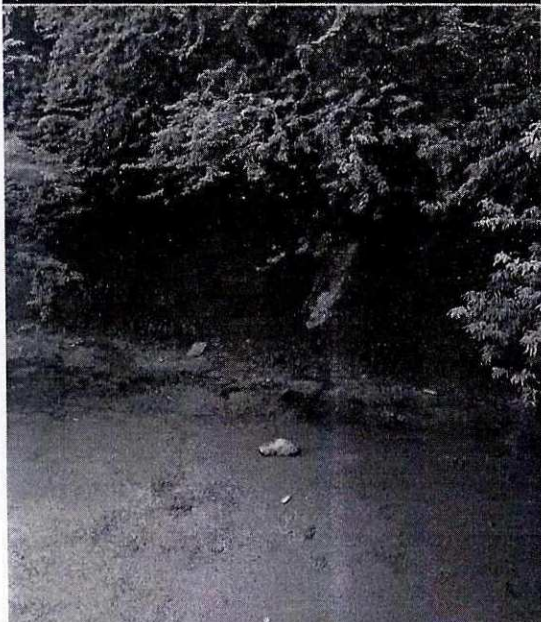
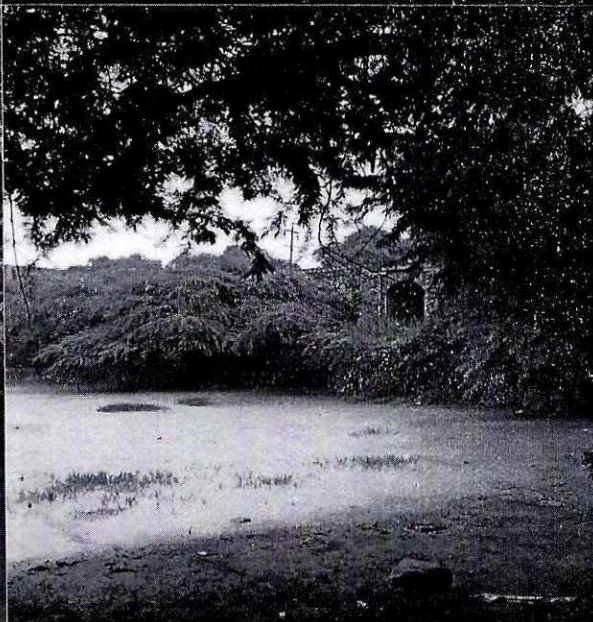
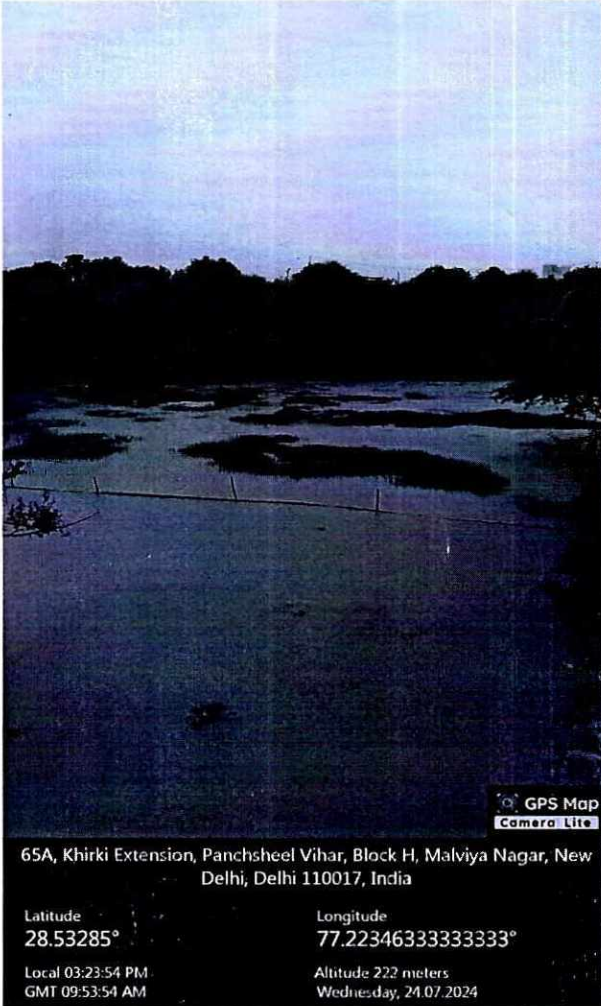
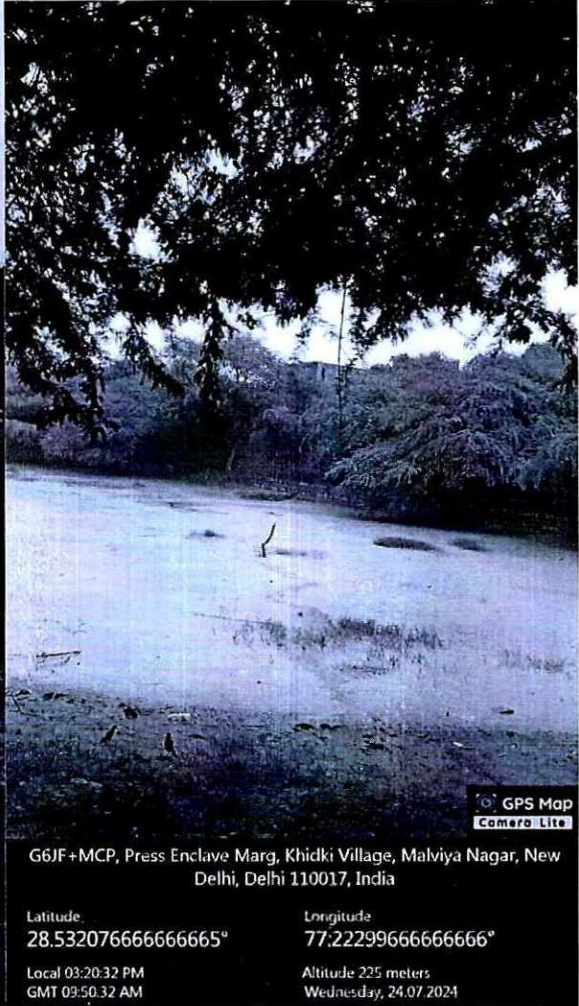
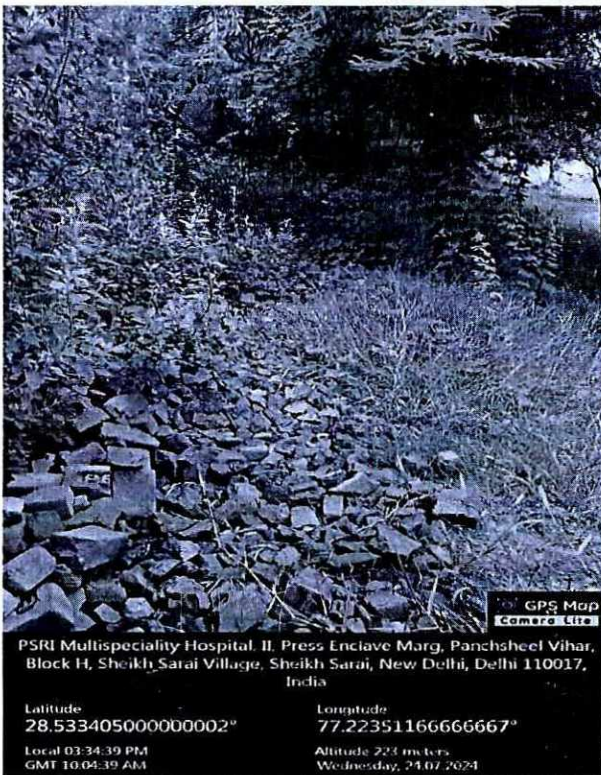
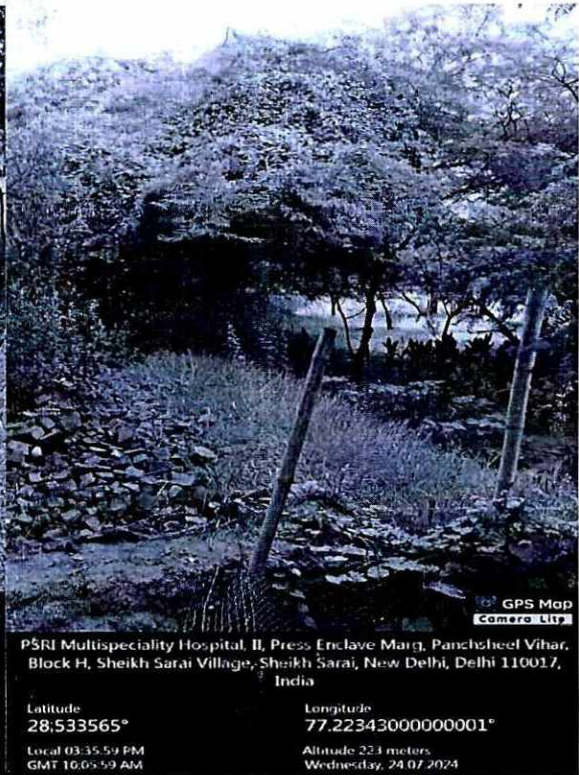
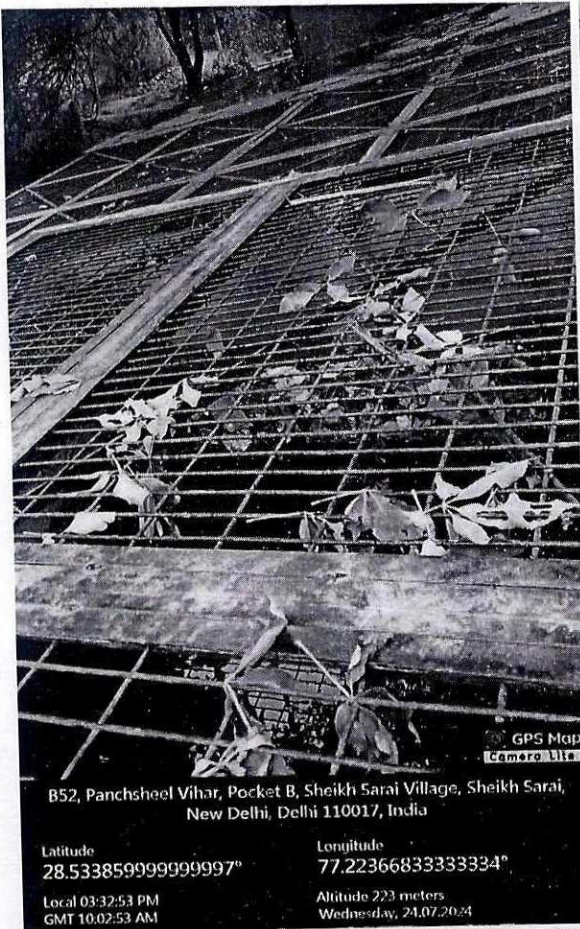
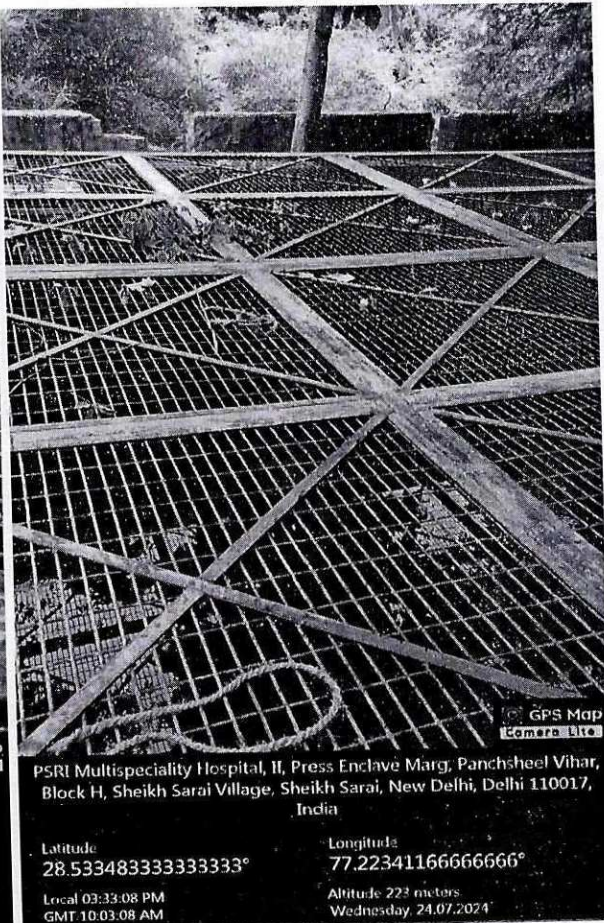
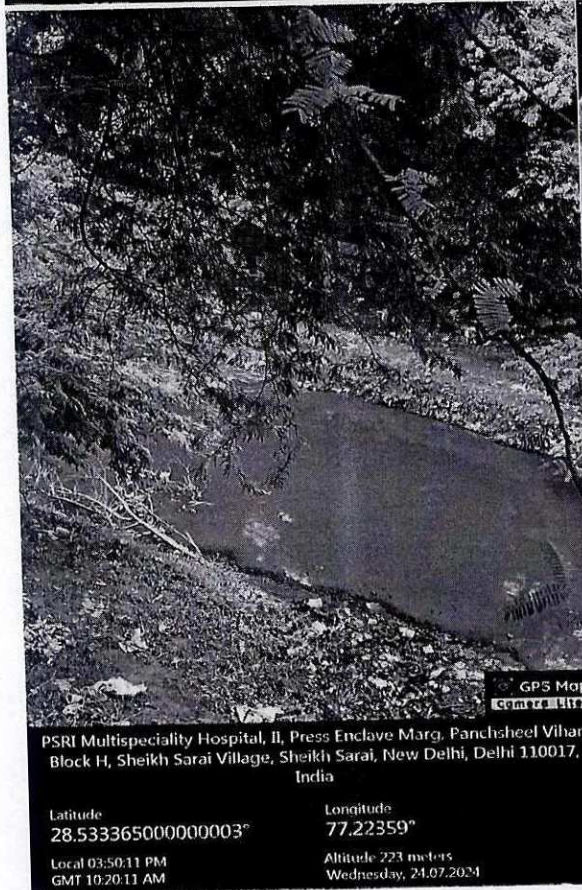
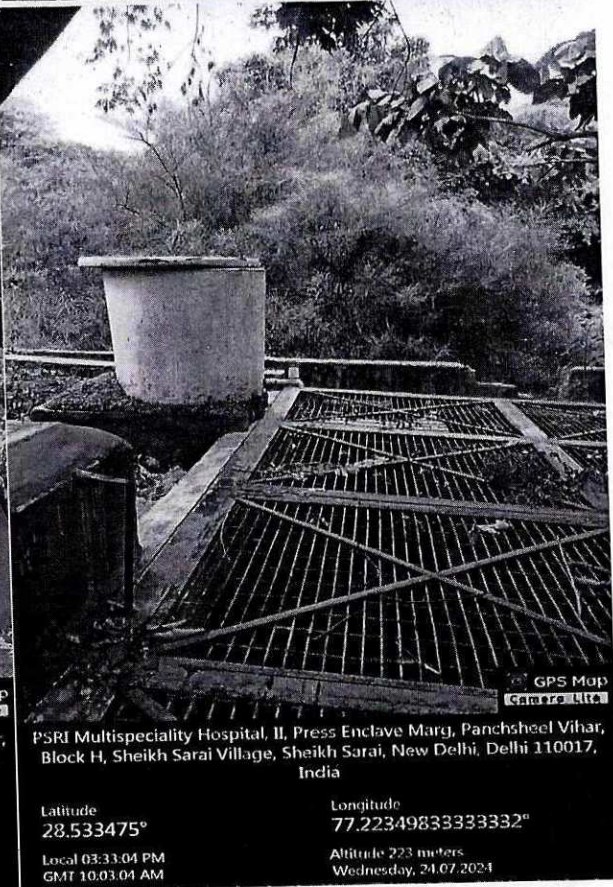
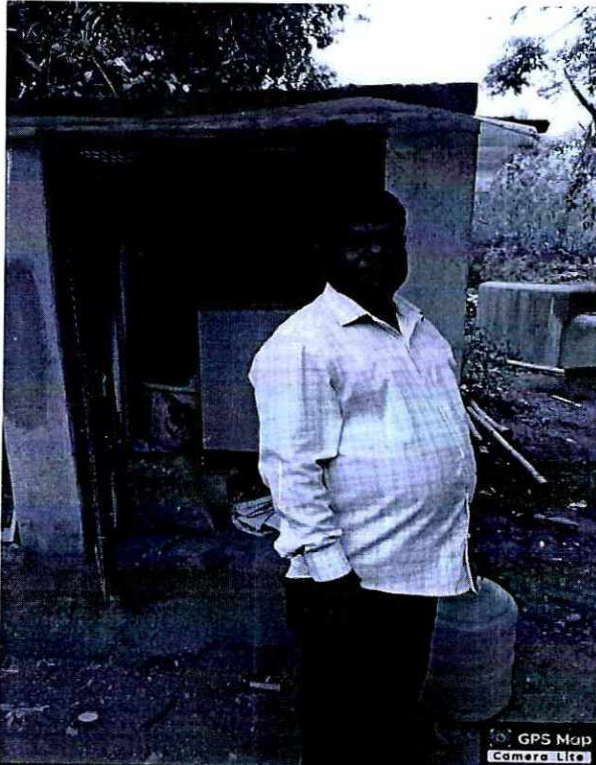
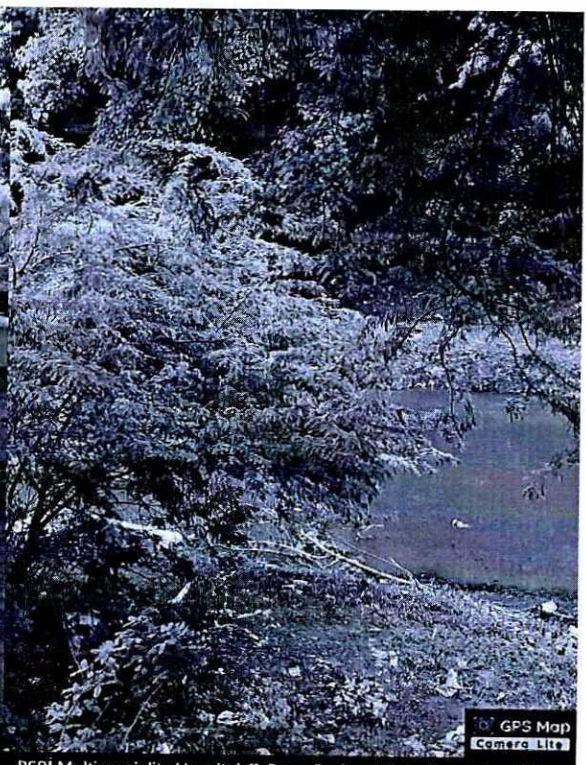
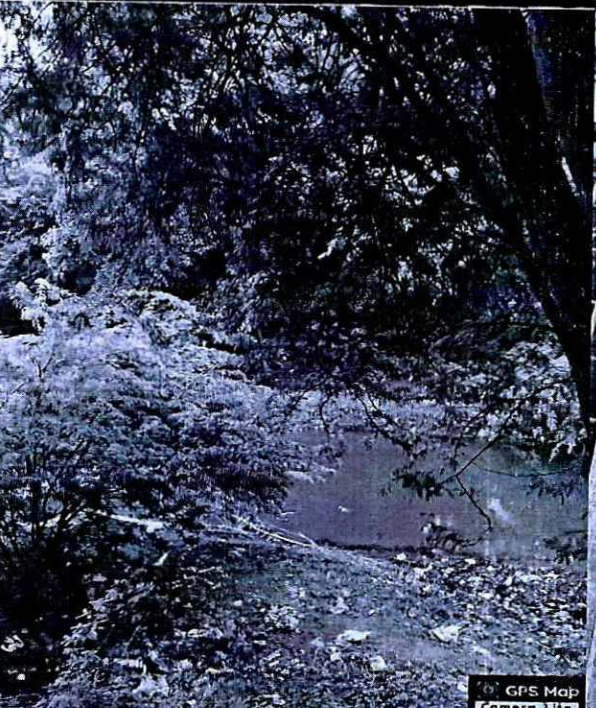
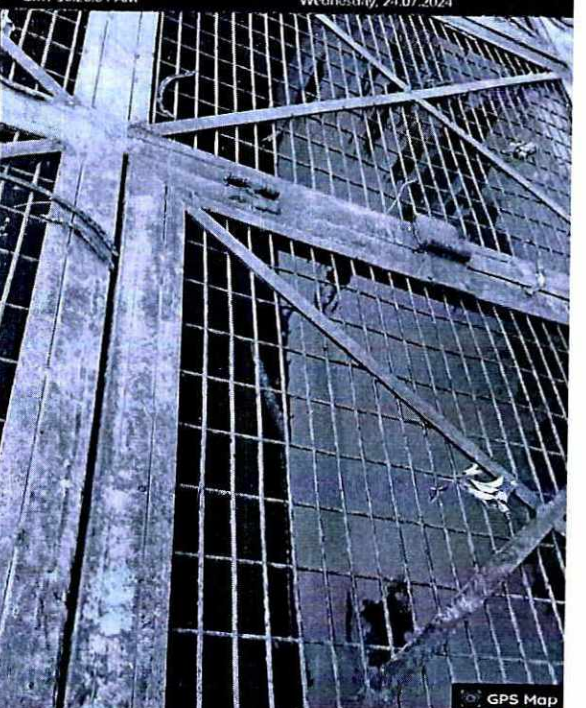
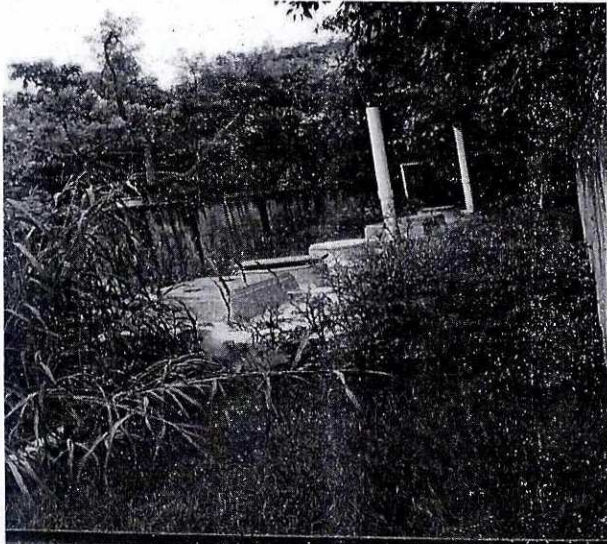
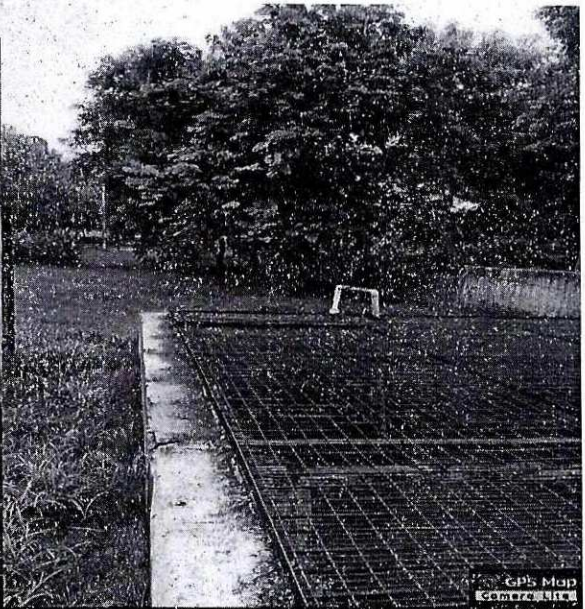
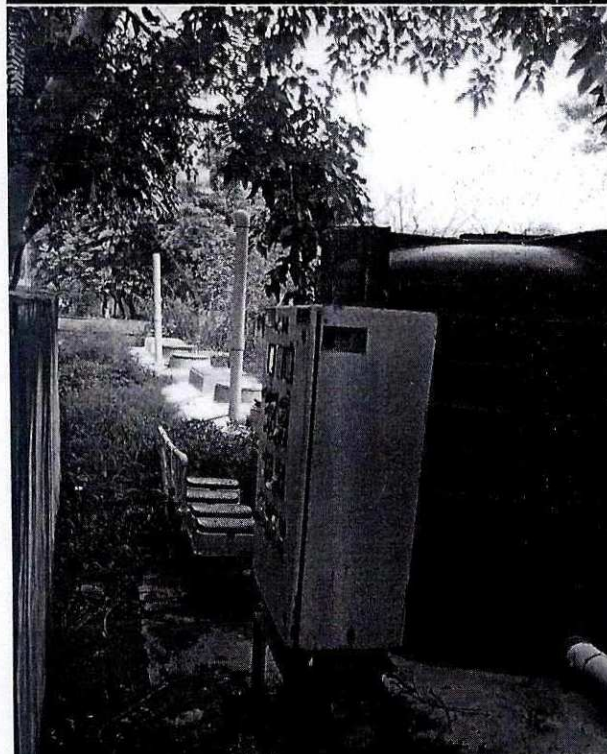
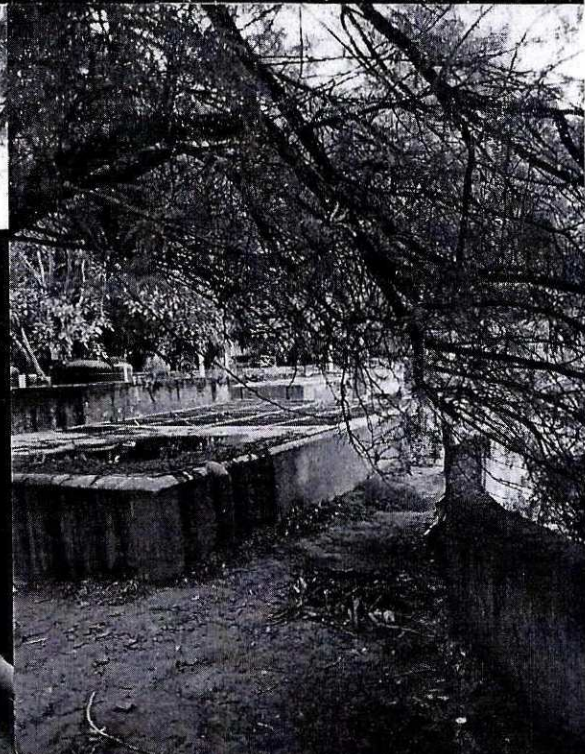
- The Satpula lake is found to be highly Eutrophic. Very less water observed in the lake despite ongoing monsoon season.
  - There is an open drain adjacent to the lake.

- The lake is situated in a DDA Park and maintained by DDA.
  - There is a STP plant in the DDA park. The plant operator Sh. Bhagwan Das informed that they take waste water from the adjacent drain and dispose the treated effluent in the pond for its rejuvenation. Plant operator also informed that the capacity of the STP plant is 20 KLD and STP plant consists of treatment

units (Inlet in drain, Screen chamber, collection tank, Chemical dosing tank and filter beds).

- It was seen that the STP is non-functional and no water is being treated and pumped into the lake since long.
- There is no garbage dumping observed in the lake.

3. That, in view of the above findings of the inspection and eutrophic conditions, DPCC issued a letter on 29.07.2024 to DDA to repair the dysfunctional parts of the STP so as to make it functional and submit the treated water analysis report of STP from DPCC lab or any other NABL accredited laboratory within 15 days. Copy of the letter dated 29.07.2024 issued to DDA is attached herewith as ANNEXURE-2.
4. That, no reply has been received from DDA so far. The present status taken report may kindly be taken on record.

In view of the above findings of the inspection and Eutrophic conditions observed in lake, you are requested to direct the concerned in DDA to repair the dysfunctional parts of the STP so as to make it functional and submit the treated water analysis report of STP from DPCC laboratory or any other NABL accredited laboratory within 15 days so that the status may be apprised to Hon'ble NGT in a time bound manner.
