FACTUAL REPORT BY MPPCB

Original Application No. 696/2019 (PB)

Factual Report

Ref. - Inspection as per the Hon'ble NGT order on dated 13/10/2020 in OA No 696/2019 (PB) (Villagers of Village, Jhirnia vs. State of MP)

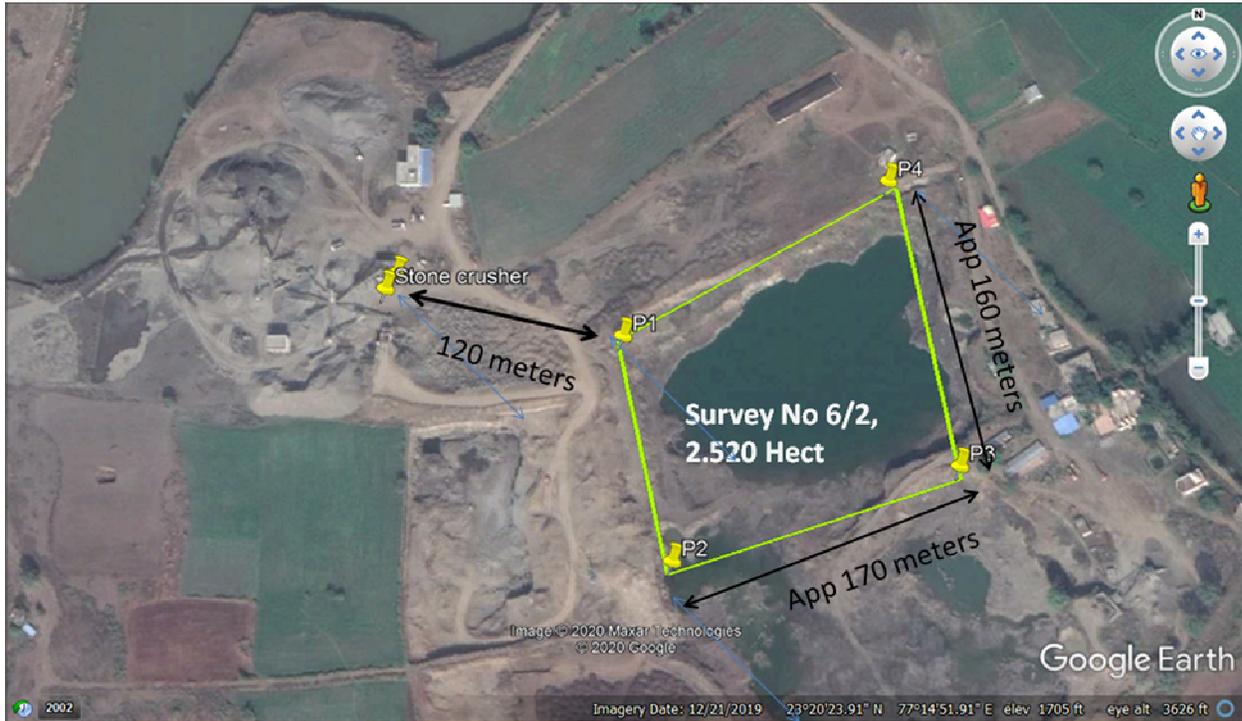
Screen shots of Google Map:

5. As per the locations marked on Google map, the location of stone crusher is found approx. 120 meter away from the nearest boundary of Survey No. 6/2, Village – Rasuliya Pathar, Tehsil –Huzur, District –Bhopal. This shows the crusher is located outside the area of Survey No. 6/2, Village – Rasuliya Pathar, Tehsil –Huzur, District –Bhopal.

Showing location of Survey No. 6/2, Village – Rasuliya Pathar, Tehsil –Huzur, District –Bhopal

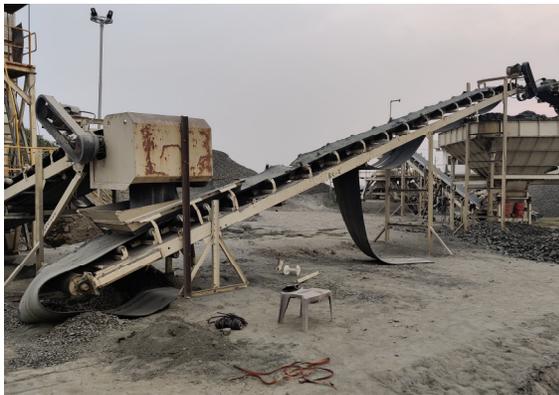
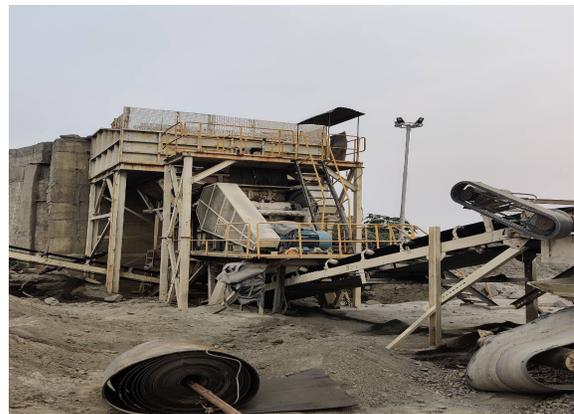
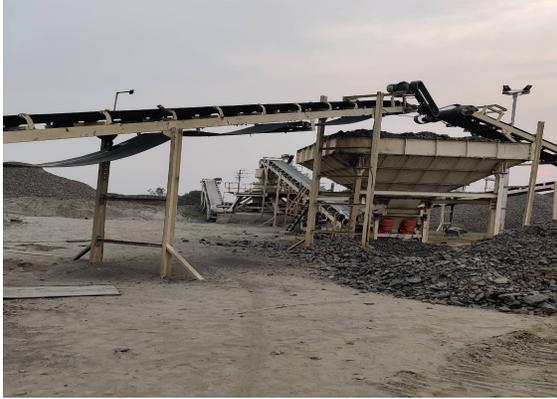
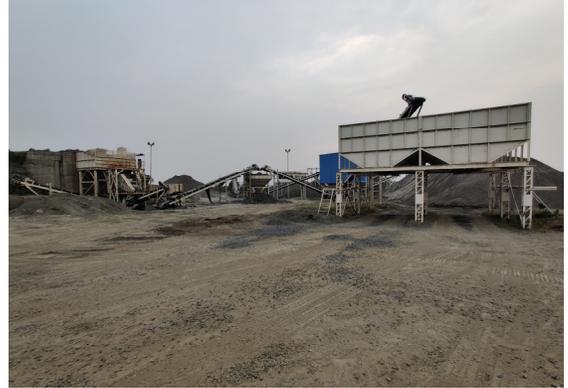
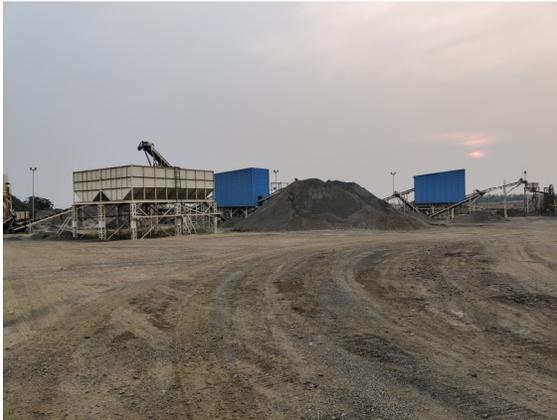
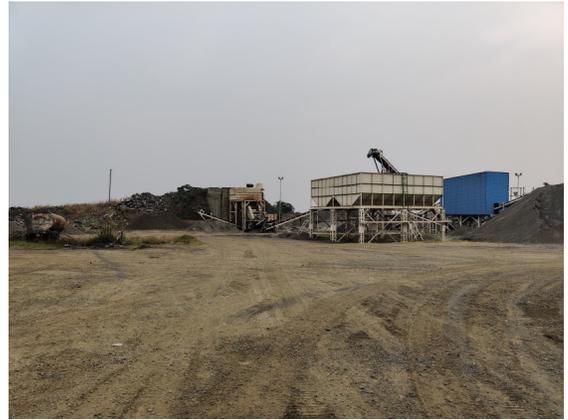
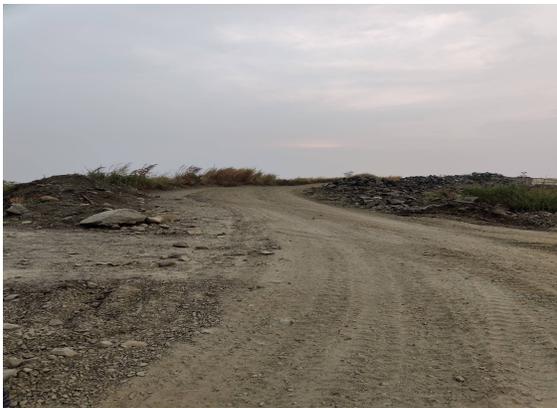
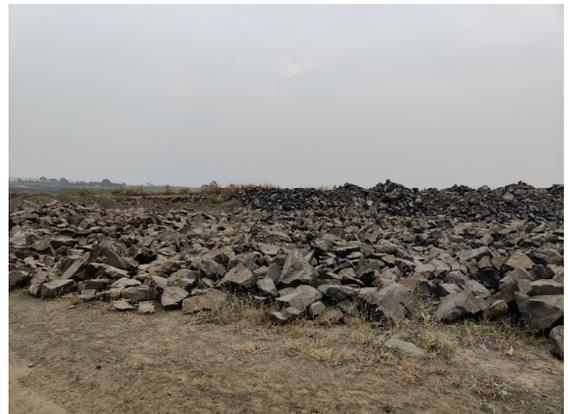
Photographs of Stone Crusher:

6. During inspection, the stone crusher was not found in operation. The conveyor belt connected the jaw crusher to nearest vibratory screen was found broken. The heaps of crushed stone were observed in the premises. The photographs of the stone crusher and surrounding are enclosed.

- The air pollution control arrangements were not appropriate. No green plantation provided around the stone crusher boundary, Jaw crusher not covered, Wind breaking wall around crusher not provided, thick layer of fine dust found all around the crusher area which indicates that dust suppression system not functional properly during operation.
