SUB: SUBMISSION OF REPORT BY NCSCM IN THE MATTER OF OA NO. 625/2023 IN THE HON'BLE NGT (PRINCIPAL BENCH), NEW DELHI.

Report on Sea Erosion at Uchila Endpoint along the Mangaluru Coast, Karnataka in OA No. 625/2023, Hon'ble NGT, Principal Bench, New Delhi

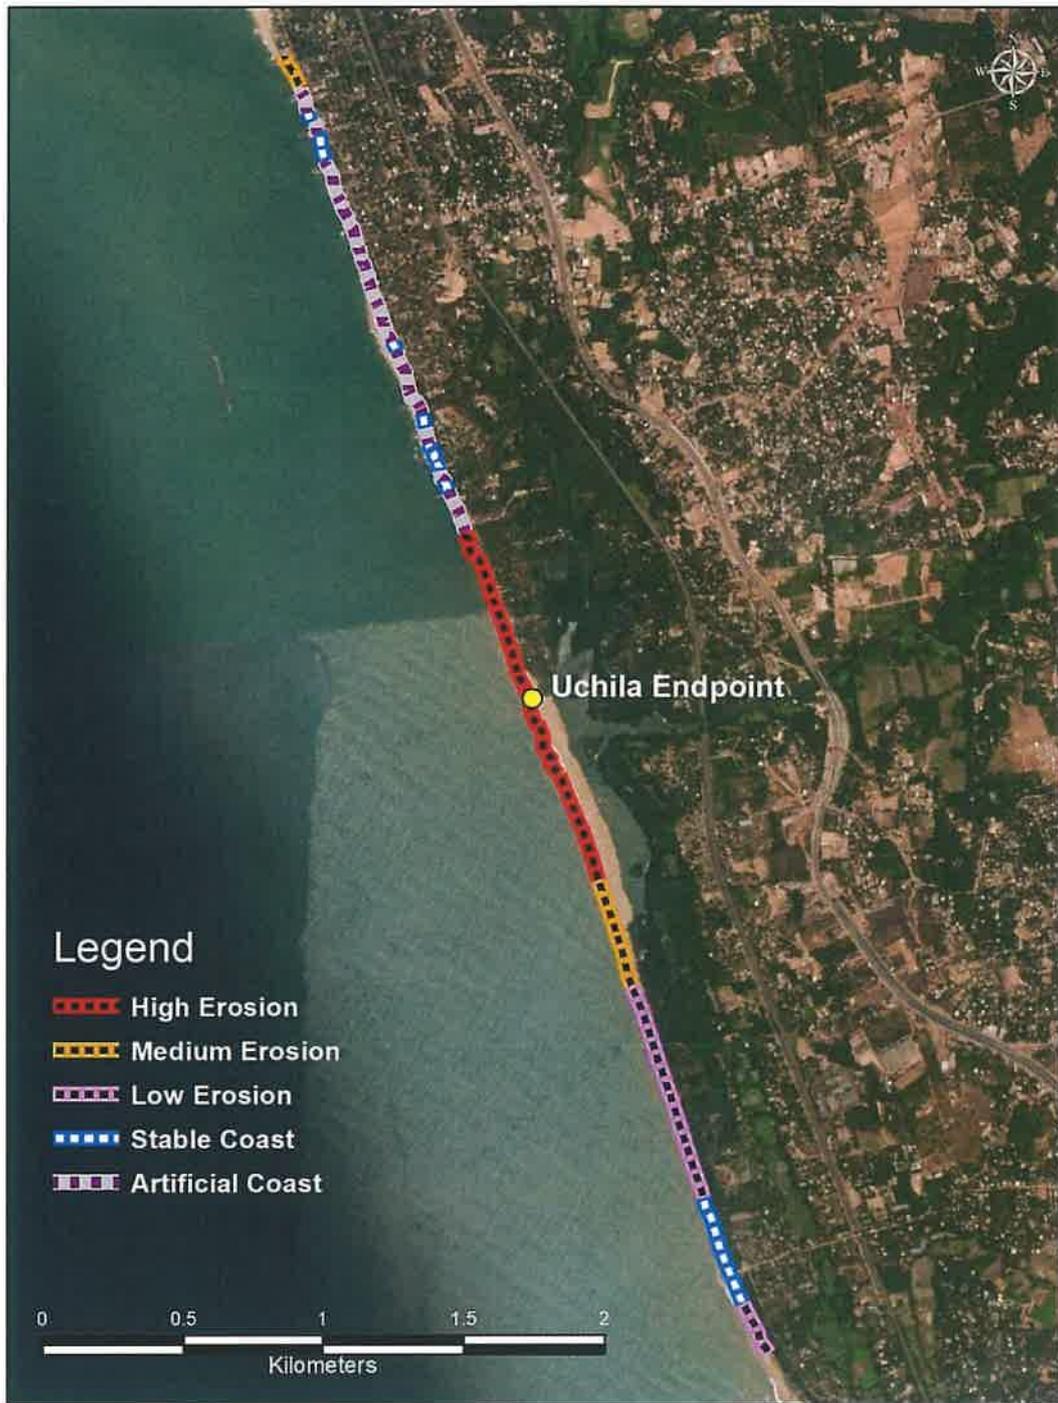
Figure 1: shoreline change analysis at Uchil Endpoint, Mangaluru coast, Karnataka

A preliminary analysis of shoreline change (erosion and accretion characteristics) was conducted using satellite and Google Earth images for a 5.06 km stretch (2.5 km on each side of Uchil Endpoint) along the Mangaluru coast on short-term timescales (2010–2022). This analysis was performed utilizing the Digital Shoreline Analysis System (DSAS). The details of the shoreline change analysis are depicted in Figure 1, while their particulars and percentages are detailed in Table 1.

The analysis clearly indicates a high erosion rate of approximately 7 m/yr observed at Uchil Endpoint and its surrounding areas. The estimated percentage of high erosion and cumulative percentage of erosion are approximately 27.09% and 57.40%, respectively, along the coastal stretch. Consequently, the Uchil Endpoint area is significantly eroded and necessitates protection by implement the suitable shore protection interventions through the study of coastal processes and sediment transport. Additionally, the study should investigate the causes of the high erosion along the Uchil Endpoint stretch of the Mangaluru coast.
