Action Taken Report

Expert Committee's Report
on
**Muck Disposal and Management in
Tapovan -Vishnugad Hydroelectric Project**
National Thermal Power Corporation Ltd., Uttarakhand

Original Application No. 61/2019
Gram Pradhan and Residents of Tapovam vs State of Uttarakhand

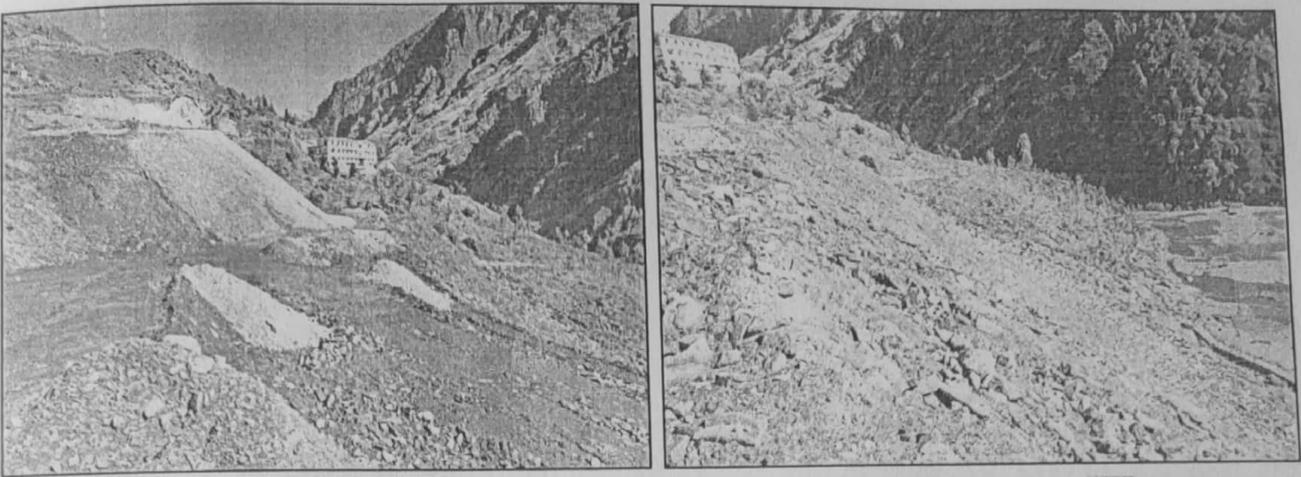
1. Dhak muck disposal site is located with geographical coordinate of latitude 30° 30' 10.6"N, longitude 79° 36' 47.0" and altitude 2015m. This site is active but near completion (Photo 1a and 1b). Gabion toe wall has been constructed but found to be with improper foundation and backfilling. Downstream slope of dumped material is more than 45° which is prone to very severe erosion during high intensity rainfall event. Dump surface is mostly uneven and undulating with dominance of boulder, rock fragments and inert material. Comparatively a little amount of soil has been spread over a few patches of the muck dump. This site has not been fully utilized to its capacity as usable part of muck generated might have been used in construction.

Photo 1a and 1b: Current view of the active dumping site at Dhak near ITI

- First of all toe/contour stone wall in each of the muck dump should be strengthened / constructed with proper engineering design. Another important aspect of the

toe/contour stone wall is the ratio of its height and bottom width which should be maintained around 1:2/3. Third important aspect of toe/contour stone wall construction at muck dump site is the porous nature of the structure; therefore, gabion structures are preferred. Fourth – foundation of toe/contour stone wall should be kept in originally existing land condition.

- Downstream slope of the muck dump should be kept within the range of 20° - 30° .
- Up-stream side of the muck dump, water entry should be restricted by providing concrete diversion drain. Flat portion of muck dump may be merged with sloping surface which will not only help in easing out of downstream steep slope but also restrict the entry of water in muck dump.

- Stepwise consolidation is required to be provided from bottom to top.
- Boulders, lumps of inert materials and rock fragments should be removed from the surface. These materials can be used in strengthening or constructing the toe wall or contour stone barriers.

- Contour stone barrier may be provided at 3-4 m vertical interval but their foundation should be kept in originally existing land condition and not on loose muck dump.

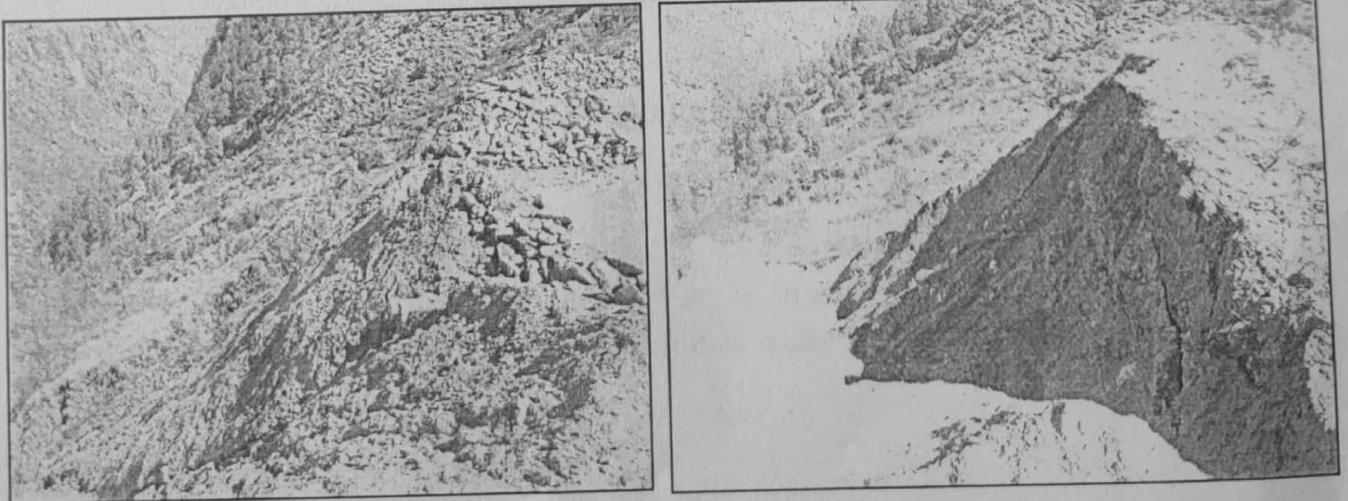
2. Muck disposal near TBM adit is located with geographical coordinate of latitude $30^{\circ} 32' 25.2''N$, longitude $79^{\circ} 31' 29.9''$ and altitude 1713 m. This site is active and dumping of the muck material being generated in tunnelling is going on (Photo 2a and 2b). The toe wall has been constructed but it was found as damaged in one side of the dumping zone. The slope of muck dump is observed to be about 60° which is hazardously double the standards. Upstream side of the muck dump is subjected to the entry of water which has further added to trigger severe mass erosion. Under such unstable conditions, as expected, huge mass erosion has been seen in terms of very deep gully formation in downstream of this muck dump. Since, deep excavations are inevitable in tunnelling, only grounded and fragmented rocks are being dumped and no soil is available to spread over this muck dump site. On older portion of this dump, native grass (*Chrysopogon*), shrub (*Eupatorium*) and tree (*Alnus*) could be observed.

Photo 2a and 2b: Current view of the active dumping site at TBM adit

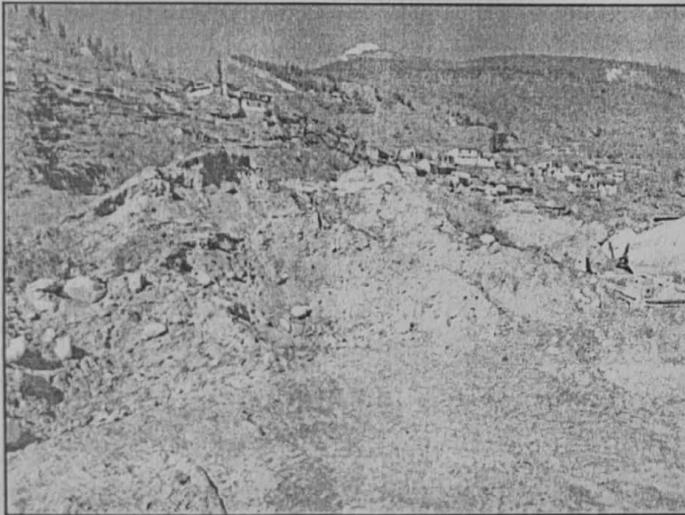
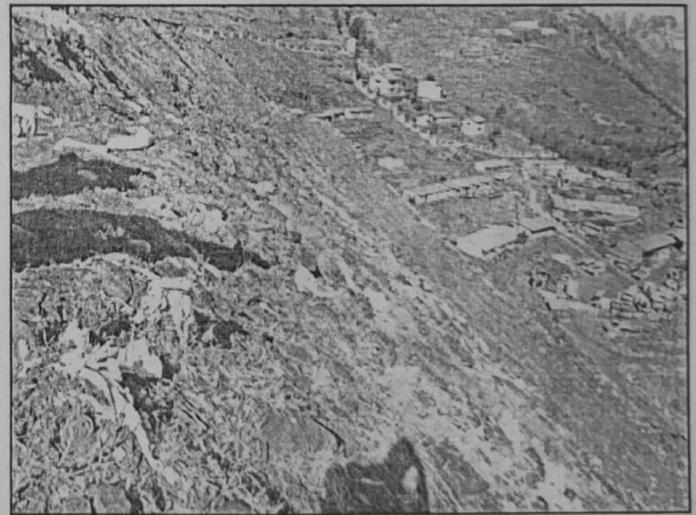
1. **Barrage Site at Tapovan:** This sites is located with geographical coordinates of latitude $30^{\circ} 29' 30.7''$ N, longitude $79^{\circ} 37' 33.5''$ and altitude 1918m. In this site dumping of the material has been completed 4 years back (Photo 3a and 3b). The site is more or less stabilized but toe protection and contour stone barriers are damaged at some places. Some good soil was kept separately but not spread over the muck dump. Top surface is not smoothed and found uneven and undulating with bounders and other materials.

Photo 3a and 3b: Status of Daumping Site at Barrage Site, Tapovan

- Damaged toe protection and contour stone walls should be repaired and strengthened with proper engineering design.
- Suitable fencing may be provided to control excess human and animal interference.
- Unattended works of leveling, surface smoothening, removal of unwanted material and spreading of available soil at Tapovan site should be completed.
- Manures and fertilizers may be applied to improve the soil fertility.
- Suitable species of grasses, shrubs and trees, as listed above, may be planted in degraded area.

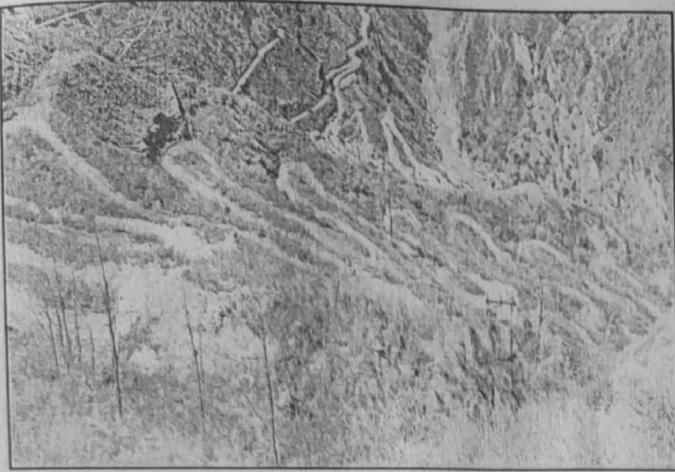
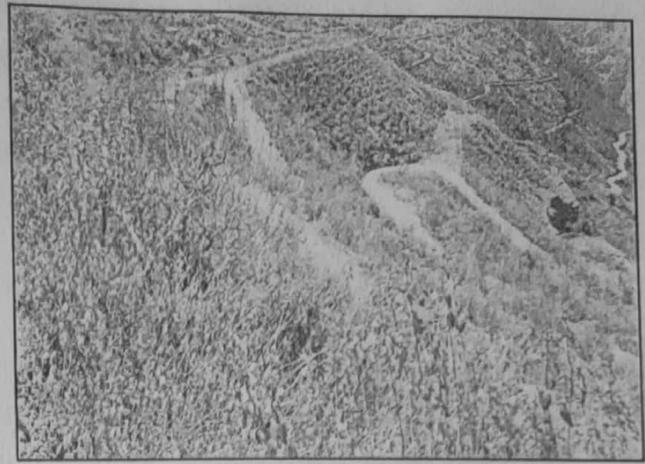
2. **Near BVC/Pressure Shaft:** This sites is located at latitude $30^{\circ} 32' 08.4''$ N, longitude $79^{\circ} 31' 27.8''$ and altitude 1704 m. In this site dumping of the material has been completed 3 years back. The site is more or less stabilized (Photo 4a and 4b).

Photo 4a and 4b: Status of Daumping Site at BVC/Pressure Shaft

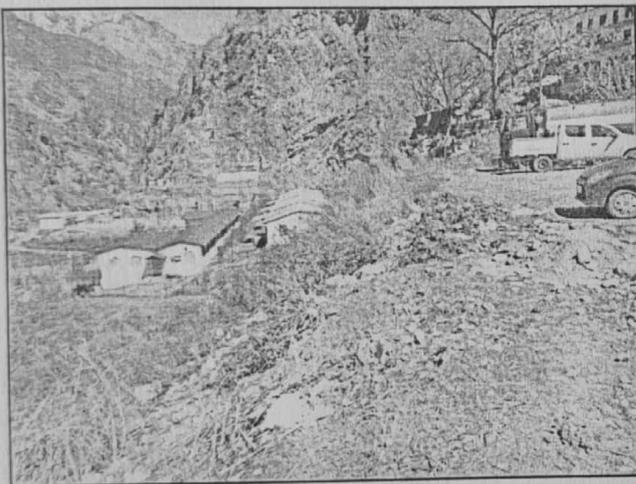
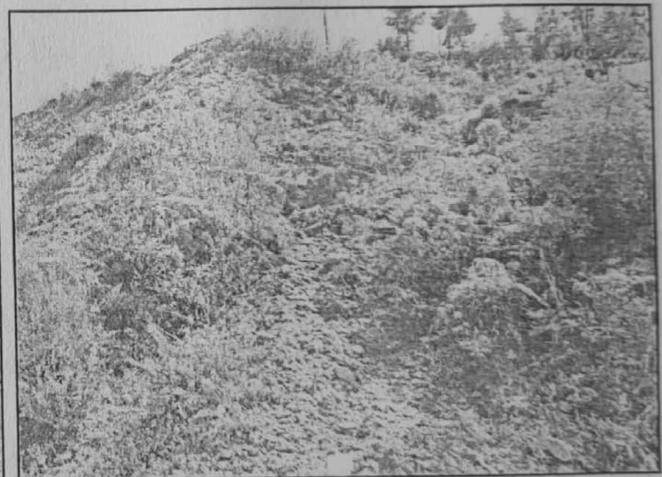
3. **Power House Site at Animath:** This sites is located at latitude $30^{\circ} 32' 00.1''$ N, longitude $79^{\circ} 31' 10.01''$ and altitude 1422 m. Muck dumping has been completed 5 years back in this site. The site has been moderately stabilized but area is not protected from uncontrolled human and animal interference (Photo 5a and 5b).

Photo 5a and 5b: Status of Daumping Site at Power House Site, Animath
