STATUS REPORT

IN THE MATTER OF O. A. 669 OF 2018, MARVADA AMRUTLAL BECHARLAL Vs. STATE OF GUJARAT – ASHAPURA GROUP OF COMPANIES, KUTCH

**REPORT
ON
GYPSUM SITE CLEARANCE**

ASHAPURA PERFOCLAY LTD.(APL)
PLOT NO. 163, 164 & 167, VILLAGE: LER, TALUKA: BHUJ,
DIST.: KUTCH, GUJRAT, INDIA

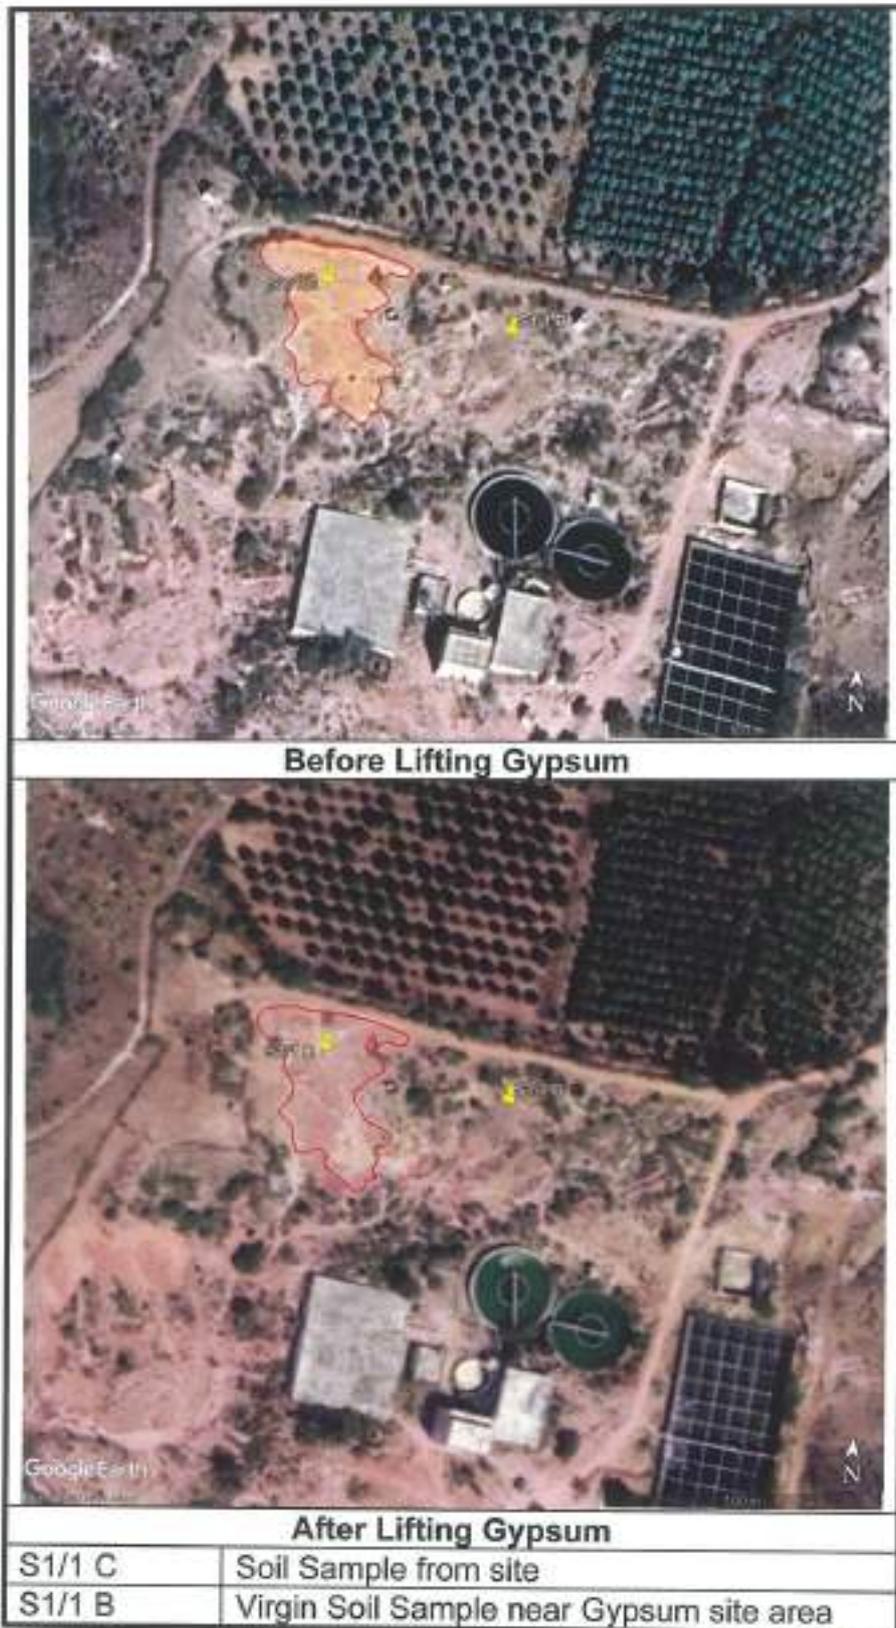
Figure No. 3.2
Location Map Before & After Lifted of Gypsum along with Soil Samples for
Site S1- Besides of water tank of GWIL Sump, Kukma Village

Sr. No.	Parameters	S1/1 C Soil Sample from site	S1/1 B Virgin Soil Sample near Gypsum site area
1	Moisture %	5.70	5.22
2	pH	7.36	7.25
3	Conductivity, mS/cm	2.190	0.894
4	Calcium, g/Kg	3.80	0.72
5	Sodium, g/Kg	10.0	0.4
6	Potassium, g/Kg	0.5	BDL
7	Sulphate, g/Kg	0.74	0.22
8	Ammonia, g/Kg	0.013	0.011
9	Copper, g/Kg	0.015	0.014
10	Nickel, g/Kg	0.010	0.009
11	Zinc, g/Kg	0.018	0.017
12	Cadmium, g/Kg	0.001	BDL
13	Lead, g/Kg	0.014	0.013
14	Chromium, g/Kg	0.004	0.02
15	Manganese, g/Kg	0.012	0.06
16	Cobalt, g/Kg	0.005	0.004
17	Nitrate, g/Kg	BDL	BDL
18	Gypsum as CaSO ₄ .2H ₂ O, %	BDL	BDL

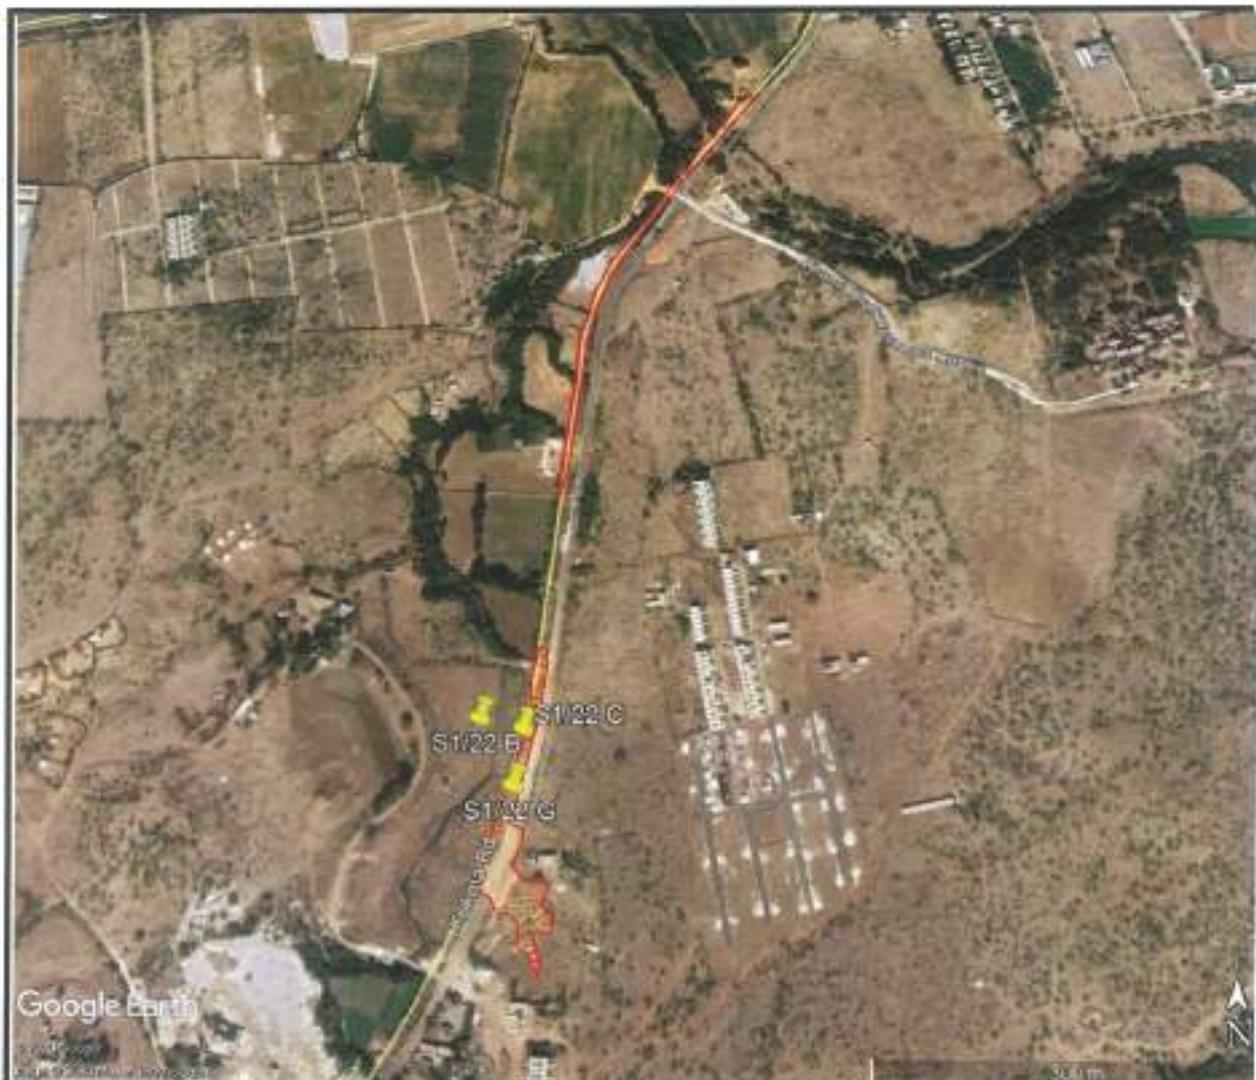
Figure No. 4.2
Site Location Map with Gypsum, Soil and water Sample of
Site-S1/22–Beside Kukma–Lakhond Village Road

S1/22 G	Gypsum Composite Sample
S1/22 C	Soil Sample near Gypsum site
S1/22 B	Virgin Soil Sample near Gypsum site area
Latitude : 23°13'28.55"N, Longitude: 69°46'43.28"E	
To	
Latitude : 23°13'53.41"N, Longitude: 69°46'50.85"E

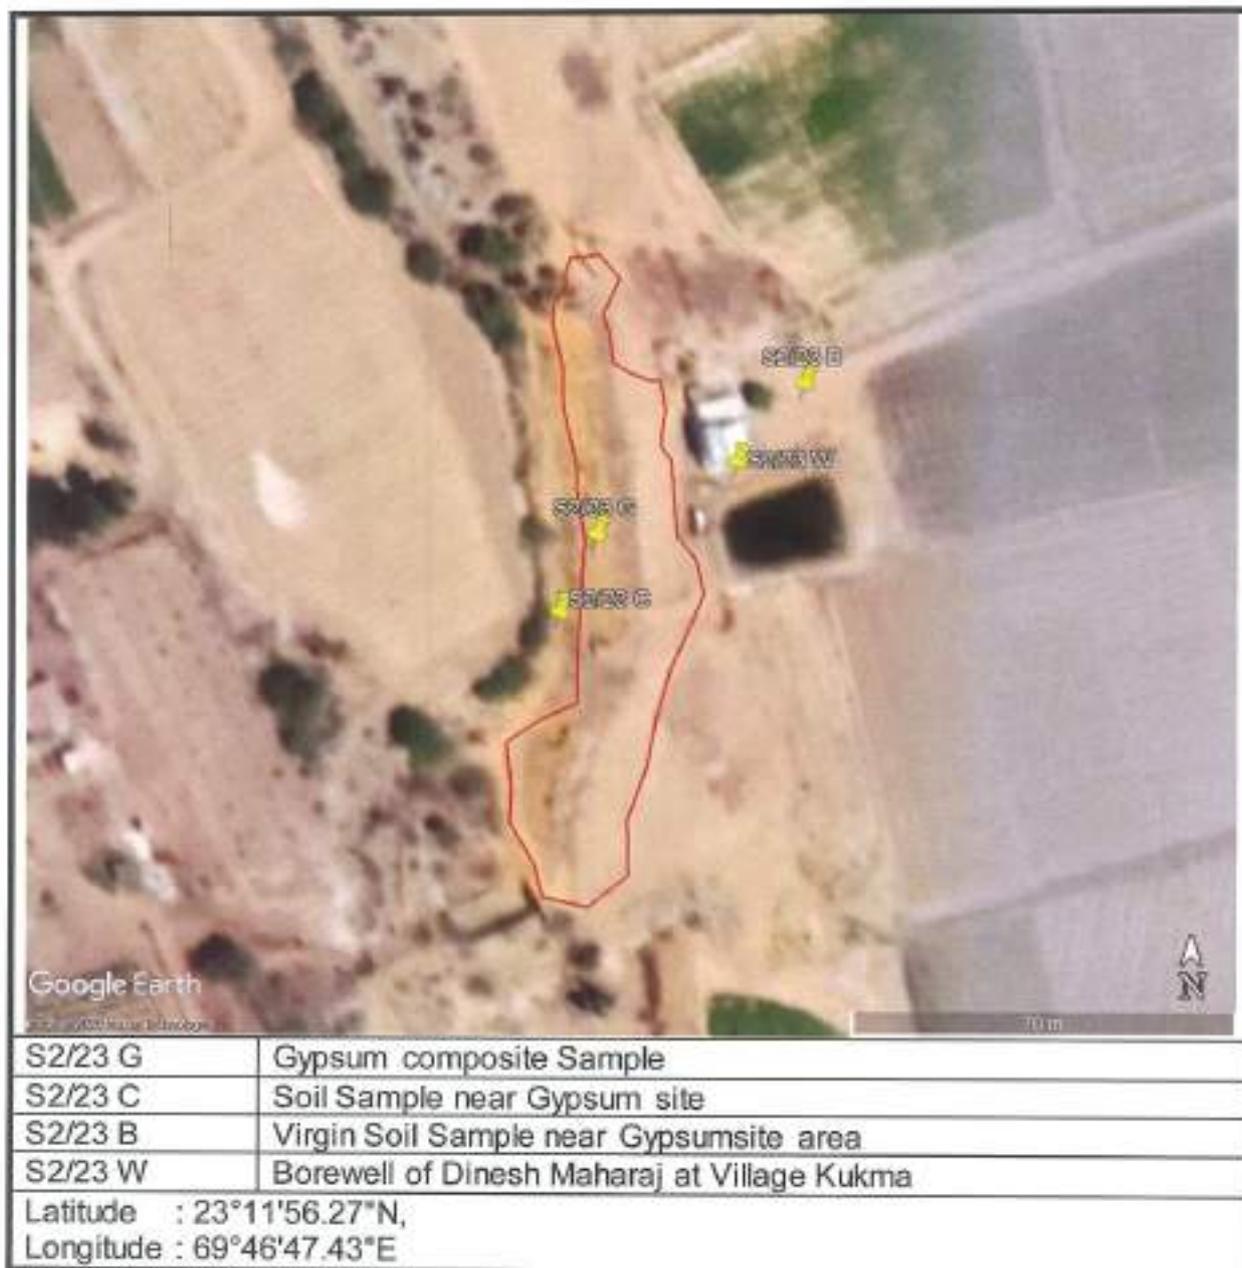
Figure No. 4.4
Site Location Map with Gypsum, Soil and water Sample of
Site-S2/23 - Natural drain between farm of Dinesh Maharaj and Govind Vankar,
Kukma Village

4.	7.	Natural drain between farm of Dinesh Maharaj and Govind Vanker, survey no : 218, Kukma Village 23° 11' 56" N 69° 46' 47" E	The site is an agricultural land. Gypsum is mixed with soil on this agricultural land. Also some Gypsum is dumped on sides of the farm for making bund. Kukma Survey No. 218 Shri Dinesh Bhailal Joshi Private Land	Gypsum is used here to provide support to embankment of farm slope which can reduce the chances of soil erosion. Majorly Gypsum is used as Soil conditioner in the farm where crops are grown already. Gypsum helps to retain the moisture which is very beneficial to crops along with providing some necessary nutrients. Removal of gypsum from farm and slope may cause damage to the farming land and lead to soil erosion from the slope of the farm.

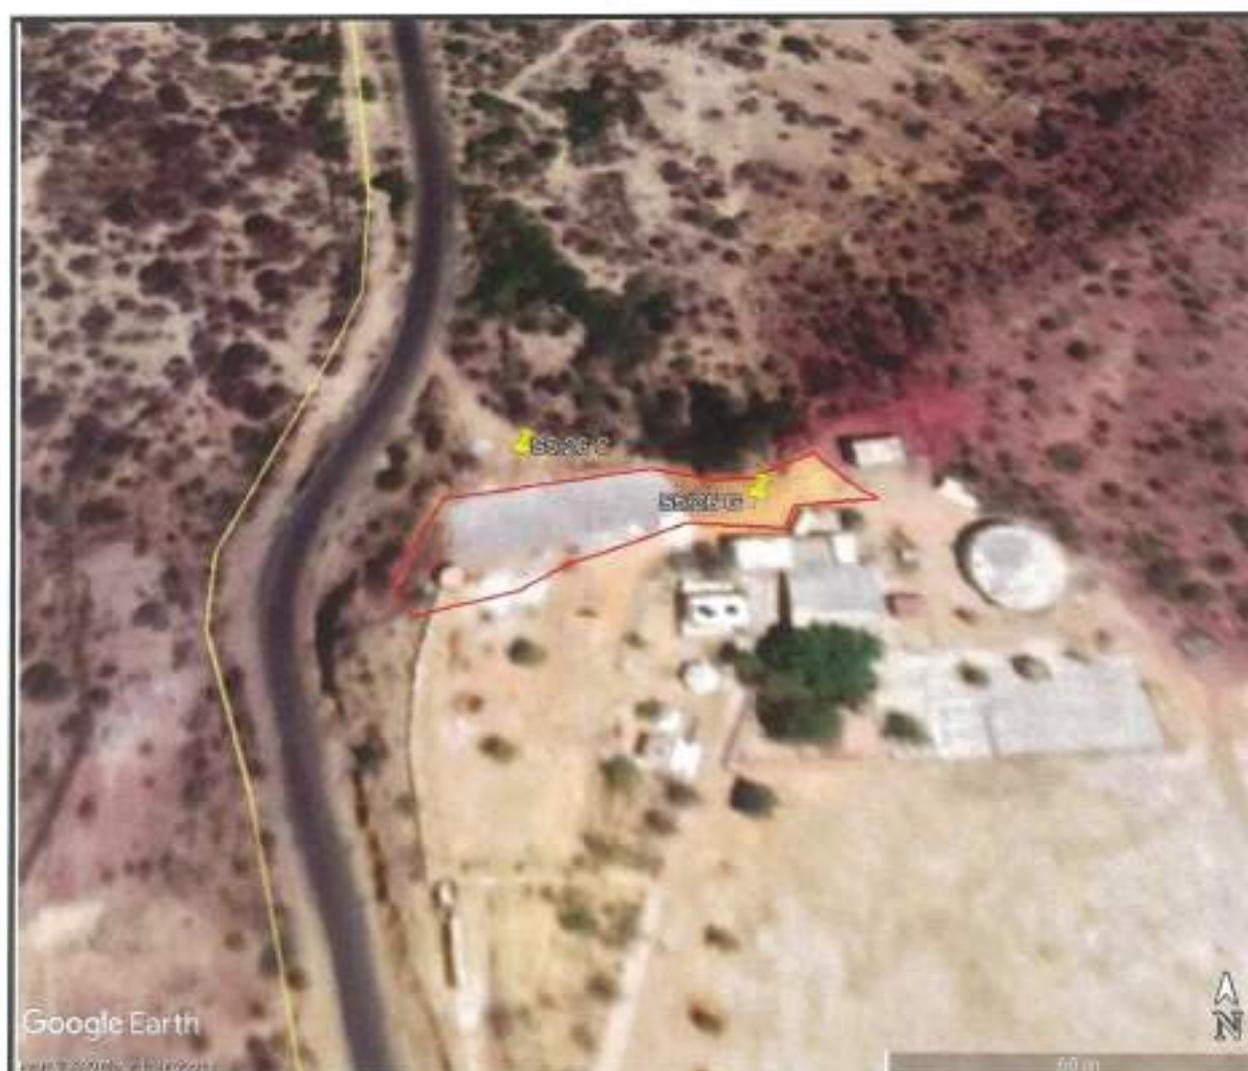
Figure No. 4.10
Site Location Map with Gypsum, Soil and water Sample of
Site-S5/26 – Pithoradada Mandir, Ler Village

11.	26.	Pithoradada Mandir, Ler Village. 23° 10' 23" N 69° 46' 05" E	The site is outer boundary of Pithoradada Mandir. Gypsum is dumped on the side slope of temple boundary. Vadva Survey No 151 Temple /Government Land	Gypsum is used to provide structural support on the hill side of temple as temple is situated on a hill. One entire side of the temple is supported by gypsum alone, thus removal of gypsum from there may cause substantial damage to the property. Gypsum is also used to level nearby area of temple on which See-Saw, Swing and Slide is constructed for recreational activities for kids. Removal of gypsum may turn the land uneven and as a consequence lead to structural damage.

S5/26 G	Gypsum Sample from 10 Different Location
S5/26 C	Soil Sample near Gypsum site area
Latitude : 23°10'23.18"N	
Longitude: 69°46'05.05"E

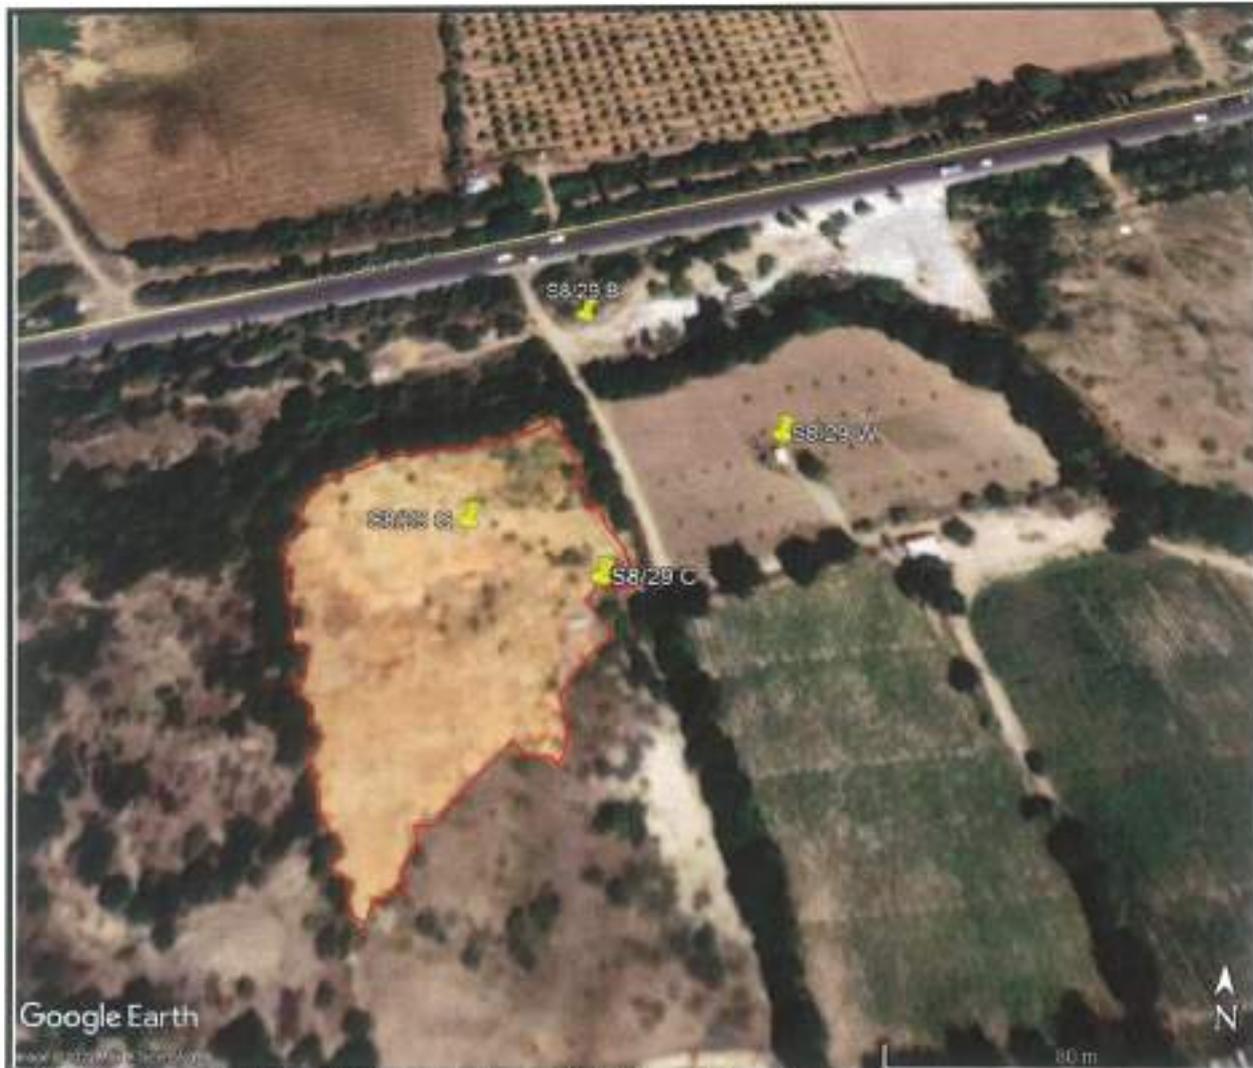
Figure No. 4.16
Site Location Map with Gypsum, Soil and water Sample of
Site-S8/29 - On Government Land, Padhdhar Village

10.	18.	Government land on Padhdhar village 23° 14' 29" N 69° 48' 44" E	The site is an abandoned location where Gypsum was found spread on top soil in about 1000 M ² area. Padhar Survey no 741/P Government Land	Gypsum was used again to level land and as it added moisture to the soil, plants and shrubs were grown, such as Babool plants etc. At present many Babool plants and other wild plants are growing which show that land is now suitable for the farming, which however, will be adversely affected after gypsum removal.

S8/29 G	Gypsum Sample from 10 Different Location
S8/29 C	Soil Sample near Gypsum site
S8/29 B	Virgin Soil Sample near Gypsumsite area
S8/29 W	Borewell at Govindbhai, Nr. Padhdhar Police Station, Vill.: Padhdhar
Latitude : 23°14'25.30"N,	
Longitude: 69°48'44.13"E

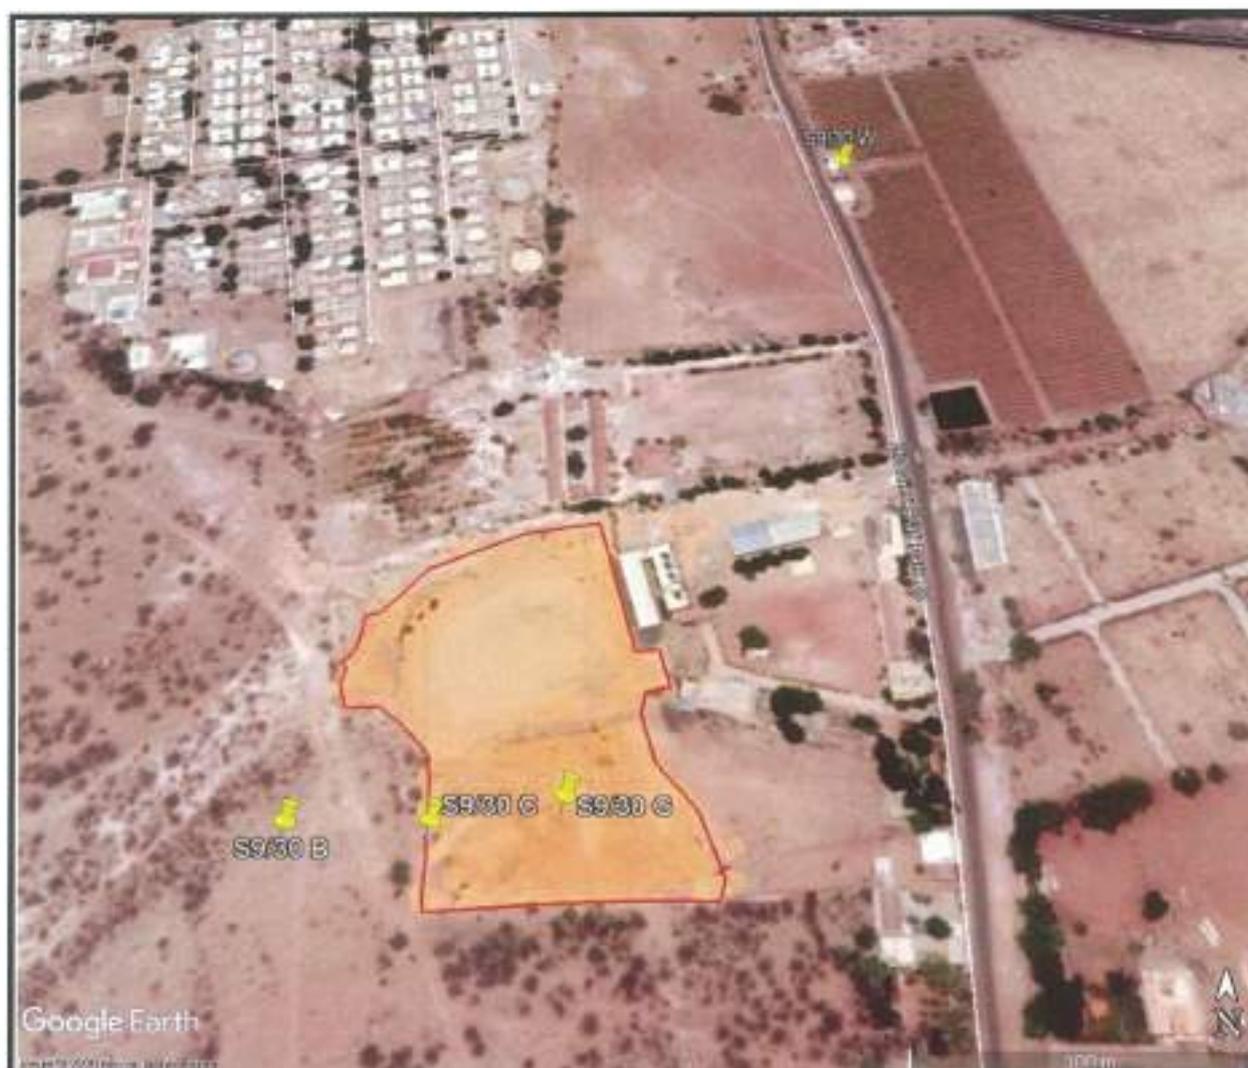
Figure No. 4.18
Site Location Map with Gypsum, Soil and water Sample of
Site-S9/30 – B/h. Mangal Mandir School, Village Bhujodi

12.	38.	Maldhari Mangal Mandir Chhatralay, Bhujodi 23° 13' 45" N 69° 44' 09" E	The site is open land of about 100 × 150 M ² . Gypsum was found spread in this land area covered with white silica on top. Bhujodi Survey No. 158 School (Waste land & Others)	Gypsum is used for leveling of land where a hostel has been constructed on one side while the whole area is being used as school playground and other sports facilities are also being developed over there such as Volley ball court etc.

S9/30 G	Gypsum Composite sample from site
S9/30 C	Soil Sample near Gypsum site
S9/30 B	Virgin Soil Sample near Gypsum site area
S9/30 W	Borewell of Jinabhai Farm opp. Mangal Mandir School at Village Bhujodi
Latitude : 23°13'45.11"N	
Longitude: 69°44'08.96"E

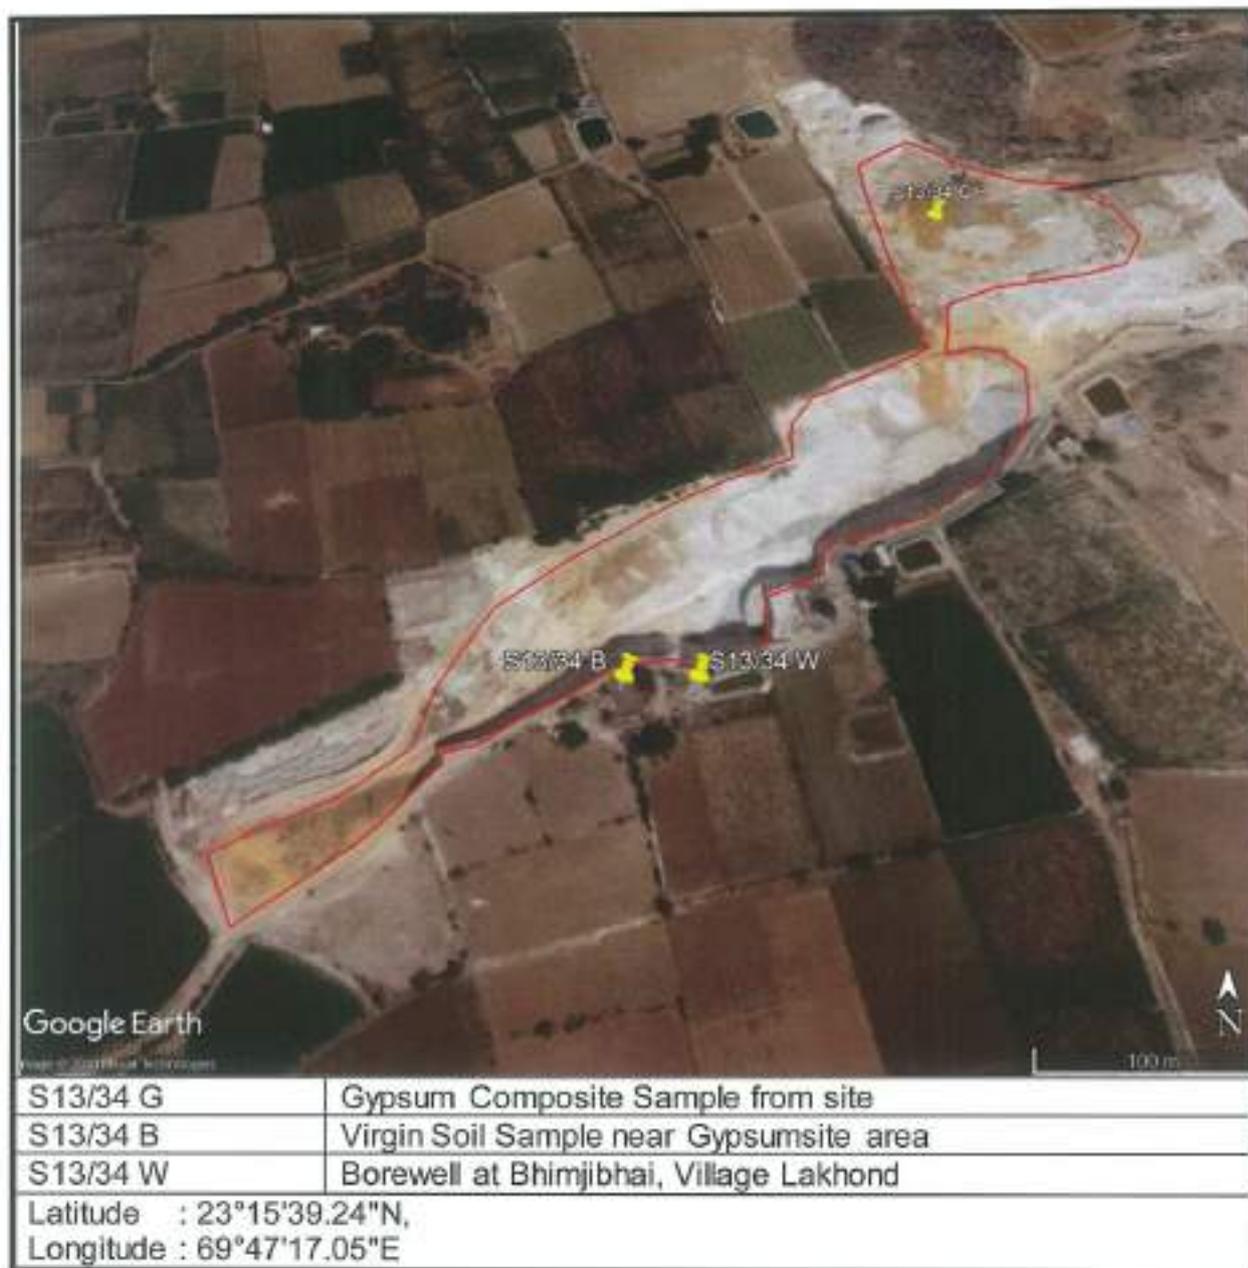
Figure No. 4.26
Site Location Map with Gypsum, Soil and water Sample of
Site-S13/34 - China Clay mine of Vastabhai, Village Lakhond, Abandoned mine

9.	17.	China Clay mine of Vastabhai, Village lakhond, Abandoned mine 23° 15' 39" N 69° 47' 17" E	The site is an abandoned china clay mine. Gypsum was observed dumped in the mine. Lakhond Mine Lease	Abandoned mines wherein Gypsum has been utilized for backfilling as per EC conditions. It is pertinent to note that as per EC condition SEIAA/ GUJ/ EC/ 2(b)/ 497/2016 Gypsum could be utilized in backfilling of abandoned mines.
