**BEFORE THE NATIONAL GREEN TRIBUNAL  
PRINCIPAL BENCH SITTING AT NEW DELHI  
ORIGINAL APPLICATION NO. 241 OF 2021**

**RESPONSE TO THE COMPLIANCE REPORT DATED 10.12.2025 OF THE  
COMMISSIONER/SECRETARY, GOVERNMENT FOREST, ECOLOGY &  
ENVIRONMENT DEPARTMENT, UT OF JAMMU & KASHMIR.**

**Subject:** Structural, hydrological and geotechnical assessment of the main bridge Chadoora site and existing bridge structure: Site visit observations and recommendations.

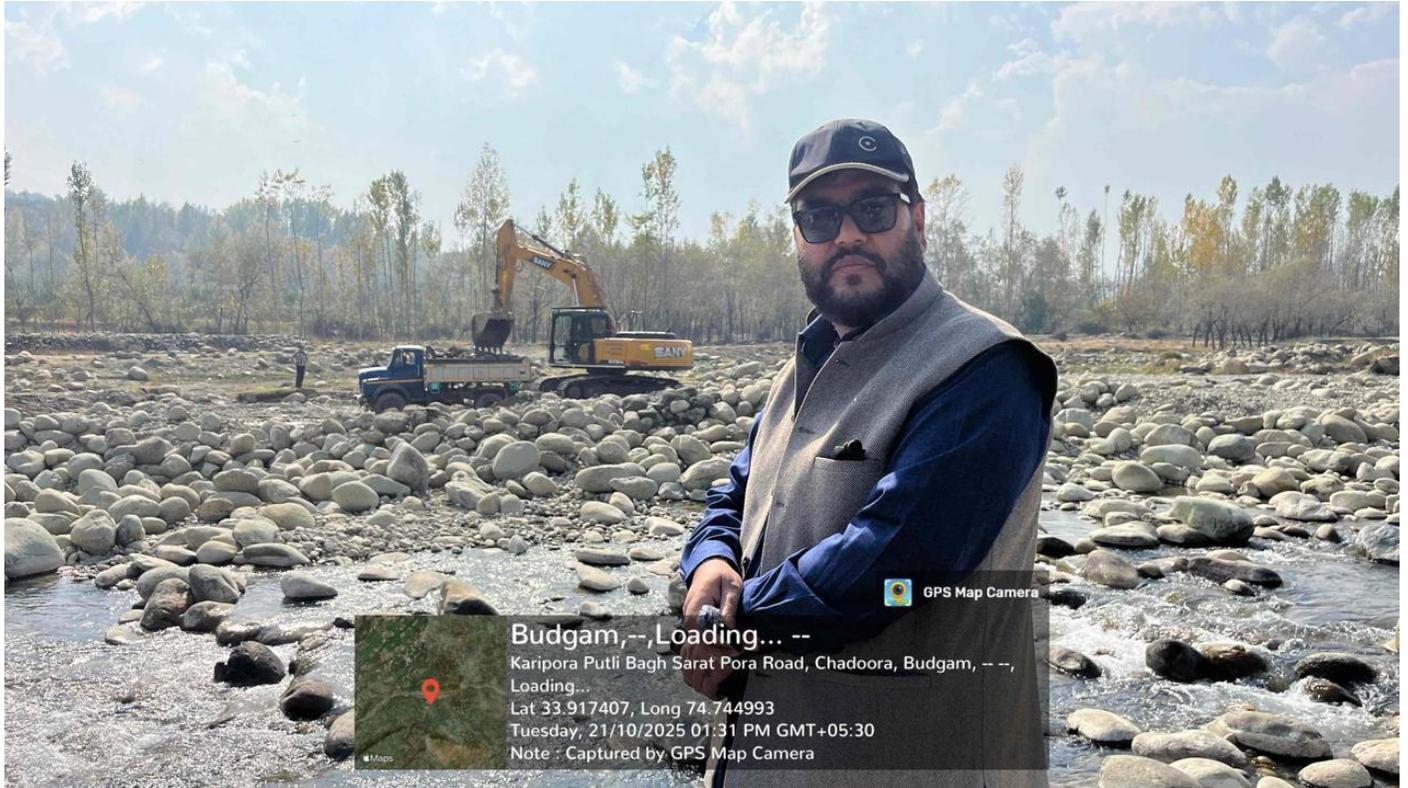
**ANNEXURE A/1**

**COPY OF THE IMAGE TAKEN BY THE APPLICANT ON 21.10.2025 SHOWS USAGE OF JCBS IN THE RIVER DOODHGANGA FOR ILLEGAL MINING IN VIOLATION OF THE HON'BLE TRIBUNAL'S ORDER:**

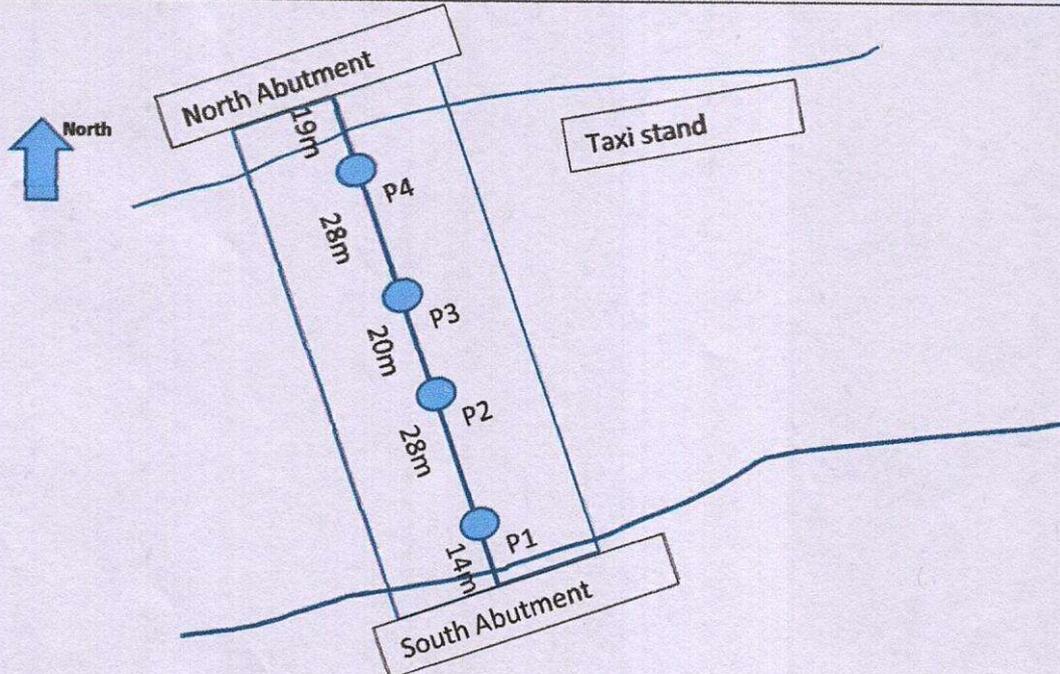
Fig. 1: Rough plan of Chadoora bridge.

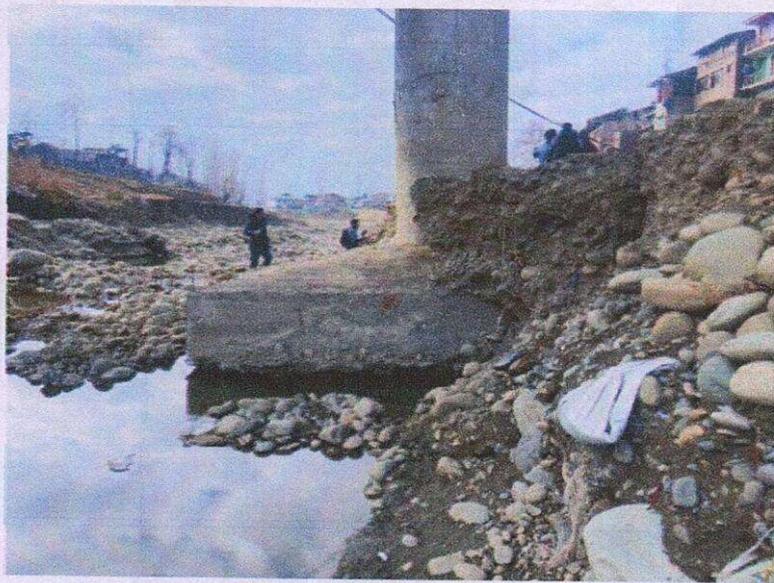
4. The foundations of piers P3 and P2 have been exposed due to the dredging of the riverbed material (Fig. 2 and Fig. 3). The material at the current foundation level consists of a boulders and gravels mixed with small amount of sand and clay. The dredging and washing away of this fine matrix have caused settlement and a loss of contact area for the foundation.

8. The affected pier, P3, sits on the isolated square footing of approximately size 6.40 m x 6.40 m x 1.2 m (D) and free edge thickness 0.8 m. Due to the tilting of the pier, the

foundation has lost part of its bearing area contact with the underlying supporting soil (Fig. 2), thereby jeopardizing safe load transfer and safe bearing pressure, as well as compromising the overturning factors of safety for the affected substructure. The foundation, in its current state, can be considered structurally unsafe, posing an imminent risk of instability.

Fig. 2: Non-uniform foundation erosion and loss of foundation contact area of the foundation

1. At the outset, minimize the load transfer from RC girder span on the affected pier P3 by way of introducing stone mounds encased with crate wire at regular intervals, 5 m c/c to prevent further tilt in the pier. The steel girder span be loaded up to design load level to prevent further tilting of the bridge.

5. Sheetpiles/cut-offs of sufficient depths below the design scour levels around the pier foundation will form an enclosed compartment, thus providing stable pier foundation conditions. The same arrangement may also be provided for the adjacent piers (Fig. 5).

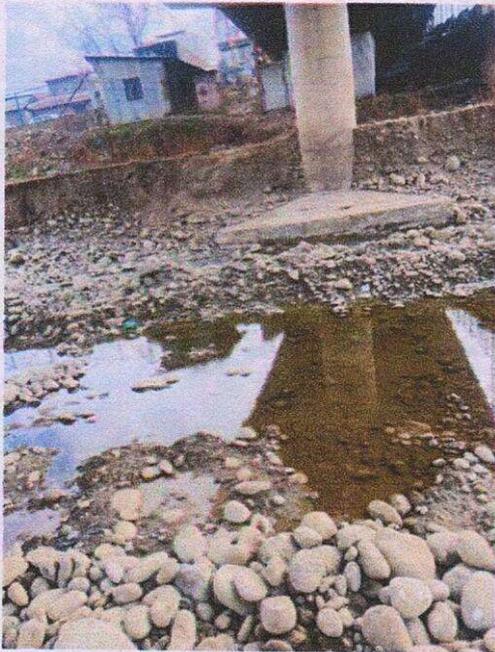
Fig. 3: Exposed foundation of the P2 and P3 due to dredging.

6. An RC mat riverbed across the waterway along with aprons on both sides of the piers with sufficient length on u/s and d/s of the pier are recommended.

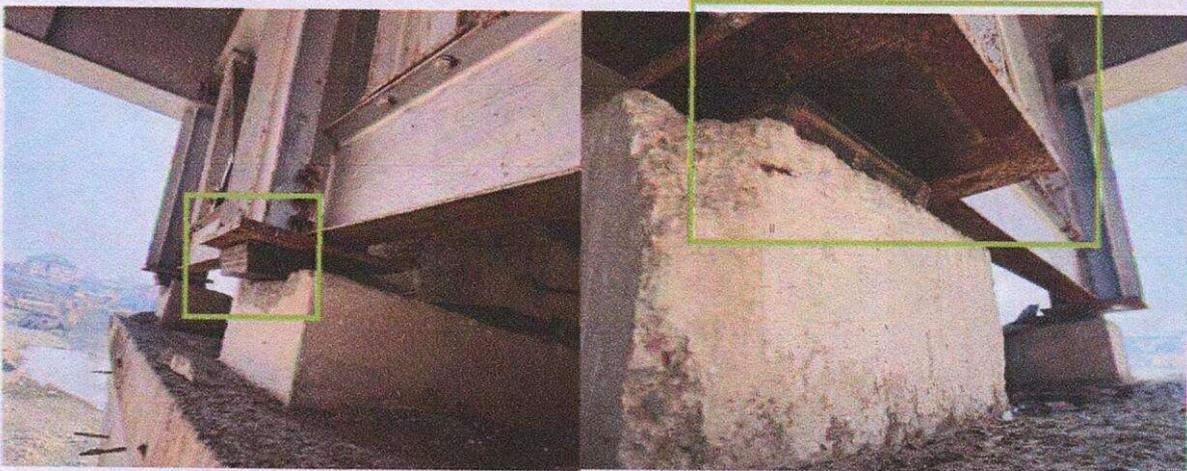
7. Under existing conditions, the elastomeric bearing on the bridge does not meet the desired constraints or provide a load-transfer mechanism to prevent the superstructure from dislodging imminently, especially during impact, ambient vibrations, or seismic events. Mandatory transverse and longitudinal reaction blocks have not been provided on the bridge structure to prevent mishaps of superstructure dislodgement. The bearings in their current state are considered unsafe for the load transfer mechanism.

Fig. 4: Misalignment of bearings (a) bearing extruding from the base, (b) Edge dislodging on the bearing

9. It is recommended to replace all the bridge bearings in the bridge with properly designed POT-PTFE bearing types that safely transfer loads from the superstructure to the substructure while allowing controlled movements and rotations.

10. Suitable and properly designed reaction blocks (for transverse and longitudinal directions) are to be designed and constructed on all piers and abutments to prevent unforeseen dislodgment of superstructures. This inherent deficiency in the existing bridge requires urgent attention to ensure the stability and safety of the individual bridge spans.
