**BEFORE THE HON'BLE NATIONAL GREEN TRIBUNAL,
PRINCIPAL BENCH, NEW DELHI**

OA No. 50/2024

Subject: Special audit report of existing legacy waste dumpsite in Municipal Council, Sirsa.

“Assessment Report of Special audit of sites of Bioremediation of legacy waste in Municipal Council, Sirsa”

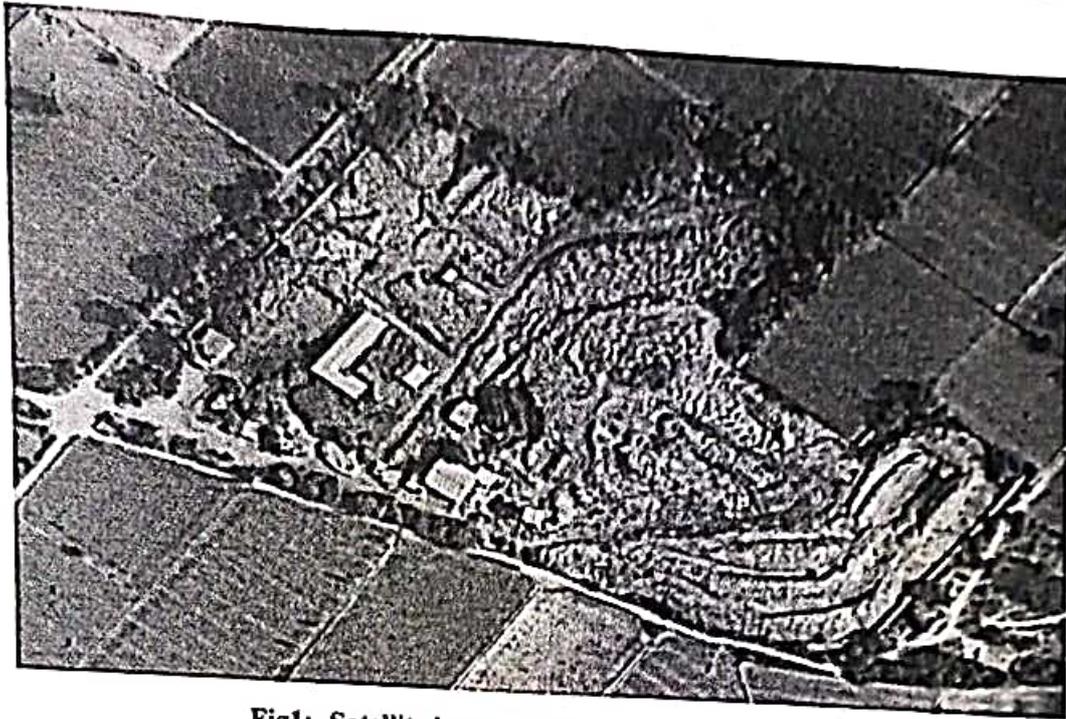
Fig1:- Satellite image of Bakariyawala, M.C, Sirsa

Sirsa city is a municipal council located in Haryana. It is at a distance of 260 km NW of New Delhi and 240 km from the state capital of Chandigarh. The dumping site for the residential waste is located in the village of Bakariyawala, Sirsa. The coordinates of the location are $29^{\circ}24'50''$ N and $74^{\circ}59'28''$ E.

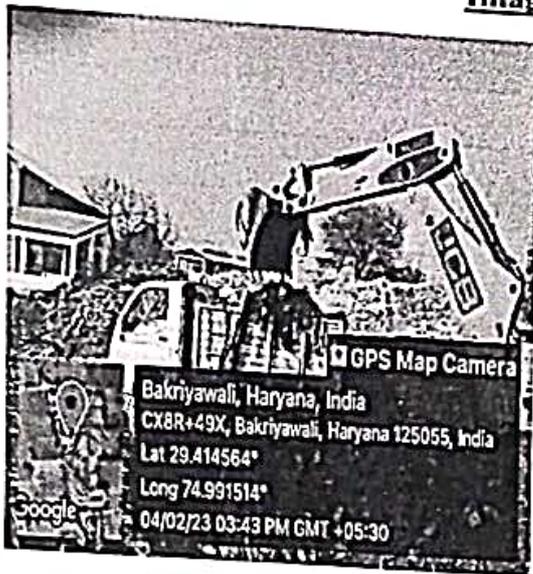
(i) Excavation process at the site

- (ii) **Height** - The height of garbage above and below the ground is the average value of the measured garbage height at five points at the site. For underground depth was obtained by the JCB machine scratches the area until soil is visible.

1. Zone -1: The heights of windrows vary from 0.50 m to 3m. Average height is 2.5m.
 2. Zone -2: The heights of windrows vary from 3 m to 8m. Average height is 7.4 m.
 3. Zone -3: The heights of windrows vary from 8 m to 13m. Average height is 11.5m.
- Underground depth varies from 0 to 6m. Average depth is 3.5m.

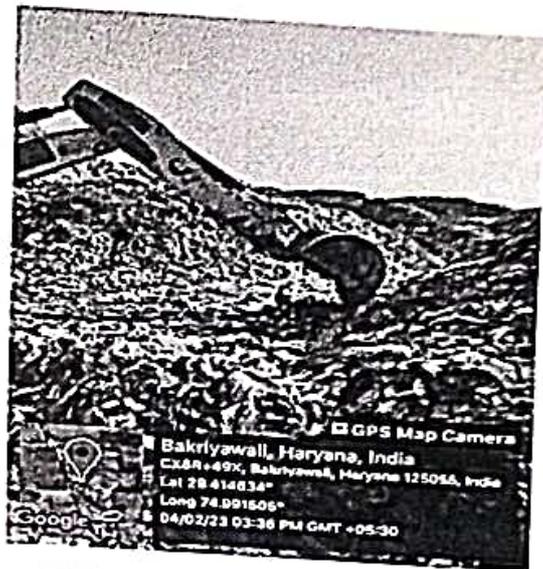
(ii) Excavation process at the site

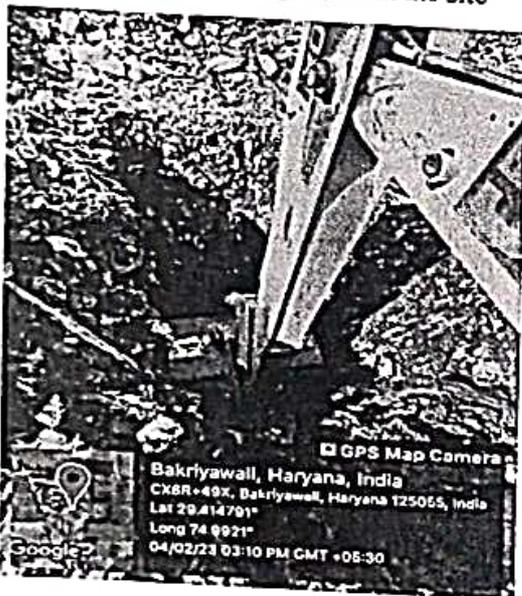
(ii) Excavation process at the site
