**BEFORE THE NATIONAL GREEN TRIBUNAL,
WESTERN ZONE BENCH, AT NAGPUR**

**ORI. APPLICATION NO. 28/2024(WZ)
Earlier Application No. 796/23(WZ)**

**REPLY ON BEHALF OF THE PETROLEUM &
EXPLOSIVES SAFETY ORGANISATION (PESO)
THE RESPONDENT NO: 4 HEREIN**

Sub: Explosion occurred on 17/12/2023 at 9.00 AM in the explosives manufacturing unit of M/s Solar Industries India Ltd. located at Survey No: 75, 78, 79, 81, 82, 83, 39, 40, 71, 38, 1, 3, 8/1, 8/2, 31, 37, 70, 72, 73/1 in HMX / RDX Compounded Product Pellet Casting House (HR-CPCH-2), Chakdoh & Bazargaon, Nagpur, Maharashtra covered under licence No. E/HQ/MH/20/98 (E113453) in Form LE-1 of the Explosives Rules, 2008, Killed: 9, Injured: Nil, Accident Investigation- Regarding.

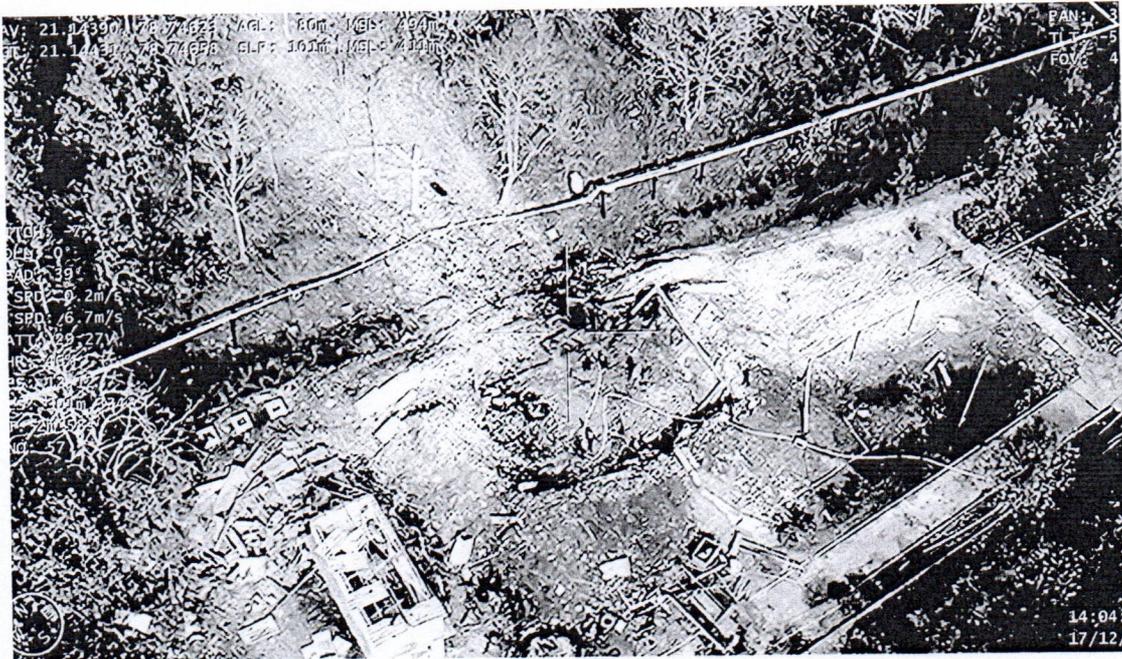
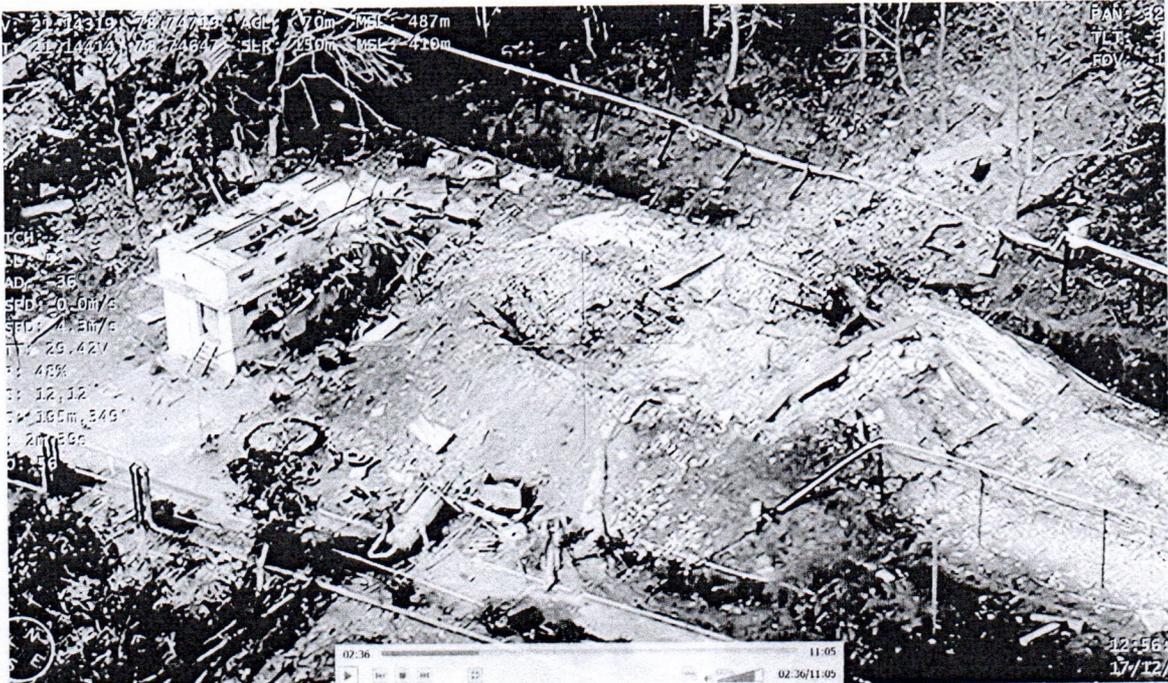
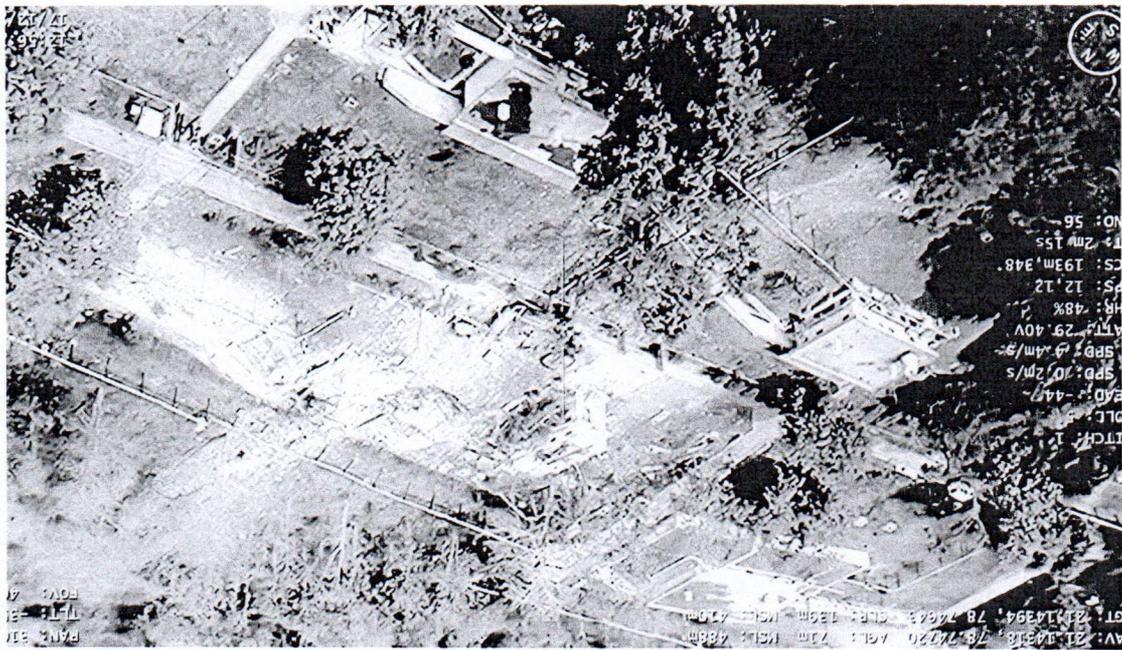
Annexure-2 The photographs of the Accident Site. **469**

The entire building was found razed to ground in the explosion. Mangled machinery and debris was found scattered within the radius of approximately 500 meters. The internal walls of the mounds on the sides other than north side were found partially damaged. The mound on the north side of the building was found completely damaged. The machinery provided in the building was found in mangled state and scattered all around the accident site. Utility pipelines near the building as well as those entering into the building including steam pipelines were found damaged. A building located at a distance of three meters from the outer edge of the mound on west direction was also found damaged.

Unexploded TNT was observed approximately two meters inside from entrance of the building near the mound of north direction. Fire marks were also noticed on the inner wall of the mound and black soot was found deposited on the wall underneath of which unexploded TNT was observed. Two dead bodies & some body parts were also observed near the said entrance.

- No crater was observed on the floor of the building.
- The mound on the north side was completely damaged and debris was thrown in north direction.
- The roof over room C of the building (main process area) was blown off and beams were found collapsed.
- The roof over room A and B of building was found collapsed and damaged slab was found lying over the same place.
- Internal walls of mounds in east, west and south directions found partially collapsed.
- Unexploded TNT was found approximately two meters away from the entrance on the north side of the building.

- The debris including RCC beams of the building were found lying on the north and east sides where the entry passage to the building was located.
