BEFORE THE HON'BLE NATIONAL GREEN TRIBUNAL**WESTERN ZONE BENCH, PUNE, AT PUNE****ORIGINAL APPLICATION NO. 03 OF 2020**Devraj Bhatia and another ... **APPLICANT**

SR NO	ANNEXURE	PARTICULARS	PAGE NOS.	
			From	To
1.		Reply to report on behalf of Applicant No.1	171	187
2.		Affidavit in Support	188	189
3.	A-1	Collectively Copy of Existing Land Usage (ELU) Map, layout of the area from the relevant portion of ELU Map prepared by the PMC and satellite view of encroached stream	190	192
4.	A-2	Copy of the relevant portions of the Proposed Land Usage(PLU) map	193	193
5.	A-3	Copy of Relevant portion of the Final Development Map of area	194	194
6.	A-4	Copy of Relevant Portion of Primove Stream Survey map of the location	195	195
7.	A-5	Copy of terrain map of the hill range	196	196
8.	A-6	Copy of relevant pages of the TERI report	197	200

Rough Cross-section of the Stream, adjoining properties and effect of encroachment of streambed by road

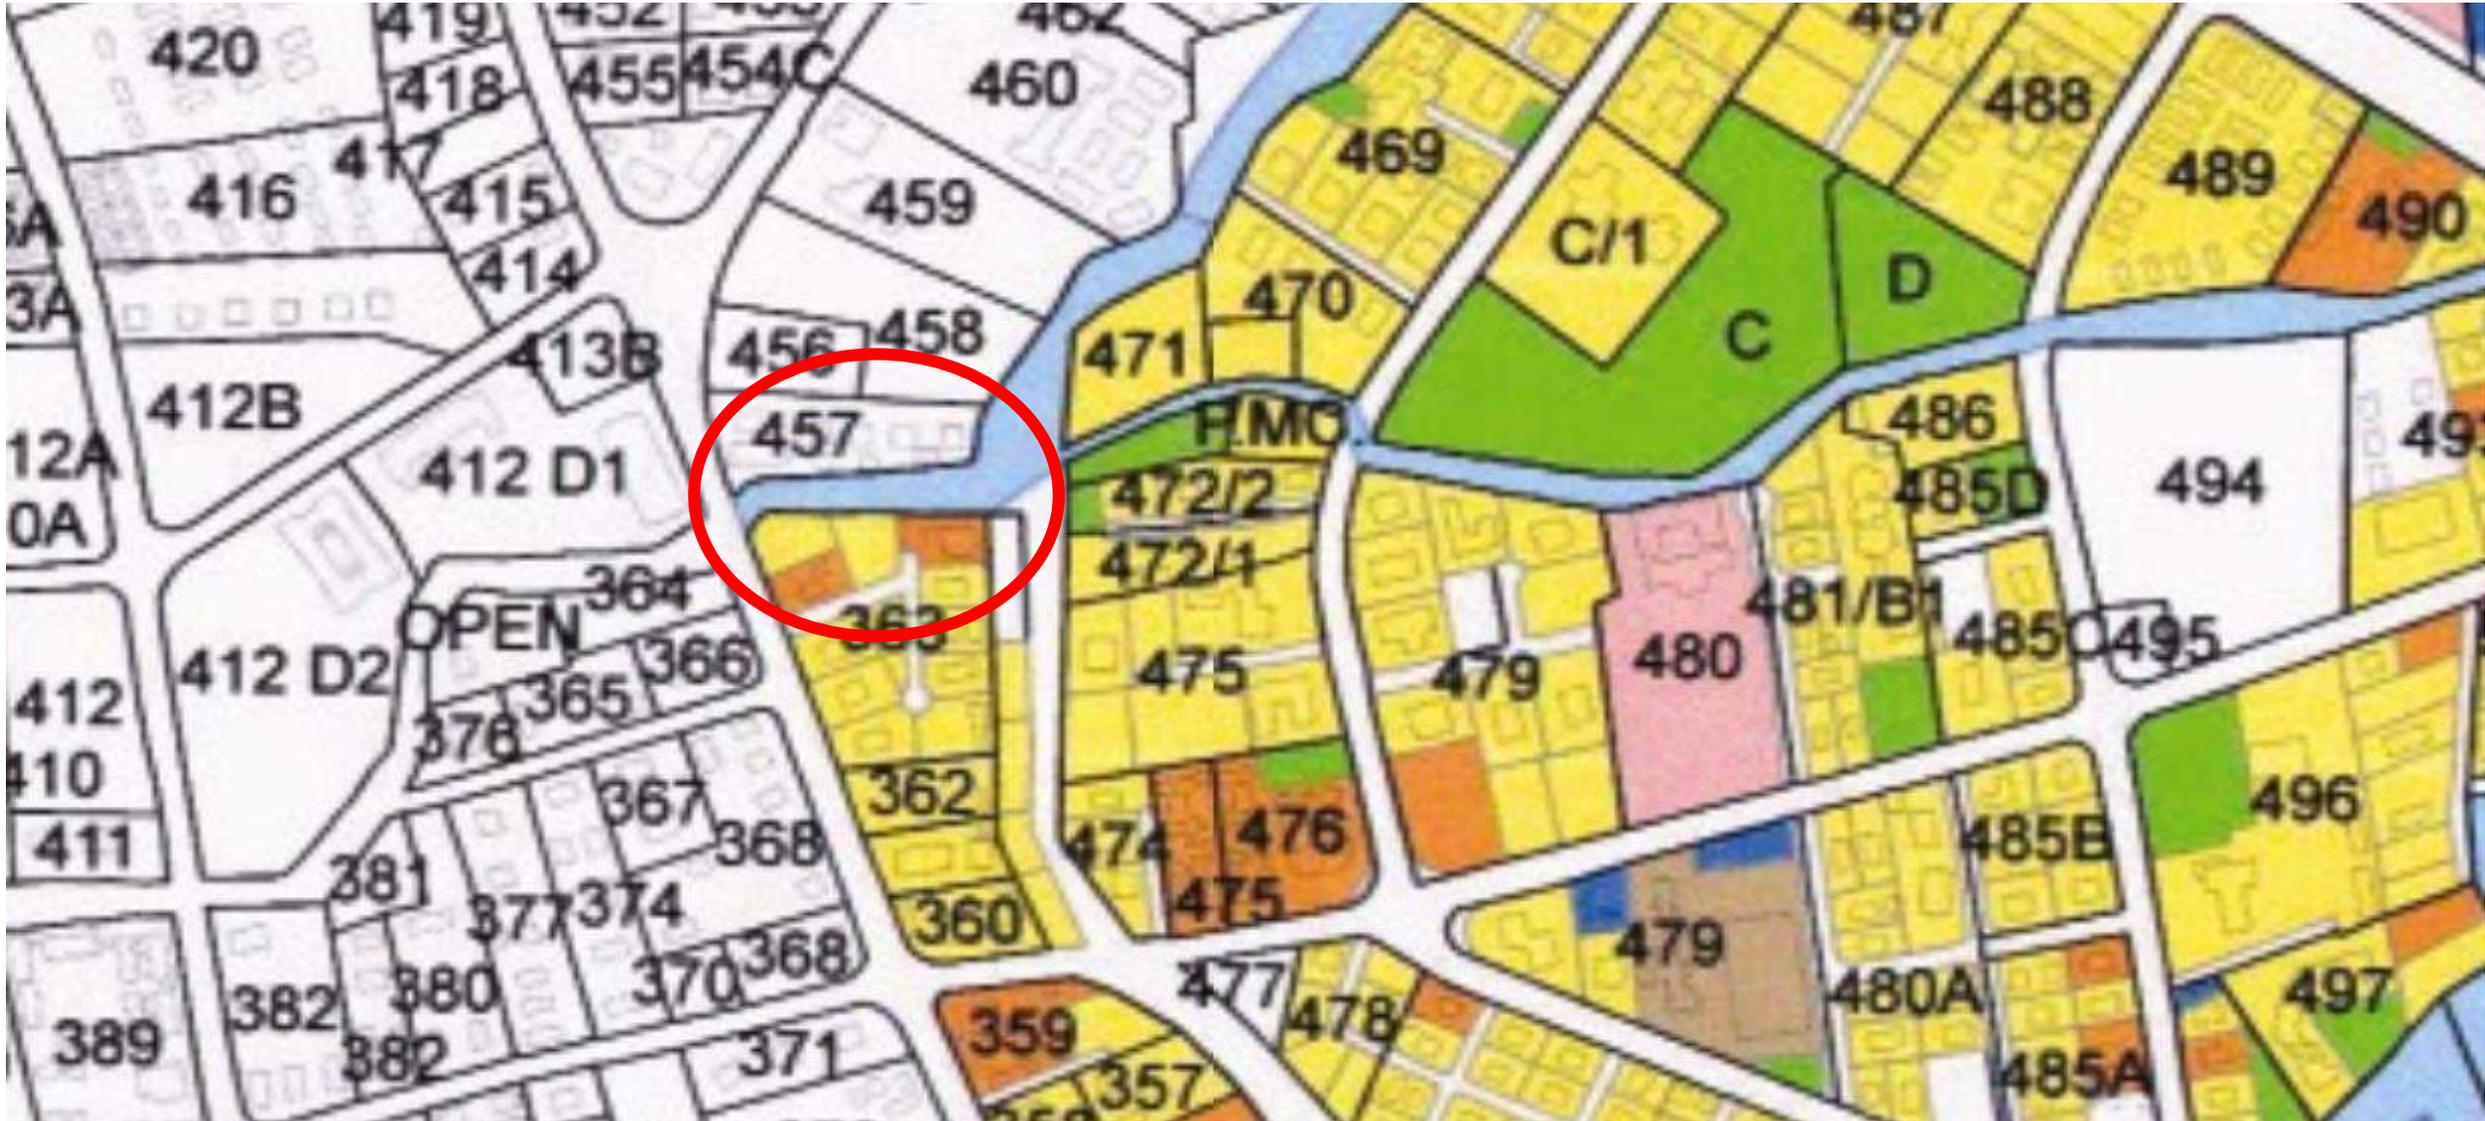
Annexure A-1 (Colly)

Zoom of Existing Land Use Map for Proposed Development Plan (Affected Area Circled)

5. The Respondent No.1 has prepared the existing land use (ELU) map for the Pune City in and around 2008 and 2009. ELU Maps are the base maps on which the Development Plan maps are prepared. In the said map, the existing land use clearly shows that, there is a Nala, which passes through the southern boundary of land, Survey No.457, Shivajinagar, Pune. No road is to be seen in the ELU. The ELU is annexed. In fact, in its own report titled 'Draft DP 2007-2027 ELU' the Respondent No.1, has acknowledged several times the importance of the Nalas as storm water corridors and that these should be free from encroachments.

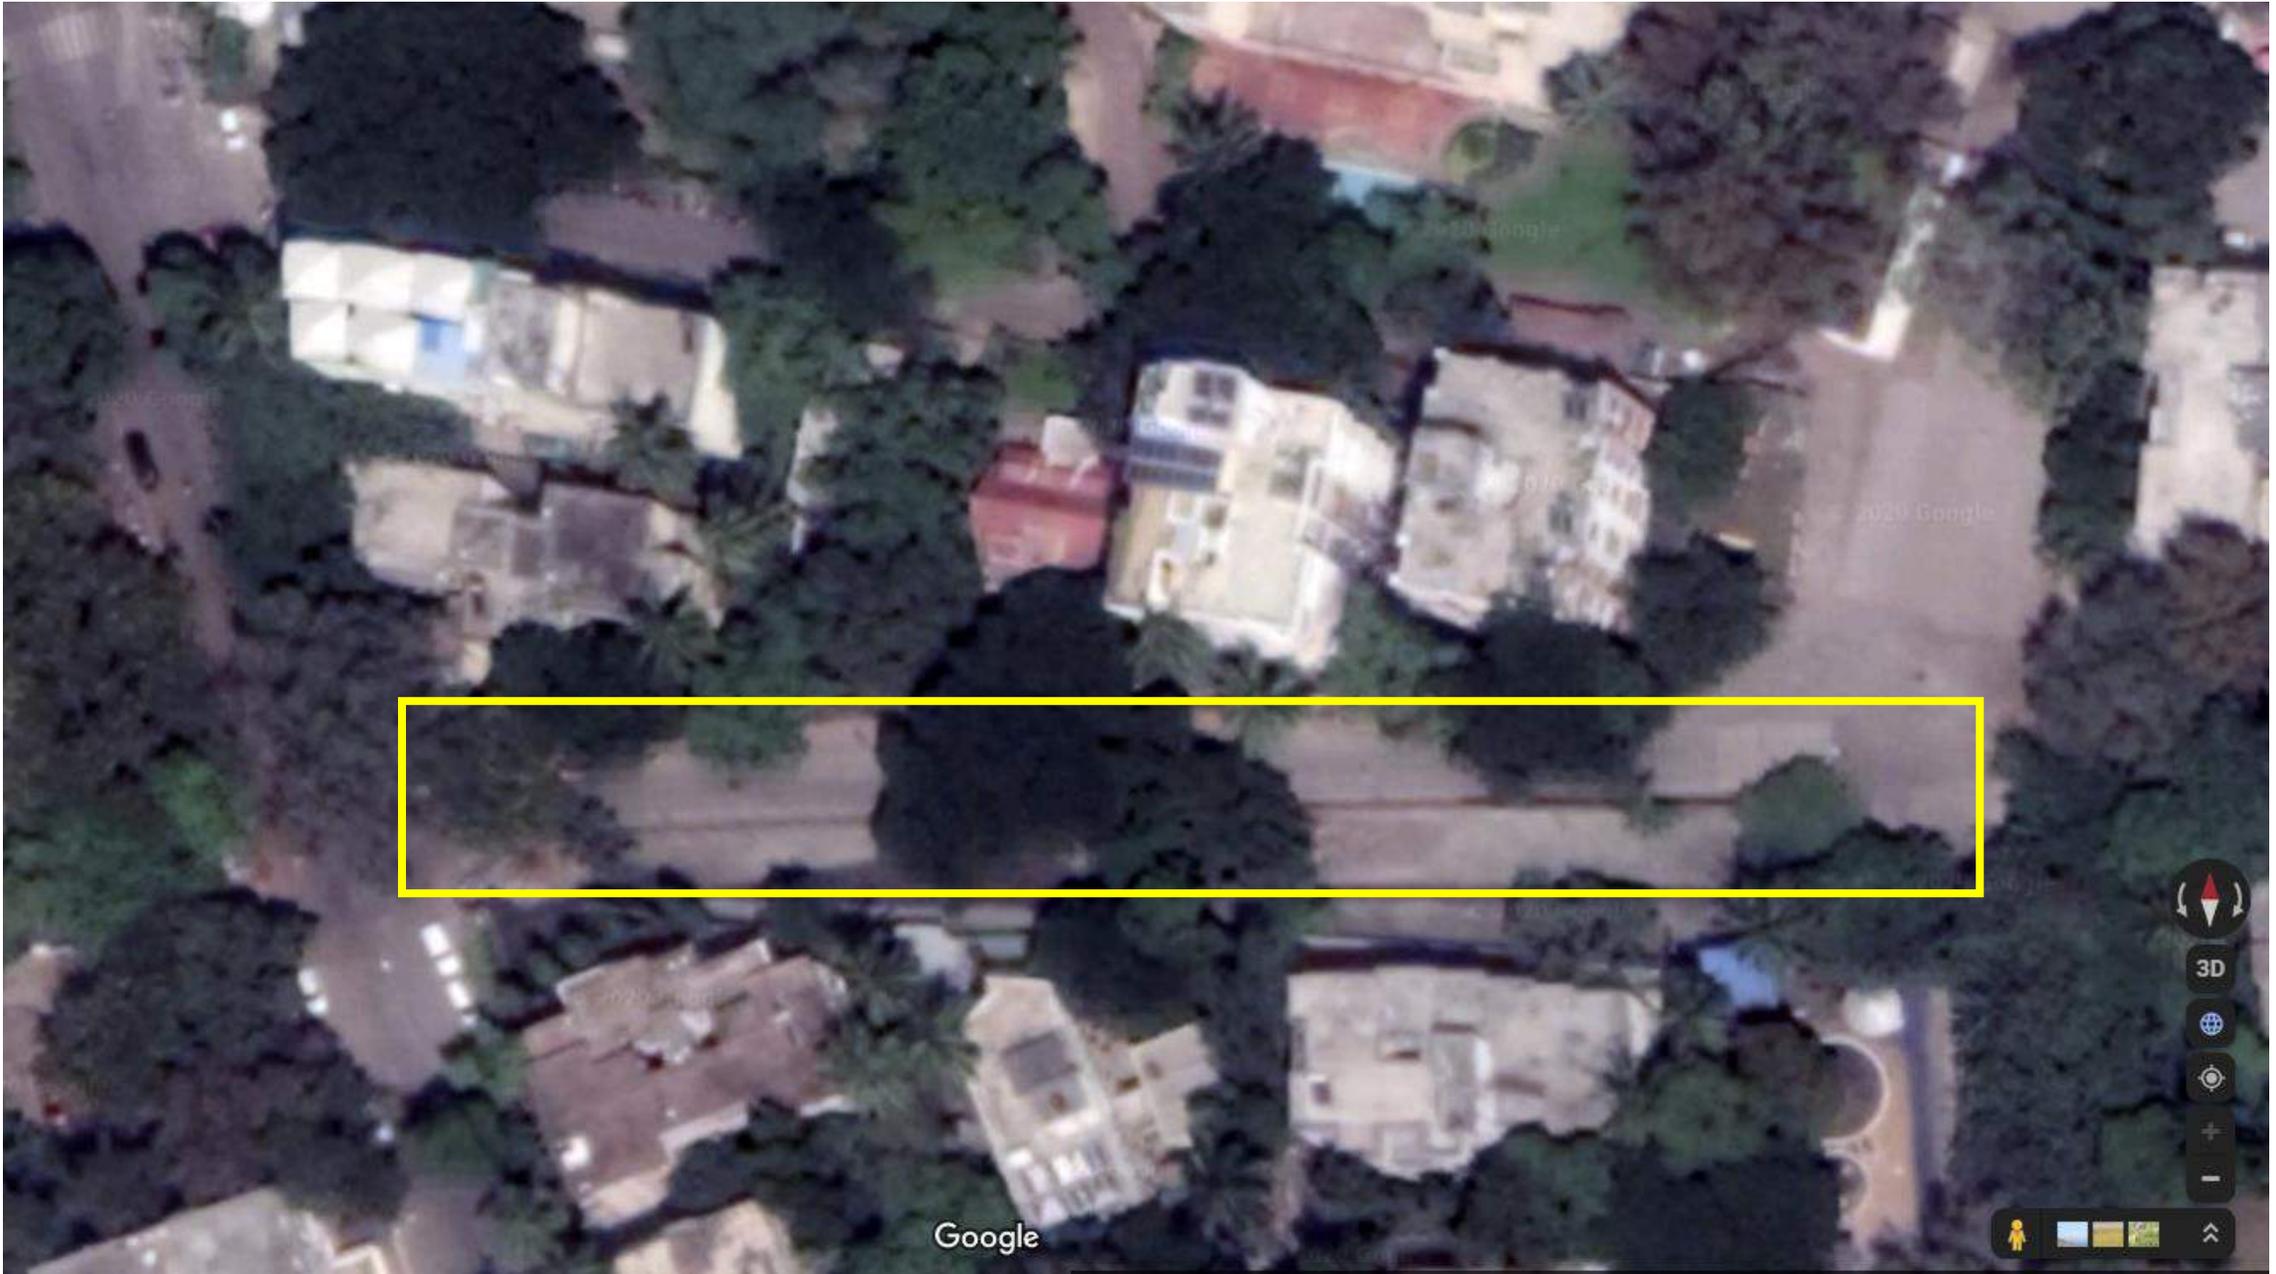
Satellite view of encroached stream

4. The Applicants submit that a road of length 130 meters has been constructed on the streambed and the road is passing between Survey No.457, Shivajinagar, Pune and the stream. The stream originates about 1.5 km away from the base of Bhamburda Hill Range. The stream is on the South of the Road and flows from West to East. Survey No.457, Shivajinagar, Pune, where six buildings are constructed, is on the North side of the road. The layout of the area where the road is constructed can be seen from the relevant portion of Existing Land Usage (ELU) Map prepared by the PMC. Copy of the ELU Map, relevant portion of the ELU map and a satellite view of the encroached stream are annexed hereto and collectively marked as **ANNEXURE A-1**.

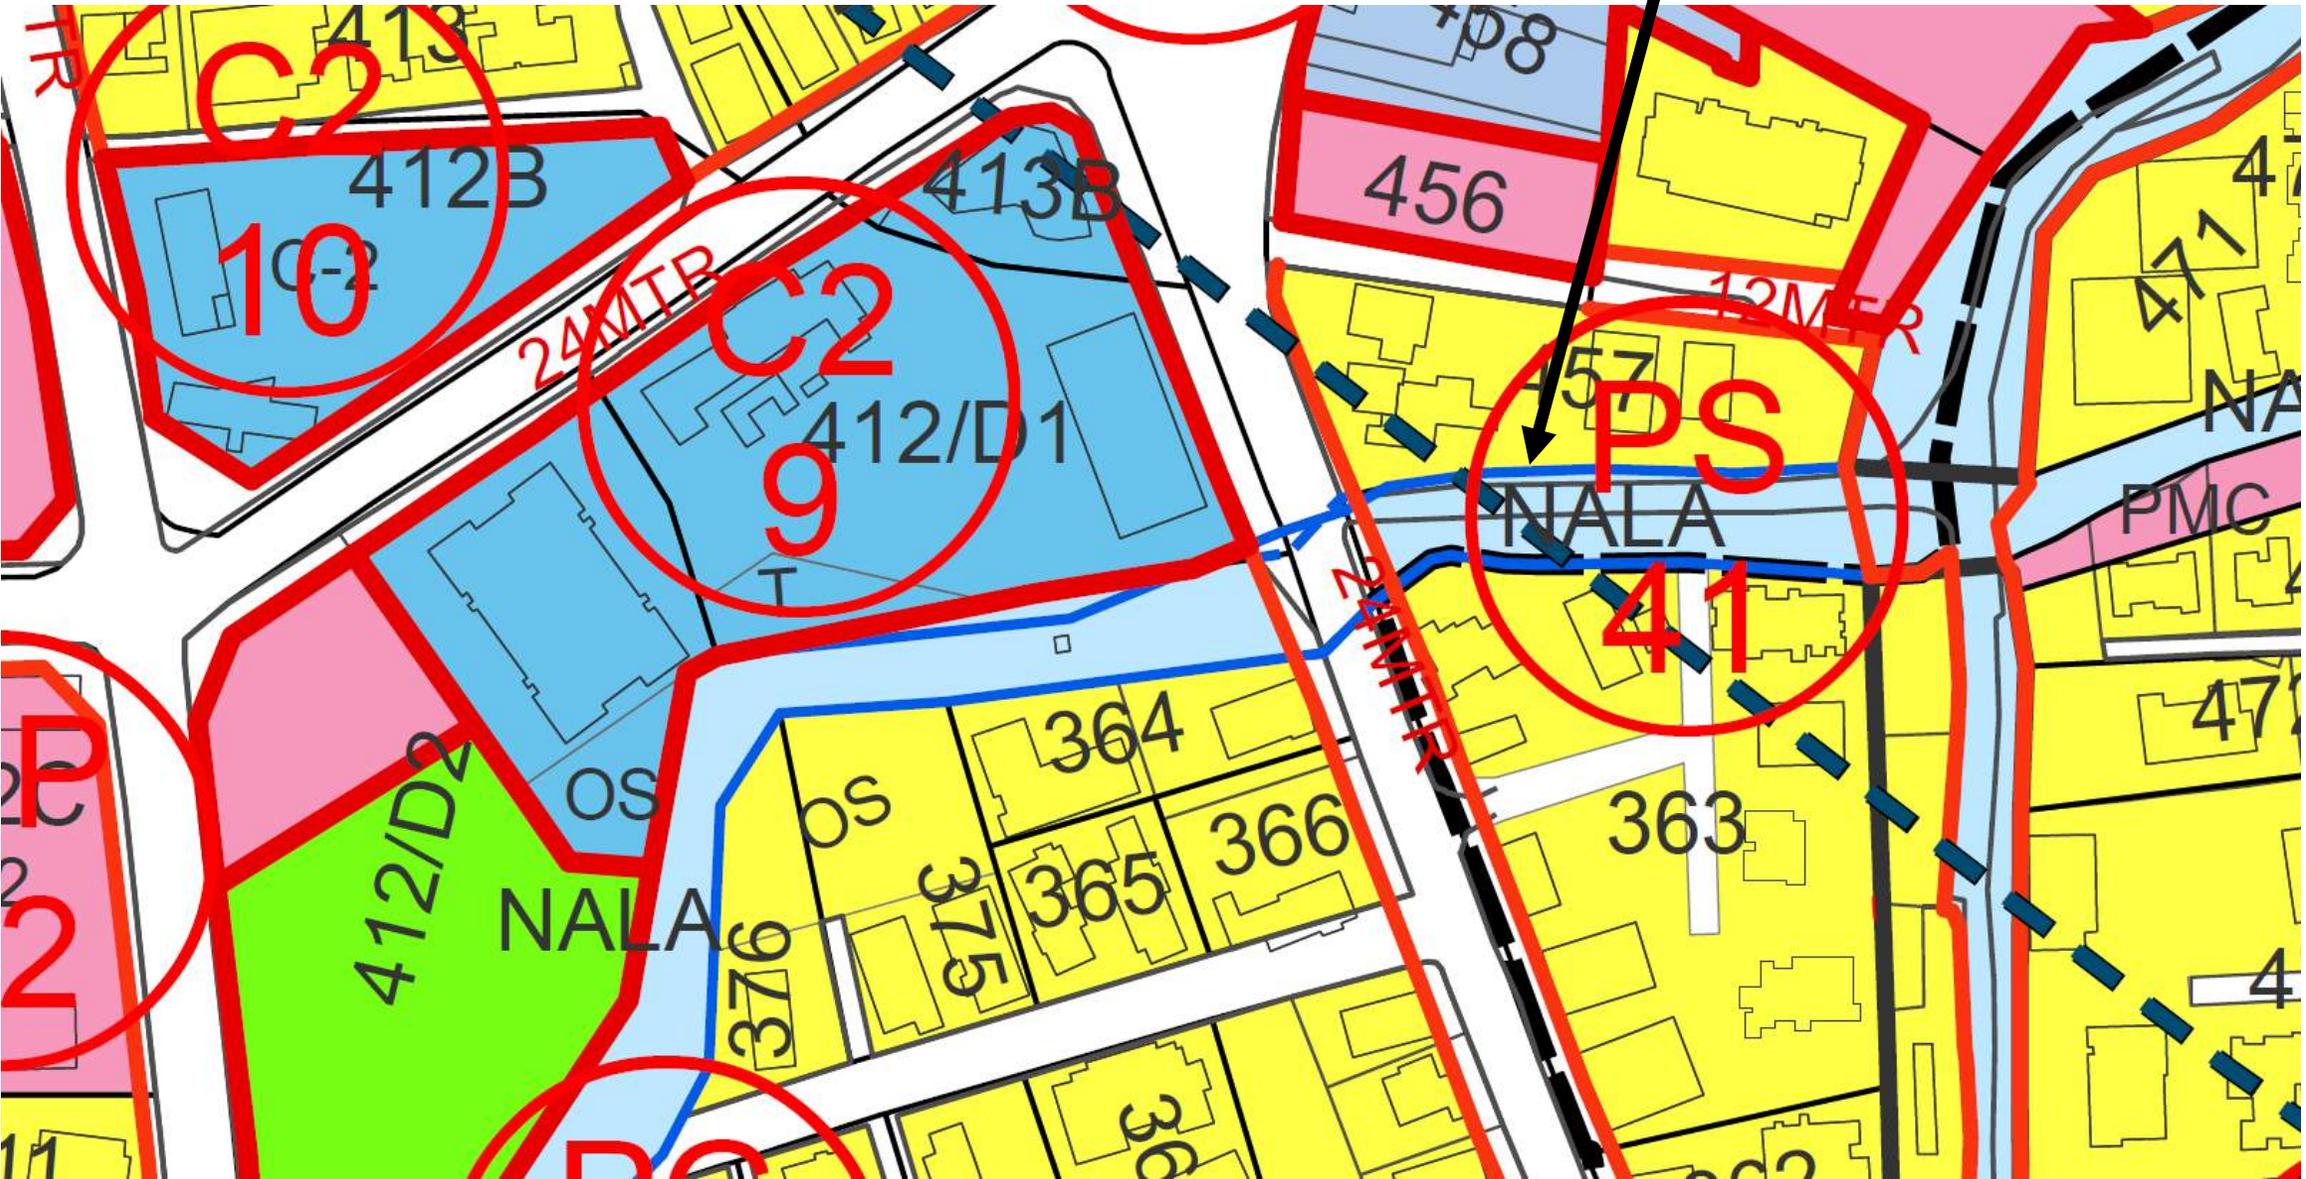
Annexure A-2

Zoom of Proposed Land Use Map showing the stream in blue marked as NALA. Note (arrow) the left bank of NALA touches south boundary of Survey Number 457

6. The Applicants submit that after preparation of the ELU, the Respondent No.1 prepared the proposed land use (PLU) maps. The map represented the land use proposed by the Respondent No.1 at the particular survey number or relevant portion of the land. In the said PLU also, the left bank of the stream is up to the southern boundary of the land in Survey No.457, Shivajinagar, Pune. It clearly shows that no road was proposed between stream and Survey No.457, Shivajinagar, Pune when the Respondent No.1 prepared the Proposed Land Use Maps. Copy of the relevant

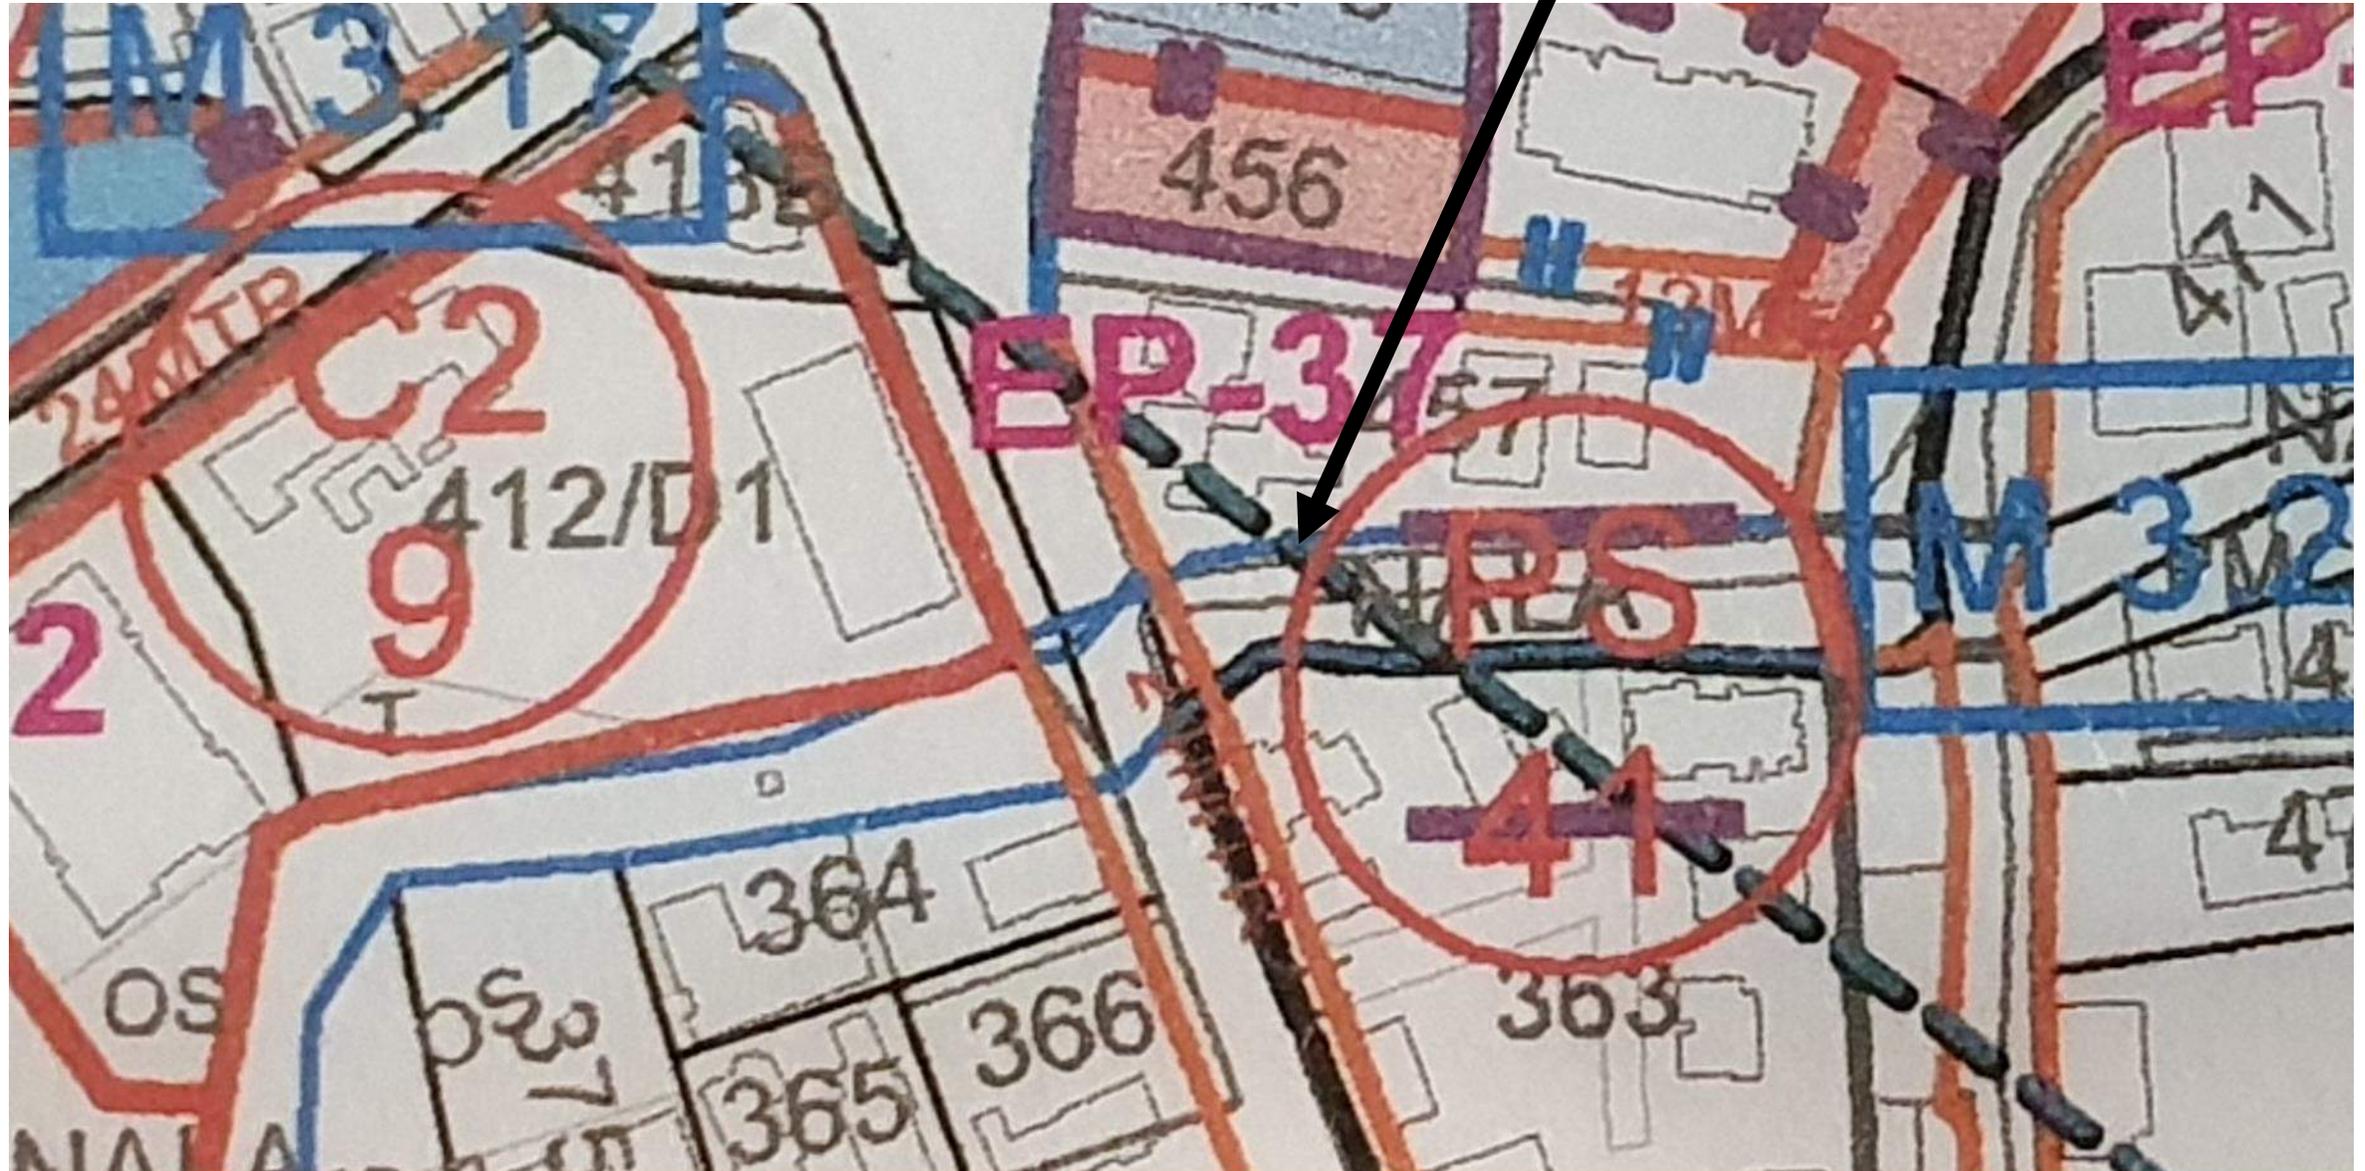
Zoom of Final Development Plan Showing the stream marked as NALA. Note (Arrow) the left bank of NALA touches south boundary of Survey Number 457

7. The Applicants submit that the Respondent No.1 thereafter published its Development Plan, which was finalized by the Govt. of Maharashtra and the same was issued on or around 5th January 2017. In the final Development Plan as well, the left bank of the stream is up to the southern boundary of Survey No.457, Shivajinagar, Pune as seen by the blue boundaries of the Nala. Copy of the relevant portion of the Development Plan is annexed hereto and marked as **ANNEXURE – A-3.**

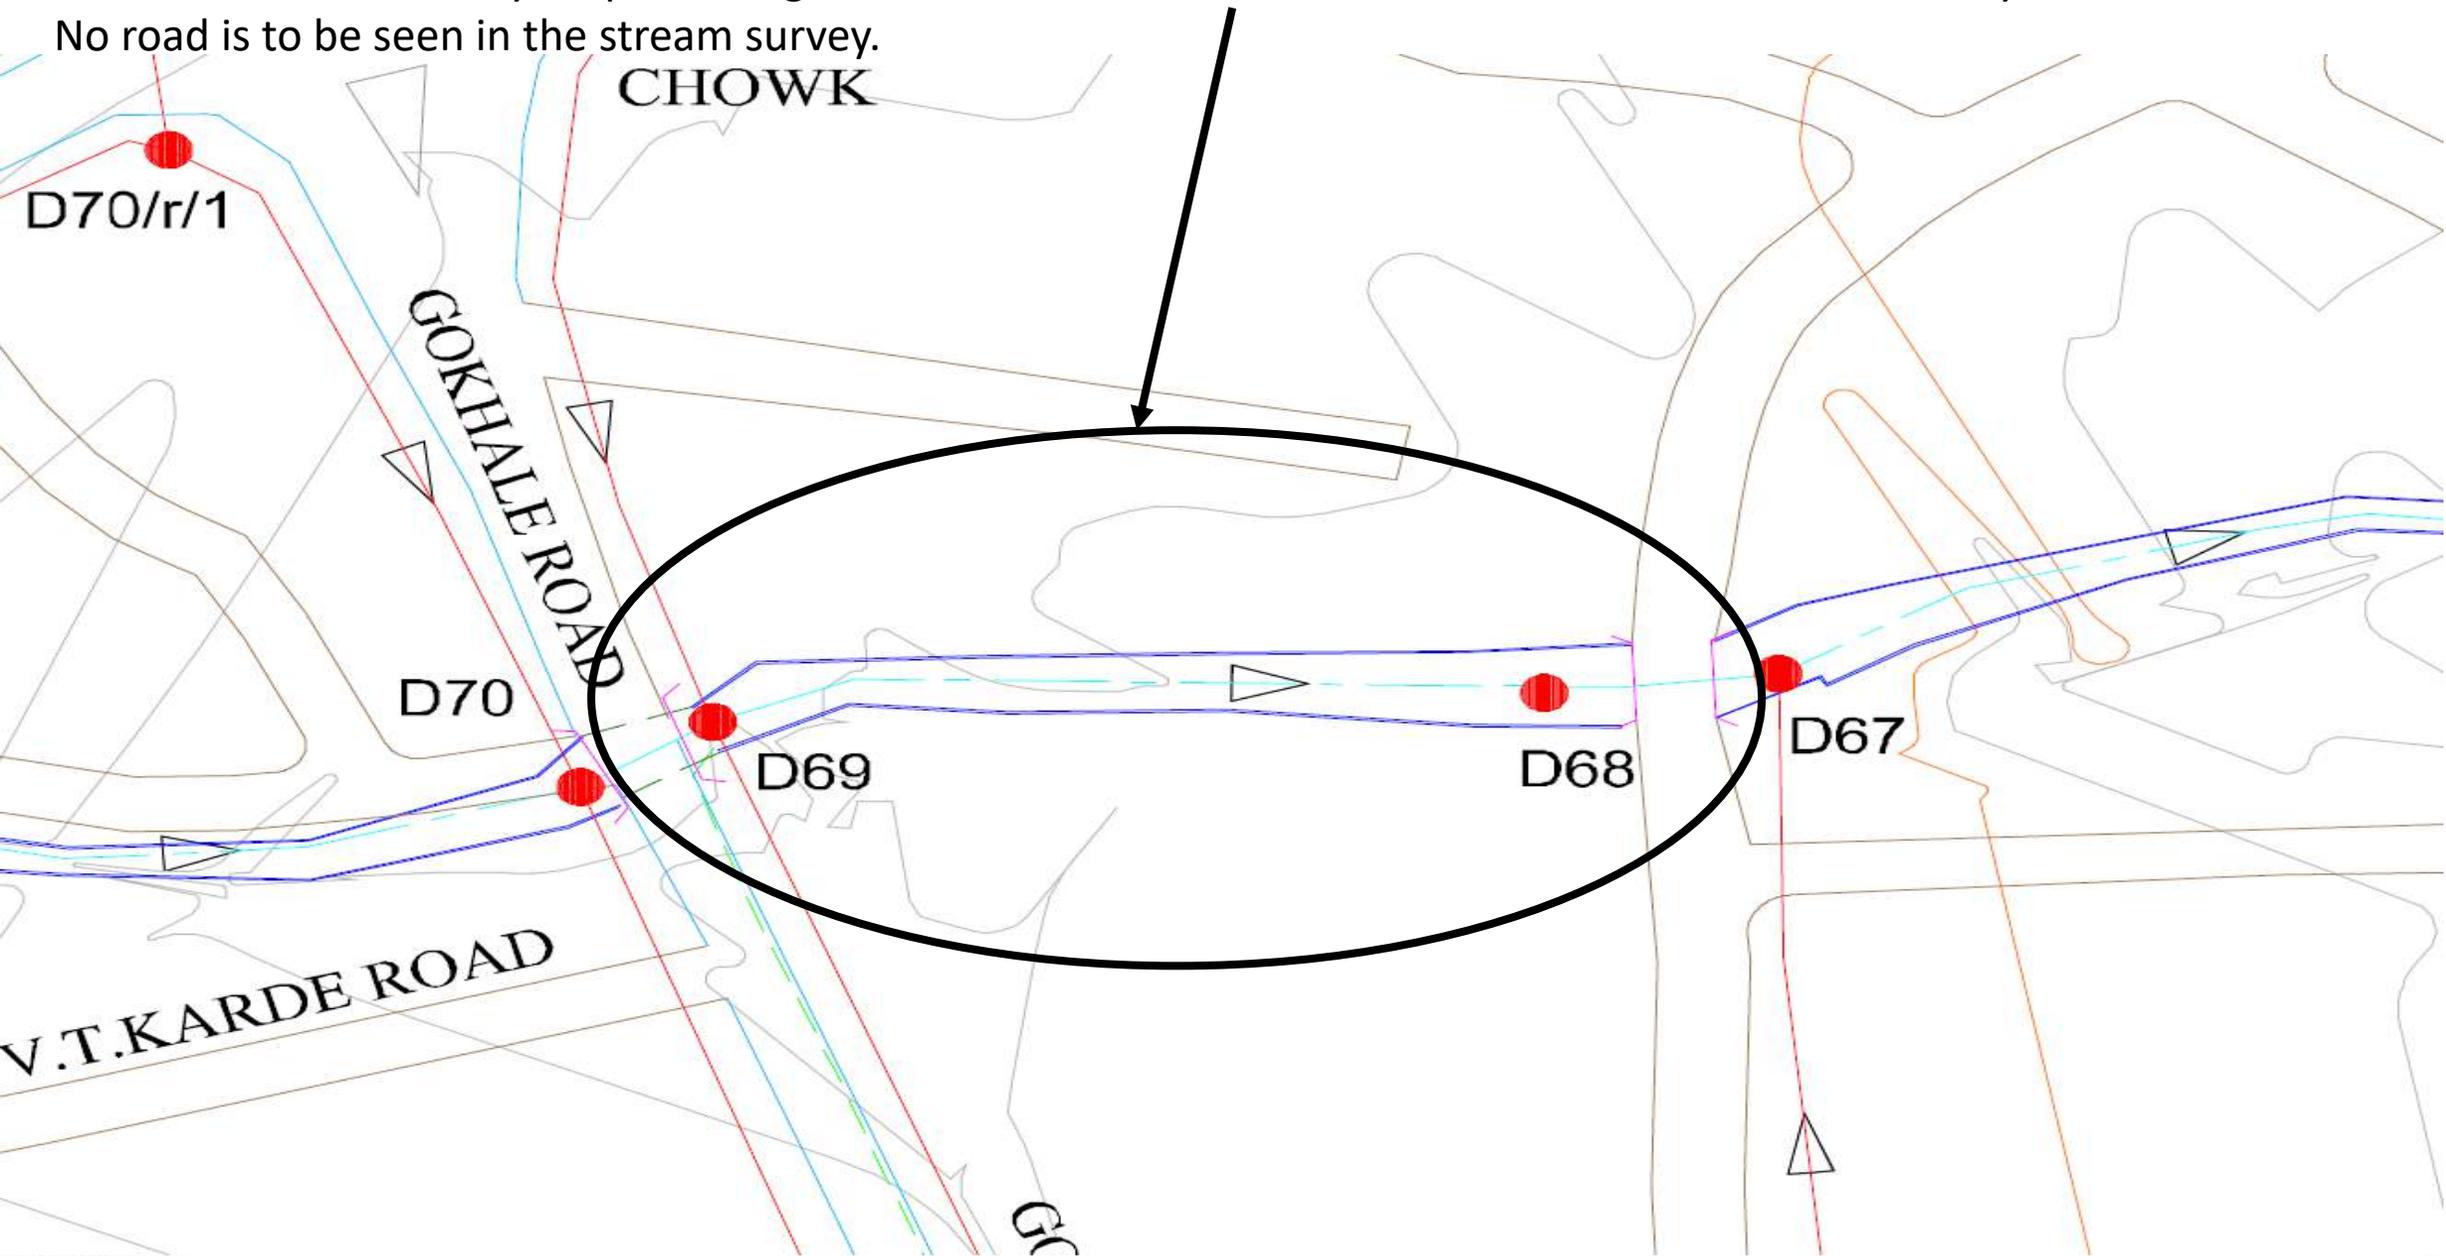
Zoom of PriMove Survey Map Showing the stream. Circled area shows area of stream south of Survey No. 457.
No road is to be seen in the stream survey.

8. The Applicants submit that a survey of the Water Bodies was conducted by M/s PriMove Consultants Pvt. Ltd., for and on behalf of the Respondent No.1 in and around 2005-2010. Contours around all streams were surveyed and were shown on the maps submitted by PriMove to the Respondent No.1. The stream is shown in the PriMove map and as per the contours, there is no road along the left bank of the stream, i.e. on the North side of the stream adjoining Applicant's property. Copy of the relevant

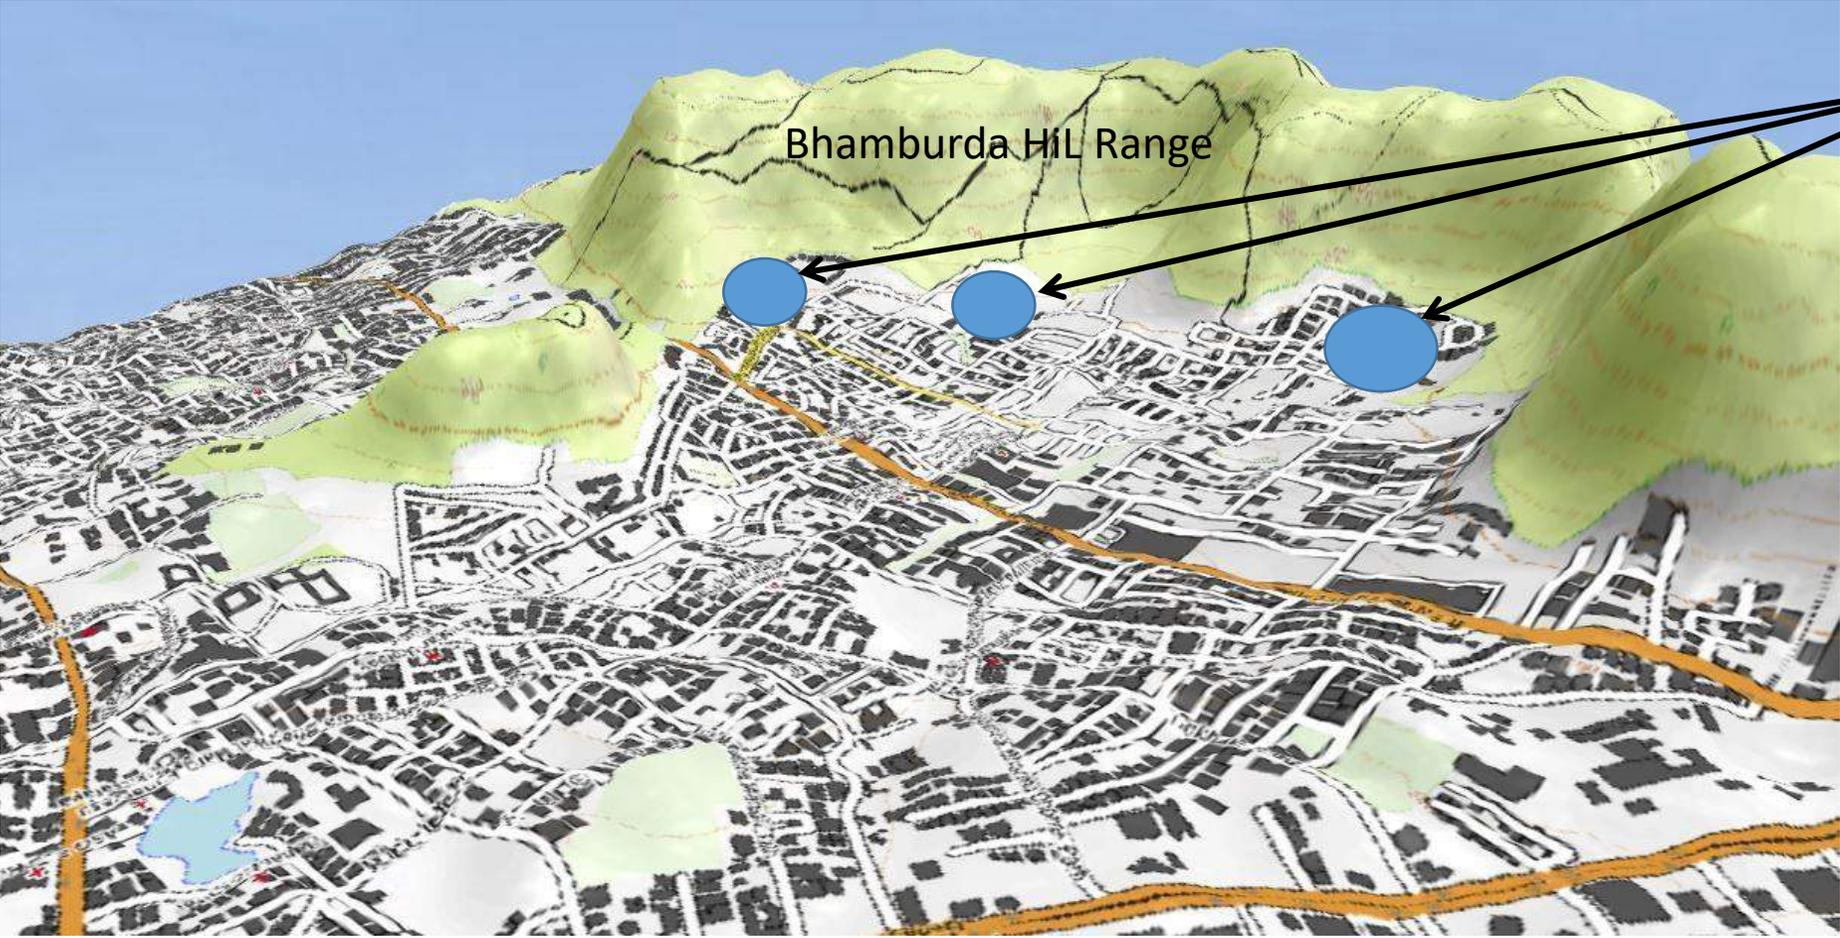
Annexure A-5

Terrain map of the Hills at the origin of the stream.

Approximate origin of several streams all merging into the Nala

11. The Applicants submit that the catchment basin of the said stream is very steep and catchment area is about 577000 sq.mtrs. This can be seen from the terrain map of the hill range. The source of the stream is hardly 1.5 km from the said location. Due to the topography, huge quantities of water are carried by the said stream in monsoon. Copy of the terrain map is annexed hereto and marked as **ANNEXURE – A-5**.

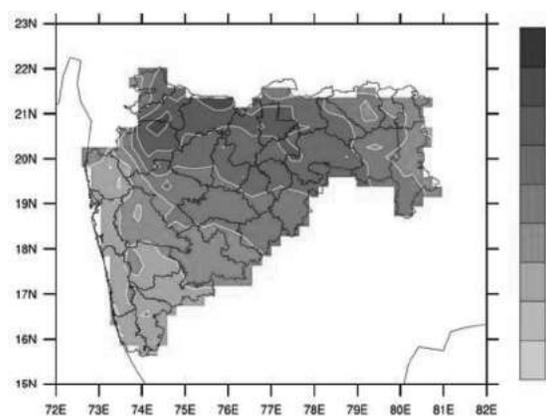
Figure 5. Increase in extreme rainfall in 2030s relative to baseline (in %)

12. The Applicants submit that, according to the TERI Report, the rainfall in Pune region is going to rise by an average of 25.7% in the 2030s (Page 28) with increased frequency of extreme rainfall by 14-18 % (Page 13). TERI report has in fact recommended increasing storm-water drainage capacity to accommodate 15% increase in flood magnitude (see Page 20 of TERI Report). In the light of the TERI Report, it is crucial that, the original water carrying capacity of the natural stream is not impeded by way of any anthropogenic interventions. Copy of the relevant portions of

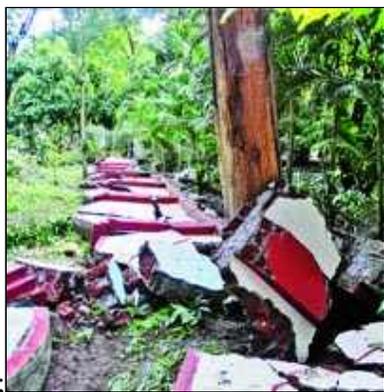
The boundary wall was swept away in the flash floods in October

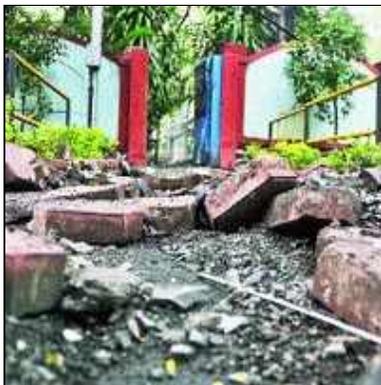
Debris outside PMC Commissioner's house caused by flooding

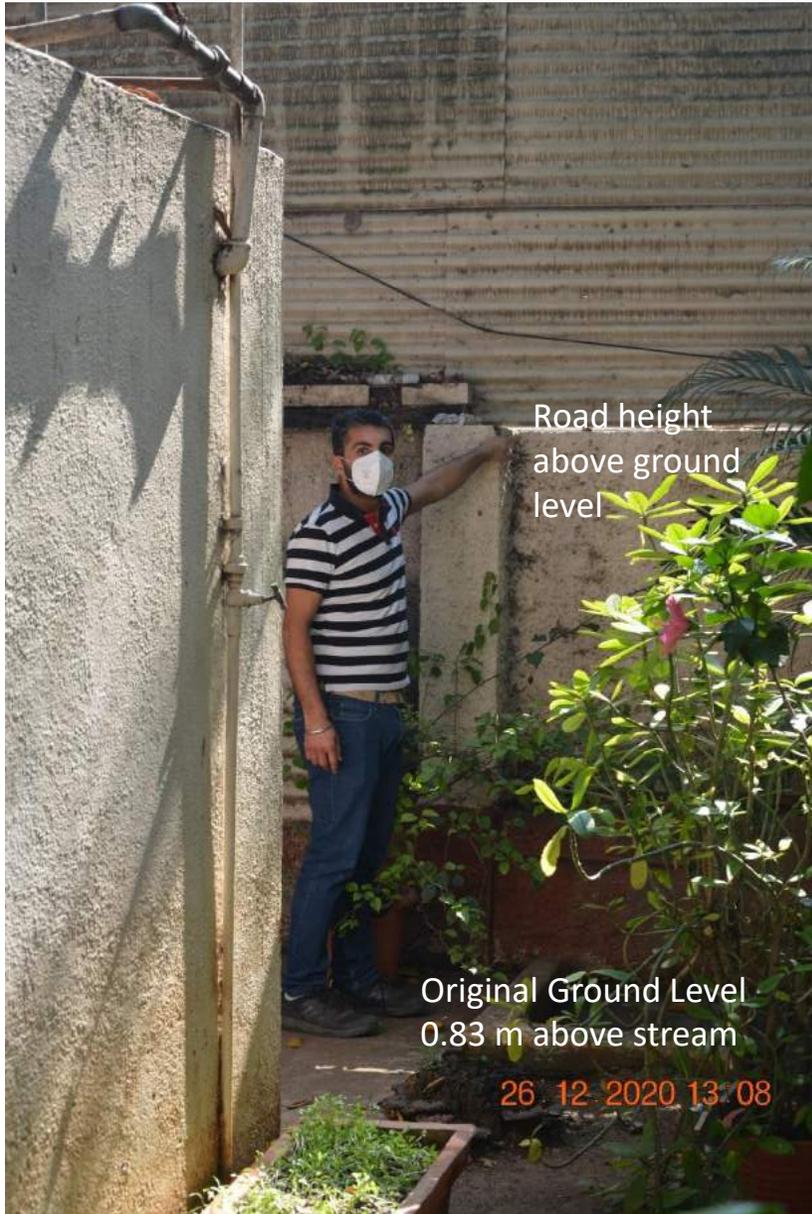
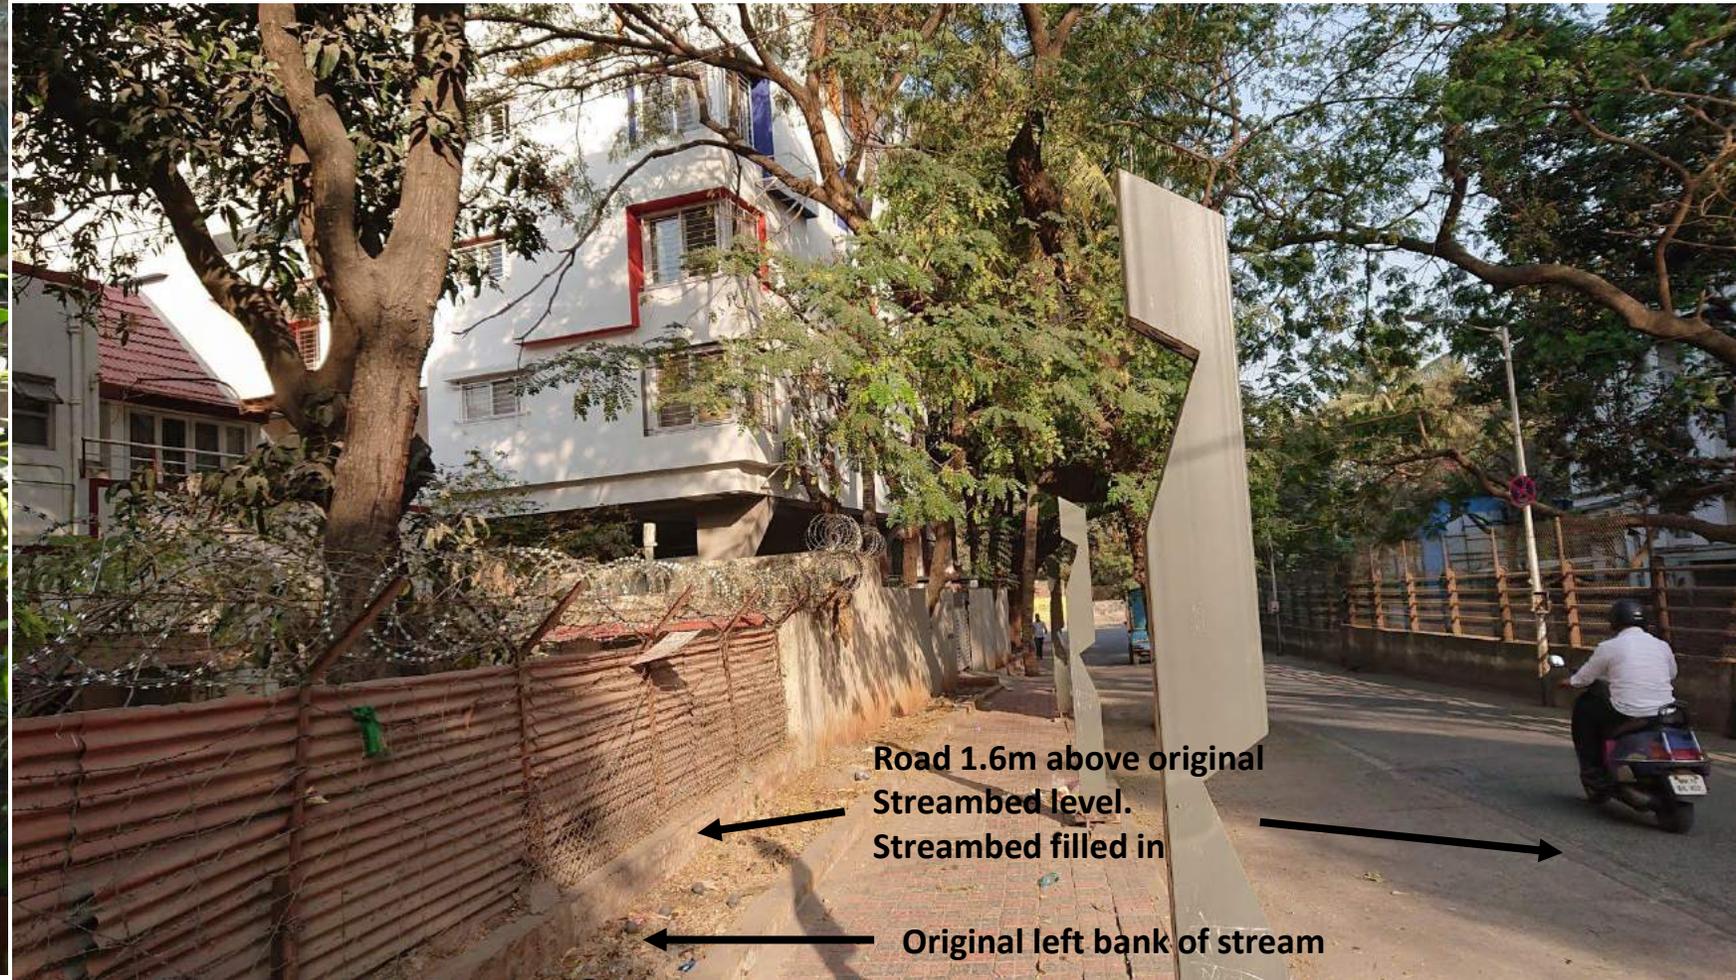
Photos showing filling of original ground level of the stream bed.
Wall in photo on the left was originally the left bank of the stream

(b) In Para 4 of the Committee Report, it is claimed in the report that *'neither PMC has procured any new material from outside for filling the road nor the level of the original ground level is increased'*. It is submitted that the statement is completely incorrect and deliberately misleading. The streambed has been filled in up to 1.6 meters above the original ground level and a concrete road constructed. The Committee Report itself admits in Para 10 of the report that the level of the Applicants' Property is 0.83 metres above the stream lining level. The natural slope of the ground is towards the stream. This can be seen from the cross-section of the area. The constructed road is
