BEFORE THE HON'BLE NATIONAL GREEN TRIBUNAL**WESTERN ZONE BENCH, PUNE, AT PUNE****ORIGINAL APPLICATION NO. 03 OF 2020**Devraj Bhatia and another ... **APPLICANT**

SR NO	ANNEXURE	PARTICULARS	PAGE NOS.	
			From	To
1.		Reply to report on behalf of Applicant No.1	171	187
2.		Affidavit in Support	188	189
3.	A-1	Collectively Copy of Existing Land Usage (ELU) Map, layout of the area from the relevant portion of ELU Map prepared by the PMC and satellite view of encroached stream	190	192
4.	A-2	Copy of the relevant portions of the Proposed Land Usage(PLU) map	193	193
5.	A-3	Copy of Relevant portion of the Final Development Map of area	194	194
6.	A-4	Copy of Relevant Portion of Primove Stream Survey map of the location	195	195
7.	A-5	Copy of terrain map of the hill range	196	196
8.	A-6	Copy of relevant pages of the TERI report	197	200

Rough Cross-section of the Stream, adjoining properties and effect of encroachment of streambed by road

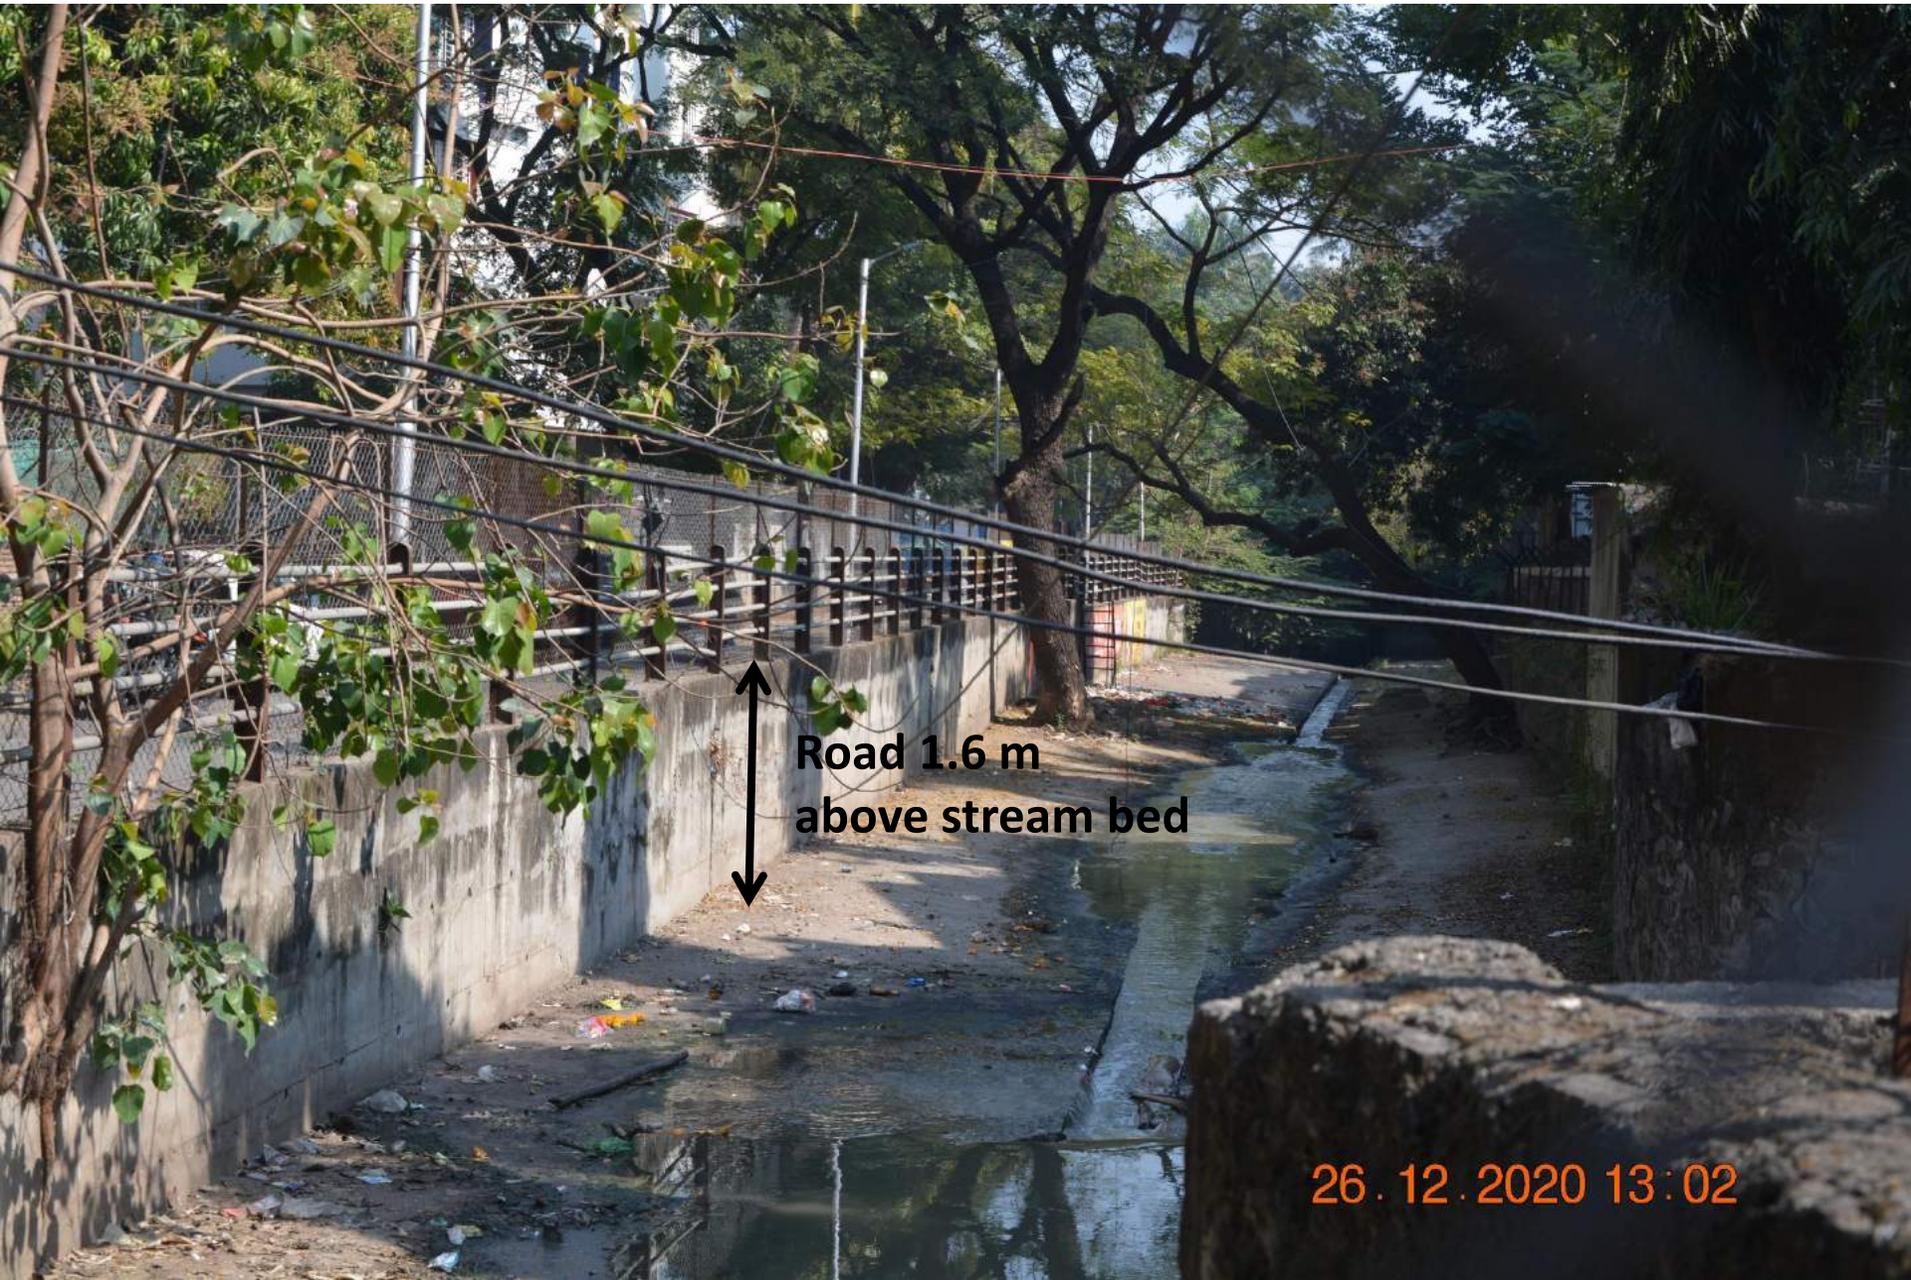
Photo showing the road constructed 1.6 m above Stream lining by filling in stream bed

(b) In Para 4 of the Committee Report, it is claimed in the report that *'neither PMC has procured any new material from outside for filling the road nor the level of the original ground level is increased'*. It is submitted that the statement is completely incorrect and deliberately misleading. The streambed has been filled in up to 1.6 meters above the original ground level and a concrete road constructed. The Committee Report itself admits in Para 10 of the report that the level of the Applicants' Property is 0.83 metres above the stream lining level. The natural slope of the ground is towards the stream. This can be seen from the cross-section of the area. The constructed road is

much higher than the ground level of the property of Applicants. It is inconceivable that a road much higher than the ground level of the Applicant No.1's property and between the property and the stream can be constructed without filling in the original streambed and without raising the original ground level. Photos of the Applicant No.1's property, the road and the stream with dimensions clearly show the raising of the ground level and are annexed hereto and collectively marked as **ANNEXURE A-9**. The photos clearly prove that the statement in the Para 4 of the report that the streambed has not been filled in is completely false and misleading.

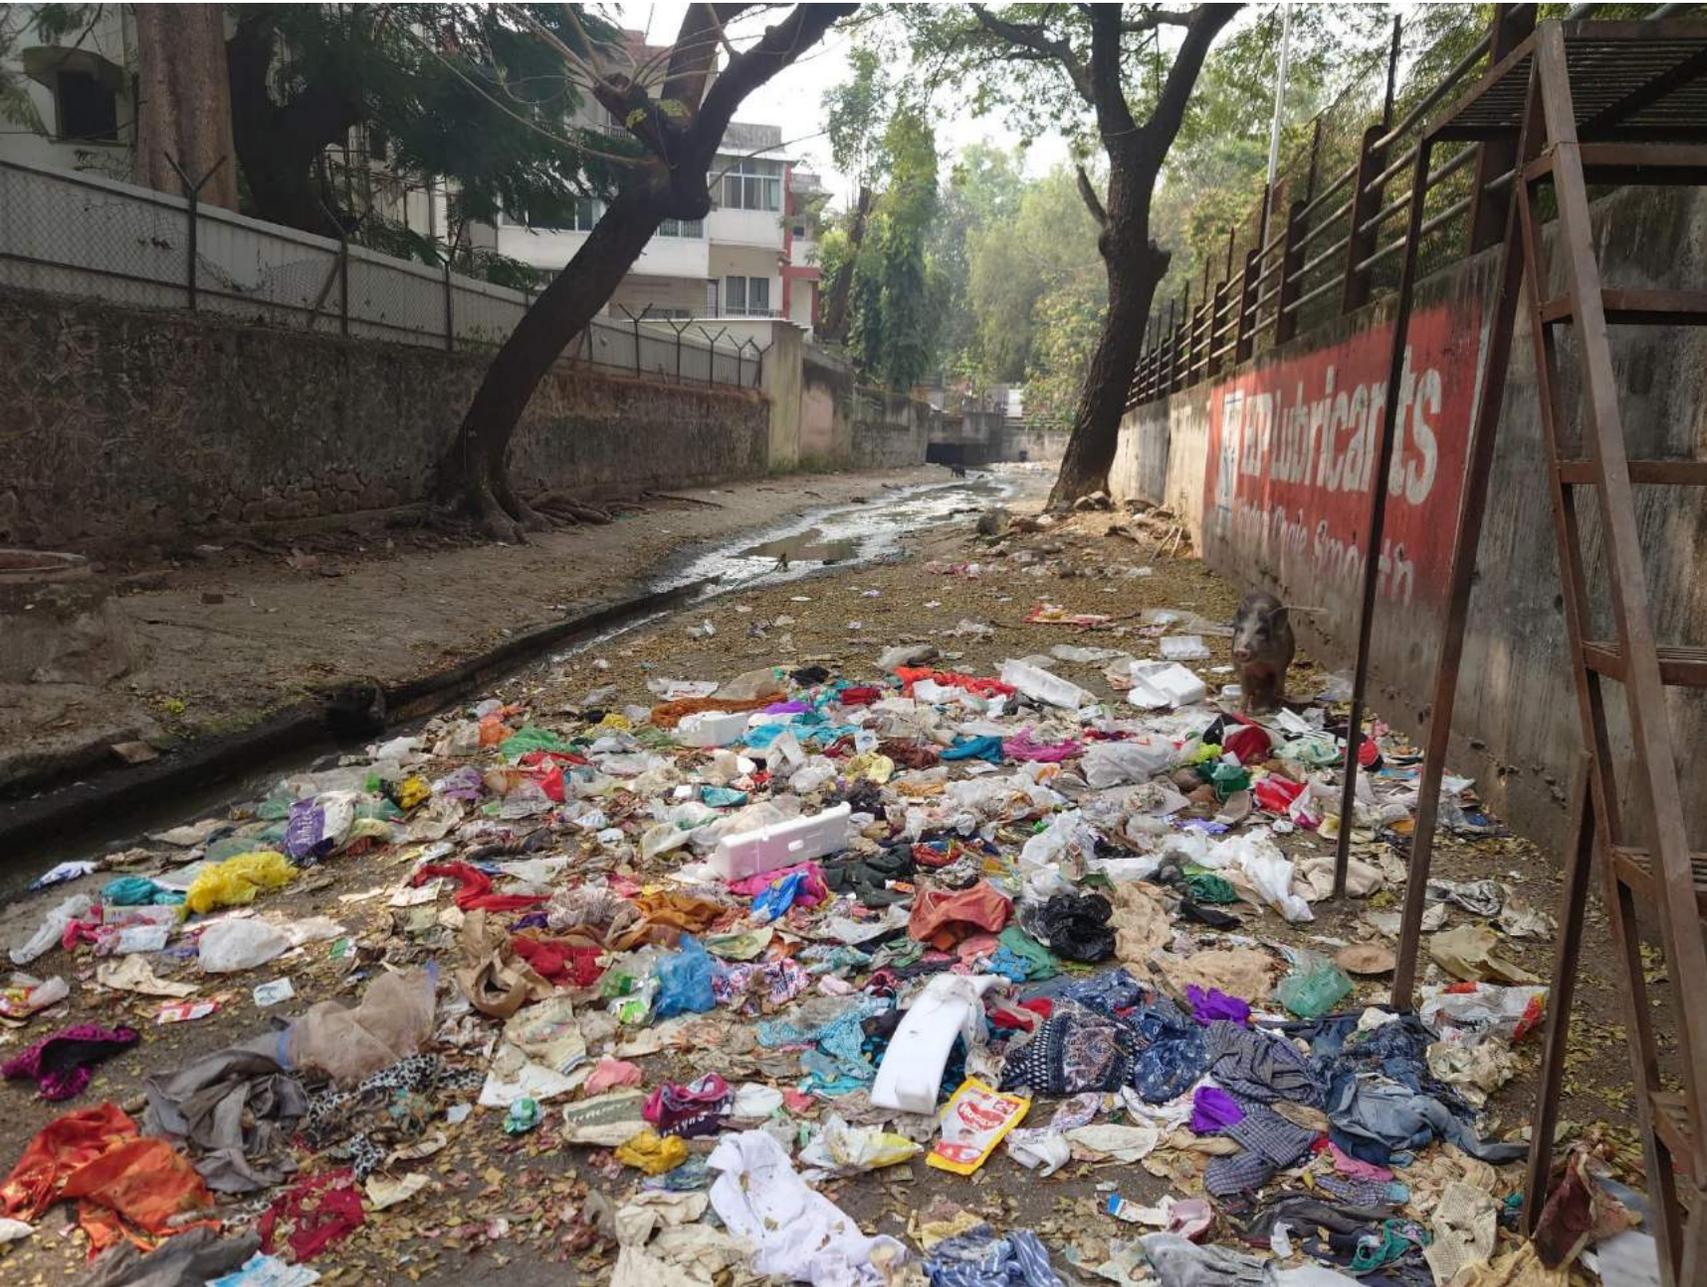
Photo dated 2nd January 2021
Showing garbage and pigs on the
stream bed

(d) In reply to the contents of Para 6 of the Report which mentions the agricultural canal, it is submitted that, the agricultural canal mentioned in the report barely exists anymore as the PMC has completely concretised and filled it in. In any case, the canal is not the primary issue here under consideration. The concretised road is the main issue raised by the Applicants here. The issue of foul smell, garbage and pigs persists until today. The Respondent No.1 has just tried to hide the issue, by construction of a wall and lining the stream instead of trying to clean up the area and restore natural environment and eco-

system of the stream. The photographs to show the same, taken recently, are annexed herewith and marked collectively as **ANNEXURE-A-10**. Moreover, the Applicants have never alleged that, the water from the stream has entered its property. The report has not addressed the main concern that the construction of the road has changed the natural drainage pattern of the area.

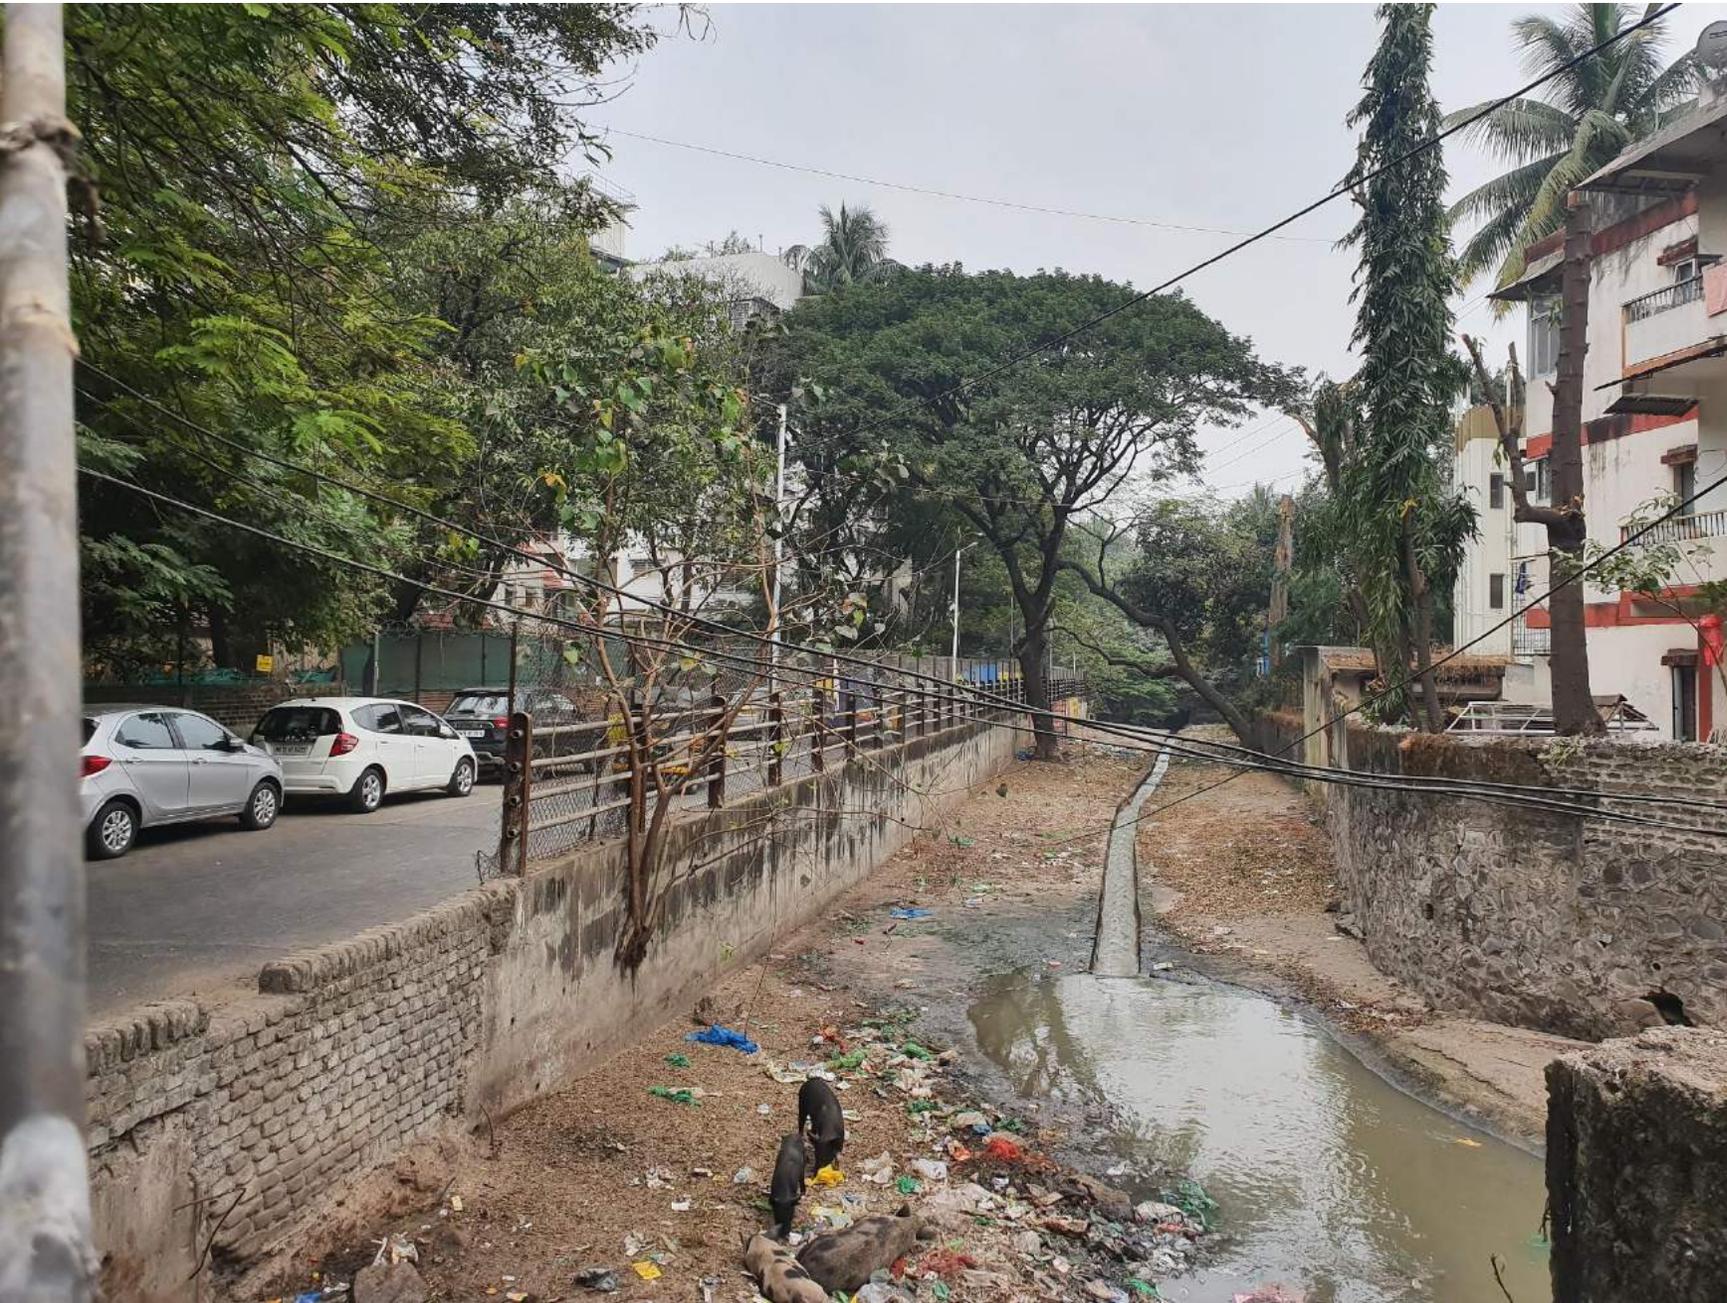
Photo garbage and pigs on the stream lining
