Office of the Chairman, NGT Monitoring Committee (J&K)
Justice Janak Raj Kotwal
(Former Judge High Court of Jammu & Kashmir)

Subject: Report of the Chairman in compliance to Hon'ble NGT order
dated 20.03.2020.

In the matter of : Execution Application No. 32/2016
In
Original Application No. 295/2016
And
Original Application No. 295/2016
(M.A.No.539/2016)

Report in compliance to Hon'ble NGT Order dated 20. 03. 2020

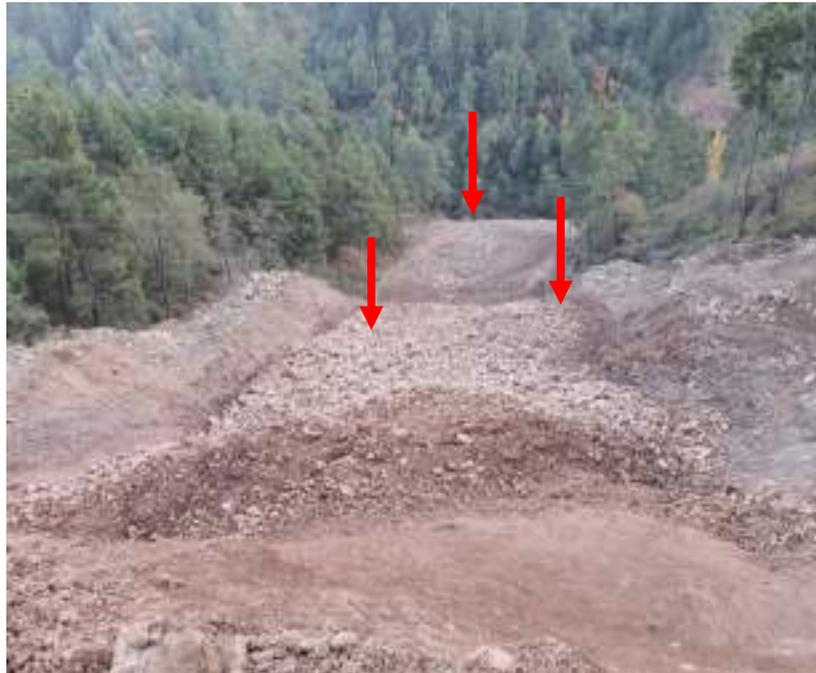
Photograph dated: (19th **Feb**, 2020): Nashri

S.No.	Name of the Site / Village	Chainage/ (NB/SB)	Title /Area of the land	Total Capacity (cu.m)	Quantity dumped as on July 2019 (cu.m)	Capacity remaining as on July 2019 (cu.m)	Status	Observations
1)	Nashri	130+690 to 130+800 km (NB)	Forest/ 01 Hectare	95,000	57,000	38,000	Land Sinking/ Closed site	Illegal dumping going on. Loose Muck, Gabions need to be provided. MSW also found dumped by MC Batote at this site.

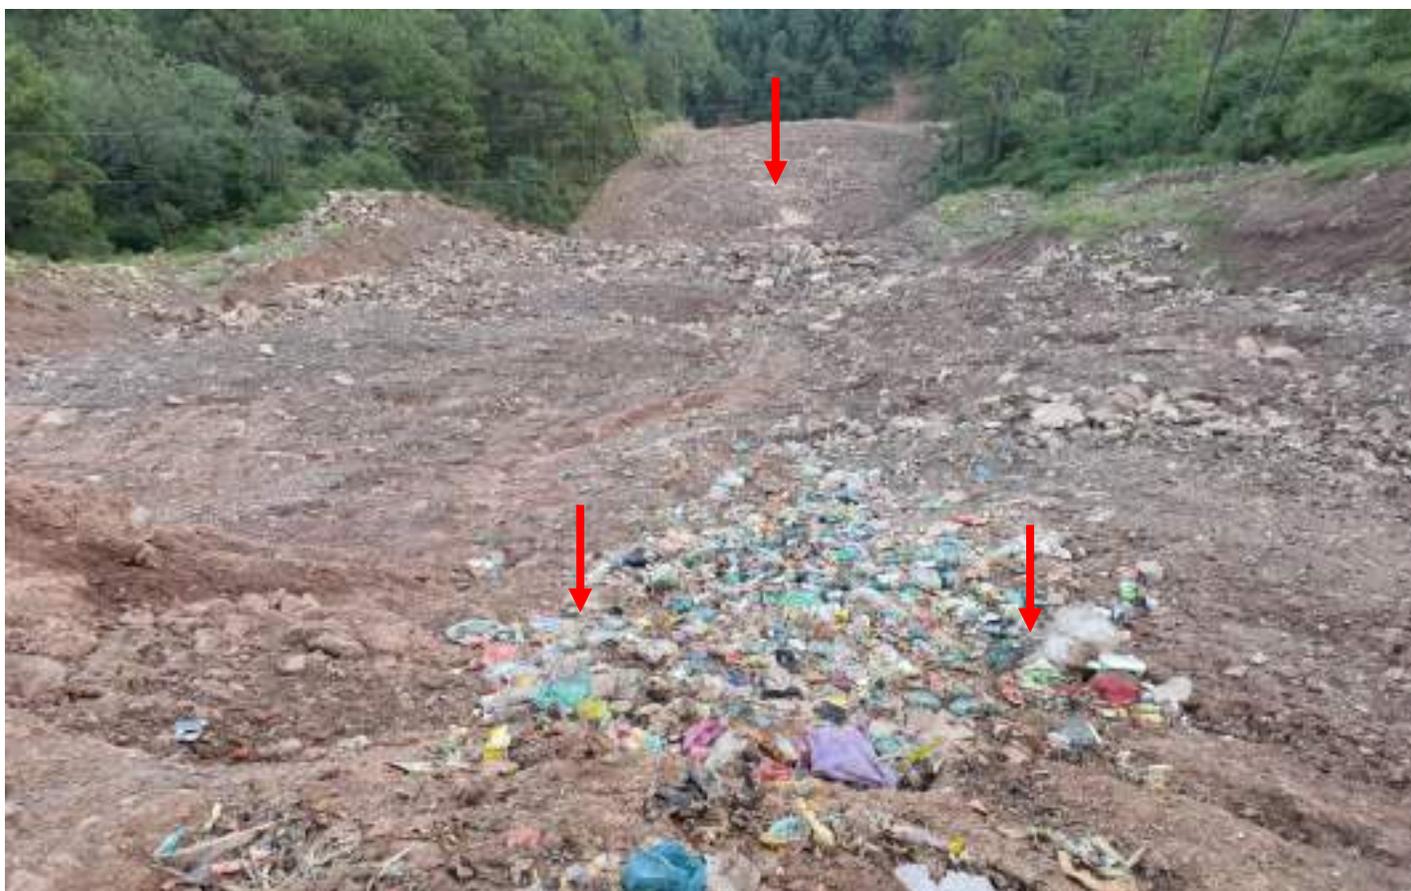
Photograph dated: (2nd Sept, 2020): Nashri

S.No	Name of the site	Chainage in km	Title of the land/ Designated /Non designated	Specific Observations
1.	Nashri (110 m)	130+690 to 130+800 (NB)	Forest-Designated	Site Closed but illegal dumping is going on. No retaining structure constructed and area is in sinking zone. MSW also found dumped by MC Batote at this site.

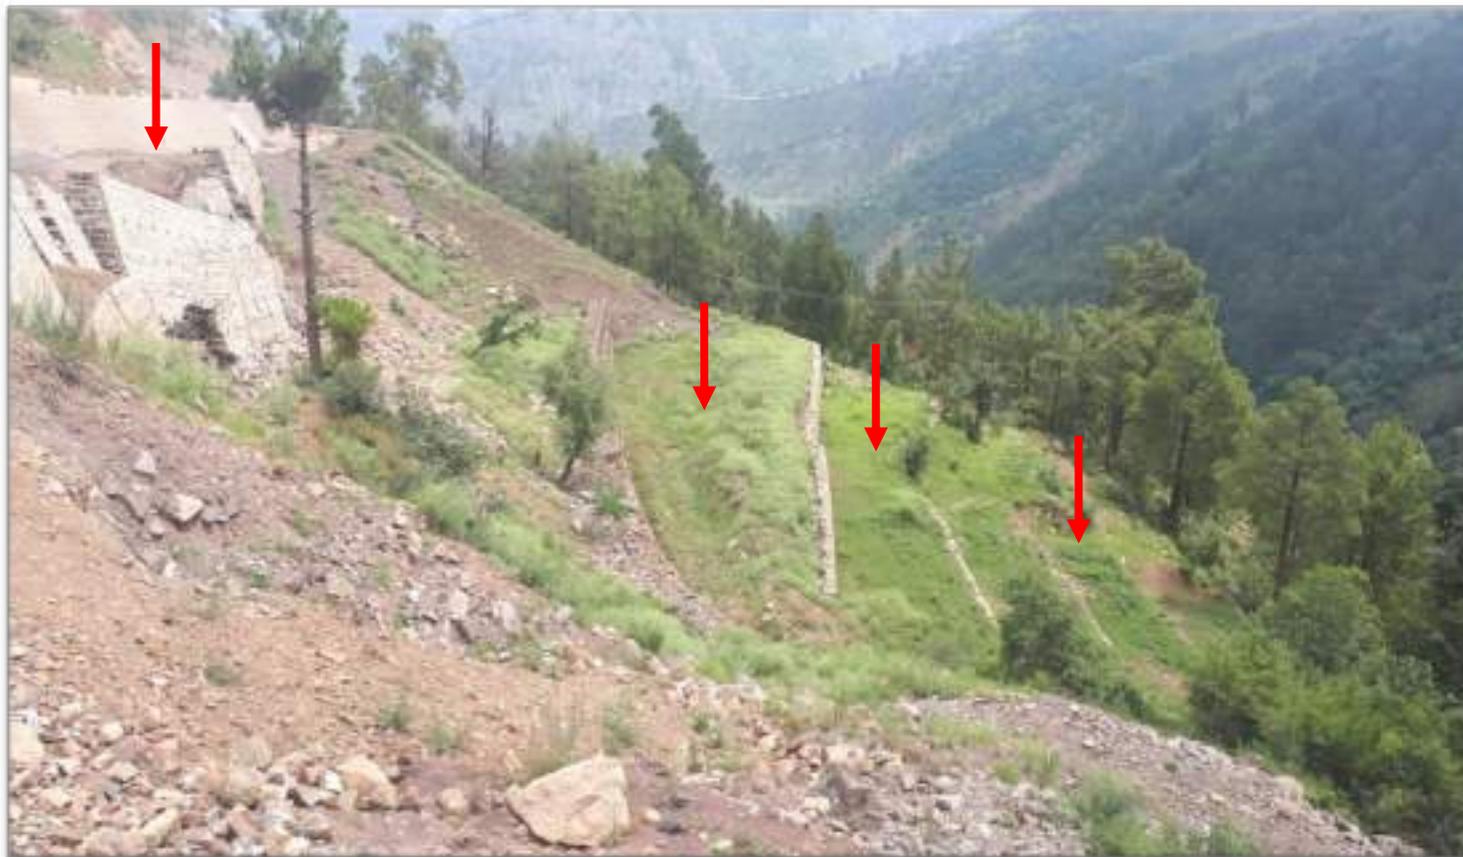
Photograph dated: (19th Feb, 2020): Nashri -II (Near Lucky Dhaba)

.No.	Name of the Site / Village	Chainage/ (NB/SB)	Title /Area of the land	Total Capacity (cu.m)	Quantity dumped as on July 2019 (cu.m)	Capacity remaining as on July 2019 (cu.m)	Status	Observations
2)	Nashri -II (Near Lucky Dhaba)	131+280 to 131+350 km (NB)	Private/ 0.61 Hectare	60,000	60,000	Nil	Closed	<i>Green cover has come up in major portion of this site. Road has sunk along this site.</i>

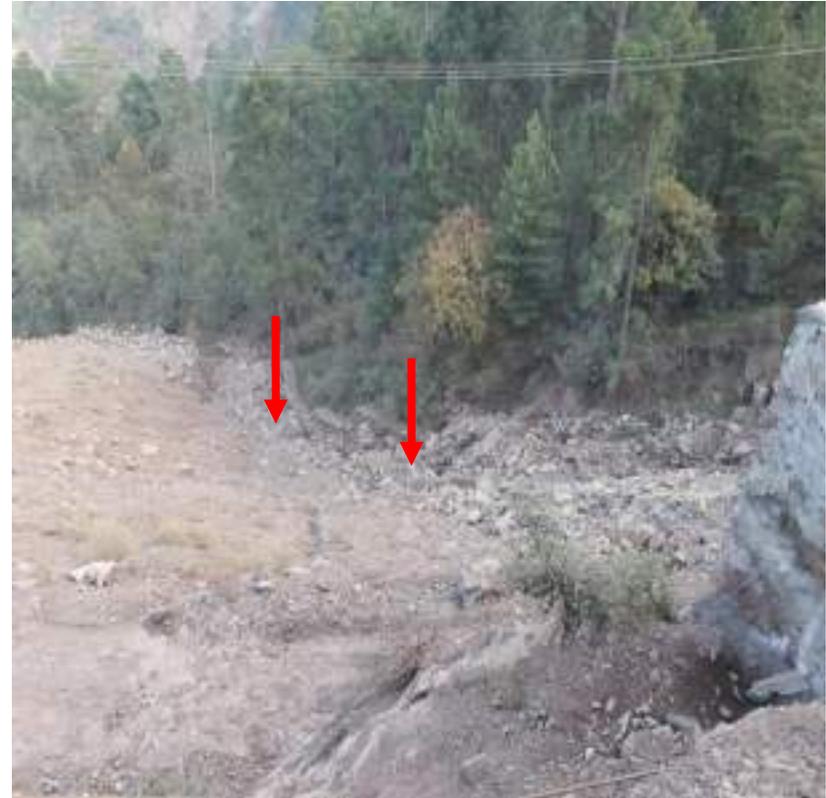
Photograph dated: (19th Feb, 2020): Sarge Temple

2.	Sarga Temple (100 m)	132+400 to 132+500 (NB)	Forest-Designated	Green cover has come up in large portion of this site. Muck Spill over/Gabion damaged, needs urgent repair. Nallah channelization work stopped midway.

S.No.	Name of the Site / Village	Chainage/ (NB/SB)	Title /Area of the land	Total Capacity (cu.m)	Quantity dumped as on July 2019 (cu.m)	Capacity remaining as on July 2019 (cu.m)	Status	Observations
3)	Sarga Temple	132+400 to 132+500 km (NB)	Forest/ 1.20 Hectare	1,10,000	95,000	15,000	In-Use	<i>Green cover has come up in large portion of this site. Muck Spill over/Gabion damaged, needs urgent repair. Nallah channelization work stopped midway.</i>

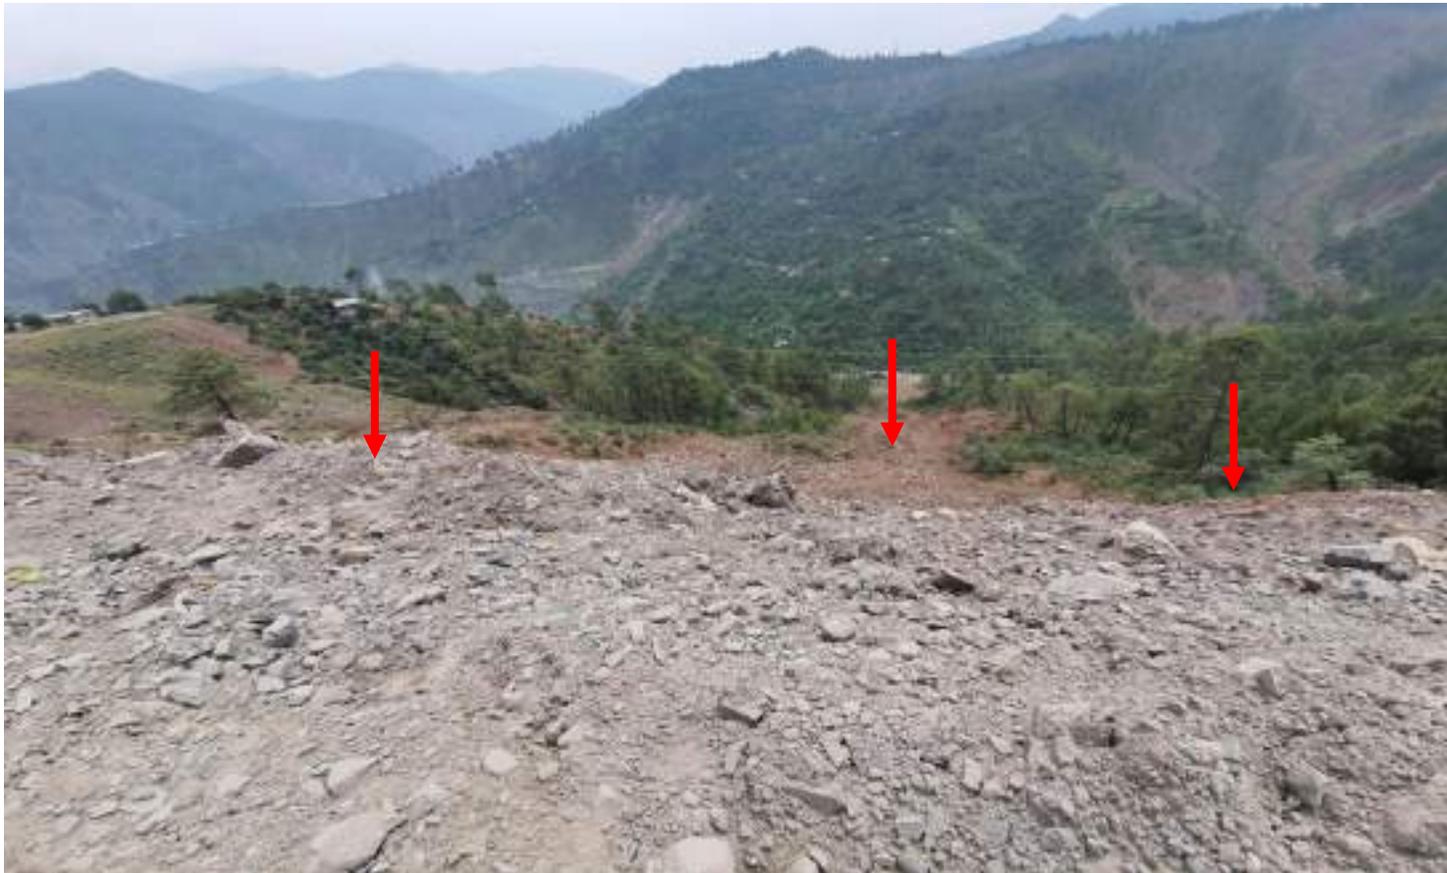
Photograph dated: (29th July, 2020): Dhalwas: Landslide & Road sunked.

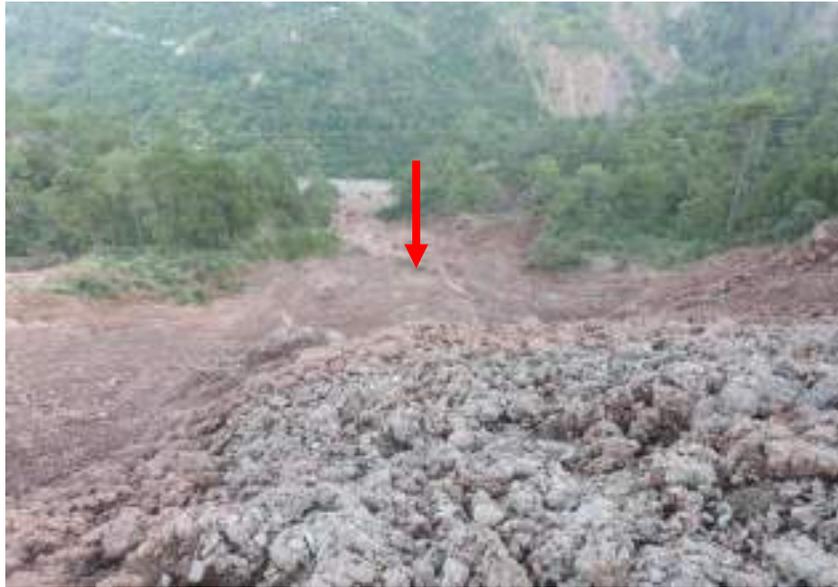
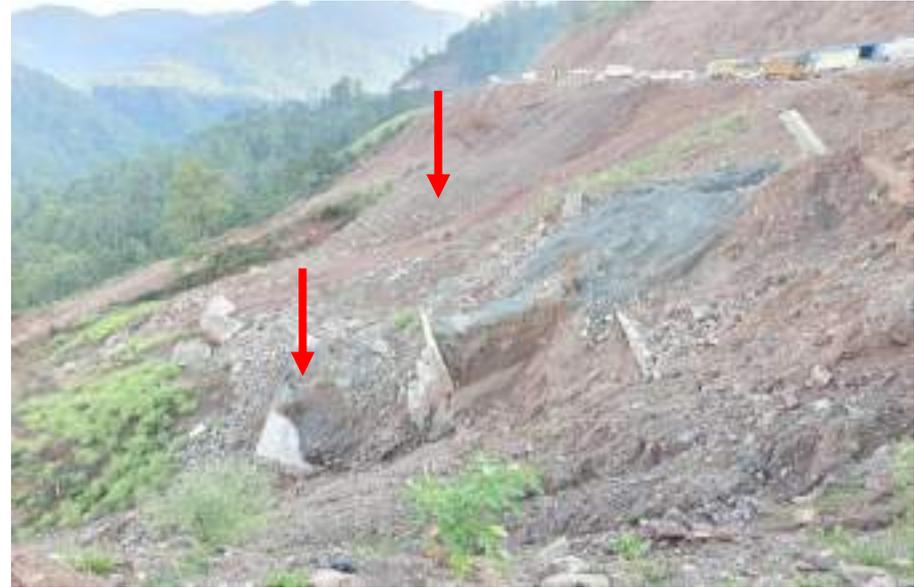
Photograph dated: (2nd Sept, 2020): Dhalwas: Landslide & Road sunked.

S.No.	Name of the Site / Village	Chainage/ (NB/SB)	Title /Area of the land	Total Capacity (cu.m)	Quantity dumped as on July 2019 (cu.m)	Capacity remaining as on July 2019 (cu.m)	Status	Observations
4)	Dhalwas	132+700 to 133+100 km (NB)	Non designated	-	-	-	-	<i>Land slide debris dumped/Road Sunked.</i>

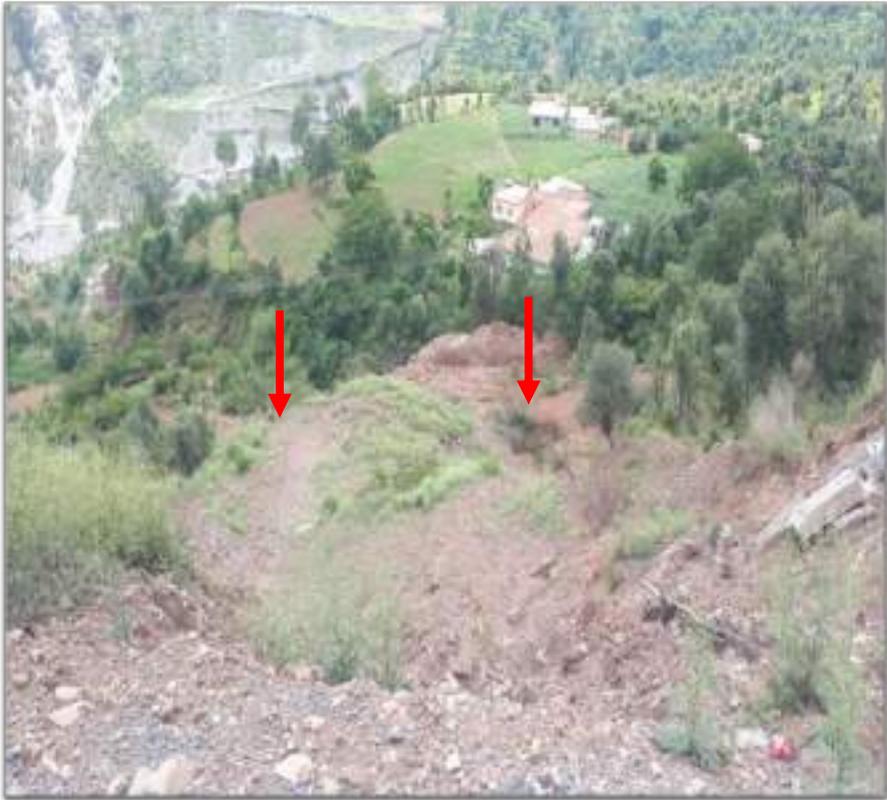
Photograph dated: (19th **Feb**, 2020): Dhalwas-I

S.No.	Name of the Site / Village	Chainage/ (NB/SB)	Title /Area of the land	Total Capacity (cu.m)	Quantity dumped as on July 2019 (cu.m)	Capacity remaining as on July 2019 (cu.m)	Status	Observations
5)	Dhalwas-I	133 +350 to 133+400 (NB)	NHAI Acquired/ 0.98 Hectare	72,000	45,000	27,000	Site Closed	<i>Green cover has come up in large portion of this site. Capacity available, but because of school at the bottom of the slope, dumping has been stopped.</i>

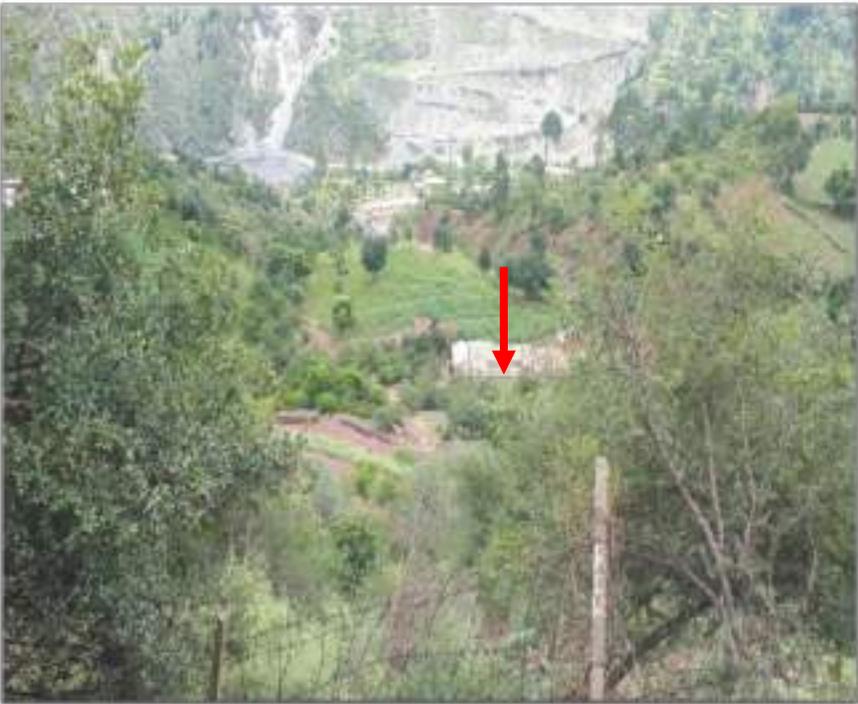
Photograph dated :(19th Feb, 2020): Dhalwas-II (Near School)

S.No.	Name of the Site / Village	Chainage/ (NB/SB)	Title /Area of the land	Total Capacity (cu.m)	Quantity dumped as on July 2019 (cu.m)	Capacity remaining as on July 2019 (cu.m)	Status	Observations
6)	Dhalwas-II (Near school)	133 +420 to 133+460 (NB)	NHAI Acquired/ 1.01 Hectare	72,000	21,600	50,400	Site Closed	<i>Green cover has come up in some portion of this site. Capacity available, but because of school at the bottom of the slope, dumping has been stopped.</i>

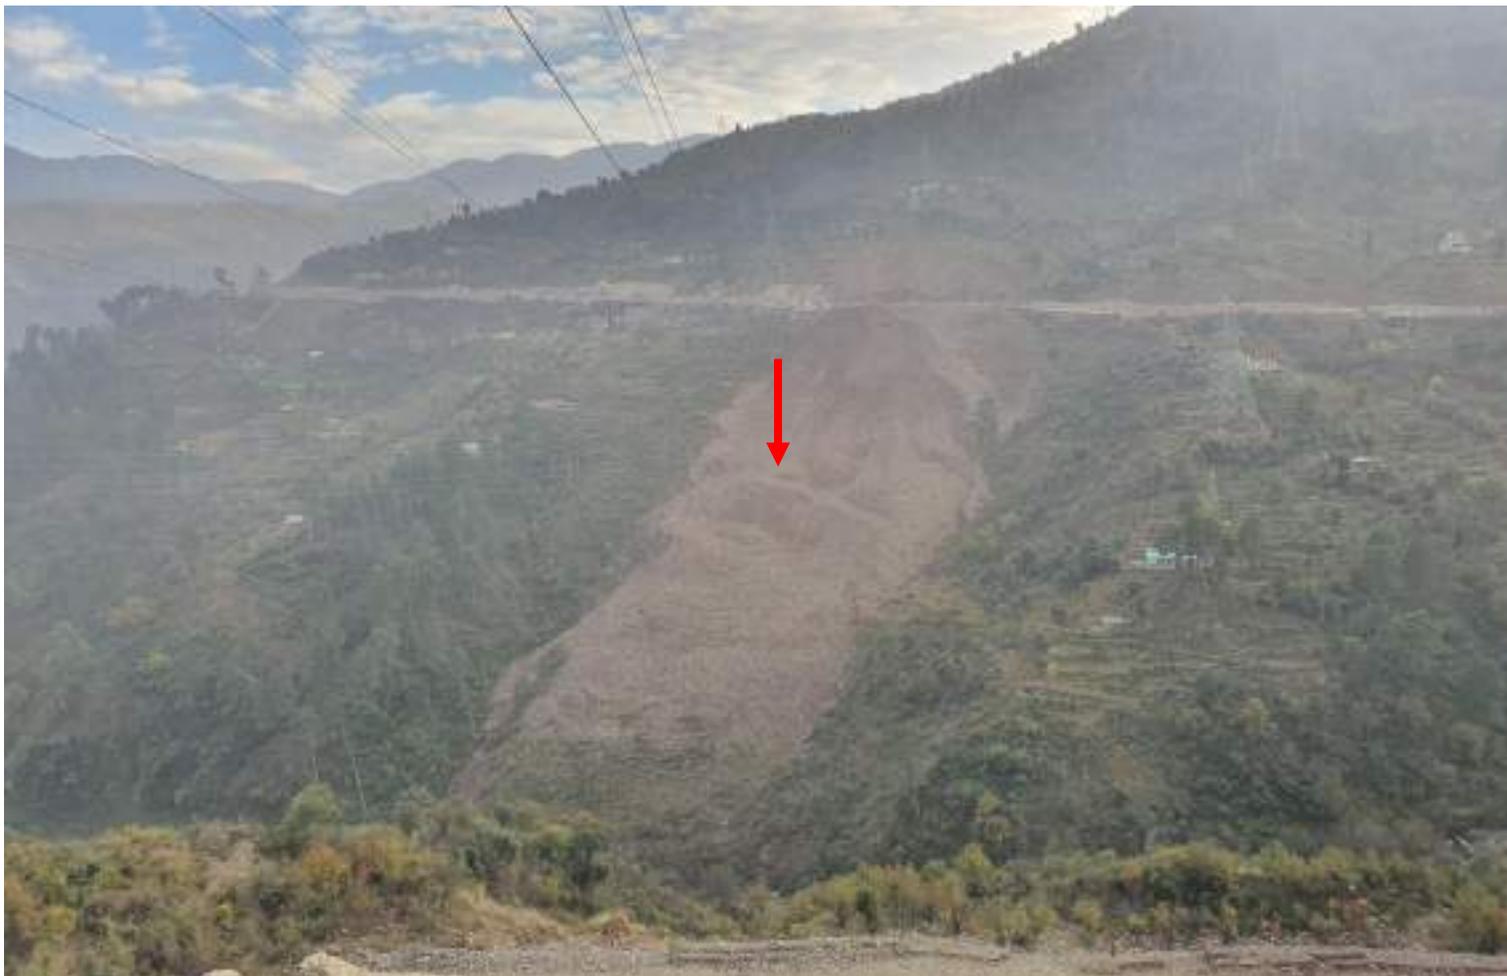
Photograph dated: (19th Feb, 2020): Dhalwas (Peerah-I).

3.	Dhalwas- Peerah- I (50 m)	134 +770 to 134+820 (NB)	Forest-Designated	Dumping in-progress and no protection provided.
4.	Dhalwas- Peerah- II (50 m)	135+300 to 135+350 (NB)	Forest-Designated	Dumping in-progress and no protection provided. Peerah Nallah getting choked due to muck dumping and needs to be channelized .Gabion damaged needs immediate repair.

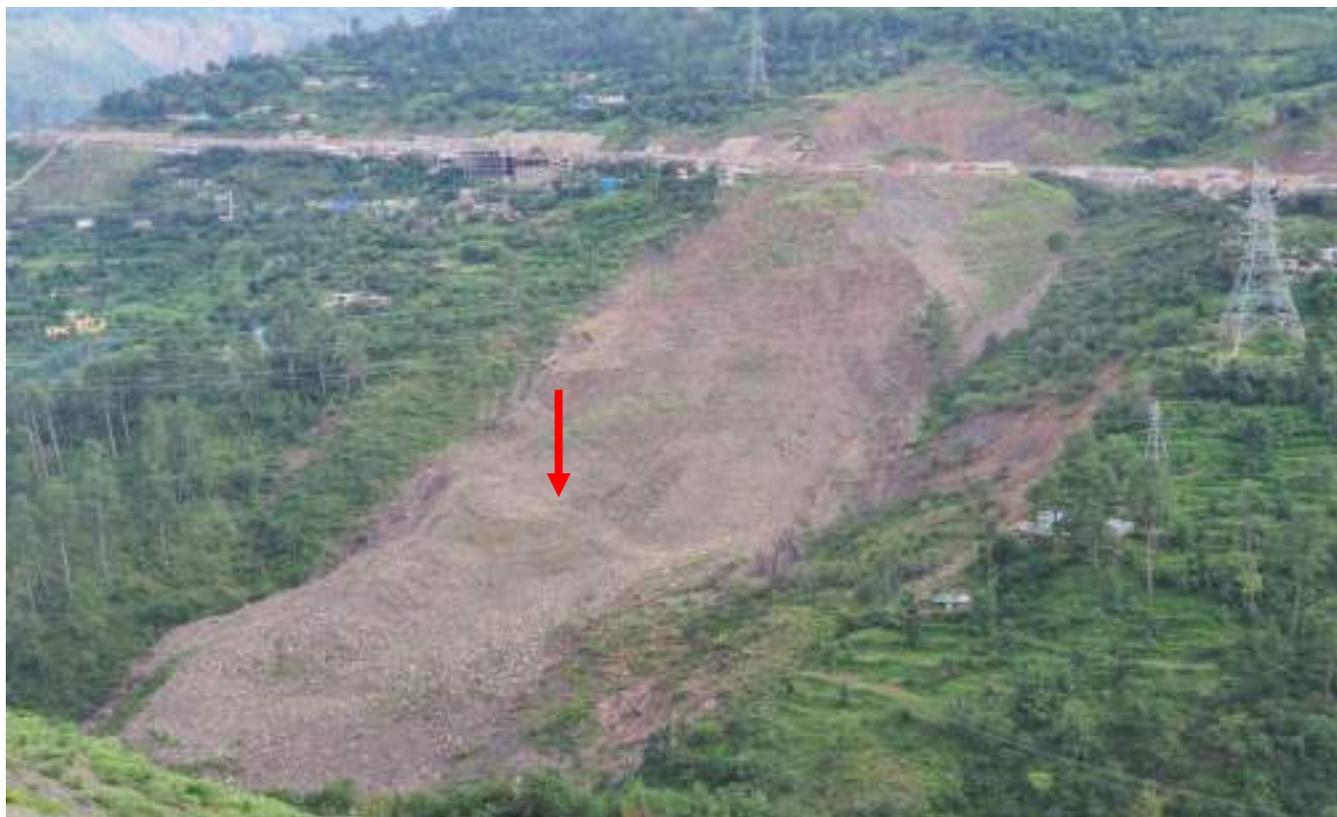
Photograph dated: (2nd Sept, 2020): Dhalwas (Peerah-I).

S.No.	Name of the Site / Village	Chainage/ (NB/SB)	Title /Area of the land	Total Capacity (cu.m)	Quantity dumped as on July 2019 (cu.m)	Capacity remaining as on July 2019 (cu.m)	Status	Observations
7)	Dhalwas (Peerah-I)	134 +770 to 134+820(NB)	Forests/ 05.07 Hectare	5,20,000	2,75,000	2,45,000	In-Use	<i>Green cover has come up in some portion of this site. Gabions not provided.</i>

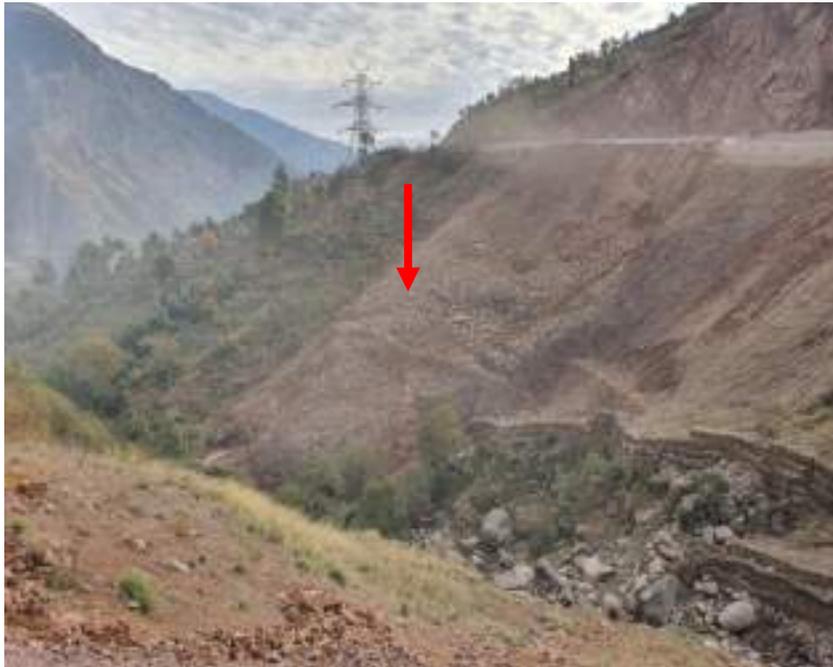
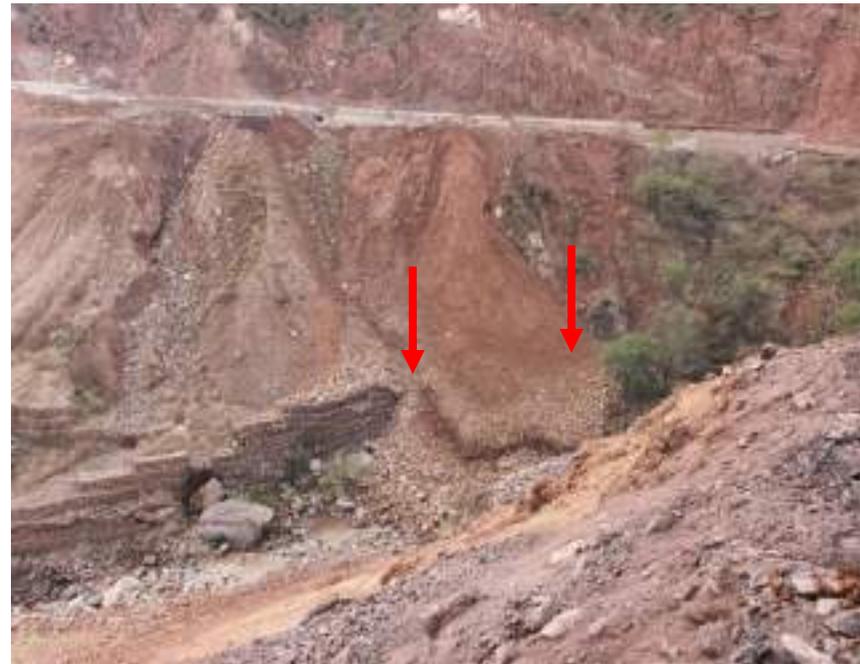
Photographs dated: (19th Feb, 2020): Dhalwas (Peerah-II)

S.No.	Name of the Site / Village	Chainage/ (NB/SB)	Title /Area of the land	Total Capacity (cu.m)	Quantity dumped as on July 2019 (cu.m)	Capacity remaining as on July 2019 (cu.m)	Status	Observations
8)	Dhalwas (Peerah-II)	135+300 to 135+350 km (NB)	Forests/ 07.55 Hectare	7,80,000	4,50,000	3,30,000	In-Use	<i>Peerah Nallah getting choked due to muck dumping and needs to be channelized .Gabion damaged needs immediate repair.</i>

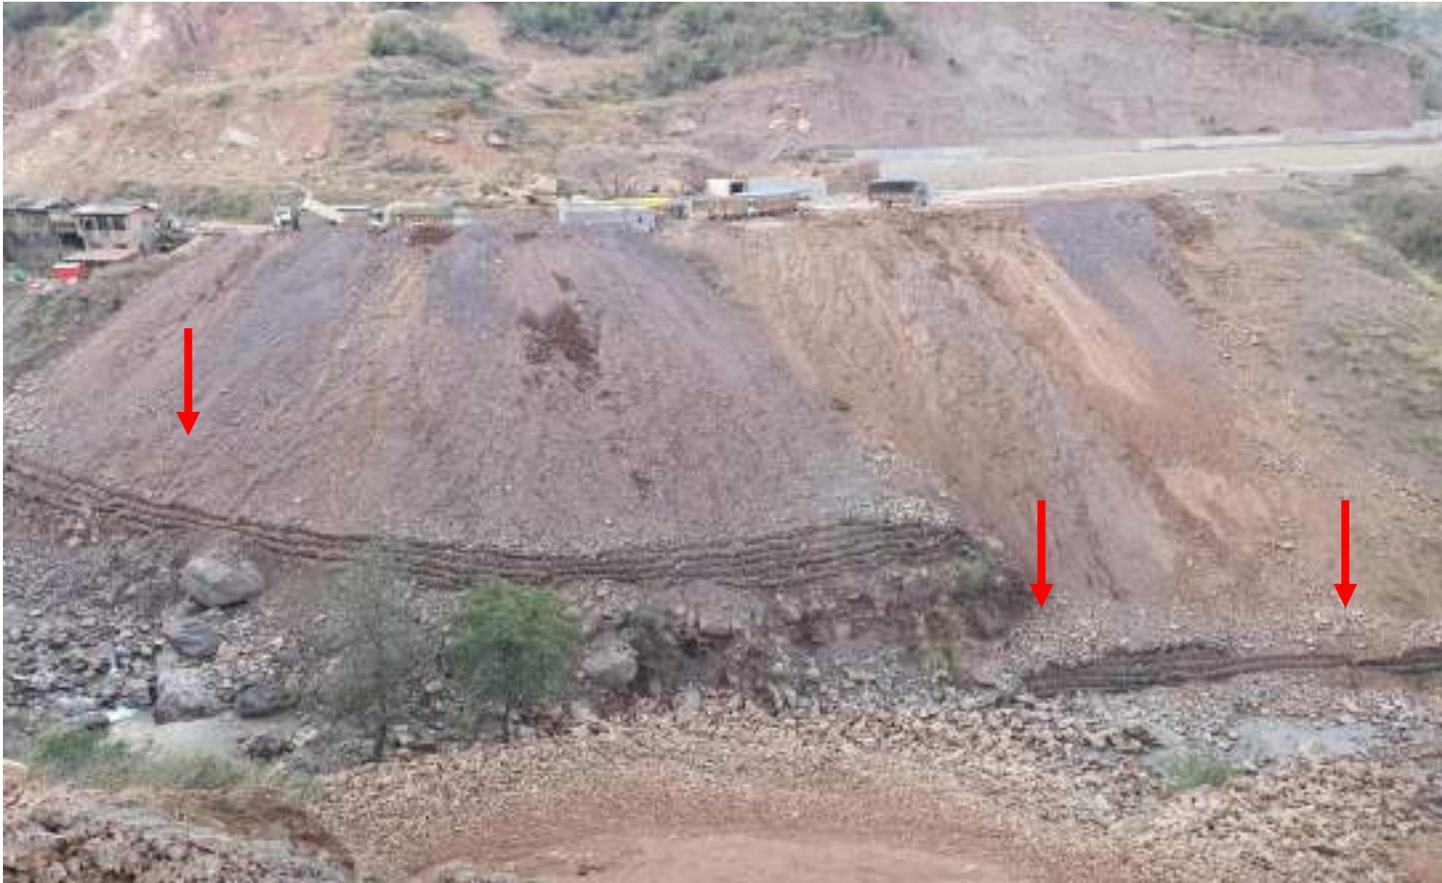
Photograph dated: (19th Feb, 2020): Sawani-I .

S.No.	Name of the Site / Village	Chainage/ (NB/SB)	Title /Area of the land	Total Capacity (cu.m)	Quantity dumped as on July2019 (cu.m)	Capacity remaining as on July2019 (cu.m)	Status	Observations
9)	Sawani -I	135+900 to 135+940 km (NB)	NHAI Acquired / 01.76 Hectare	1,40,000	1,40,000	Nil	Closed/Illegal Dumping going on.	<i>Peerah Nallah getting choked due to muck dumping .Gabion damaged/ Needs immediate repair.</i>

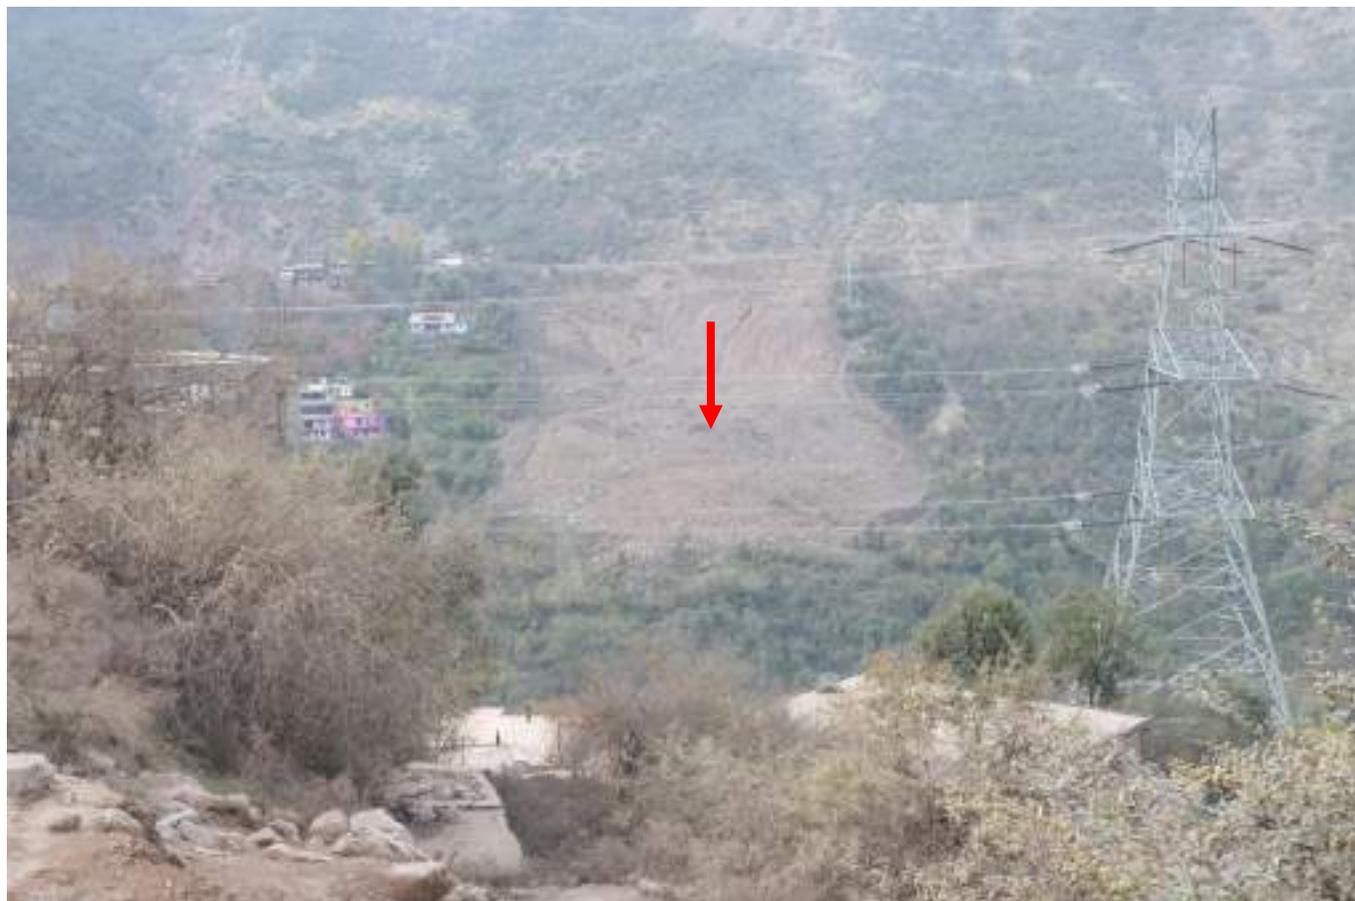
Photograph dated: (19th Feb, 2020): Sawani-II.

S.No.	Name of the Site / Village	Chainage/ (NB/SB)	Title /Area of the land	Total Capacity (cu.m)	Quantity dumped as on July 2019 (cu.m)	Capacity remaining as on July 2019 (cu.m)	Status	Observations
10)	Sawani -II	136+760 to 136+810 km (NB)	NHAI Acquired / 02.83 Hectare	2,18,648	2,10,000	8,648	Closed	<i>Green cover has come up in some portion of this site. Muck spill over/Gabion damaged needs to be repaired.</i>

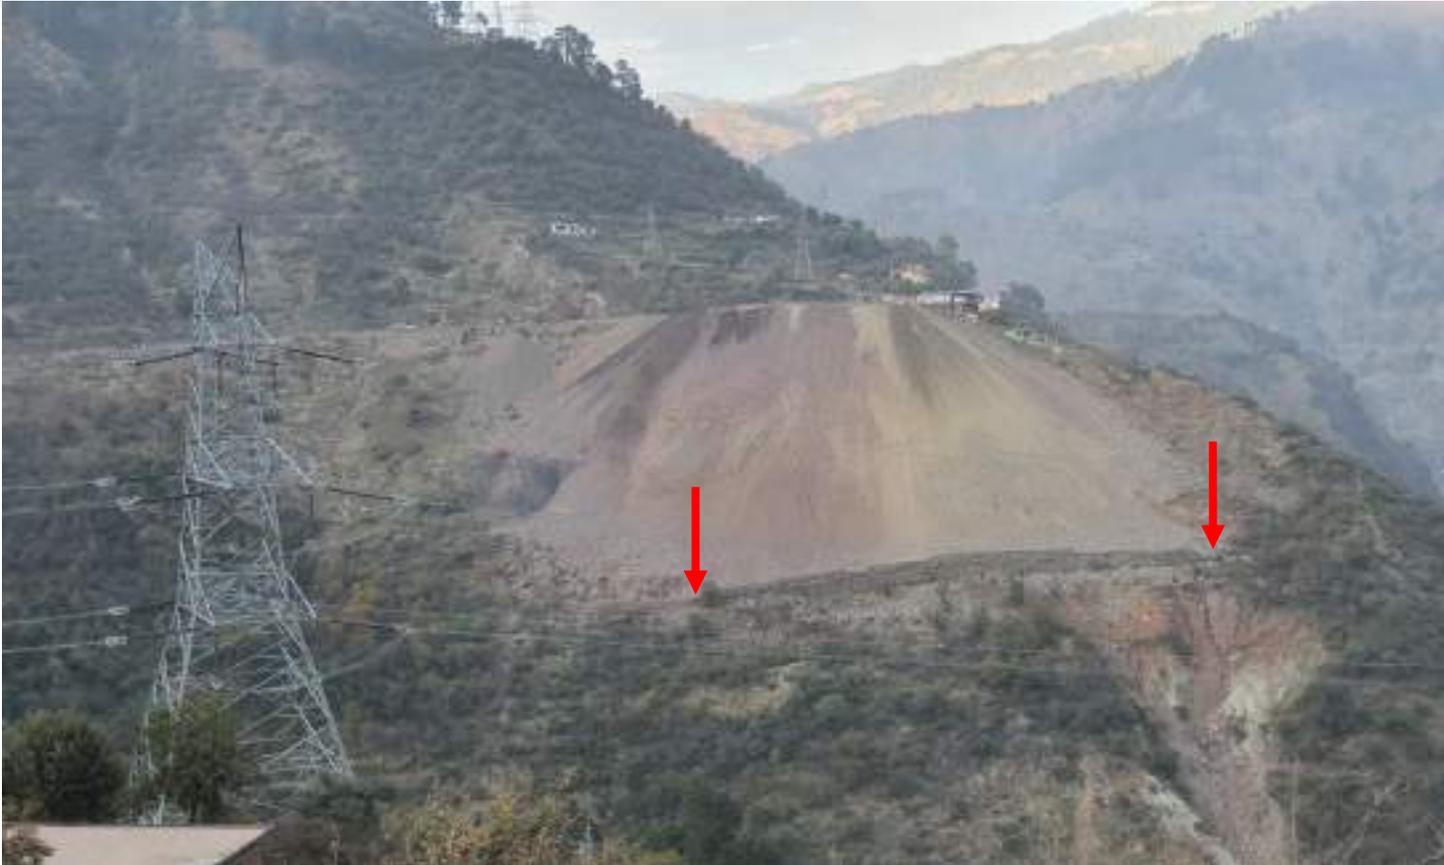
Photograph dated: (19th Feb, 2020): Sawani-III (Near dam view hotel).

S.No.	Name of the Site / Village	Chainage/ (NB/SB)	Title /Area of the land	Total Capacity (cu.m)	Quantity dumped as on July2019 (cu.m)	Capacity remaining as on July2019 (cu.m)	Status	Observations
11)	Sawani-III (Near Hotel Dam View)	138+050 to 138+100 km (SB)	Private / 01.89 Hectare	1,79,645	1,20,000	59,645	In-Use	<i>Green cover has come up in some portion of this site. Muck spill over/Gabion needs to be strengthened & raised.</i>

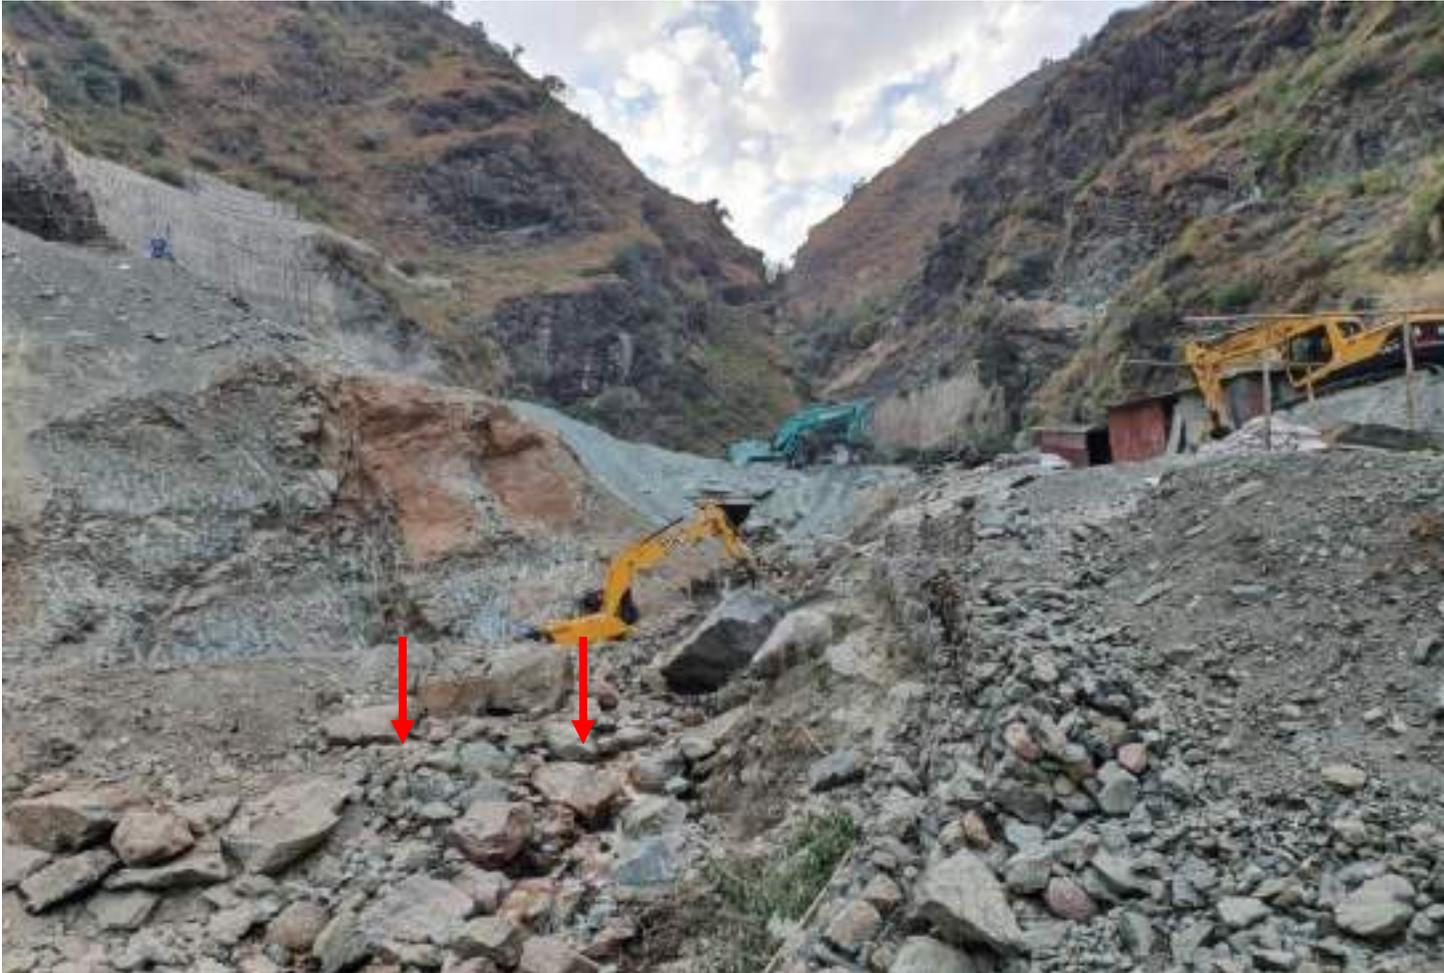
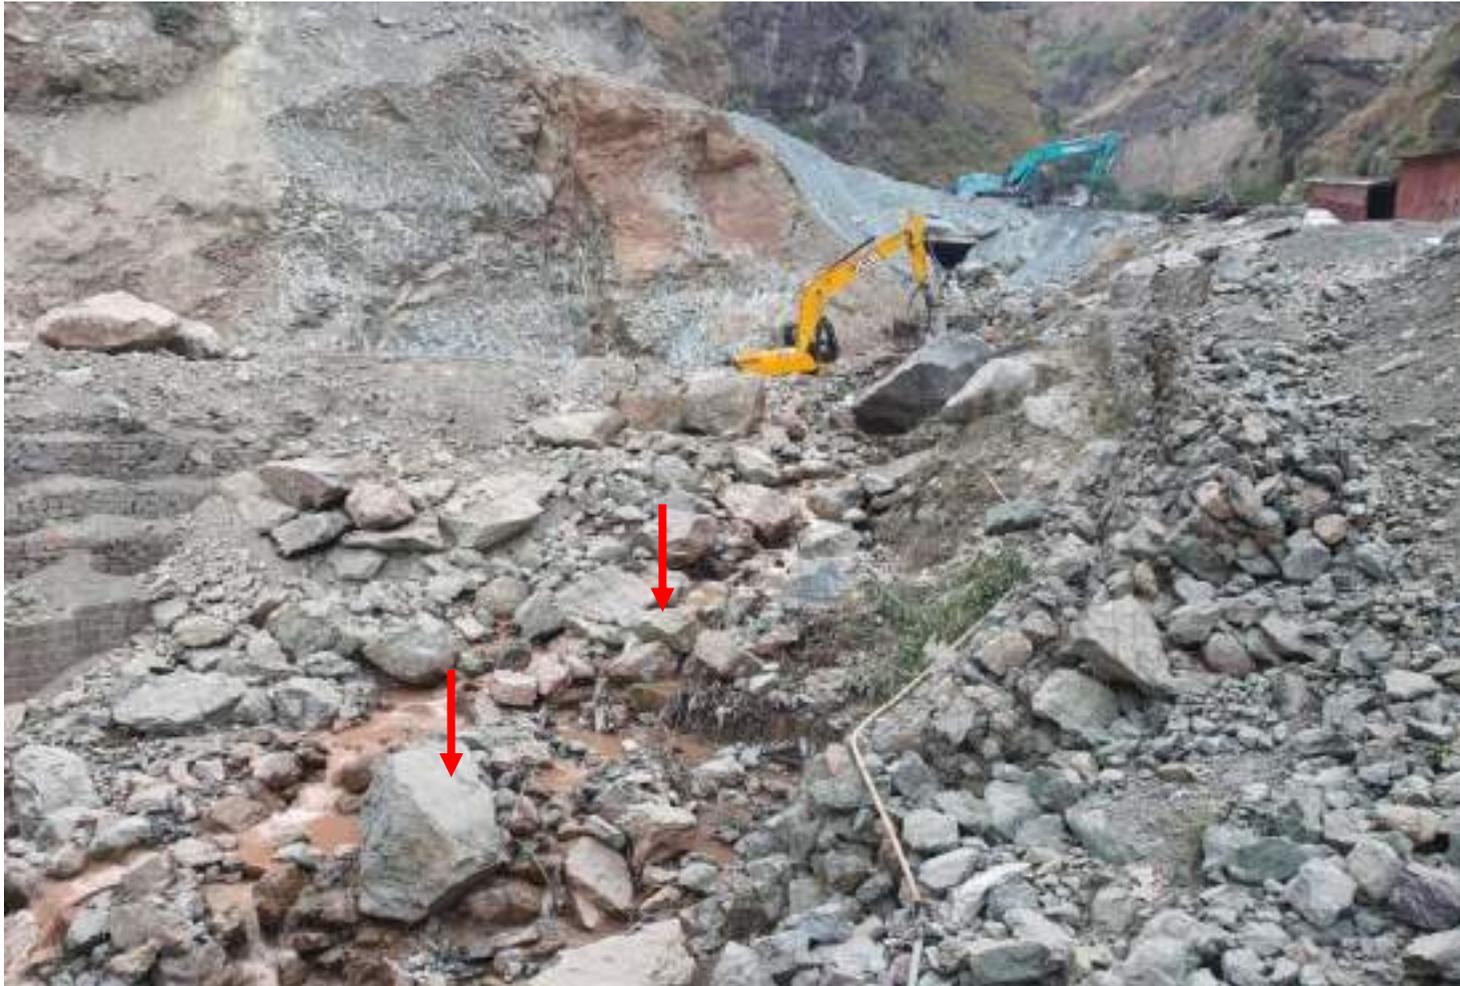
Photograph dated: (9th Dec, 2019): Near 44 Bridge Tunnel T-1 & T-2 (Kunfer Nallah) Chanderkote.

S.No.	Name of the Site / Village	Chainage/ (NB/SB)	Title /Area of the land	Total Capacity (cu.m)	Quantity dumped as on July2019 (cu.m)	Capacity remaining as on July2019 (cu.m)	Status	Observations
12)	Near 44 Bridge Tunnel T-1 & T-2 (Kunfer Nallah) Chanderkote	139+297 to 139+319 km (SB)	Tunnel Site	-	-	-	-	<i>Illegal dumping going on/.Kunfer Nallah getting choked due to dumping of heavy boulders and needs to be channelized.</i>
