Office of the Chairman, NGT Monitoring Committee (J&K)
Justice Janak Raj Kotwal
(Former Judge High Court of Jammu & Kashmir)

Subject: Report of the Chairman in compliance to Hon'ble NGT order
dated 20.03.2020.

In the matter of : Execution Application No. 32/2016
In
Original Application No. 295/2016
And
Original Application No. 295/2016
(M.A.No.539/2016)

Report in compliance to Hon'ble NGT Order dated 20. 03. 2020

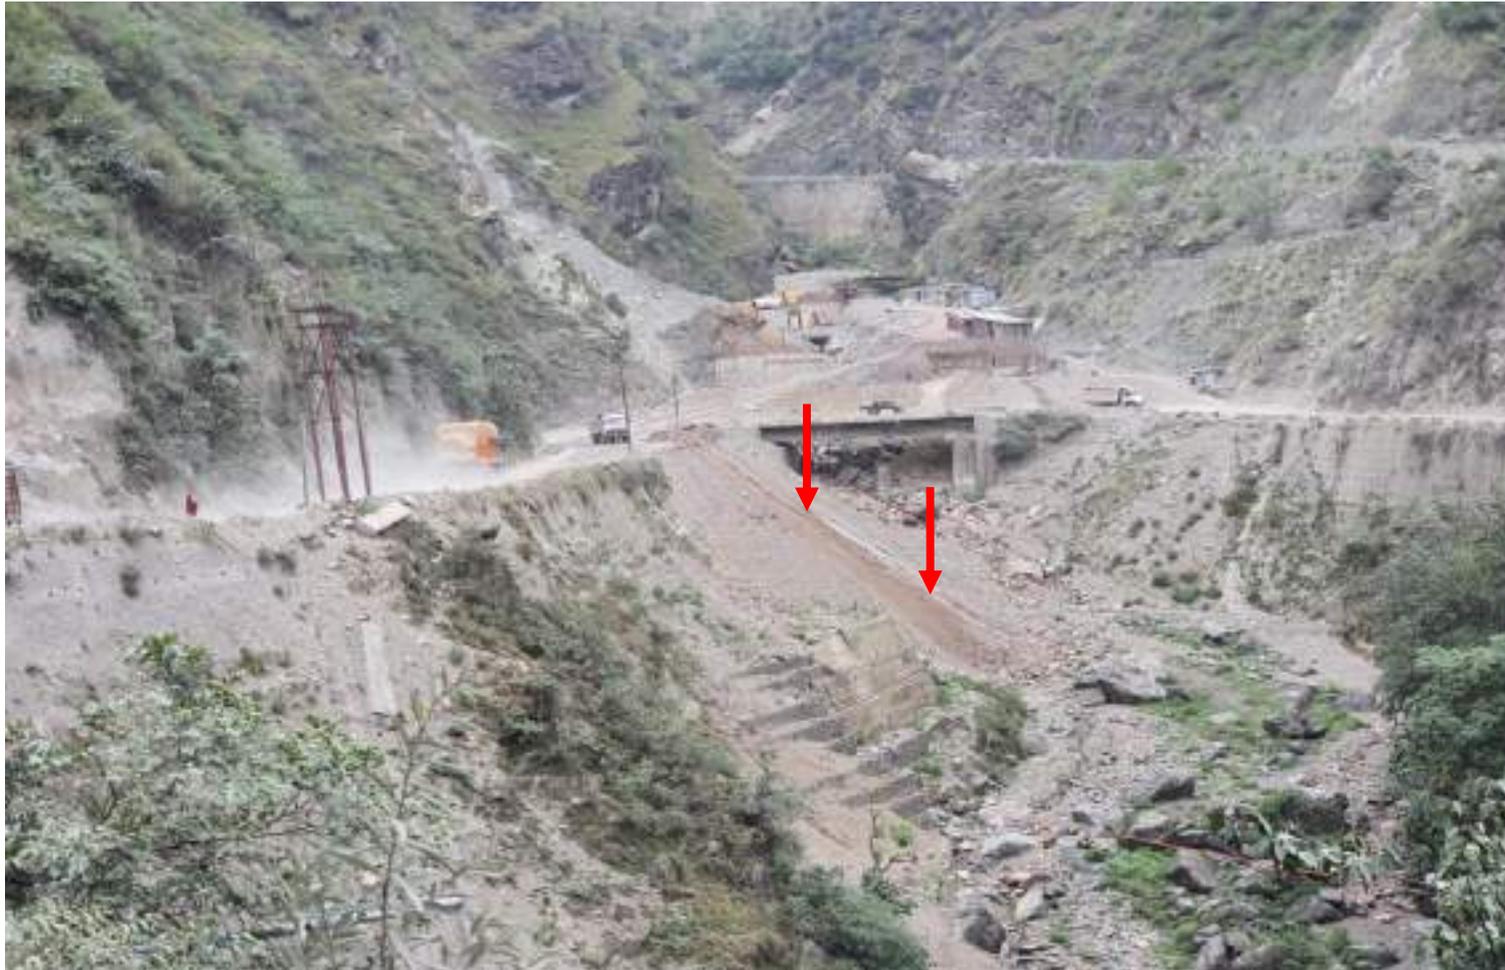
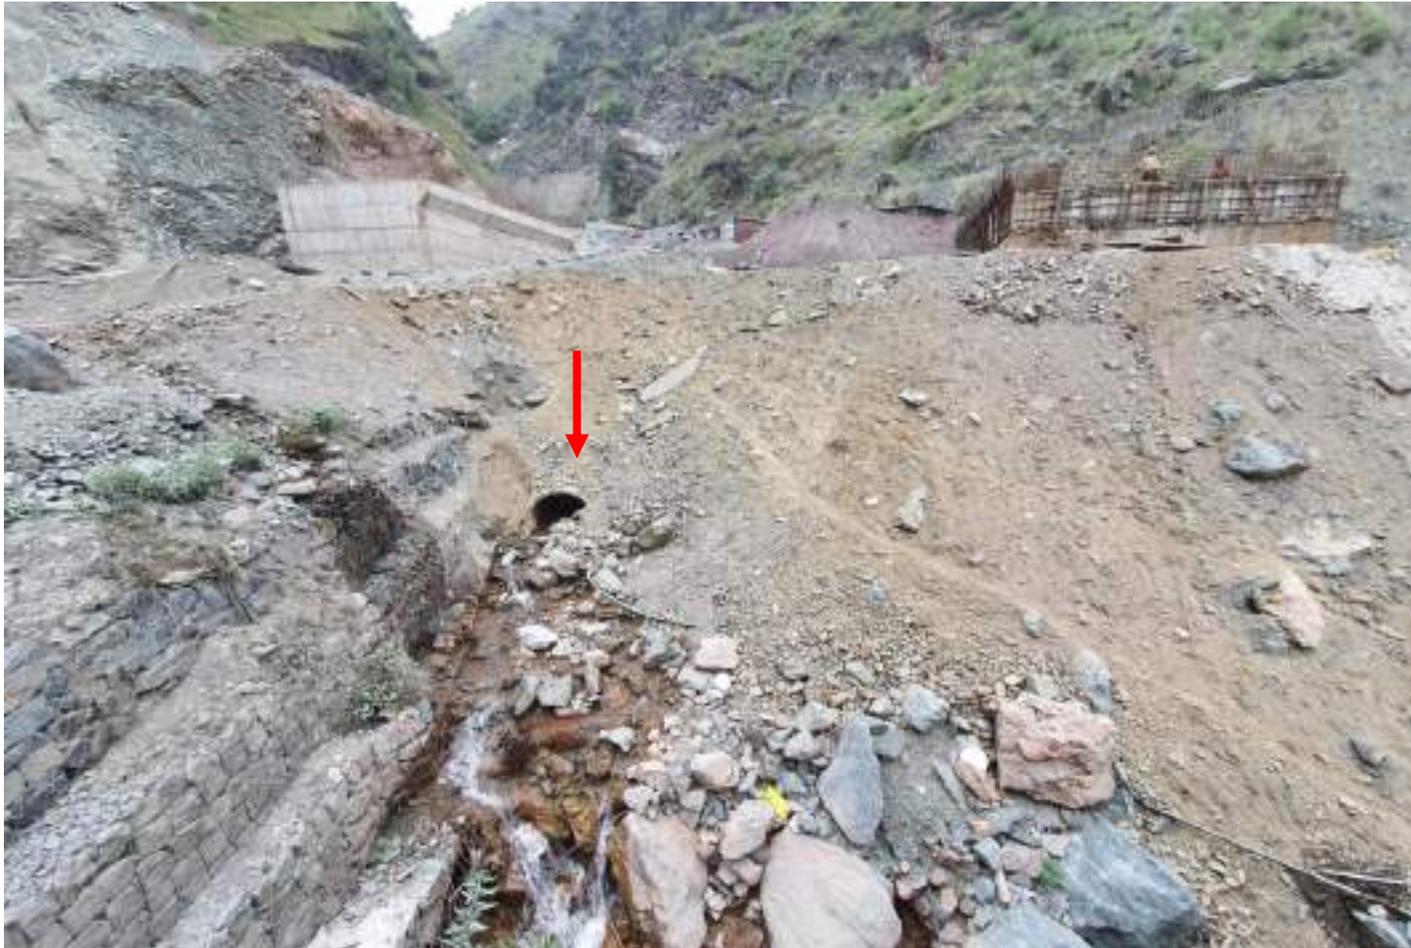
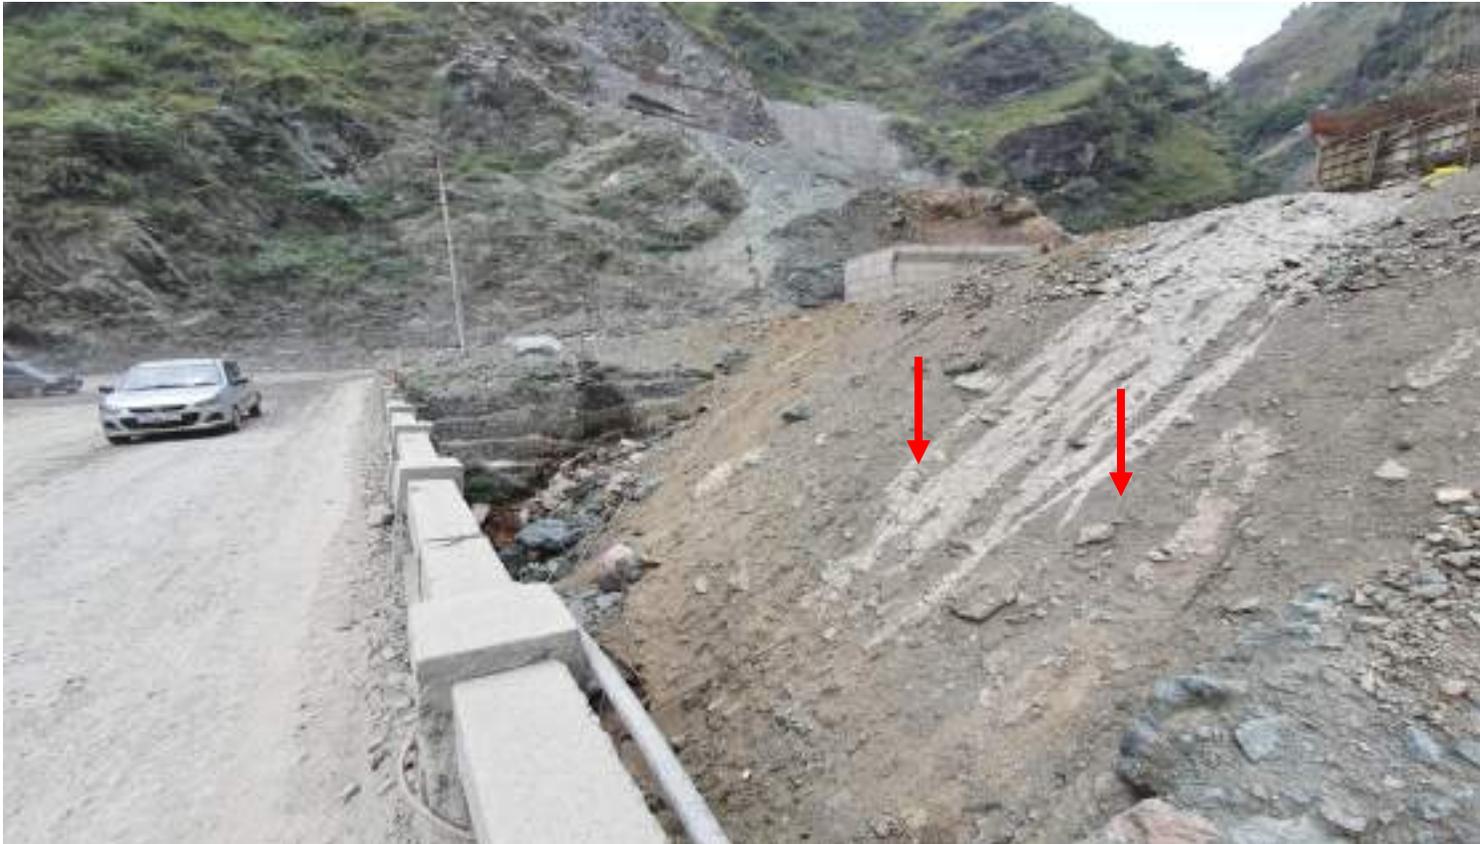
Photograph dated: (29th July, 2020): Near 44 Bridge Tunnel T-1 & T-2 (Kunfer Nallah) Chanderkote.

S.No.	Name of the Site / Village	Chainage/ (NB/SB)	Title /Area of the land	Total Capacity (cu.m)	Quantity dumped as on July2019 (cu.m)	Capacity remaining as on July2019 (cu.m)	Status	Observations
12)	Near 44 Bridge Tunnel T-1 & T-2 (Kunfer Nallah) Chanderkote	139+297 to 139+319 km (SB)	Tunnel Site	-	-	-	-	<i>Illegal dumping going on/.Kunfer Nallah getting choked due to dumping of heavy boulders and needs to be channelized.</i>

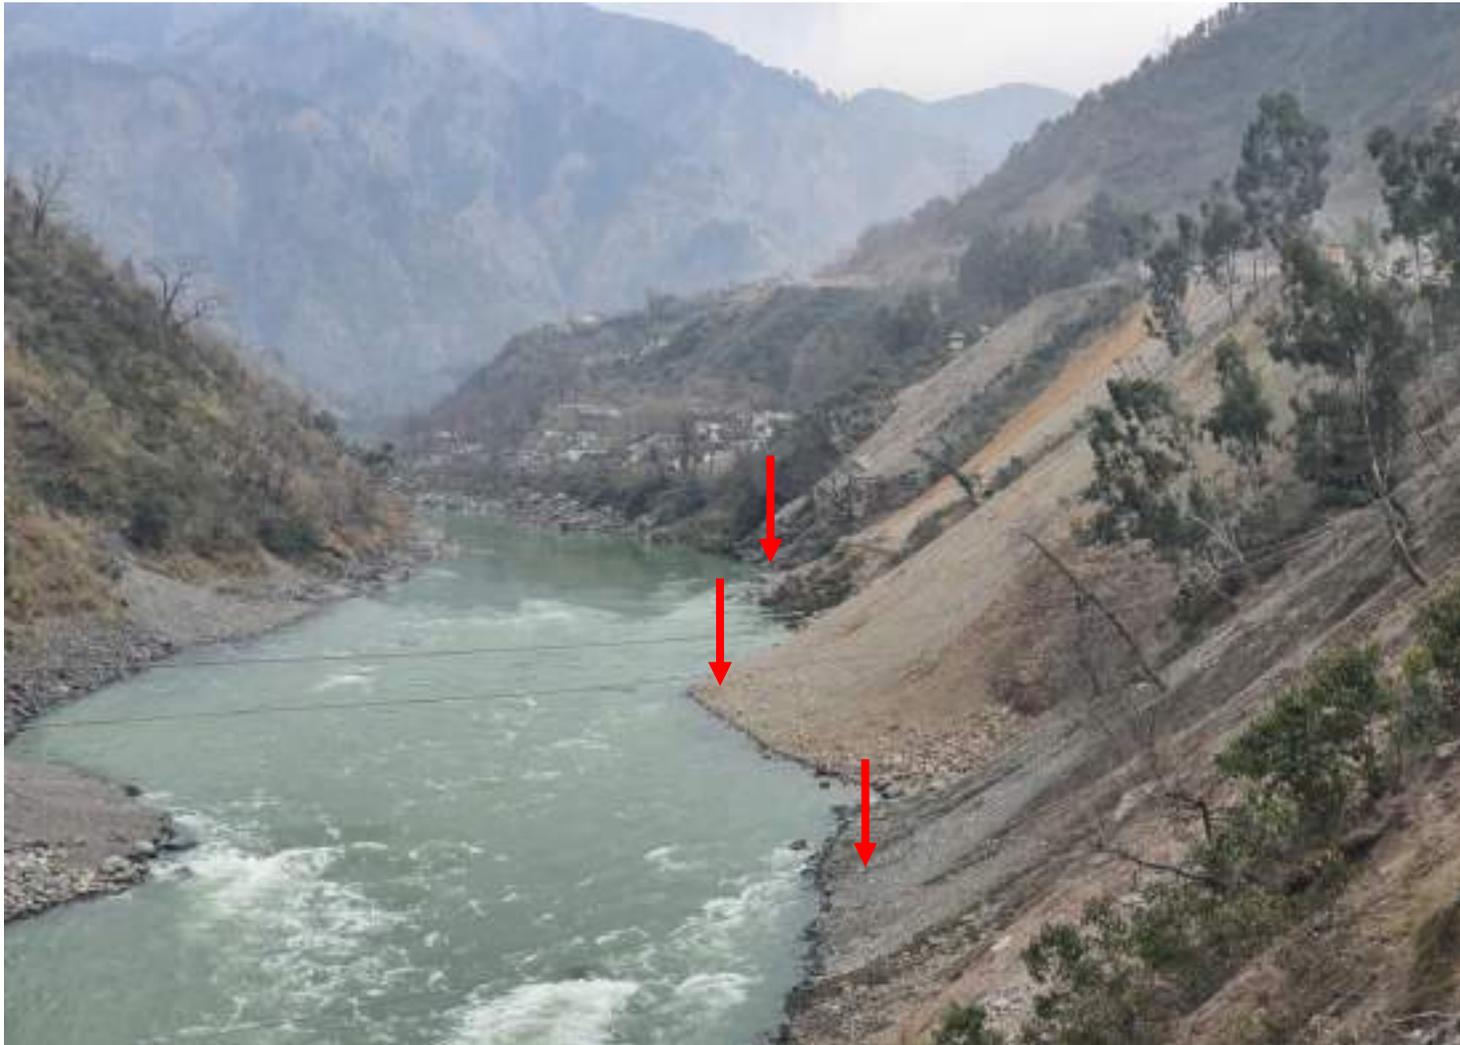
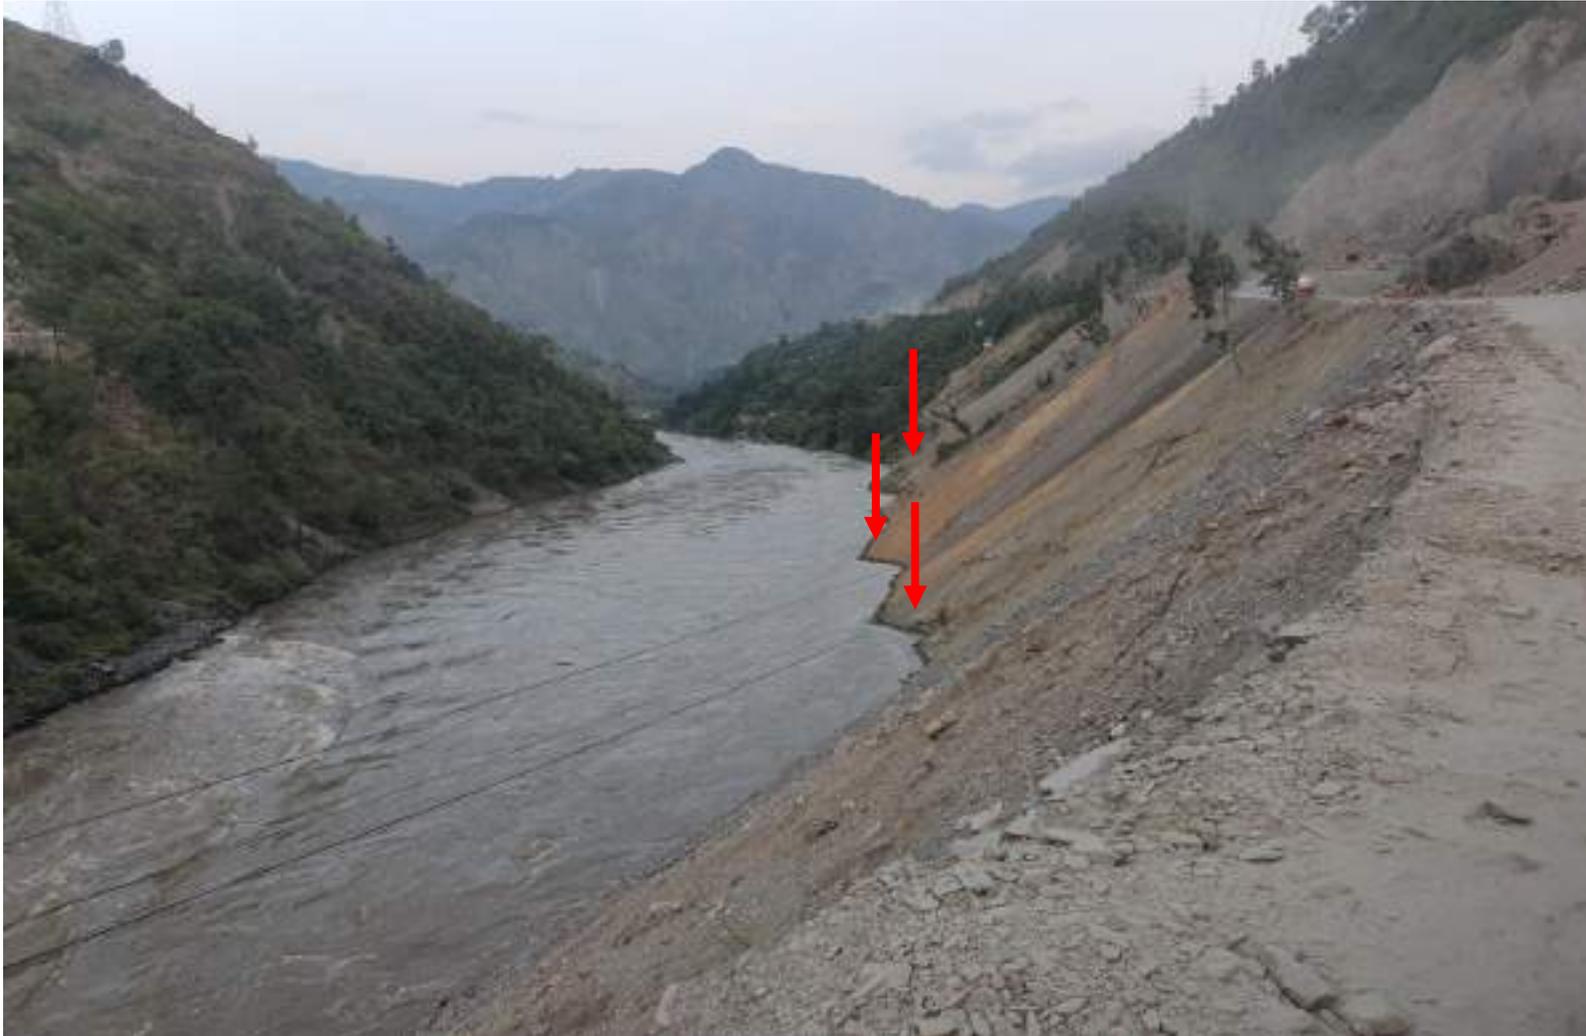
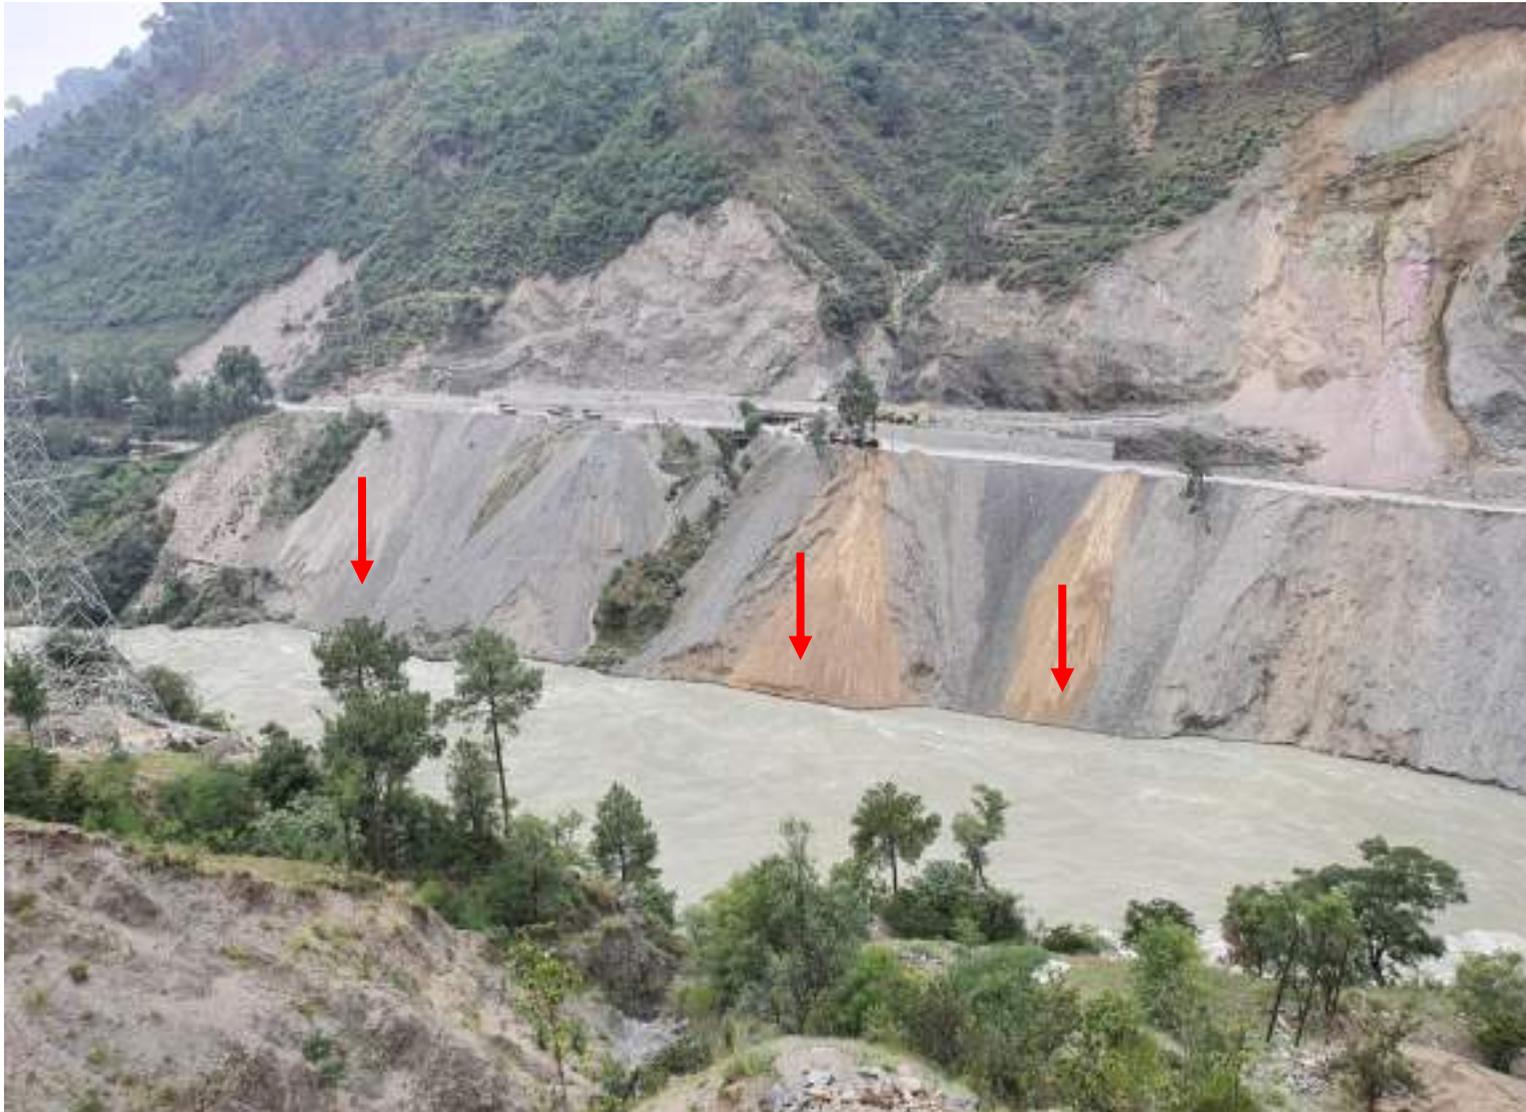
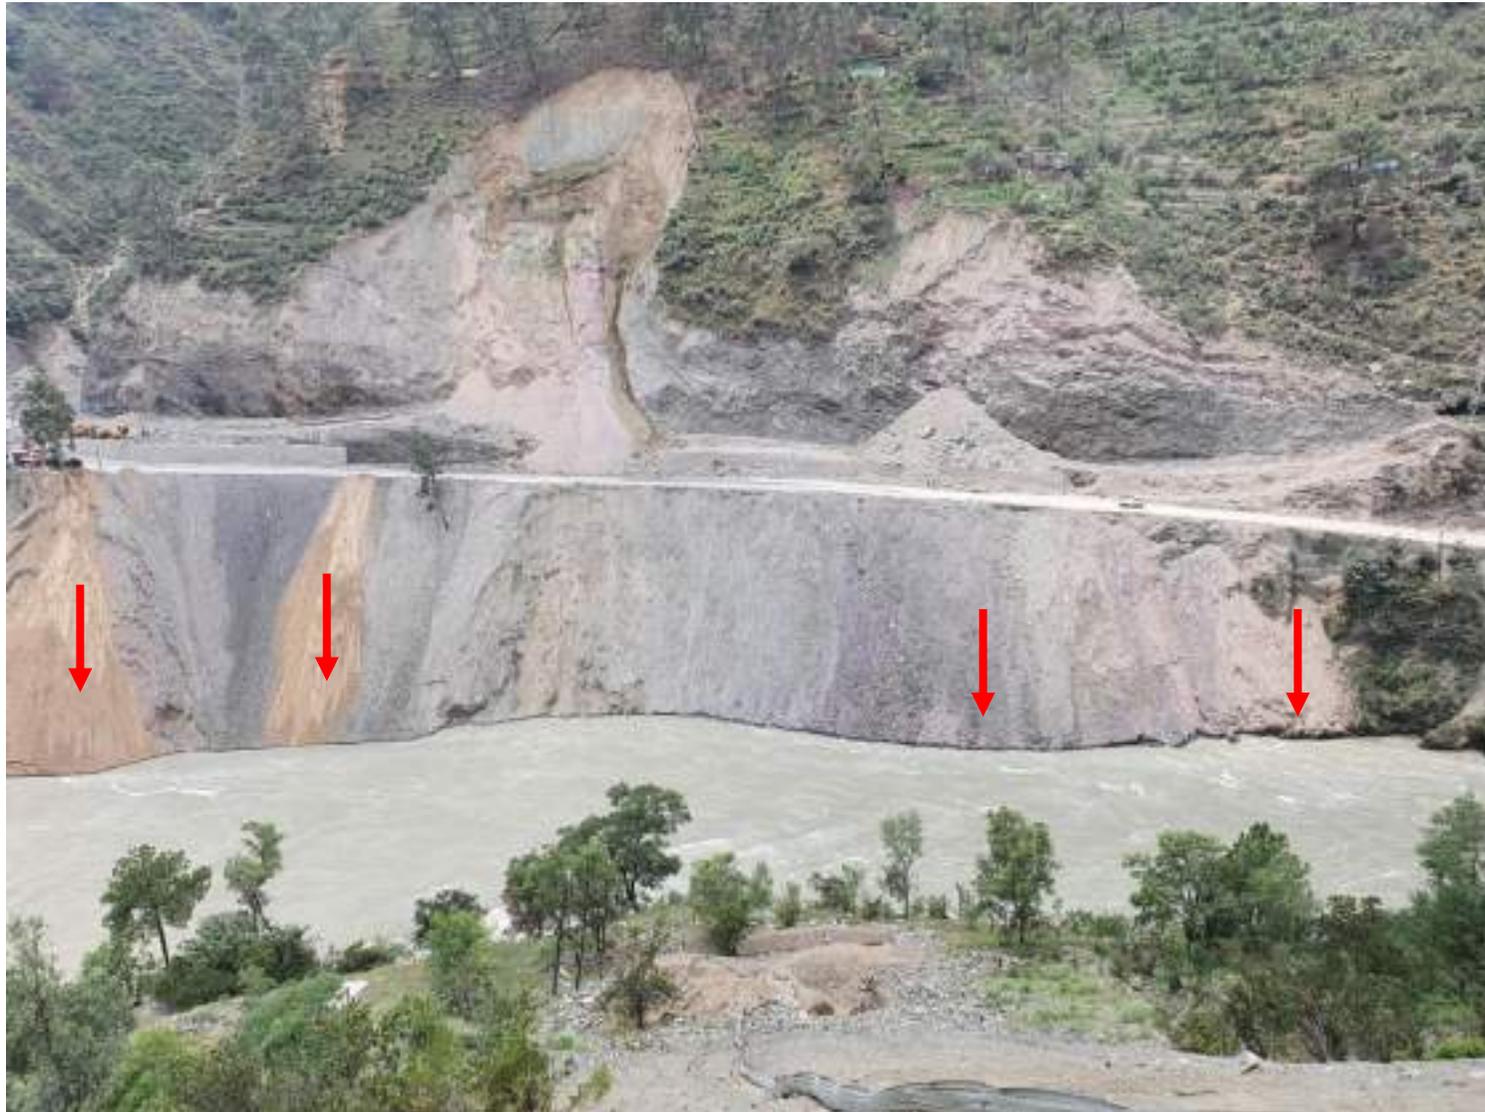
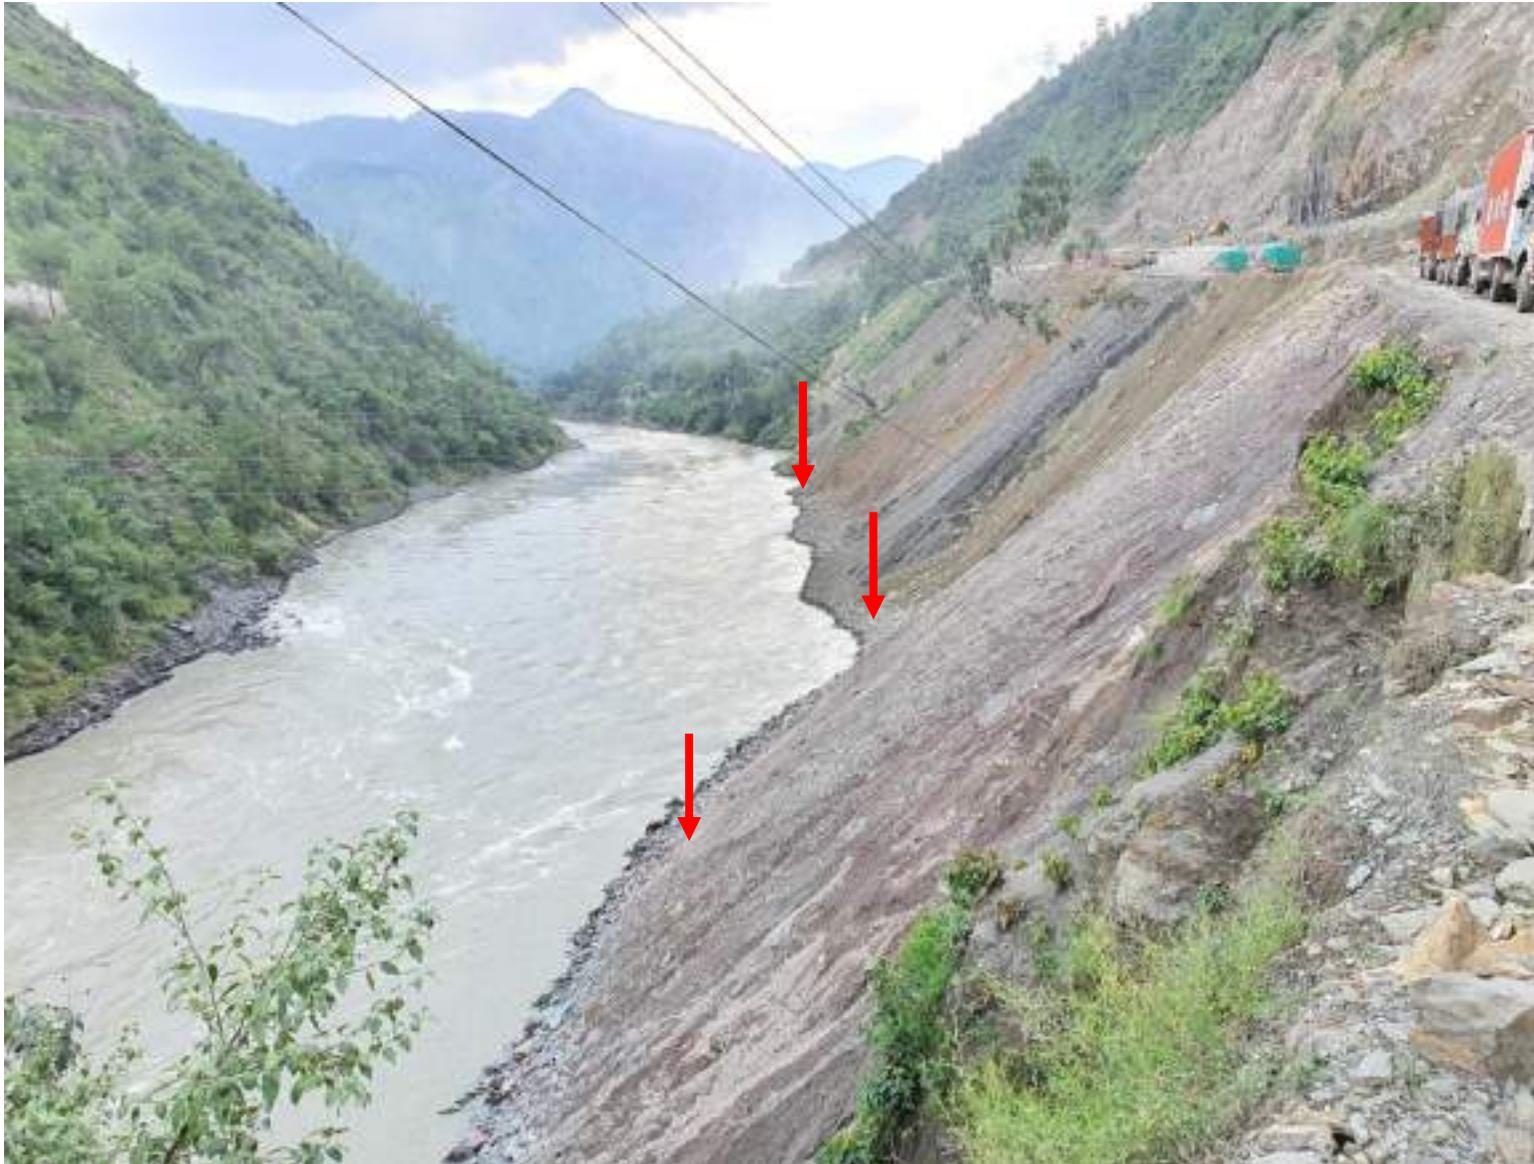
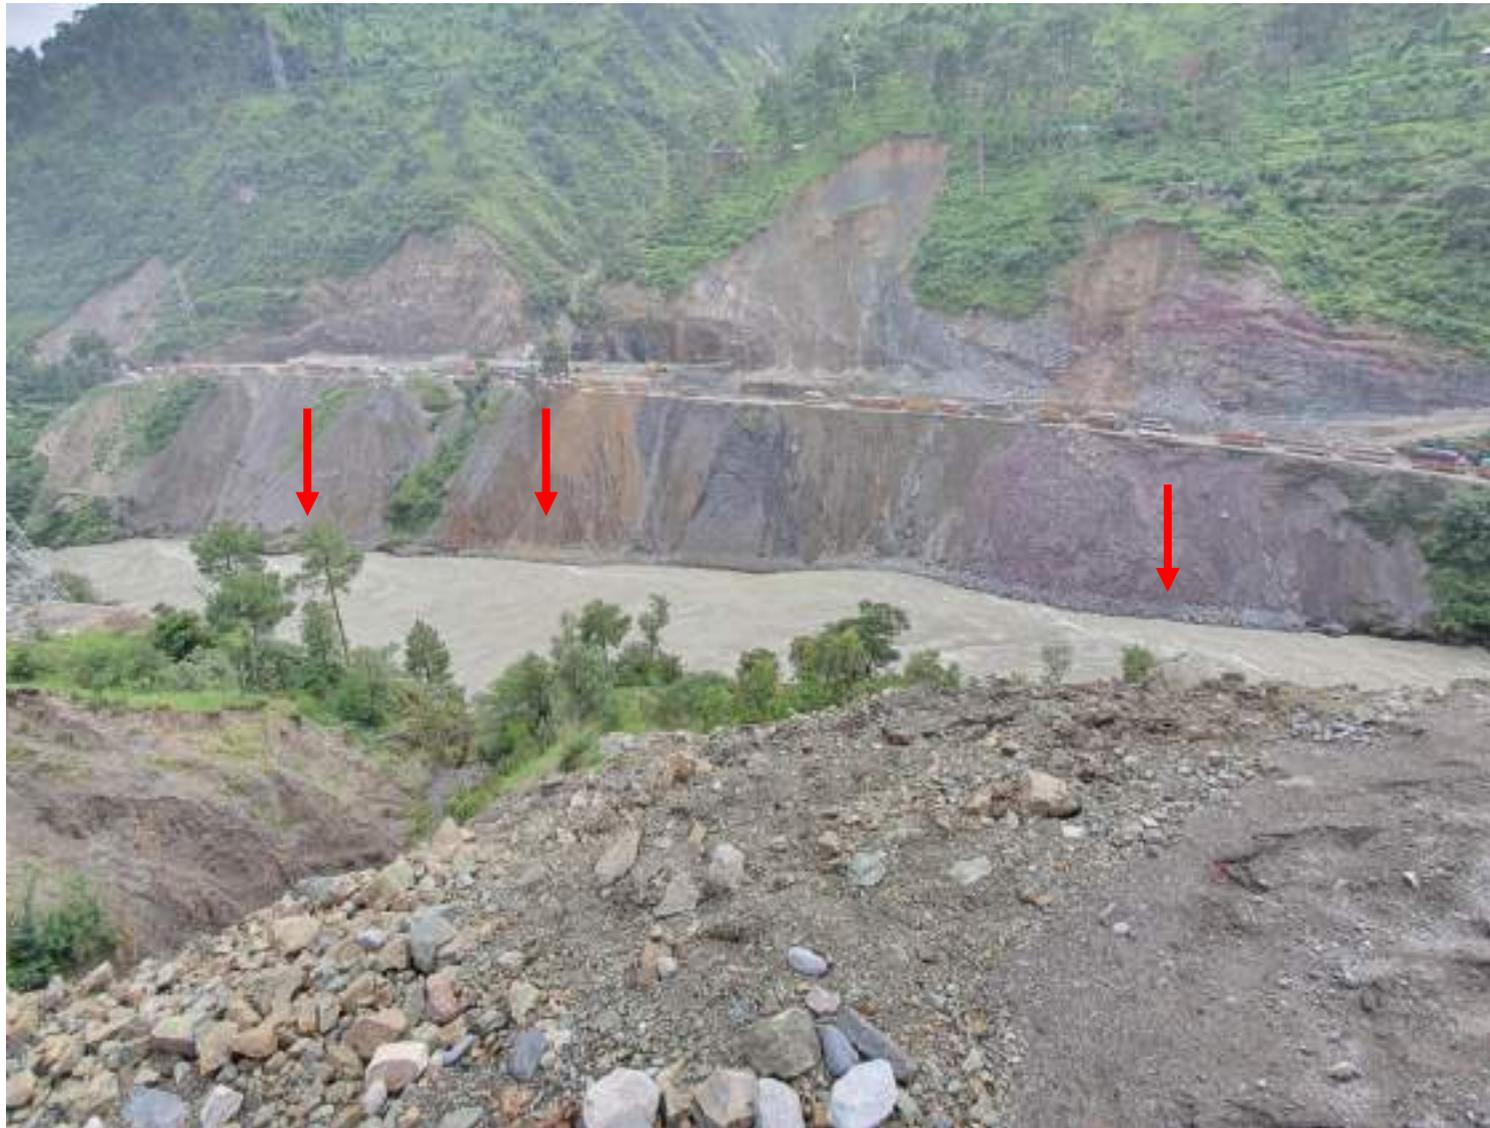
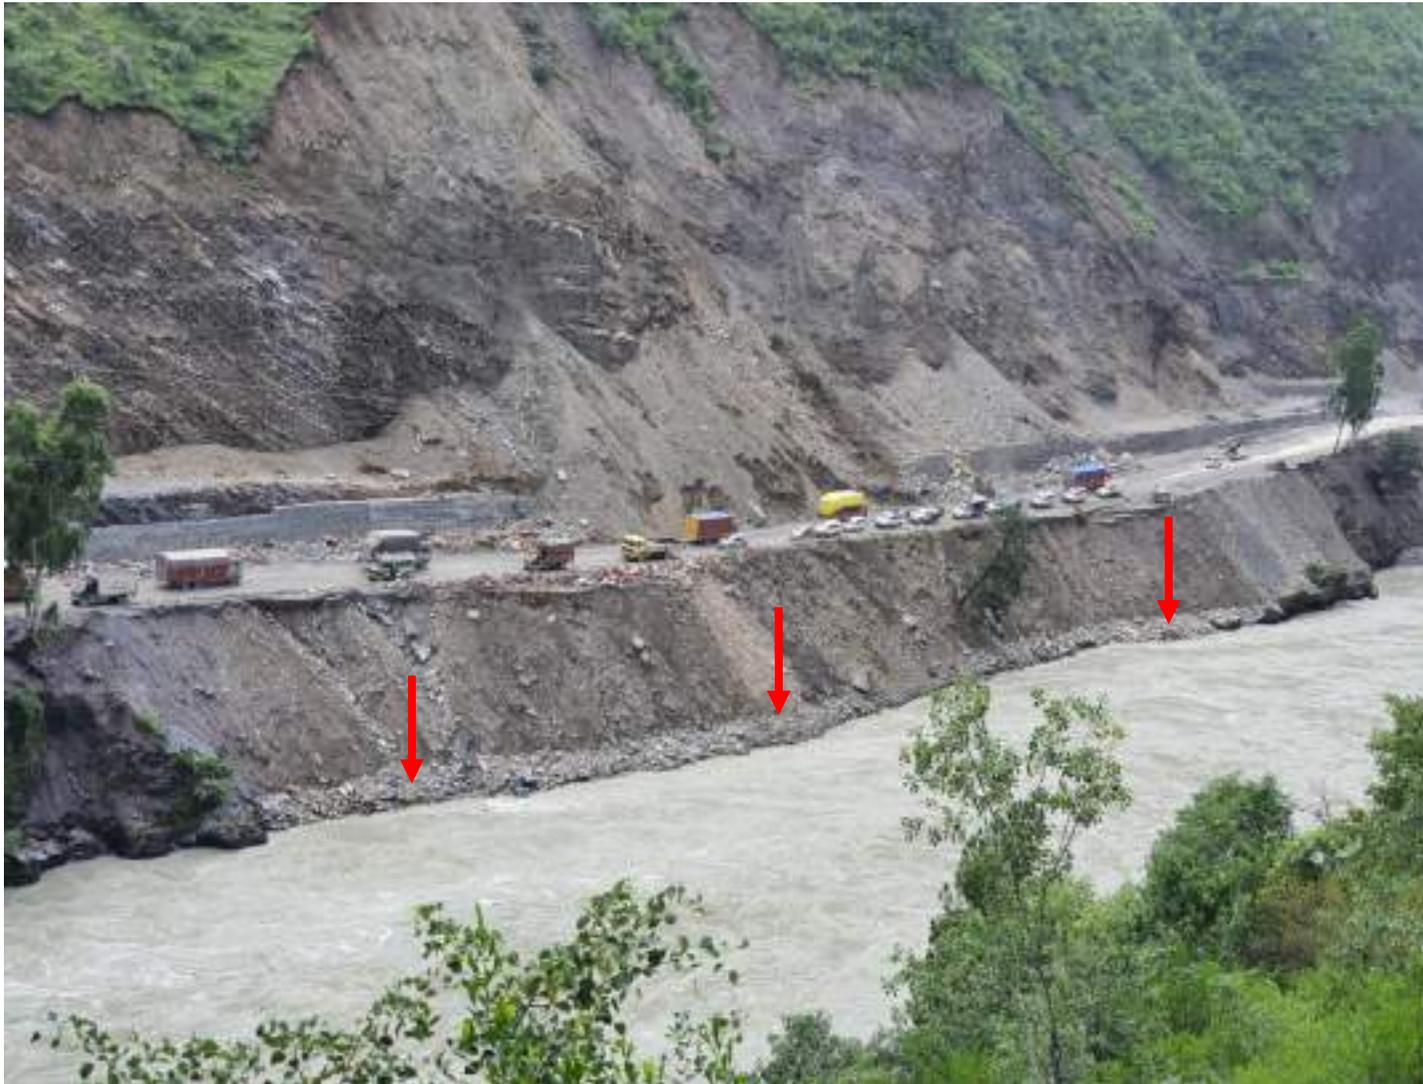
Photograph dated: (19th Feb, 2020): Chanderkote (Near 84 Bn CRPF Camp and Bridge-48)

S.No.	Name of the Site / Village	Chainage/ (NB/SB)	Title /Area of the land	Total Capacity (cu.m)	Quantity dumped as on July2019 (cu.m)	Capacity remaining as on July2019 (cu.m)	Status	Observations
13)	Chanderkote (Near 84 Bn CRPF Camp)	141+200 to km 141+320 (SB)	Private / 01.76 Hectare	3,750	3,750	Nil	Closed but illegal dumping going on.	<i>Muck going directly into Chenab River. Gabion needs to be provided.</i>
(14-16)	Chanderkote (Near 48 Bridge)	143+360 to km 143+380 (SB)	Non Designated	-	-	-	Illegal dumping going on.	<i>Muck going directly into Chenab River. Gabion needs to be provided.</i>
		143+380 to km 143+420 (SB)	Non Designated	-	-	-	Illegal dumping going on.	
		143+720 to km 143+740 (SB)	Non Designated	-	-	-	Illegal dumping going on.

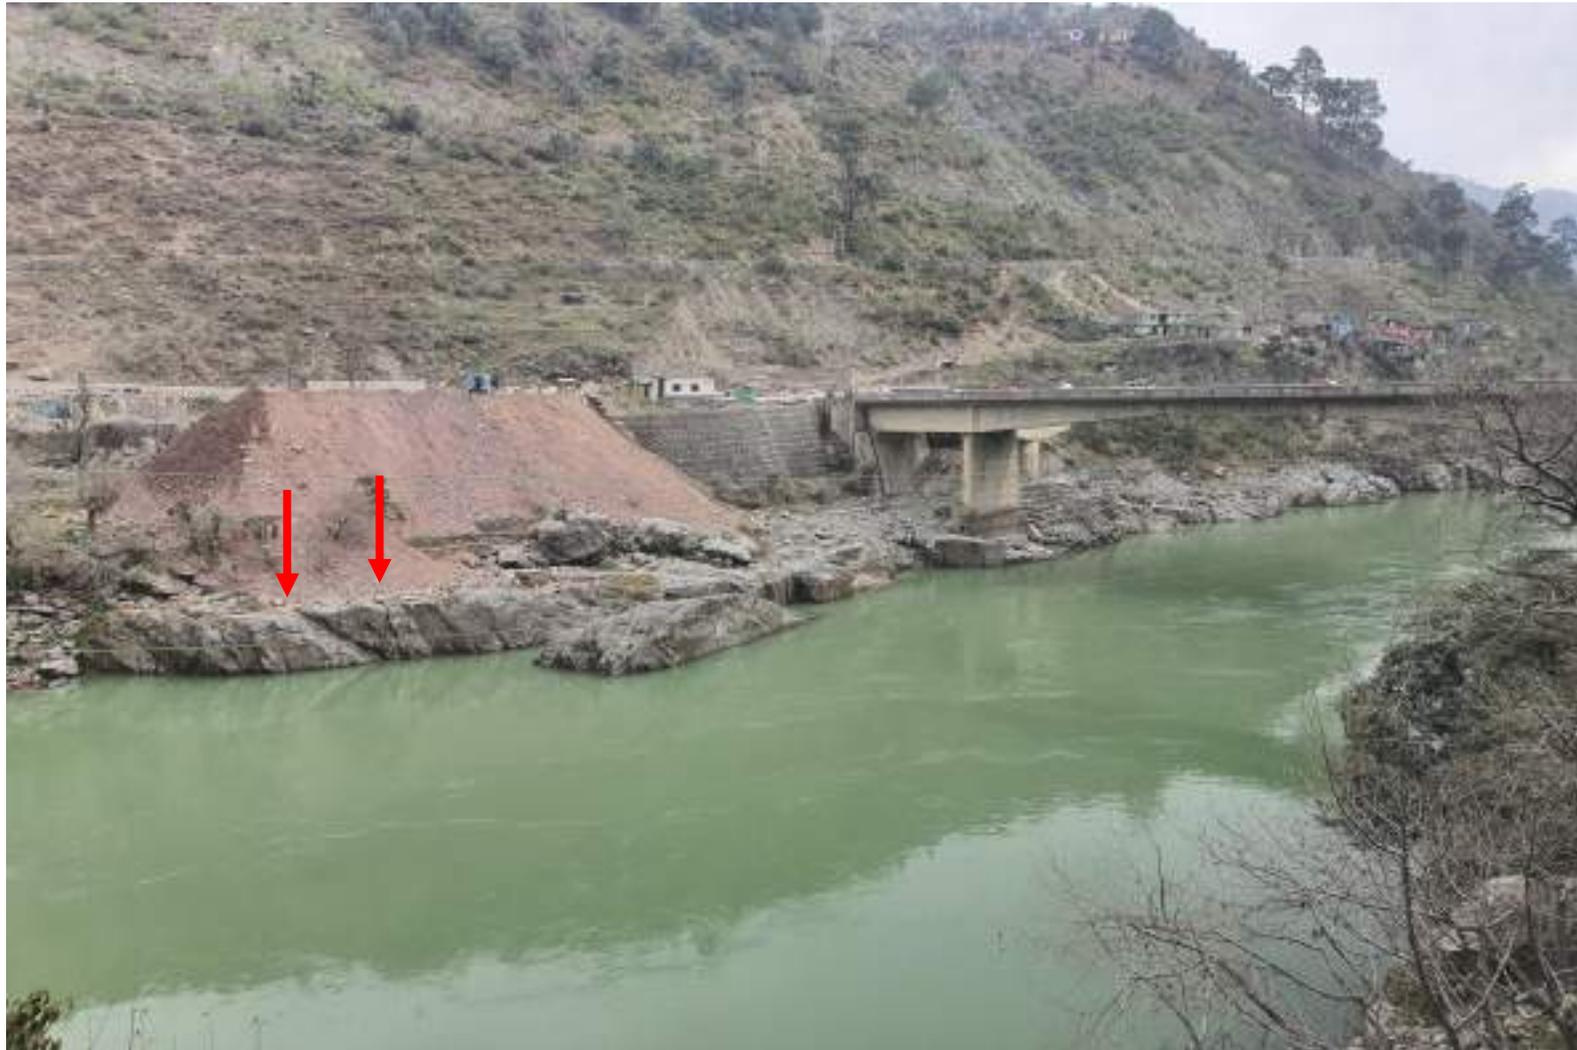
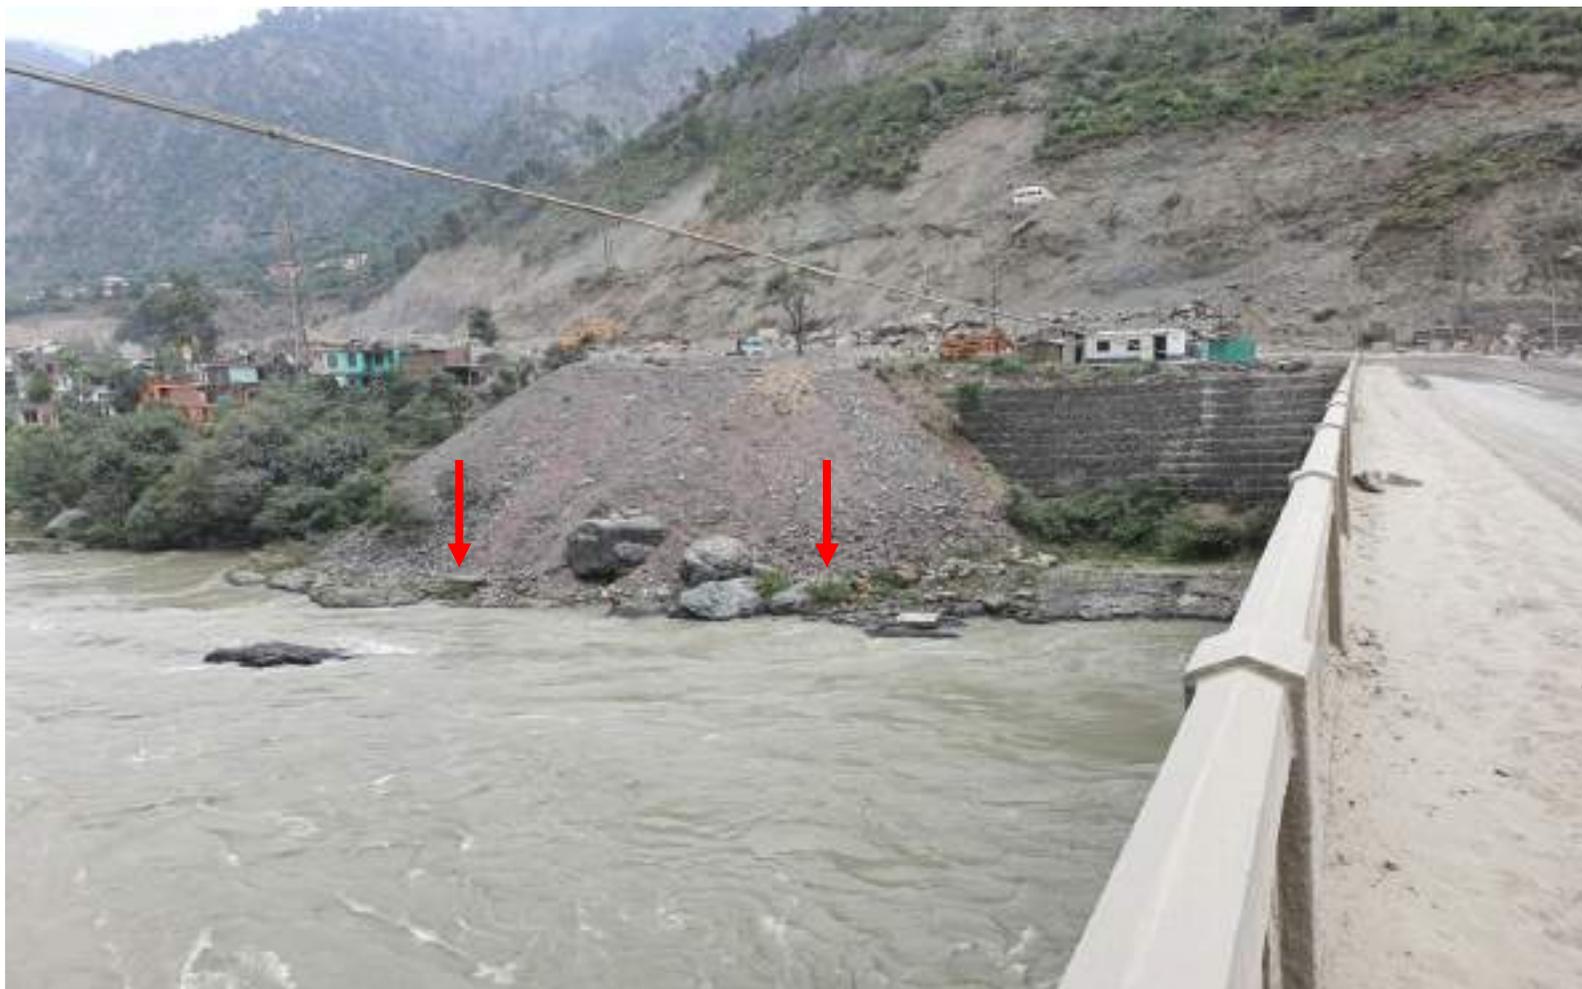
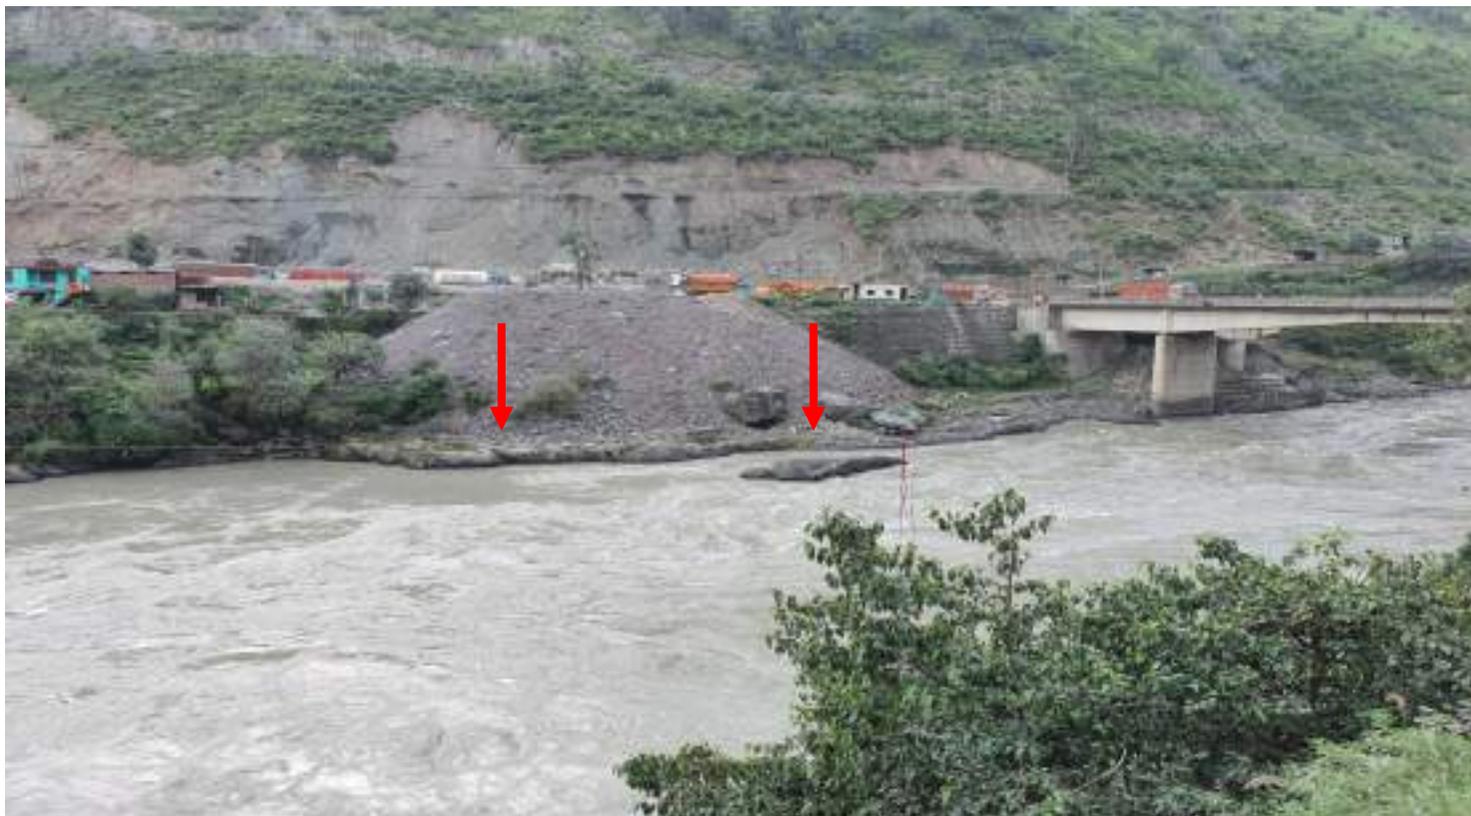
Photograph dated: (19th Feb, 2020): Near Jaswal Bridge

S.No.	Name of the Site / Village	Chainage/ (NB/SB)	Title /Area of the land	Total Capacity (cu.m)	Quantity dumped as on July2019 (cu.m)	Capacity remaining as on July2019 (cu.m)	Status	Observations
17)	Near Jaswal Bridge	144+500 to km 144+550 (SB)	Private Land	-	-	-	-	<i>Muck overflow. Gabion needs to be raised.</i>
