Office of the Chairman, NGT Monitoring Committee (J&K)
Justice Janak Raj Kotwal
(Former Judge High Court of Jammu & Kashmir)

Subject: Report of the Chairman in compliance to Hon'ble NGT order
dated 20.03.2020.

In the matter of : Execution Application No. 32/2016
In
Original Application No. 295/2016
And
Original Application No. 295/2016
(M.A.No.539/2016)

Report in compliance to Hon'ble NGT Order dated 20. 03. 2020

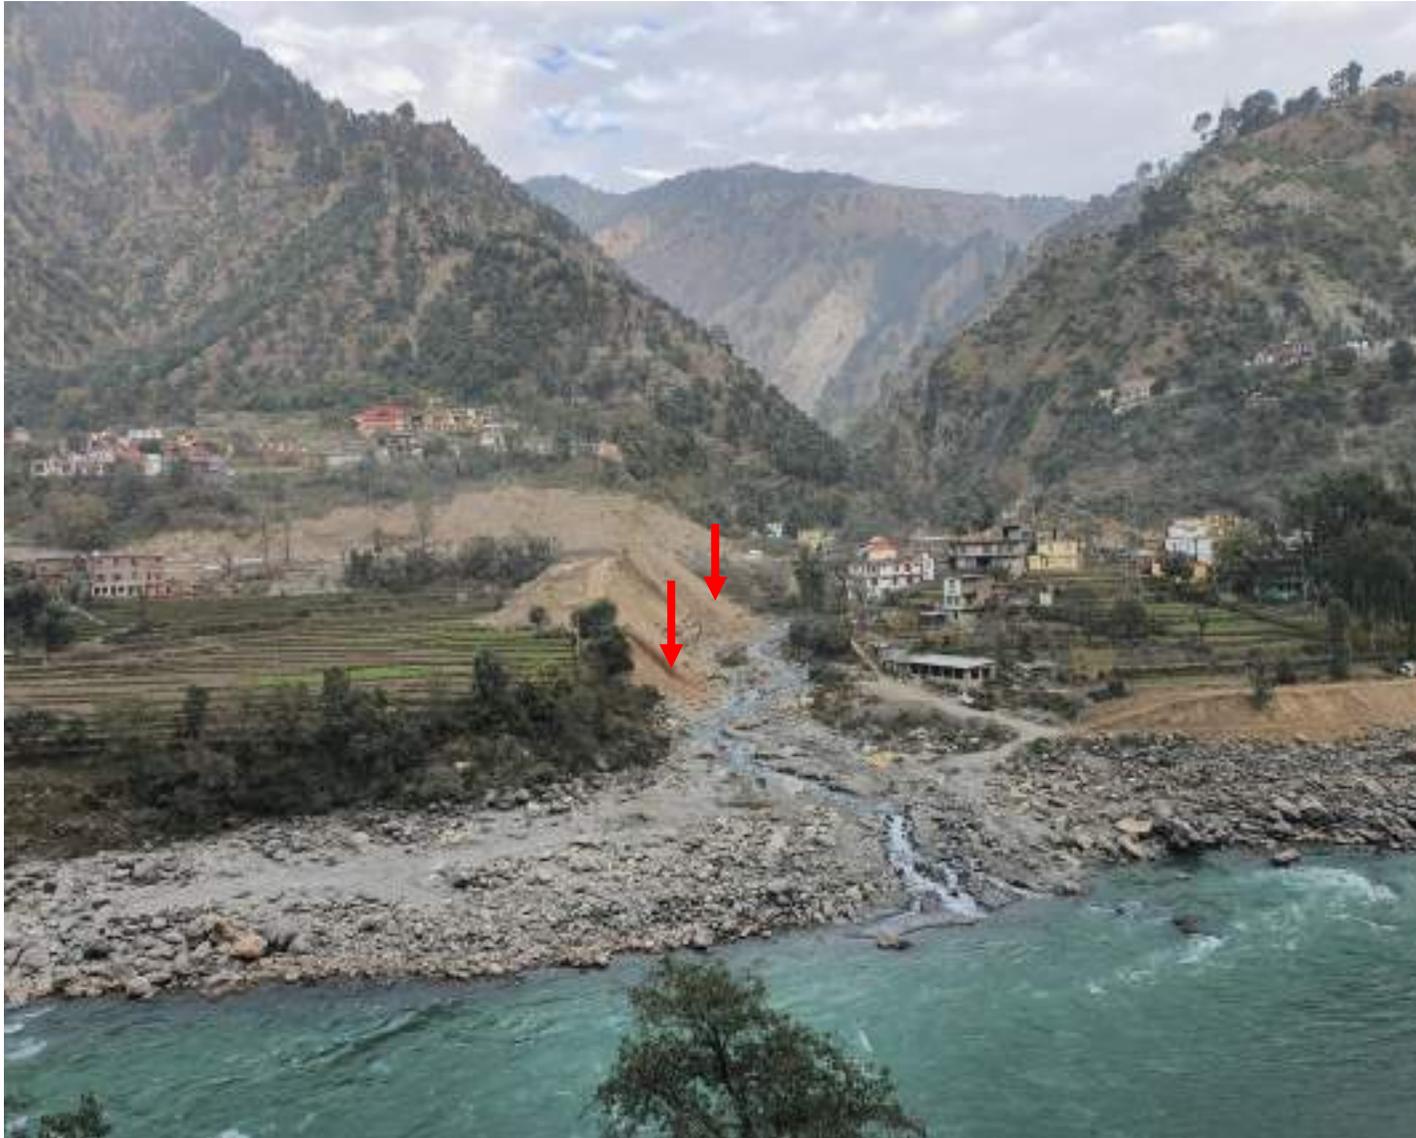
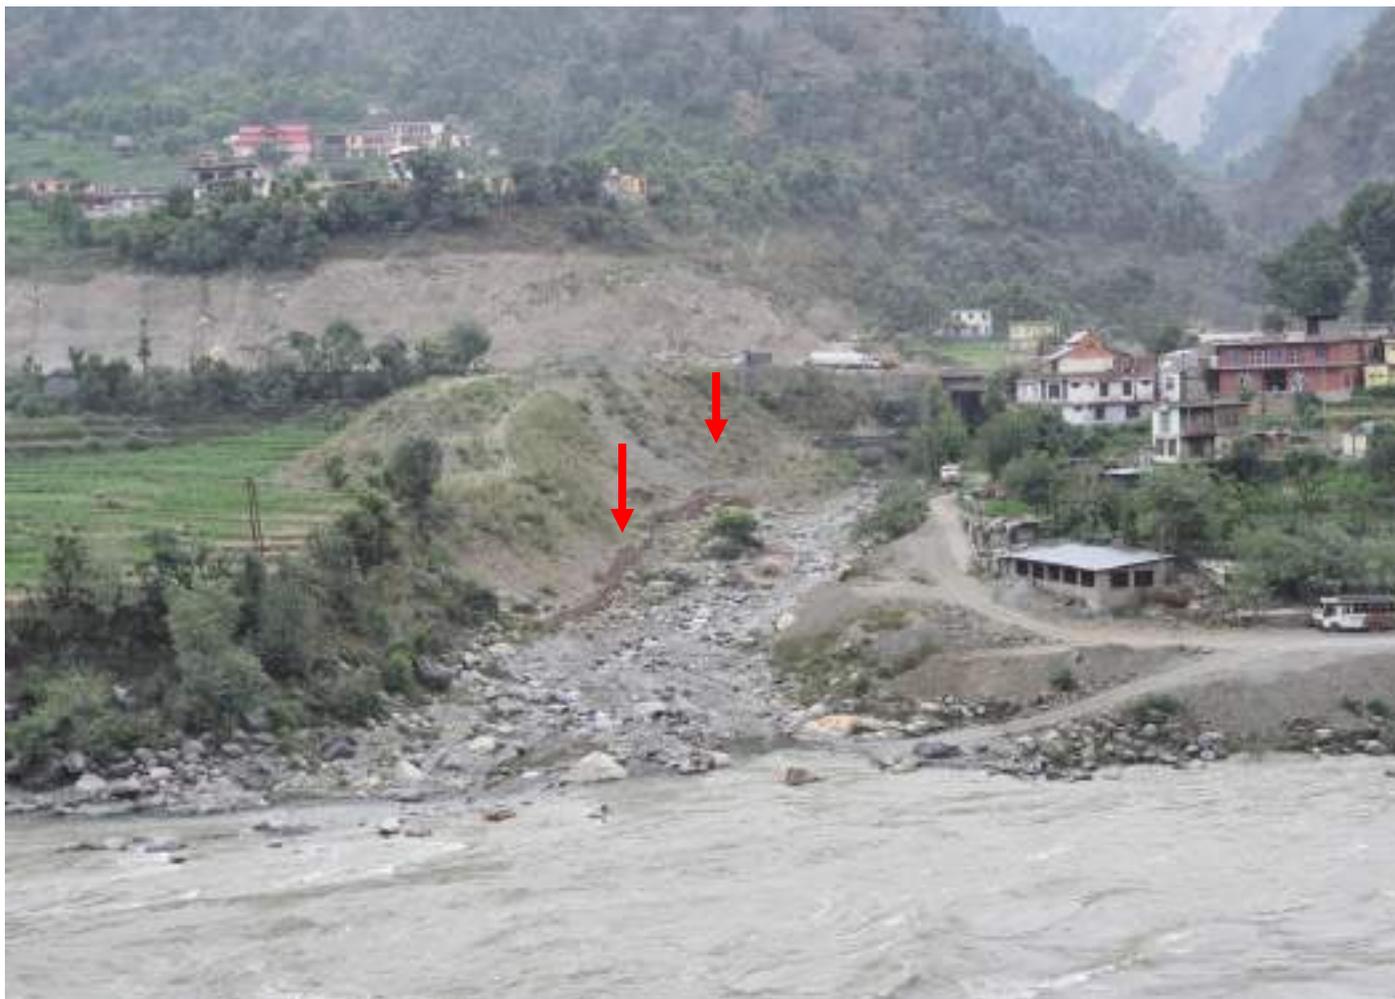
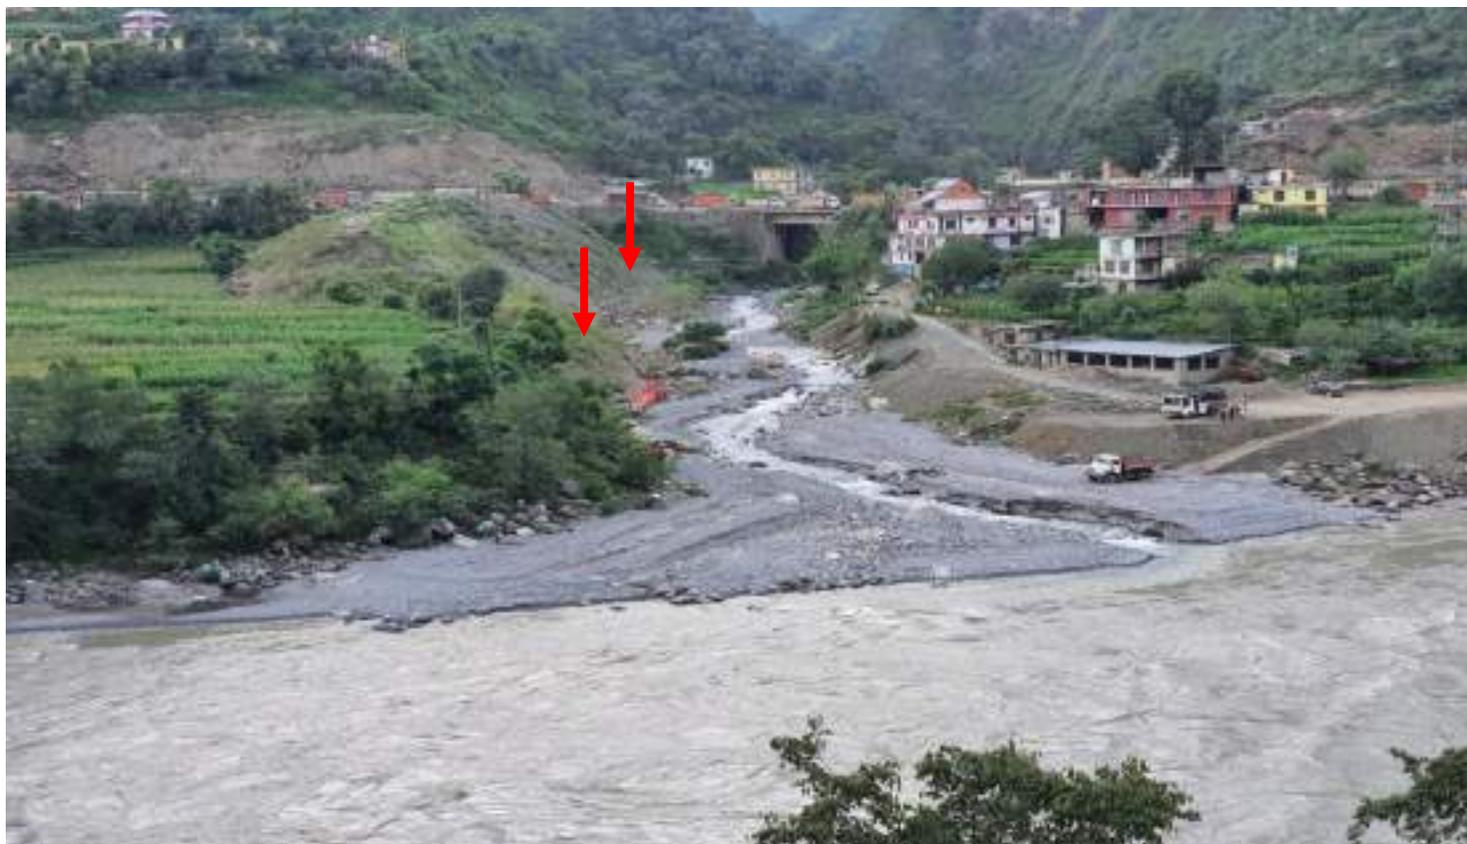
Photograph dated: (19th Feb, 2020): Kanthi (Karol-I) Bridge-51 (Near Hotel Khana Khazana)

S.No.	Name of the Site / Village	Chainage/ (NB/SB)	Title /Area of the land	Total Capacity (cu.m)	Quantity dumped as on July2019 (cu.m)	Capacity remaining as on July2019 (cu.m)	Status	Observations
18)	Kanthi (Karol-I) Bridge- 51 (Near Hotel Khana Khazana)	144+950 to 144+970 km (SB)	Private / 0.48 Hectare	33,500	33,500	Nil	Closed	<i>Green cover has come up in large portion of this site. Gabion needs to be raised.</i>

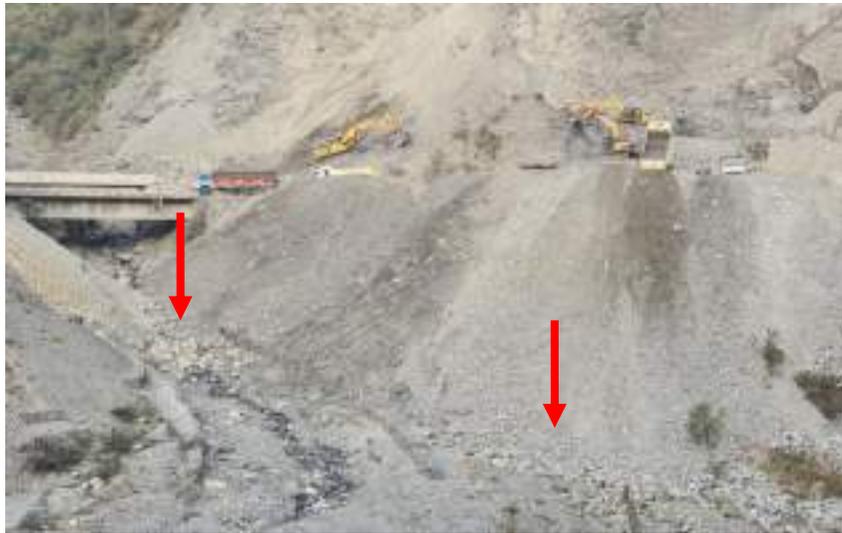
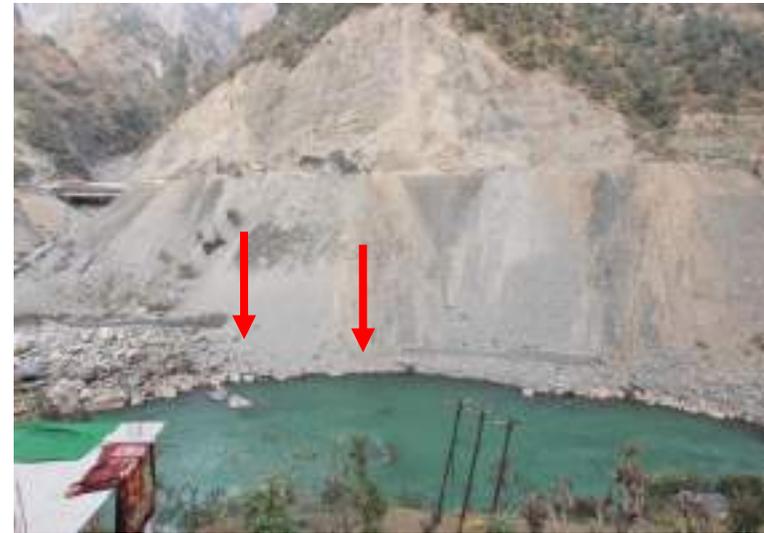
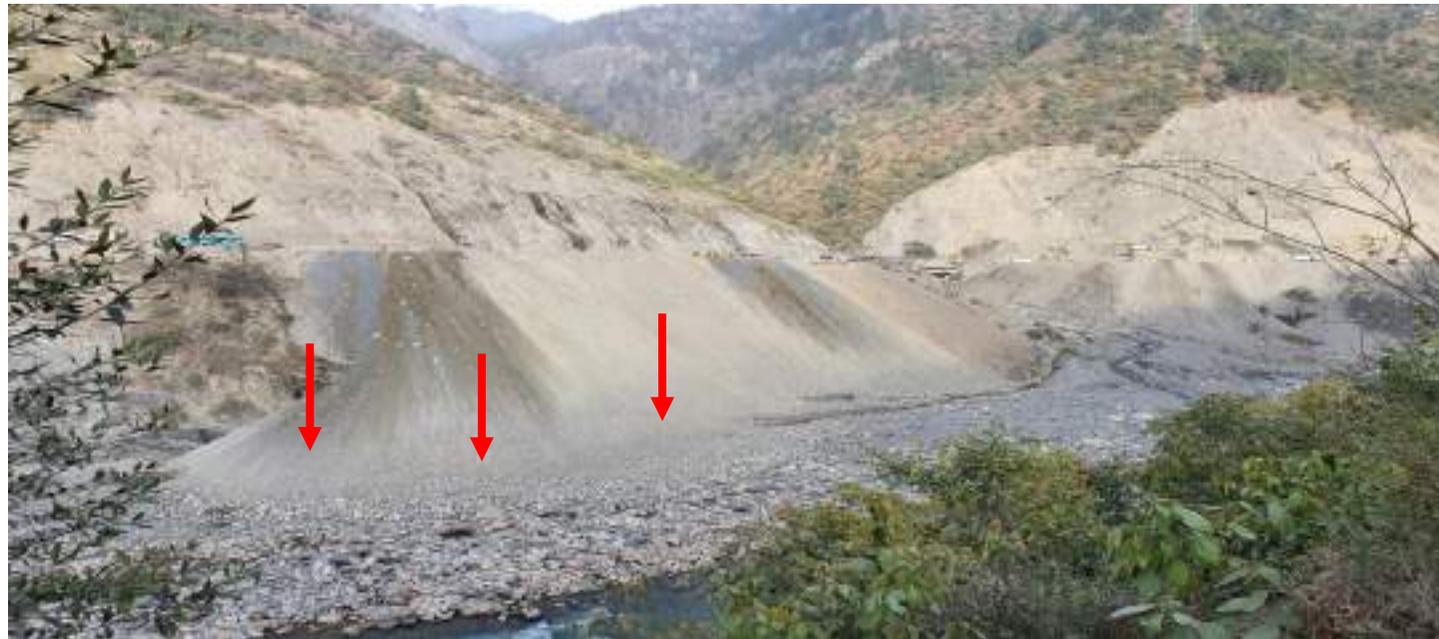
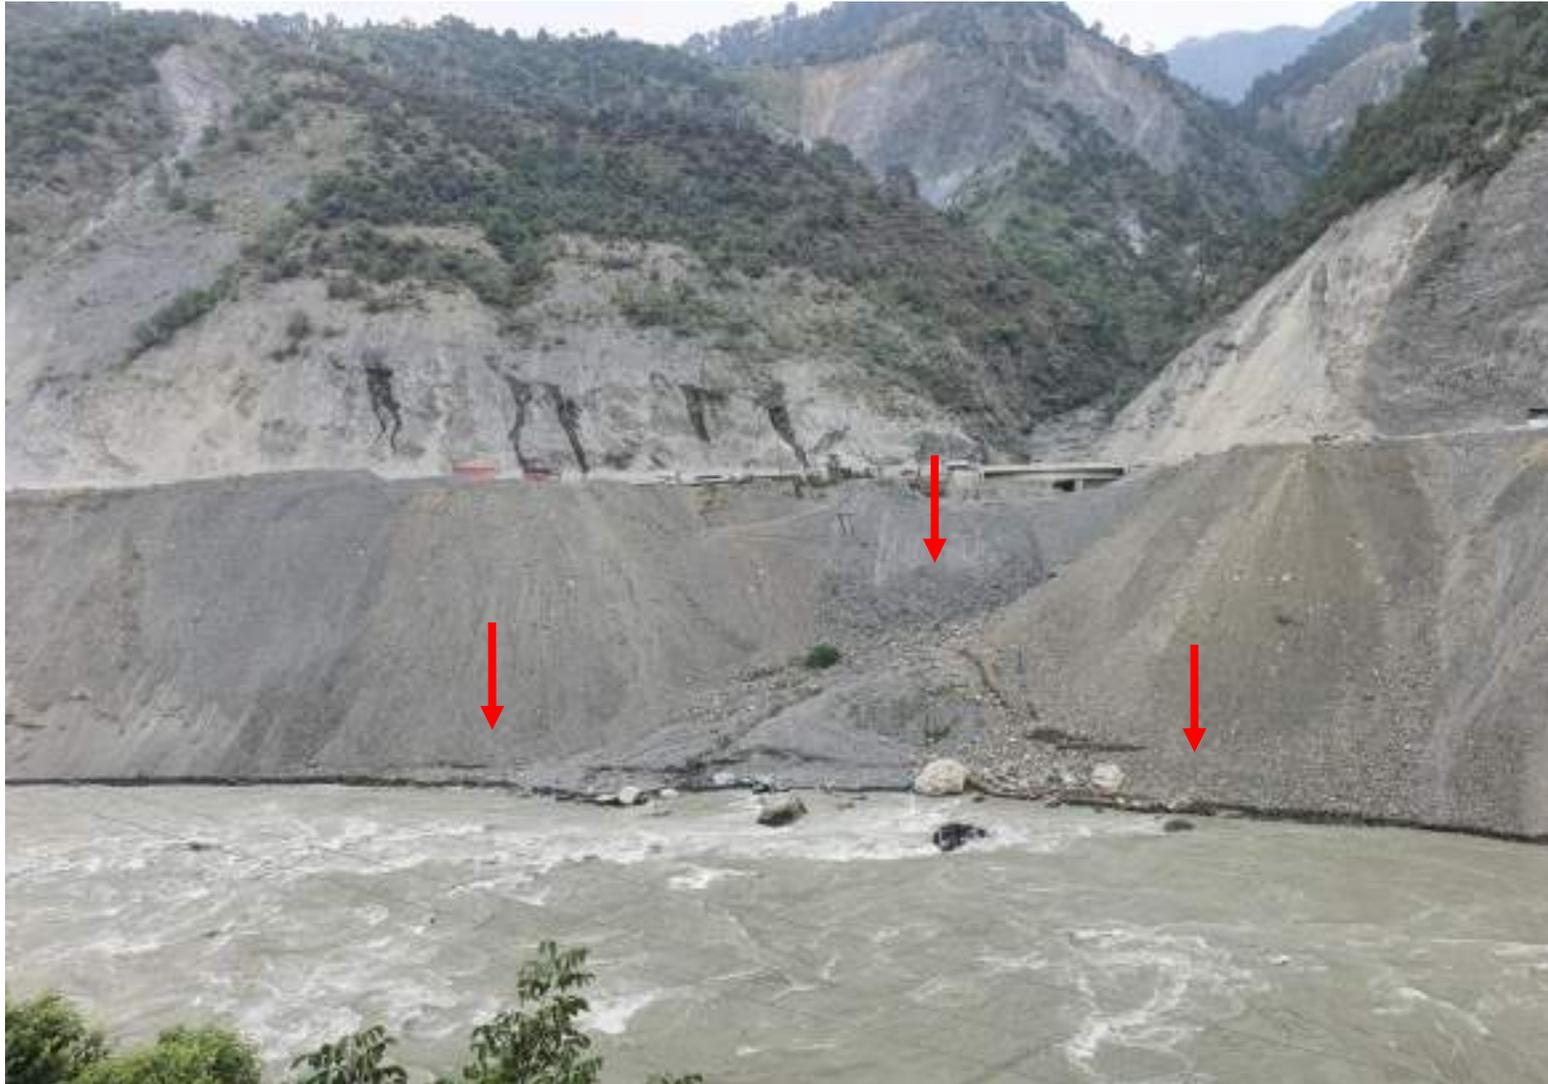
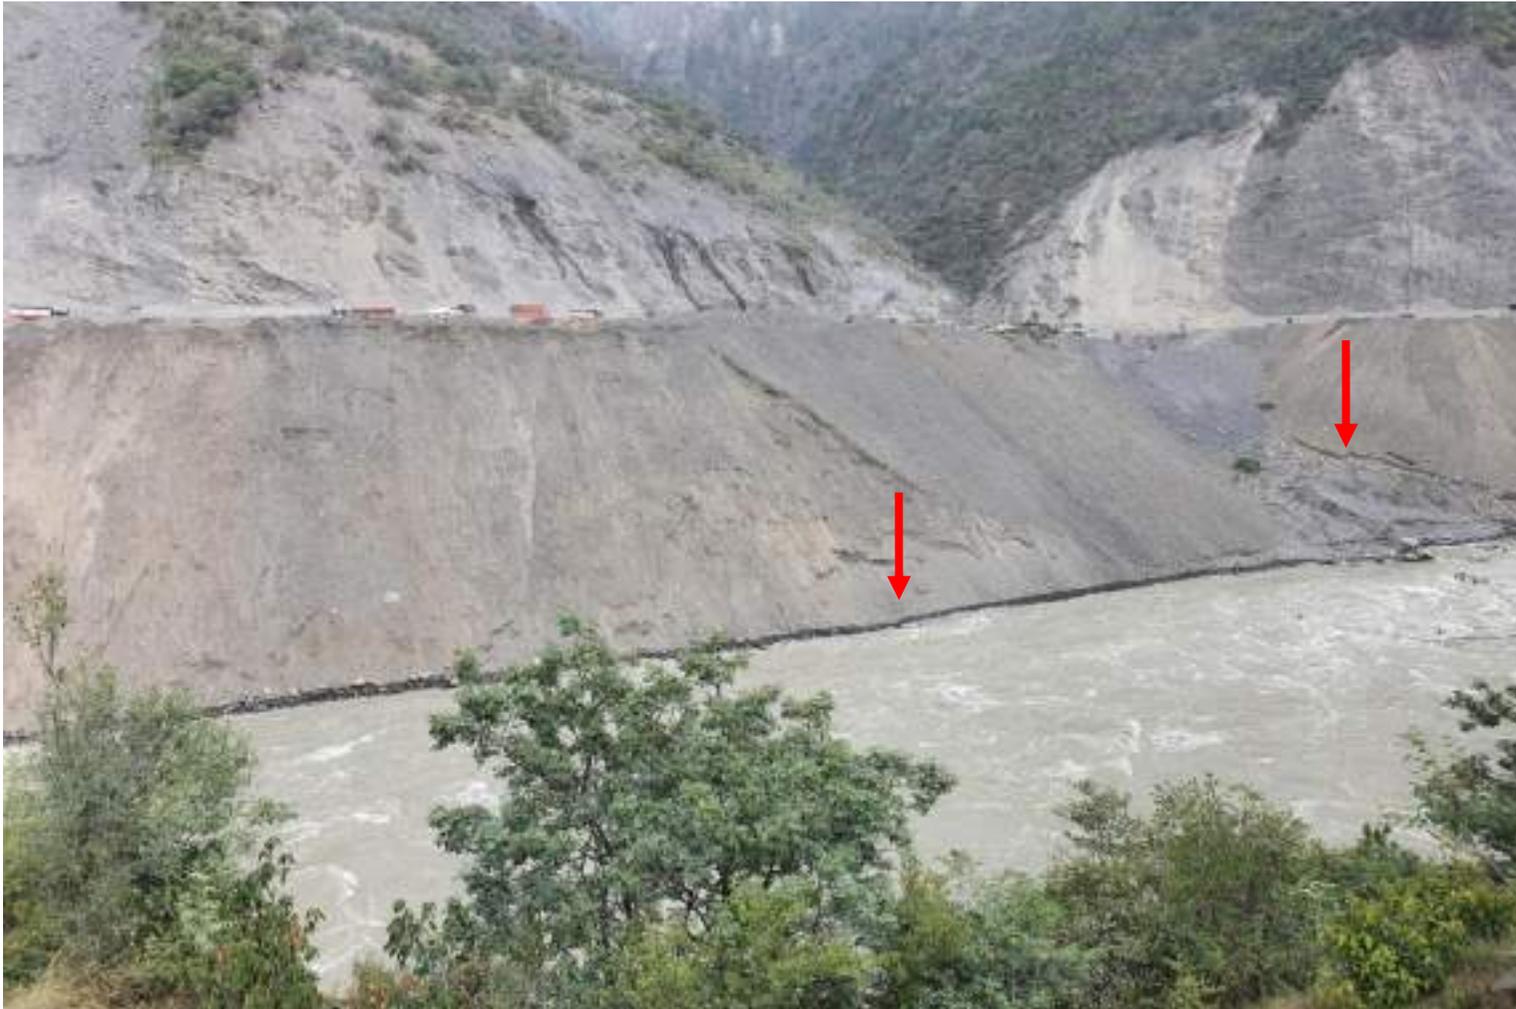
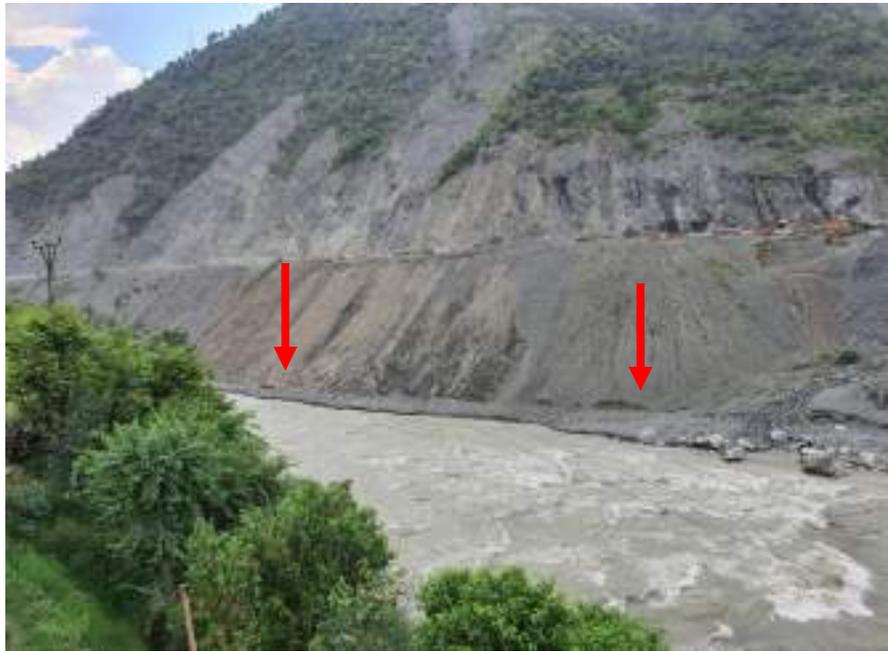
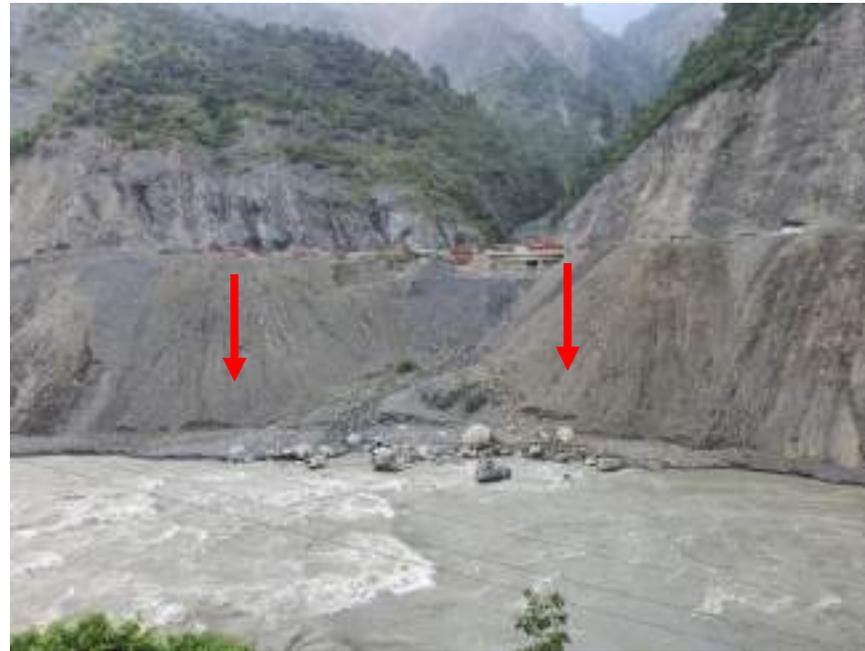
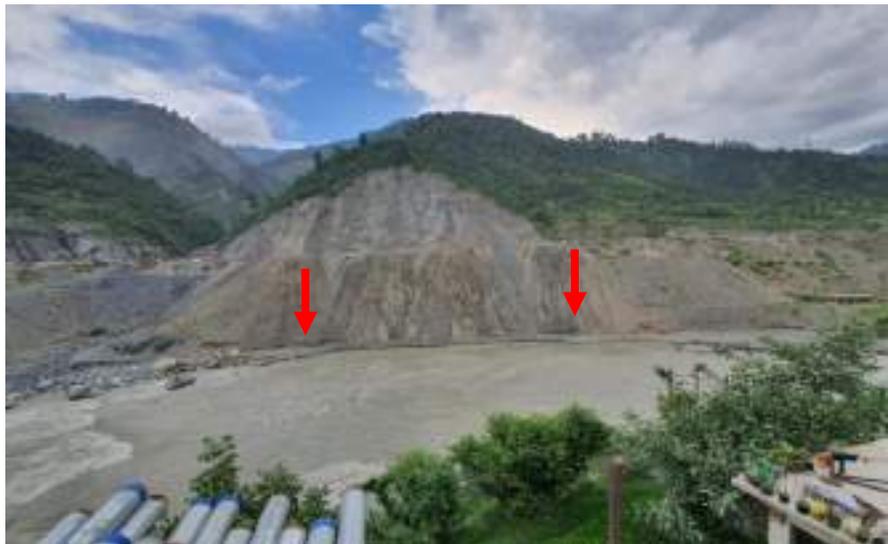
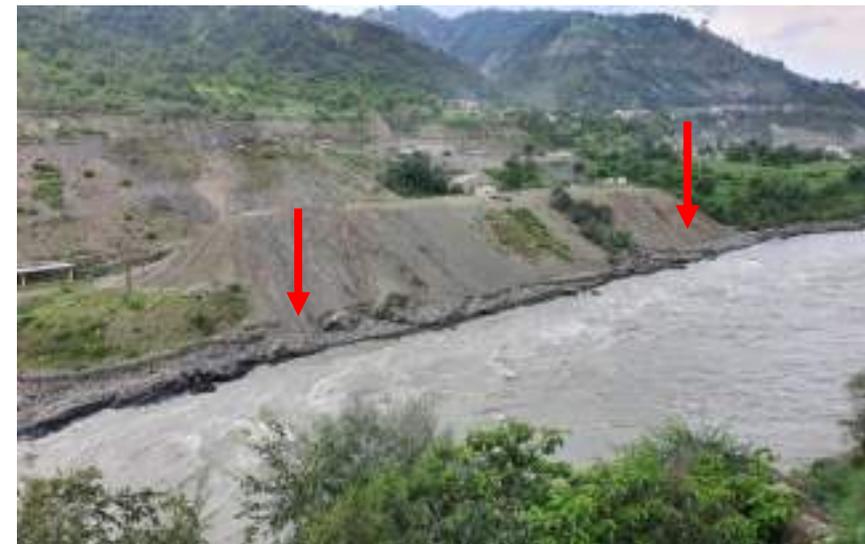
Photograph dated: (19th Feb, 2020): Kanthi (Karol-II) Near Kundi Nallah Bridge-53.

(19)	Kanathi (Karol-II)	145+440 to 145+500 km (SB)	Private / 0.78 Hectare	78,000	78,000	Nil	Closed	<i>Gabion damaged needs to be repaired.</i>
(20)	Kanathi	145+520 to 145+620 Km (SB)	Private / 1.76 Hectare	1,40,000	1,35,000	5,000	Closed	-do-

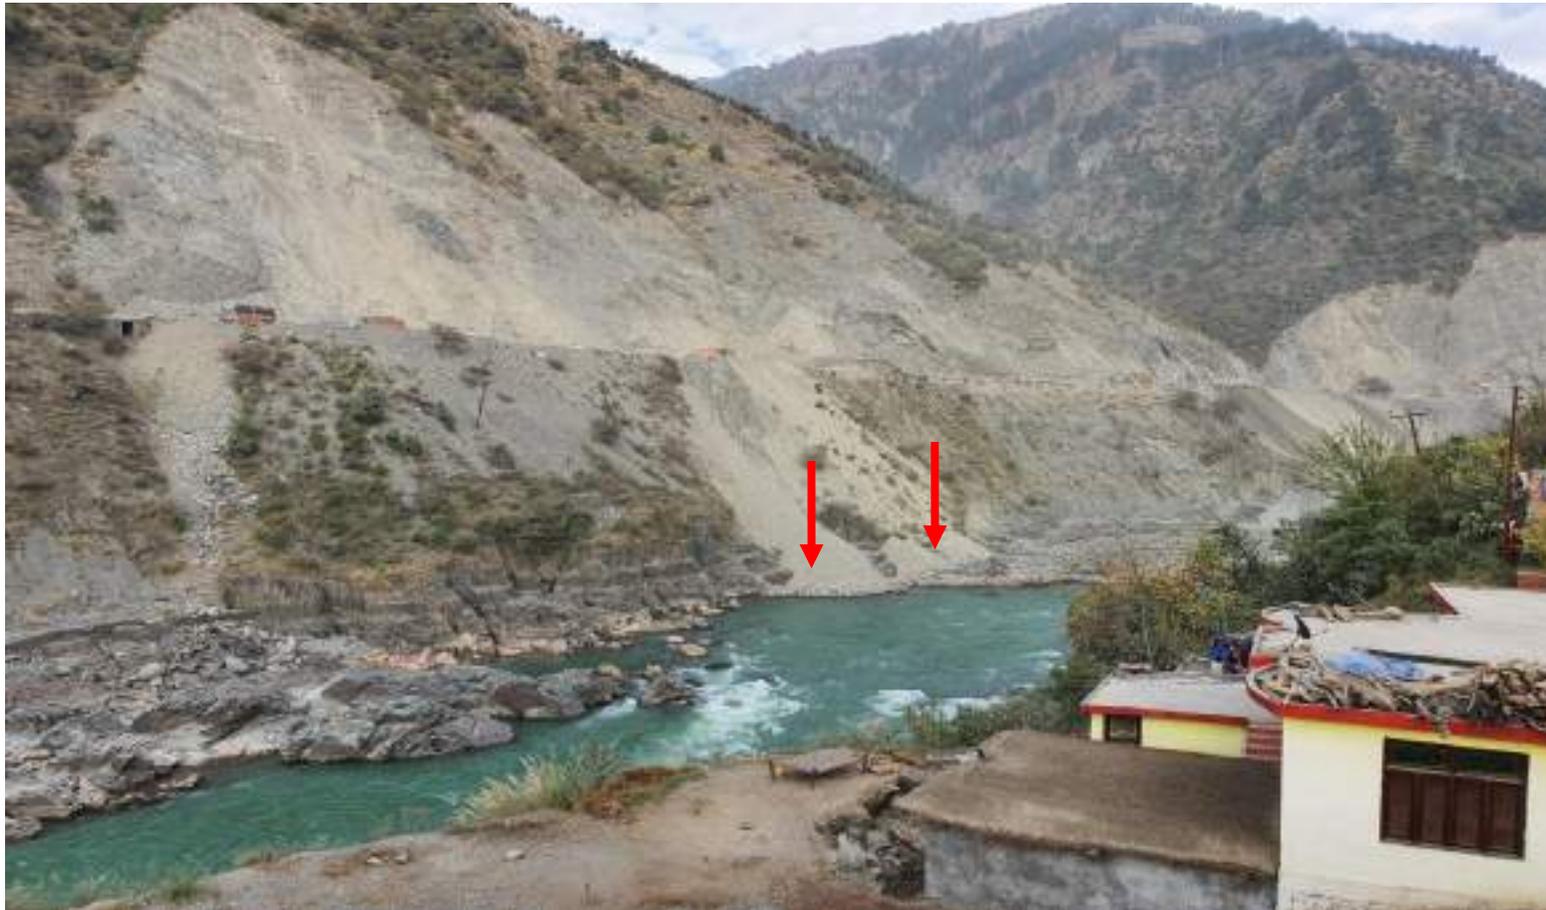
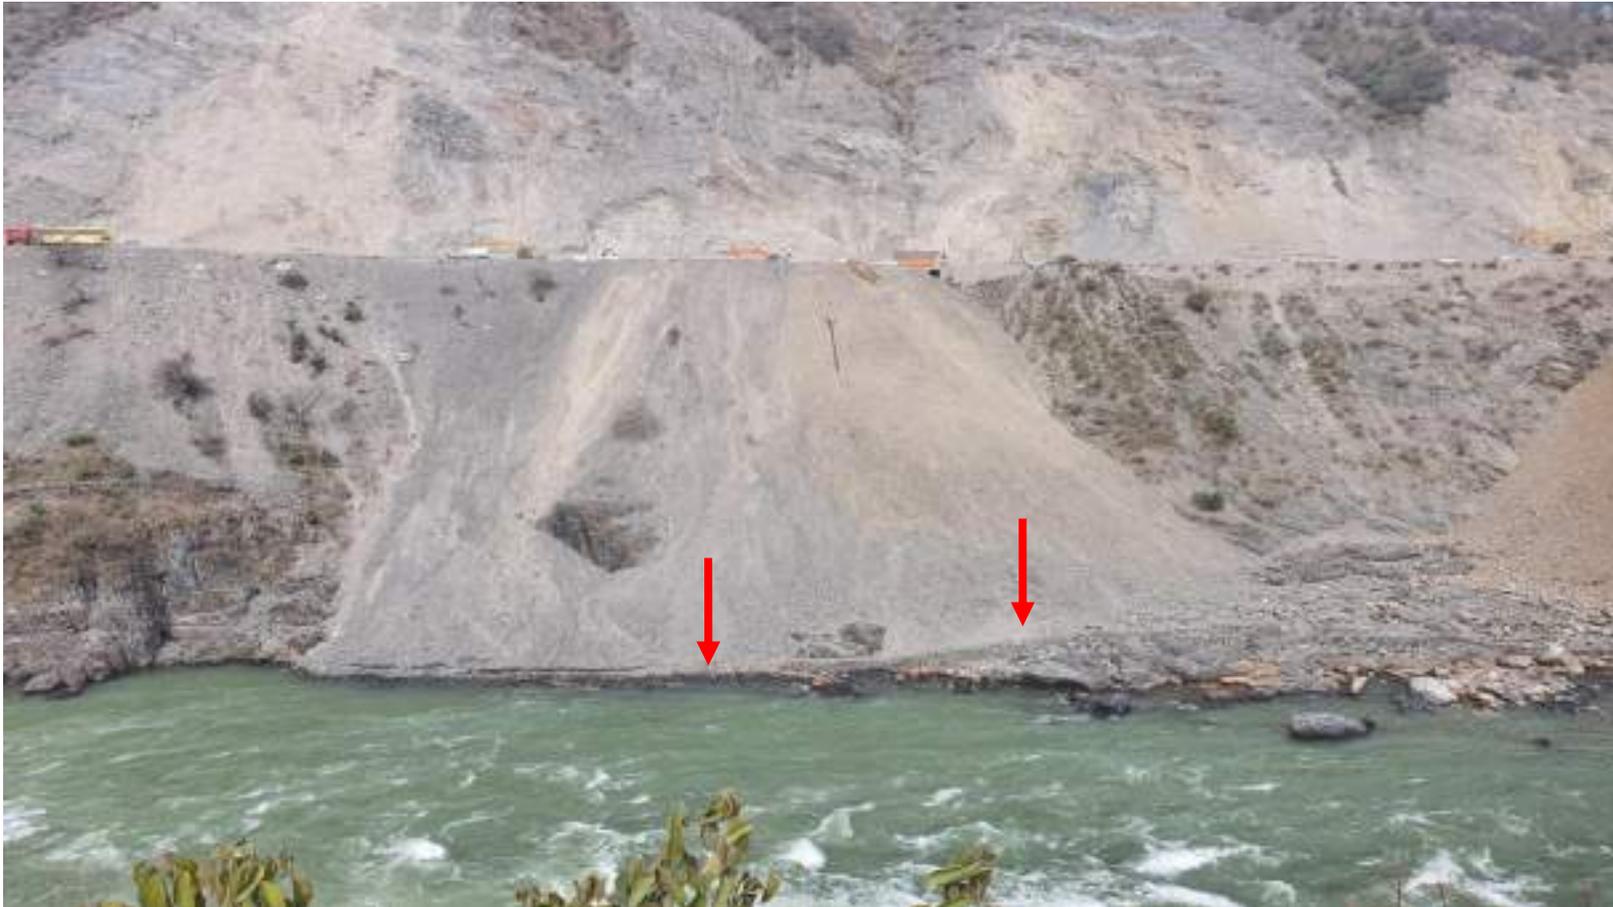
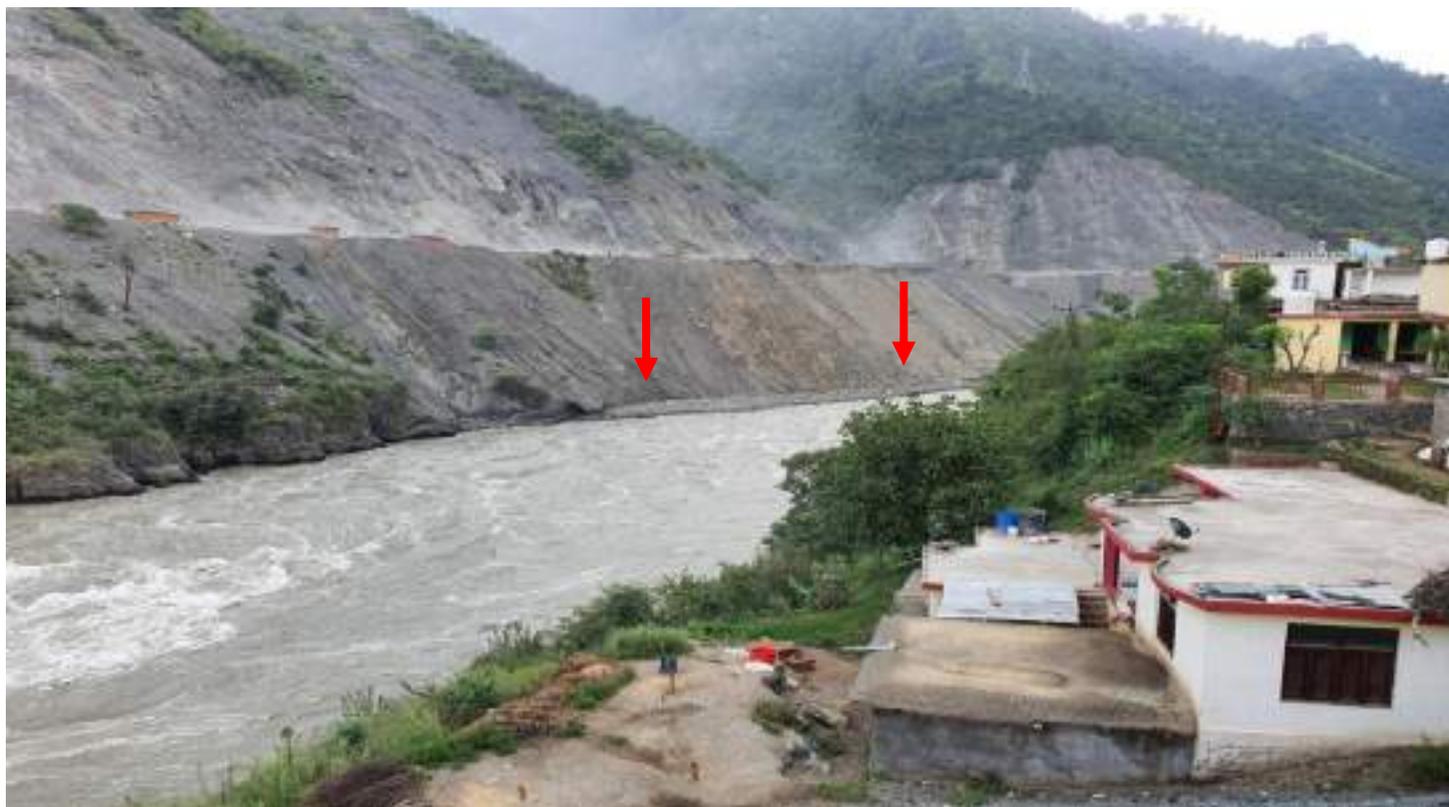
Photograph dated: (19th Feb, 2020): Opp. Horticulture Office Gate.

S.No.	Name of the Site / Village	Chainage/ (NB/SB)	Title /Area of the land	Total Capacity (cu.m)	Quantity dumped as on July2019 (cu.m)	Capacity remaining as on July2019 (cu.m)	Status	Observations
24)	Opp. Horticulture Office Gate	146+200 to 146+230 km (SB)	Non Designated	-	-	-	Illegal Dumping is going on.	<i>Muck going into Chenab River. Gabion structure needs to be provided.</i>

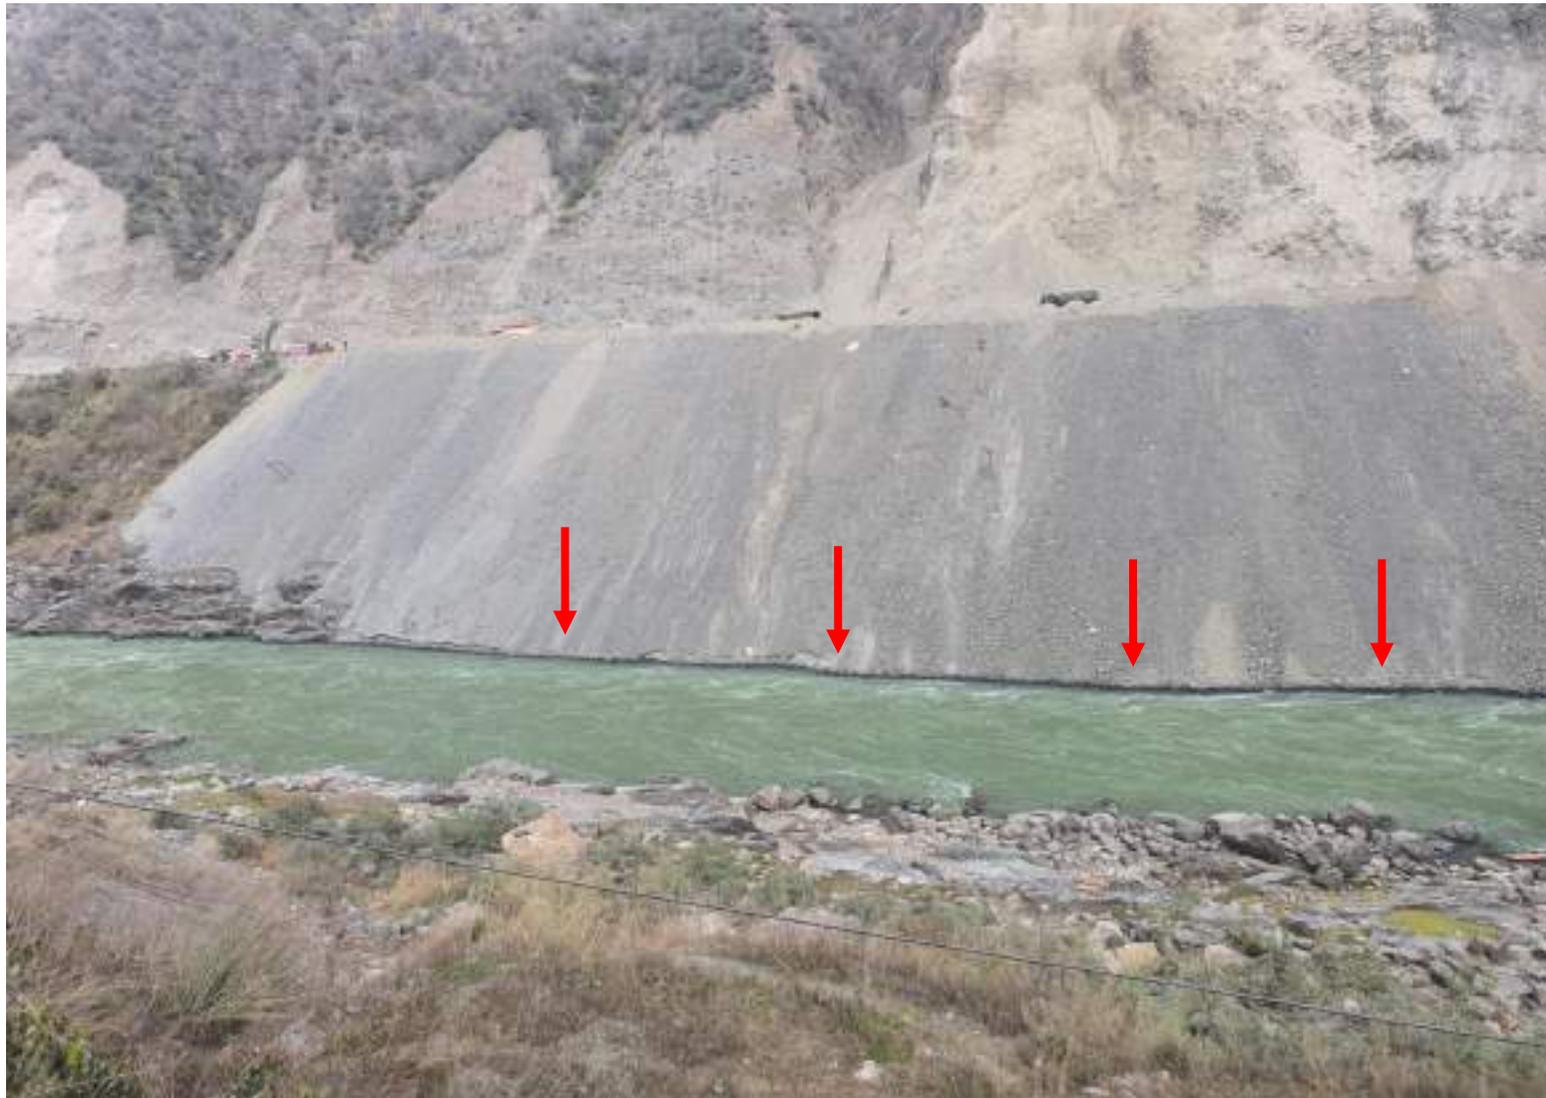
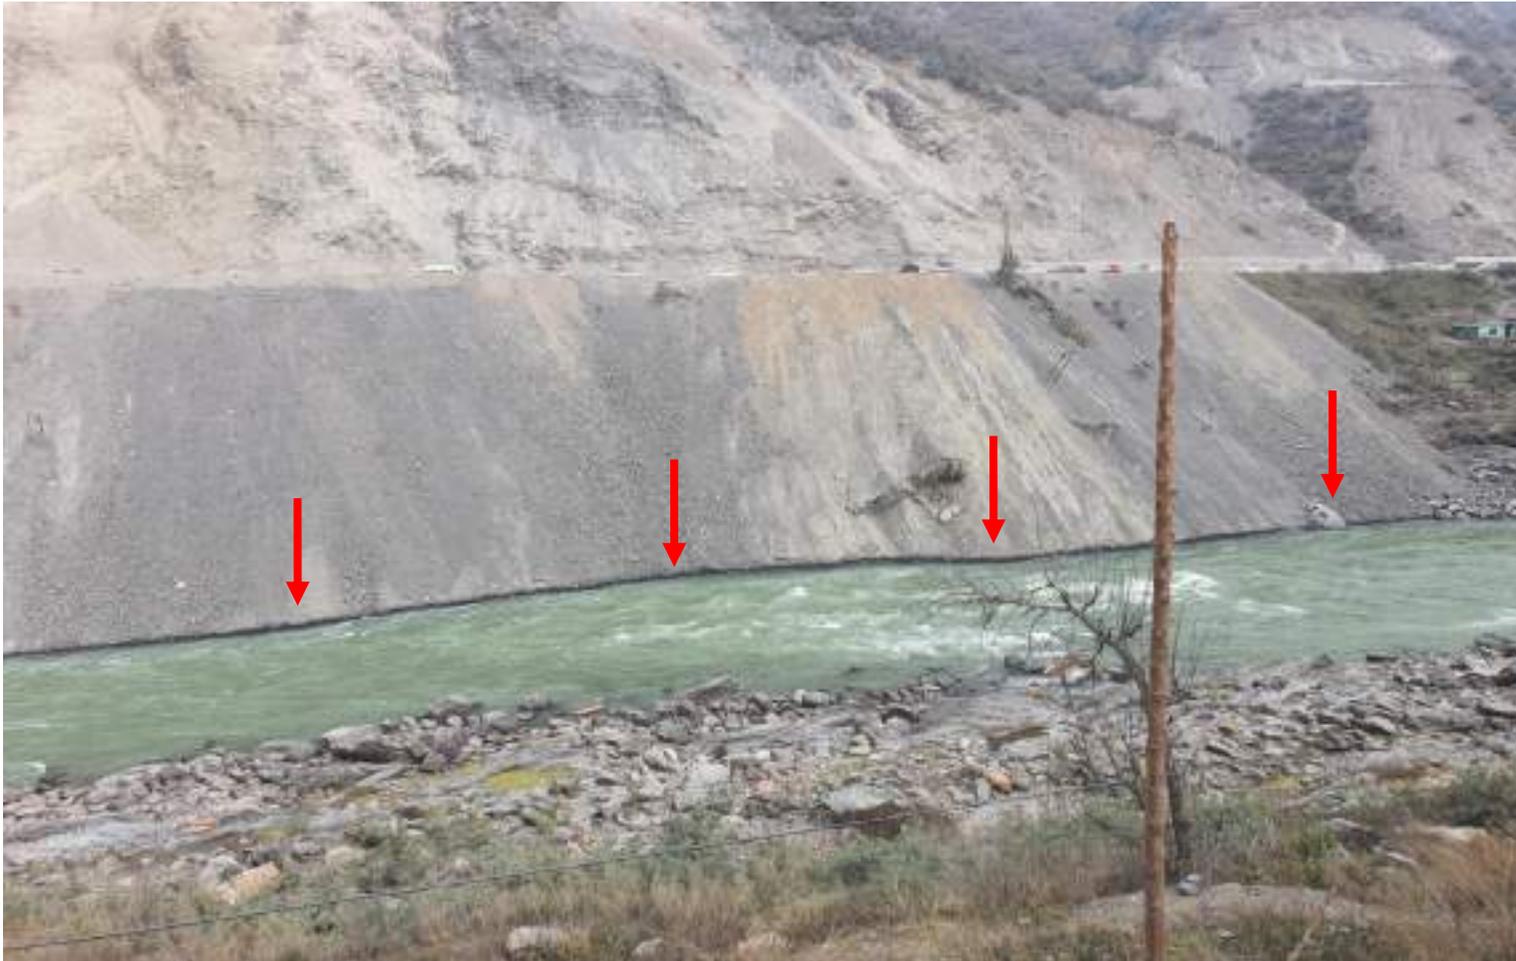
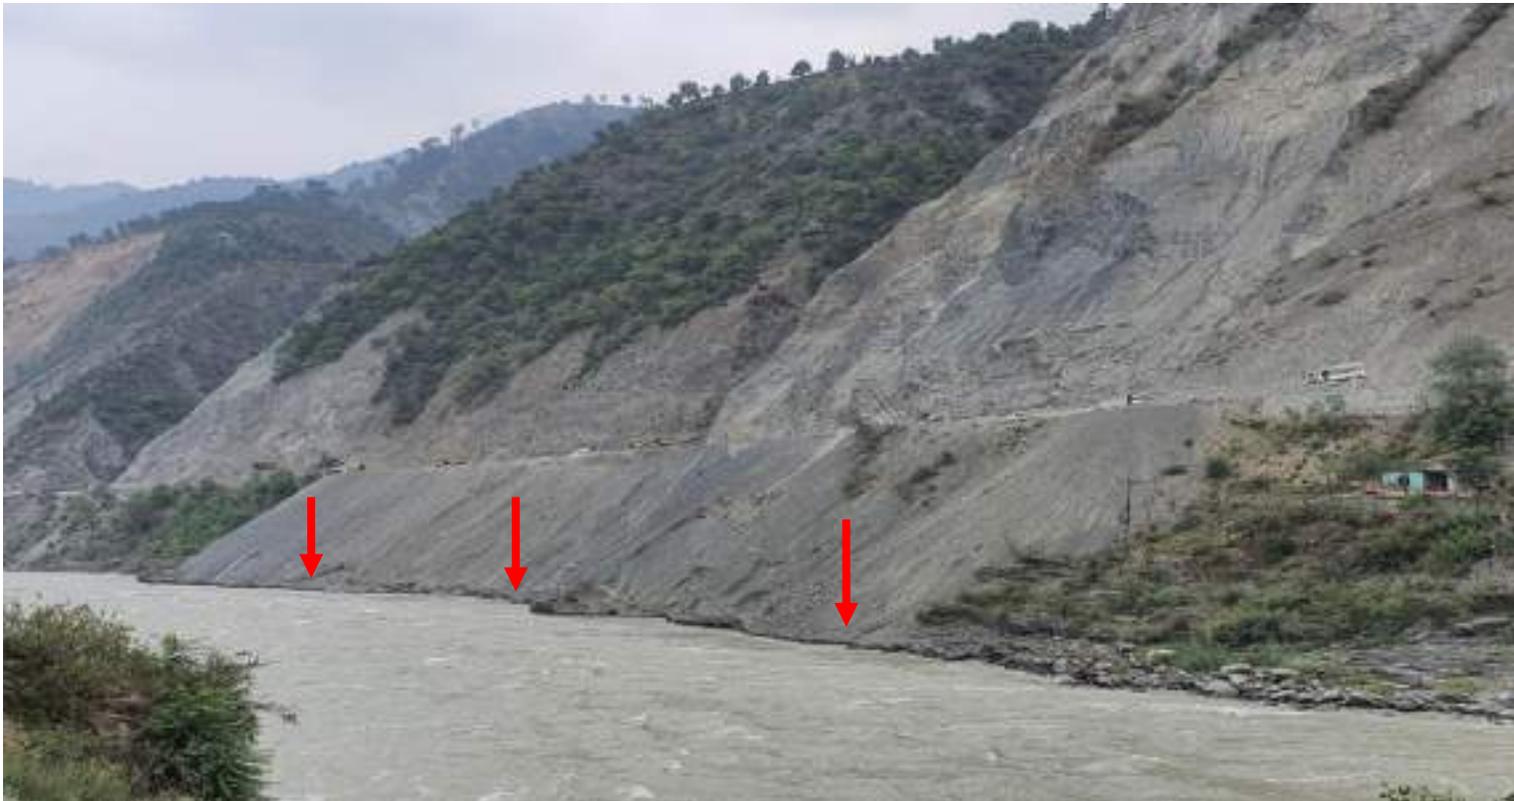
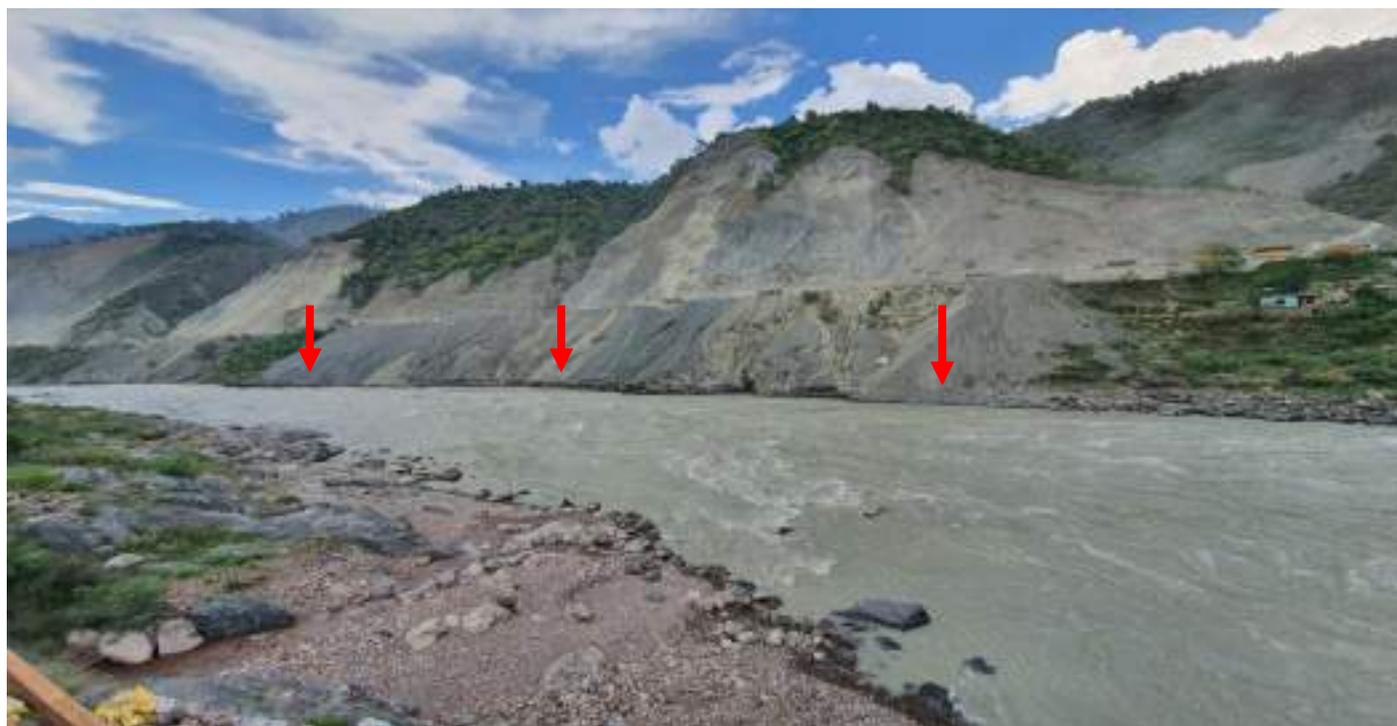
Photograph dated :(19th **Feb**, 2020): Neera, Opp. PHE Water filling station, (New Identified site) State land.

S.No.	Name of the Site / Village	Chainage/ (NB/SB)	Title /Area of the land	Total Capacity (cu.m)	Quantity dumped as on July2019 (cu.m)	Capacity remaining as on July2019 (cu.m)	Status	Observations
25)	Neera (Opp. PHE Water filling station) (New Identified site)	147+225 to 147+525 km (SB)	State land/ 300 m	-	-	-	In-use	<i>Muck going into Chenab River. Gabion structure needs to be provided.</i>
		147+525 to 147+560 km (SB)	35 m	-	-	-		<i>Illegal dumping in 35 m stretch.</i>
