Office of the Chairman, NGT Monitoring Committee (J&K)
Justice Janak Raj Kotwal
(Former Judge High Court of Jammu & Kashmir)

Subject: Report of the Chairman in compliance to Hon'ble NGT order
dated 20.03.2020.

In the matter of : Execution Application No. 32/2016
In
Original Application No. 295/2016
And
Original Application No. 295/2016
(M.A.No.539/2016)

Report in compliance to Hon'ble NGT Order dated 20. 03. 2020

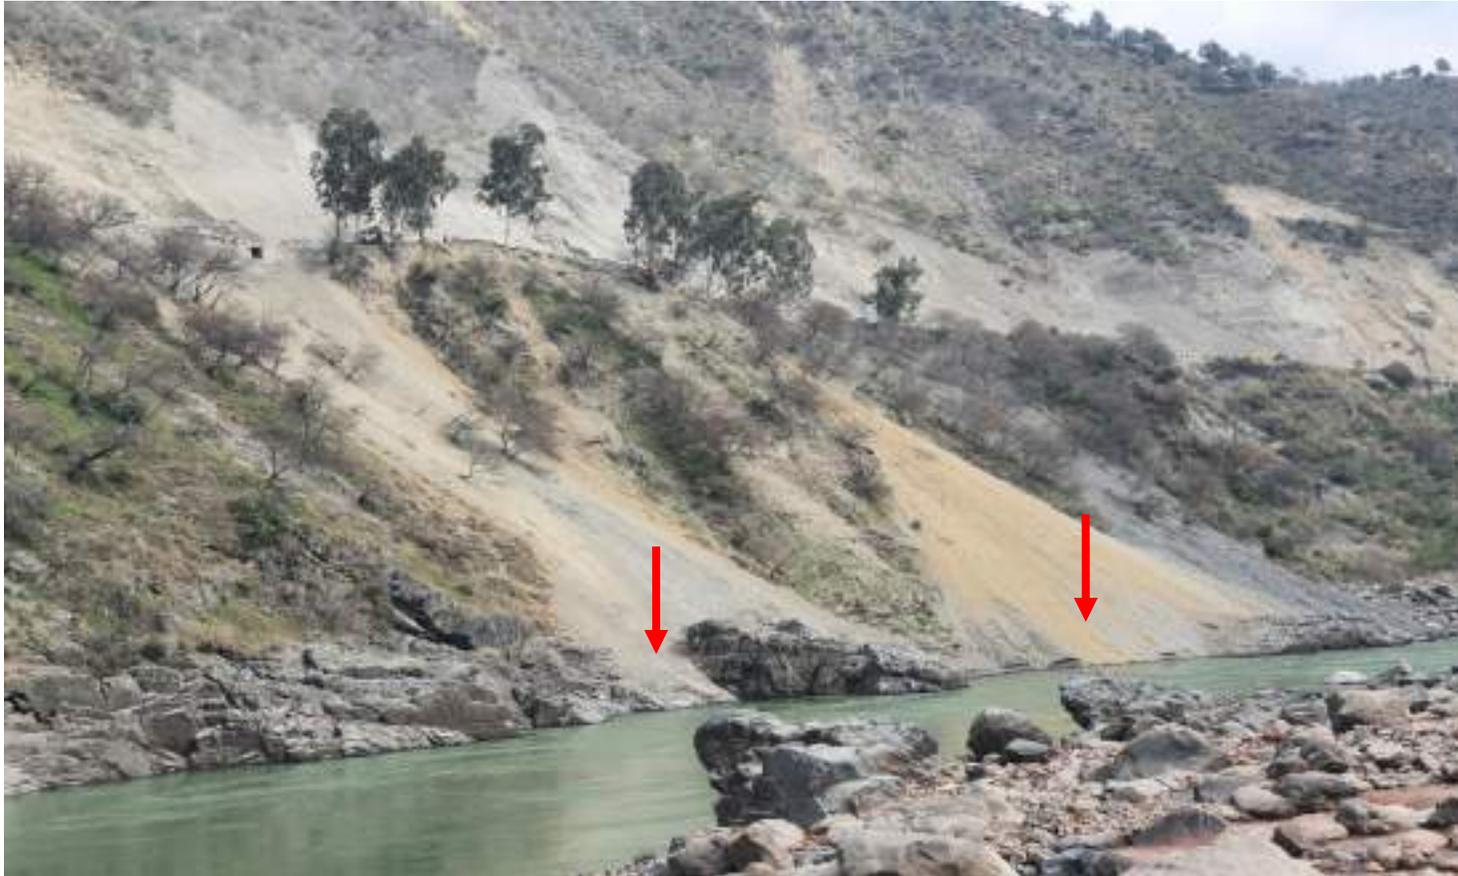
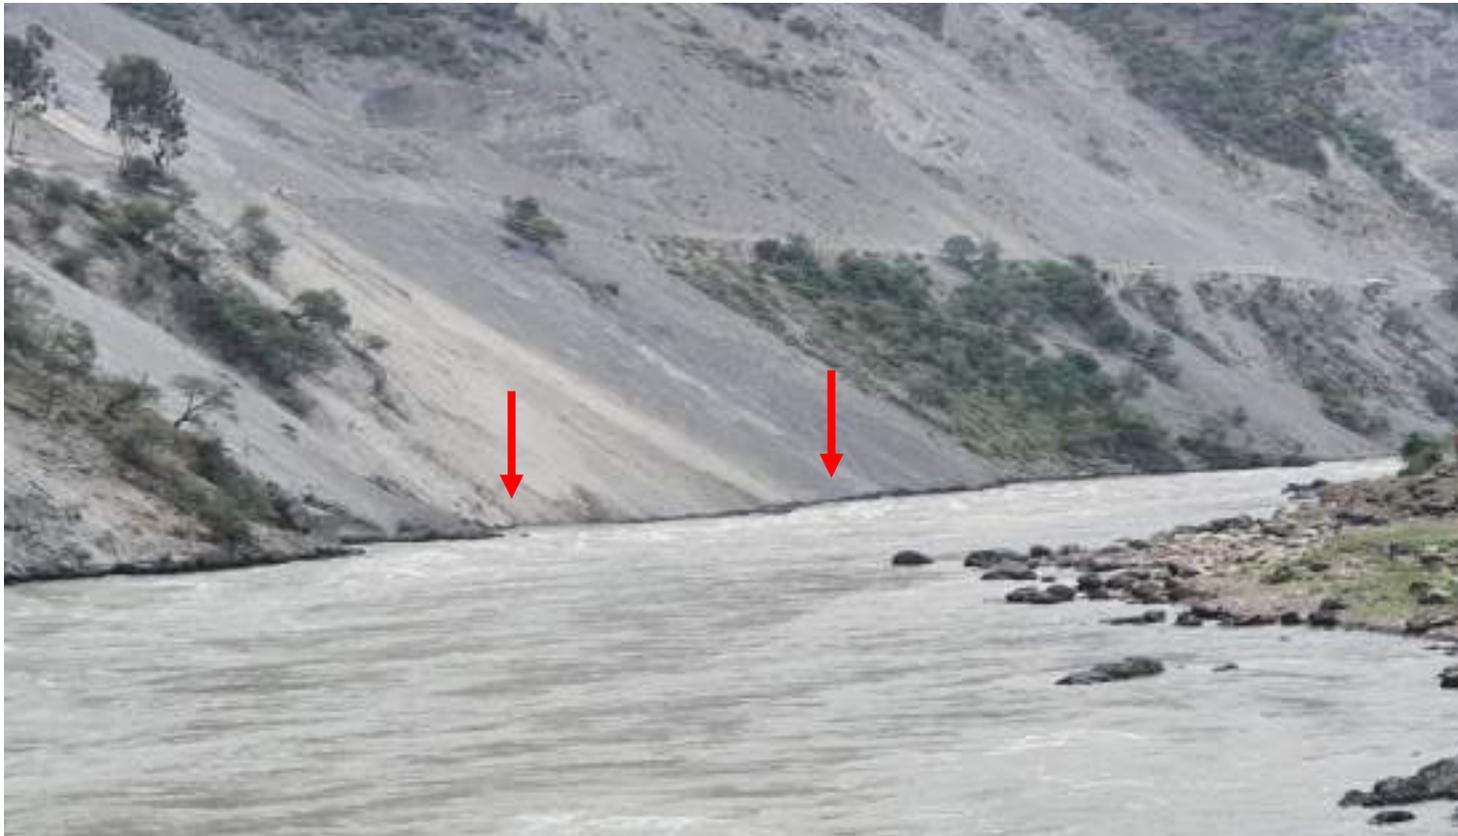
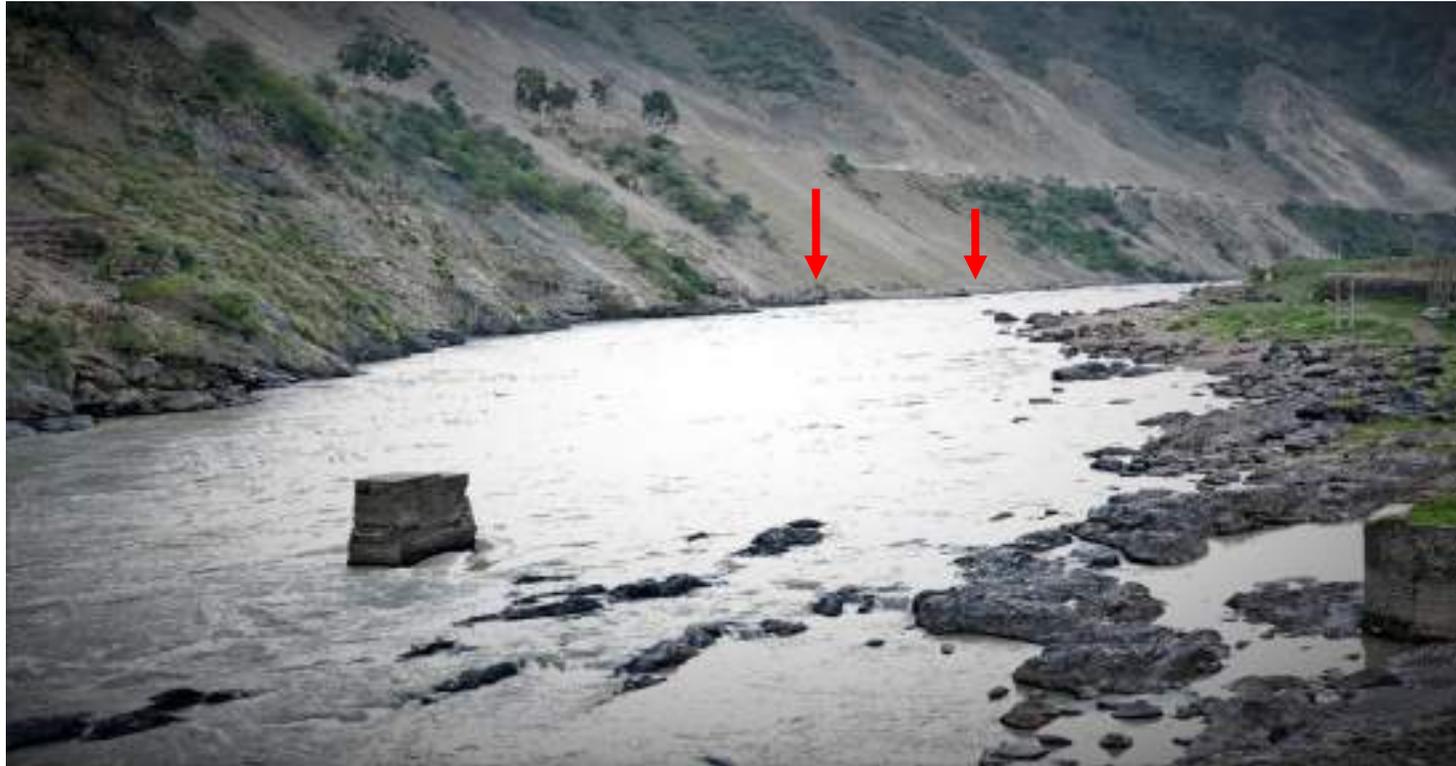
Photograph dated: (19th **Feb**, 2020): Cafeteria Morh, Opp. Army Transit Camp, Maitra (New Identified site)

S.No.	Name of the Site / Village	Chainage/ (NB/SB)	Title /Area of the land	Total Capacity (cu.m)	Quantity dumped as on July2019 (cu.m)	Capacity remaining as on July2019 (cu.m)	Status	Observations
26)	Cafeteria Morh, Opp. Army Transit Camp, Maitra (New Identified site)	147+850 to Km 148+700 (SB)	State land/ 850 m	-	-	-	In-use	<i>Muck going into Chenab River. Gabion structure needs to be provided.</i>

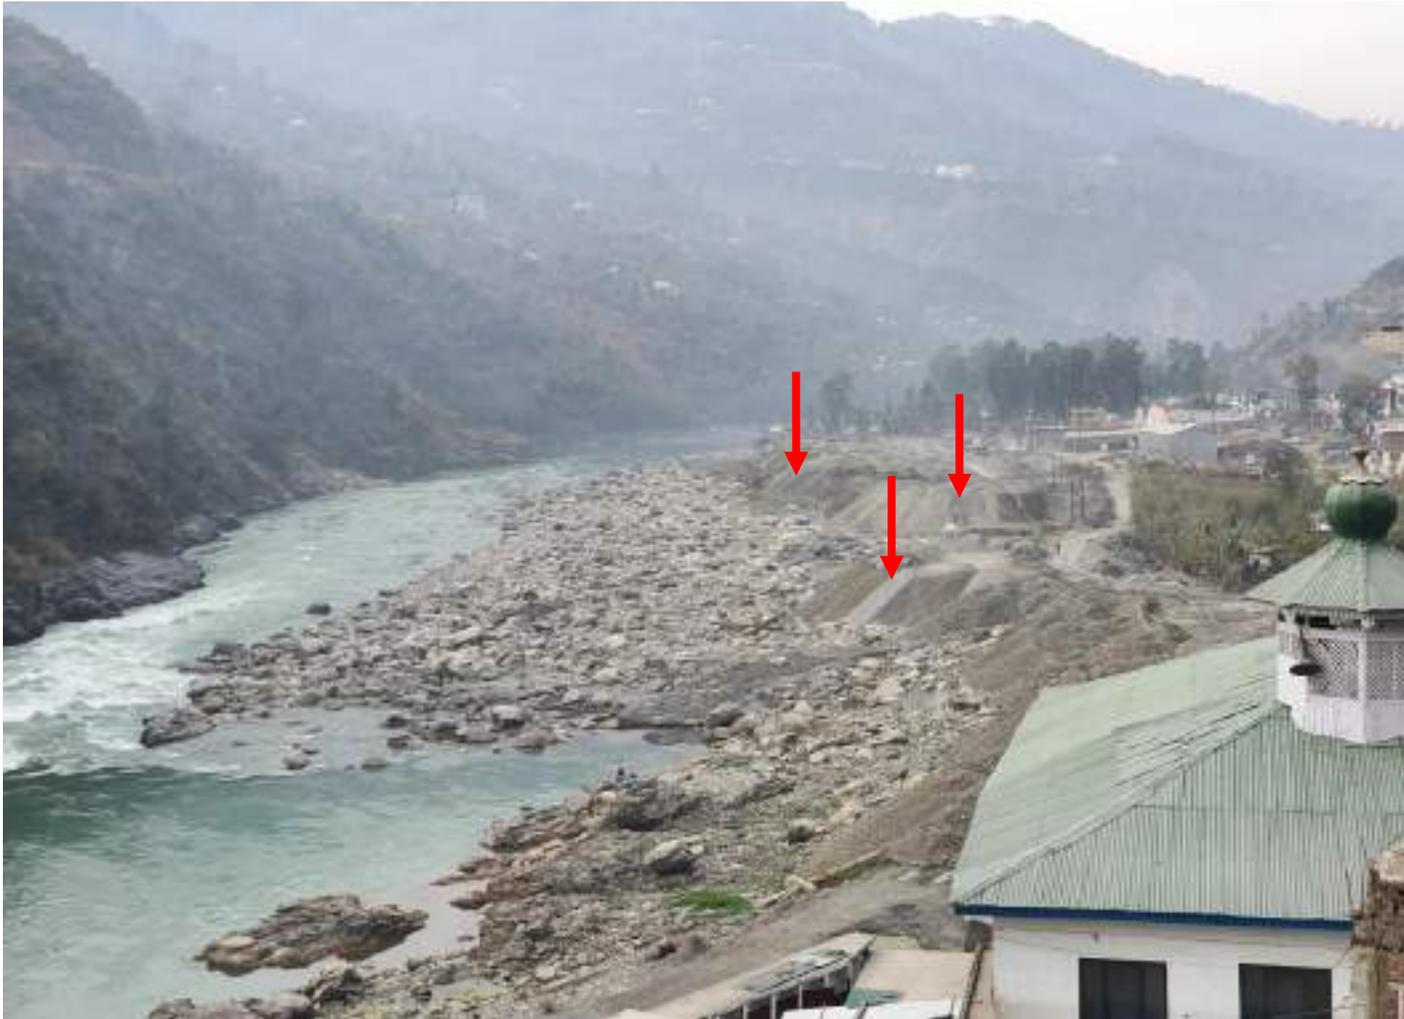
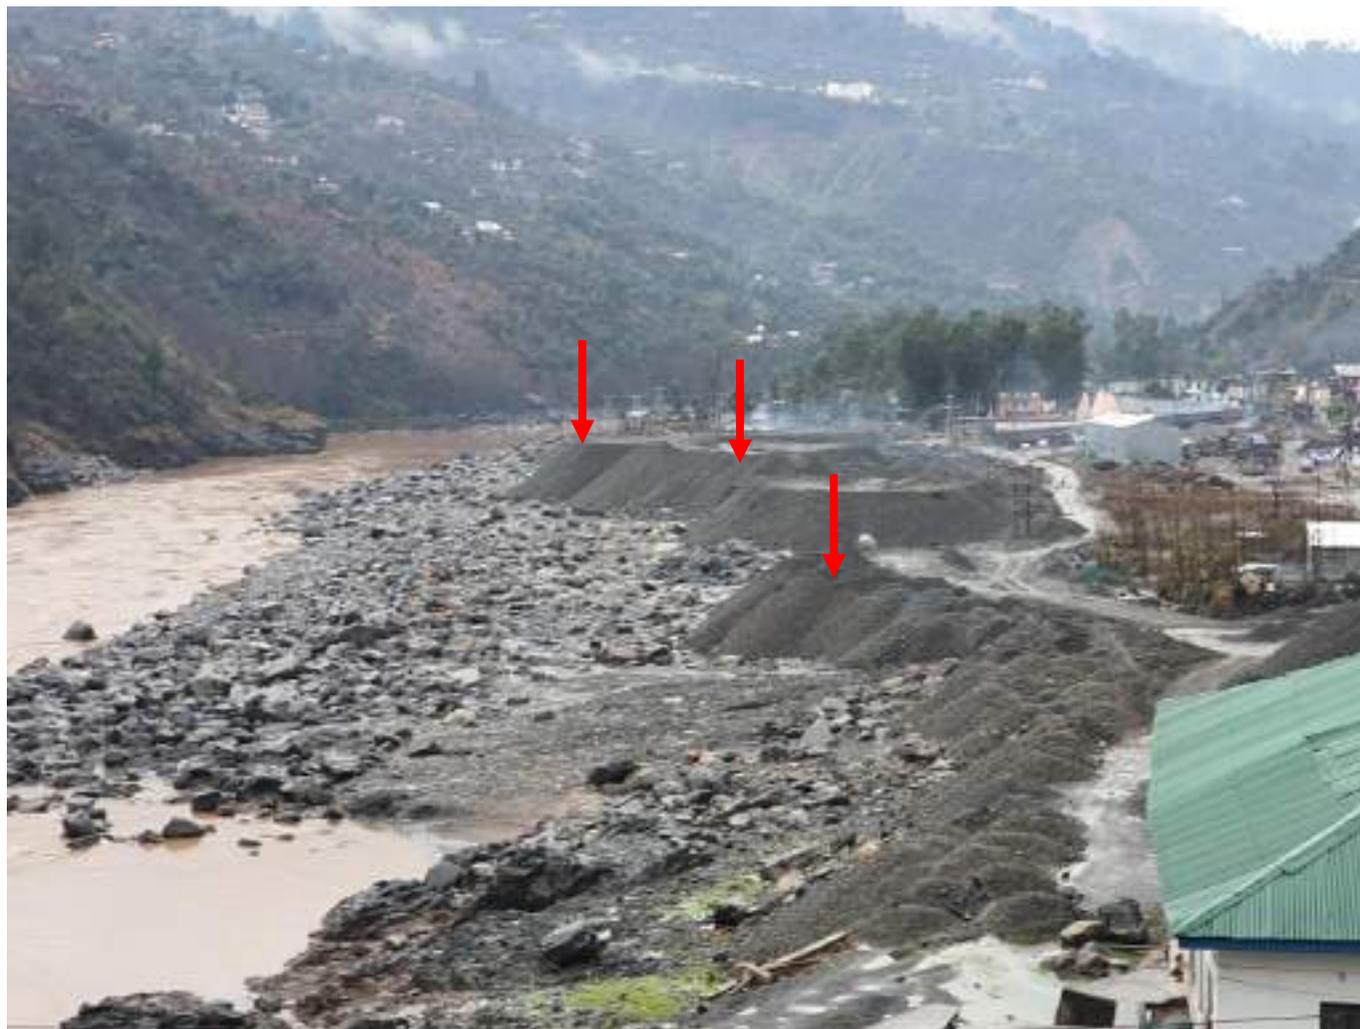
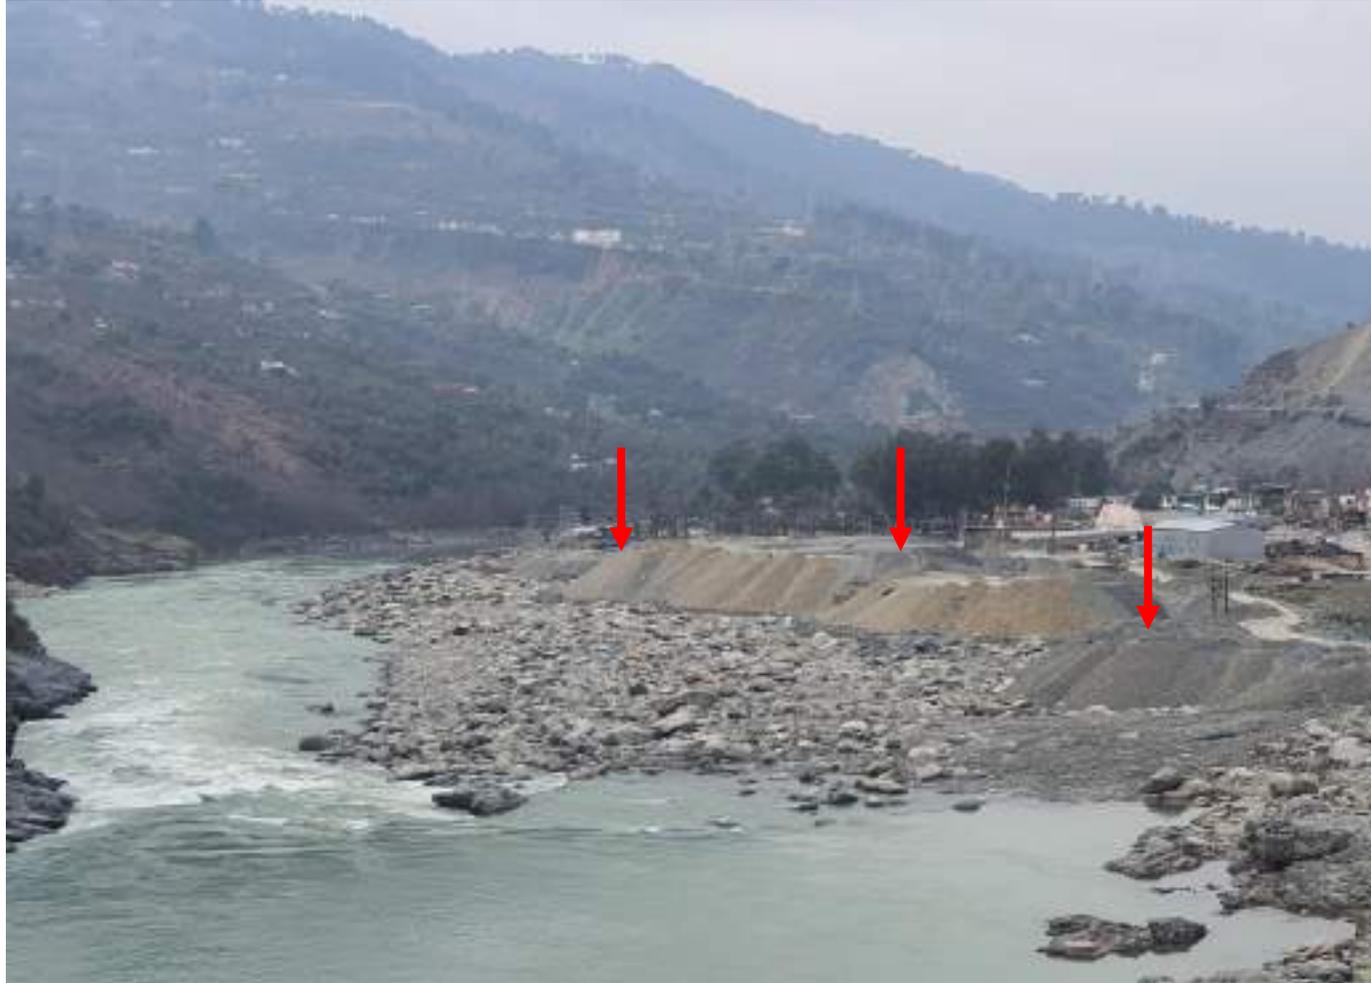
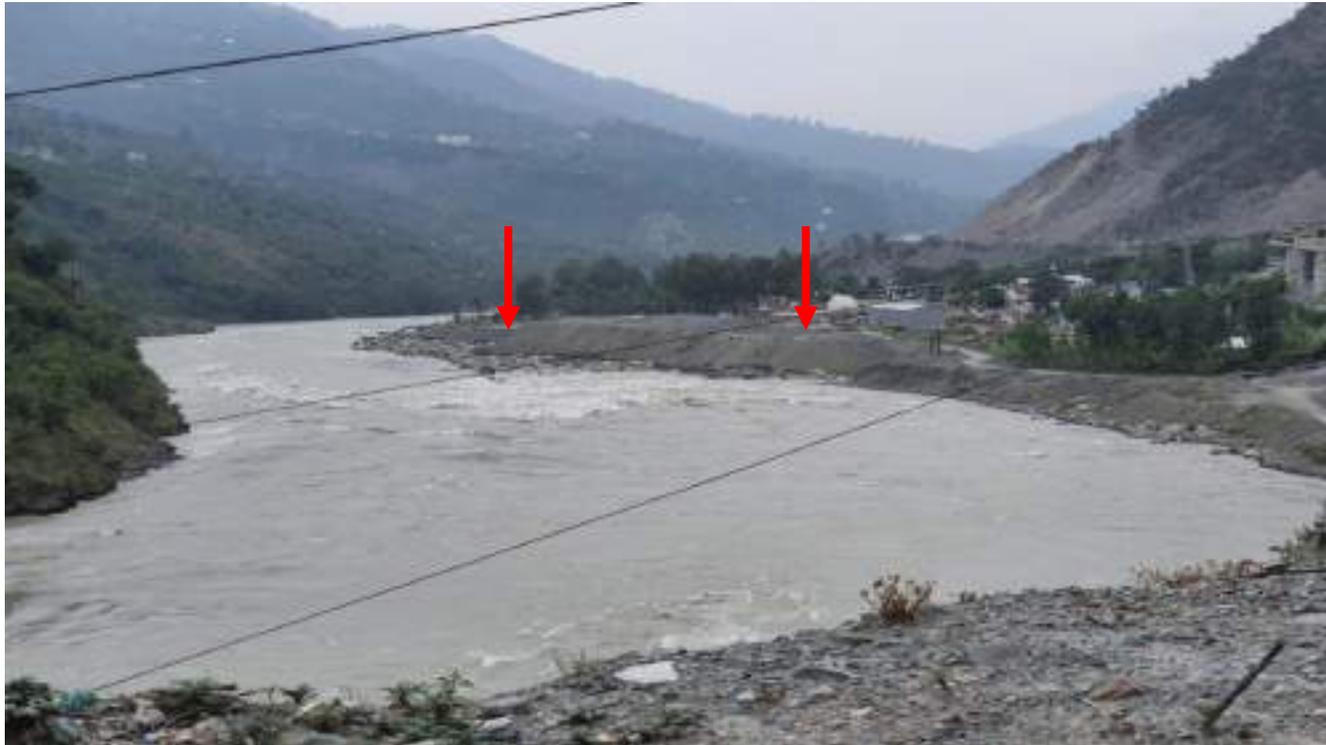
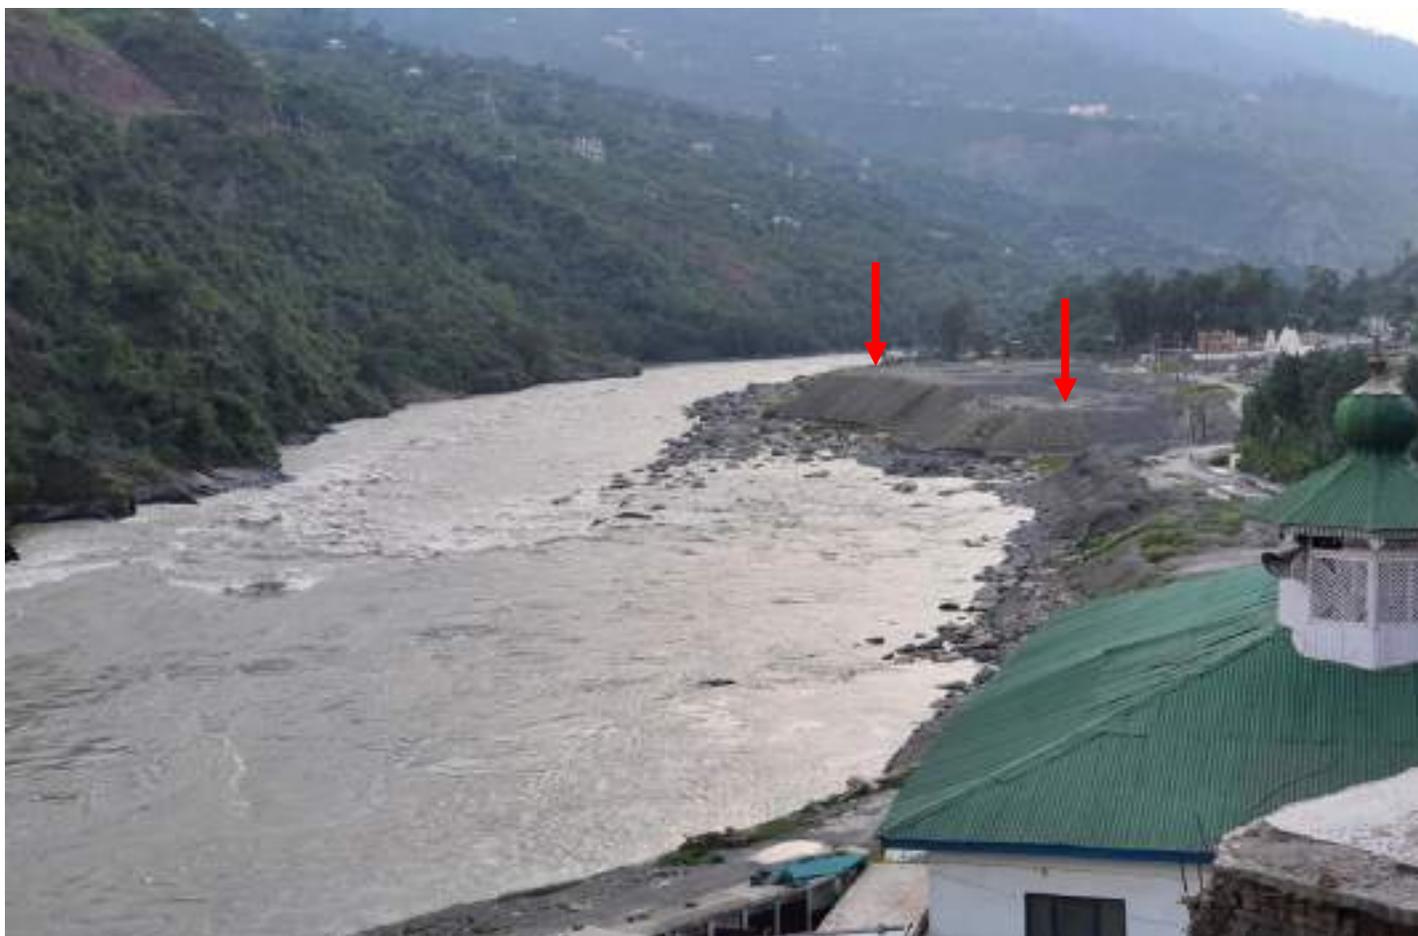
S.No.	Name of the Site / Village	Chainage/ (NB/SB)	Title /Area of the land	Total Capacity (cu.m)	Quantity dumped as on July2019 (cu.m)	Capacity remaining as on July2019 (cu.m)	Status	Observations
27)	Kow Bagh -Ramban	149+650 to 149+750Km (SB)	Forest / 01.55 Hectare	1,40,000	91,000	49,000	Closed	<i>Dumping restricted by District Administration at this site.</i>

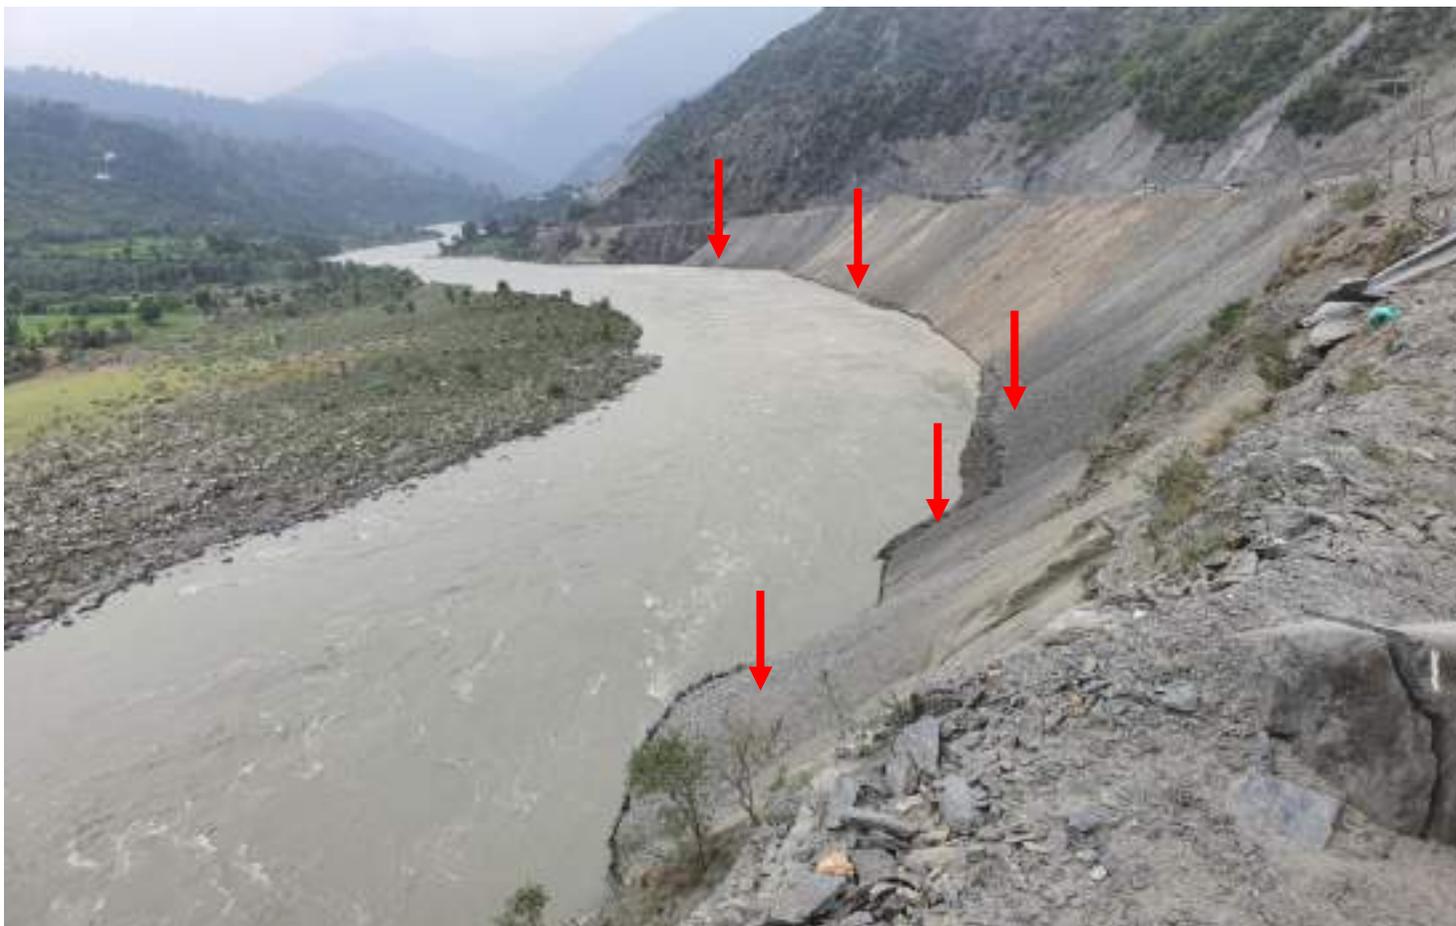
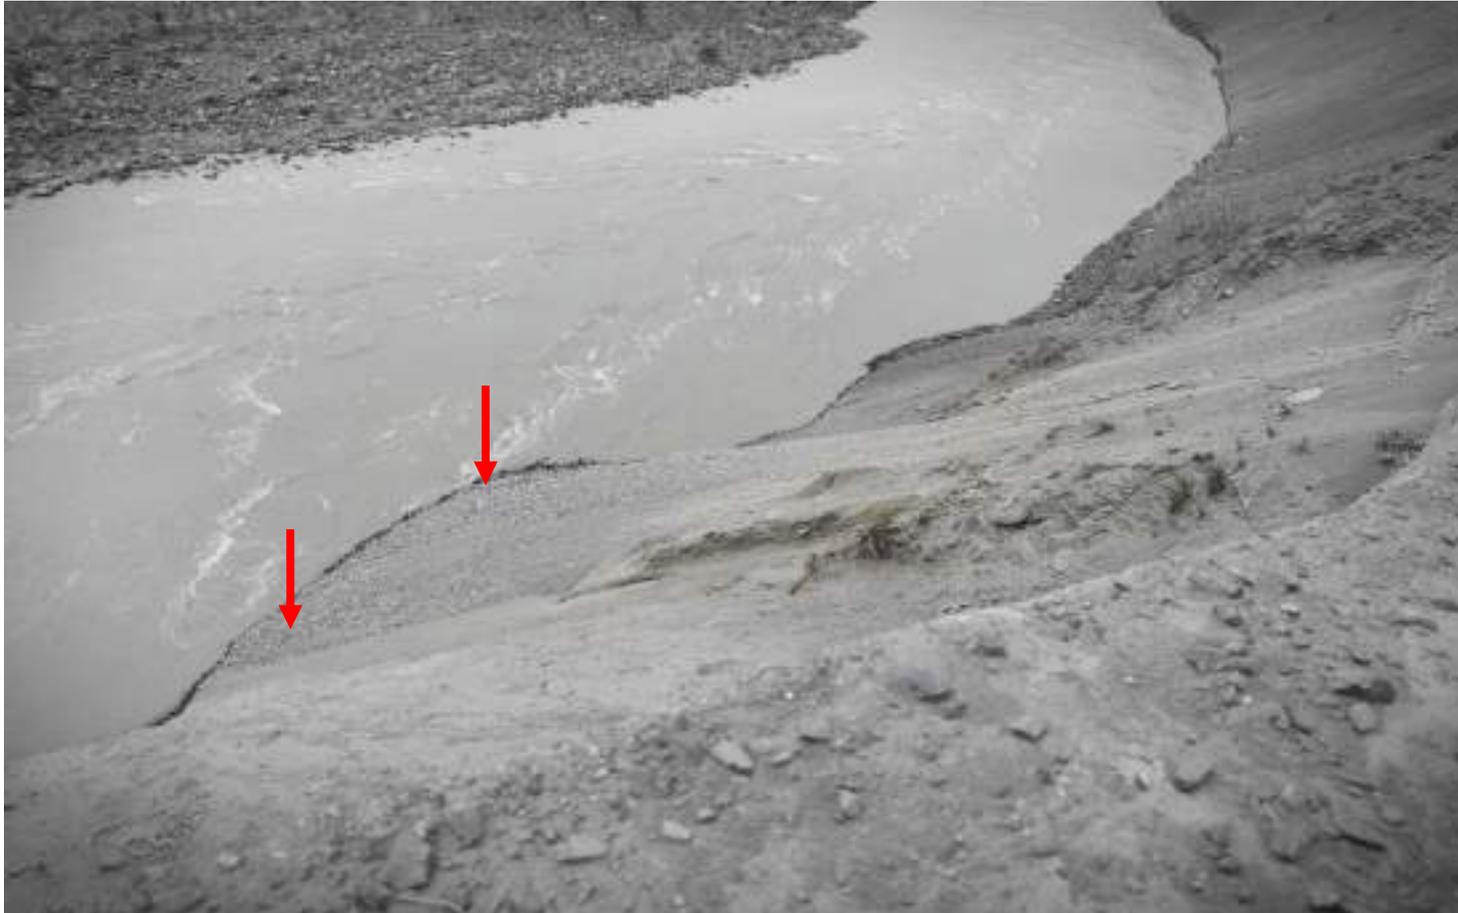
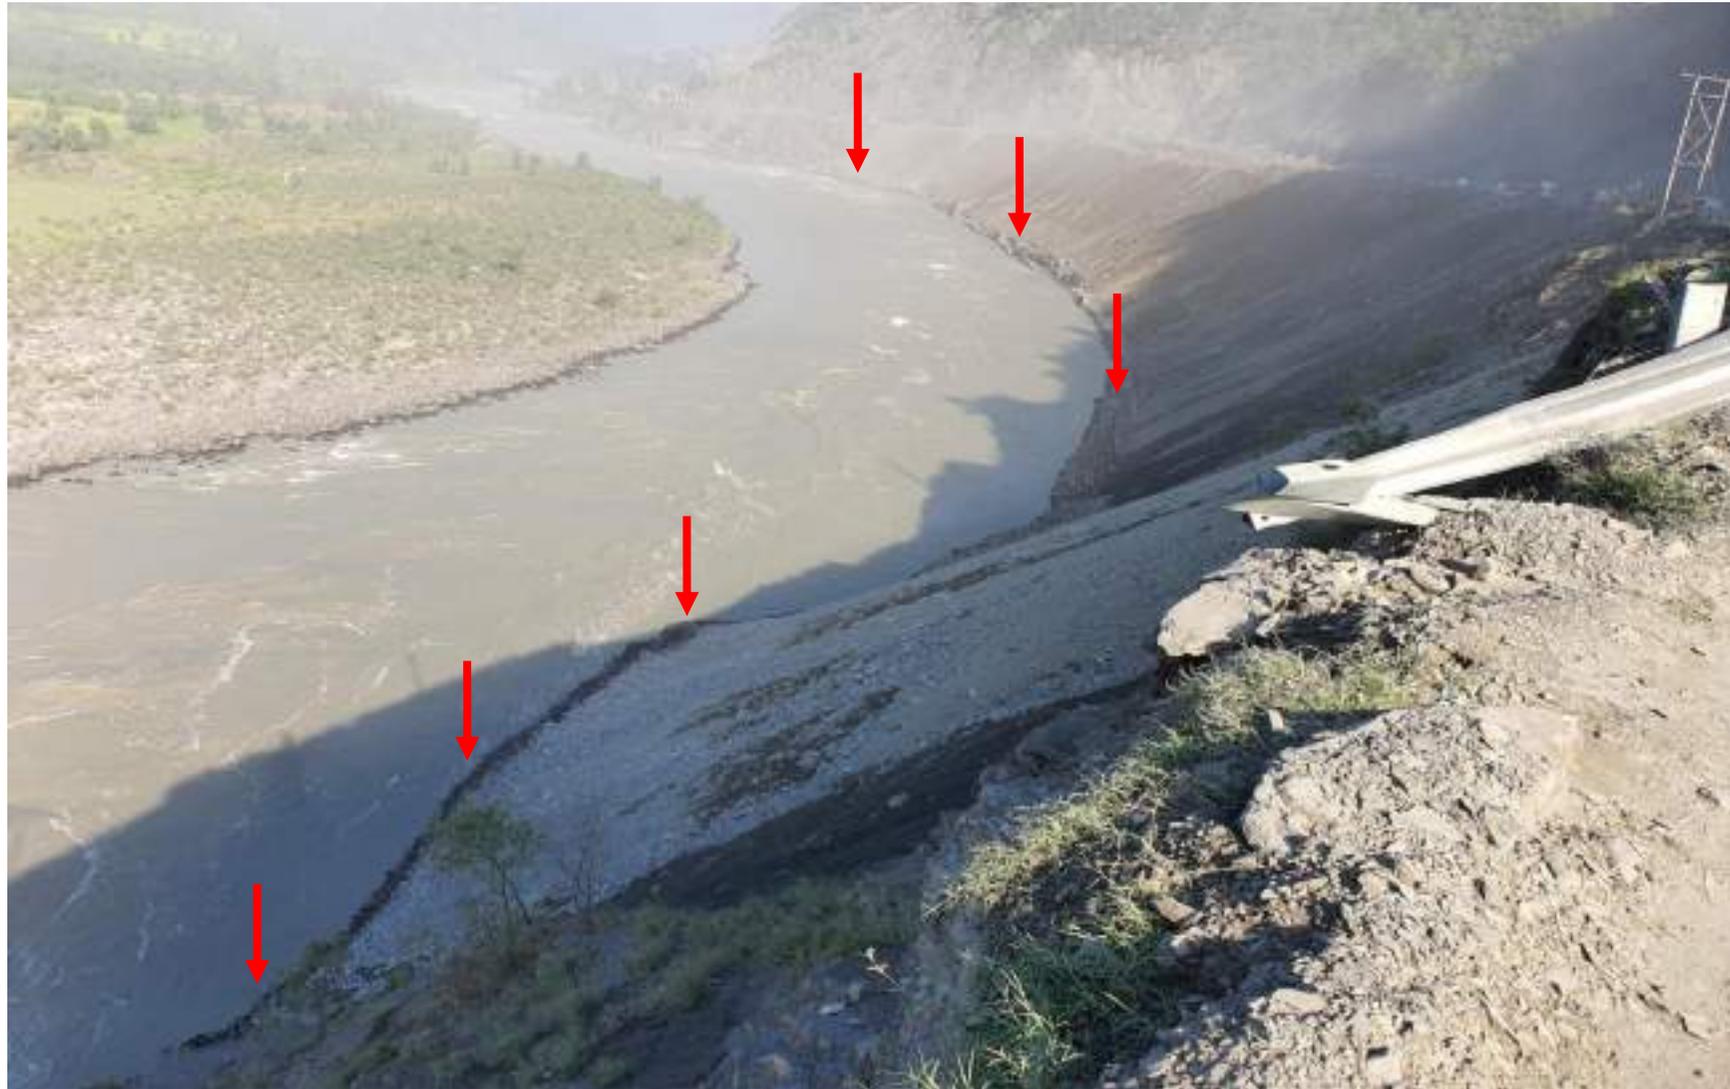
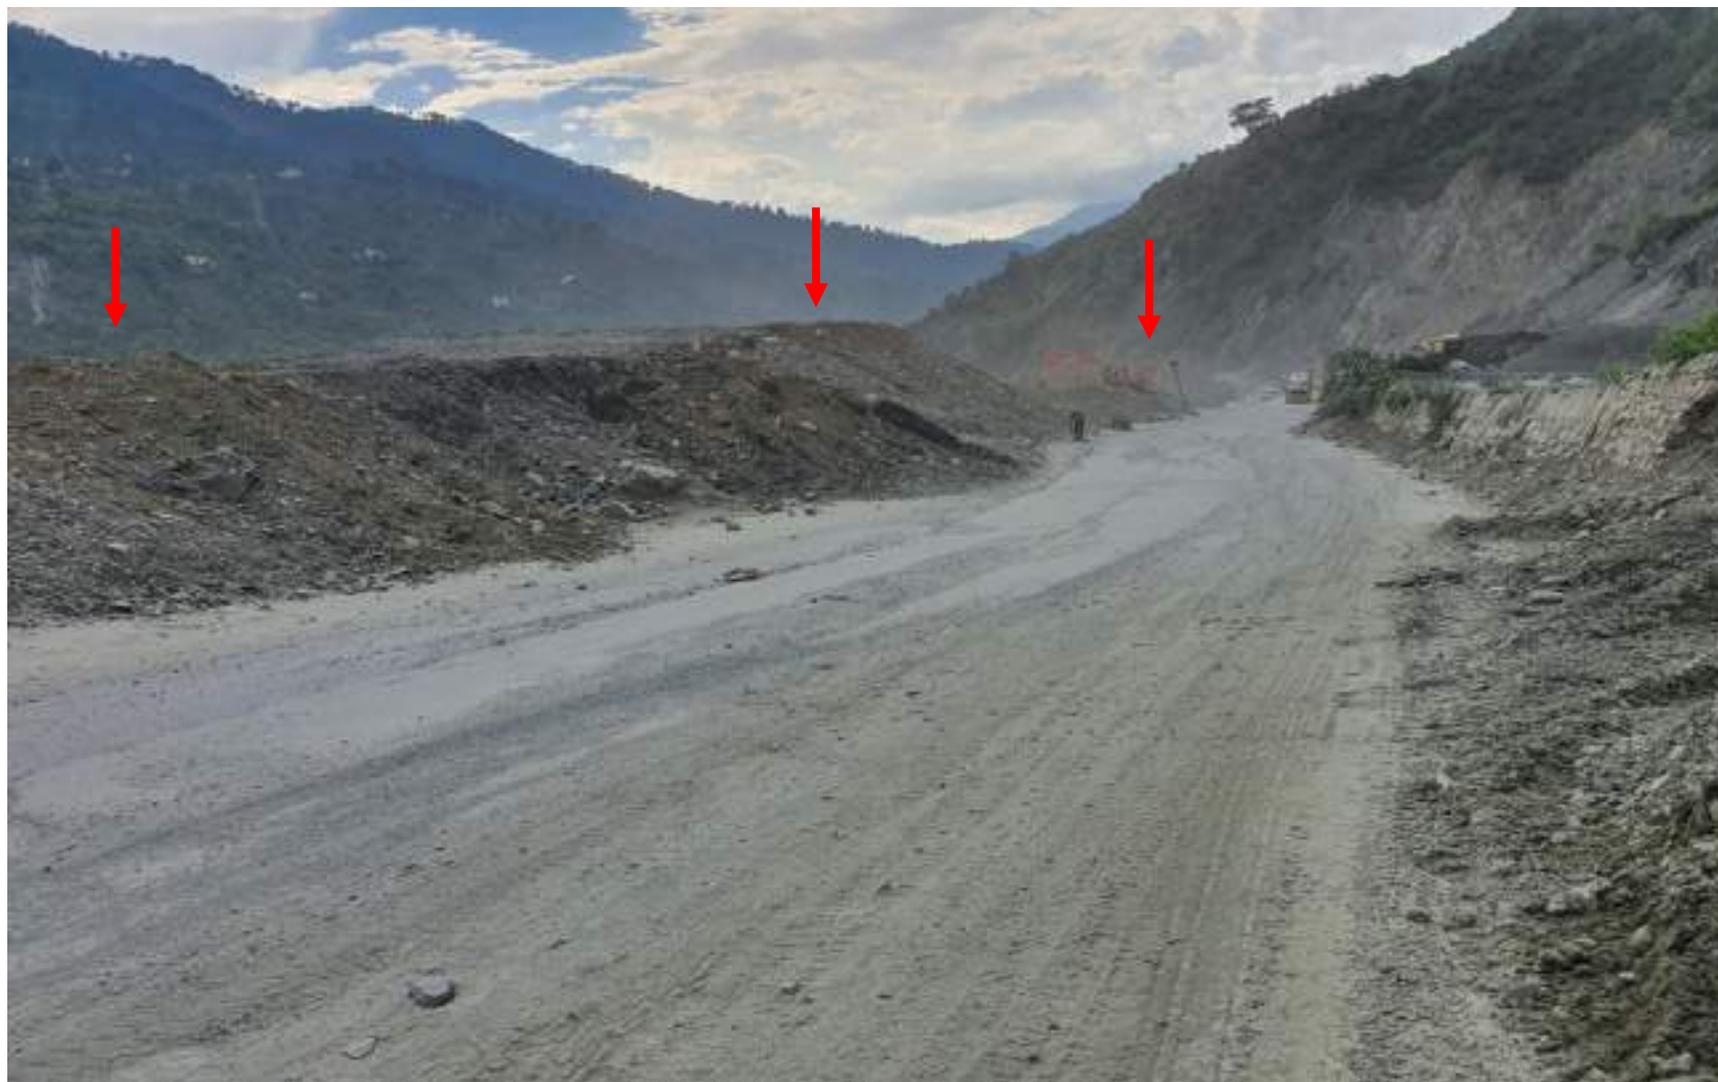
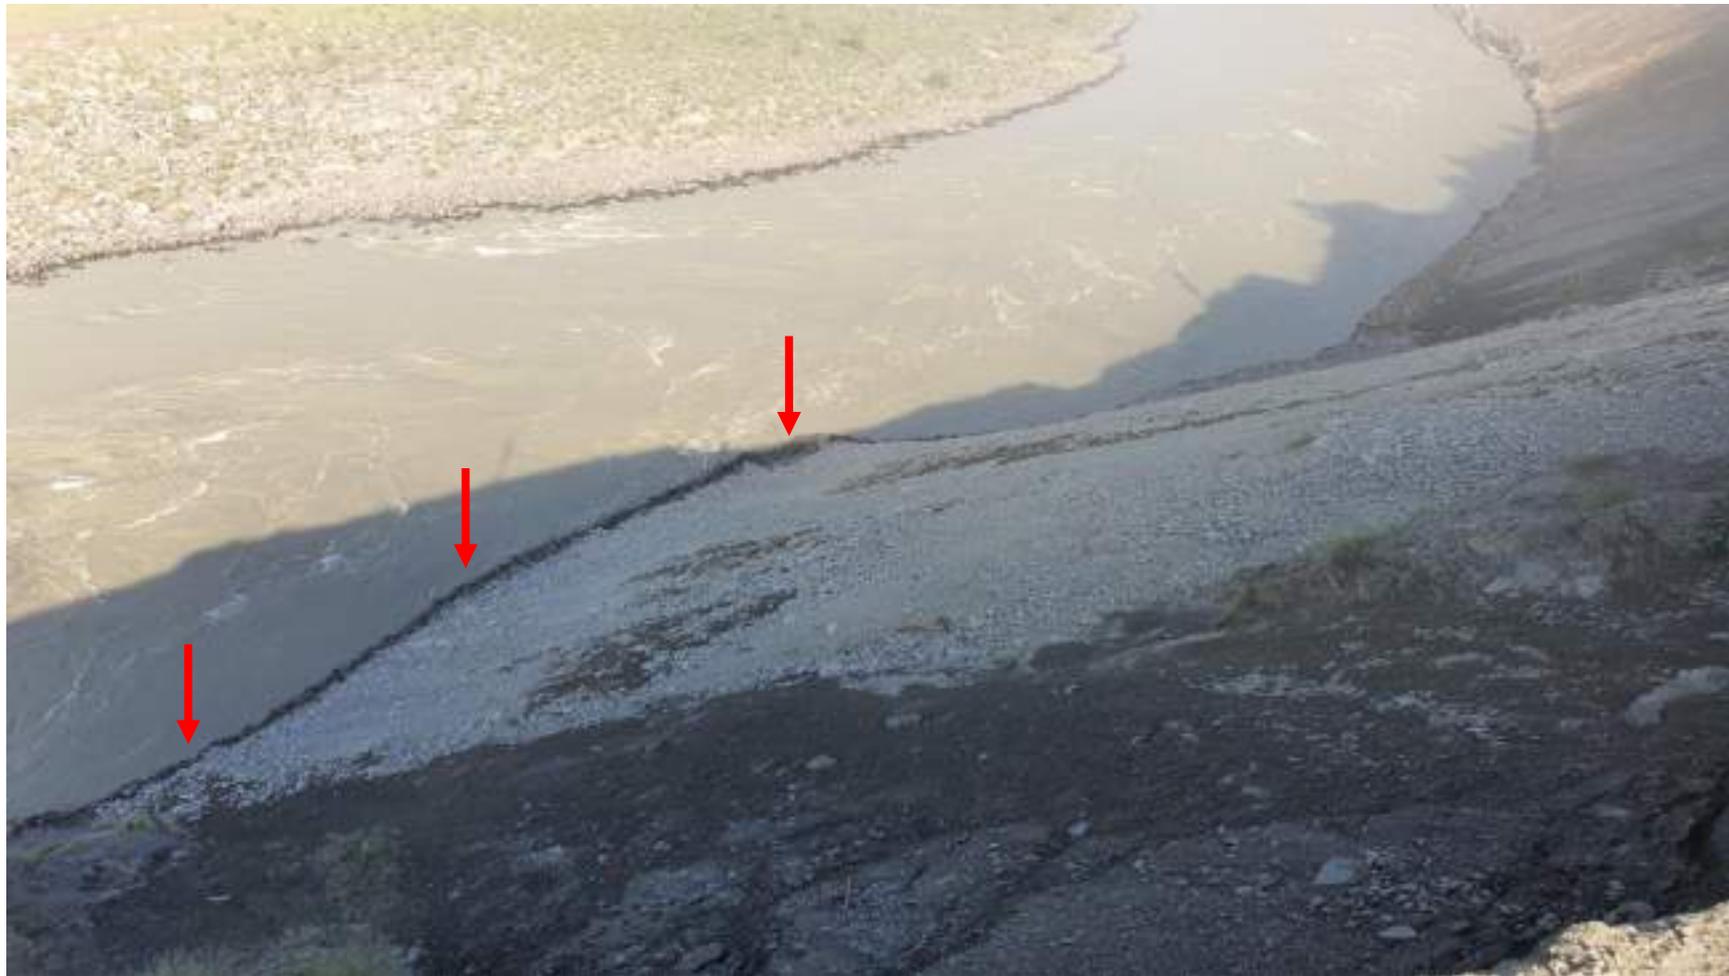
In photograph, it can be clearly seen that muck has been dumped along NH-44 illegally violating Hon'ble NGT Order.

S.No.	Name of the Site / Village	Chainage(SB)	Title /Area of the land	Total Capacity (cu.m)	Quantity dumped (cu.m)	Capacity remaining (cu.m)	Status	Observations
1)	Seri-Chamba (Morh-Gohri) Ramban	150+330 km to 150+900	Non- Designated (Old BRO site)	-	-	-	Illegal dumping going on.	Muck dumped directly into Chenab River. Gabions need to be provided.

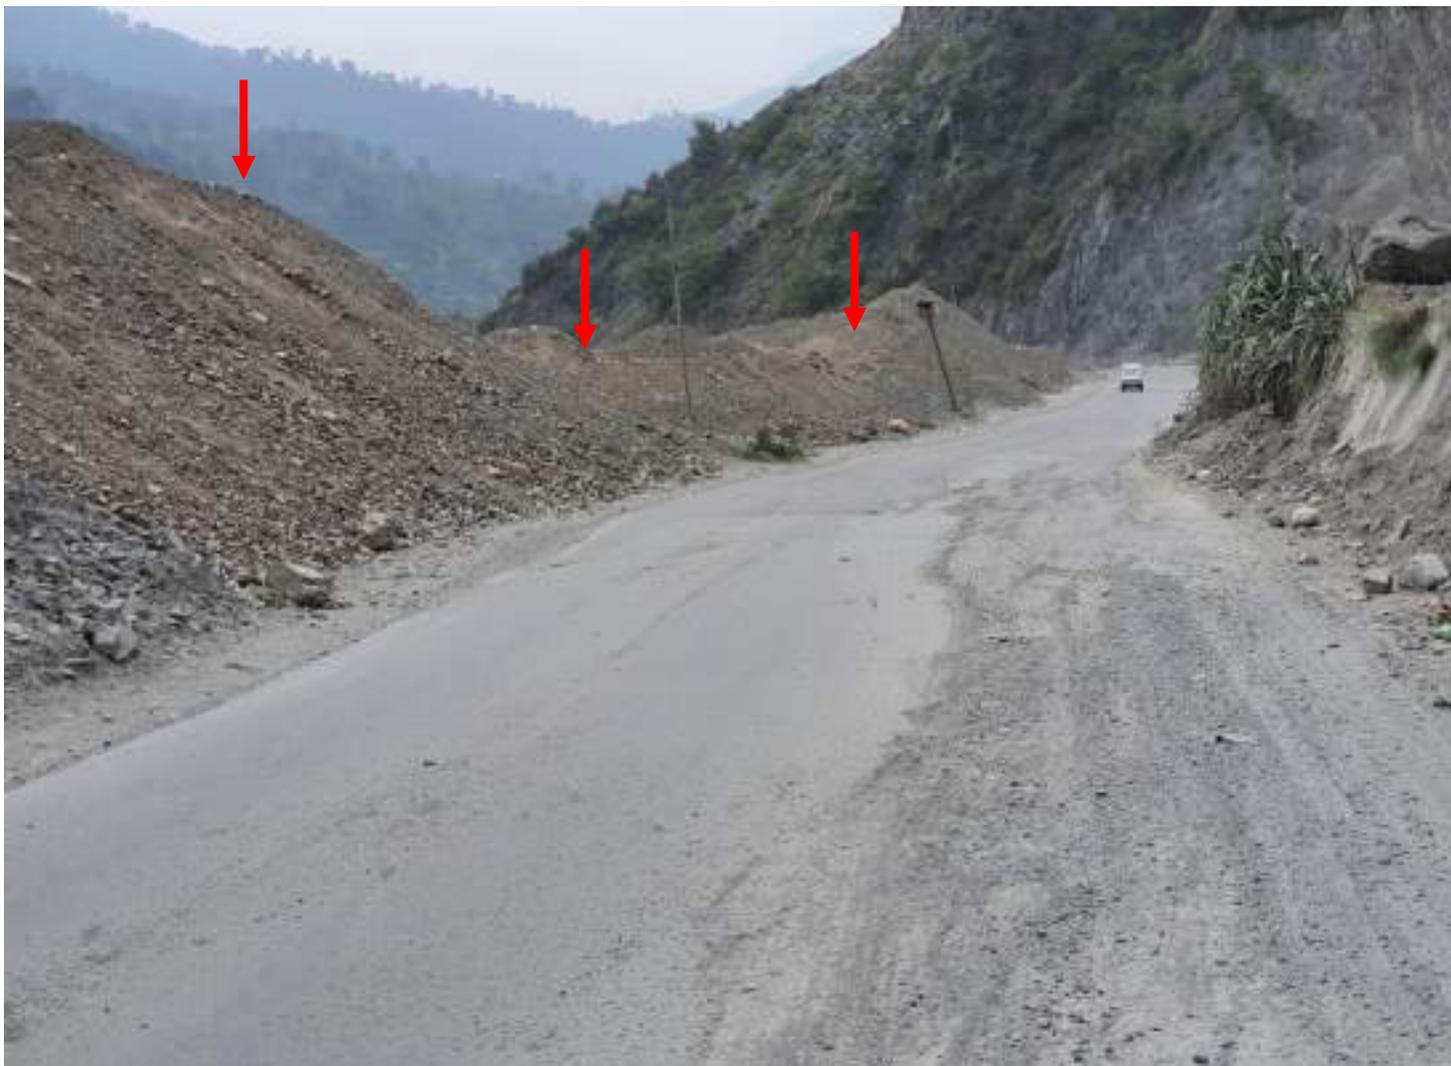
Photograph dated: (29th July, 2020): Seri Chamba (starting from Morh-Gorhi Ramban)

S.No.	Name of the site/Village	Chainage (SB)	Specific Observations
1.	Seri-Chamba	150+330 to 150+900	Illegal dumping going on. Needs to be stopped immediately.
2.	Marog Near Tunnel (T-2)	155+000 to 155+100	Dumping is being done in an unscientific manner. Terracing/ Gabions need to be provided.
3.	Near Battery Chaishma	158+710 to 158+960	Nallah choked. Few Plants survived after previous year's plantation. Green cover has come up in some portion of this site. Also, site needs to be covered with soil. Gabion structures needs to be repaired.
4.	Anokhe Fall	159+100 to 159+400	Green cover has come up in some portion of this site. Gabions need to be provided.
