Office of the Chairman, NGT Monitoring Committee (J&K)
Justice Janak Raj Kotwal
(Former Judge High Court of Jammu & Kashmir)

Subject: Report of the Chairman in compliance to Hon'ble NGT order
dated 20.03.2020.

In the matter of : Execution Application No. 32/2016
In
Original Application No. 295/2016
And
Original Application No. 295/2016
(M.A.No.539/2016)

Report in compliance to Hon'ble NGT Order dated 20. 03. 2020

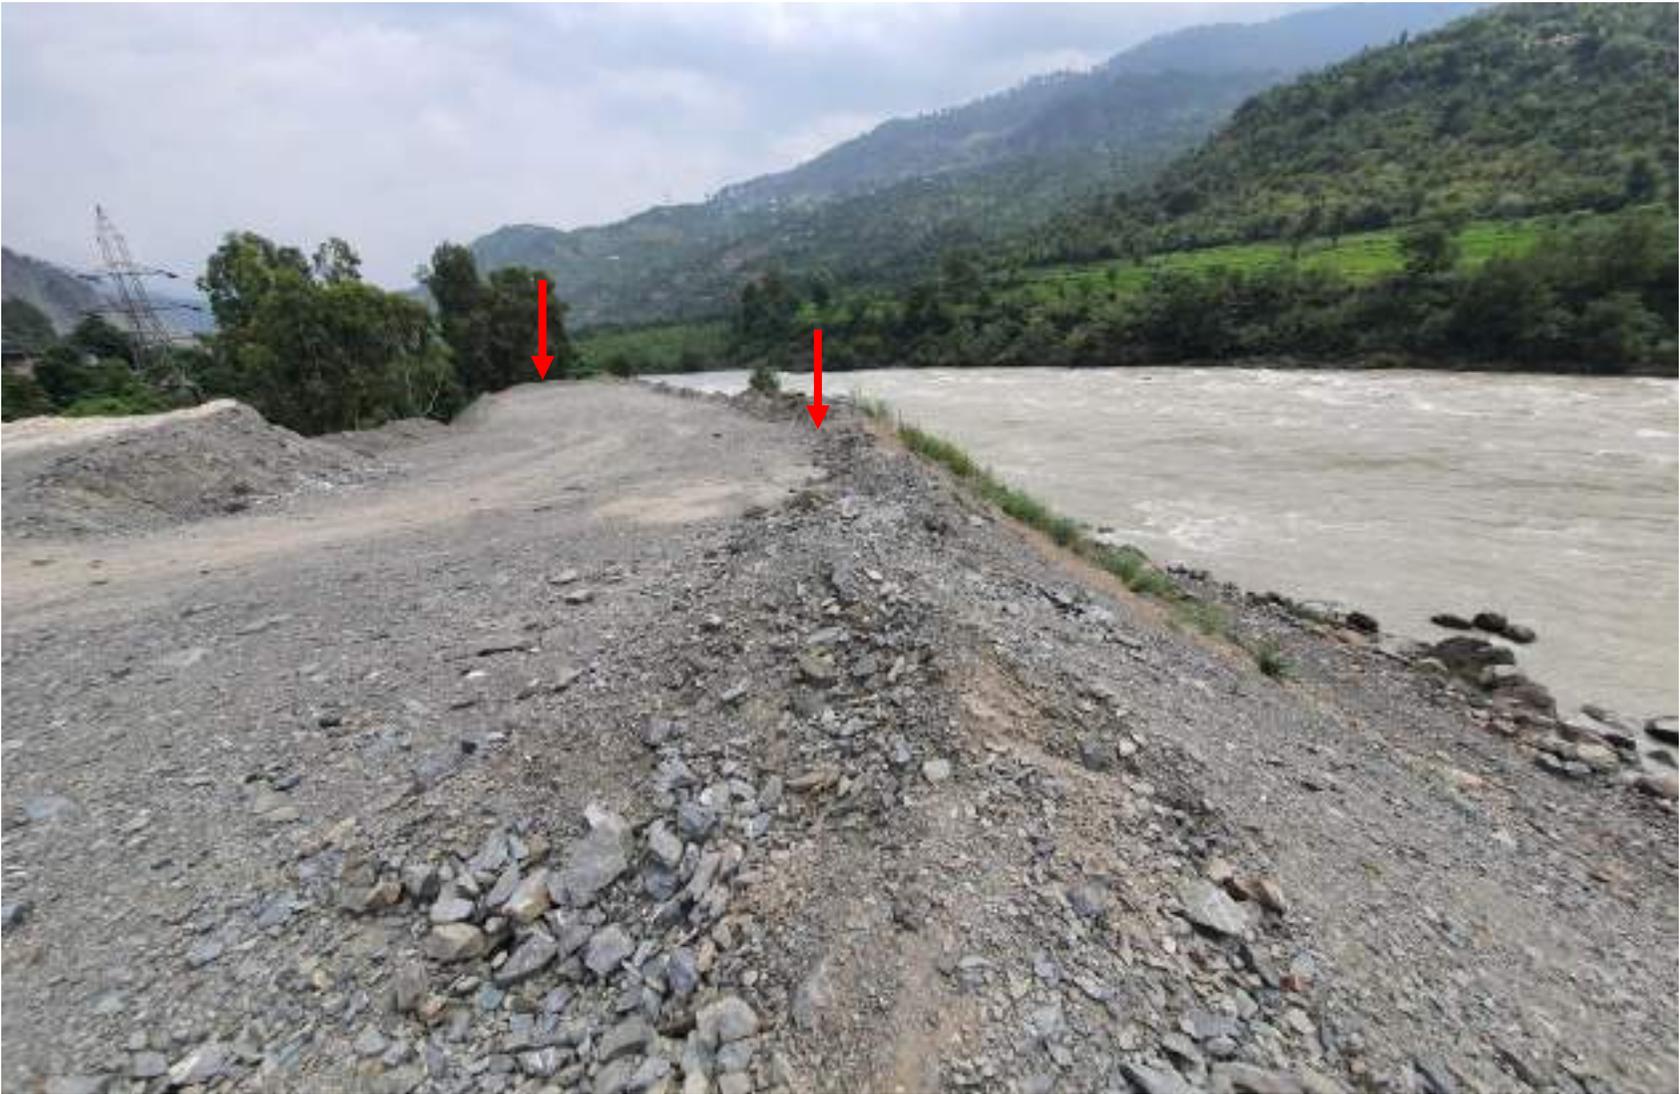
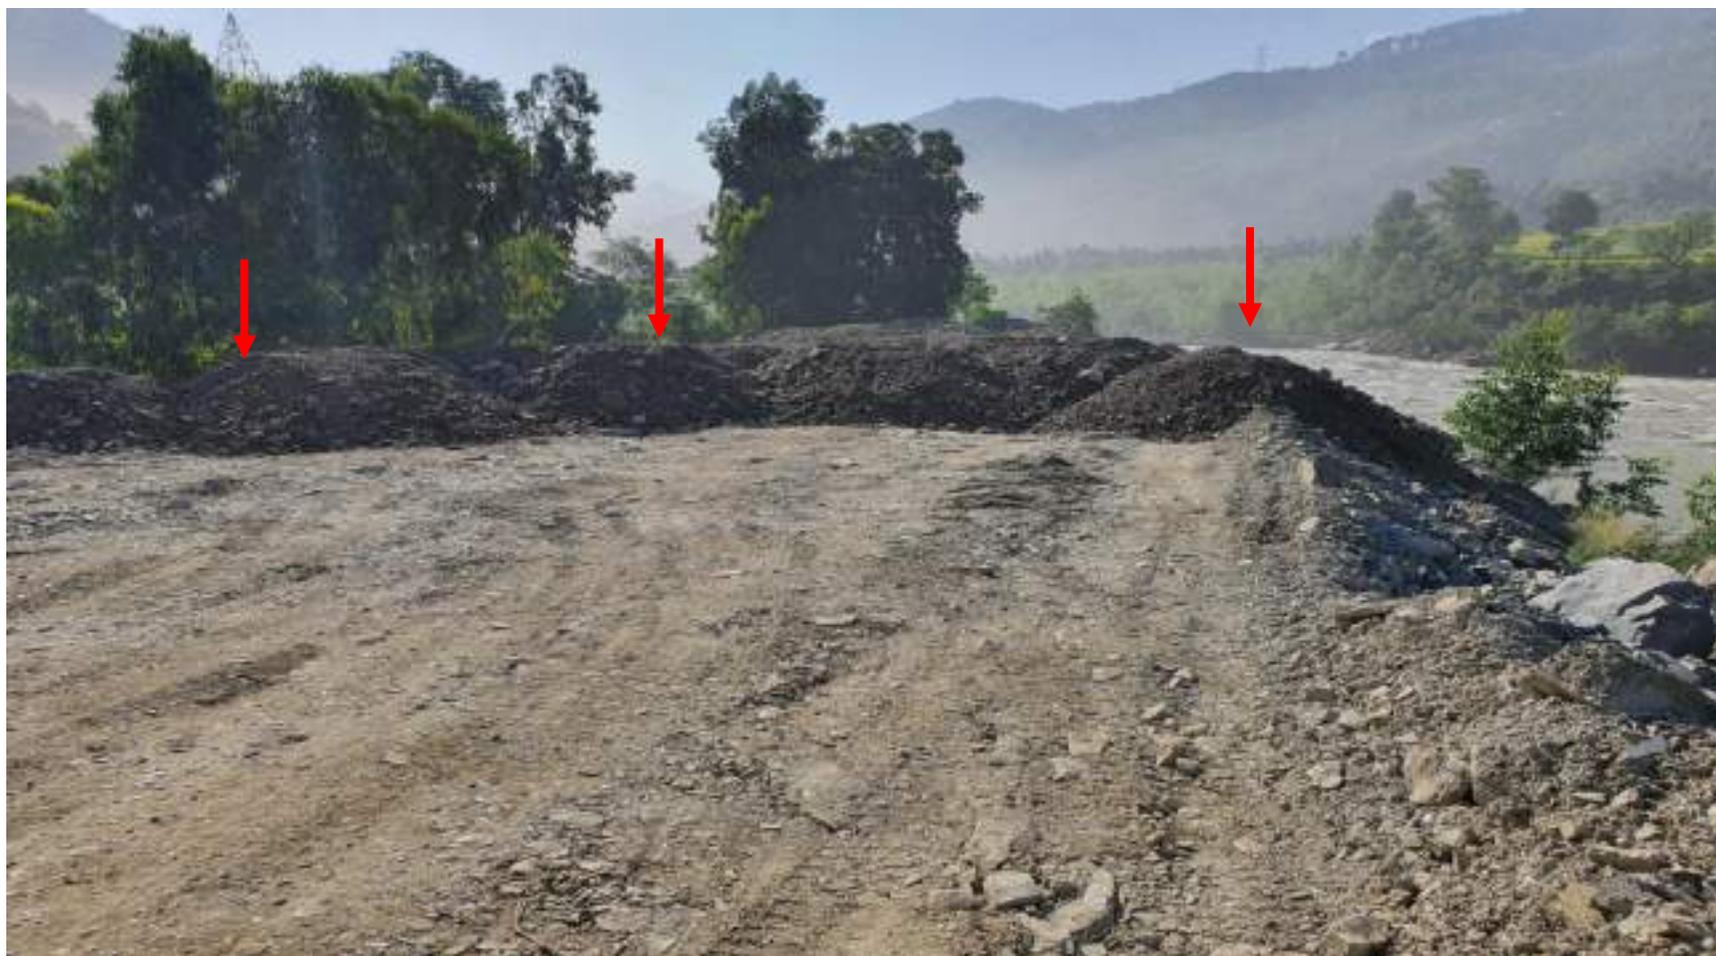
Photograph dated: (1st Sept, 2020): Seri-Near Shiv Temple

S.No.	Name of the Site / Village	Chainage(SB)	Title /Area of the land	Total Capacity (cu.m)	Quantity dumped (cu.m)	Capacity remaining (cu.m)	Status	Observations
2)	Seri (Near Shiv Temple)	151+350 km	Private/Non-designated	-	-	-	-	<i>Illegal dumping going on.</i>

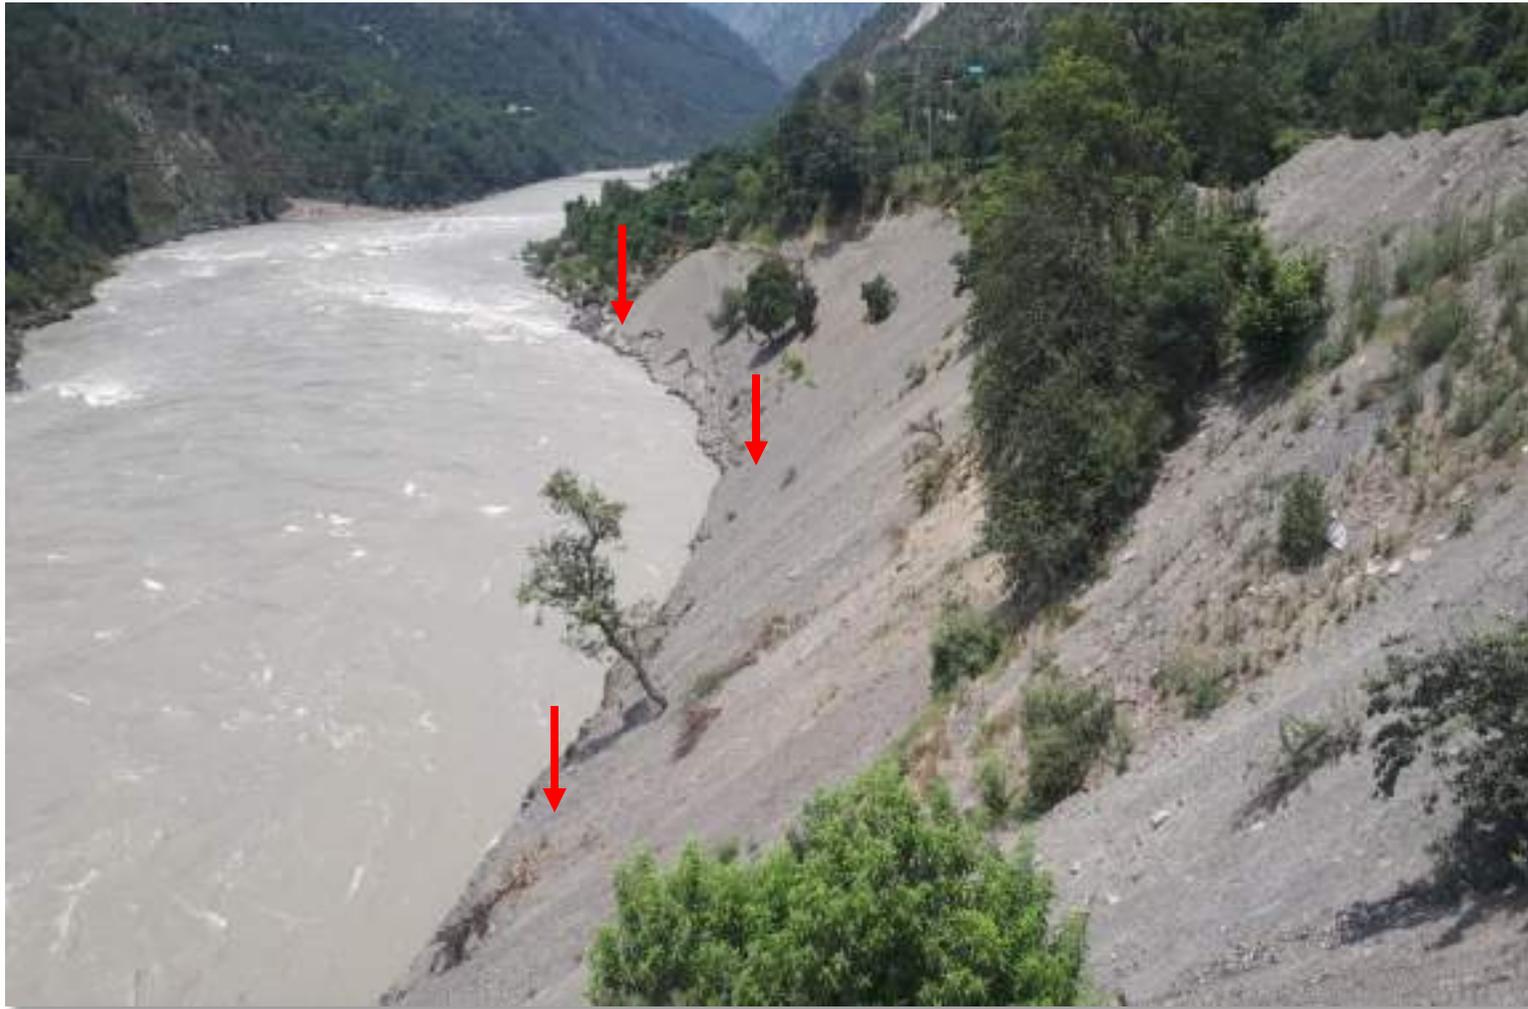
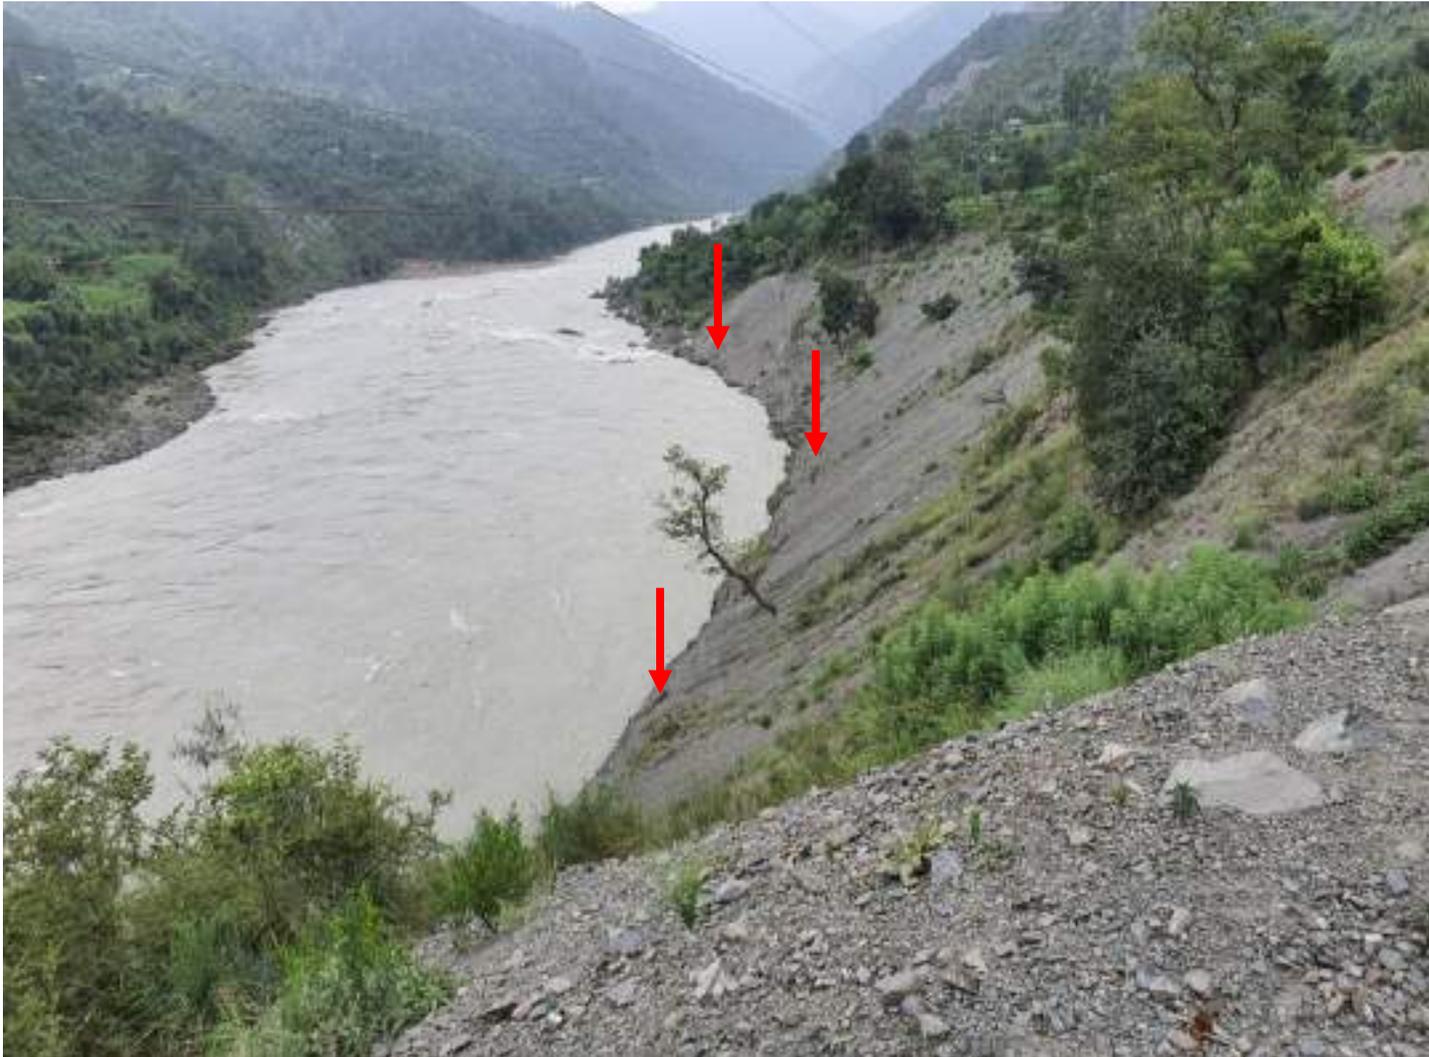
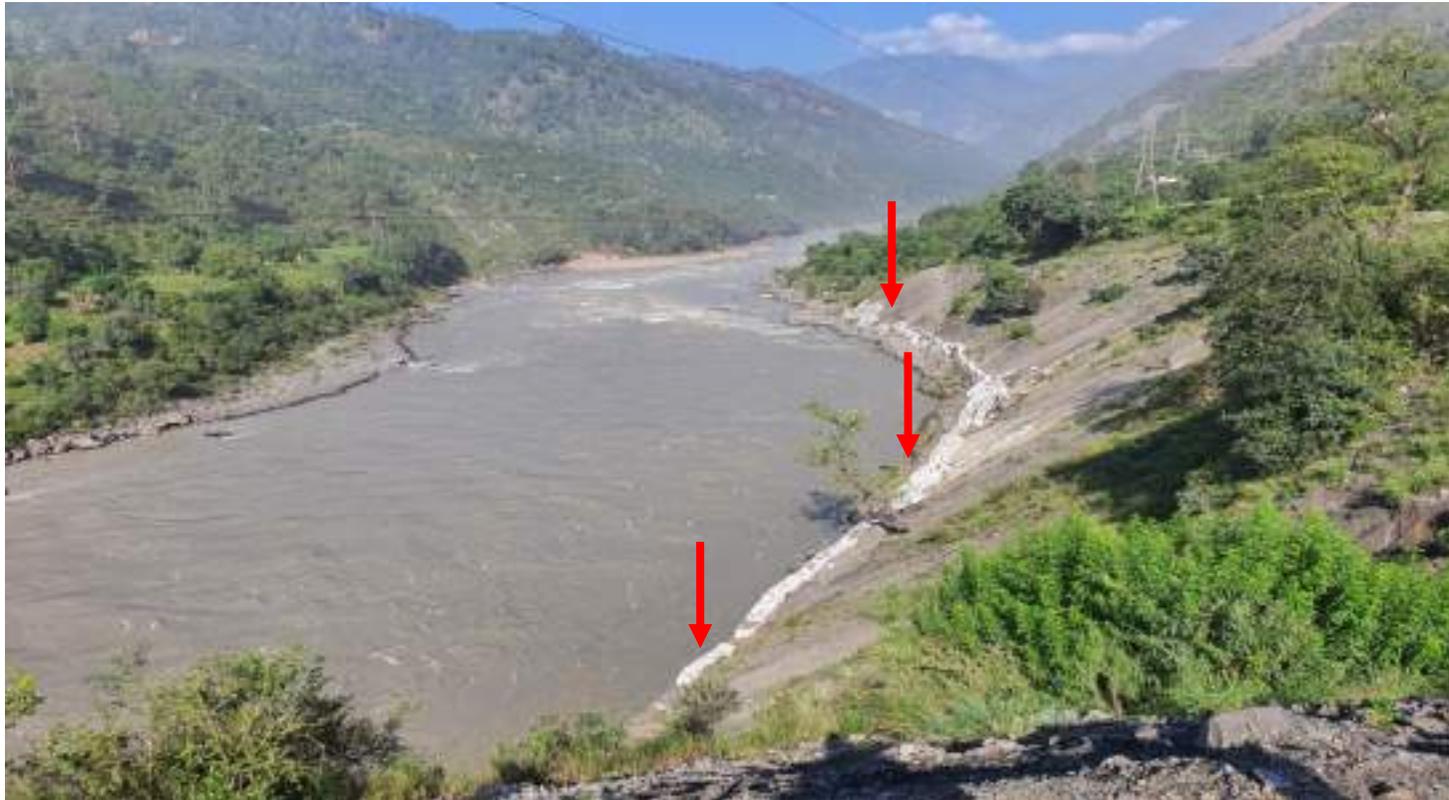
Photograph dated: (1st Sept, 2020): Seri

S.No.	Name of the Site / Village	Chainage(SB)	Title /Area of the land	Total Capacity (cu.m)	Quantity dumped as on July 2019 (cu.m)	Capacity remaining as on July 2019 (cu.m)	Status	Observations
3)	Seri	152+800 km	Private/ 2.16 Hectare	64375	64375	0	Closed	<i>Instead of repairing damaged Gabions empty cement bags filled with muck has been placed. Green cover has come up in some portion of this site</i>

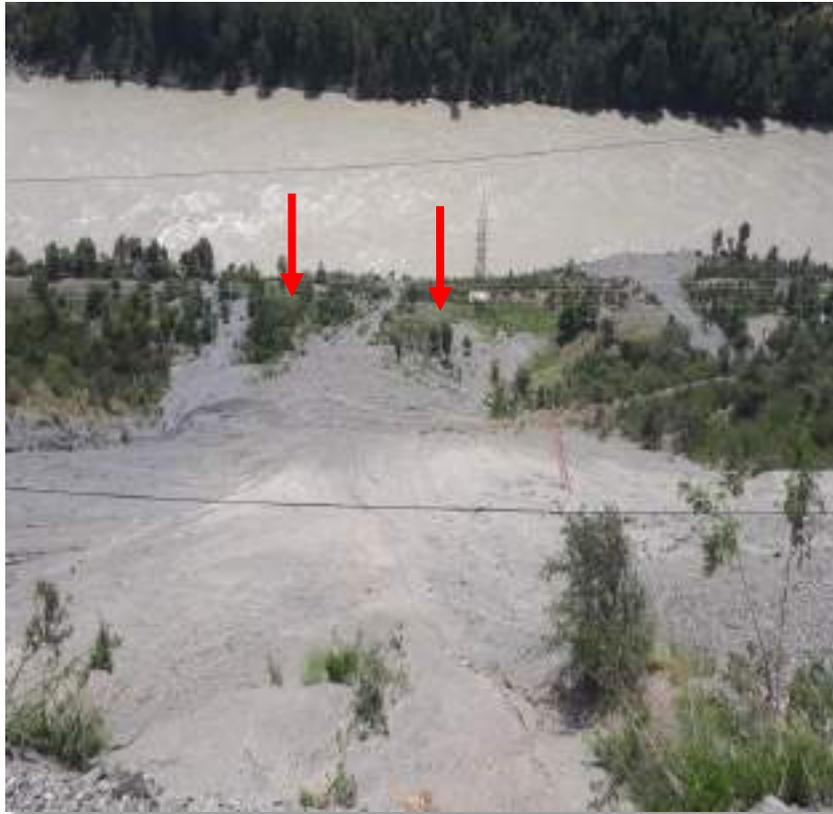
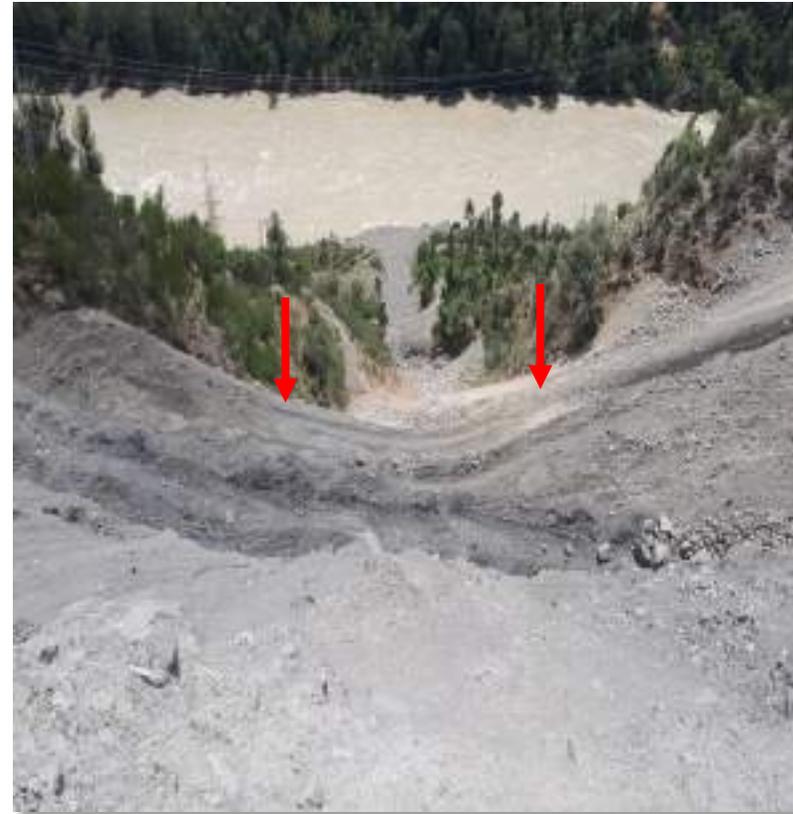
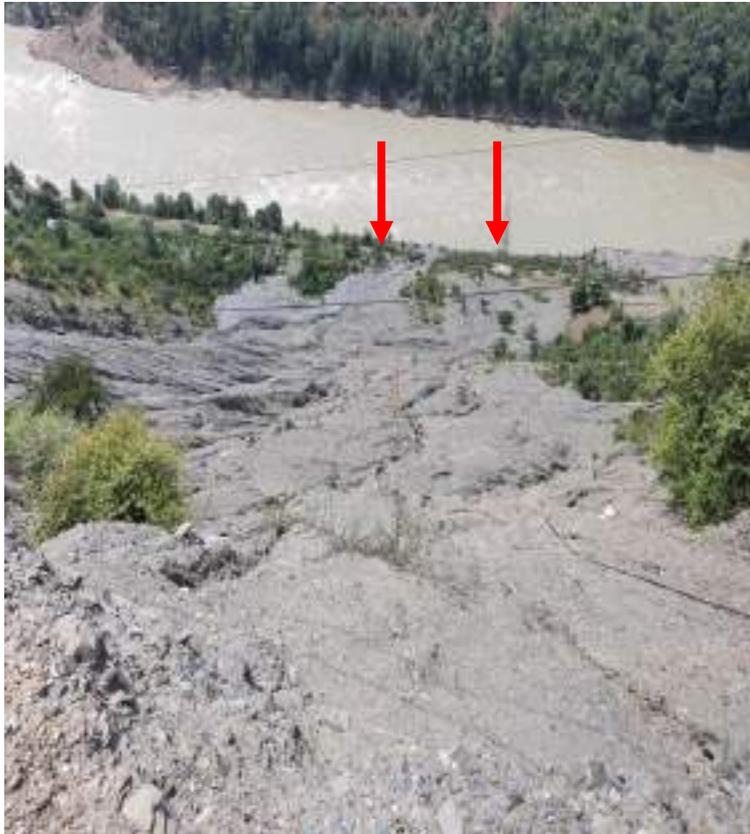
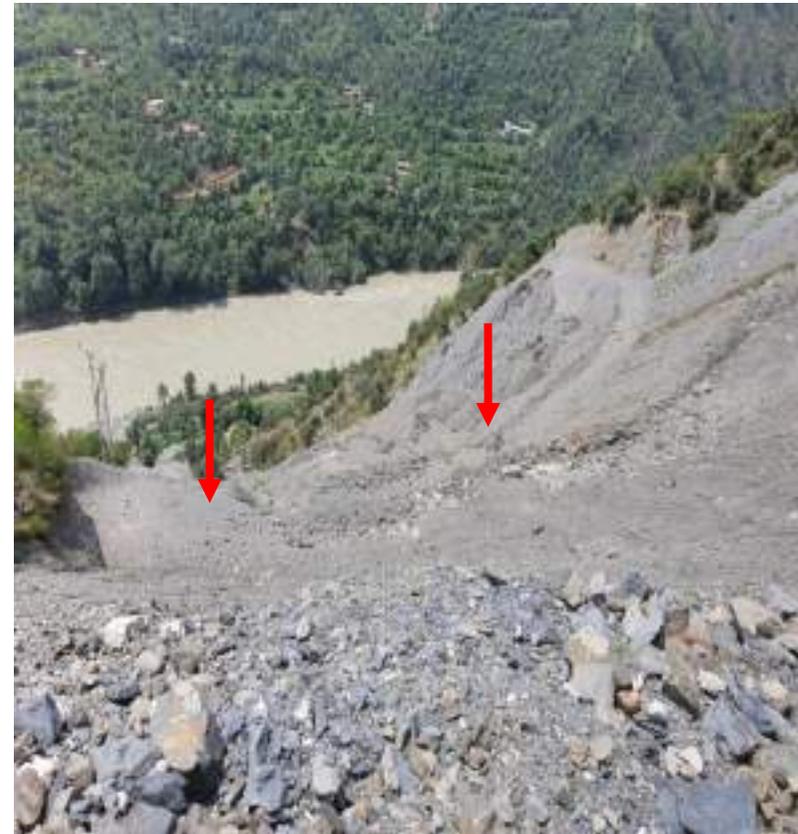
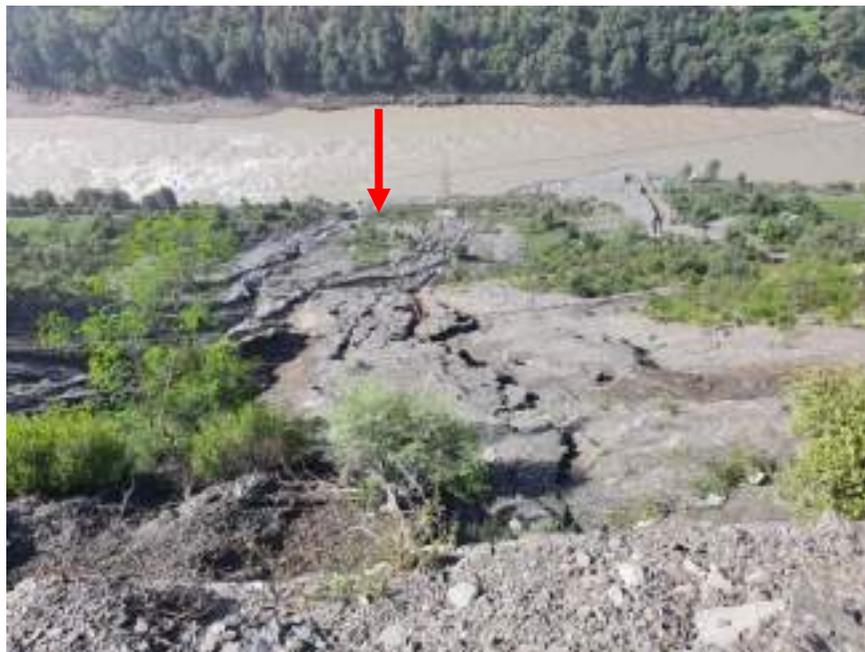
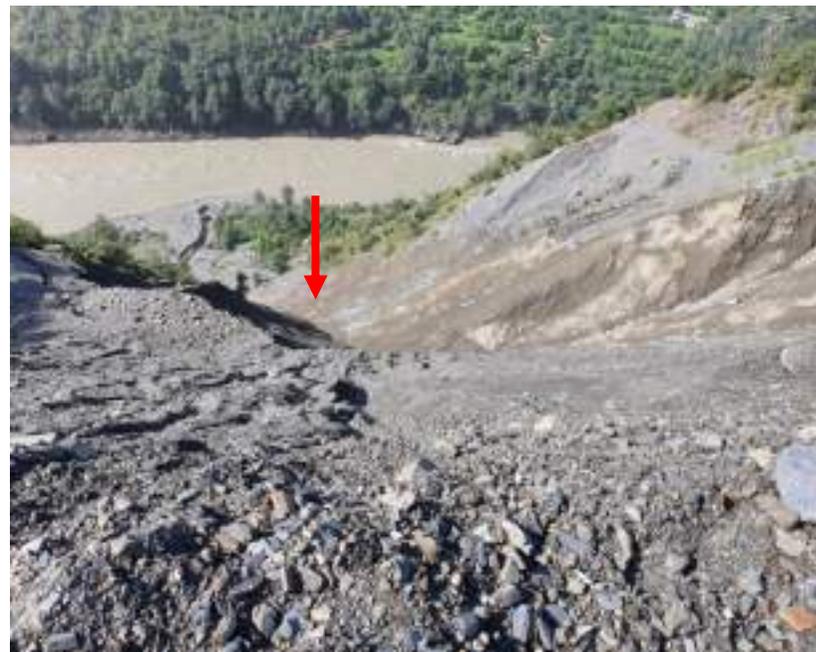
Photograph dated: (1st Sept, 2020): Marog-I (Near Tunnel T-2)

S.No.	Name of the Site / Village	Chainage(SB)	Title /Area of the land	Total Capacity (cu.m)	Quantity dumped as on July 2019 (cu.m)	Capacity remaining as on July 2019 (cu.m)	Status	Observations
4)	Marog-I (Near Tunnel T-2)	154+000 to 154+200	Forest / 0.14 Hectare	243200	243200	0	Closed	<i>Loose Muck, Gabions need to be strengthened.</i>

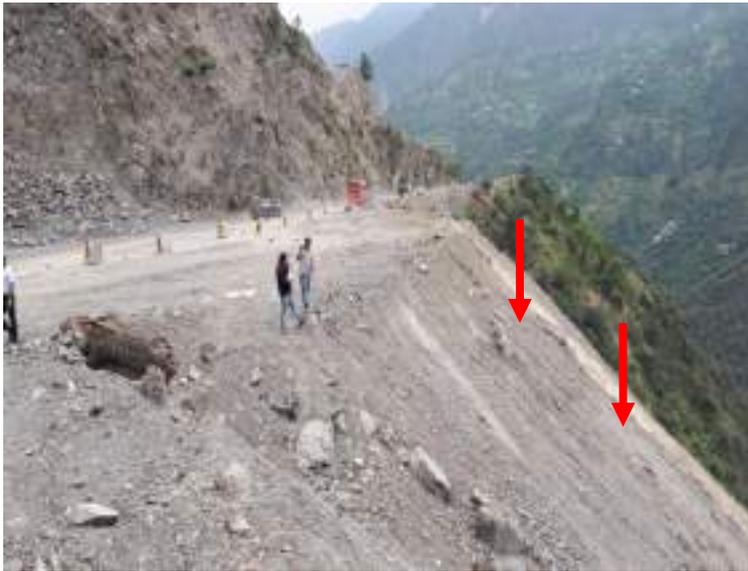
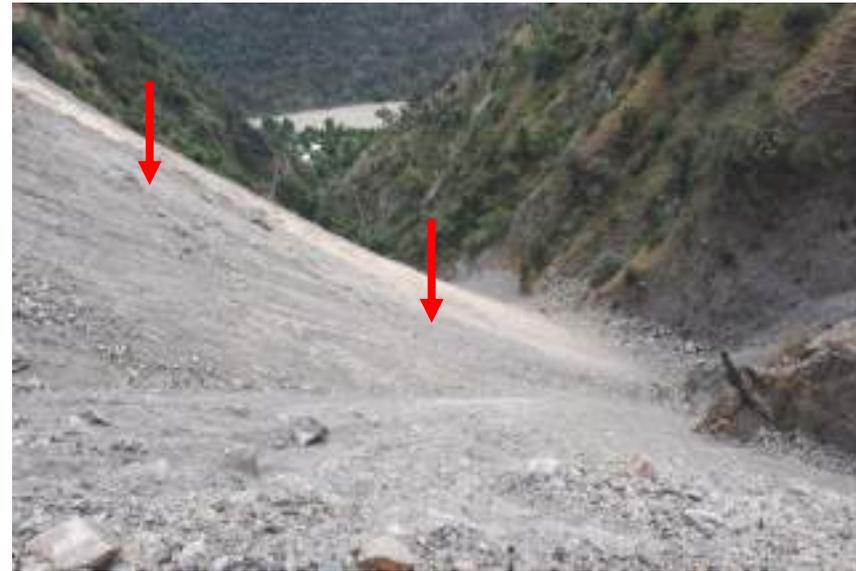
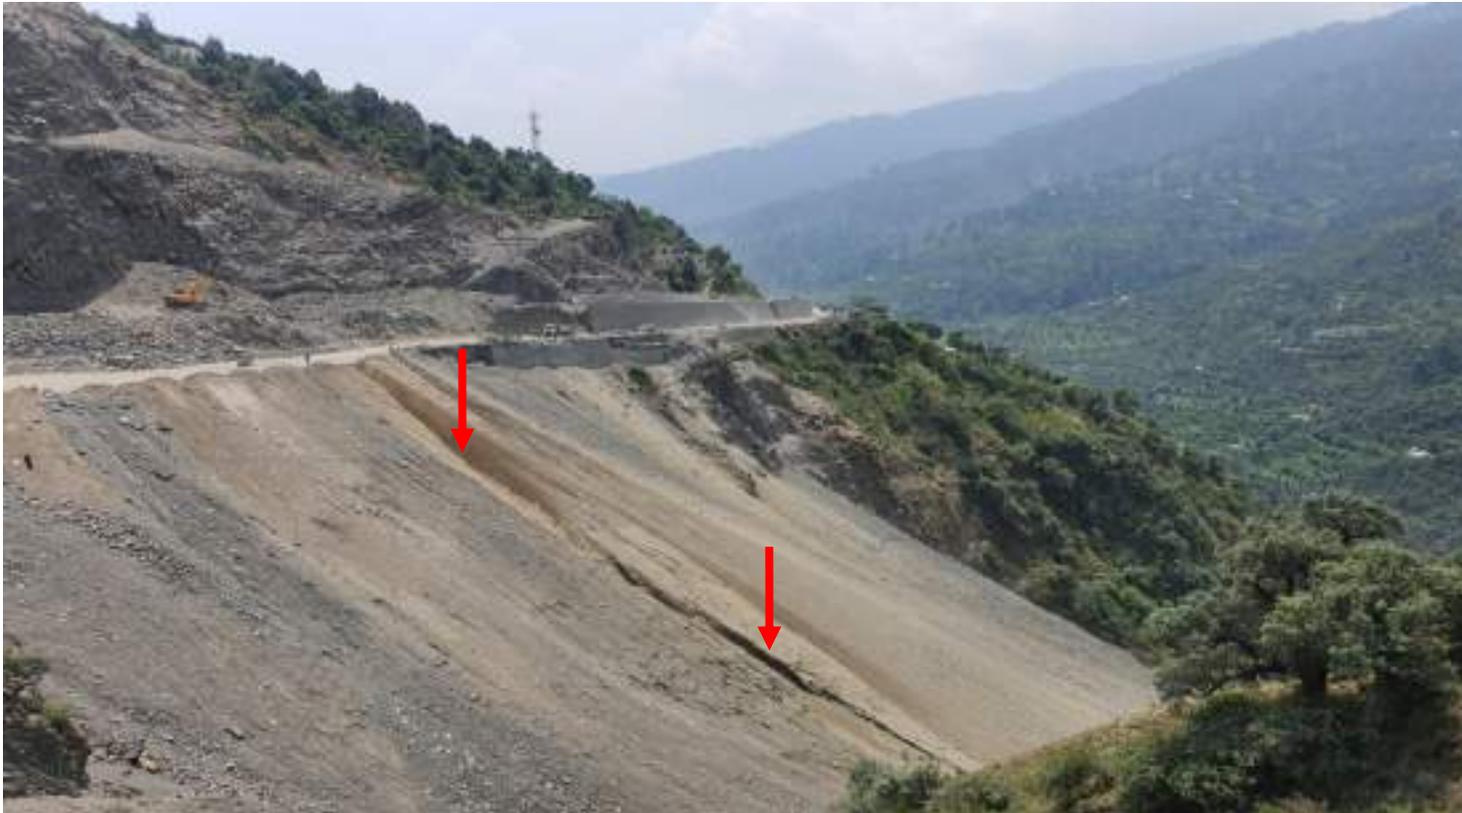
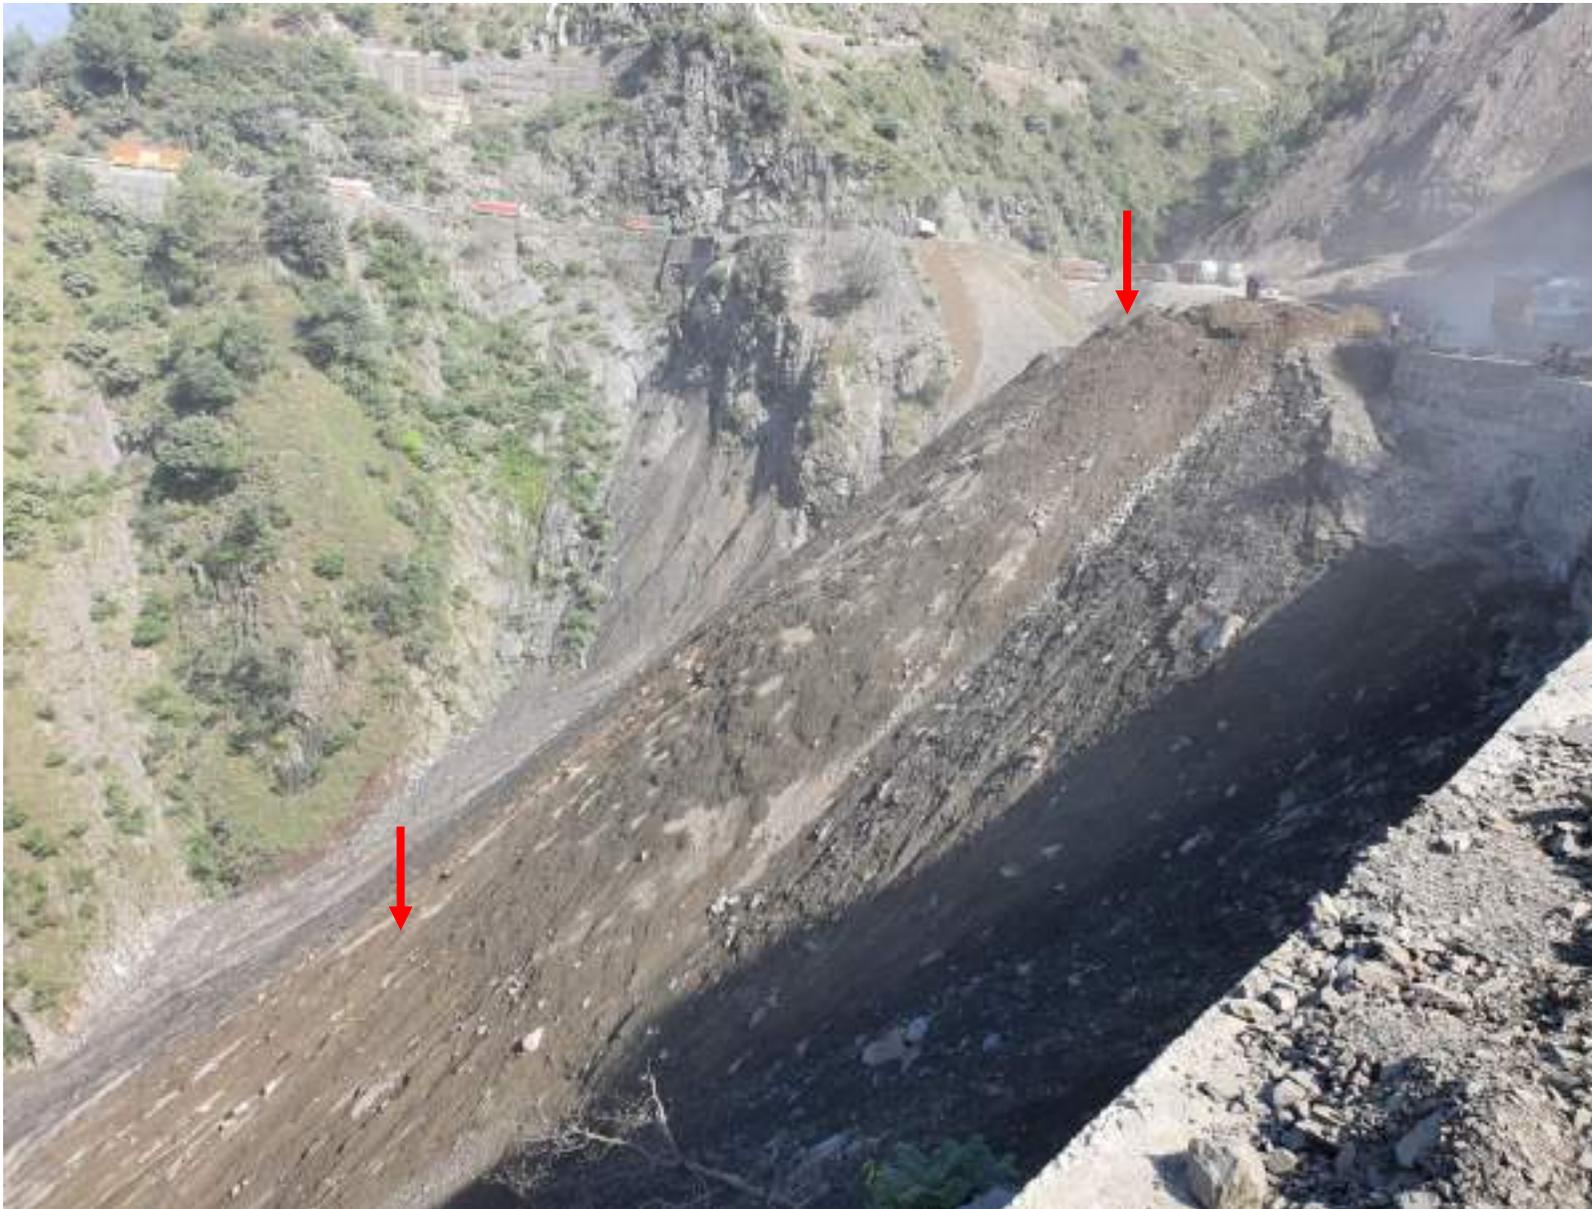
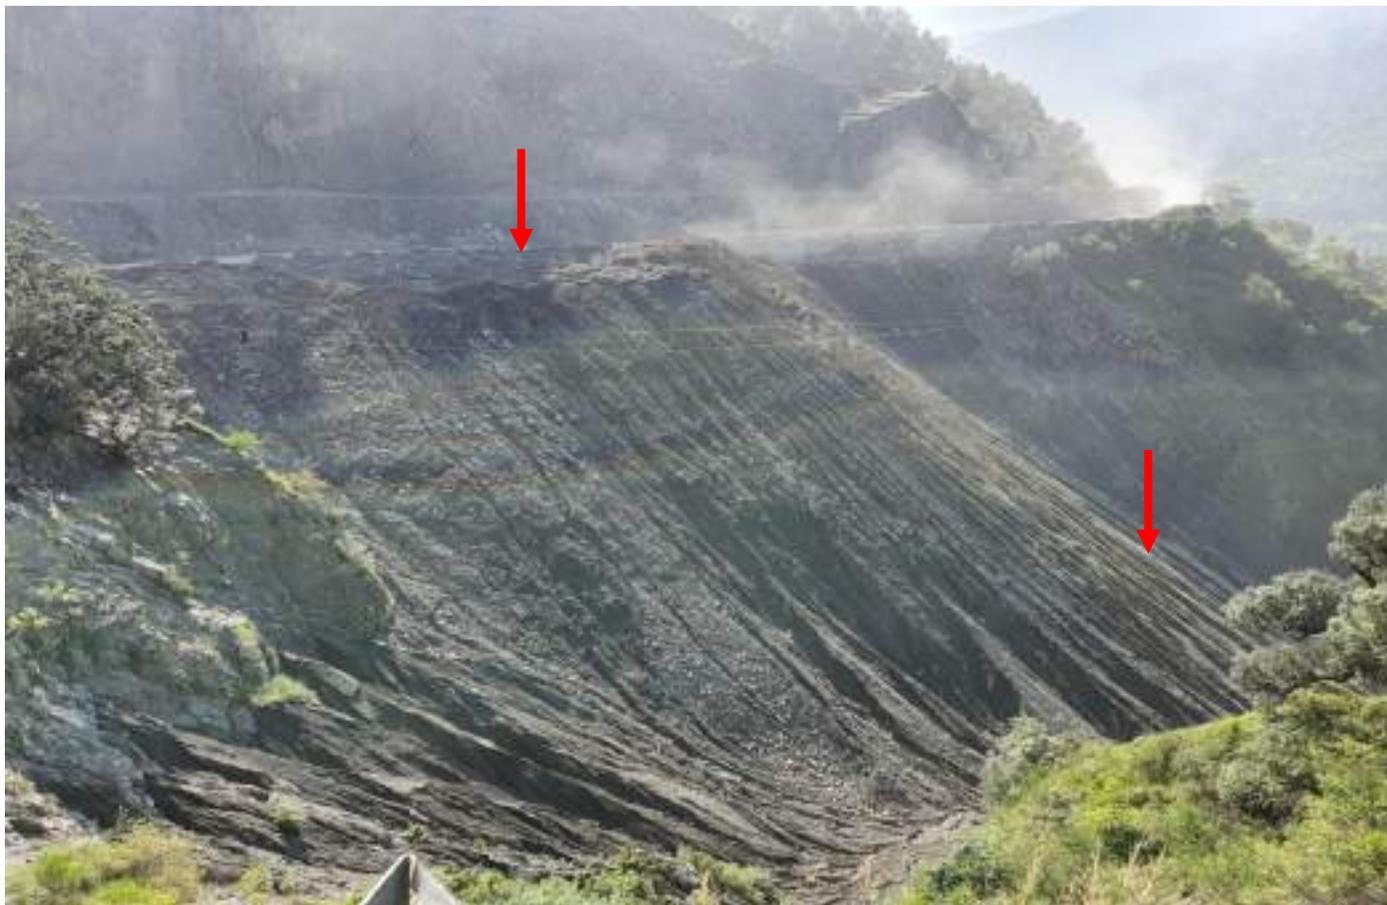
Photograph dated: (28th July, 2020): Marog-II, Un-scientific dumping is being done.

S.No.	Name of the Site / Village	Chainage(SB)	Title /Area of the land	Total Capacity (cu.m)	Quantity dumped as on July 2019 (cu.m)	Capacity remaining as on July 2019 (cu.m)	Status	Observations
5)	Marog-II	155+000 to 155+100	Private/ 2.15 Hectare	205200	205200	0	In-use	<i>Dumping is being done in an unscientific manner. Terracing /Gabions need to be provided.</i>

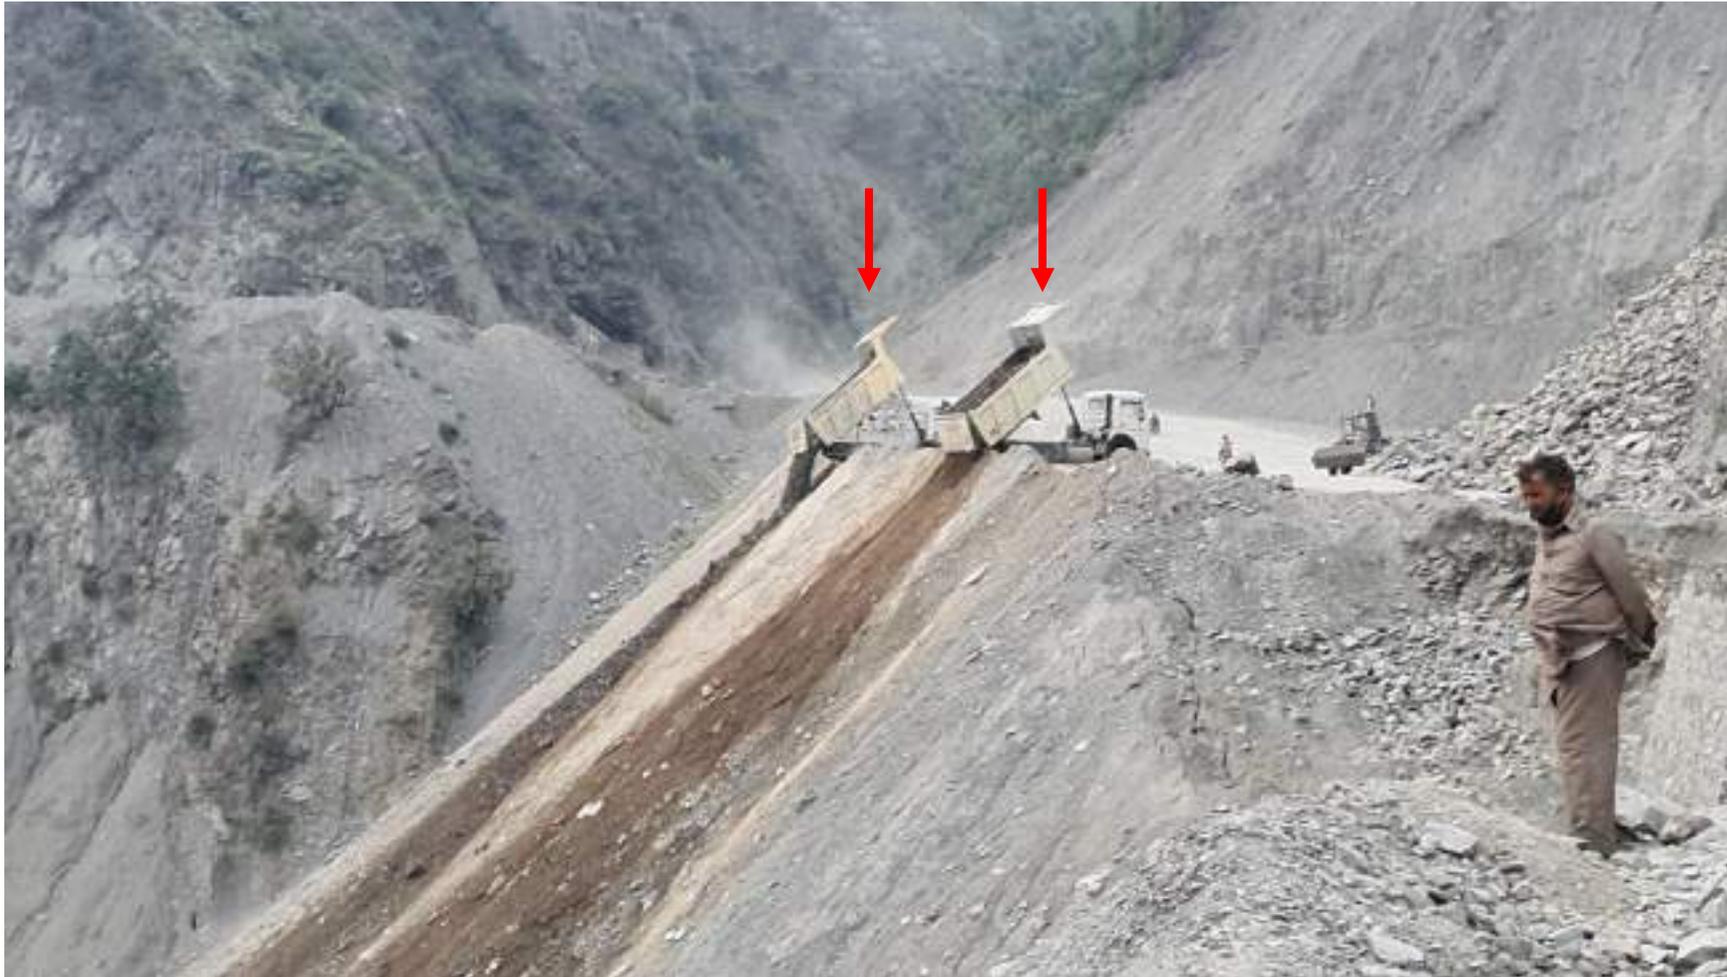
2.	Marog Near Tunnel (T-2)	155+000 to 155+100	Dumping is being done in an unscientific manner. Terracing/ Gabions need to be provided.
3.	Near Battery Chaishma	158+710 to 158+960	Nallah choked needs to be channelized. Hume pipe has been laid but not connected yet. Few Plants survived after previous year's plantation. Green cover has come up in some portion of this site. Also, site needs to be covered with soil. Gabion structures needs to be repaired.

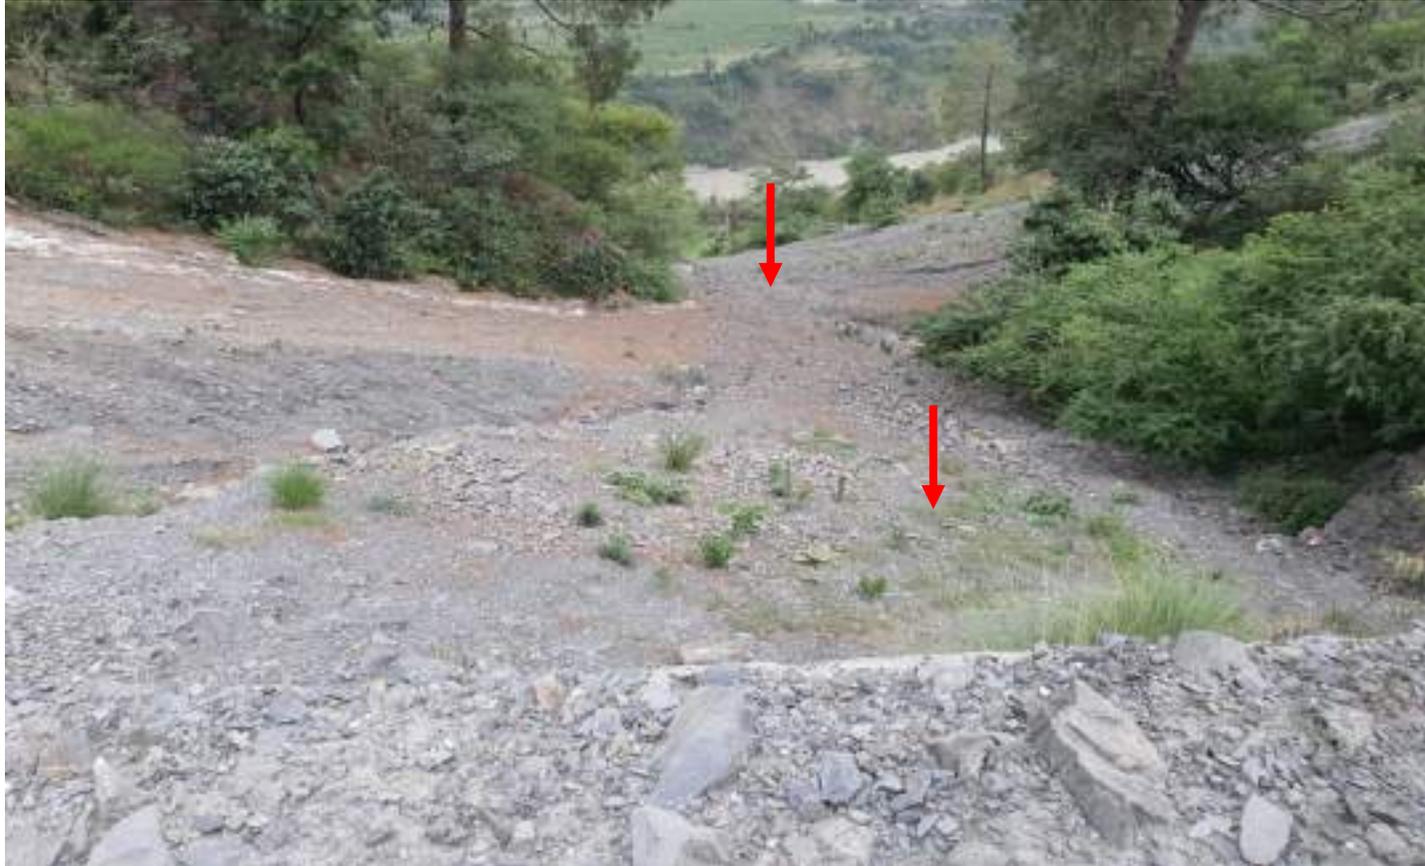
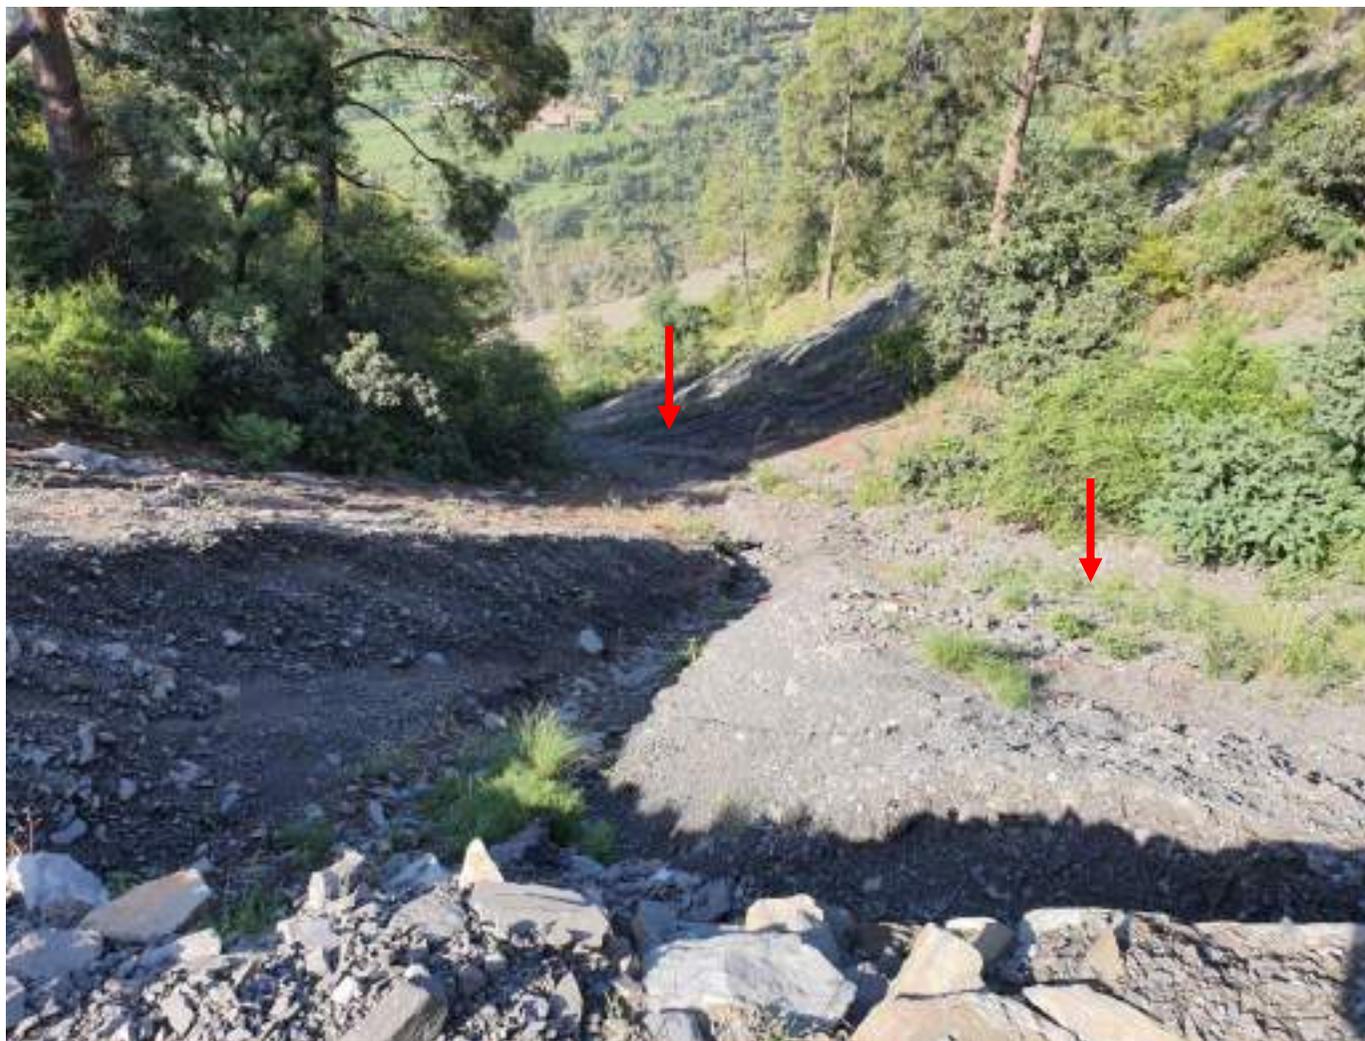
Photograph dated: (1st Sept, 2020): Marog-III

S.No.	Name of the Site / Village	Chainage(SB)	Title /Area of the land	Total Capacity (cu.m)	Quantity dumped (cu.m)	Capacity remaining (cu.m)	Status	Observations
6)	Marog-III	155+760 to 155+870	Non-designated	-	-	-	-	Slide debris dumped. Green cover has come up in some portion of this site.
