Office of the Chairman, NGT Monitoring Committee (J&K)
Justice Janak Raj Kotwal
(Former Judge High Court of Jammu & Kashmir)

Subject: Report of the Chairman in compliance to Hon'ble NGT order
dated 20.03.2020.

In the matter of : Execution Application No. 32/2016
In
Original Application No. 295/2016
And
Original Application No. 295/2016
(M.A.No.539/2016)

Report in compliance to Hon'ble NGT Order dated 20. 03. 2020

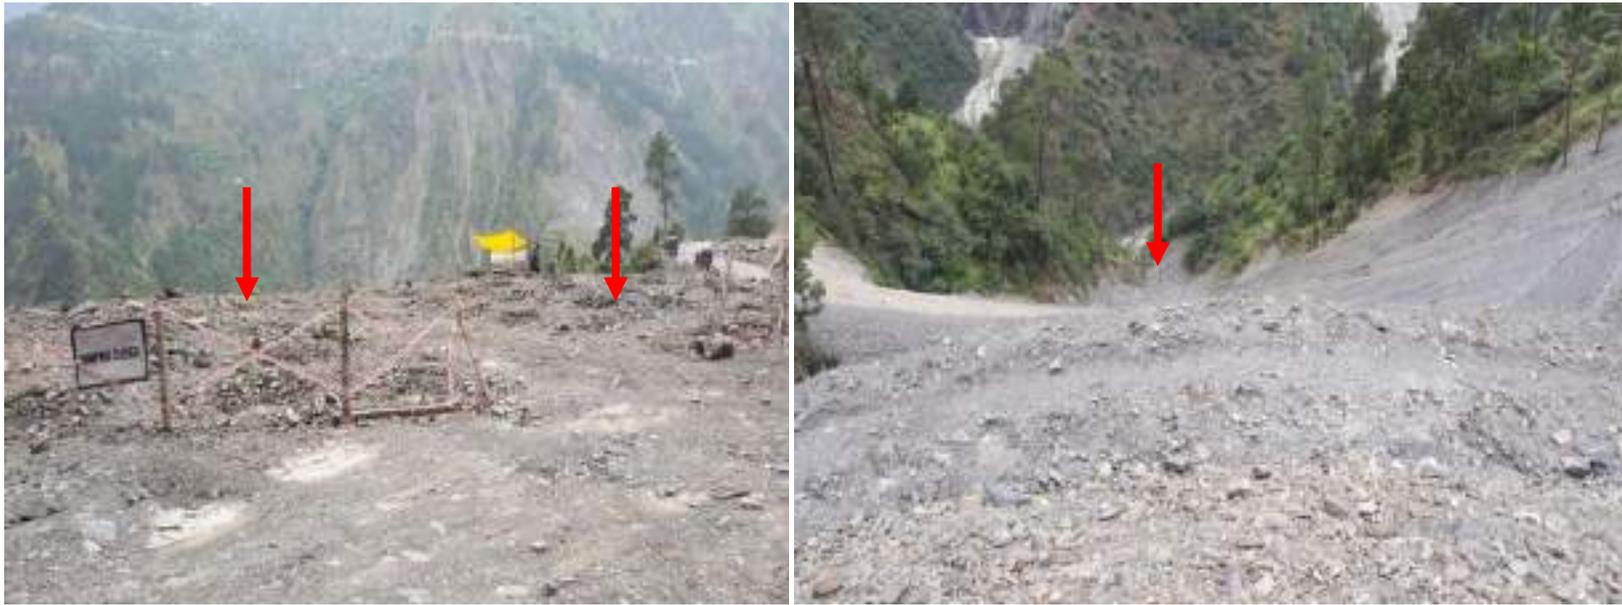
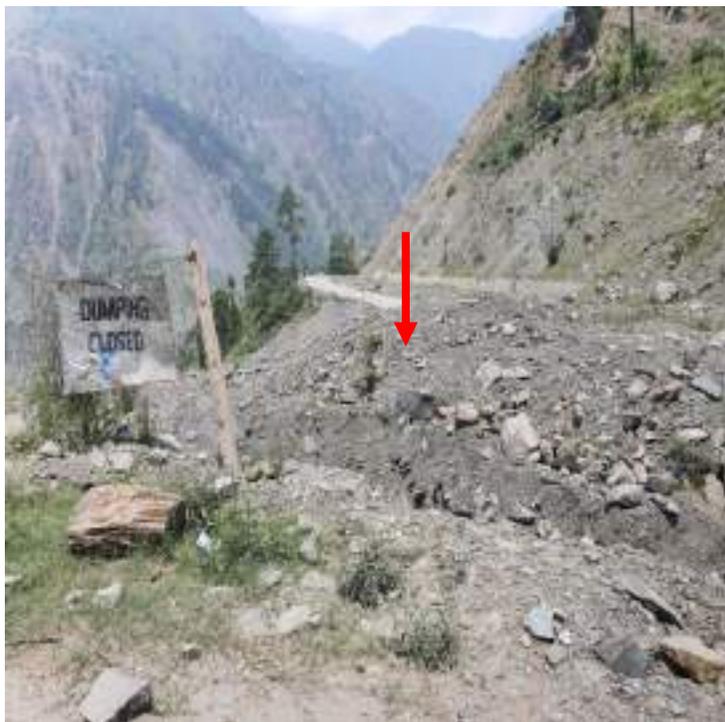
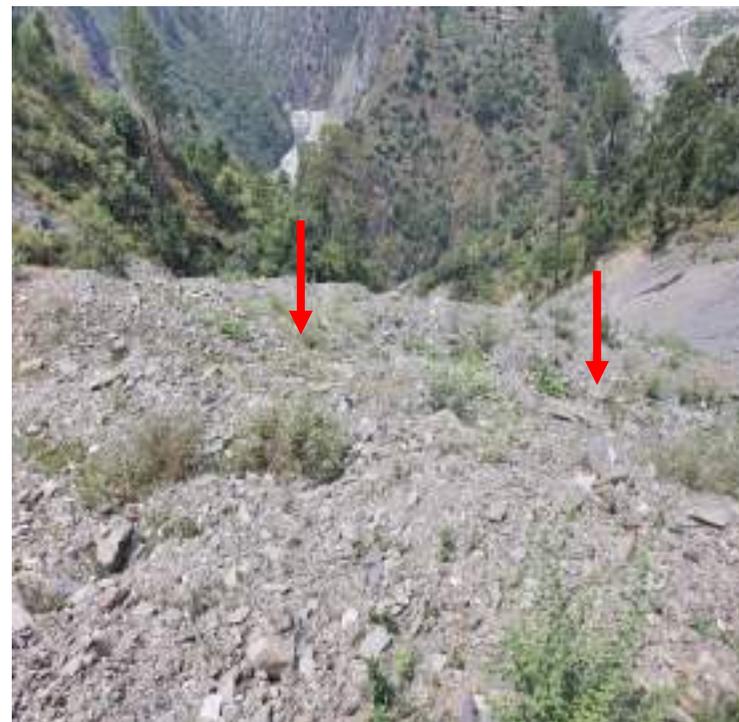
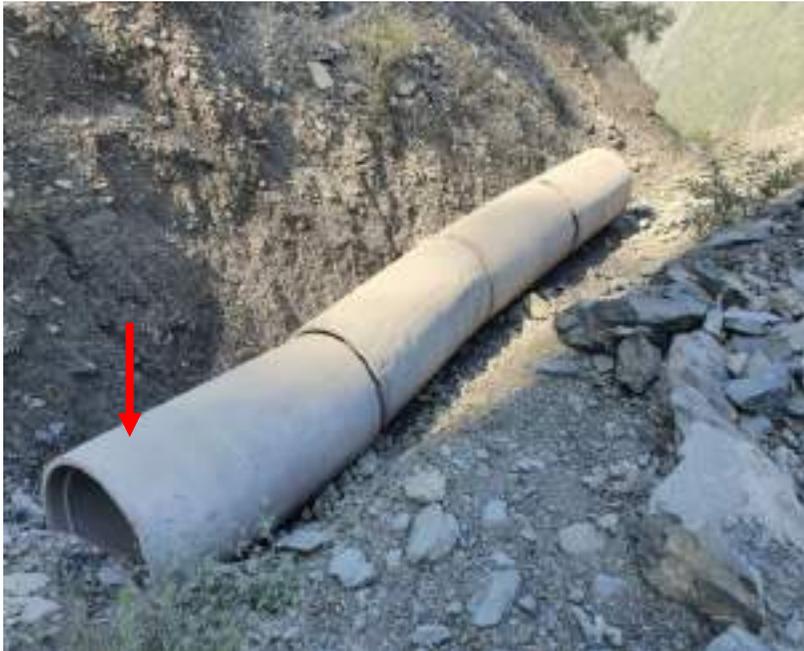
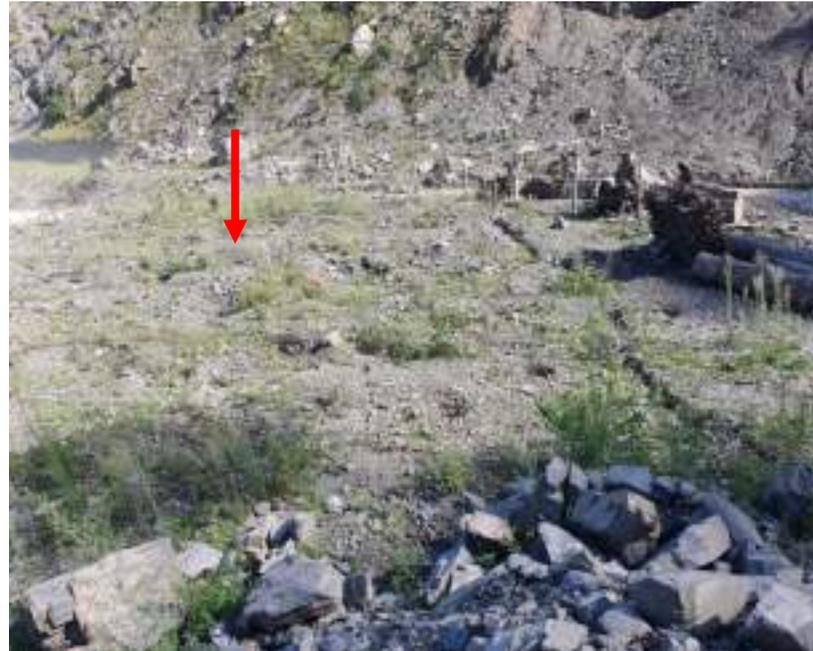
Photograph dated: (1st Sept, 2020): Battery Chaishma

S.No.	Name of the Site / Village	Chainage(SB)	Title /Area of the land	Total Capacity (cu.m)	Quantity dumped as on July 2019 (cu.m)	Capacity remaining as on July 2019 (cu.m)	Status	Observations
7)	Battery Chaishma	158+710 to 158+960	Forest / 0.18 Hectare	45360	45360	0	Closed	<i>Nallah choked needs to be channelized. Hume pipes laid but not connected yet. Few Plants survived after previous year's plantation. Green cover has come up in some portion of this site. Also, site needs to be covered with soil. Gabion structures needs to be repaired.</i>

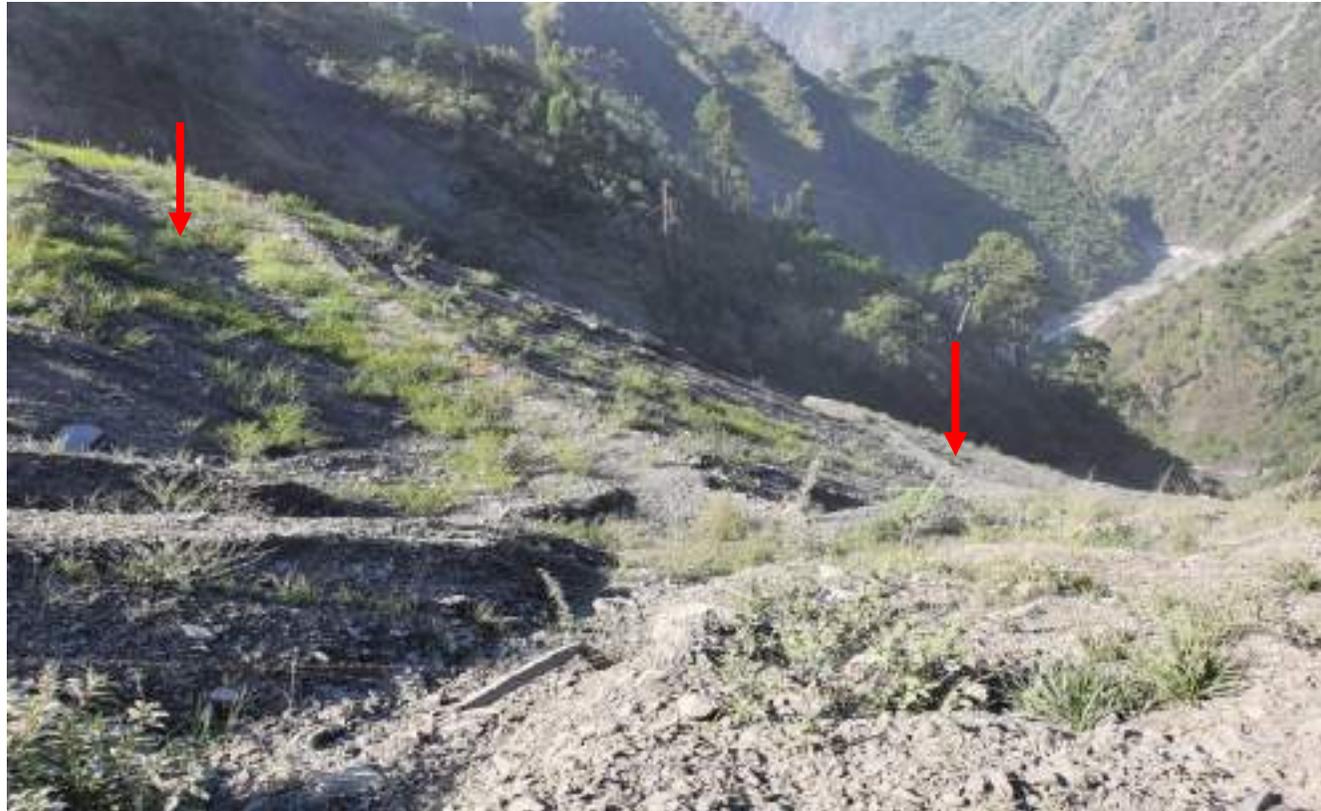
Photograph dated: (1st Sept, 2020): Battery Chaishma

2.	Marog Near Tunnel (T-2)	155+000 to 155+100	Dumping is being done in an unscientific manner. Terracing/ Gabions need to be provided.
3.	Near Battery Chaishma	158+710 to 158+960	Nallah choked needs to be channelized. Hume pipe has been laid but not connected yet. Few Plants survived after previous year's plantation. Green cover has come up in some portion of this site. Also, site needs to be covered with soil. Gabion structures needs to be repaired.

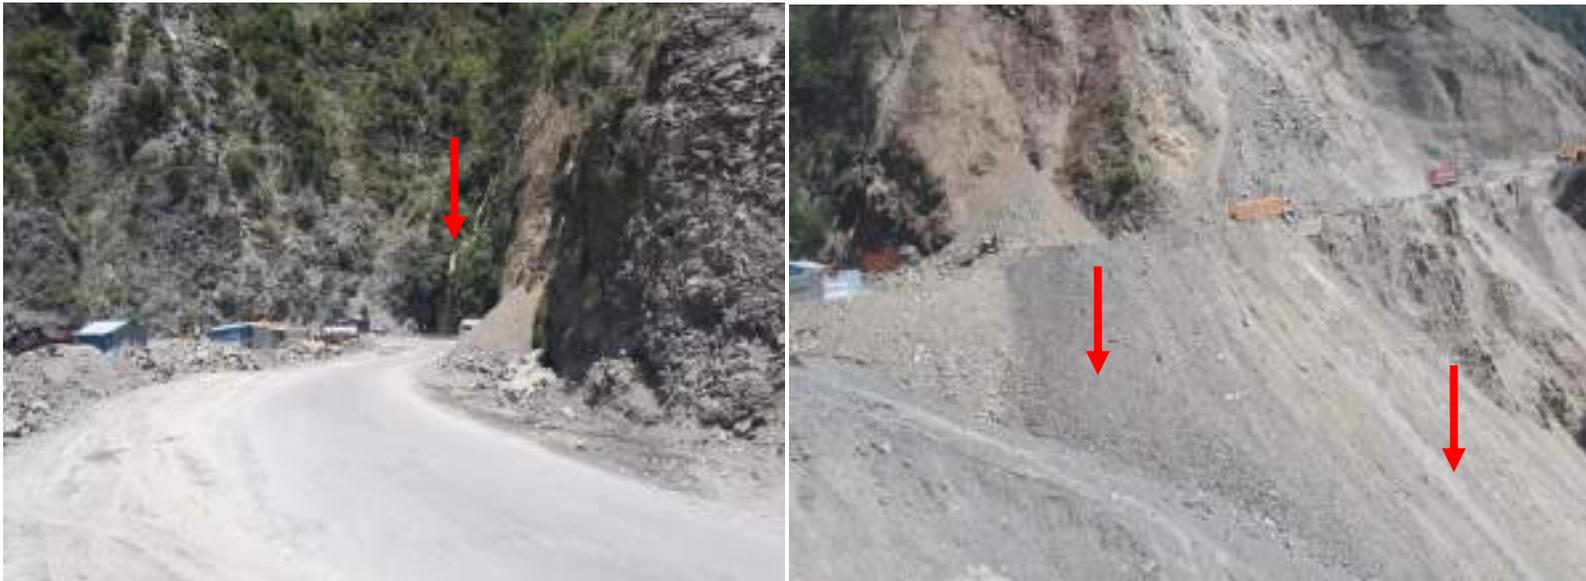
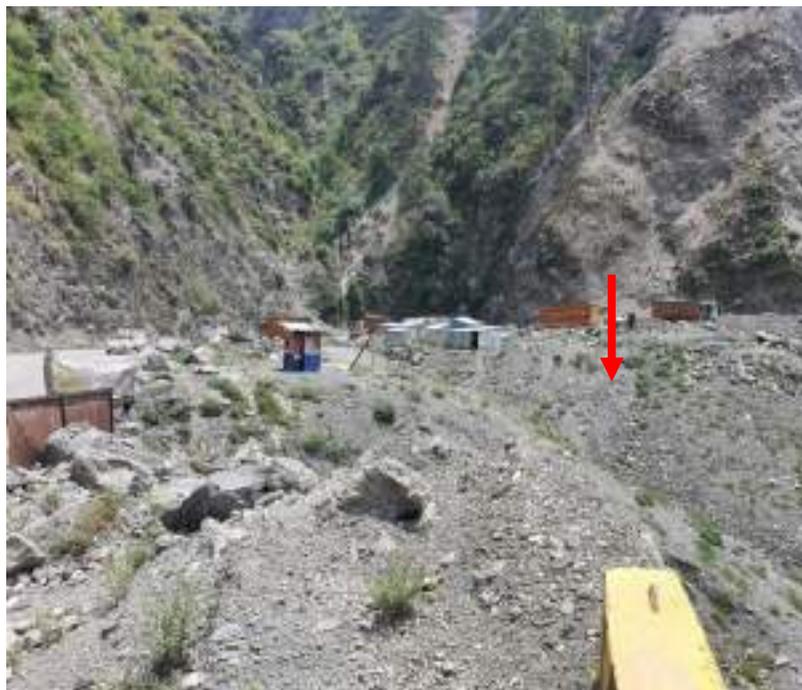
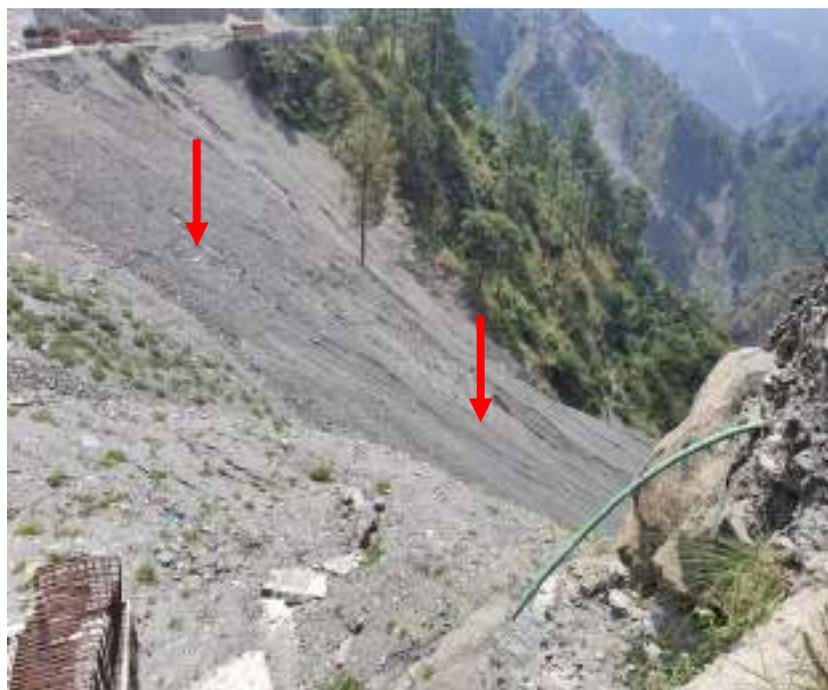
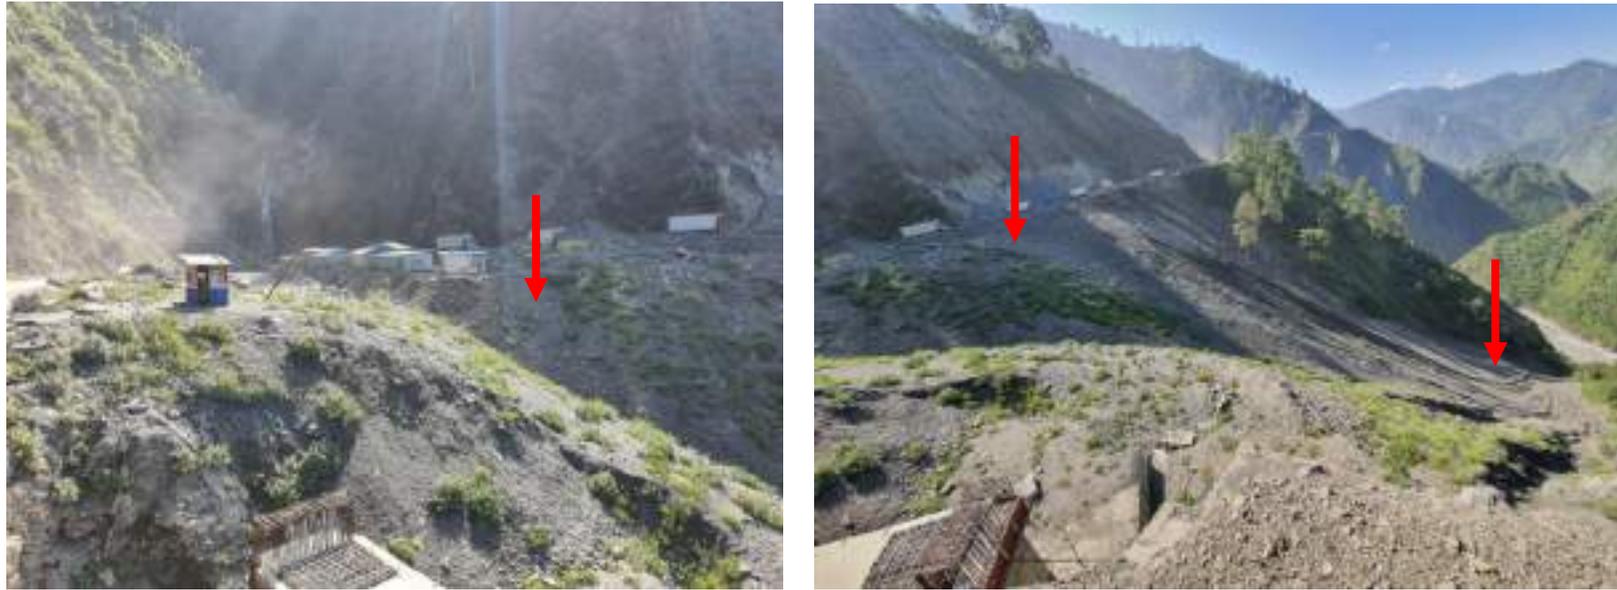
Photograph dated: (1st Sept, 2020): Anokhe Fall

S.No.	Name of the Site / Village	Chainage(SB)	Title /Area of the land	Total Capacity (cu.m)	Quantity dumped as on July 2019 (cu.m)	Capacity remaining as on July 2019 (cu.m)	Status	Observations
8)	Anokhe Fall	159+100 to 159+400 km	Forest/ 0.30 Hectare	343200	308880	34320	In-use	<i>Green cover has come up in some portion of this site. Gabions need to be provided.</i>

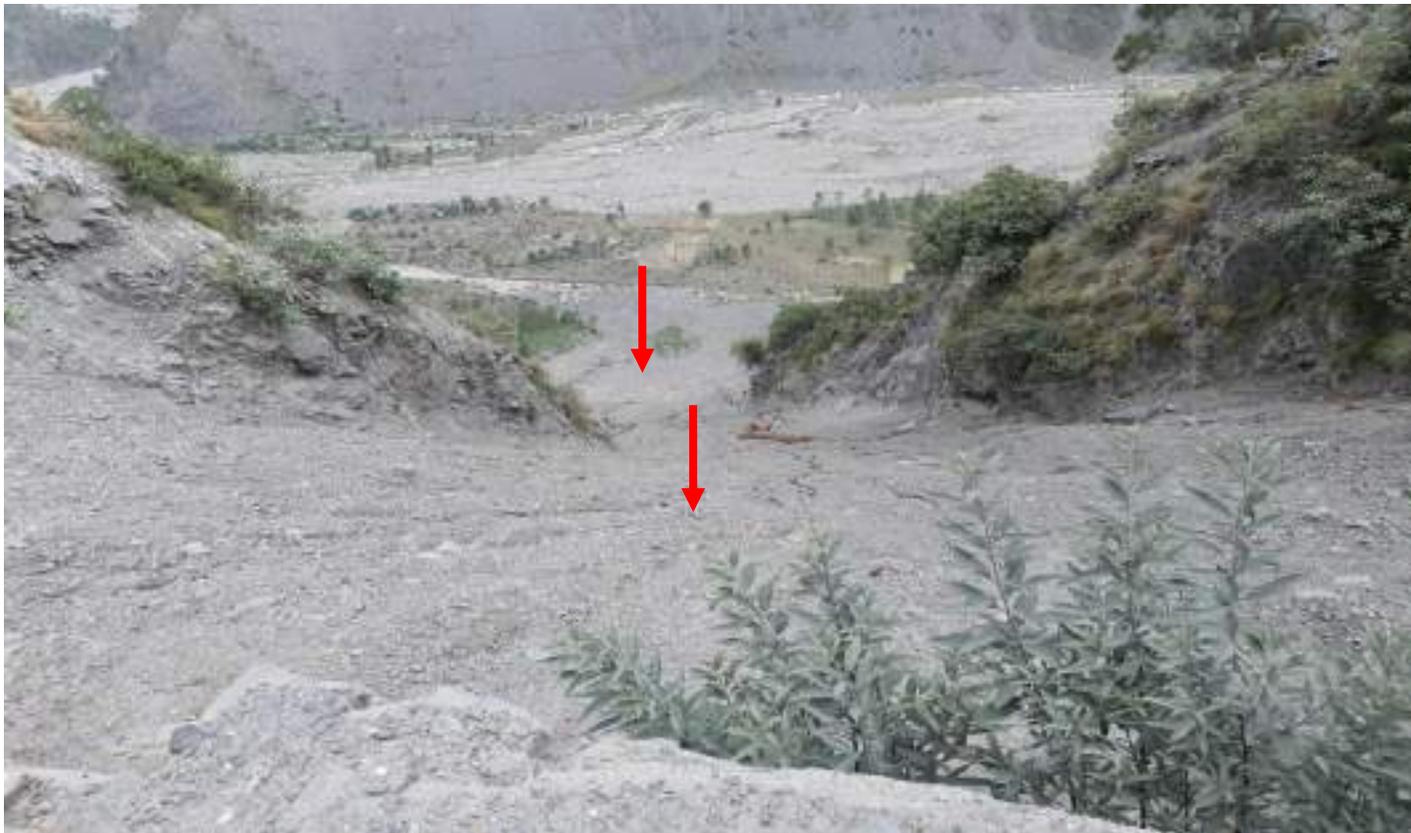
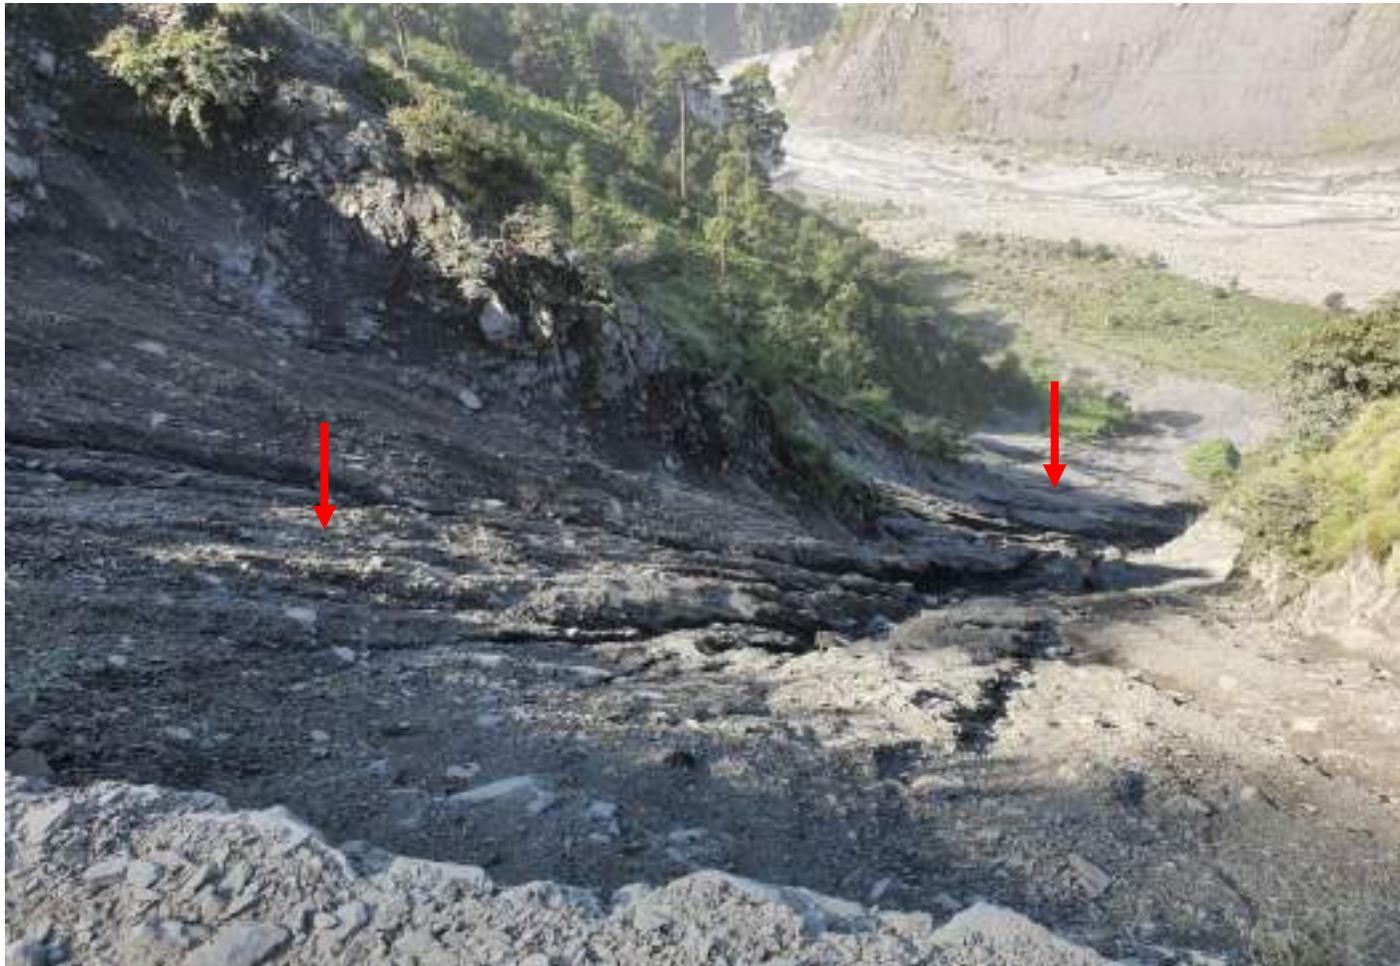
Photograph dated: (1st **Sept**, 2020): Digdole

S.No.	Name of the Site / Village	Chainage(SB)	Title /Area of the land	Total Capacity (cu.m)	Quantity dumped (cu.m)	Capacity remaining (cu.m)	Status	Observations
09)	Digdole	160+060 to 160+200 km	Non-designated	-	-	-	-	<i>Slide debris dumped.</i>

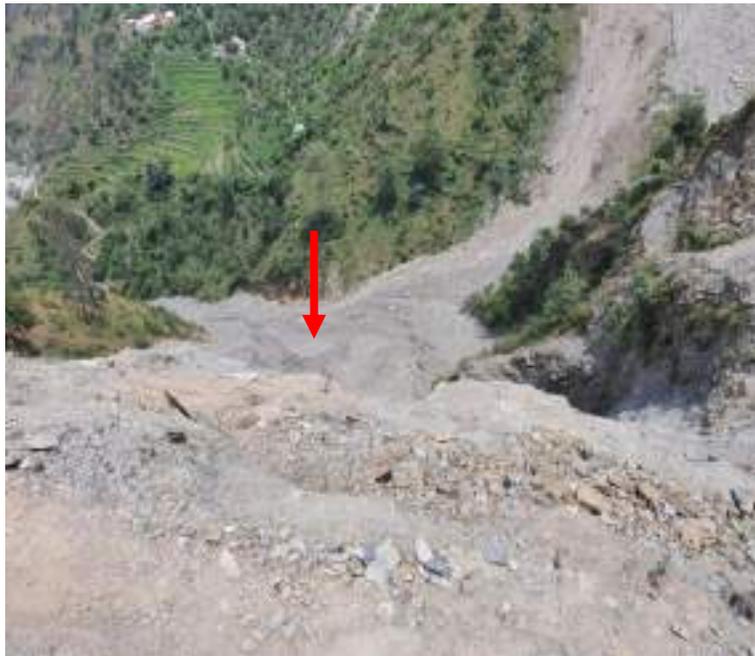
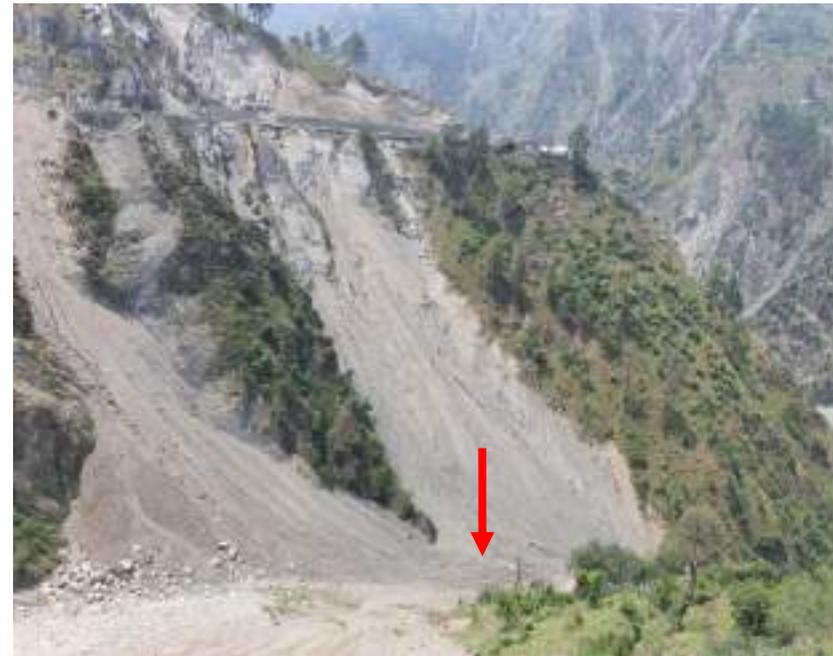
Photograph dated: (15th July, 2019): Digdole-I

S.No.	Name of the Site / Village	Chainage(SB)	Title /Area of the land	Total Capacity (cu.m)	Quantity dumped as on July 2019 (cu.m)	Capacity remaining as on July 2019 (cu.m)	Status	Observations
10)	Digdole-I	161+200 to 161+580 km	Forest/ 4.70 Hectare	878900	659175	219725	In-use	<i>Dumping is being done in an un-scientific manner with no protection provided.</i>

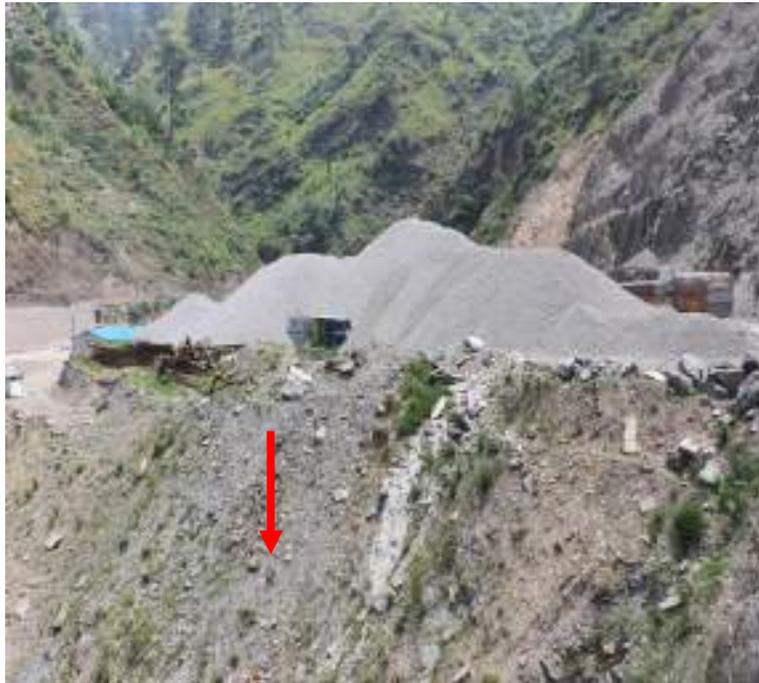
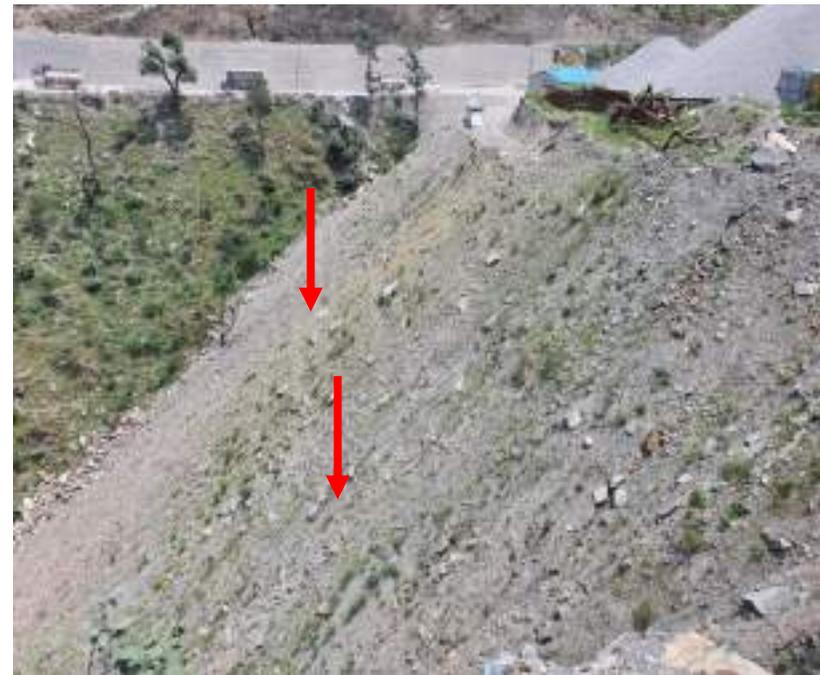
Photograph dated: (15th July, 2019): Digdole-II

S.No.	Name of the Site / Village	Chainage(SB)	Title /Area of the land	Total Capacity (cu.m)	Quantity dumped as on July 2019 (cu.m)	Capacity remaining as on July 2019 (cu.m)	Status	Observations
11)	Digdole-II	161+650 to 162+000 km	Forest/ 1.10 Hectare	447700	447700	0	Closed	<i>Green cover has come up in some portion of this site. Gabions need to be strengthened..</i>

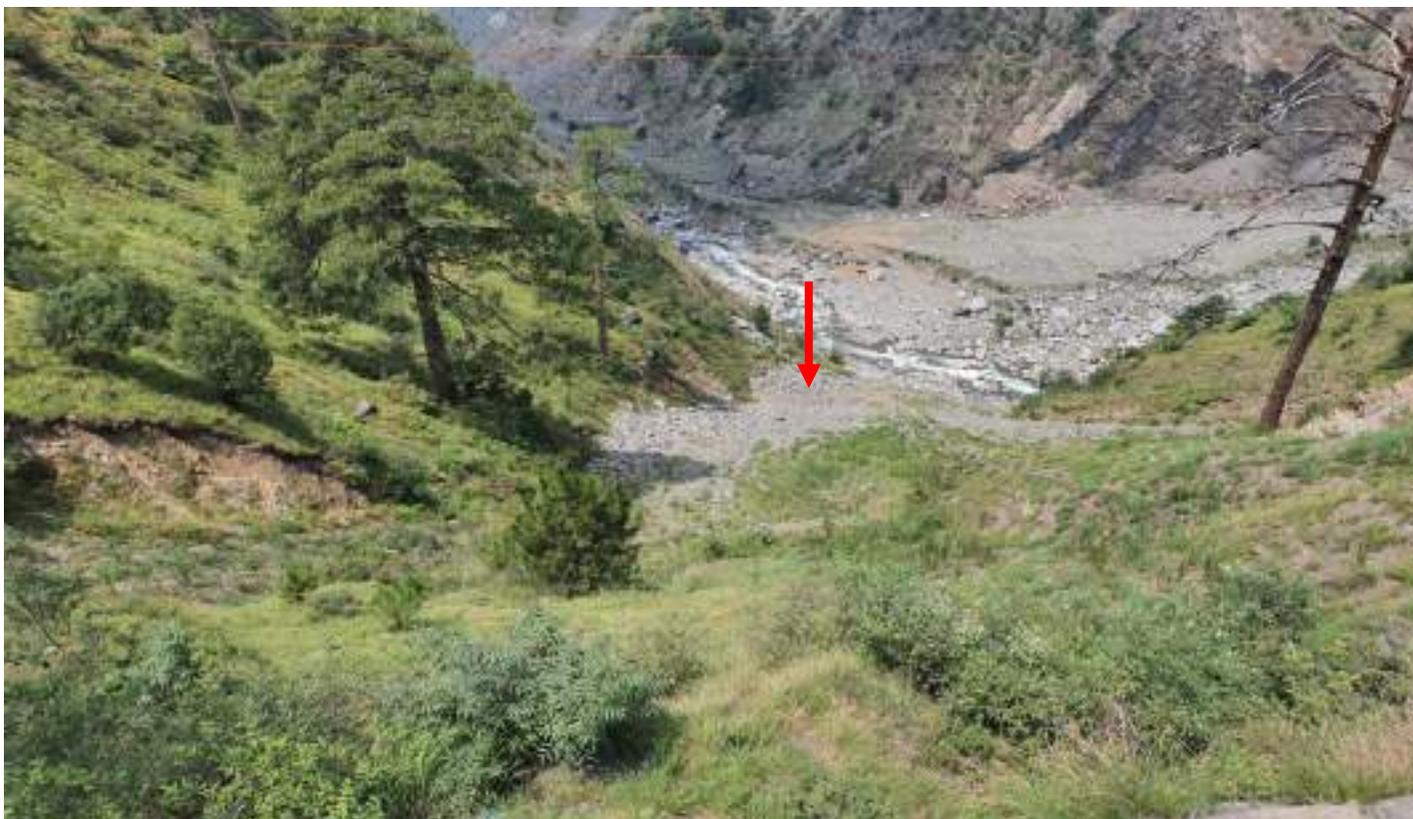
Photograph dated: (15th July, 2019): Digdole-III

S.No.	Name of the Site / Village	Chainage(SB)	Title /Area of the land	Total Capacity (cu.m)	Quantity dumped as on July 2019 (cu.m)	Capacity remaining as on July 2019 (cu.m)	Status	Observations
12)	Digdole-III	163+200 to 163+290 km	Forest/ 1.40 Hectare	260923	169600	91323	In-Use	<i>Green cover has come up in some portion of this site. Gabions need to be raised.</i>

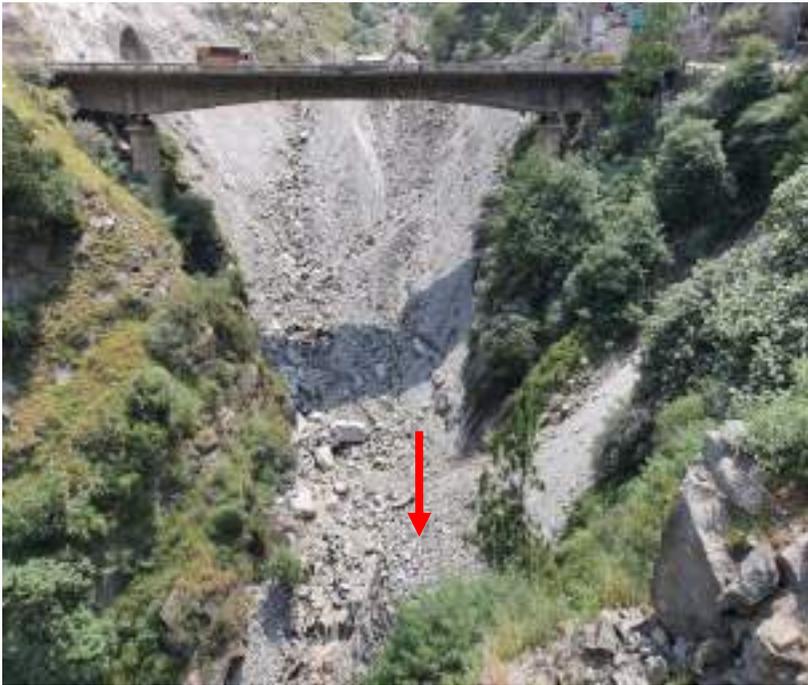
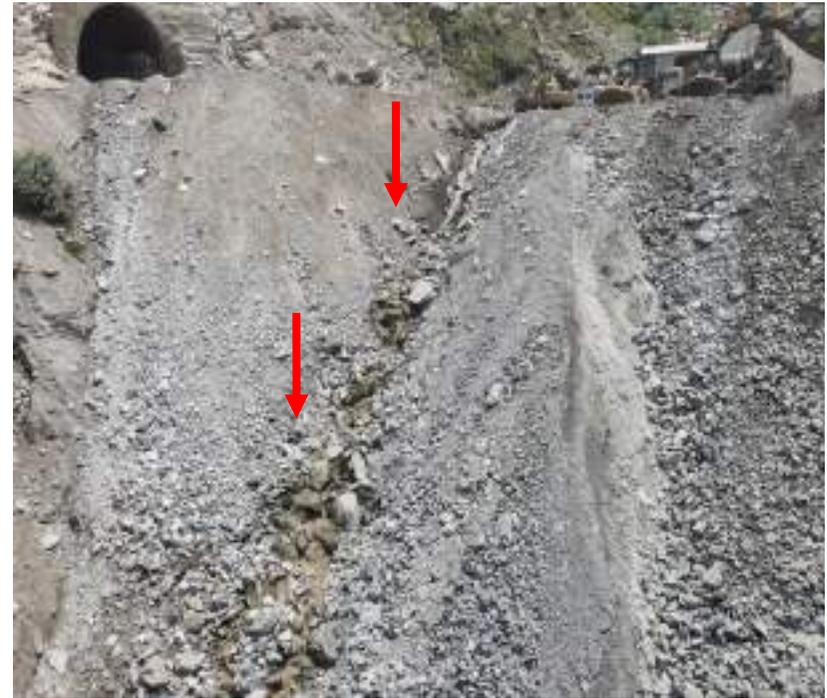
Photograph dated: (15th July, 2019): Panthyal (Near Tunnel T-3 & T-4)

S.No.	Name of the Site / Village	Chainage(SB)	Title /Area of the land	Total Capacity (cu.m)	Quantity dumped as on July2019 (cu.m)	Capacity remaining as on July2019 (cu.m)	Status	Observations
13)	Panthyal (Near Tunnel T-3 & T-4)	165+750 to 165+910 km	Forest/ 0.26 Hectare	26000	15600	10400	In-Use	<i>Dumping is in progress, gabion structures need to be repaired. Panthyal nallah needs to be channelized with Hume pipe and Tunnel water needs to be routed through settling tank in order to prevent pollution of fresh water nallah.</i>

6.	Panthyal	165+750 to 165+910	Dumping is in progress, gabion structures need to be repaired. Panthyal nallah needs to be channelized with hume pipe and Tunnel water needs to routed through settling tank in order to prevent pollution of fresh water nallah.

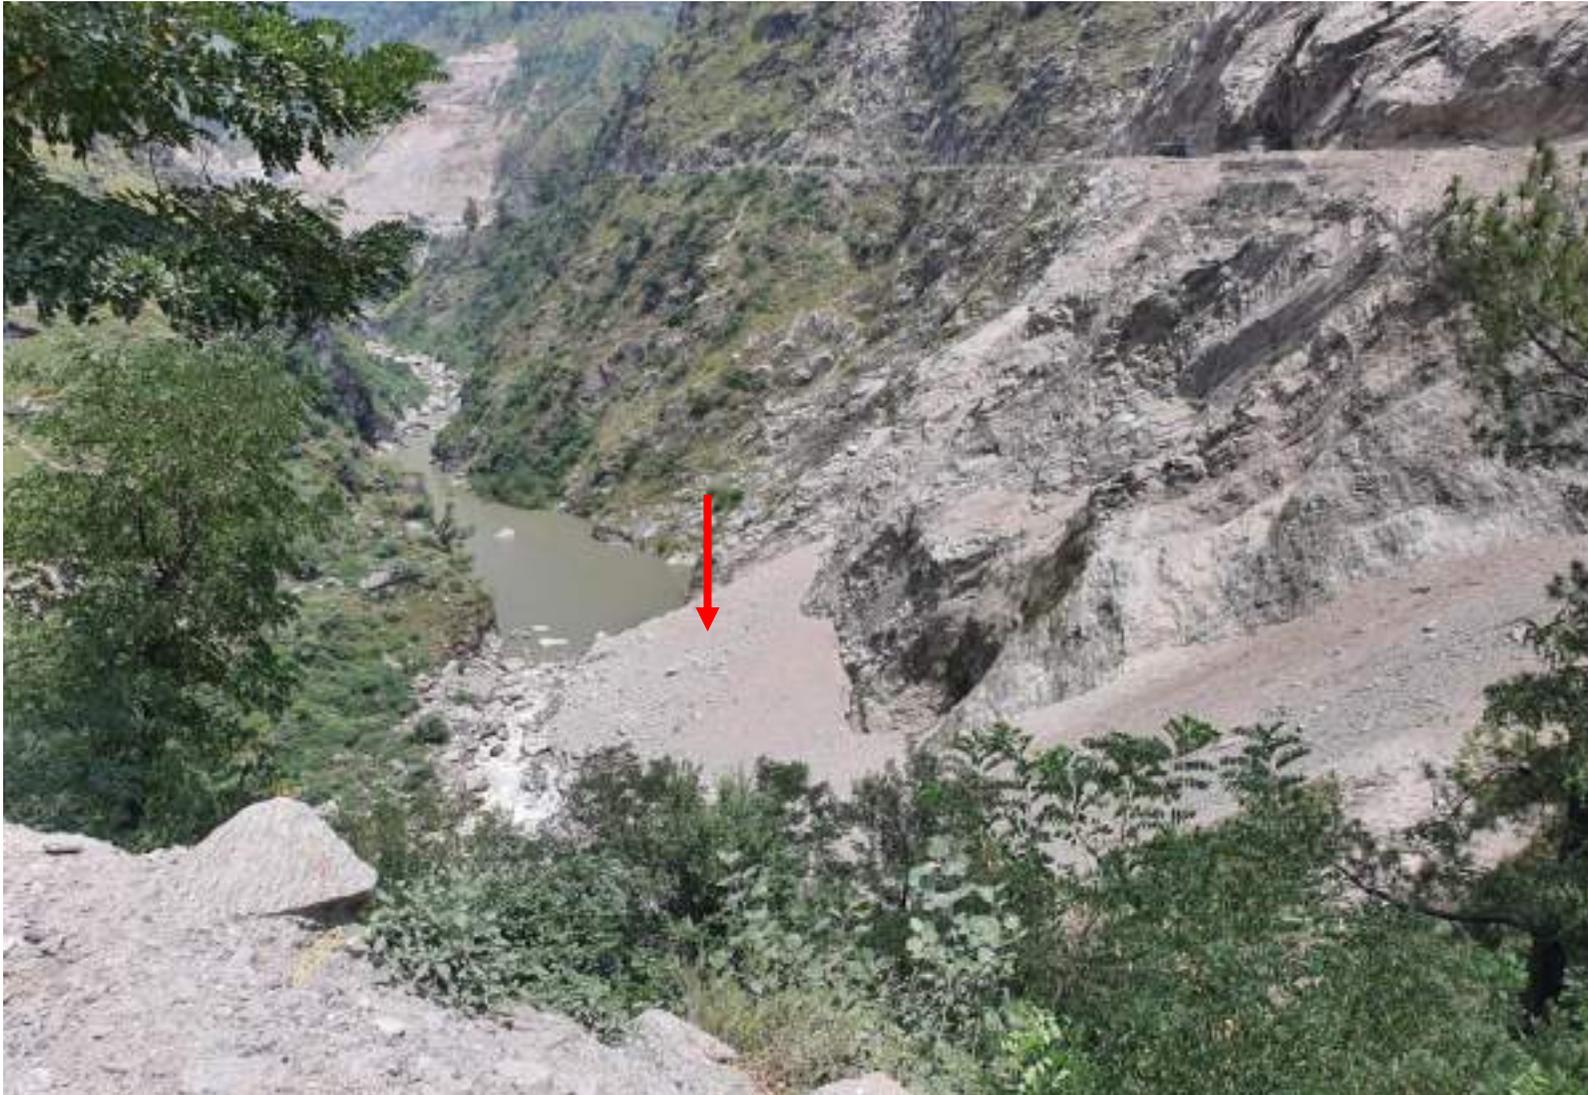
Photograph dated: (28th July, 2020): Panthyal landslide debris dumped in the Nallah.

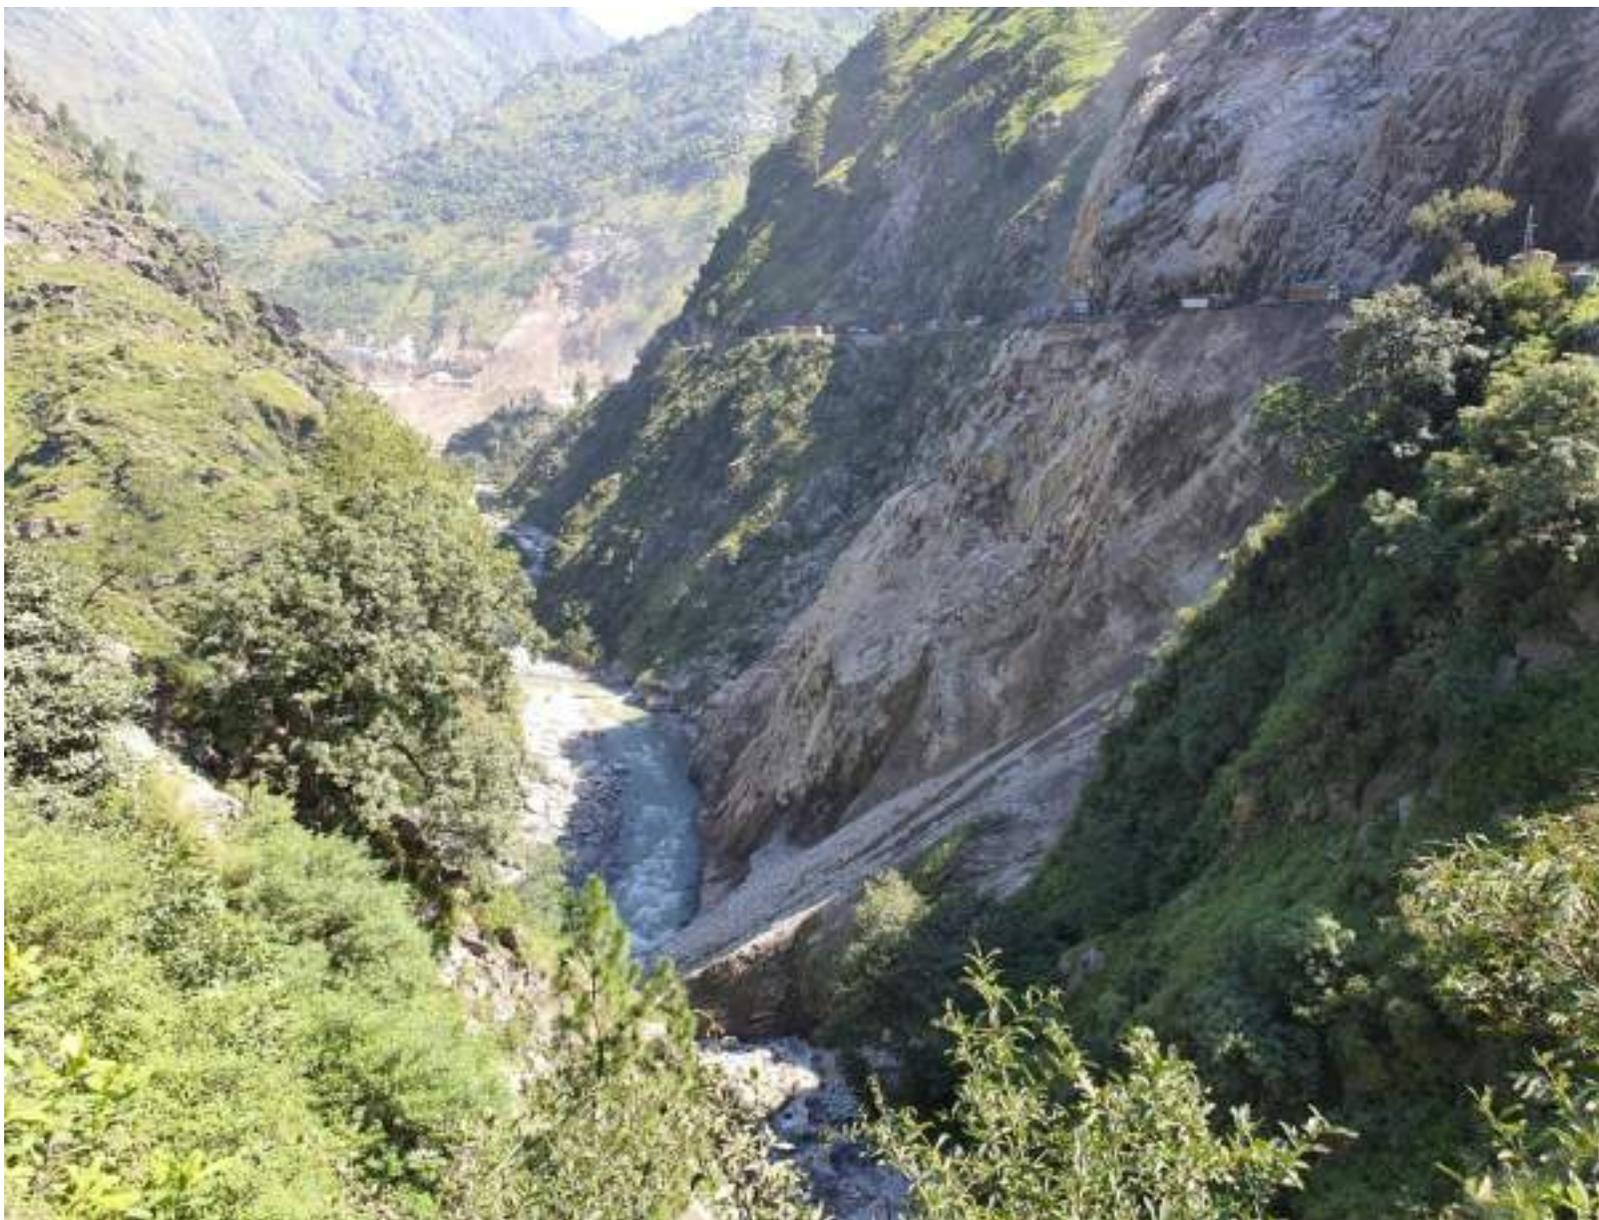
Photograph dated: (1st Sept, 2020): Panthyal landslide debris dumped in the Nallah.

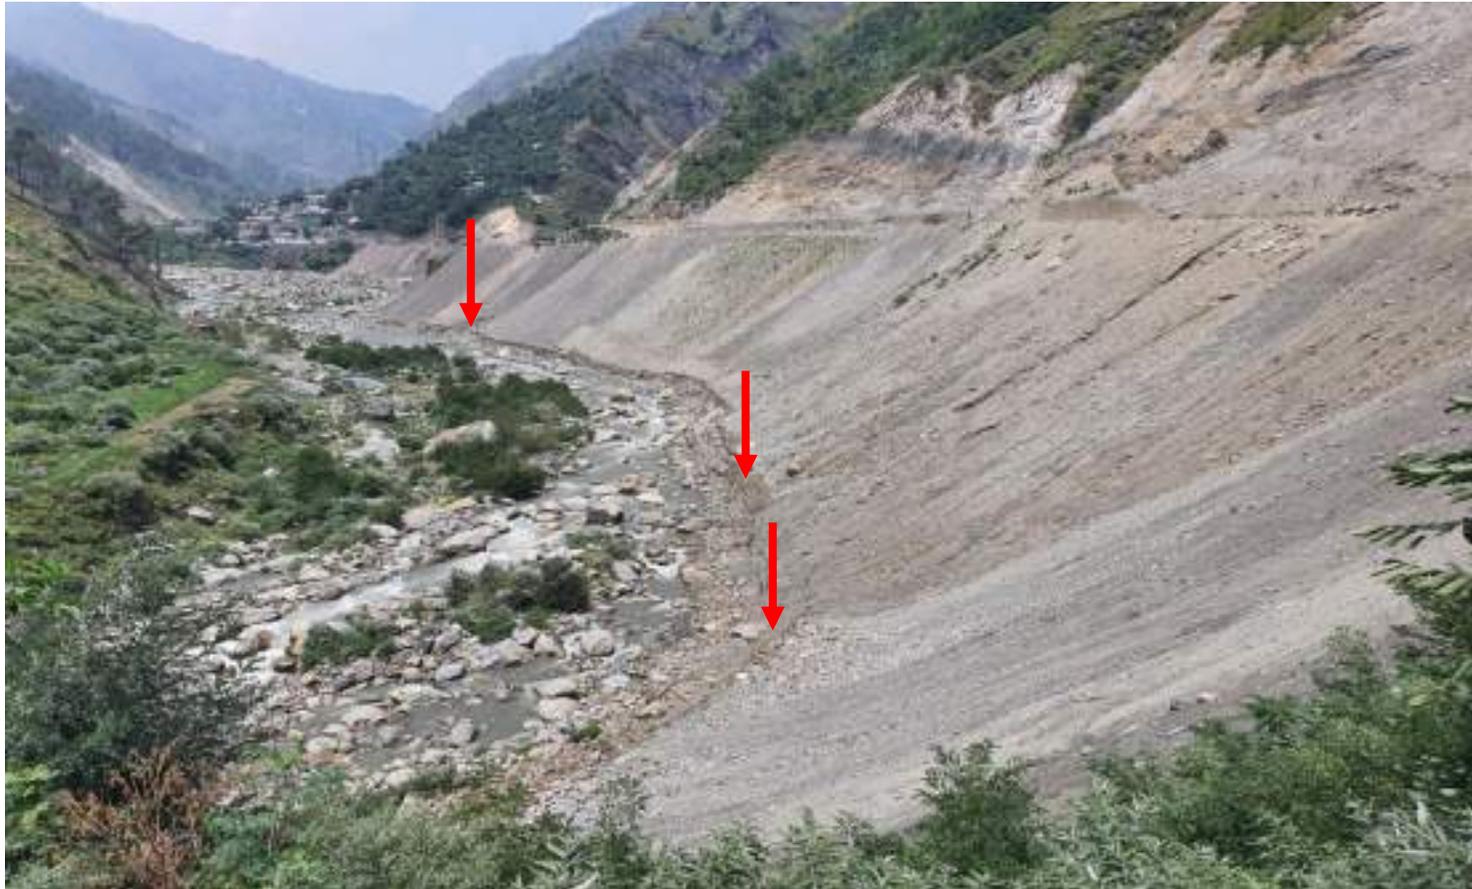
Photograph dated: (15th July, 2019): Mompassi

.No.	Name of the Site / Village	Chainage(SB)	Title /Area of the land	Total Capacity (cu.m)	Quantity dumped as on July2019 (cu.m)	Capacity remaining as on July2019 (cu.m)	Status	Observations
14)	Mompassi (Near BDO Office) Ramsoo	167+000 to 167+680 km	Forest/ 0.47 Hectare	55543	55543	0	Closed	<i>Muck Spill over, Gabions need to be strengthened.</i>

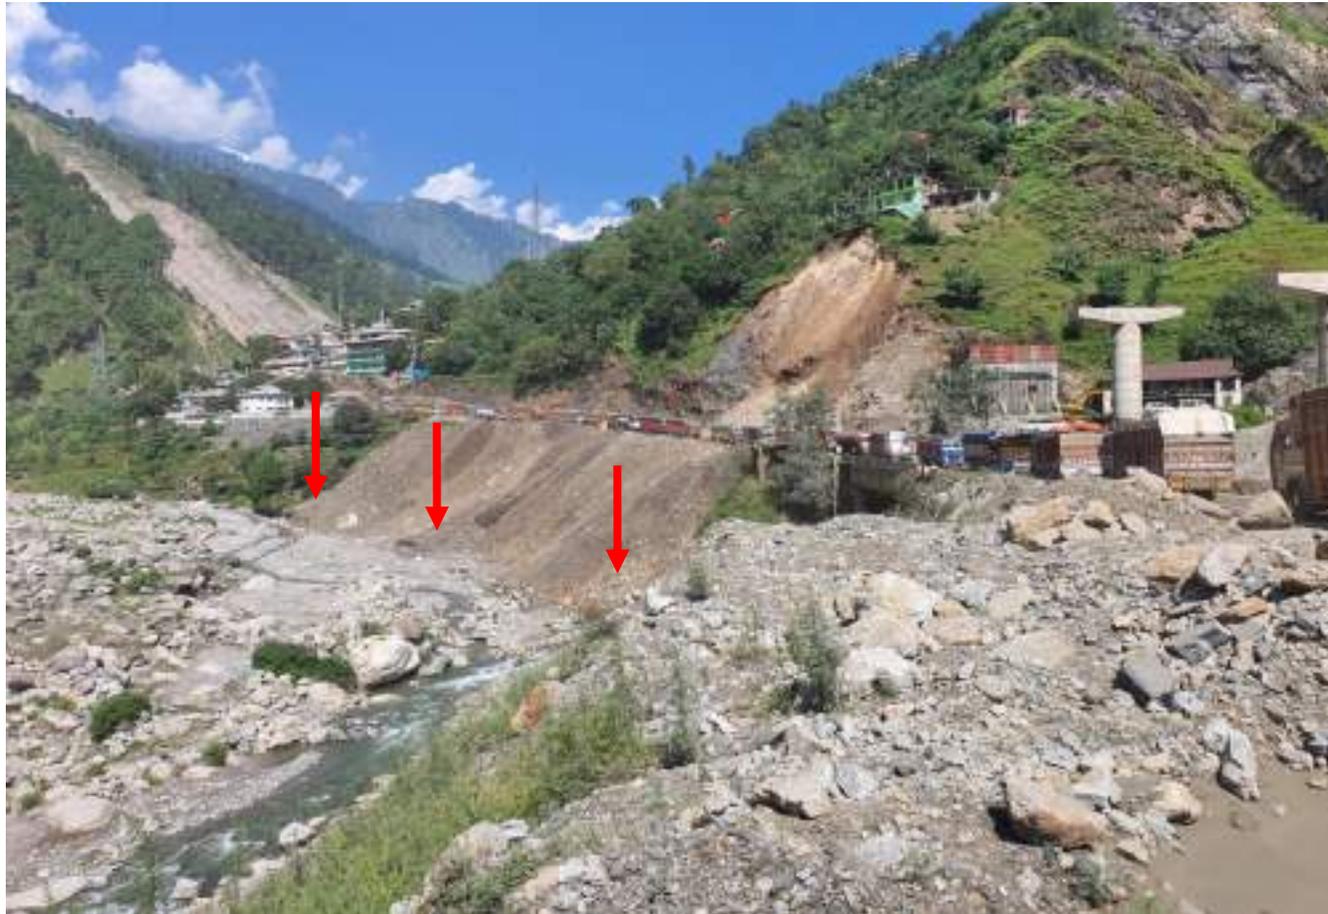
Photograph dated: (28th July, 2020): Near Ramsu Bridge

S.No.	Name of the Site / Village	Chainage(SB)	Title /Area of the land	Total Capacity (cu.m)	Quantity dumped (cu.m)	Capacity remaining (cu.m)	Status	Observations
15)	Near Ramsu Bridge	167+780 km	Non Designated	-	-	-	-	<i>Illegal dumping going on. Gabions need to be provided.</i>

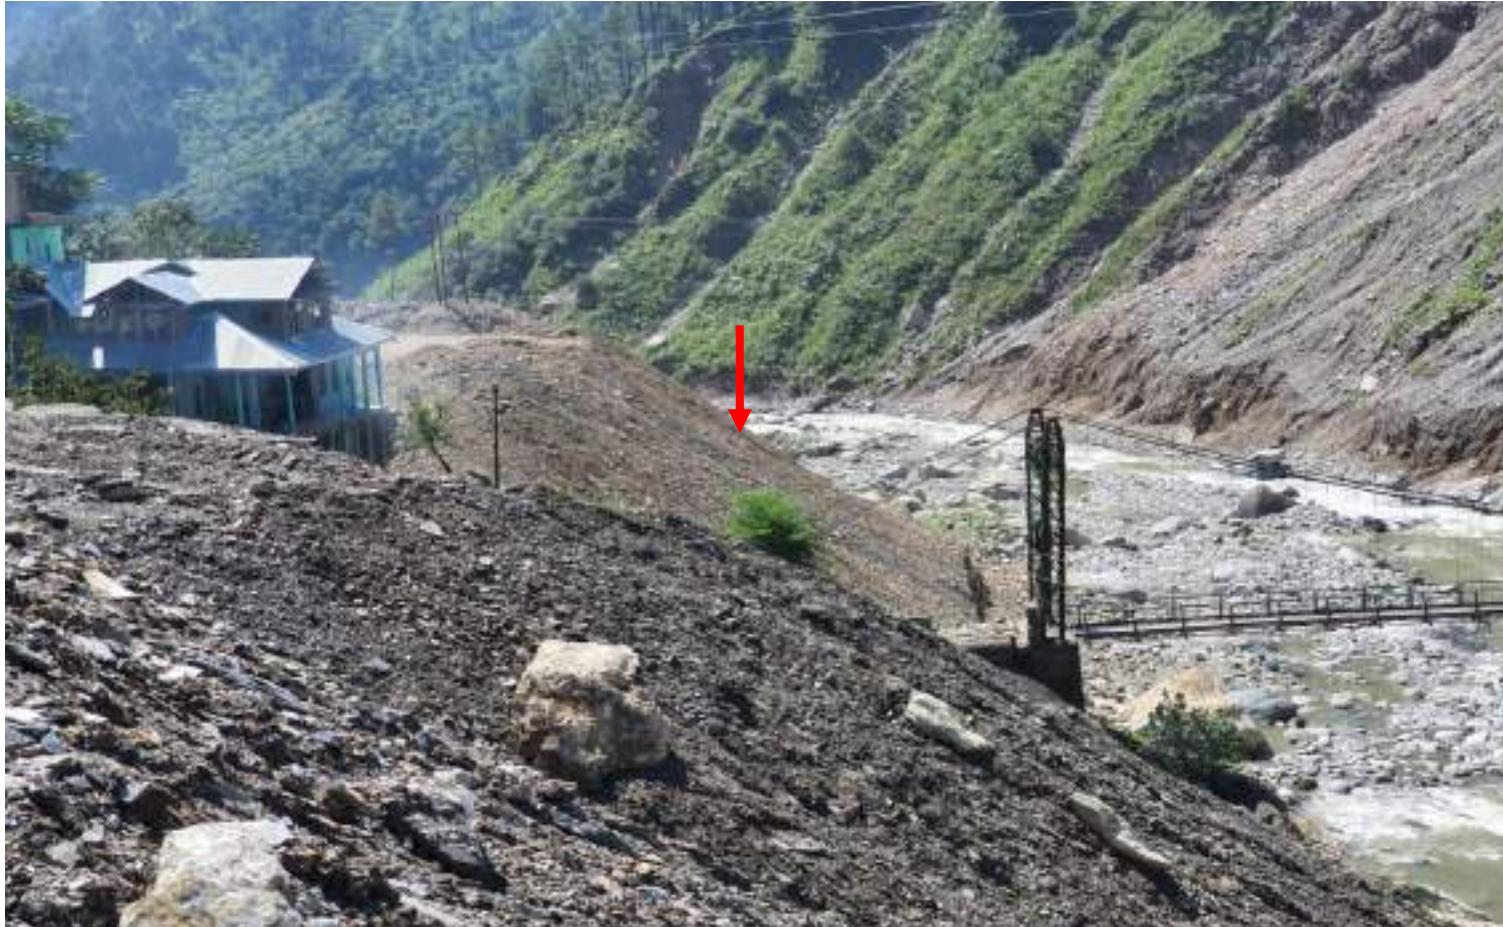
Photograph dated: (28th July, 2020): Near Ramsu Foot Bridge.

S.No.	Name of the Site / Village	Chainage(SB)	Title /Area of the land	Total Capacity (cu.m)	Quantity dumped (cu.m)	Capacity remaining (cu.m)	Status	Observations
16)	Near Ramsu Foot Bridge	168+450 km	Non Designated	-	-	-	-	<i>Illegal dumping going on. Gabions need to be provided.</i>
