Office of the Chairman, NGT Monitoring Committee (J&K)
Justice Janak Raj Kotwal
(Former Judge High Court of Jammu & Kashmir)

Subject: Report of the Chairman in compliance to Hon'ble NGT order
dated 20.03.2020.

In the matter of : Execution Application No. 32/2016
In
Original Application No. 295/2016
And
Original Application No. 295/2016
(M.A.No.539/2016)

Report in compliance to Hon'ble NGT Order dated 20. 03. 2020

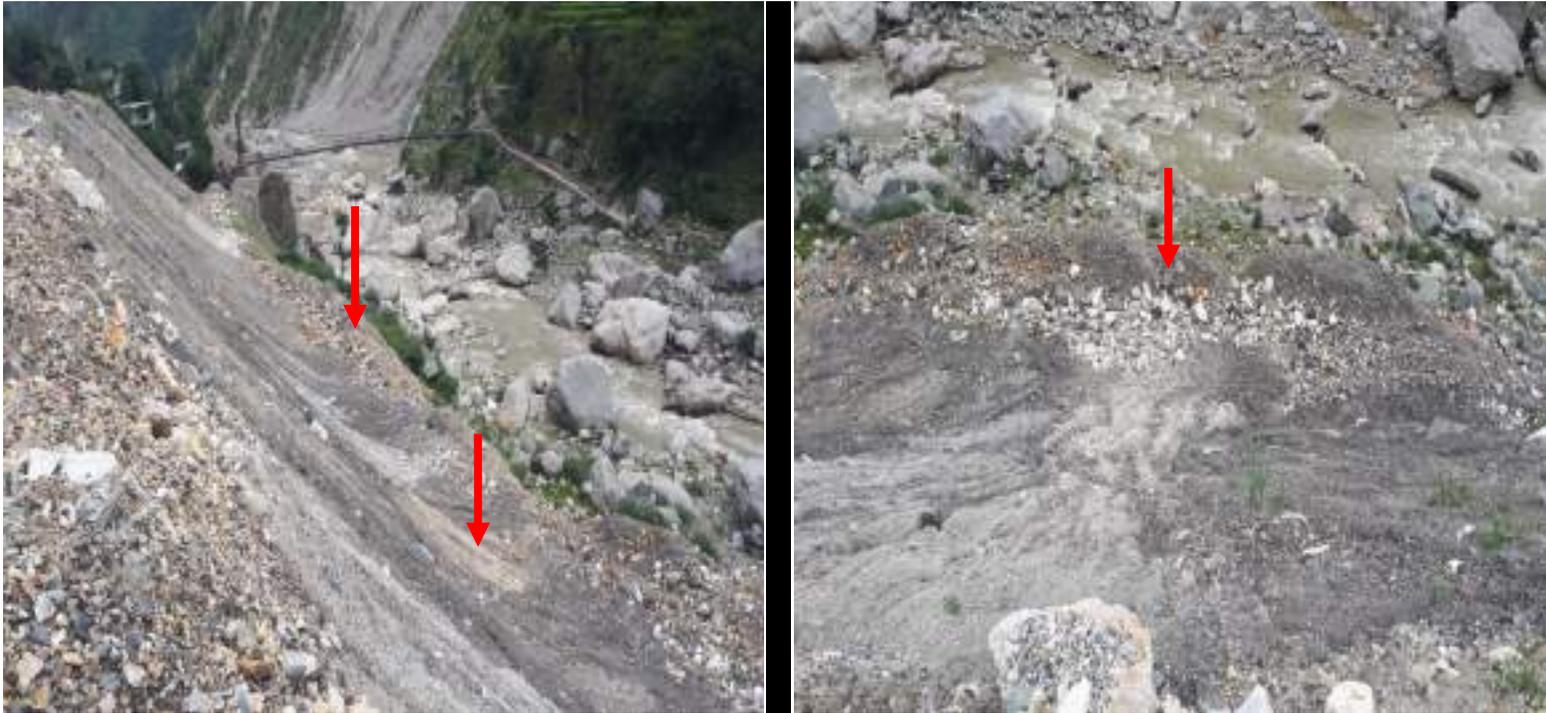
Photograph dated: (1st Sept, 2020): Near Ramsu Foot Bridge.

S.No.	Name of the Site / Village	Chainage(SB)	Title /Area of the land	Total Capacity (cu.m)	Quantity dumped (cu.m)	Capacity remaining (cu.m)	Status	Observations
16)	Near Ramsu Foot Bridge	168+450 km	Non Designated	-	-	-	-	<i>Illegal dumping going on. Gabions need to be provided.</i>

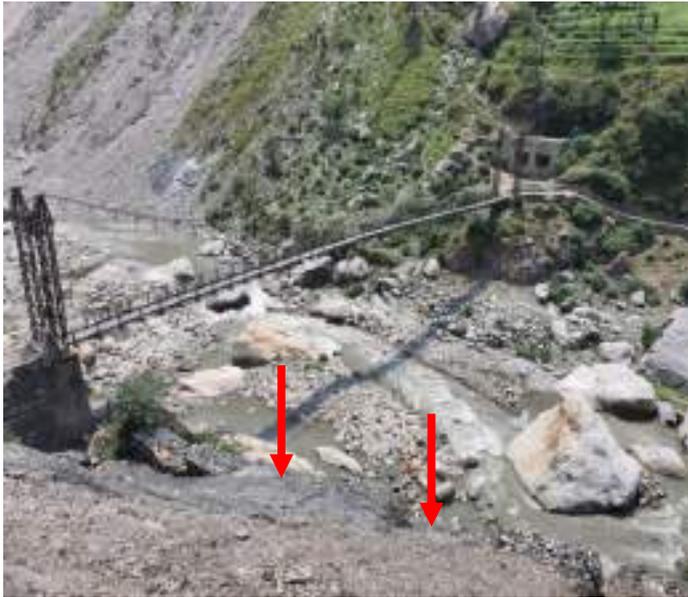
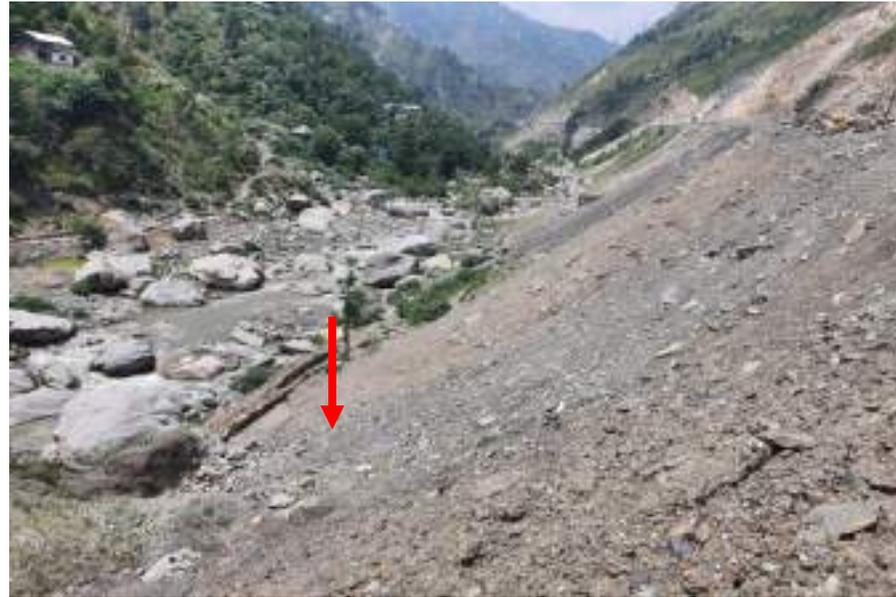
Photograph dated: (15th July, 2019): Ramsu & Gangroo-Ramsu

S.No.	Name of the Site / Village	Chainage(SB)	Title /Area of the land	Total Capacity (cu.m)	Quantity dumped as on July 2019 (cu.m)	Capacity remaining as on July 2019 (cu.m)	Status	Observations
17)	Ramsu and	168+680 to 169+100 km	Private/ 2.31 Hectare	58072	31843	23229	In-Use	<i>Dumping of muck as well as landslide debris is done in an un-scientific manner.</i>
18)	Gangroo -Ramsu	169+600 to 169+750 km

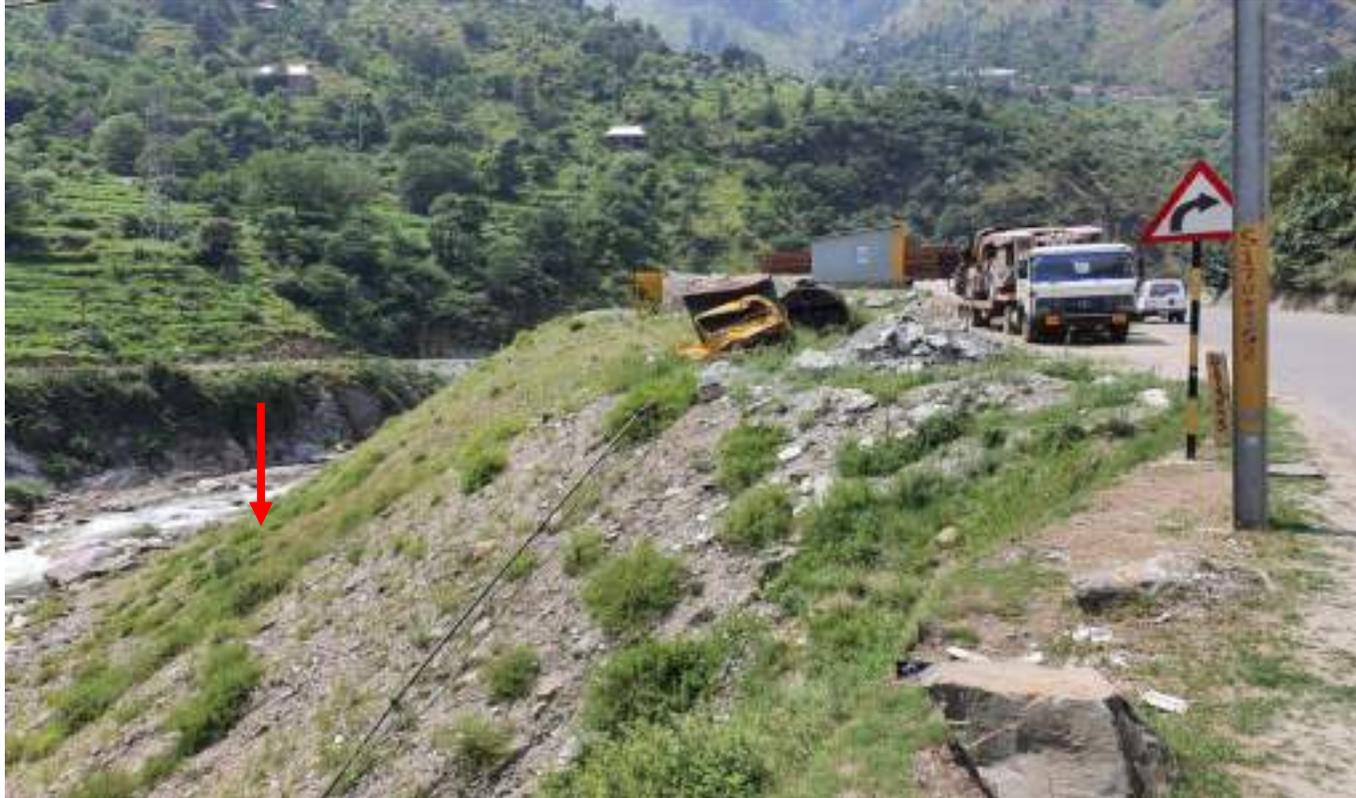
Photograph dated: (15th July, 2019): Hingini

S.No.	Name of the Site / Village	Chainage(SB)	Title /Area of the land	Total Capacity (cu.m)	Quantity dumped as on July 2019 (cu.m)	Capacity remaining as on July 2019 (cu.m)	Status	Observations
19)	Hingini	170+950 to 171+250 km	State +Private+ Forest / 1.30 Hectare	35000	35000	0	Closed	<i>Green cover has come up in large portion of this site.</i>

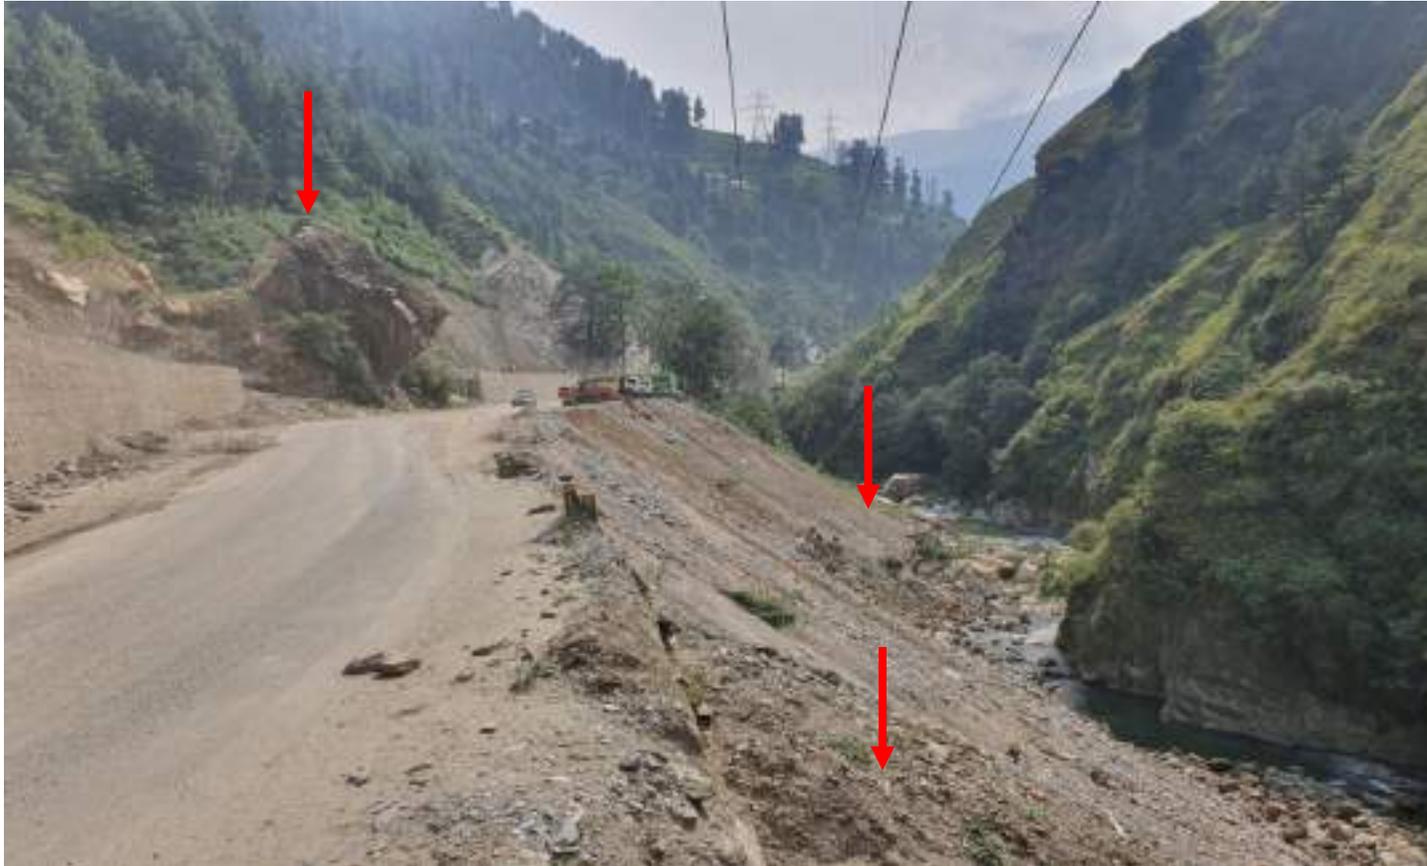
Photograph dated: (28th July, 2020): Near Kishtwari Pathar

S.No.	Name of the Site / Village	Chainage(SB)	Title /Area of the land	Total Capacity (cu.m)	Quantity dumped as on July2019 (cu.m)	Capacity remaining as on July2019 (cu.m)	Status	Observations
20)	Near Kishtwari Pathar	173+530 to 173+900 km	Non Designated	-	-	-	-	<i>Illegal Muck dumping is going on /Bislari nallah getting choked.</i>

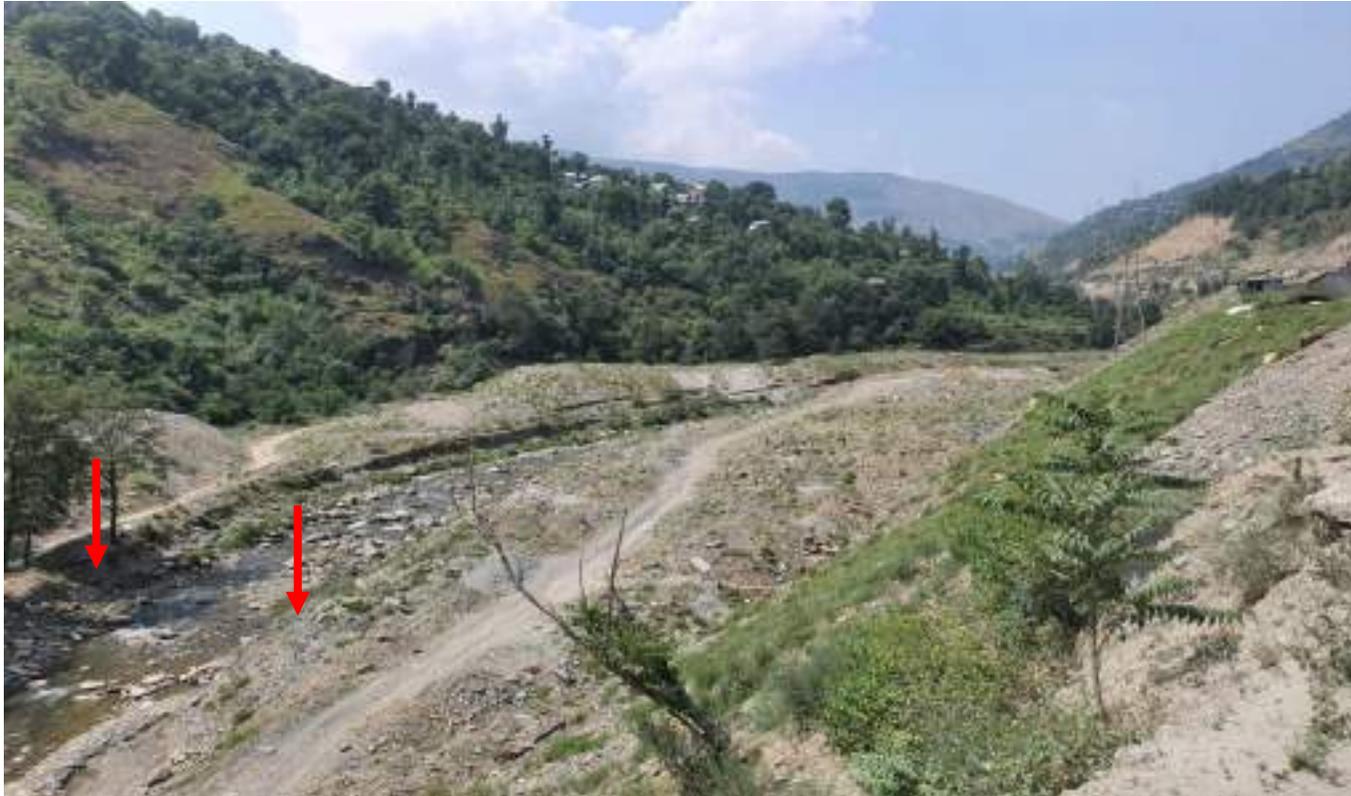
Photograph dated: (15th July, 2019): Sherbibi

S.No.	Name of the Site / Village	Chainage(SB)	Title /Area of the land	Total Capacity (cu.m)	Quantity dumped as on July2019 (cu.m)	Capacity remaining as on July2019 (cu.m)	Status	Observations
21)	Sherbibi	175+400 to 176+200 km	Private / 9.40 Hectare	528640	422912	105728	In-Use	<i>Green cover has come up in some portion of this site. Gabions need to be strengthened.</i>

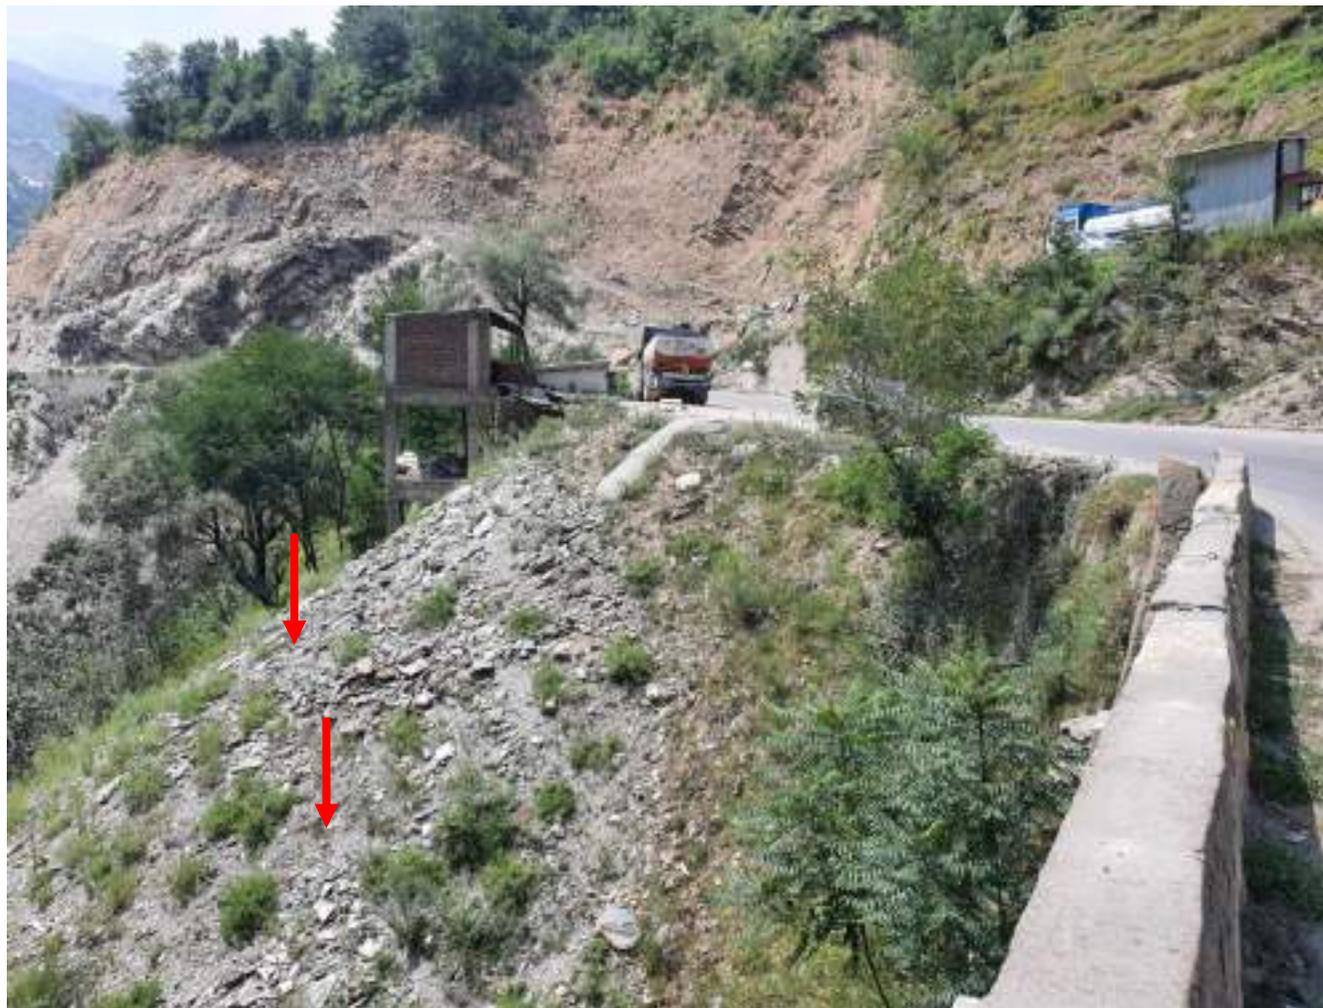
Photograph dated: (1st Sept, 2020): Sherbibi-I.

S.No.	Name of the Site / Village	Chainage(SB)	Title /Area of the land	Total Capacity (cu.m)	Quantity dumped as on July2019 (cu.m)	Capacity remaining as on July2019 (cu.m)	Status	Observations
22)	Sherbibi-I	176+900 km	Non Designated	-	-	-	-	<i>Illegal dumping is going on.</i>

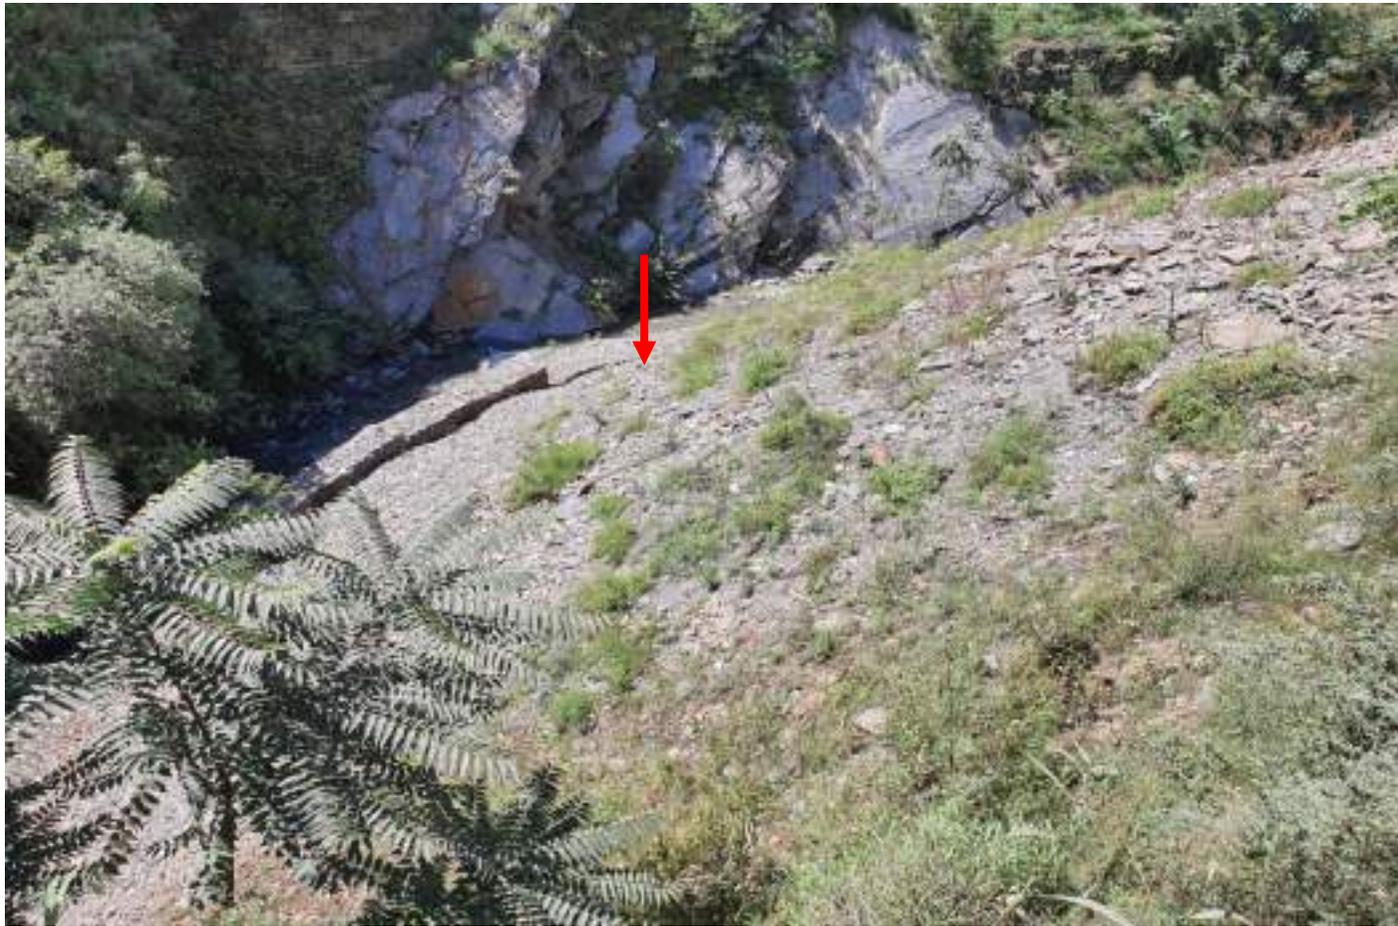
Photograph dated: (1st Sept, 2020): Chamalwas

S.No.	Name of the Site / Village	Chainage(SB)	Title /Area of the land	Total Capacity (cu.m)	Quantity dumped as on July 2019 (cu.m)	Capacity remaining as on July 2019 (cu.m)	Status	Observations
23)	Chamalwas	177+000 to 177+050 km	Private / 0.15 Hectare	8400	8400	0	Closed	<i>Green cover has come up in some portion of this site. Along Bislari nallah, gabions need to be strengthened.</i>

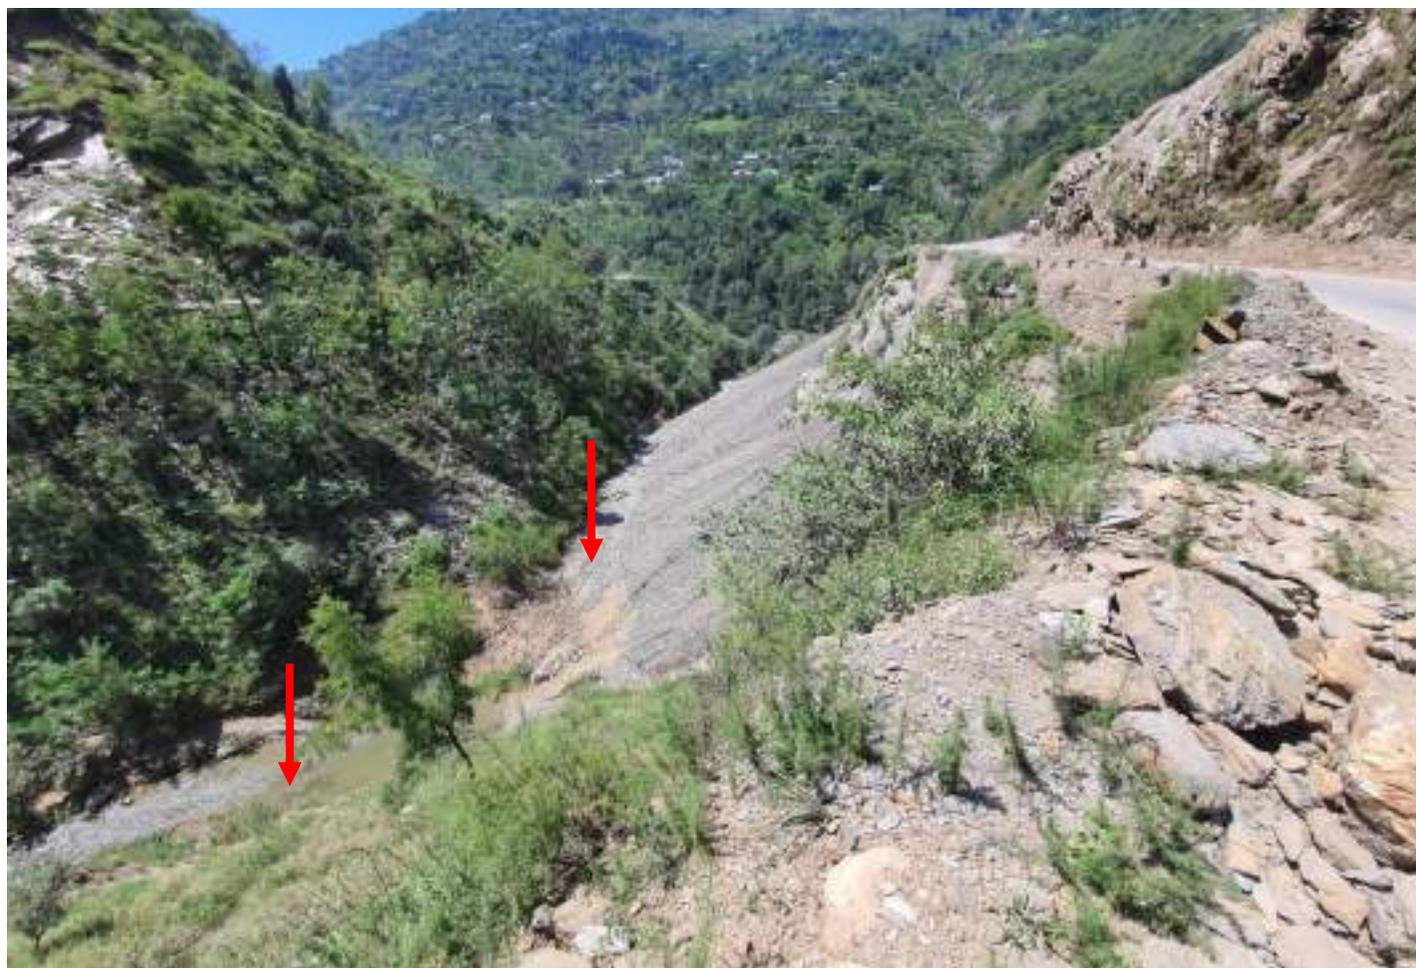
Photograph dated: (1st Sept, 2020): Chamalwas-I

S.No.	Name of the Site / Village	Chainage(SB)	Title /Area of the land	Total Capacity (cu.m)	Quantity dumped as on July2019 (cu.m)	Capacity remaining as on July2019 (cu.m)	Status	Observations
24)	Chamalwas-I	177+400 km	Non designated	-	-	-	-	<i>Nallah Choked due to illegal dumping.</i>

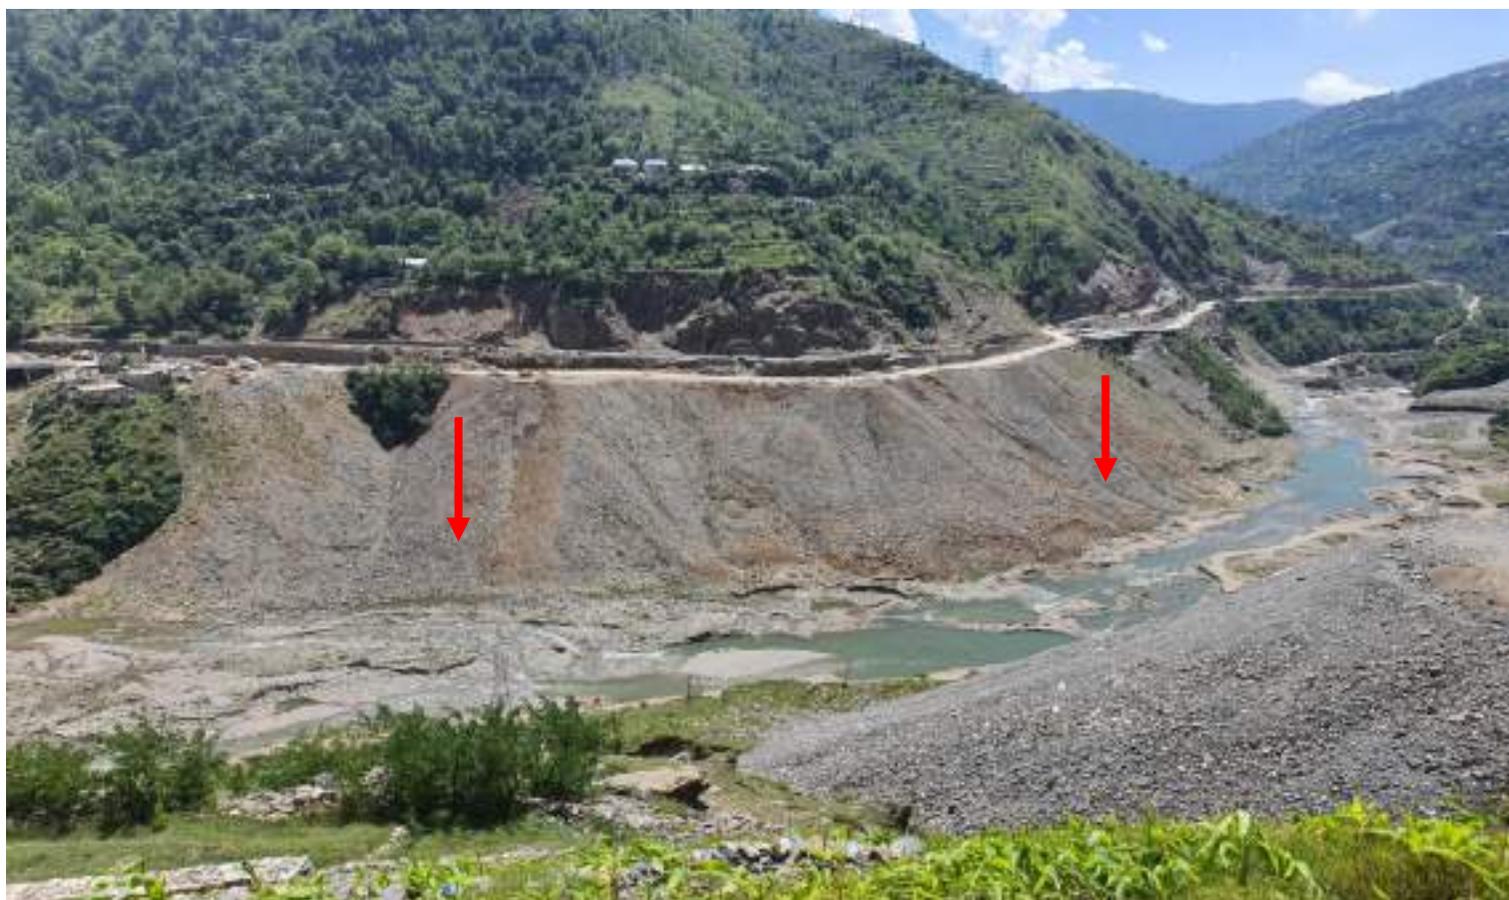
Photograph dated: (1st Sept, 2020): Ratanwas-I & II

S.No.	Name of the Site / Village	Chainage(SB)	Title /Area of the land	Total Capacity (cu.m)	Quantity dumped as on July 2019 (cu.m)	Capacity remaining as on July 2019 (cu.m)	Status	Observations
25 & 26)	Ratanwas-I & II	179+200 to 179+500 and 179+560 to 179+820	Private / 2.3 Hectare	67200	57120	10080	In-Use	<i>Along Bislari nallah, Huge dumping done and still in-progress. Gabions need to be strengthened.</i>

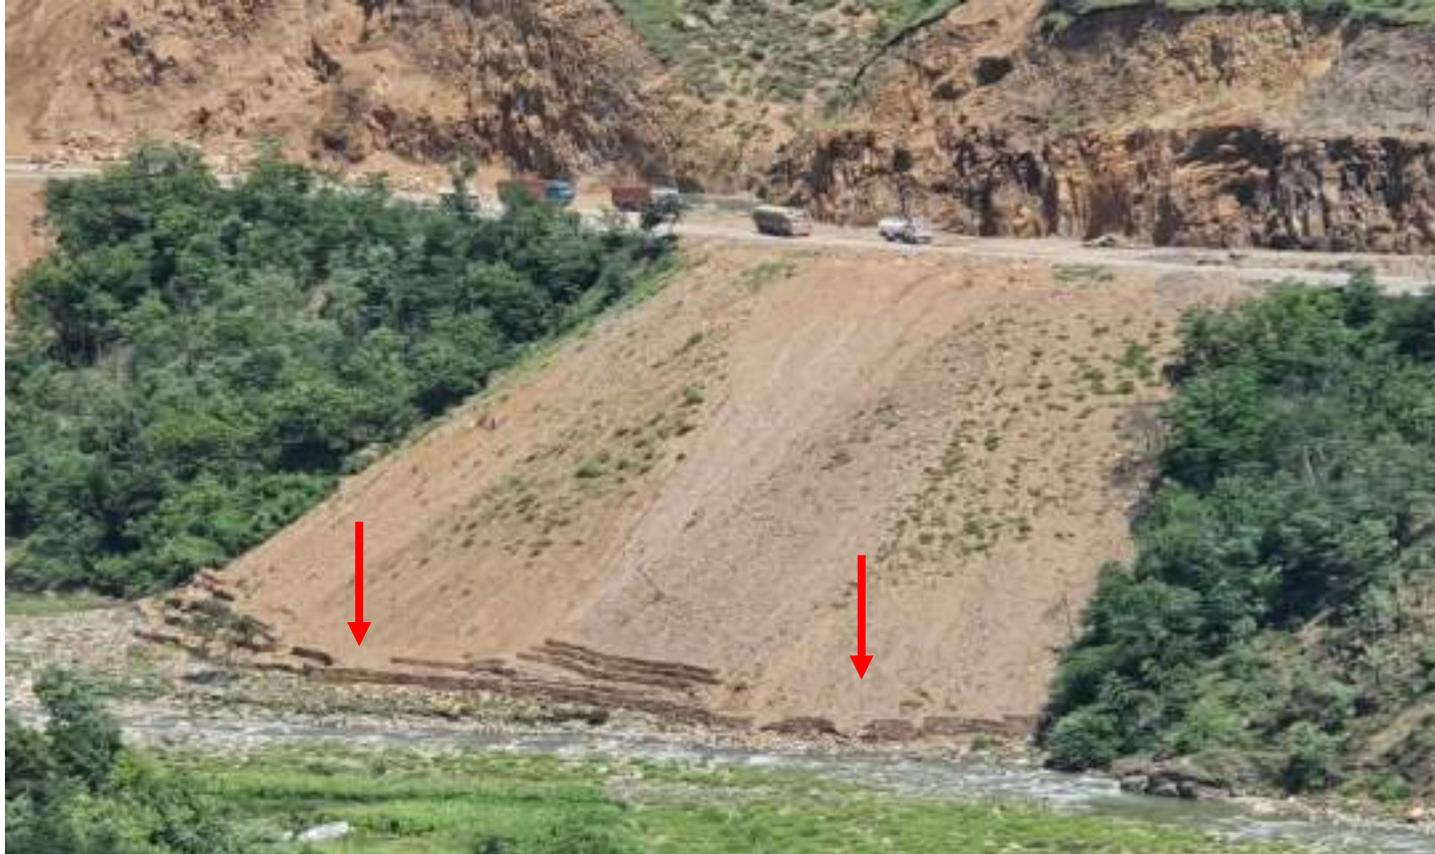
Photograph dated: (1st Sept, 2020): Ratanwas-III

S.No.	Name of the Site / Village	Chainage(SB)	Title /Area of the land	Total Capacity (cu.m)	Quantity dumped as on July 2019 (cu.m)	Capacity remaining as on July 2019 (cu.m)	Status	Observations
27)	Ratanwas-III	181+580 to 181+650 Km	Private / 0.93 Hectare	48000	43200	4800	In-Use	<i>Dumping is being done in an un-scientific manner. Gabions need to be strengthened.</i>

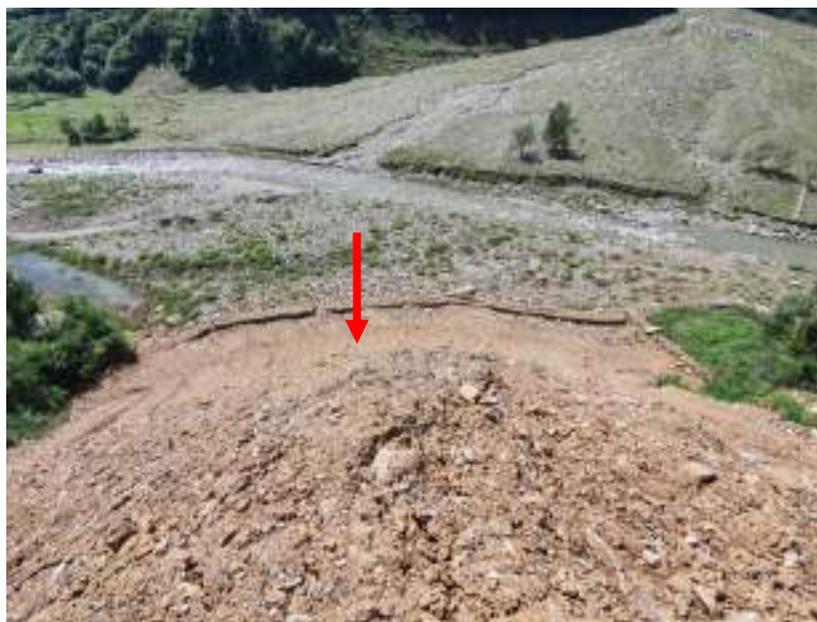
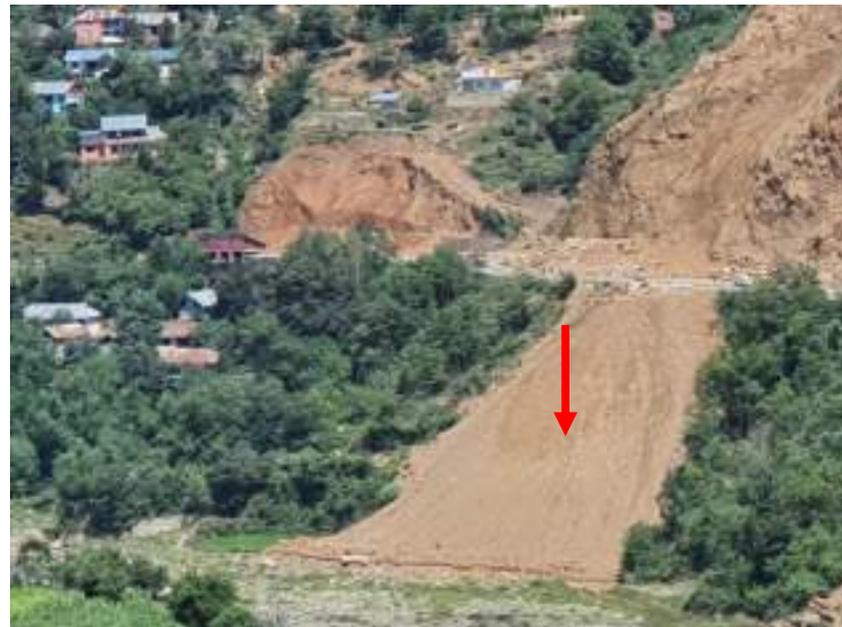
Photograph dated: (1st Sept, 2020): Kharpora Banihal

S.No.	Name of the Site / Village	Chainage(SB)	Title /Area of the land	Total Capacity (cu.m)	Quantity dumped (cu.m)	Capacity remaining (cu.m)	Status	Observations
27)	Kharpora Banihal	181+690 to 181+740 Km	Non-Designated	-	-	-	-	<i>Illegal dumping going on. Gabion structure needs to be raised.</i>

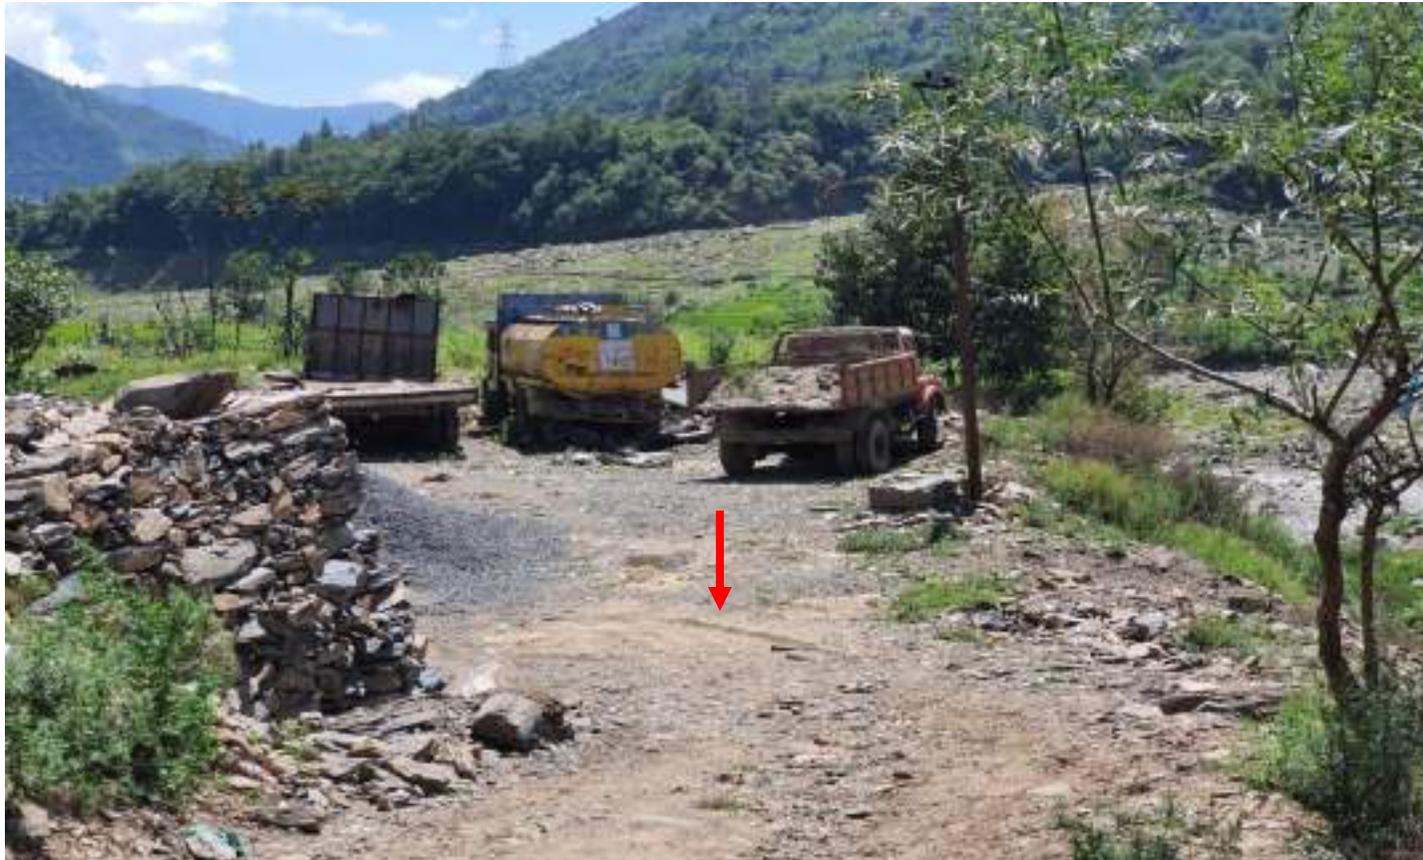
Photograph dated: (1st Sept, 2020): Banihal Pvt Land-I & II.

S.No.	Name of the Site / Village	Chainage (SB)	Title /Area of the land	Total Capacity (cu.m)	Quantity dumped as on July 2019 (cu.m)	Capacity remaining as on July 2019 (cu.m)	Status	Observations
29)	Banihal Pvt Land-I and II		Private/ 2.5 Hectare	9773	9773	0	Site Closed	<i>Green cover has come up in some portion of this site.</i>

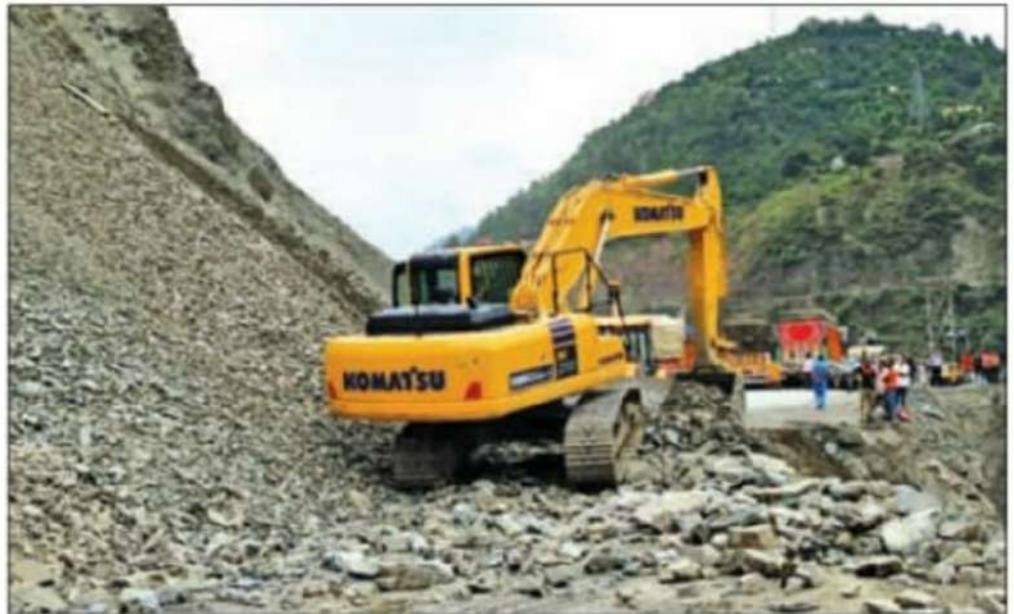
Debris being...

They said that the company engaged by the NHAI for four-laning of the road from Nashri to Ramban “has been dumping the debris in river Chenab from Chanderkote to Kelamorh, and in Nullah Bislari from Battery Chasma to Banihal, and at some other locations along the Jammu-Srinagar National Highway in Ramban district.”

They said the dumping was continuing in clear violation of National Green Tribunal directives and despite notices issued by District Magistrate Ramban in this regard.

They said the constant dumping of the debris in the Chenab creates lot of silt in the river which could cause damage to the Salal power project in district Reasi.
