**Damage Assessment report
for molasses tank burst
accident occurred
at**

**M/S. SAHAKAR MAHARSHI SHIVAJIRAO
NARAYANRAO NAGAWADE
Sahakari Sakhar Karkhana Ltd.,
Village Limpangaon, Tal. Shrigonda,
Dist. Ahmednagar- 413726**

VASANTDADA SUGAR INSTITUTE

AUGUST - 2023

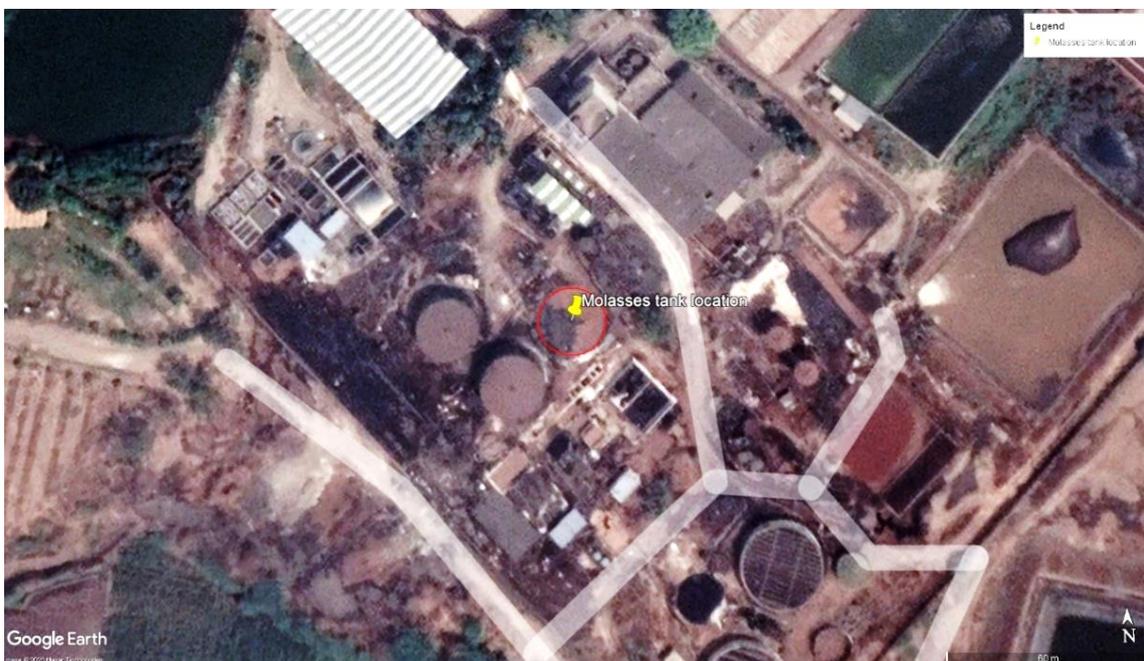
Figure 2.1: The place (tank location) of accident

On 10th Feb 2022, one of the molasses tanks of 4500 MT capacity located in the distillery unit burst at 06.45 am. Due to this, the stored molasses flowed out of the factory premises and found its way through nearby natural drainage. The factory management took immediate action to control and remove the molasses from outside premises. In the control action, the management took the following steps.

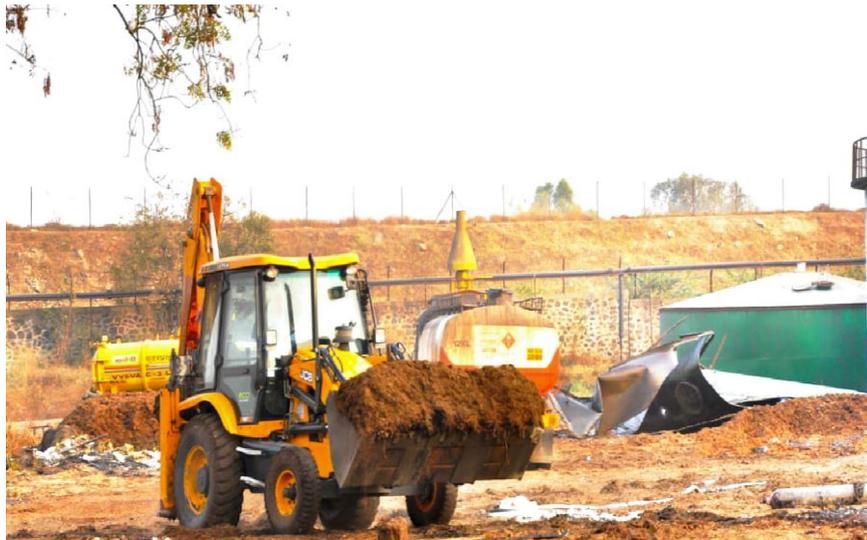
Figure 2.3: Removal of contaminated soil

- Immediate control measures implemented by the factory management after the incident:

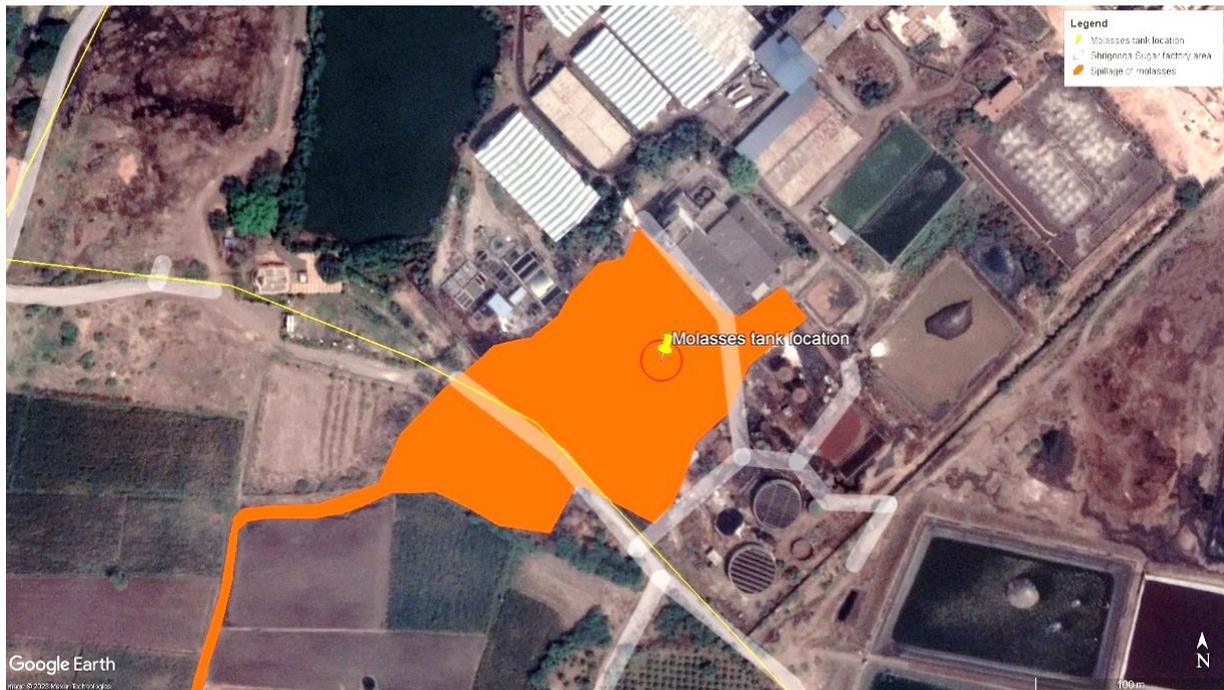
Based on the visit and collected data, an area affected due to molasses spread was demarcated on satellite image.

Figure 3.1: Image showing spillage of molasses inside factory premises

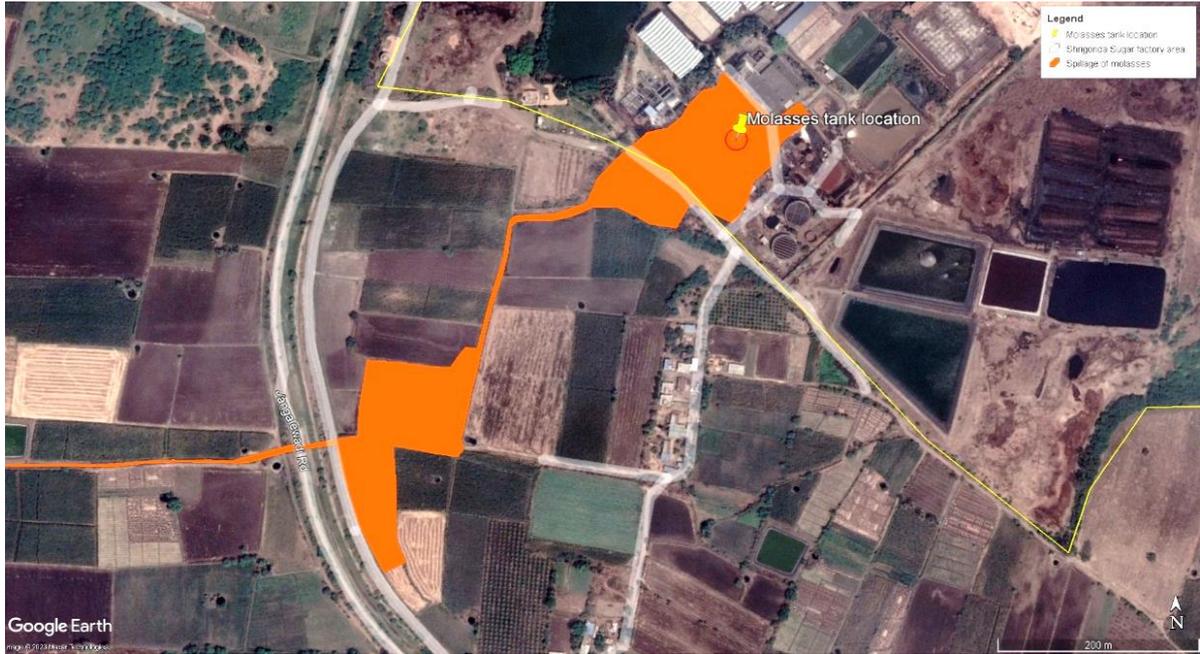
Figure 3.2: Image showing spillage of molasses outside factory premises

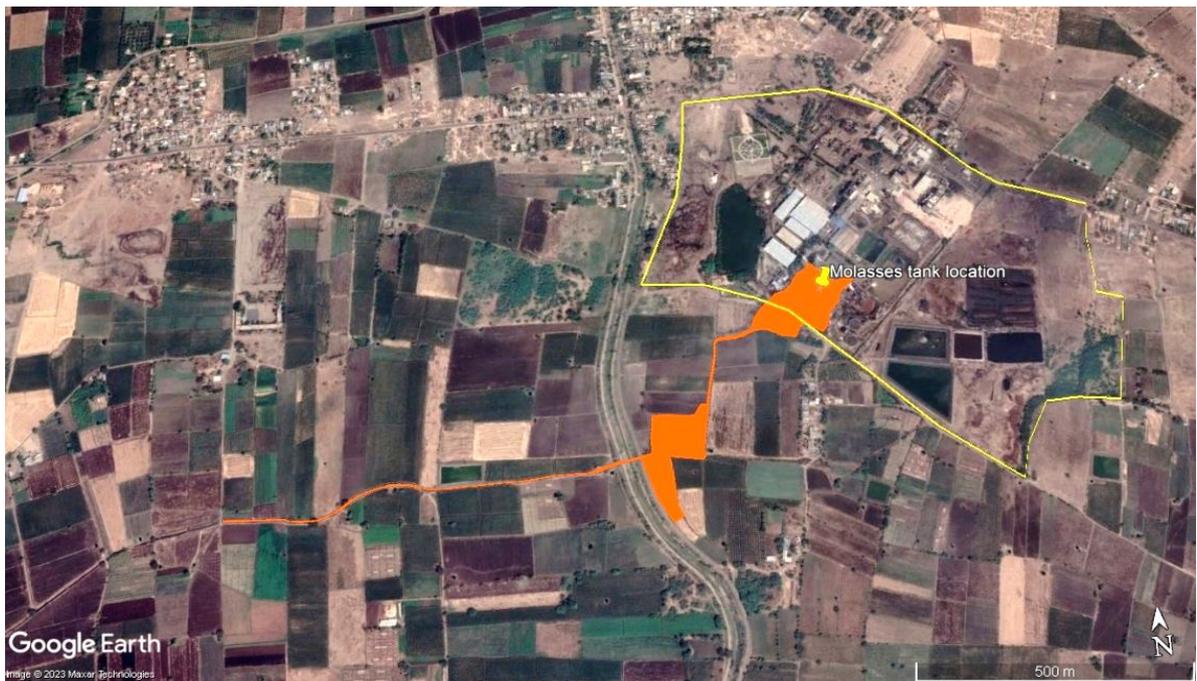
Figure 3.3: Google earth image showing spillage of molasses in the nearby area
