NO.: CIVIL/CEC-1066/DHL-77 (2)

Action plan for restoration of Environment for Padmavati Associates — Pristine Prism and Pristine Royale and Pristine Privilege, Sr. No. 6/2,7 and Sr. No.6/5 CTS No. 2560(pt), at Aundh, District Pune.

**Department of Civil Engineering
Visvesvaraya National Institute of Technology, Nagpur**

Maharashtra Pollution Control Board (MPCB)

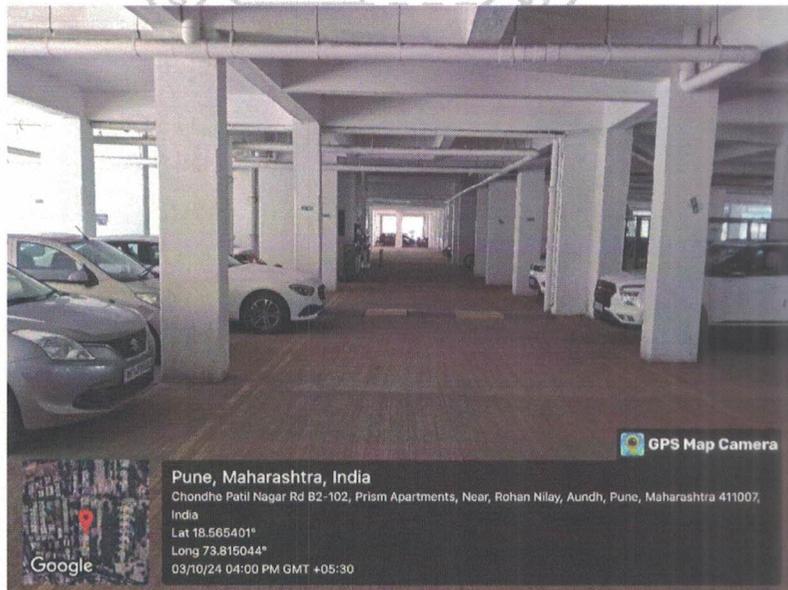
Picture 4: View of parking area of the society

- As per the documents provided by the PP, the society was constructed on a “Residential” land as classified by the PMC. As such there was no destruction of any natural habitat during the construction of the society.
- As per the PP, the topsoil was used for the landscaping. However, no comments can be made about this claim.
- The entire ground is concrete paved within the building premises.
- No provision for rain water percolation to the ground or surface rainwater harvesting. Surface runoff is discharged into public stormwater drains.

- It is recommended to replace the concrete pavement by grass pavers for parking and driveways.
- It is recommended to augment the rain water harvesting capacity by diverting the surface runoff from paved areas into recharge pits or holes.

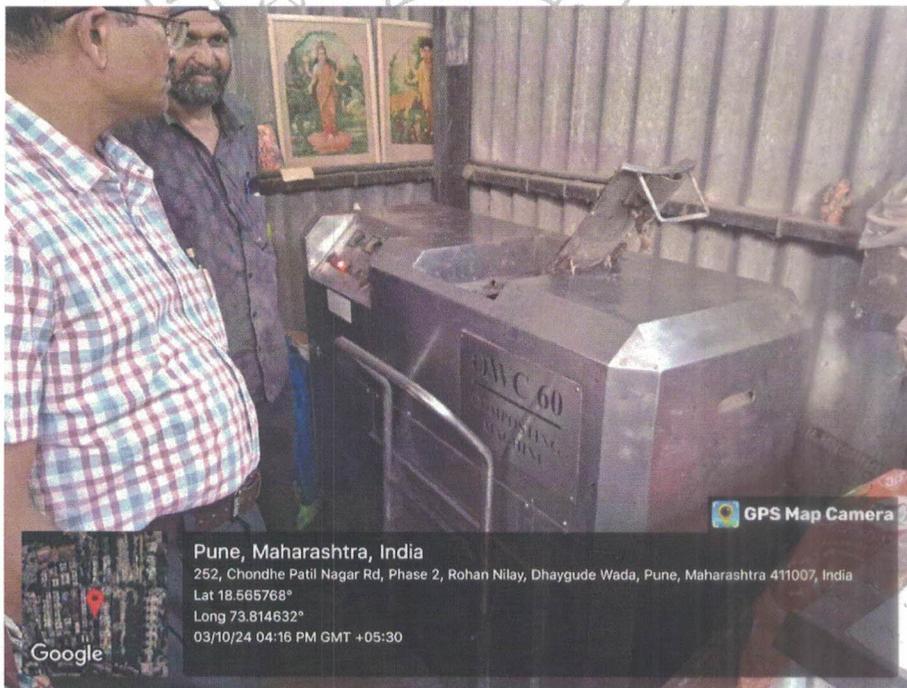
Picture 6: View of OWC installed on site

- Solid waste generated (assuming 0.35 kg/day) = approximately 350 kg/day
- Waste segregation is practiced in the society.
- The society has an operational organic waste converter (OWC) of 130 kg/day organic waste processing capacity.
- Assuming 50% of organic matter, the organic fraction would be approximately 175 kg/day. The installed OWC capacity is on the lower side with respect to the organic waste generation.
- As per information provided by the PP, part of the compost produced is used within the premises for landscaping and the remaining part is given to outside users. No documentary evidence was provided to support this claim.
- The inorganic waste is handed over to the PMC sanitation services.

- No significant impact on environment was observed due to generation of solid waste
- It is recommended that a higher capacity OCW be installed in the society.
- It is recommended to maintain a record of the compost produced, used and distributed for reference.

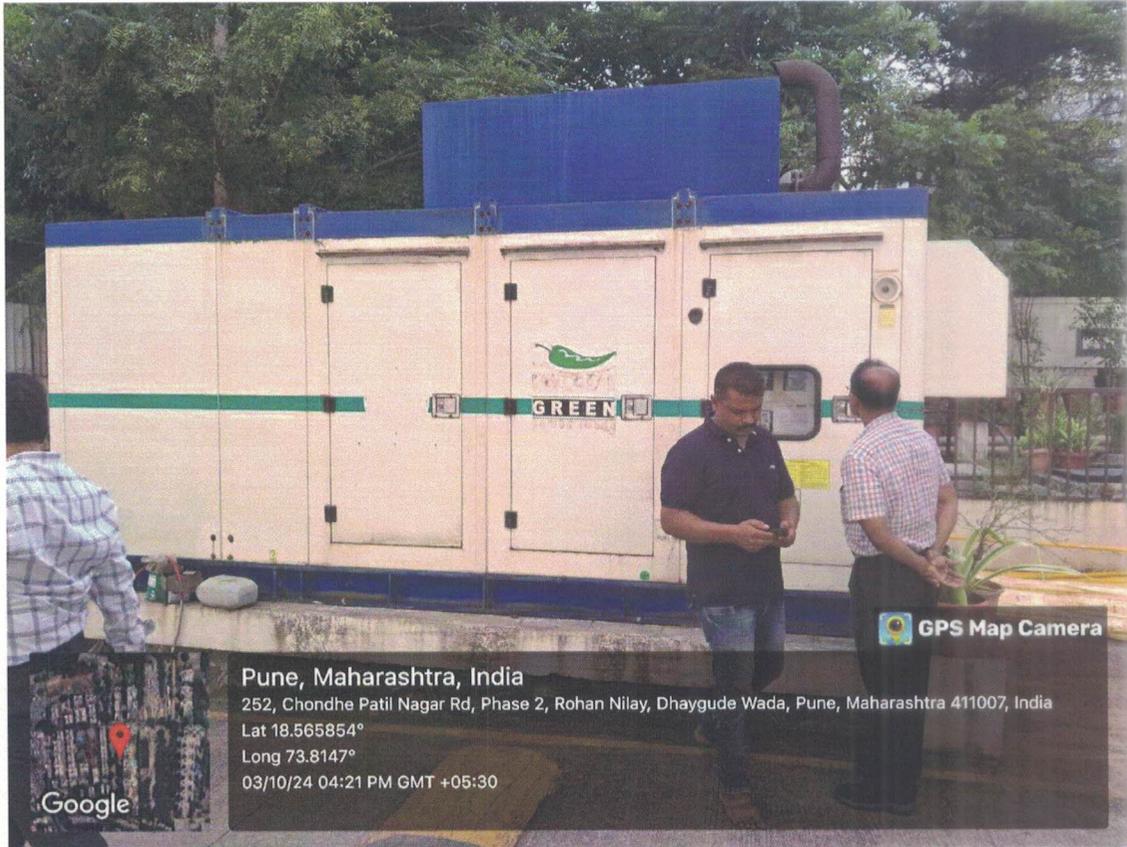
Picture 7: View of DG set installed on site

- On the day of visit no significant impact was observed on the air quality.
- The only source of air pollution found on the site was DG set of 160 KVA.
- The DG sets were enclosed in the acoustic enclosure. The canopy to protect the DG set from the rain was absent in the Prism premises.
- The stack of the DG set was at low height.
- As per the information provided, the DG set is operated as backup source during the electricity failure from Maharashtra State Electricity Board (MSEB).
- Details regarding the air quality of emissions from the DG set were not available. Hence, the status of the pollution control cannot be verified

- It is recommended that the monitoring of air quality emissions from the DG set be carried out periodically.

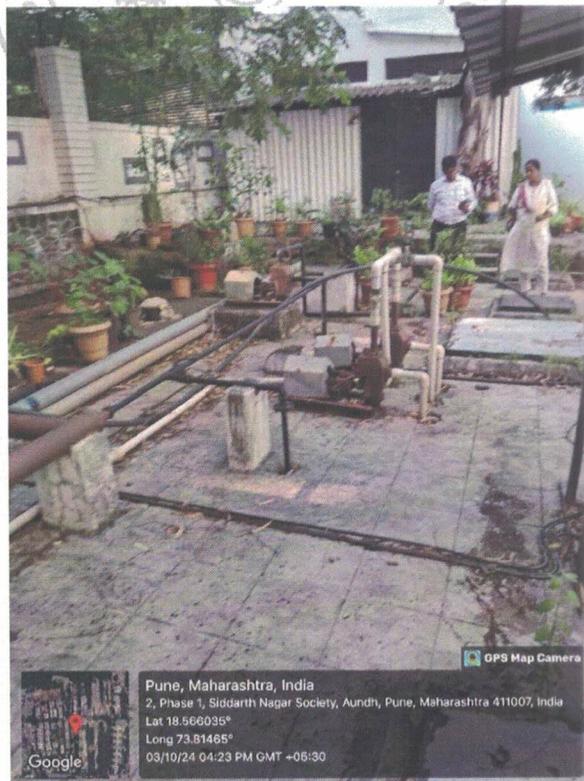
Picture 8: View of STP set installed on site

- Sewage generated on site = $0.8 \times 200 \times 4 \times 251 = 160640$ litres
 - Capacity of sewage treatment plant (STP) provided on site = 160 KL

- Mode of disposal of treated water: Discharged to public sewer, No recycling of treated effluent is done
 - Therefore, treated water available per day (assuming 10% losses) = approximately 140 KL

- It is recommended that the treated water from STP be used for toilet flushing and landscaping to minimise the use of fresh water
- It is observed that the occupants use approximately 1.8 million litres of municipal water annually for washing their 2 and 4 wheelers. It is recommended that treated water from the STP be used for washing the 2 and 4 wheelers.

- To the extent possible the treated effluent from the STP shall be used for fulfilling the non-potable water demand.
- The possibility of using the treated sewage by PMC should be explored.

- Quality of treated effluent should be monitored on a regular basis (at least once in a month)

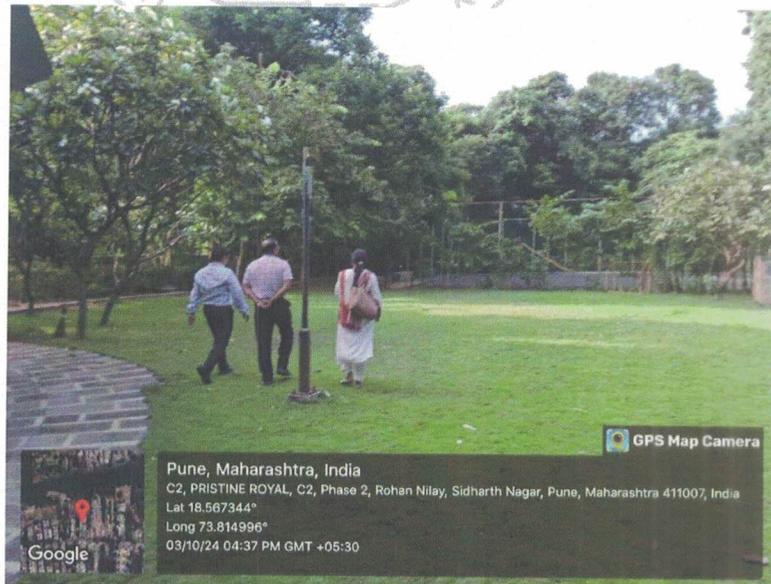
Picture 2: Green belt and open area on Site

- There are approximately 150 trees planted within the premises.
- As per clause no 6 in the certificate to commence construction issued by PMC, it is mentioned that “*every owner should plant at least 4 trees and ensure their proper growth*”. As per this clause the number of trees in the premises should have been at least 250. However, the actual number of trees are much less than the prescribed number.

- Tree plantation should be carried out to achieve the number of trees as mentioned in the certificate by PMC
- If sufficient space is not available within the premises, then arrangements shall be made to plant the trees in nearby location in consultation with PMC. Options like Miyawaki forest, dense plantations, micro forests can be explored.

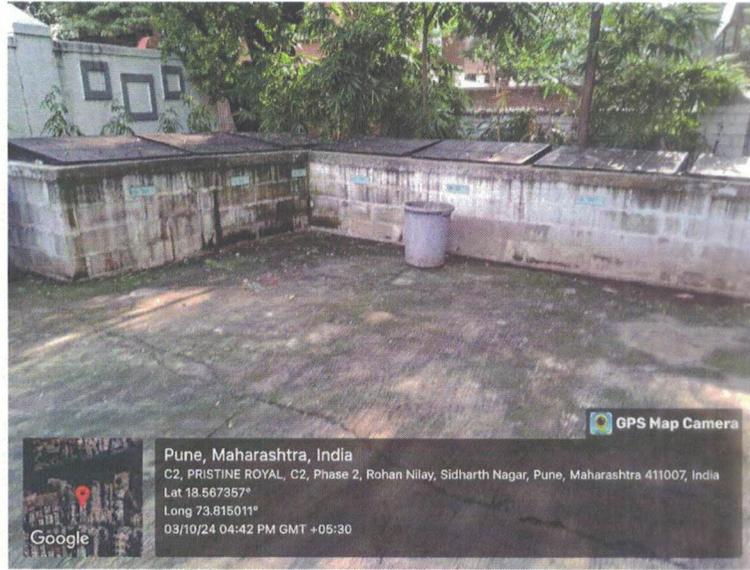
Picture 3: Non-operational compost bins on site

- No of flats = 58
- Occupants per flat: 4 (assumption)
- Solid waste generated (assuming 0.35 kg/day) = approximately 81 kg/day
- Constructed compost bins were observed on site. However, they were non-functional on the day of visit.
- The compost bins were lacking maintenance. Leachate was seeping out from the compost bins.
- The solid waste is handed over to the PMC sanitation services.

- No significant impact on site environment was observed due to generation of solid waste
- It is recommended that a OWC be installed in the society to convert the organic waste to compost.
- The existing compost bins be repaired on priority. The seeping of leachate from the bins should be stopped immediately
- It is recommended to maintain a record of the compost produced, used and distributed for reference.

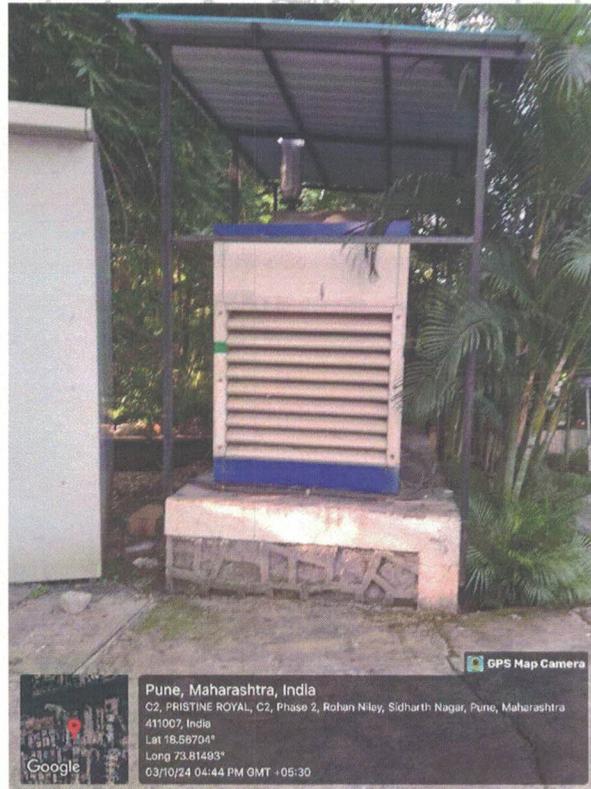
Picture 4: DG set with acoustic enclosure and canopy on site

- On the day of visit no significant impact was observed on the air quality.
- The only source of air pollution found on the site was DG set of 125 KVA.
- The DG sets were enclosed in the acoustic enclosure and canopy to protect the DG from the rain.
- The stack of the DG set was at low height.
- As per the information provided, the DG set is operated as backup source during the electricity failure from Maharashtra State Electricity Board (MSEB).
- Details regarding the air quality of emissions from the DG set were not available. Hence, the status of the pollution control cannot be verified.

- It is recommended that the monitoring of air quality emissions from the DG sets be carried out periodically.

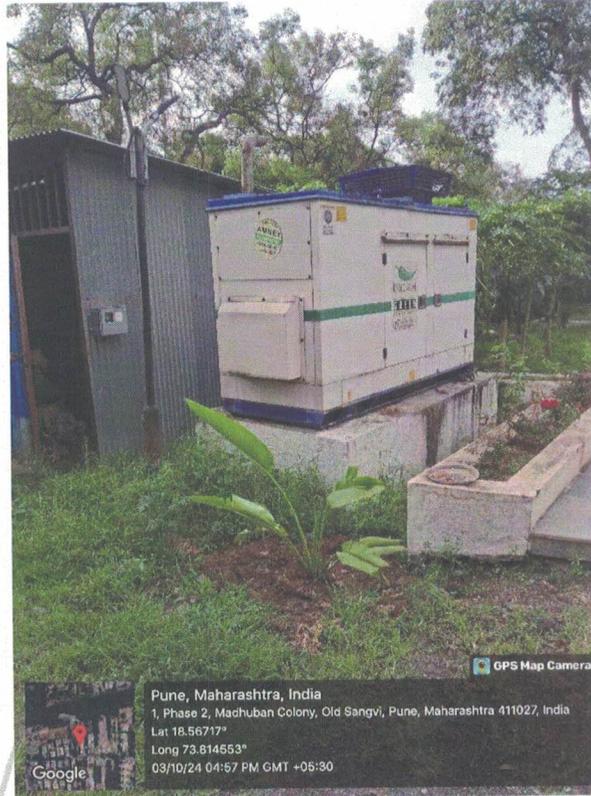
Picture 2: DG set with acoustic enclosure and canopy on site

- On the day of visit no significant impact was observed on the air quality.
- The only source of air pollution found on the site was DG set of 35 KVA.
- The DG sets were enclosed in the acoustic enclosure. The DG set is exposed to the rain.
- The stack of the DG set was at low height.
- As per the information provided, the DG set is operated as backup source during the electricity failure from Maharashtra State Electricity Board (MSEB).
- Details regarding the air quality of emissions from the DG set were not available. Hence, the status of the pollution control cannot be verified.

- It is recommended that the monitoring of air quality emissions from the DG sets be carried out periodically.
- The DG set be enclosed in a canopy to protect it from rain.

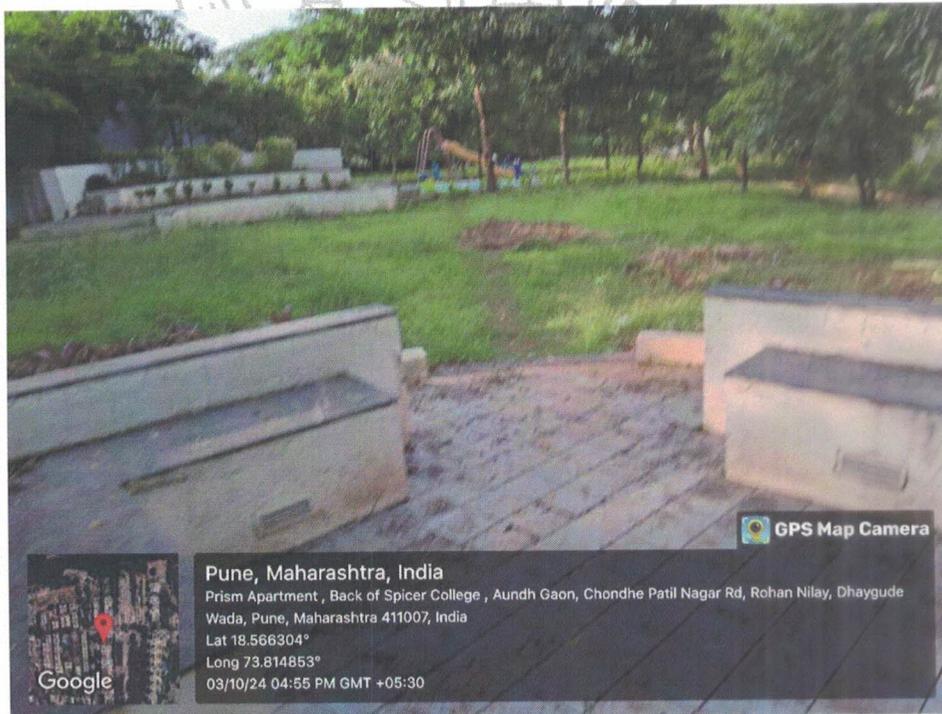
Picture 3: Open area and green belt on site

- There are approximately 56 trees planted within the premises.
- As per clause no 6 in the certificate to commence construction issued by PMC, it is mentioned that “*every owner should plant at least 4 trees and ensure their proper growth*”. As per this clause the number of trees in the premises should be at least 150. However, the actual number of trees are much less than the prescribed number.

- Tree plantation should be carried out to achieve the number of trees as mentioned in the certificate by PMC
- If sufficient space is not available within the premises, then arrangements shall be made to plant the trees in nearby location in consultation with PMC. Options like Miyawaki forest, dense plantations, micro forests can be explored.
