**Subject:** Submission of Interim Report on "Study of environmental damage and adequacy of pollution control equipment for Jakraya sugar ltd., Gut No. 61/1/A, A/p- Watwate, Tal- Mohol, Dist- Solapur"

#### **Report on environmental damage due to the Jakraya sugar ltd. Watwate, Tal- Mohol, Dist- Solapur.**

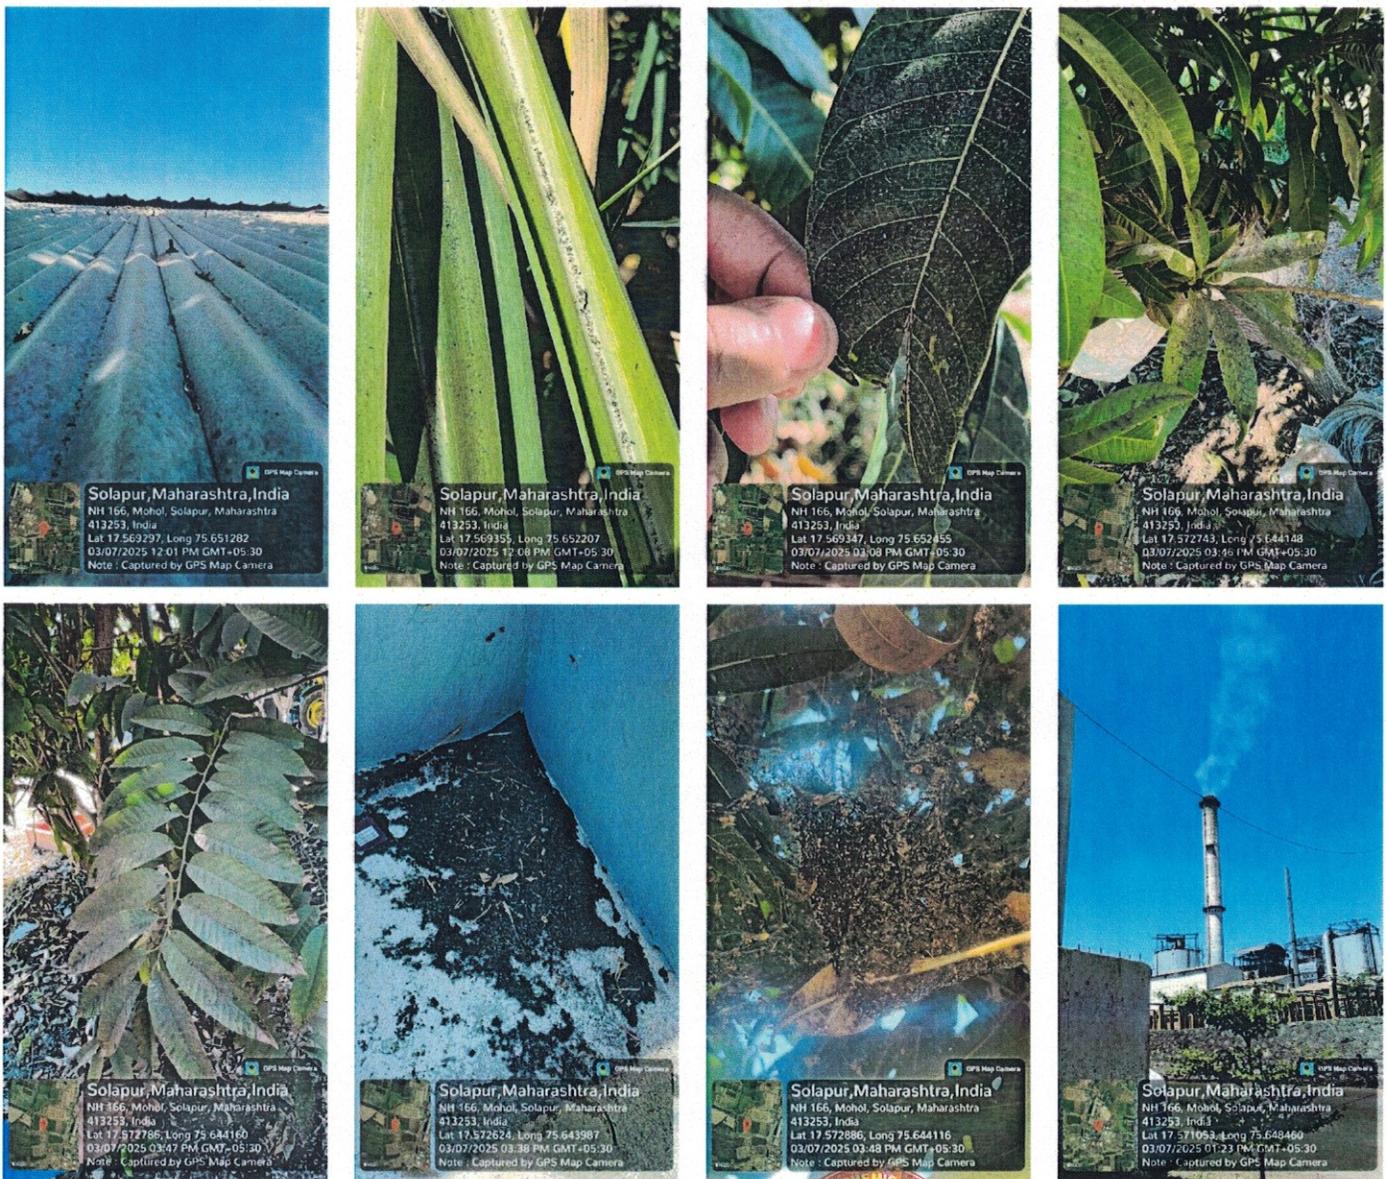
**6.3.1. Fly ash pollution:** Photographs, as shown in **Figure 7**, appear to indicate the presence of fly ash deposits on surrounding vegetation, residential rooftops, and open areas adjacent to the facility. This observation might suggest that the efficiency of mechanical ash collectors or wet scrubbers could be reviewed. These components are generally considered essential in controlling particulate emissions, and any deviation from optimal performance may lead to localized air quality concerns. The settled ash, if persistent, may also have implications for respiratory comfort and ambient dust levels affecting nearby residents and workers.

**Figure 7. Photographs show the fly ash deposit on rooftop of nearby residence and on foliage of surrounding trees.**

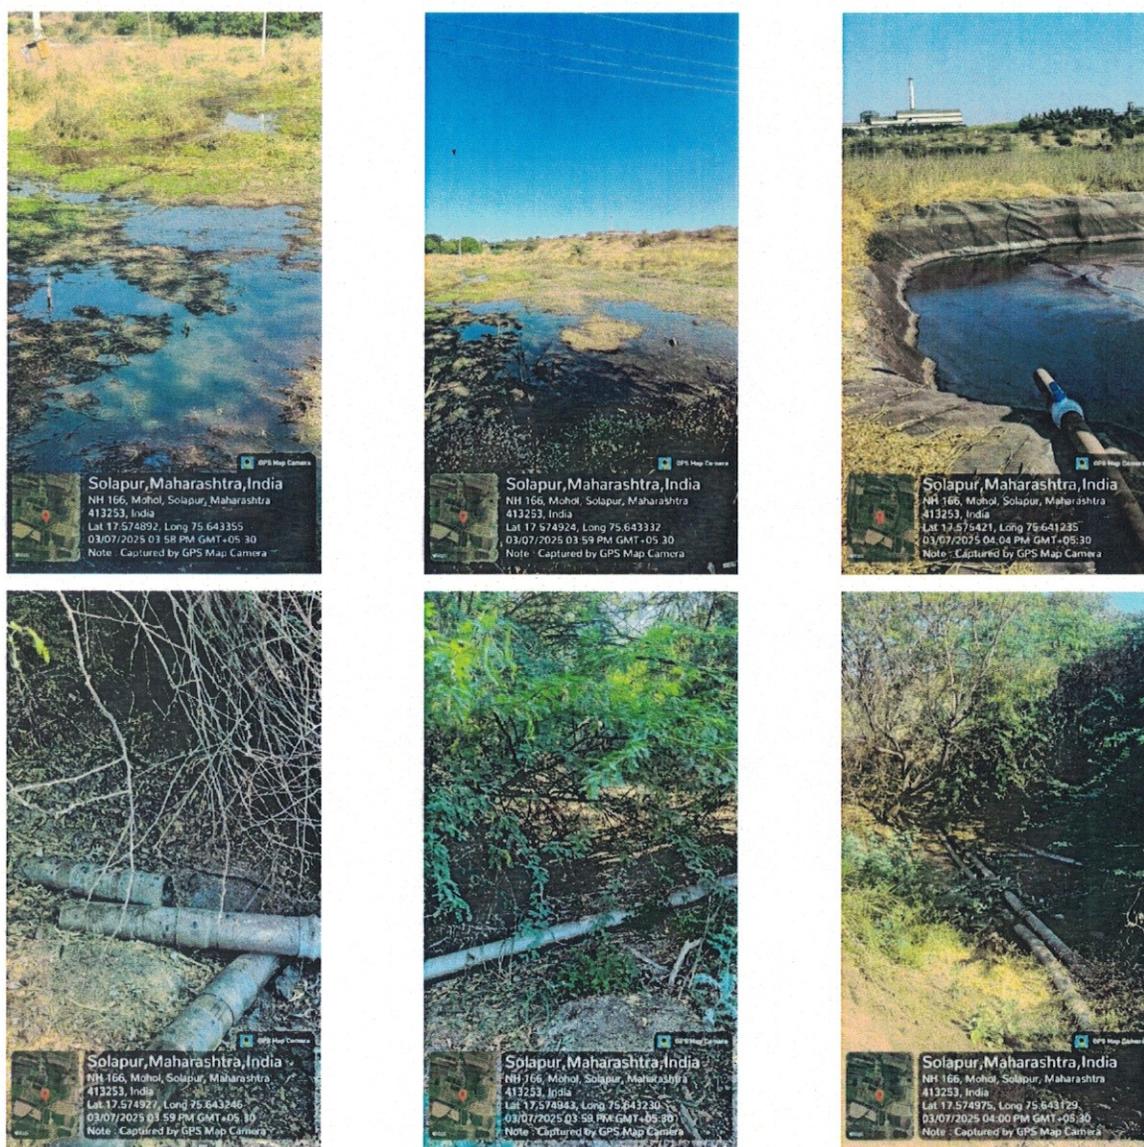
**6.3.2 Wastewater discharge into fields and natural drain:** Visual documentation obtained during the site inspection (as illustrated in Figure 8) appears to depict the discharge of wastewater from the facility into adjacent agricultural fields and a nearby natural brook (Odha), which traverses the local terrain and eventually connects to the Bhima River. The photographs show pipeline outlets extending from the plant toward this natural drainage system, which may suggest the need for further evaluation of discharge pathways and compliance mechanisms. The observed coloration and Odor of the effluent, along with the visibly saturated condition of the land, could be indicative of untreated or partially treated wastewater, including spent wash and other industrial streams, potentially influencing surface and groundwater quality. Further confirmatory sampling and assessment may be necessary to understand the extent and impact, if any.

Figure 8: Flooded agricultural field with wastewater discharge and wastewater pipeline from factory discharging into natural drain (Odha).
