FINAL REPORT ON STUDY AND  
ASSESSMENT OF  
CONTAMINATION OF WATER AND SOIL IN  
THE SURROUNDING AREA OF SPENT WASH  
STORAGE AND COMPOST YARD  
OF  
M/S. LOKNETE MARUTRAO GHULE PATIL  
DNYANESHWAR SAHAKARI SAKHAR  
KARKHANA LTD., VILLAGE: BHENDA BK.,  
TAL. NEWASA, DIST. AHILYA NAGAR 414605

VASANTDADA SUGAR INSTITUTE  
DEPARTMENT OF ENVIRONMENTAL SCIENCES  
MANJARI BK, TAL. HAVELI, DIST. PUNE MAHARASHTRA 412307 INDIA

APRIL, 2026

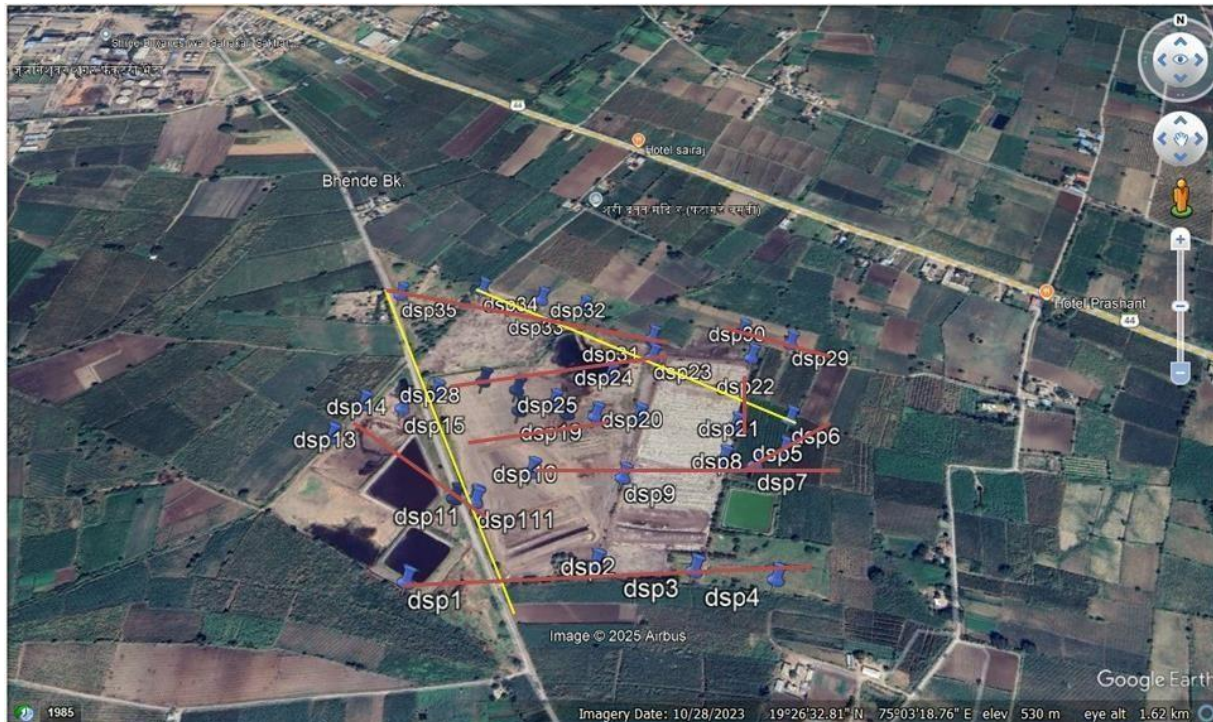
**Figure 4: Locations of VES i.e. Geo-physical surveys**

Geo-physical surveys in the form of vertical electrical resistivity survey (VES) were undertaken at the study area during the Post Monsoon (2025) and Pre Monsoon (2024) seasons.

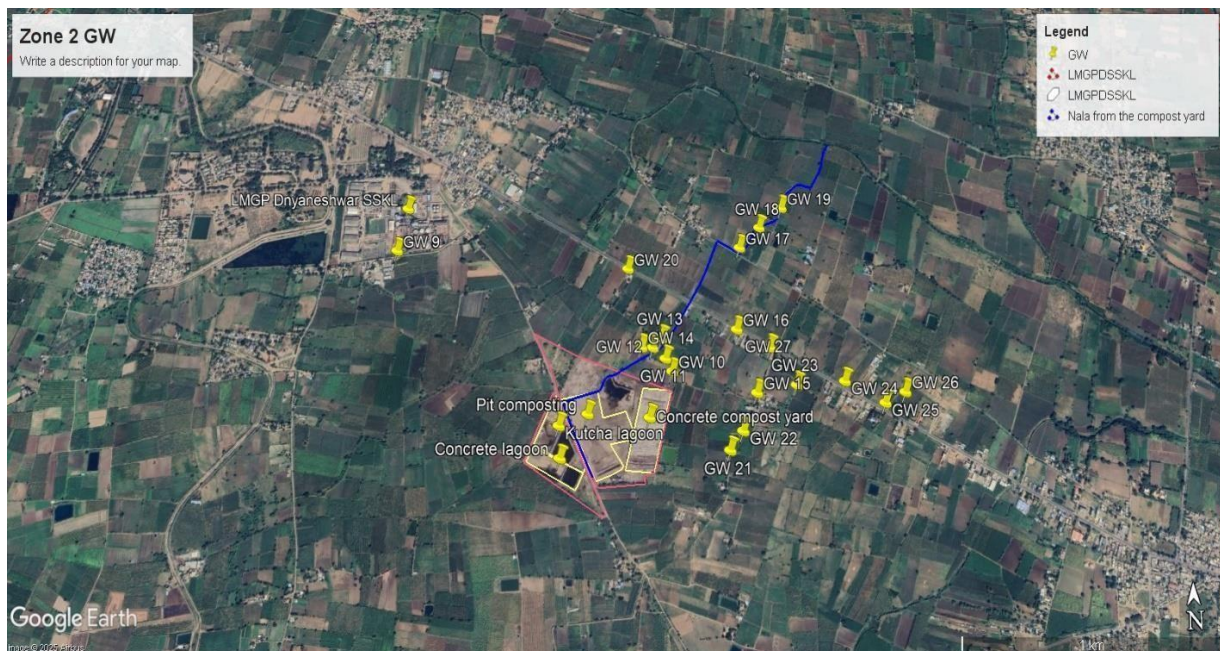
**Figure 5: Satellite image showing the ground water monitoring locations of zone 2**

GW 09 to GW 27: In this group Location GW10 to GW 16, GW 20 and GW 27 are observed in the immediate downstream areas of compost yard/storage lagoons. GW 09 is considered here only because it is located very close to the factory. This is to understand the characteristics of the water quality with respect to the regular factory operations.

GW 17 to GW 26 are in downstream but at further distance from the compost yard/storage lagoons and few locations in this group are observed in close proximity of the natural drainage that passes through the kutcha lagoon area.

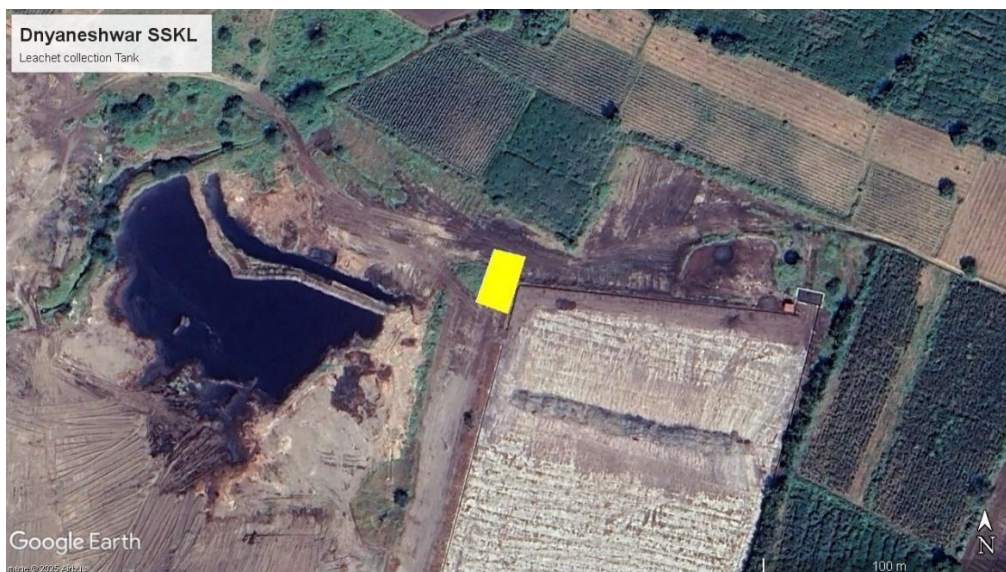
**Figure 6: Image showing site recommended for leachate collection in yellow colored polygon**

1. High resistivity along profiles VES 02, VES 03, VES 04, VES 05 and VES 07 indicate there is no leakage or contamination towards the south and east of the compost area. Similarly, high resistivity is seen at VES13, VES14, VES15, VES28 suggesting no contamination towards the west of the compost area.
2. Potential leakage to the shallow aquifer/ground water is seen at VES 08, VES 09, VES10, VES 11 and VES 12 to a depth of 15.8m similarly VES 06 to VES 20 and VES 31 to VES 34 and VES 32 shows very low resistivity values up to a depth of 12.6 bgl.

2. It is also advised to plant few Eucalyptus trees in the open plot towards north of the compost yard. Plantation should be limited.
3. Fracture seal cementation using fast settling cement/black cotton soil under high pressure grouting is recommended between VES DS 03, DS 08 - DS27 up to 40m and DS32 - DS30 up to depth of 25m to restrict the leakage to deeper aquifer and spreading of the contamination.

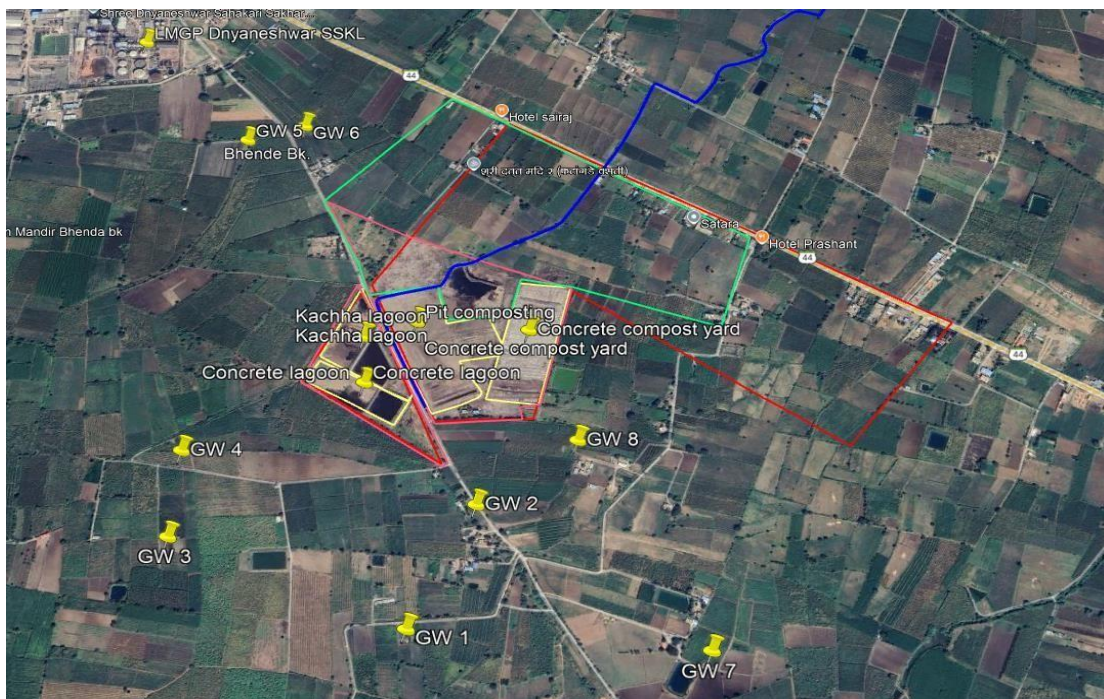
**Figure 3.1: Satellite image showing the ground water monitoring locations of Zone 1 i.e. GW 01 to GW 08**

These locations are either in upstream (considering runoff water from compost yard/storage tank) of the compost yard/lagoons or not directly influenced by the spent wash storage lagoons and composting activity. Those sampling locations were from the agricultural fields, mainly in S, SW, SE and NW of the spent wash storage and composting site. Visual and physical observation of the ground water and surrounding crop were indicating relatively no influence of spent wash storage and composting activities.

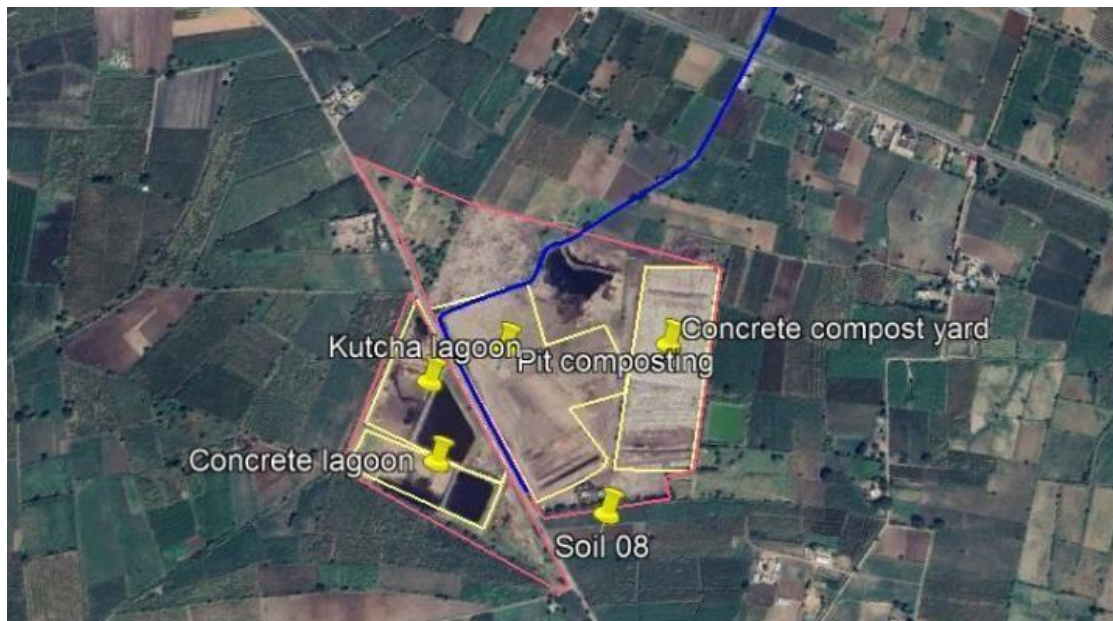
**Figure 3.2: Representative sample of Zone 1- soil monitoring location 08**

In the second cycle, GW 08 showed colour of 50 CU. This was mainly from the agricultural runoff during irrigation. Similar but relatively mild colour of 5 CU reported for location GW02 and GW 06. Apart from this, there were no significant changes reported in the chemical parameters studied during first (pre-monsoon) cycle and the second. Test results of these samples were considered as the general characteristics of ground water from the study area.

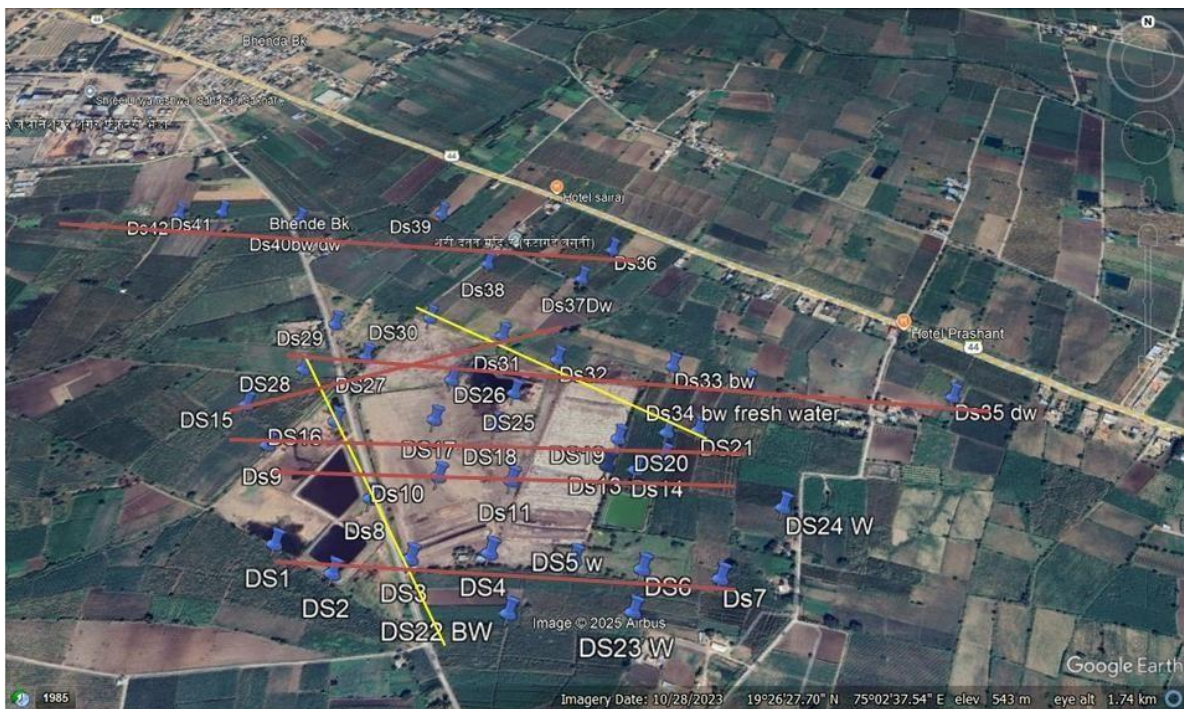
**Fig. 4.1:** The Sugar Factory compost yard with Pre Monsoon VES locations/points

During the Pre Monsoon season it is generally believed that the water table falls (goes down) with depth due to increased evapo-transpiration (natural cause) and due to ground water abstraction for drinking and irrigation (anthropogenic cause). Hence, a detailed study consisting of systematic traverses across the Dynaneshwar Sugar (DS) Factory compost yard was undertaken (DS1 - DS35). Besides this, 1 profile along a natural stream between the compost pit and the Sugar Factory (DS36 - DS41) was also undertaken to understand the nature of the aquifer in the uncontaminated condition. All these VES along several traverses have been utilized to analyze the potential contamination sites.

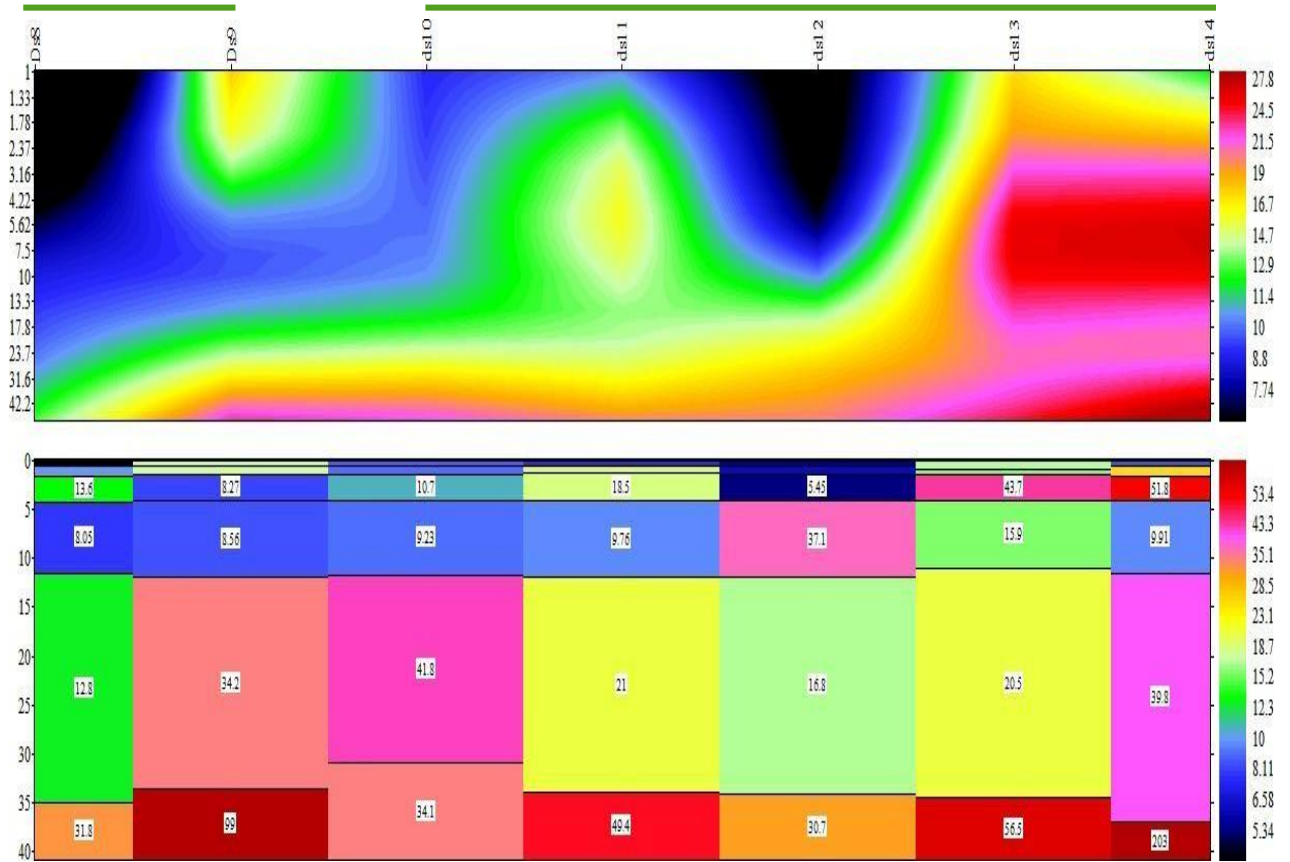
This profile is divisible to two segments. Segment 1 contains very low resistivity ( $\sim 7.4 - 10 \Omega\text{m}$ ) below DS8 extending up to a depth 31.6 m on the surface (up to 4.5 m bgl). There is a moderately impervious layer at DS9. The second section between DS10 and DS14 shows low  $\rho_a$ . At DS10 and DS12 leaky zones in the open compost shed shows significant recharge. Towards the east (DS13 and DS14), the high resistivity zones similar to the post-monsoon VES (DSP8 and DSP7) are present.

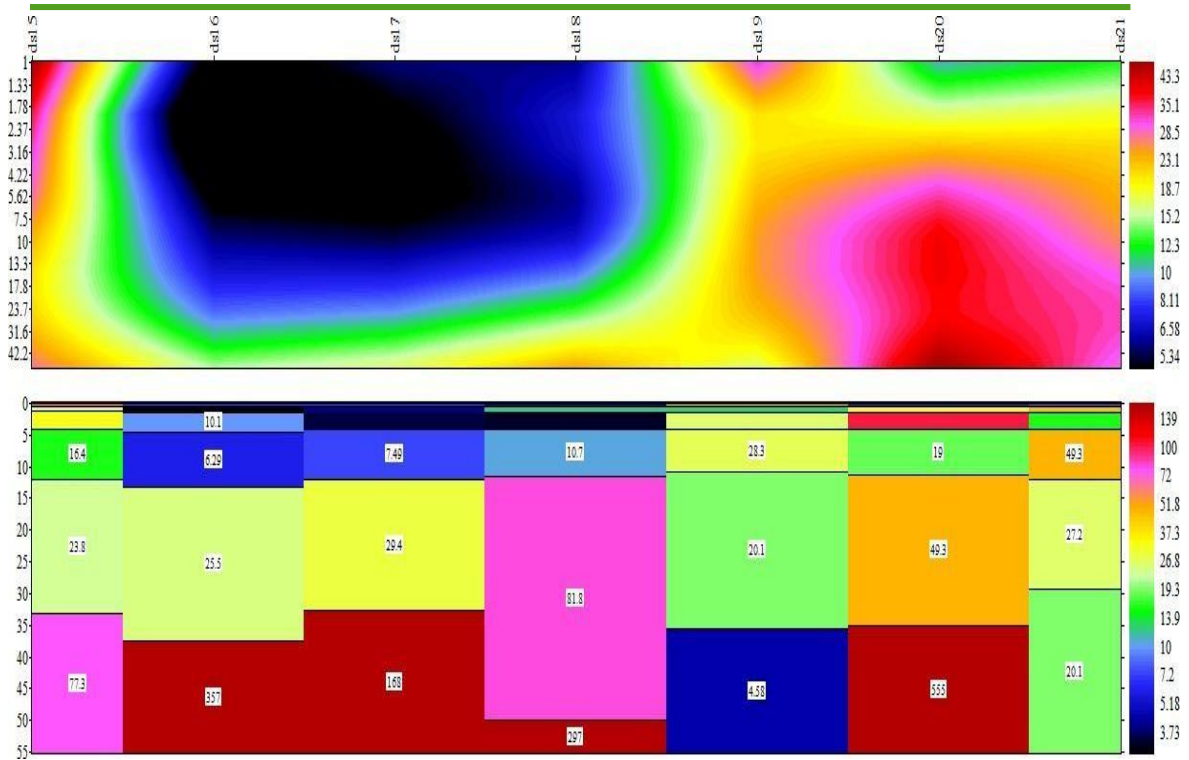
In Profile III, significant recharge is seen between DS16 and DS18 in this profile very low resistivity ( $\sim 5.3 - 10 \Omega m$ ) is seen up to a depth of 31.6 m bgl. As in DS13 and DS14 relatively high resistivity zones are seen in DS19 - DS21.

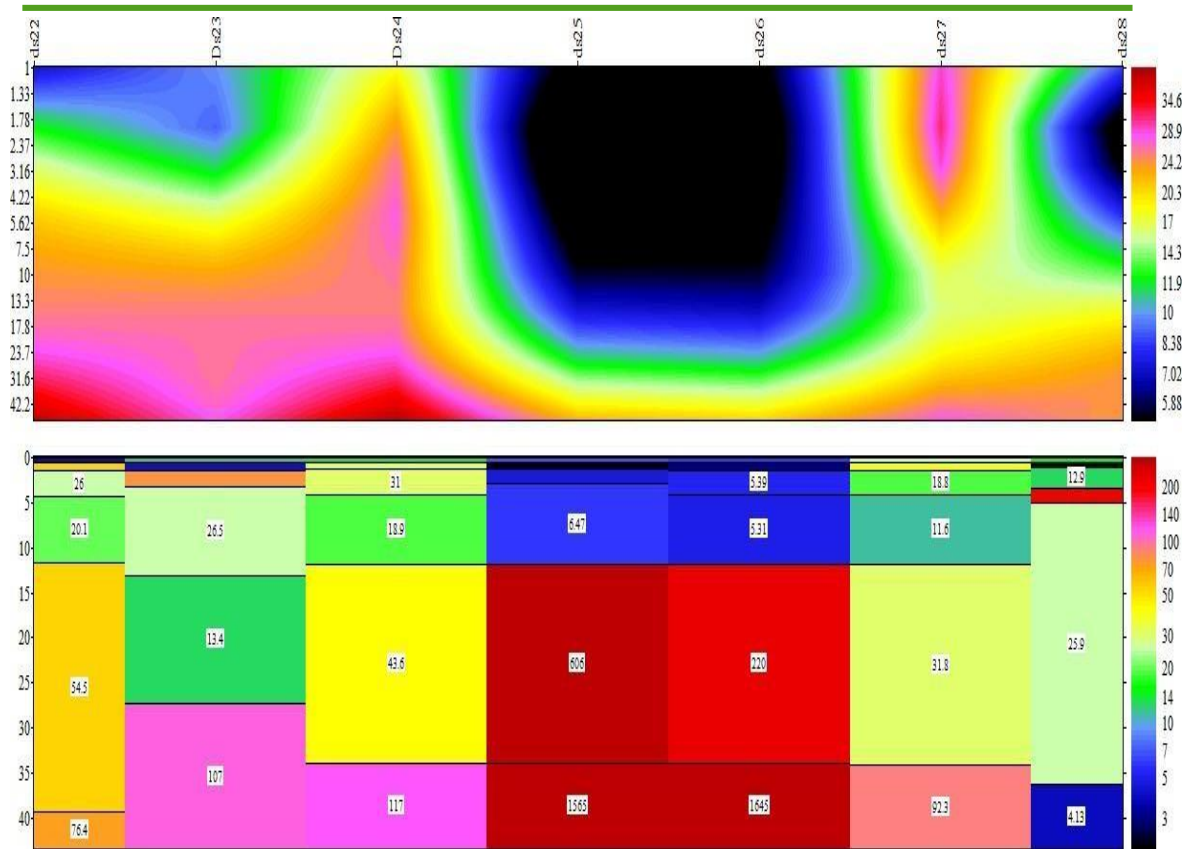
## Profile IV (DS22 - DS28)

In Profile IV shallow moisture zones up to 3 m are seen at VES DS22 - DS23. However, a large portion of the profile between DS25 - DS26 and DS28 show low apparent resistivity (5.88 - 10  $\Omega$ m) and extend up to 23.7 m bgl. These may be the zone from which surface leachate maybe percolating into the lower shallow aquifer.

In Profile IV shallow moisture zones up to 3 m are seen at VES DS22 - DS23. However, a large portion of the profile between DS25 - DS26 and DS28 show low apparent resistivity ( $5.88 - 10 \Omega m$ ) and extend up to 23.7 m bgl. This may be the zone from which surface leachate likely to be percolating into the lower shallow aquifer.

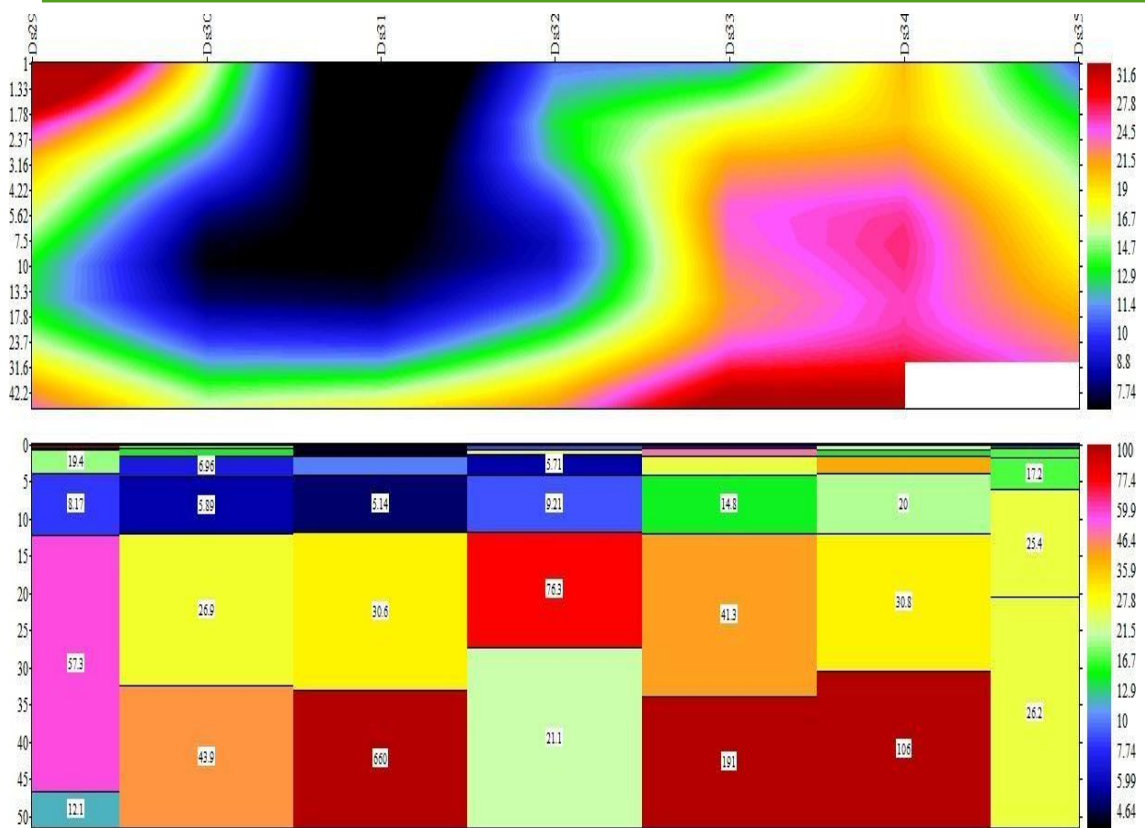
## Profile V (DS29 - DS35)

High surface resistivity is seen at DS29 and DS34 in Profile V. However, leaky segments are seen between DS31 - DS33 and DS35 ( $\rho_a \sim 7.74 - 11.4 \Omega m$ ) up to a depth 23.7 m bgl.

**High surface resistivity is seen at DS29 and DS34 in Profile V. However, leaky segments are seen between DS31 - DS33 and DS35 ( $\rho_a \sim 7.74 - 11.4 \Omega m$ ) up to a depth 23.7 m bgl.**

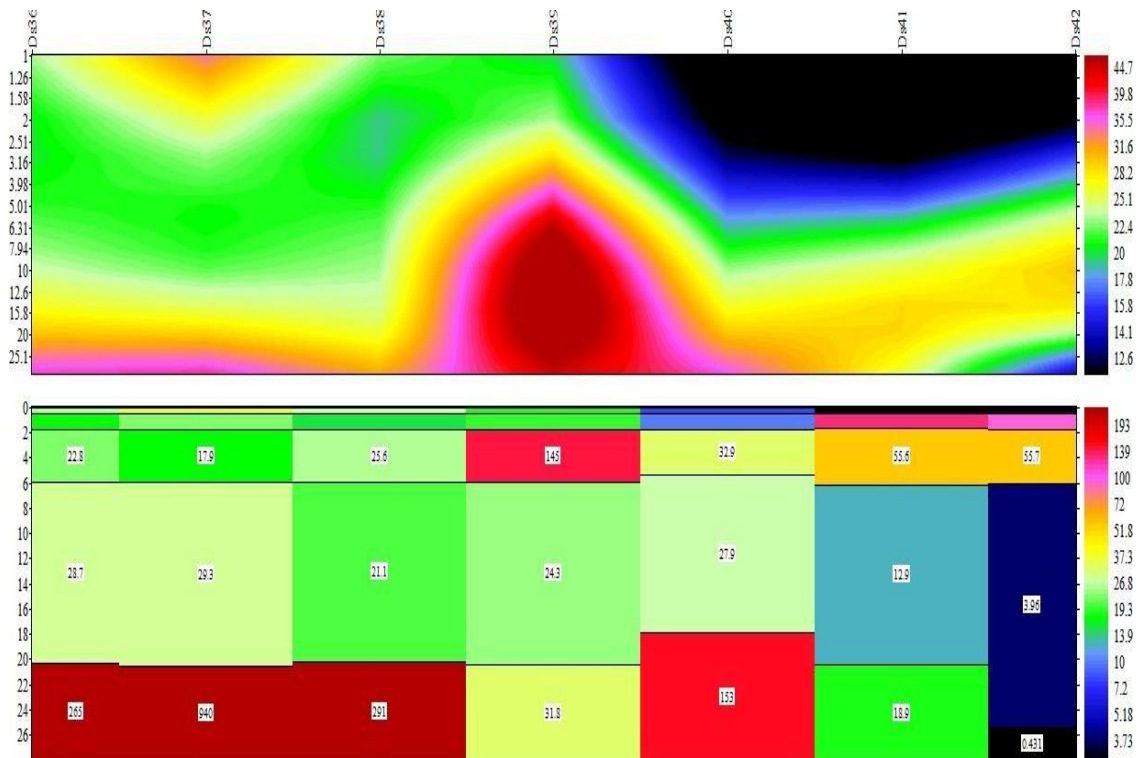
### Profile VI (DS36 - DS42)

This profile is taken along the natural stream that drains the region between the Dyaneshwar Sugar Factory and the compost yard. The resistivity profile VI shows a significant shallow aquifer upstream (DS35 - DS42) up to a depth of 6.3 m bgl. Several large diameters dug wells are present along this profile and water quality analysis from dug well along the stream show no contamination, suggesting that the low  $\rho_a$  values are related to the occurrence of a natural phreatic aquifer. Kindly note the downstream of the profile (from DS35 to DS36) shows moderate

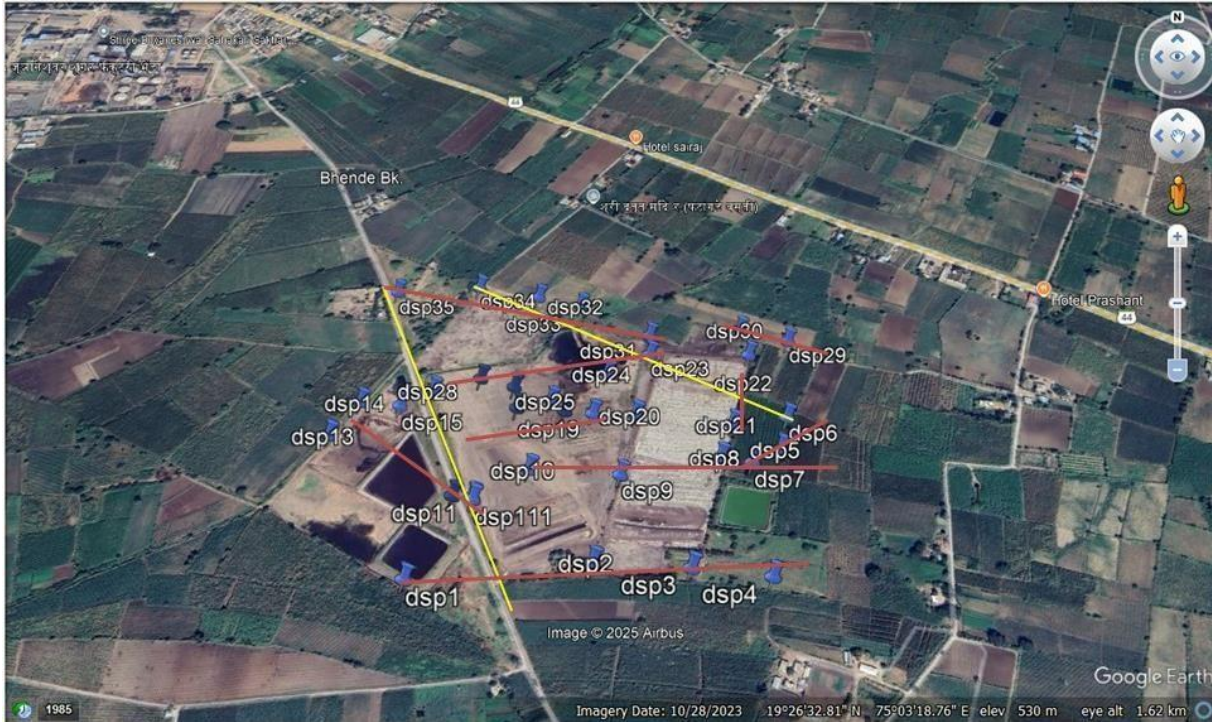
**Fig. 4.2: Locations/points of VES surveys - Post Monsoon season**

A total of 35 VES was undertaken in the Post Monsoon season of 2024-25 (Feb 2025). These were used in six layer models, the graphs of which are presented here (after the table). The Post Monsoon (Fig. 1) modeled apparent resistivity graphs were studied and converted into 4 pseudo section profiles. Post Monsoon vertical resistivity Surveys (VES) curves have been classified into 6 categories (Table 4.1).

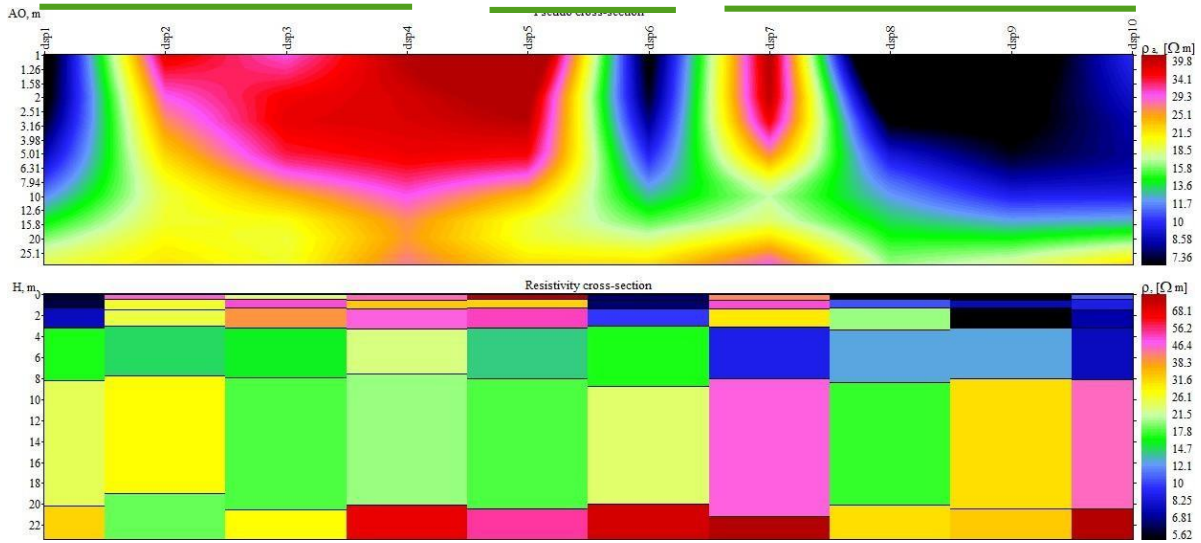
### Profile I (DSP1 - DSP10)

This profile is divided into three sections. Section 1 (DSP1- DSP4) runs in the east west direction from the storage tank to the southwest of the compost shed. In this section the moisture laden low apparent resistivity ( $\rho_a$ ) < 24  $\Omega m$  is seen up to 12.6m bgl (below ground level). However, no leakage (moisture) is seen below VES DSP2 - DSP4 were high resistivity formations are seen. Section 2 of profile 1 DSP5 and DSP6 are present to the east of the compost yard. Here high resistivity is seen in DSP5 but DSP6 show low  $\rho_a$ . Section 3 (DSP7 - DSP10) shows high resistivity at DSP7. DSP8 - DSP10 are well within the compost shed area and show low resistivity ( $\rho_a \sim 7.36 - 11.7 \Omega m$ ) indicating potential contamination to existing ground water.

direction from the storage tank to the southwest of the compost shed. In this section the moisture laden low apparent resistivity ( $\rho_a$ )  $< 24 \Omega\text{m}$  is seen up to 12.6m bgl (below ground level). However, no leakage (moisture) seen below VES DSP 2 – DSP 4 where high resistivity formations were seen.

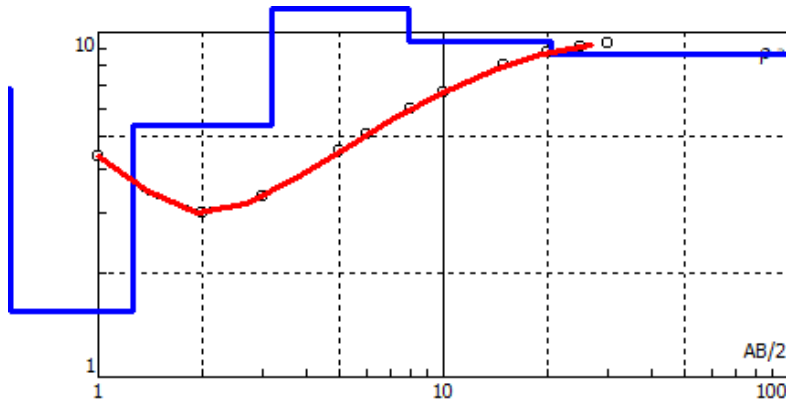
**dsp18**

N	$\rho$	h	d	Alt
1	6.86	0.5	0.5	-0.5
2	1.56	0.761	1.26	-1.261
3	5.35	1.94	3.2	-3.197
4	15.3	4.74	7.94	-7.942
5	9.45	12.5	20.4	-20.4
6	8.6

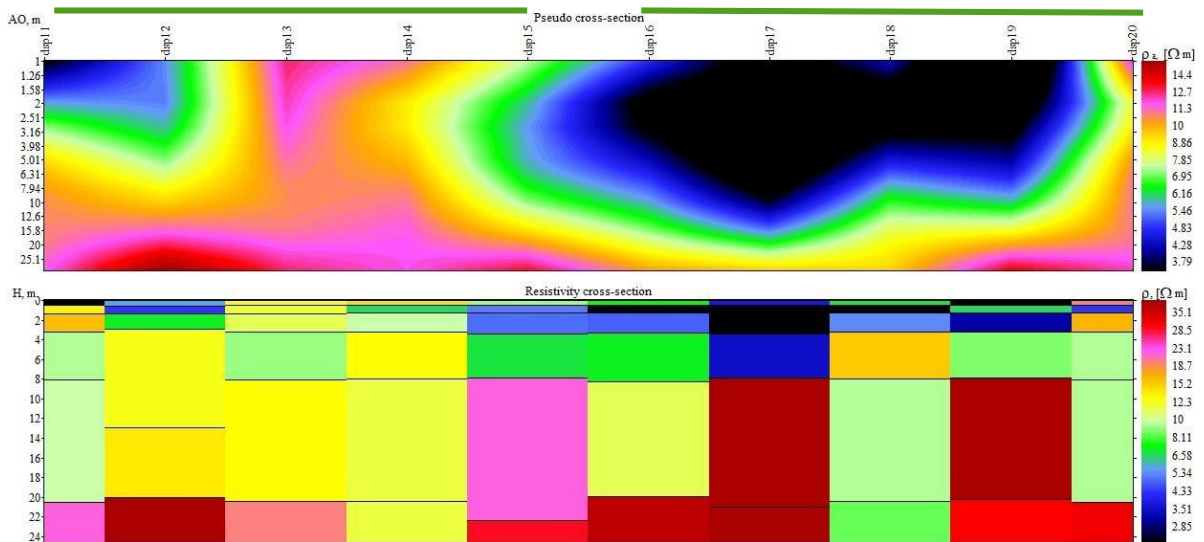
## Profile II (DSP11 - DSP20)

This profile is divided into two critical sections. Section 1 includes DSP11 to DSP15. It is clearly seen that some leakages up to 2m are seen close to the downstream side of the tanks. The remaining part of the profile that is DSP3 to DSP5 shows high resistivity values indicating no leakage. Profile DSP16 to DSP20 run across the open grounds of the compost shed and show low resistivity values ( $\rho_a \sim 3.79 - 6.95 \Omega m$ ) corresponding to an average depth of 12m.

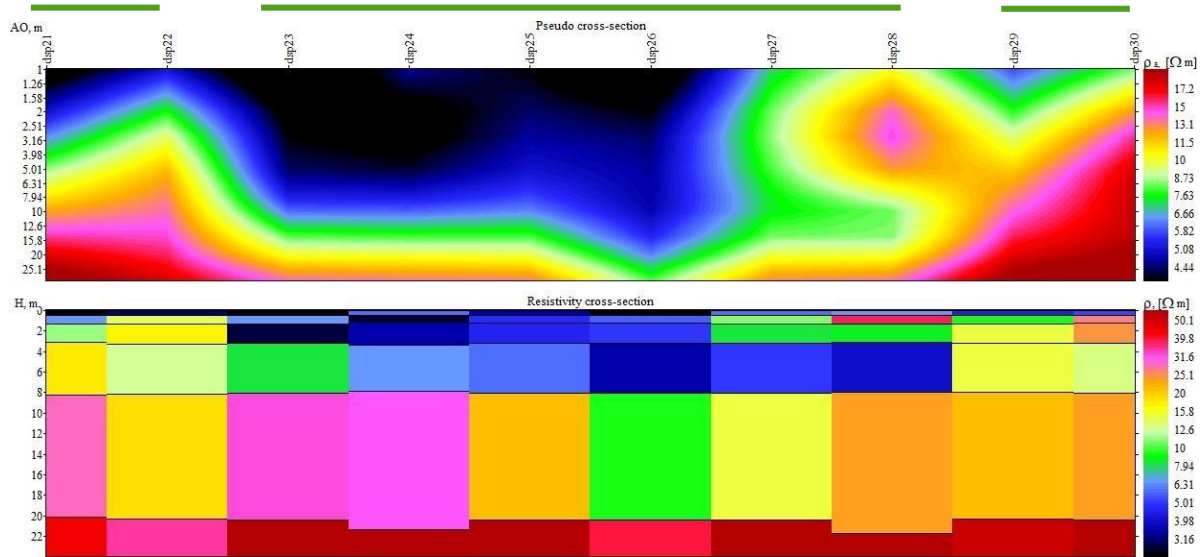
## Profile III (DSP21 - DSP30)

Profile III is divisible into three sections i.e. DSP21 - DSP22, DSP23 - DSP28 and DSP29 - DSP30. Very low apparent resistivity (less than 4.4 - 6.66 Ωm) is seen between section DSP21 to DSP27. Here the maximum depth of contamination is seen at DSP26 to a depth approx. 20m. High resistivity is seen at VES28.

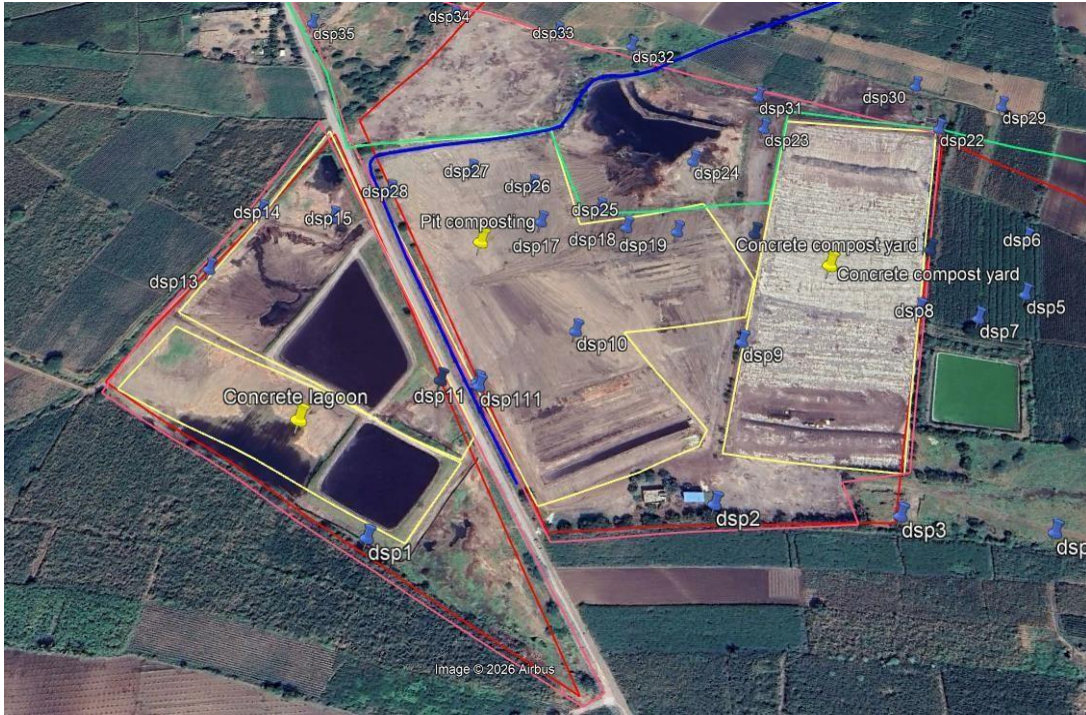
**Figure 5.1: Image is showing VES points in and around the compost yard and spent wash storage lagoon (DSP is a VES point for Dnyaneshwar Sugar)**

3. Potential leakage to the shallow aquifer/ground water is seen at VES 08, VES 09, VES10, VES 11 and VES 12 to a depth of 15.8m similarly VES 06 to VES 20 and VES 31 to VES 34 and VES 32 shows very low resistivity values up to a depth of 12.6 bgl. These locations are plotted in the figure 5.1 (below). Most of the ground water samples of zone 2 are towards north of these points. Ground water samples of zone 2 are in the downstream considering the surface runoff from the spent wash storage and composting site.
