Sub: Report of the Committee constitute by the Hon'ble National Green Tribunal, Principal Bench, New Delhi.

Ref: O.A. NO. 440/2021/PB (News Item Published in Economic Times dt. 21.12.2021 titled "3 dead, 44 injured in flash fire at IOC's Haldia Refinery")

जांच समिति की रिपोर्ट
 आग की घटना आई ओ सी एल, हल्दिया रिफाइनरी
 घटना की तिथि 21st दिसम्बर, 2021
 INVESTIGATION COMMITTEE REPORT
 ON FIRE INCIDENT AT IOCL - HALDIA REFINERY
 DATE OF INCIDENT: 21st DECEMBER, 2021

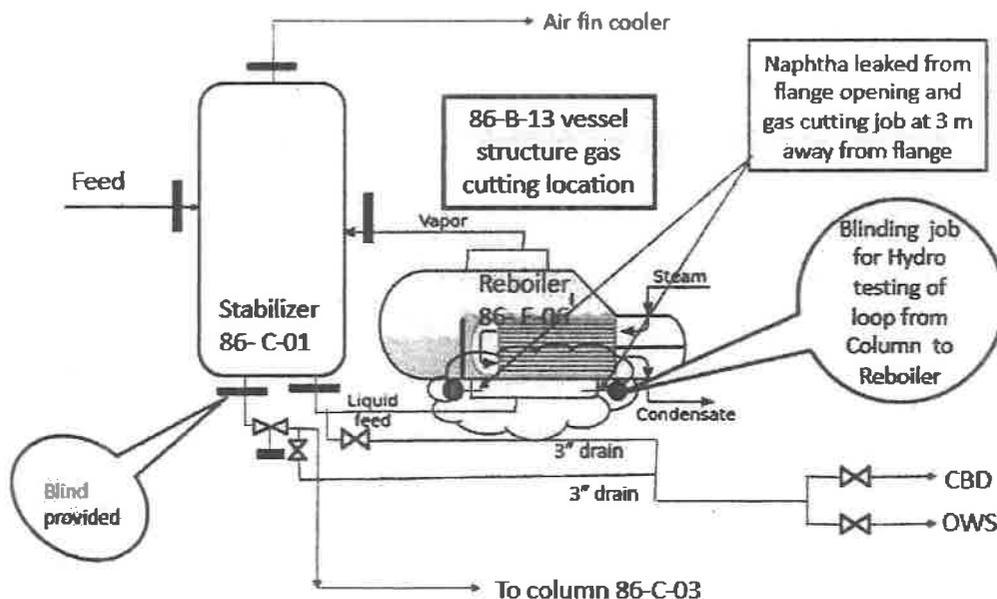
Fig.1 (Site activities being carried out on the day at the time of incident)

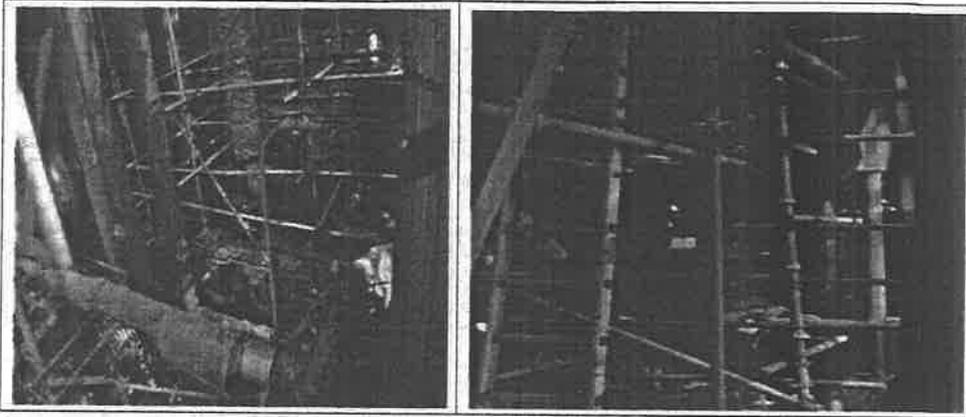
- * | 4) ISOM unit was observed to be congested with scaffolding without having proper escape routes for the large numbers of contract workmen deployed in the unit for maintenance activities. The Operation, Maintenance and Fire & Safety team should have carried out the Hazard Identification and Risk Assessment (HIRA) for such high number of manpower deployed in the unit. The job scheduling should commensurate with the available space for working and escape provisions.

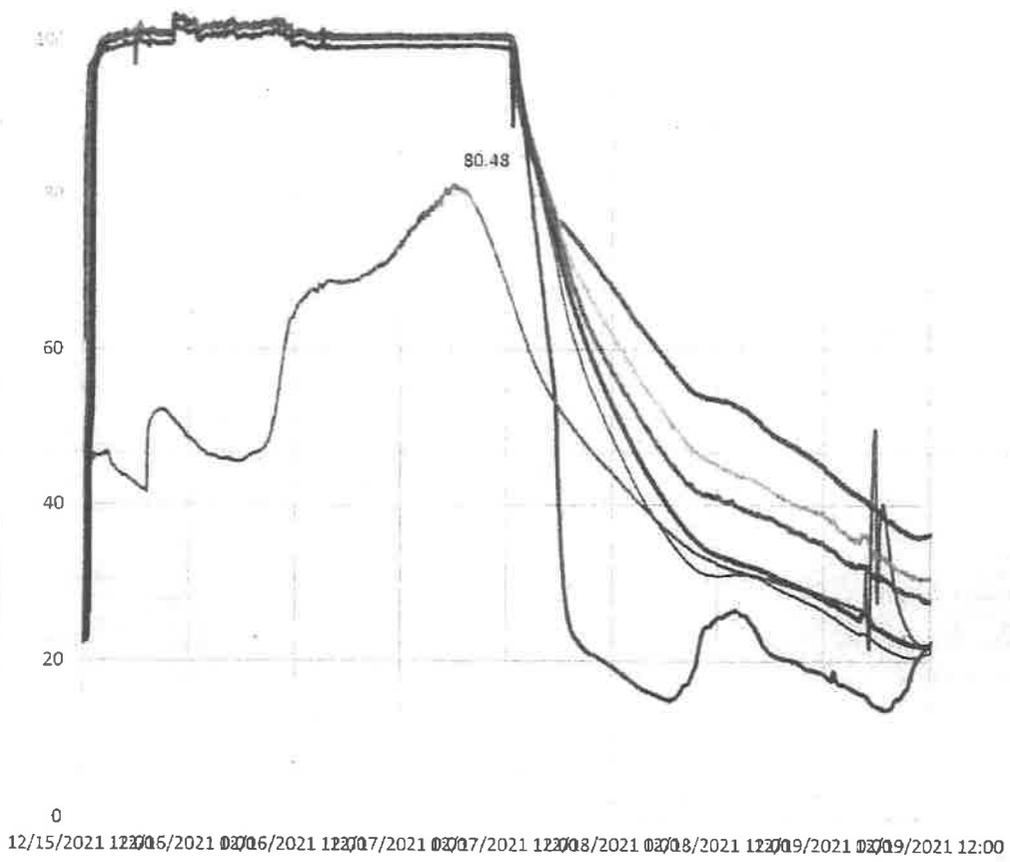
Annexure-4

- Stabilizer top temperature
- Reboiler inlet temperature
- Reboiler outlet temperature
- Stabilizer Column temperature near Tray No. 06
- Stabilizer Column temperature near Tray No. 11
- Stabilizer Column temperature near Tray No. 21
- Stabilizer Column temperature near Tray No. 24

- 4) Reboiler 86-E-06 inlet temperature reached maximum of 81°C (TI-0616 tag) on 17.12.2021 during the steam purging phase. It is inferred that reboiler circuit did not get steam purged adequately.

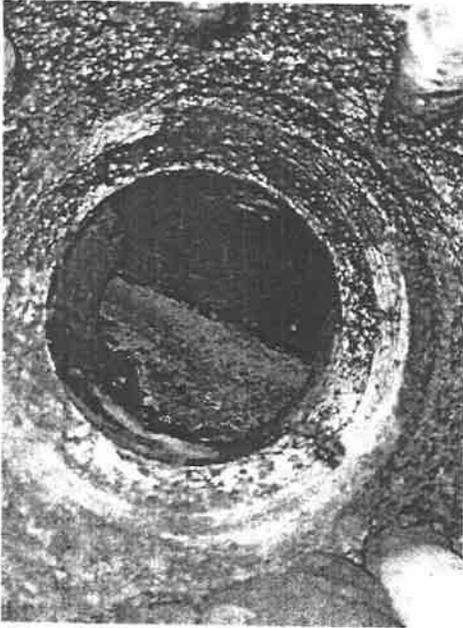
During inspection of the dropped valve a piece of cloth inside the valve. This has led to inadequate flushing of the 86-C-01/ 86-E-06 circuit.

Inside valve view after dropping the valve for inspection

The root cause of the chokage of reboiler circuit drain is considered as debris, which might have accumulated during plant operation. This possibility can be established after opening of reboiler channel head & pulling out of the U tube bundle.

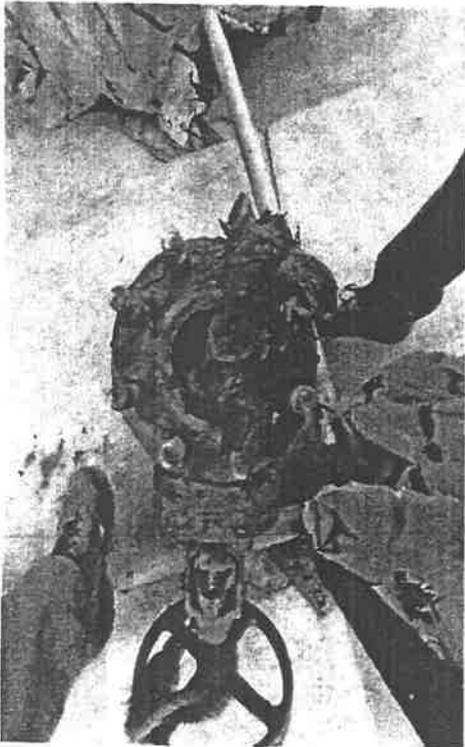
Debris being removed from the valve

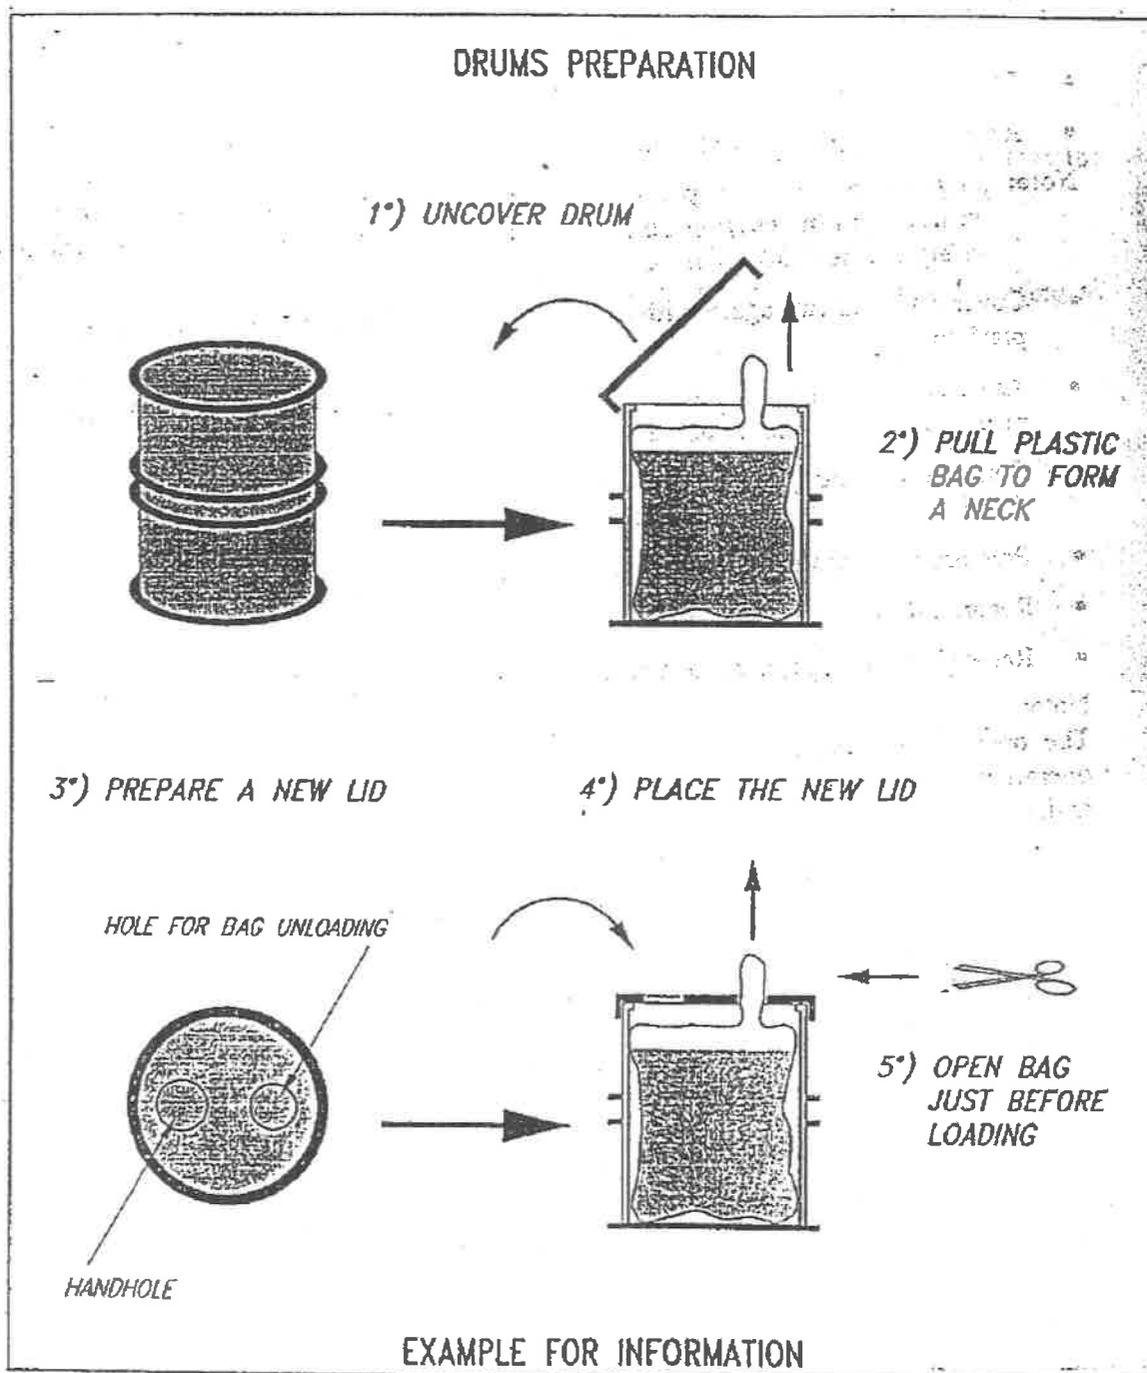
FIGURE 5
PREPARATION OF THE DRUMS

The benzene hydrogenation catalyst LD-412 R and the isomerization catalyst IS-614 A manufactured by Axens are shipped in sealed drums (120 kg for LD-412R and 130 Kg for IS-614A) that have a special protective lining (see Figure 5).

The catalyst is contained in a heavy plastic bag with an unloading neck. This bag is inside another heat-sealed plastic bag. Care should be taken in the drums handling so as not to break or puncture the plastic bags.
