**BEFORE THE HON'BLE NATIONAL GREEN TRIBUNAL
PRINCIPAL BENCH, NEW DELHI
ORIGINAL APPLICATION NO.164/2018**

**RESPONSE OF THE VINDHYACHAL SUPER THERMAL POWER STATION LTD. [NTPC - VINDHYACHAL] TO THE FOURTH
QUARTERLY REPORT OF THE OVERSIGHT COMMITTEE**

Report # DSI/NTPC/2021-21/01c

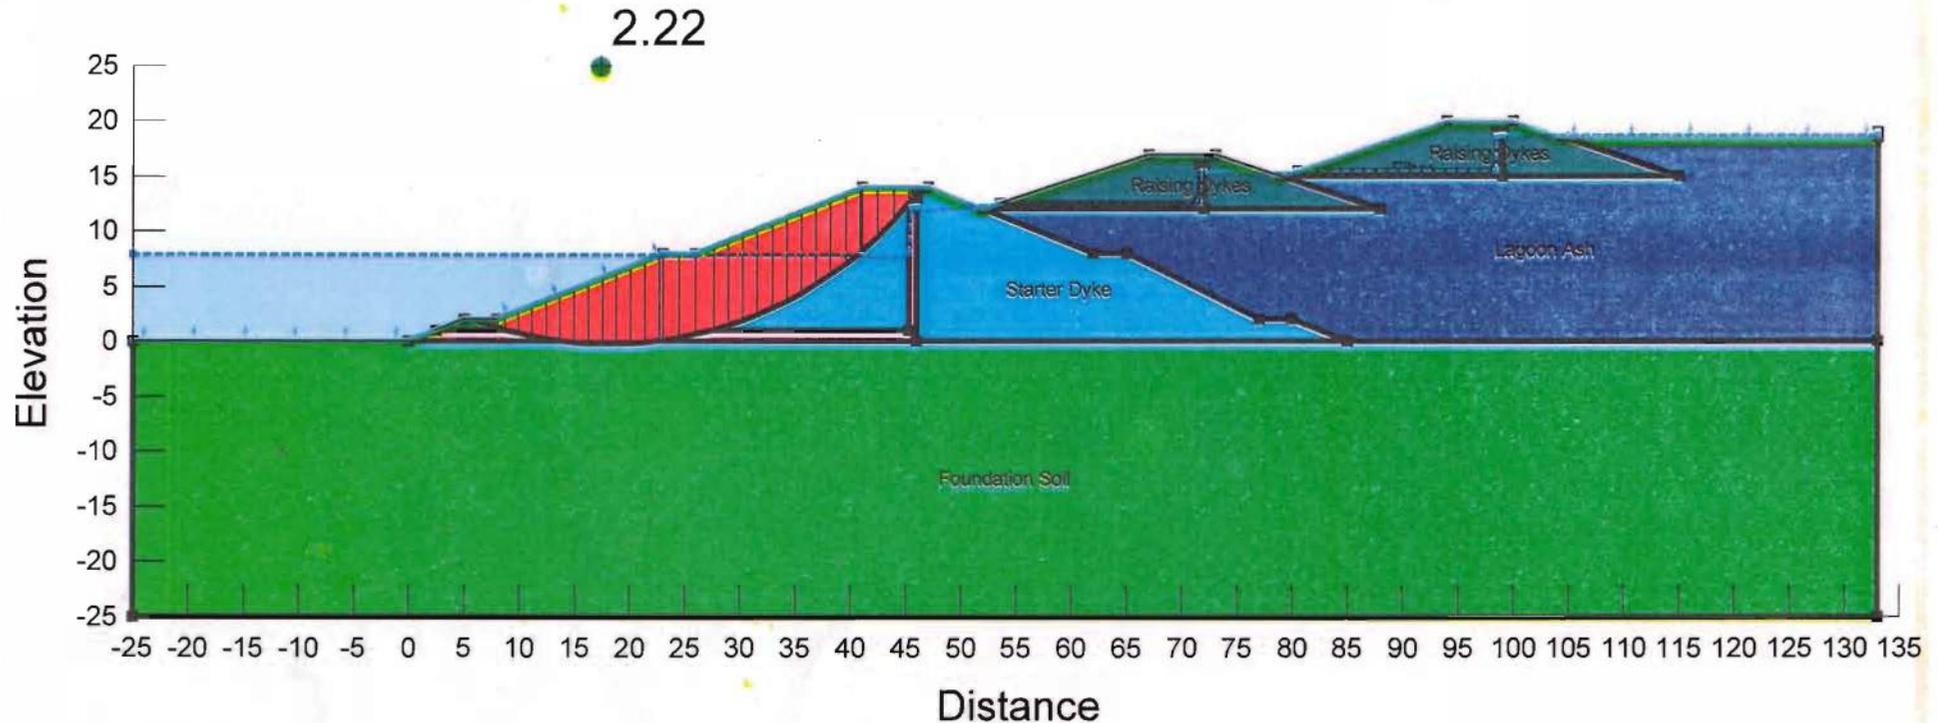
SLOPE STABILITY ANALYSIS(BISHOP METHOD) FOR STARTER DYKE WITH TWO RAISINGS
(STATIC CASE)

OBTAINED CRITICAL FOS > 1.5, SO SAFE

Name: Foundation Soil	Unit Weight: 19 kN/m ³	Cohesion: 10 kPa	Phi: 32 °
Name: Starter Dyke	Unit Weight: 18 kN/m ³	Cohesion: 10 kPa	Phi: 31 °
Name: Raising Dykes	Unit Weight: 15 kN/m ³	Cohesion: 0 kPa	Phi: 31 °
Name: Lagoon Ash	Unit Weight: 15.5 kN/m ³	Cohesion: 0 kPa	Phi: 30 °
Name: Filter	Unit Weight: 19 kN/m ³	Cohesion: 0 kPa	Phi: 35 °

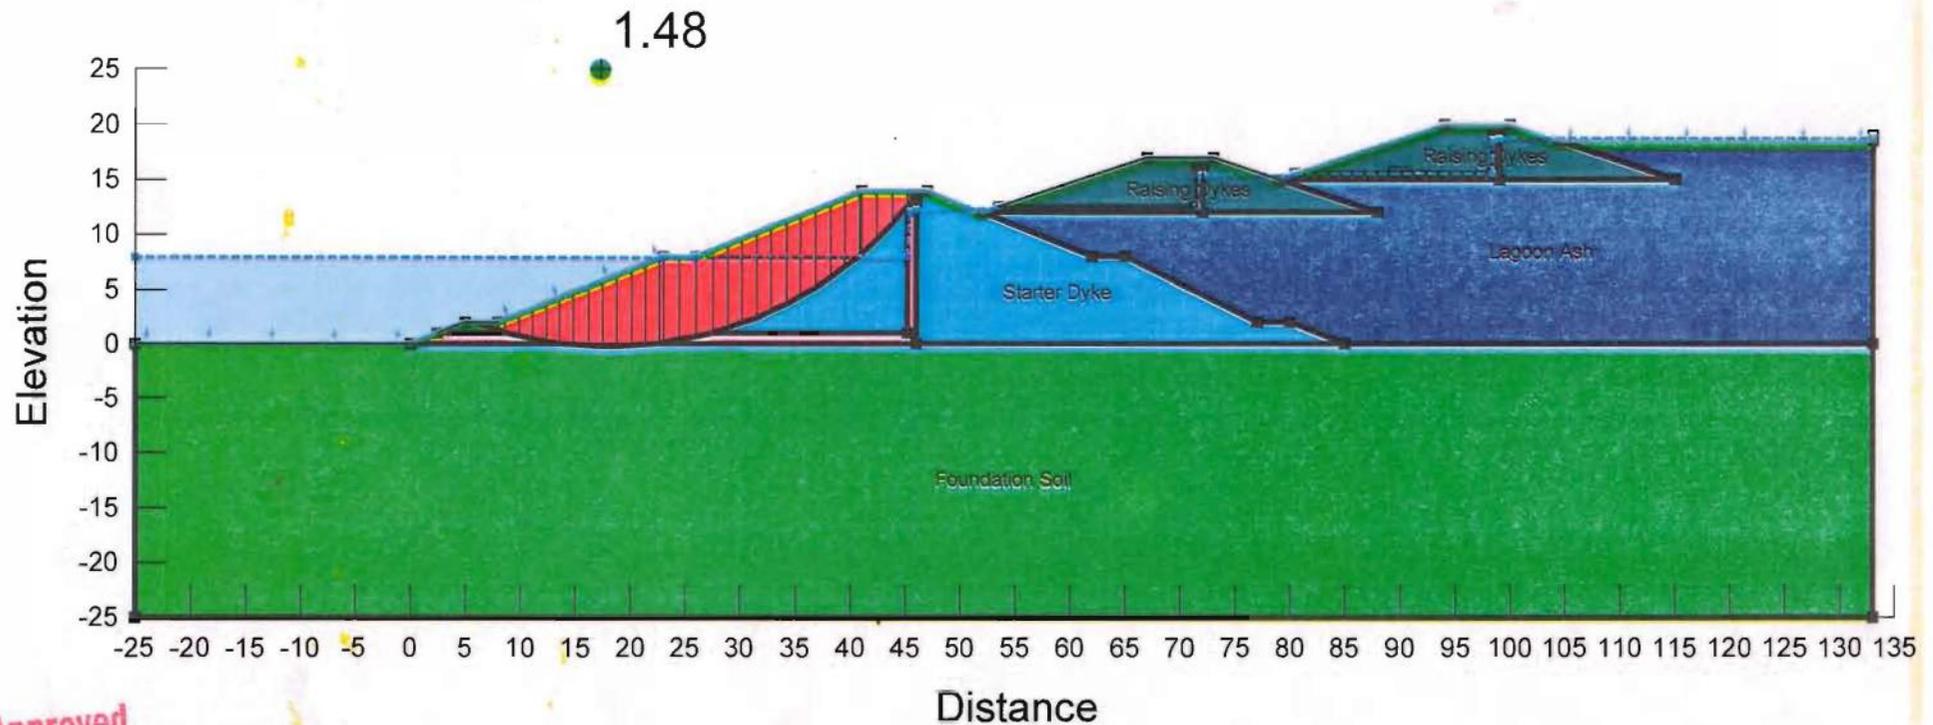
SLOPE STABILITY ANALYSIS(BISHOP METHOD) FOR STARTER DYKE WITH TWO RAISINGS
(SEISMIC CASE)

OBTAINED CRITICAL FOS > 1.0, SO SAFE

Name: Foundation Soil	Unit Weight: 19 kN/m ³	Cohesion: 10 kPa	Phi: 32 °
Name: Starter Dyke	Unit Weight: 18 kN/m ³	Cohesion: 10 kPa	Phi: 31 °
Name: Raising Dykes	Unit Weight: 15 kN/m ³	Cohesion: 0 kPa	Phi: 31 °
Name: Lagoon Ash	Unit Weight: 15.5 kN/m ³	Cohesion: 0 kPa	Phi: 30 °
Name: Filter	Unit Weight: 19 kN/m ³	Cohesion: 0 kPa	Phi: 35 °

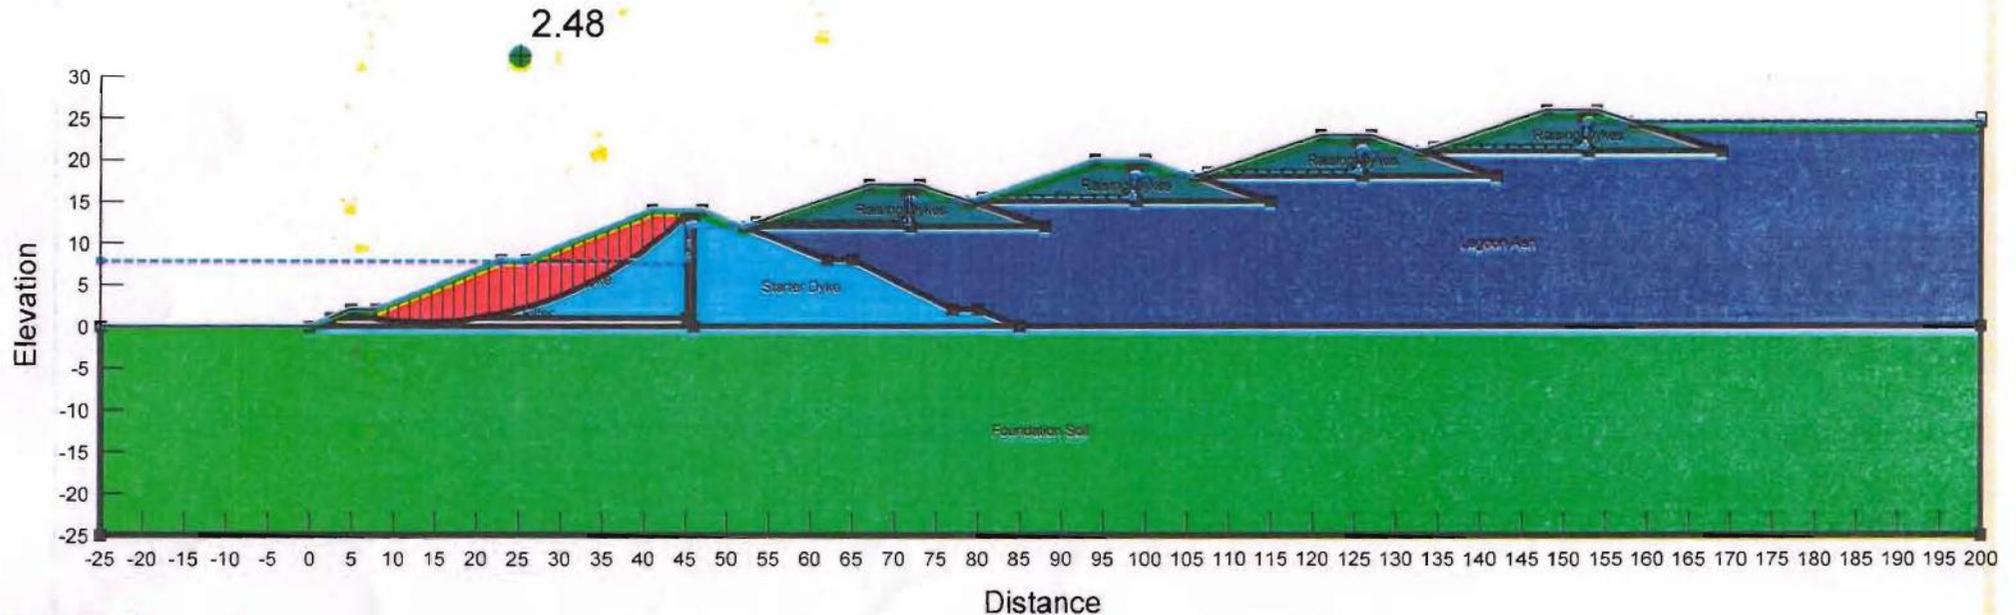
SLOPE STABILITY ANALYSIS(BISHOP METHOD) FOR STARTER DYKE WITH FOUR RAISINGS
(STATIC CASE)

OBTAINED CRITICAL FOS>1.5, SO SAFE

Name: Foundation Soil	Unit Weight: 19 kN/m ³	Cohesion: 10 kPa	Phi: 32 °
Name: Starter Dyke	Unit Weight: 18 kN/m ³	Cohesion: 10 kPa	Phi: 31 °
Name: Raising Dykes	Unit Weight: 15 kN/m ³	Cohesion: 0 kPa	Phi: 31 °
Name: Lagoon Ash	Unit Weight: 15.5 kN/m ³	Cohesion: 0 kPa	Phi: 30 °
Name: Filter	Unit Weight: 19 kN/m ³	Cohesion: 0 kPa	Phi: 35 °

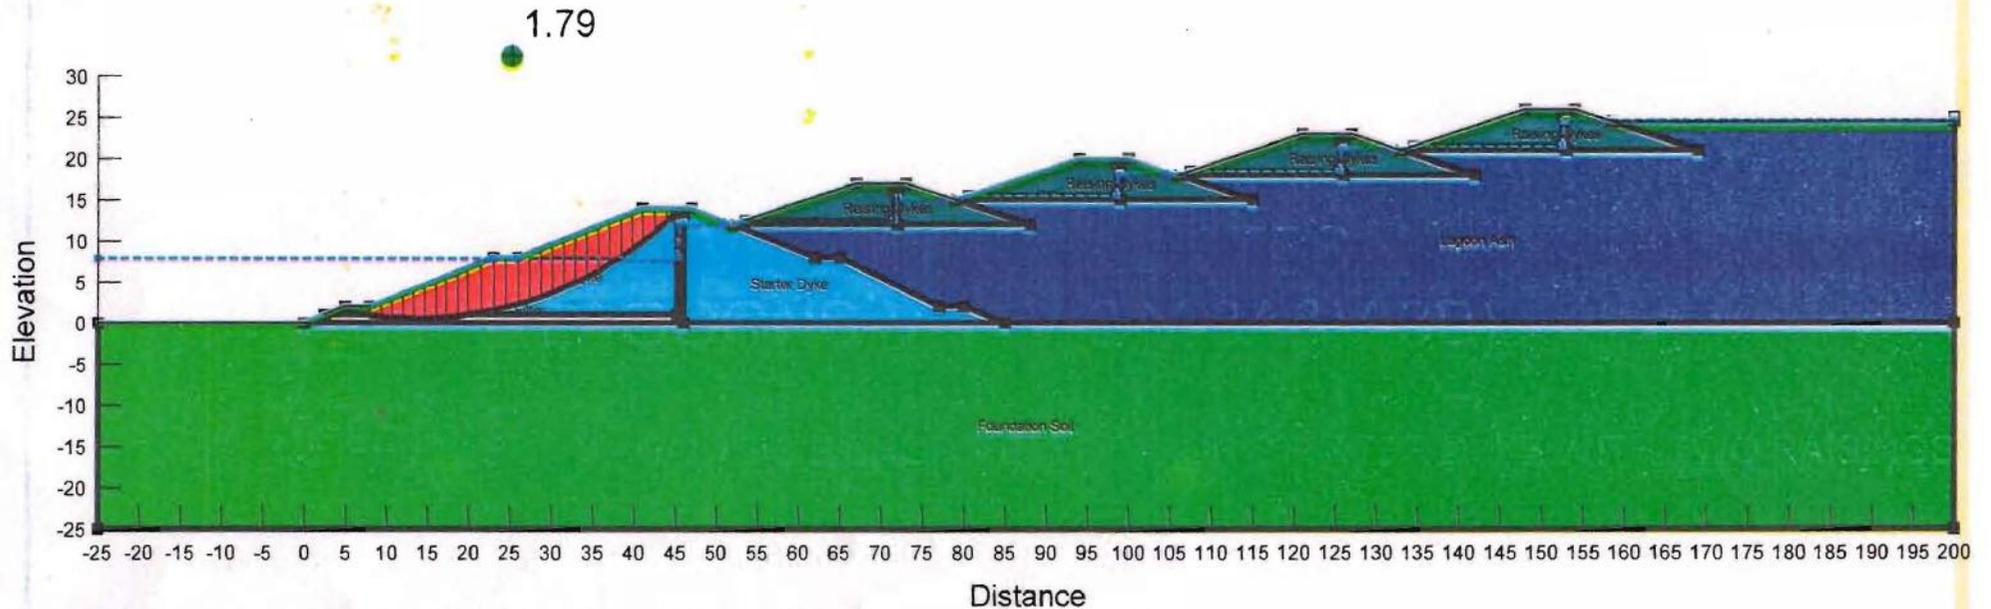
SLOPE STABILITY ANALYSIS(BISHOP METHOD) FOR STARTER DYKE WITH FOUR RAISINGS
(SEISMIC CASE)

OBTAINED CRITICAL FOS>1.0, SO SAFE

- Name: Foundation Soil Unit Weight: 19 kN/m³ Cohesion: 10 kPa Phi: 32 °
- Name: Starter Dyke Unit Weight: 18 kN/m³ Cohesion: 10 kPa Phi: 31 °
- Name: Raising Dykes Unit Weight: 15 kN/m³ Cohesion: 0 kPa Phi: 31 °
- Name: Lagoon Ash Unit Weight: 14 kN/m³ Cohesion: 0 kPa Phi: 30 °
- Name: Filter Unit Weight: 19 kN/m³ Cohesion: 0 kPa Phi: 35 °

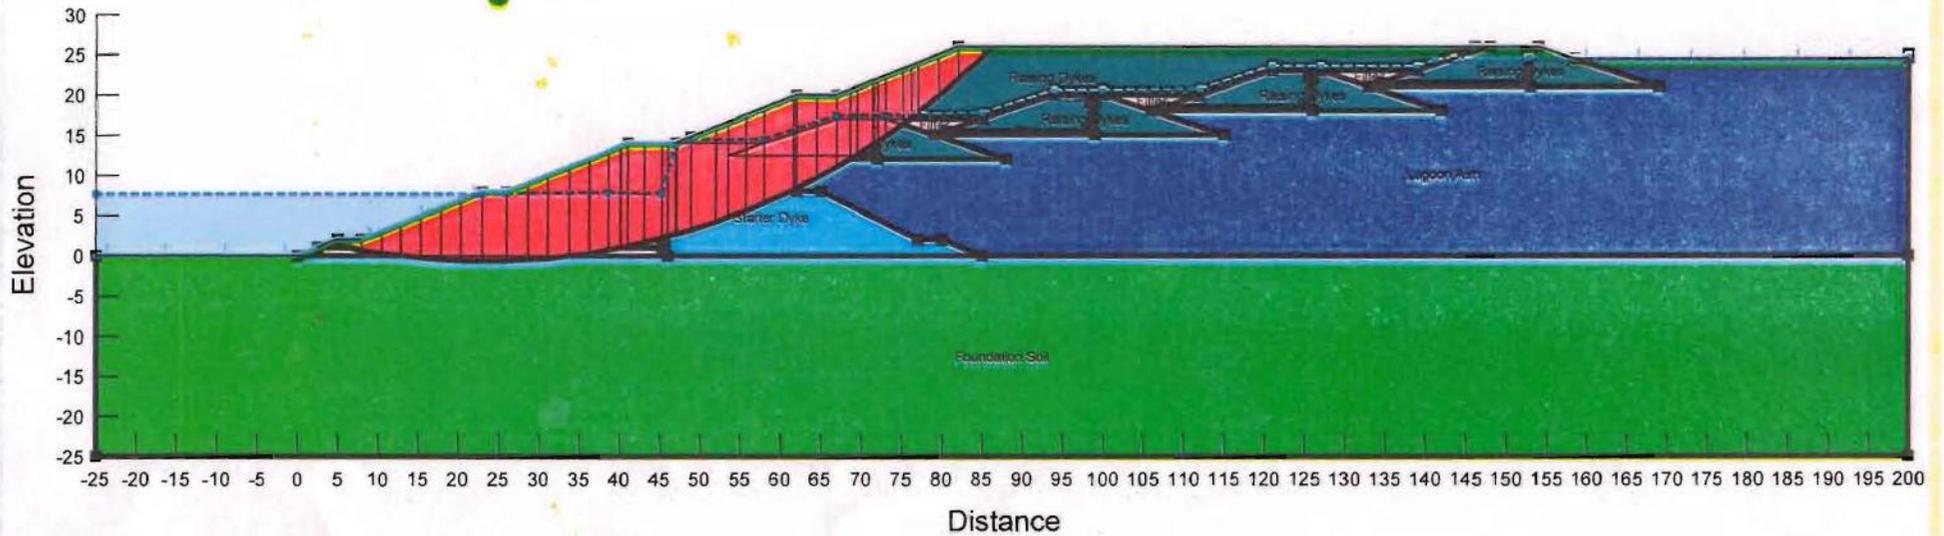
OBTAINED CRITICAL FOS>1.5, SO SAFE

1.78

Name: Foundation Soil	Unit Weight: 19 kN/m ³	Cohesion: 10 kPa	Phi: 32 °
Name: Starter Dyke	Unit Weight: 18 kN/m ³	Cohesion: 10 kPa	Phi: 31 °
Name: Raising Dykes	Unit Weight: 15 kN/m ³	Cohesion: 0 kPa	Phi: 31 °
Name: Lagoon Ash	Unit Weight: 15.5 kN/m ³	Cohesion: 0 kPa	Phi: 30 °
Name: Filter	Unit Weight: 19 kN/m ³	Cohesion: 0 kPa	Phi: 35 °

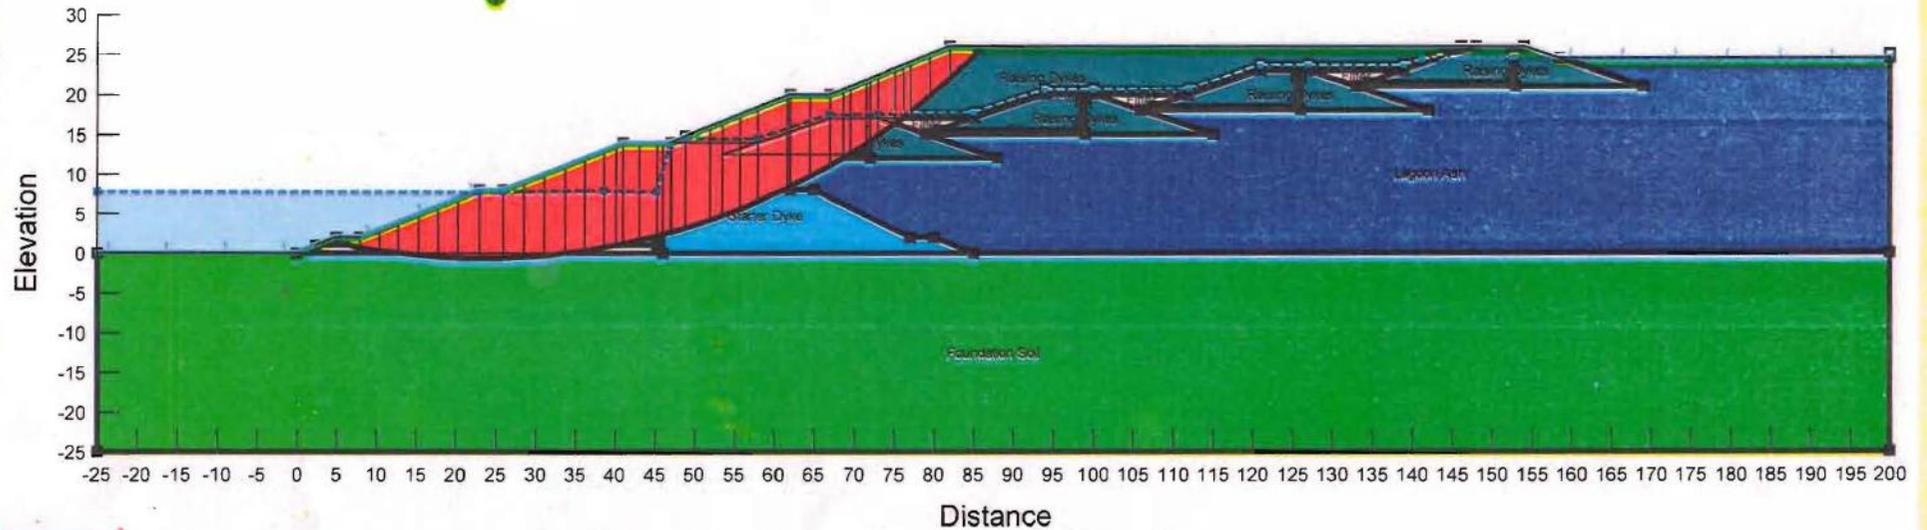
OBTAINED CRITICAL FOS>1.0, SO SAFE

1.22

Name: Foundation Soil	Unit Weight: 19 kN/m ³	Cohesion: 10 kPa	Phi: 32 °
Name: Starter Dyke	Unit Weight: 18 kN/m ³	Cohesion: 10 kPa	Phi: 31 °
Name: Raising Dykes	Unit Weight: 15 kN/m ³	Cohesion: 0 kPa	Phi: 31 °
Name: Lagoon Ash	Unit Weight: 15.5 kN/m ³	Cohesion: 0 kPa	Phi: 30 °
Name: Filter	Unit Weight: 19 kN/m ³	Cohesion: 0 kPa	Phi: 35 °

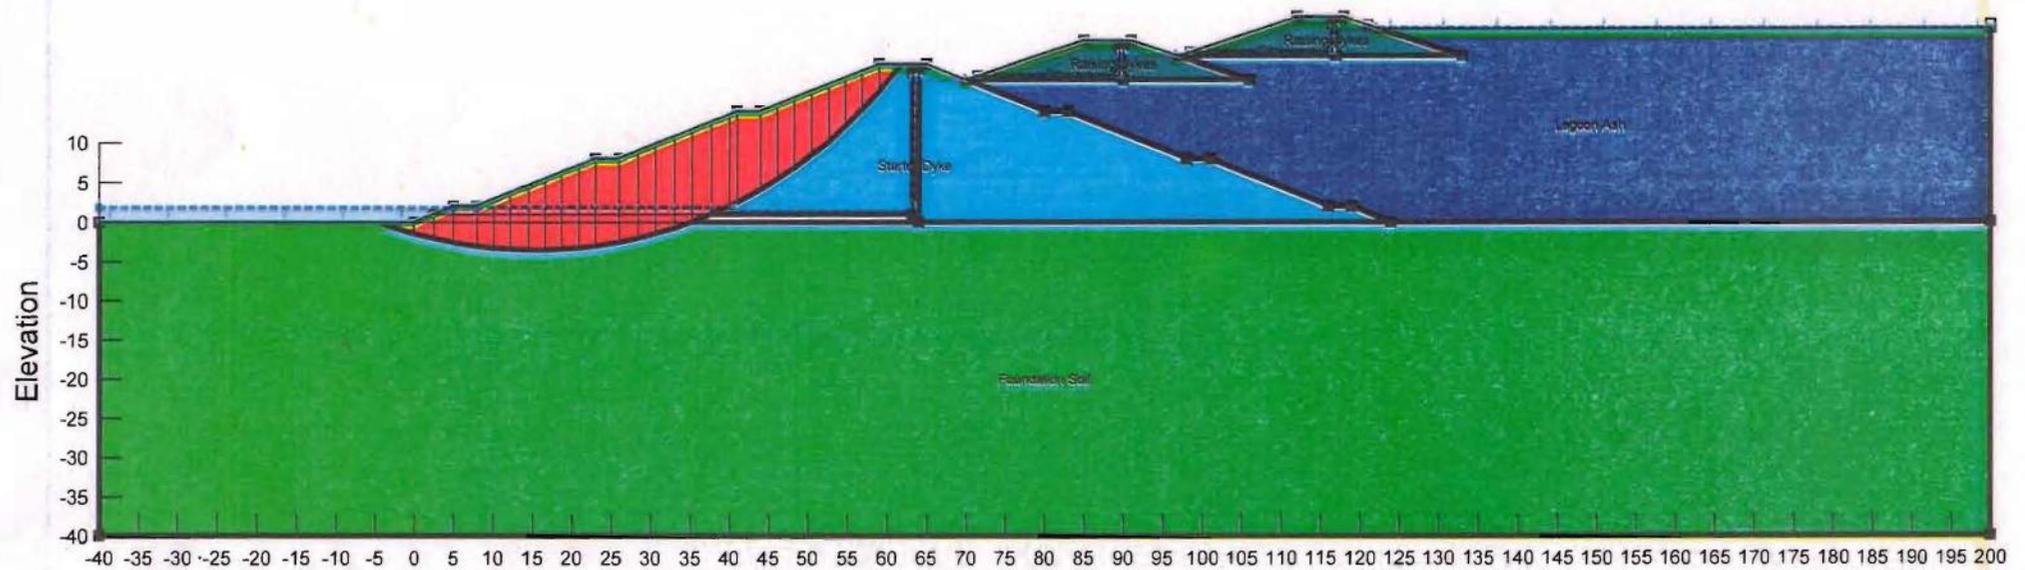
OBTAINED CRITICAL FOS>1.5, SO SAFE
2.18

(STATIC CASE)

Name	Unit Weight	Cohesion	Phi
Name: Foundation Soil	Unit Weight: 19 kN/m ³	Cohesion: 10 kPa	Phi: 32 °
Name: Starter Dyke	Unit Weight: 18 kN/m ³	Cohesion: 10 kPa	Phi: 31 °
Name: Raising Dykes	Unit Weight: 15 kN/m ³	Cohesion: 0 kPa	Phi: 31 °
Name: Lagoon Ash	Unit Weight: 15.5 kN/m ³	Cohesion: 0 kPa	Phi: 30 °
Name: Filter	Unit Weight: 19 kN/m ³	Cohesion: 0 kPa	Phi: 35 °

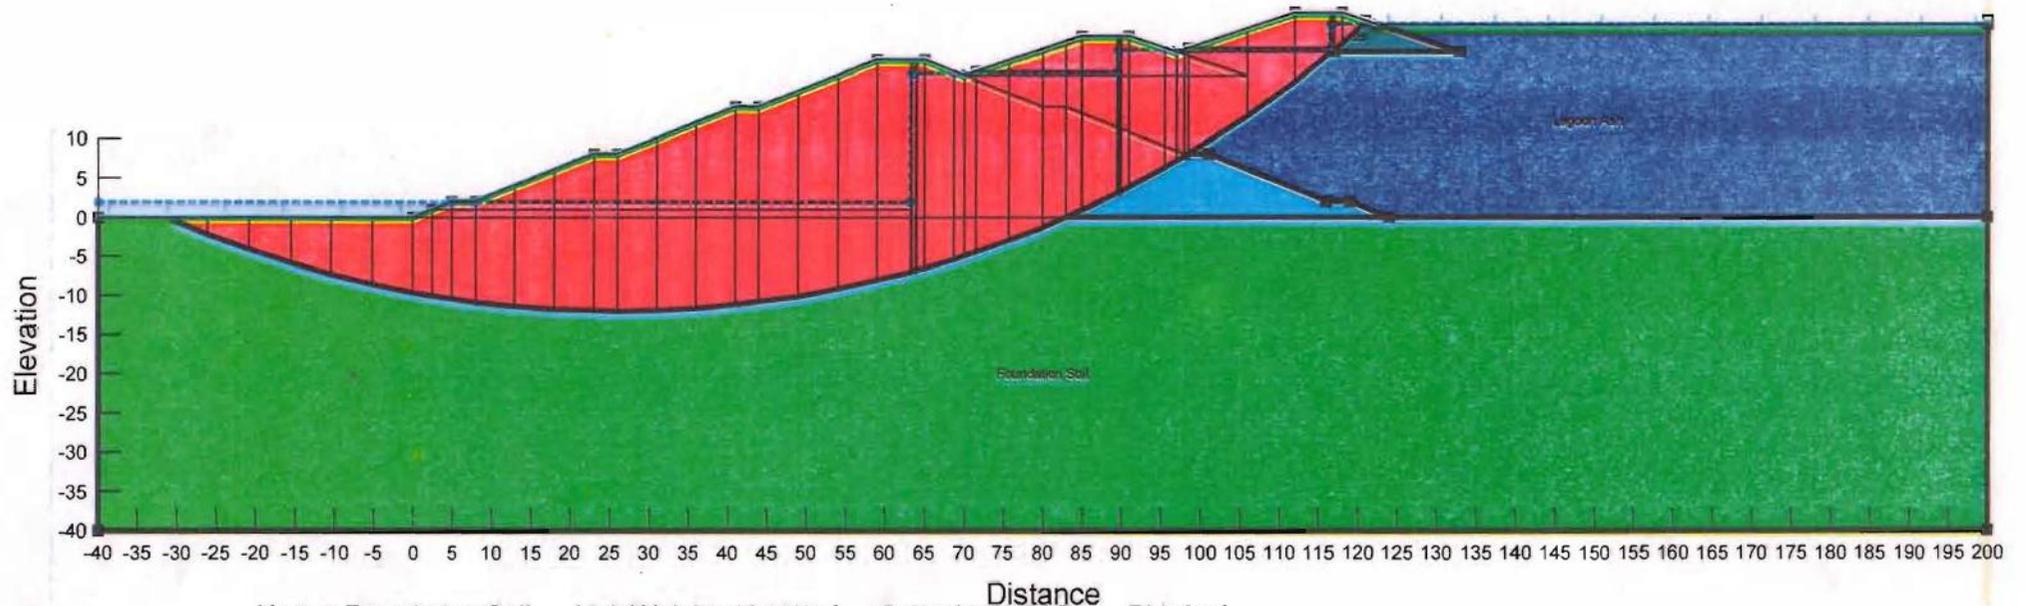
SLOPE STABILITY ANALYSIS(BISHOP METHOD) FOR STARTER DYKE WITH TWO RAISINGS
(SEISMIC CASE)

OBTAINED CRITICAL FOS>1.0, SO SAFE 1.52

Name: Foundation Soil	Unit Weight: 19 kN/m ³	Cohesion: 10 kPa	Phi: 32 °
Name: Starter Dyke	Unit Weight: 18 kN/m ³	Cohesion: 10 kPa	Phi: 31 °
Name: Raising Dykes	Unit Weight: 15 kN/m ³	Cohesion: 0 kPa	Phi: 31 °
Name: Lagoon Ash	Unit Weight: 15.5 kN/m ³	Cohesion: 0 kPa	Phi: 30 °
Name: Filter	Unit Weight: 19 kN/m ³	Cohesion: 0 kPa	Phi: 35 °

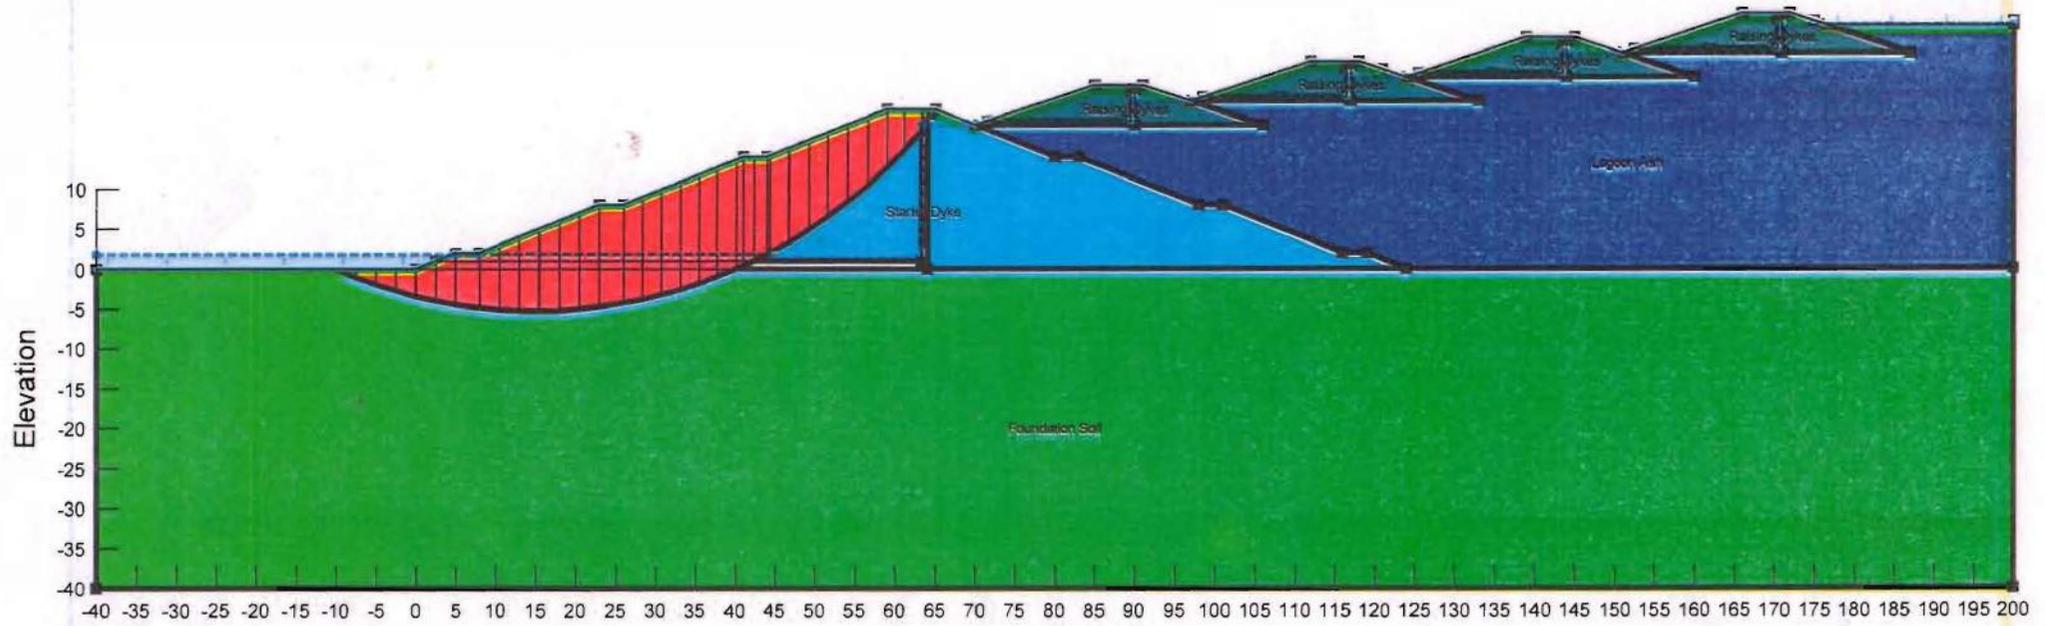
VINDHYACHAL STPS (LAGOONS- V-4A&V-4B)

SLOPE STABILITY ANALYSIS(BISHOP METHOD) FOR STARTER DYKE WITH FOUR RAISINGS
 OBTAINED CRITICAL FOS > 1.5, SO SAFE (STATIC CASE)
 2.20

Name	Unit Weight	Cohesion	Phi
Name: Foundation Soil	Unit Weight: 19 kN/m ³	Cohesion: 10 kPa	Phi: 32 °
Name: Starter Dyke	Unit Weight: 18 kN/m ³	Cohesion: 10 kPa	Phi: 31 °
Name: Raising Dykes	Unit Weight: 15 kN/m ³	Cohesion: 0 kPa	Phi: 31 °
Name: Lagoon Ash	Unit Weight: 15.5 kN/m ³	Cohesion: 0 kPa	Phi: 30 °
Name: Filter	Unit Weight: 19 kN/m ³	Cohesion: 0 kPa	Phi: 35 °

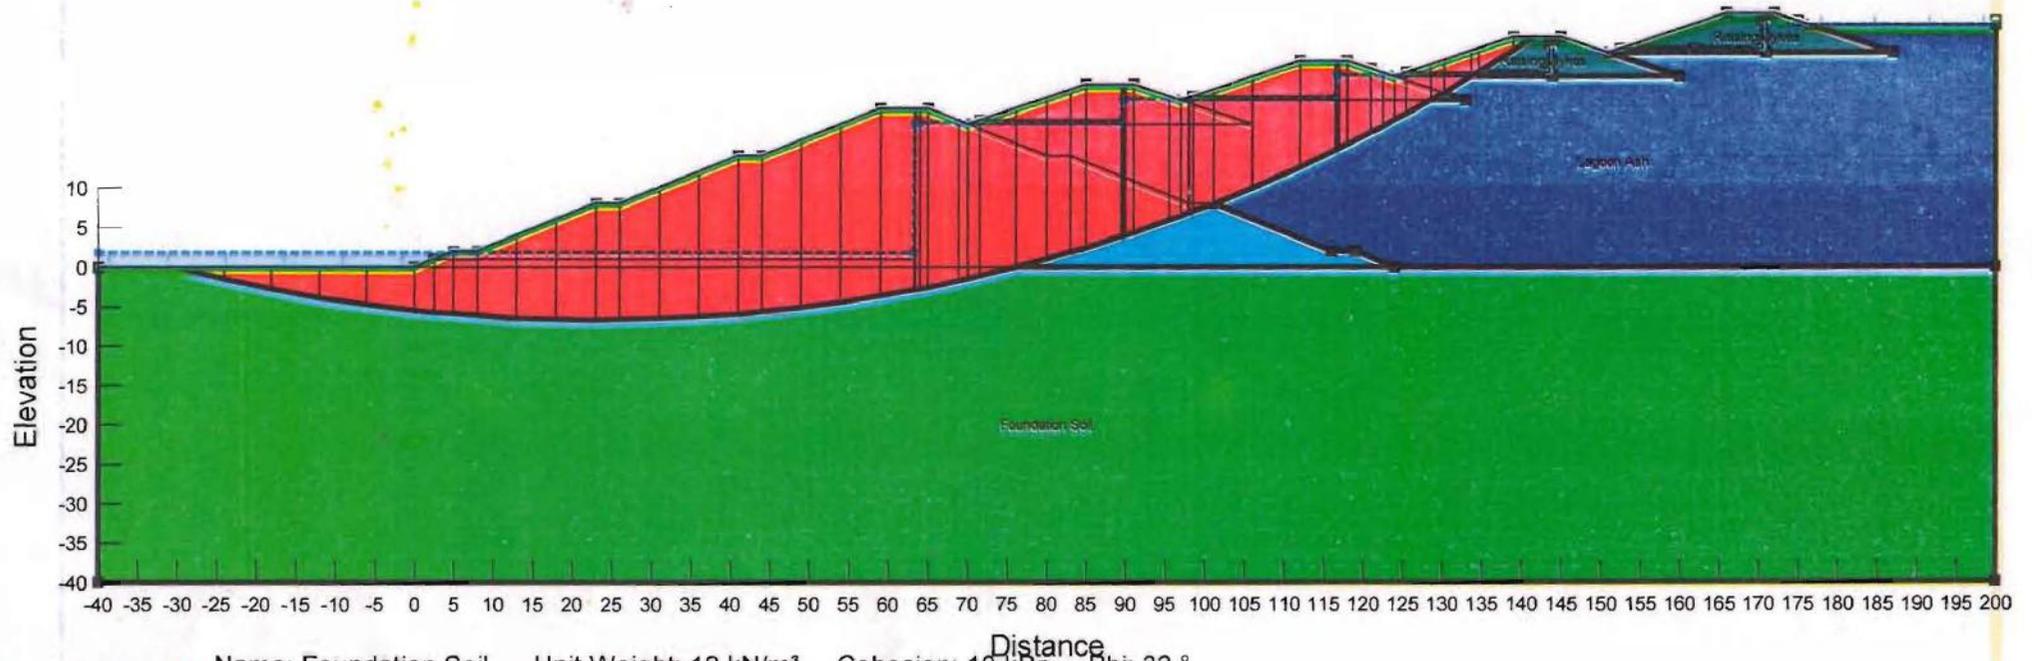
OBTAINED CRITICAL FOS>1.0, SO SAFE (SEISMIC CASE)
1.52

Name: Foundation Soil	Unit Weight: 19 kN/m ³	Cohesion: 10 kPa	Phi: 32 °
Name: Starter Dyke	Unit Weight: 18 kN/m ³	Cohesion: 10 kPa	Phi: 31 °
Name: Raising Dykes	Unit Weight: 15 kN/m ³	Cohesion: 0 kPa	Phi: 31 °
Name: Lagoon Ash	Unit Weight: 15.5 kN/m ³	Cohesion: 0 kPa	Phi: 30 °
Name: Filter	Unit Weight: 19 kN/m ³	Cohesion: 0 kPa	Phi: 35 °

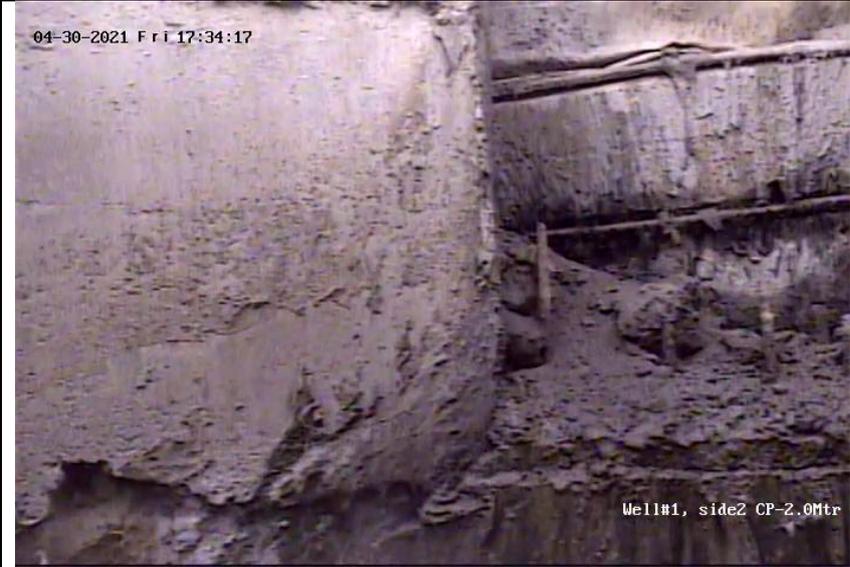
Large Visible Gap in Window (Well#1) at 2MTR depth

1. **Well no.1:** Reinforcements were visible at 2mtr depth all around the well. The second window (side #2) has a large visible gap at this depth. Improper construction joints were found along entire depth of well. While some such joints had visible exposed reinforcements, some had missing mortar, and some had exposed jute/plastic bags. Leakages were found at depths of 9m depth along Side #1 and at depths of 3m and 8m along Side #1.

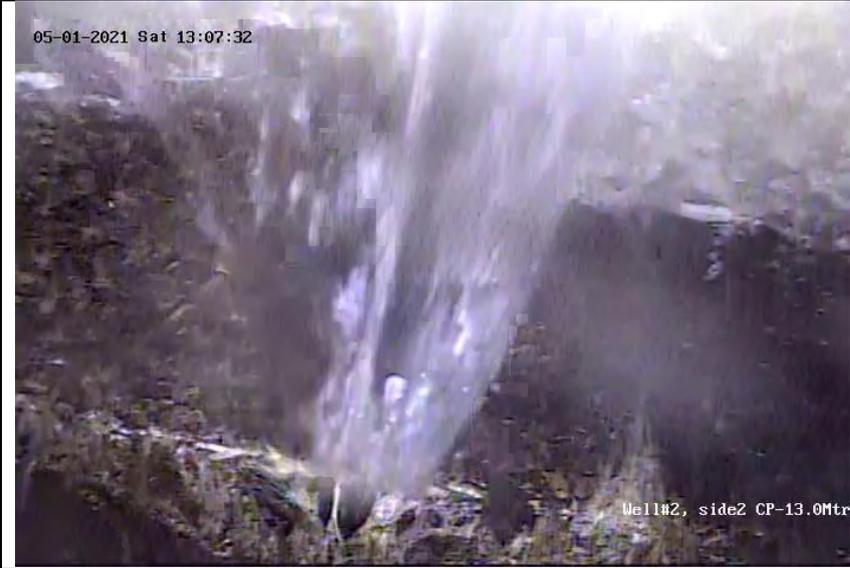
Heavy Leakage in Well#2 at 13MTR depth (Inverted image because of camera position)

Well no.2: While most of this well had similar issues like well no.1, there were two major defects found. The window is either not closed properly at a depth of 8-9m. At 12-13mtr depth, there is a huge infiltration of water into the well.

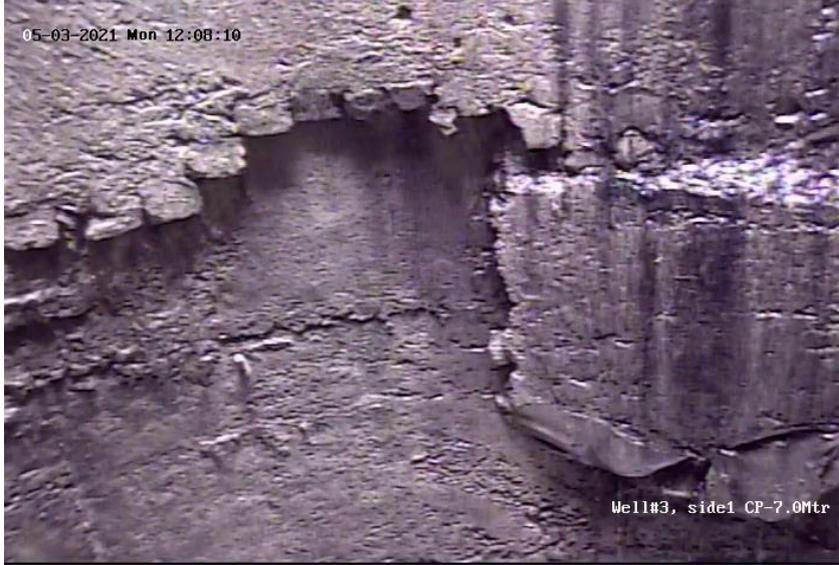
<p>Well#3, side1 CP-7.0Mtr</p>	<p>Displaced Concrete chunk in Well#3 at 7MTR depth</p>
<p>05-05-2021 Wed 11:13:01</p>

Well no.3: General condition is similar to well 1. At 7m - 8m a concrete chunk is displaced and there is water infiltration. The concrete in this well from 7m to 12m depth is deteriorating fast and a major leakage was found at 11mtr depth.

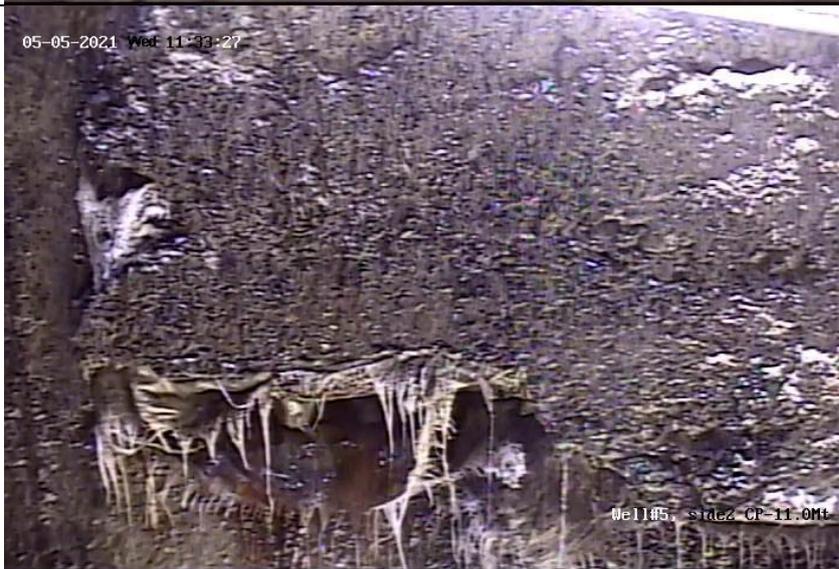
<p>Well#5, side2 CP-11.0Mtr</p>	<p>Hole in Well#5 (Leakage is also visible) at 11MTR depth</p>

Well no. 5: General condition is similar to well 1. Along 7mtr depth, the concrete appears to be displaced and a huge hole was found at 8mtr depth. The construction joint is leaking around 9mtr. Another hole was found at 11mtr depth. The window at 13mtr depth is leaking along the bottom.

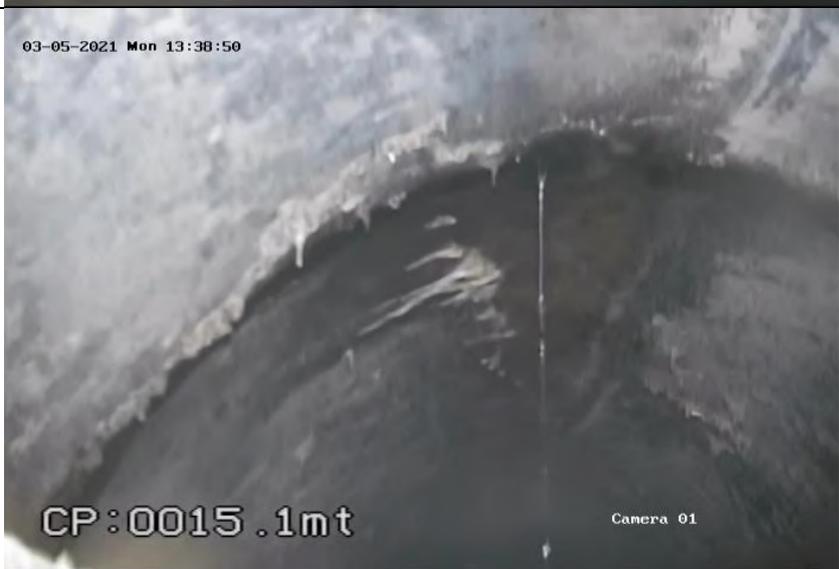
<p>CP:0015 .1mt</p> <p>Camera 01</p>	<p>Dripping Leakage along pipe joint at 15.1MTR from Well#3</p>

Pipeline 3: Mild seepage was found at 8.5m. A major dripper (water continuously entering) at 15.1m.

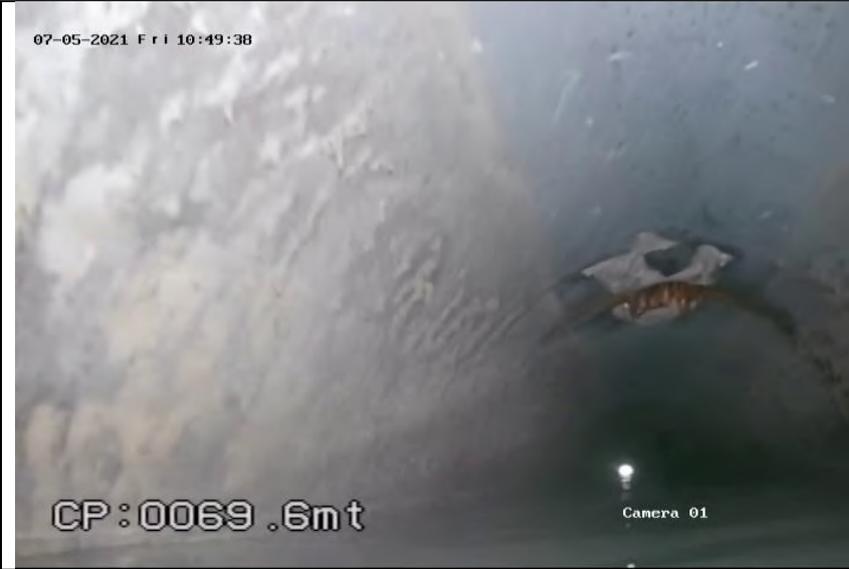
Hole in pipe at 12:00clock position along pipe joint at 69.6MTR from Well#5

Dripping Infiltration could be seen through this hole.

Pipeline 5: Water seepage was found at several joints viz.50.5m, 84.9m, 105.6m, 110.2m. A major hole (damage) was found in the pipe at 70.1m at 12:00 O'clock position.

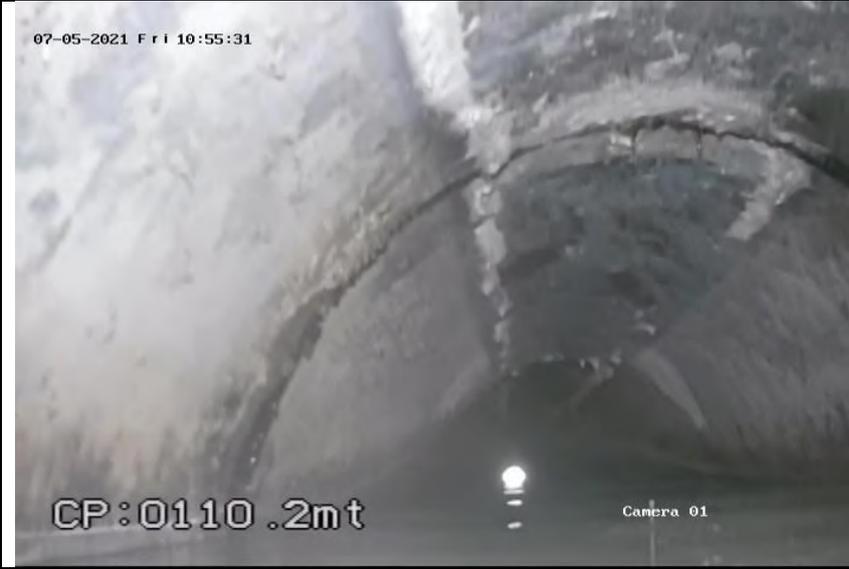
Dripping infiltration along pipe joint at 110.2MTr from Well#5

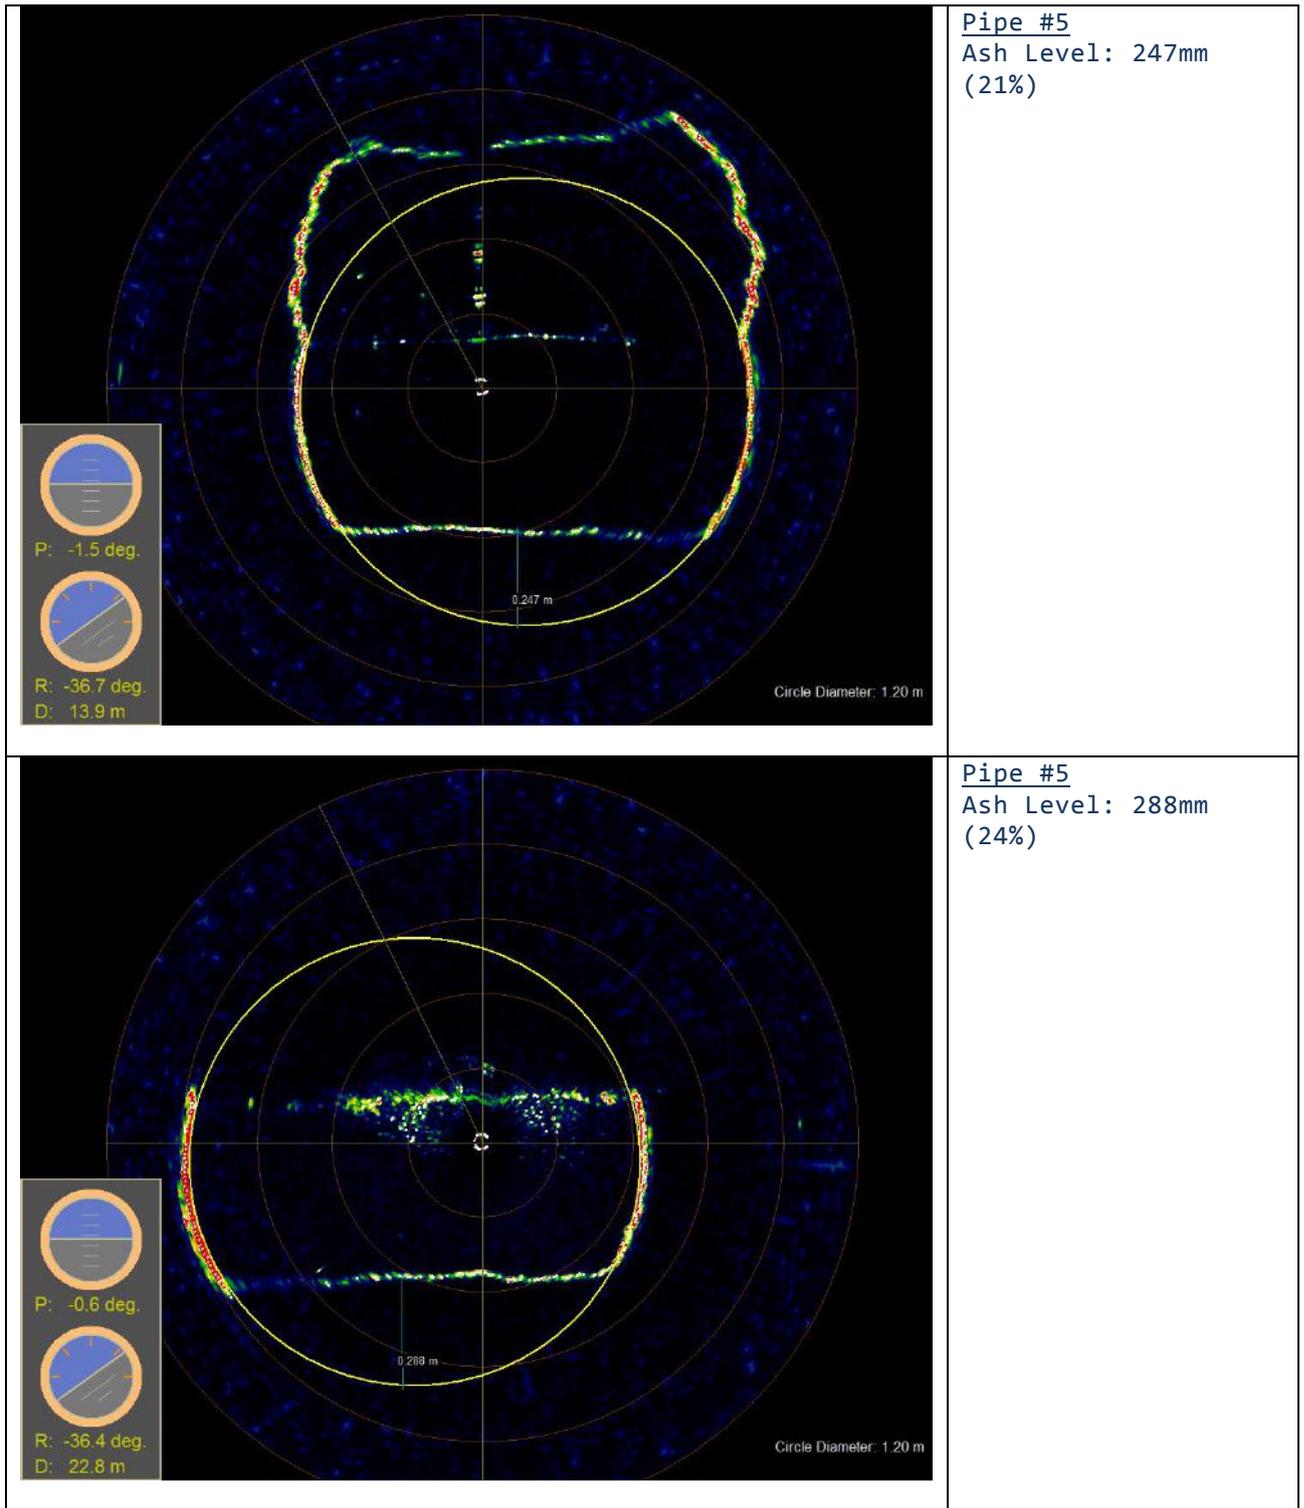
The following charts show the longitudinal plot of ash level inside the pipe. The top and bottom black lines represent the crown and invert of pipe respectively and are separated by 1200mm (pipe diameter).

Ash buildup in pipes: Ash deposits were found in all pipes. The level of ash in pipe varied from 5% to 40%. The ash level was generally highest near the well and it decreased towards the mid length. The level of ash increased towards exit at overflow lagoon.

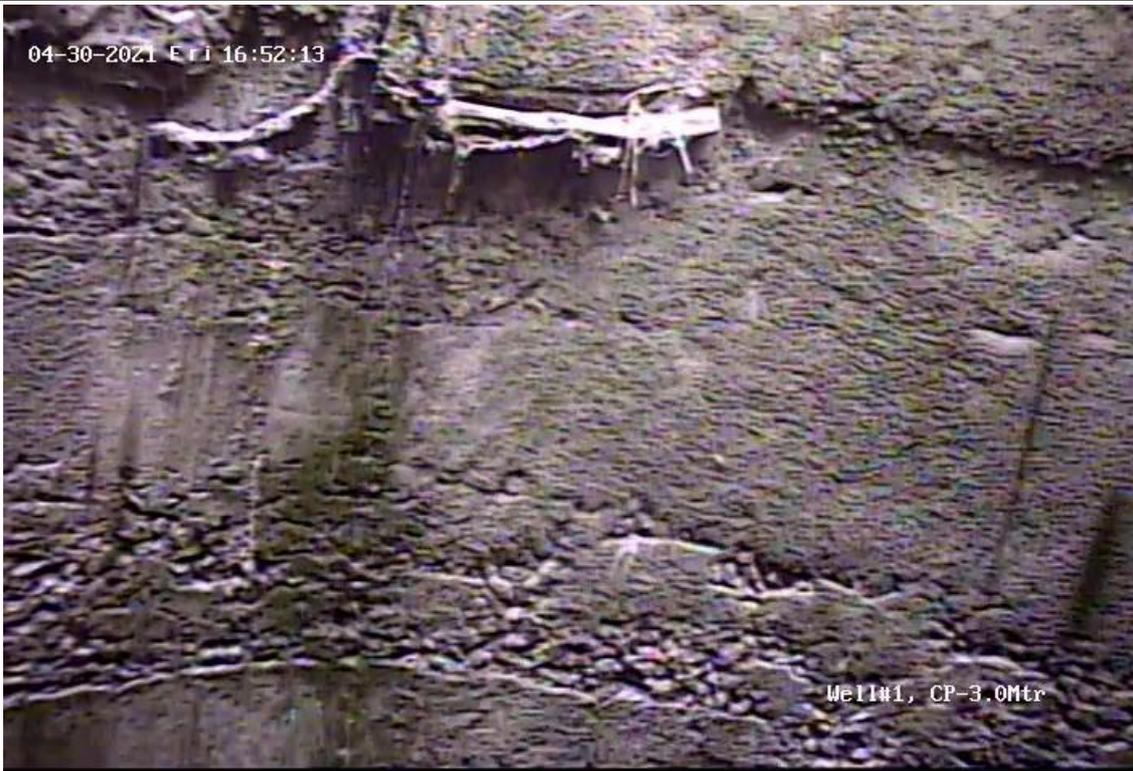
SLIDE: Well#1_03

ID Leakage at side1

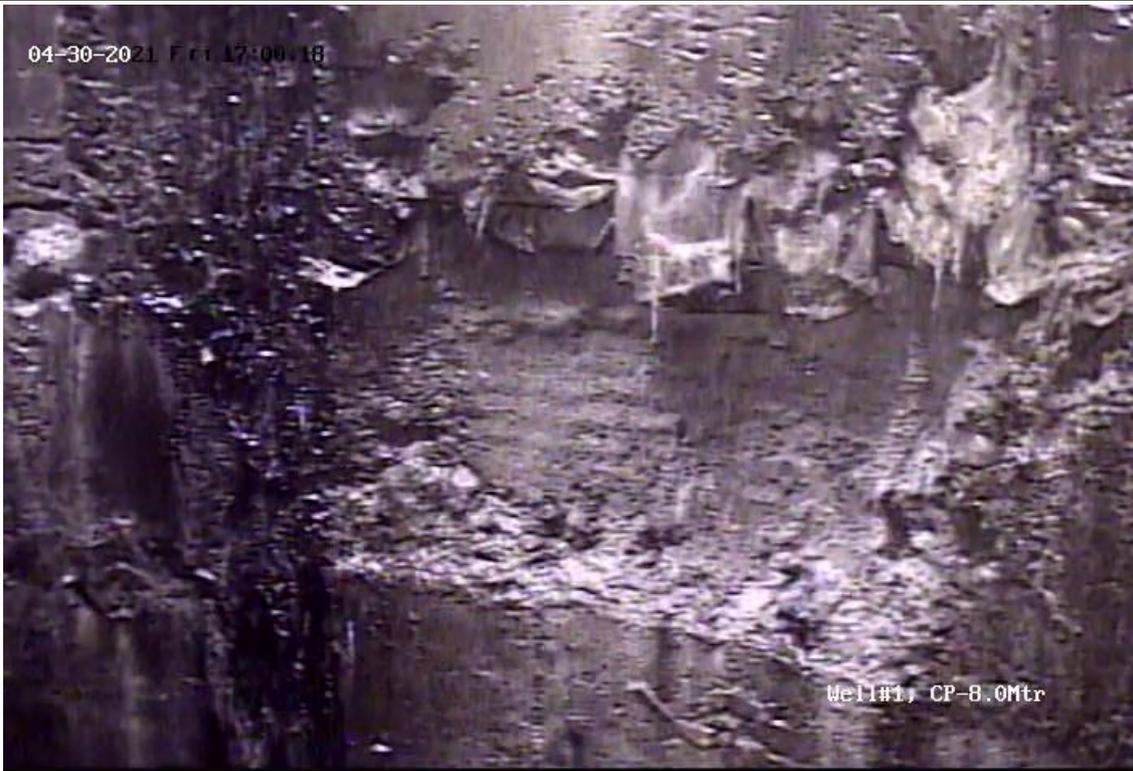
SLIDE: Well#1_07

ID Leakage at side1

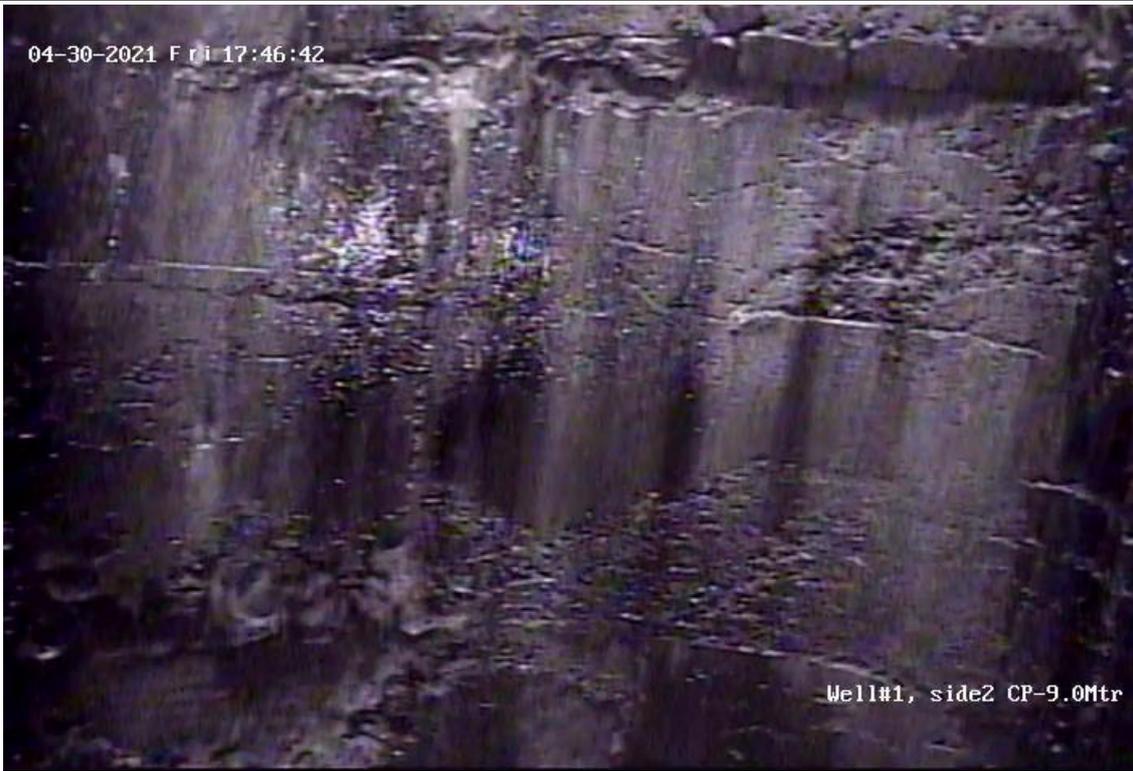
SLIDE: Well#1_09

ID Leakage at side2

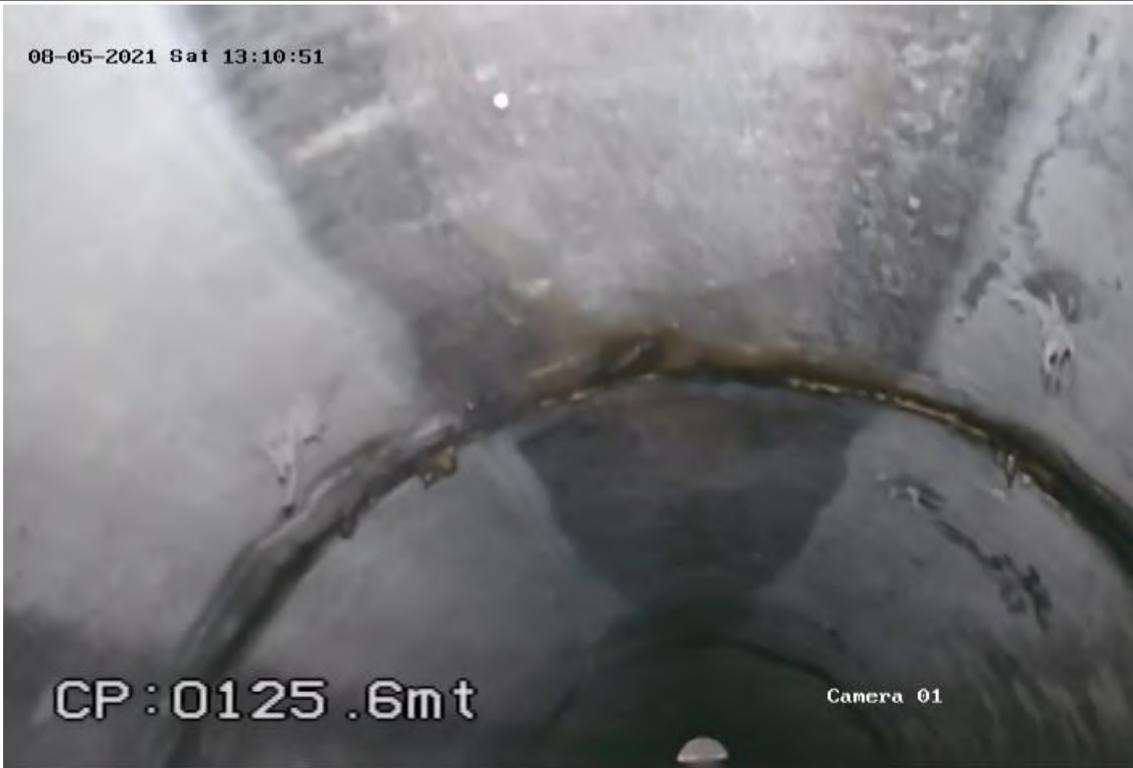
SLIDE: Pipe#1_11

ID(J)	Infiltration dripping at joint	0
-------	--------------------------------	---
