**BEFORE THE HON'BLE NATIONAL GREEN TRIBUNAL
PRINCIPAL BENCH, NEW DELHI
ORIGINAL APPLICATION NO.164/2018**

**RESPONSE OF THE VINDHYACHAL SUPER THERMAL POWER STATION LTD. [NTPC - VINDHYACHAL] TO THE FOURTH
QUARTERLY REPORT OF THE OVERSIGHT COMMITTEE**

Report # DSI/NTPC/2021-21/01c

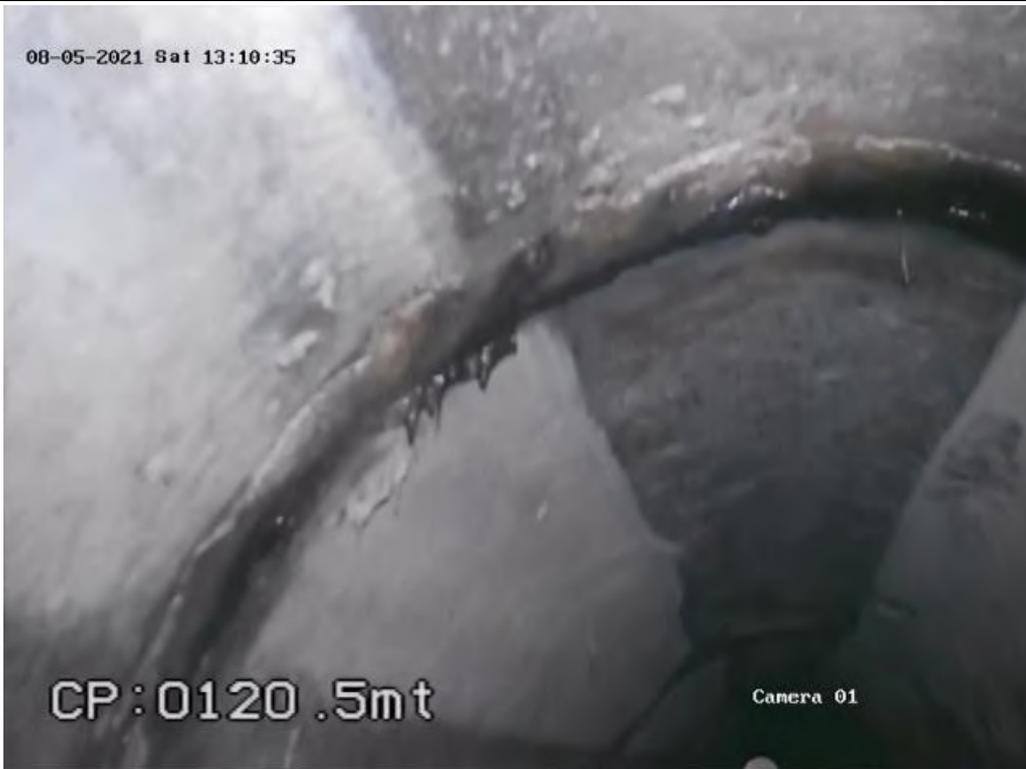
SLIDE: Pipe#1_10

ID(J)	Infiltration dripping at joint	0
-------	--------------------------------	---

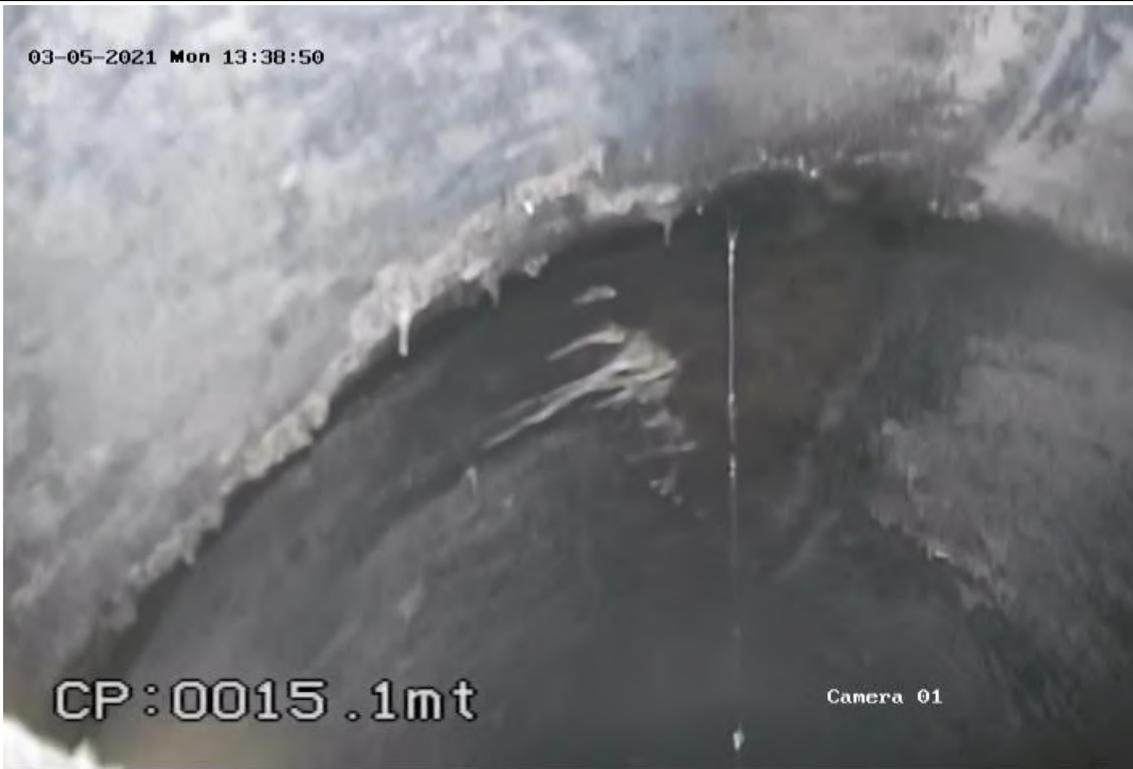
SLIDE: Pipeline#3_02

IS(J) Infiltration dripping at joint 0
