BEFORE THE NATIONAL GREEN TRIBUNAL
PRINCIPAL BENCH, NEW DELHI

Original Application No. 927 of 2024

3. Applicant respectfully submits that on 18th February 2025, applicant had visited the lake and taken photographs, which have been uploaded on NGT Portal. In view of the status of water on that day, the test reports dated 11.01.2025, 06.02.2025 raise a serious question on the conduct of the Respondent No. 1. While placing on record the test Reports, Respondent No.1 has not placed on record work order placed on the Laboratory, name and designation of the officer who accompanied the Test Lab staff to pick up the sample, geo tagged photographs evidencing picking up of sample from which part of the lake the sample was picked up and how it was picked which was carried to the lab for the purpose of testing. Therefore, the test report cannot be relied upon in absence of aforesaid details and also in view of the status of the lake on 18-02-2025 as evidenced by photographs, that were sent through email on 21.05.2025 and uploaded on NGT Portal on 05.06.2025. The copies of the email dated 21.06.2025 and the Photographs dated 18.02.2025 of Kitchner Lake are annexed herewith as **Annexure A-1 (

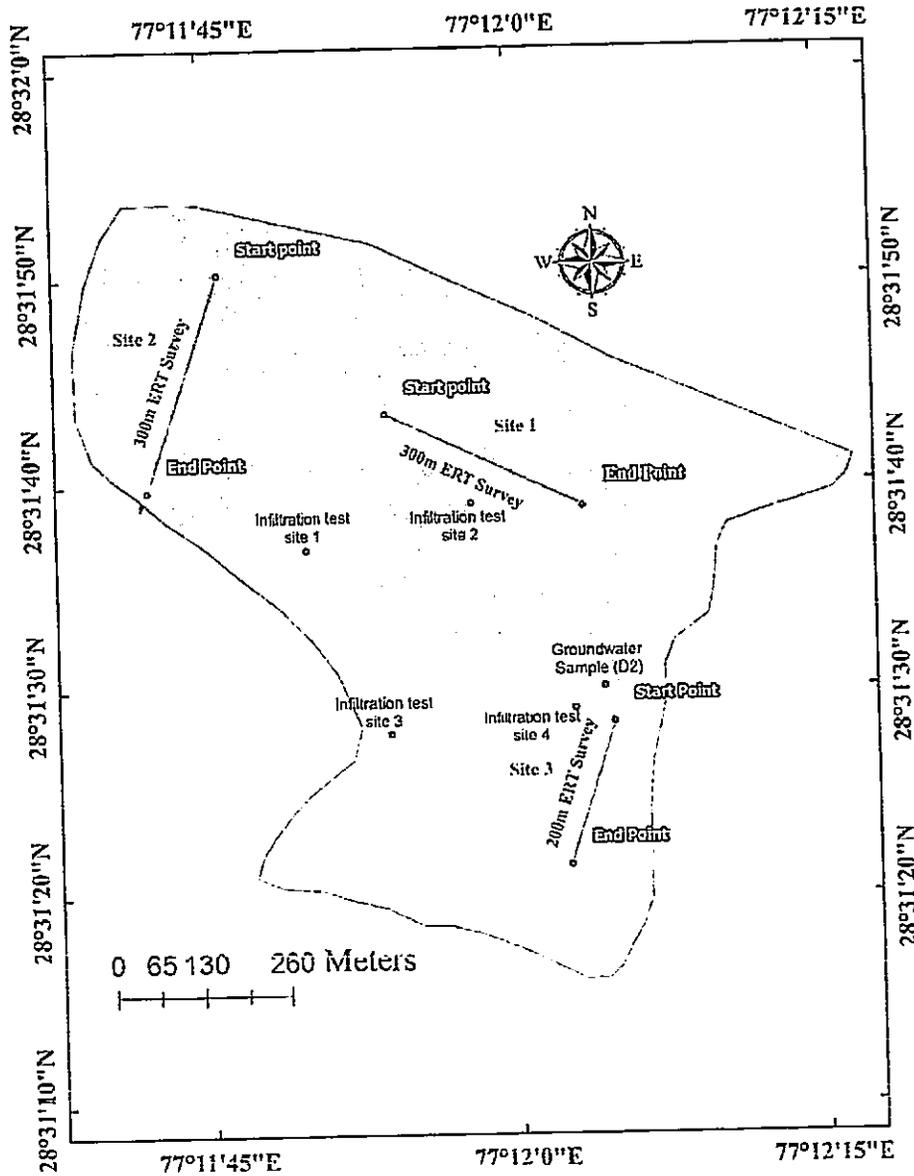
Fig. 1: Locations of ERT surveys, infiltration test, groundwater sample in the study area.

Tree FRT surveys were conducted based on the availability of the spread length for the electrodes to map the subsurface of the Golf course during this study. Infiltration test were also conducted at four locations nearby to the water bodies to get an idea of the influx rate of the applied water or rainfall taking over the grass turf (Fig. 1). Also, surface and groundwater

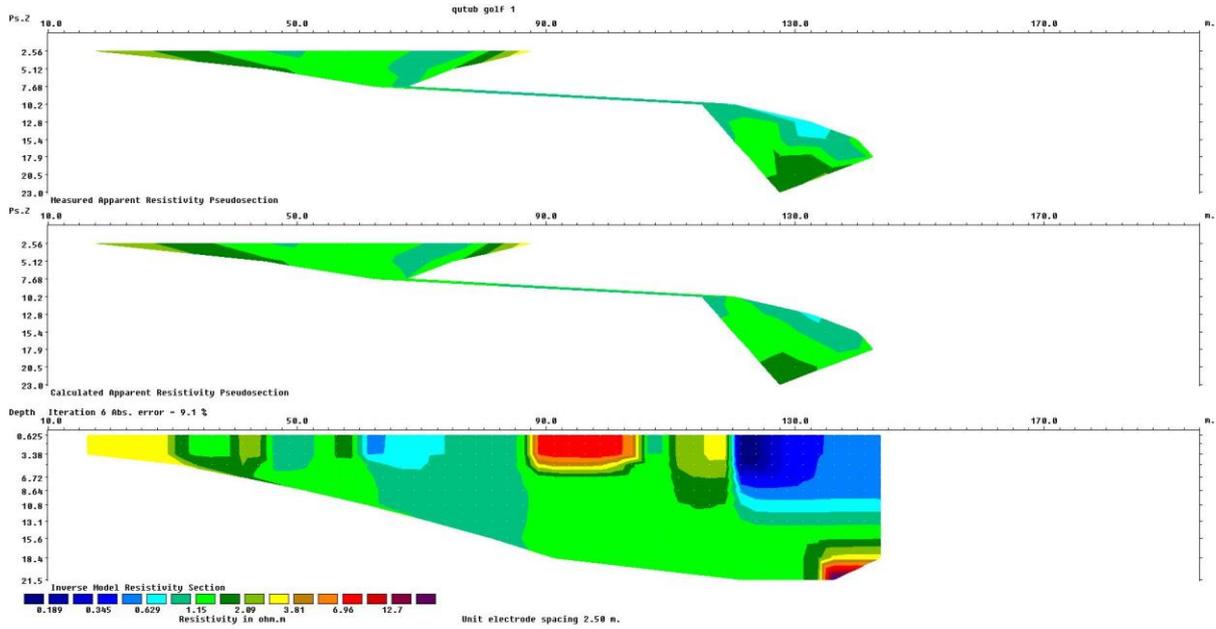
Figure 1. The 200m length Two-dimensional ERT subsurface resistivity profile using Wenner array configuration.

The first ERT survey (ERT-01) of 200 m was conducted at a site near the boundary of the Golf Course. The initial and final electrode coordinates for the linear survey line are shown in Figure 3, where the first electrode is situated at 28.5259°N, 77.1973°E and the last electrode is located at 28.5245°N, 77.1989°E. Throughout the survey, the contact resistance between the ground and electrodes remained favourable. However, the resistivity values obtained for most points were remarkably low and negative, indicating the presence of noise in the data, which was likely caused by underground features such as electrical cable lines, conductive pipes, and fencing. After data processing and noise removal, the determined depth was found to be 21.5 meters. In certain areas, the obtained resistivity value was less than 0.2 ohm-m, probably indicative of saltwater content in the soil. The resulting ERT subsurface profile is shown in Figure 1, and the subsurface resistivity is listed in Table 1.

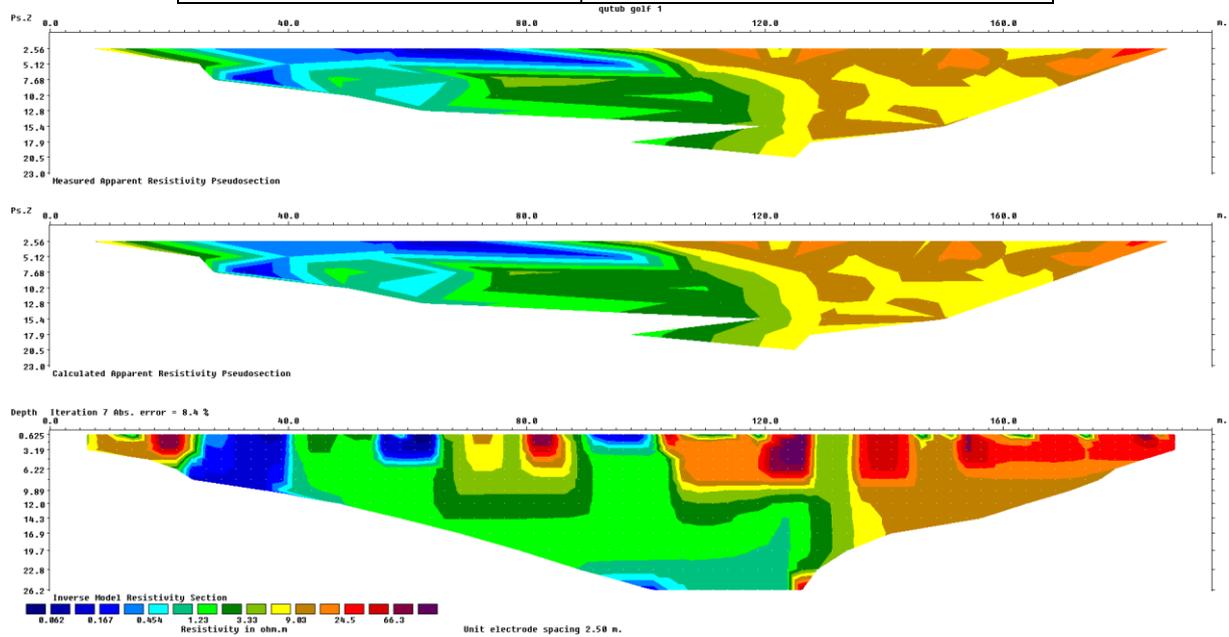
Figure 2. The 200m length Two-dimensional ERT subsurface resistivity profile.

Depth of Investigation (m)	ERT-02
	Average resistivity (Ohm-m)
0-5	21.23
5-10	9.28
10-15	4.08
15-20	2.13
>20	3.62

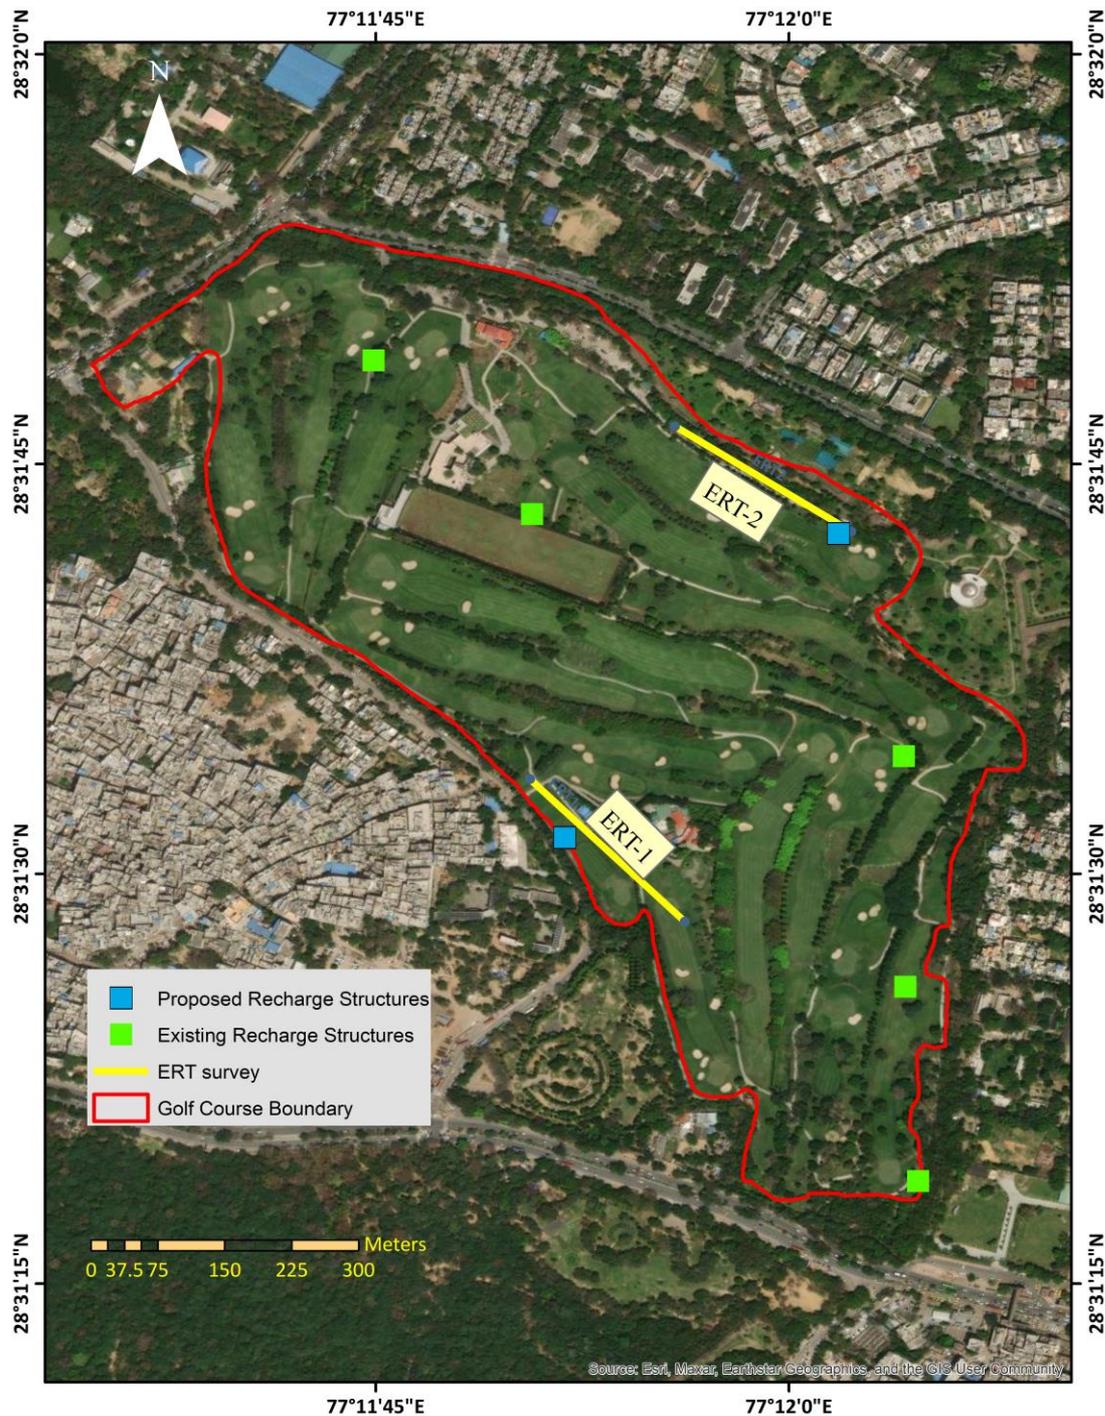
Figure 3. Locations of Electrical Resistivity Tomography (ERT) surveys within the Golf course premise

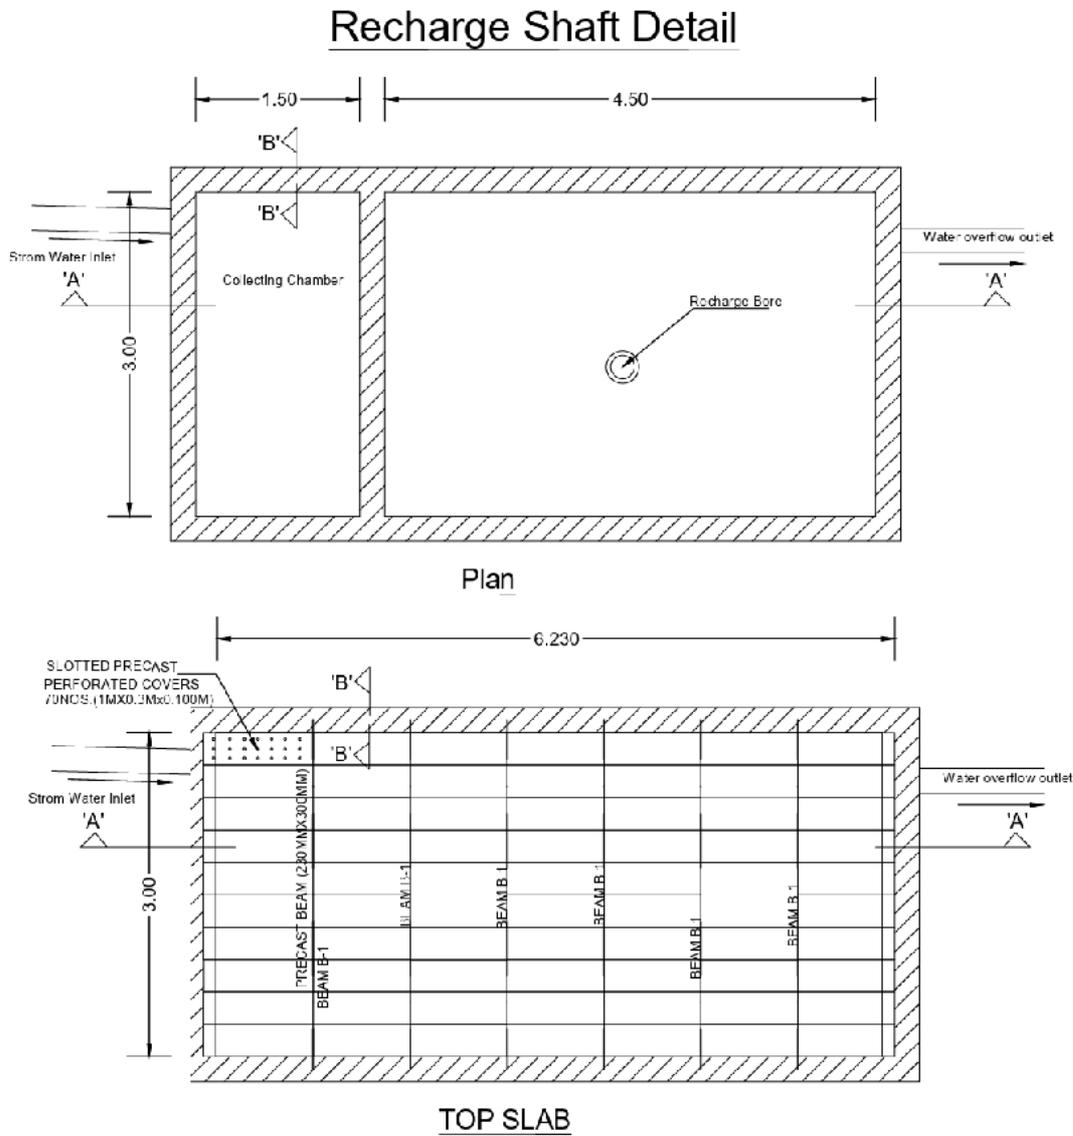
Figure 4. Top view of the recharging shaft with borewell provided at the Golf Course.

Moreover, in accordance with the Rainwater harvesting and conservation manual by CPWD, New Delhi (2019), the diameter of the recharge shaft should be within the range of 500 mm to

3000 mm, considering the water availability. Therefore, it is advisable to expand the diameter of the existing recharge shafts to the specified range of 500–3000 mm to facilitate efficient groundwater recharge.

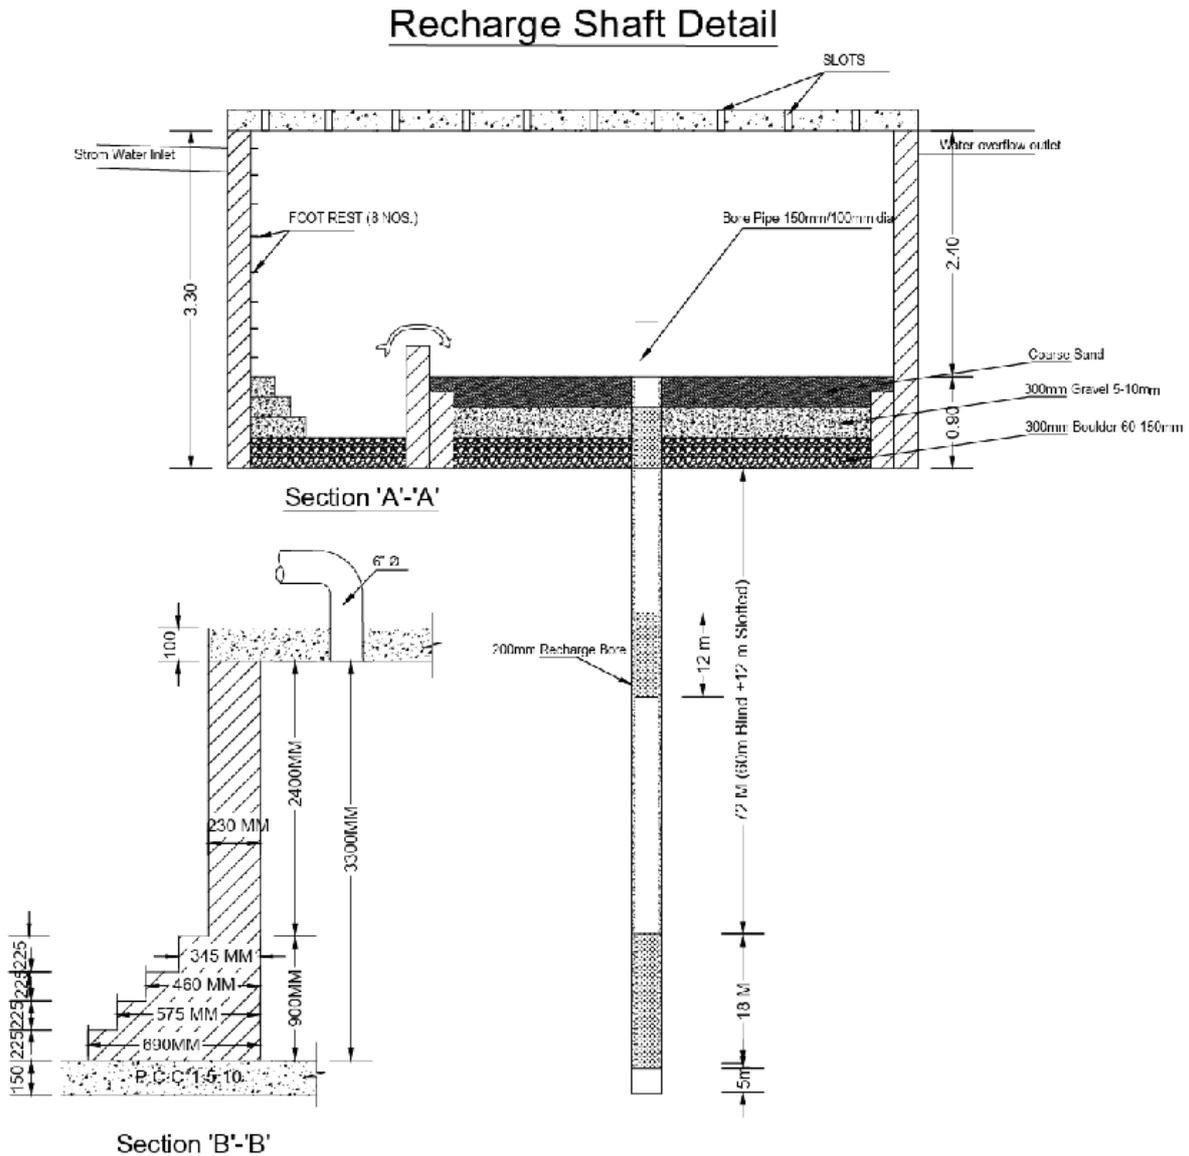
Figure 5. Existing section plan of the recharging shaft with borewell provided in the Golf Course.

The filter bed may clog owing to the recharge of rainwater, as the runoff may contain fine particles of sand and silt. The filter bed should be cleaned annually, preferably by scraping the top layer of sand and refilling the bed timely. The silt deposited on the filter bed may reduce recharge efficiency hence, it should be periodically removed or scrapped.

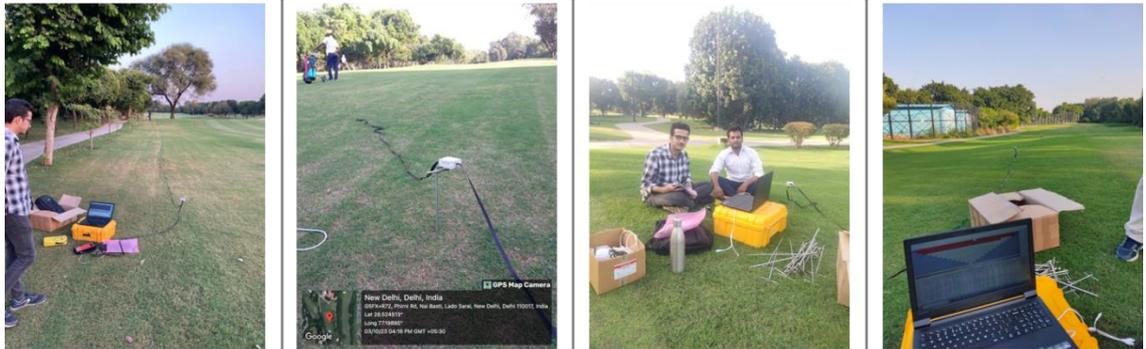
1. ERT Survey

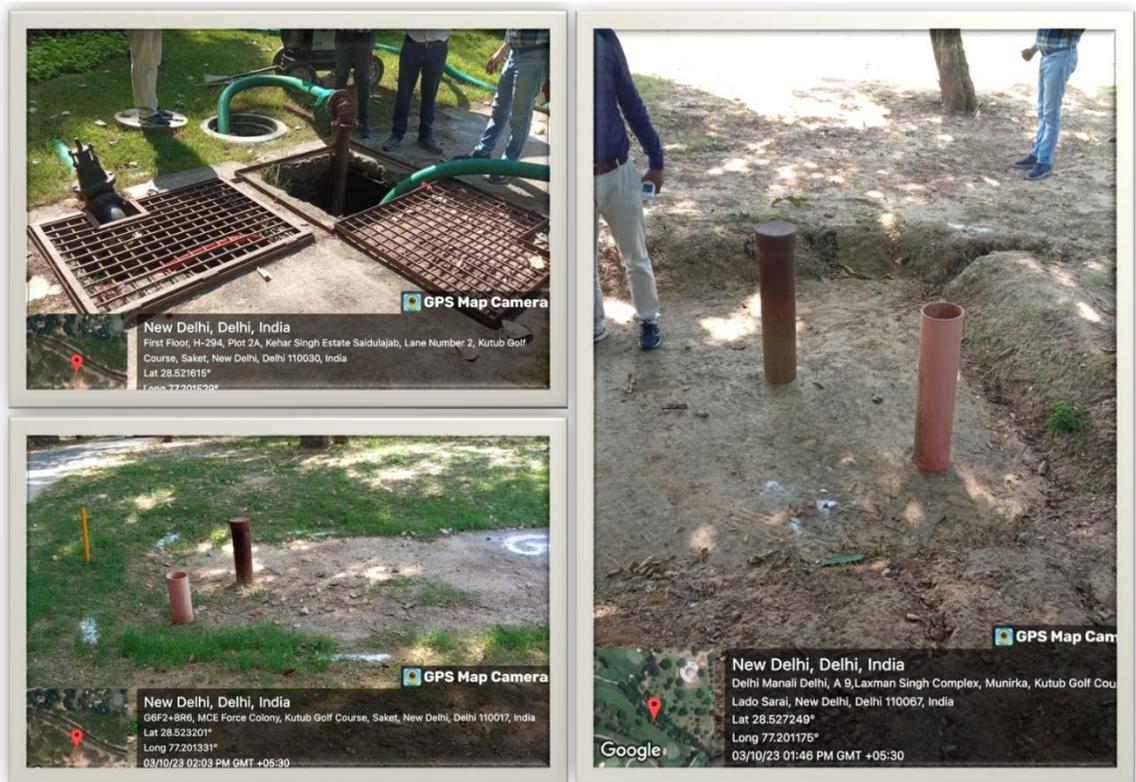
2. Existing recharging structures in the golf course area
