## STATUS REPORT

### IN THE MATTER OF O. A. 669 OF 2018, MARVADA AMRUTLAL BECHARLAL Vs. STATE OF GUJARAT – ASHAPURA GROUP OF COMPANIES, KUTCH

**REPORT  
ON  
GYPSUM SITE CLEARANCE**

**ASHAPURA PERFOCLAY LTD.(APL)**  
**PLOT NO. 163, 164 & 167, VILLAGE: LER, TALUKA: BHUJ,**  
**DIST.: KUTCH, GUJRAT, INDIA**

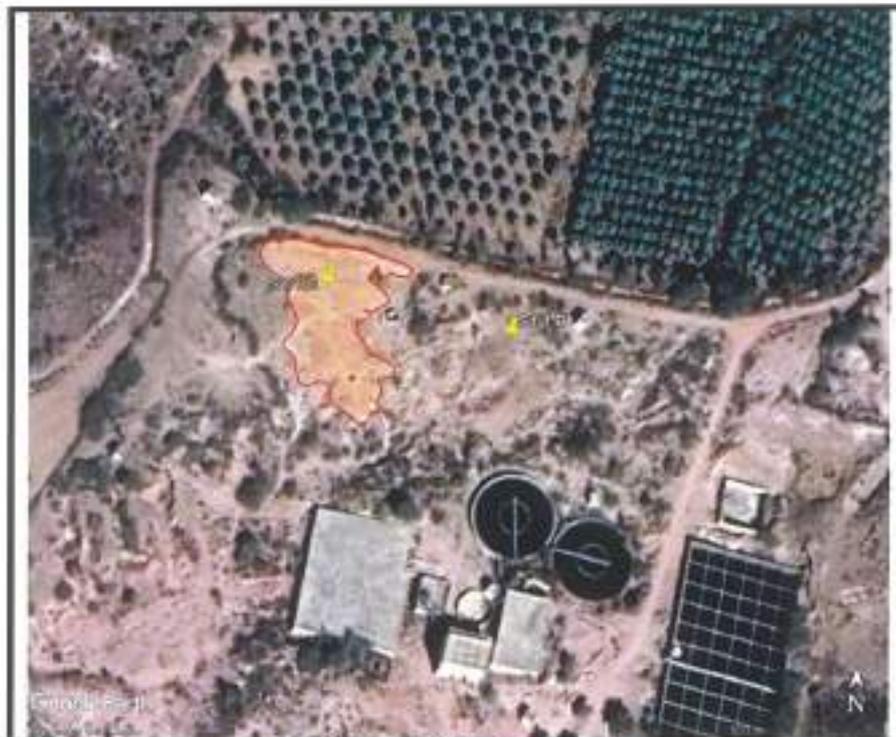
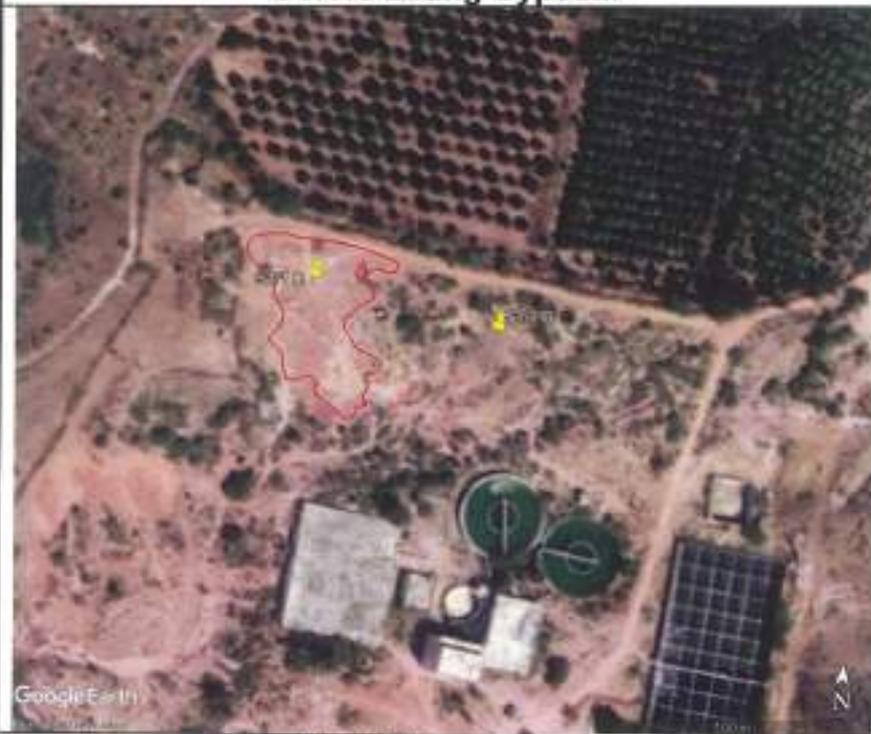
**Figure No. 3.2**  
**Location Map Before & After Lifted of Gypsum along with Soil Samples for**  
**Site S1- Besides of water tank of GWIL Sump, Kukma Village**

**Before Lifting Gypsum**

**After Lifting Gypsum**

S1/1 C	Soil Sample from site
S1/1 B	Virgin Soil Sample near Gypsum site area

<b>Location</b>	: Beside water tank of GWIL Sump, Kukma Village Latitude: 23°13'18" N Longitude: 69°45'46" E
<b>Site Photographs:</b>	: Please refer Photograph of site presented at <b>Figure No 3.1</b>
<b>Google Image</b>	: Site location map along with sample location is presented at <b>Figure No. 3.2.</b>
<b>Soil Analysis</b>	: Soil analysis report is presented at <b>Table No. 3.2</b>  The soil analysis in above table indicates that, Gypsum as $\text{CaSO}_4 \cdot 2\text{H}_2\text{O}$ is not present in soil sample. Thus, Gypsum has been removed from the site.  At Gypsum site, low elevated levels of mineral contents viz. Ca, Na, K and $\text{SO}_4$ were observed compared to virgin soil samples. This could be due to mixing of Gypsum with the native soils. This will not have any detrimental effect on soil quality. It may be noted that, Potassium is a major group-II primary nutrient, Calcium and Sulphur are secondary major plant nutrients in soil and they are categorized as essential nutrients for plant growth.  Comparing the virgin and site soil sample with Screening and Responsive Level as specified by MoEF(*), it indicates that levels in both virgin and site sample are below screening levels.

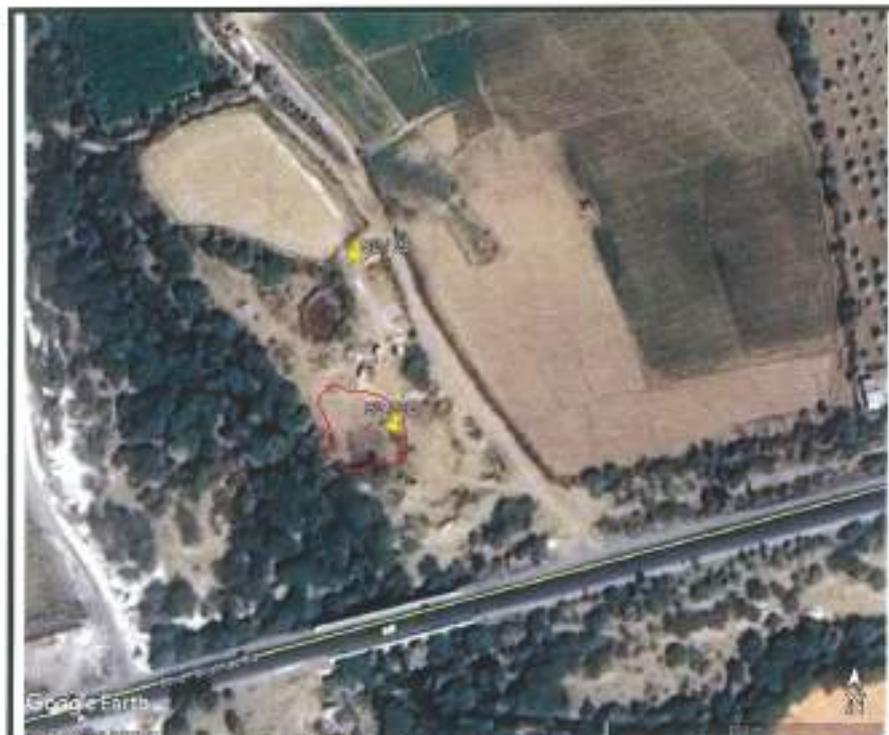
**Figure No. 3.4**  
**Location Map Before and After Lifted of Gypsum along with Soil Samples for**  
**Site S2 - Land opposite and besides of Paddhar Village police station**

**Before Lifting of Gypsum**

Location	:	Land opposite and besides of Paddhar Village police station  Latitude: 23°14'29" N Longitude: 69°48'38" E
Site Photographs:	:	Please refer Photograph of site presented at <b>Figure No 3.3.</b>
Google Image	:	Site location map along with sample location is presented at <b>Figure No. 3.4.</b>
Soil Analysis	:	Soil analysis report is presented at <b>Table No. 3.3.</b>  The soil analysis in above table indicates that, Gypsum as $\text{CaSO}_4 \cdot 2\text{H}_2\text{O}$ is not present in soil sample. Thus, Gypsum has been removed from the site.  At Gypsum site, low elevated levels of mineral contents viz. Ca, Na, K and $\text{SO}_4$ were observed compared to virgin soil samples. This could be due to mixing of Gypsum with the native soils. This will not have any detrimental effect on soil quality. It may be noted that, Potassium is a major group-II primary nutrient, Calcium and Sulphur are secondary major plant nutrients in soil and they are categorized as essential nutrients for plant growth.  Comparing the virgin and site soil sample with Screening and Responsive Level as specified by MoEF (*), it indicates that levels in both virgin and site sample are below screening levels.

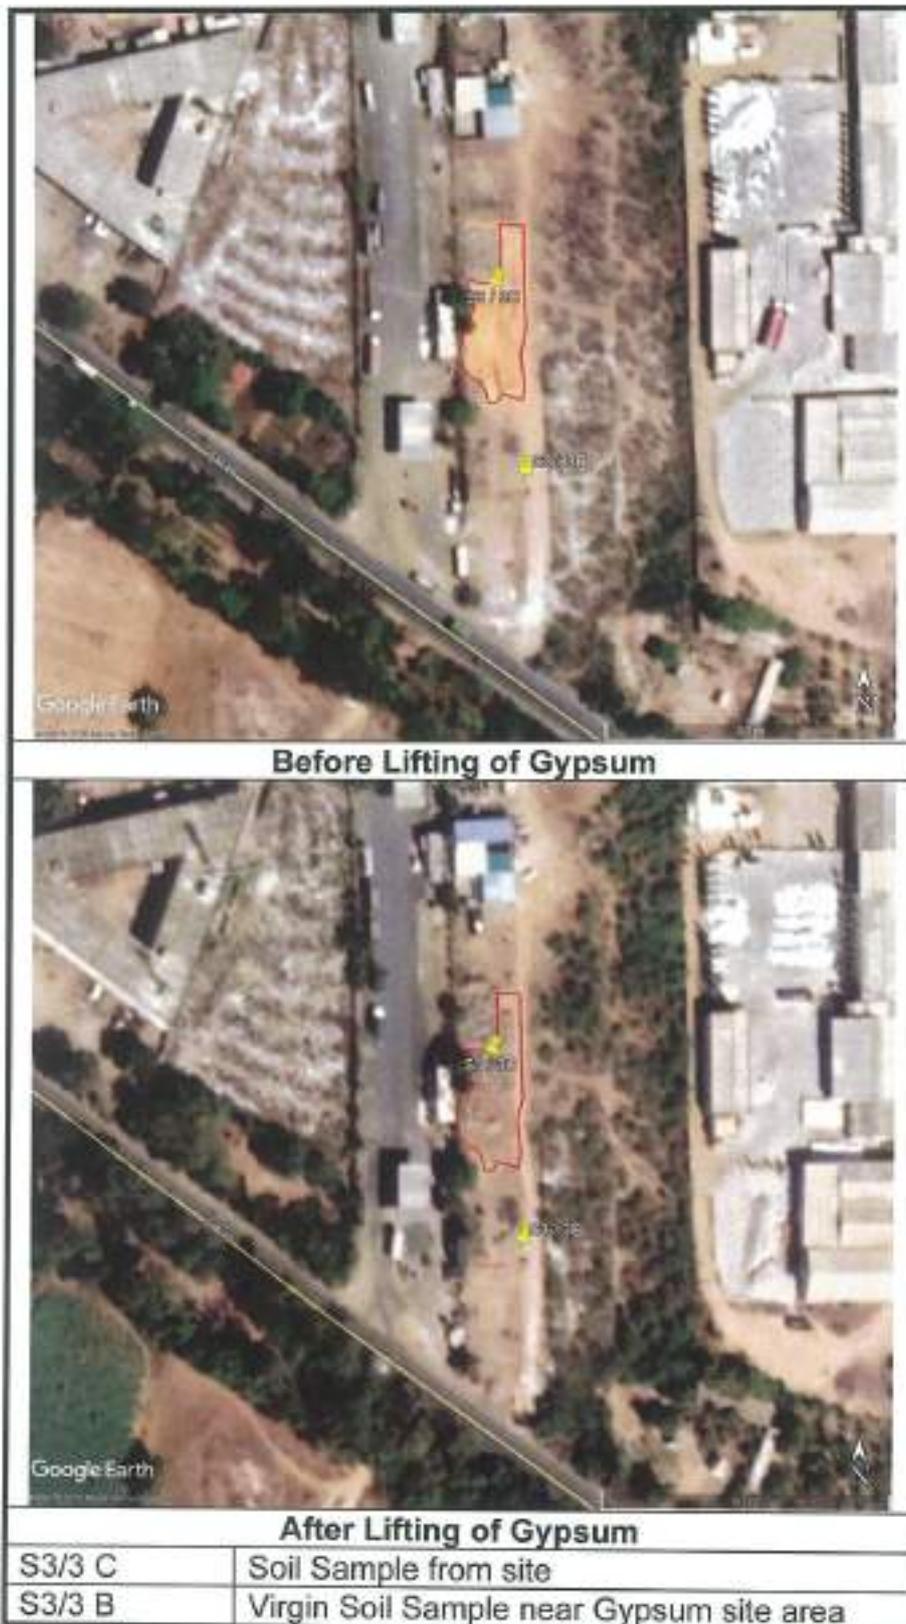
**Figure No. 3.6**  
**Location Map Before and After Lifted of Gypsum along with Soil Samples for**  
**Site S3-Behind Balaji Petrol Pump, Shaikhpur Chokdi, Bhuj Anjar Highway**

Sr. No.	Parameters	S3/3 C Soil Sample from site	S3/3 B Virgin Soil Sample near Gypsum site area
1	Moisture %	6.22	4.74
2	pH	7.38	7
3	Conductivity, mS/cm	1.075	0.342
4	Calcium, g/Kg	2.84	1.36
5	Sodium, g/Kg	5.2	0.8
6	Potassium, g/Kg	1.6	0.1
7	Sulphate, g/Kg	0.65	0.22
8	Ammonia, g/Kg	BDL	BDL
9	Copper, g/Kg	0.033	0.030
10	Nickel, g/Kg	0.027	0.020
11	Zinc, g/Kg	0.052	0.05
12	Cadmium, g/Kg	BDL	BDL
13	Lead, g/Kg	0.012	0.010
14	Chromium, g/Kg	0.101	0.090
15	Manganese, g/Kg	0.215	0.190
16	Cobalt, g/Kg	0.010	0.010
17	Nitrate, g/Kg	0.01	0.01
18	Gypsum as CaSO <sub>4</sub> .2H <sub>2</sub> O, %	BDL	BDL

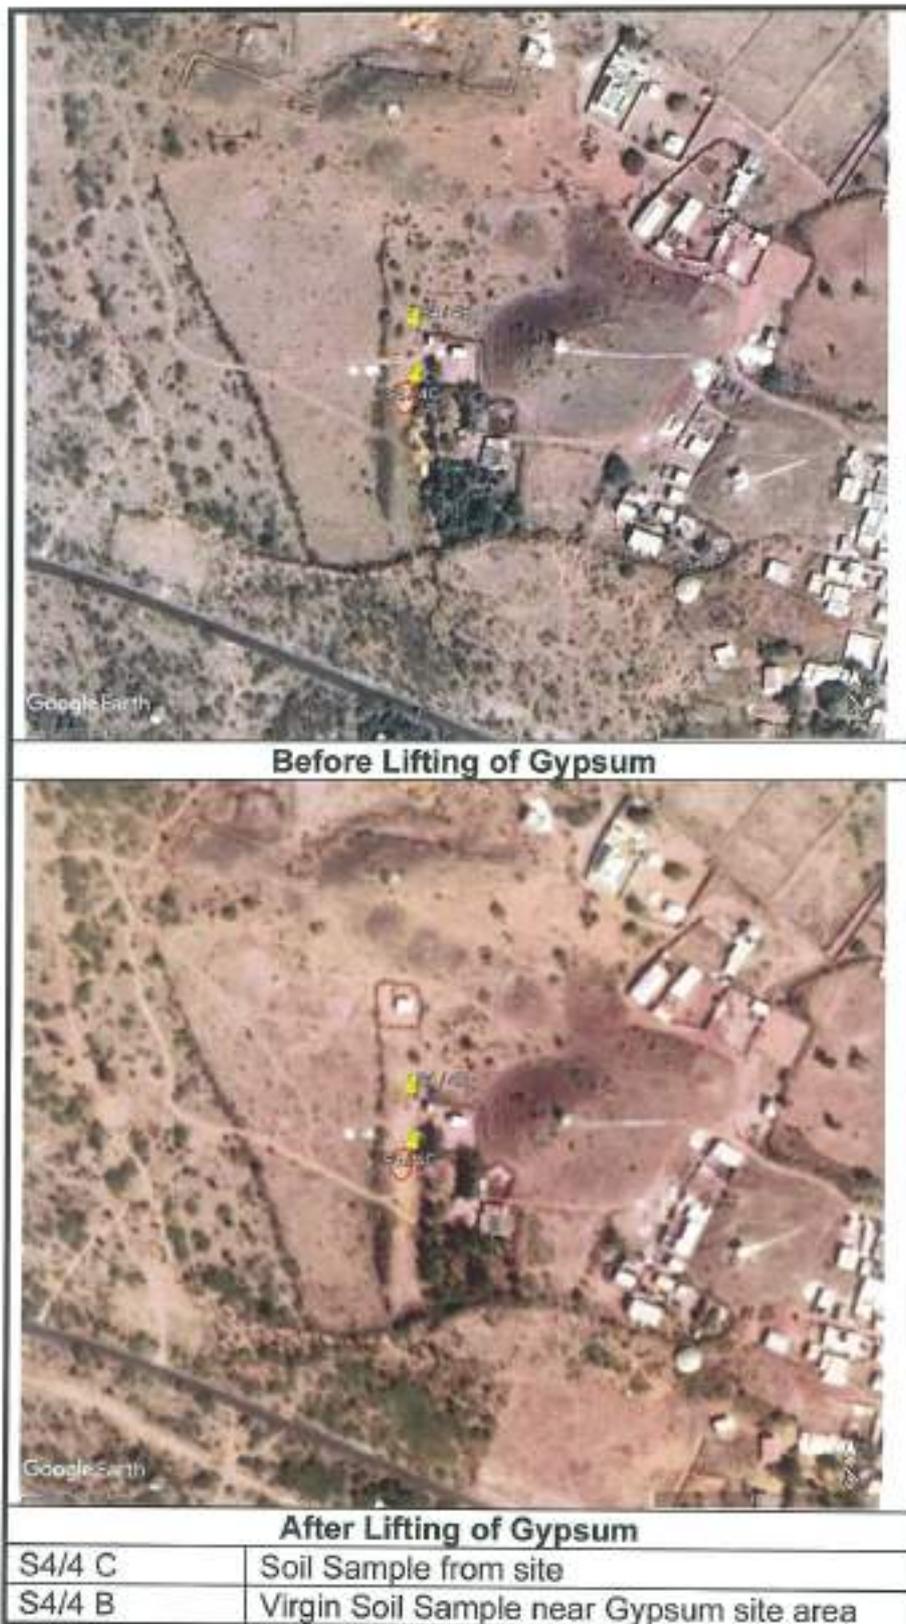
**Figure No. 3.8**  
**Location Map Before and After Lifted of Gypsum along with Soil Samples for**  
**Site S4 - Near Matiyadev Mandir, Kukma Village**

Sr. No.	Parameters	S4/4 C Soil Sample from site	S4/4 B Virgin Soil Sample near Gypsum site area
1	Moisture %	5.30	4.90
2	pH	7.34	7.17
3	Conductivity, mS/cm	0.687	0.224
4	Calcium, g/Kg	0.96	0.72
5	Sodium, g/Kg	5.6	1.0
6	Potassium, g/Kg	2.2	BDL
7	Sulphate, g/Kg	0.25	0.20
8	Ammonia, g/Kg	BDL	BDL
9	Copper, g/Kg	0.02	0.02
10	Nickel, g/Kg	0.02	0.02
11	Zinc, g/Kg	0.02	0.03
12	Cadmium, g/Kg	BDL	BDL
13	Lead, g/Kg	0.01	0.01
14	Chromium, g/Kg	0.03	0.03
15	Manganese, g/Kg	0.090	0.005
16	Cobalt, g/Kg	0.01	0.01
17	Nitrate, g/Kg	0.01	BDL
18	Gypsum as CaSO <sub>4</sub> .2H <sub>2</sub> O, %	BDL	BDL

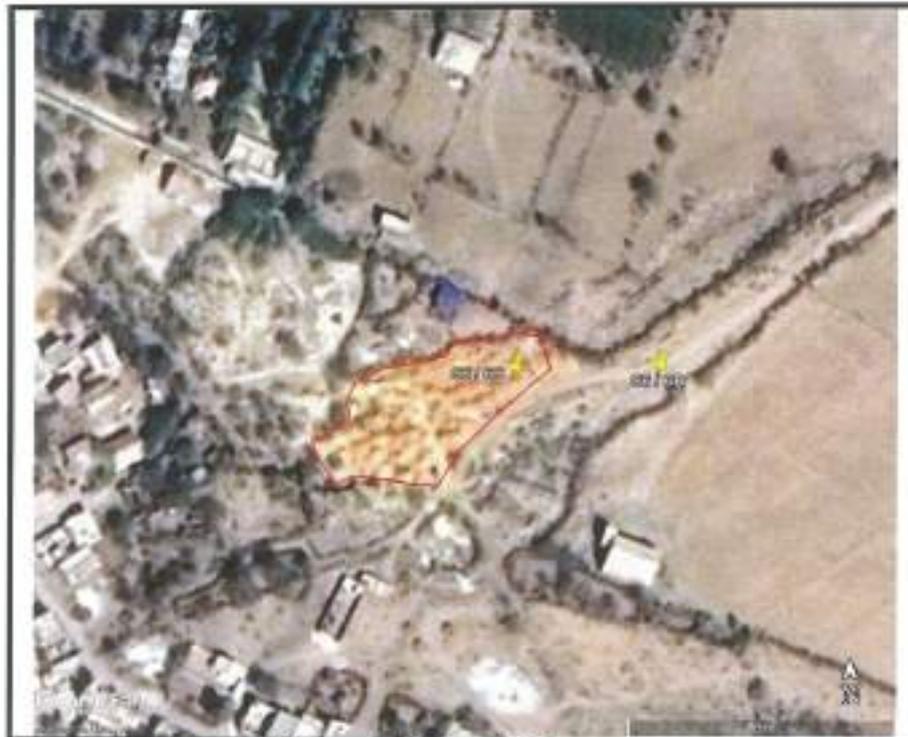
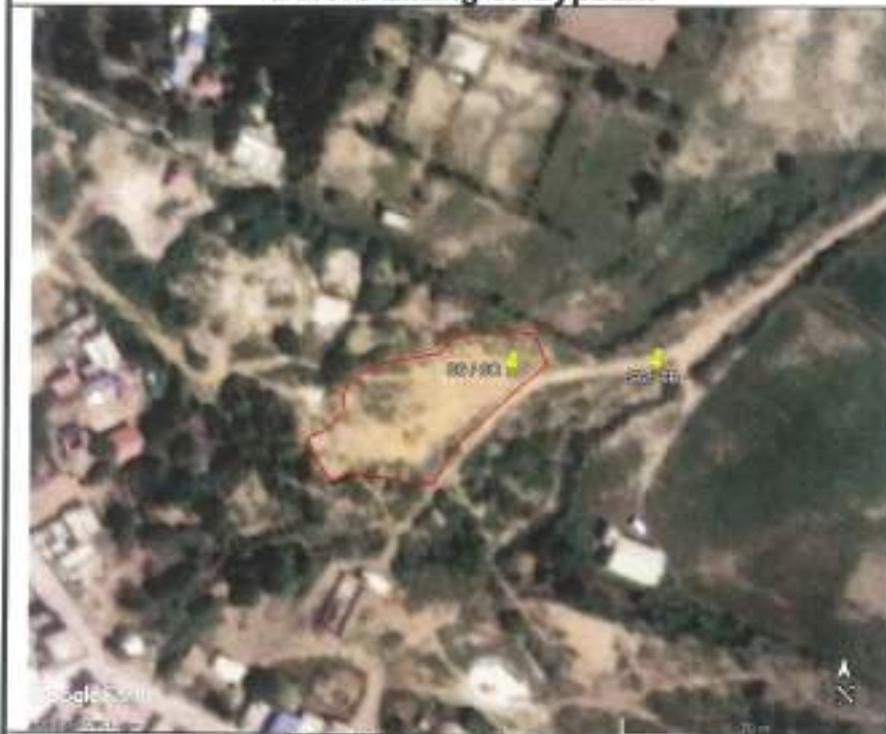
**Figure No. 3.12**  
**Location Map Before and After Lifted of Gypsum along with Soil Samples for**  
**Site S6 - Natural Drain near Sanjot nagar, Behind Swaminarayanwadi**

**Before Lifting of Gypsum**

**After Lifting of Gypsum**

S6/6 C	Soil Sample from site
S6/6 B	Virgin Soil Sample near Gypsum site area

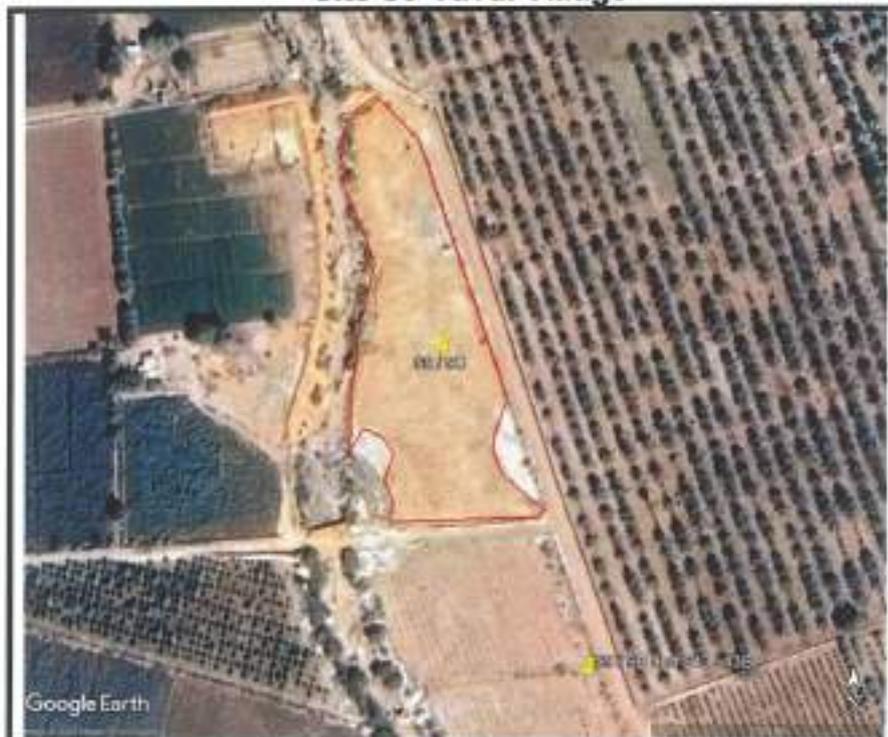
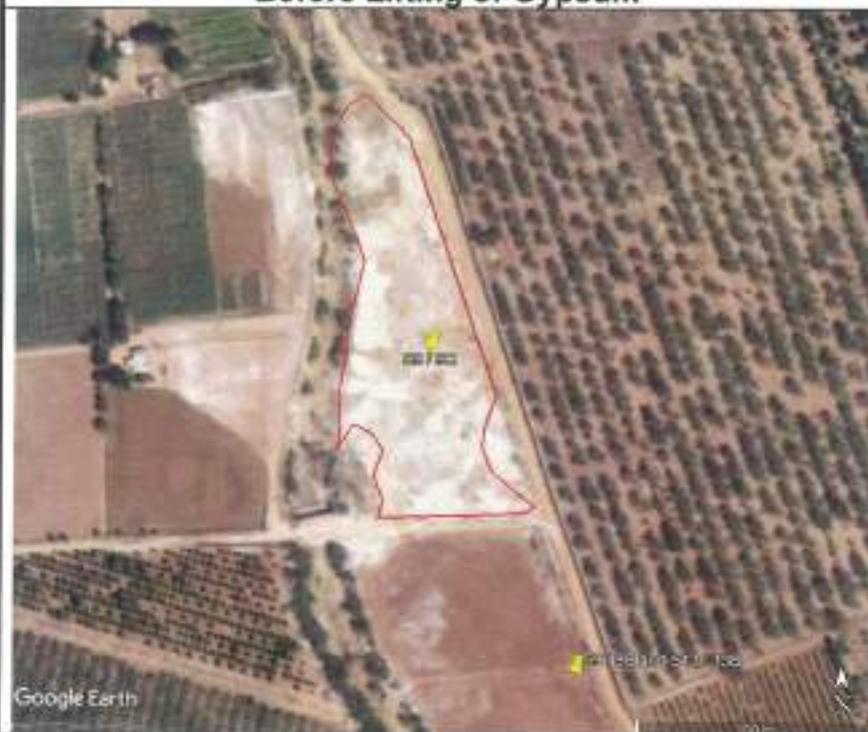
**Figure No. 3.18**  
**Location Map Before and After Lifted of Gypsum along with Soil Samples for**  
**Site S9-Vavdi Village**

**Before Lifting of Gypsum**

**After Lifting of Gypsum**

S9/9 C	Soil Sample from site
S9/9 B and S13/13 B	Common Virgin Soil Sample Nr. Gypsum site area

<b>Location</b>	:	Vavdi Village  Latitude: 23°11'35" N Longitude: 69°49'42" E
<b>Site Photographs:</b>	:	Please refer Photograph of site presented at <b>Figure No 3.17</b> .
<b>Google Image</b>	:	Site location map along with sample location is presented at <b>Figure No. 3.18</b> .
<b>Soil Analysis</b>	:	Soil analysis report is presented at <b>Table No. 3.10</b> .  The soil analysis in above table indicates that, Gypsum as $\text{CaSO}_4 \cdot 2\text{H}_2\text{O}$ is not present in soil sample. Thus, Gypsum has been removed from the site.  At Gypsum site, low elevated levels of mineral contents viz. Na and K were observed compared to virgin soil samples. This could be due to mixing of Gypsum with the native soils. This will not have any detrimental effect on soil quality. It may be noted that, Potassium is a major group-II primary nutrient in soil and it is categorized as essential nutrient for plant growth.  Comparing the virgin and site soil sample with Screening and Responsive Level as specified by MoEF (*), it indicates that levels in both virgin and site sample are below screening levels.

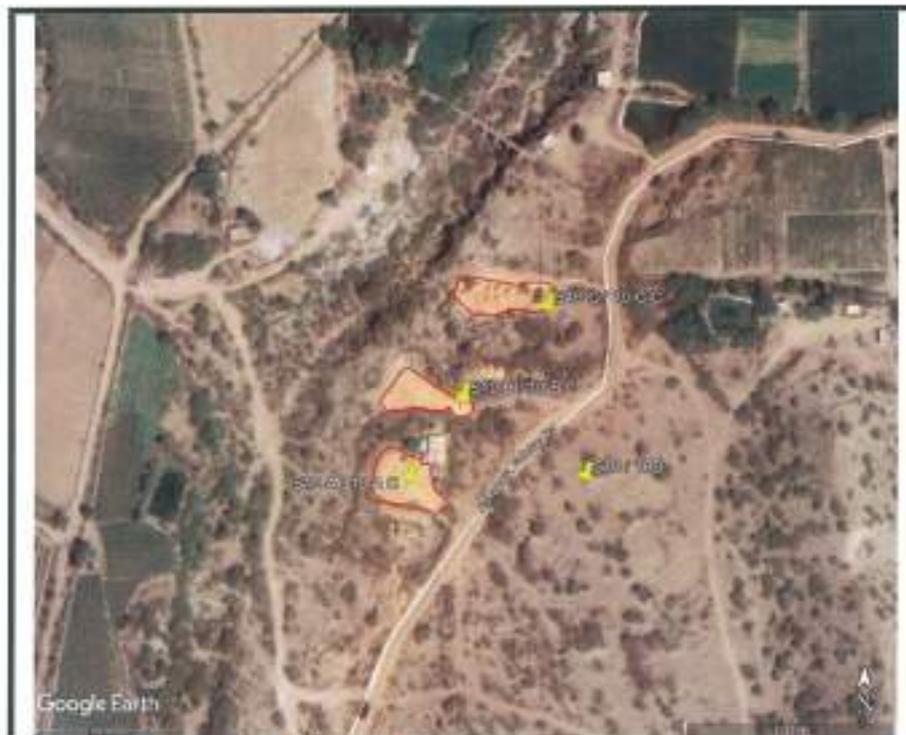
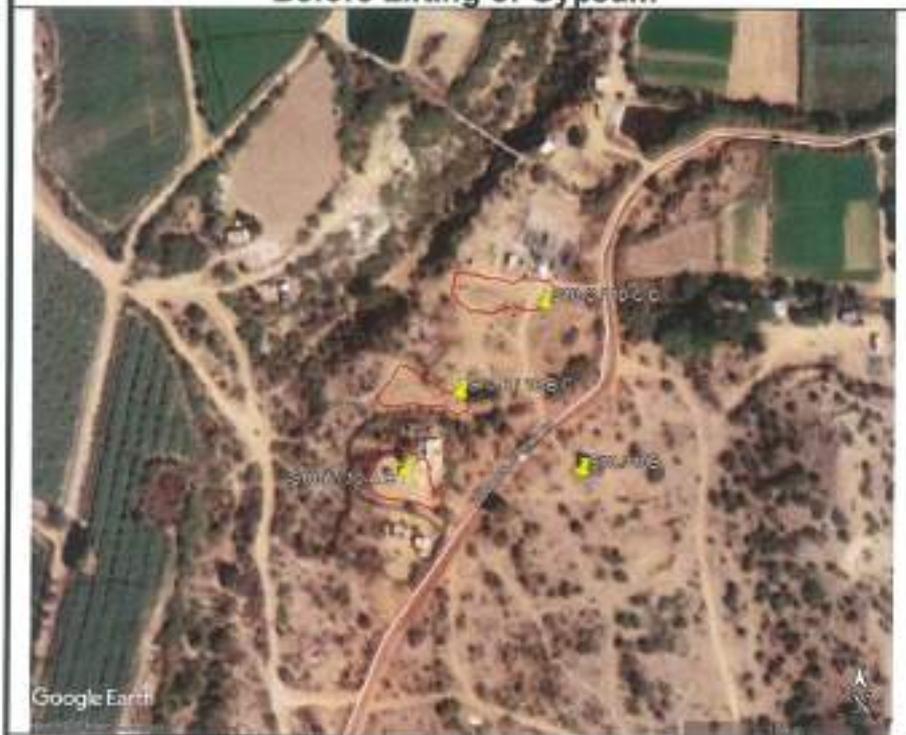
**Figure No. 3.22**  
**Location Map Before and After Lifted of Gypsum along with Soil Samples for**  
**Site S10/B-Land of Hetubha Jadeja Near Block Factory, Ler Village**

**Before Lifting of Gypsum**

**After Lifting of Gypsum**

S10B/10B C	Soil Sample from site
S10/10 B	Virgin Soil Sample near Gypsum site area

<b>Location</b>	:	Land of Hetubha Jadeja Near Block Factory, Ler Village  Latitude: 23°12'05" N Longitude: 69°45'35" E
<b>Site Photographs:</b>	:	Please refer Photograph of site presented at <b>Figure No 3.21.</b>
<b>Google Image</b>	:	Site location map along with sample location is presented at <b>Figure No. 3.22.</b>
<b>Soil Analysis</b>	:	Soil analysis report is presented at <b>Table No. 3.12.</b>  The soil analysis in above table indicates that, Gypsum as $\text{CaSO}_4 \cdot 2\text{H}_2\text{O}$ is not present in soil sample. Thus, Gypsum has been removed from the site.  Levels of mineral content at Gypsum site is at par with virgin soil quality. Thus, there will not be any detrimental effect on soil quality.  Comparing the virgin and site soil sample with Screening and Responsive Level as specified by MoEF (*), it indicates that levels in both virgin and site sample are below screening levels.

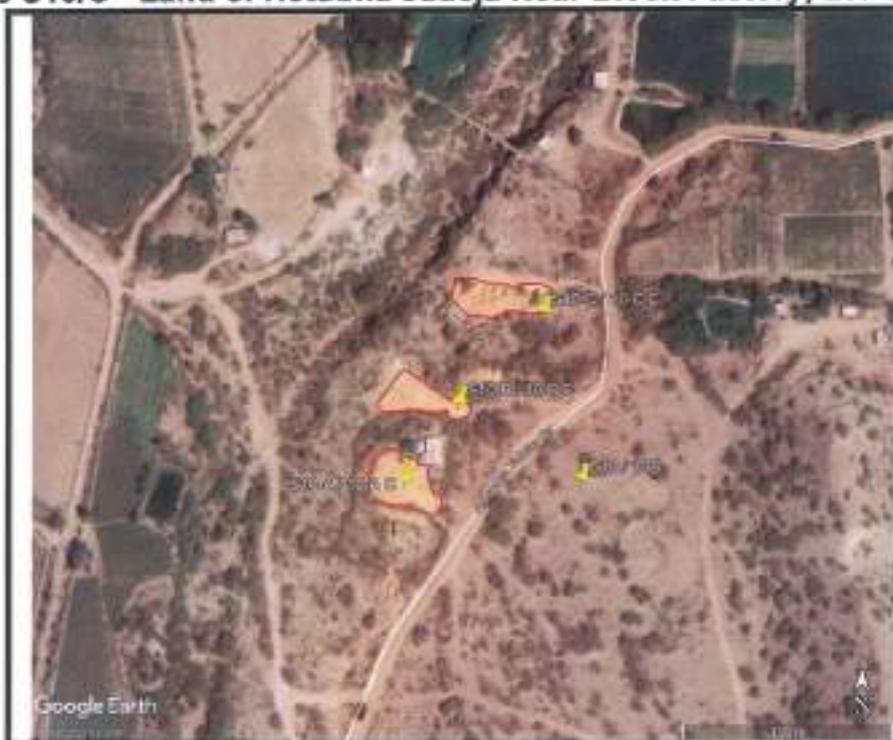
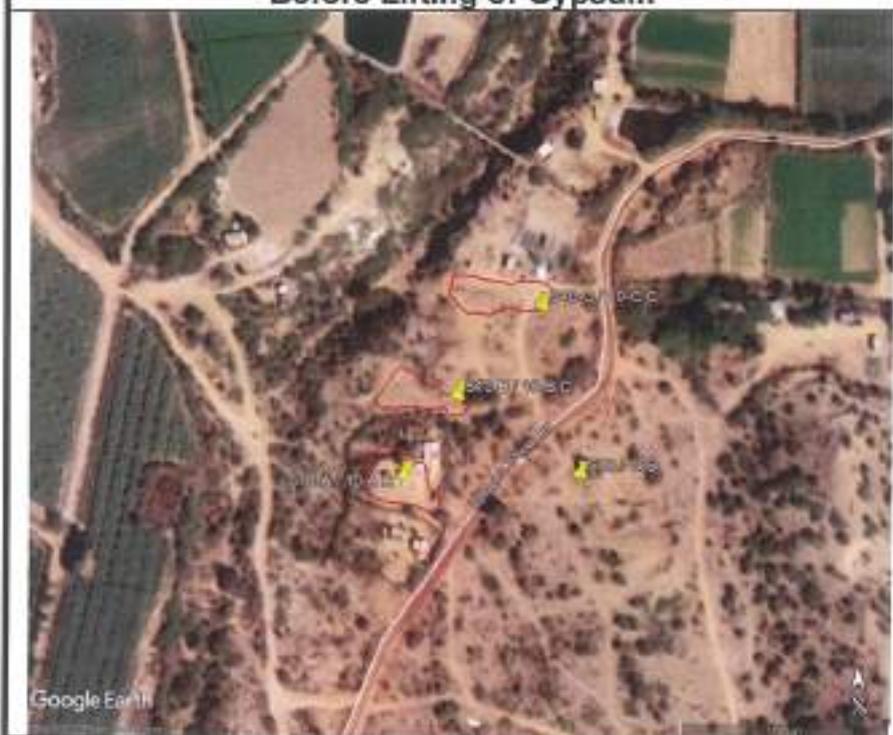
**Figure No. 3.24**  
**Location Map Before and After Lifted of Gypsum along with Soil Samples for**  
**Site S10/C - Land of Hetubha Jadeja Near Block Factory, Ler Village**

**Before Lifting of Gypsum**

**After Lifting of Gypsum**

S10C/10C C	Soil Sample from site
S10/10 B	Virgin Soil Sample near Gypsum site area

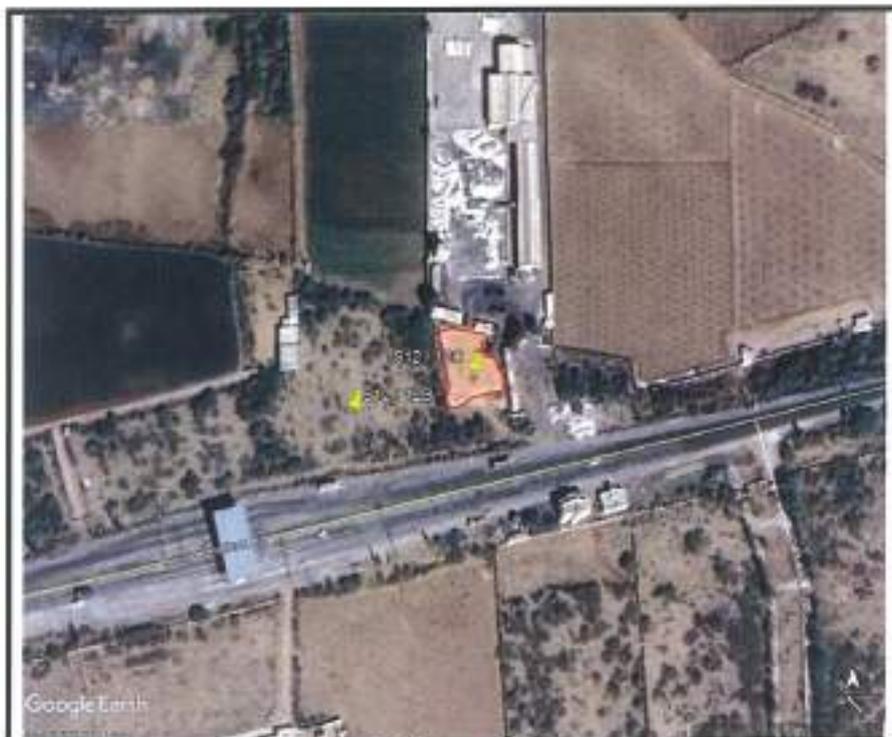
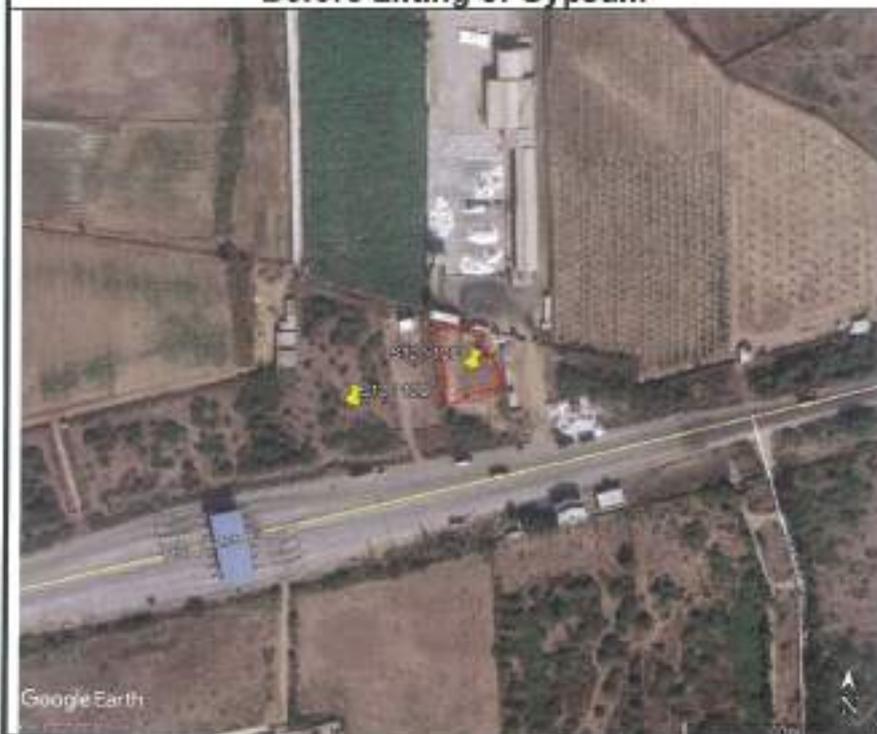
**Figure No. 3.28**  
**Location Map Before and After Lifted of Gypsum along with Soil Samples for**  
**Site S12- Near toll gate lakhond**

**Before Lifting of Gypsum**

**After Lifting of Gypsum**

S12/12 C	Soil Sample from site
S12/12 B	Virgin Soil Sample near Gypsum site area

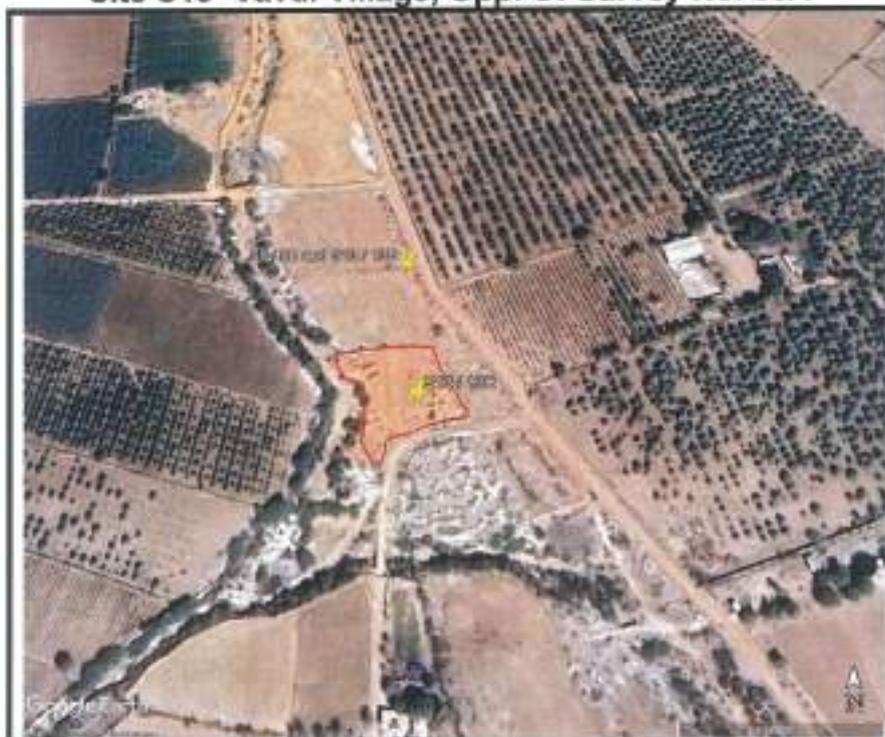
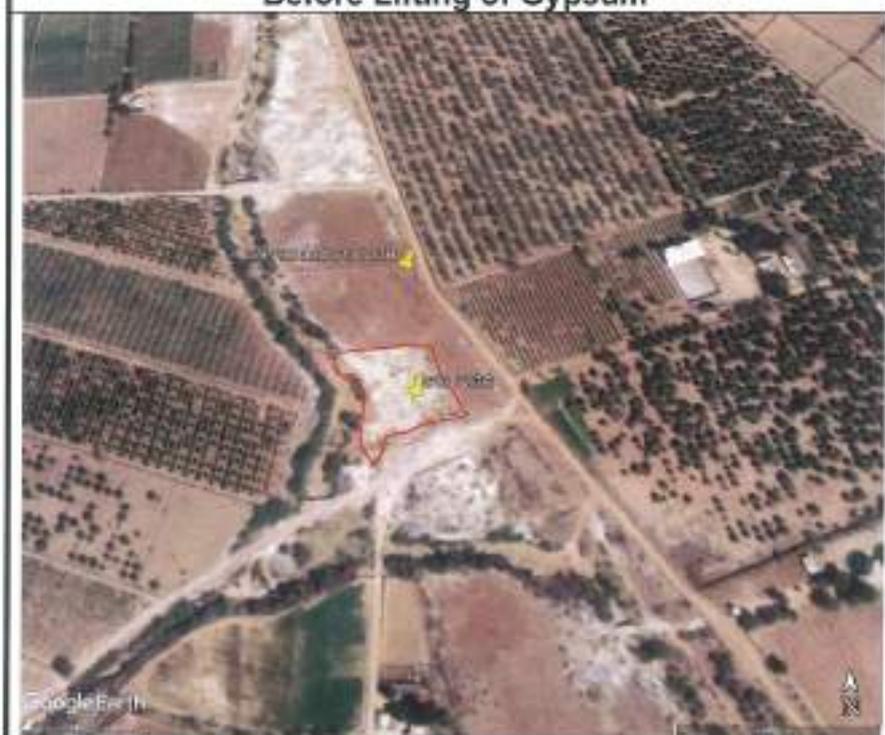
**Figure No. 3.30**  
**Location Map Before and After Lifted of Gypsum along with Soil Samples for**  
**Site S13- Vavdi Village, Opp. Of Survey No. 85/1**

**Before Lifting of Gypsum**

**After Lifting of Gypsum**

S13/13 C	Soil Sample from site
S9/9 B and S13/13 B	Common Virgin Soil Sample near Gypsum site area

<b>Location</b>	:	Vavdi Village, Opp. of Survey No. 85/1  Latitude: 23°11'31" N Longitude: 69°49'45" E
<b>Site Photographs:</b>	:	Please refer Photograph of site presented at <b>Figure No 3.29.</b>
<b>Google Image</b>	:	Site location map along with sample location is presented at <b>Figure No. 3.30.</b>
<b>Soil Analysis</b>	:	Soil analysis report is presented at <b>Table No. 3.16.</b>  The soil analysis in above table indicates that, Gypsum as $\text{CaSO}_4 \cdot 2\text{H}_2\text{O}$ is not present in soil sample. Thus, Gypsum has been removed from the site.  At Gypsum site, low elevated levels of mineral contents viz. Na, K and $\text{SO}_4$ were observed compared to virgin soil samples. This could be due to mixing of Gypsum with the native soils. This will not have any detrimental effect on soil quality. It may be noted that, Potassium is a major group-II primary nutrient, Calcium and Sulphur are secondary major plant nutrients in soil and they are categorized as essential nutrients for plant growth.  Comparing the virgin and site soil sample with Screening and Responsive Level as specified by MoEF (*), it indicates that levels in both virgin and site sample are below screening levels.

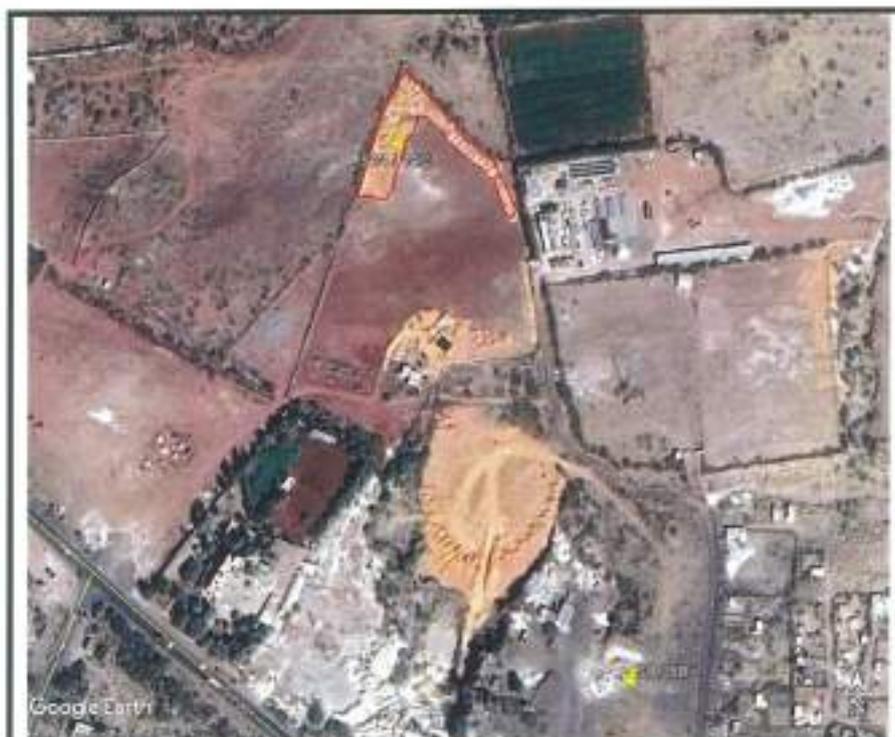
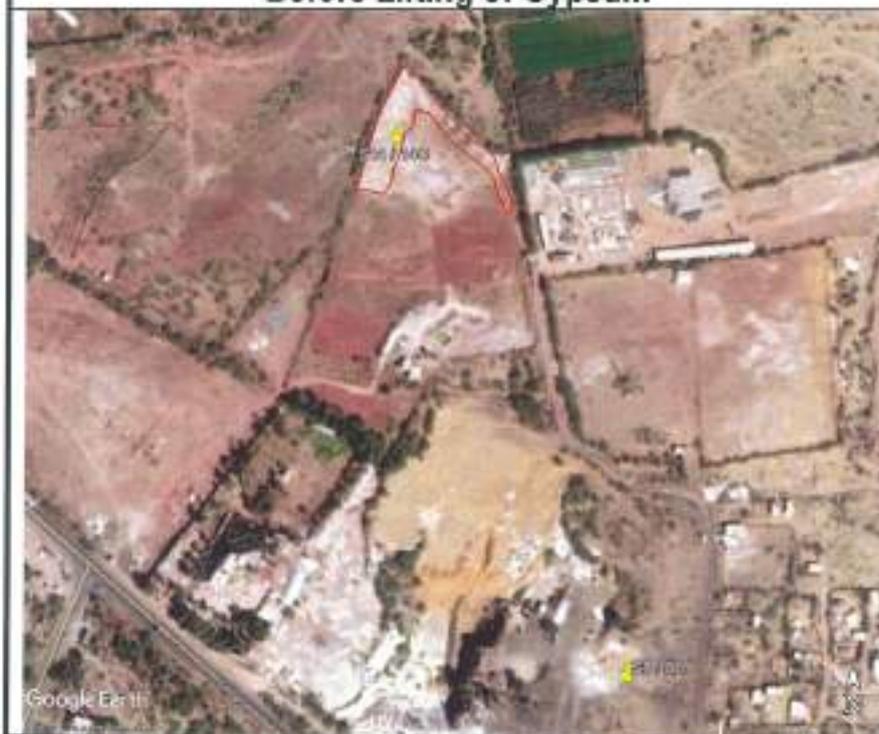
**Figure No. 3.32**  
**Location Map Before and After Lifted of Gypsum along with Soil Samples for**  
**Site S14- Beside Lehriya Hanuman Temple, Kukma village**

**Before Lifting of Gypsum**

**After Lifting of Gypsum**

S14/14C	Soil Sample from site
S8/8 B	Virgin Soil Sample near Gypsum site area

<b>Location</b>	:	Beside Lehriya Hanuman Temple, Kukma village  Latitude: 23°13'24" N Longitude: 69°46'19" E
<b>Site Photographs:</b>	:	Please refer Photograph of site presented at <b>Figure No 3.31.</b>
<b>Google Image</b>	:	Site location map along with sample location is presented at <b>Figure No. 3.32.</b>
<b>Soil Analysis</b>	:	Soil analysis report is presented at <b>Table No. 3.17.</b>  The soil analysis in above table indicates that, Gypsum as $\text{CaSO}_4 \cdot 2\text{H}_2\text{O}$ is not present in soil sample. Thus, Gypsum has been removed from the site.  At Gypsum site, low elevated levels of mineral contents viz. Ca, Na, K and $\text{SO}_4$ were observed compared to virgin soil samples. This could be due to mixing of Gypsum with the native soils. This will not have any detrimental effect on soil quality. It may be noted that, Potassium is a major group-II primary nutrient, Calcium and Sulphur are secondary major plant nutrients in soil and they are categorized as essential nutrients for plant growth.  Level of Nickel is slightly higher as compared to virgin soil samples. However, Comparing the virgin and site soil sample with Screening and Responsive Level as specified by MoEF (*), it indicates that levels in both virgin and site sample are below screening levels.

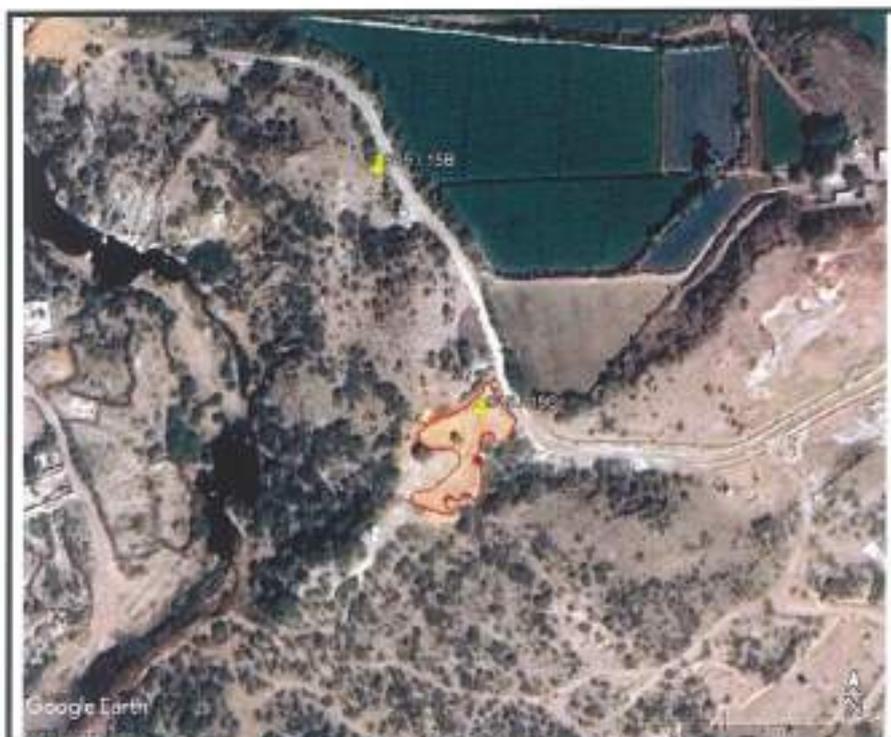
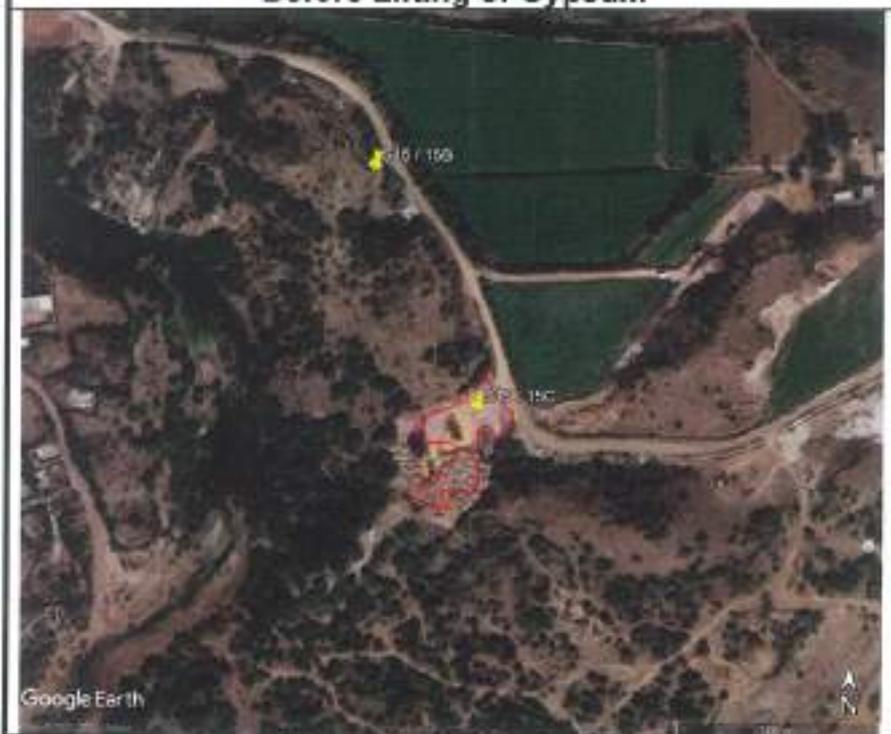
**Figure No. 3.34**  
**Location Map Before and After Lifted of Gypsum along with Soil Samples for**  
**Site S15- At Dargah, Village Lakhond**

**Before Lifting of Gypsum**

**After Lifting of Gypsum**

S15/15 C	Soil Sample from site
S15/15 B	Virgin Soil Sample near Gypsum site area

<b>Location</b>	:	At Dargah, Village Lakhond Latitude: 23°15'31" N Longitude: 69°46'55" E
<b>Site Photographs:</b>	:	Please refer Photograph of site presented at <b>Figure No 3.33.</b>
<b>Google Image</b>	:	Site location map along with sample location is presented at <b>Figure No. 3.34.</b>
<b>Soil Analysis</b>	:	<p>Soil analysis report is presented at <b>Table No. 3.18.</b></p> <p>The soil analysis in above table indicates that, Gypsum as <math>\text{CaSO}_4 \cdot 2\text{H}_2\text{O}</math> is not present in soil sample. Thus, Gypsum has been removed from the site.</p> <p>At Gypsum site, low elevated levels of mineral contents viz. Ca, Na, K and <math>\text{SO}_4</math> were observed compared to virgin soil samples. This could be due to mixing of Gypsum with the native soils. This will not have any detrimental effect on soil quality. It may be noted that, Potassium is a major group-II primary nutrient, Calcium and Sulphur are secondary major plant nutrients in soil and they are categorized as essential nutrients for plant growth.</p> <p>Level of Nickel is slightly higher as compared to virgin soil samples. However, Comparing the virgin and site soil sample with Screening and Responsive Level as specified by MoEF (*), it indicates that levels in both virgin and site sample are below screening levels.</p>

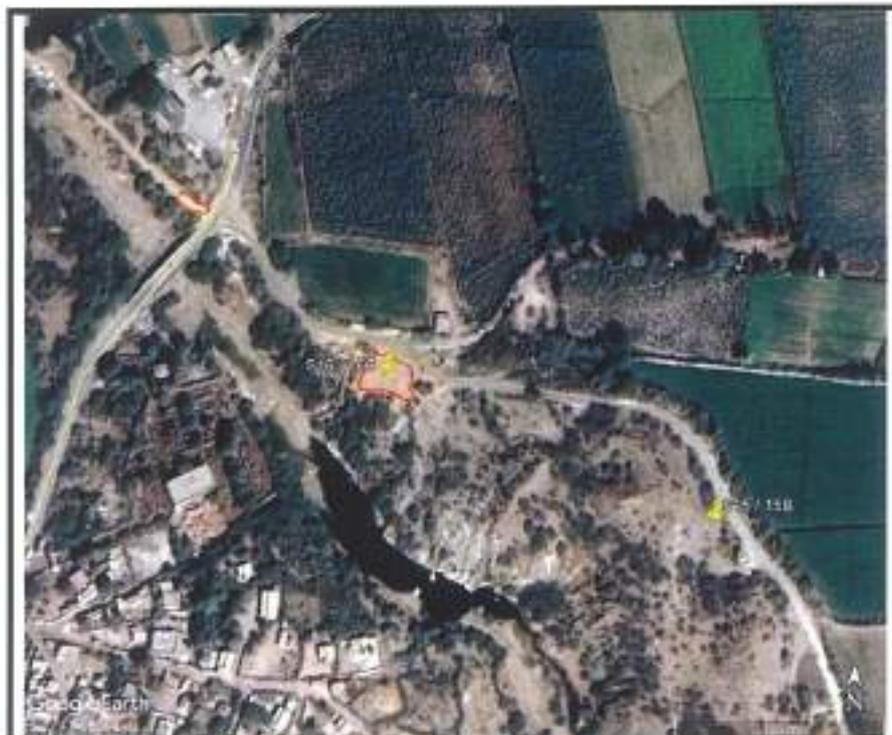
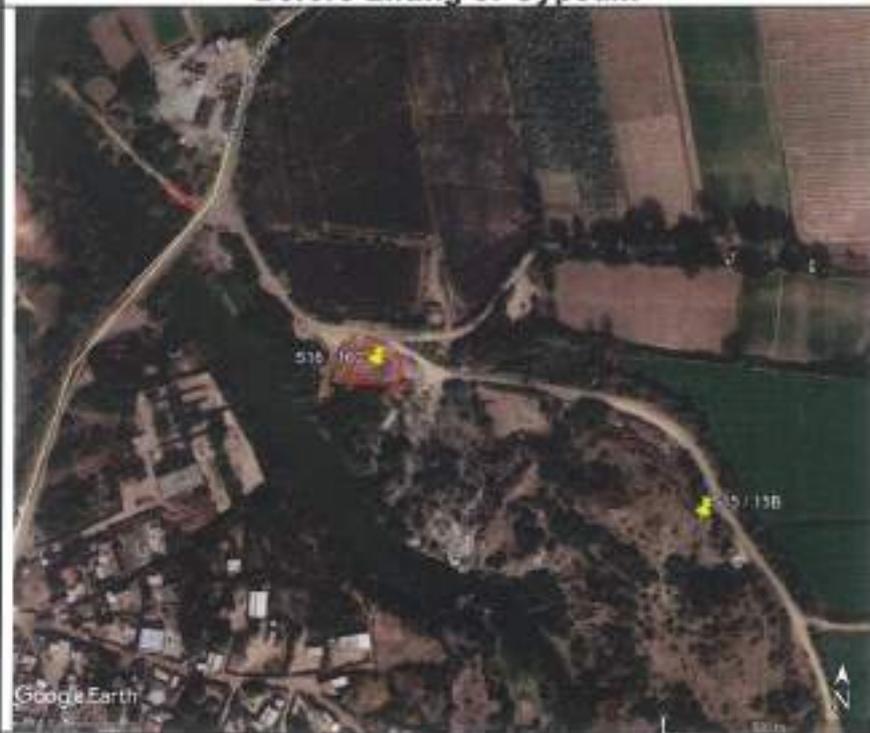
**Figure No. 3.36**  
**Location Map Before and After Lifted of Gypsum along with Soil Samples for**  
**Site S16/A- At Village Lakhond**

**Before Lifting of Gypsum**

**After Lifting of Gypsum**

S16/16 C	Soil Sample from site
S15/15 B	Virgin Soil Sample near Gypsum site area

<b>Location</b>	:	At Village Lakhond  Latitude: 23°15'39" N Longitude: 69°46'44" E
<b>Site Photographs:</b>	:	Please refer Photograph of site presented at <b>Figure No 3.35.</b>
<b>Google Image</b>	:	Site location map along with sample location is presented at <b>Figure No. 3.36.</b>
<b>Soil Analysis</b>	:	Soil analysis report is presented at <b>Table No. 3.19.</b>  The soil analysis in above table indicates that, Gypsum as $\text{CaSO}_4 \cdot 2\text{H}_2\text{O}$ is not present in soil sample. Thus, Gypsum has been removed from the site.  At Gypsum site, low elevated levels of mineral contents viz. Ca, Na, K and $\text{SO}_4$ were observed compared to virgin soil samples. This could be due to mixing of Gypsum with the native soils. This will not have any detrimental effect on soil quality. It may be noted that, Potassium is a major group-II primary nutrient, Calcium and Sulphur are secondary major plant nutrients in soil and they are categorized as essential nutrients for plant growth.  Level of Nickel is slightly higher as compared to virgin soil samples. However, Comparing the virgin and site soil sample with Screening and Responsive Level as specified by MoEF (*), it indicates that levels in both virgin and site sample are below screening levels.

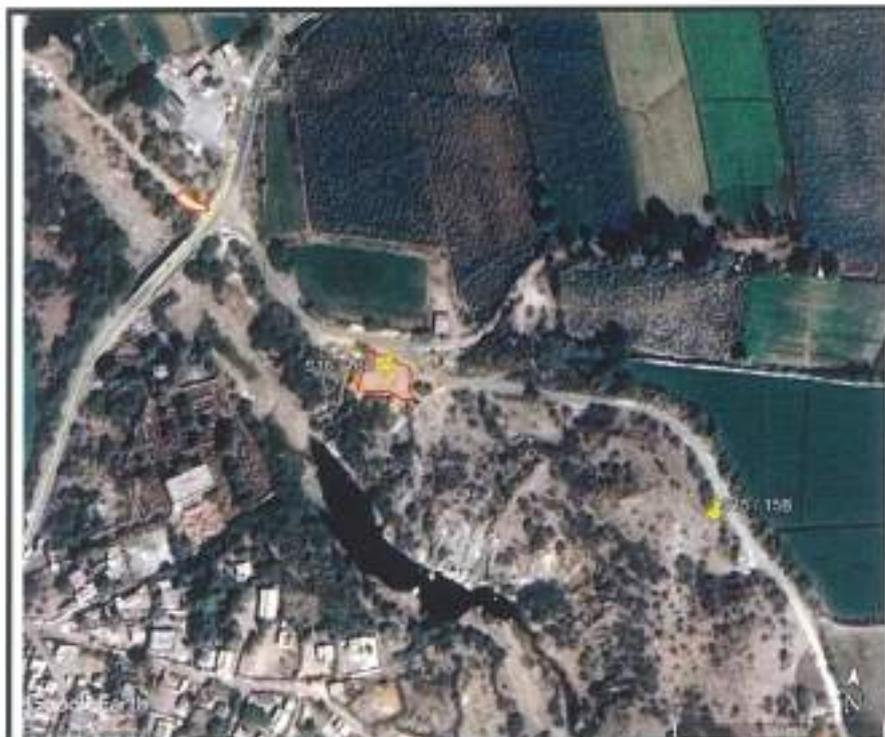
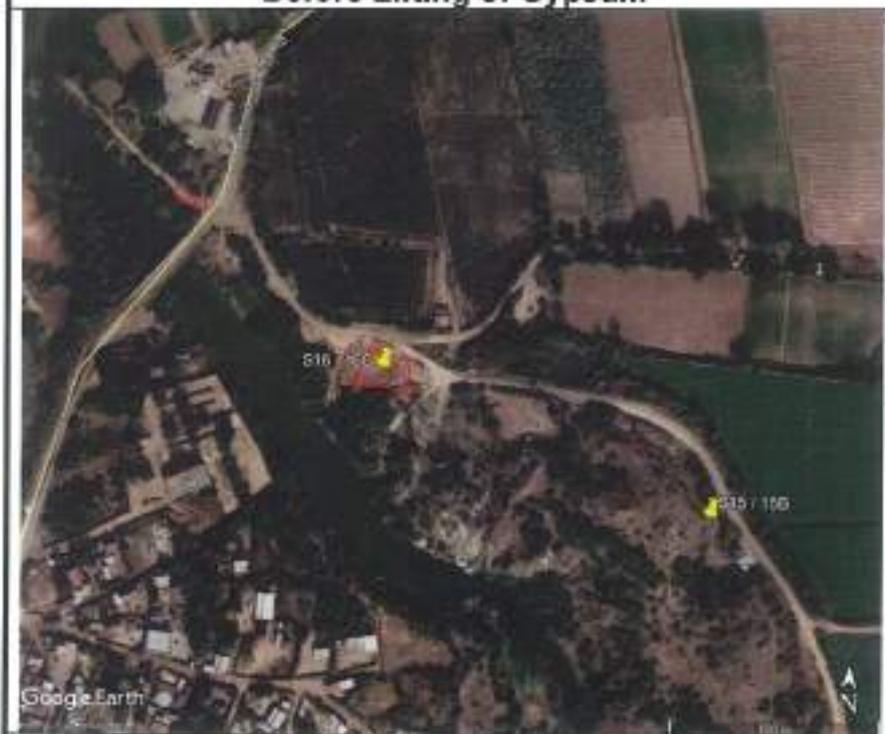
**Figure No. 3.38**  
**Location Map Before and After Lifted of Gypsum along with Soil Samples for**  
**Site S16/B- At Village Lakhond**

**Before Lifting of Gypsum**

**After Lifting of Gypsum**

S16/16 C	Soil Sample from site
S15/15 B	Virgin Soil Sample near Gypsum site area

<b>Location</b>	:	At Village Lakhond  Latitude: 23°15'36" N Longitude: 69°46'48" E
<b>Site Photographs:</b>	:	Please refer Photograph of site presented at <b>Figure No 3.37.</b>
<b>Google Image</b>	:	Site location map along with sample location is presented at <b>Figure No. 3.38.</b>
<b>Soil Analysis</b>	:	Soil analysis report is presented at <b>Table No. 3.20.</b>  The soil analysis in above table indicates that, Gypsum as $\text{CaSO}_4 \cdot 2\text{H}_2\text{O}$ is not present in soil sample. Thus, Gypsum has been removed from the site.  At Gypsum site, low elevated levels of mineral contents viz. Ca, Na, K and $\text{SO}_4$ were observed compared to virgin soil samples. This could be due to mixing of Gypsum with the native soils. This will not have any detrimental effect on soil quality. It may be noted that, Potassium is a major group-II primary nutrient, Calcium and Sulphur are secondary major plant nutrients in soil and they are categorized as essential nutrients for plant growth.  Level of Nickel is slightly higher as compared to virgin soil samples. However, Comparing the virgin and site soil sample with Screening and Responsive Level as specified by MoEF (*), it indicates that levels in both virgin and site sample are below screening levels.
