## STATUS REPORT

### IN THE MATTER OF O. A. 669 OF 2018, MARVADA AMRUTLAL BECHARLAL Vs. STATE OF GUJARAT – ASHAPURA GROUP OF COMPANIES, KUTCH

**REPORT  
ON  
GYPSUM SITE CLEARANCE**

**ASHAPURA PERFOCLAY LTD.(APL)**  
**PLOT NO. 163, 164 & 167, VILLAGE: LER, TALUKA: BHUJ,**  
**DIST.: KUTCH, GUJRAT, INDIA**

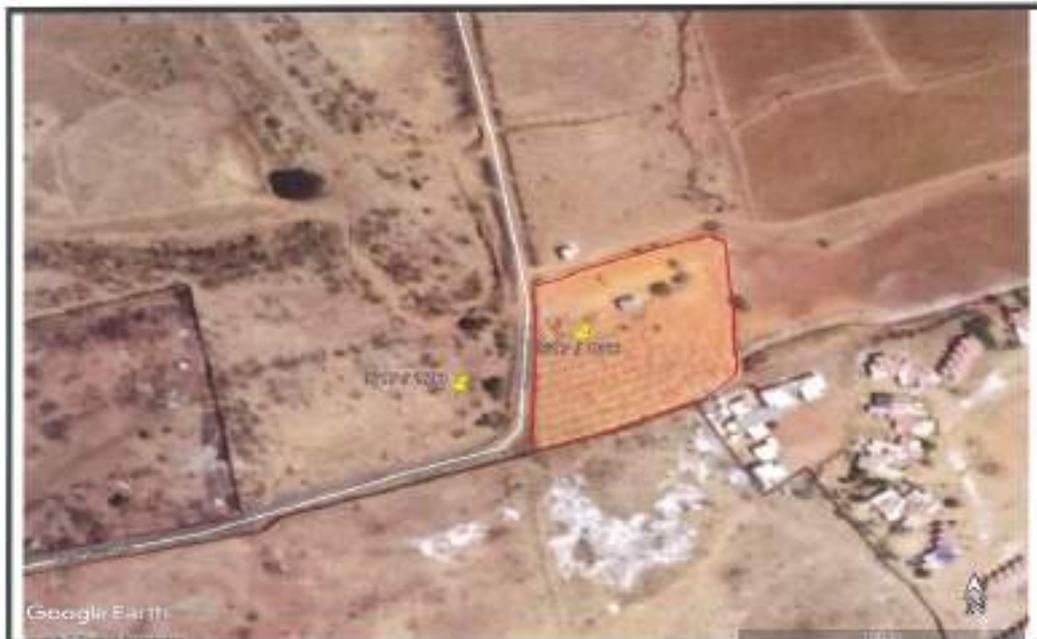
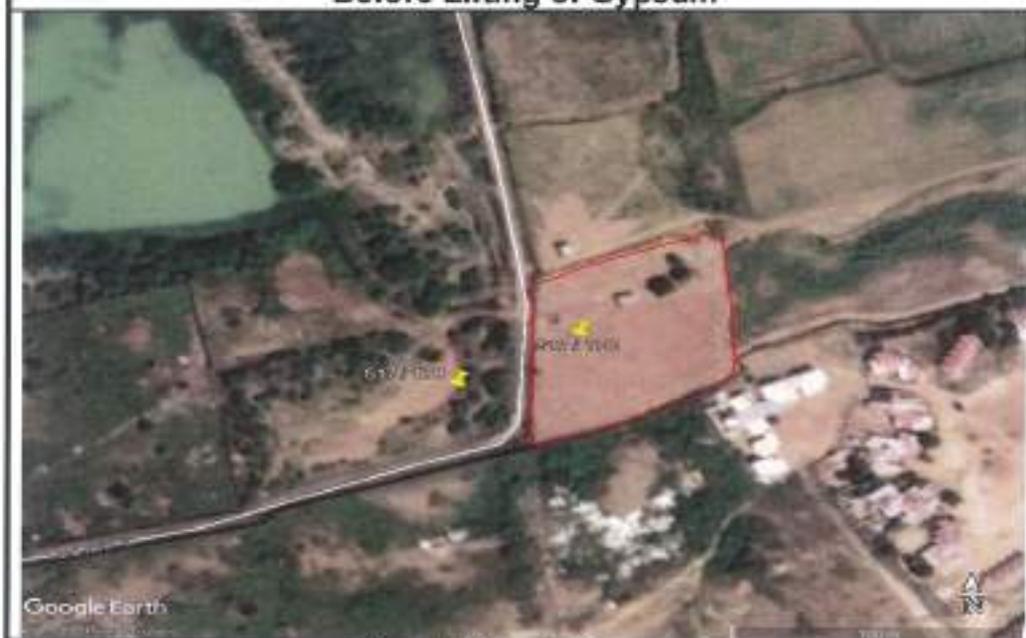
**Figure No. 3.40**  
**Location Map Before and After Lifted of Gypsum along with Soil Samples for**  
**Site S17- B/h. Ashapura Foundation school, Ashapura Colony, Bhachau Road,**  
**Kukma**

**Before Lifting of Gypsum**

**After Lifting of Gypsum**

S17/17 C	Soil Sample from site
S17/17 B	Virgin Soil Sample near Gypsum site area

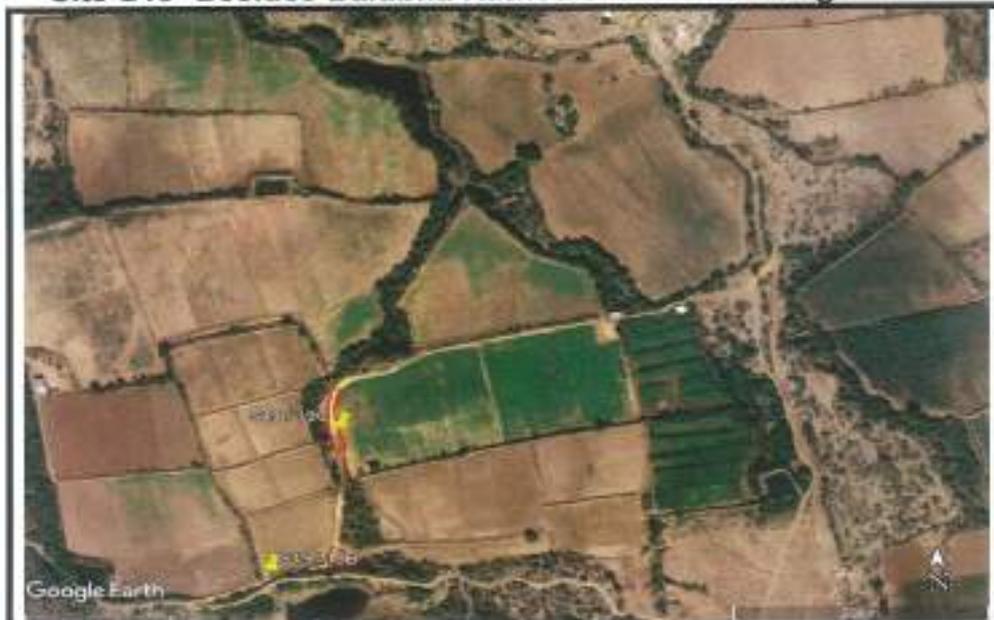
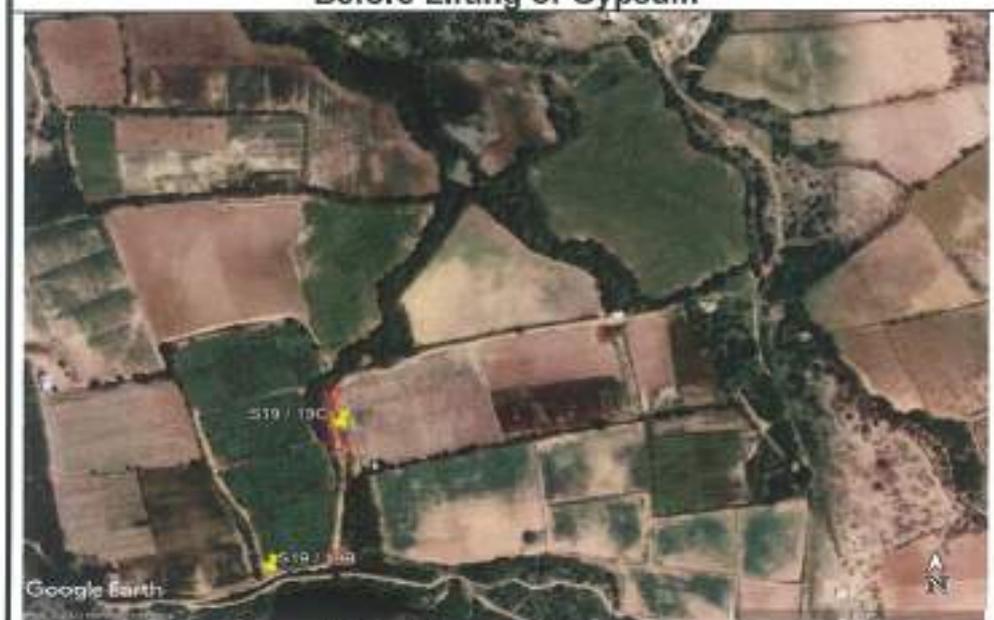
**Figure No. 3.44**  
**Location Map Before and After Lifted of Gypsum along with Soil Samples for**  
**Site S19- Besides Balubha Rathod's Lake Ler Village**

**Before Lifting of Gypsum**

**After Lifting of Gypsum**

S19/19 C	Soil Sample from site
S19/19 B	Virgin Soil Sample near Gypsum site area

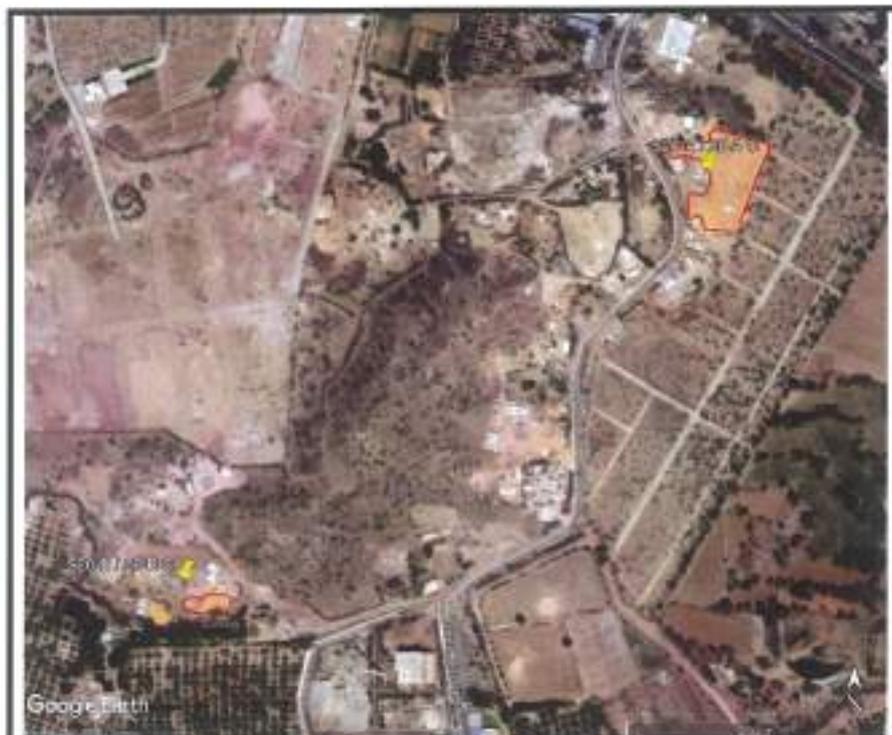
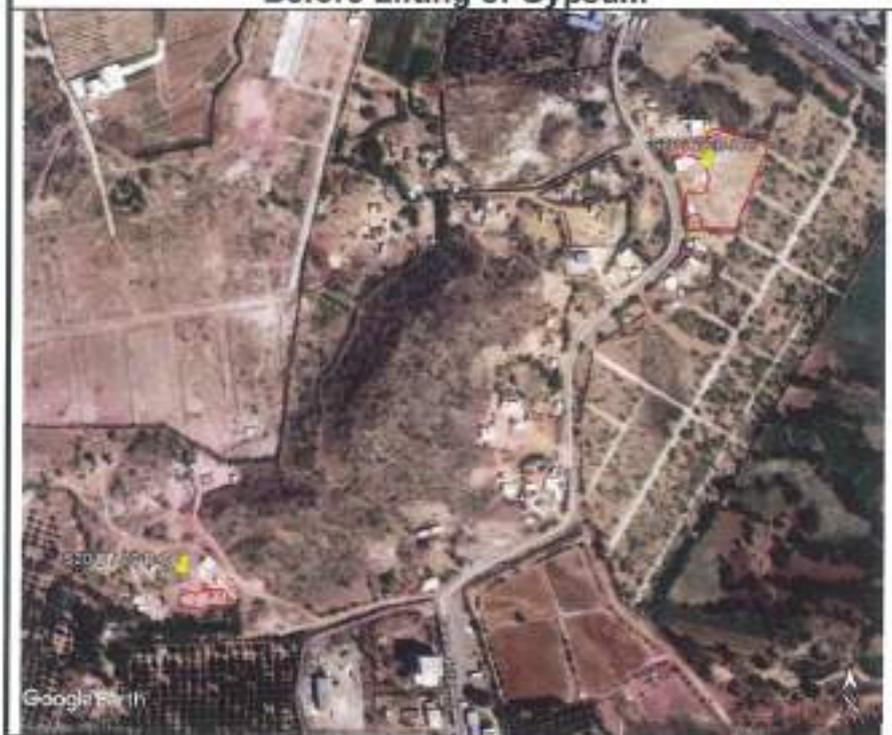
**Figure No. 3.46**  
**Location Map Before and After Lifted of Gypsum along with Soil Samples for**  
**Site S20/A- At Shekhpur Parle**

**Before Lifting of Gypsum**

**After Lifting of Gypsum**

S20A/20A C	Soil Sample from site
S20B/20B C	Soil Sample from site

Sr. No.	Parameters	S20A/20A C Soil Sample from site
1	Moisture %	4.78
2	pH	7.60
3	Conductivity, mS/cm	0.689
4	Calcium, g/Kg	1.92
5	Sodium, g/Kg	5.8
6	Potassium, g/Kg	1.0
7	Sulphate, g/Kg	0.44
8	Ammonia, g/Kg	0.022
9	Copper, g/Kg	0.009
10	Nickel, g/Kg	0.011
11	Zinc, g/Kg	0.120
12	Cadmium, g/Kg	BDL
13	Lead, g/Kg	0.011
14	Chromium, g/Kg	0.013
15	Manganese, g/Kg	0.064
16	Cobalt, g/Kg	0.009
17	Nitrate, g/Kg	BDL
18	Gypsum as CaSO <sub>4</sub> .2H <sub>2</sub> O, %	BDL

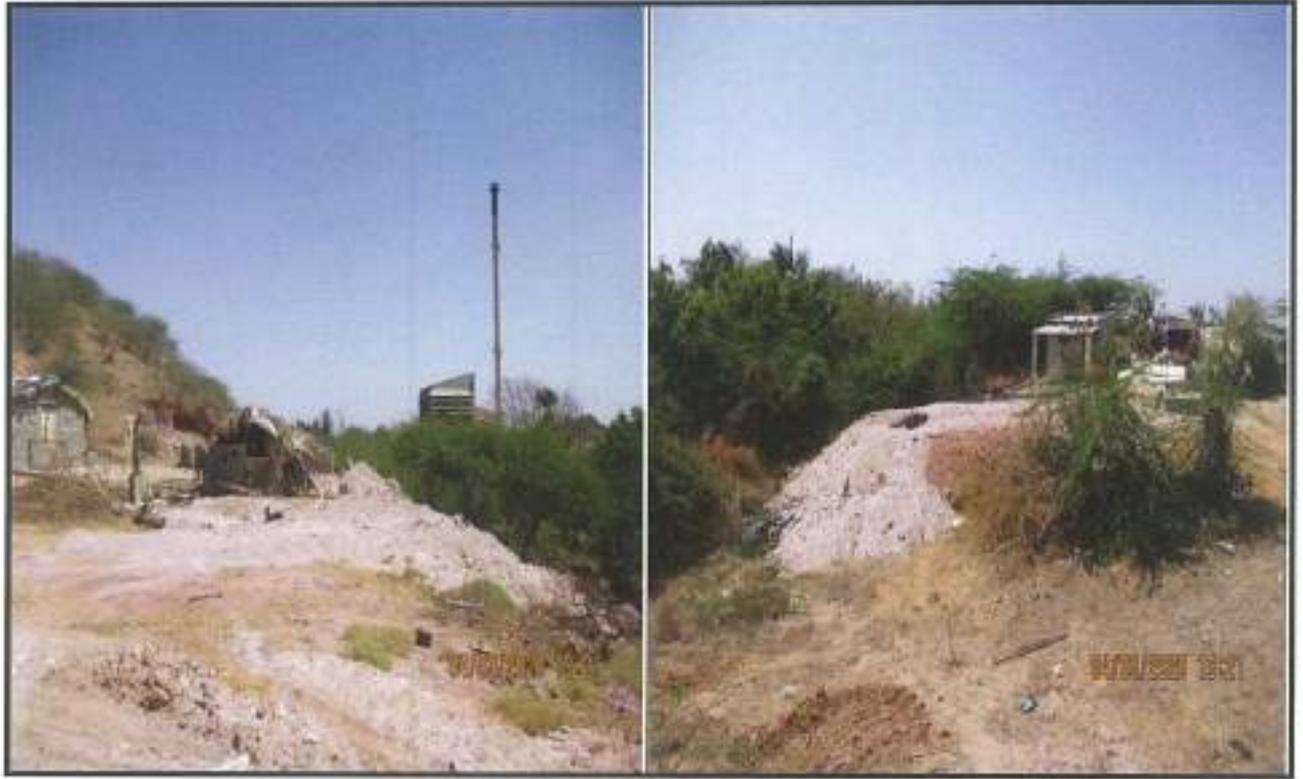
Figure No. 3.47  
Photograph of Site S20/B-  
At Shekhpur Parle

<b>Location</b>	:	At Shekhpur Parle  Latitude: 23°13'33" N Longitude: 69°45'28" E
<b>Site Photographs:</b>	:	Please refer Photograph of site presented at <b>Figure No 3.47.</b>
<b>Google Image</b>	:	Site location map along with sample location is presented at <b>Figure No. 3.48.</b>
<b>Soil Analysis</b>	:	Soil analysis report is presented at <b>Table No. 3.25.</b>  The soil analysis in above table indicates that, Gypsum as $\text{CaSO}_4 \cdot 2\text{H}_2\text{O}$ is not present in soil sample. Thus, Gypsum has been removed from the site.  The virgin sample was not available at site to comparative analysis of site soil quality is not ascertain.  Comparing the soil sample with Screening and Responsive Level as specified by MoEF(*), it indicates that levels in site sample are below screening levels.
<b>Inspection Report</b>	:	Based on our visual observations and soil analysis report it is inferred that Gypsum has been lifted from the said site.

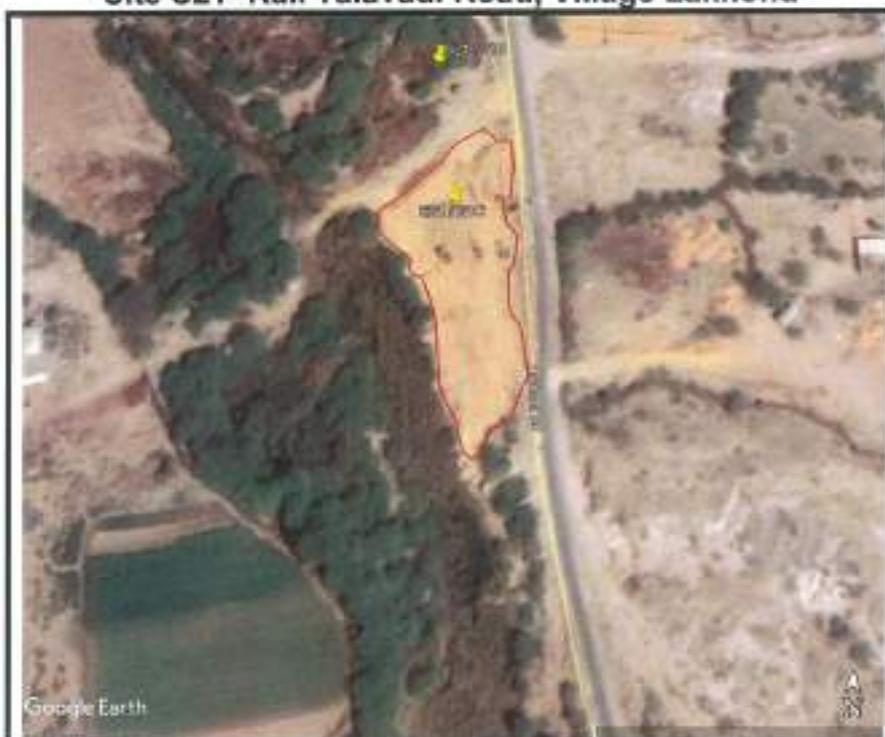
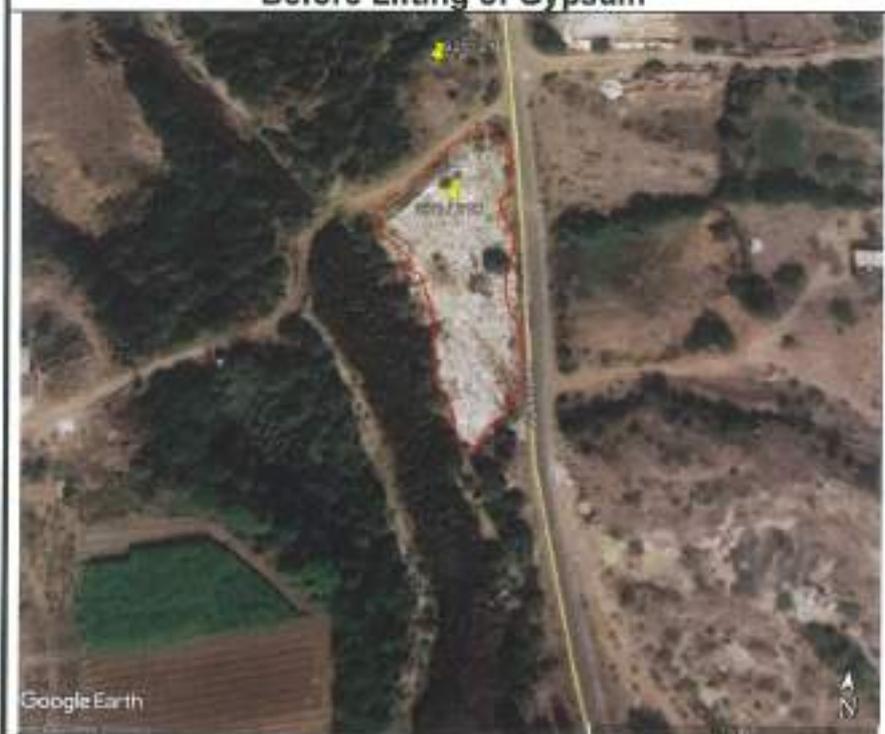
**Figure No. 3.50**  
**Location Map Before and After Lifted of Gypsum along with Soil Samples for**  
**Site S21- Kali Talavadi Road, Village Lakhond**

**Before Lifting of Gypsum**

**After Lifting of Gypsum**

S21/21 C	Soil Sample from site
S21/21 B	Virgin Soil Sample near Gypsum site area

Sr. No.	Parameters	S21/21 C Soil Sample from site	S21/21 B Virgin Soil Sample near Gypsum site area
1	Moisture %	5.92	6.84
2	pH	7.52	8.08
3	Conductivity, mS/cm	1.985	0.313
4	Calcium, g/Kg	4.81	2.01
5	Sodium, g/Kg	14.4	10.2
6	Potassium, g/Kg	6.0	3.6
7	Sulphate, g/Kg	1.24	0.24
8	Ammonia, g/Kg	BDL	BDL
9	Copper, g/Kg	0.022	0.020
10	Nickel, g/Kg	0.013	0.012
11	Zinc, g/Kg	0.04	0.04
12	Cadmium, g/Kg	BDL	BDL
13	Lead, g/Kg	0.012	0.010
14	Chromium, g/Kg	BDL	BDL
15	Manganese, g/Kg	0.019	0.021
16	Cobalt, g/Kg	0.008	0.010
17	Nitrate, g/Kg	0.01	0.01
18	Gypsum as CaSO <sub>4</sub> .2H <sub>2</sub> O, %	BDL	BDL

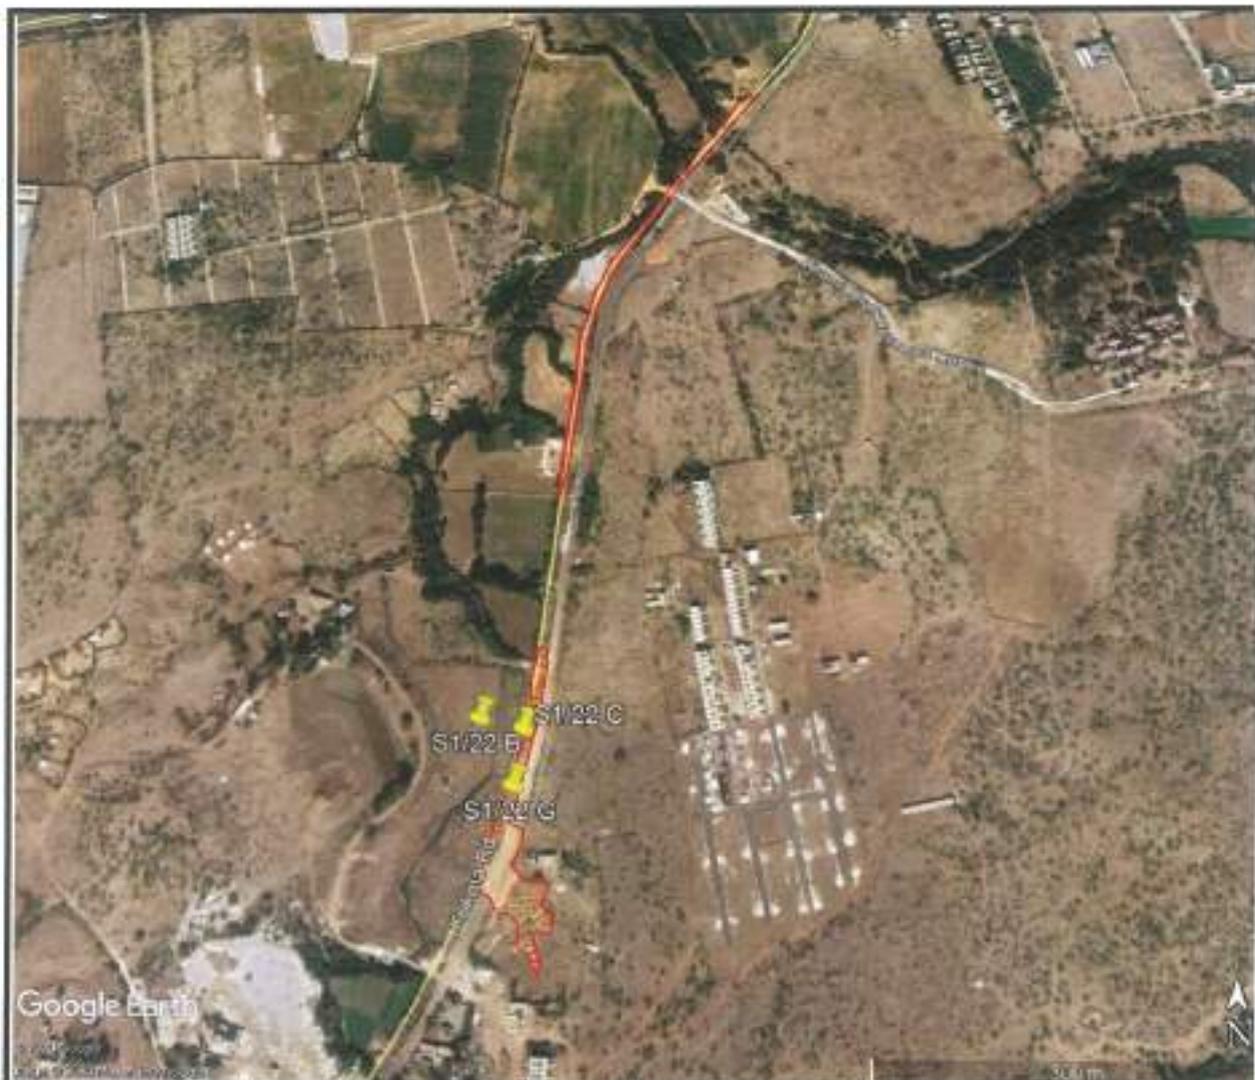
**Figure No. 4.2**  
**Site Location Map with Gypsum, Soil and water Sample of**  
**Site-S1/22–Beside Kukma–Lakhond Village Road**

S1/22 G	Gypsum Composite Sample
S1/22 C	Soil Sample near Gypsum site
S1/22 B	Virgin Soil Sample near Gypsum site area
Latitude : 23°13'28.55"N, Longitude: 69°46'43.28"E	
To	
Latitude : 23°13'53.41"N, Longitude: 69°46'50.85"E

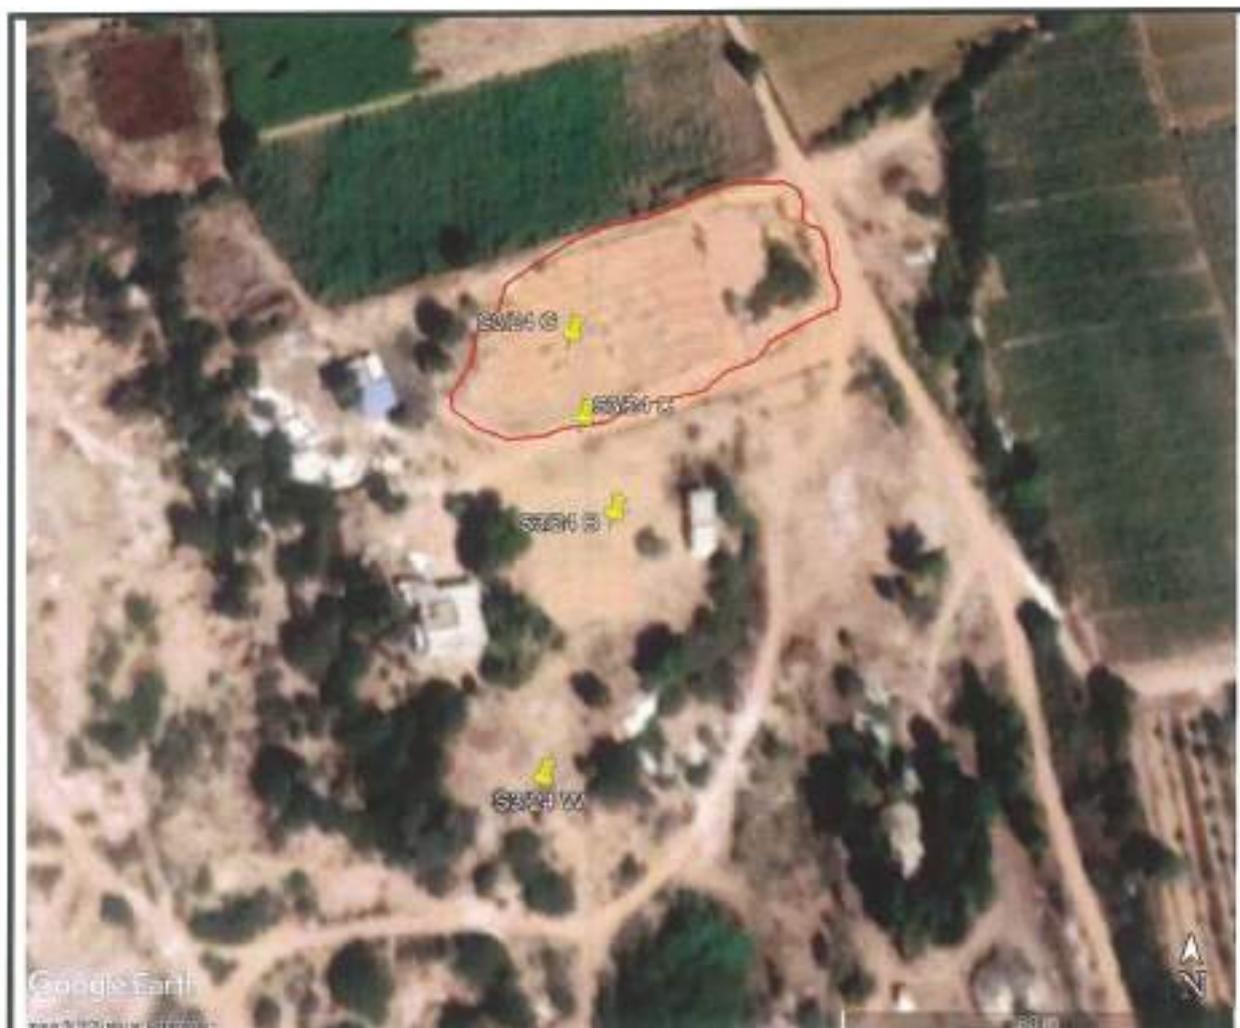
**Figure No. 4.6**  
**Site Location Map with Gypsum, Soil and water Sample of**  
**Site-S3/24 - Shri Vankal mata Mandir**

S3/24 G	Gypsum composite Sample from 10 Different Location
S3/24 C	Soil Sample near Gypsum site
S3/24 B	Virgin Soil Sample near Gypsum site area
S3/24 W	Borewell at Shri Vankal mata Temple, Village Bhujodi
Latitude	: 23°13'35.44"N
Longitude	: 69°44'41.32"E

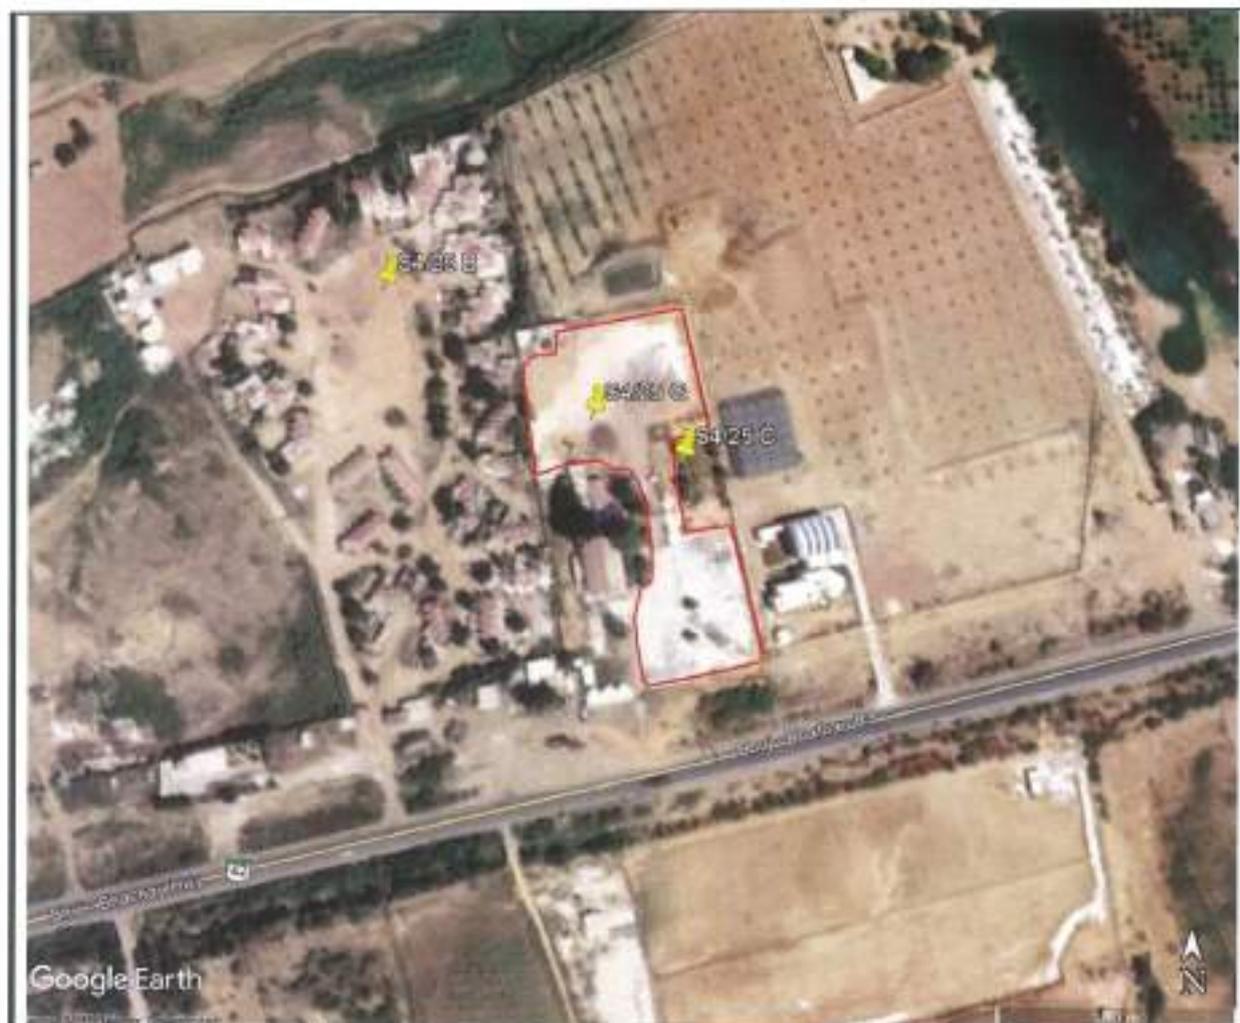
**Figure No. 4.8**  
**Site Location Map with Gypsum, Soil and water Sample of Site-S4/25**  
**Vrundavan Gir Gaudham, Shree Swaminarayan Mandir, Besides Ashapura**  
**Colony, Bhuj-Bhachau Road**

S4/25 G	Gypsum Sample from 10 Different Location
S4/25 C	Soil Sample near Gypsum site
S4/25 B	Virgin Soil Sample near Gypsumsite area
Latitude : 23°14'04.33"N,	
Longitude : 69°46'35.57"E

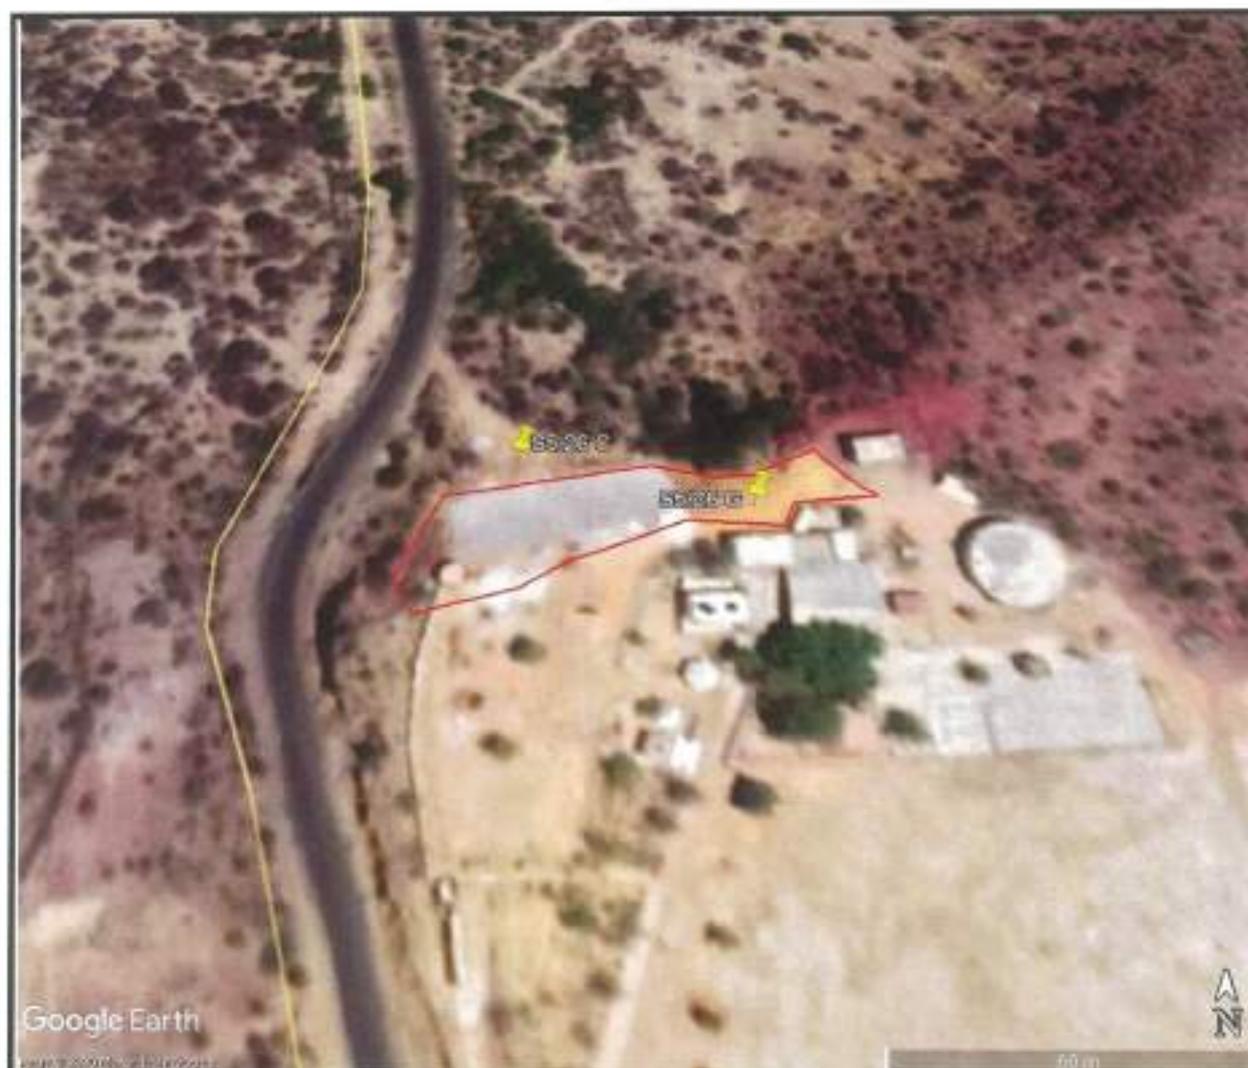
**Figure No. 4.10**  
**Site Location Map with Gypsum, Soil and water Sample of**  
**Site-S5/26 – Pithoradada Mandir, Ler Village**

S5/26 G	Gypsum Sample from 10 Different Location
S5/26 C	Soil Sample near Gypsum site area
Latitude : 23°10'23.18"N	
Longitude: 69°46'05.05"E

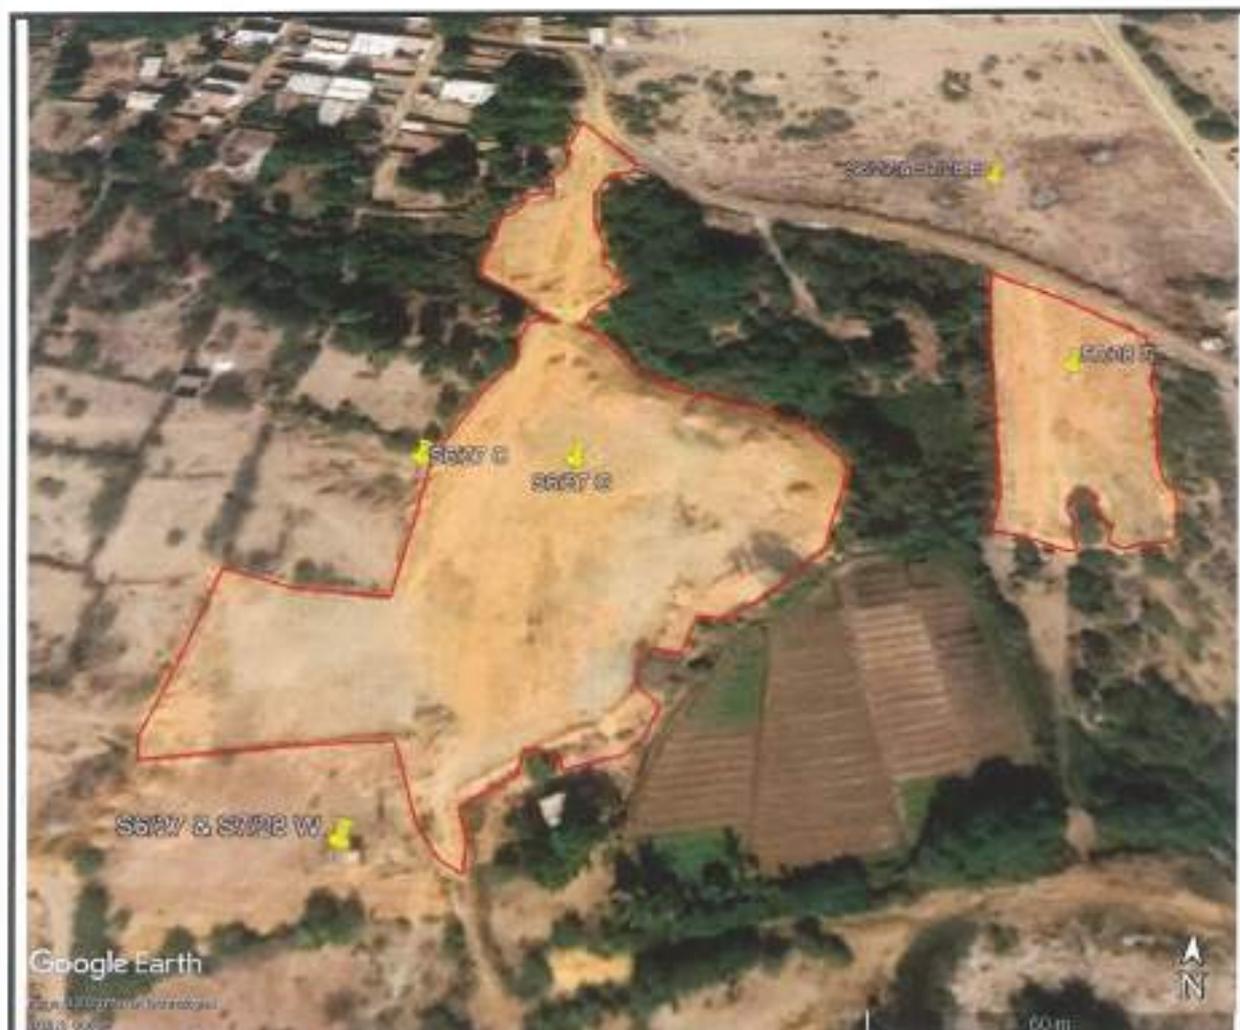
**Figure No. 4.12**  
**Site Location Map with Gypsum, Soil and water Sample of**  
**Site-S6/27 - Land of Lakhond Village**

S6/27 G	Gypsum composite sample from sites
S6/27 C	Common for Site S6/27 and S7/28 Soil Sample near Gypsum site
S6/27 & S7/28 B	Common for Site S6/27 and S7/28 Virgin Soil Sample near Gypsum site area
S6/27 & S7/28 W	Common for Site S6/27 and S7/28 Borewell at Near Gypsum site area, Lakhond Village
Latitude : 23°15'12.11"N	
Longitude: 69°46'41.11"E

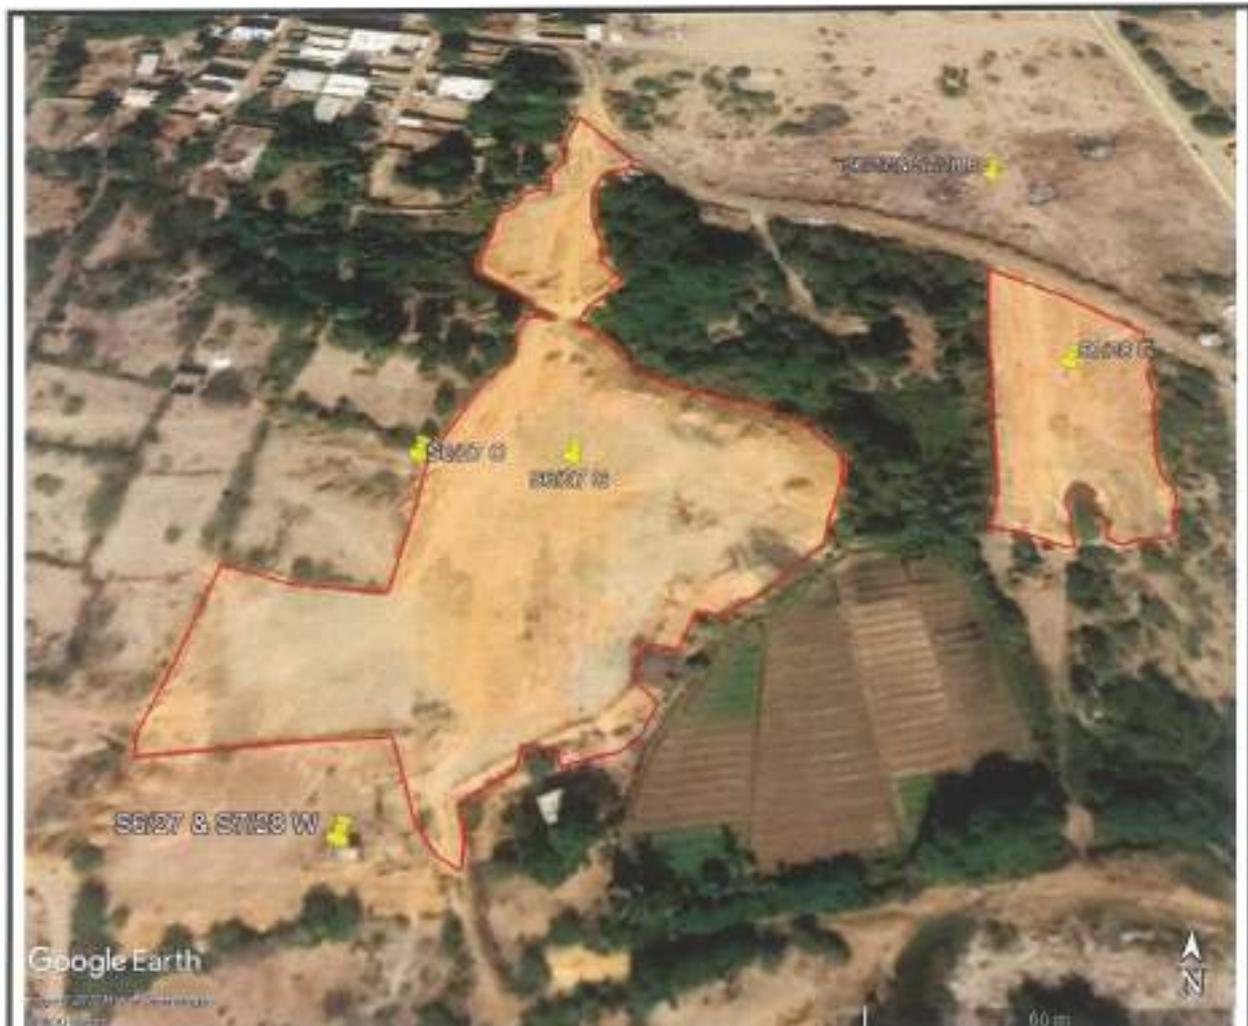
**Figure No. 4.14**  
**Site Location Map with Gypsum, Soil and water Sample of**  
**Site-S7/28 - Adjacent site of site no. S6/27, Lakhond Village**

S7/28 G	Gypsum composite sample from site
S6/27 C	Common for Site S6/27 and S7/28 Soil Sample near Gypsum site
S6/27 & S7/28 B	Common for Site S6/27 and S7/28 Virgin Soil Sample near Gypsum site area
S6/27 & S7/28 W	Common for Site S6/27 and S7/28 Borewell at Near Gypsum site area, Lakhond Village
Latitude : 23°15'11.04"N, Longitude: 69°46'44.89"E

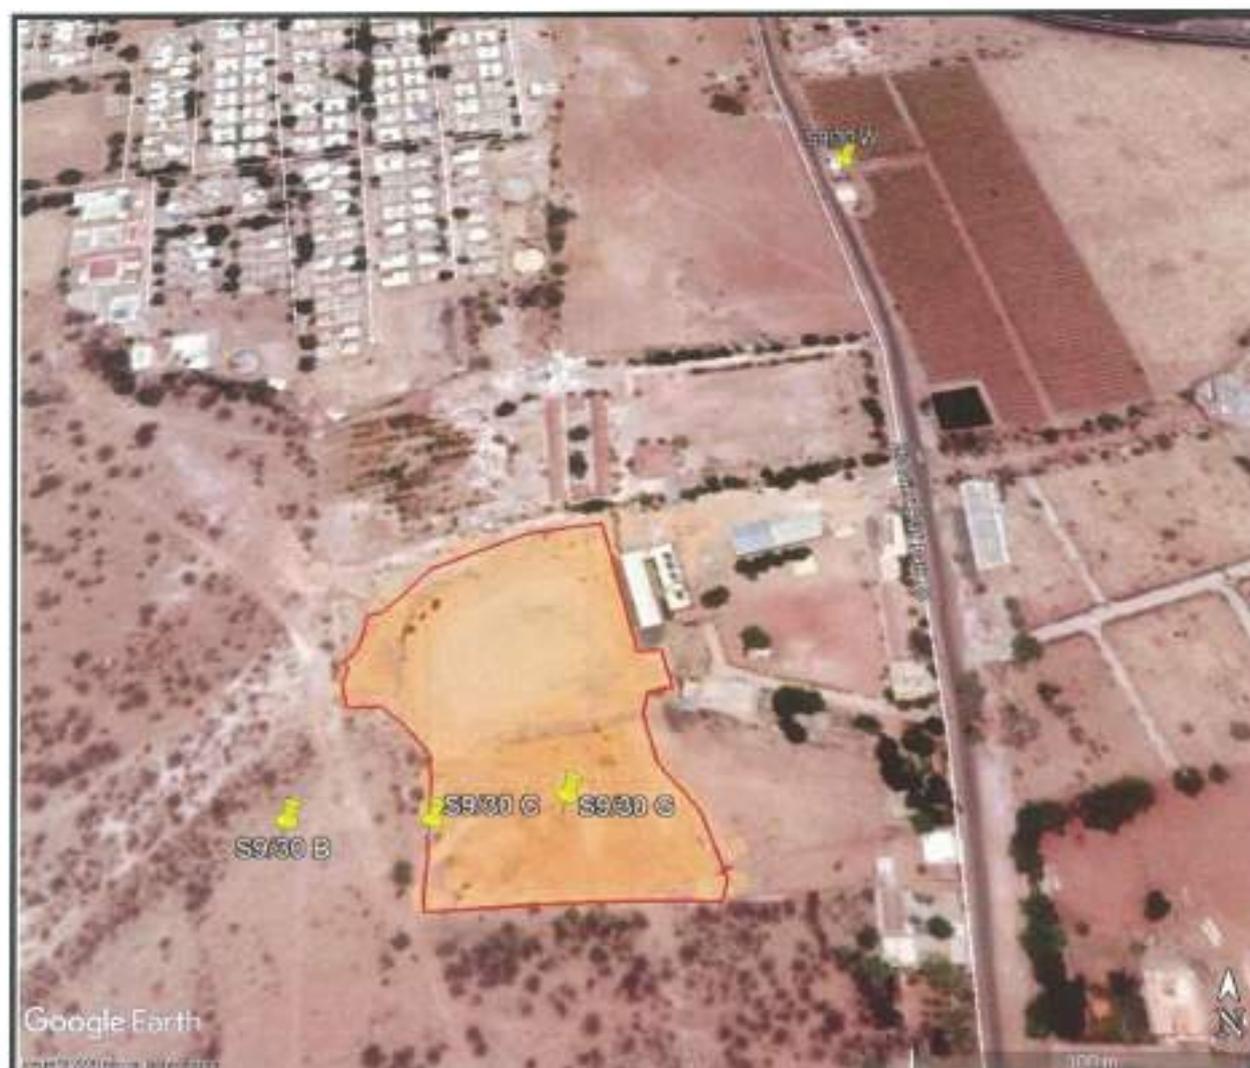
**Figure No. 4.18**  
**Site Location Map with Gypsum, Soil and water Sample of**  
**Site-S9/30 – B/h. Mangal Mandir School, Village Bhujodi**

S9/30 G	Gypsum Composite sample from site
S9/30 C	Soil Sample near Gypsum site
S9/30 B	Virgin Soil Sample near Gypsum site area
S9/30 W	Borewell of Jinabhai Farm opp. Mangal Mandir School at Village Bhujodi
Latitude : 23°13'45.11"N	
Longitude: 69°44'08.96"E

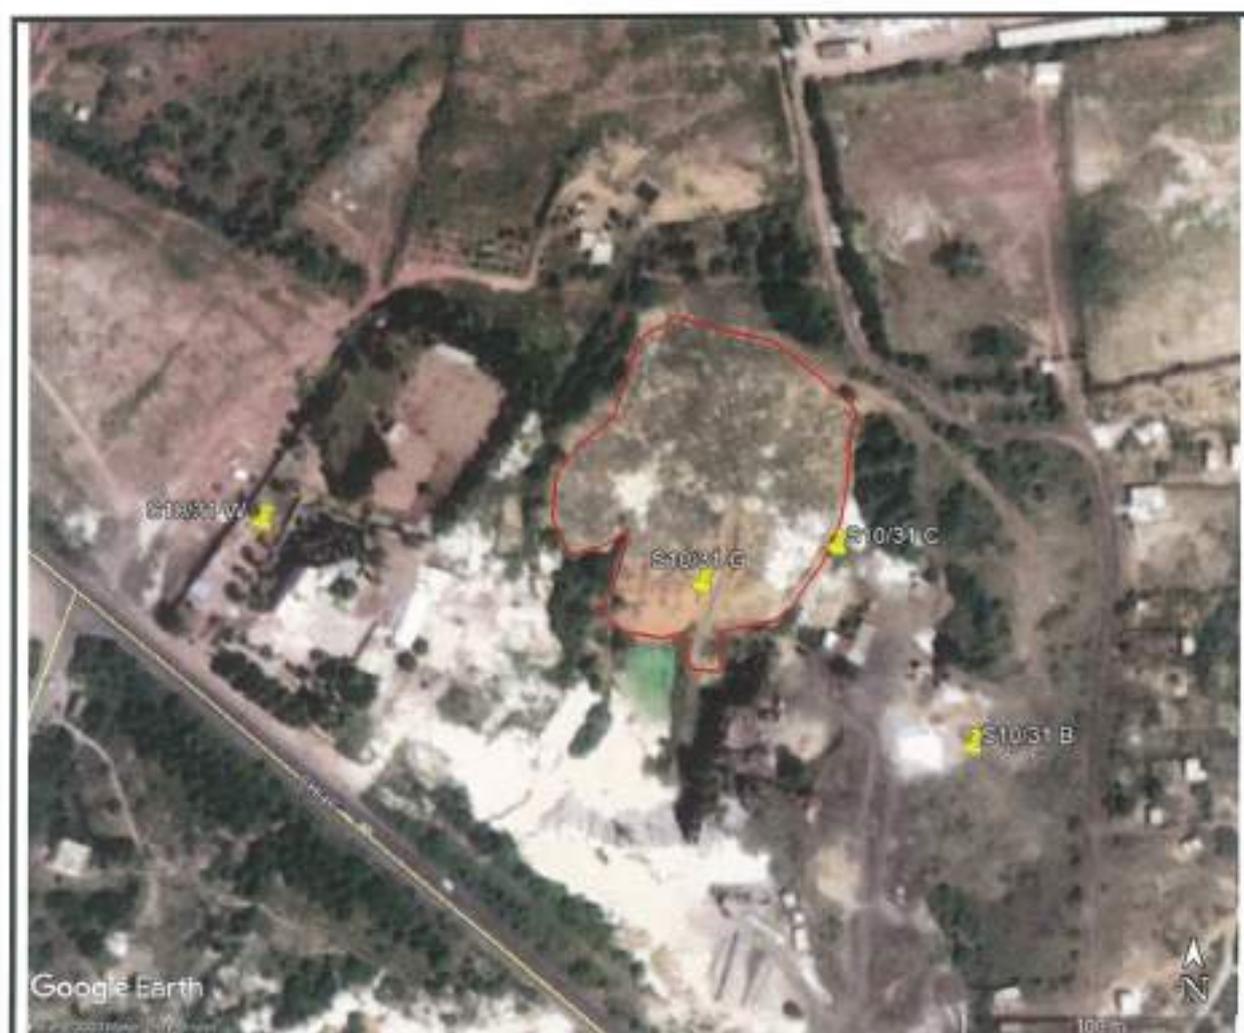
**Figure No. 4.20**  
**Site Location Map with Gypsum, Soil and water Sample of**  
**Site-S10/31 - Behind Lehriya Hanuman at Village Kukma**

S10/31 G	Gypsum Sample from 10 Different Location
S10/31 C	Soil Sample near Gypsum site
S10/31 B	Virgin Soil Sample near Gypsumsite area
S10/31 W	Borewell of Laheriya Hanuman Temple at Village Kukma
Latitude : 23°13'21.14"N,	
Longitude : 69°46'21.09"E

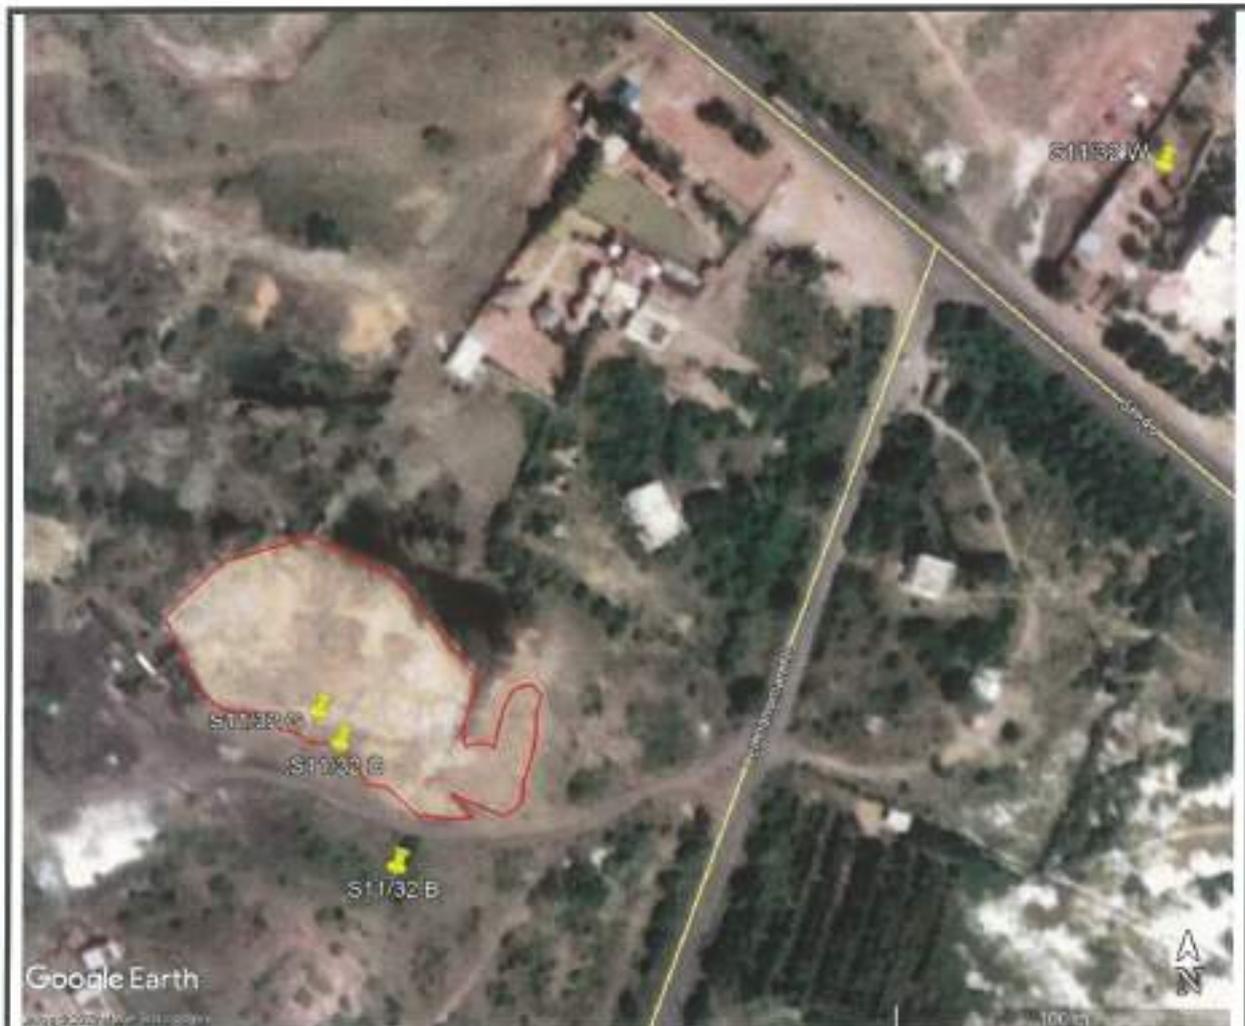
**Figure No. 4.22**  
**Site Location Map with Gypsum, Soil and water Sample of**  
**Site-S11/32 - Old stone mine of Prakash Patel, Beside old Hot Mix plant, Kukma**  
**Village**

S11/32 G	Gypsum Composite Sample
S11/32 C	Soil Sample near Gypsum site
S11/32 B	Virgin Soil Sample near Gypsum site area
Latitude : 23°13'14.95"N,	
Longitude : 69°46'06.28"E

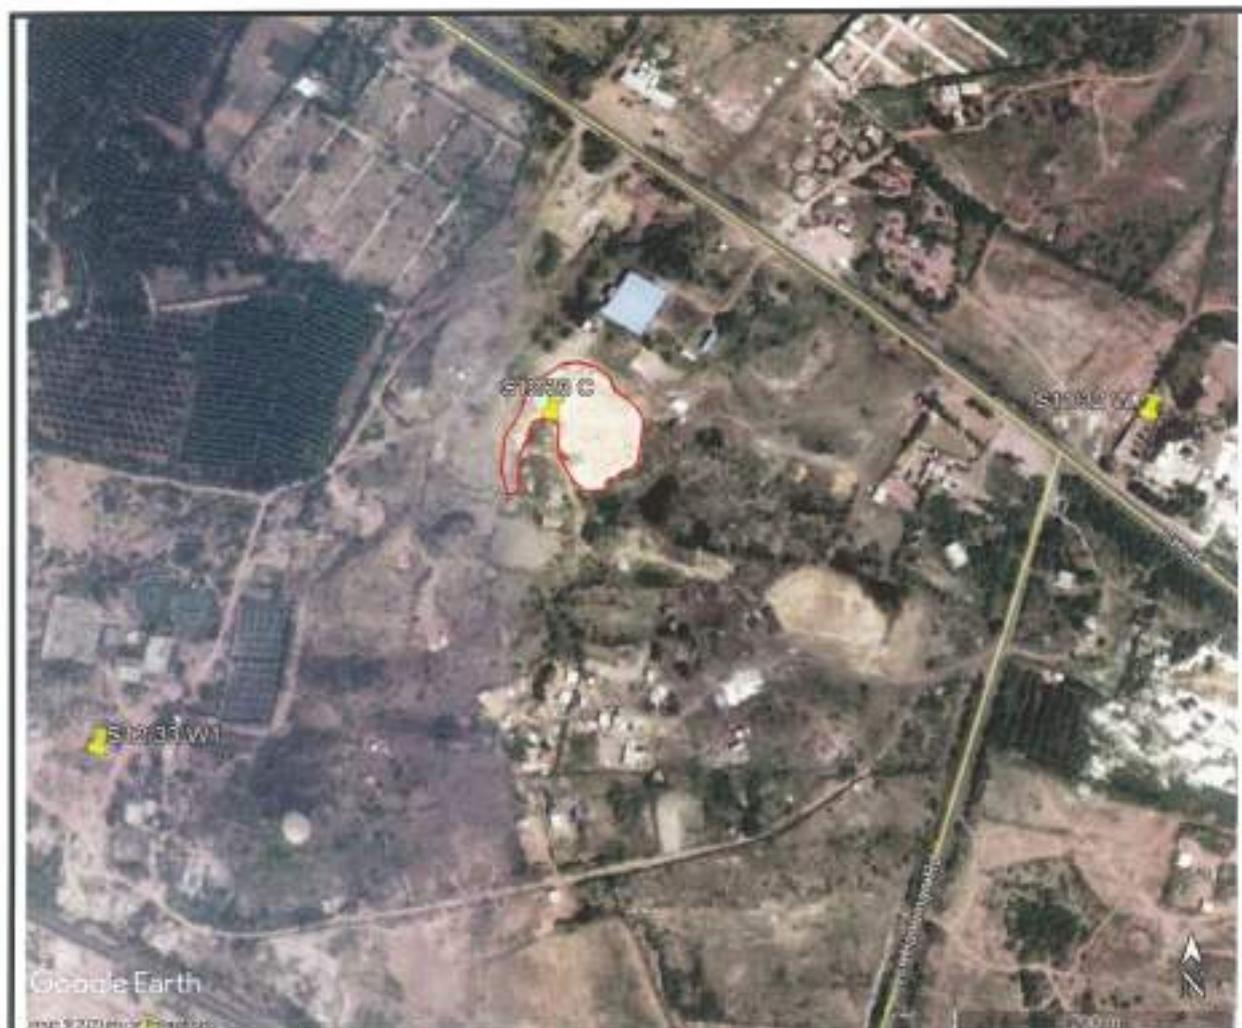
**Figure No. 4.24**  
**Site Location Map with Gypsum, Soil and water Sample of**  
**Site-S12/33 - Behind khatri mills, Beside of above site, Traverse, Government**  
**land, KukmaVillage**

S12/33 G	Gypsum Composite sample from 1 ft depth at site
S12/33C	Soil Sample near Gypsum site
S12/33B	Virgin Soil Sample near Gypsum site area
S12/33 W1	Borewell at Near GWIL 650 ft, Kukma Village
Latitude : 23°13'20.70"N,	
Longitude : 69°45'58.87"E
