SITE INSPECTION REPORT

G+1 RCC Structure in survey No. 269/4, 5 and 6 of Junaswada, Mandrem, Pernem, Goa

To prepare a sketch therein as to how the said structure is lying in NDZ and illegally constructed.

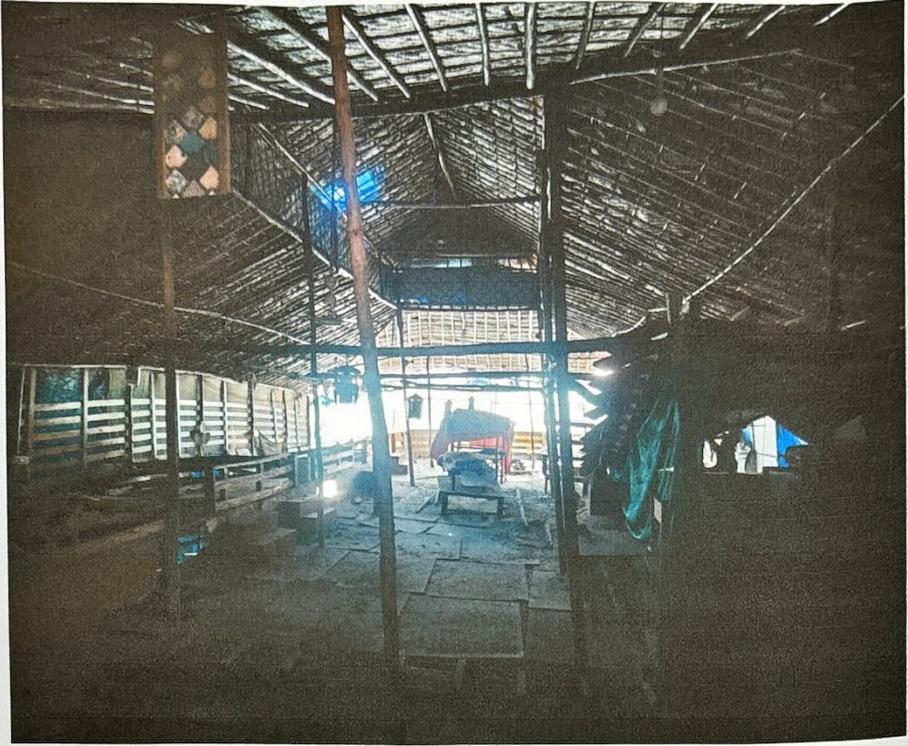
ANNEXURE 'I'
TEMPORARY STRUCTURE 'A'

1. At loco there is one temporary structure 'A' made up wooden framework with wooden battens covered with wooden roofing with sand /mud flooring and remaining part cement flooring. The western side of temporary structure is resting on the R.C.C retaining wall in Survey No. 269/3 of Mandrem village of Pernem Taluka.

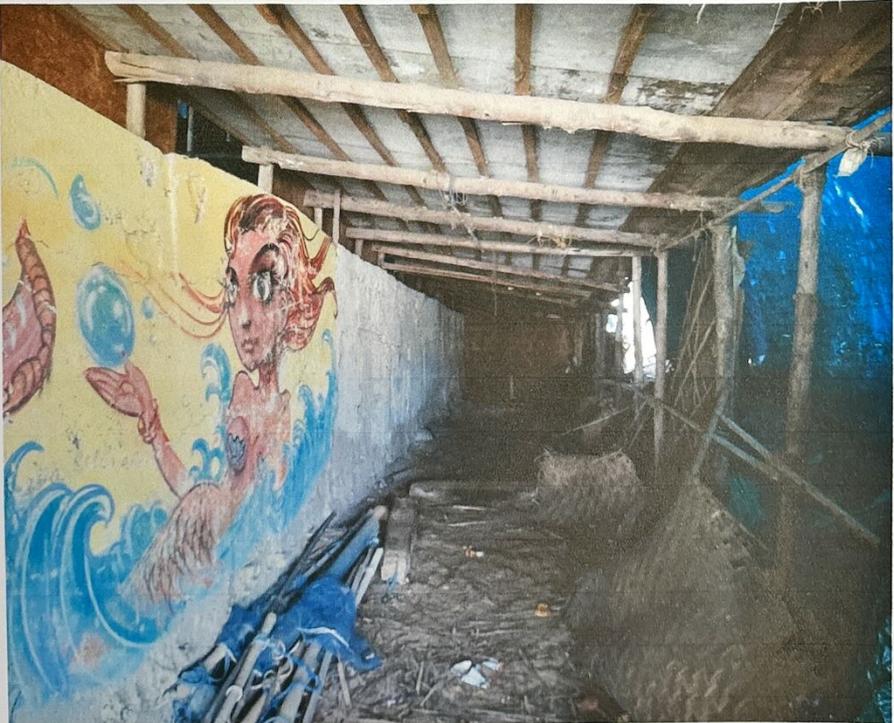
TEMPORARY STRUCTURE
'B'

2. At loco there is one temporary shed 'B' at the beach level comprises of wooden framework covered with wooden roofing/plastic sheet roofing with sand / mud flooring located on the southern side of the temporary structure 'A'. The northern side of temporary shed is resting on the R.C.C retaining wall and southern side is resting on wooden props in Survey No.269/3 of Mandrem village of Pernem Taluka.

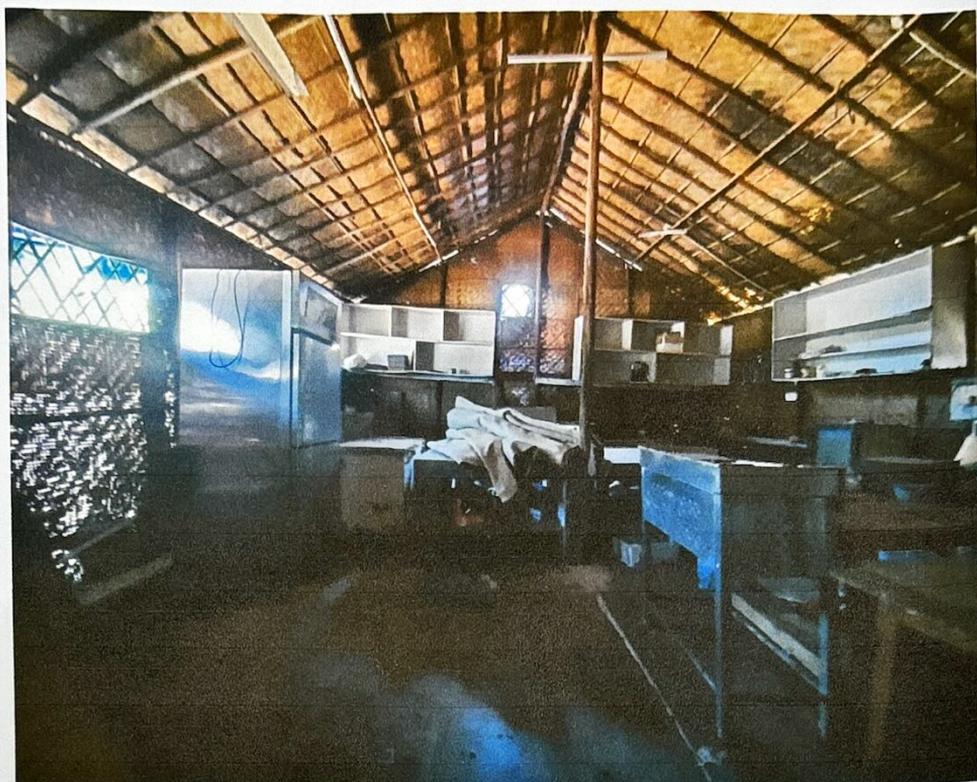
TEMPORARY STRUCTURE 'C'

3. At loco there is one temporary structure 'C' on the landwards side made up wooden framework with wooden battens covered with wooden roofing/plastic sheet roofing and cement concrete flooring/ tile flooring located on the eastern side of structures 'A' and 'B' in Survey No.269/3 of Mandrem village of Pernem Taluka.

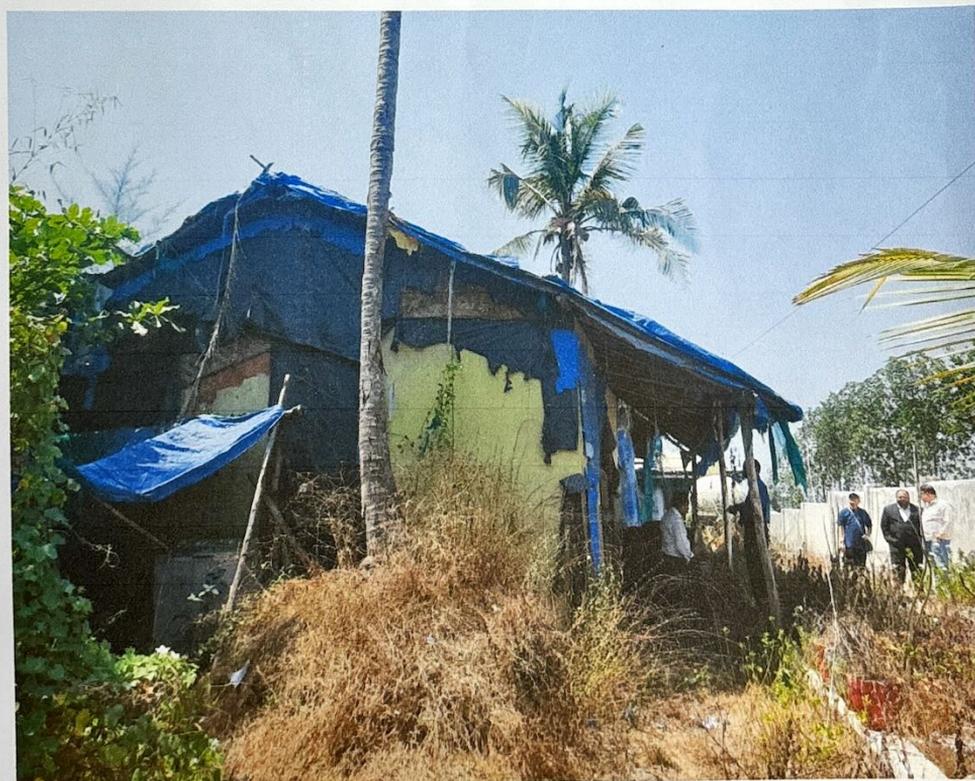
TEMPORARY STRUCTURES 'D' & 'E'

4. At loco there is one temporary structure 'D' on the landwards side made up wooden framework with wooden battens covered with wooden roofing/plastic sheet roofing and sand /mud flooring located on the eastern side of structures 'C' in Survey No.269/3 of Mandrem village of Pernem Taluka.

5. At loco there is one temporary shed 'E' located on the northern side of temporary structure 'D' comprises of wooden framework with wooden roofing in Survey No.269/3 of Mandrem village of Pernem Taluka.

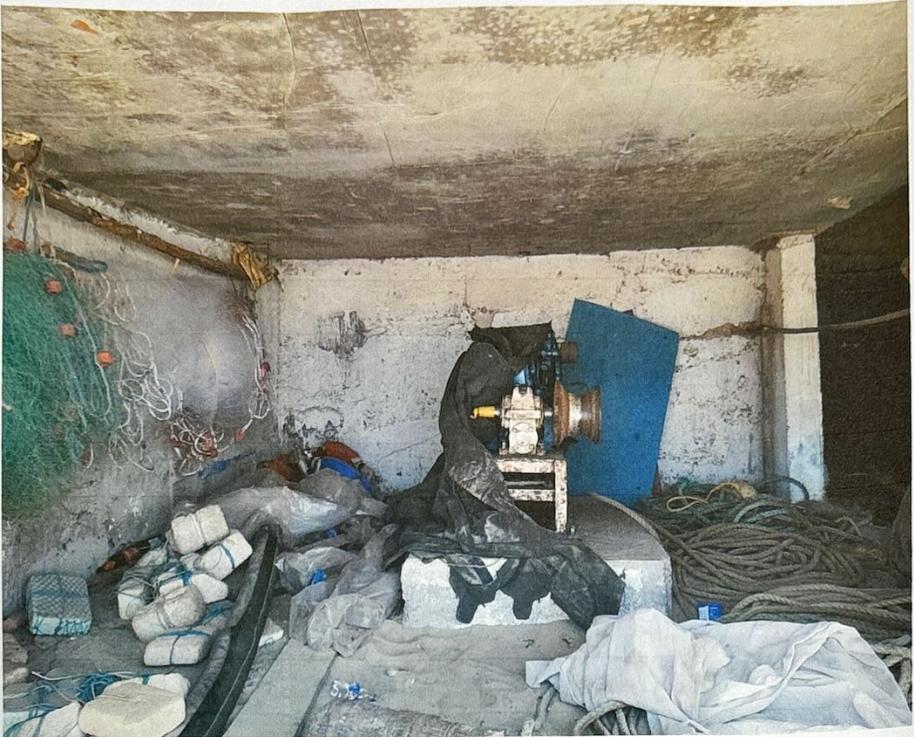
PERMANENT STRUCTURE 'F'

6. At loco there is one underground permanent R.C.C framework structure 'F' with R.C.C slab with cement concrete flooring on the landward side

- located on the western side of temporary structure 'A' in Survey No. 269/3 of Mandrem village of Pernem Taluka.
7. At loco there is one cylindrical shape permanent structure 'G' made up of cement concrete erected over square shaped permanent structure located on the eastern side of temporary structures 'A' in Survey No. 269/3 of Mandrem village of Pernem Taluka.

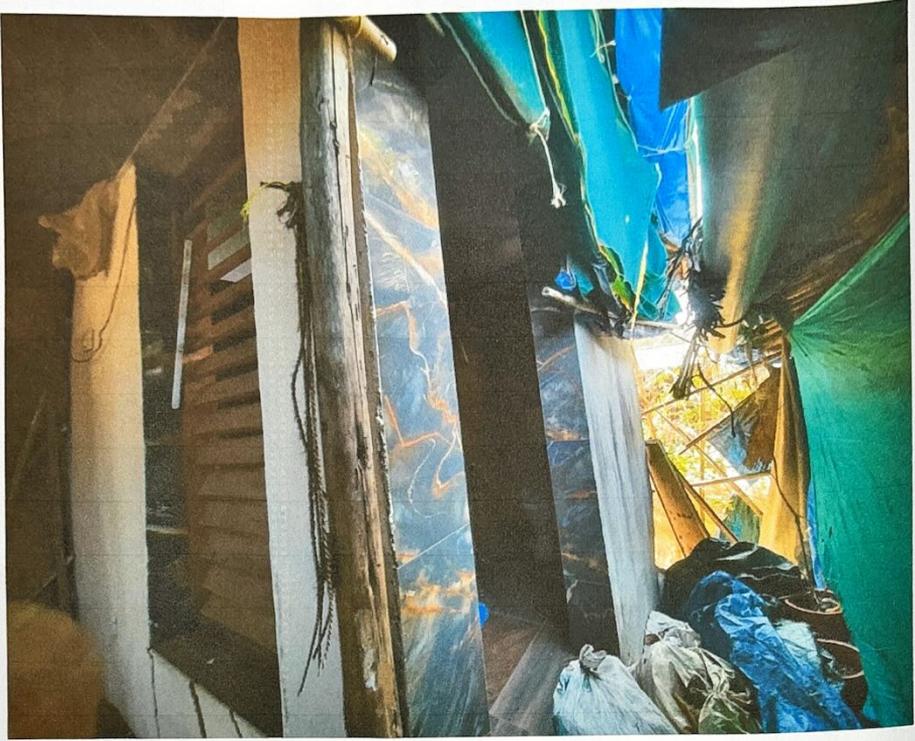
PERMANENT STRUCTURE 'H'

8. At loco there is one square shape permanent structure 'H' (Toilet) made up of stone masonry walls utilized as located on the landwards side on the south western side of temporary structure 'C' in Survey No.269/3 of Mandrem village of Pernem Taluka.

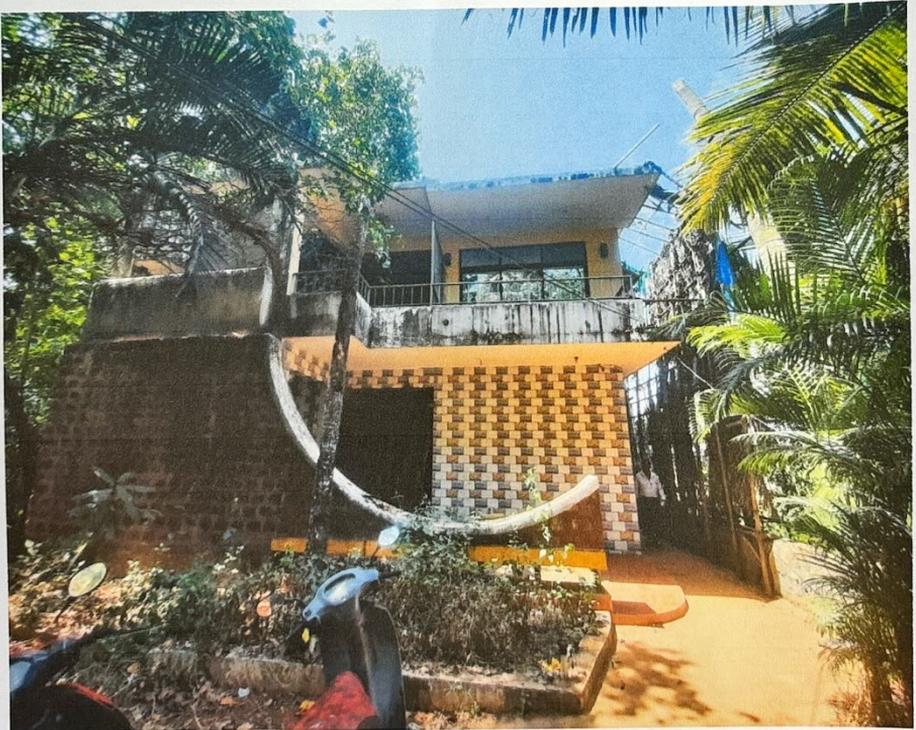
PERMANENT STRUCTURE 'I'

9. At loco there is one rectangular shape G+1 permanent structure 'I' with additional mezzanine floor above the first floor comprising of stone masonry walls and R.C.C framework structure with R.C.C slab, plinth and R.C.C staircase leading to the first floor, mezzanine floor above first floor and terrace which is located on the eastern side of temporary structure 'D' in Survey No.269/3(part), 4(part), 5(part) and 6(part) of Mandrem village of Pernem Taluka.

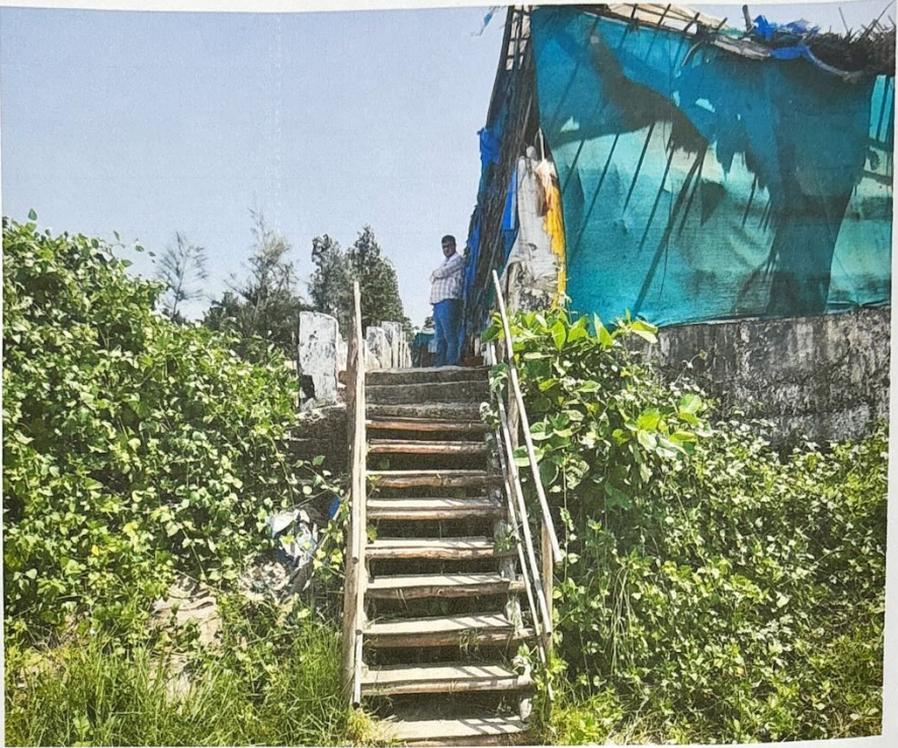
WOODEN STAIRCASE LEADING DOWN TO THE BEACH

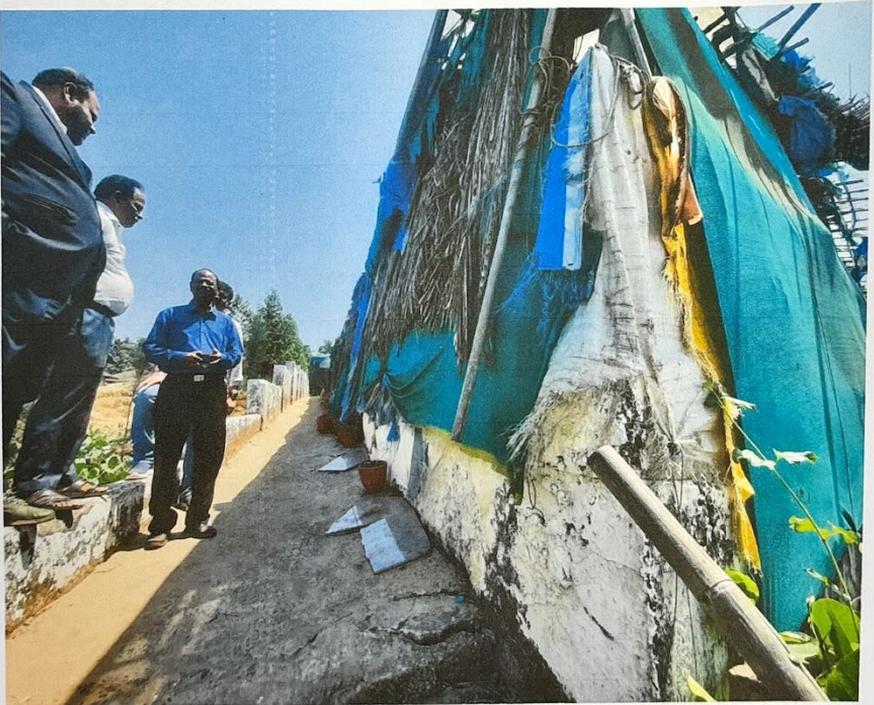
10. At loco there is a cement concrete pathway on the northern side of Survey No. 269/3,4,5,6 of Mandrem village of Pernem Taluka.
 11. The necessary measurements of the relevant temporary and permanent structure were taken and recorded for preparation of sketch.

4. The cement concrete pathway surveyed under Survey No. 269/3,4,5,6 of Mandrem village of Pernem Taluka is lying under No Development Zone as per CZMP 2011.
5. As per online computerized Bhunaksha Map and Form I & XIV no structures are reflected in Survey No. 269/3,4,5,6 of Mandrem village of Pernem Taluka.
6. The Survey No. 269/3,4,5,6 of Mandrem village of Pernem Taluka is lying under No Development Zone as per CZMP 2011.

**PATHWAY ON THE NORTHERN SIDE OF SURVEY NO. 269/3, 4,
5, 6 OF MANDREM VILLAGE OF PERNEM TALUKA**

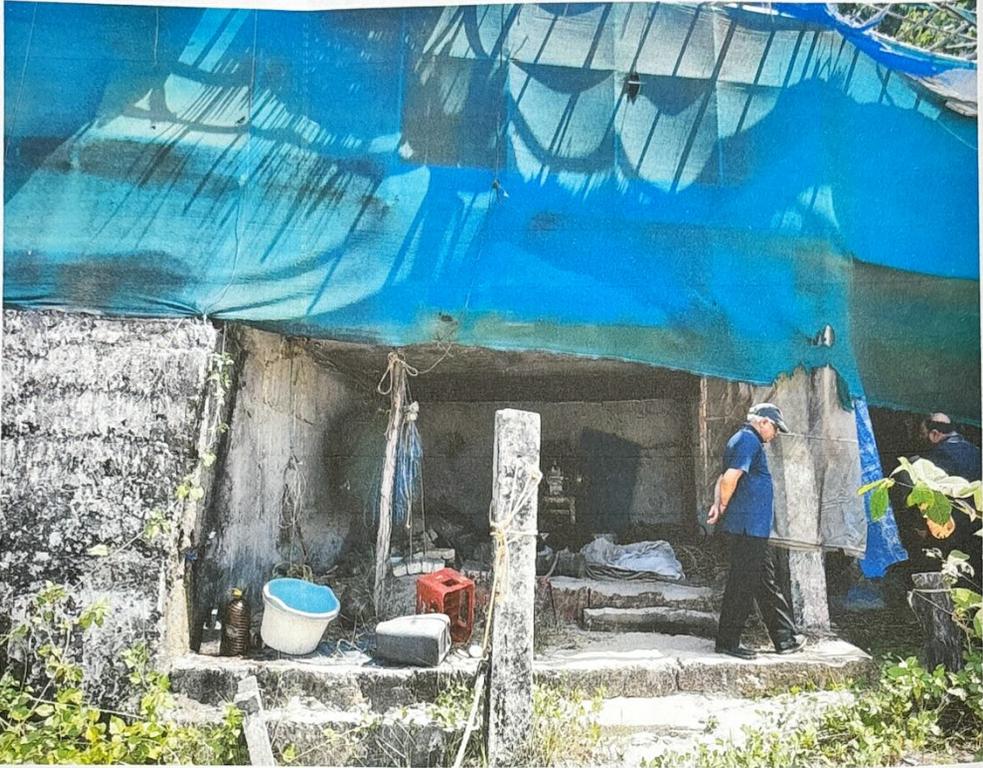
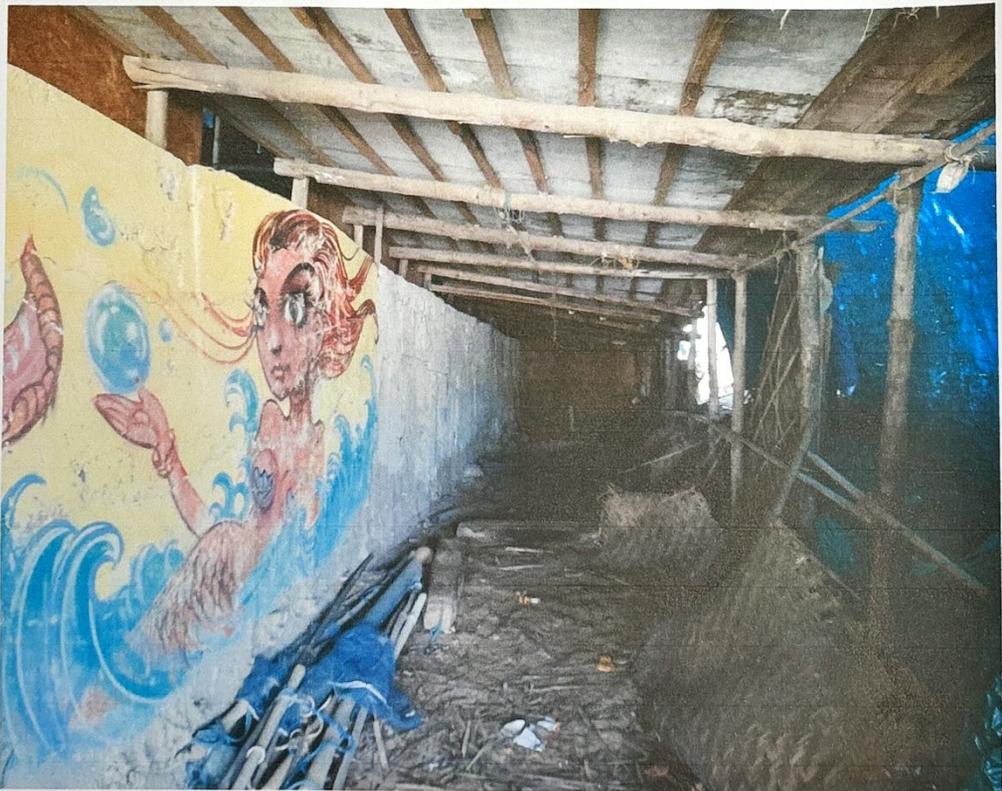
12. There is a R.C.C retaining wall along the western and southern boundary of temporary structure 'A'
 13. There is one stone masonry compound wall on the northern side of Survey No. 269/3, 4, 5, 6 and the other stone masonry wall on the eastern side of structure 'B'.

**R.C.C RETAINING WALL ON THE WESTERN SIDE OF
TEMPORARY STRUCTURE 'A'**

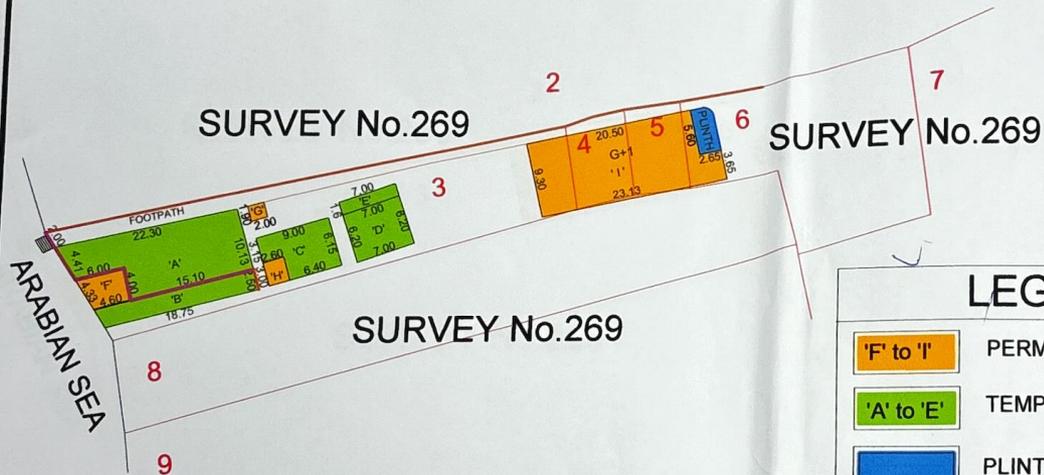
SKETCH

1. The temporary structures 'A', 'B', 'C', 'D', 'E' are surveyed under Survey No. 269/3(part) of Mandrem village of Pernem Taluka is lying under No Development Zone as per CZMP 2011.
2. The permanent structures 'F', 'G', 'H', are surveyed under Survey No. 269/3(part) of Mandrem village of Pernem Taluka is lying under No Development Zone as per CZMP 2011.
3. The permanent G+1 structure 'I' with mezzanine floor above first floor is surveyed under Survey No. 269/3(part),4(part),5(part), 6(part) of Mandrem village of Pernem Taluka is lying under No Development Zone as per CZMP 2011.

SHOWING THE STRUCTURES LYING IN NO DEVELOPMENT ZONE (NDZ)
AS PER CZMP 2011 IN SURVEY NO. 269/ 3, 4, 5, 6 OF MANDREM VILLAGE
OF PERNEM TALUKA.
