**BEFORE THE HON'BLE NATIONAL GREEN TRIBUNAL
PRINCIPAL BENCH AT NEW DELHI**

ORIGINAL APPLICATION NO. 288/2019

**COMPLIANCE REPORT OF THE HON'BLE TRIBUNAL
ORDER DATED 19.06.2020, ON BEHALF OF
RAJASTHAN STATE POLLUTION CONTROL BOARD.**

Scientific studies on blast induced ground vibration and air overpressure and investigation on its damage potential vis-à-vis housing structures in Pur village, Bhilwara Distt., Rajasthan

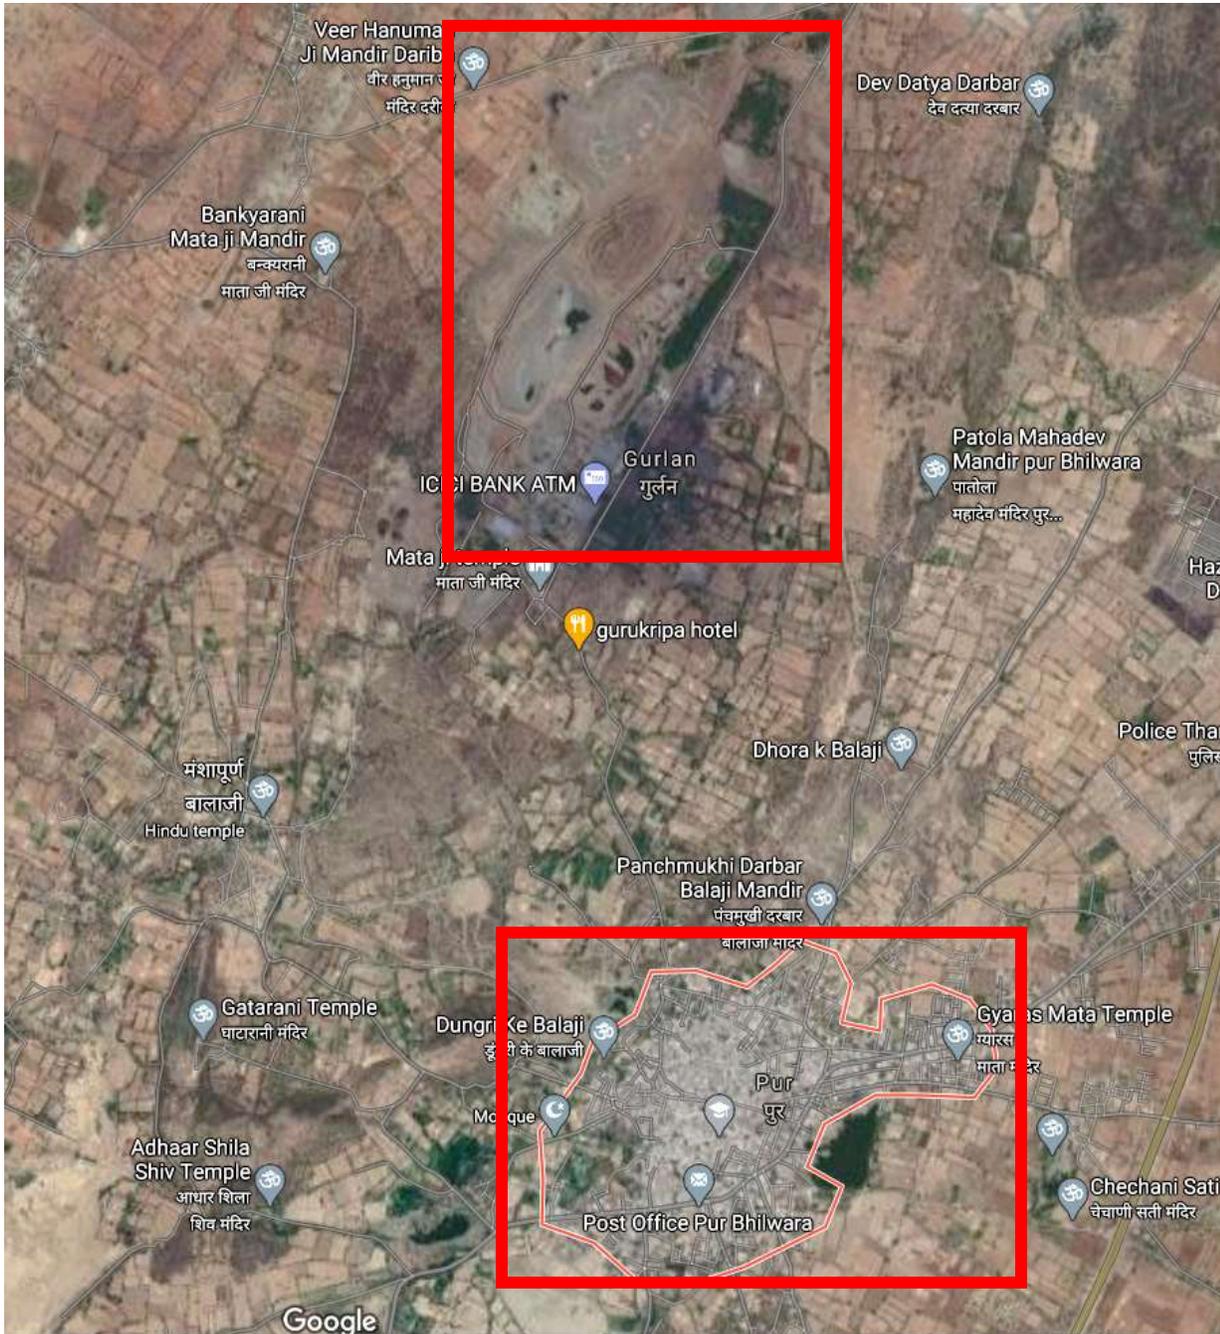
Fig. 1: Map showing relative location of Dhedwas Iron Ore Mine and Pur Village

It is pertinent to mention here that there is a low grade iron ore (Magnetite) reserve near Pur village. This reserve is allotted to Dhedwas Iron Ore and Associated Mineral Mine of M/s Jindal Saw Limited (JSL) for commercial exploitation. M/s JSL is carrying out mining activities. The rock containing iron ore is broken down in small pieces by drill and blasting method. The fragmented rock material is further processed to prepare iron pallets for use in steel industry. Villagers have made complaints to District Magistrate that the blasting operation in the Dhedwas Iron Ore mine is the primary cause of the cracks in the domestic houses. The mine is approx.. 2.5 m away from the village. A location map showing relative position of the Dhedwas Iron Ore mine and Pur village is presented in Figure 1.

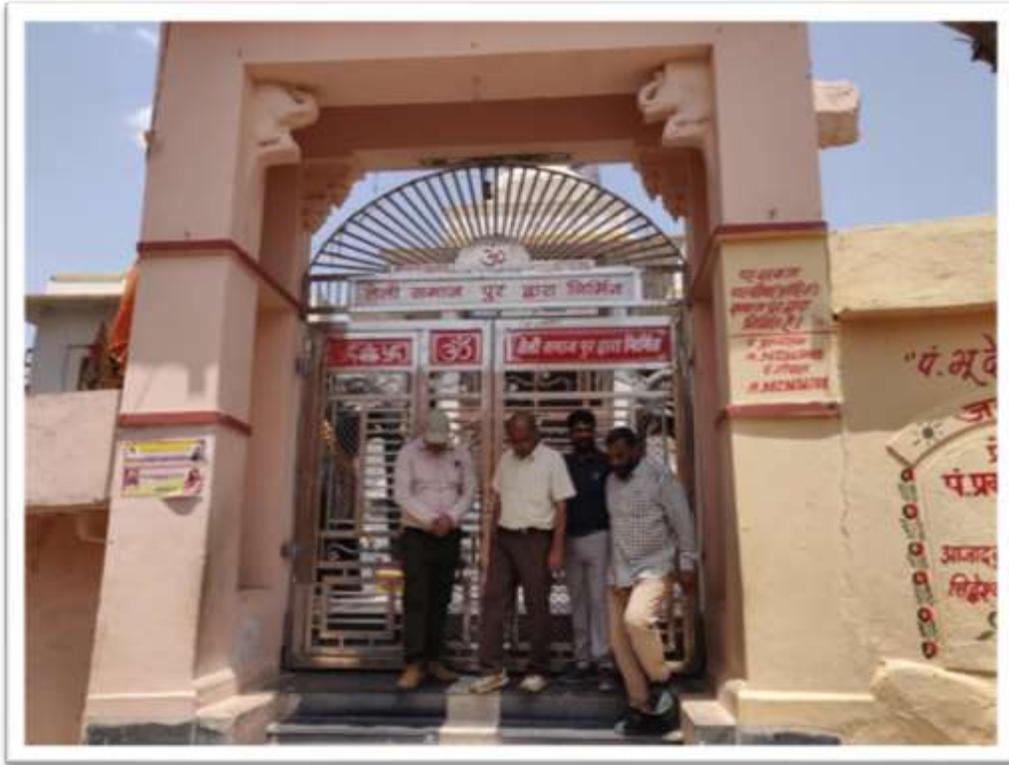
Fig 2: Cracks along column in Laxminarayan Temple

CSIR-CIMFR team initially made survey of the damage in the housing structures of Pur village. Various domestic houses were surveyed and have taken observation on cracks, their characteristics, location, width etc. Photographs of the cracks in the domestic houses and temple of Pur village are presented in Fig(s) 2 to 10.

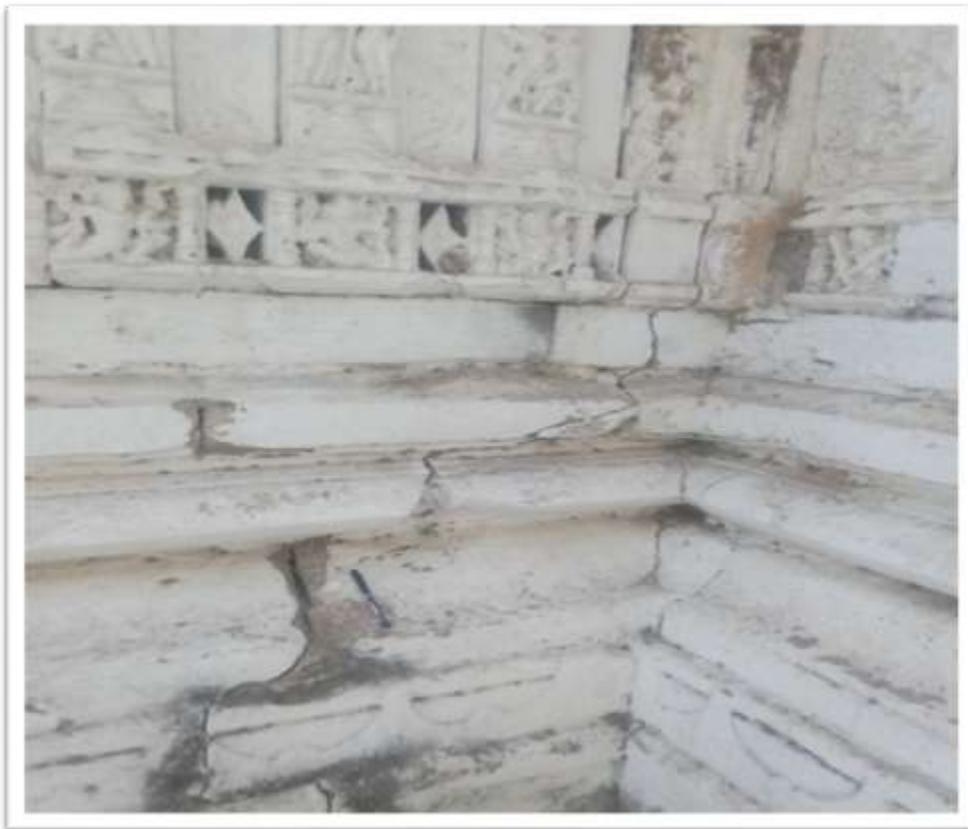
Fig 3: Cracks in the corners of the Laxminarayan Temple

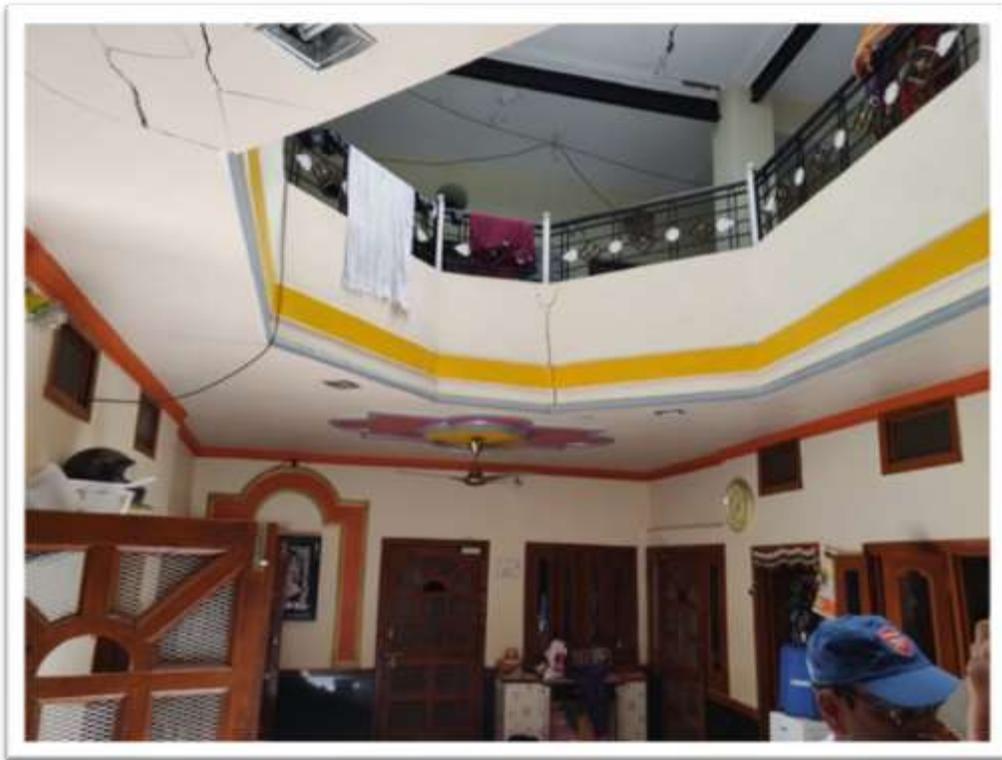
Fig. 4: Cracks in the housing structure at middle level

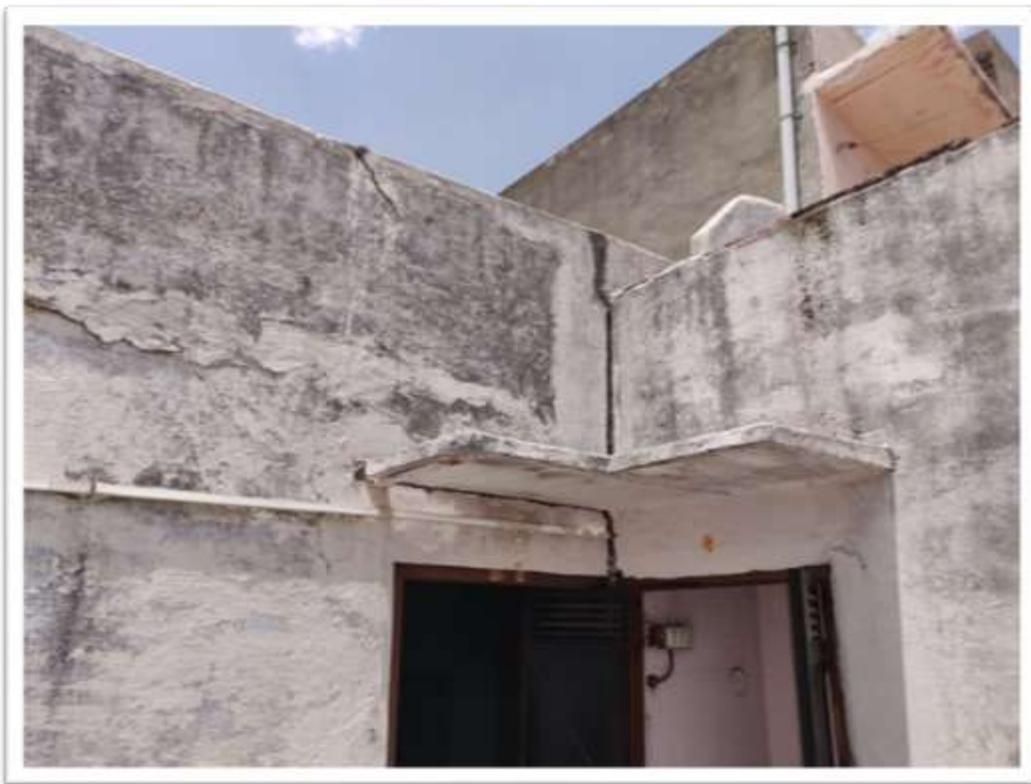
Fig 5: Cracks along the joints of the domestic structures

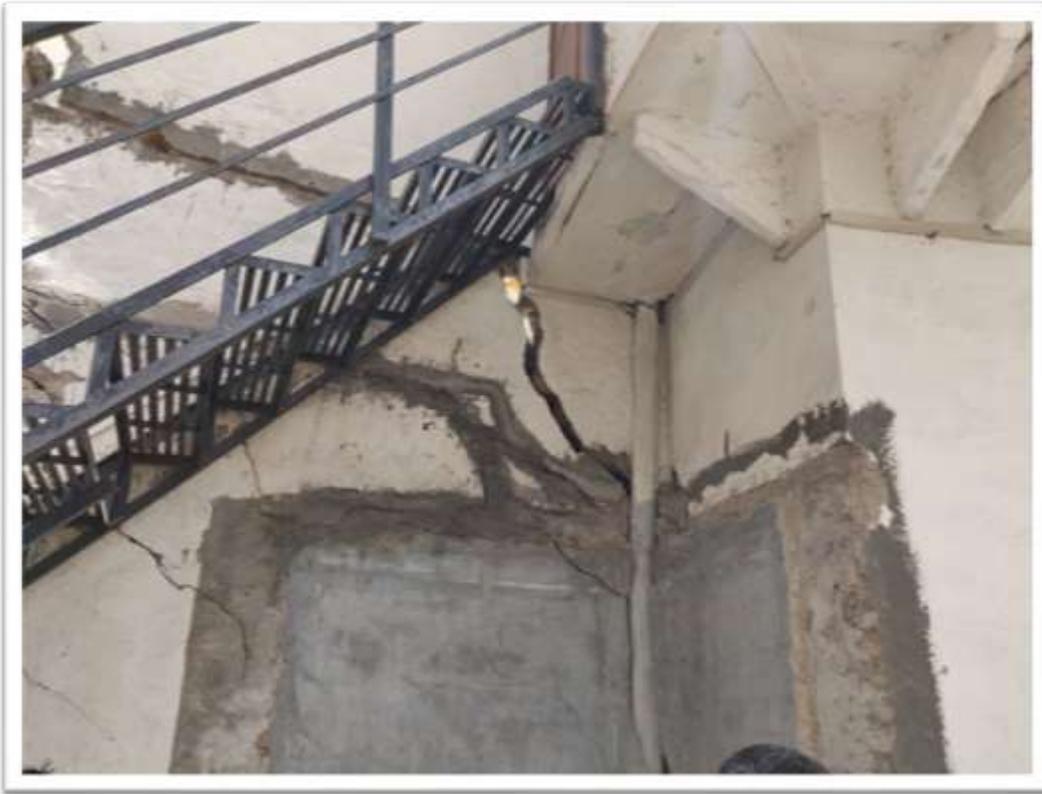
Fig 6: Cracks along the joints of the domestic structures

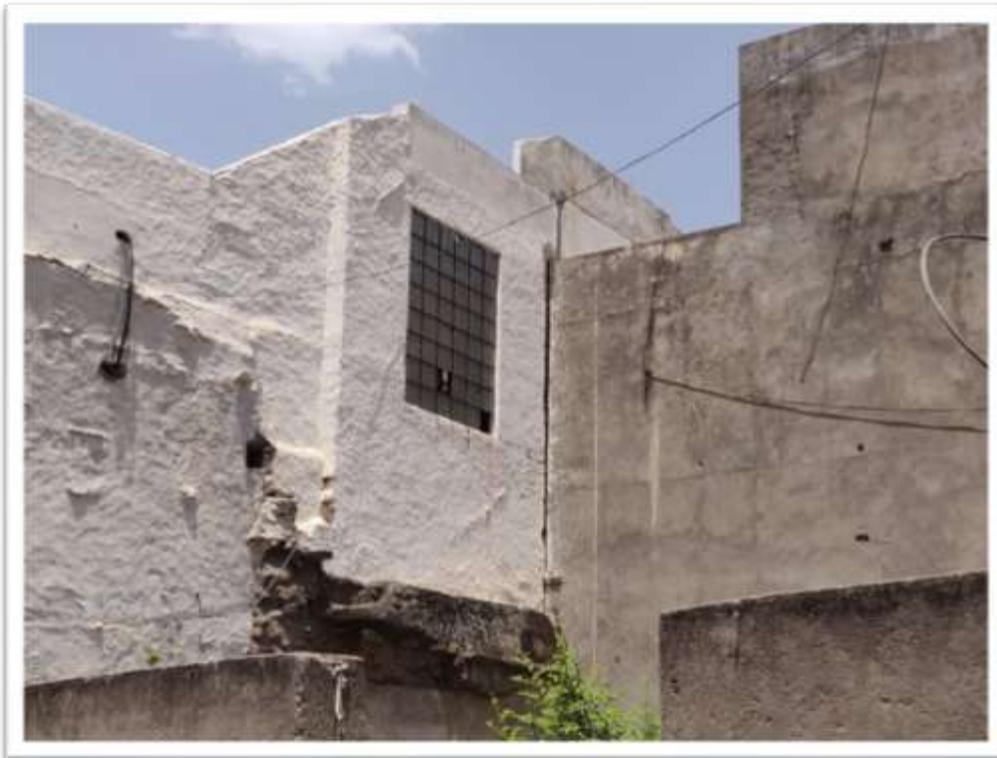
Fig 7: Widening of Separation joint along two joints indicating settlement of the foundation

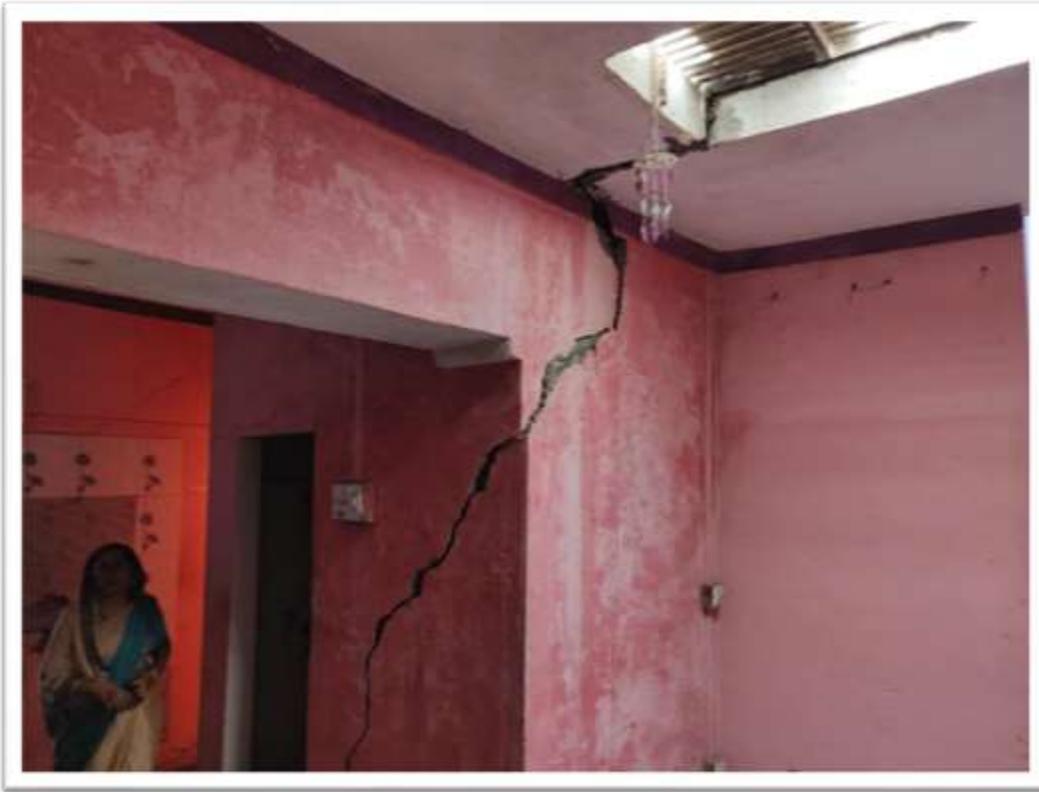
Fig 8: Cracks across the beam and column of housing structure

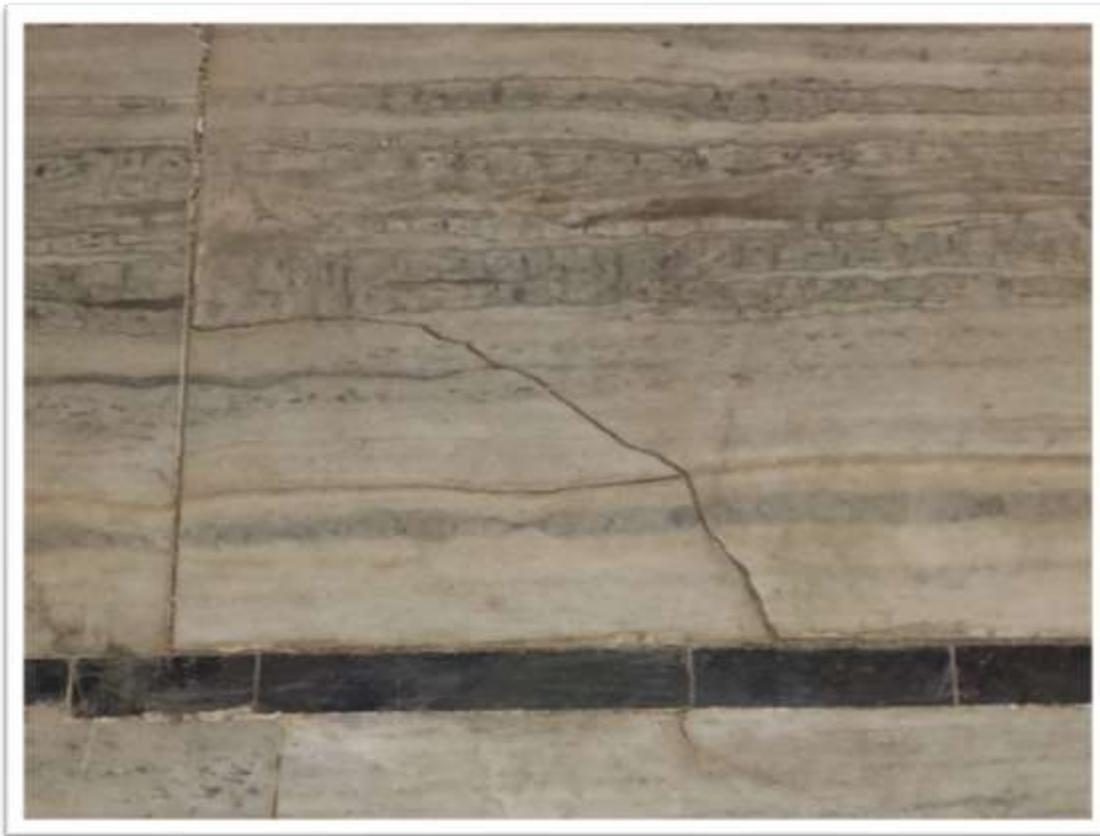
Fig 9: Cracks in the floor level of housing structures

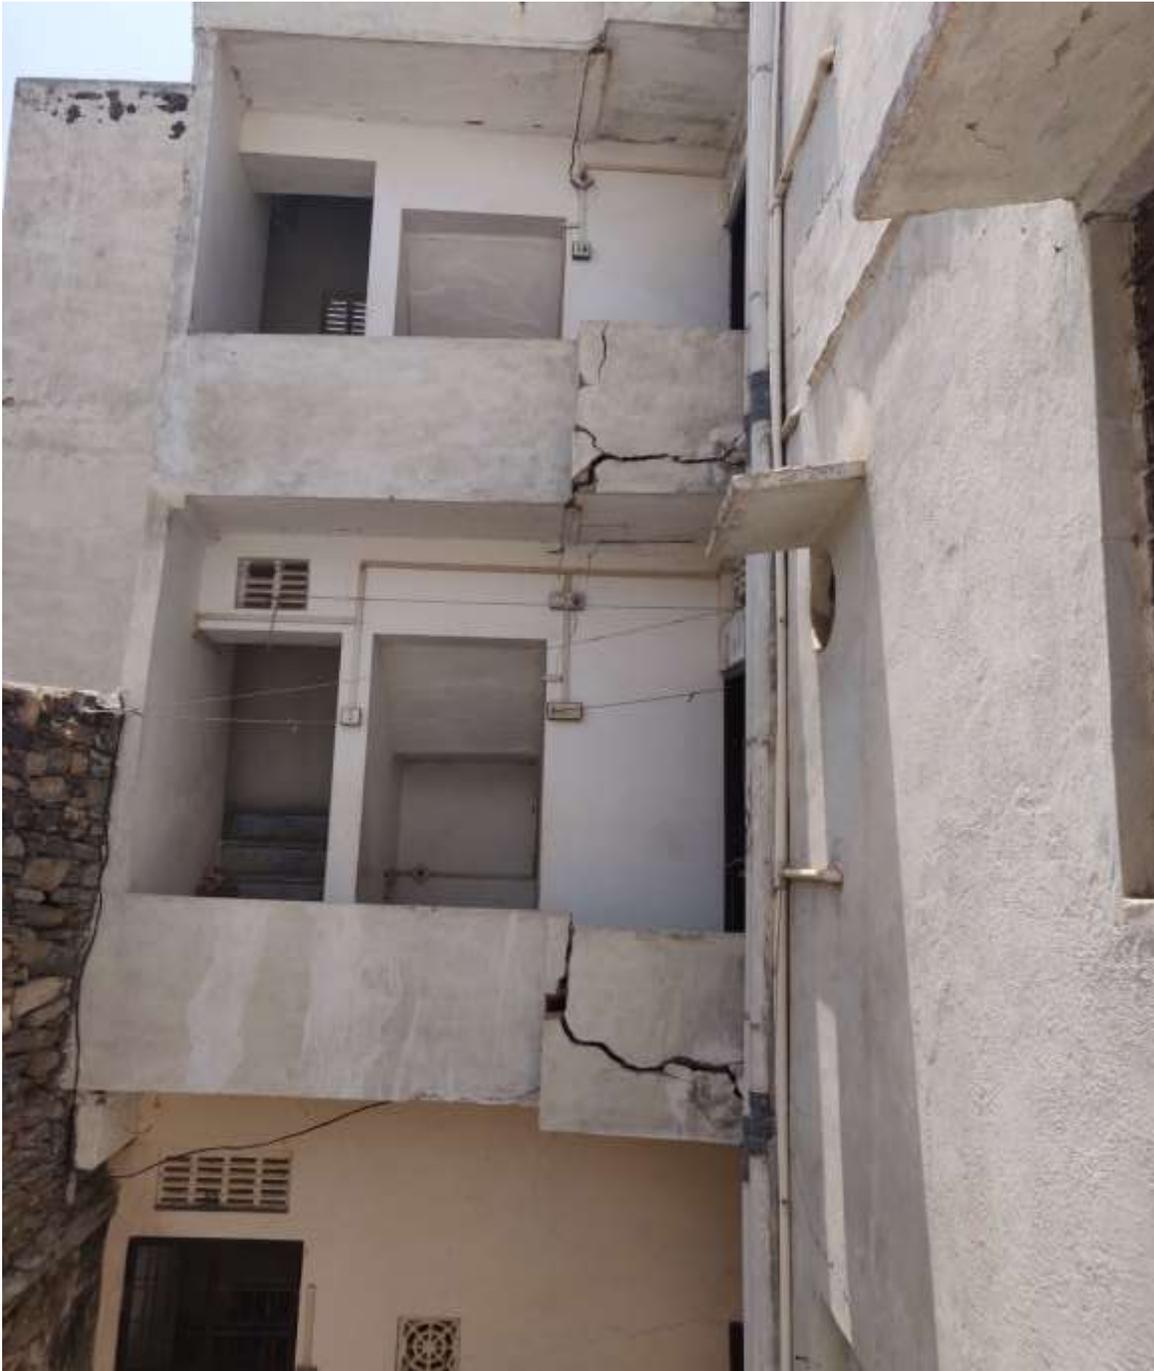
Fig 10: Cracks in the floor level of housing structures

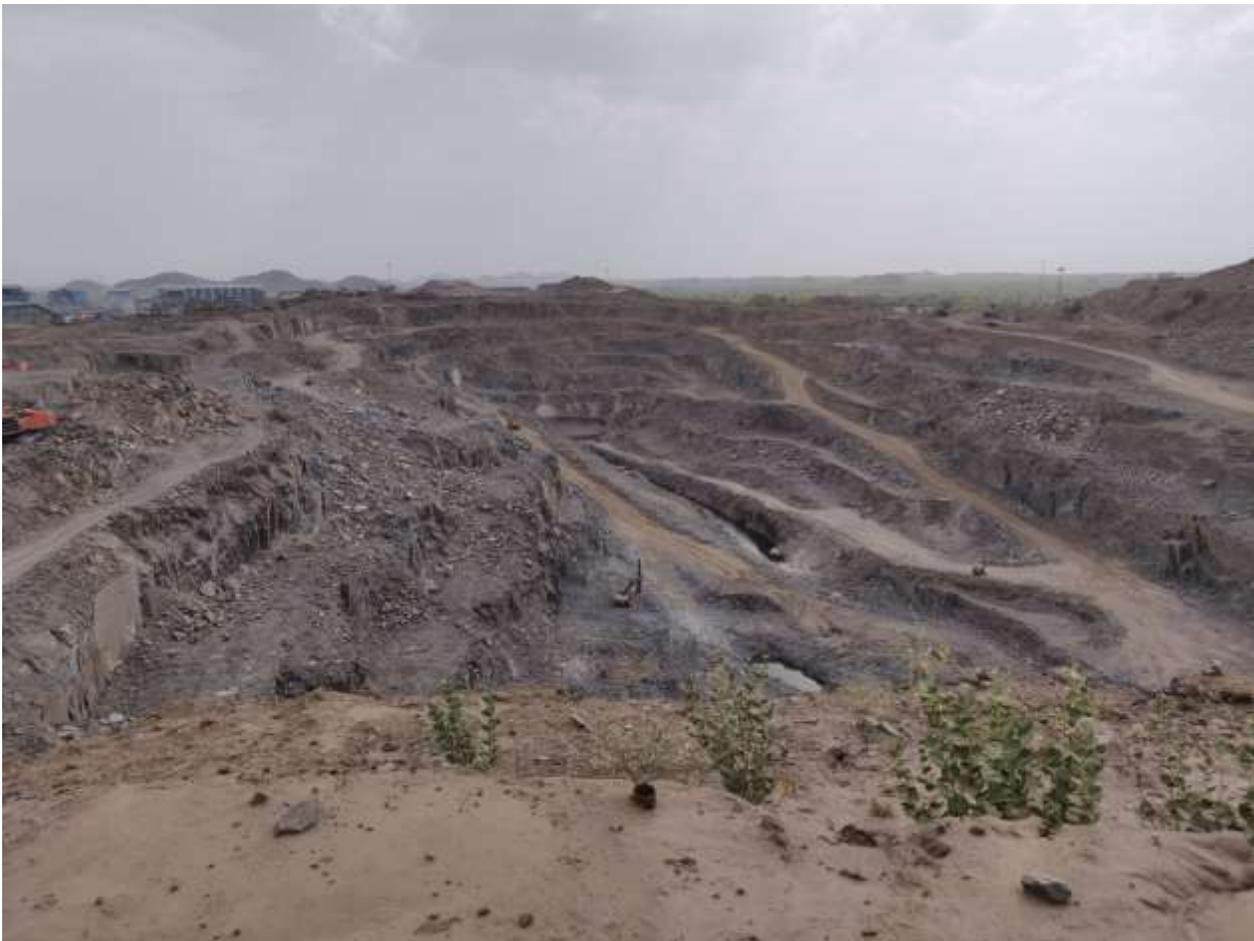
Fig 11: Photograph showing Dhedwas Iron Ore mine working in different benches

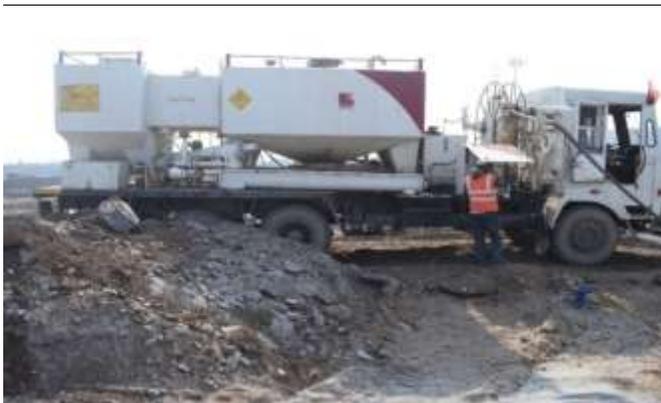
13(A): 10 Ton Capacity Site Mix Emulsion (SME) Truck

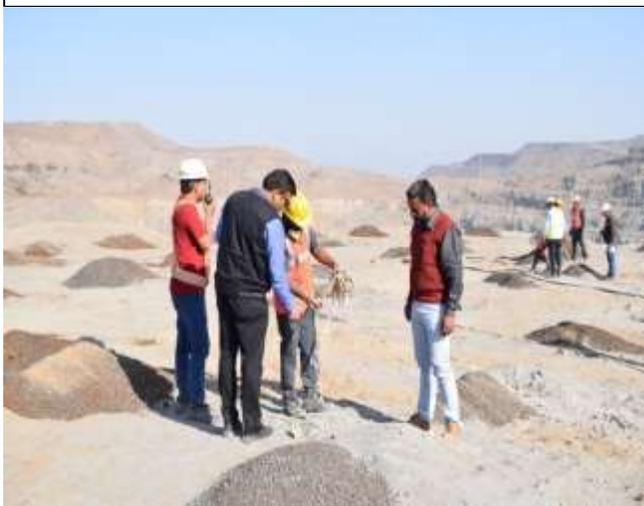
13(C): Measuring depth of experimental blast holes before charging

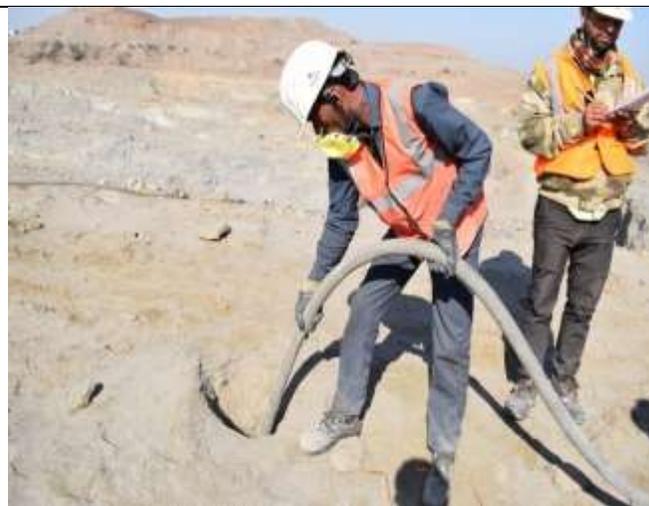
13(D): Loading of experimental blast holes

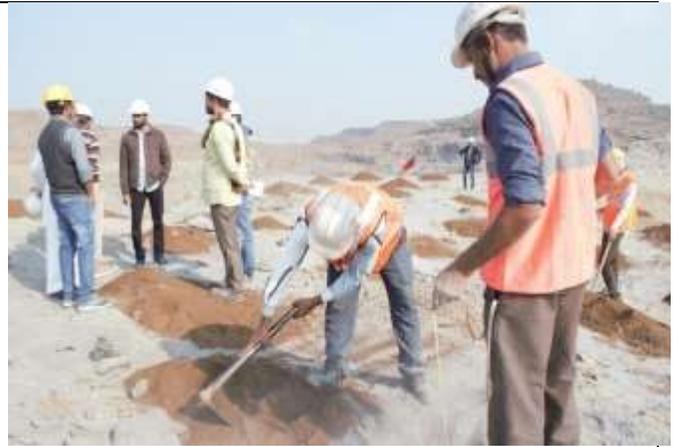
13(F): Stemming in loaded blast holes

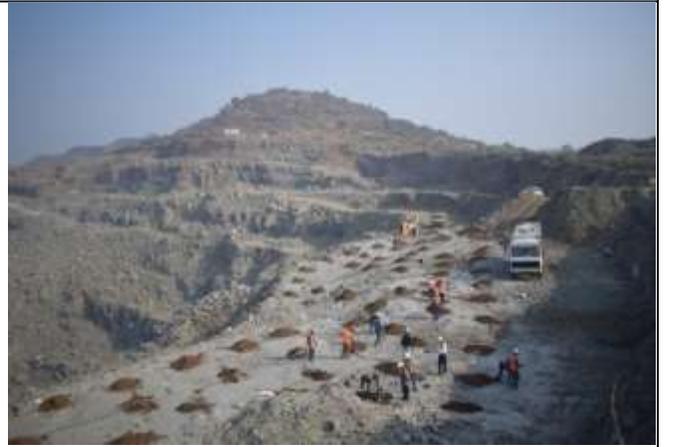
13(H): View of charged blast holes

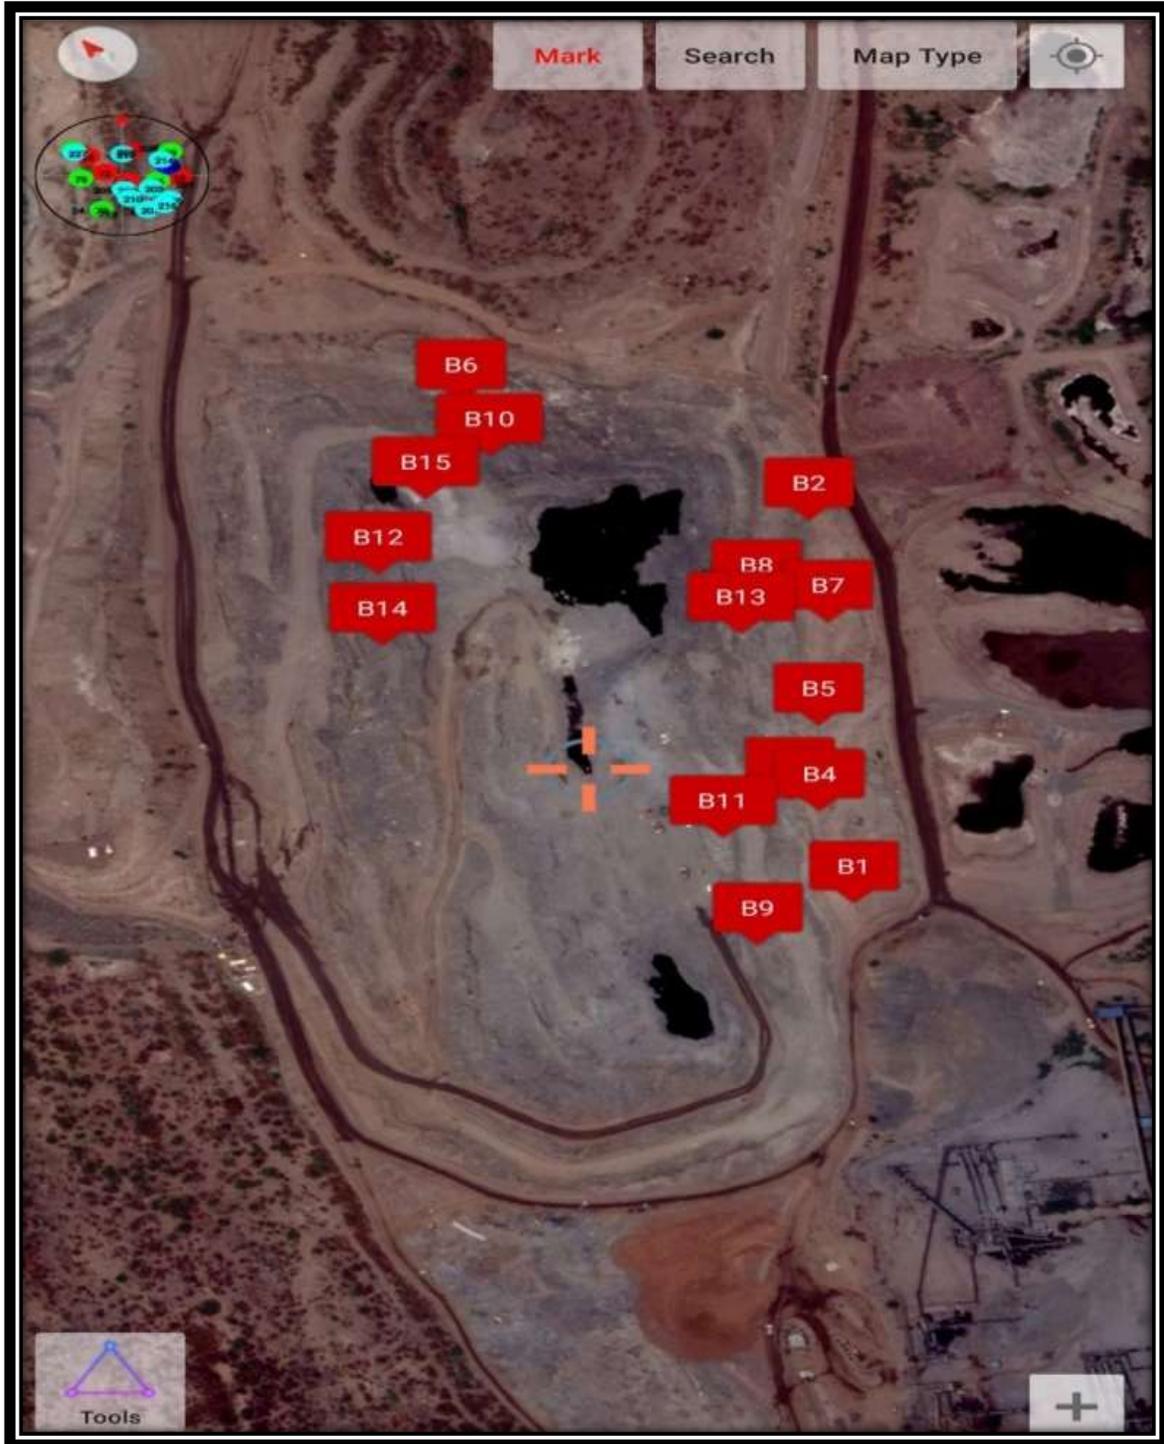
Fig.14: Location of Experimental Blasts Conducted at Dhedwas Iron Ore Mine of M/s JSL Mine, Bhilwara

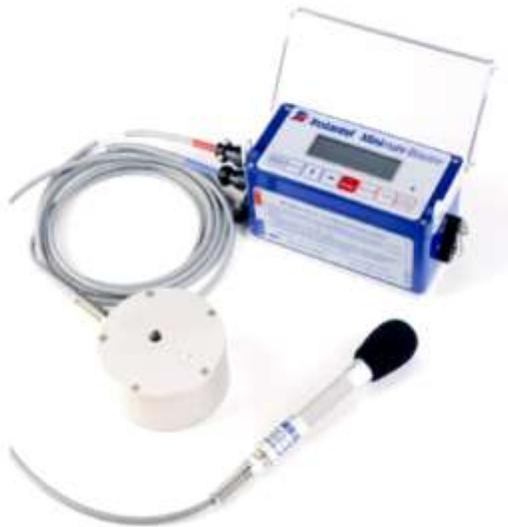
Figure 15: View of MiniMate Seismograph along with external geophone and microphone

operation at Dhedwas iron ore mine of M/s JSL, Bhilwara. Blast vibration and air overpressure monitoring have been carried out at more than 60 locations such as housing structures, temples, mosque in and around Pur village during experimental blasts. In each phase of field investigations, four set of engineering seismographs of InstanTel Canada Make have been used. All these instruments are four-channel seismographs provided with one tri-axial transducer for monitoring of vibration (in mm/s or inch/s) and one-channel for monitoring of air overpressure/noise in dB (L) or Pa. The instrument records vibrations in three orthogonal directions [i.e. Longitudinal (L), Vertical (V) and Transverse (T)] and peak frequency of vibration in individual directions as well as compute the peak vector sum of vibrations. The instruments permit full wave recording at any instant of time for a preset duration. Sensors are having an articulation of spikes for proper coupling with the ground for more precise reading of particle velocity. One such seismographs namely MiniMate Blaster is viewed in **Figure- 15**.

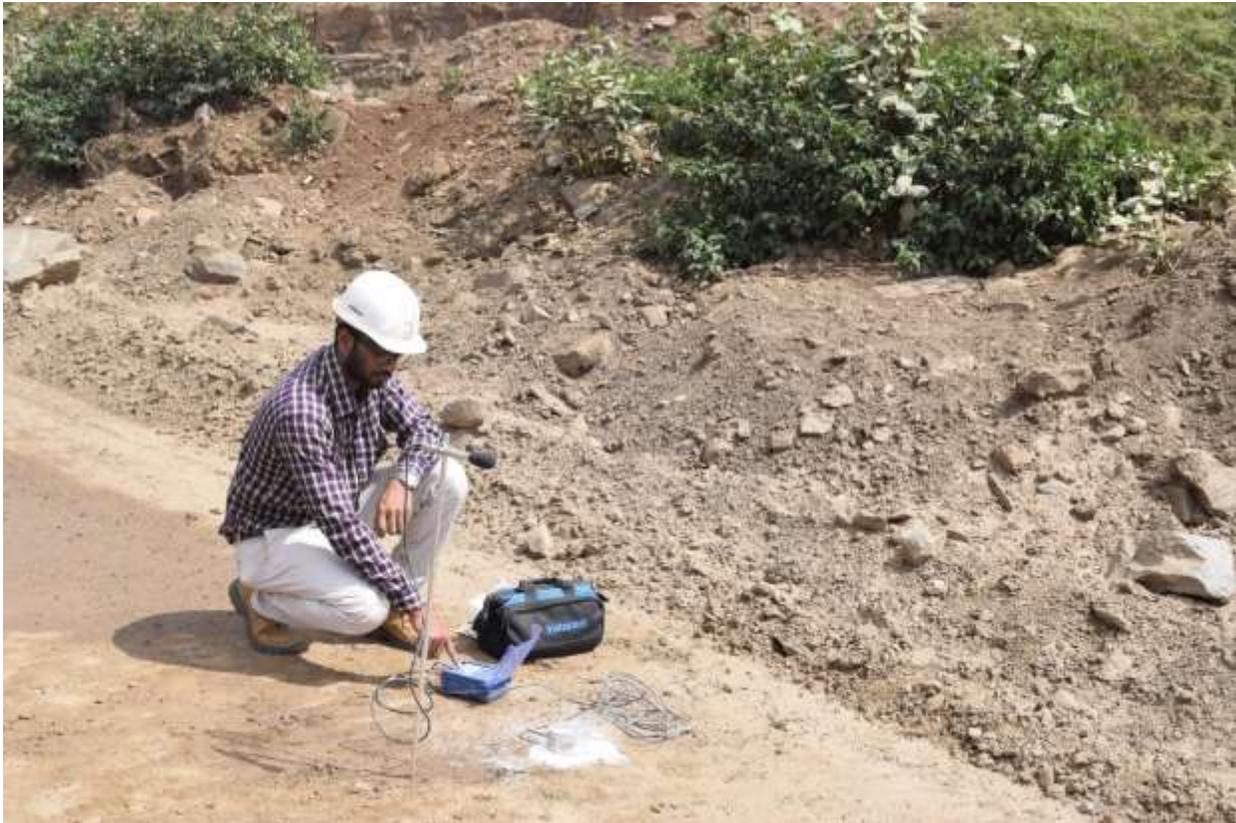
Fig 16: Photograph illustrating sensor coupling using Plaster of Paris during vibration monitoring

achieved by burying the transducer when the measurement surface consists of soil and by bolting or quick setting cement (plaster of paris) when the measurement on surface consists of rock or concrete. Burial is desirable for particle acceleration exceeding 0.2 g but it is essential if it is greater than 1.0 g (Dowding, 1996; Stagg and Engler, 1980; ISEE, 2005, ISRM, 1991). Coupling of sensors is illustrated in Fig 16. Below.

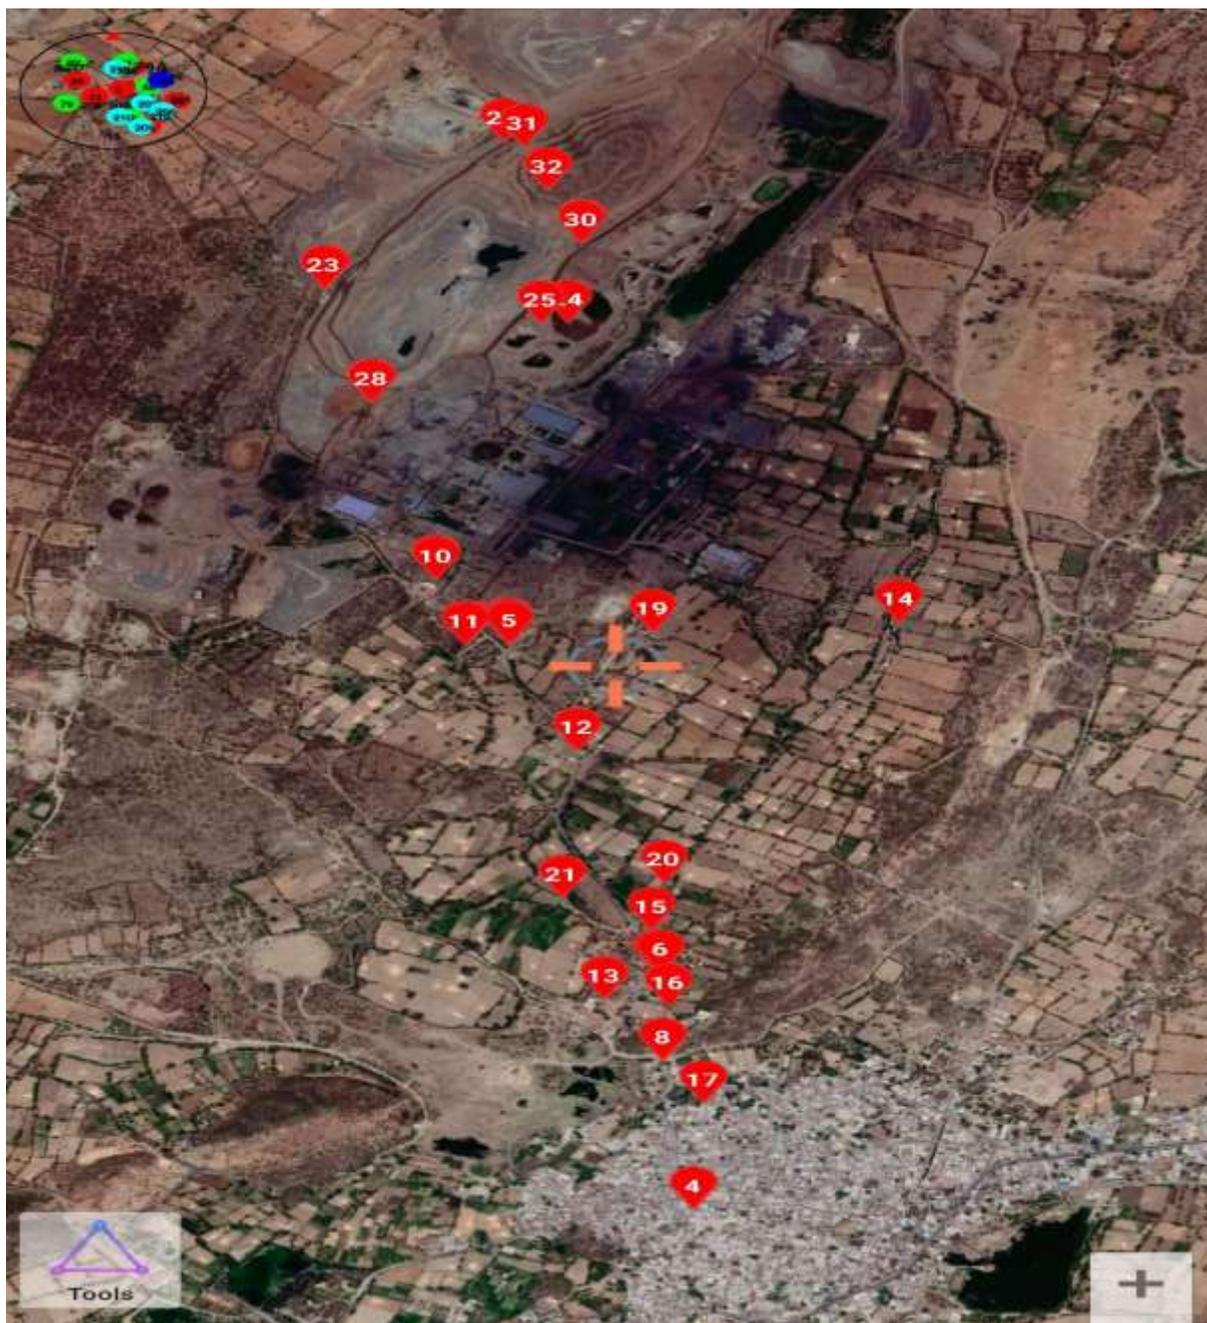
Fig. 17: Location of blast induced ground vibration & AOP monitors in M/s JSL Mine and Pur Village, Bhilwara

direction with an intention to record maximum vibration as well as air overpressure intensity. The geophone trigger level for all the seismographs were fixed at 0.5mm/s. This indicates that the vibration value of $\geq 0.5\text{mm/s}$ will be recorded in instrument. The consolidated plan showing different vibration monitoring locations are presented in Figure 17.

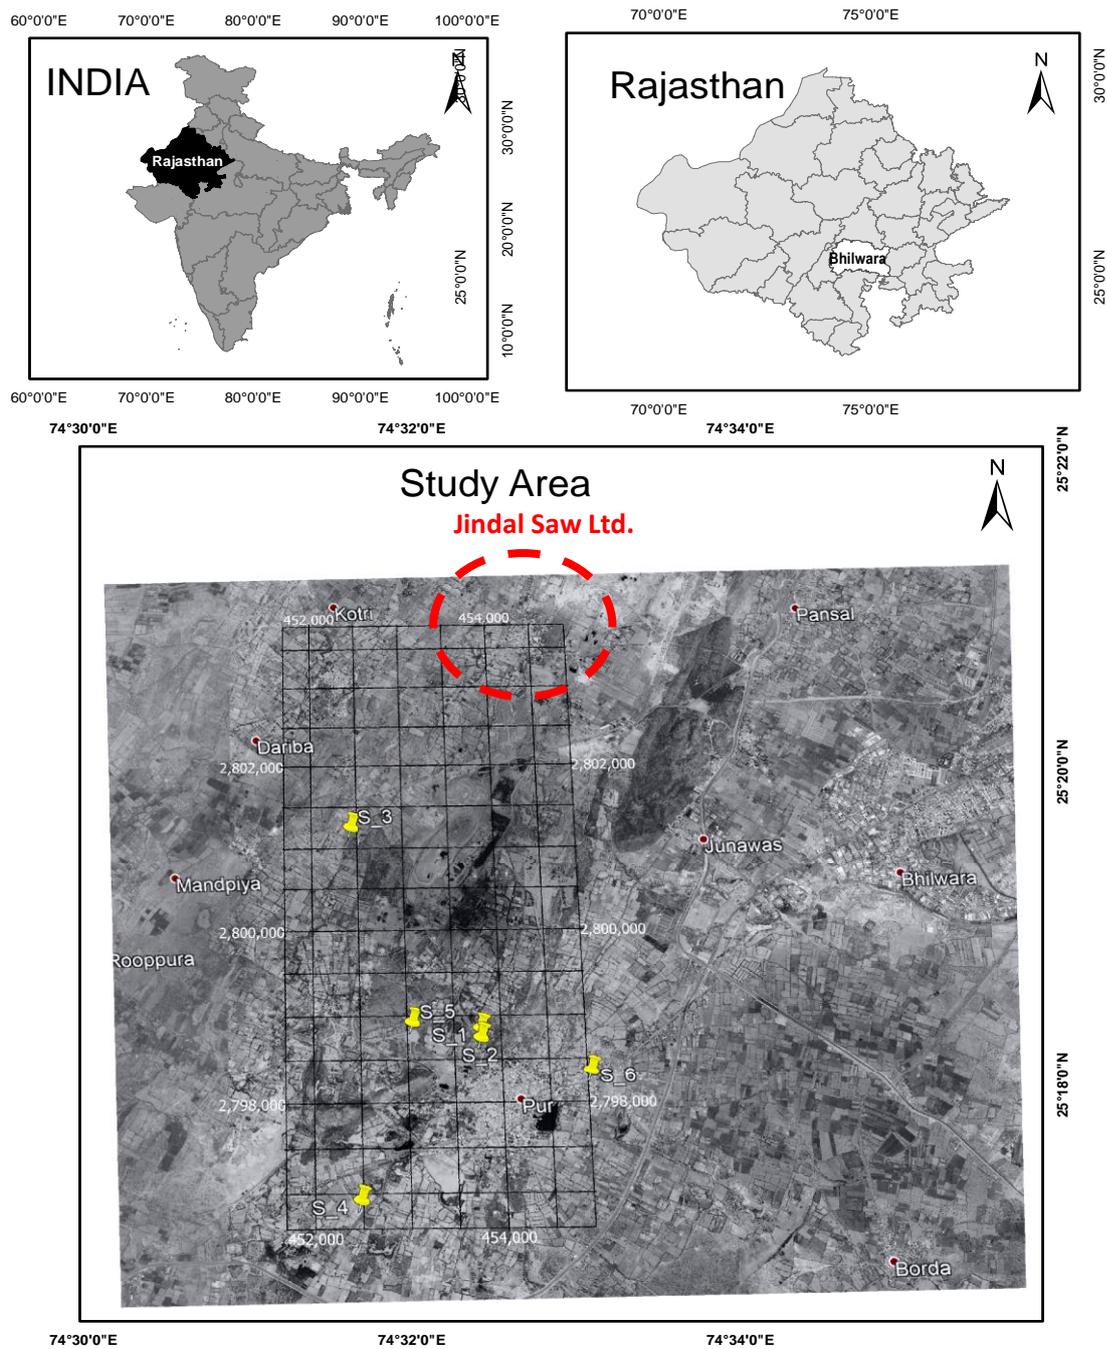
Figure 1: Figure showing the extent (grid) and location of the study area with marking for survey sites correspond to first field visit and Jindal saw Ltd. Area

The study revolves around the Pur village and the Jindal Saw Ltd. of Bhilwara District. The study area is located towards southwest of Bhilwara town, between the latitude $26^{\circ}18'$ - $26^{\circ}20'$ N and longitude $74^{\circ}31'$ – $74^{\circ}33'$ E having an area of about 24 sq. Km. The map of the target area along with grid range marked by selected locations used for surveying during first field work is shown in figure 1.

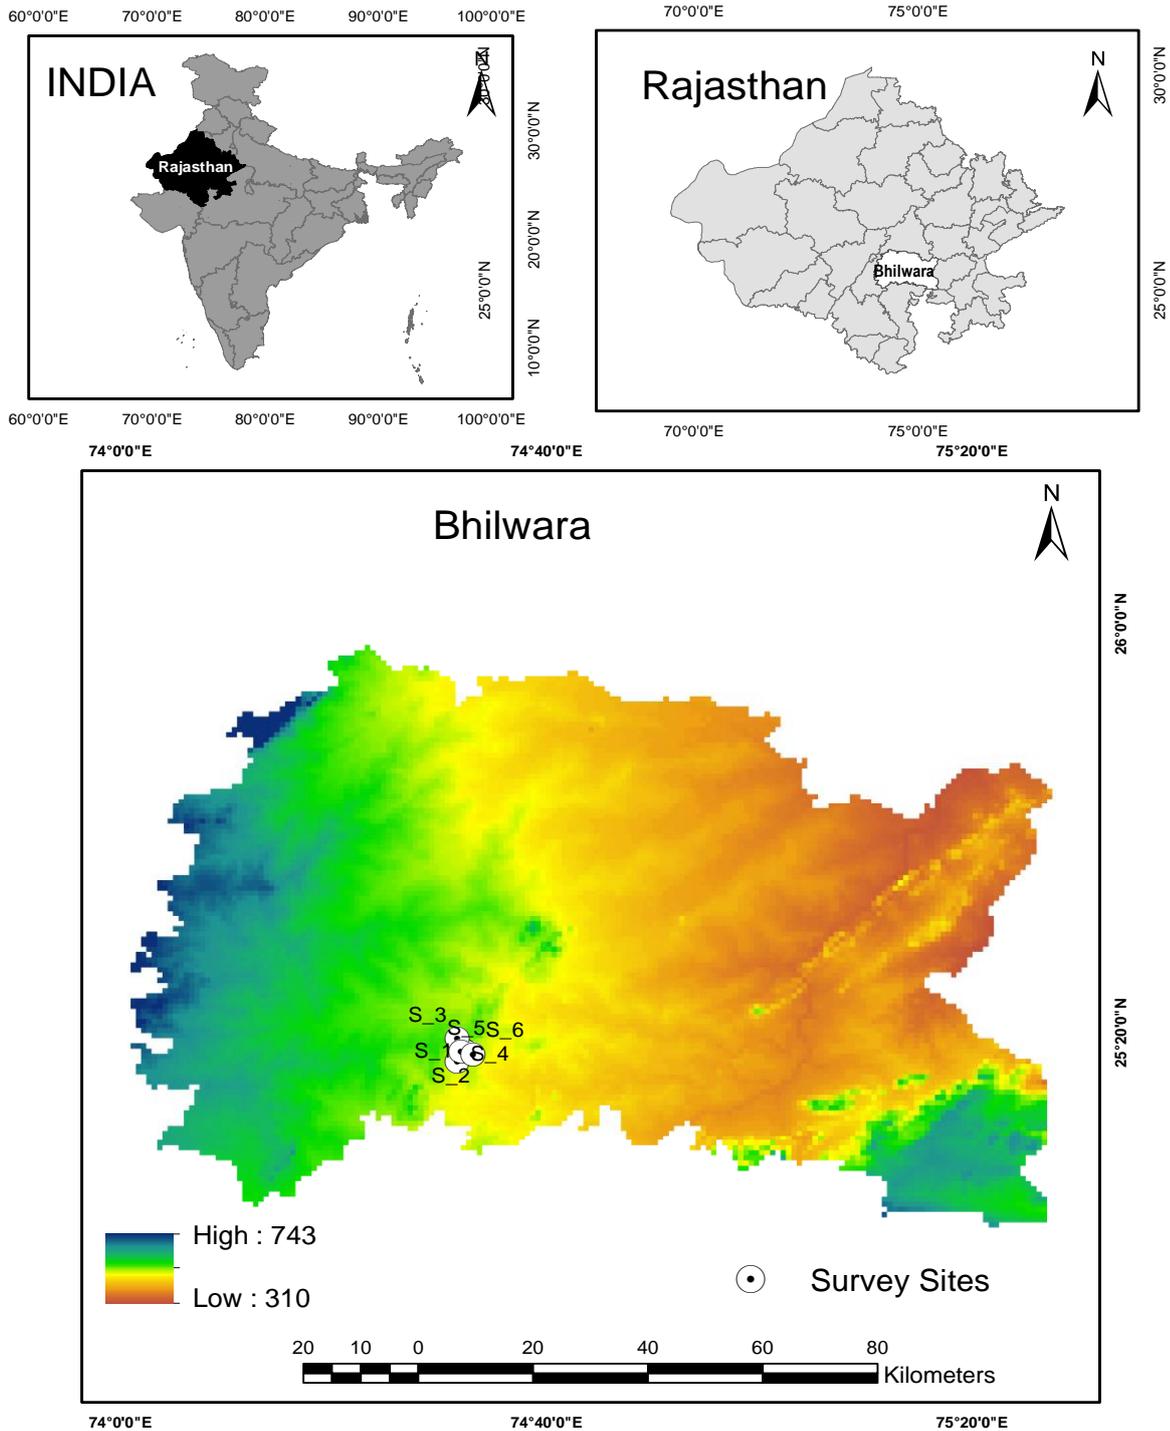
Figure 2: Digital elevation map (DEM) of the Bhilwara District showing surface elevation in meters with mark for survey sites correspond to first field visit.

The Digital Elevation Model (DEM) of the Bhilwara District showing the anomaly in surface elevation along with mark for the initial survey sites is shown in figure 2.
